# Welcome Center Program Update

**January 2014**

## Wiley|Wilson Welcome Center Assessment:

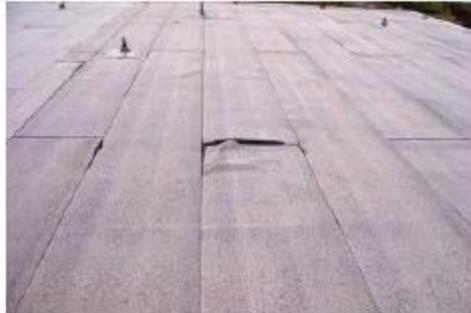
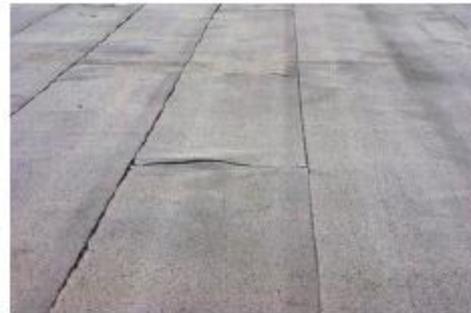
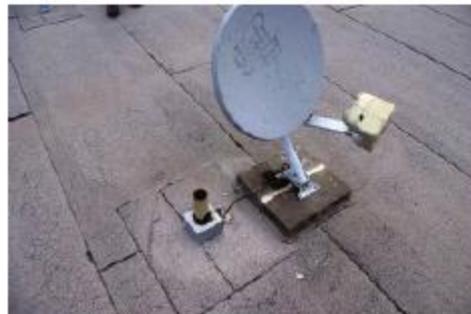
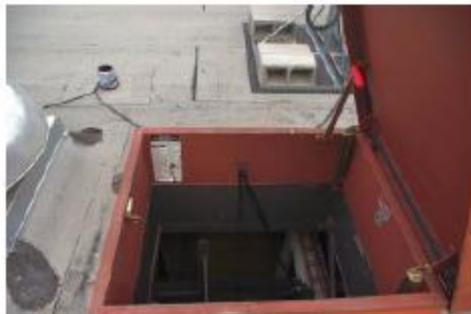
1. The low slope portion of the roof system appears to be a multiply asphalt system with a modified bitumen granular cap sheet. There were noticeable bubbles and raised areas in the roof indicating moisture under the roof membrane. It is beyond the end of its life cycle. It is recommended that this system be removed and replaced with a new fully adhered membrane roof. It is also recommended that the roof hatch be replaced at the same time.

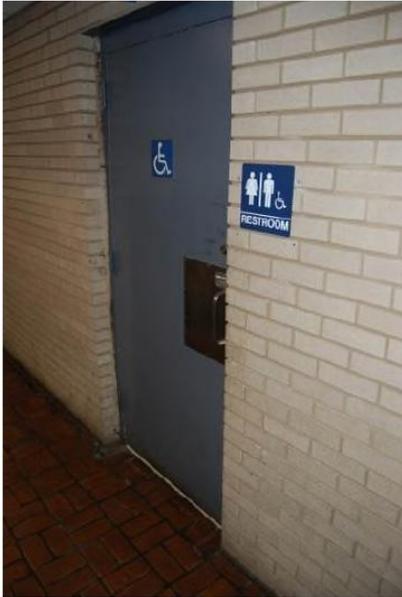
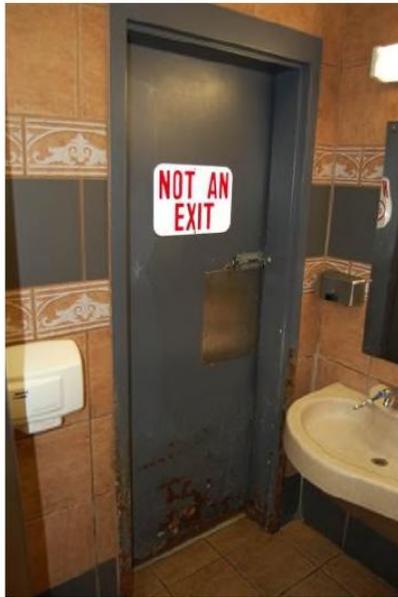
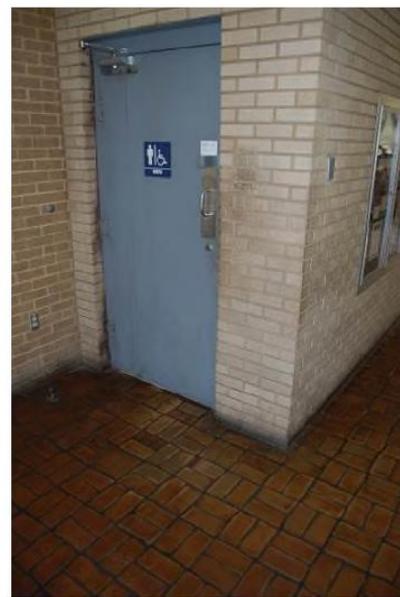
6. Several interior hollow metal service doors and frames were corroded or damaged. It is recommended that they be replaced along with correct and appropriate hardware.

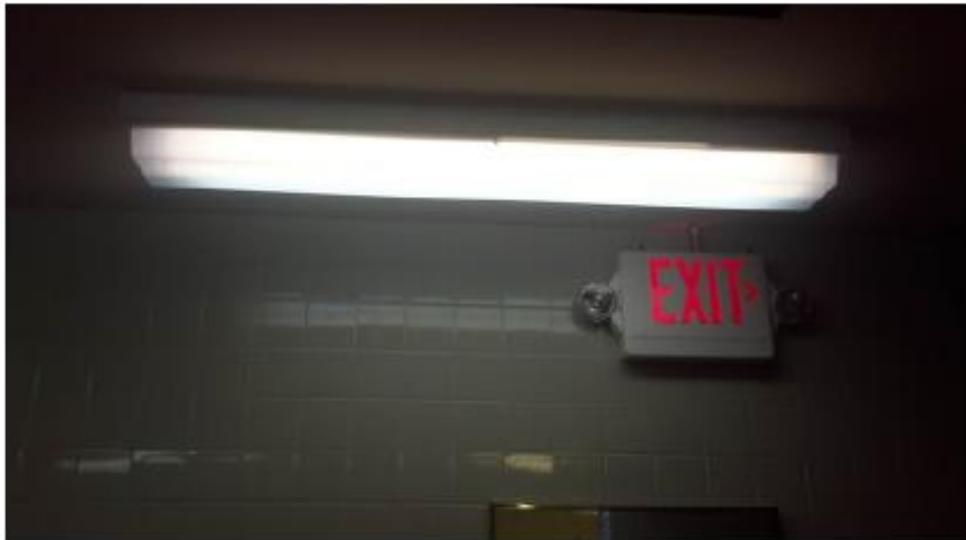
DOT-74 State Welcome Centers Assessments  
Columbus – Muscogee County  
Page 15

6. The restroom lighting is providing a foot candela level of 15fc, and the lens is yellowish from age. The existing interior lighting system is providing 7-12fc during mid-day, a complete lighting system upgrade is recommended for the entire facility, to provide light levels per IES standards.

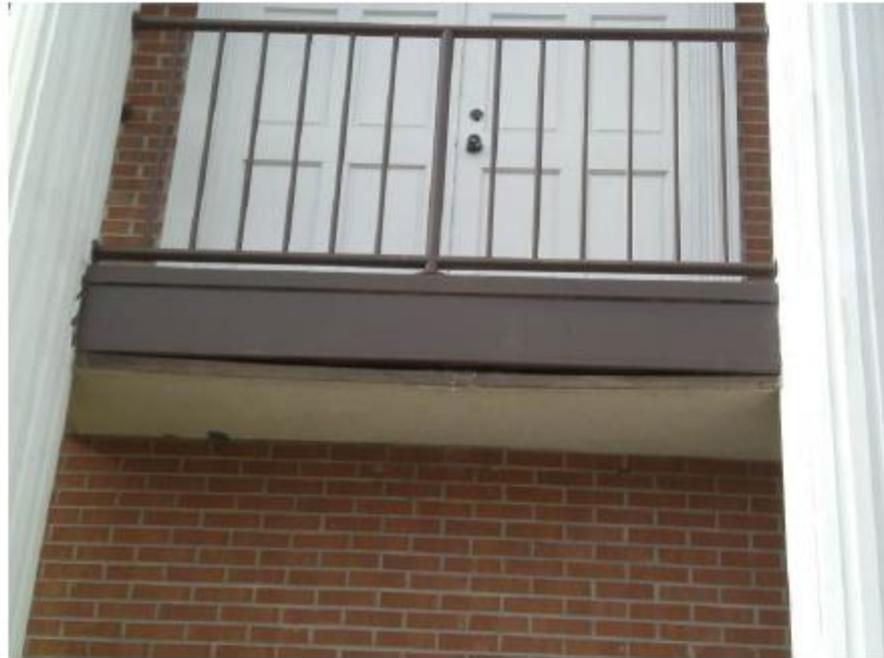
DOT-74 State Welcome Centers Assessments  
Lake Park - Lowndes County  
Page 10

11. There is a significant sag in the soffit under the balcony of the main building. This should be repaired or replaced since water is most likely intruding into the gap.

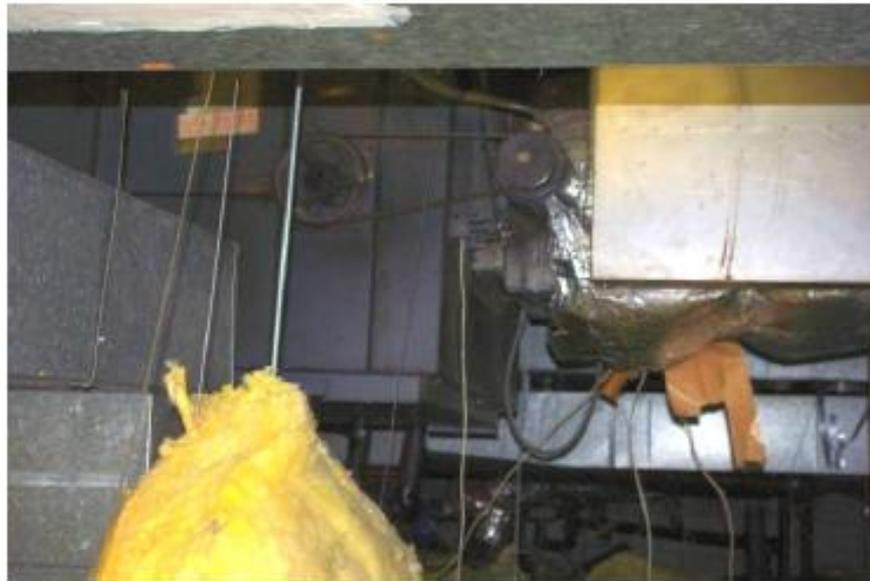
3. The two indoor air handling units are located above the ceiling of the mechanical/electrical room. Access for service is nearly impossible. The fan is externally belt driven and the OSHA required belt guard is missing. Both air units appear to be the original equipment.
