Evaluation of Performance and Maximum Length of Continuous Decks in Bridges – Part 2

Office of Materials and Research Georgia Department of Transportation

GDOT Research Project No. 10-29 Task Order No. 02-81

August 2012

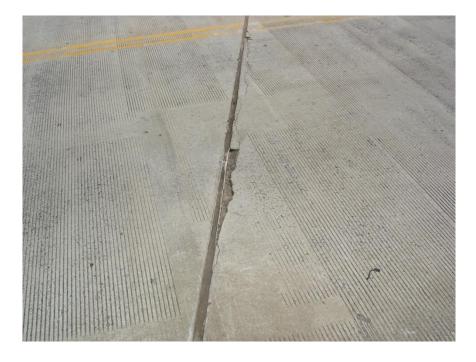
Figure 1.4.2: Construction joint in field with damage (Structure ID: 067-5186-0)

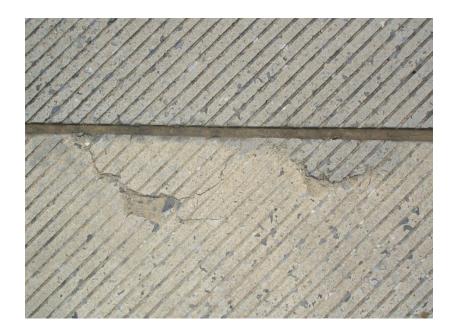
It can be observed that bent 2, where some cracking occurred, had fixed rather than expansion bearings on each side of the link slab. Figure 3.3.5 is a photo of the cracking adjacent to the construction joint at bent 2; Figure 3.3.6 is a photo of plant growth in the expansion joint at bent 1.

Figure 3.3.5: Cracking at bent 2 of Silver Comet Trail bridge (COB1)

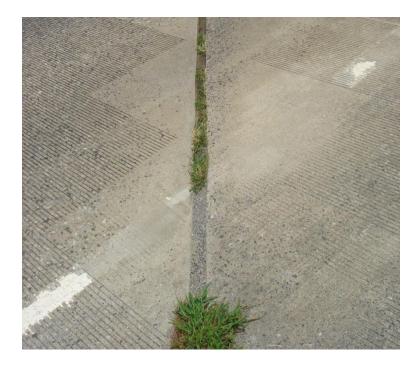
Figure 3.3.6: Plant growth at bent 1 of Silver Comet Trail bridge (COB1)

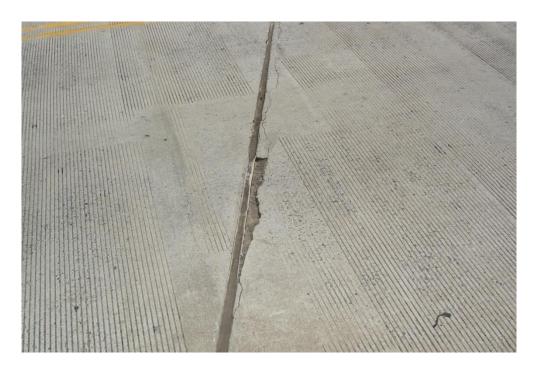
This bridge had a deck condition rating of 7, which might be considered somewhat high due to the spalling at bents 2 and 3 and the widened expansion joint at bent 4. Photos of the damage at these locations are provided in Figures 3.3.9 and 3.3.10.

Figure 3.3.9: Spalling on bent 2 of Silver Comet Trail bridge (COB2)

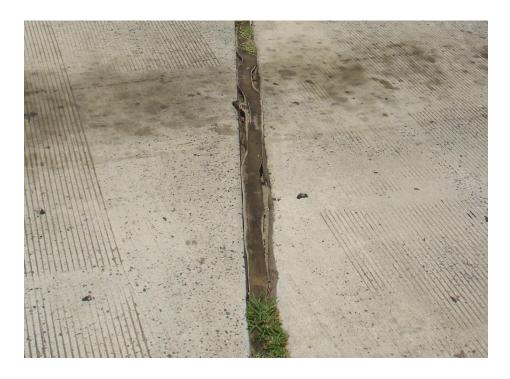
Figure 3.3.10: Evazote joint (3.5"-4.5") at bent 4 of Silver Comet Trail bridge (COB2)

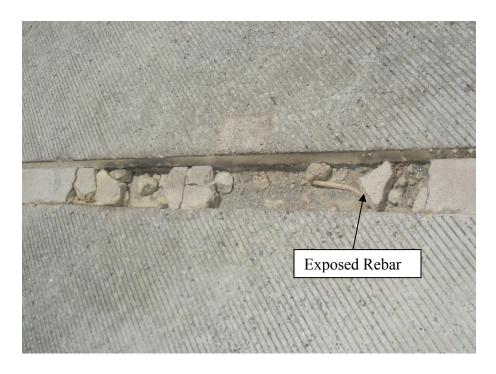
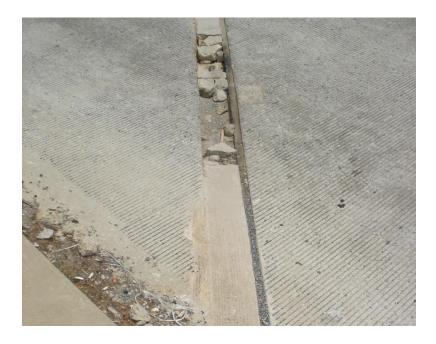
The condition of this bridge deck was the worst of the decks examined during the study. There were 6.25" wide patches of new concrete in the deck adjacent to the construction joints over bents 2 and 3 with cracks perpendicular to the joints along their lengths. A 4'-11" piece of the patch in the deck over bent 3 was spalled off to the point where rebar was exposed. The orientation of the exposed reinforcement indicated that it was one of the bars in the edge beam that extends up into the deck. In addition, there were diagonal cracks at the corners of the deck at bents 1 and 4 due to the skew, and the expansion joint at bent 1 was 3 inches wide but in good condition and the joint filler was still attached to the concrete. Photos of the exposed reinforcement are shown in Figures 3.3.13 and 3.3.14.

The extensive damage at the above construction joint was most likely due to the following: the corners of the joint seemed to be squared off instead of rounded as the Georgia detail (Figure 1.3.4) specifies. This led to spalling of the concrete at the edge of the joint due to impact from vehicle tires. The patch repair then failed due to shrinkage of the repair material.

Figure 3.3.13: Exposed rebar in patch over bent 3 on Silver Comet Trail bridge (COB3)

Figure 3.3.14: Exposed rebar in patch over bent 3 on Silver Comet Trail bridge (COB3)

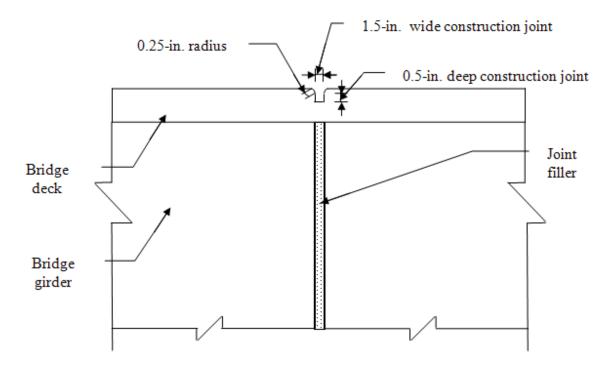
Overall, cracking at the intermediate bents was observed in two of the five bridges, with the Silver Comet Trail bridge, Structure ID #067-5208-0, Cobb County, having the cracking at these bents concentrated within the concrete patches. Cracking that occurred at construction joints seemed to be primarily due to improper forming of the joints. The joints were squared off instead of being rounded as shown in Figure 3.3.15.

Figure 3.3.15: Detail of construction joint

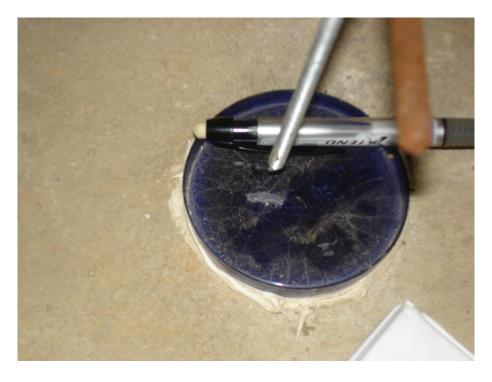
Figure 4.1.3: Wax plate after a year in the field
