COOK COUNTY AIRPORT

PAVEMENT EVALUATION REPORT

JULY 2002

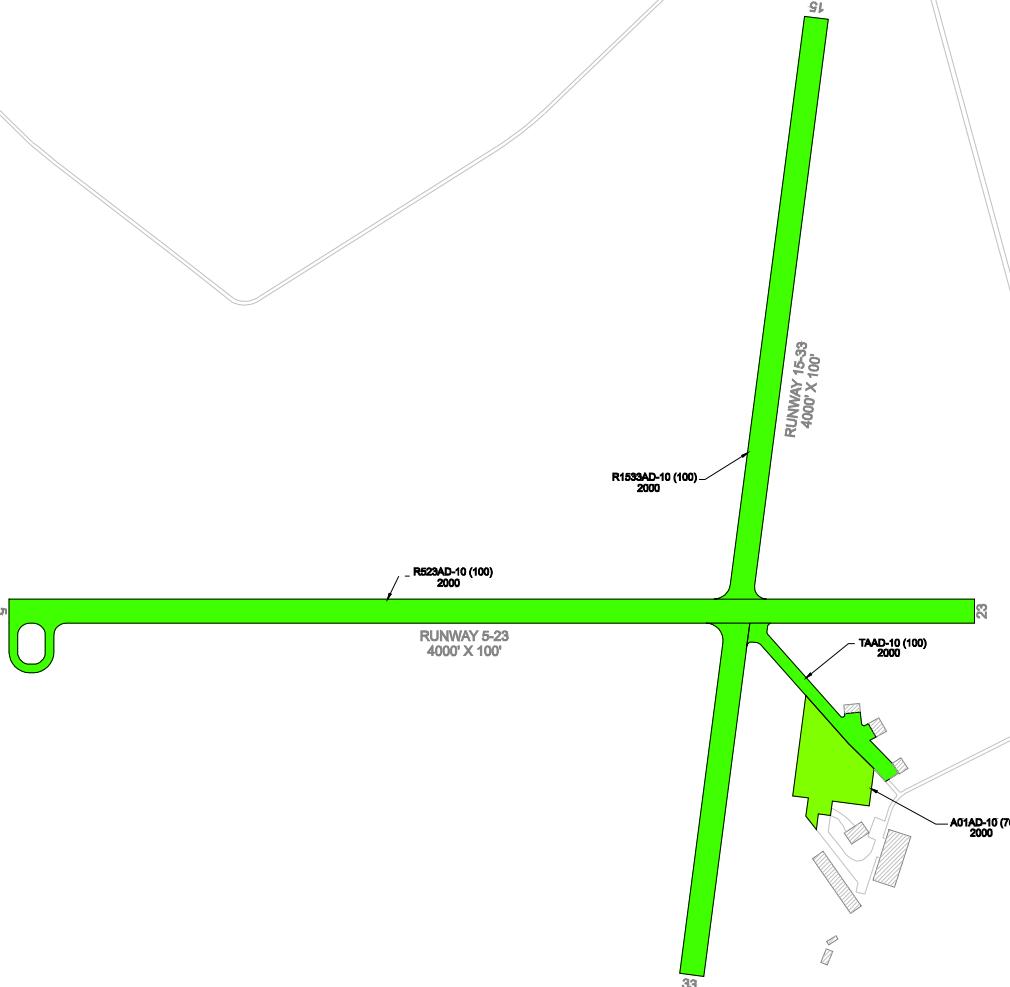
Figure 8. INSERT PCR MAP
(11 x 17)

The 2001 area-weighted condition of Cook County Airport is 98, with conditions ranging from 76 to 100 [on a scale of 0 (failed) to 100 (excellent)]. Figures 6 and 7 provide graphs summarizing the overall condition of the pavements at Cook County Airport. Figure 8 is a map that displays the condition of the pavements evaluated. Table 1 summarizes the results of the pavement evaluation.

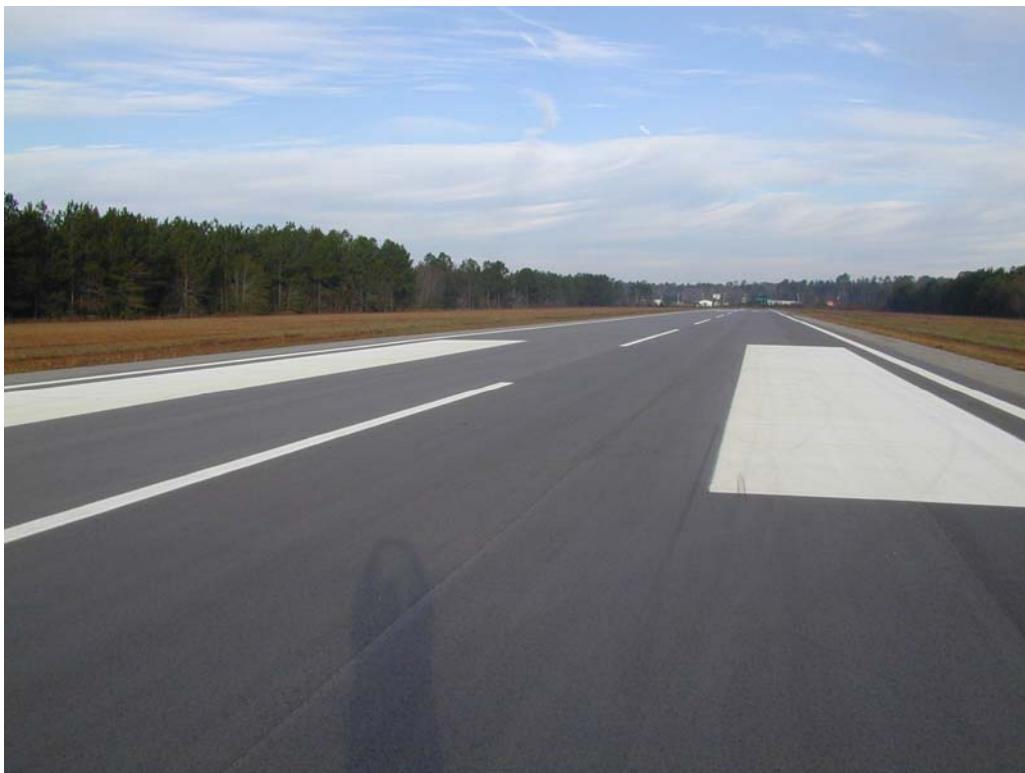
The inspection of Cook County Airport was completed on December 19th, 2001. Four sections were defined during the inspection. With the exception of the apron, all other pavements on the airport were recently rehabilitated and free of any distress.

Runway 15-33 overview.

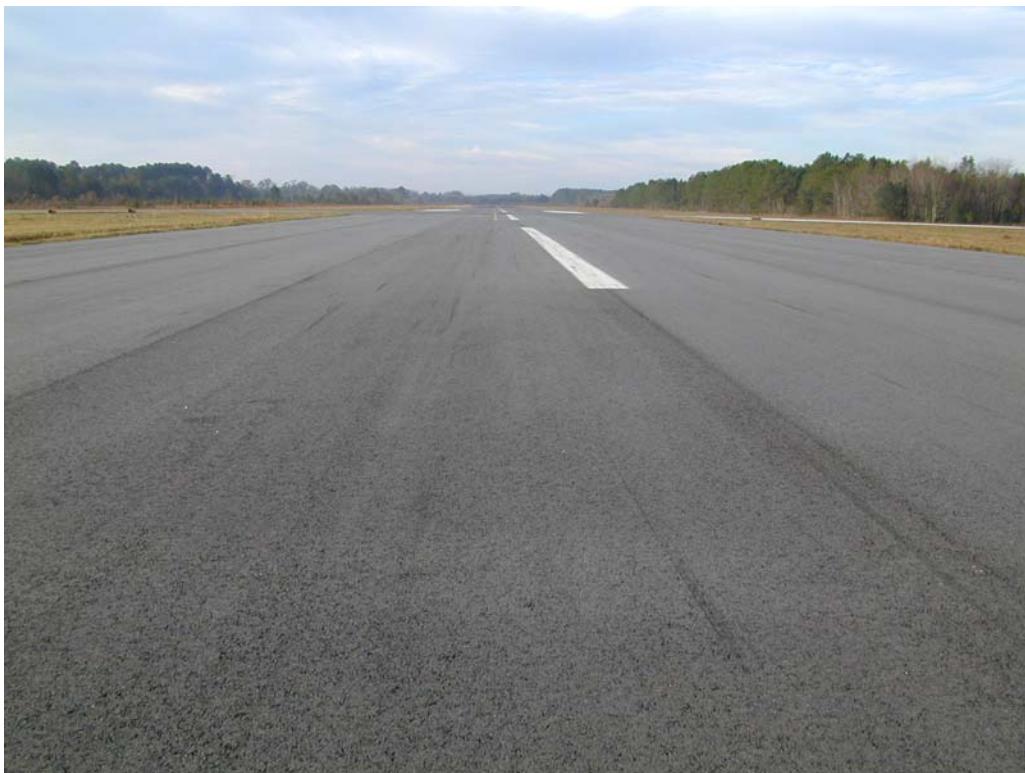
Runway 5-23 overview.

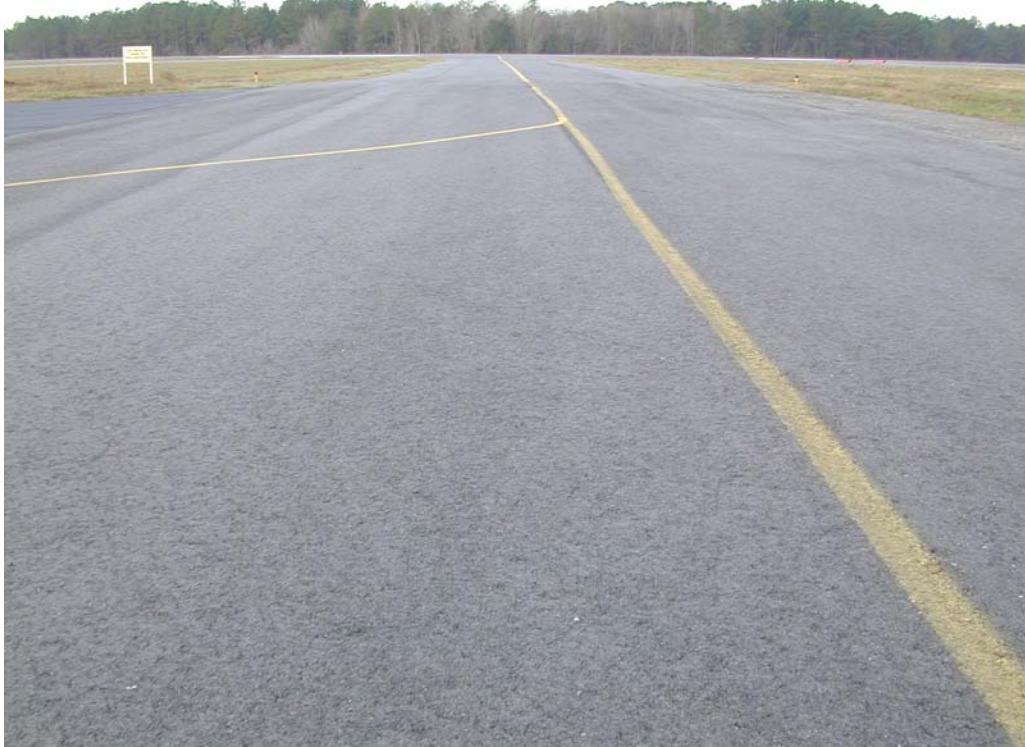
Taxiway A overview.

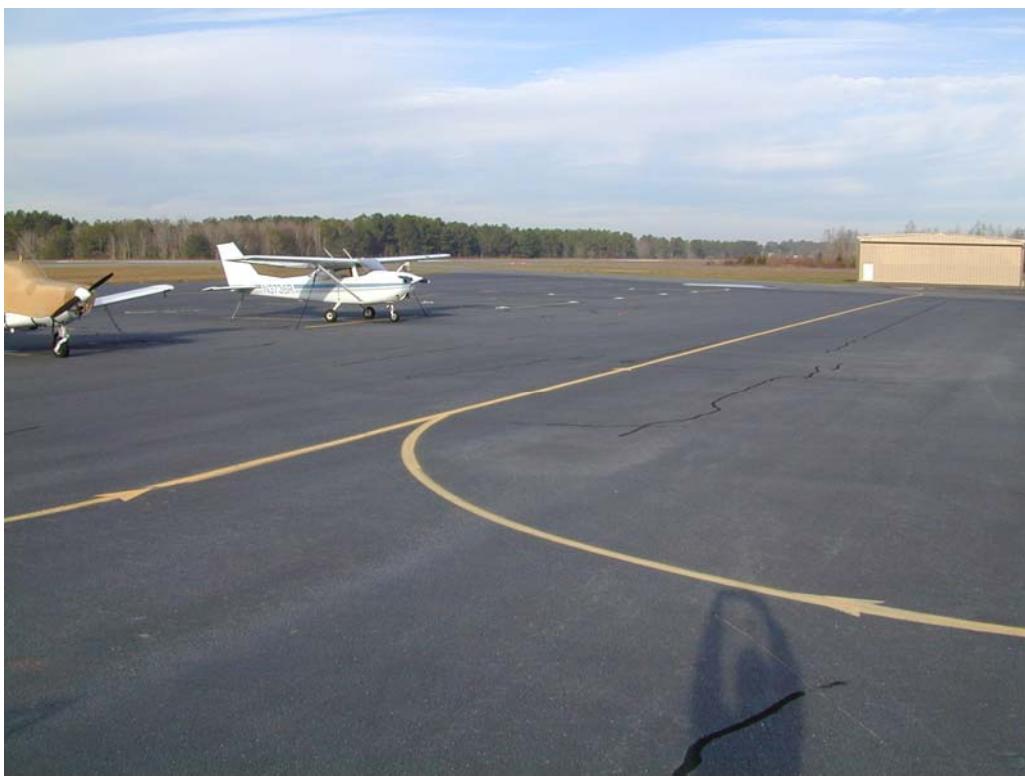
The apron is in good condition with only significant amounts of low and medium-severity longitudinal and transverse (L&T) cracking being observed. The majority of the low-severity cracking was sealed at the time of inspection.

Apron 01 overview.

Branch ¹	Section	Year	Type of Repair ²	Estimated Cost ³
A01AD	10	2006	Preventive	\$12,419
