BEN EPPS FIELD

PAVEMENT EVALUATION REPORT

JULY 2002

Prepared By:

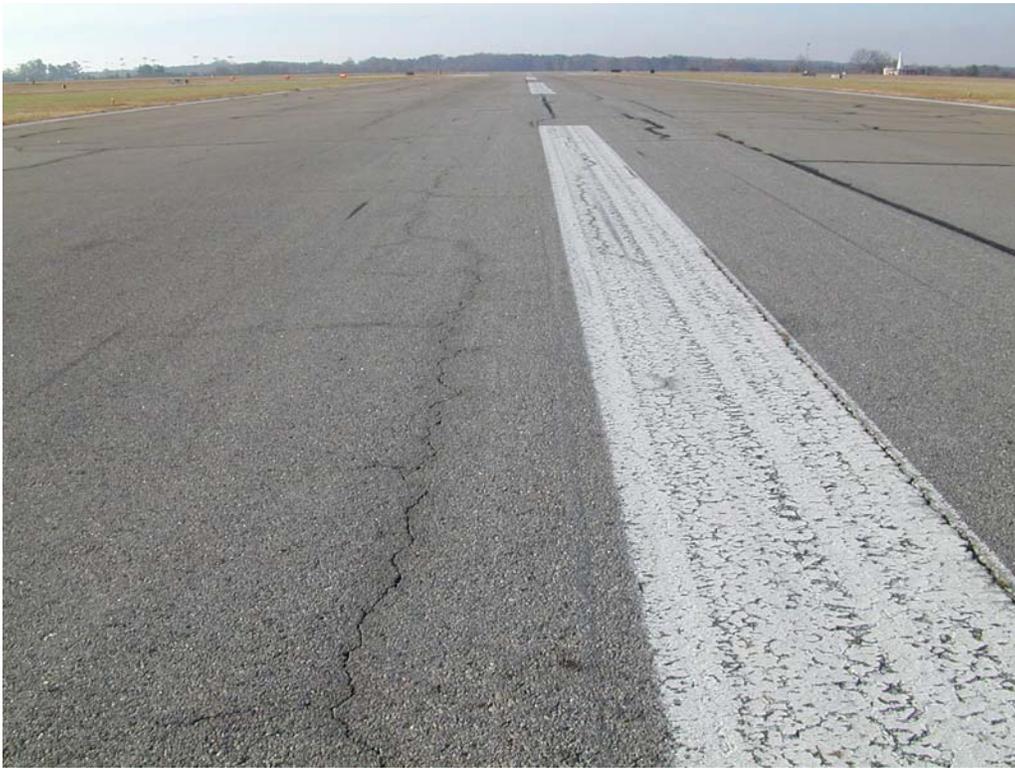
Runway 2-20 was divided into three sections. RW220AT-10 comprises the pavement north of Runway 9-27. Significant amounts of low and medium-severity L&T cracking were observed throughout the section. Crack sealant that had failed and that was allowing moisture to penetrate into the pavements underlying layers accounted for the majority of L&T cracking that was observed at medium-severity. An area near the intersection of Taxiway A contained a large area of patching. This pavement is in better condition and has distresses that are atypical of those observed throughout the rest of the section which require it to be identified as an additional sample unit.

Overview of section R220AT-10.

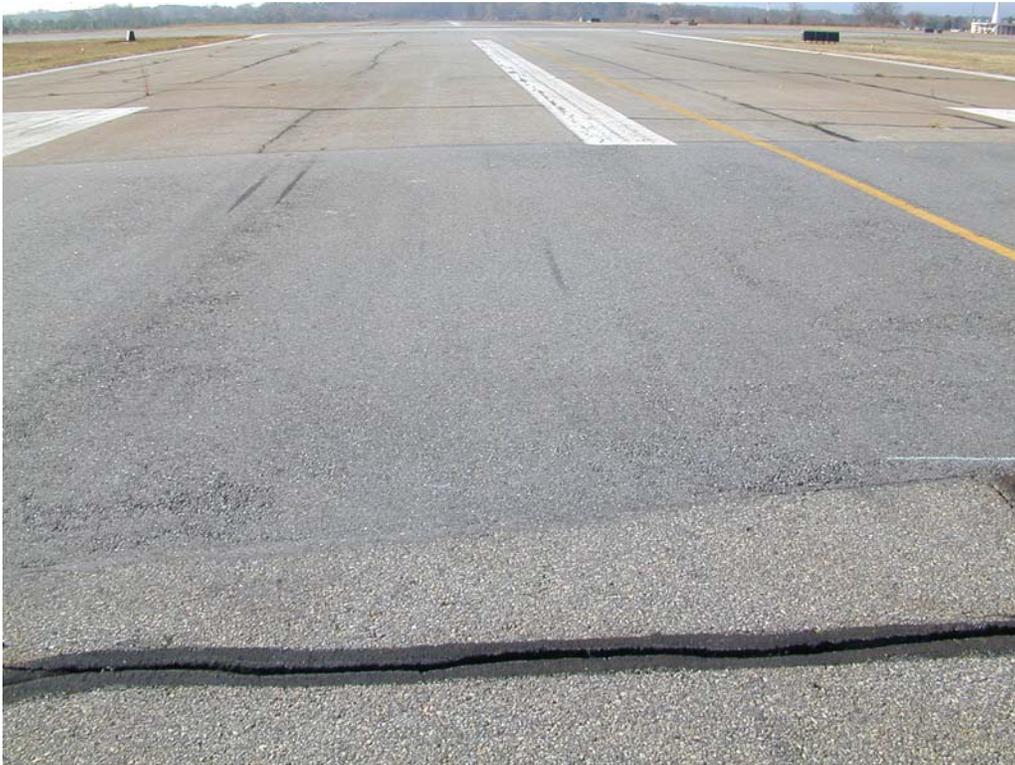
Overview of an additional sample unit in section R220AT-10.

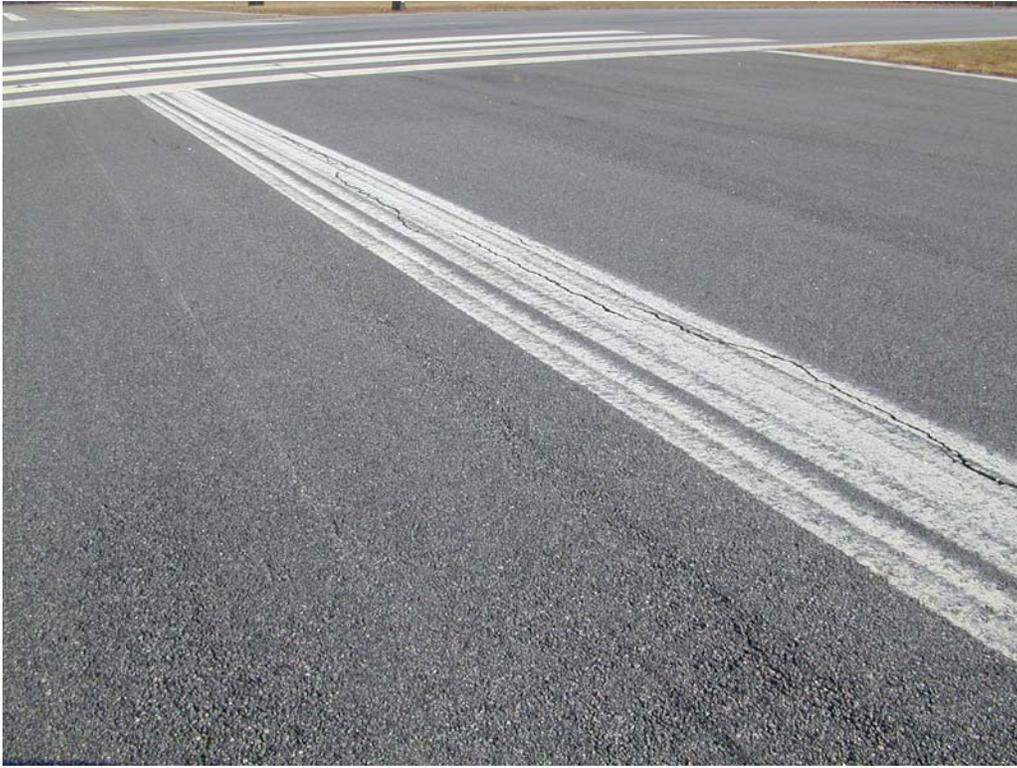
RW220AT-20 consisted of newer pavement on either side of Runway 9-27. Moderate amounts of low-severity L&T cracking were observed throughout the section. Lesser amounts of medium-severity L&T cracking were also observed.

Overview of section R220AT-20.

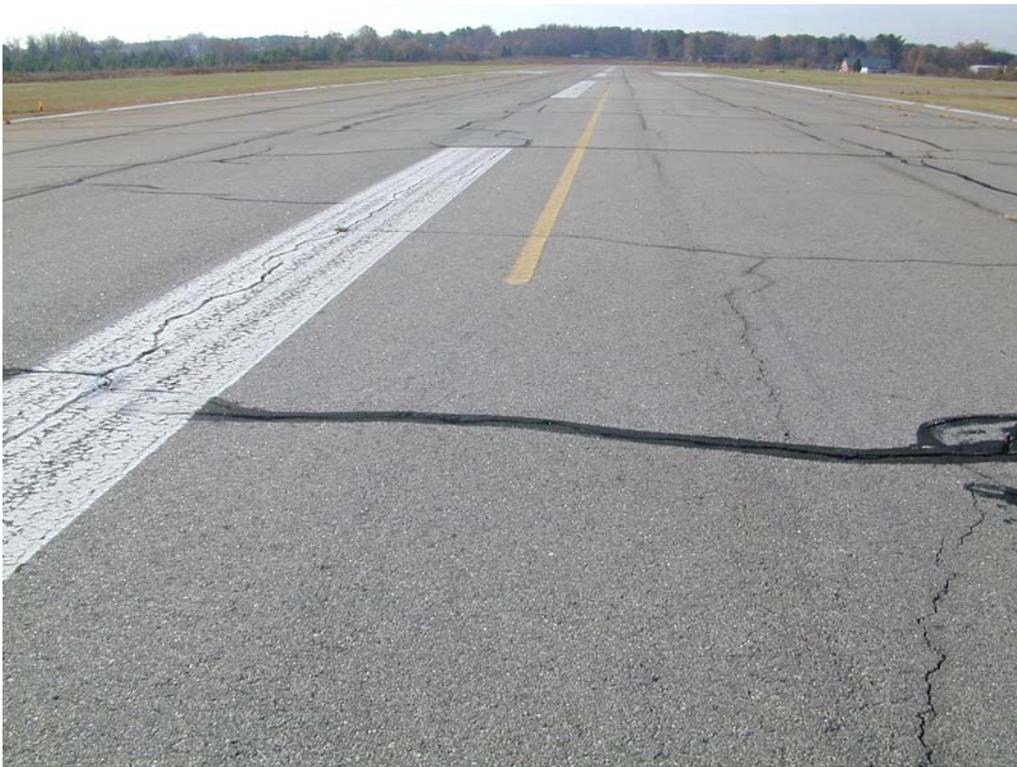
RW220AT-30 is in fair condition with large amounts of low and medium severity L&T cracking being observed. Failed joint sealant accounted for nearly all of the medium-severity L&T cracking.

Overview of section R220AT-30.

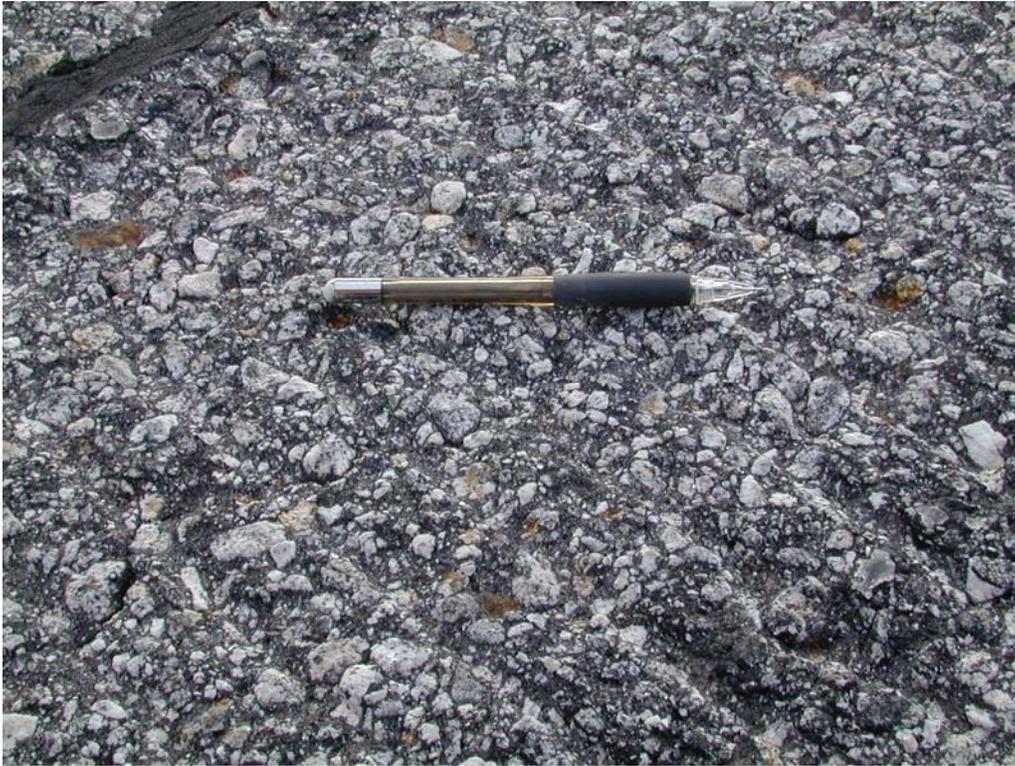
Two sections were defined in Runway 9-27. R927AT-10 consisted of the pavement west of Runway 2-20 and was the largest section of the two. Moderate amounts of low-severity longitudinal and transverse (L&T) cracking, both sealed and unsealed, were observed in the

section. In addition, some medium-severity L&T cracking was found. Raveling and weathering was recorded throughout the section where abrasive methods were used to remove old paint and portions of the surface affected.

Raveling and weathering in section R927AT-10.

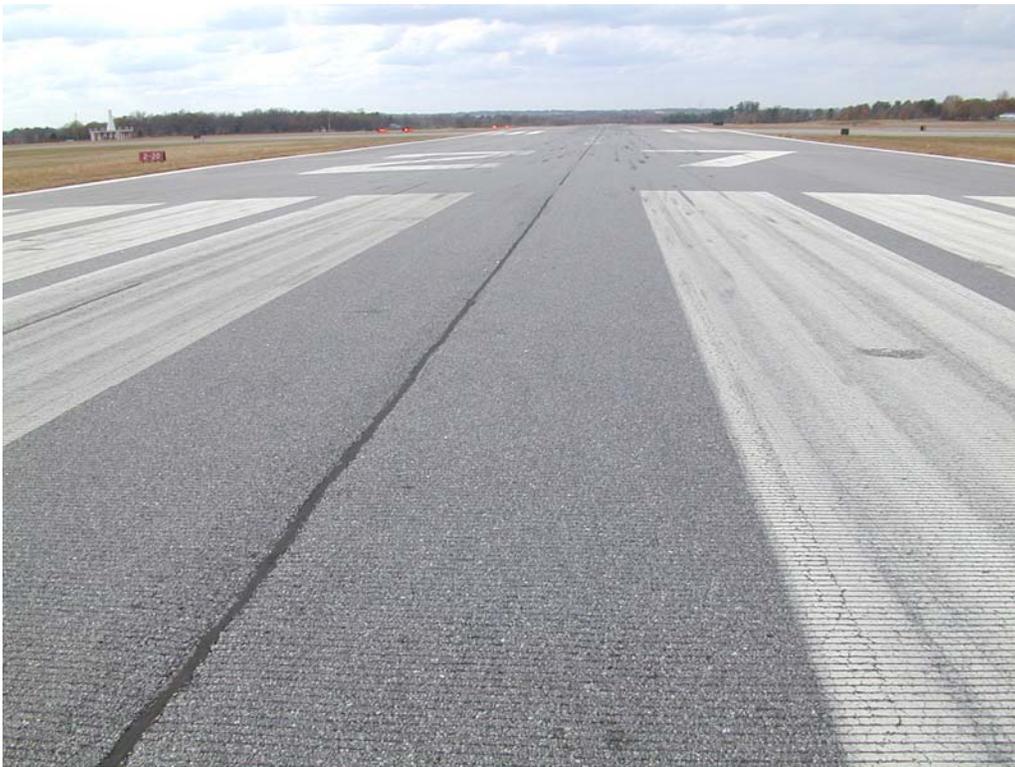
R927AT-20 is in similar condition to R927AT-10 with lesser amounts on L&T cracking being observed. Occasional small amounts of medium-severity L&T cracking were also found to exist. A small area of jet blast erosion was observed near the departure end of Runway 27.

Overview of section R927AT-20.

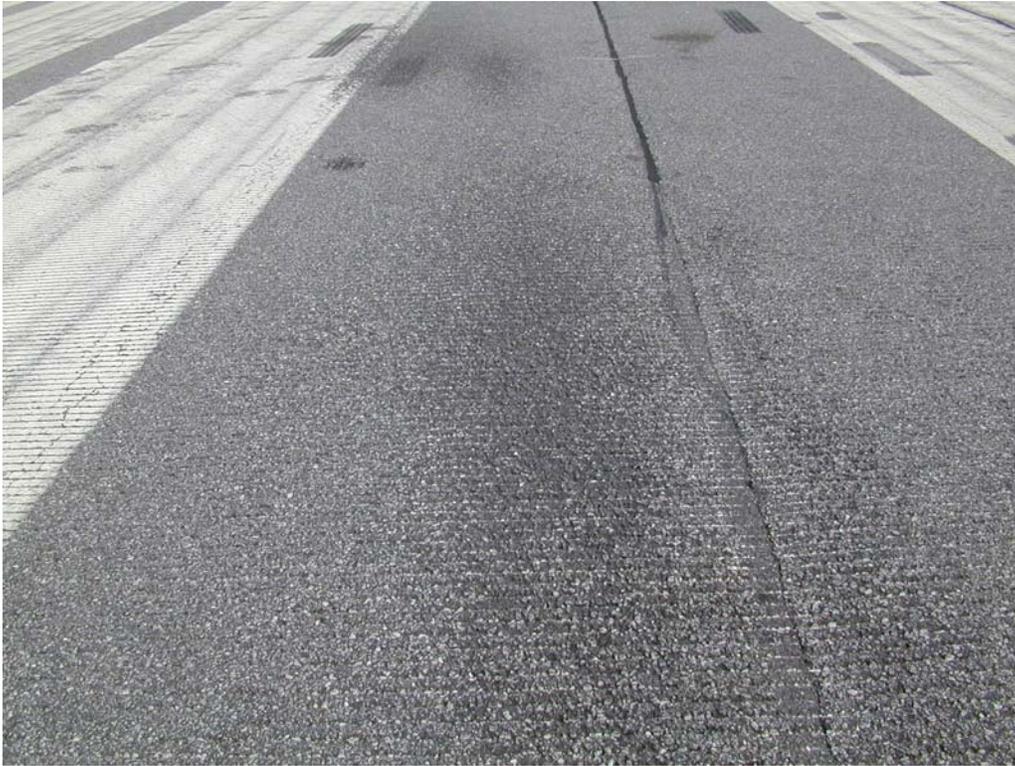
Jet blast erosion in section R927AT-20.

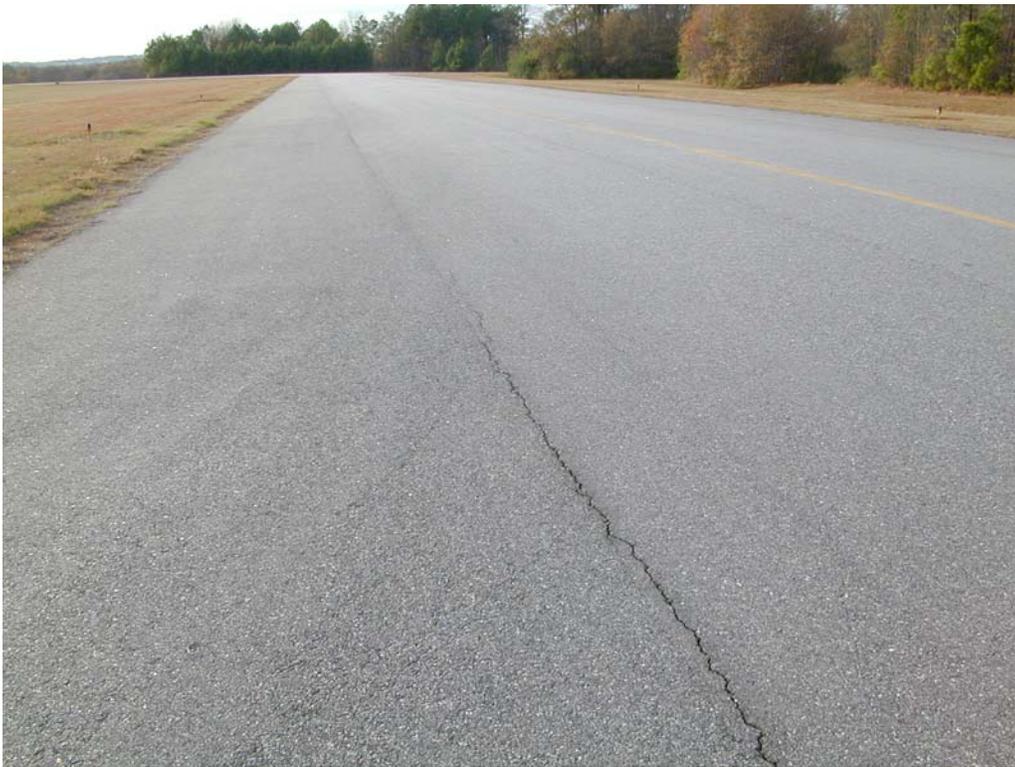
Taxiway A is divided into four sections. TAAT-10 is in good condition with only moderate amounts of low-severity L&T cracking being observed.

Overview of section TAAT-10.

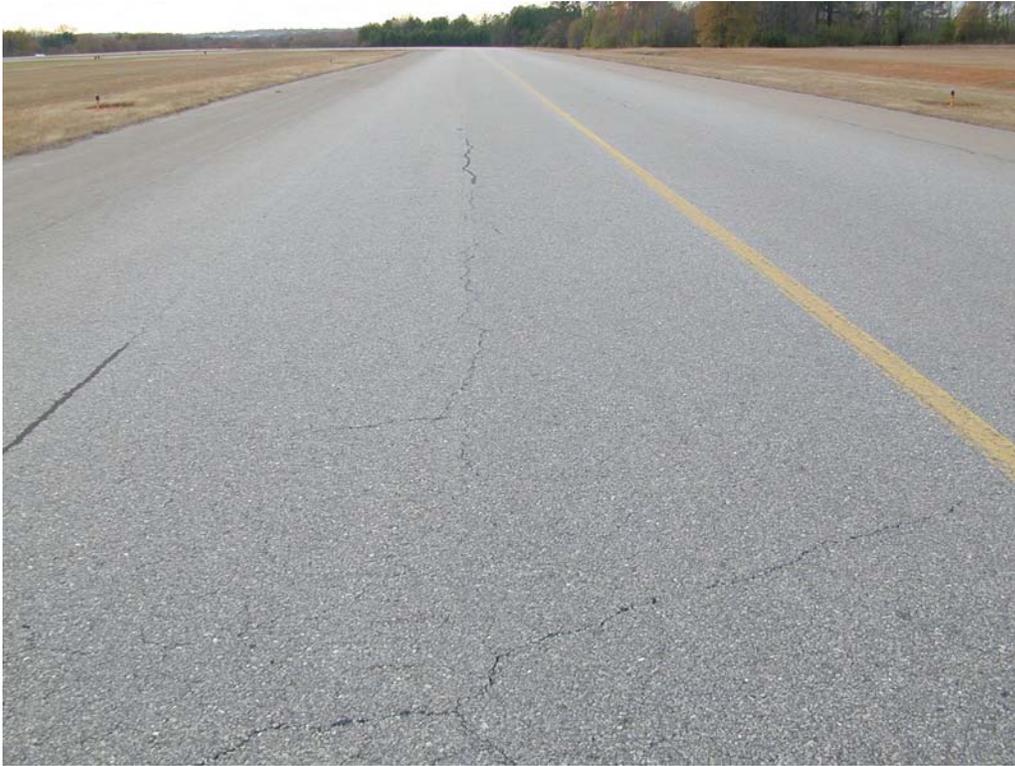
Significant amounts of low-severity L&T cracking, both sealed and unsealed, were observed in TAAT-20. In addition to this cracking, large quantities of raveling and weathering were observed throughout the surface of the pavement. Isolated areas of alligator cracking were also observed throughout the section. Areas containing roller marks were identified during the inspection. The cracking associated with the roller marks is starting to form an interconnecting pattern which may be mistaken for alligator cracking in the future. Since these cracks only extend ¼ of an inch into the surface of the pavement they were noted as a blemish and not recorded as a distress.

Overview of section TAAT-20.

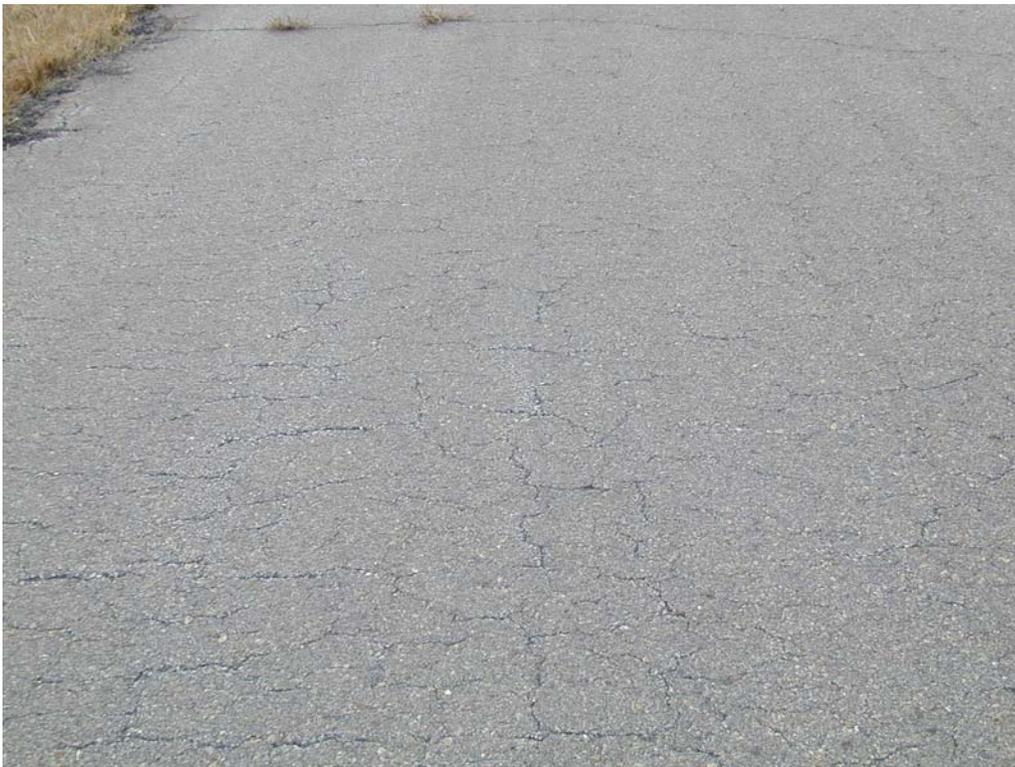
Roller marks in section TAAT-20.

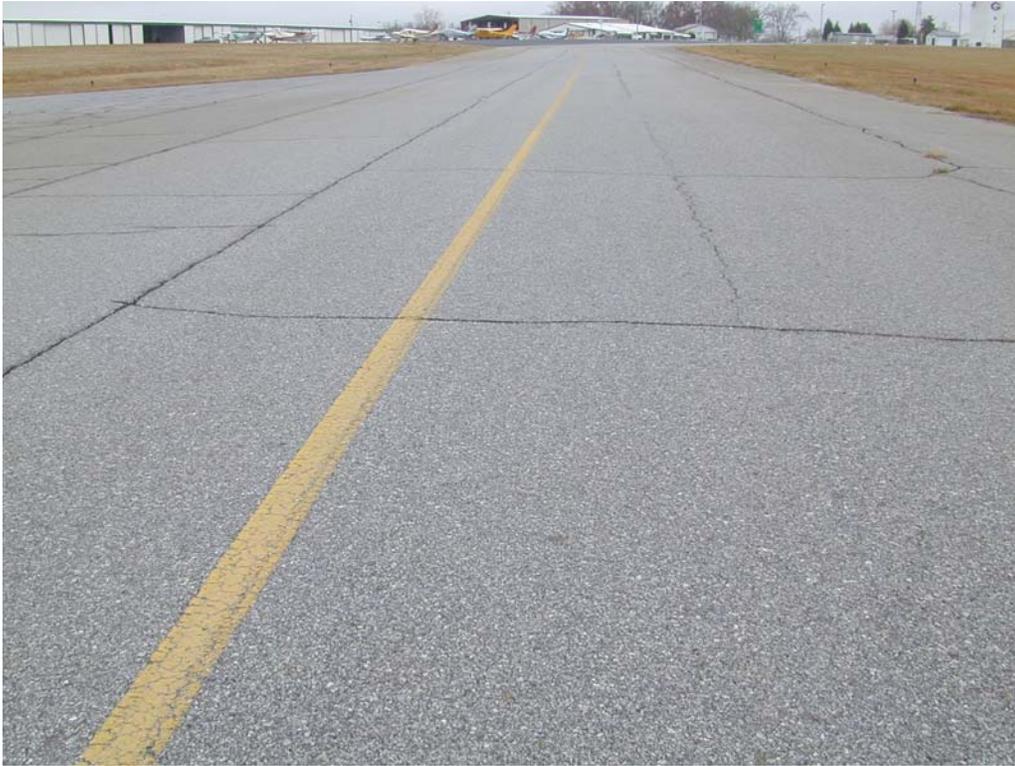
Low and medium-severity L&T cracking, low and medium-severity block cracking, alligator cracking and raveling and weathering were all observed in TAAT-30. With the exception of alligator cracking, the other distresses were present in large quantities. This section of Taxiway A is in the worst condition of the four.

Overview of section TAAT-30.

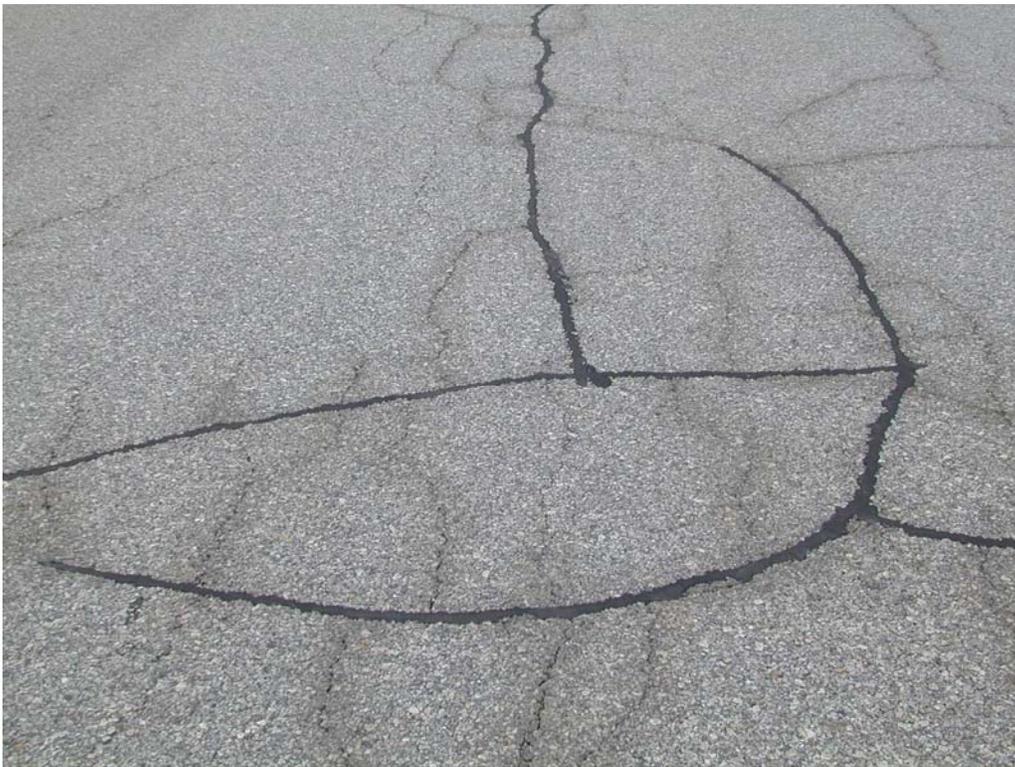
Alligator cracking in section TAAT-30.

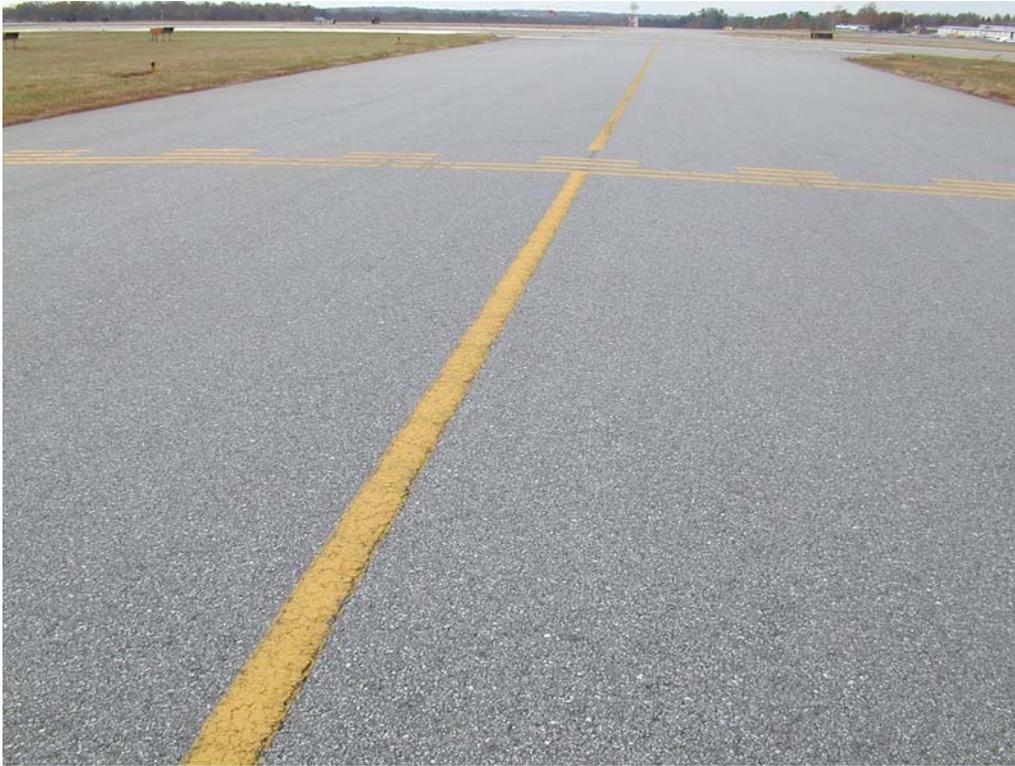
TAAT-40 is a newer pavement and is in excellent condition. Small amounts of low-severity L&T cracking were observed throughout the section.

Overview of section TAAT-40.

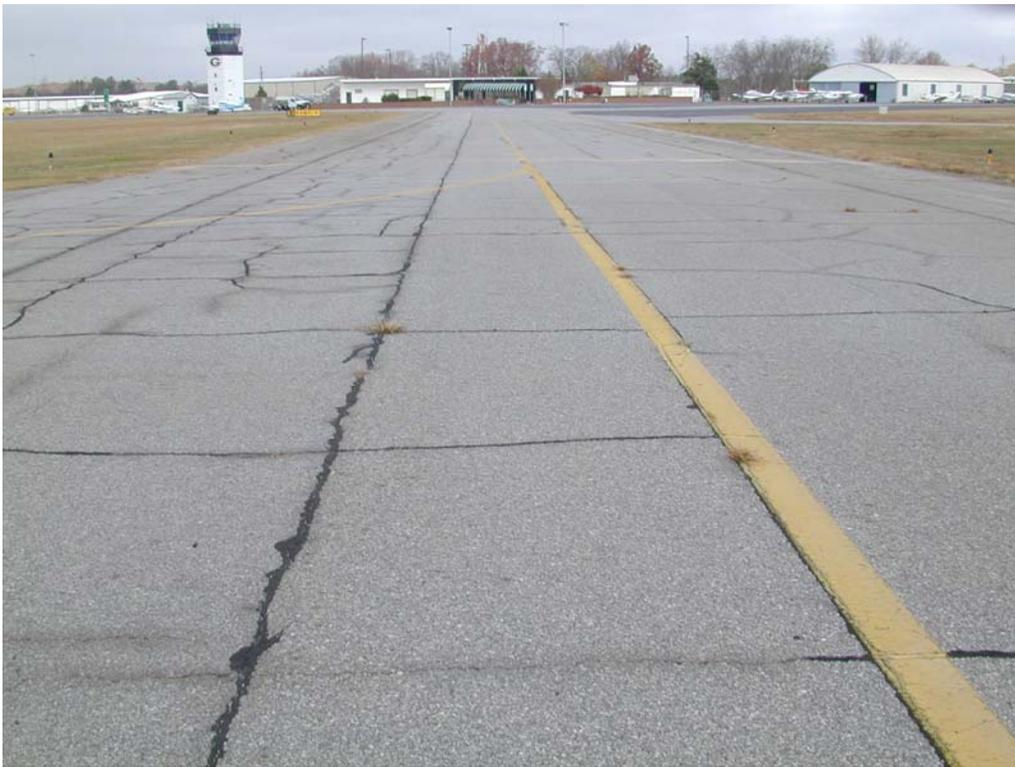
Two sections were defined in Taxiway B. The pavement north of Runway 9-27 comprised section TBAT-10. Large amounts of low-severity L&T and block cracking, both sealed and unsealed, were observed throughout the section. Some isolated amounts of medium-severity L&T cracking were also found. In addition to the cracking, large amounts of raveling and weathering were observed. In some instances, raveling and weathering was observed over the entire pavement surface. Similar to TAAT-30, roller marks were evident over the entire pavement surface and were not recorded as a distress.

Overview of section TBAT-10.

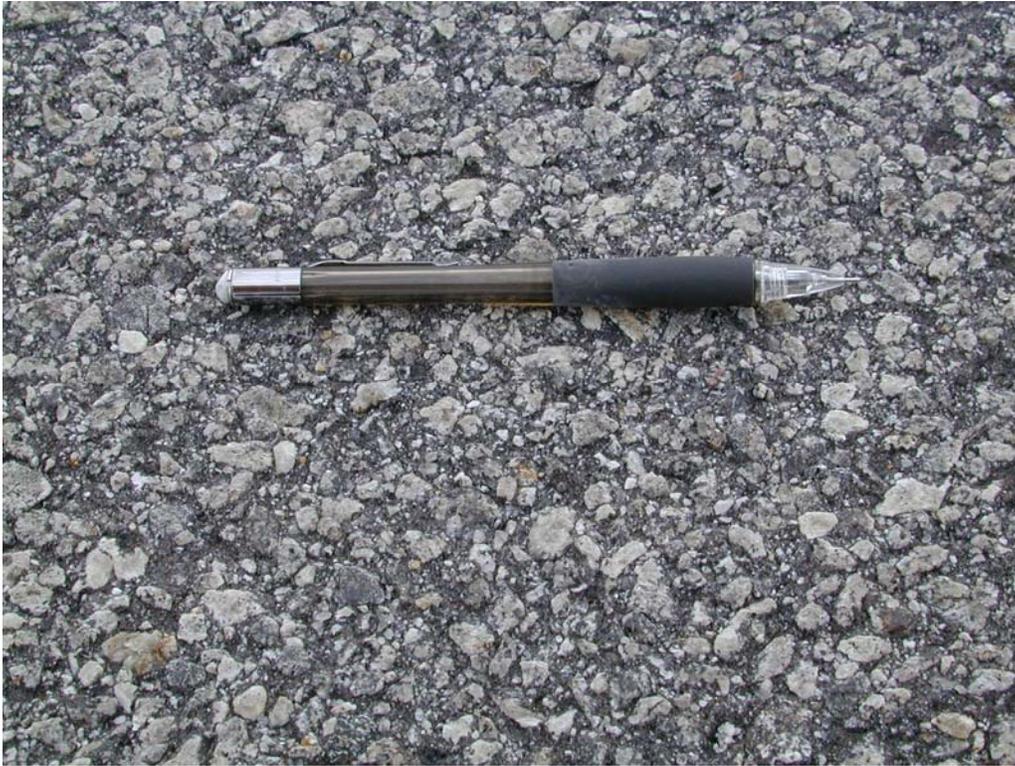
Raveling and weathering in section TBAT-10.

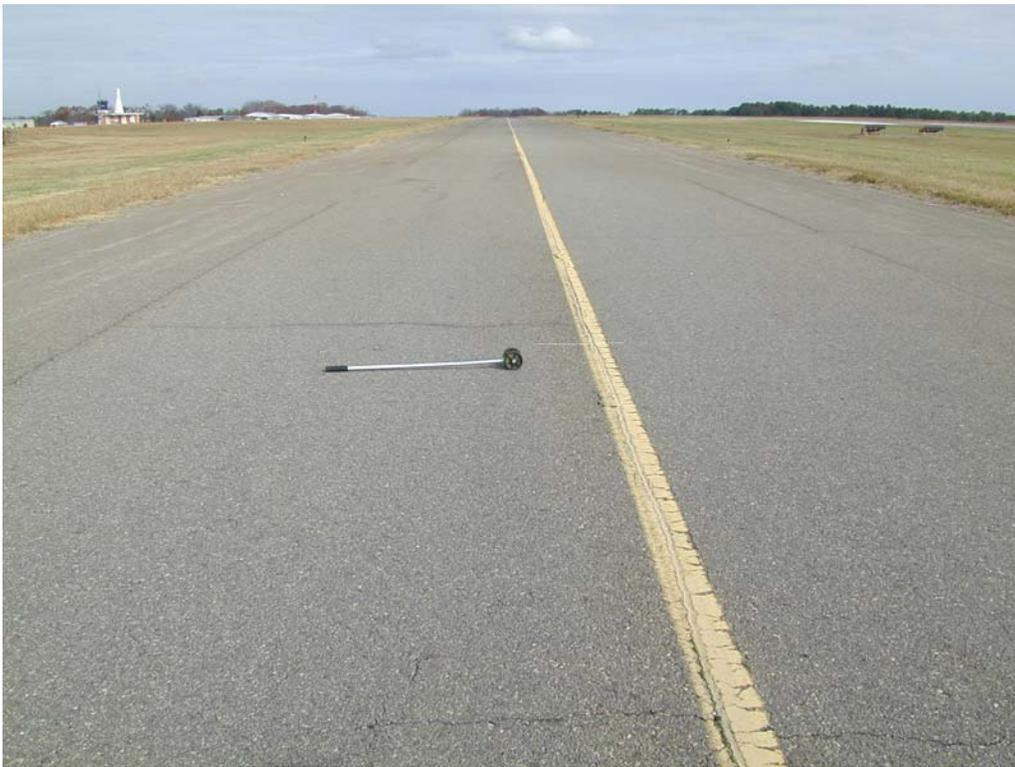
TBAT-20 is in better condition than TBAT-10 with moderate amounts of low-severity L&T cracking comprising the majority of the distress that was observed. Smaller amounts of medium-severity cracking and raveling and weathering were also found throughout the section.

Overview of section TBAT-20.

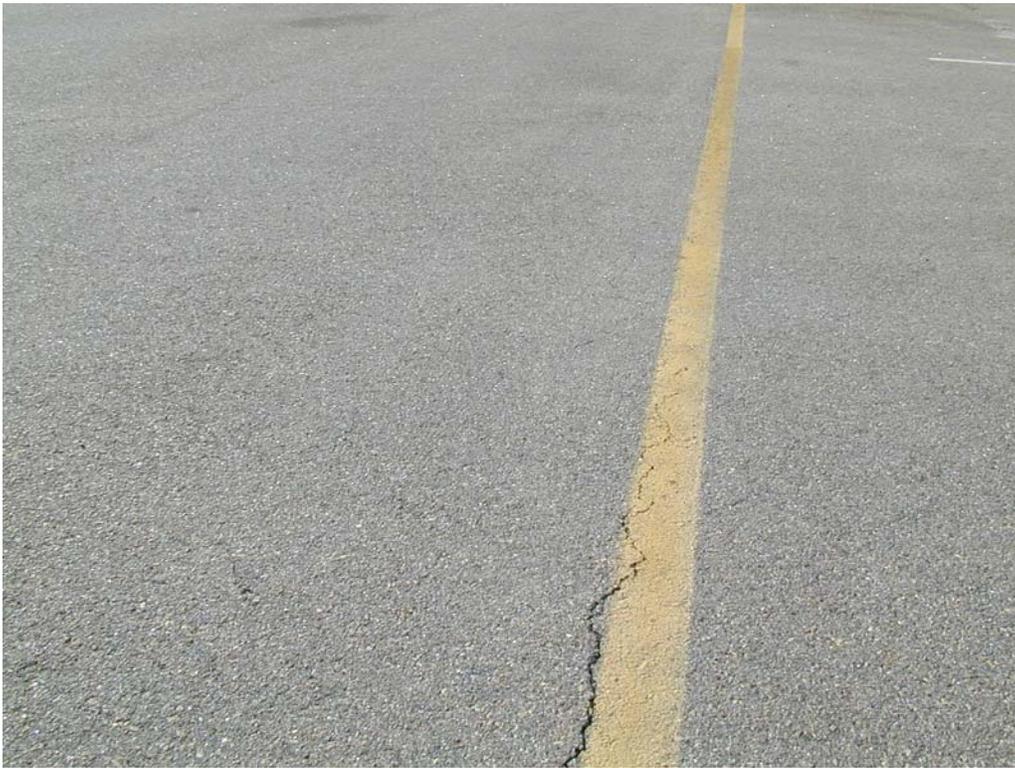
The apron at Athens was divided into three sections. A01AT-10 defines approximately the western ¼ of the apron area. Significant amounts of low and medium-severity L&T cracking were found throughout the section. Failed joint sealant accounted for most of the cracking that was recorded at medium-severity. Large amounts of raveling and weathering were also observed throughout the section. An isolated area containing significant amounts of alligator cracking was identified and inspected as an additional sample unit.

Overview of section A01AT-10.

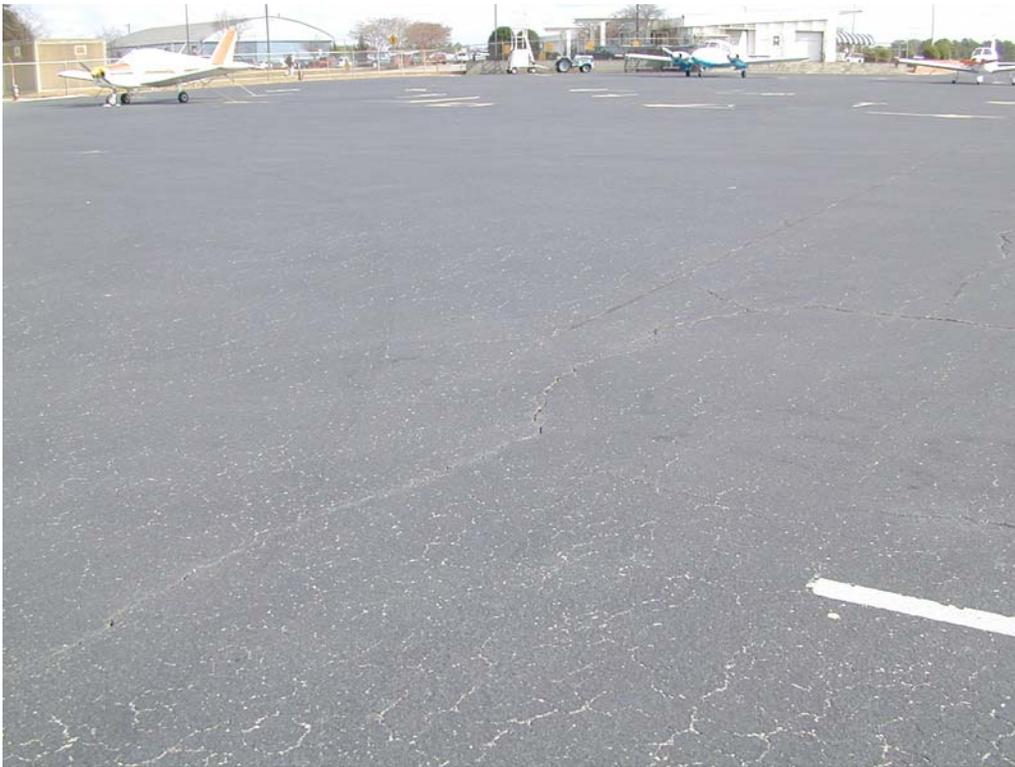
A01AT-20 is in better condition than A01AT-10. Significant amounts of low-severity L&T cracking were observed throughout the section. Some areas on the eastern portion of the section contained large amounts of low-severity block cracking. Isolated amounts of medium-severity L&T and block cracking were also observed. The pavement has had a surface treatment applied to it. In many areas thermal cracking in this surface treatment is beginning to resemble alligator cracking. This thermal cracking is only associated with the surface treatment and was not recorded as a distress.

Overview of section A01AT-20.

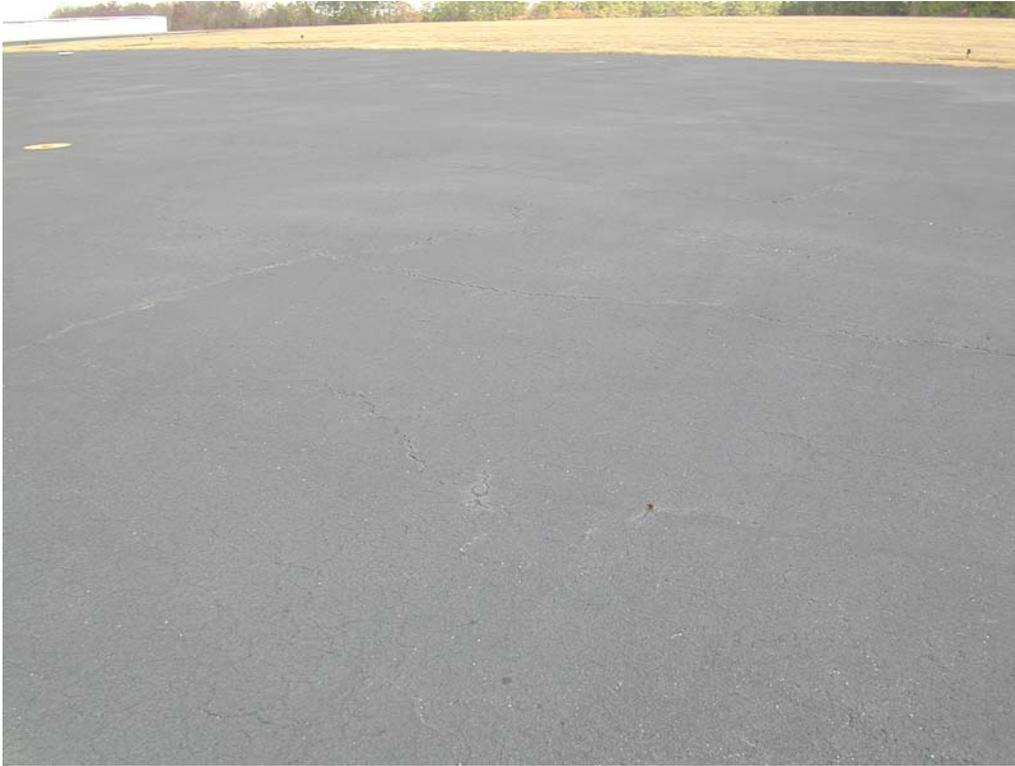
A01AT-30 is in similar condition to A01AT-20 with significant amounts of low-severity L&T cracking being observed throughout the section. Moderate amounts of medium-severity L&T cracking were also observed. A few isolated areas of swell, associated with the L&T cracking, were found in the section.

Overview of section A01AT-30.

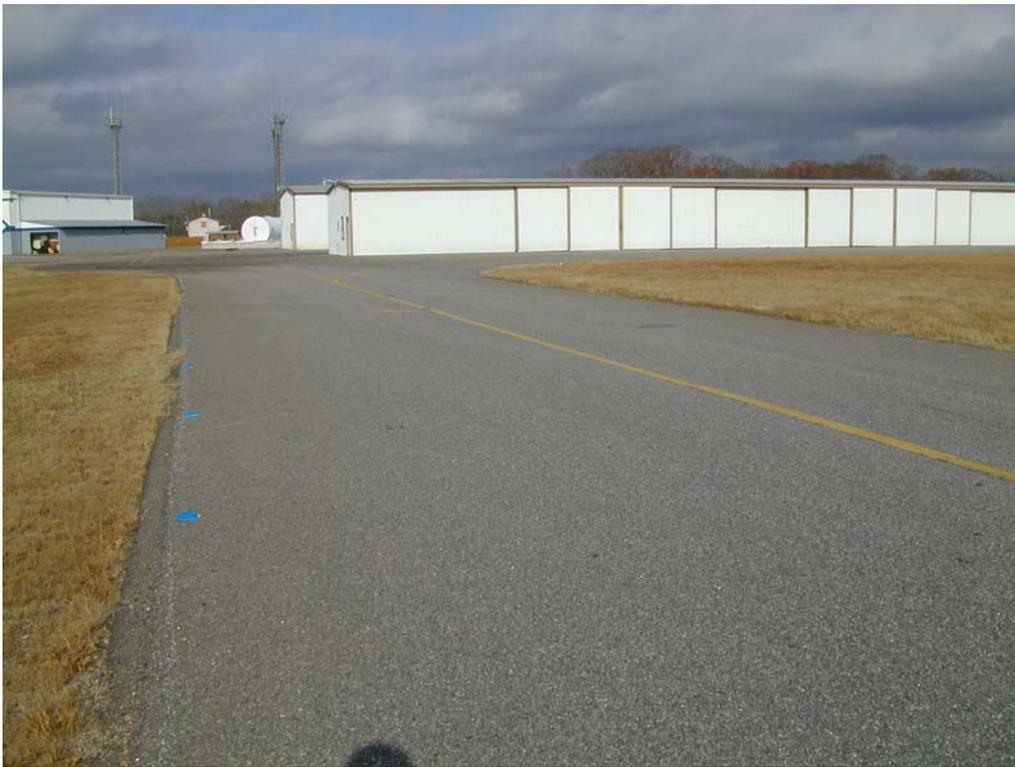
Two taxiways leading into the t-hangars near the northeastern portion of the apron are defined in this facility. THANGAT-10 is in good condition with only moderate amounts of low-severity L&T cracking and an isolated area of patching being found in the section.

Overview of section THANGAT-10.
