GLYNCO JETPORT

PAVEMENT EVALUATION REPORT

JULY 2002

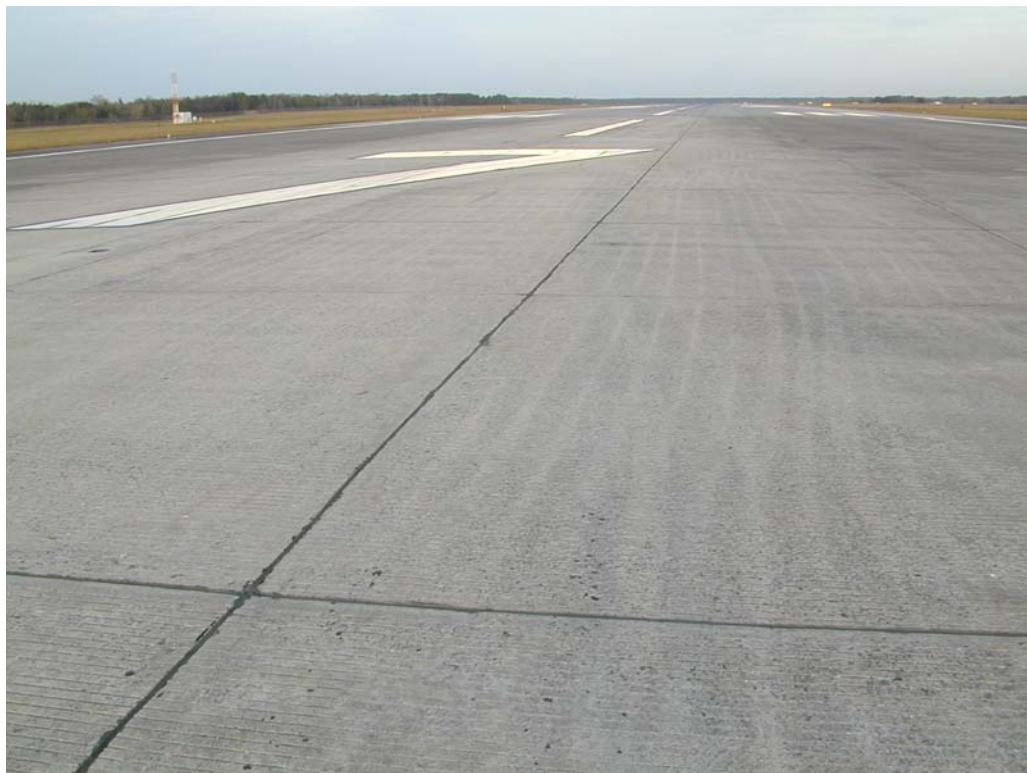
Sections R725GJP-10N, R725GJP-10C, and R725GJP-10S comprise the western 500 feet of the runway and are constructed of portland cement concrete (PCC). All three sections are similar in condition with only a few small patches and joint spalls being observed.

Overview of section R725GJP-10C.

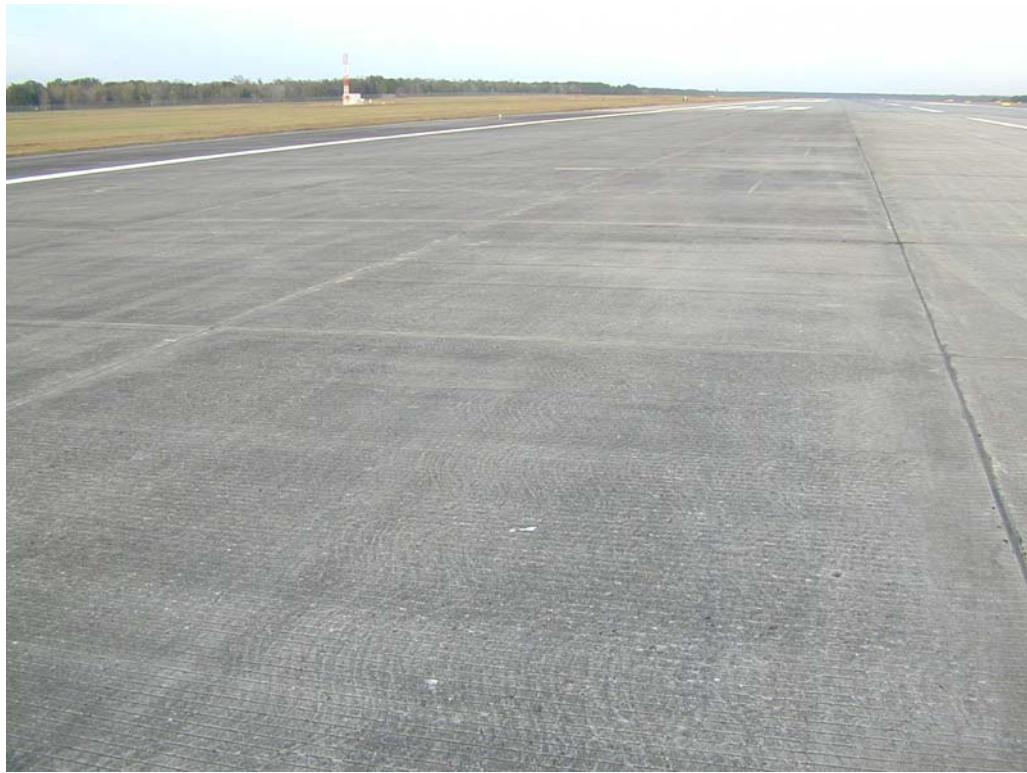
Overview of section R725GJP-10N.

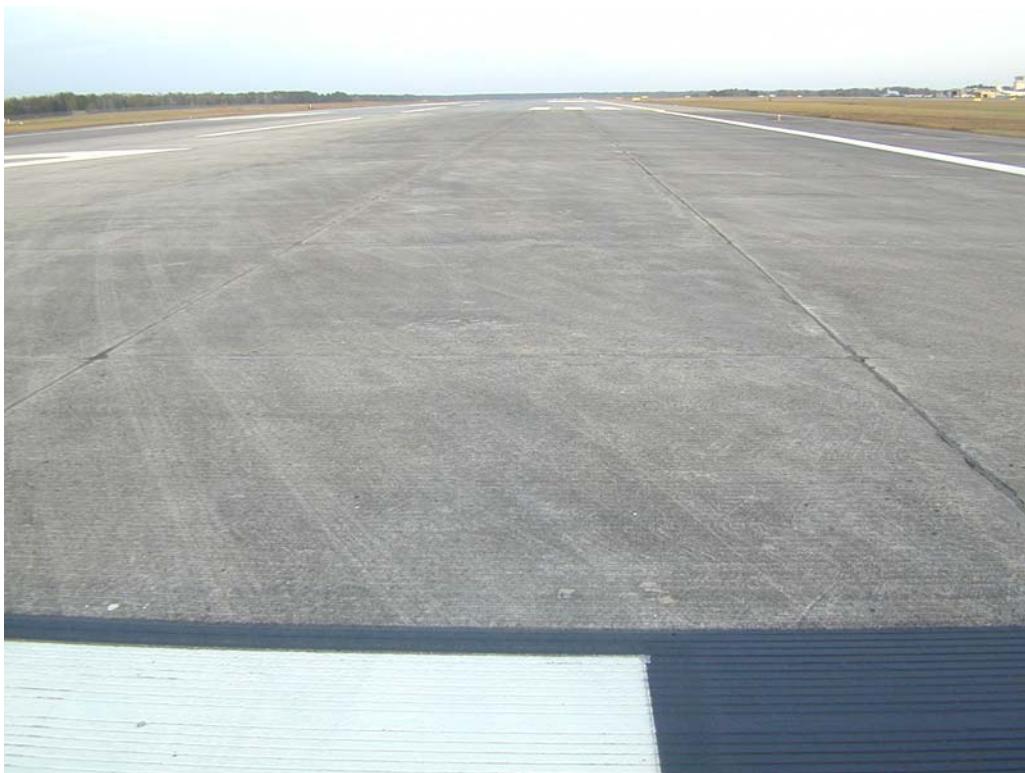
Overview of section R725GJP-10S.

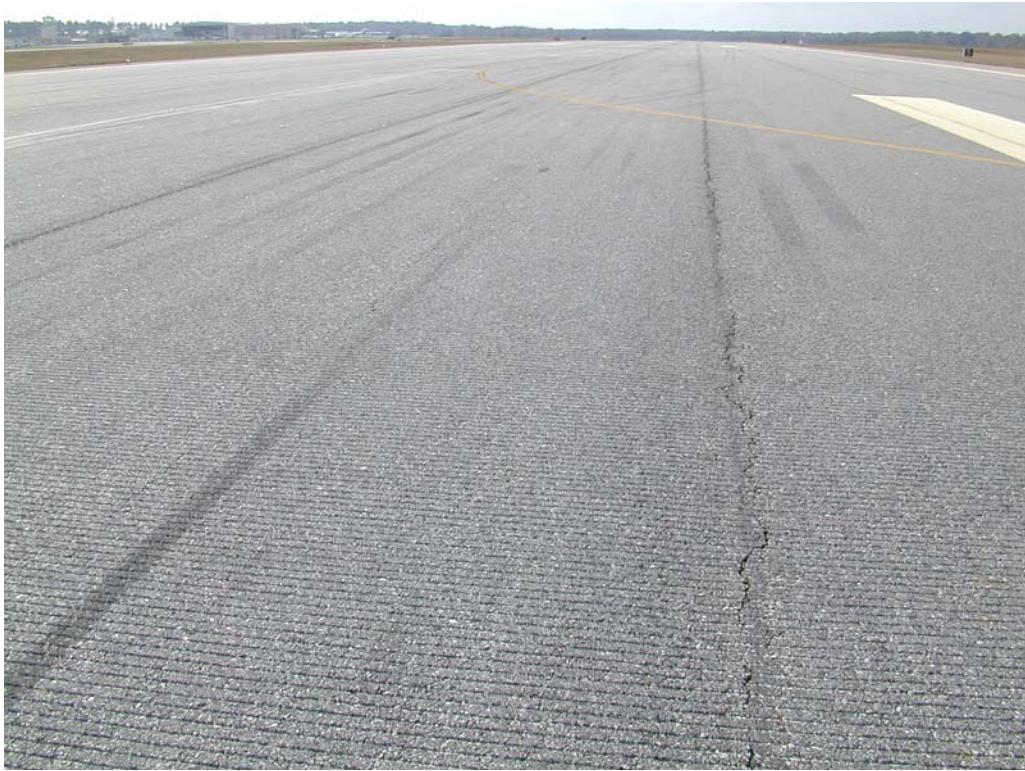
The asphalt surfaced area of Runway 7-25 defines the extent of sections R725GJP-20N, R725GJP-20C, and R725GJP-20S. All three sections have similar conditions with significant amounts of low-severity L&T and joint reflective cracking being observed. None of the cracking has been sealed with maintenance. Occasional isolated amounts of swelling were observed throughout the sections as well.

Overview of section R725GJP-20C.

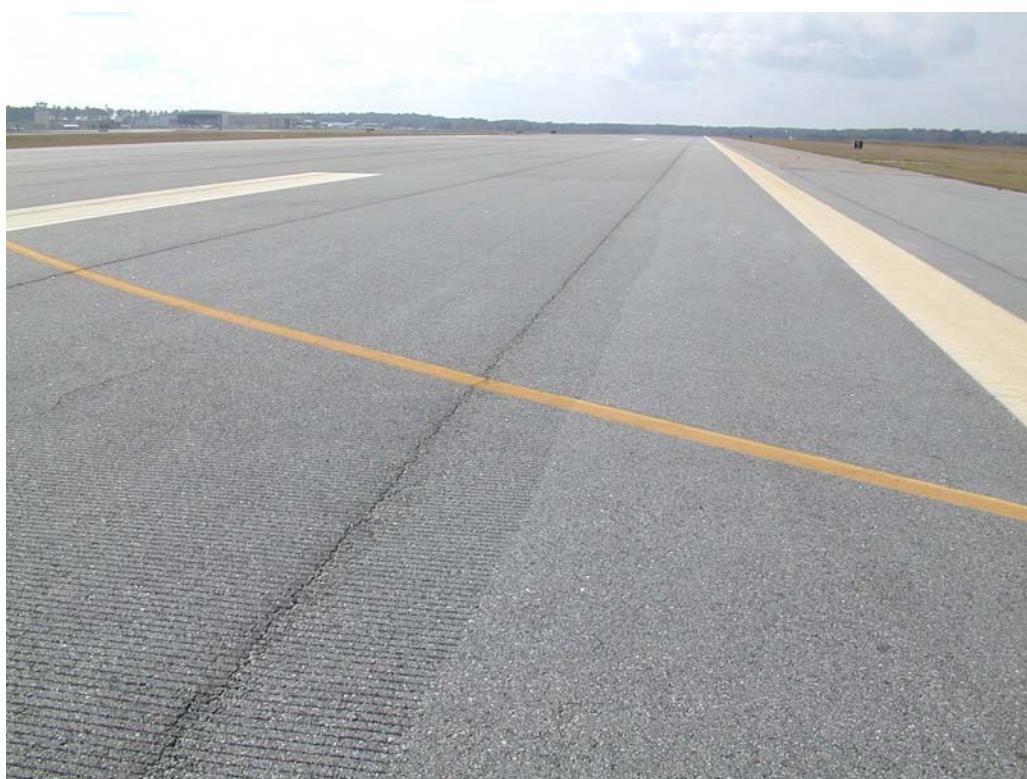
Overview of section R725GJP-20N.

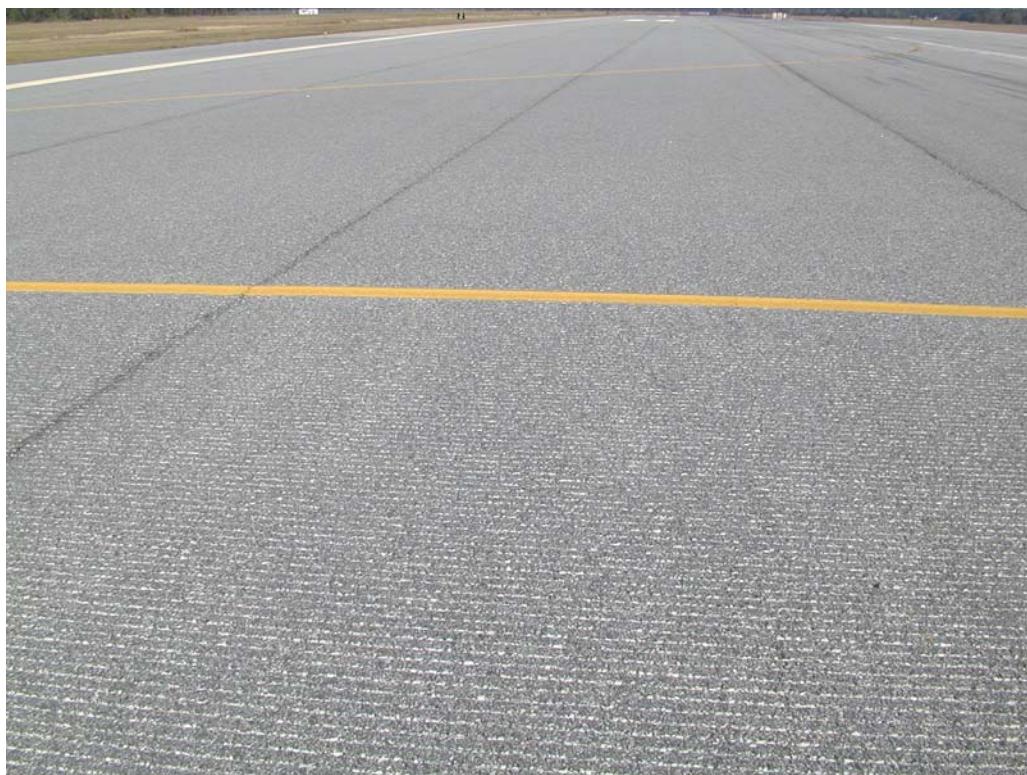
Overview of section R725GJP-20S.

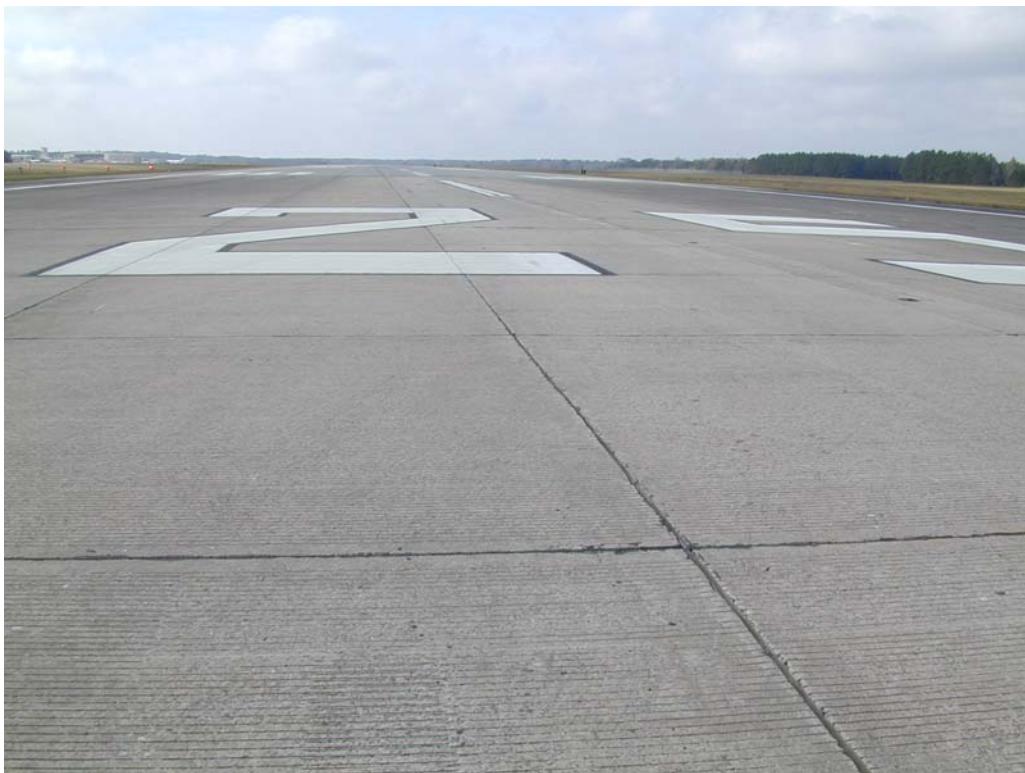
Similar in construction to the first three sections in the runway, R725GJP-30N, R725GJP-30C, and R725GJP-30S comprise the eastern 500 feet of Runway 7-25. These sections are also similar in condition with small patching, joint spalling, and corner spalling being observed. In addition, some joint seal damage was found at low severity in moderate amounts.

Overview of section R725GJP-30C.

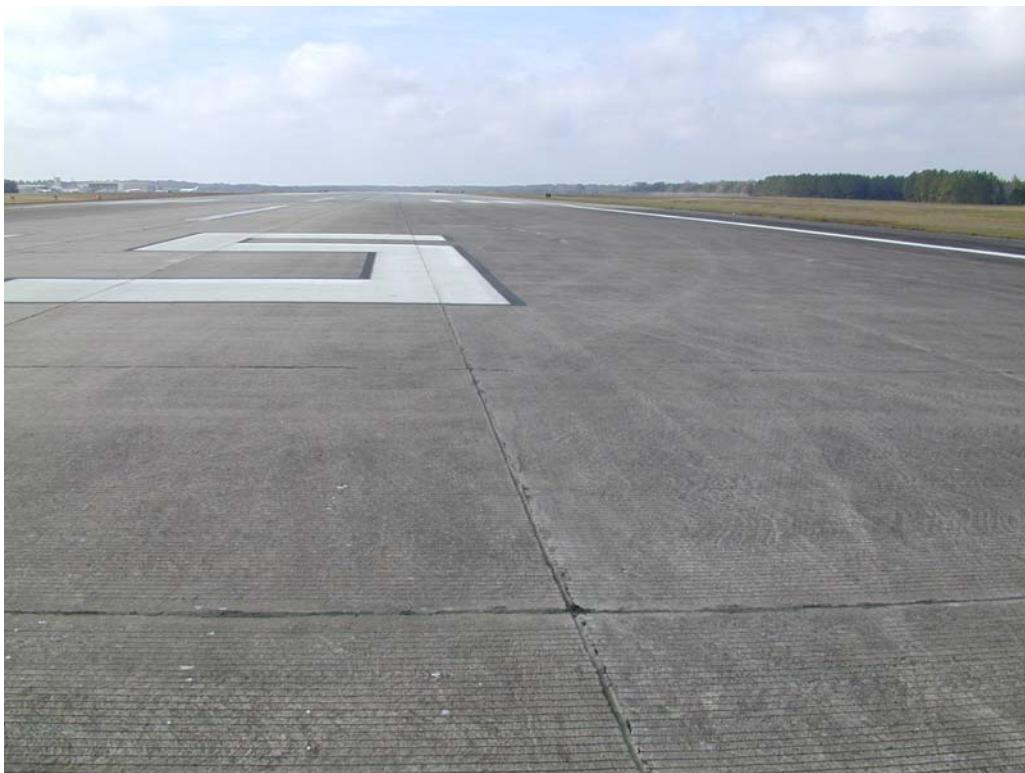
Overview of section R725GJP-30N.

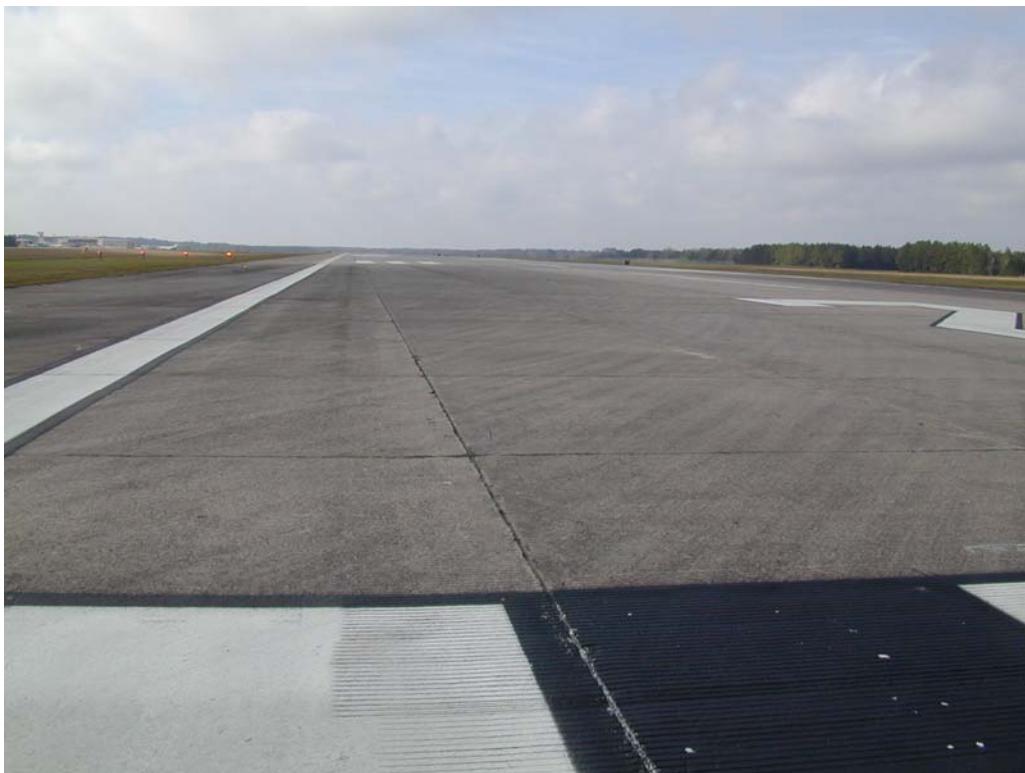
Overview of section R725GJP-30S.

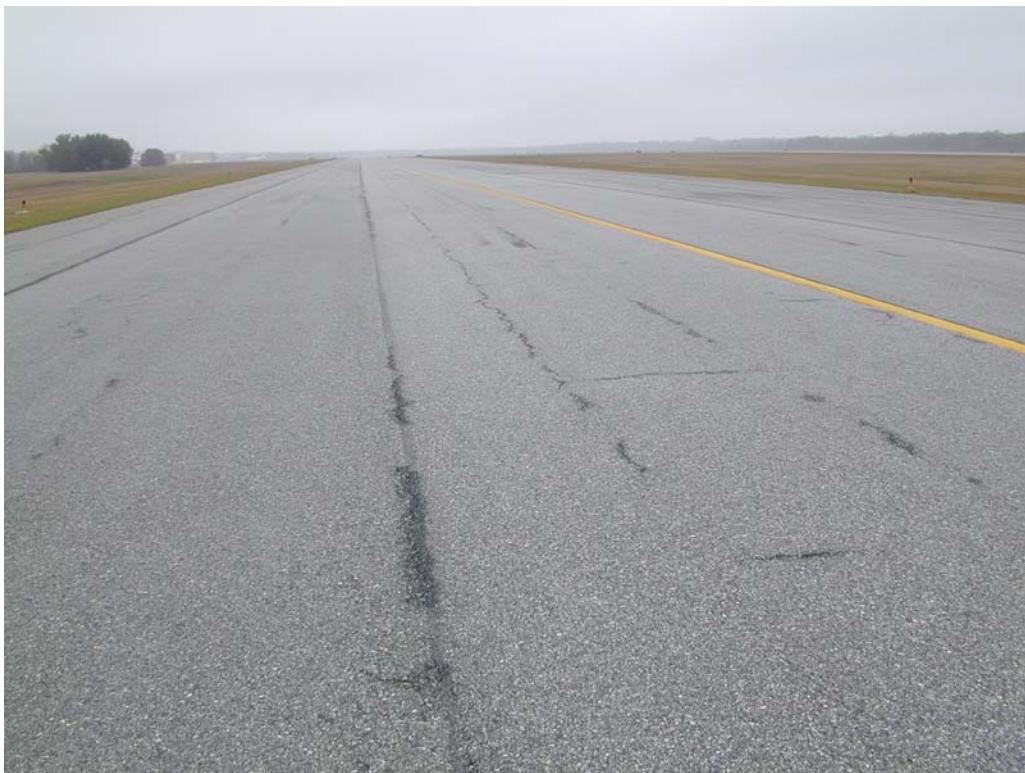
TWAGJP-10 is in fair condition with large amounts of low-severity L&T and joint reflective cracking being observed. Moderate amounts of swelling were also found throughout the section. In isolated areas throughout the section, secondary cracking associated with L&T or joint reflective cracking has produced an area of failed pavement greater than one foot in width. These areas were identified as low severity alligator cracking.

Overview of section TAGJP-10.

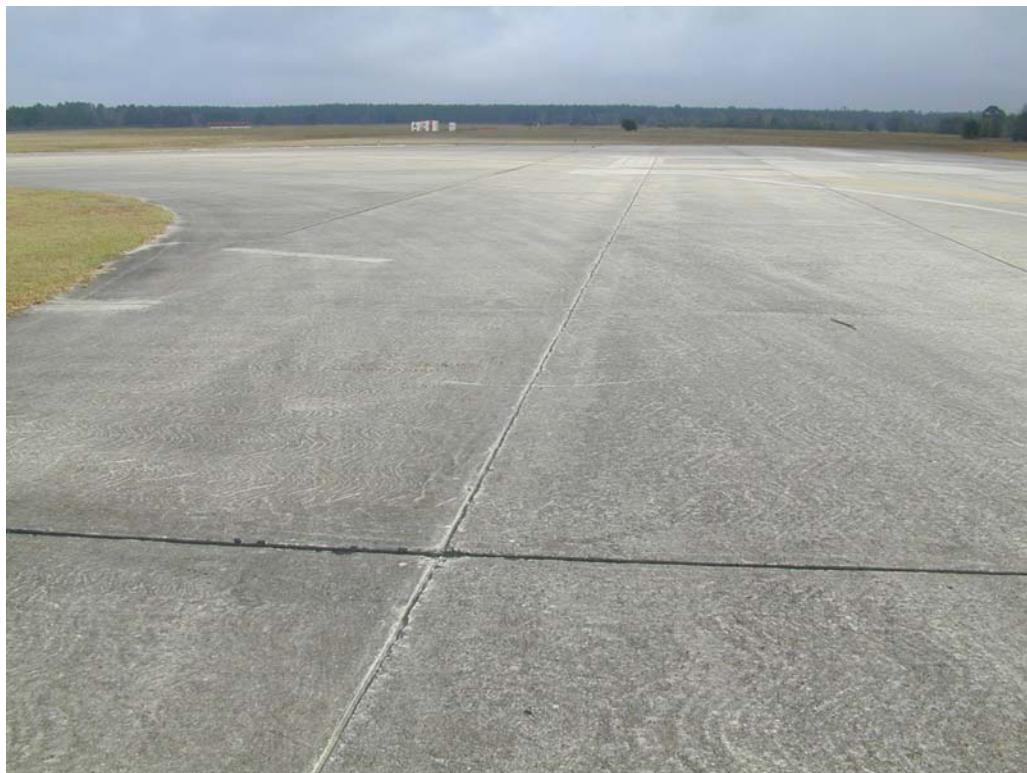
TWAGJP-20 was constructed at the same time as the PCC pavements in Runway 7-25. As a result, its condition is similar with moderate amounts of patching and spalling being observed. Some isolated amounts of pumping were found in the eastern most area of the section.

Overview of section TAGJP-20.

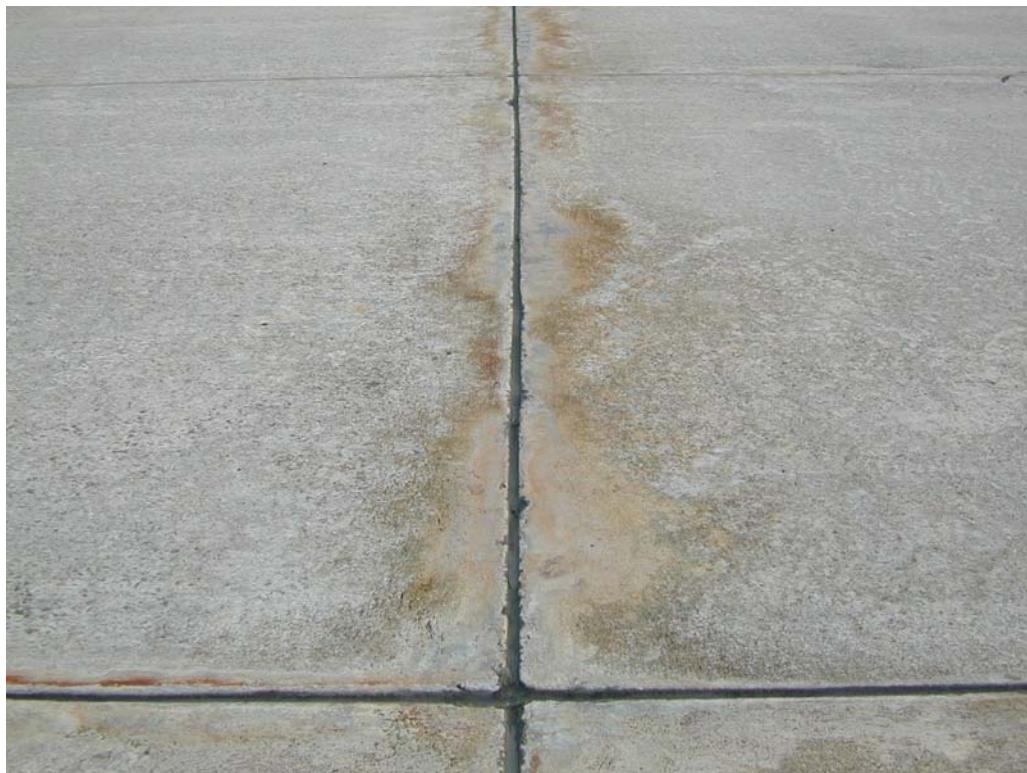
Pumping in section TAGJP-20.

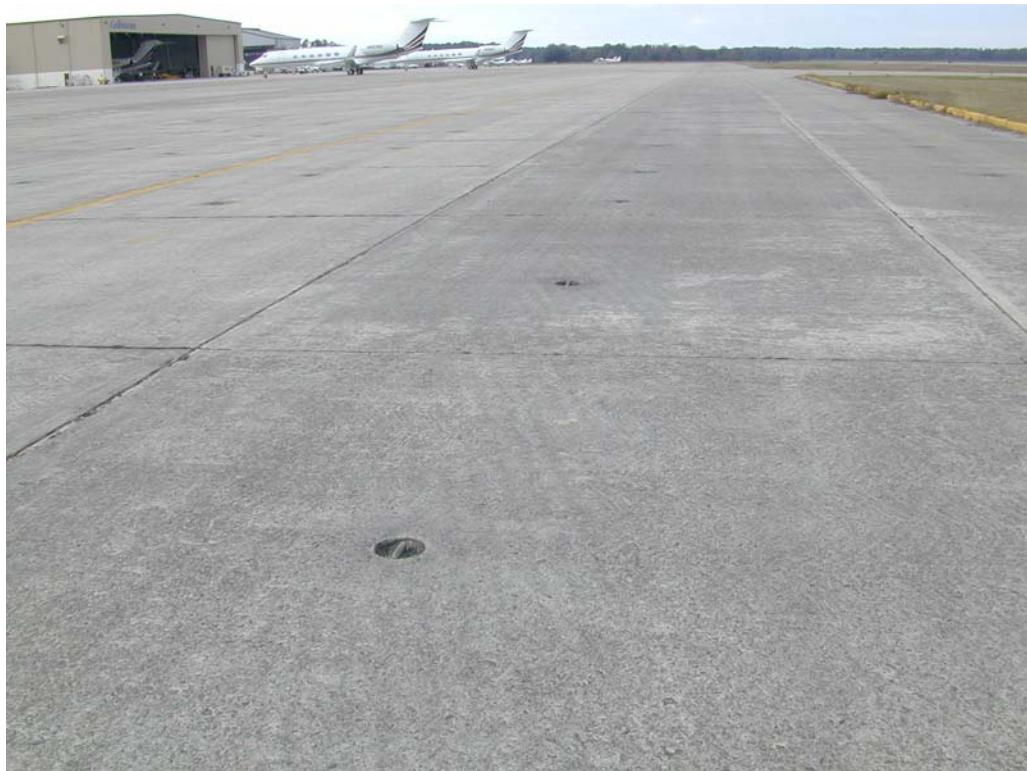
A01GJP-10 is the only section defined in the apron. Moderate amounts of joint and corner spalling at various severities were observed throughout the section. Patching was also frequently found. In addition, the majority of the joints were found to have high-severity joint seal damage.

Overview of section A01GJP-10.

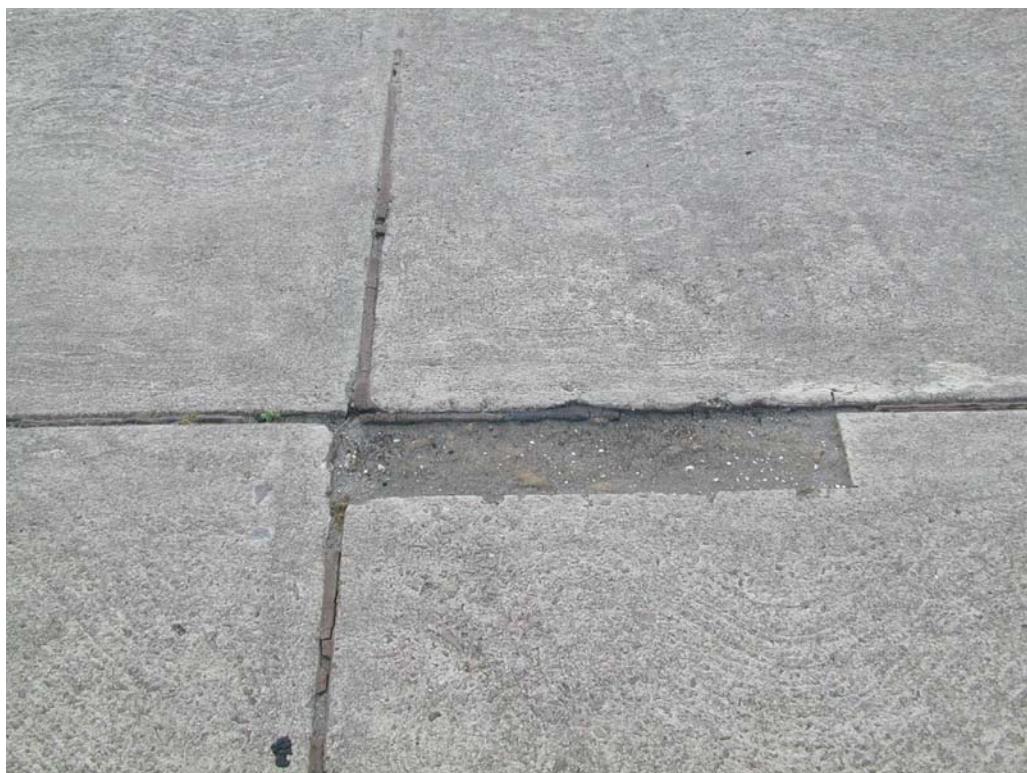
Small patch in section A01GJP-10.
