DANIEL FIELD

# PAVEMENT EVALUATION REPORT

JULY 2002

Applied Pavement Technology, Inc.  
3001 Research Road, Suite C  
Champaign, Illinois 61822  
217-398-3977  
[www.pavementsolutions.com](http://www.pavementsolutions.com)

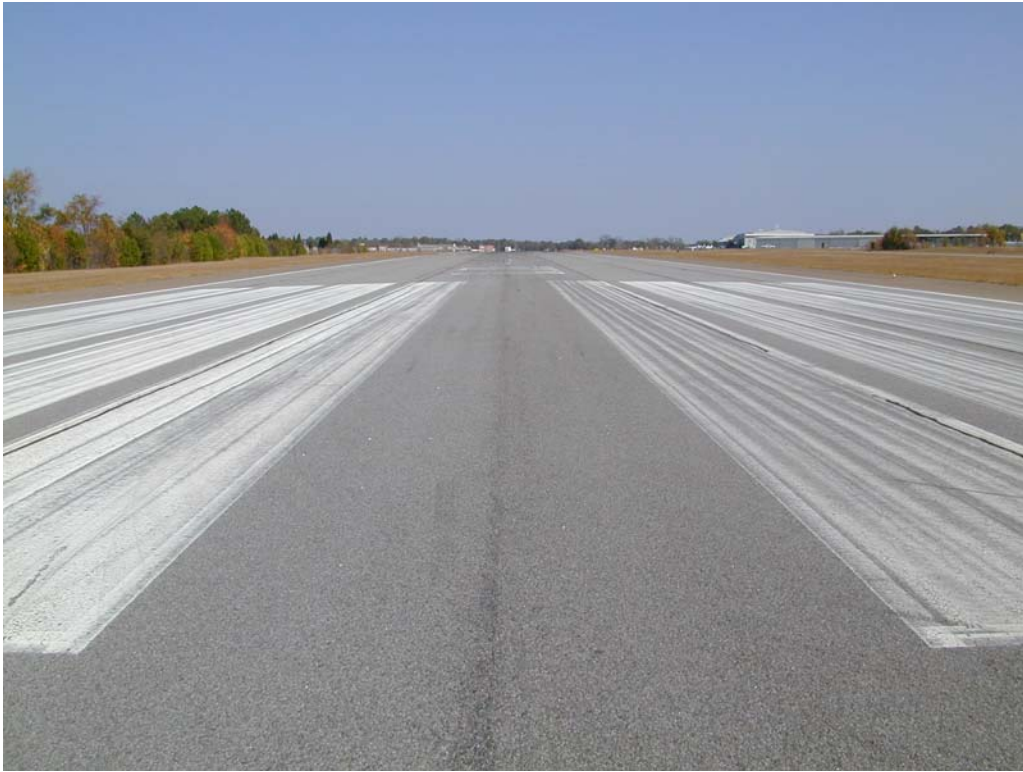
Runway 5-23 was defined by two sections. R523AG-10 is in good condition with significant amounts of longitudinal and transverse (L&T) cracking found throughout the section, the majority of which were sealed. Low-severity patching was also found. R523AG-20 is located at

Overview of section R523AG-10.

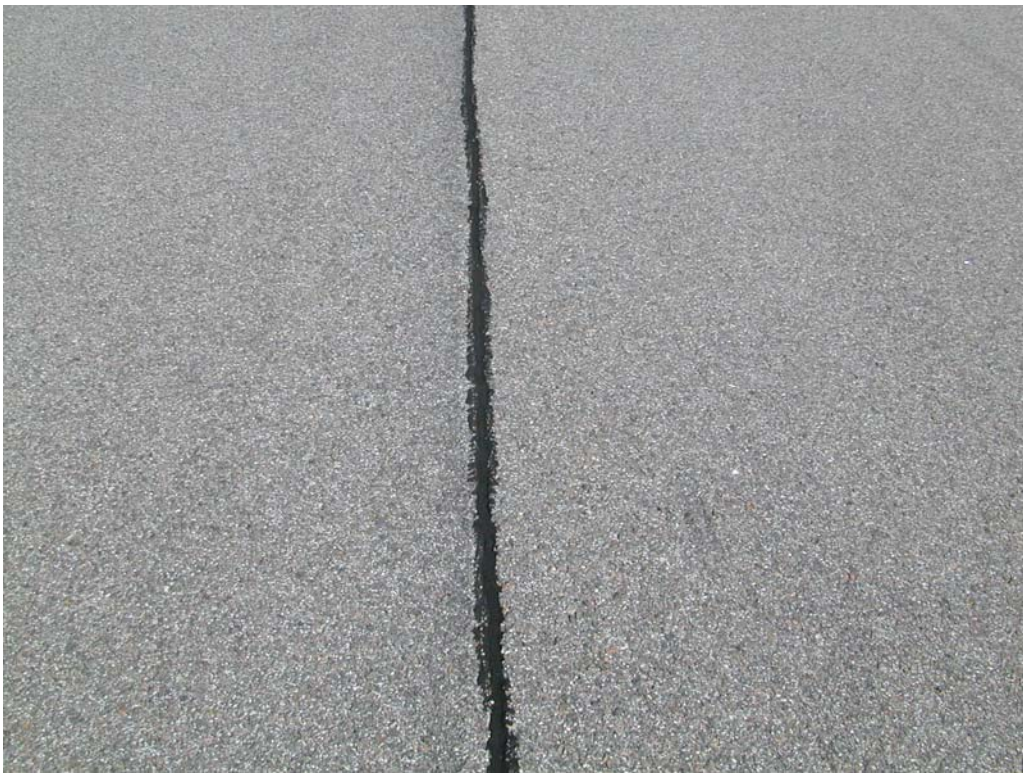
L&T cracking in section R523AG-10.

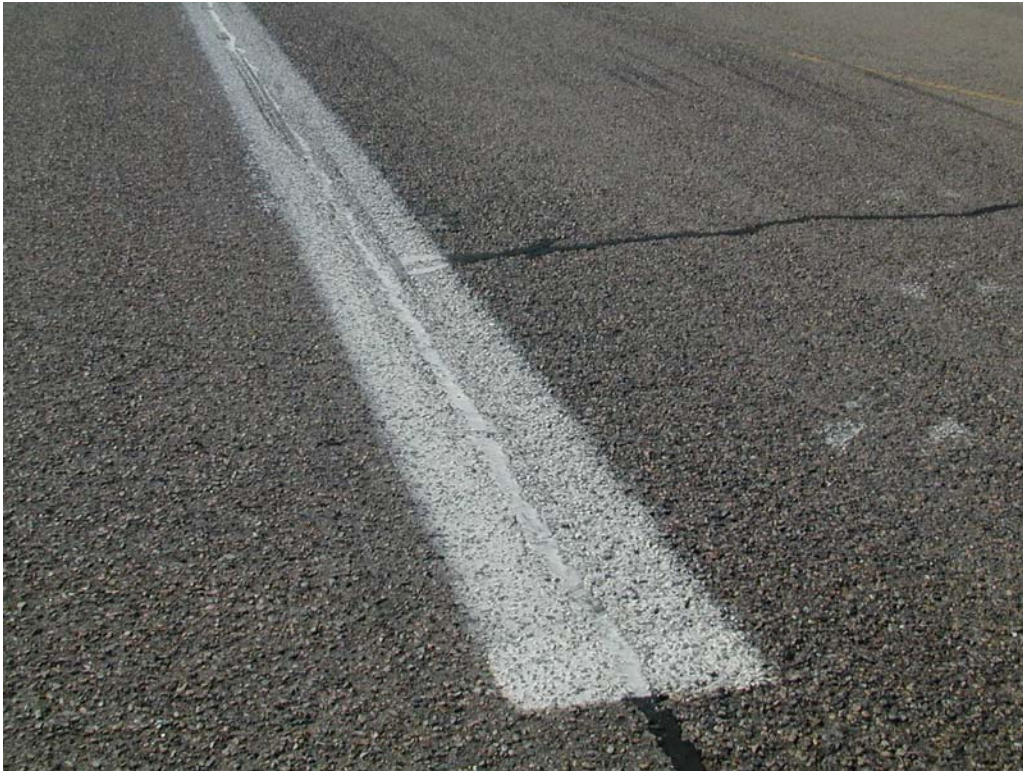
Weathering in section R523AG-10.

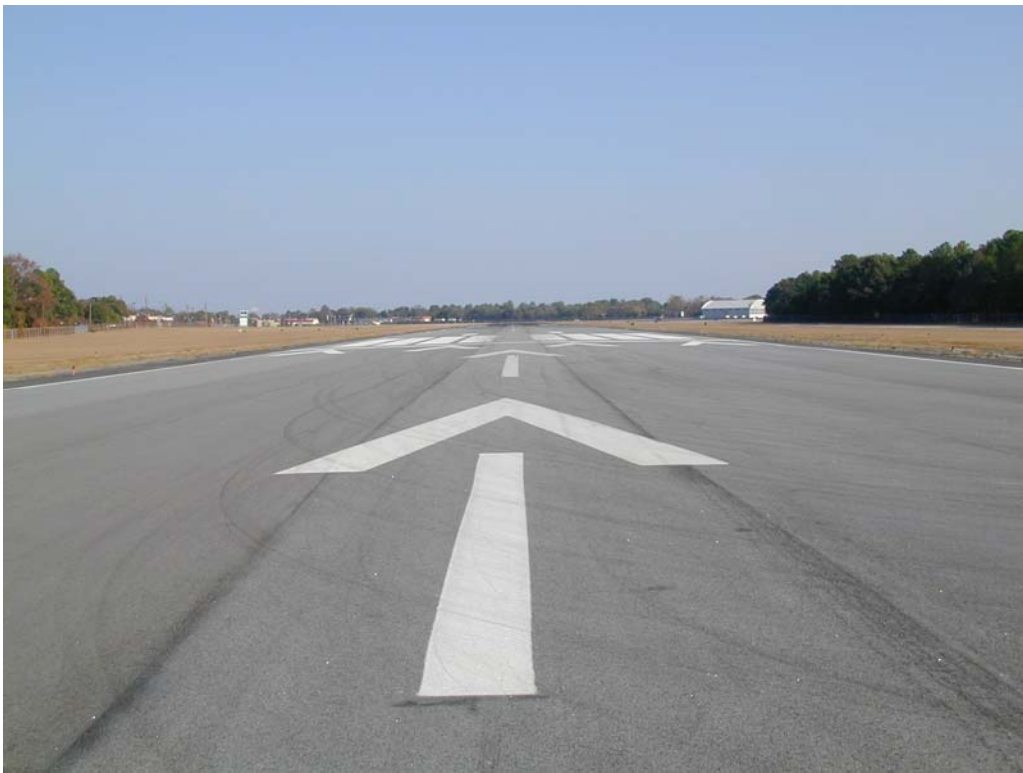
Runway 11-29 is defined by one section running the full length of the runway. During the inspection in 1998, R1129AG-10 was functioning as 150 feet wide runway. The recent overlay in 2000 on the runway was done only on the center 100 feet of the runway. The rest of the older pavement is now serving as a shoulder. The runway is in excellent condition with small quantities of low-severity, unsealed, L&T cracking found throughout.

Overview of section R1129AG-10.

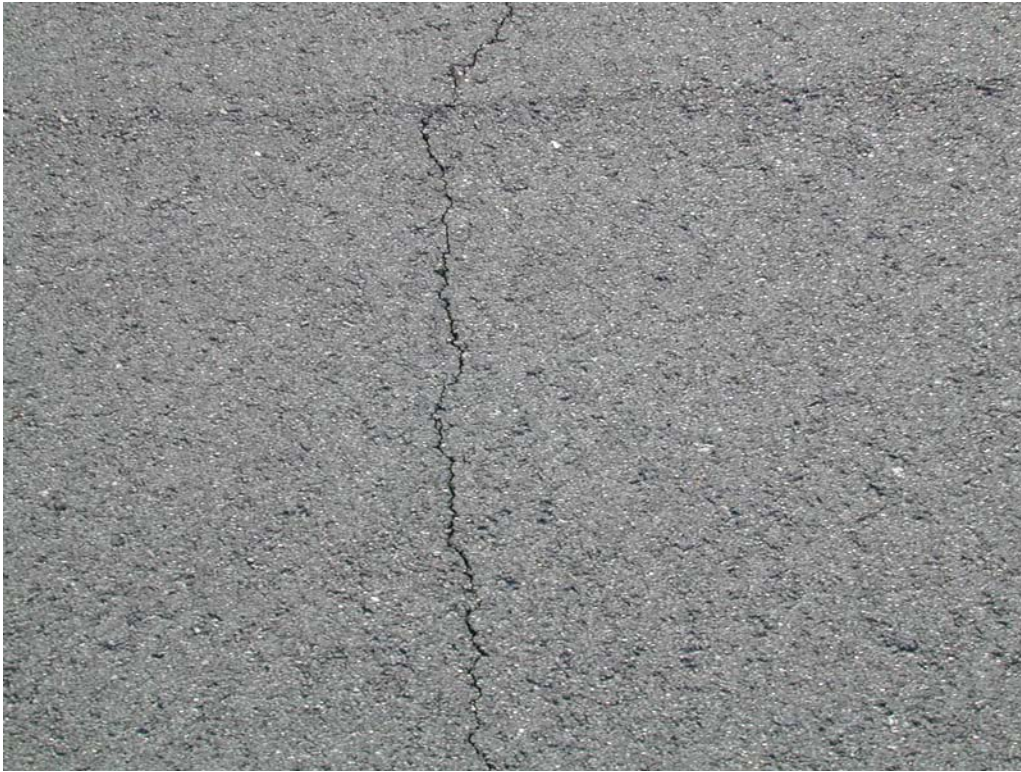
L&T cracking in section R1129AG-10.

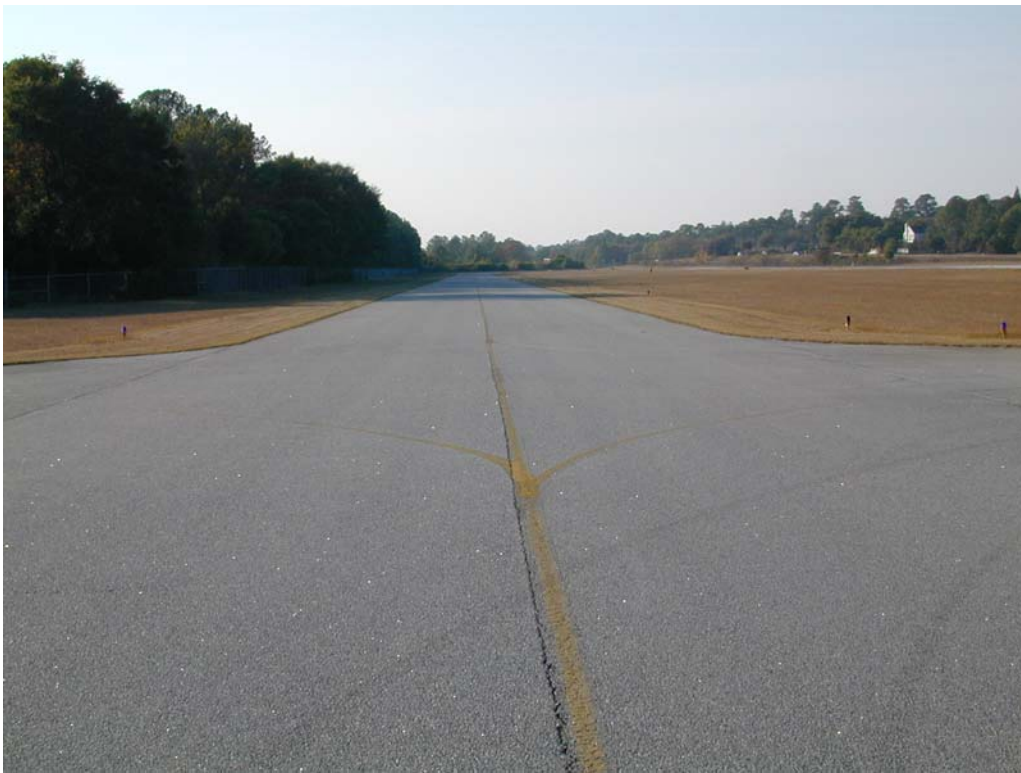
Taxiway A is defined by one section and is in good condition. Extensive amounts of low and medium-severity L&T cracking were observed throughout the taxiway.

Overview of section TAAG-10.

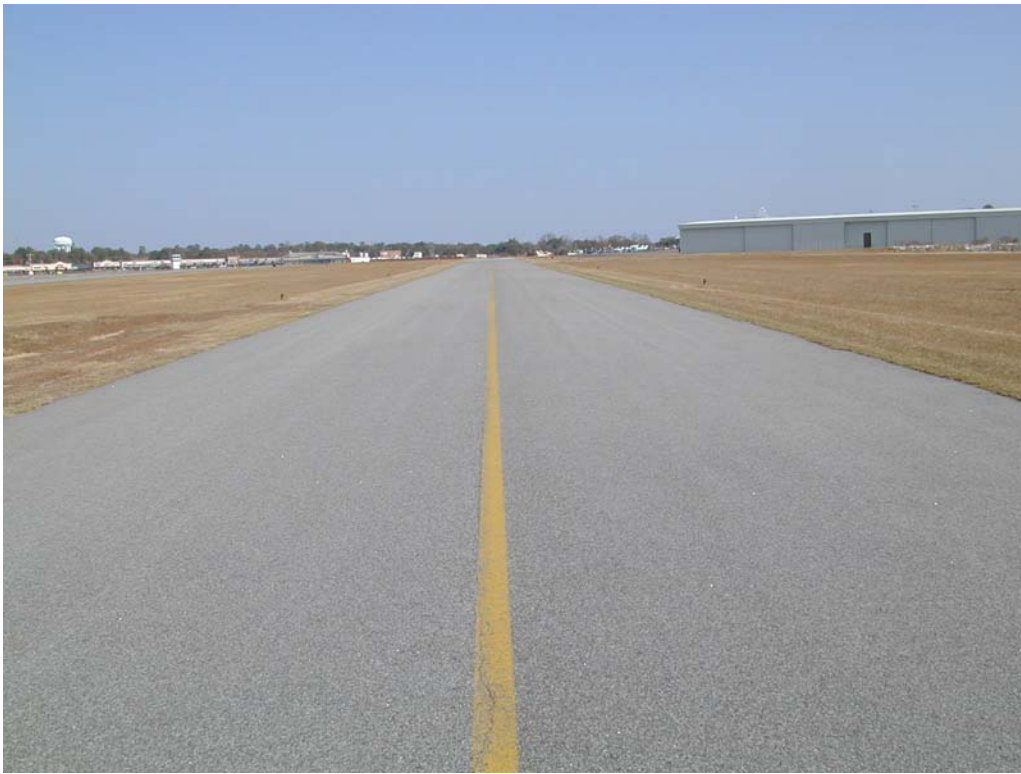
Taxiway D is in excellent condition with low-severity L&T cracking and raveling and weathering observed throughout. The majority of L&T cracking was unsealed.

Overview of section TDAG-10.

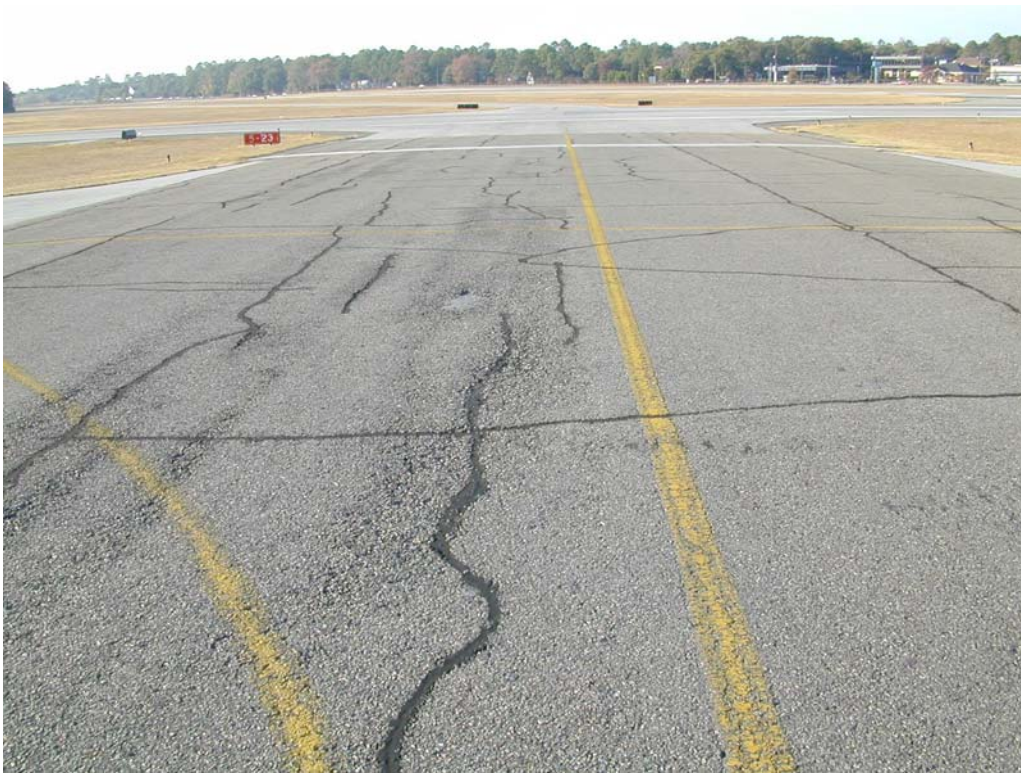
Taxiway E is in fair condition with significant amounts of low-severity block cracking and patching. Low, medium and high-severity raveling and weathering were also found throughout.

Overview of section TEAG-10.

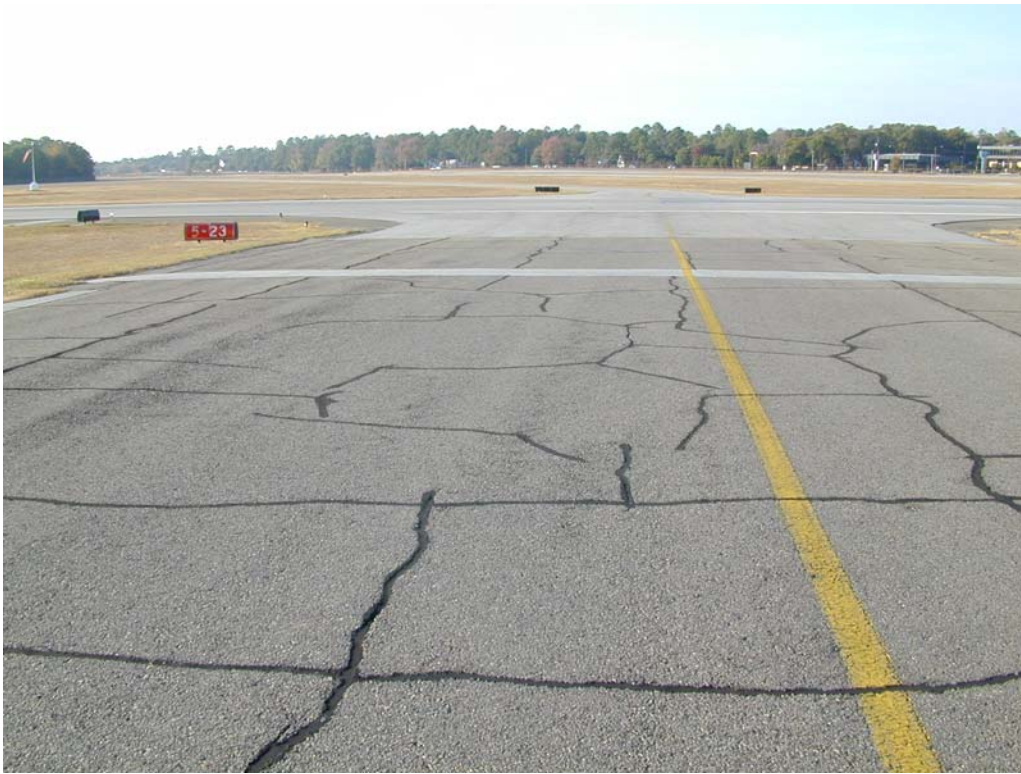
Block cracking in section TEAG-10.

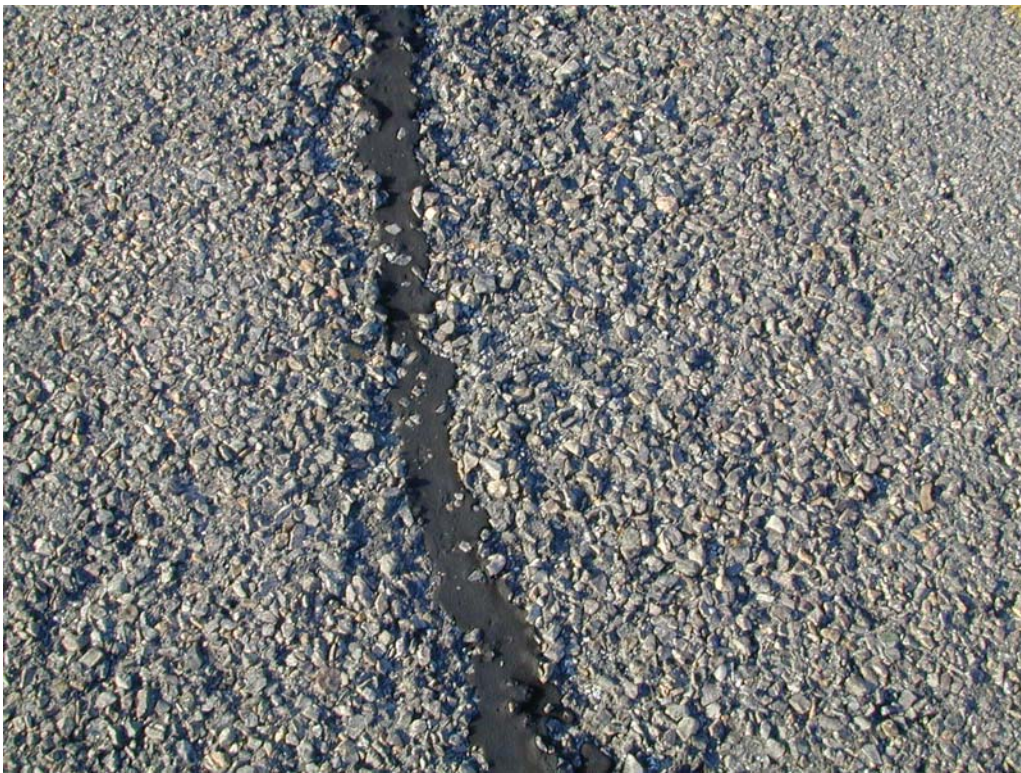
Weathering in section TEAG-10.

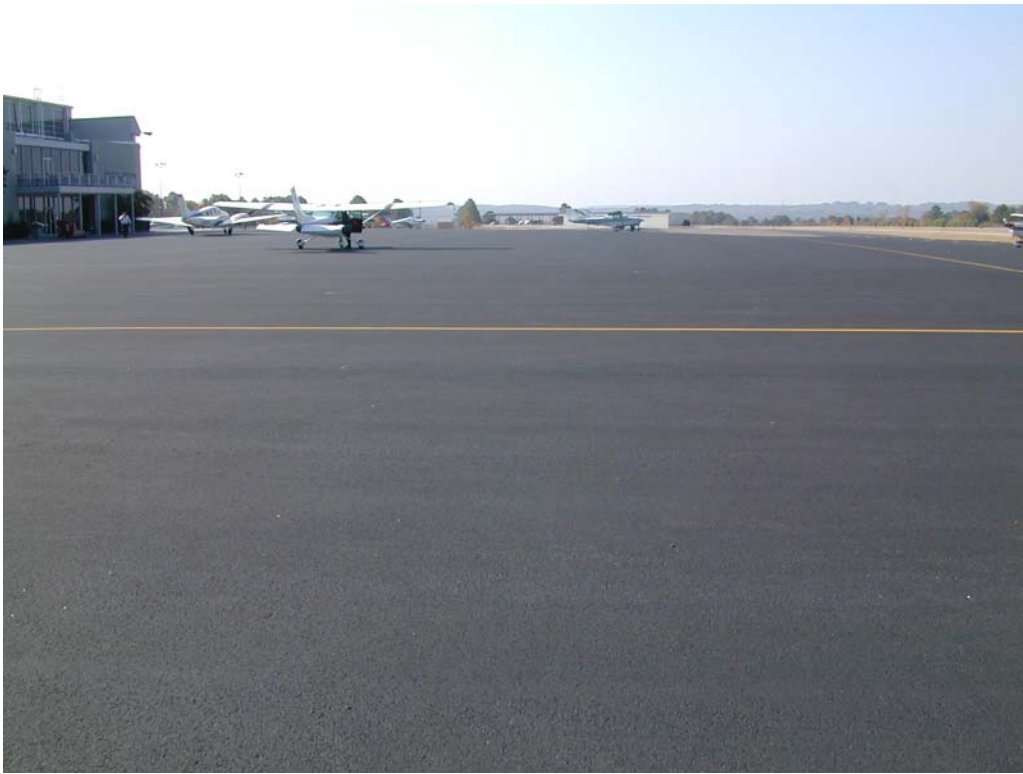
ATERMAG-10 was last overlaid in 2000. This section is presently in excellent condition with isolated areas with low-severity L&T cracking. Only one sample unit was noted with extensive amounts of low-severity block cracking. Hence this sample unit was surveyed as an additional sample unit.

Overview of section ATERMAG-10.

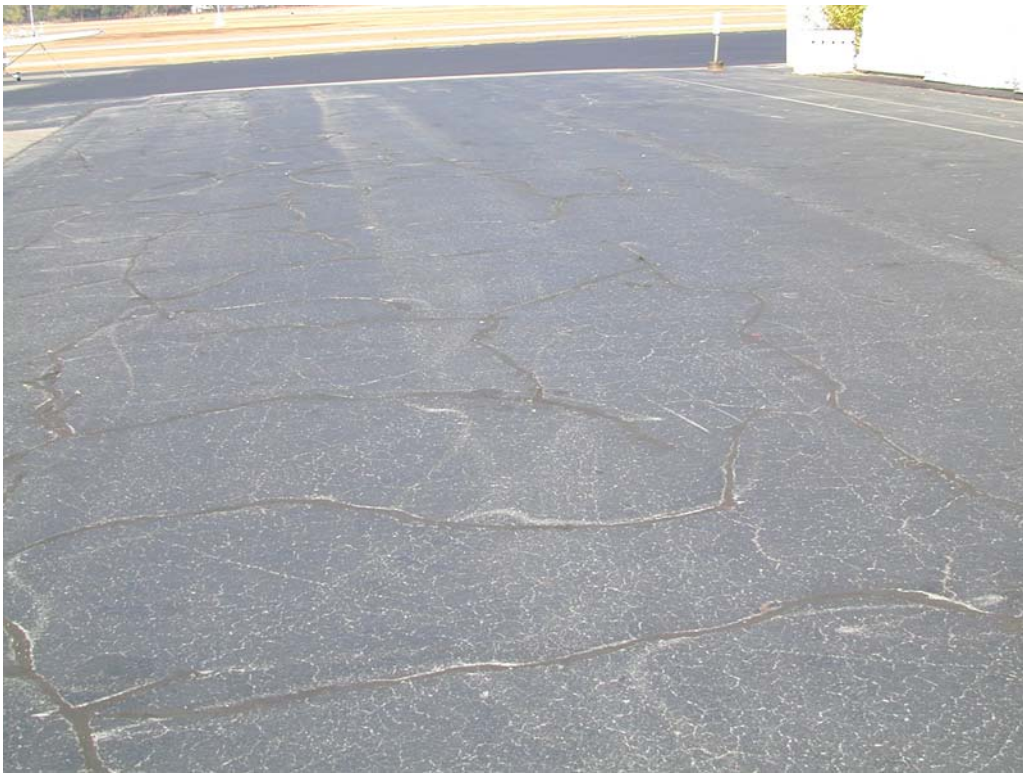
Block cracking in section ATERMAG-10.

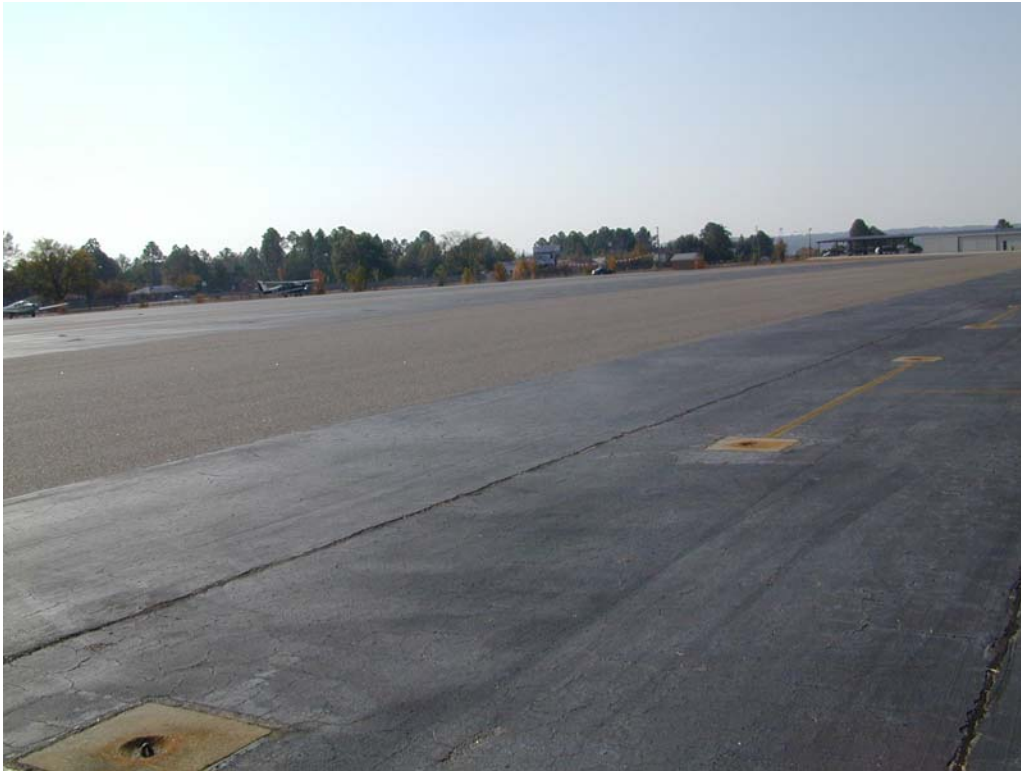
ATERMAG-20 was last overlaid in 2000 and presently is in excellent condition. No distress was observed in this section.

Overview of section ATERMAG-20.

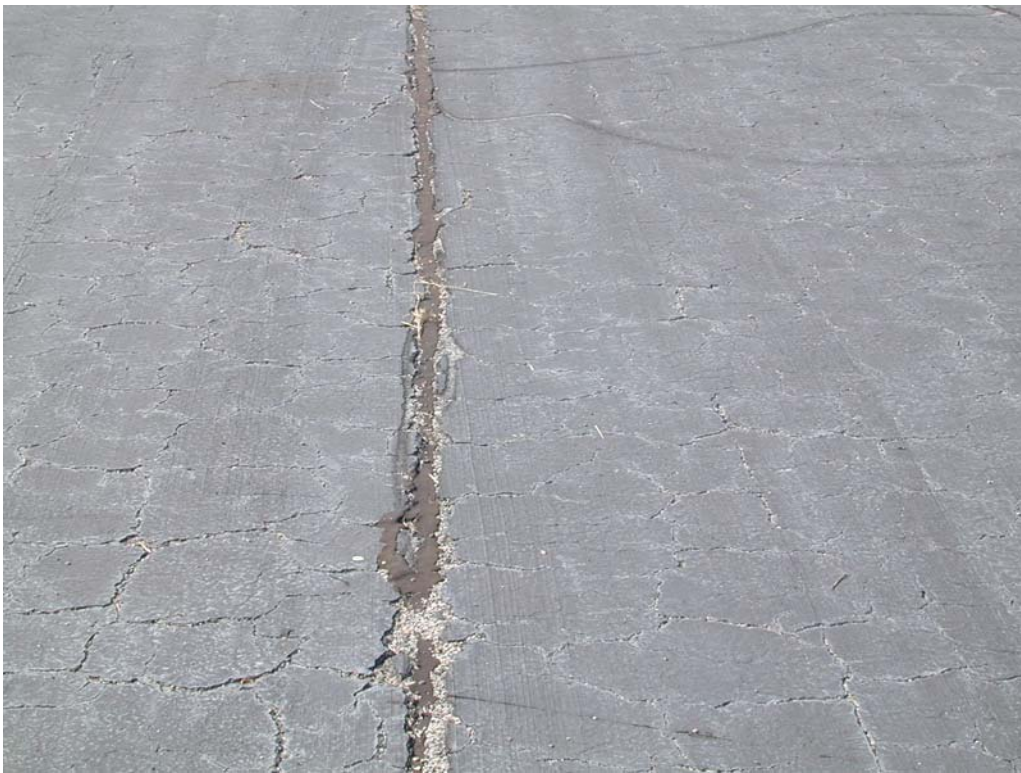
L&T Cracking in section ATERMAG-20.

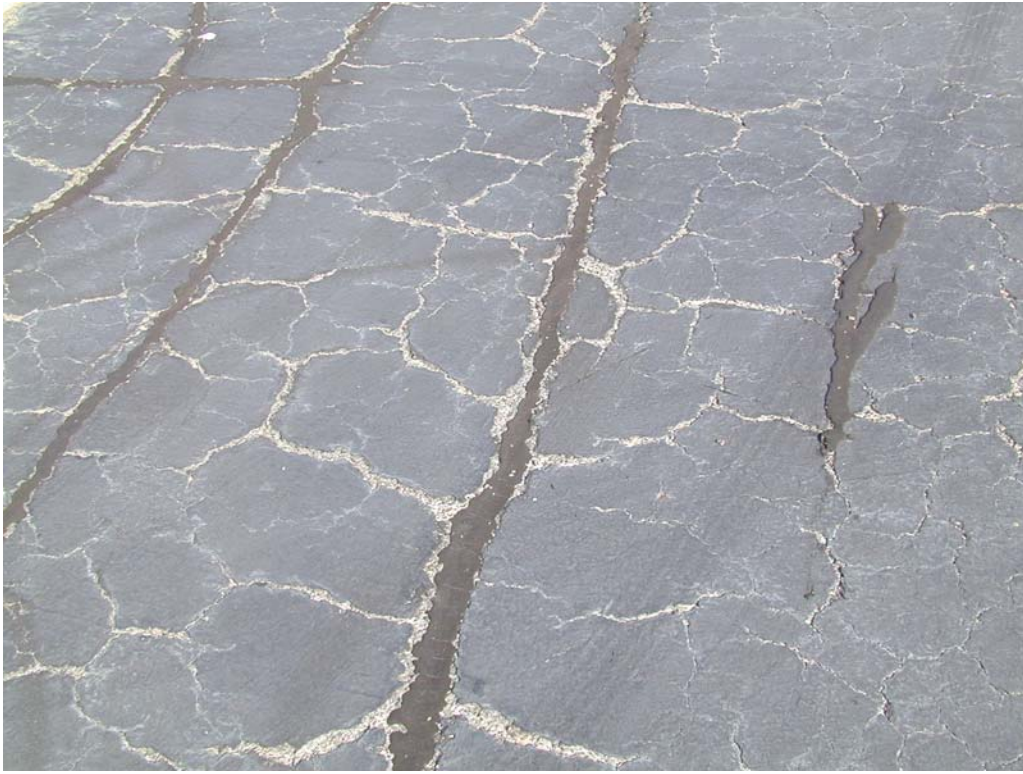
Weathering in section ATERMAG-20.

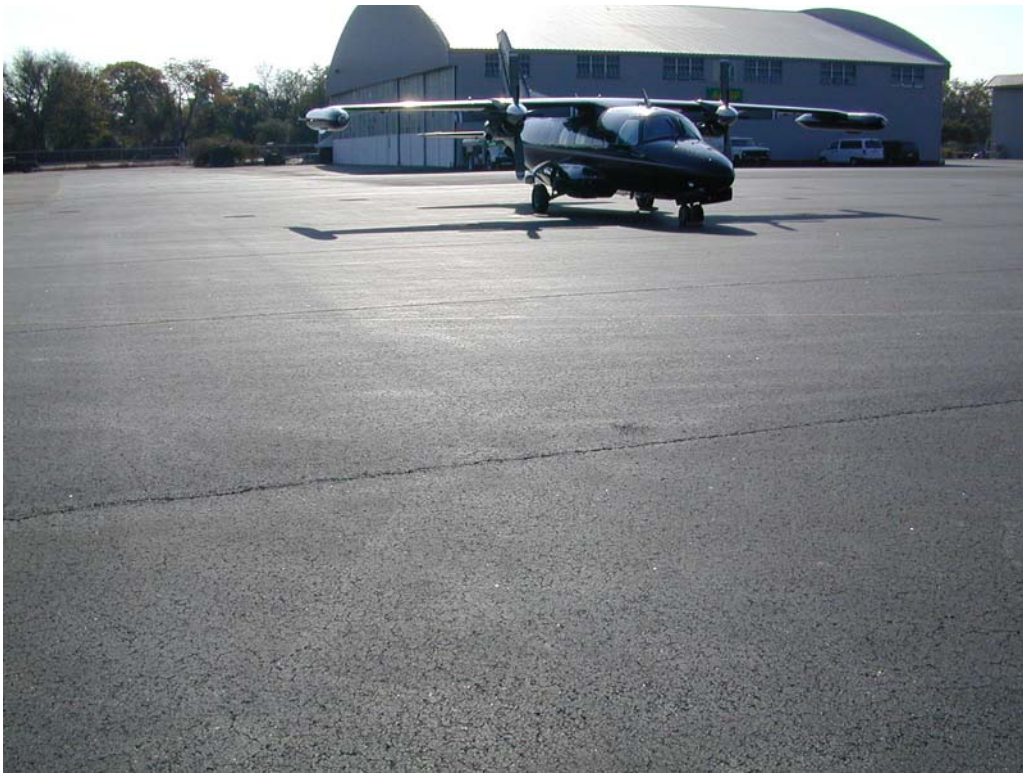
ATERMAG-40 is similar to ATERMAG-30 and is in good condition. The only distress found in this section was low and medium-severity L&T cracking.

Overview of section ATERMAG-40.

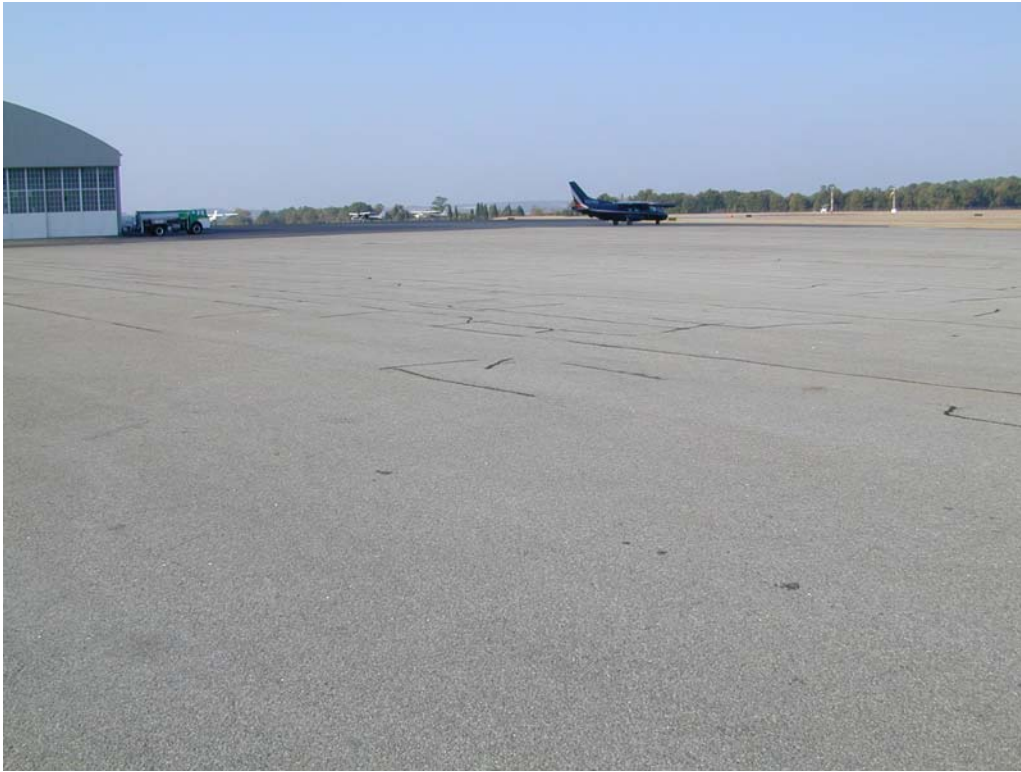
ATERMAG-50 is in good condition with extensive amounts of low-severity block cracking, L&T cracking and raveling and weathering. Some isolated areas of low-severity patching and depression were also observed in the section.

Overview of section ATERMAG-50.

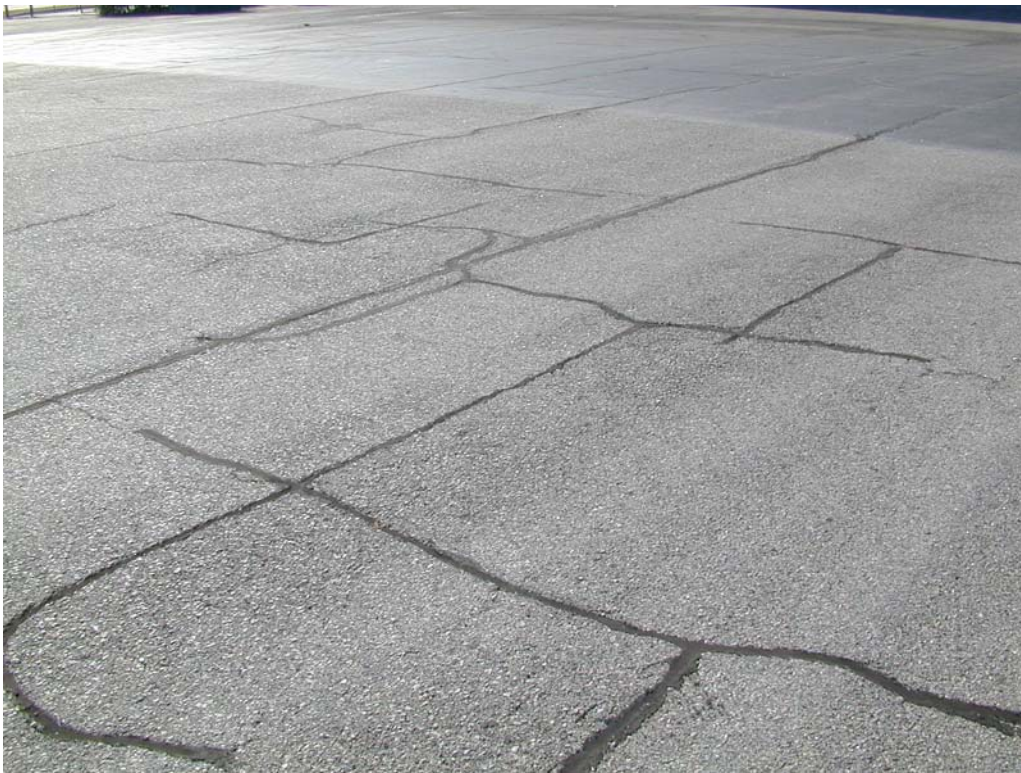
Block cracking in section ATERMAG-50.

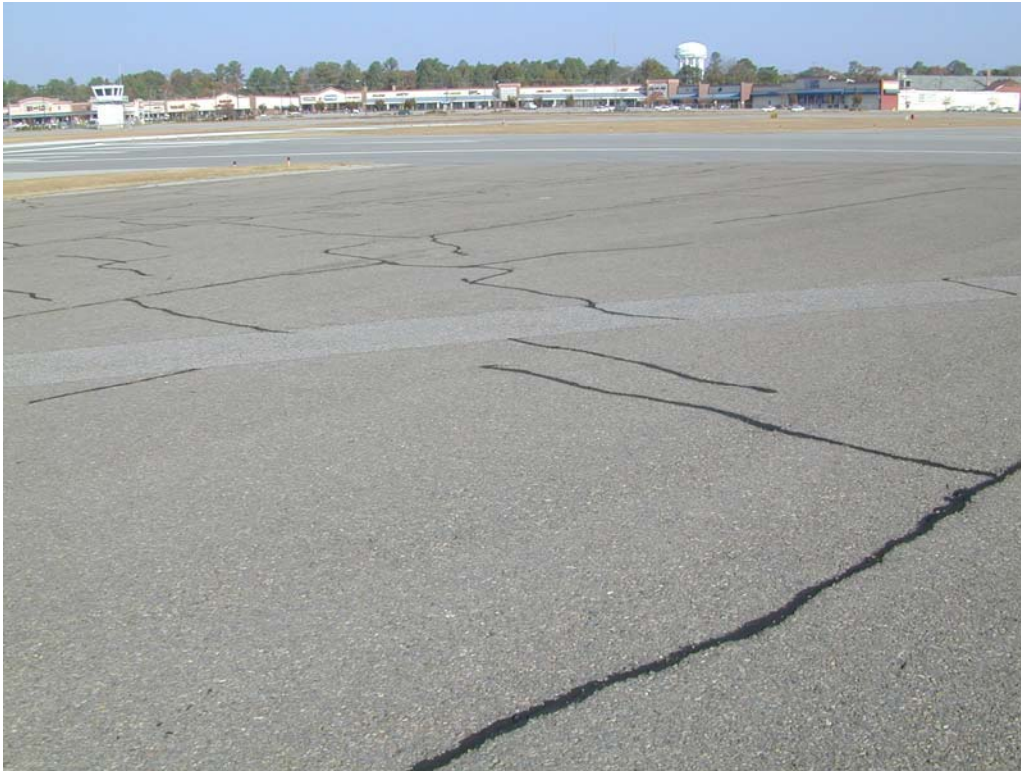
ATERMAG-60 is older pavement and is in fair condition. Extensive amounts of low, medium and high-severity patching were observed throughout the section. Other distresses found included low-severity block cracking, depression and L&T cracking.

Overview of section ATERMAG-60.

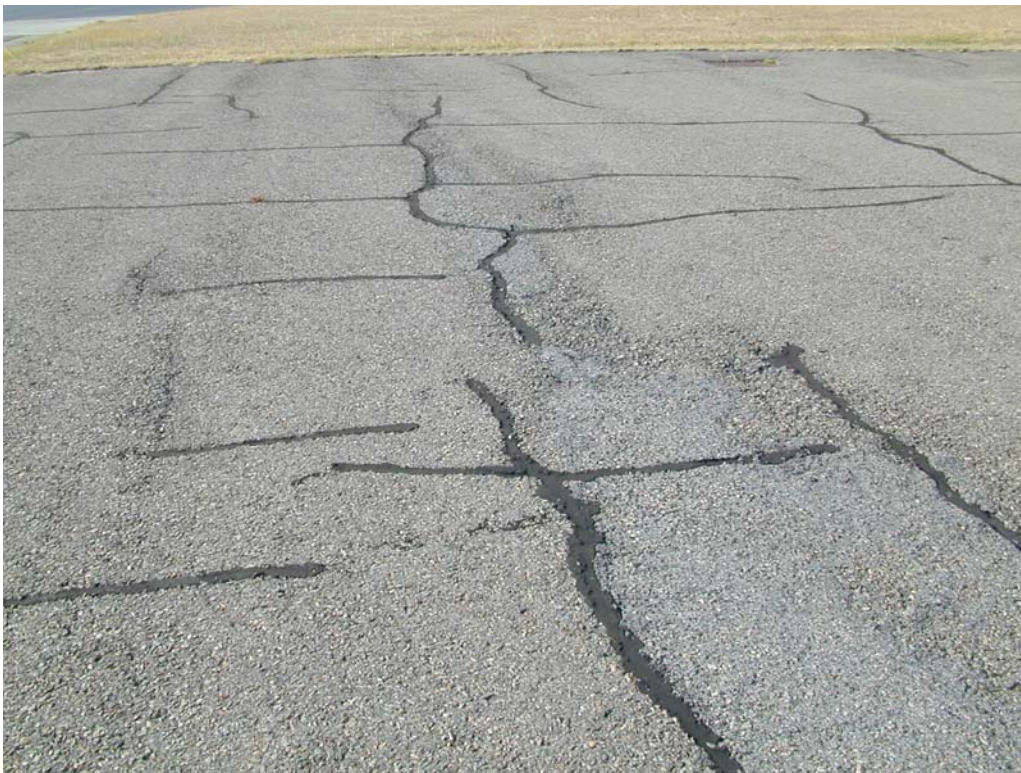
Block cracking in section ATERMAG-60.

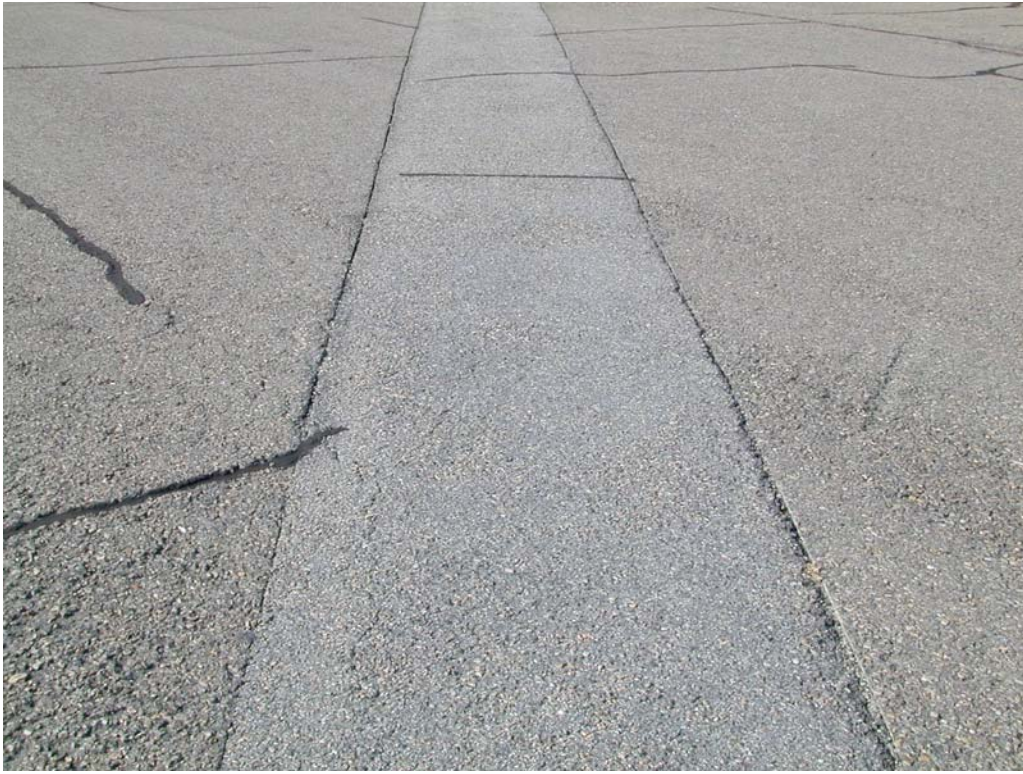
Patching in section ATERMAG-60.

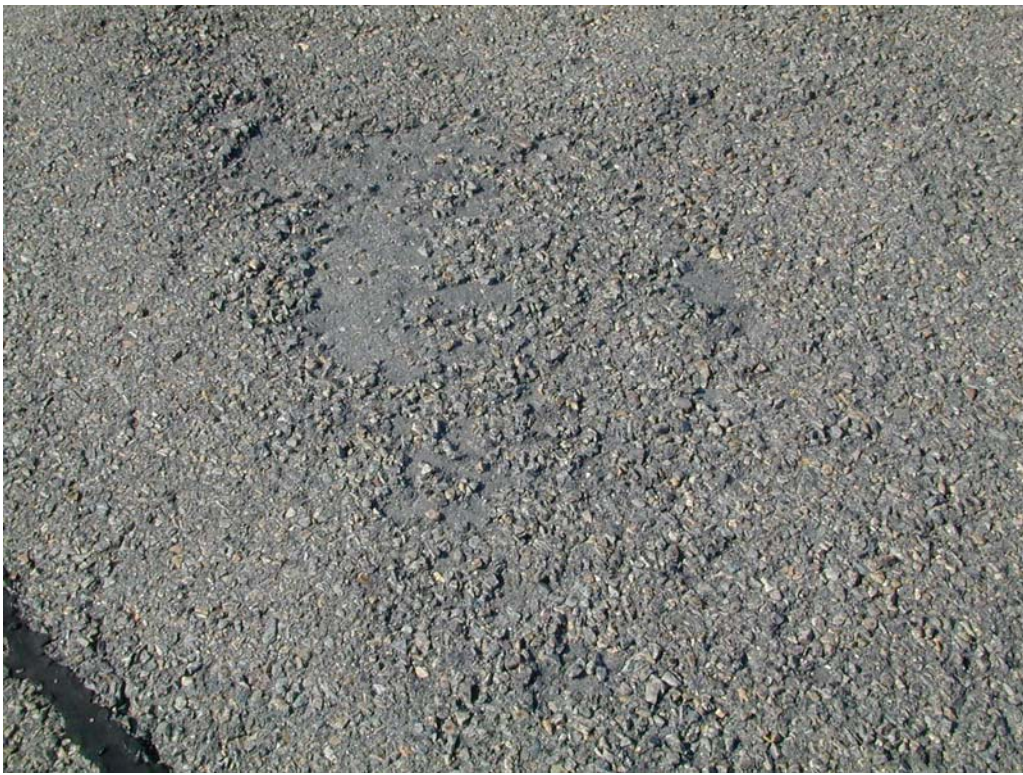
Weathering in section ATERMAG-60.

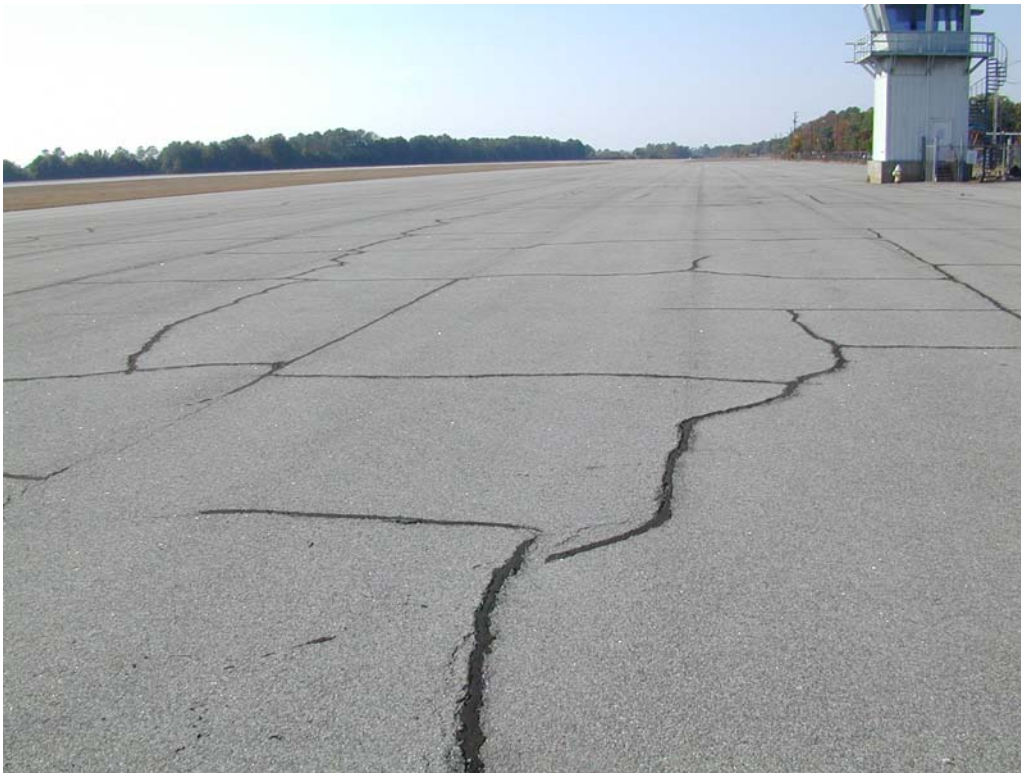
ATOWERAG-10 is in good condition with moderate amounts of low-severity L&T cracking and swelling observed throughout the section.

Overview of section ATOWERAG-10.

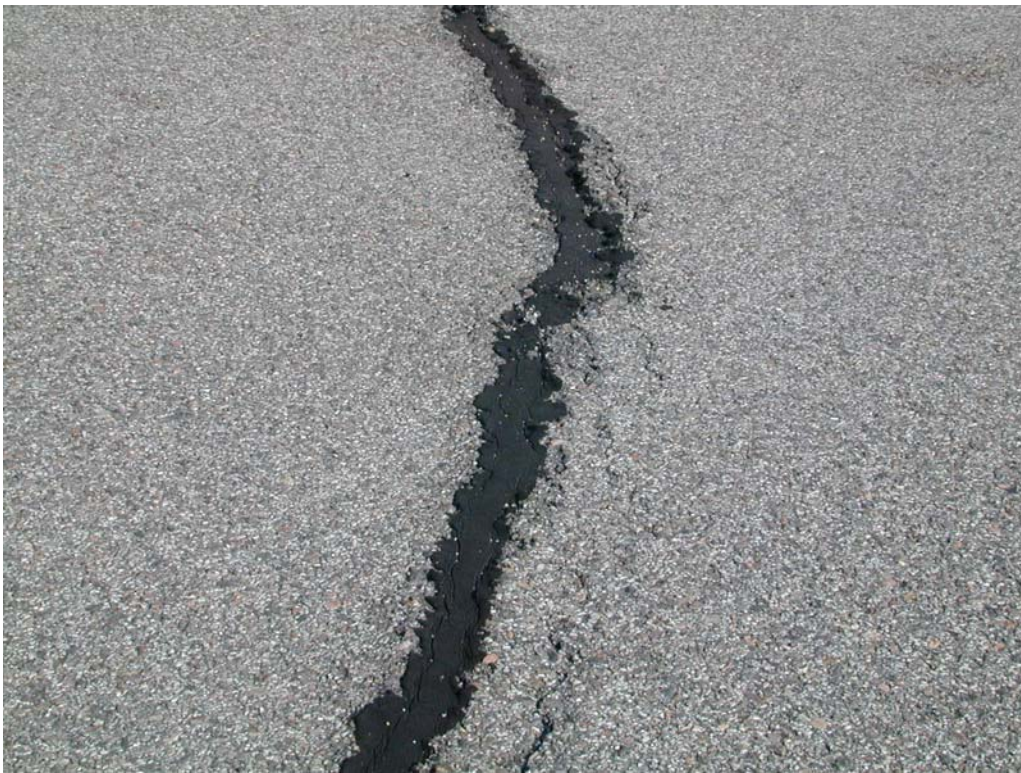
Swelling in section ATOWERAG-10.

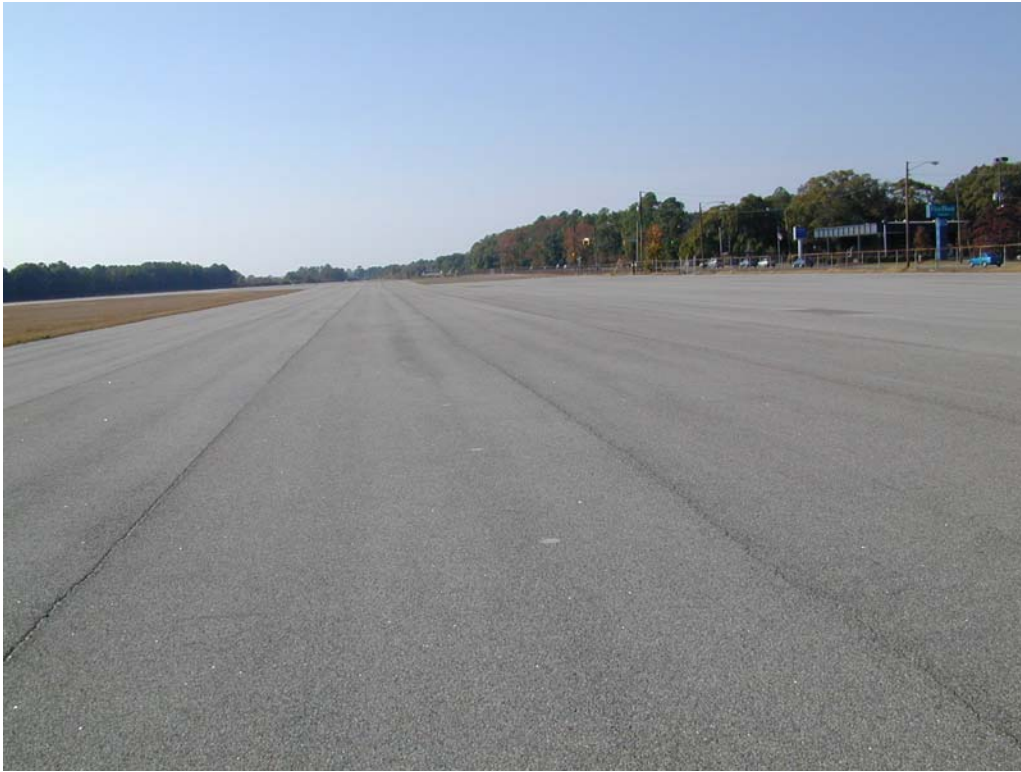
ATOWERAG-20 is also in good condition. Extensive amounts of medium-severity block cracking and low and medium-severity L&T cracking were found throughout the section. Other distresses present in this section included low-severity depression, patching and raveling and weathering.

Overview of section ATOWERAG-20.

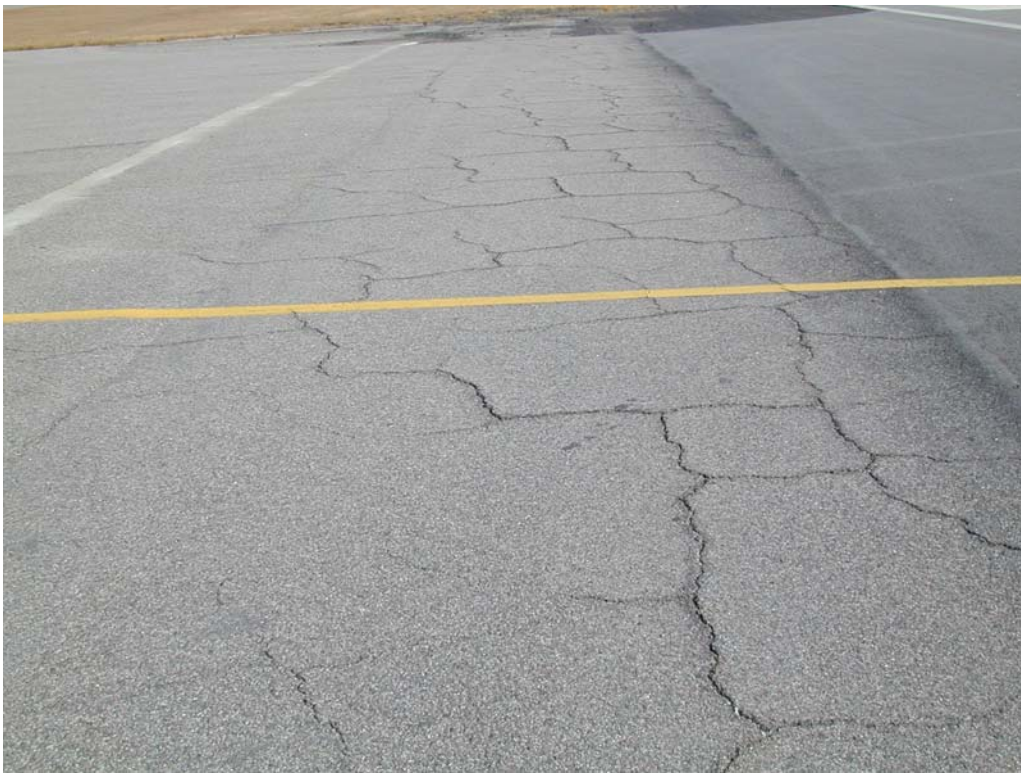
Block cracking in section ATOWERAG-20.

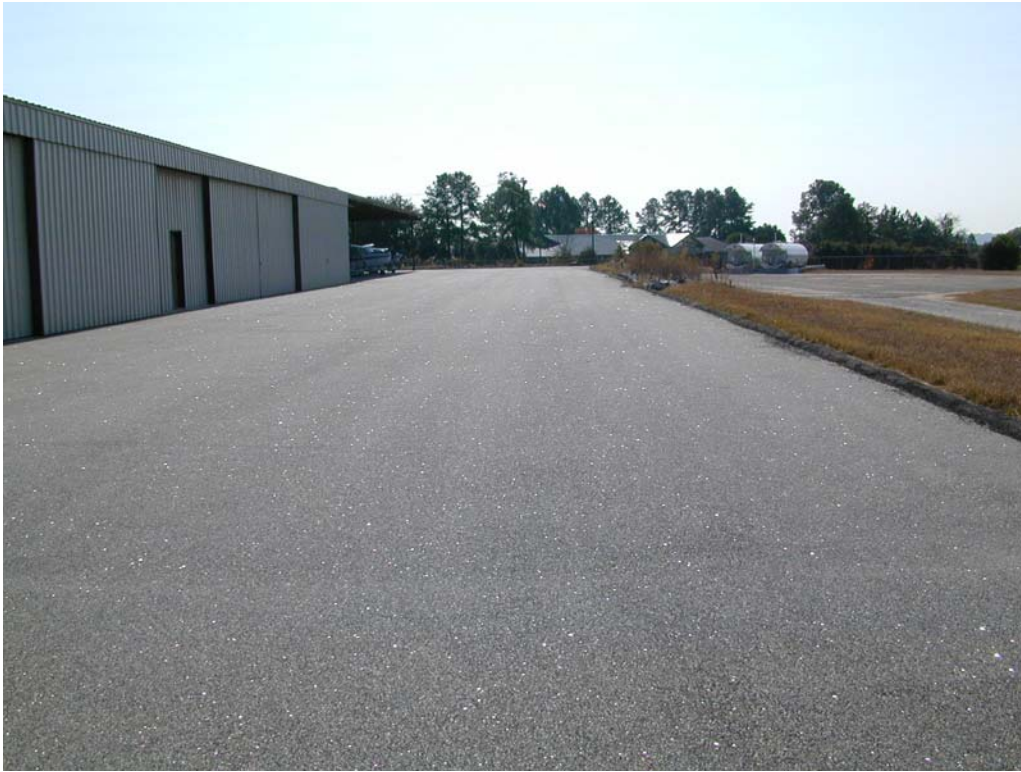
One section defines the t-hangar area on the airport. THANGAG-10 is in very good condition with extensive amounts of low-severity raveling and weathering observed throughout the section.

Overview of section THANGAG-10.

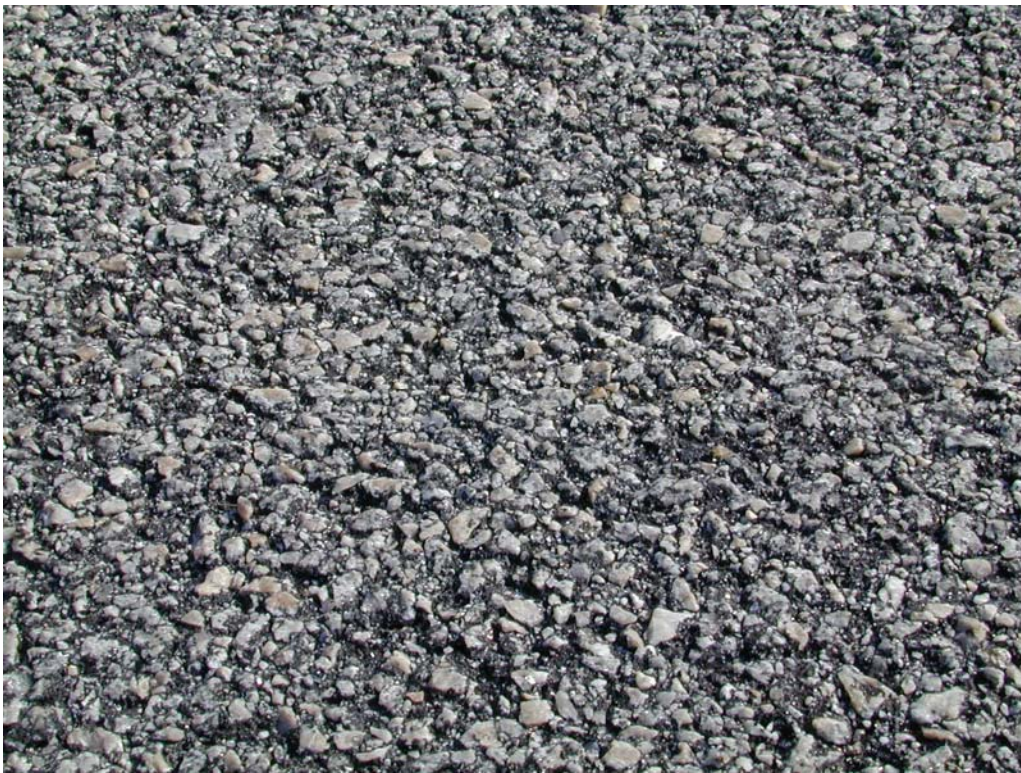
Weathering in section THANGAG-10.
