GWINNETT COUNTY - BRISCOE FIELD

PAVEMENT EVALUATION REPORT

JULY 2002

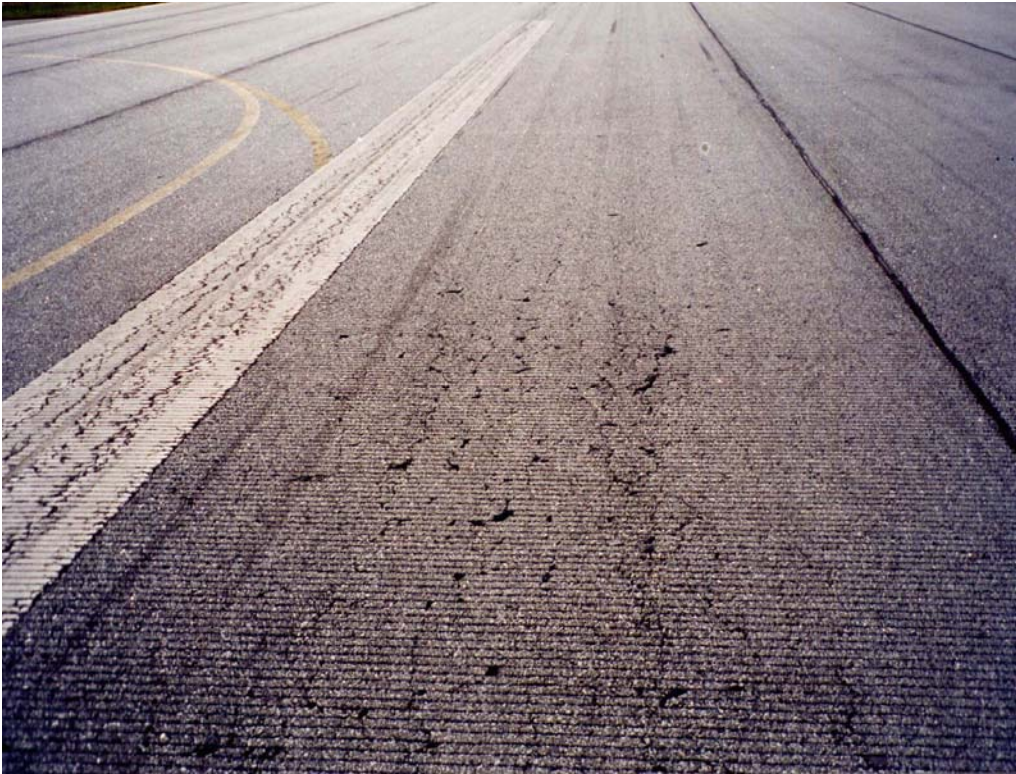
Runway 7-25 is composed of just one section, R725LW-10, that is fair condition. The majority of the distresses are environmentally related but there are some areas containing load-associated distress. The load-associated distresses were found in small quantities and are low and medium-severity alligator cracking. The environmental distresses found are low and medium-severity

Alligator cracking in section R725LW-10.

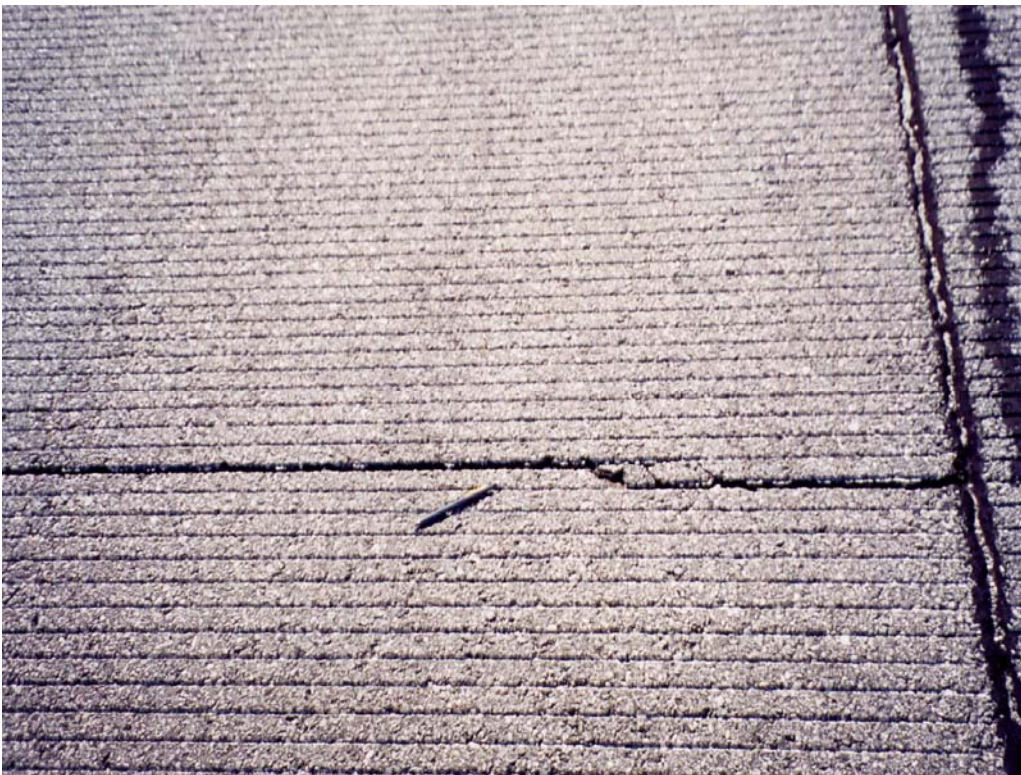
longitudinal and transverse (L&T) cracking and low-severity weathering. The only other distress type identified is low-severity patching.

L&T cracking in section R725LW-10.

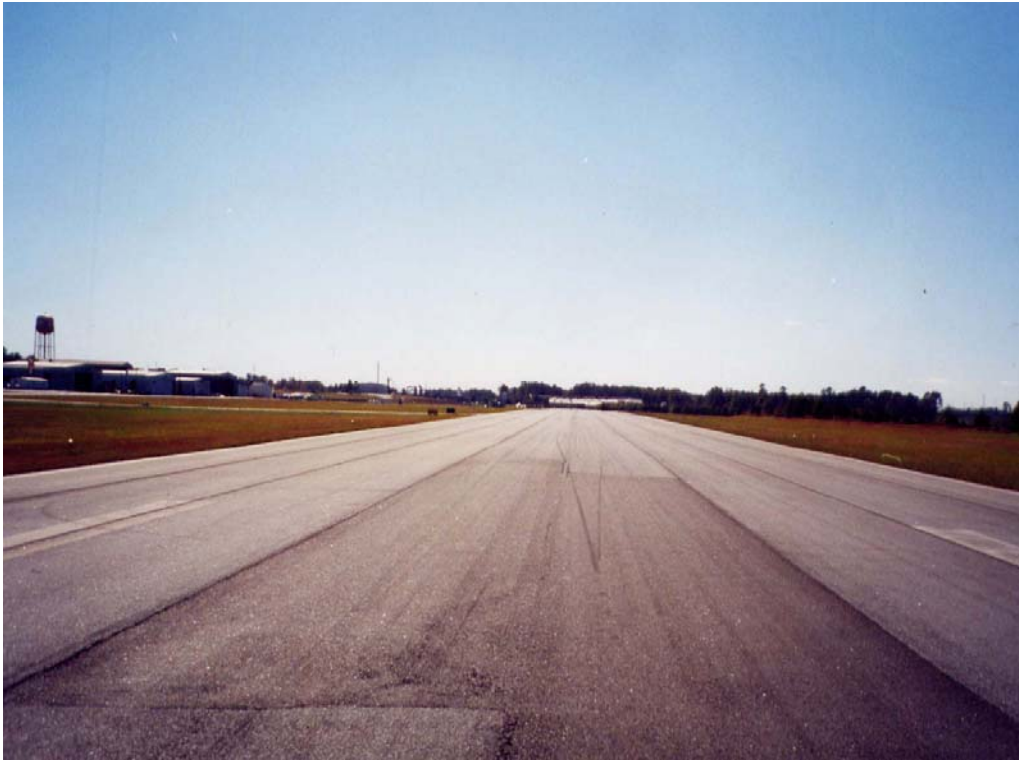
Patch in section R725LW-10.

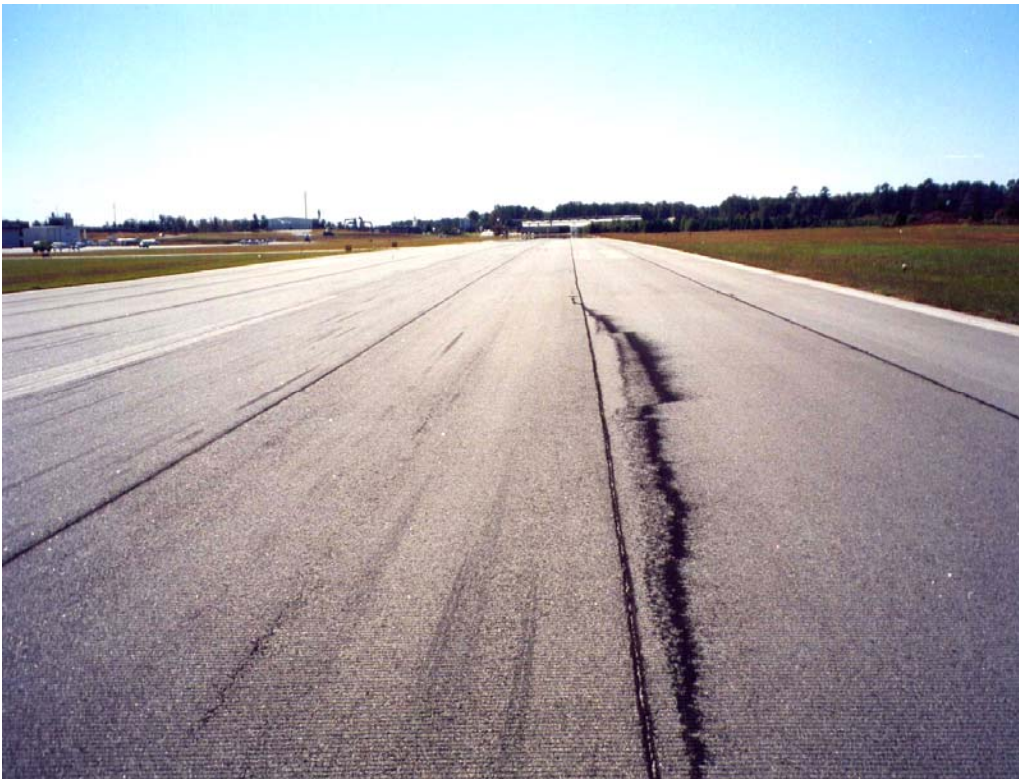
Overview of paving lane and longitudinal crack in section R725LW-10.

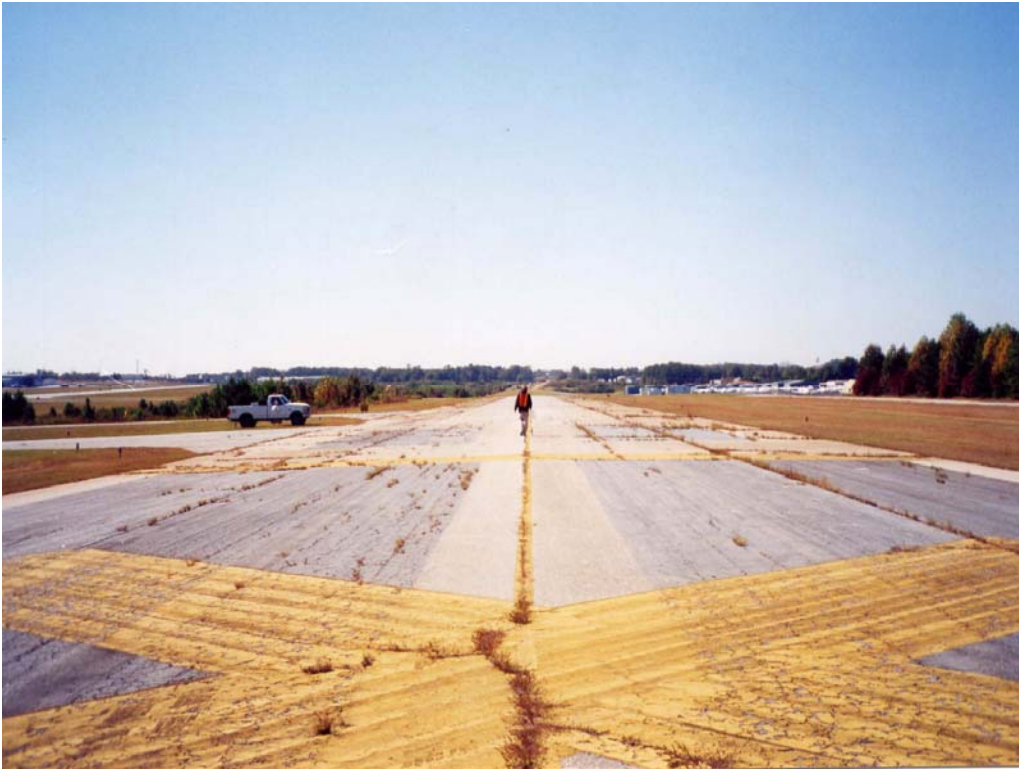
The portion of Taxiway C west of Taxiway D has been removed leaving approximately half of the sample units from the previous survey. The taxiway is only one section TCLW-10, and is in poor condition with significant amounts of distress, although none are rated high-severity. The predominant distresses identified include low and medium-severity alligator, block, and L&T cracking.

Overview of section TCLW-10.

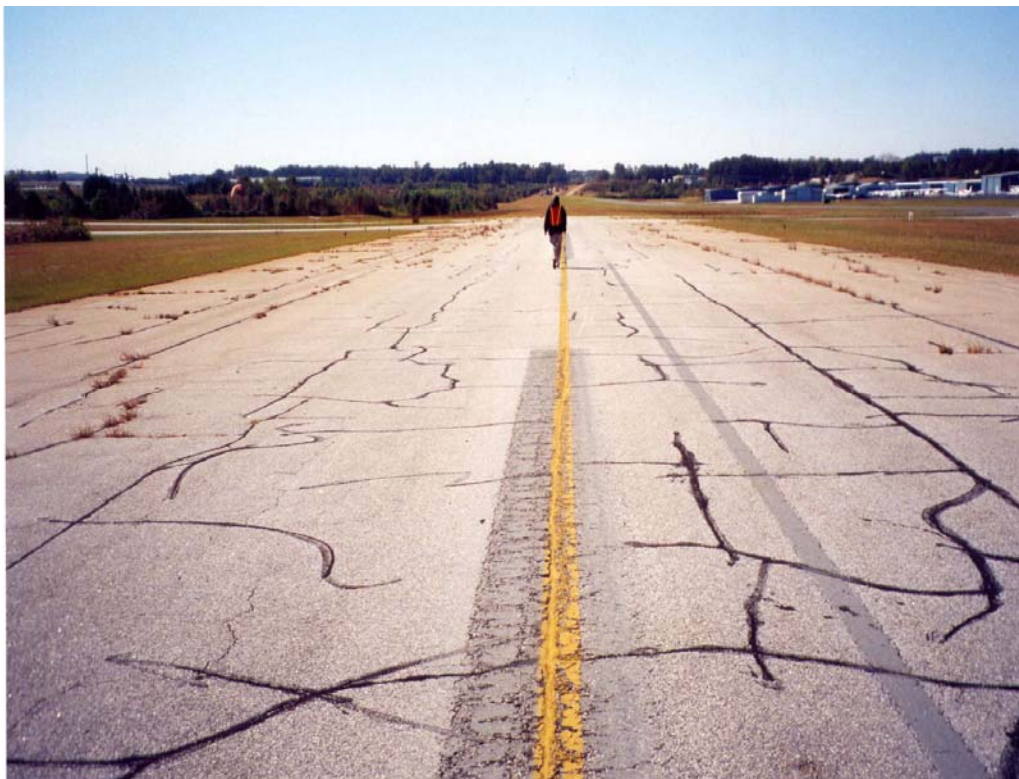
Overview of block cracking in section TCLW-10.

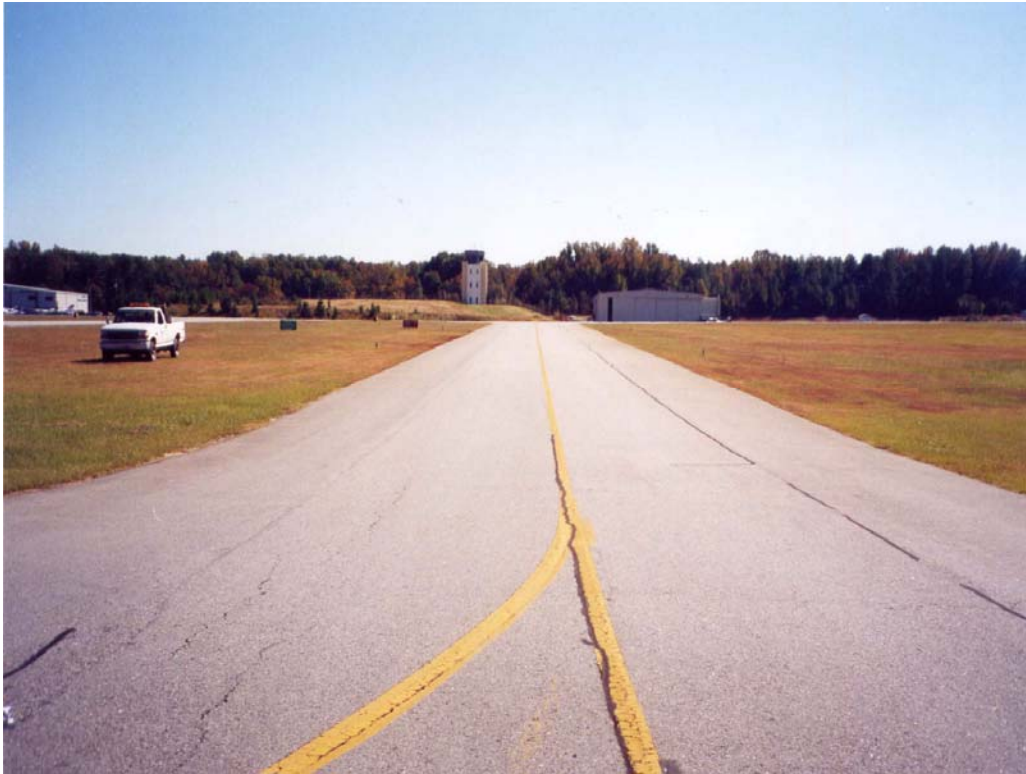
Overview of section TDLW-10.

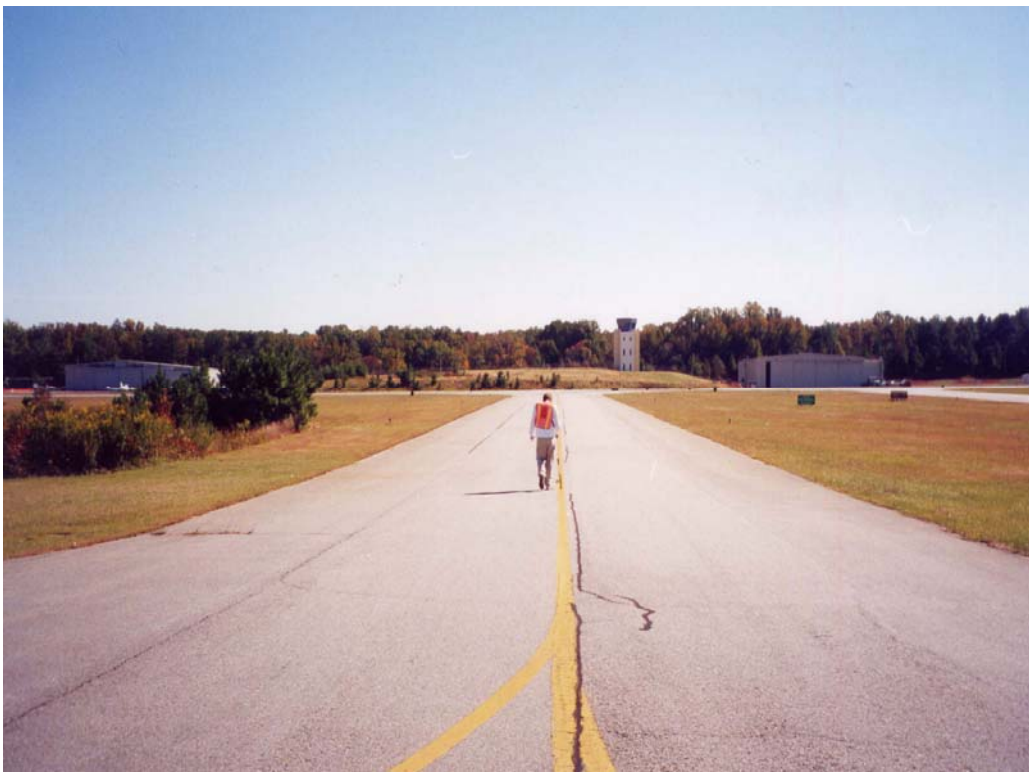
Overview of section TELW-10.

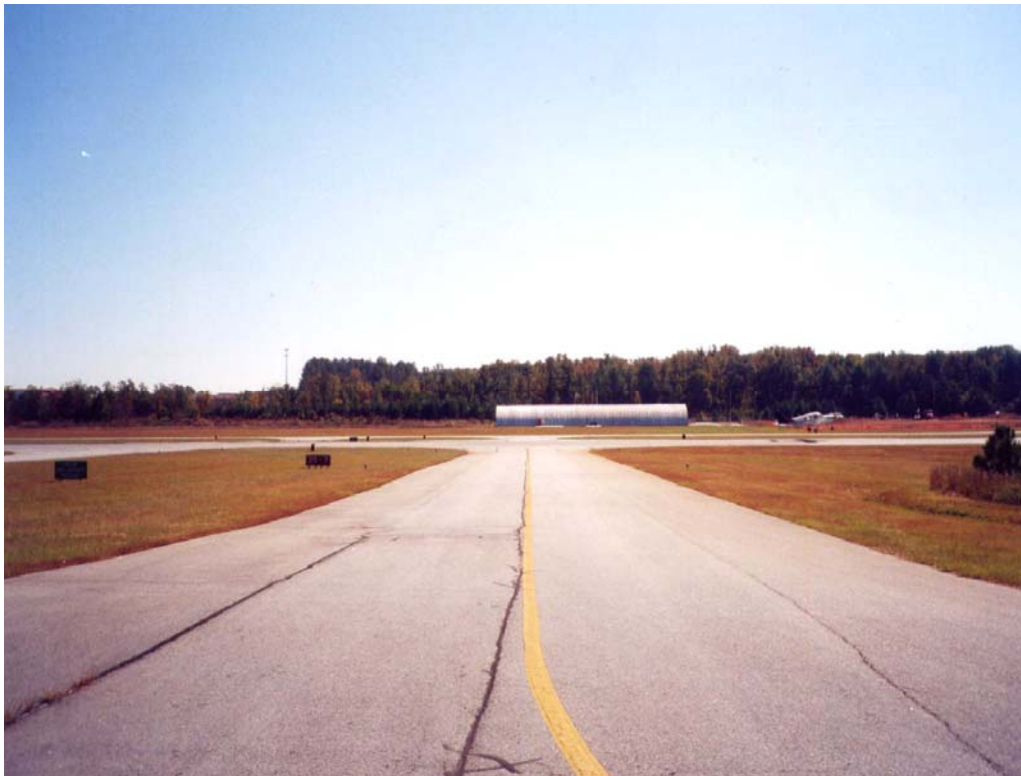
Overview of section TFLW-10.

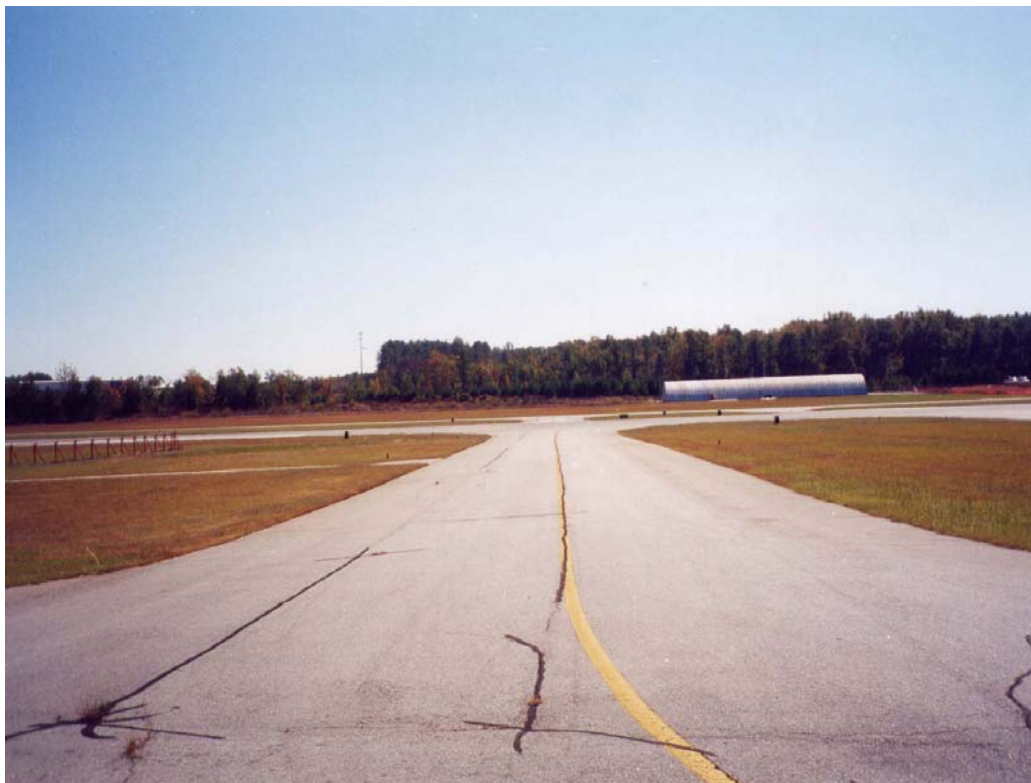
Overview of section TGLW-10.

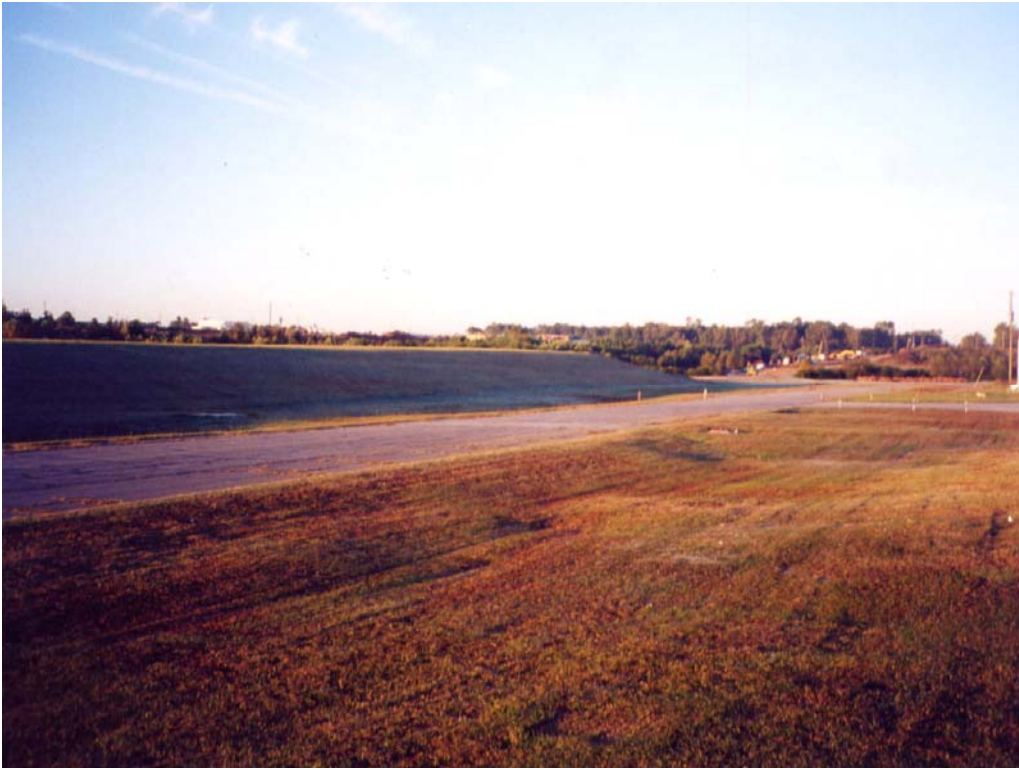
Taxiway H has had portions realigned since the 1998 condition inspections requiring the section to be split into three sections. Section THLW-10 is in fair condition with significant amounts of low and medium-severity block cracking. Section THLW-20 was constructed since the previous inspection and is in excellent condition with no noted distresses. Section THLW-30 is in fair condition with significant amounts of low and medium-severity block cracking and small quantities of weathering.

Overview of section THLW-10.

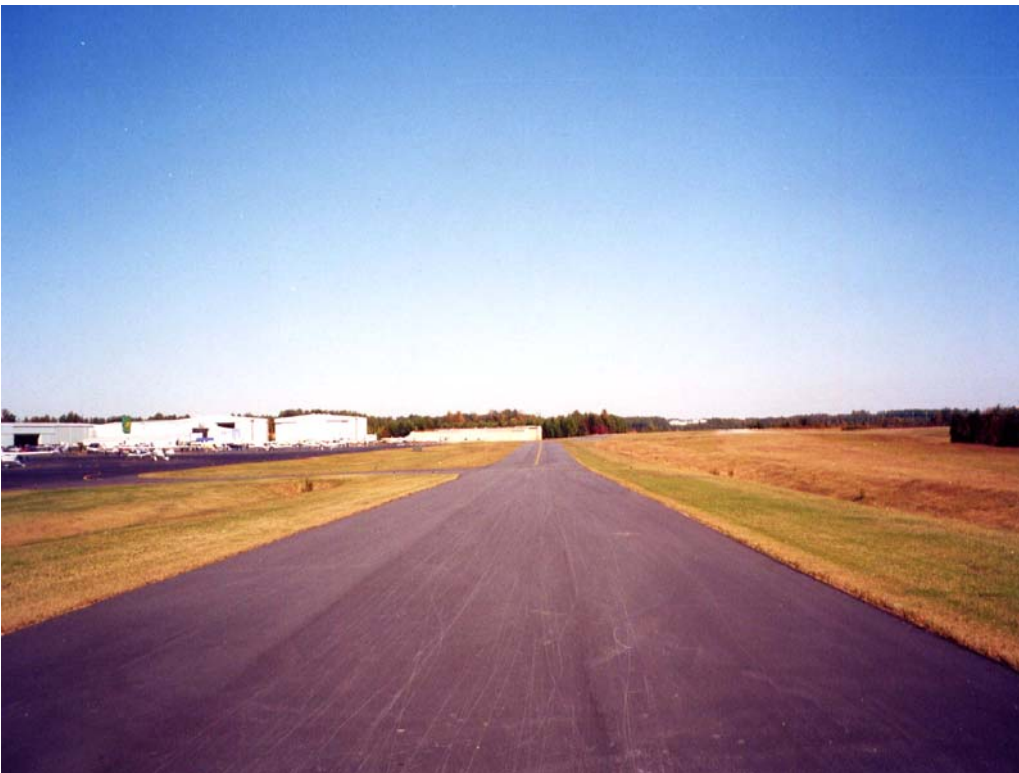
Overview of section THLW-20.

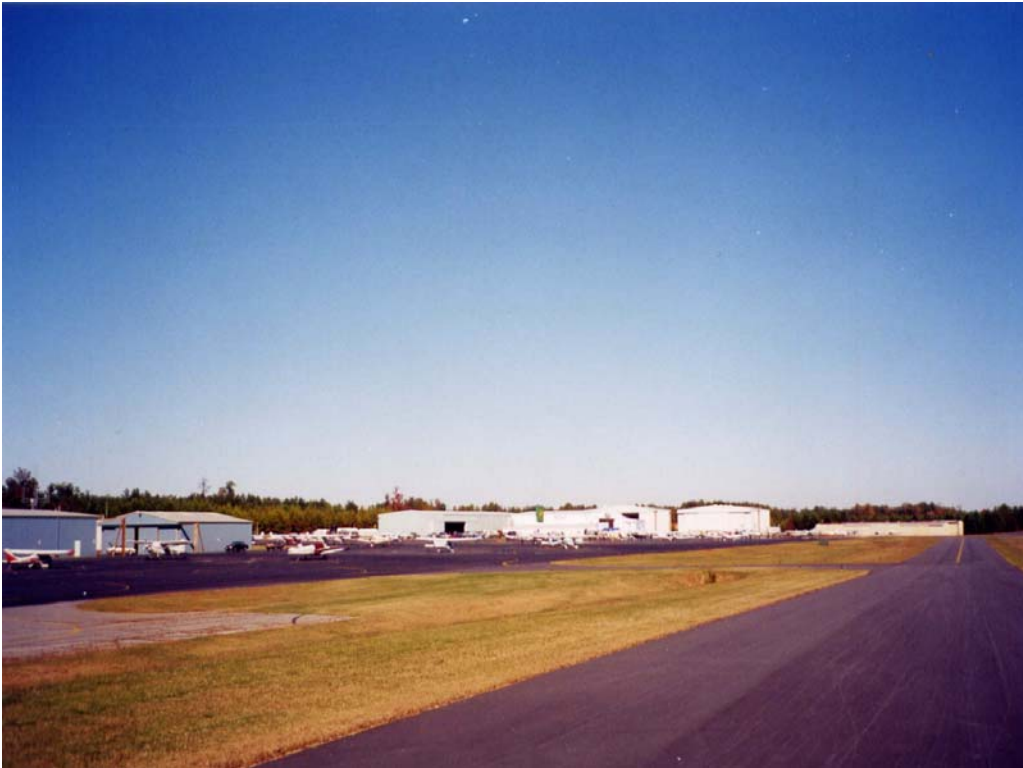
Overview of sections THLW-20 and A01LW-20.

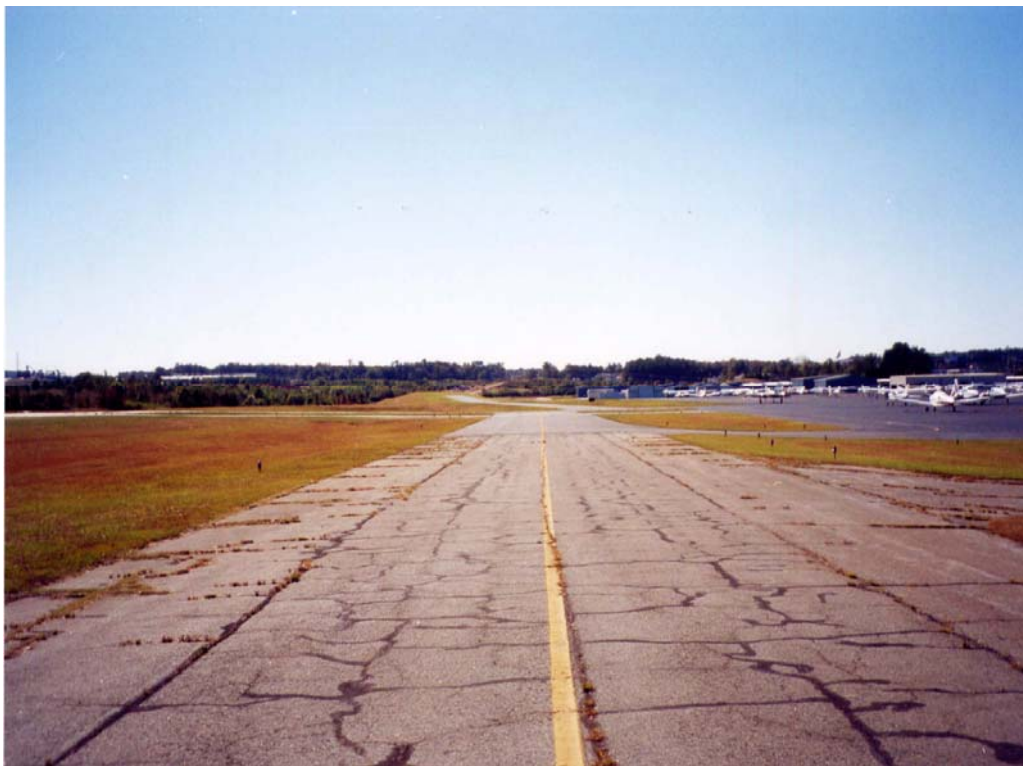
Overview of section THLW-30.

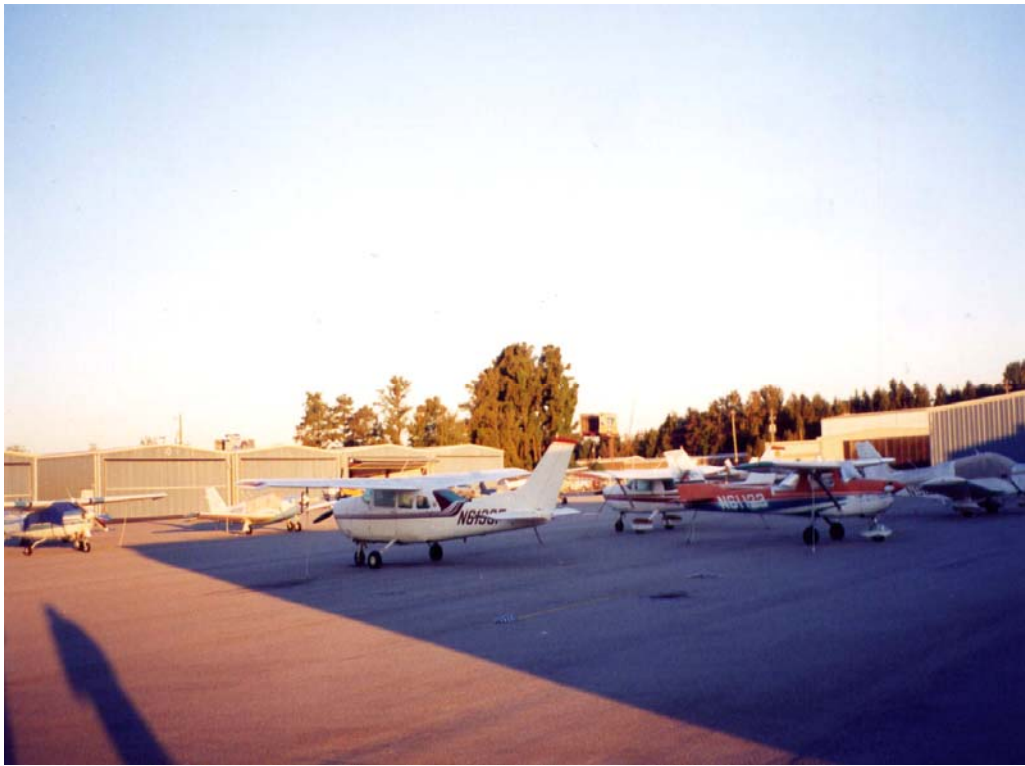
Overview of section A01LW-10.

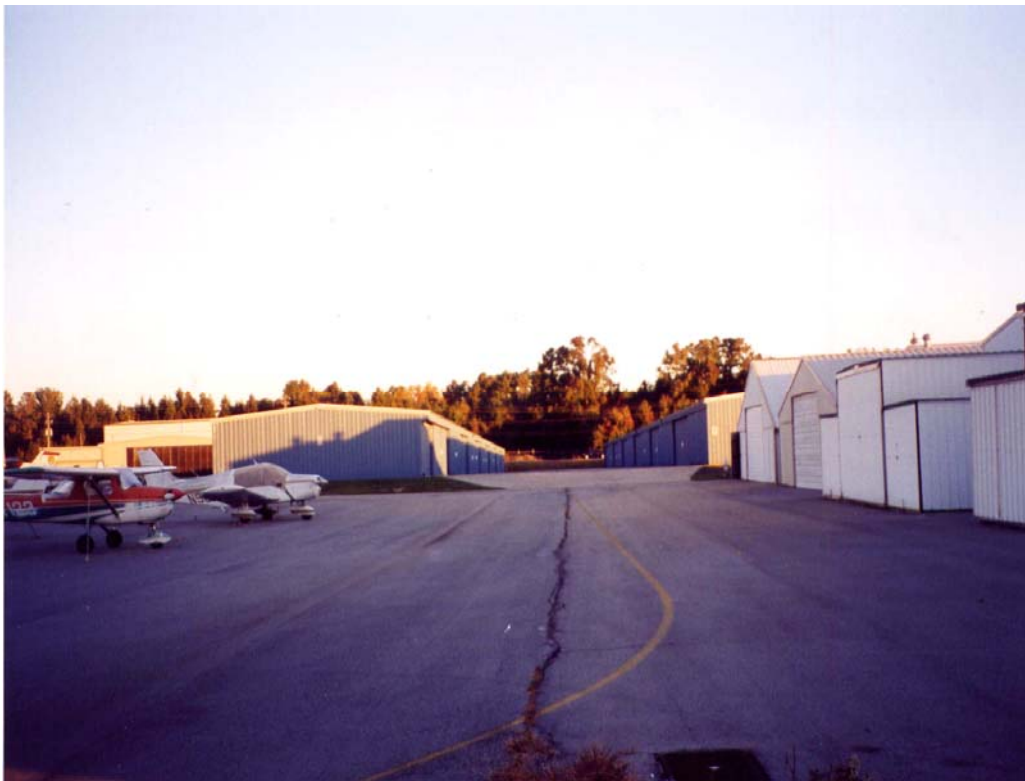
Overview of sections A01LW-10 and THANGLW-10.

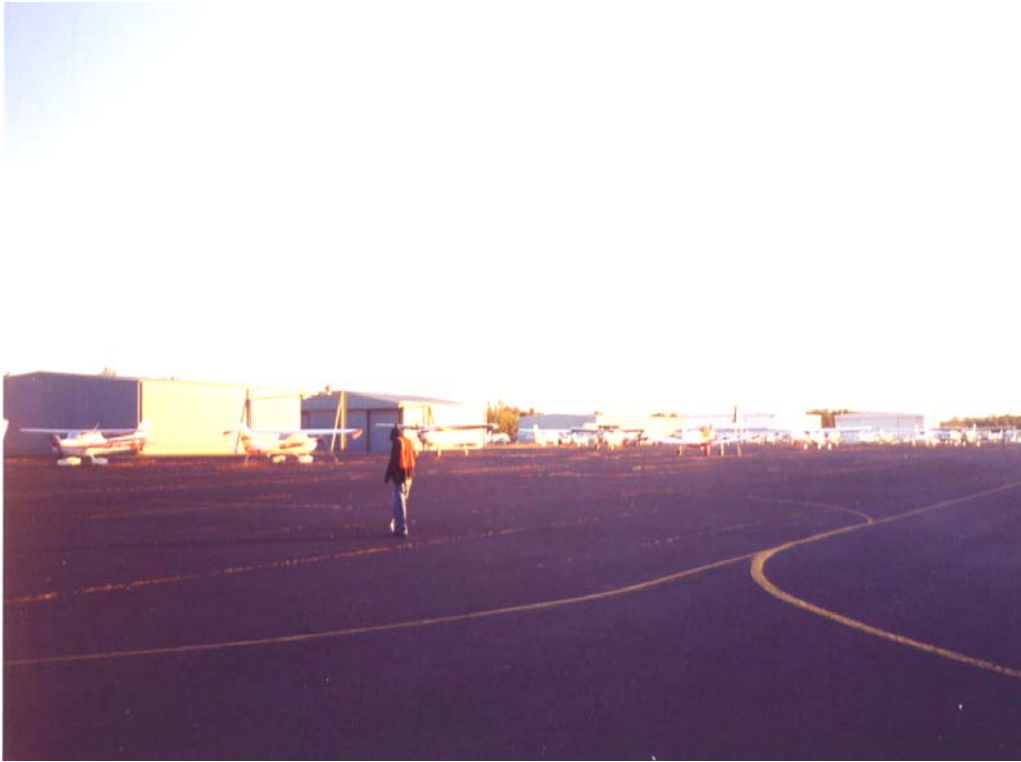
A01LW-20 is the largest section in the branch and it is in good condition. Sealed and unsealed, low and medium-severity L&T cracking are the predominant distresses. In several areas, small

ruts from standing aircraft were also identified, and the seal coat is starting to age but has not deteriorated enough to be considered a distress.

Overview of section A01LW-20.

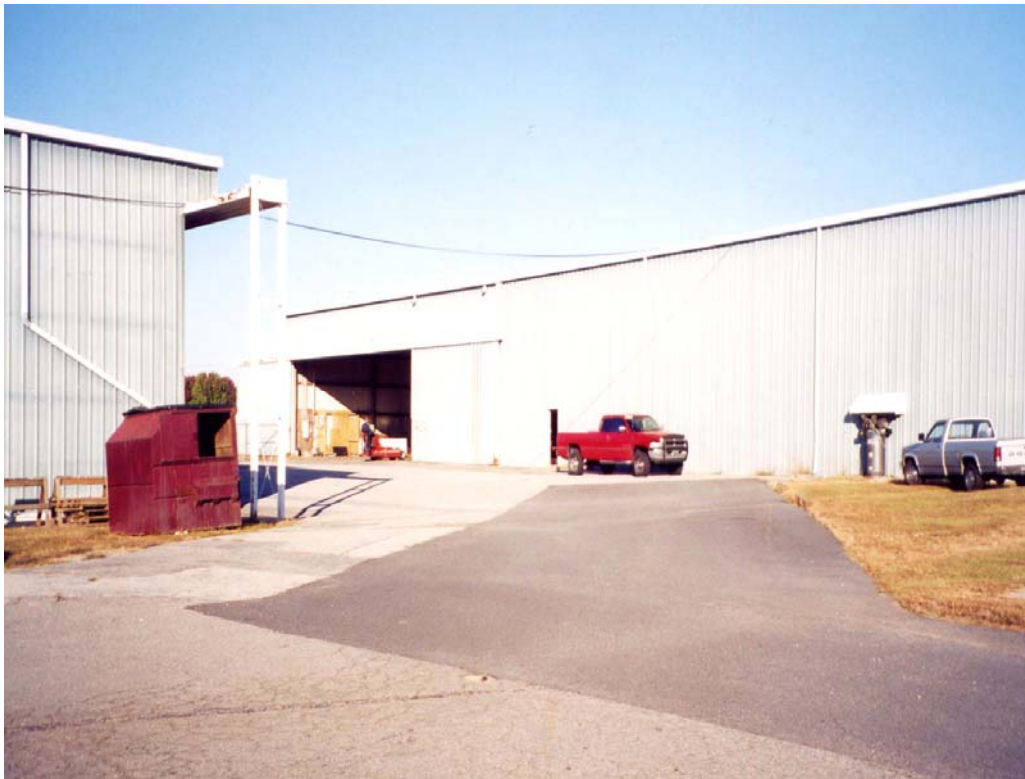
Section A01LW-30 is in poor condition with significant quantities of distress. The section is exhibiting relatively high amounts of all severity levels of alligator cracking along with large areas of low and medium-severity patches.

Overview of section A01LW-30.

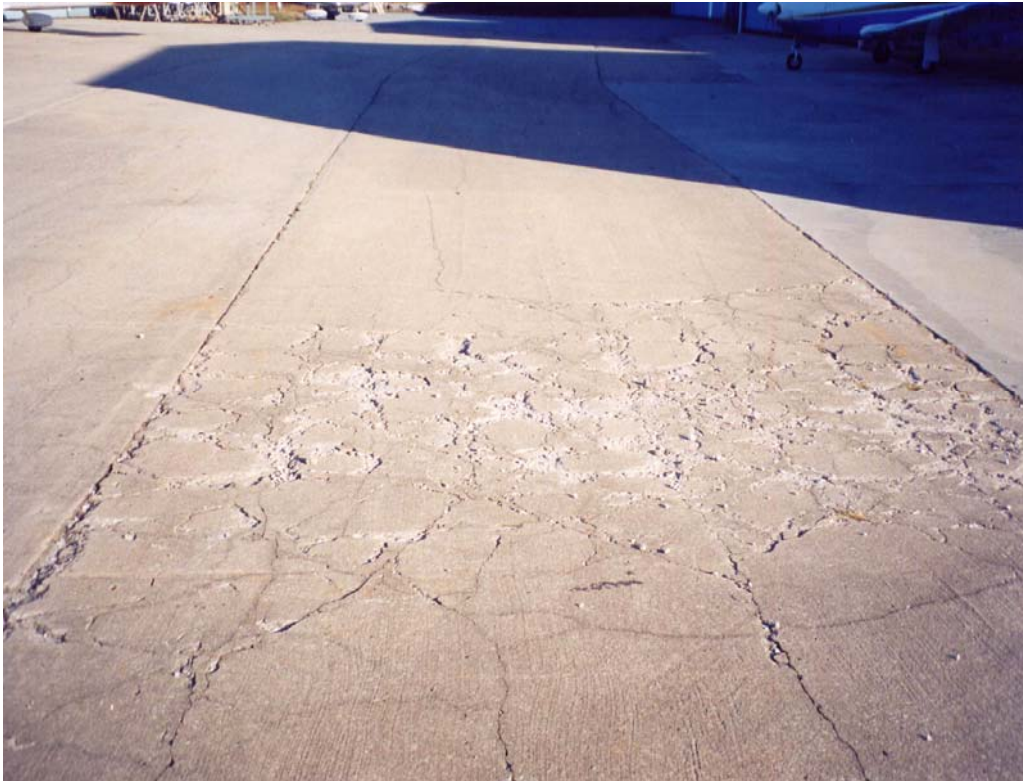
Section A01LW-40 is in poor condition with all severity levels of shattered slabs and corner breaks. Also identified in this section are low and medium-severity linear cracks, patches, and joint spalls.

Shattered slab in section A01LW-40.

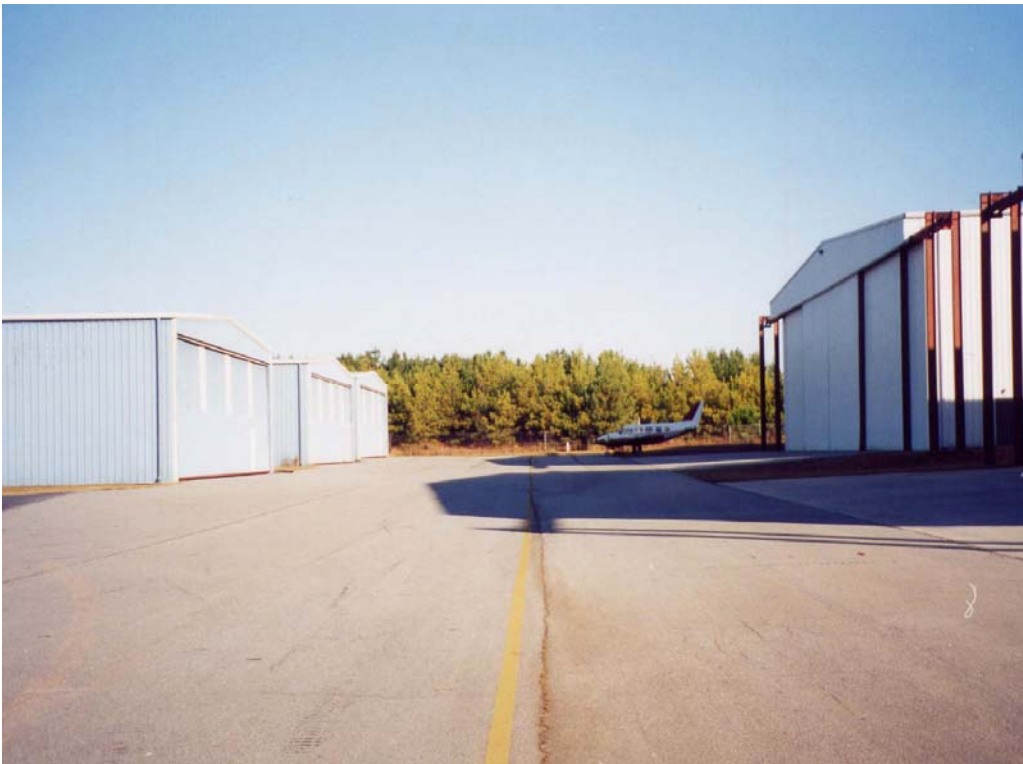
Section A01LW-60 is in good condition but is exhibiting some load related distresses; predominantly low-severity alligator cracking. Other distresses include unsealed, low-severity L&T cracking and low-severity weathering.

Overview of section A01LW-60.
