# MIDDLE GEORGIA REGIONAL AIRPORT

## PAVEMENT EVALUATION REPORT

JULY 2002

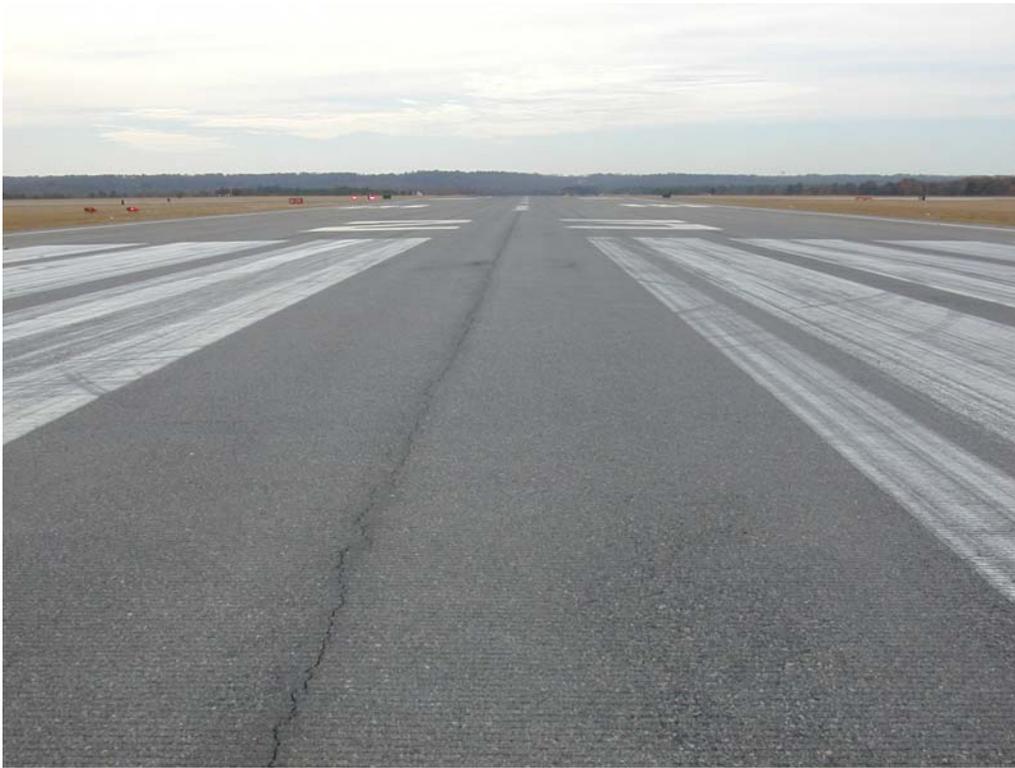
R523MGRA-10C and R523MGRA-20C are in good condition with low-severity rutting and L&T cracking found throughout. Some vegetation growth was present in the cracking. R523MGRA-10N, R523MGRA-10S, R523MGRA-20N and R523MGRA-20S are all in fair condition with increased amounts of medium-severity L&T cracking present. Vegetation growth was also found in this cracking.

Overview of section R523MGRA-10C.

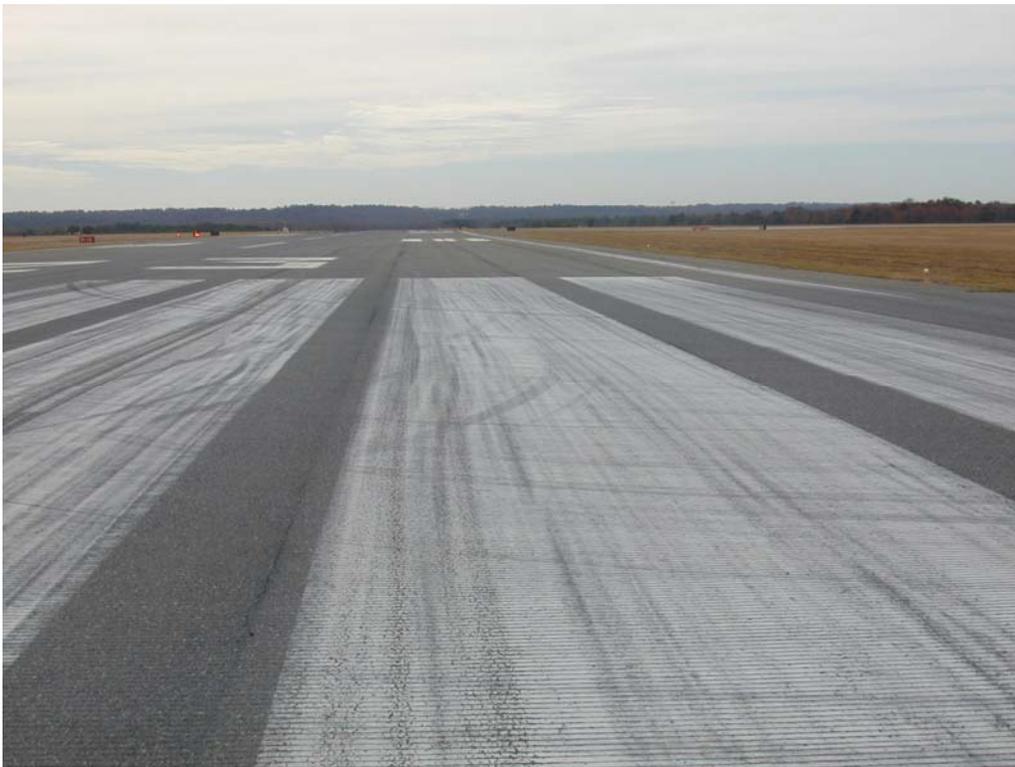
Overview of section R523MGRA-10N.

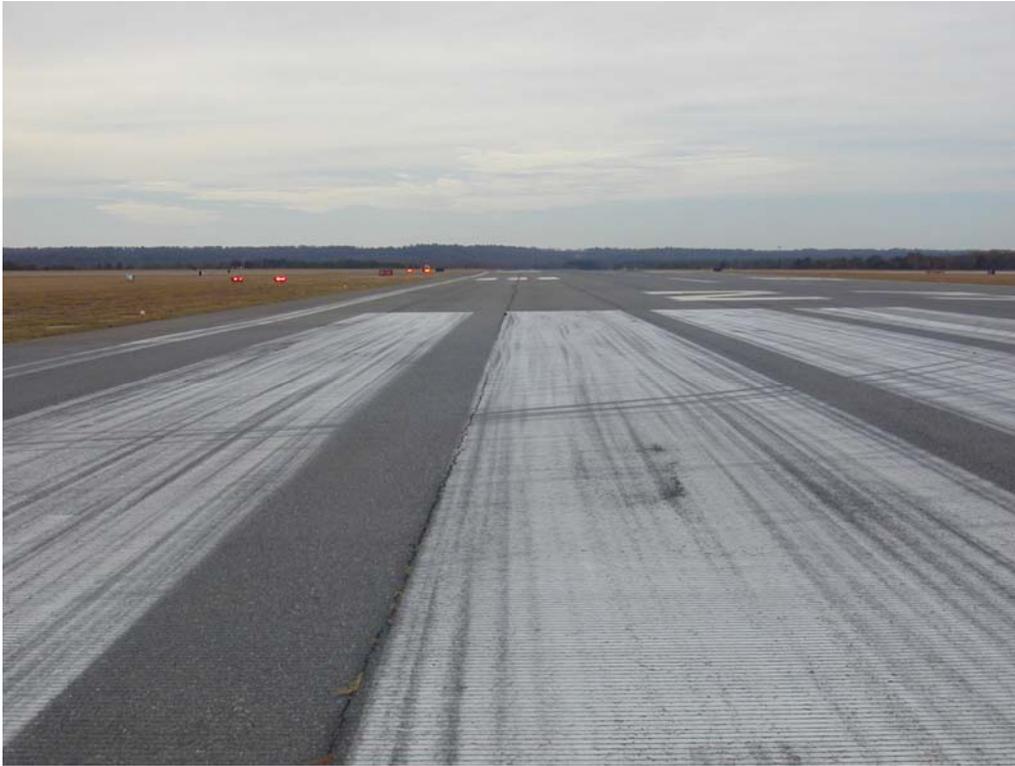
Overview of section R523MGRA-10S.

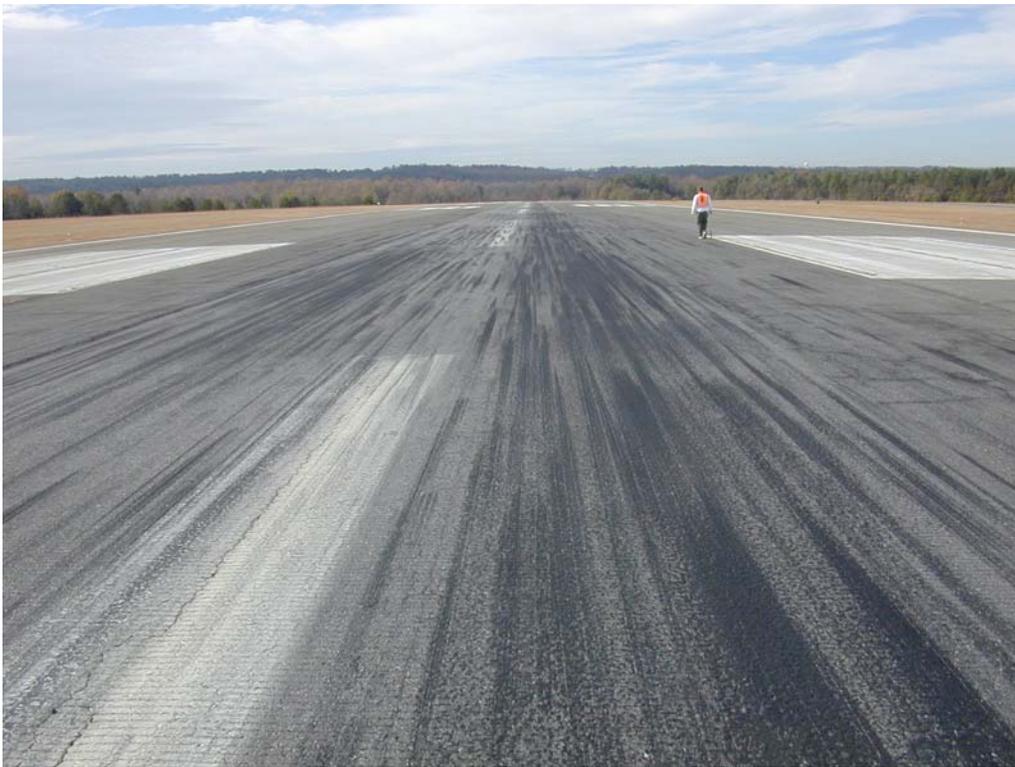
Overview of section R523MGRA-20C.

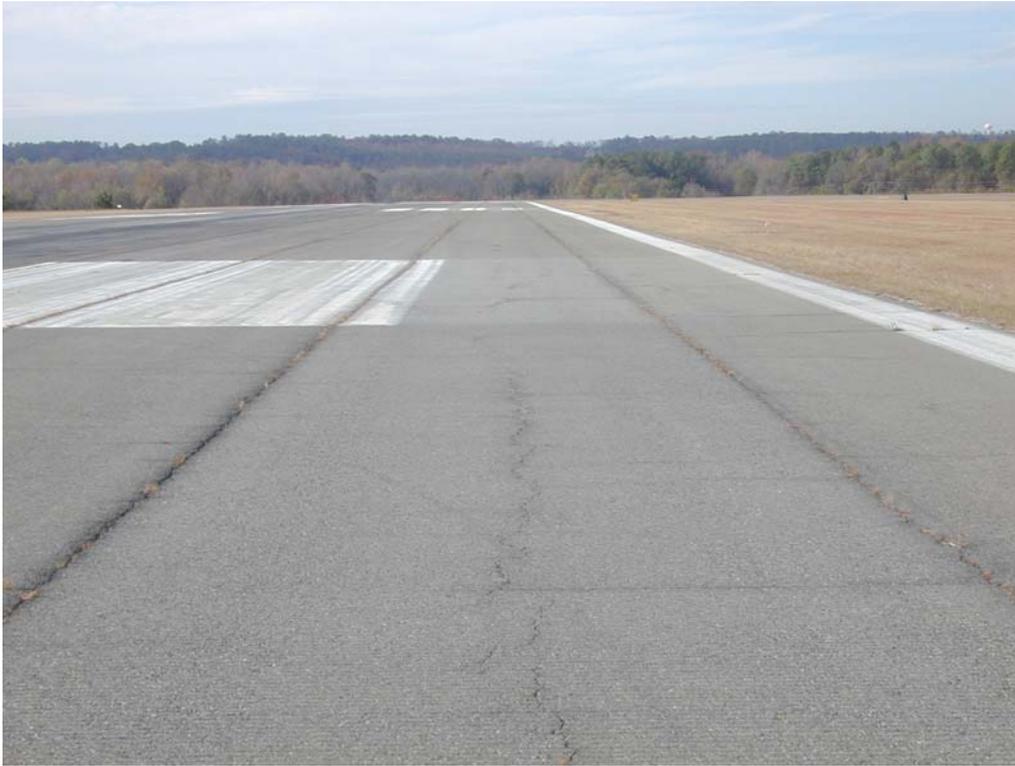
Overview of section R523MGRA-20N.

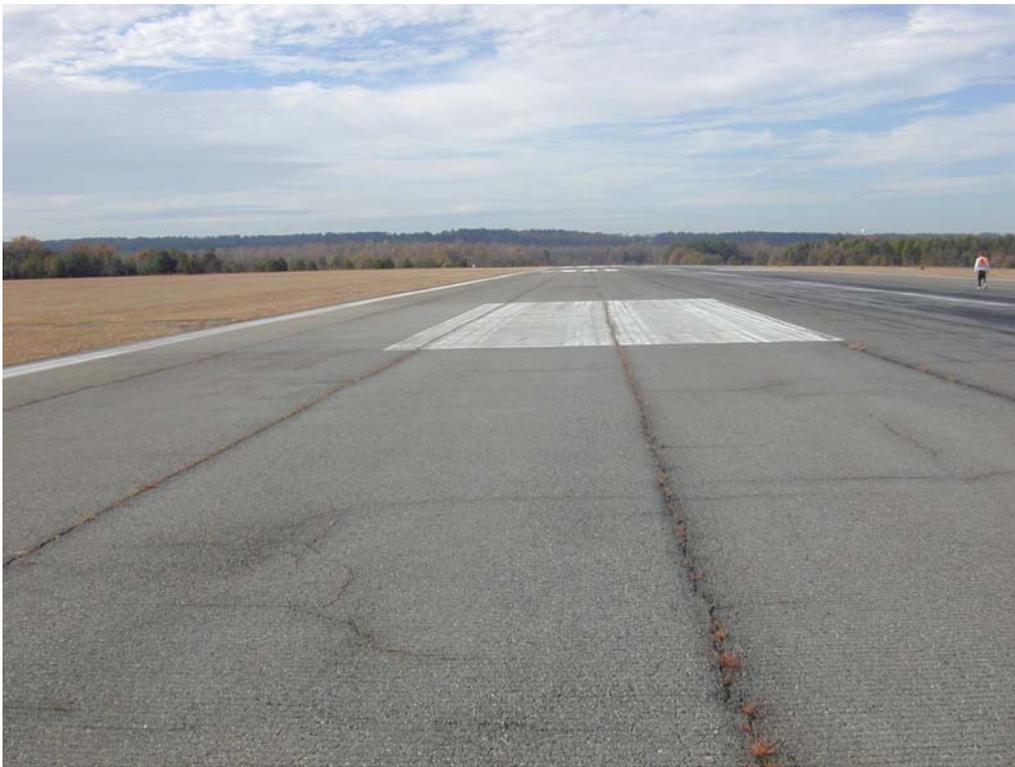
Overview of section R523MGRA-20S.

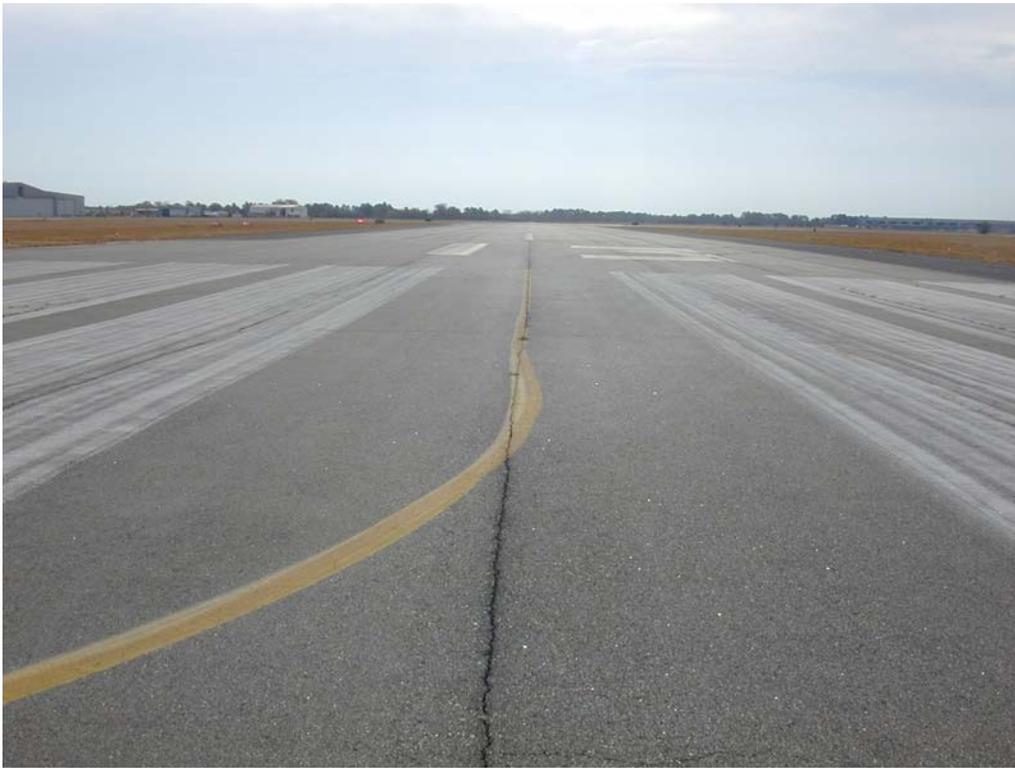
R1331MGRA-10C consists of the center 100 feet of the runway. This portion is in good condition with low-severity, unsealed, longitudinal and transverse (L&T) cracking present. R1331MGRA-10N, the north 25 feet of the runway, and R1331MGRA-10S, the south 25 feet of

Overview of section R1331MGRA-10C.

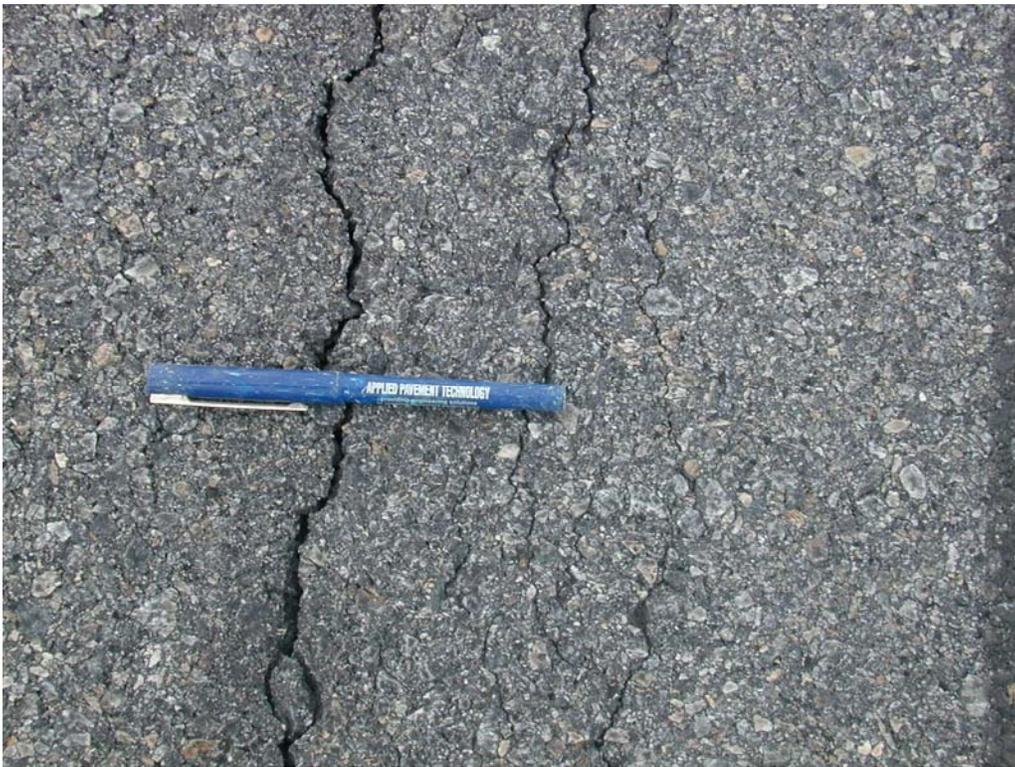
Alligator cracking in section R1331MGRA-10C.

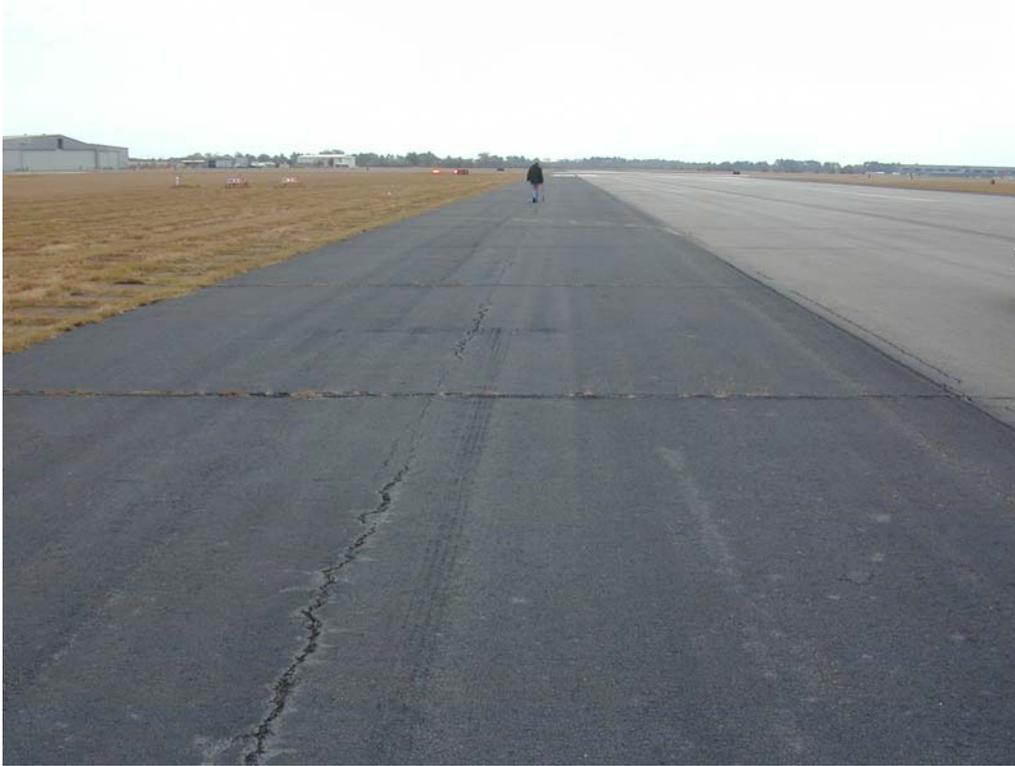
the runway, both contain medium-severity L&T cracking and are in fair condition. All sections have had a surface treatment applied on them that is starting to show signs of wear in areas.

Overview of section R1331MGRA-10N.

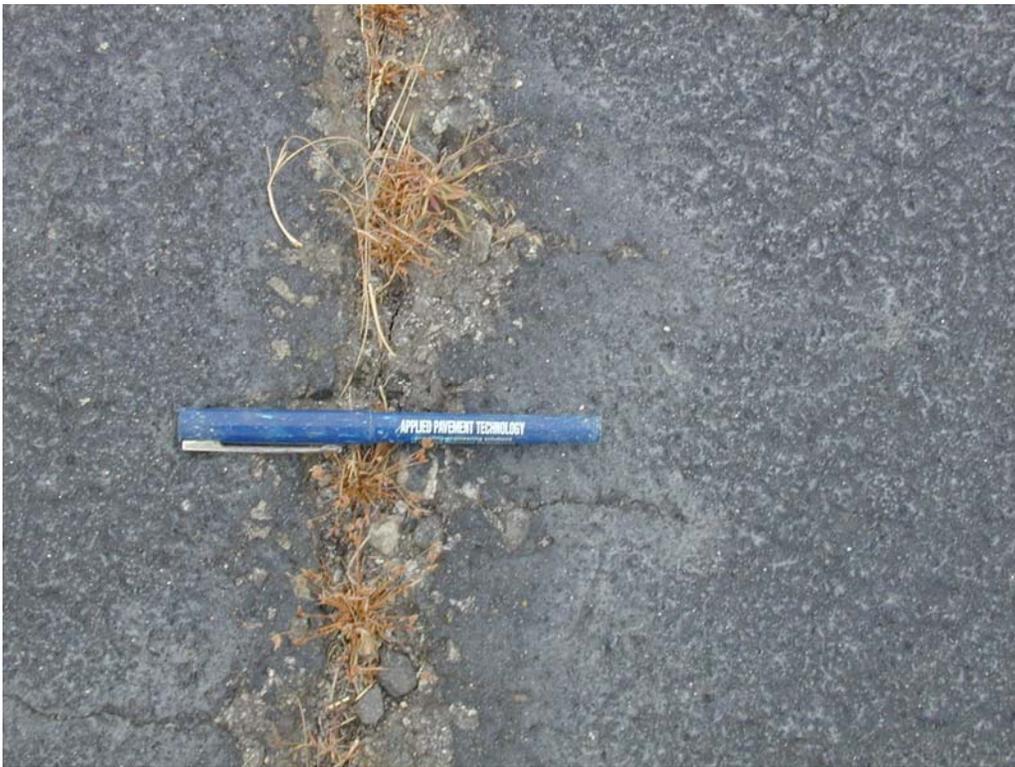
L&T cracking in section R1331MGRA-10N.

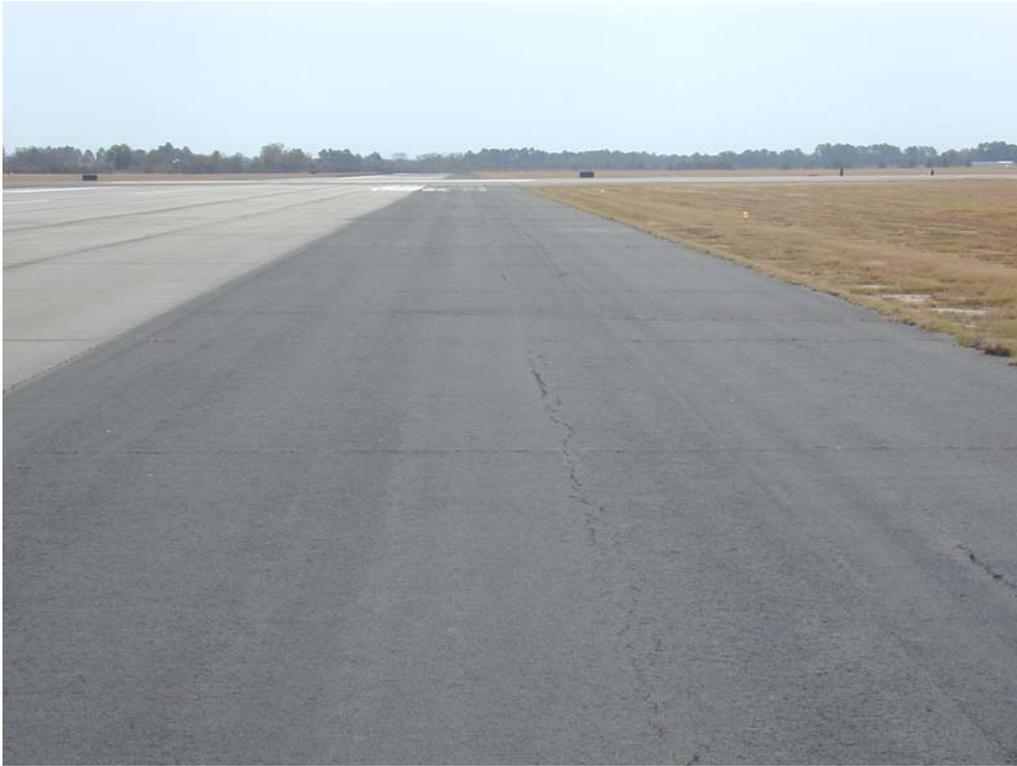
Overview of section R1331MGRA-10S.

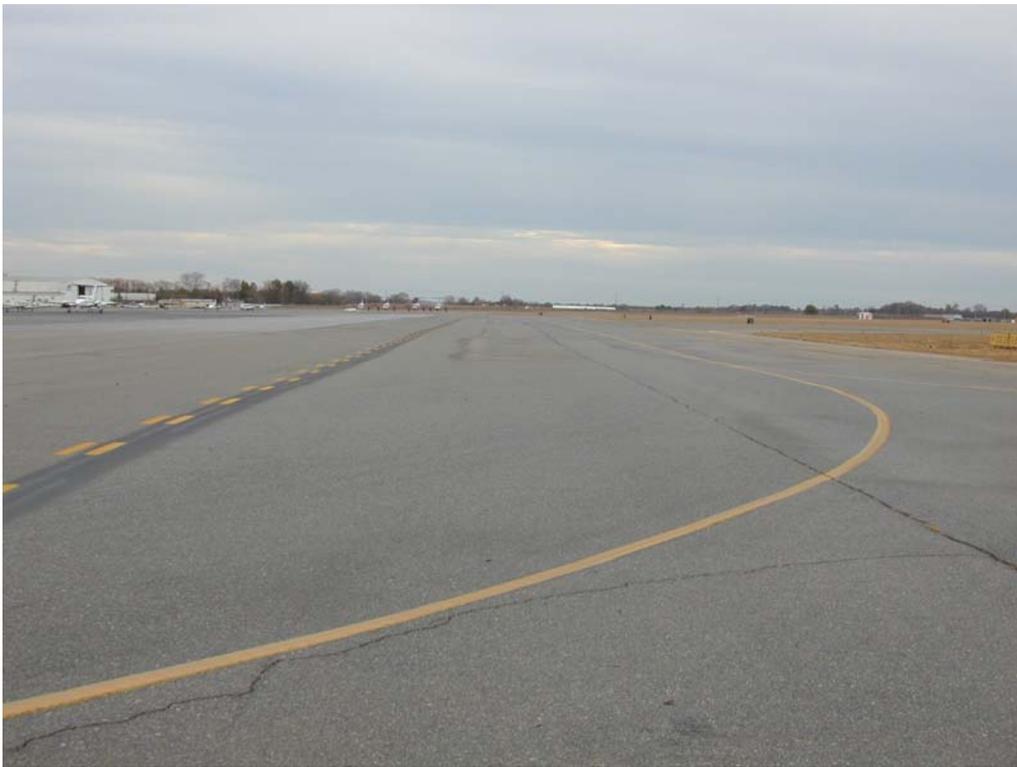
Taxiway A, adjacent to the apron area, is defined as one section. TAMGRA-10 is in fair condition with low-severity, unsealed, L&T and block cracking found throughout the section.

Overview of section TAMGRA-10.

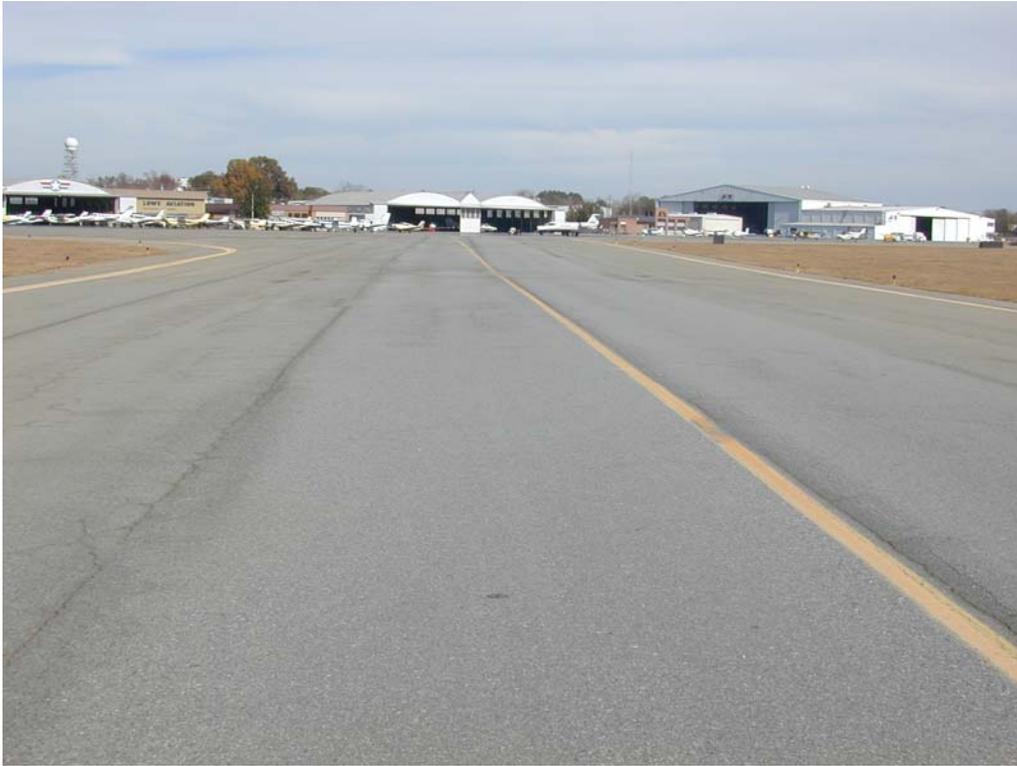
TBMGRA-10 connects Taxiway A to Runway 13-31. It is in fair condition with low-severity, unsealed, L&T cracking observed.

Overview of section TBMGRA-10.

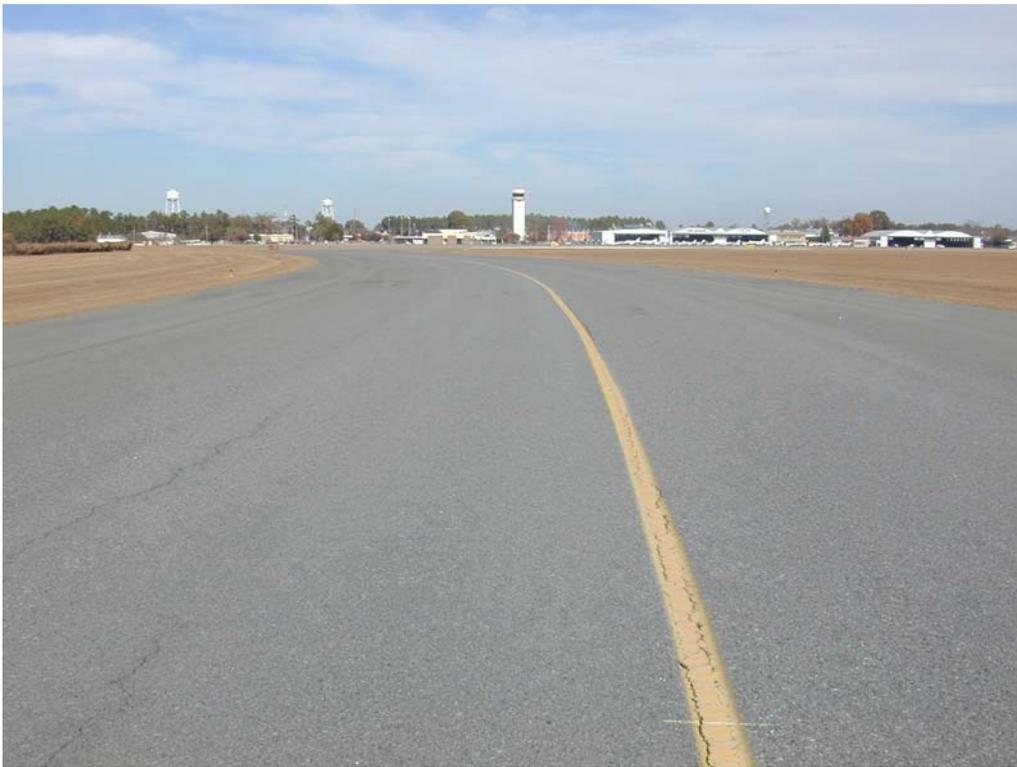
TBMGRA-20 runs from Runway 13-31 to TBMGRA-30 and is in very good condition. Low-severity, unsealed, L&T cracking was found in this section. The majority of the cracking was found along paving lane joints.

Overview of section TBMGRA-20.

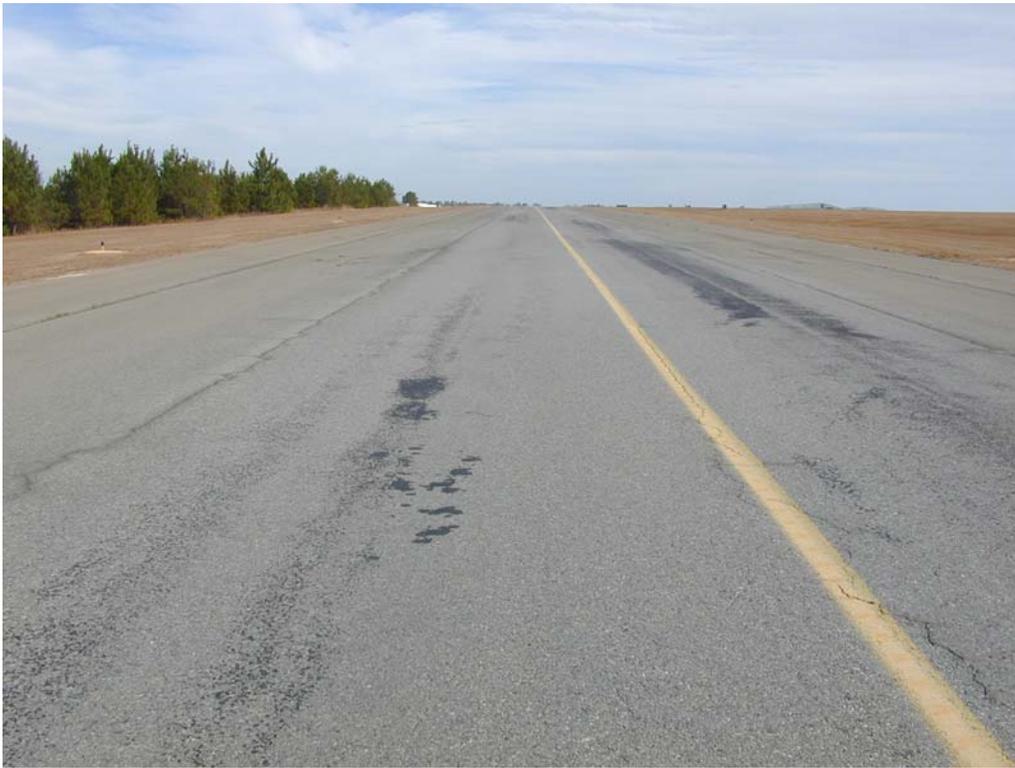
TBMGRA-30 extends to Runway 5-23 and is fair condition. Medium-severity L&T cracking and bleeding were observed in this section. Vegetation growth was present in much of the cracking.

Overview of section TBMGRA-30.

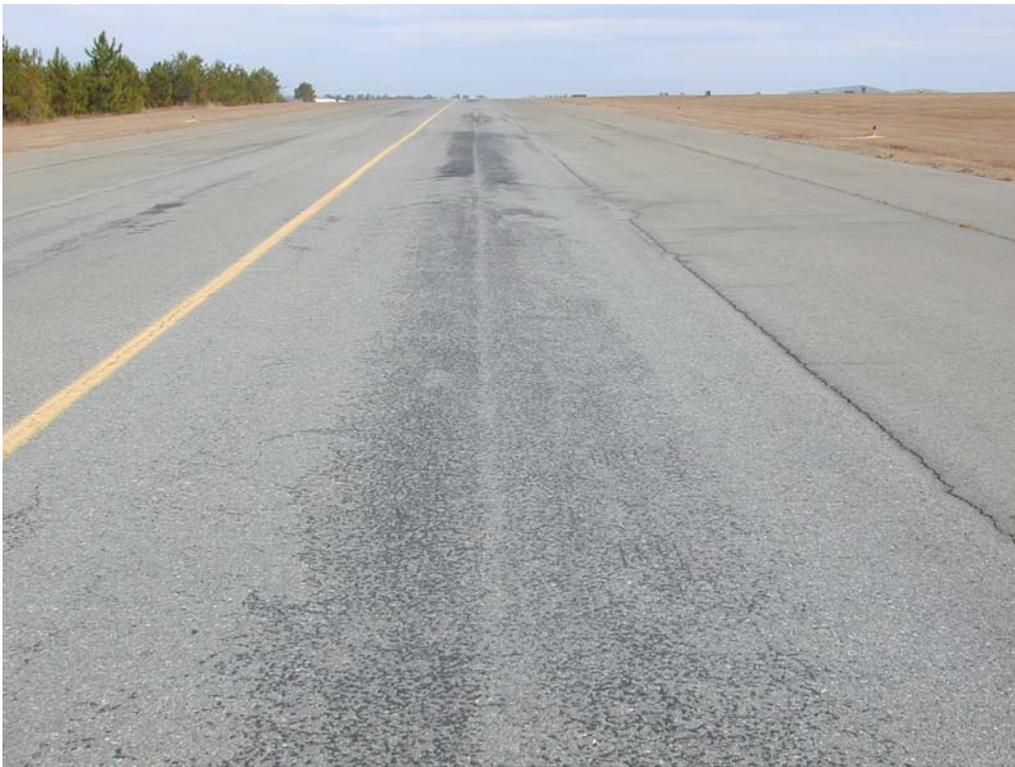
Bleeding in section TBMGRA-30.

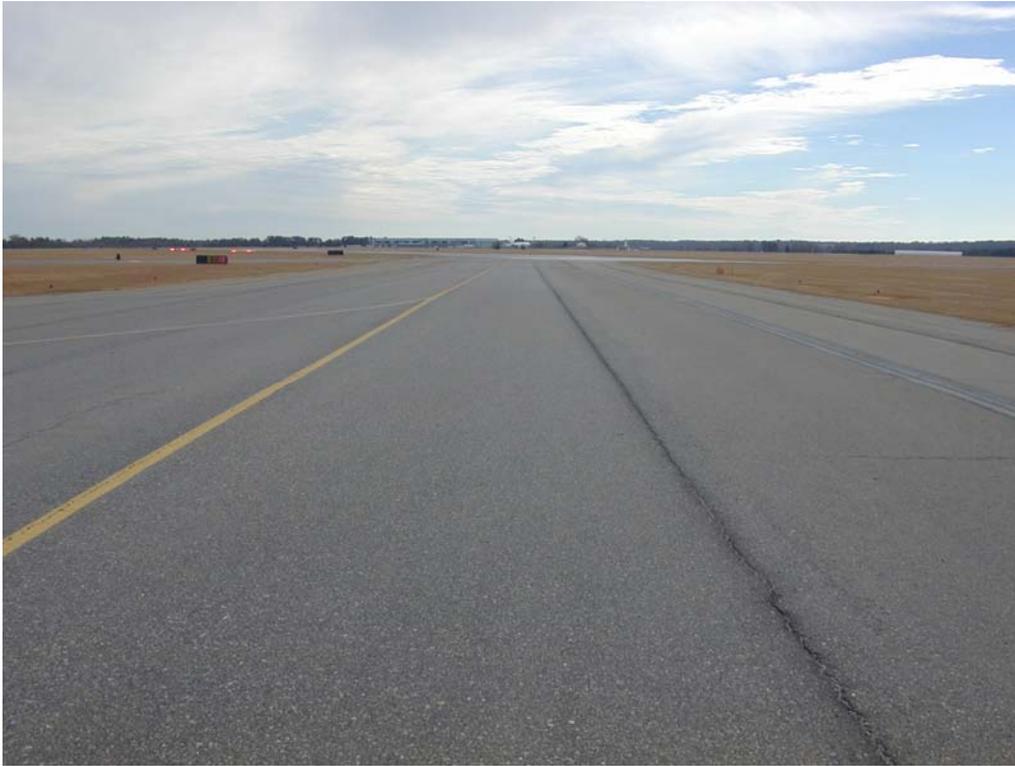
Taxiway B3, defined as one section, connects Taxiway A to Runway 13-31. TB3MGRA-10 is in good condition with moderate amounts of medium-severity L&T cracking and isolated areas of swell.

Overview of section TB3MGRA-10.

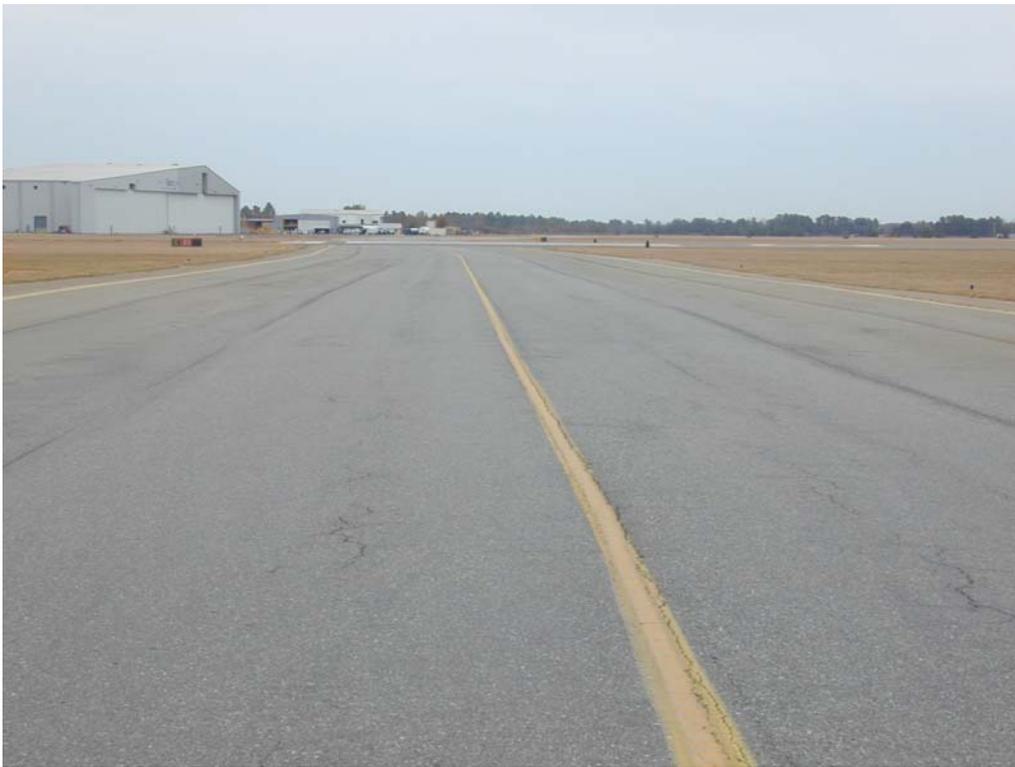
TCMGRA-10 connects Taxiway A to the 23 end of Runway 5-23 and is in fair condition with large quantities of low-severity, unsealed, L&T, block and alligator cracking observed.

Overview of section TCMGRA-10.

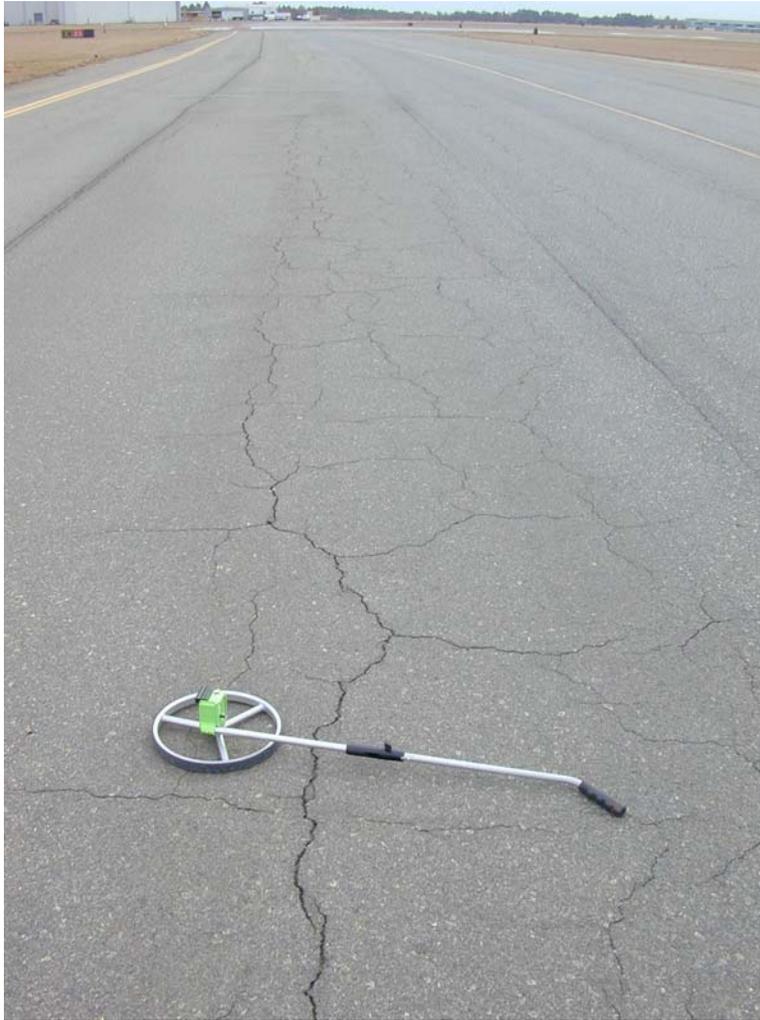
Block cracking in section TCMGRA-10.

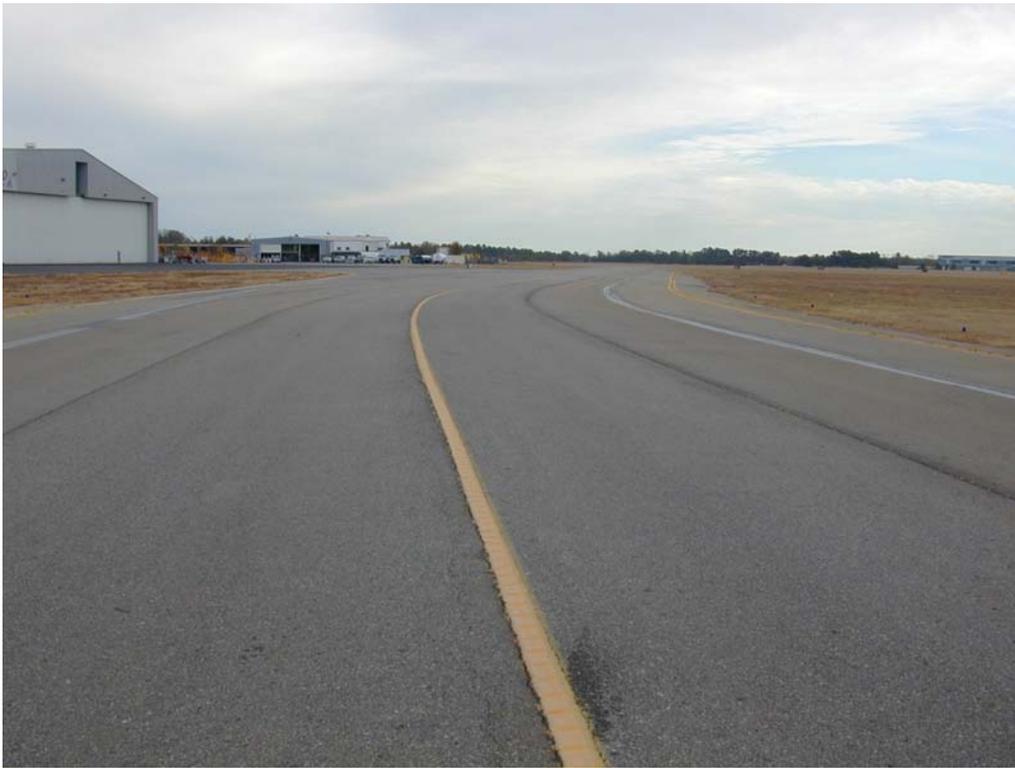
TCMGRA-20 runs from the approach end of Runway 23 to the approach end of Runway 31. This section is in good condition with low-severity, unsealed, L&T cracking found throughout.

Overview of section TCMGRA-20.

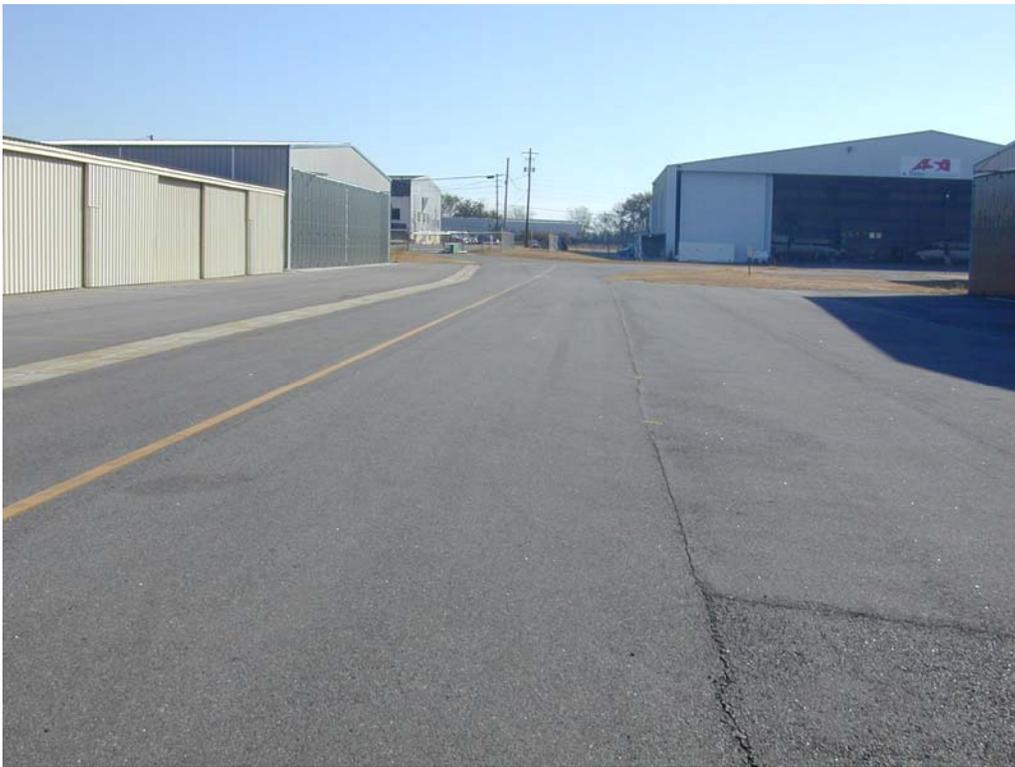
Taxiway GA, defined by one section, is in very good condition with small amounts of L&T and alligator cracking observed throughout.

Overview of section TGAMGRA-10.

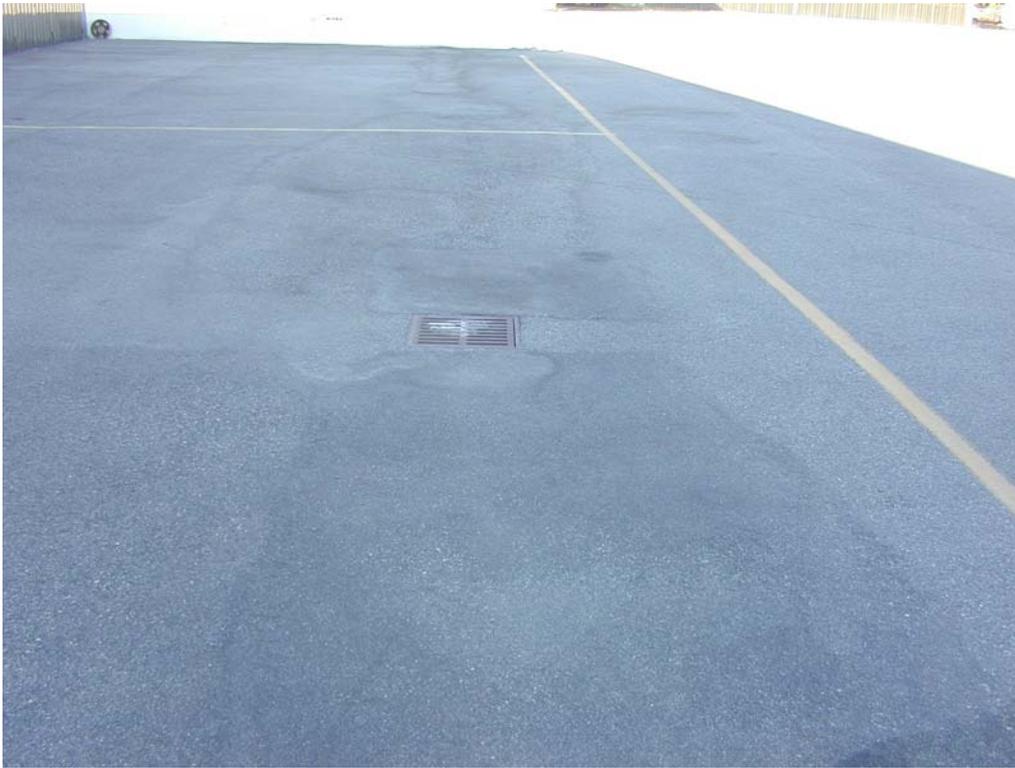
Patch in section TGAMGRA-10.

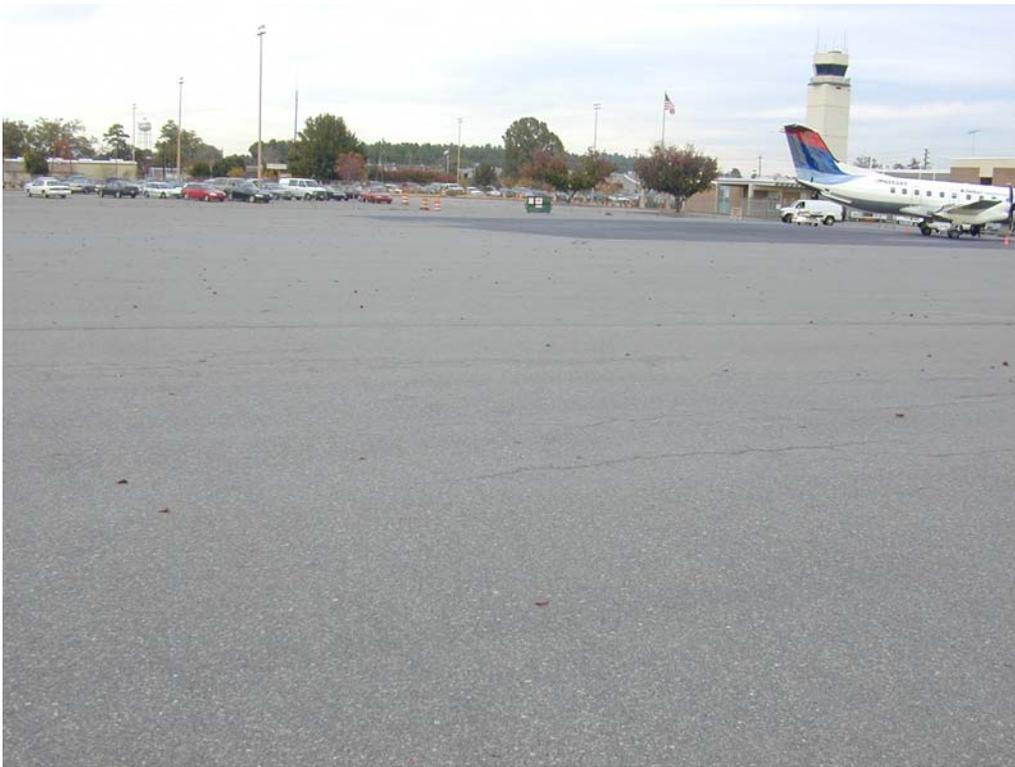
A01MGRA-10 is in fair condition with low-severity block and L&T cracking present throughout the section.

Overview of section A01MGRA-10.

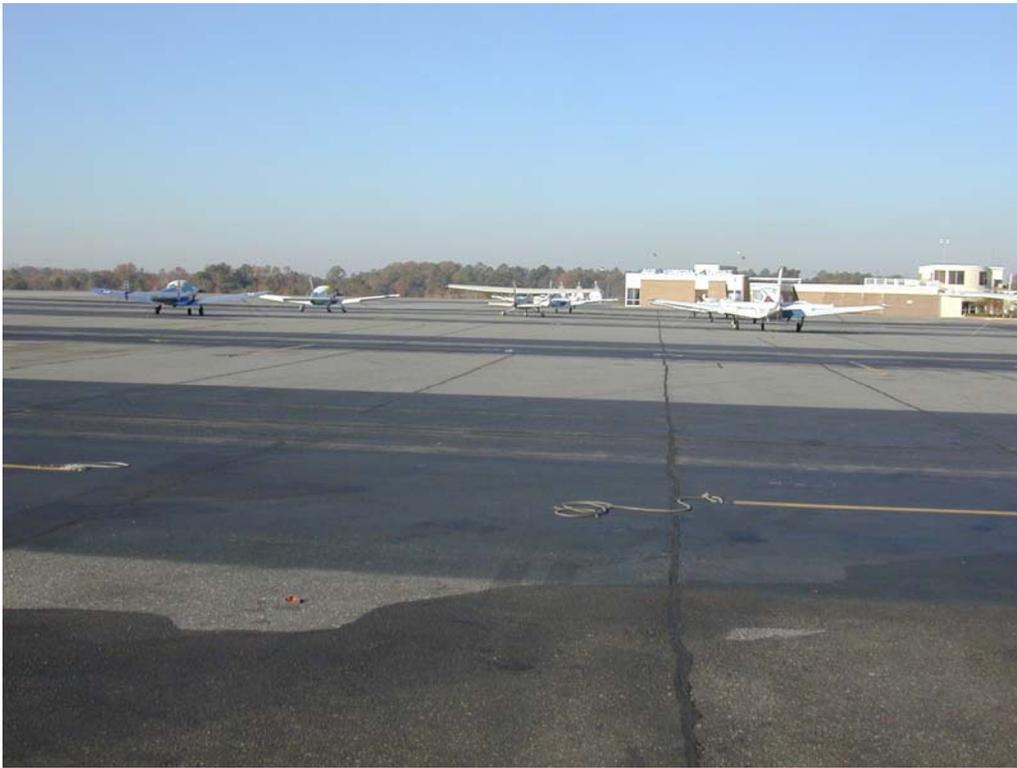
A01MGRA-20 is in good condition with low-severity, sealed, L&T cracking and occasional areas of swell.

Overview of section A01MGRA-20.

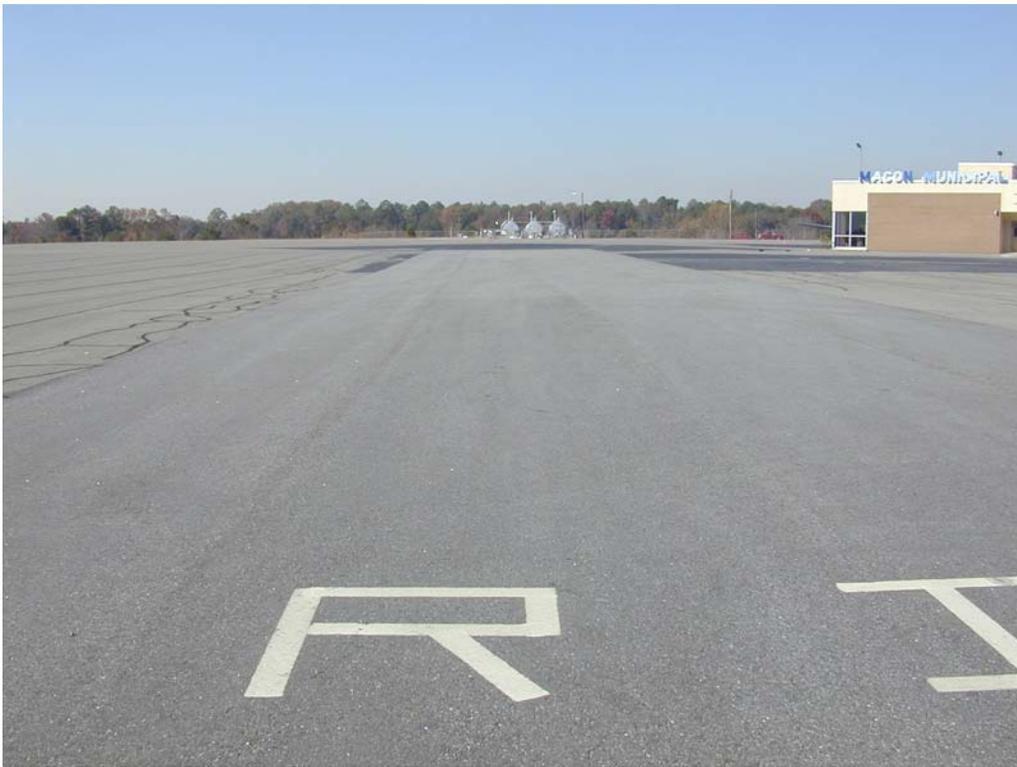
A01MGRA-30, A01MGRA-40 and A01MGRA-50 were all recently rehabilitated and are in excellent condition. Isolated small amounts of low-severity L&T cracking were found scattered throughout each section with the exception of A01MGRA-30 which was found free of any distress.

Overview of section A01MGRA-30.

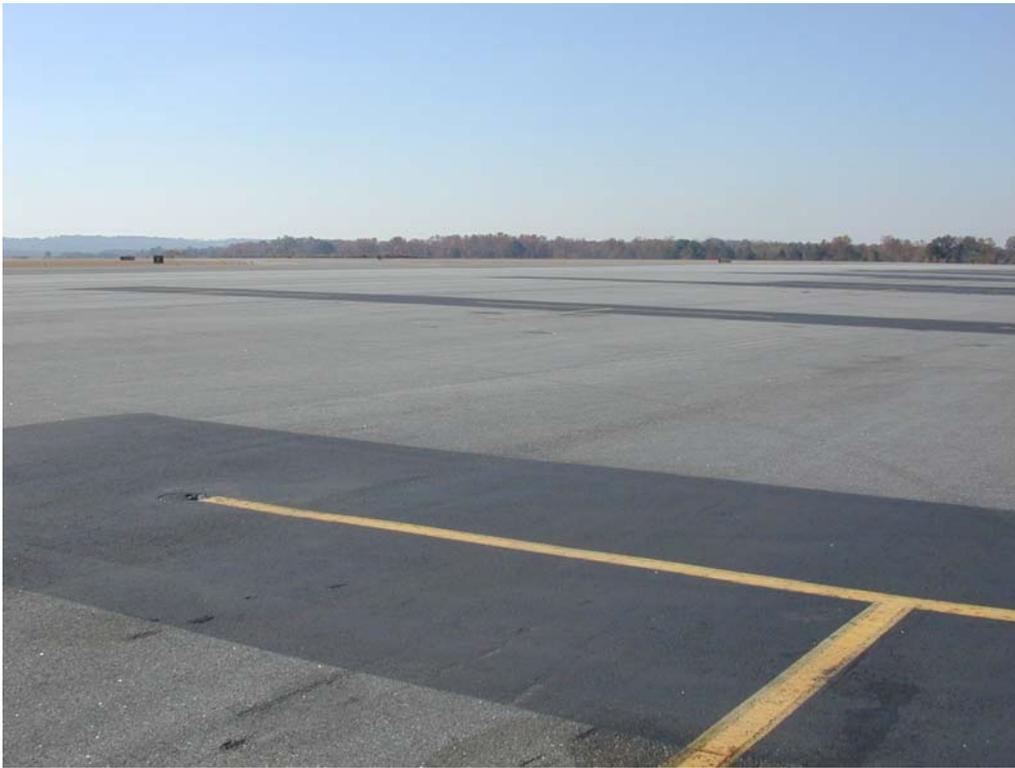
Overview of section A01MGRA-40.

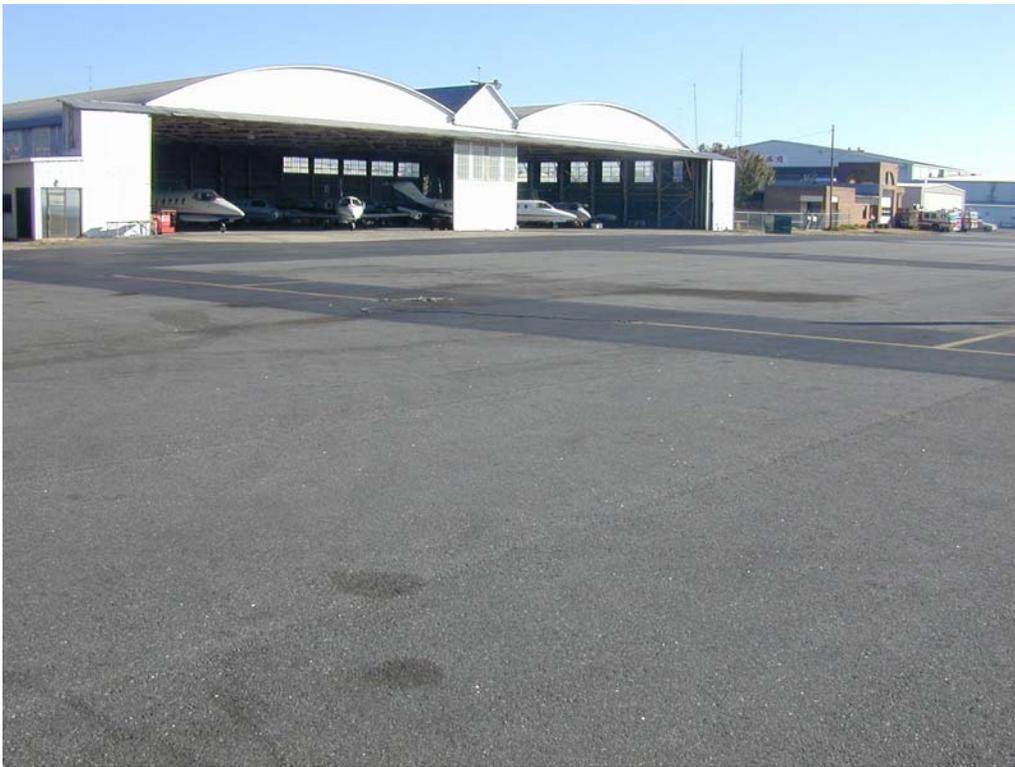
Overview of section A01MGRA-50.

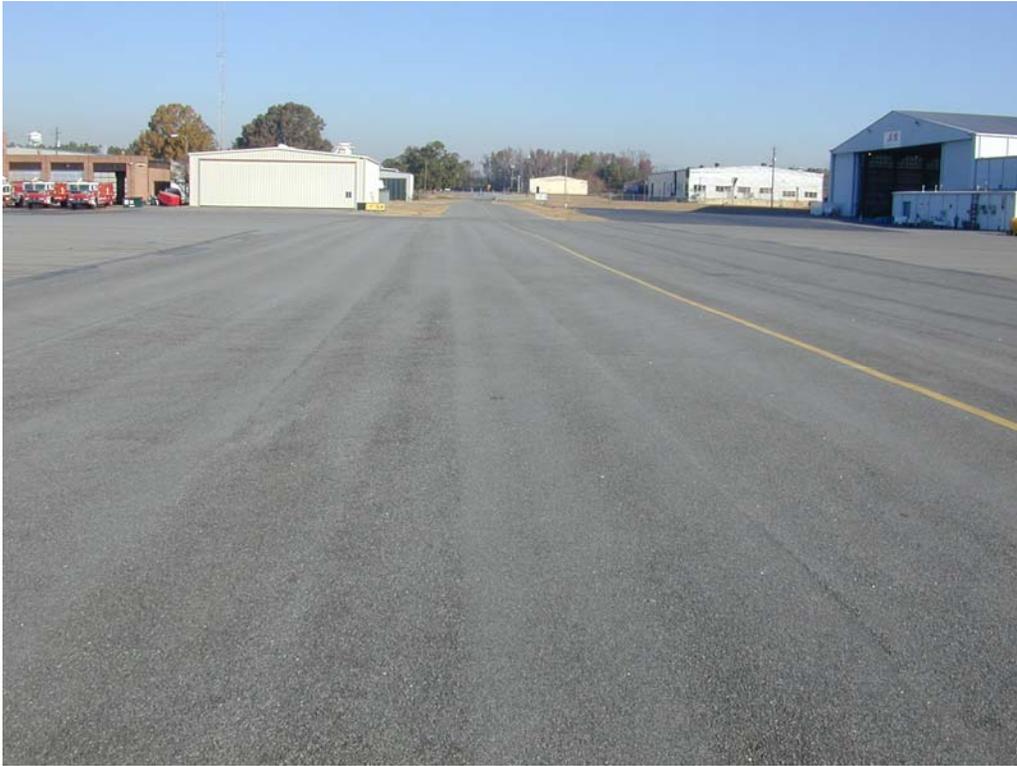
A01MGRA-60 is in very good condition with low-severity, unsealed, L&T cracking and isolated raveling and weathering being observed.

Overview of section A01MGRA-60.
