# MIDDLE GEORGIA REGIONAL AIRPORT

## PAVEMENT EVALUATION REPORT

JULY 2002

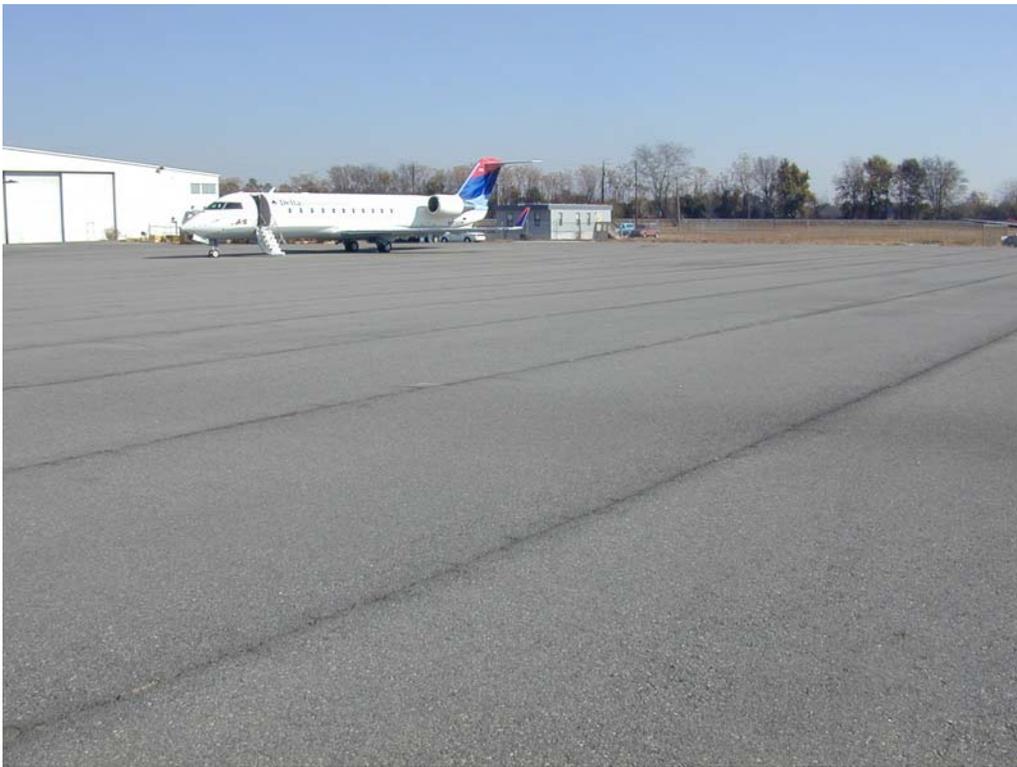
A01MGRA-70 is in fair condition with significant amounts of low-severity, unsealed, block cracking and medium-severity L&T cracking present.

Overview of section A01MGRA-70.

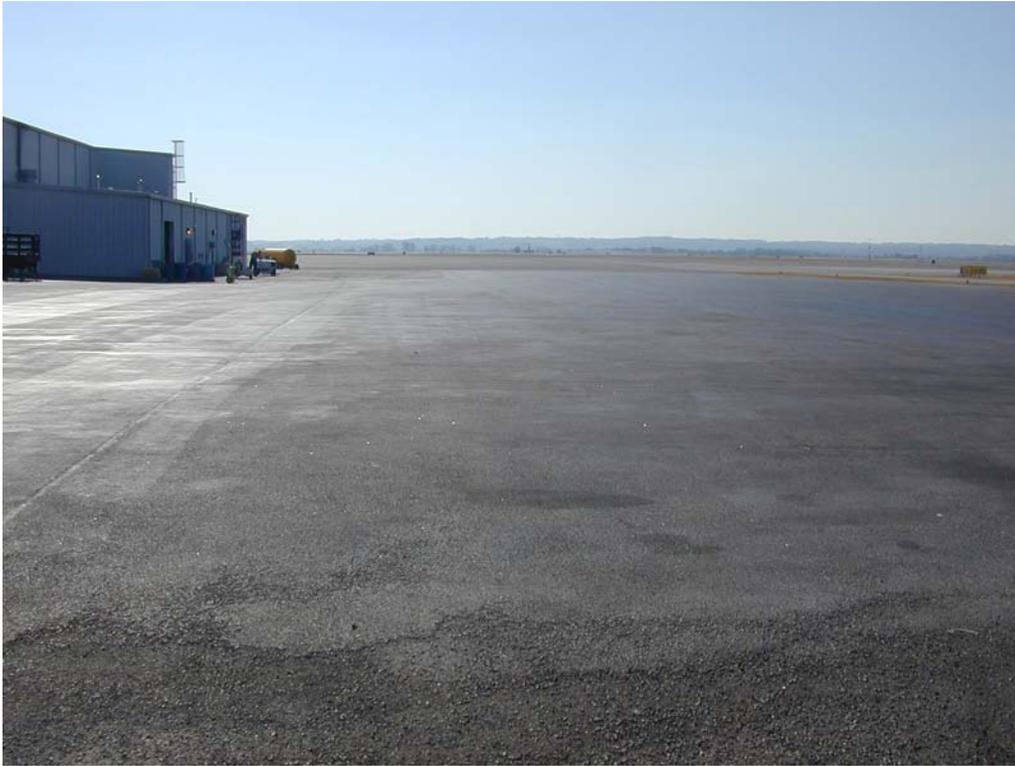
A01MGRA-80 is in good condition. Low-severity, unsealed, L&T cracking and medium-severity raveling and weathering were found in this section. In addition, a surface treatment has been applied over the area.

Overview of section A01MGRA-80.

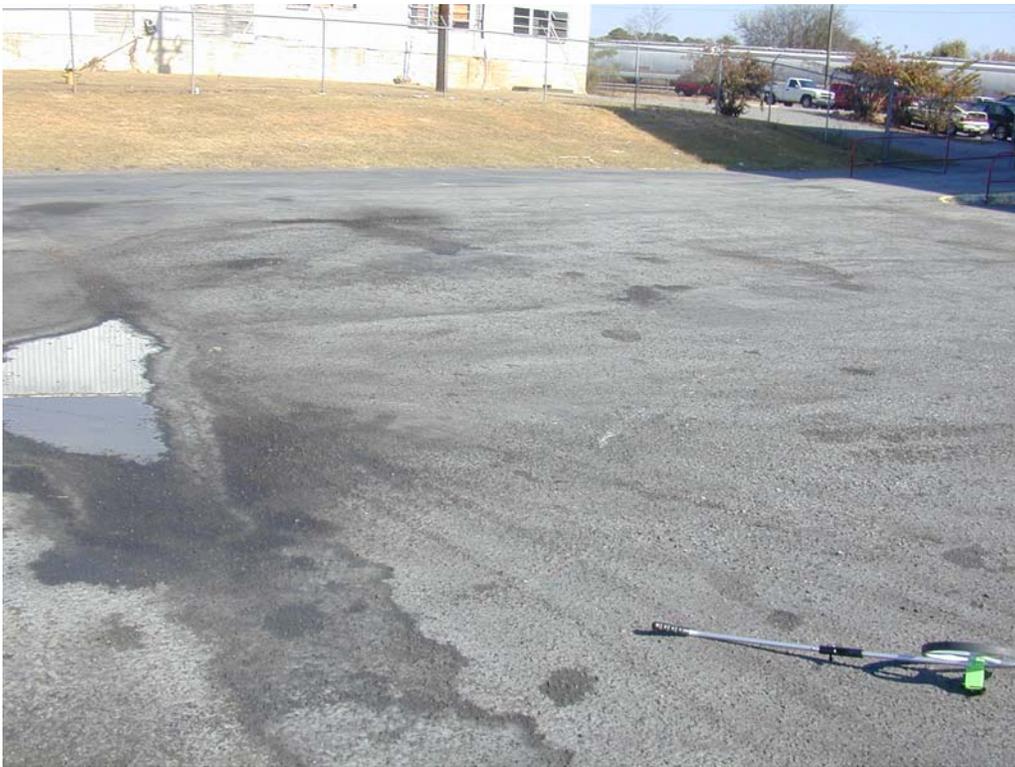
Raveling and weathering in section A01MGRA-80.
