COBB COUNTY - MCCOLLUM FIELD

PAVEMENT EVALUATION REPORT

JULY 2002

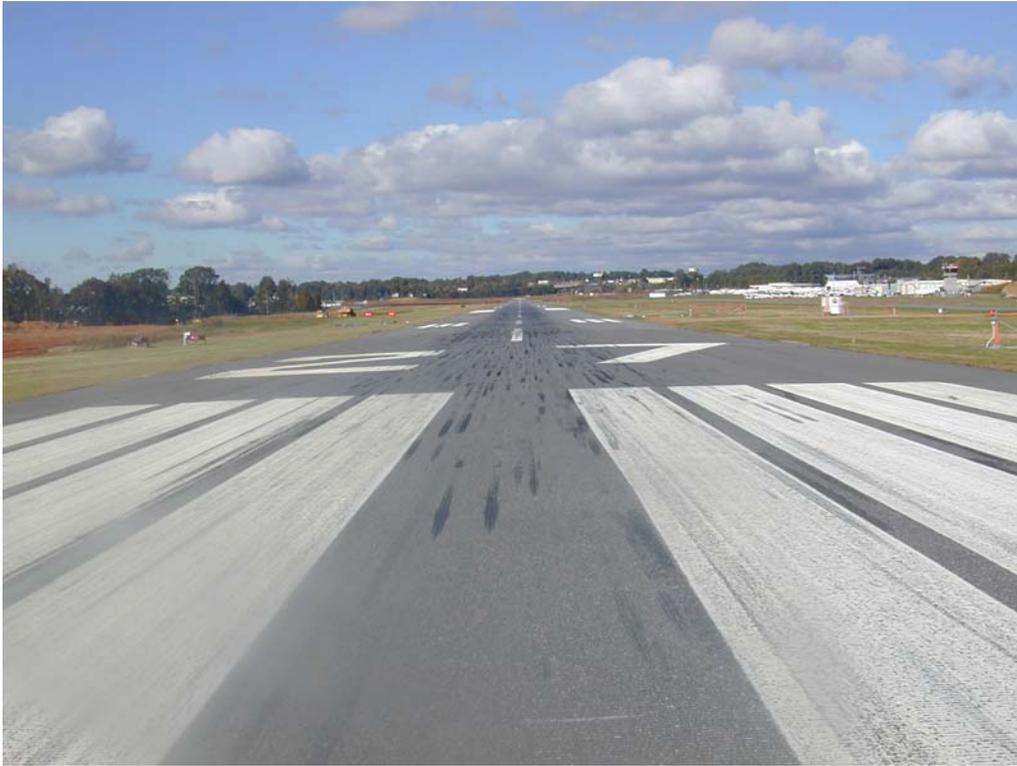
Runway 9-27 is defined by one section. R927MR-10 is in good condition with low and medium-severity longitudinal and transverse (L&T) cracking being found throughout the section. The majority of cracking was sealed, however most of sealant was not performing well. In addition, isolated areas of raveling and weathering were recorded.

Overview of section R927MR-10.

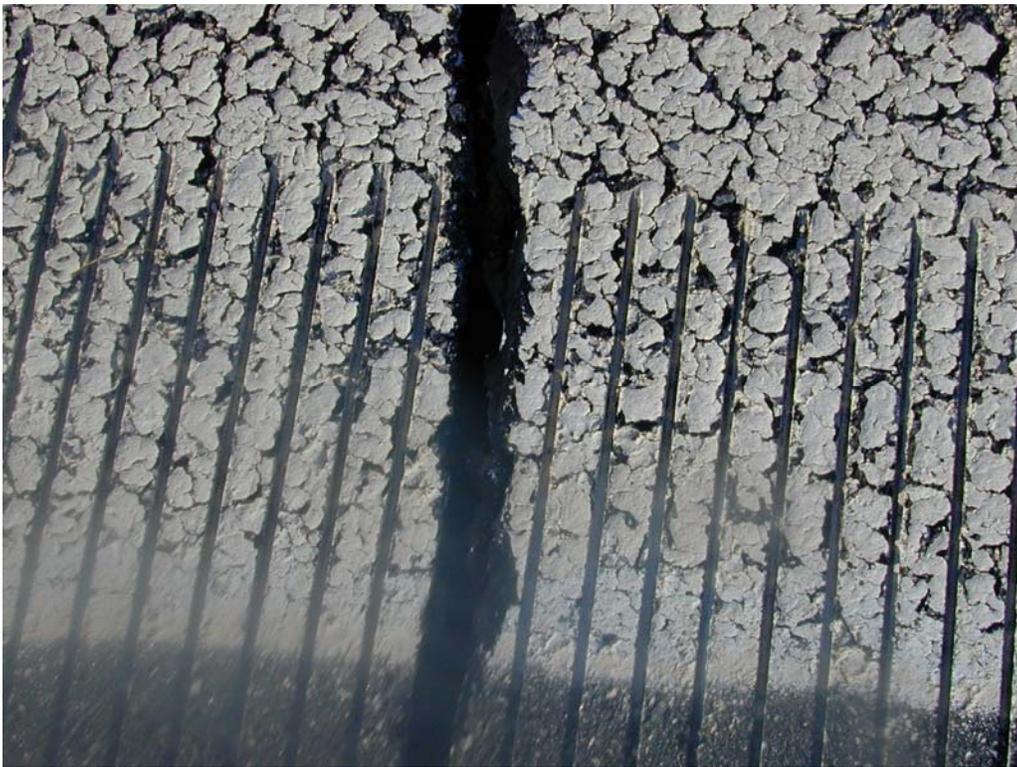
L&T cracking in section R927MR-10.

Plan Year	Network	Branch	Section	Distress Description	Severity	Work Description	Work Qty.	Work Unit	Unit Cost	Work Cost
2002	MARIETTA	A01MR	40	OIL SPILLAGE	L	Patching	1,029	SF	\$1.02	\$1,050
2002	MARIETTA	R927MR	10	L & T CR	M	Crack Sealing	15,175	LF	\$1.28	\$19,424

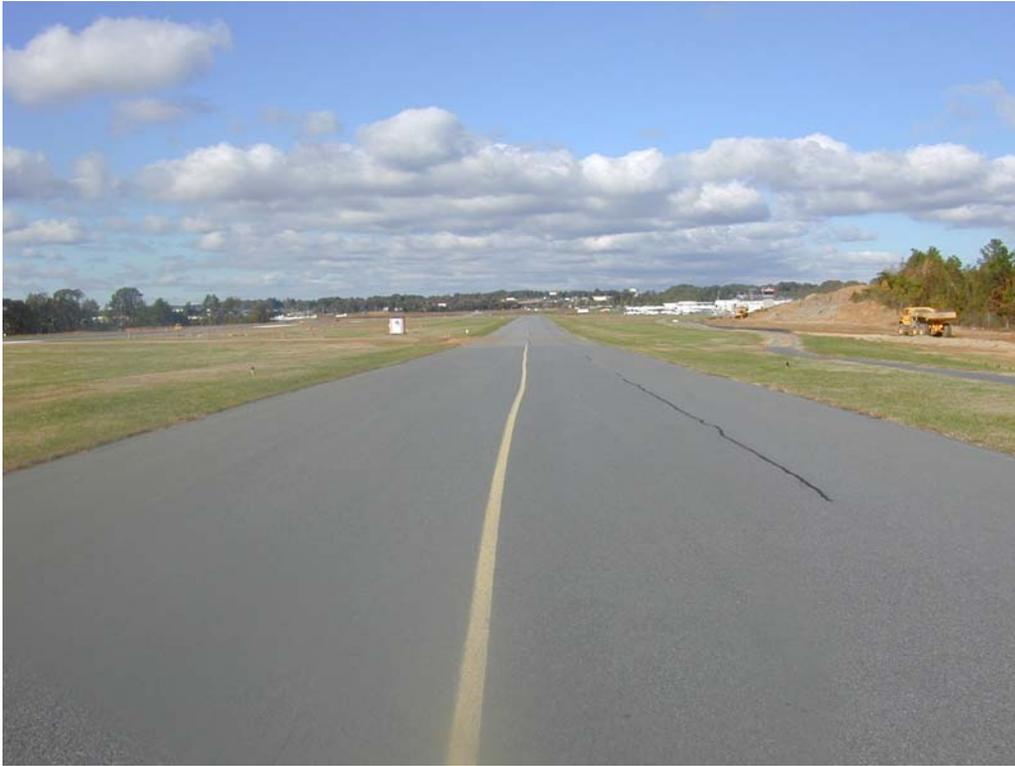
Taxiway A runs parallel to the Runway. This taxiway is defined by one section and is in fair condition. Moderate amounts of low and medium-severity L&T cracking were found throughout. The majority of the cracking was sealed, however most of sealant was not performing well. In addition, isolated areas of low and medium-severity alligator cracking were recorded.

Overview of section TAMR-10.

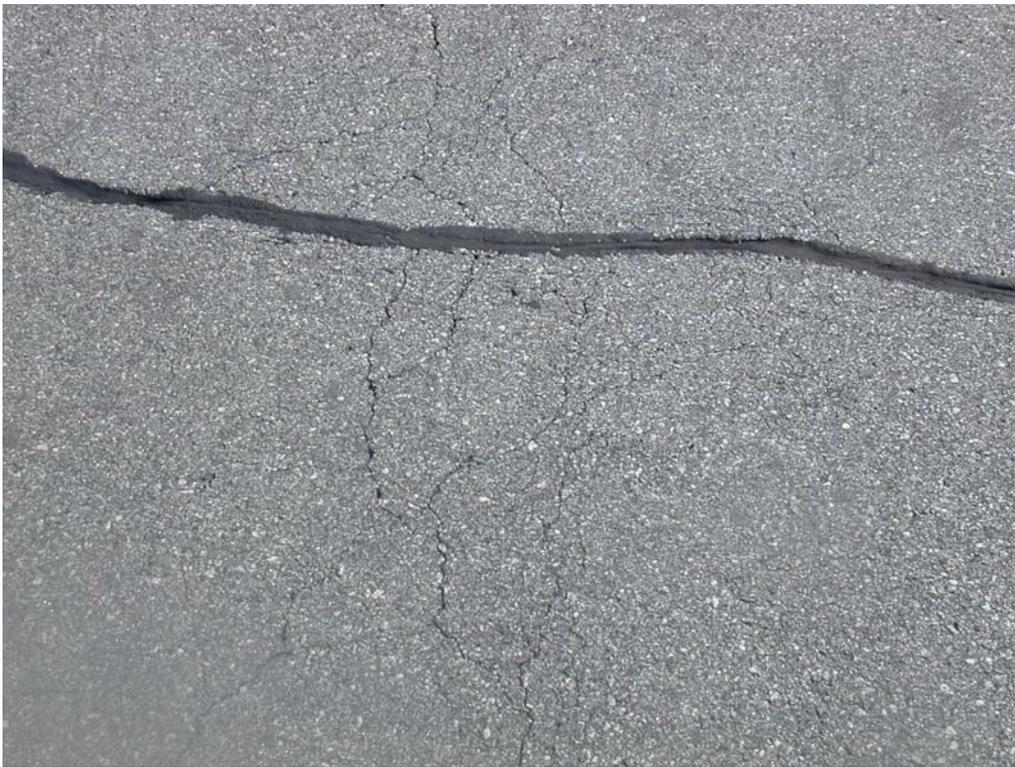
Alligator cracking in section TAMR-10.

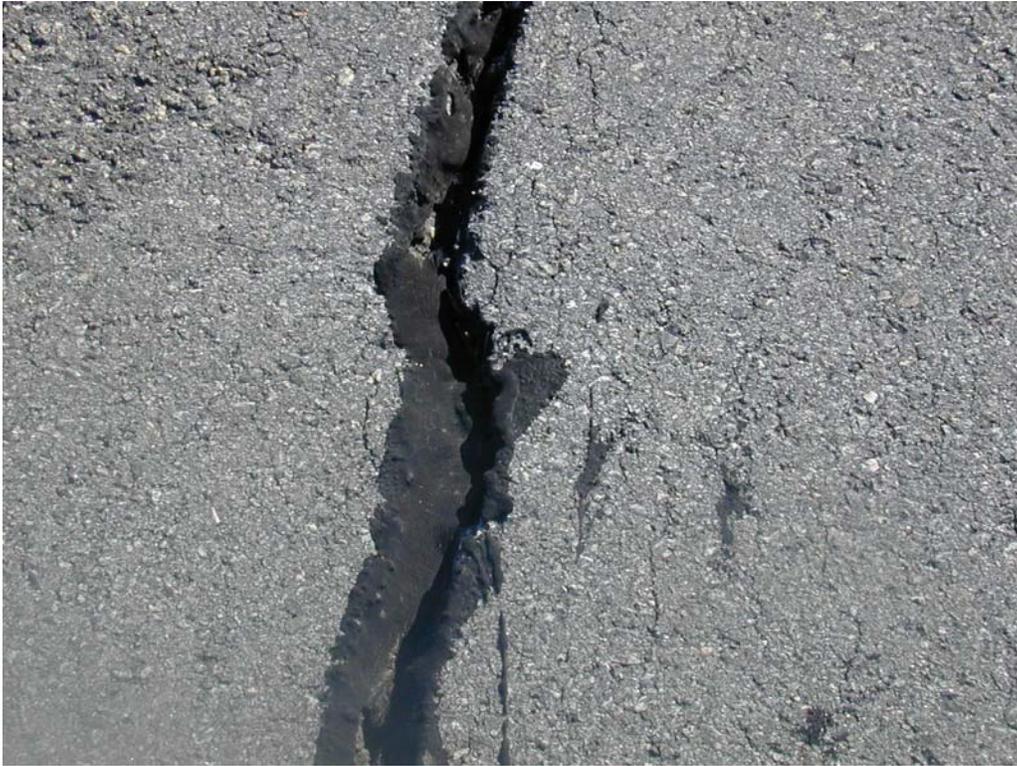
L&T cracking in section TAMR-10.

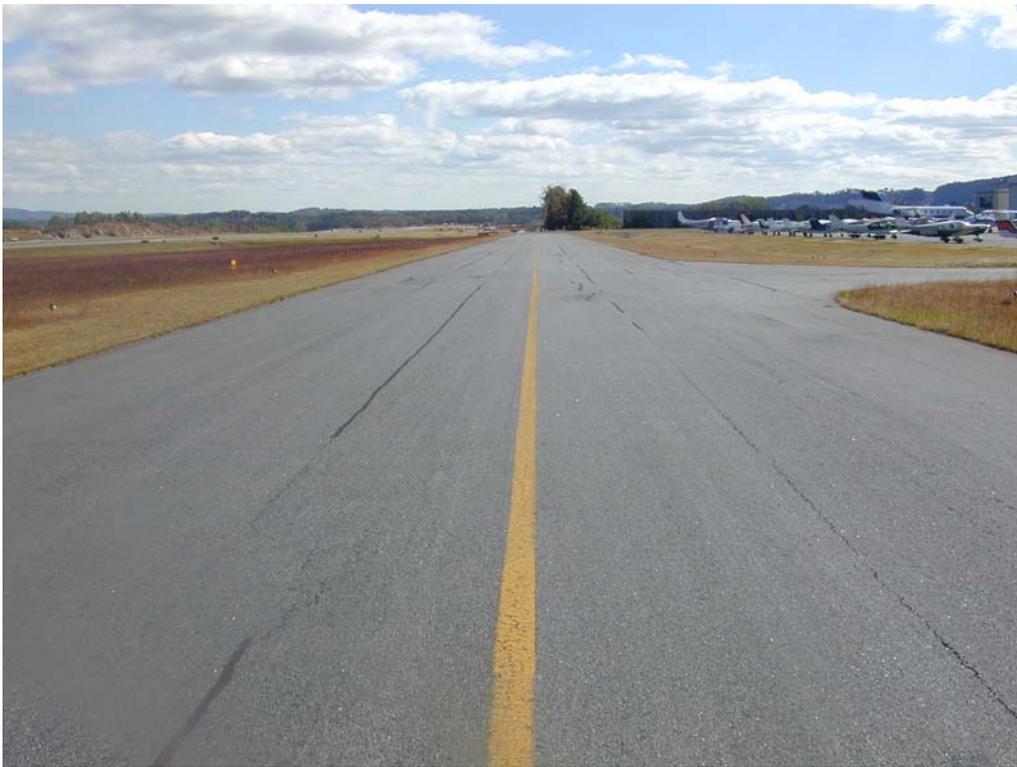
Taxiway B, also defined by one section, runs parallel to the south apron area. TBMR-10 is in fair condition with significant amounts of low and medium-severity L&T and alligator cracking being found. Most of the cracks were sealed, however the majority of the sealant had failed. Isolated areas of raveling and weathering were also present. An extension is under construction, and will run parallel to the runway. It will be open to traffic in 2002.

Overview of section TBMR-10.

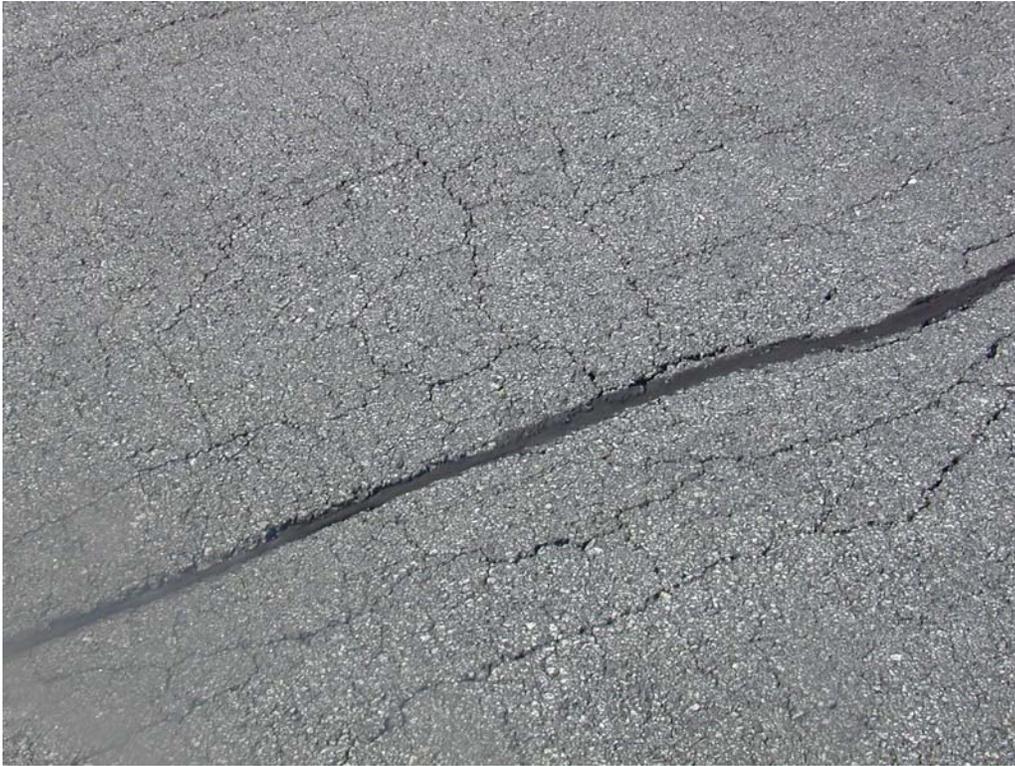
Alligator cracking in section TBMR-10.

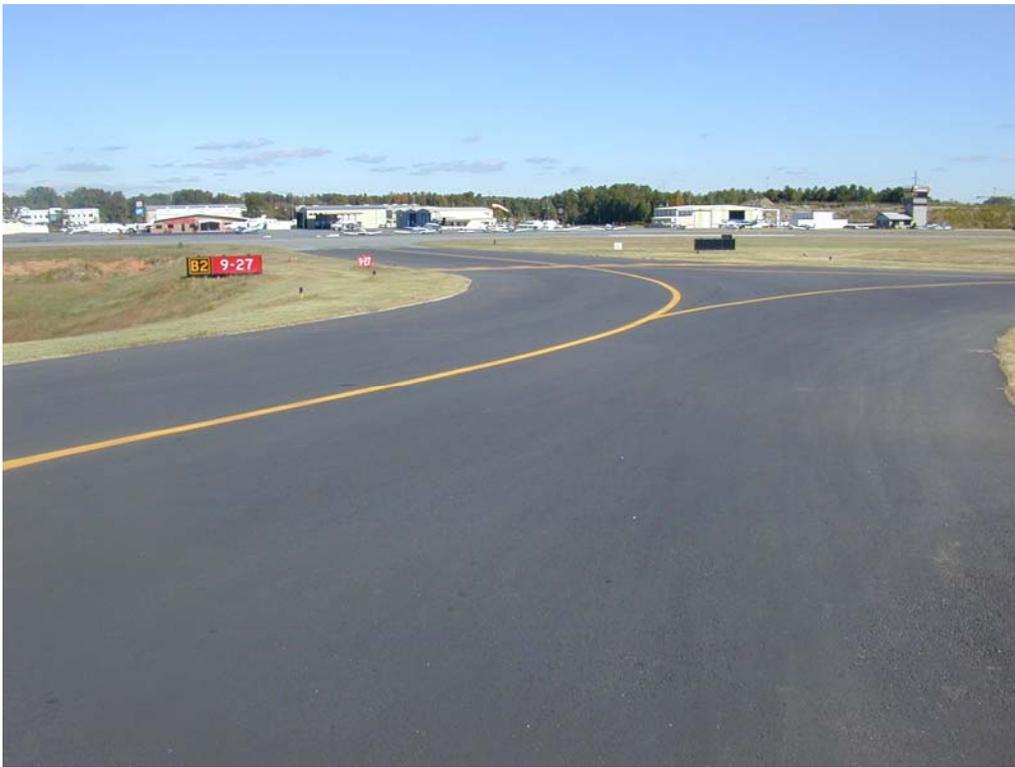
Overview of overlay in section TBMR-10.

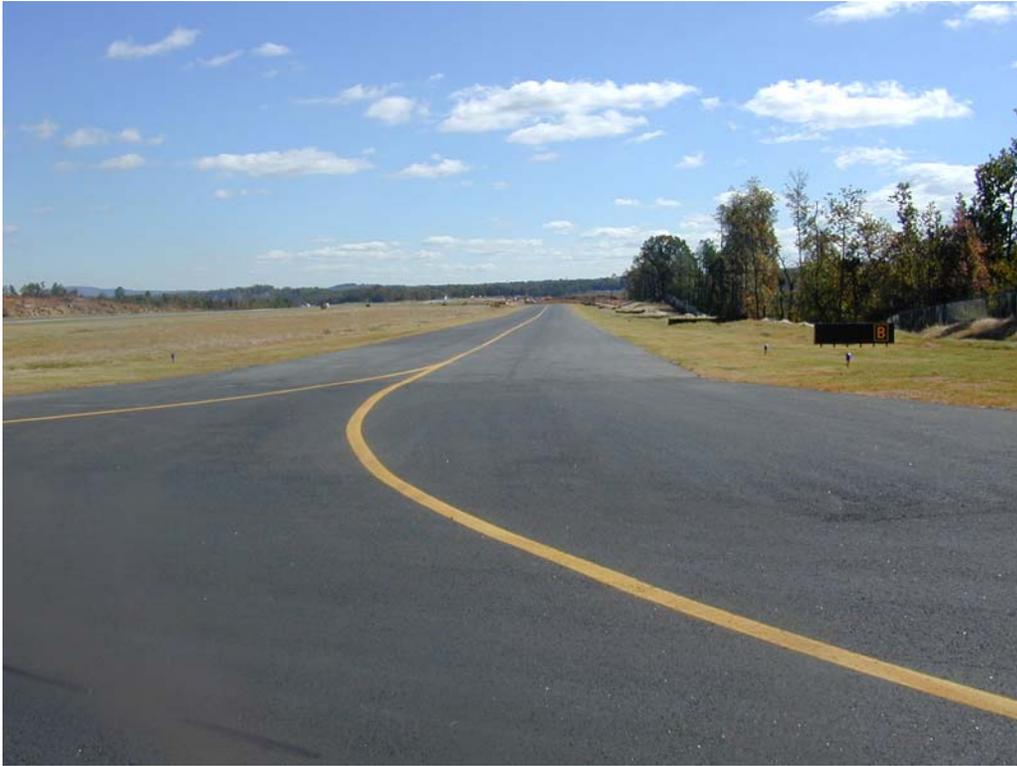
Overview of construction of section TBMR-20.

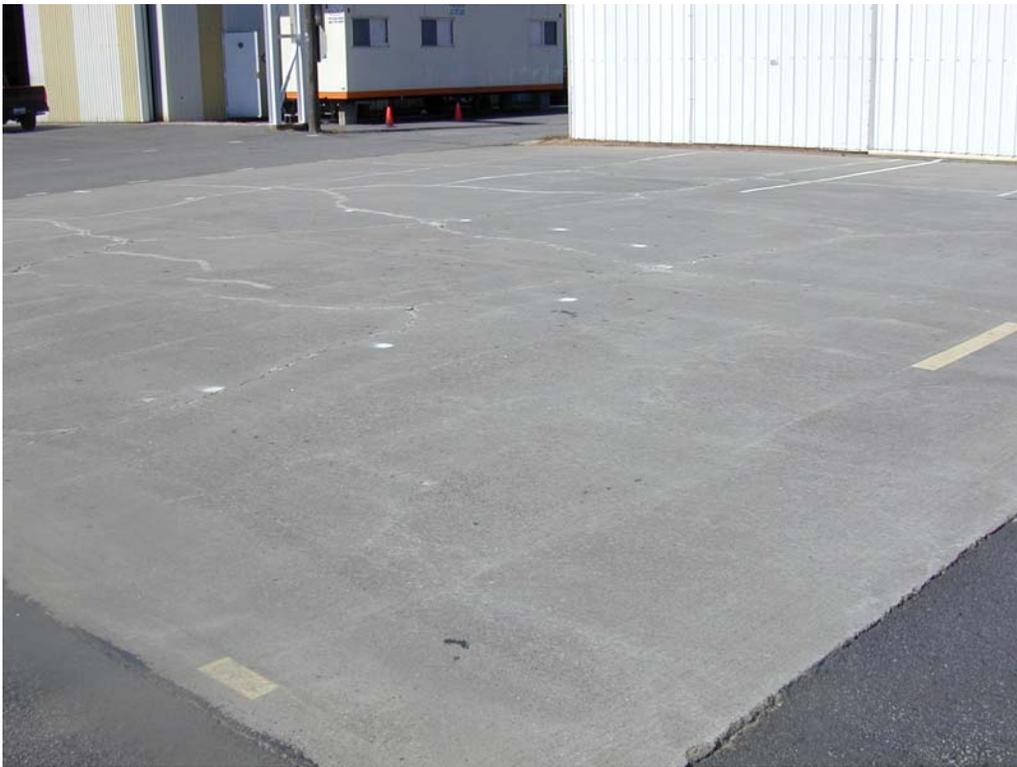
A01MR-20 is located next to A01MR-10 and is in poor condition. All of the slabs were shattered.

Overview of section A01MR-20.

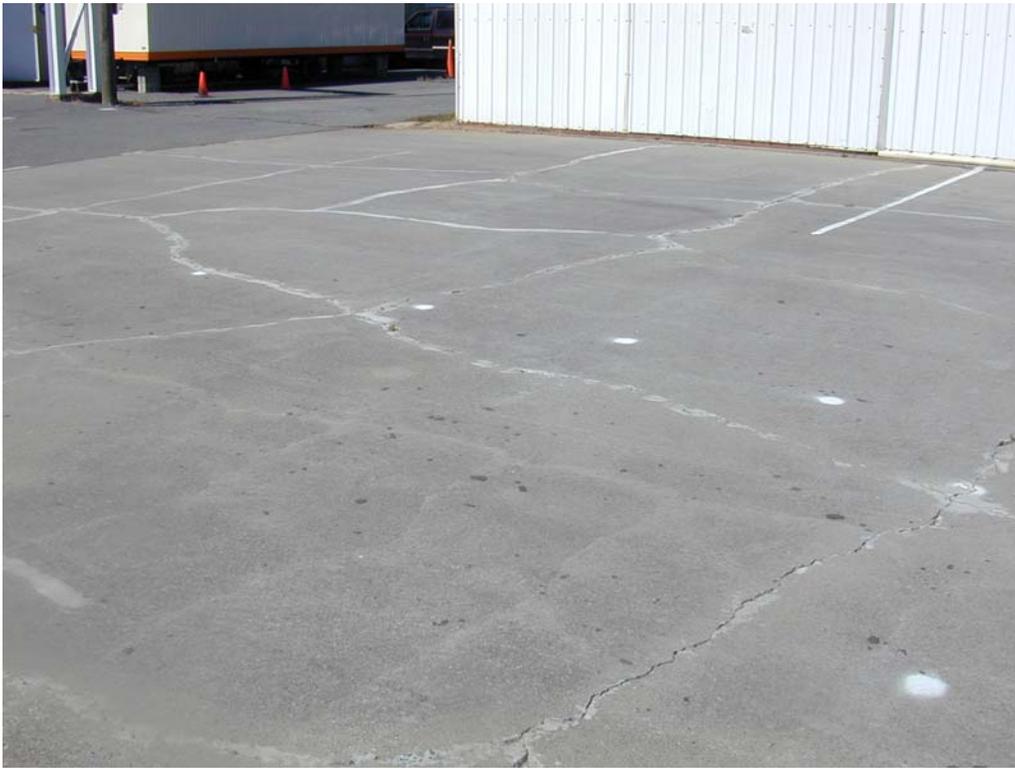
Shattered slab in section A01MR-20.

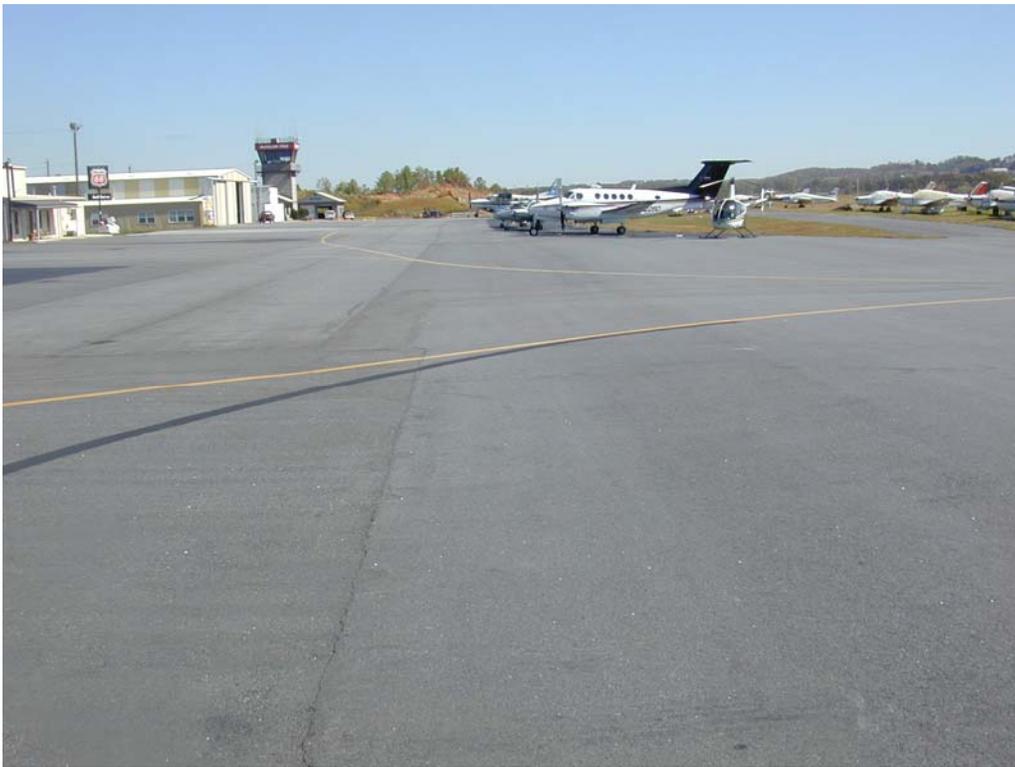
A01MR-30, located in the center of the main apron north of the runway, was recently rehabilitated and is in very good condition. Isolated amounts of low-severity, unsealed, L&T cracking, patching and rutting were observed in this section.

Overview of section A01MR-30.

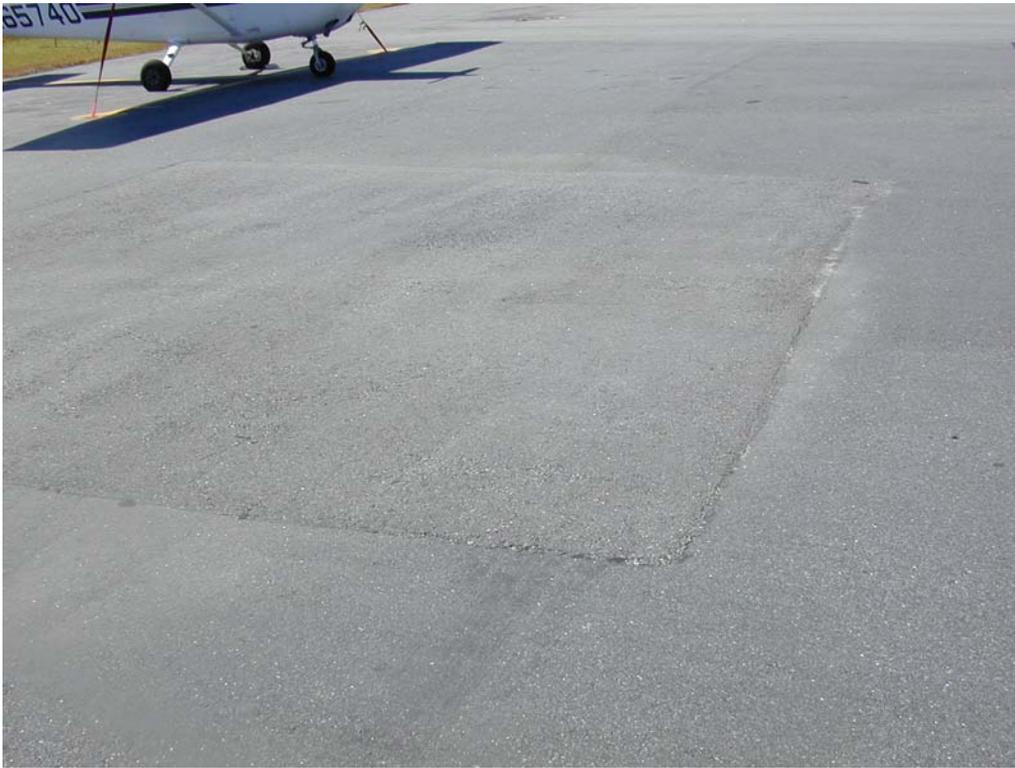
Patch in section A01MR-30.

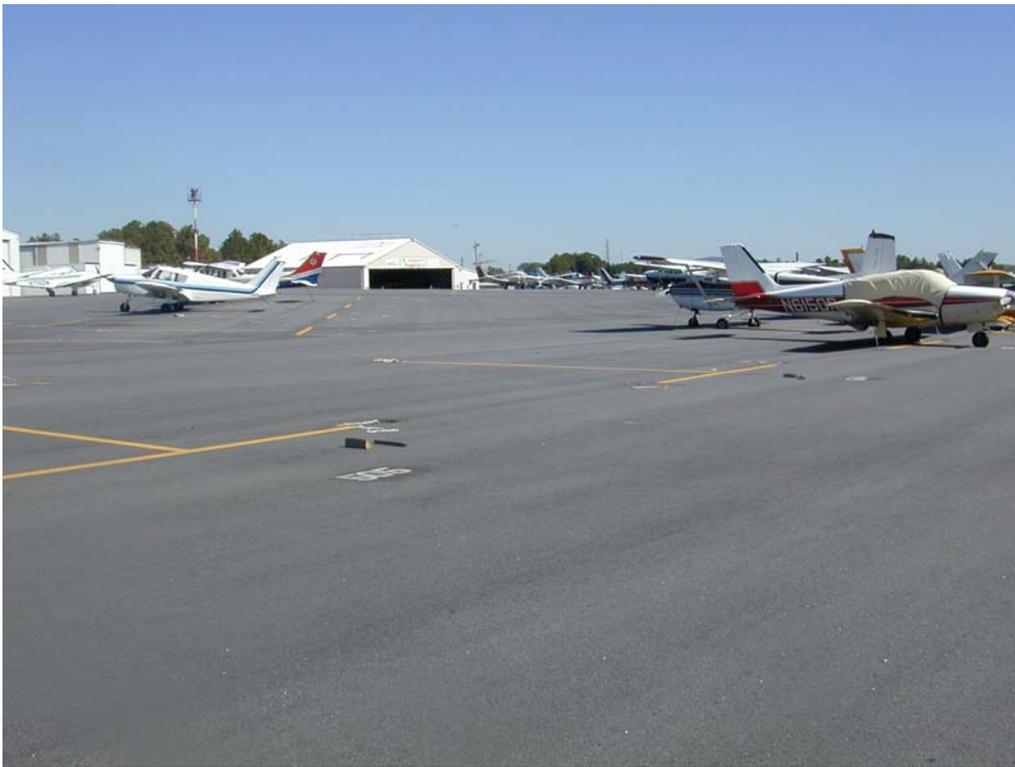
A01MR-40 covers the west side of the north apron. This section was overlaid in 1998 and is in excellent condition. Low-severity, unsealed, L&T cracking, found mainly along paving lane joints, patching, and oil spillage were observed throughout the section.

Overview of section A01MR-40.

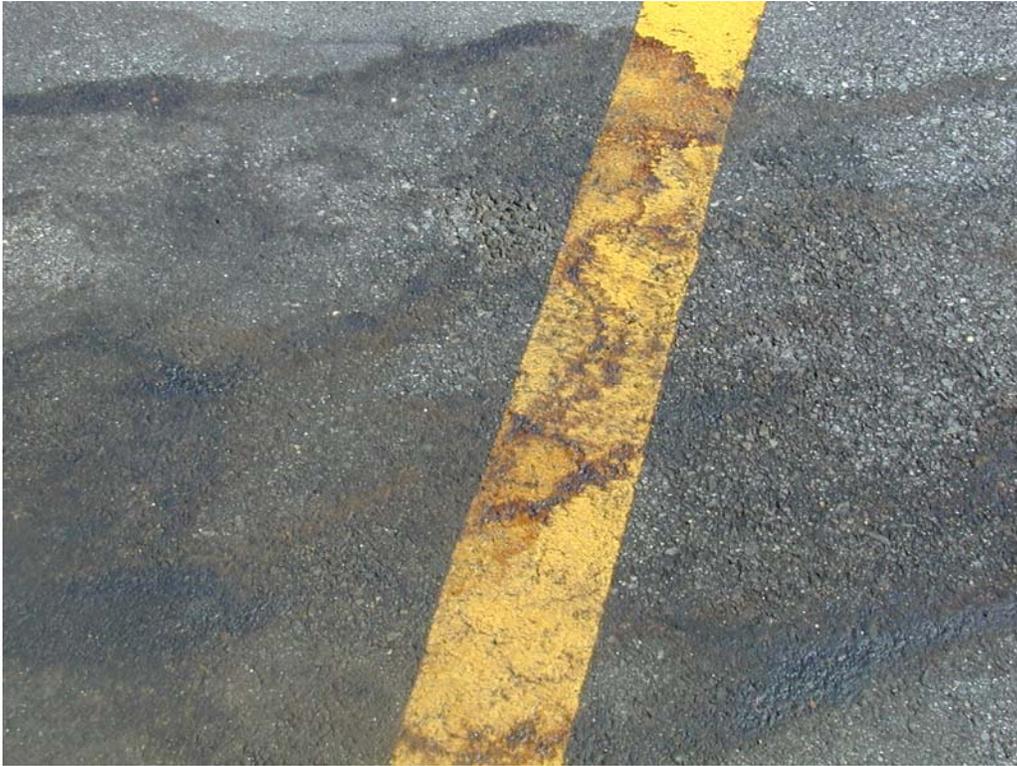
Oil spill in section A01MR-40.

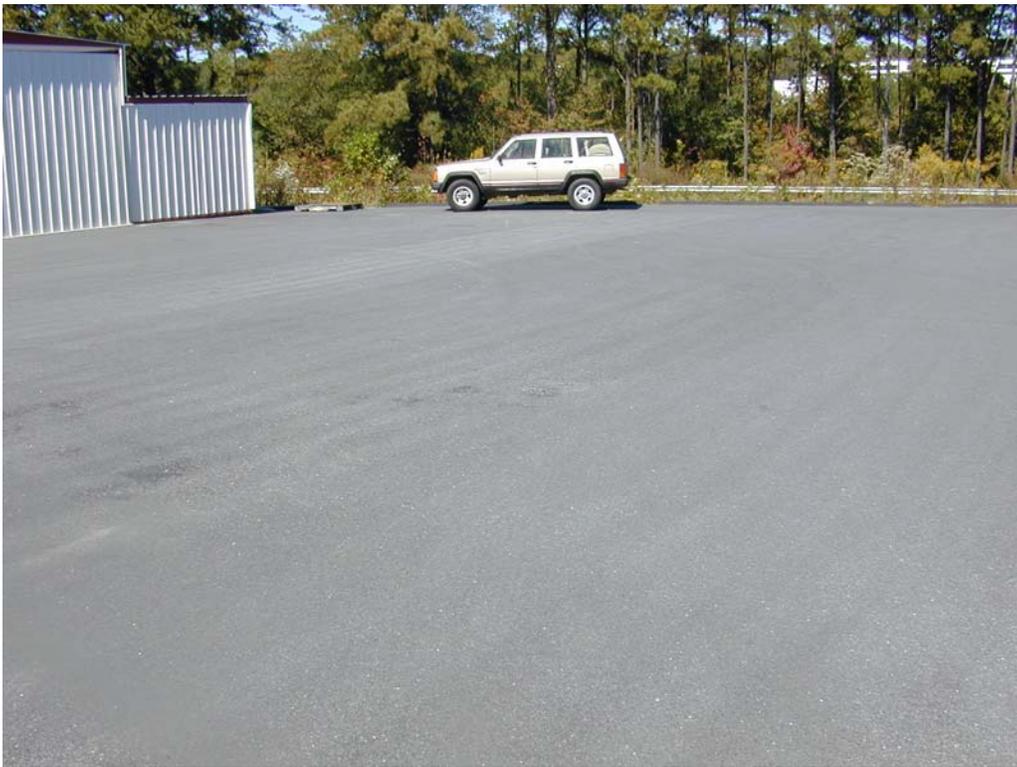
A01MR-50 is located in the northern part of the main apron and is in poor condition. Significant amounts of medium-severity alligator and L&T cracking were found in this section. Small quantities of medium-severity block cracking, raveling and weathering, and patching were also observed. Most of the low-severity cracking were unsealed while medium-severity cracking was recorded due to failed sealant.

Overview of section A01MR-50.

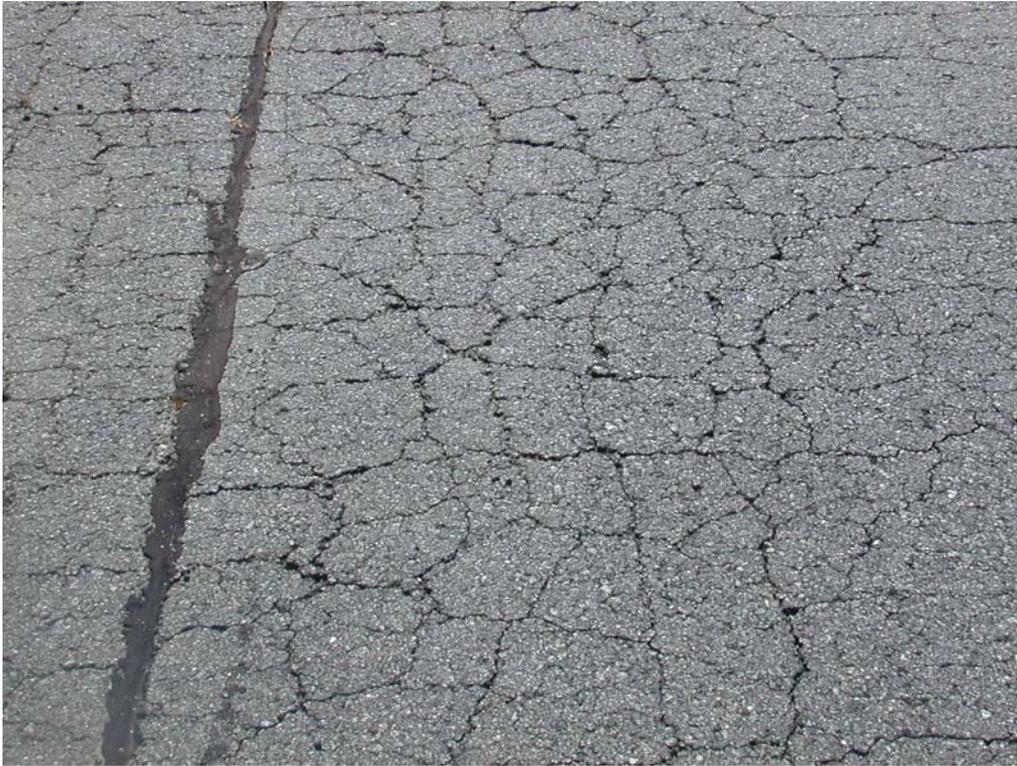
Alligator cracking in section A01MR-50.

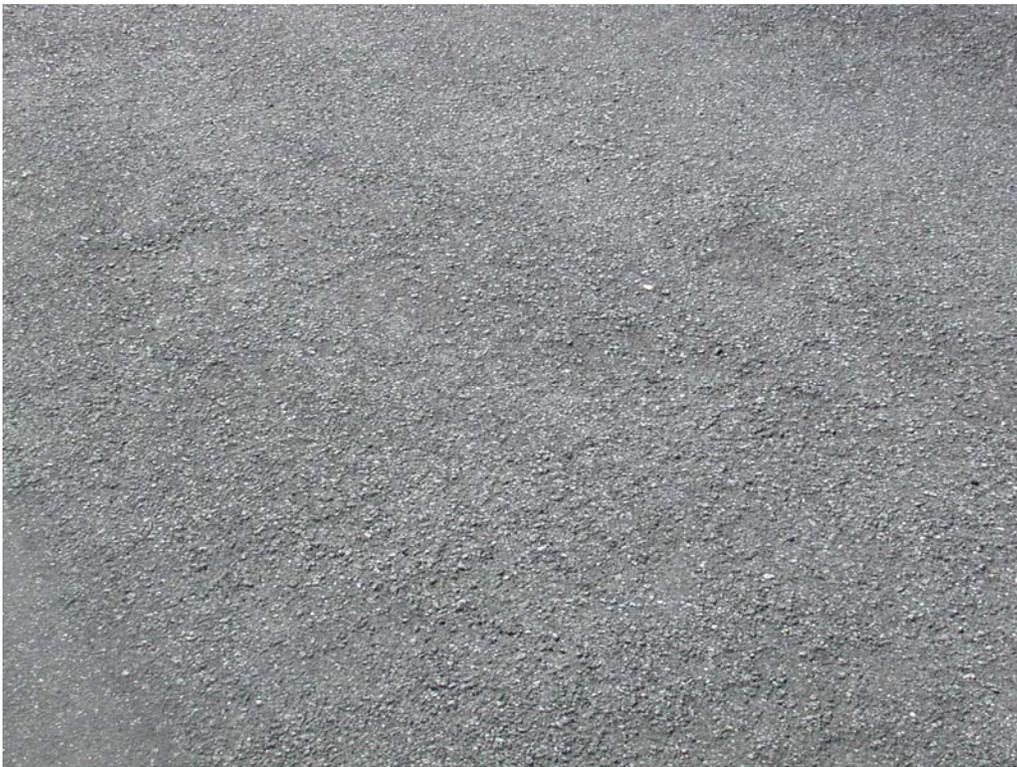
Raveling and Weathering in section A01MR-50.

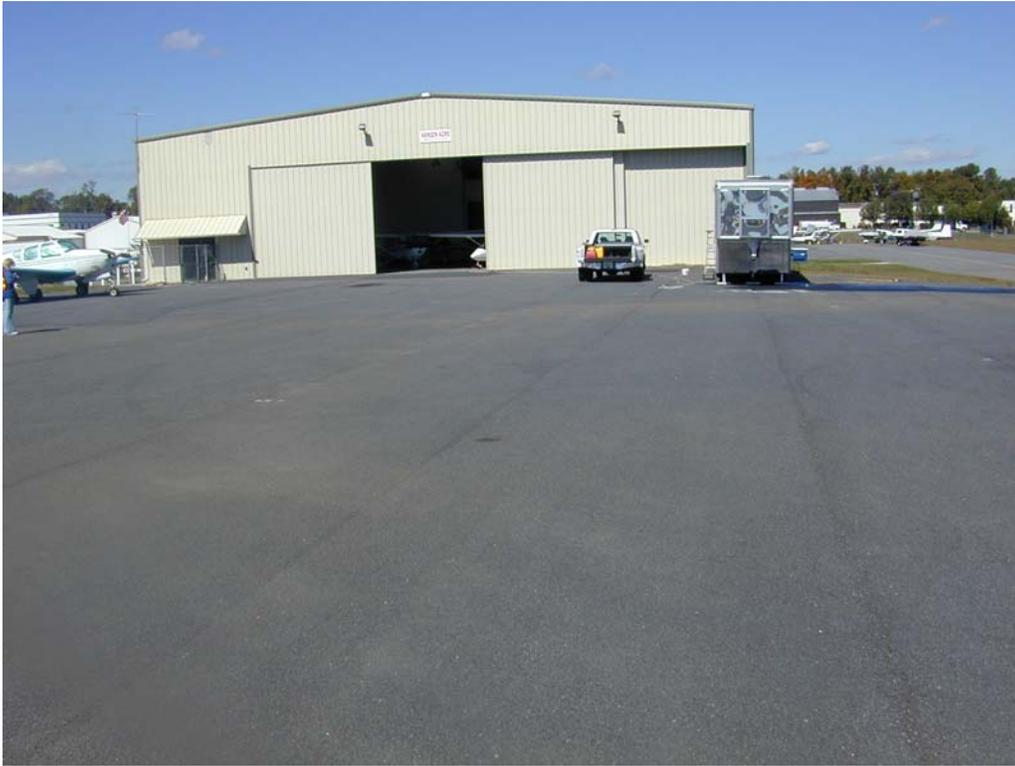
A01MR-60 is located on the east edge of the north apron running parallel to the main road. This section is in fair condition with moderate amounts of low and medium-severity L&T cracking and raveling and weathering being found. In addition, isolated areas of rutting, oil spillage,

patching, alligator cracking, and depression were observed. The majority of the cracking was unsealed.

Overview of section A01MR-60.

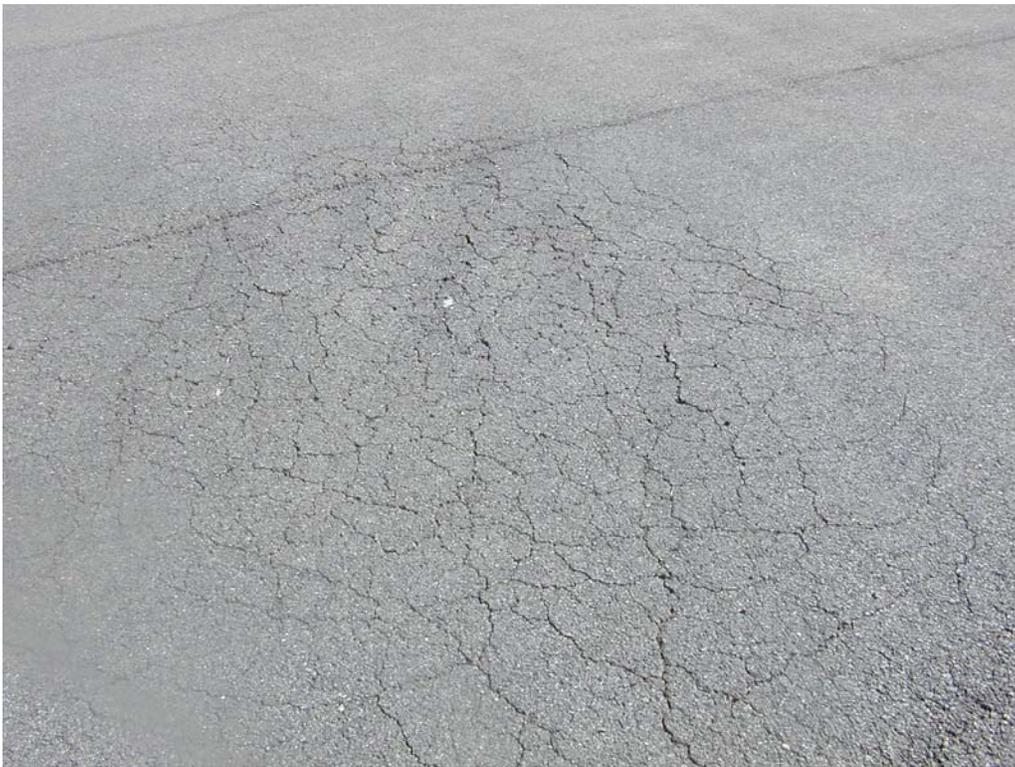
Alligator cracking in section A01MR-60.

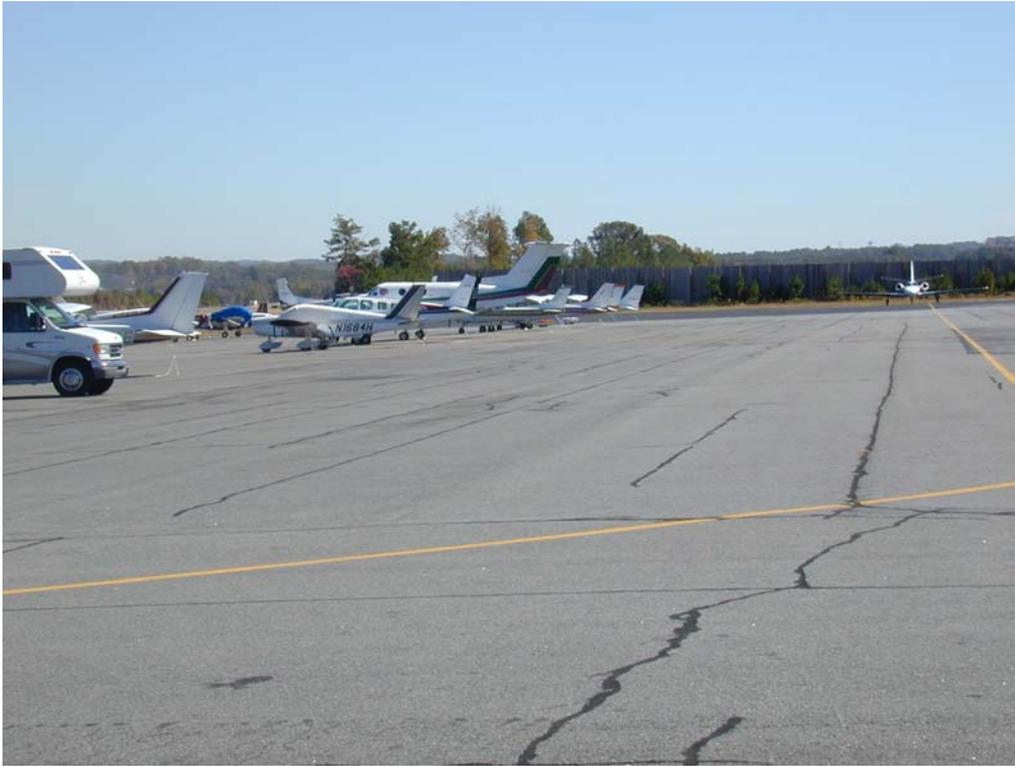
A02MR-10, located in the center of the south apron, is in good condition with small amounts of low-severity L&T cracking found throughout. Small quantities of medium-severity L&T, alligator cracking, and raveling and weathering were also observed. The majority of the cracking was sealed, some of which had failed.

Overview of section A02MR-10.

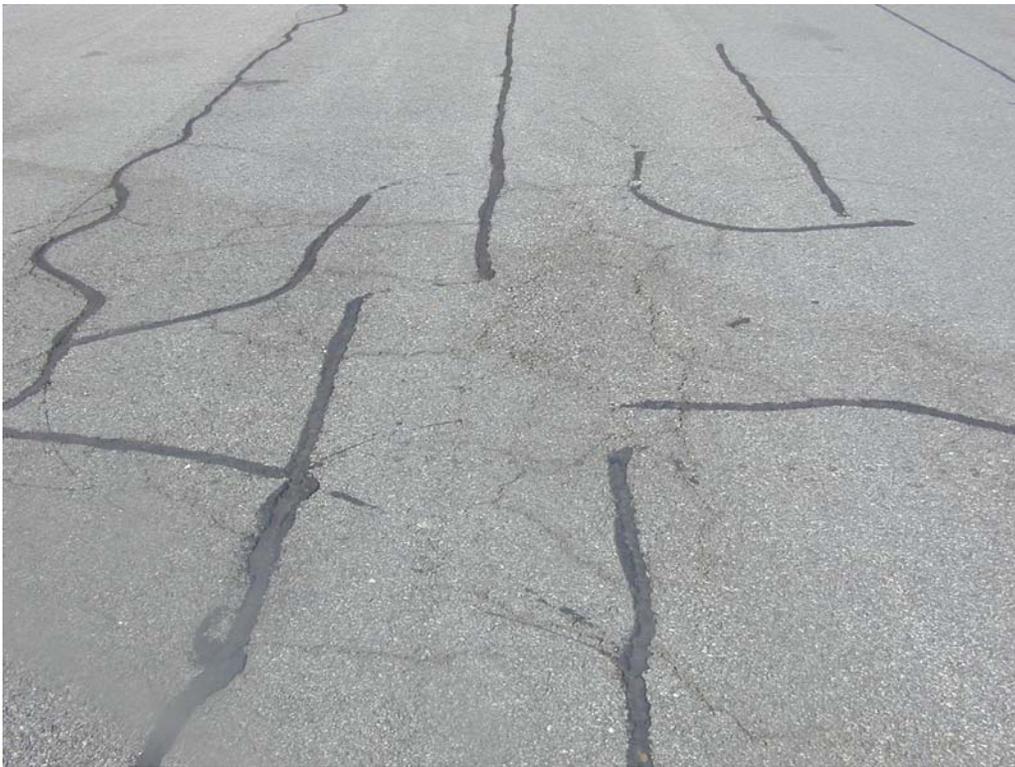
Alligator cracking in section A02MR-10.

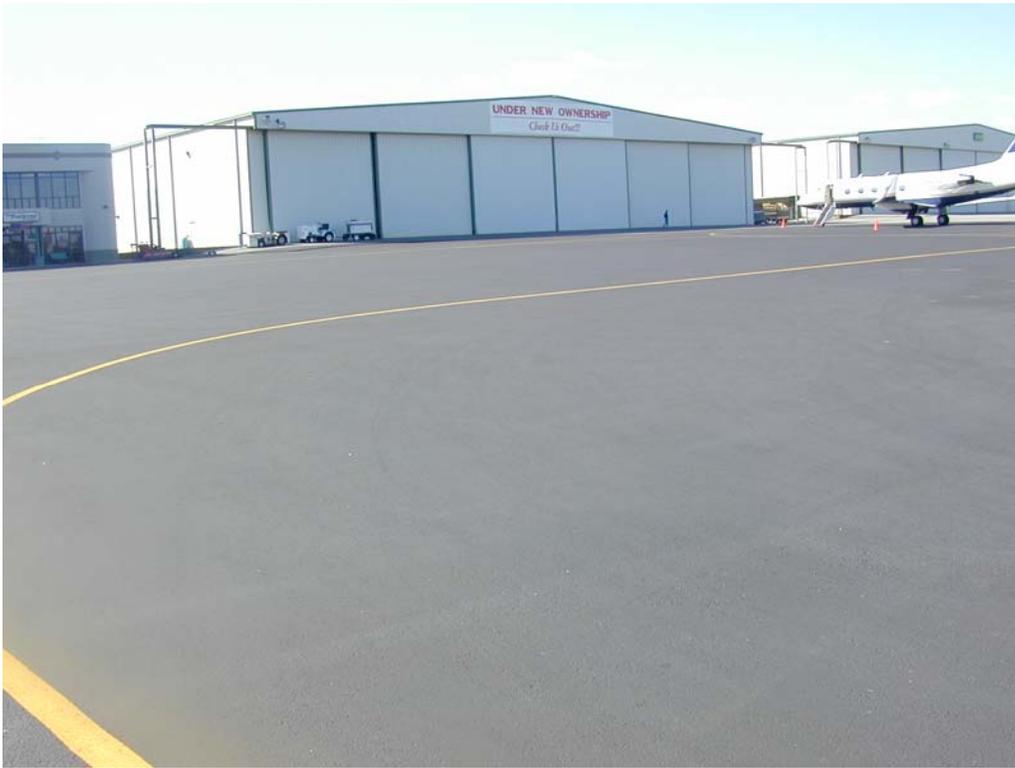
A02MR-20 covers the eastern part of the south apron and was overlaid in 1999. The apron is in excellent condition free from any distress.

Overview of section A02MR-20.

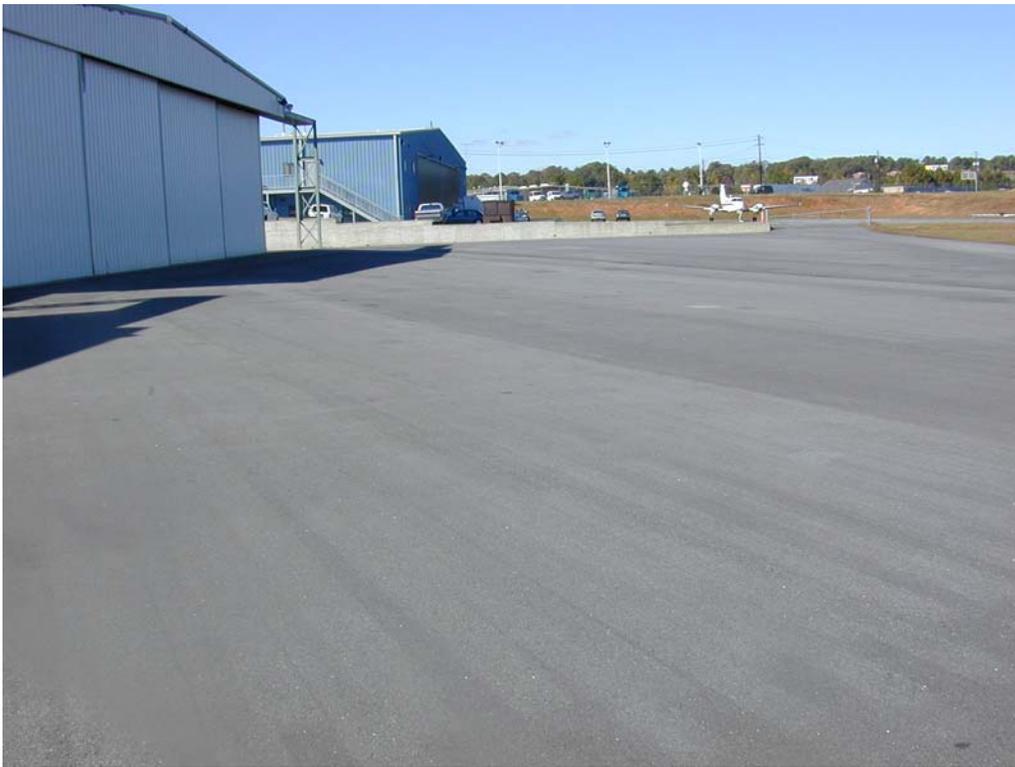
A02MR-30 was built in 1999 west of A02MR-10. This section is also in excellent condition with no distress observed.

Overview of section A02MR-30.

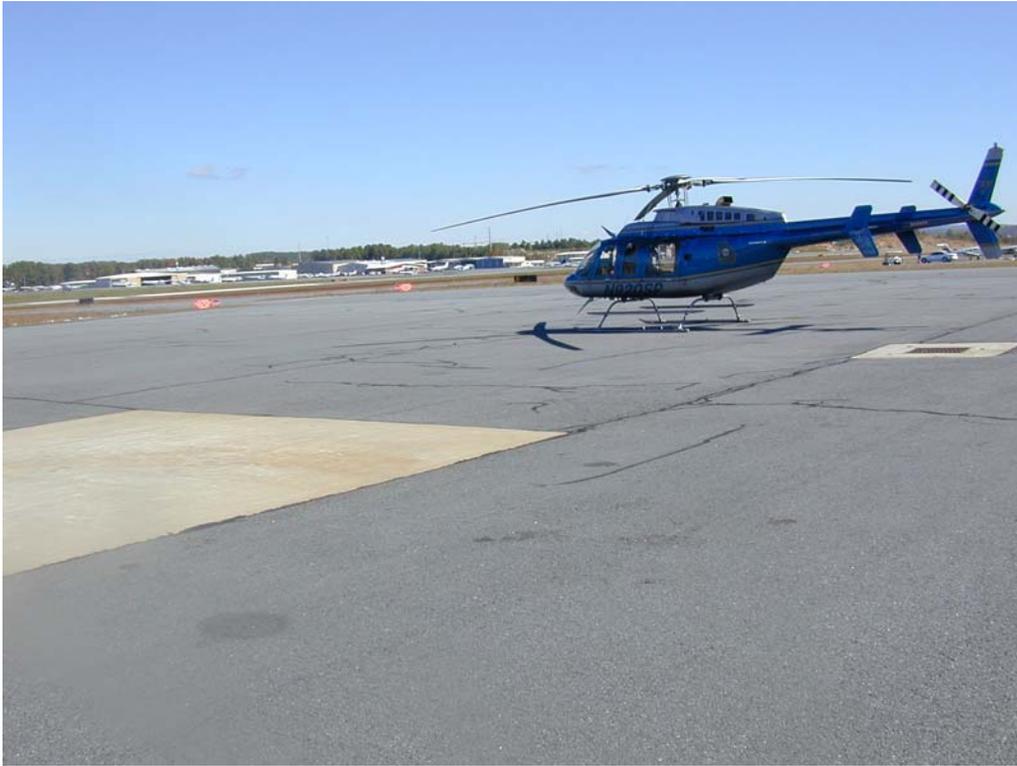
A03MR-10 consists of one section, and is located on the west end of the south apron. This section is in fair condition with moderate amounts of low and medium-severity L&T cracking, patching, and alligator cracking found throughout. All cracking was sealed, however some of the sealant had failed.

Overview of section A03MR-10.
