SAVANNAH INTERNATIONAL AIRPORT

PAVEMENT EVALUATION REPORT

JULY 2002

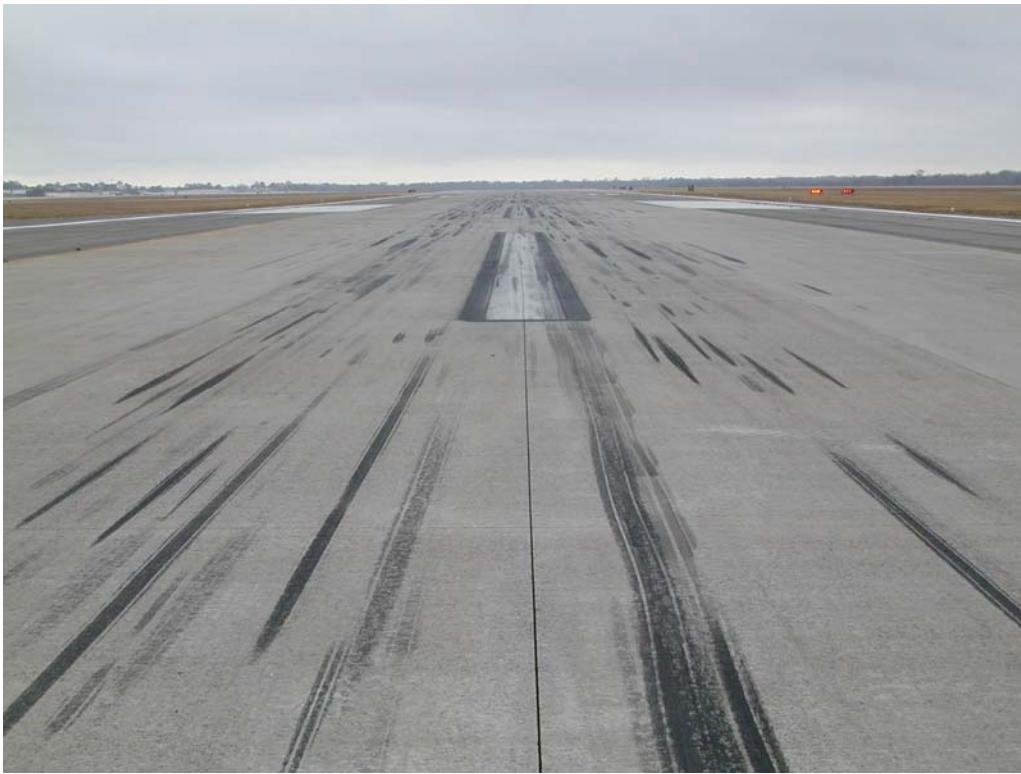
Overview of section R1836SV-10C.

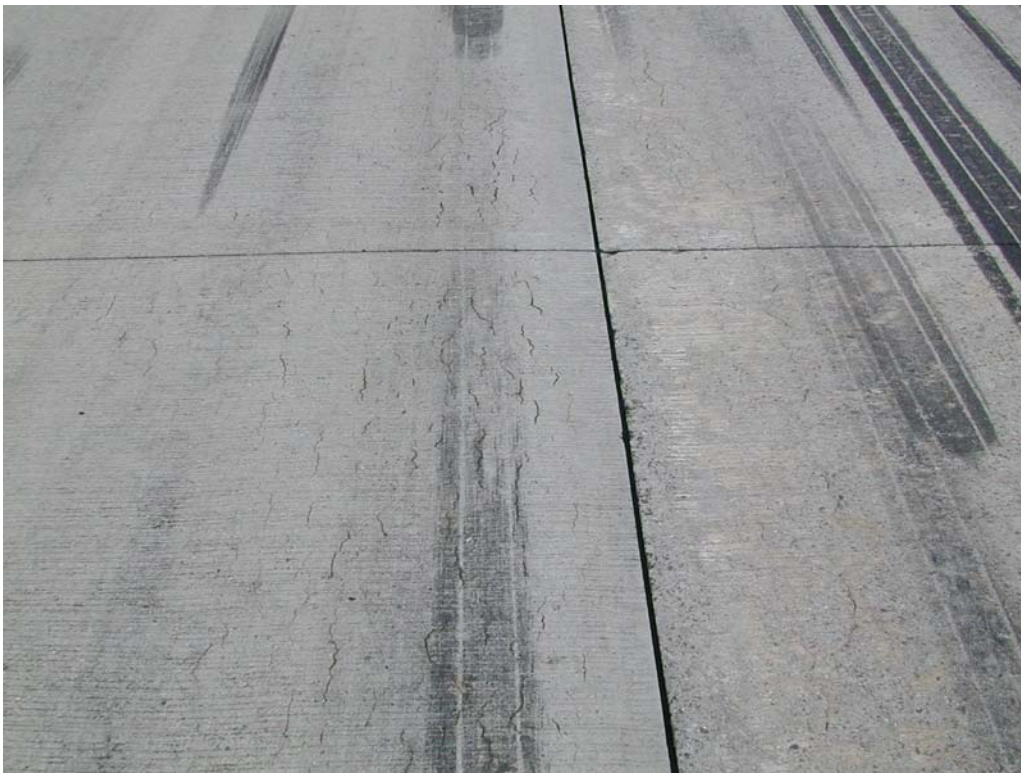
Shrinkage cracking in section R1836SV-10C.

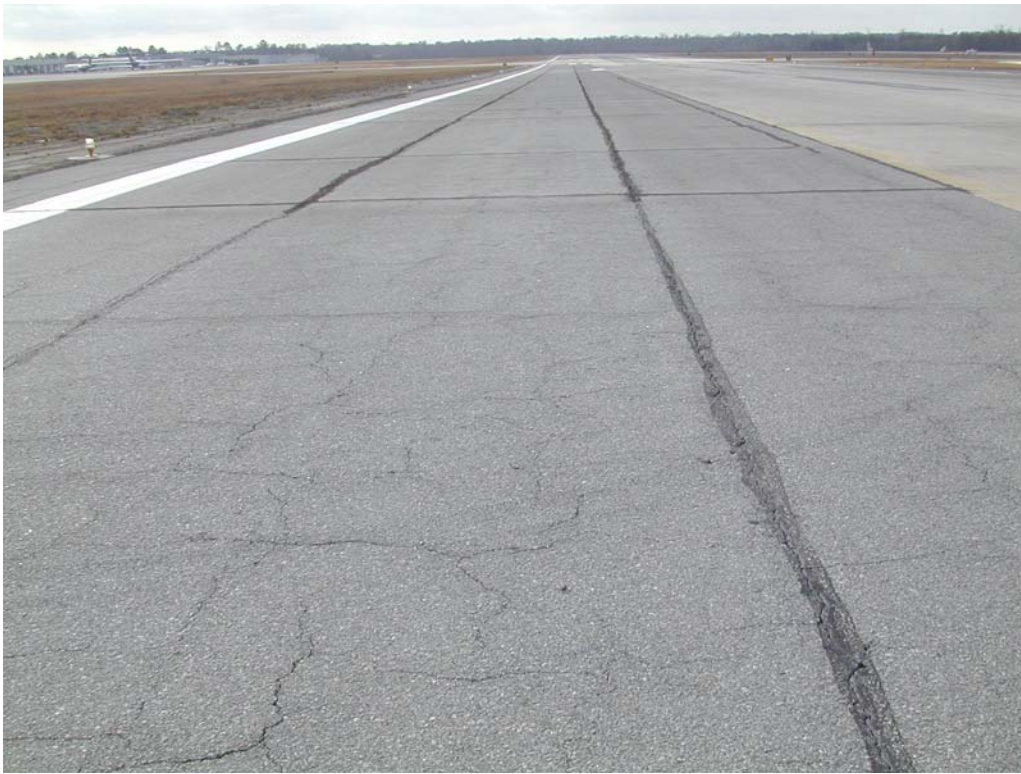
Six sections were defined in Runway 18-36. R1836SV-10W and R1836SV-10E are in poor condition with significant quantities of low and medium-severity L&T, joint reflective, and block cracking. Smaller amounts of swelling primarily associated with joint reflective cracking were found throughout the sections. Raveling and weathering was also observed in small amounts. R1836SV-10C is constructed of PCC. This section is in good condition with shrinkage cracking and patching observed throughout the section. At first glance the shrinkage cracking resembles durability cracking. However, through discussion with airport staff it was determined that this cracking appeared shortly after construction and has not progressed in size or severity since. The process that causes durability cracking usually will not halt and is rarely found in southern climates therefore shrinkage cracking was recorded. Low-severity joint seal damage was also found.

Overview of section R1836SV-10E.

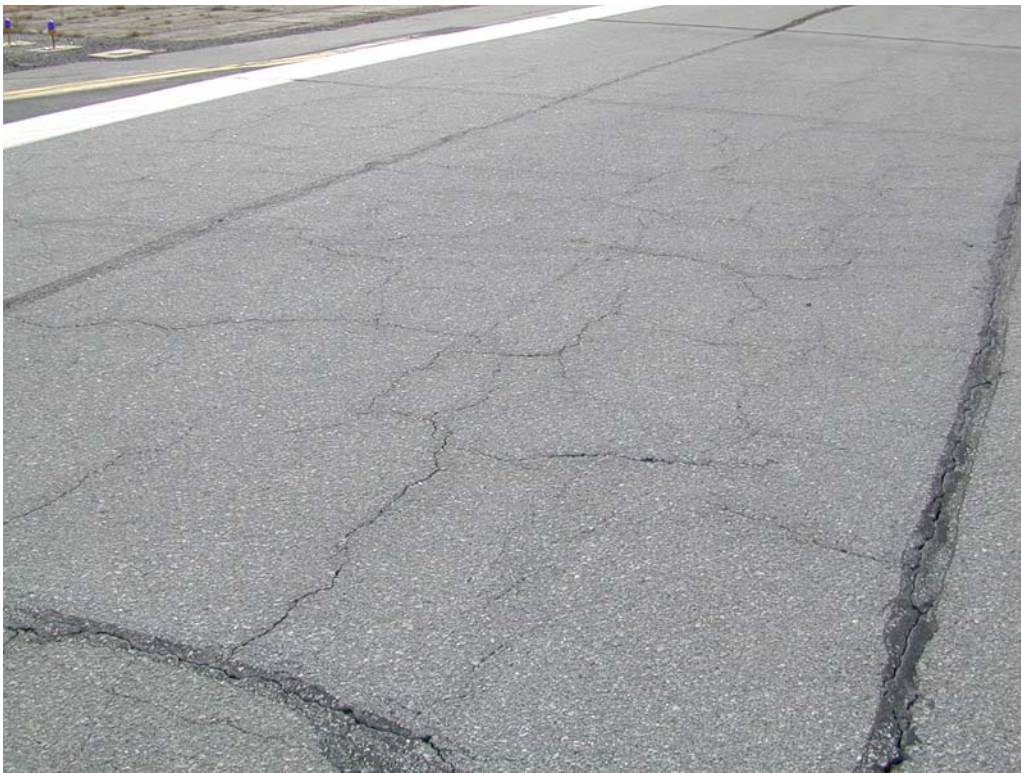
Block cracking in section R1836SV-10E.

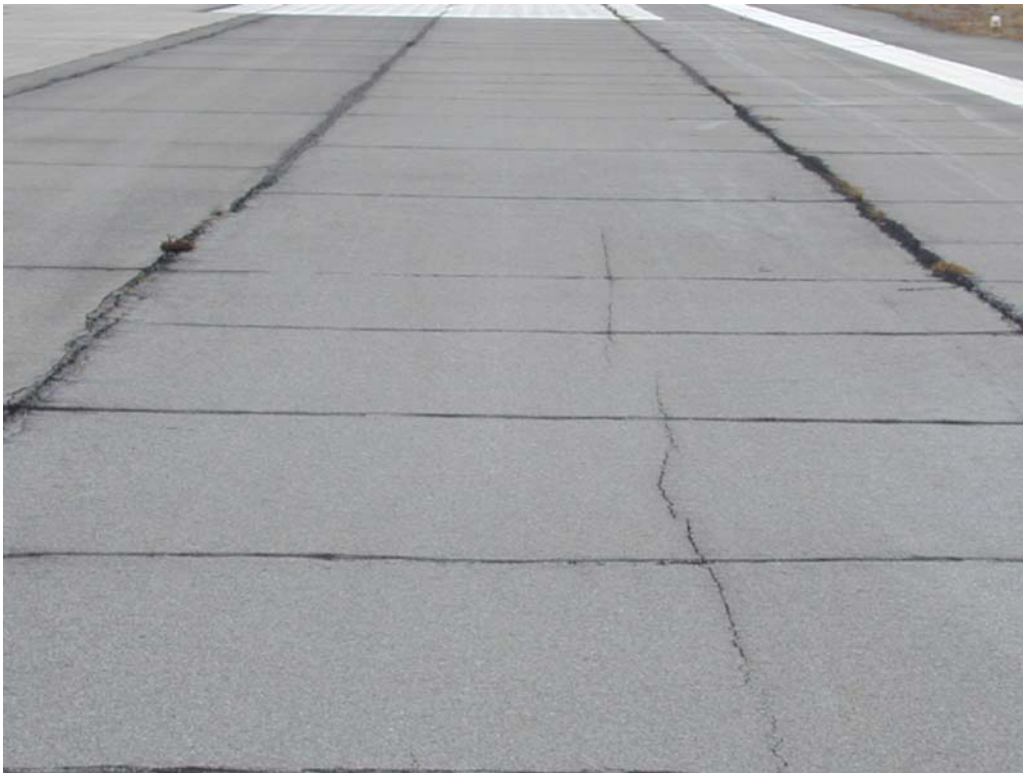
Overview of section R1836SV-10W.

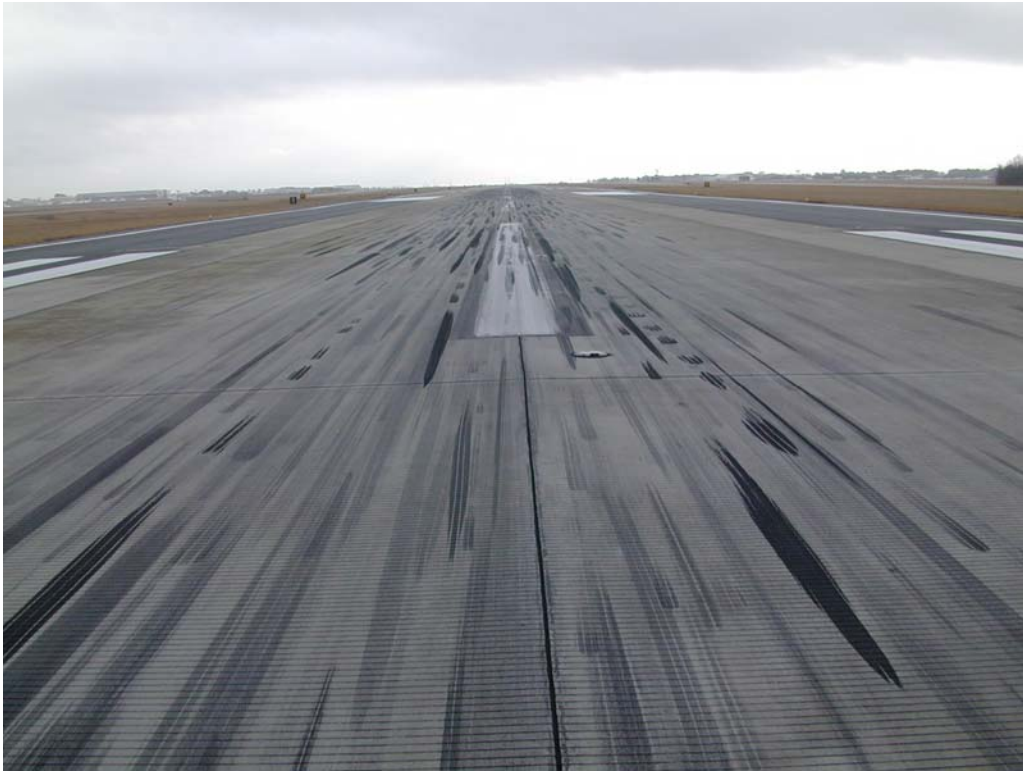
cracking is adjacent to the portland cement concrete (PCC) pavement in the center of the runway and appears to be the precursor to shoving. No vertical deformation was measured however, and shoving was not called. R927SV-10C comprises the center 100' and is constructed of PCC. Isolated small patches were found in the section.

Overview of section R927SV-10C.

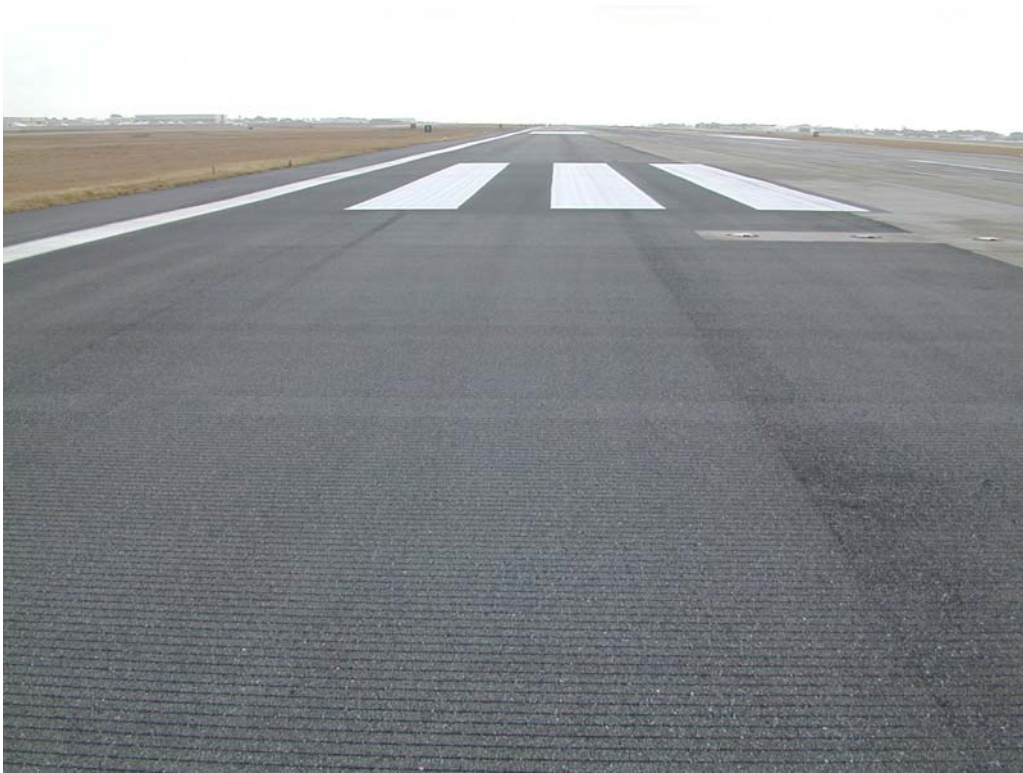
Three sections were defined in Runway 9-27. R927SV-10N, R927SV-10C, and R927SV-10S are all in excellent condition. Both R927SV-10N and R927SV-10S are asphalt surfaced pavements with small quantities of longitudinal and transverse (L&T) cracking. Some of this

Overview of section R927SV-10N.

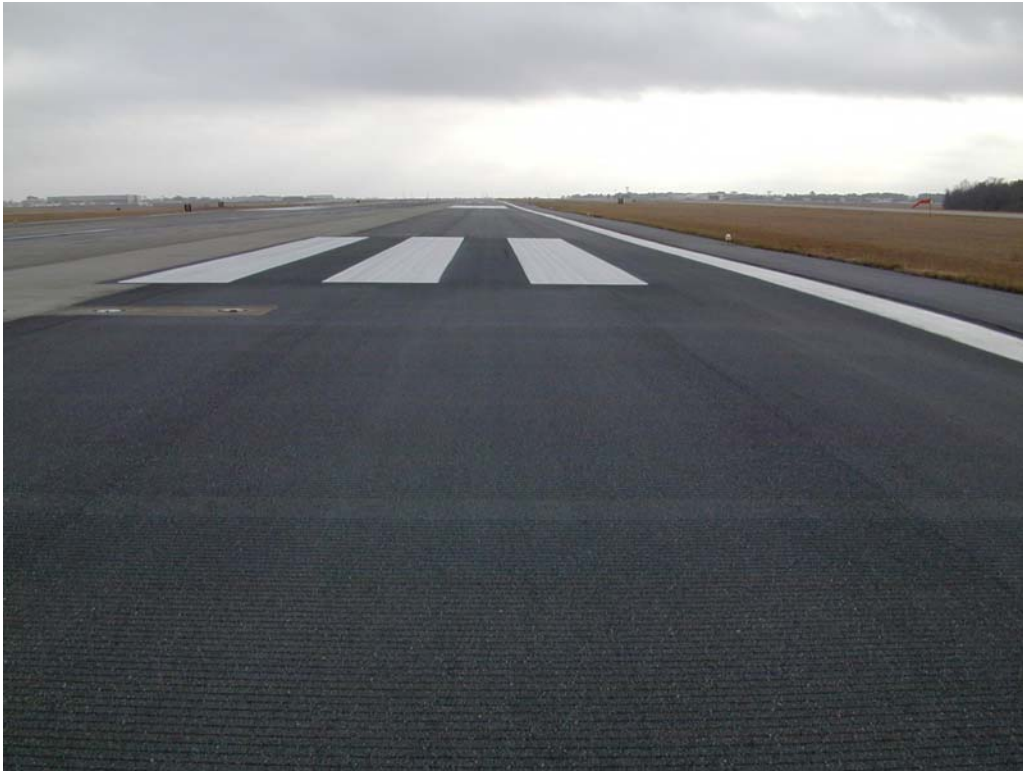
Overview of section R927SV-10S.

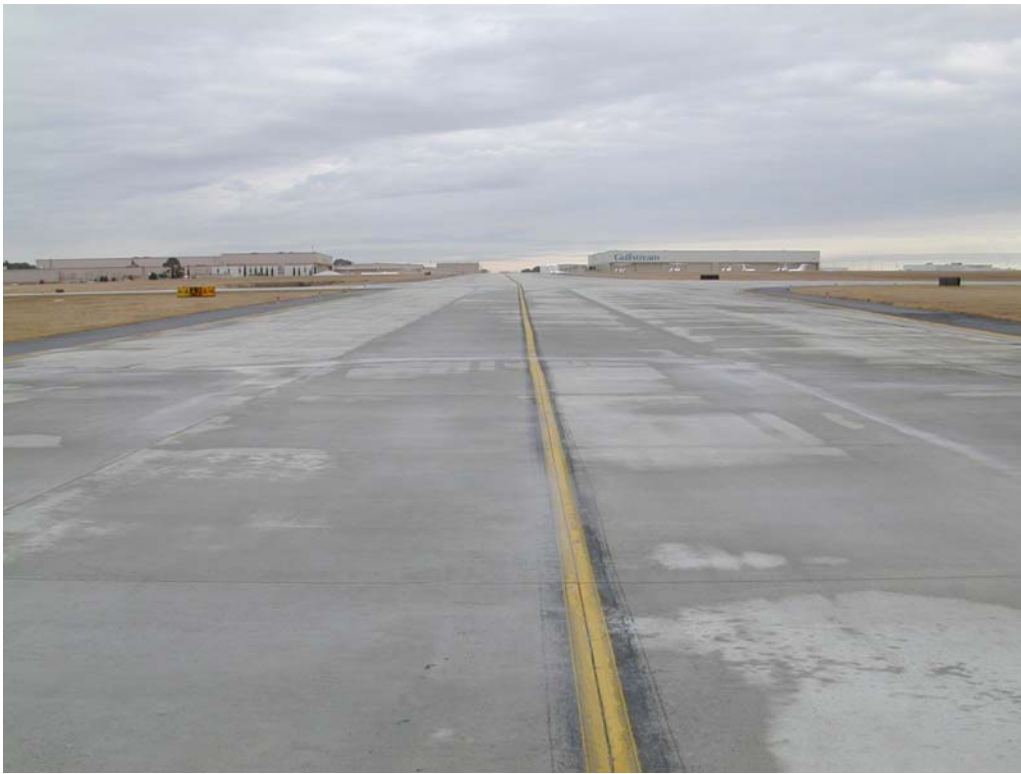
Two sections were defined in Taxiway A2. TA2SV-10 runs from the Terminal Apron to Taxiway A and is in very good condition. Significant quantities of pumping and low-severity joint seal damage were observed along with isolated amounts of longitudinal, transverse, and diagonal (LTD) and shrinkage cracking. TA2SV-20 is in excellent condition with isolated areas of patching and spalling observed.

Overview of section TA2SV-10.

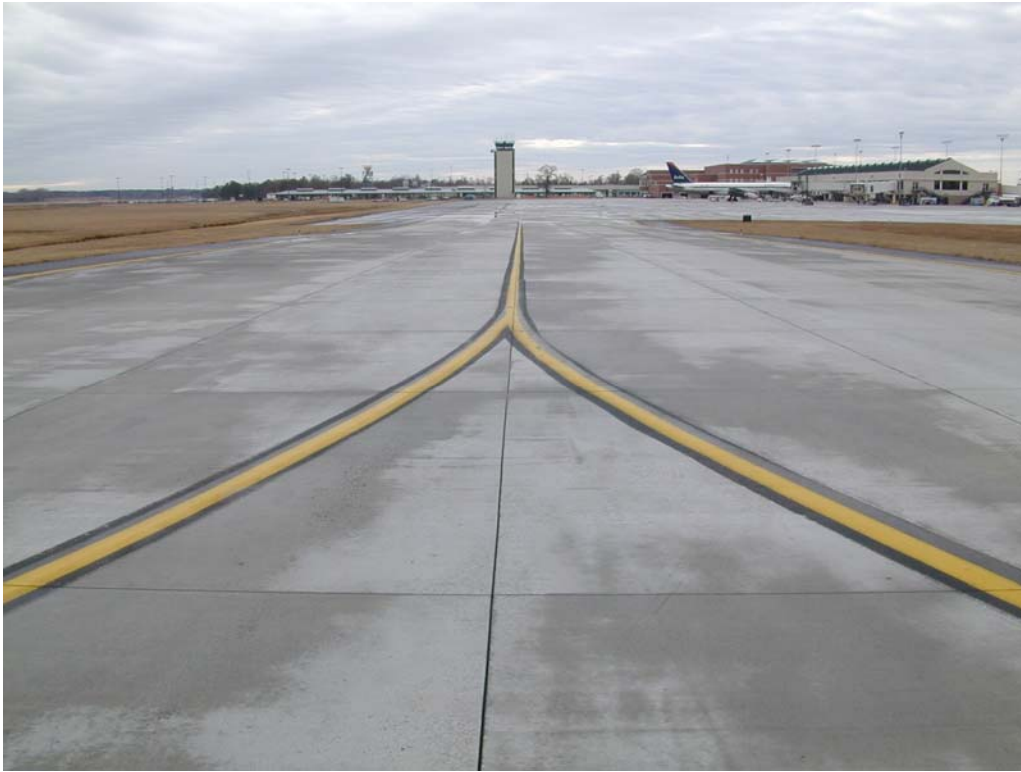
One section was defined in Taxiway A3. TA3SV-10 is in excellent condition. However, significant quantities of pumping were found in several areas throughout the section. Smaller amounts of patching were also observed.

Overview of section TA3SV-10.

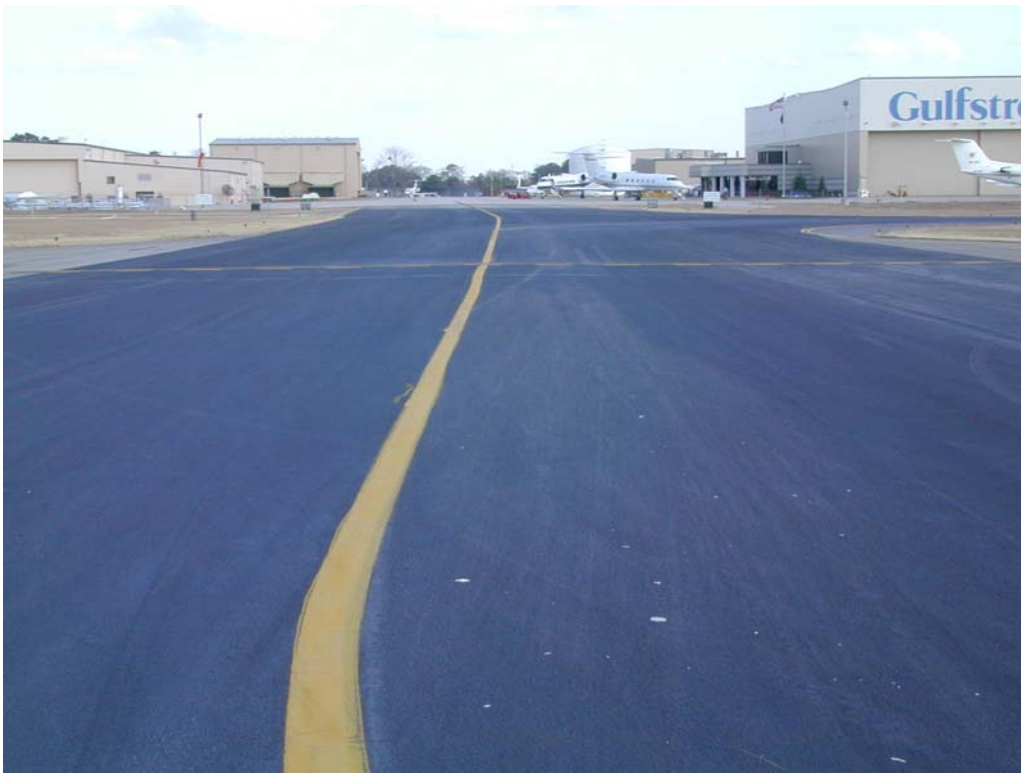
Two sections were defined in Taxiway B. TBSV-10 is located at the north end of field and lies between Runway 18-36 and the main portion Taxiway B. A small piece of pavement leading into the Gulfstream facility is also included in this section. This section is in good condition with significant amounts of low-severity L&T cracking found throughout the section. Isolated amounts of swelling associated with the L&T cracking were also found. Finally, substantial amounts of bleeding were observed throughout the section. TBSV-20 is constructed of PCC and contains the remaining pavement in Taxiway B. This section is in excellent condition with large amounts of shrink cracking and small quantities of patching and spalling being found throughout the section.

Overview of section TBSV-10.

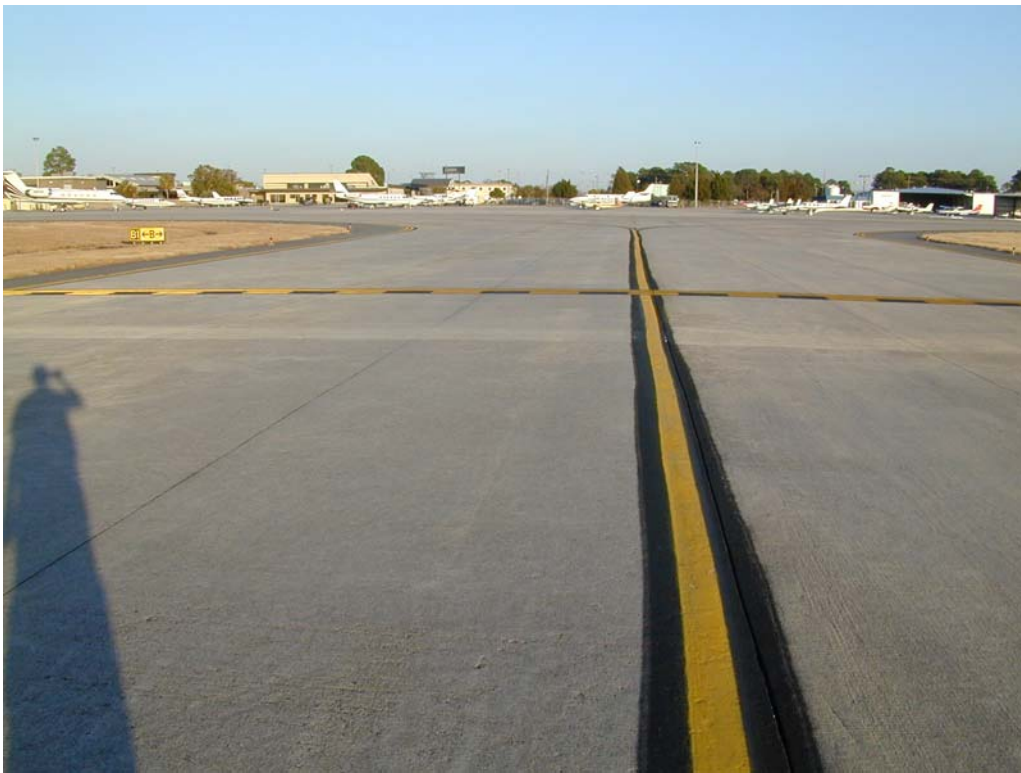
One section was defined in Taxiway B1. TB1SV-10 is in excellent condition with significant amounts of shrinkage cracking along with smaller quantities of patching being found throughout.

Overview of section TB1SV-10.

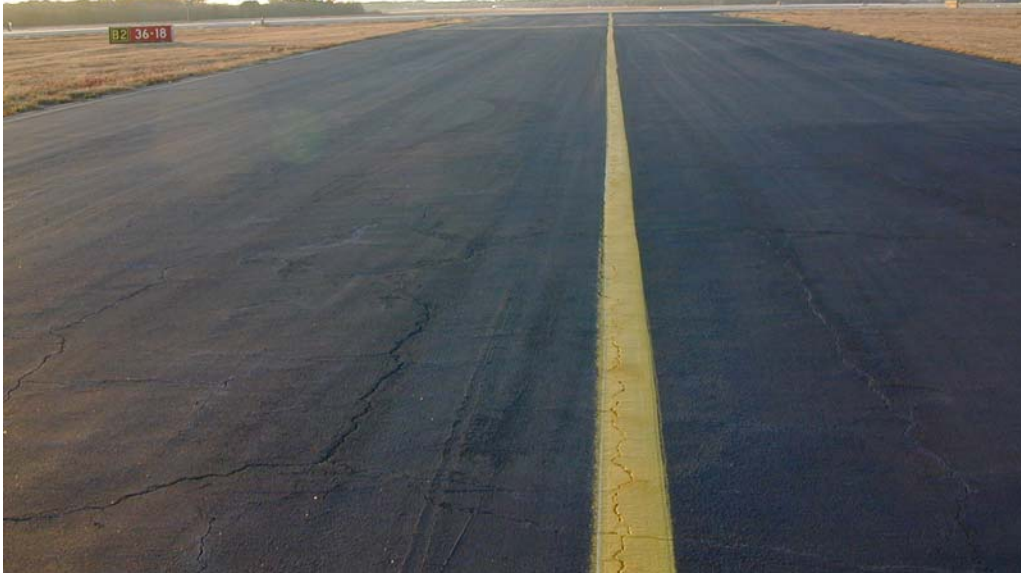
One section was also defined in Taxiway B2. This section is in fair condition with large amounts of low and medium-severity block cracking being found. Significant amounts of swelling associated with the cracking were also observed.

Overview of section TB2SV-10.

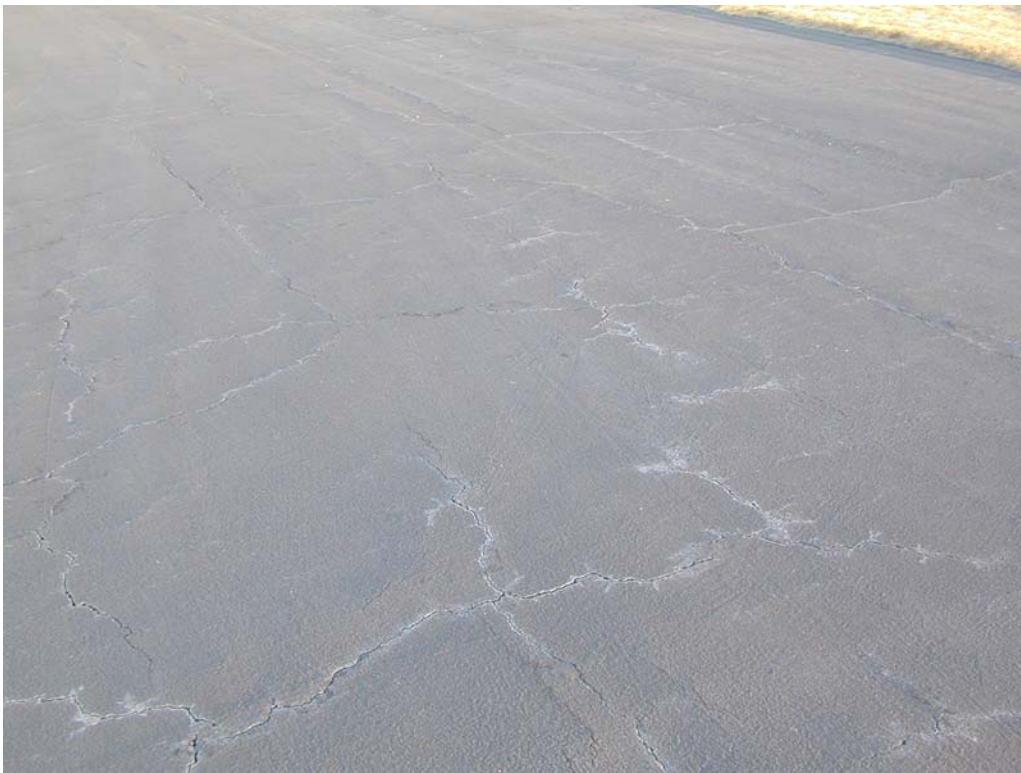
Block cracking in section TB2SV-10.

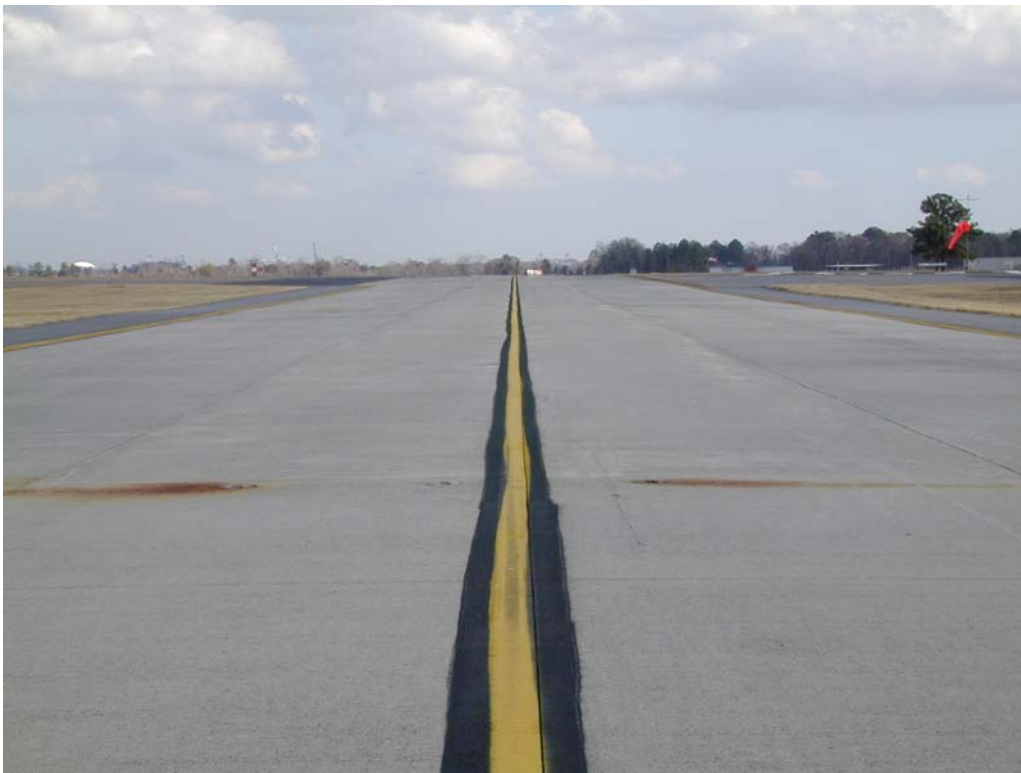
Six sections were defined in Taxiway C. With the exception of TCSV-40, all other sections are in excellent condition. Low-severity joint seal damage, however, was found in TCSV-30. TCSV-40 is in good condition with significant quantities of shrinkage cracking and low-severity joint seal damage found throughout.

Overview of section TCSV-40.

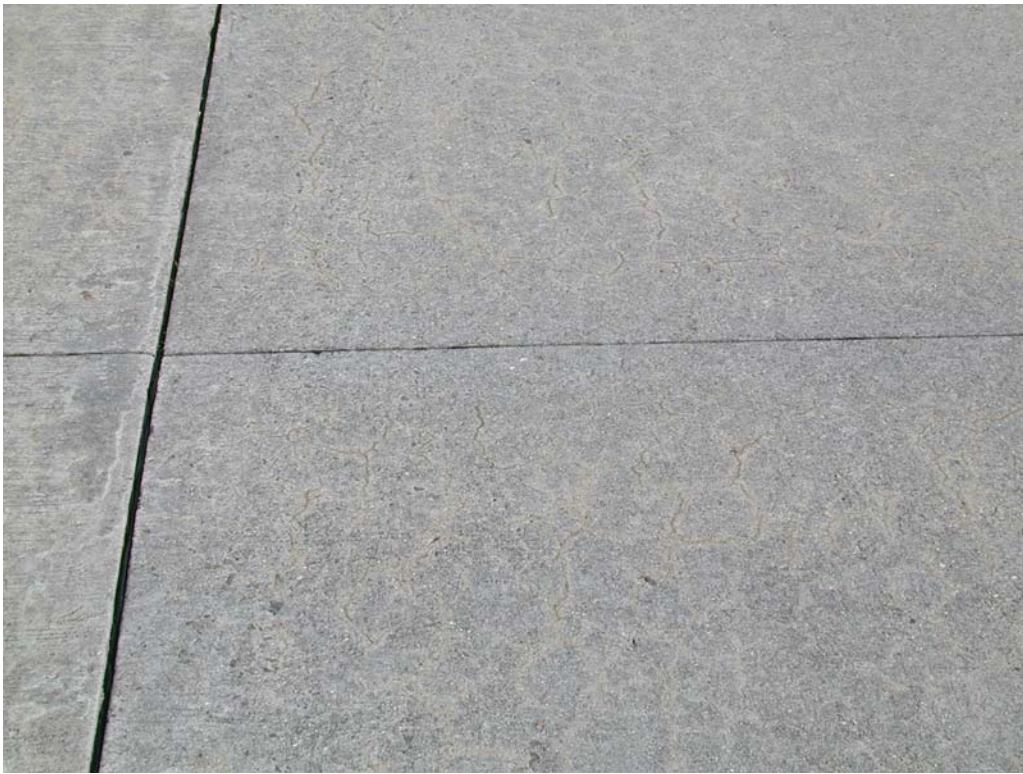
Shrinkage cracking in section TCSV-40.

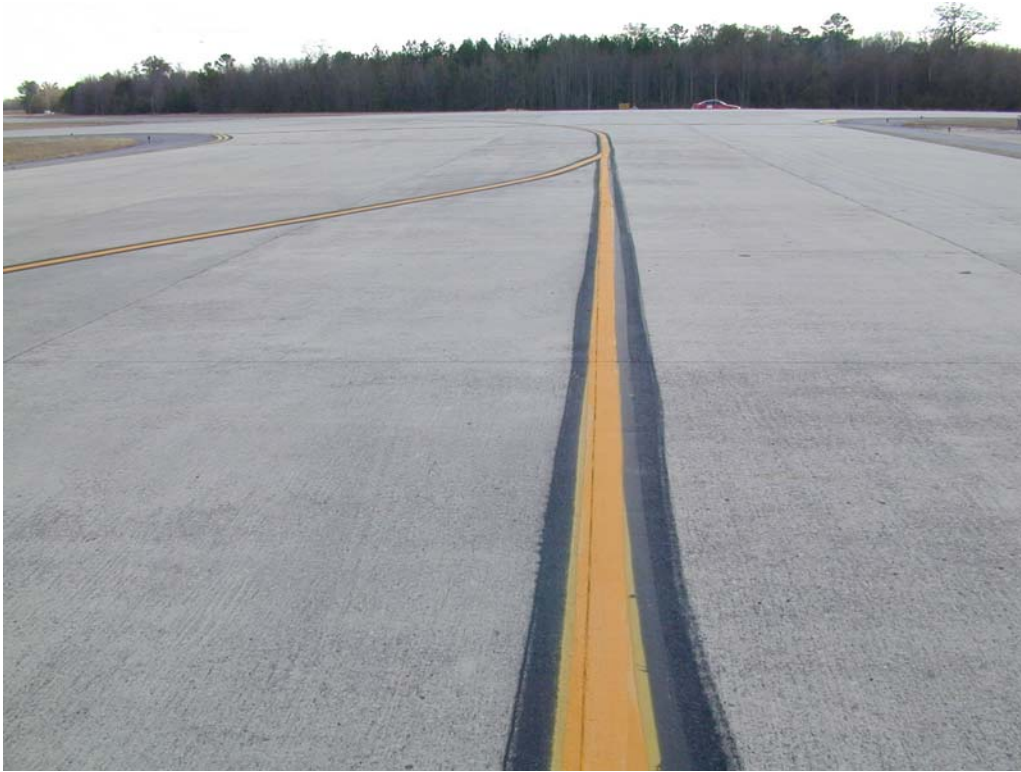
One section was defined in Taxiway C1. TC1SV-10 is in excellent condition. Isolated amounts of patching, shrinkage cracking, and spalling were found in the section.

Overview of section TC1SV-10.

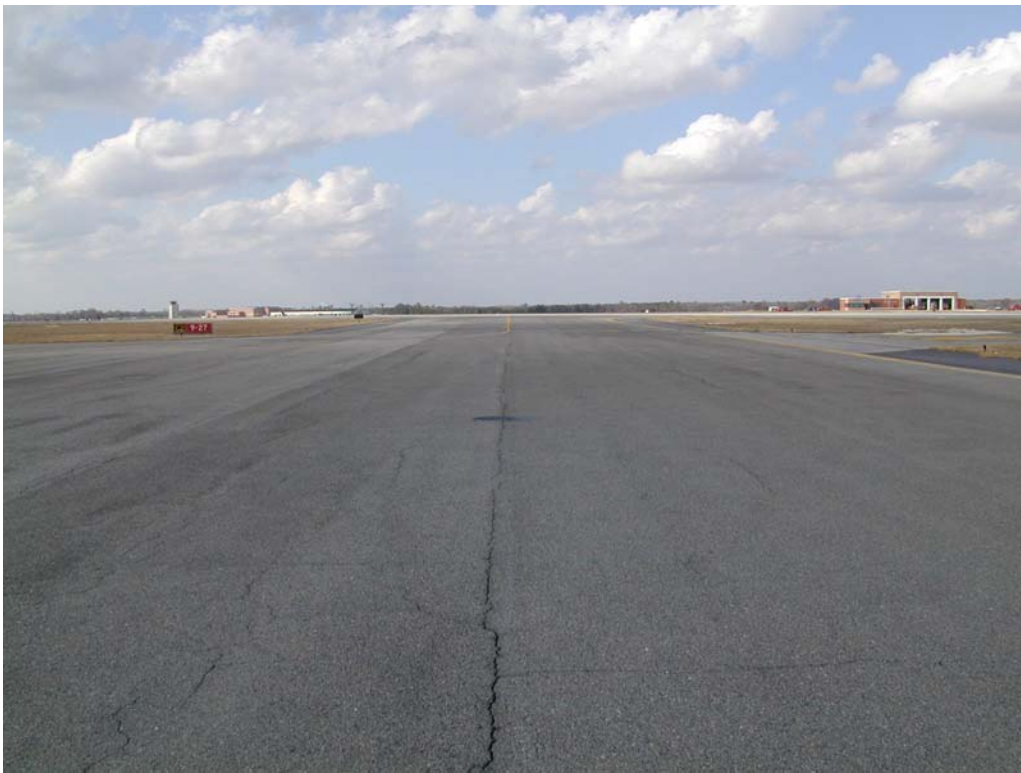
One section was also defined in Taxiway C2. TC2SV-10 is in fair condition with large quantities of mostly low-severity L&T cracking and raveling and weathering observed throughout. Substantial amounts of swelling were also found.

Overview of section TC2SV-10.

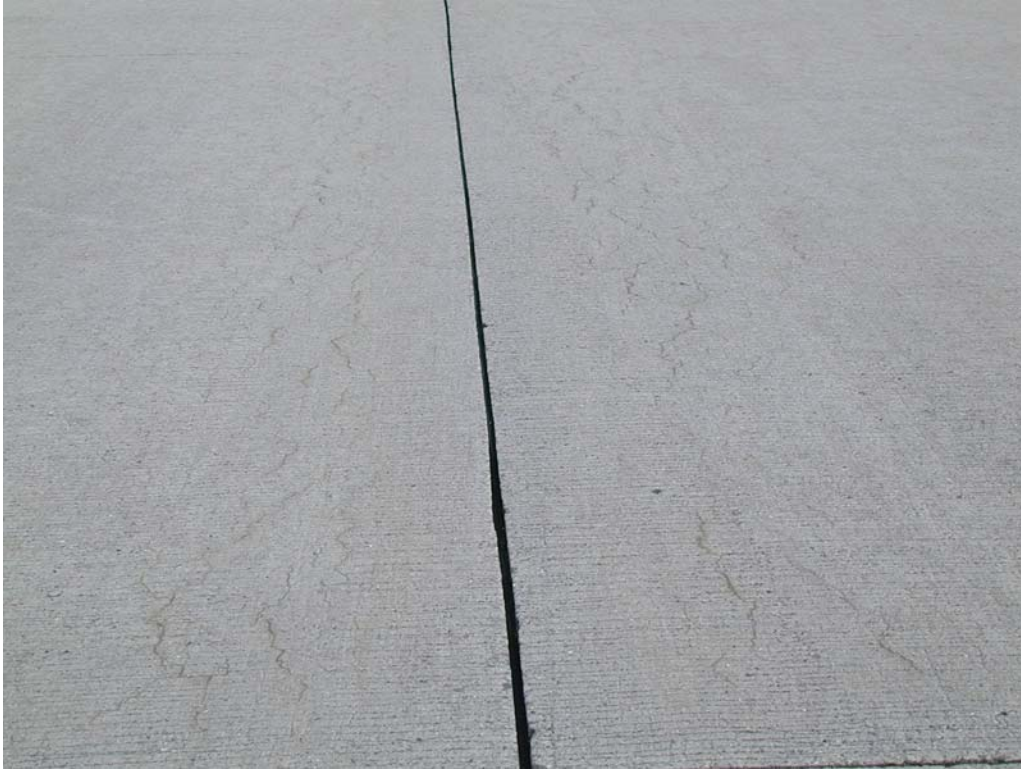
Shrinkage cracking in section TESV-20.

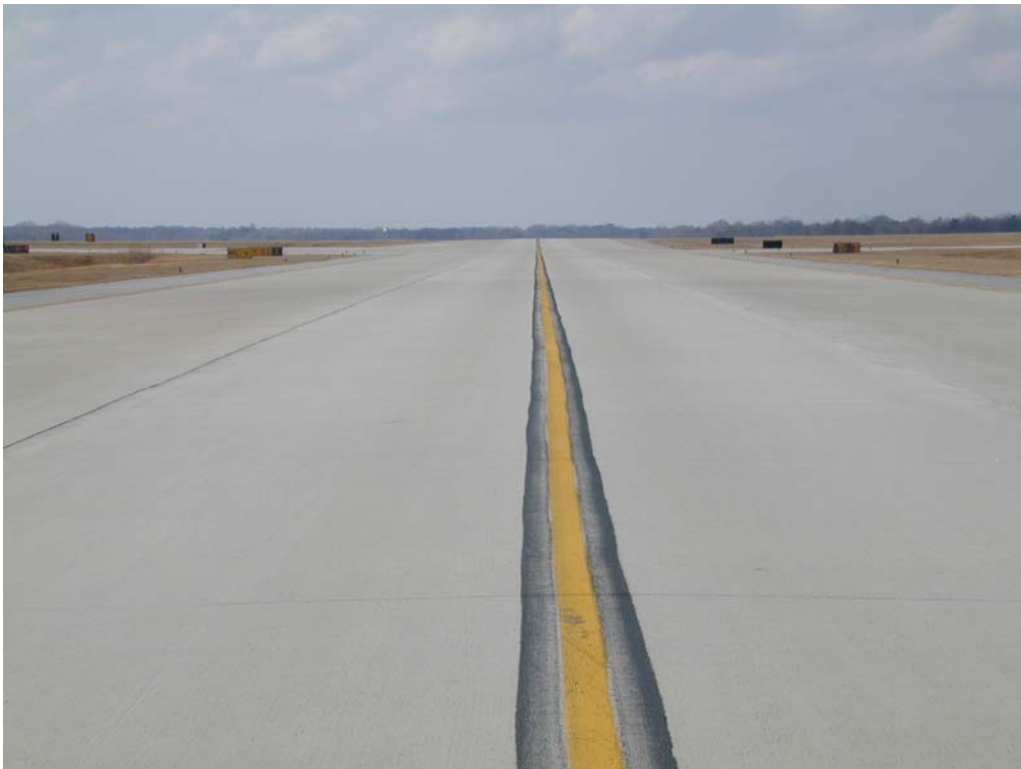
Four sections were defined in Taxiway E. With the exception of TESV-30, the other sections in the taxiway are in excellent condition. Patching was found in TESV-20 in moderate amounts. TESV-30 is in good condition with shrinkage cracking and patching being found throughout. Isolated amounts of spalling were also observed.

Overview of section TESV-30.

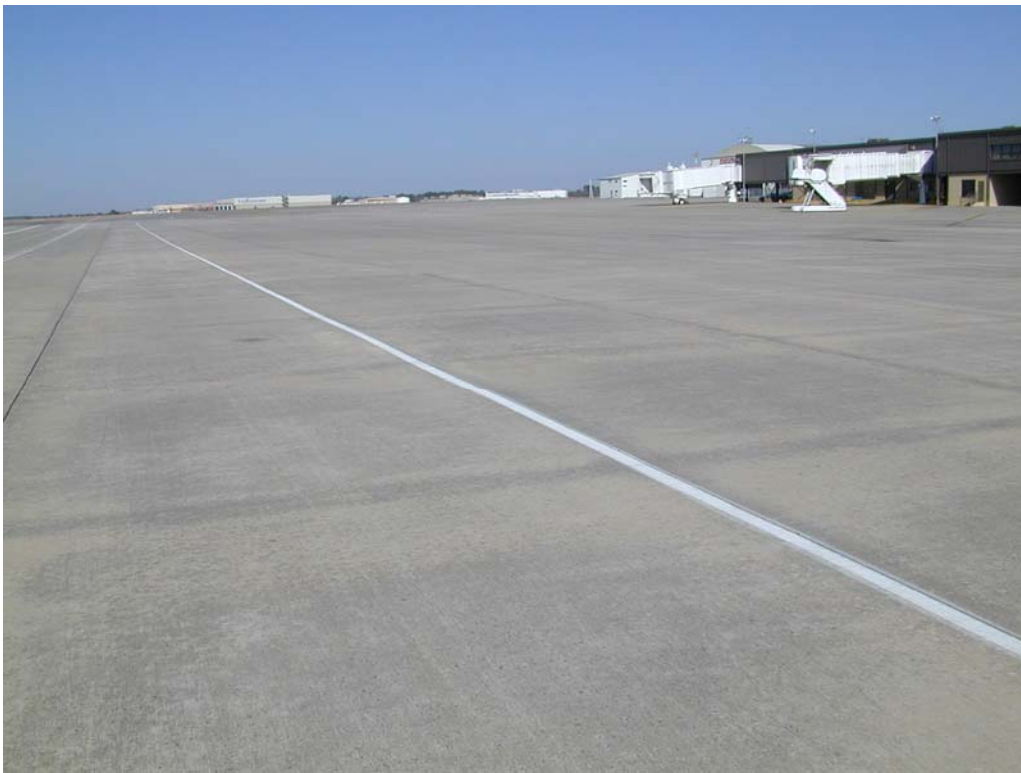
One large section was defined in the Old Terminal Apron for the purposes of this inspection. AOLDTERMSV-10 is in excellent condition with isolated quantities of patching, spalling, and high-severity joint seal damage found throughout the section.

Overview of section AOLDTERMSV-10.

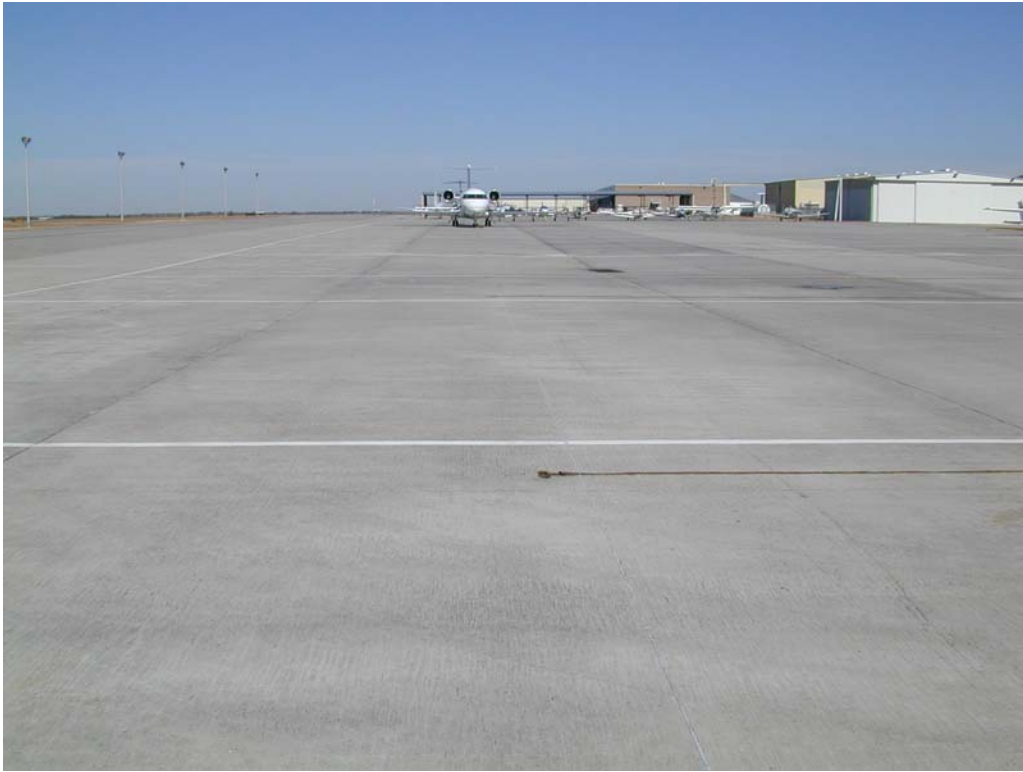
One section was defined in the Savannah Air Apron. ASAVAIRSV-10 is in excellent condition with moderate amounts of patching found throughout. Isolated amounts of spalling, faulting, and shrinkage cracking were also observed.

Overview of section ASAVAIRSV-10.

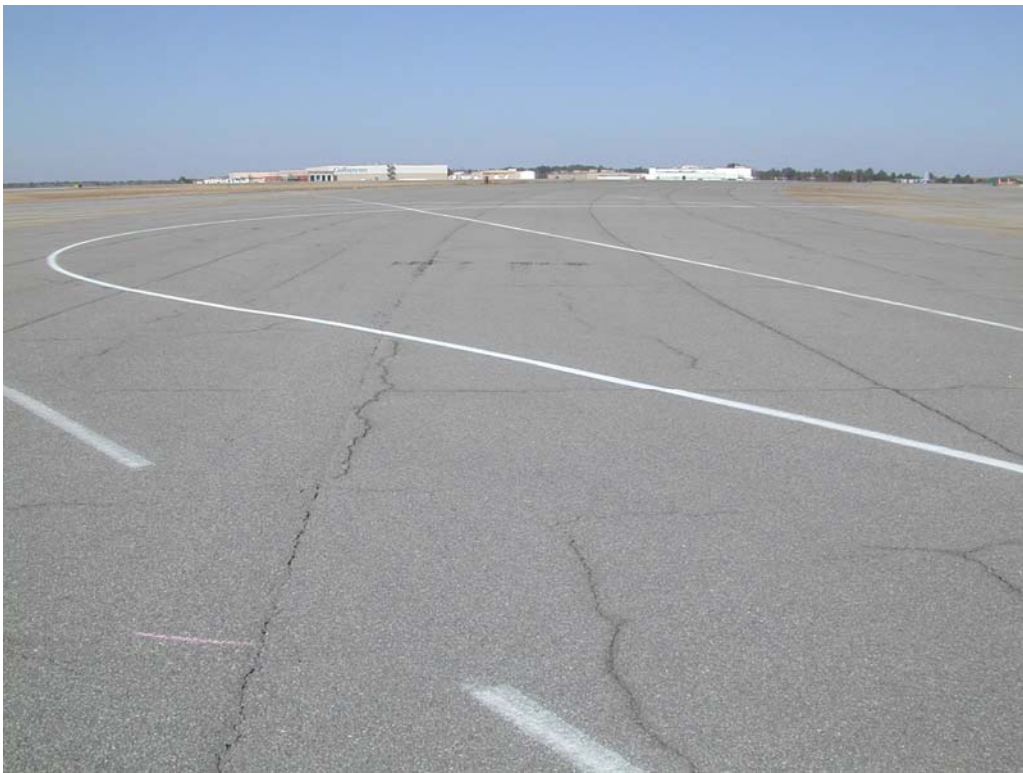
Two sections were defined in the Signature North Apron. ASIGNORSV-10 is in poor condition with large quantities of low and medium-severity L&T and joint reflective cracking being found throughout. Raveling and Weathering was observed over the entire pavement's surface. Isolated amounts of swelling and depression were also found. ASIGNORSV-20 is older PCC pavement

Overview of section ASIGNORTHSV-10.

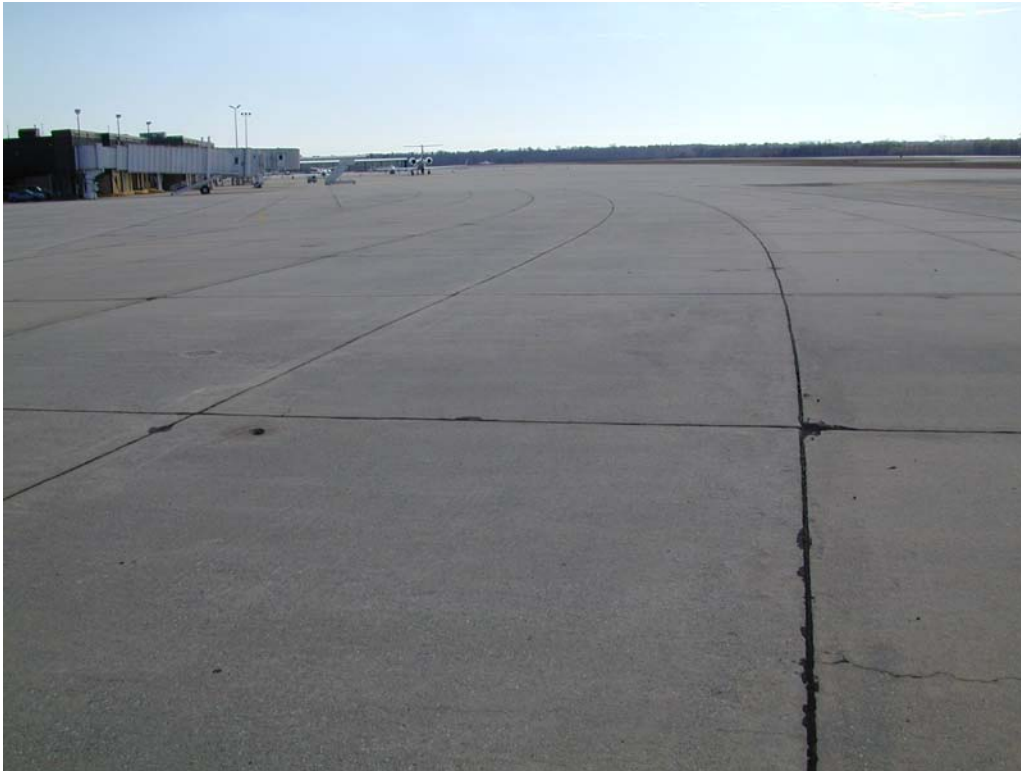
and is also in poor condition. Large quantities of spalling at all severities along with high-severity joint seal damage were found throughout the section. Moderate amounts of shattered slabs, patching, and shrinkage cracking were also observed.

Overview of section ASIGNORTHSV-20.

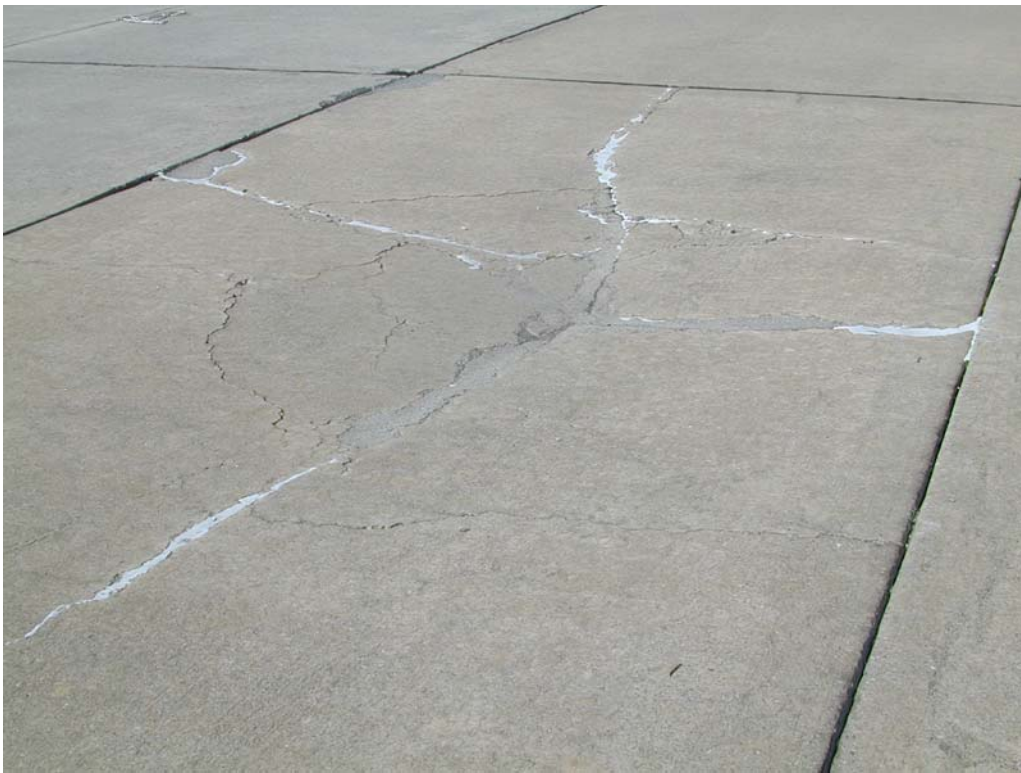
Shattered slab in section ASIGNORTHSV-20.

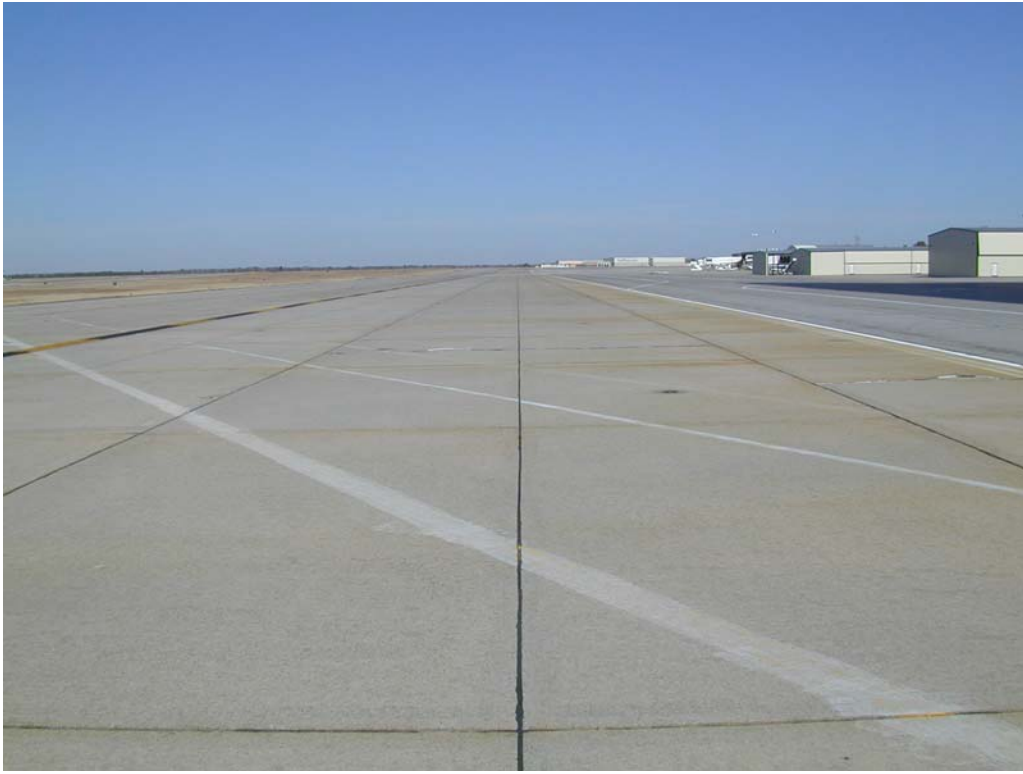
Two sections were defined in the Signature South Apron. ASIGSTHSV-10 is similar in construction to ASIGNORSV-20 in the Signature North Apron. However, ASIGSTHSV-10 is in good condition with moderate quantities of spalling, patching, and shrinkage cracking found throughout. An occasional LTD crack was also found. ASIGSTHSV-20 is similar in construction and condition to ASIGNORSV-20 in the Signature North Apron.

Overview of section ASIGSOUTHSV-10.

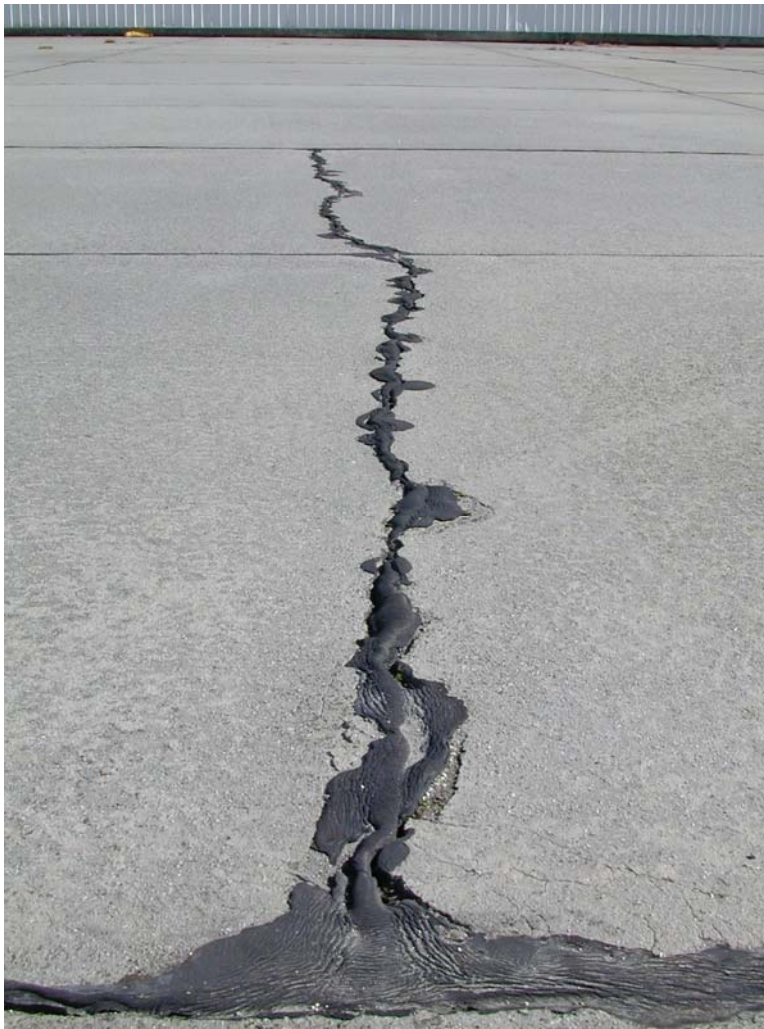
LTD cracking in section ASIGSOUTHSV-10.
