SAVANNAH INTERNATIONAL AIRPORT

PAVEMENT EVALUATION REPORT

JULY 2002

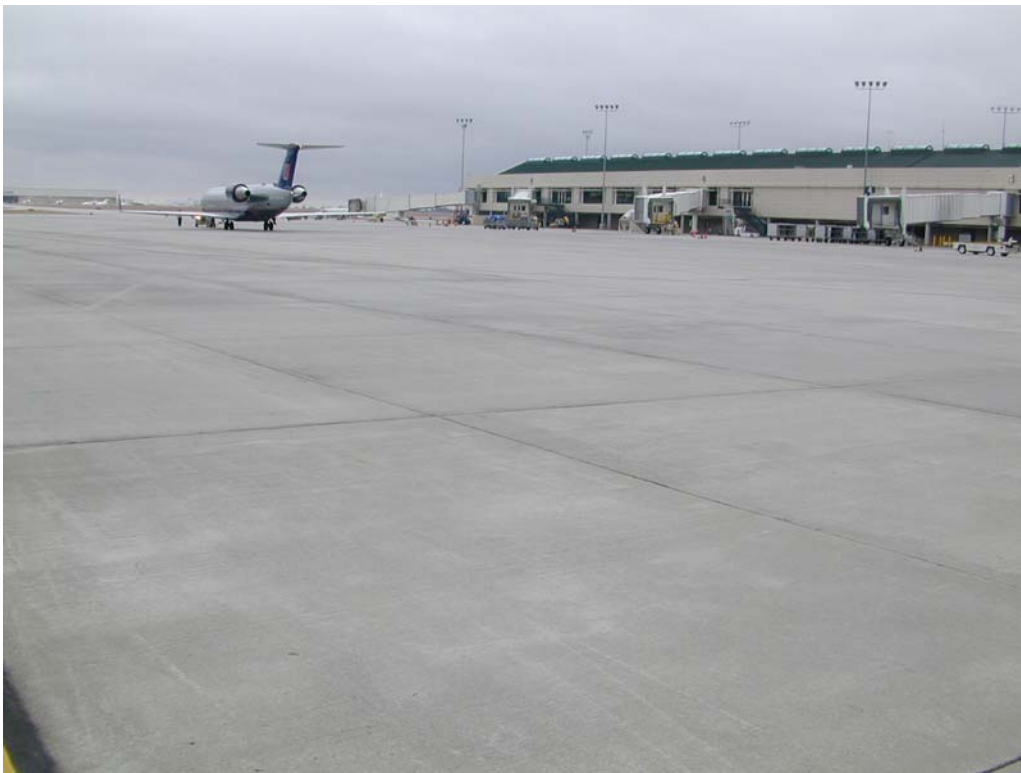
Three sections were defined in the Terminal Apron. All three sections are in excellent condition. Isolated amounts of patching and spalling were found in ATERMSV-10, while ATERMSV-20 and ATERMSV-30 were found to be free of any distress.

Overview of section ATERMSV-10.
