VALDOSTA REGIONAL AIRPORT PAVEMENT EVALUATION REPORT

JULY 2002

PAVEMENT EVALUATION REPORT

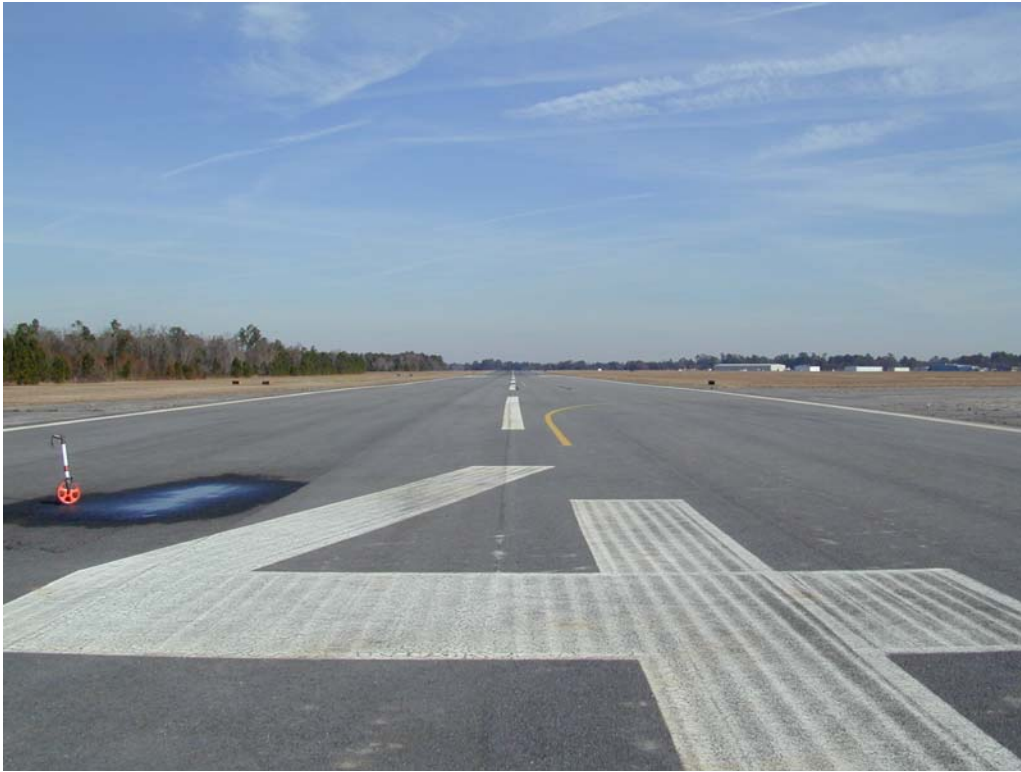
Runway 4-22, section R422VL-10, is in very good condition with only two distress types identified. Bleeding was noted in several areas along the runway and low-severity depressions were observed near the 4 Approach. The center 100 feet of the runway has been recently rehabilitated. The older pavement outside of the current runway dimension contains nearly 100 percent of medium-severity block cracking.

Overview of section R422VL-10.

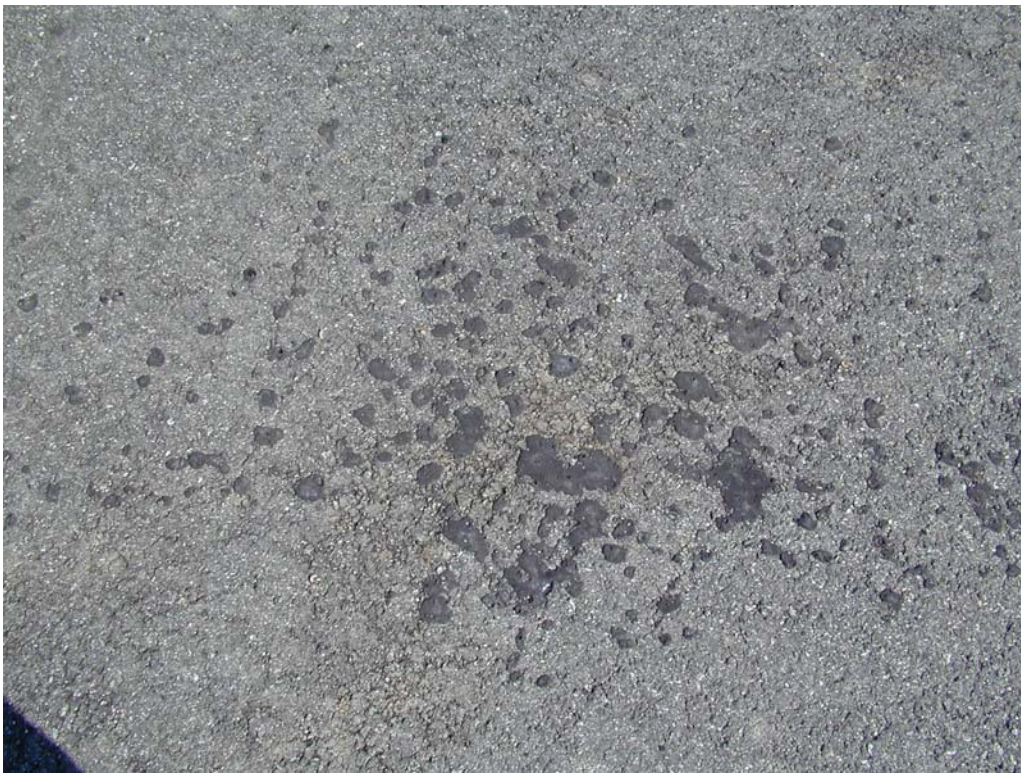
Bleeding in section R422VL-10.

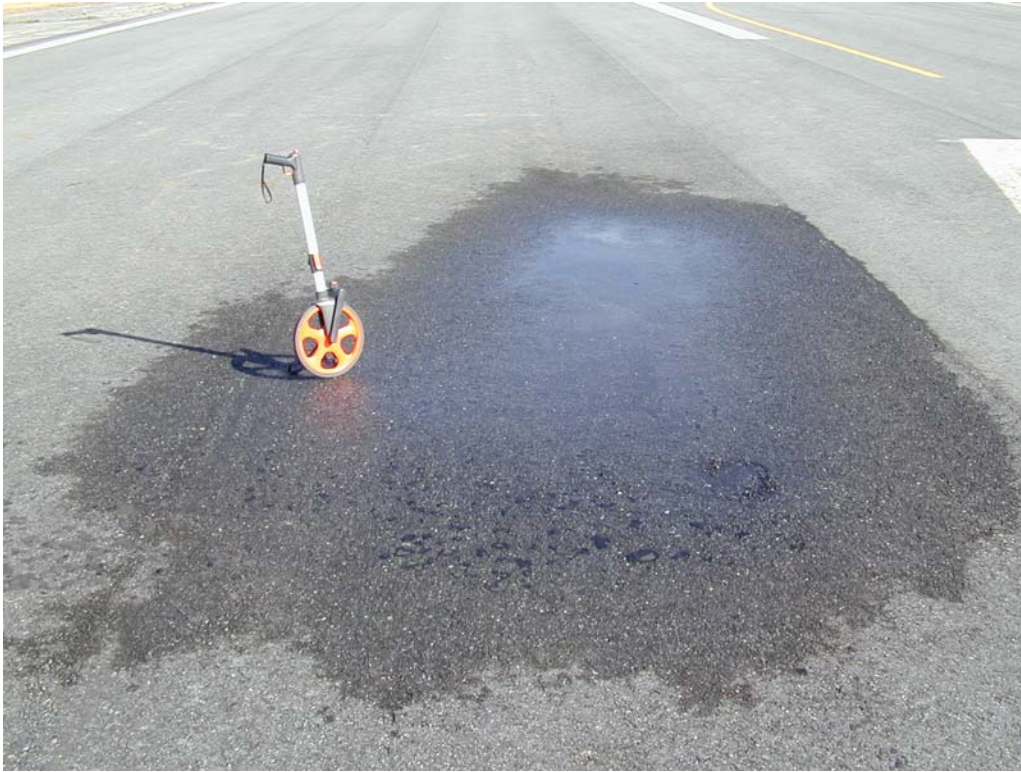
Depression and weathering in section R422VL-10.

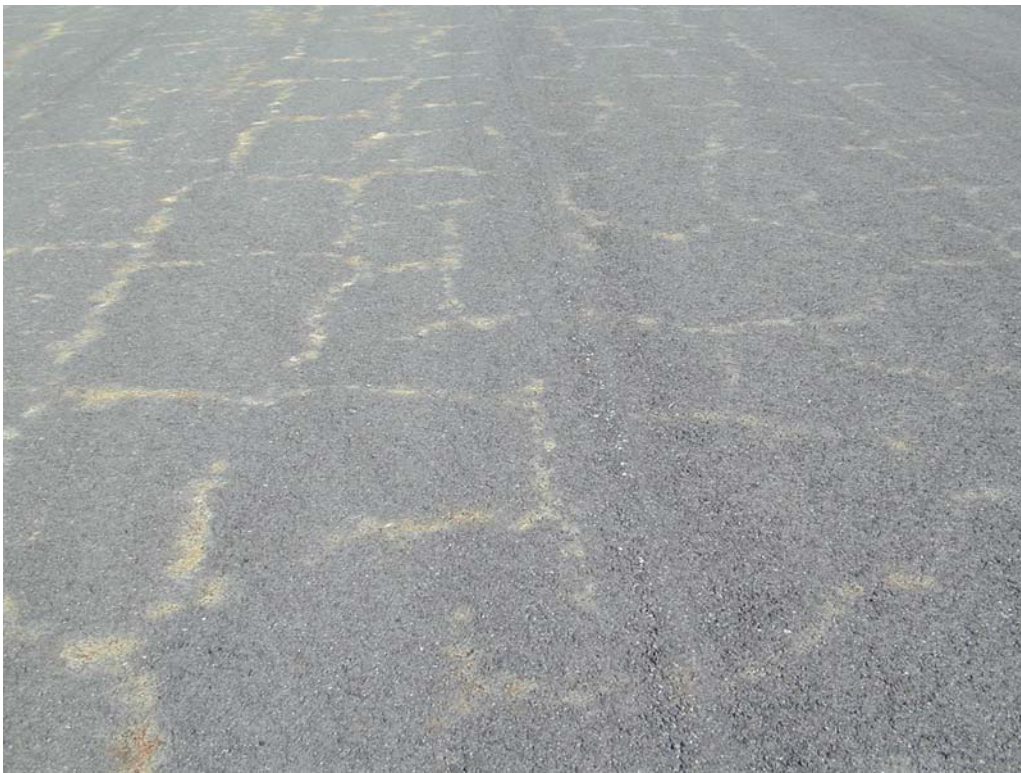
L&T cracking beginning to form blocks in section R422VL-10.

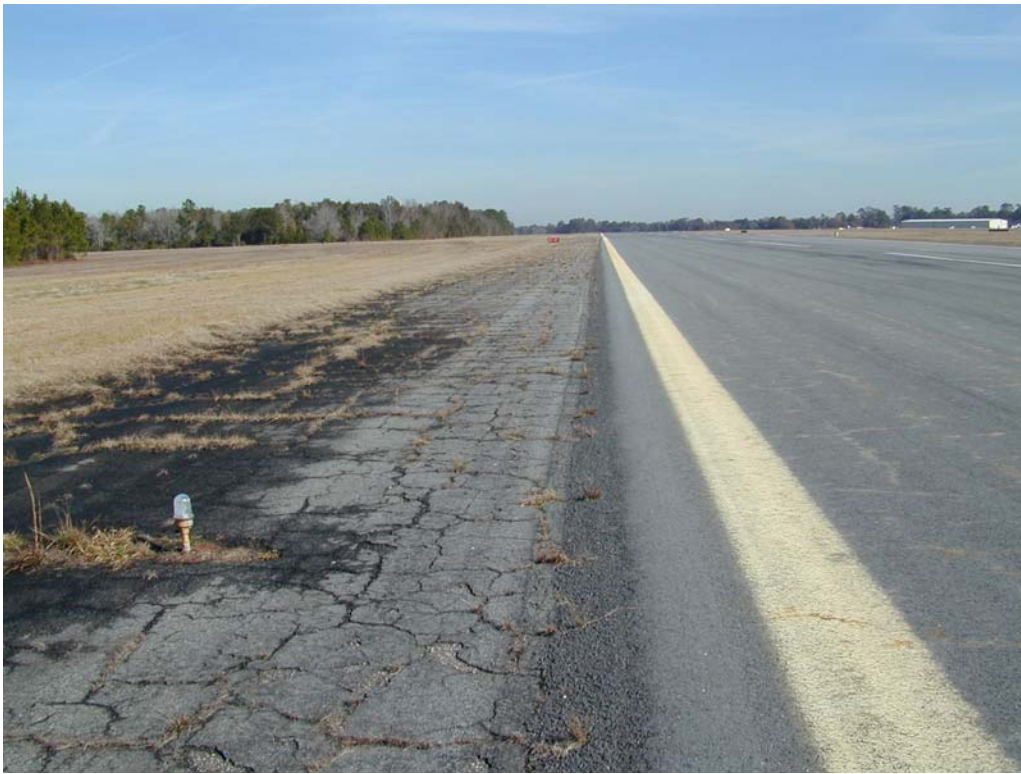
Overview of underlying pavement in section R422VL-10.

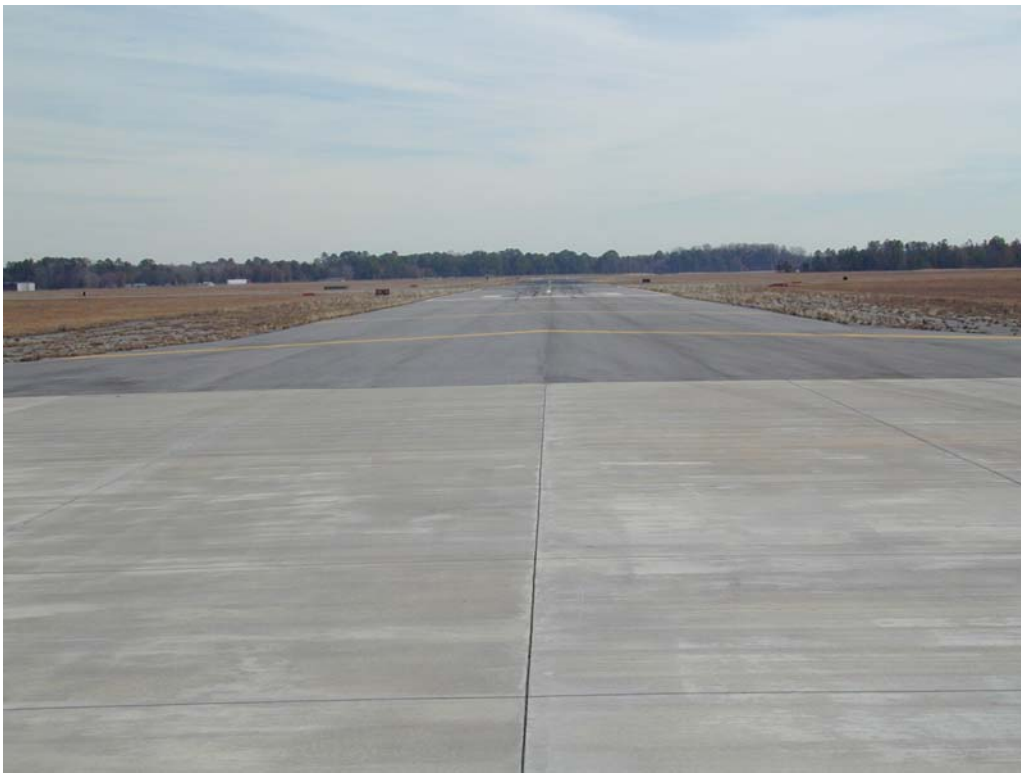
Runway 13-31 is comprised of a PCC section, R1331VL-10, and an AAC section, R1331VL-20. R1331VL-10 is in excellent condition with no noted distress. R1331VL-20 is in very good condition with relatively small quantities of unsealed, low-severity longitudinal and transverse (L&T) cracks identified along the runway. The center 75 feet of this runway was recently rehabilitated. The older pavement outside of the current runway dimension contains nearly 100 percent of medium-severity block cracking.

Overview of section R1331VL-10.

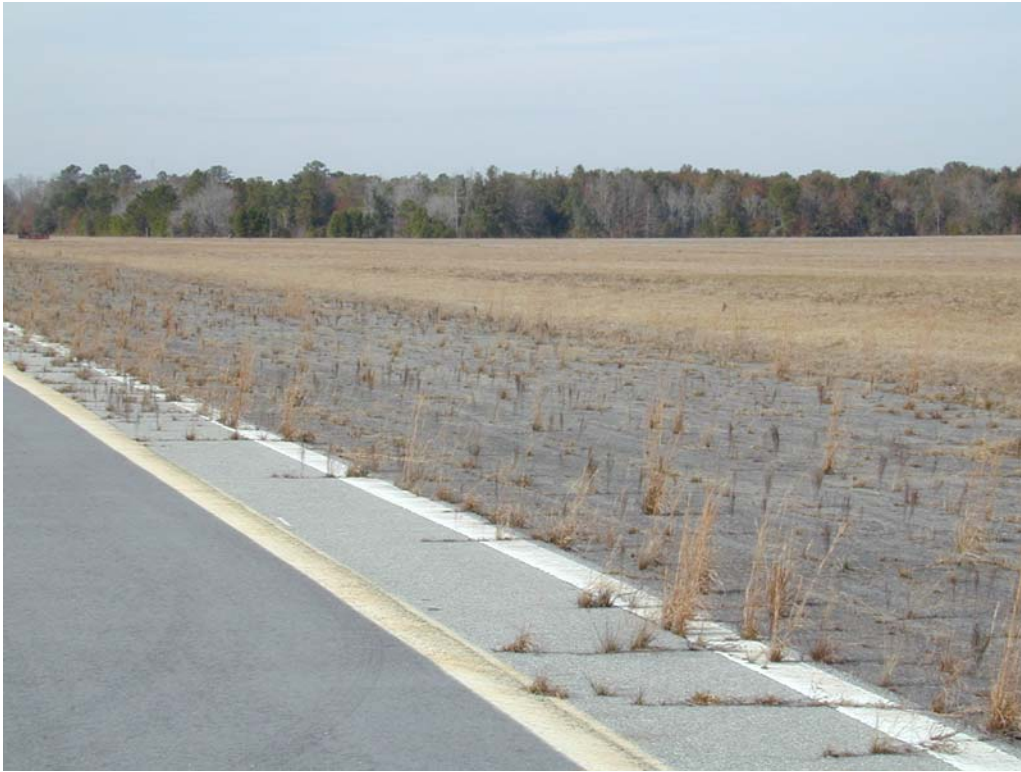
Overview of underlying pavement in section R1331VL-10.

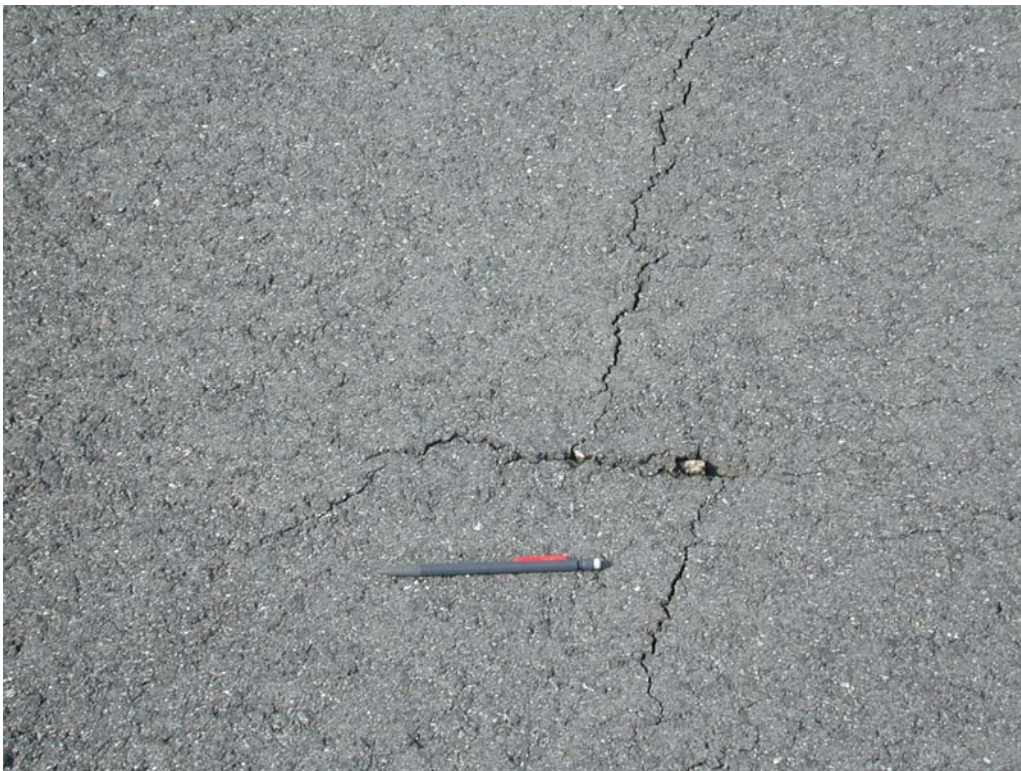
L&T cracking in section R1331VL-10.

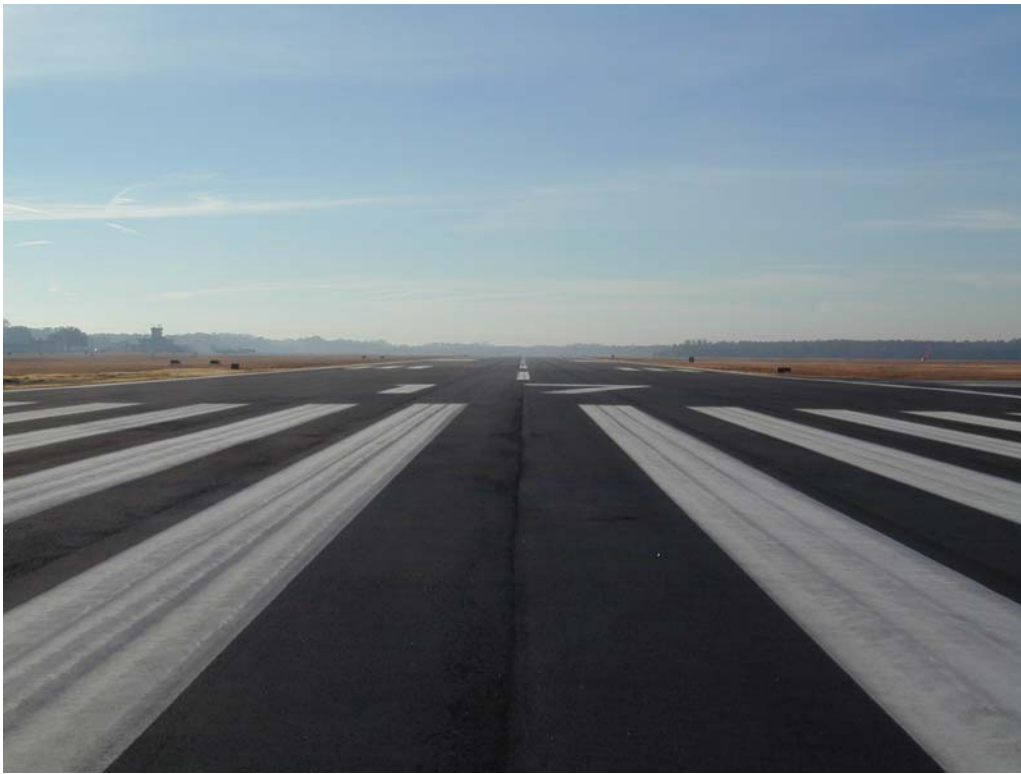
Runway 17-35, section R1735VL-10, is in excellent condition with no distresses observed on the recently rehabilitated pavement.

Overview of section R1735VL-10.

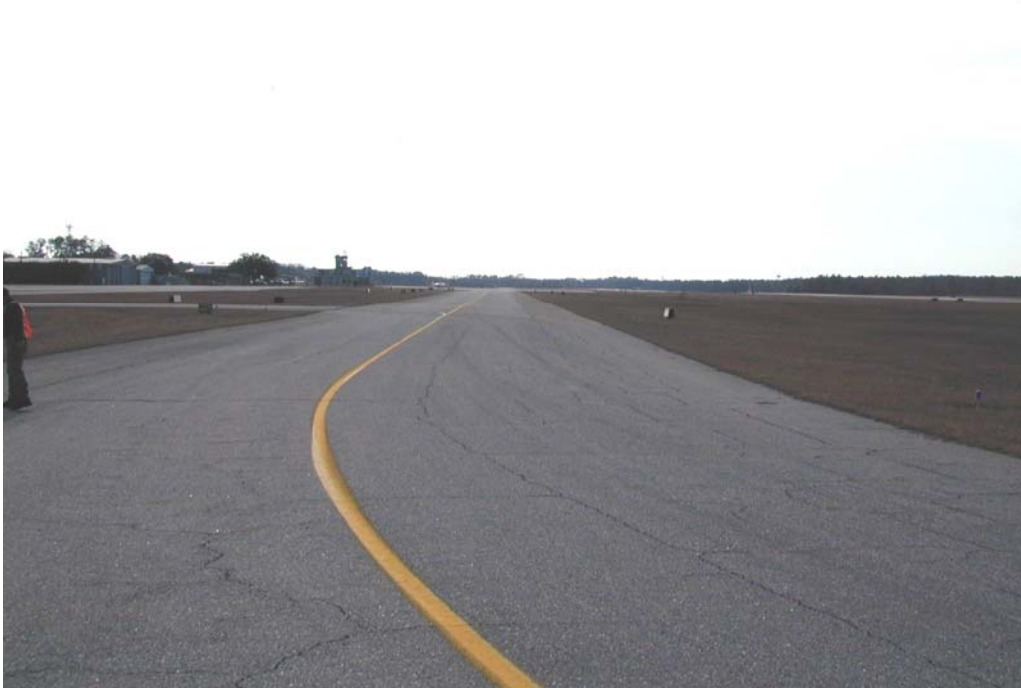
Taxiway A runs parallel to Runway 17-35 and is composed of one section, TAVL-10. This pavement is in fair condition. The predominant distress on this pavement is unsealed, low-severity L&T cracks. Other distresses noted on the taxiway include medium-severity L&T cracks and areas of unsealed, low-severity block cracking. The block cracking was limited to the northern end of the taxiway near the Runway 17 approach.

Overview of section TAVL-10.

Plan Year	Network	Branch	Section	Distress Description	Severity	Work Description	Work Qty.	Work Unit	Unit Cost	Work Cost
2002	VALDOSTA	A01VL	10	L & T CR	M	Crack Sealing	1,039	LF	\$3.20	\$3,325
2002	VALDOSTA	TAVL	10	L & T CR	M	Crack Sealing	6,409	LF	\$3.20	\$20,508

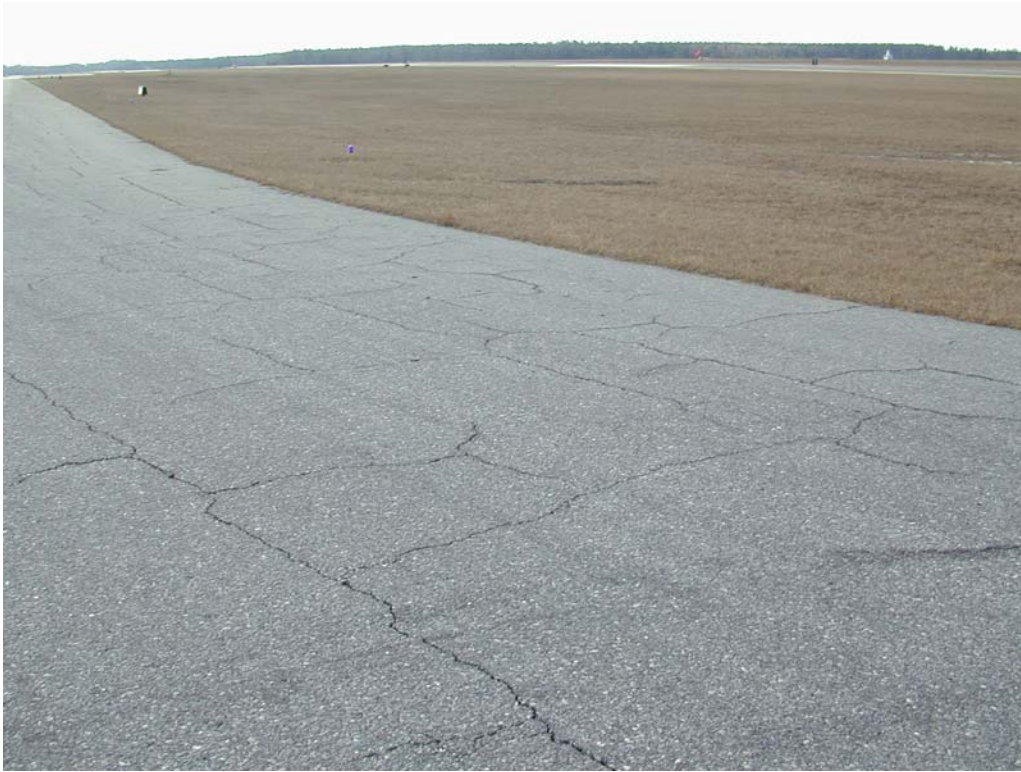
Block cracking in section TAVL-10.

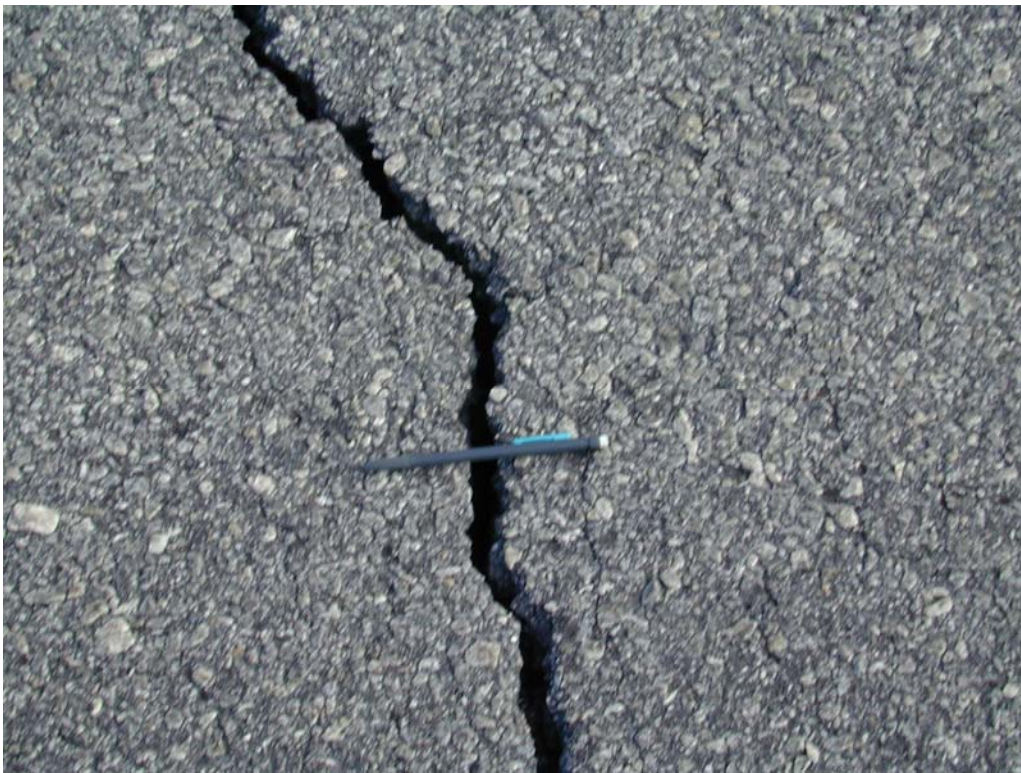
L&T cracking in section TAVL-10.

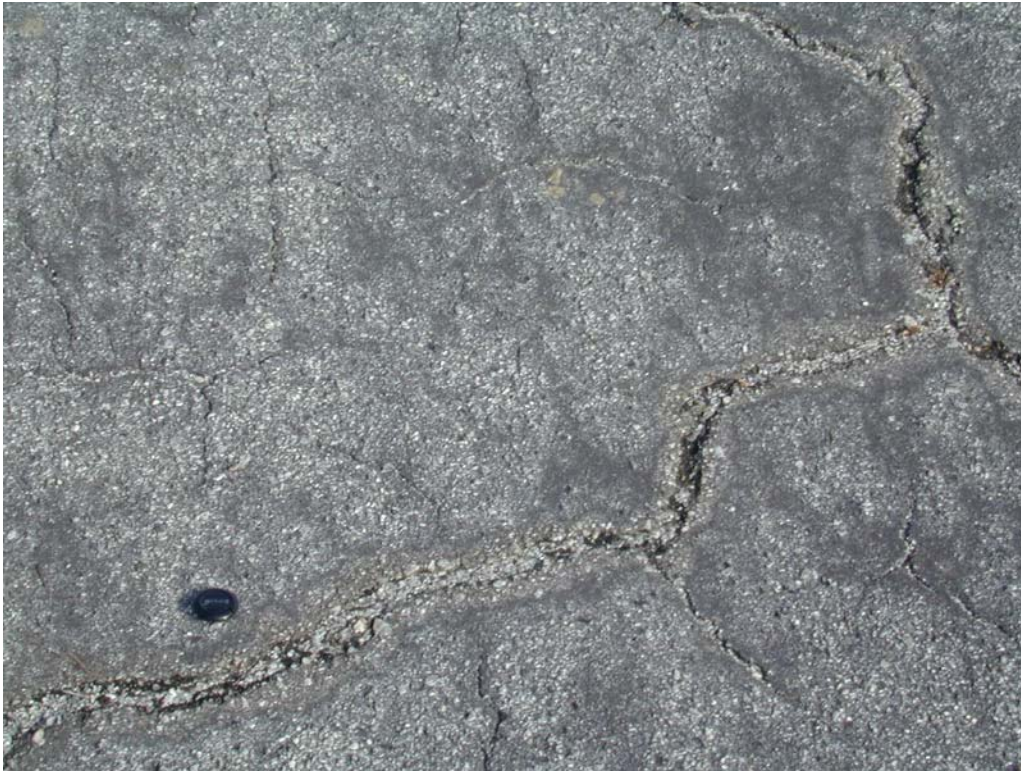
Taxiway C is composed of one section, TCVL-10, and connects the Runway 4 approach with the Runway 31 approach. The pavement is in very poor condition with significant areas of medium-severity block cracking and high-severity weathering. The airport restricts the use of jets on the pavement due to the high FOD potential.

Block cracking in section TCVL-10.

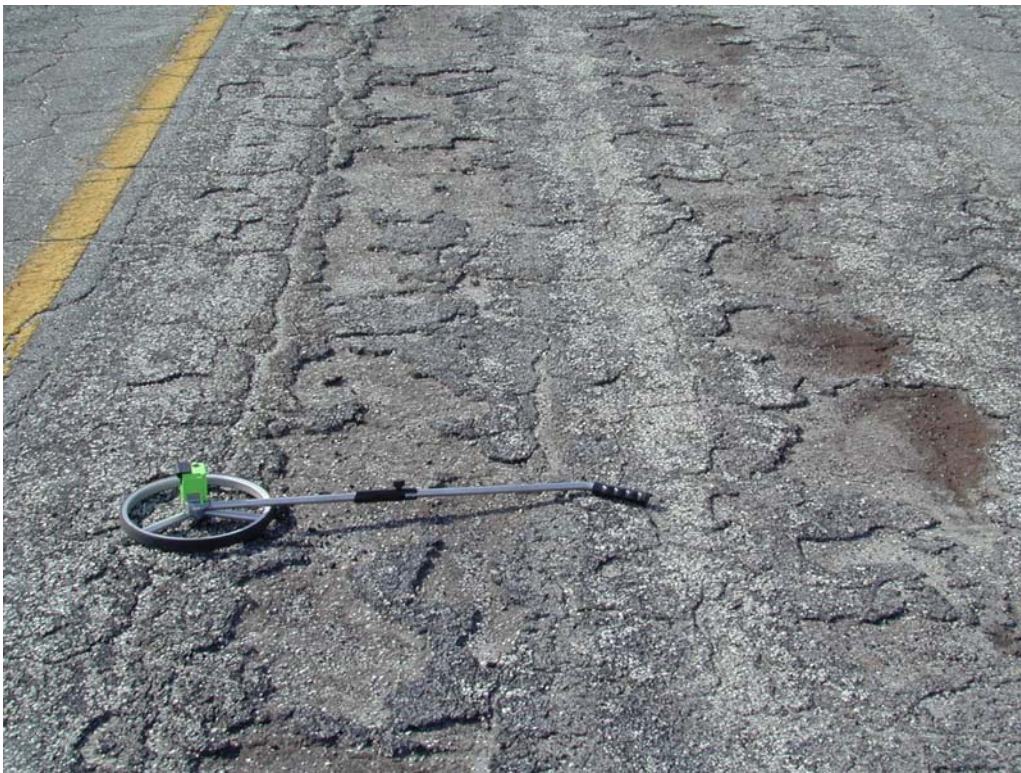
Raveling and weathering in section TCVL-10.

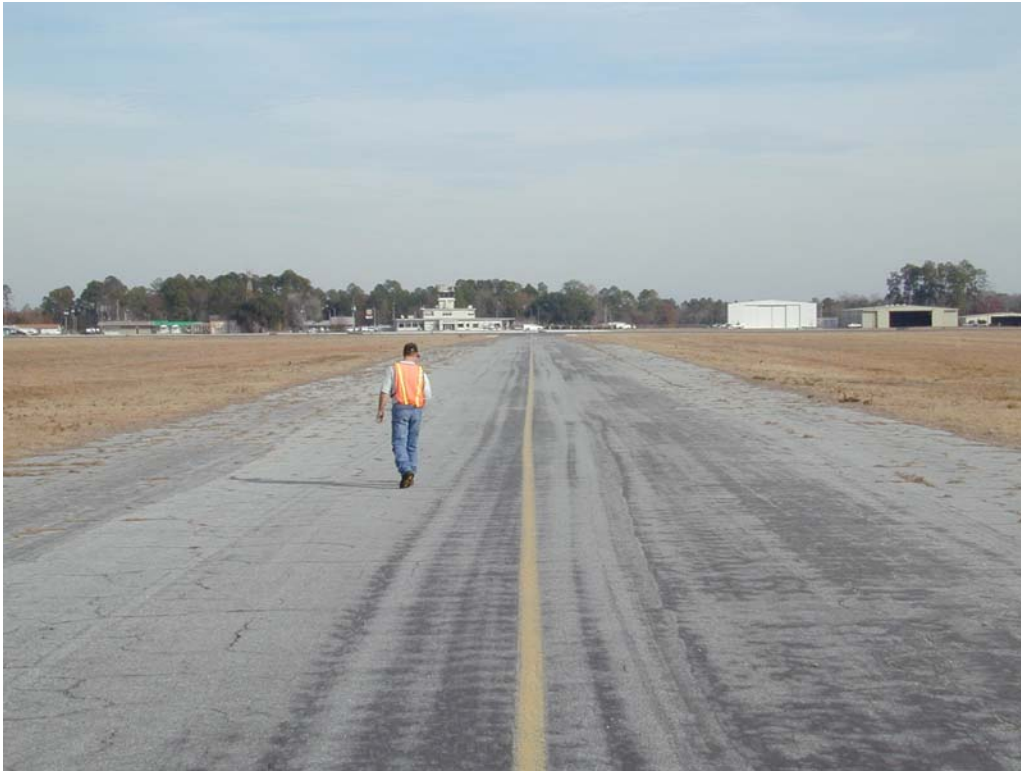
The sections for Taxiways D and E were combined into A01VL-40 because of their similar condition and work history. Taxiway F is divided into two sections, TFVL-10 and TFVL-20, and are separated by Runway 17-35. TFVL-10 is in poor condition due the large quantities of unsealed, low and medium-severity block cracking. Other distresses identified on section TFVL-10 are medium-severity swells, low-severity weathering, and low and medium-severity L&T cracking. TFVL-20 was rehabilitated at the same time as Runway 17-35 and is in excellent condition with no noted distresses.

Overview of section TFVL-10.

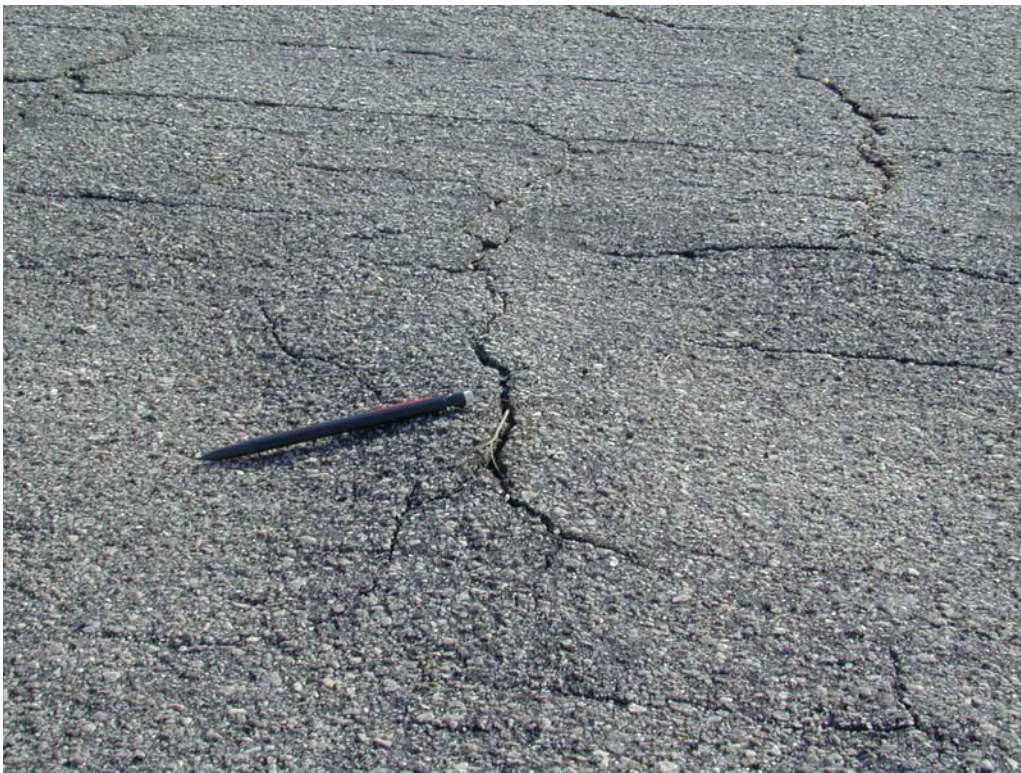
L&T cracking with swelling in section TFVL-10.

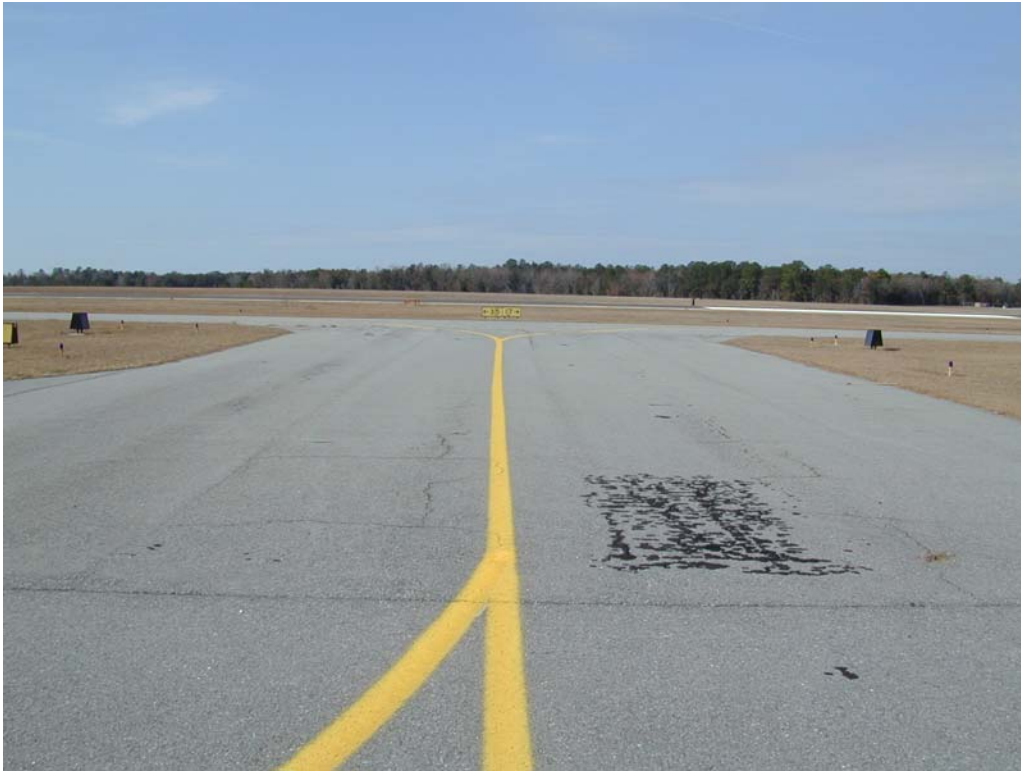
Taxiways H, J, K and L are small taxiways providing access to Taxiway A and are in similar condition to the aprons they are associated with. Taxiways H and J are connected to section A01VL-20, and Taxiway K is connected to A01VL-10. Taxiway L also connects A01VL-10 to Taxiway A; however, it has its own distinct condition and work history. TLVL-10 is in good condition with the only identified distress being unsealed, low-severity L&T cracks.

Overview of section TLVL-10.

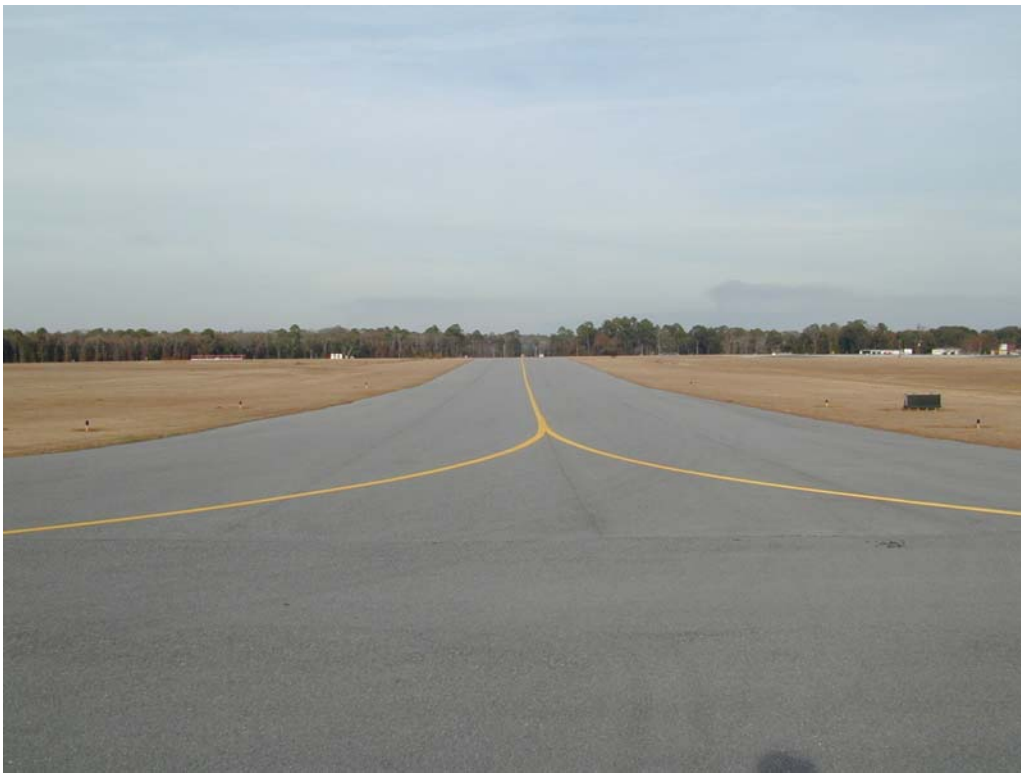
Taxiways M and N connect the terminal apron with Runways 22 and 17, respectively. Section TMVL-10 is in excellent condition with a limited amount of unsealed, low-severity L&T cracking. TNVL-10 is in excellent condition with no observed distresses.

Overview of section TMVL-10.

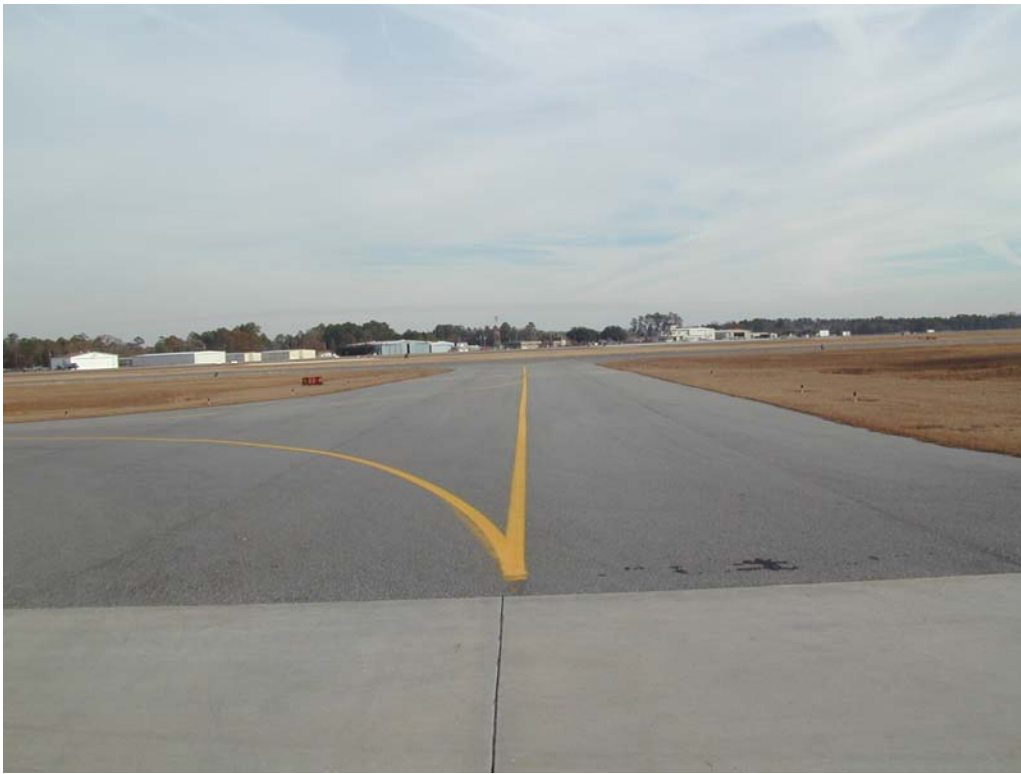
Overview of section TNVL-10.

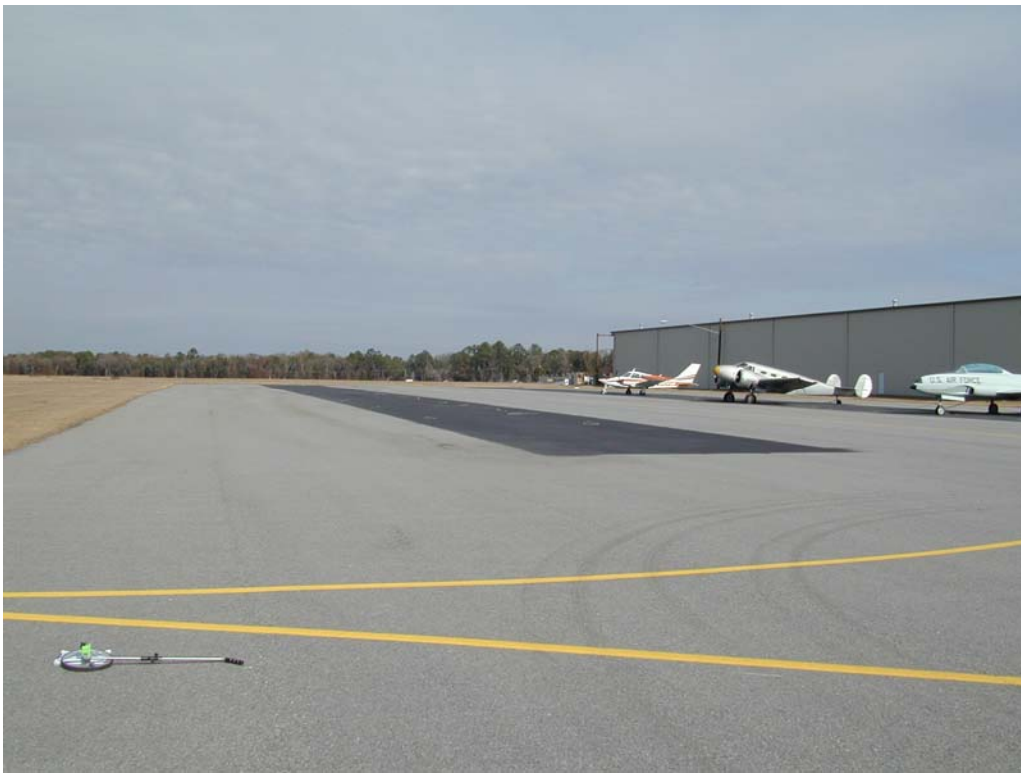
Section A01VL-10 is in good condition with limited amounts of low and medium-severity L&T cracking. The only other distress type observed on this section was an area of bleeding near Taxiway K. A surface treatment was present along the tie-down areas but not in the taxilanes.

Overview of section A01VL-10.

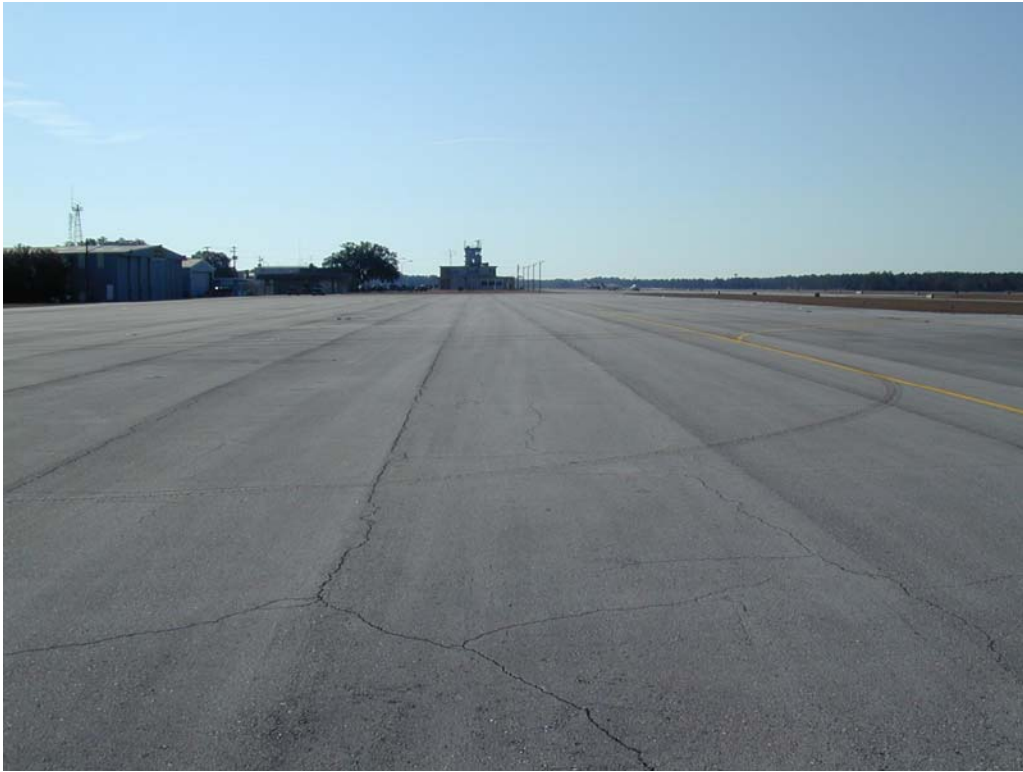
Section A01VL-20 is in fair condition with block cracking representing the predominant distress type. Unsealed, low-severity block cracking was present over 100 percent of the area. Also present are areas of low and medium-severity weathering.

Overview of section A01VL-20.

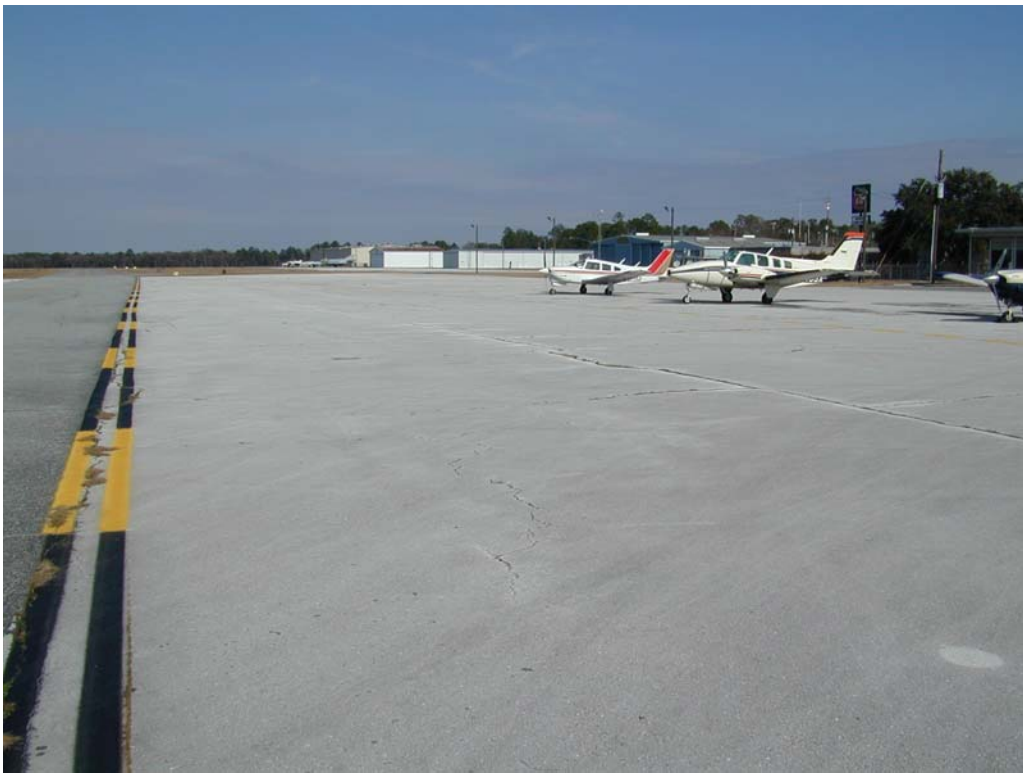
Section A01VL-30 is in fair condition with moderate amounts of unsealed, low and medium-severity block cracking. Unsealed, low and medium-severity L&T cracks are also present.

Overview of section A01VL-30.

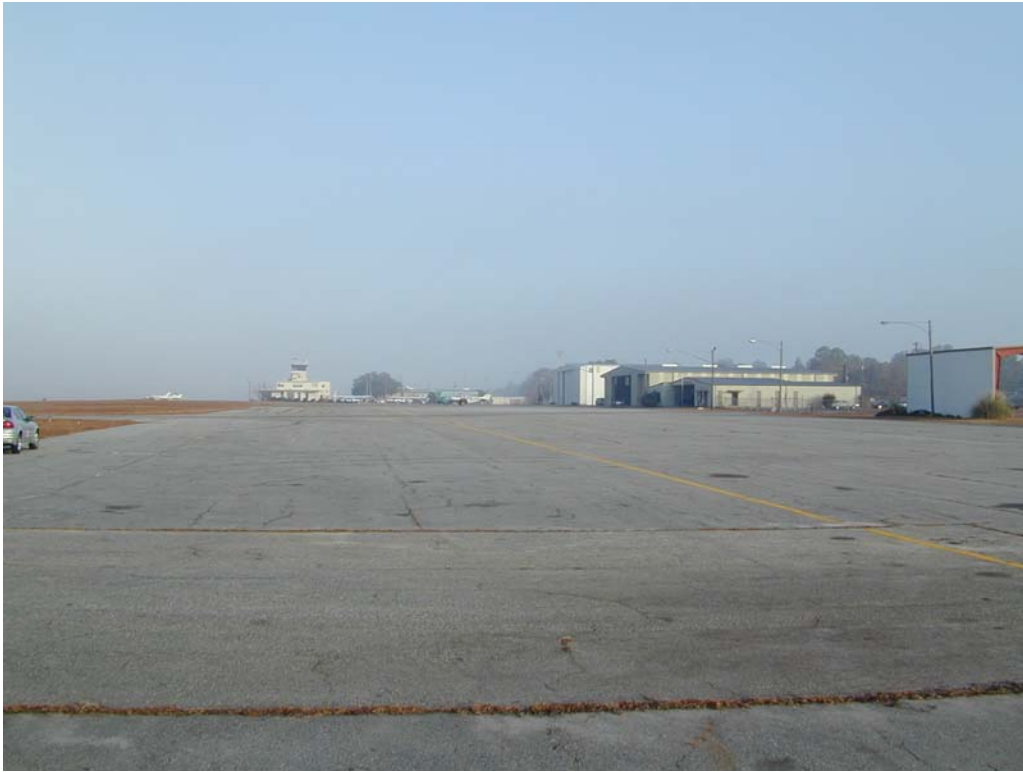
Section A01VL-40 is in fair condition with large quantities of unsealed, low-severity block cracking present in several areas. Other typical distresses for this section include unsealed, low and medium-severity L&T cracks. Several additional sample units were required to account for distresses limited to a few areas. These distresses include medium-severity depressions, medium-severity alligator cracking, and medium-severity patching.

Overview of section A01VL-40.

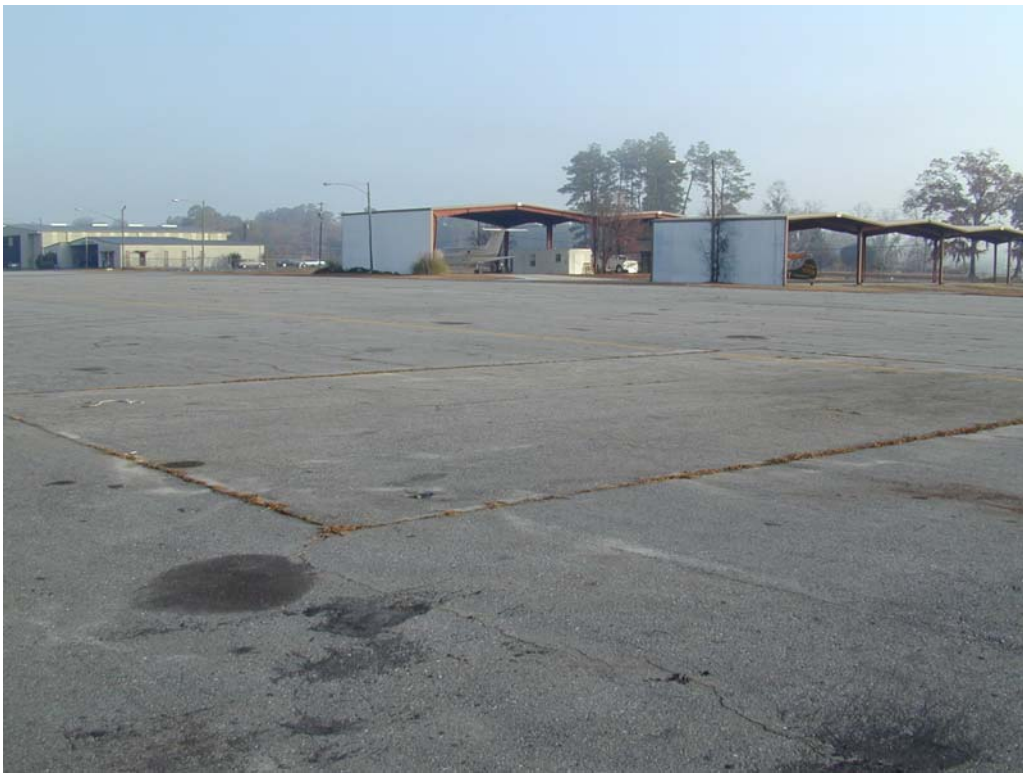
Patching in an additional sample unit in section A01VL-40.

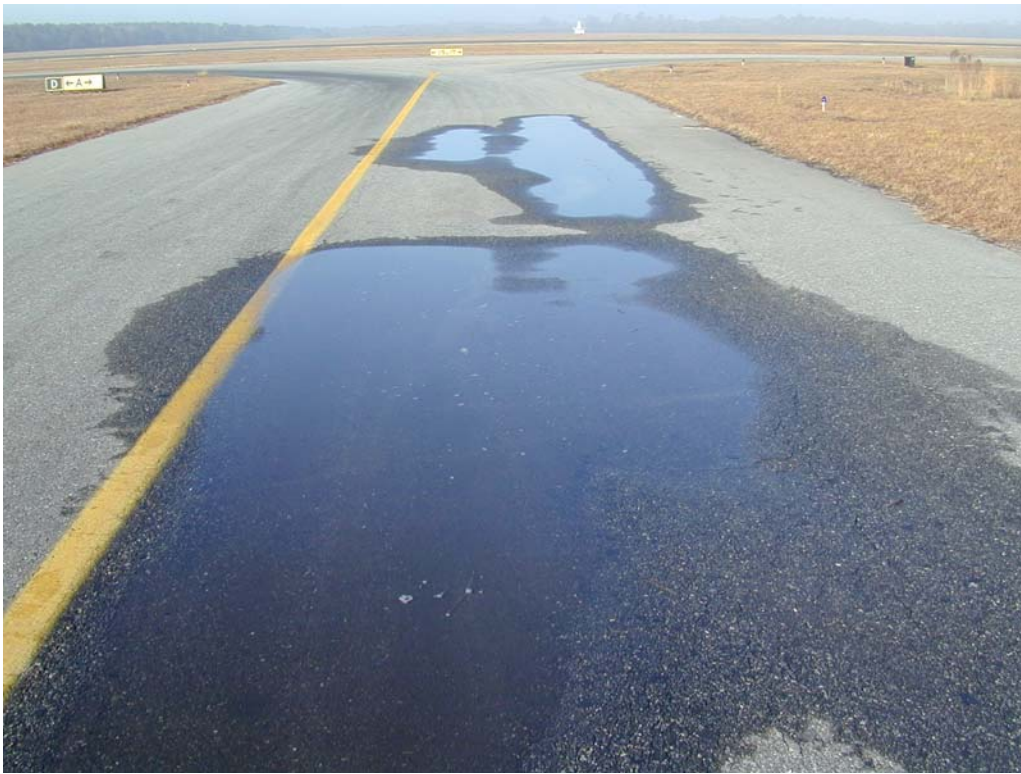
Depression with alligator cracking in sample unit 12 of section A01VL-40.

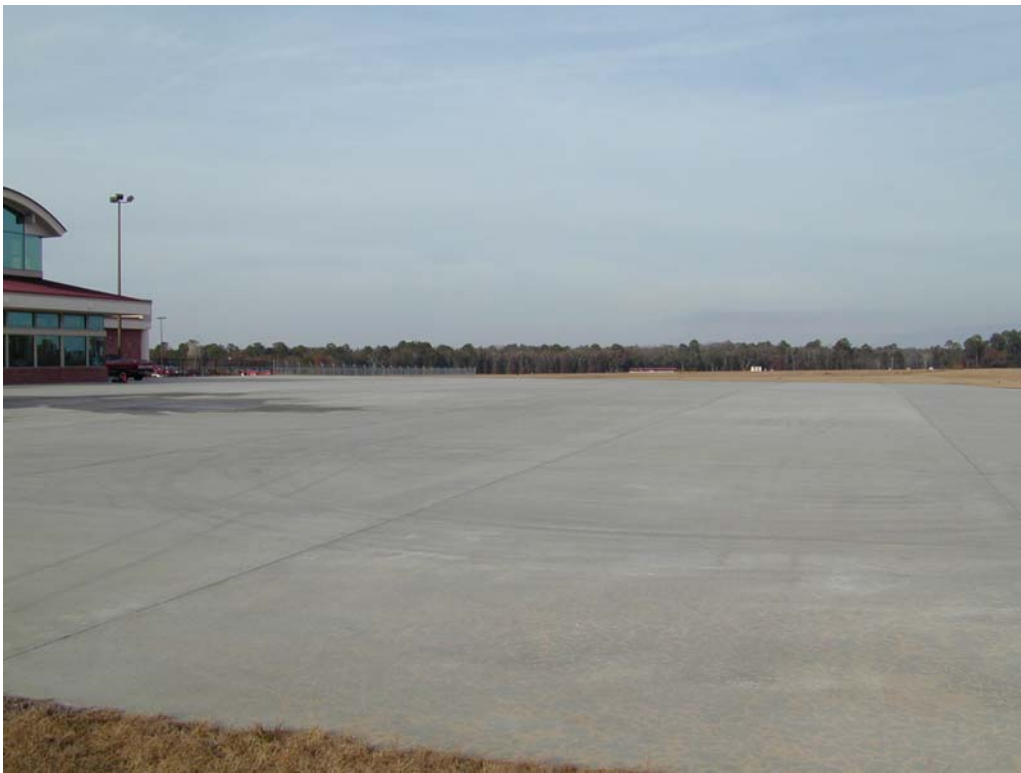
The terminal apron, ATERMVL-10, is in very good condition, however shrinkage cracking was noted on every inspected slab.

Overview of section ATERMVL-10.

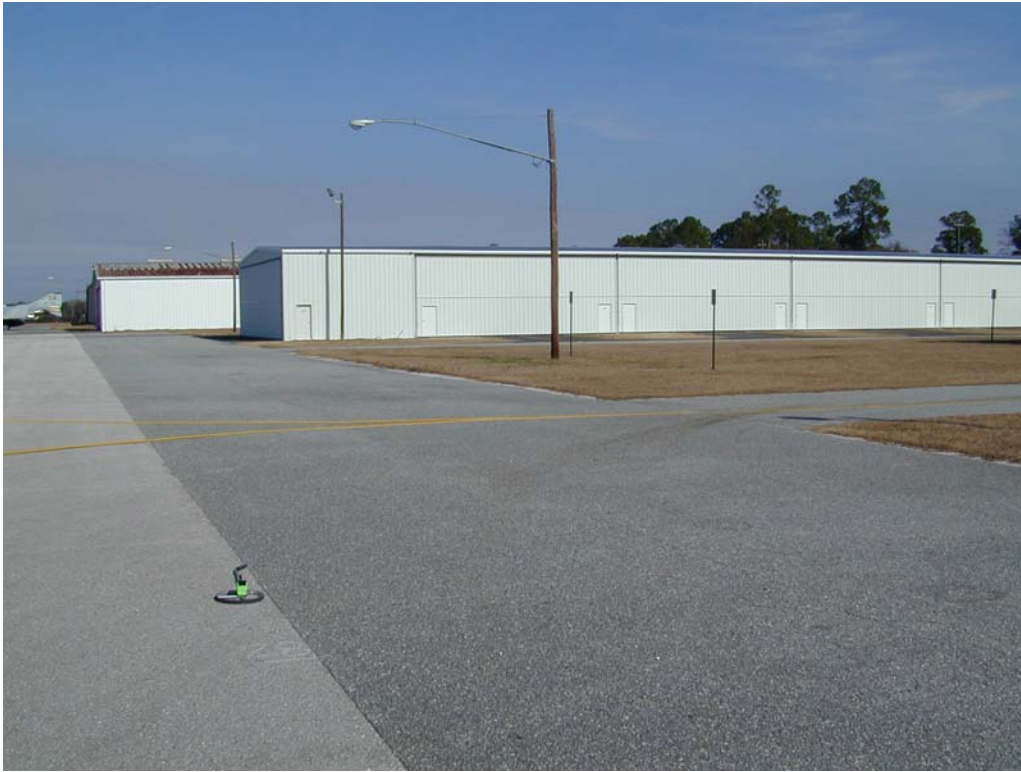
There are two separate T-Hanger areas located along the eastern border of the facility. THANG01VL-10 is adjacent to A01VL-20, and it is in fair condition. Significant quantities of unsealed, low-severity block and L&T cracking were observed. THANG02VL-10 is located near A01VL-40 and is in very good condition. Relatively low quantities of unsealed, low-severity L&T cracks were identified.

Overview of section THANG01VL-10.
