# WINDER - BARROW AIRPORT

## PAVEMENT EVALUATION REPORT

JULY 2002

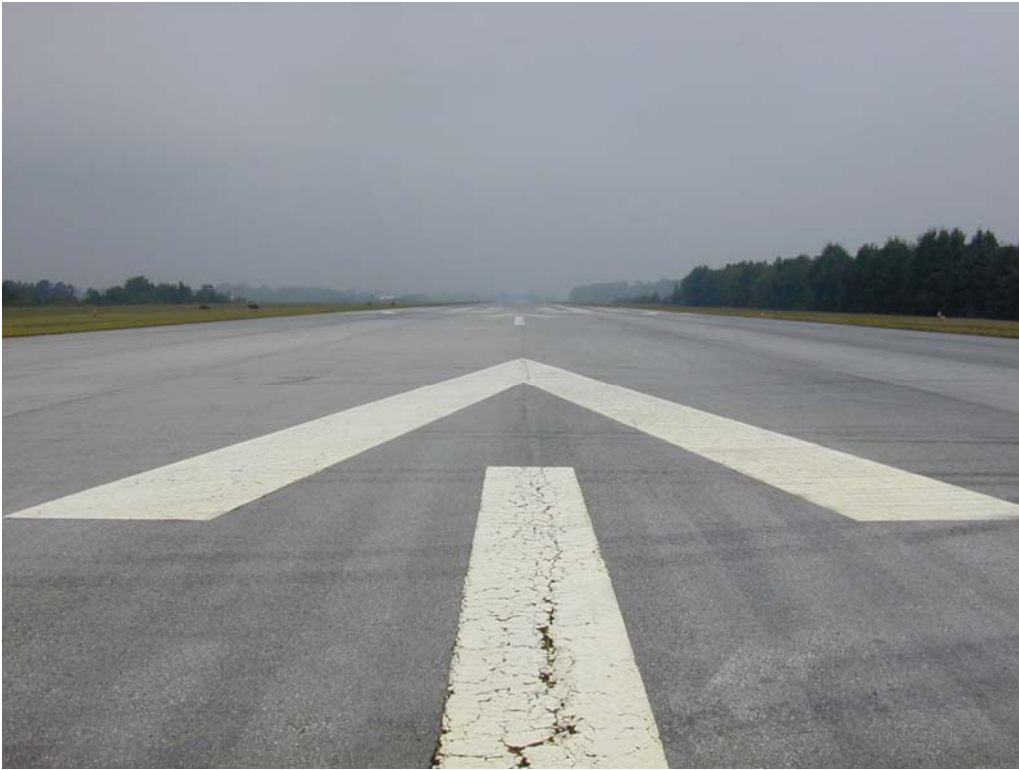
Runway 13-31 was defined by one section and is in very good condition. Moderate amounts of low-severity, unsealed, longitudinal and transverse (L&T) cracking were found during the inspection.

Overview of section R1331WI-10.

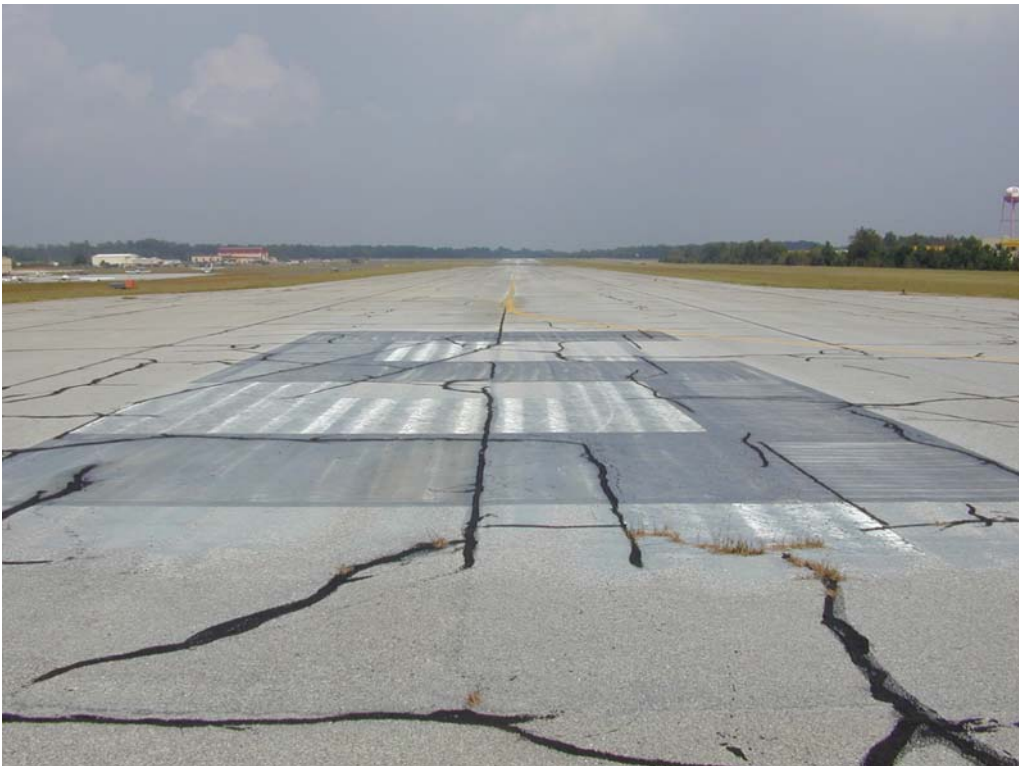
Runway 5-23, also defined by one section, is in good condition with large quantities of low-severity, sealed, L&T cracking found throughout the runway. Occasional areas of low-severity, sealed, block cracking were also observed.

Overview of section R523WI-10.

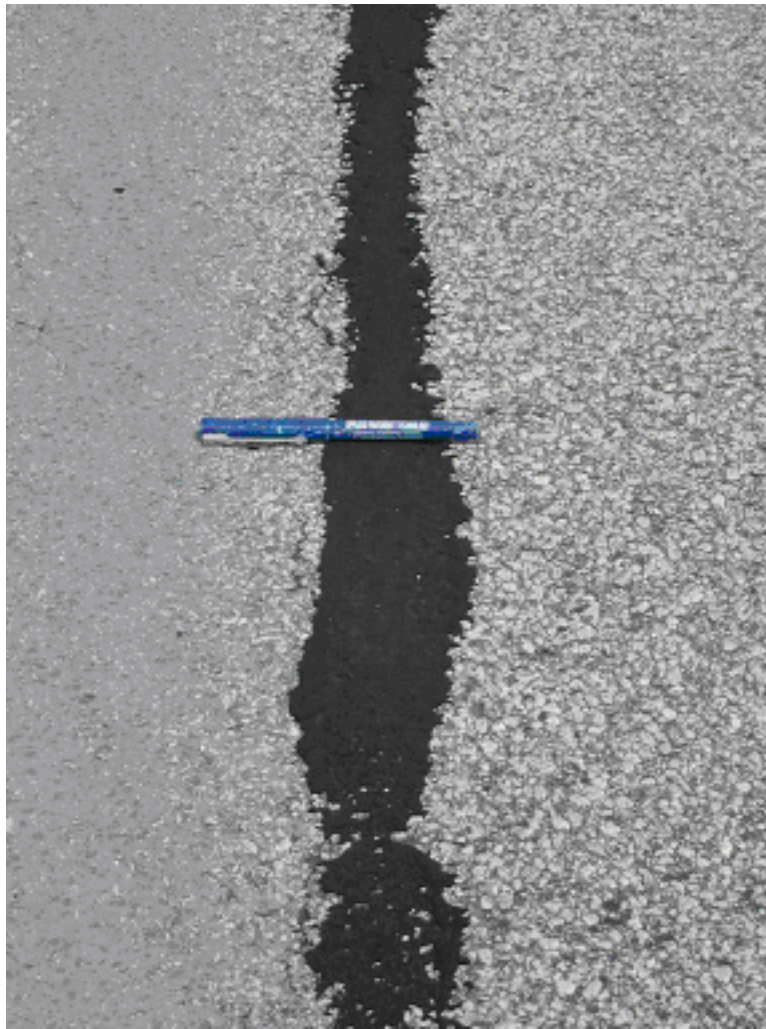
L&T cracking in section R523WI-10.

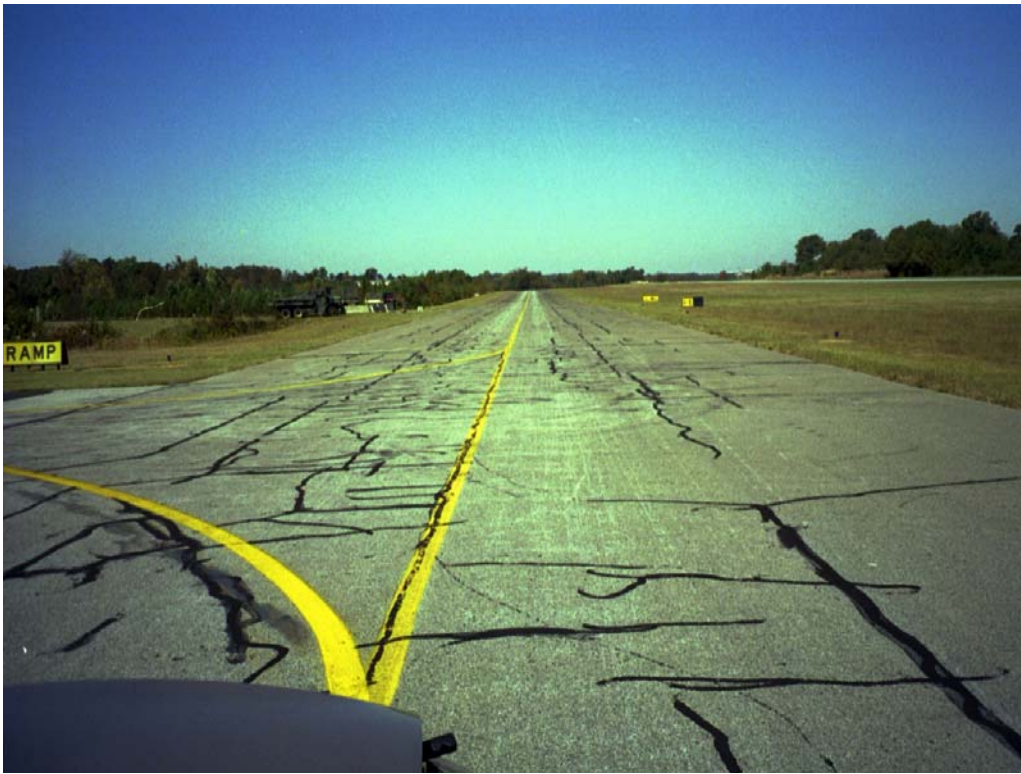
Taxiway A runs parallel to Runway 13-31 and consists of one section. The primary distress found was low-severity L&T cracking, the majority of which were sealed. Other distresses identified on the taxiway include low-severity, sealed, block cracking and low-severity raveling and weathering.

Overview of section TAWI-10.

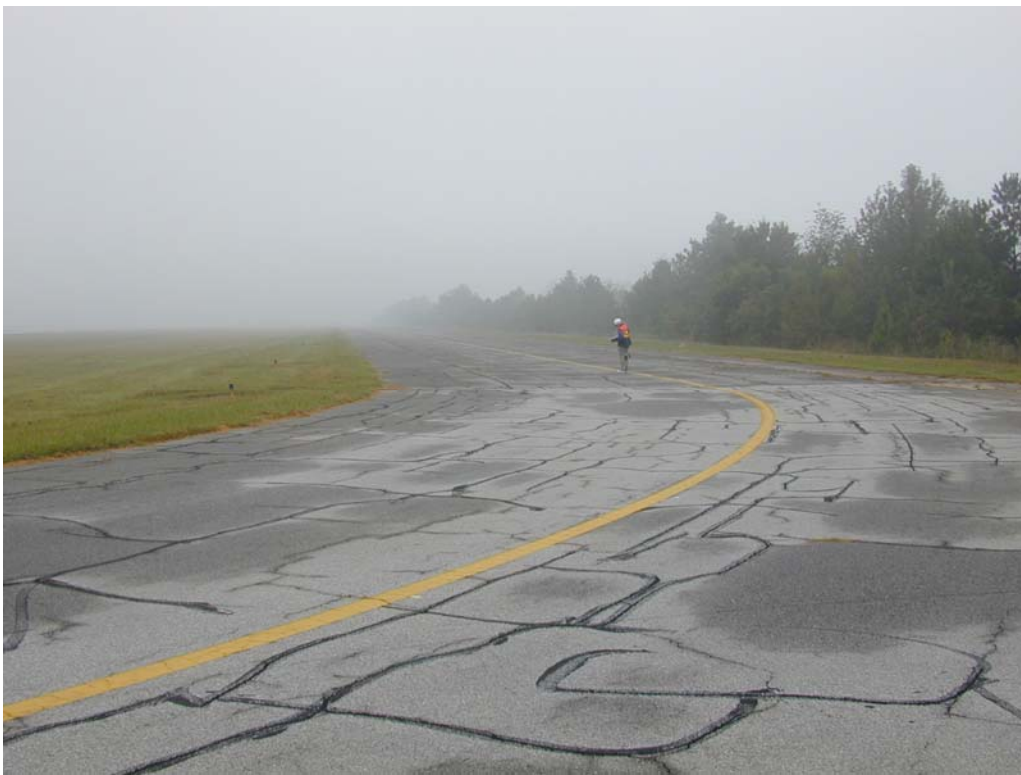
Taxiway B runs parallel to Runway 5-23 and was defined by one section. TBWI-10 is in poor condition with large amounts of medium-severity L&T and block cracking observed throughout the taxiway.

Overview of L&T cracking in section TBWI-10.

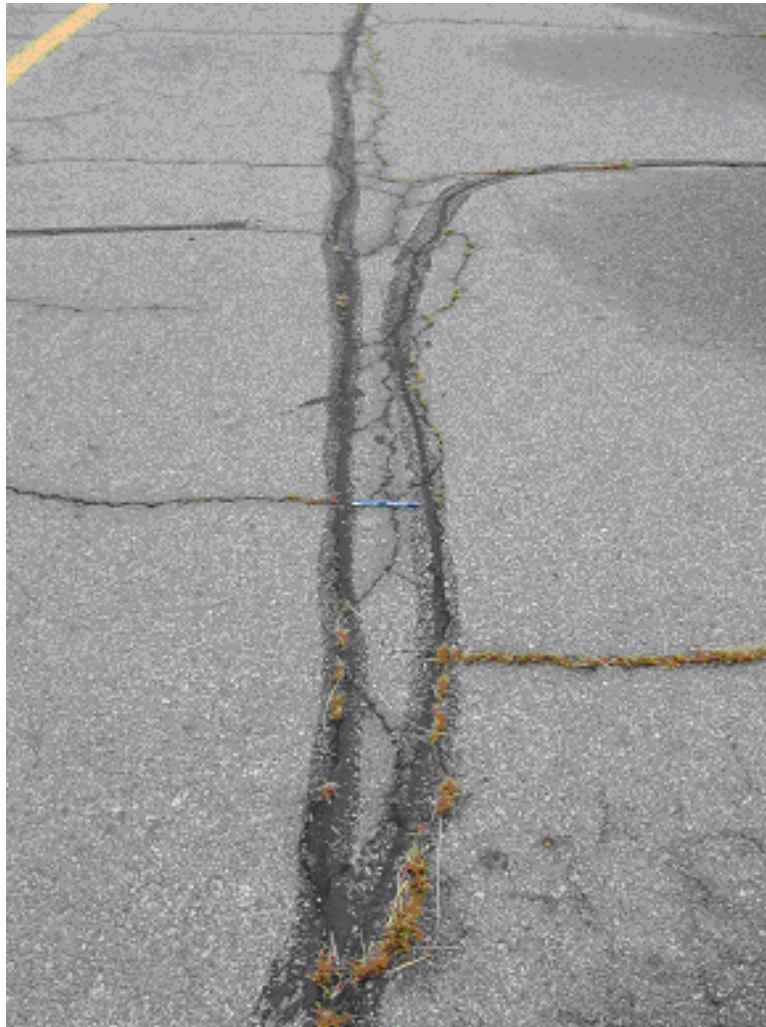
Alligator cracking in section TBWI-10.

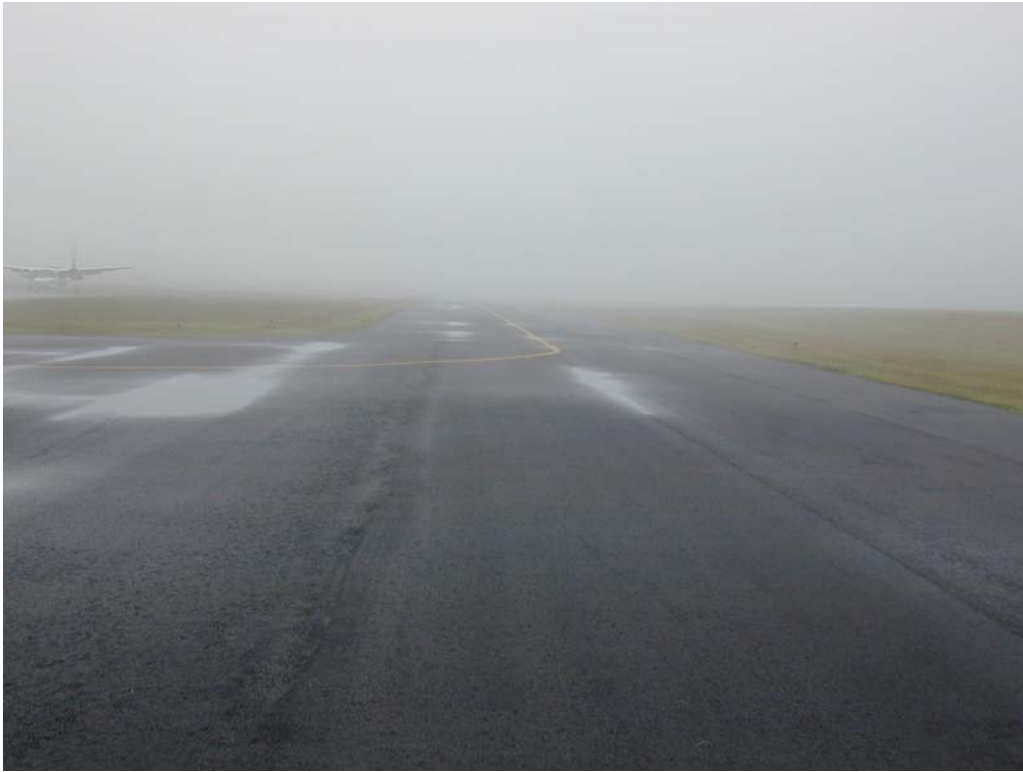
TDWI-10 was overlaid in 2001 and is in excellent condition. Both TDWI-20 and TDWI-30 are in fair condition with significant amounts of L&T cracking found throughout each of them.

Overview of section TDWI-10.

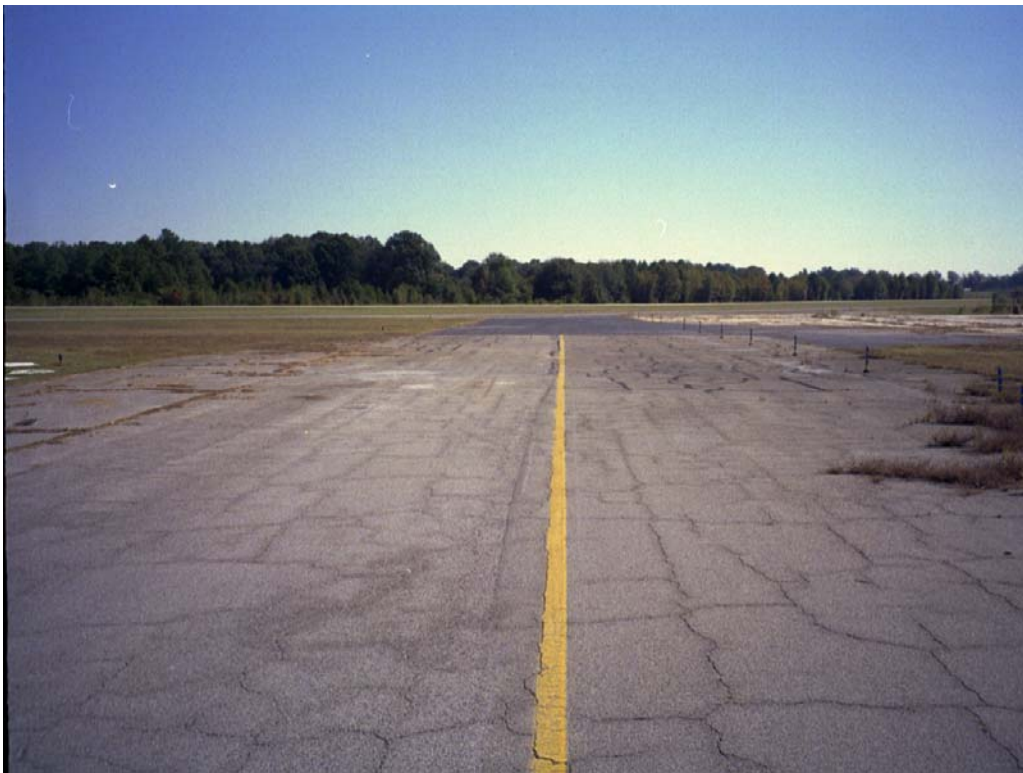
Taxiway F is a small connector taxiway between Taxiways A and B. One section was defined during the inspection in this taxiway. Significant amounts of low and medium-severity block cracking were found throughout the section. It appears that a variety of maintenance activities have been completed at different times over the section. None of the cracking has been sealed in the area defined by the first two sample units. Approximately half of the cracking has been sealed in the center portion of the section. Finally, a surface treatment appears to have been placed in lieu of cracking sealing in the remaining portion of the section. All of the sample units defined in this section have been inspected and the section was found to be in fair condition.

Overview of section TFWI-10.

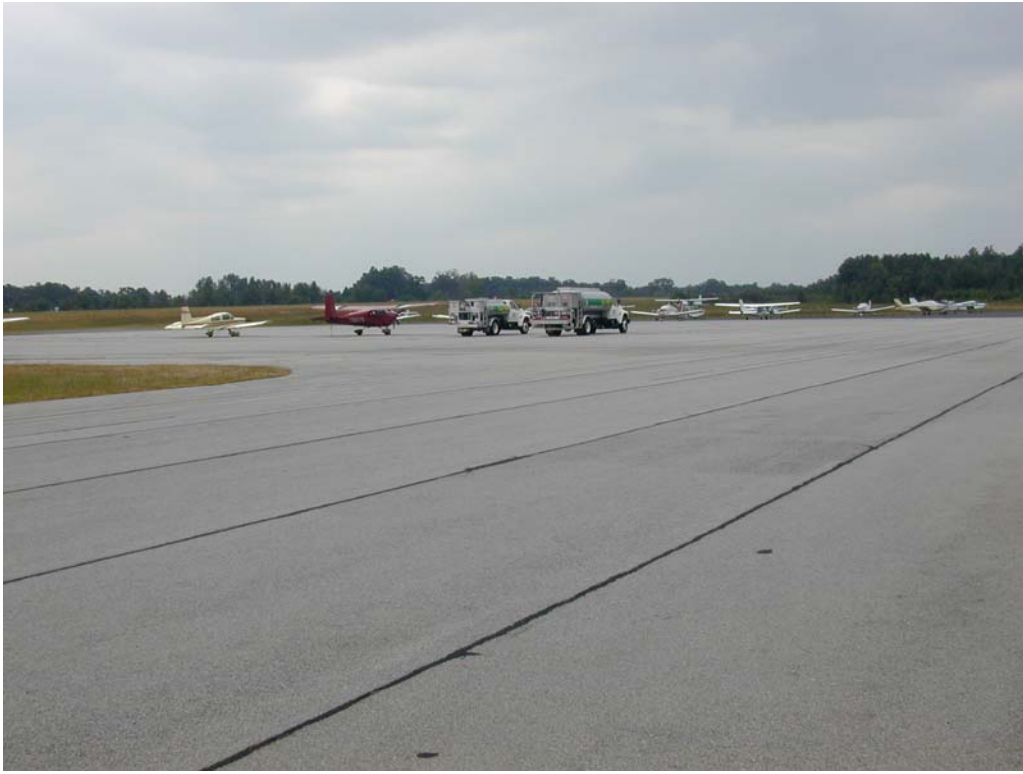
A01WI-10 is in good condition with low-severity, sealed, L&T cracking observed.

Overview of section A01WI-10.

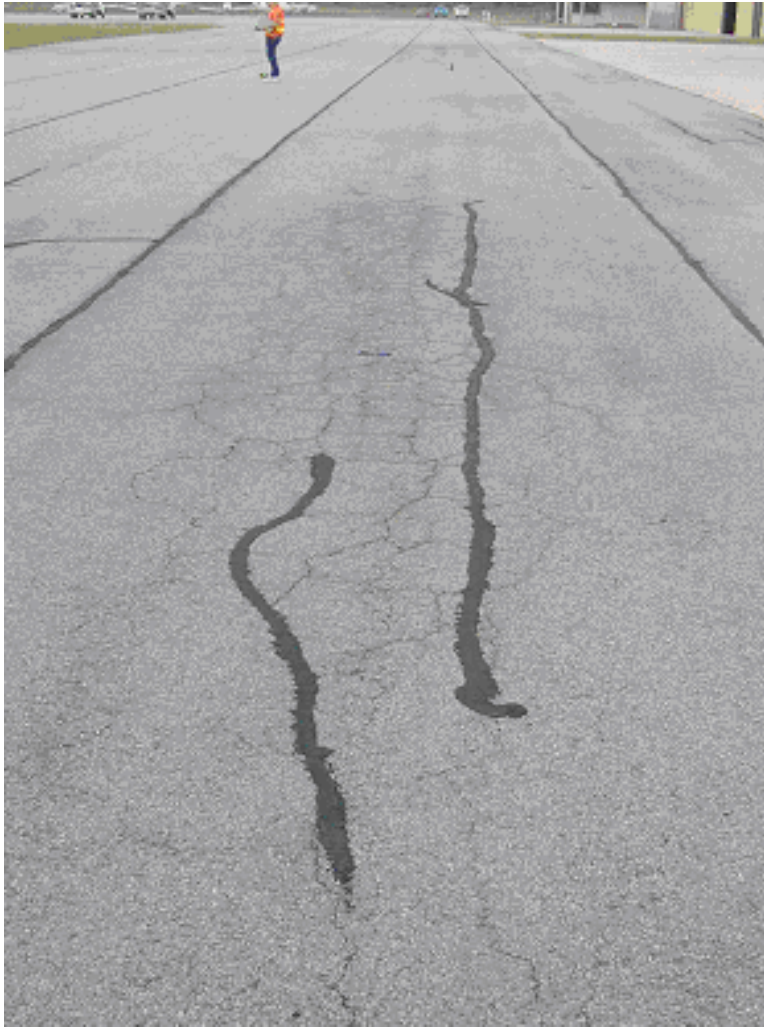
Alligator cracking in section A01WI-10.

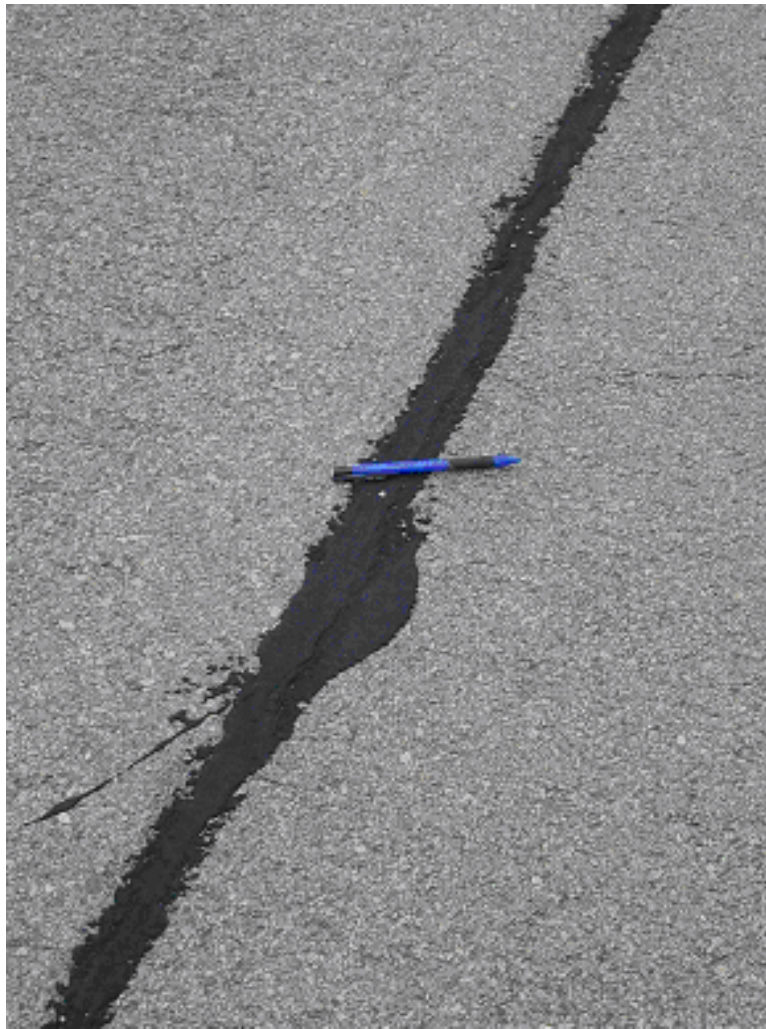
L&T cracking in section A01WI-10.

Plan Year	Network	Branch	Section	Distress Description	Severity	Work Description	Work Qty.	Work Unit	Unit Cost	Work Cost
2002	WINDER	A01WI	10	L & T CR	M	Crack Sealing	1,751	LF	\$1.28	\$2,241

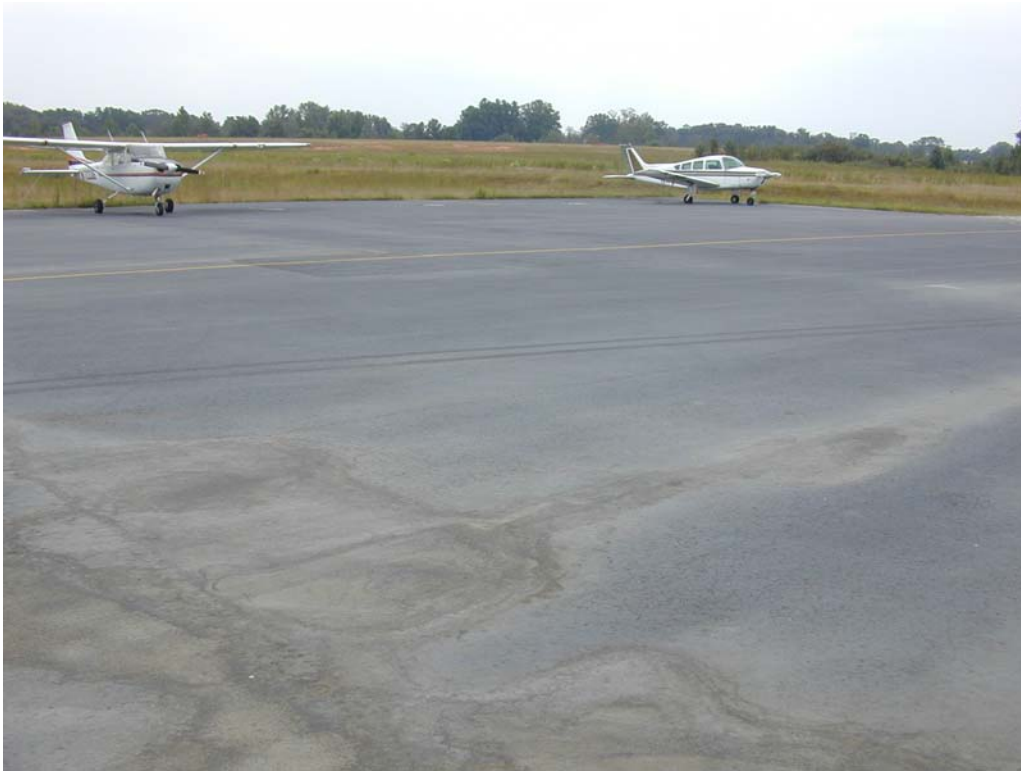
A01WI-20 is in excellent condition with isolated amounts of low-severity L&T cracking, patching and depression found throughout the section.

Overview of section A01WI-20.

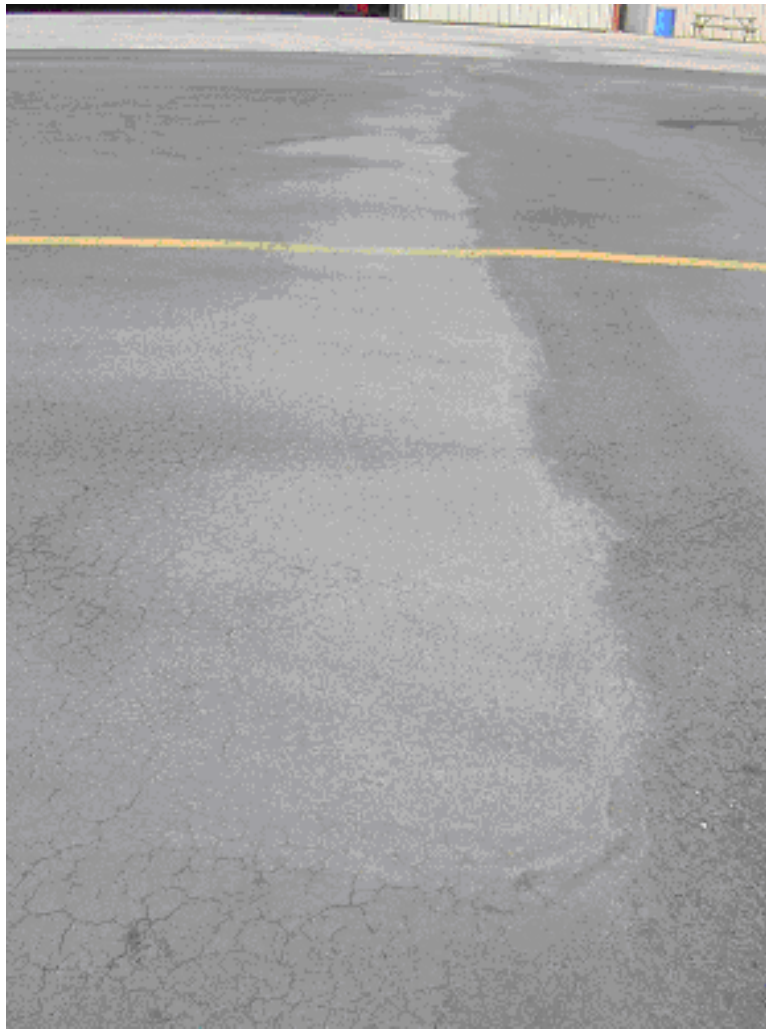
Depression in section A01WI-20.

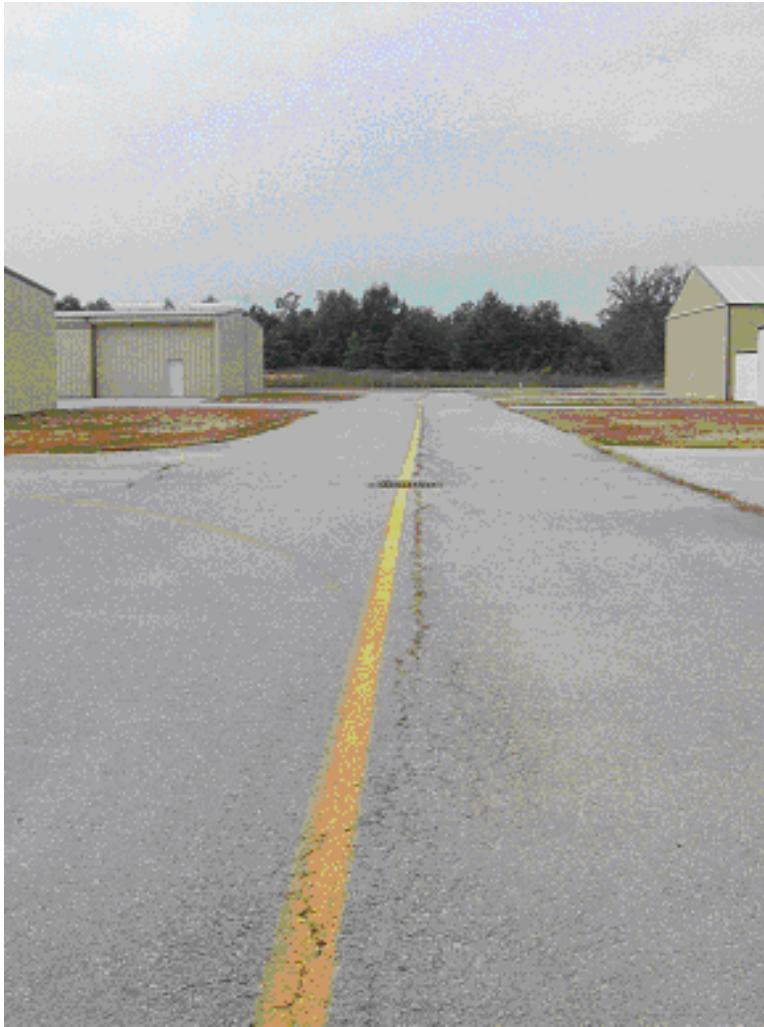
THANGWI-10 is in fair condition with medium-severity alligator and low-severity, unsealed, L&T cracking present.

Overview of section THANGWI-10.

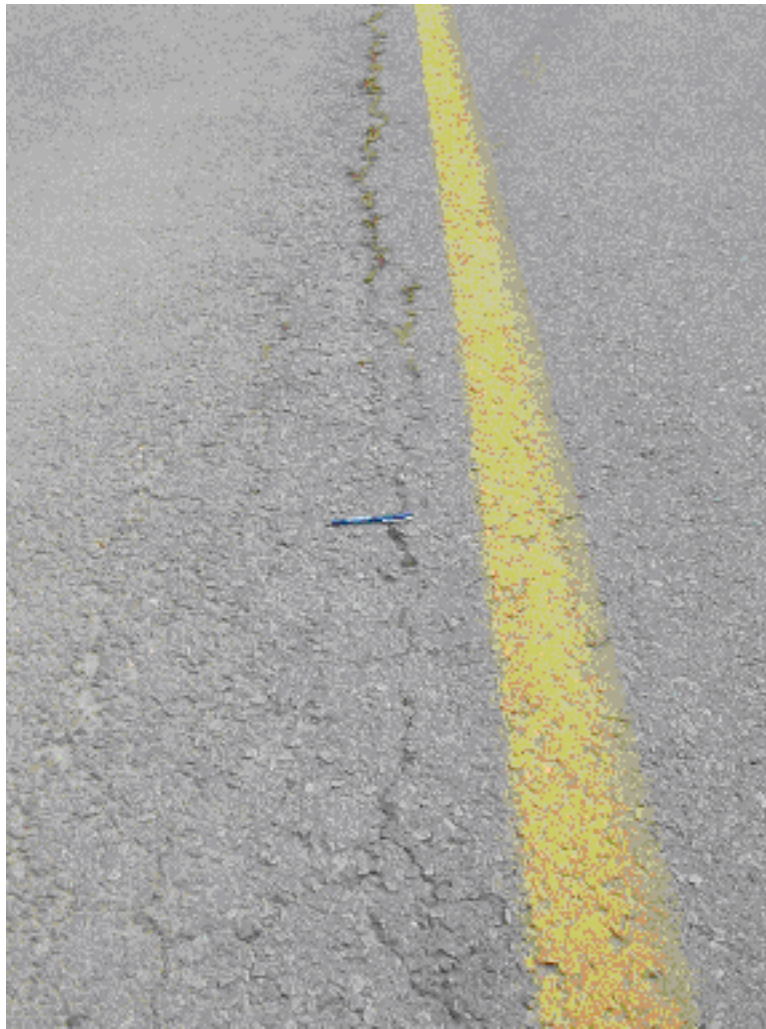
Raveling and weathering in section THANGWI-10.

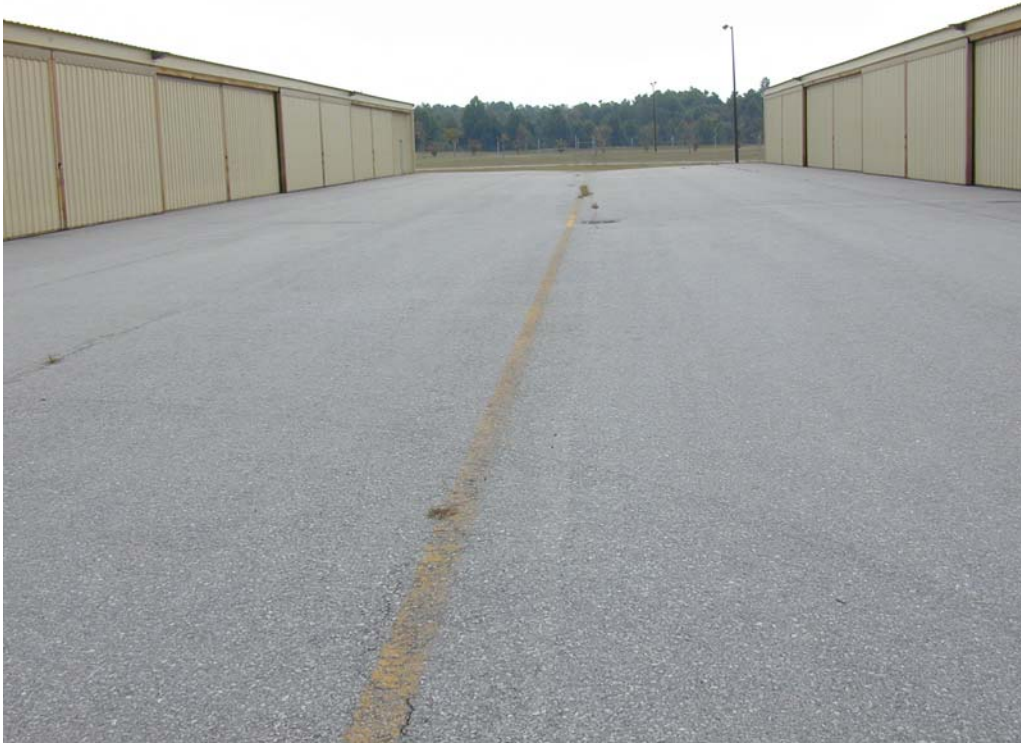
THANGWI-20 is in good condition with moderate amounts of low-severity, unsealed, L&T cracking found throughout the section.

Overview of section THANGWI-20.

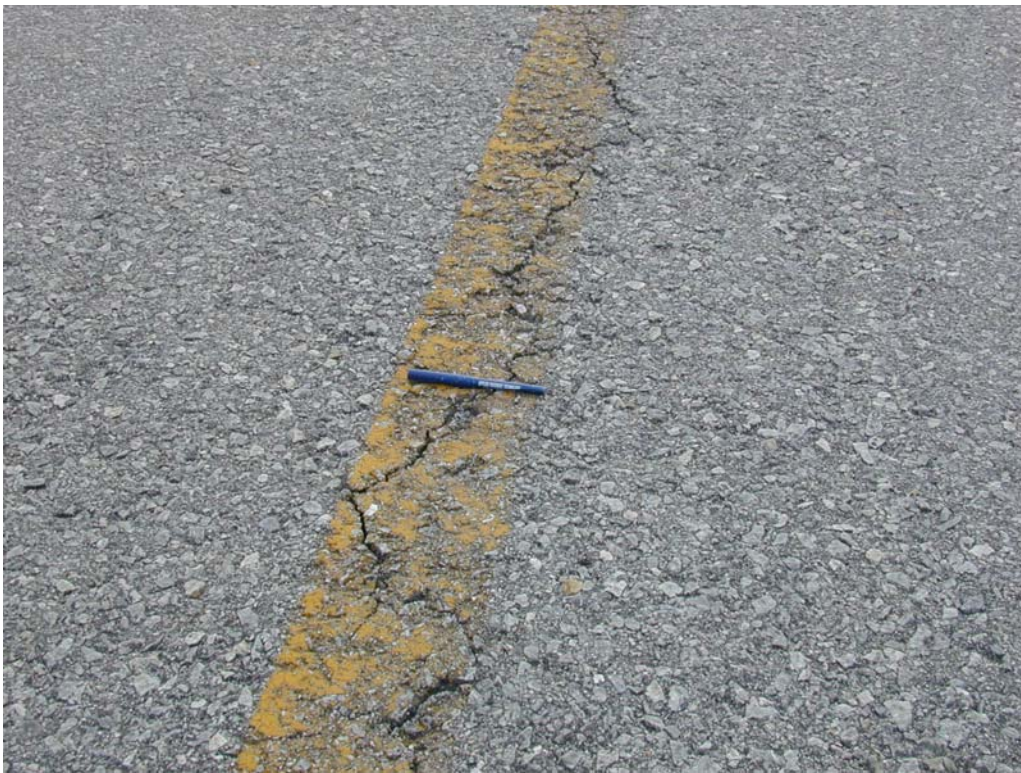
L&T cracking in section THANGWI-20.
