2012 Southwest Georgia Regional Airport Pavement Management Plan

SOUTHWEST GEORGIA REGIONAL AIRPORT

PAVEMENT MANAGEMENT REPORT

DECEMBER 2012

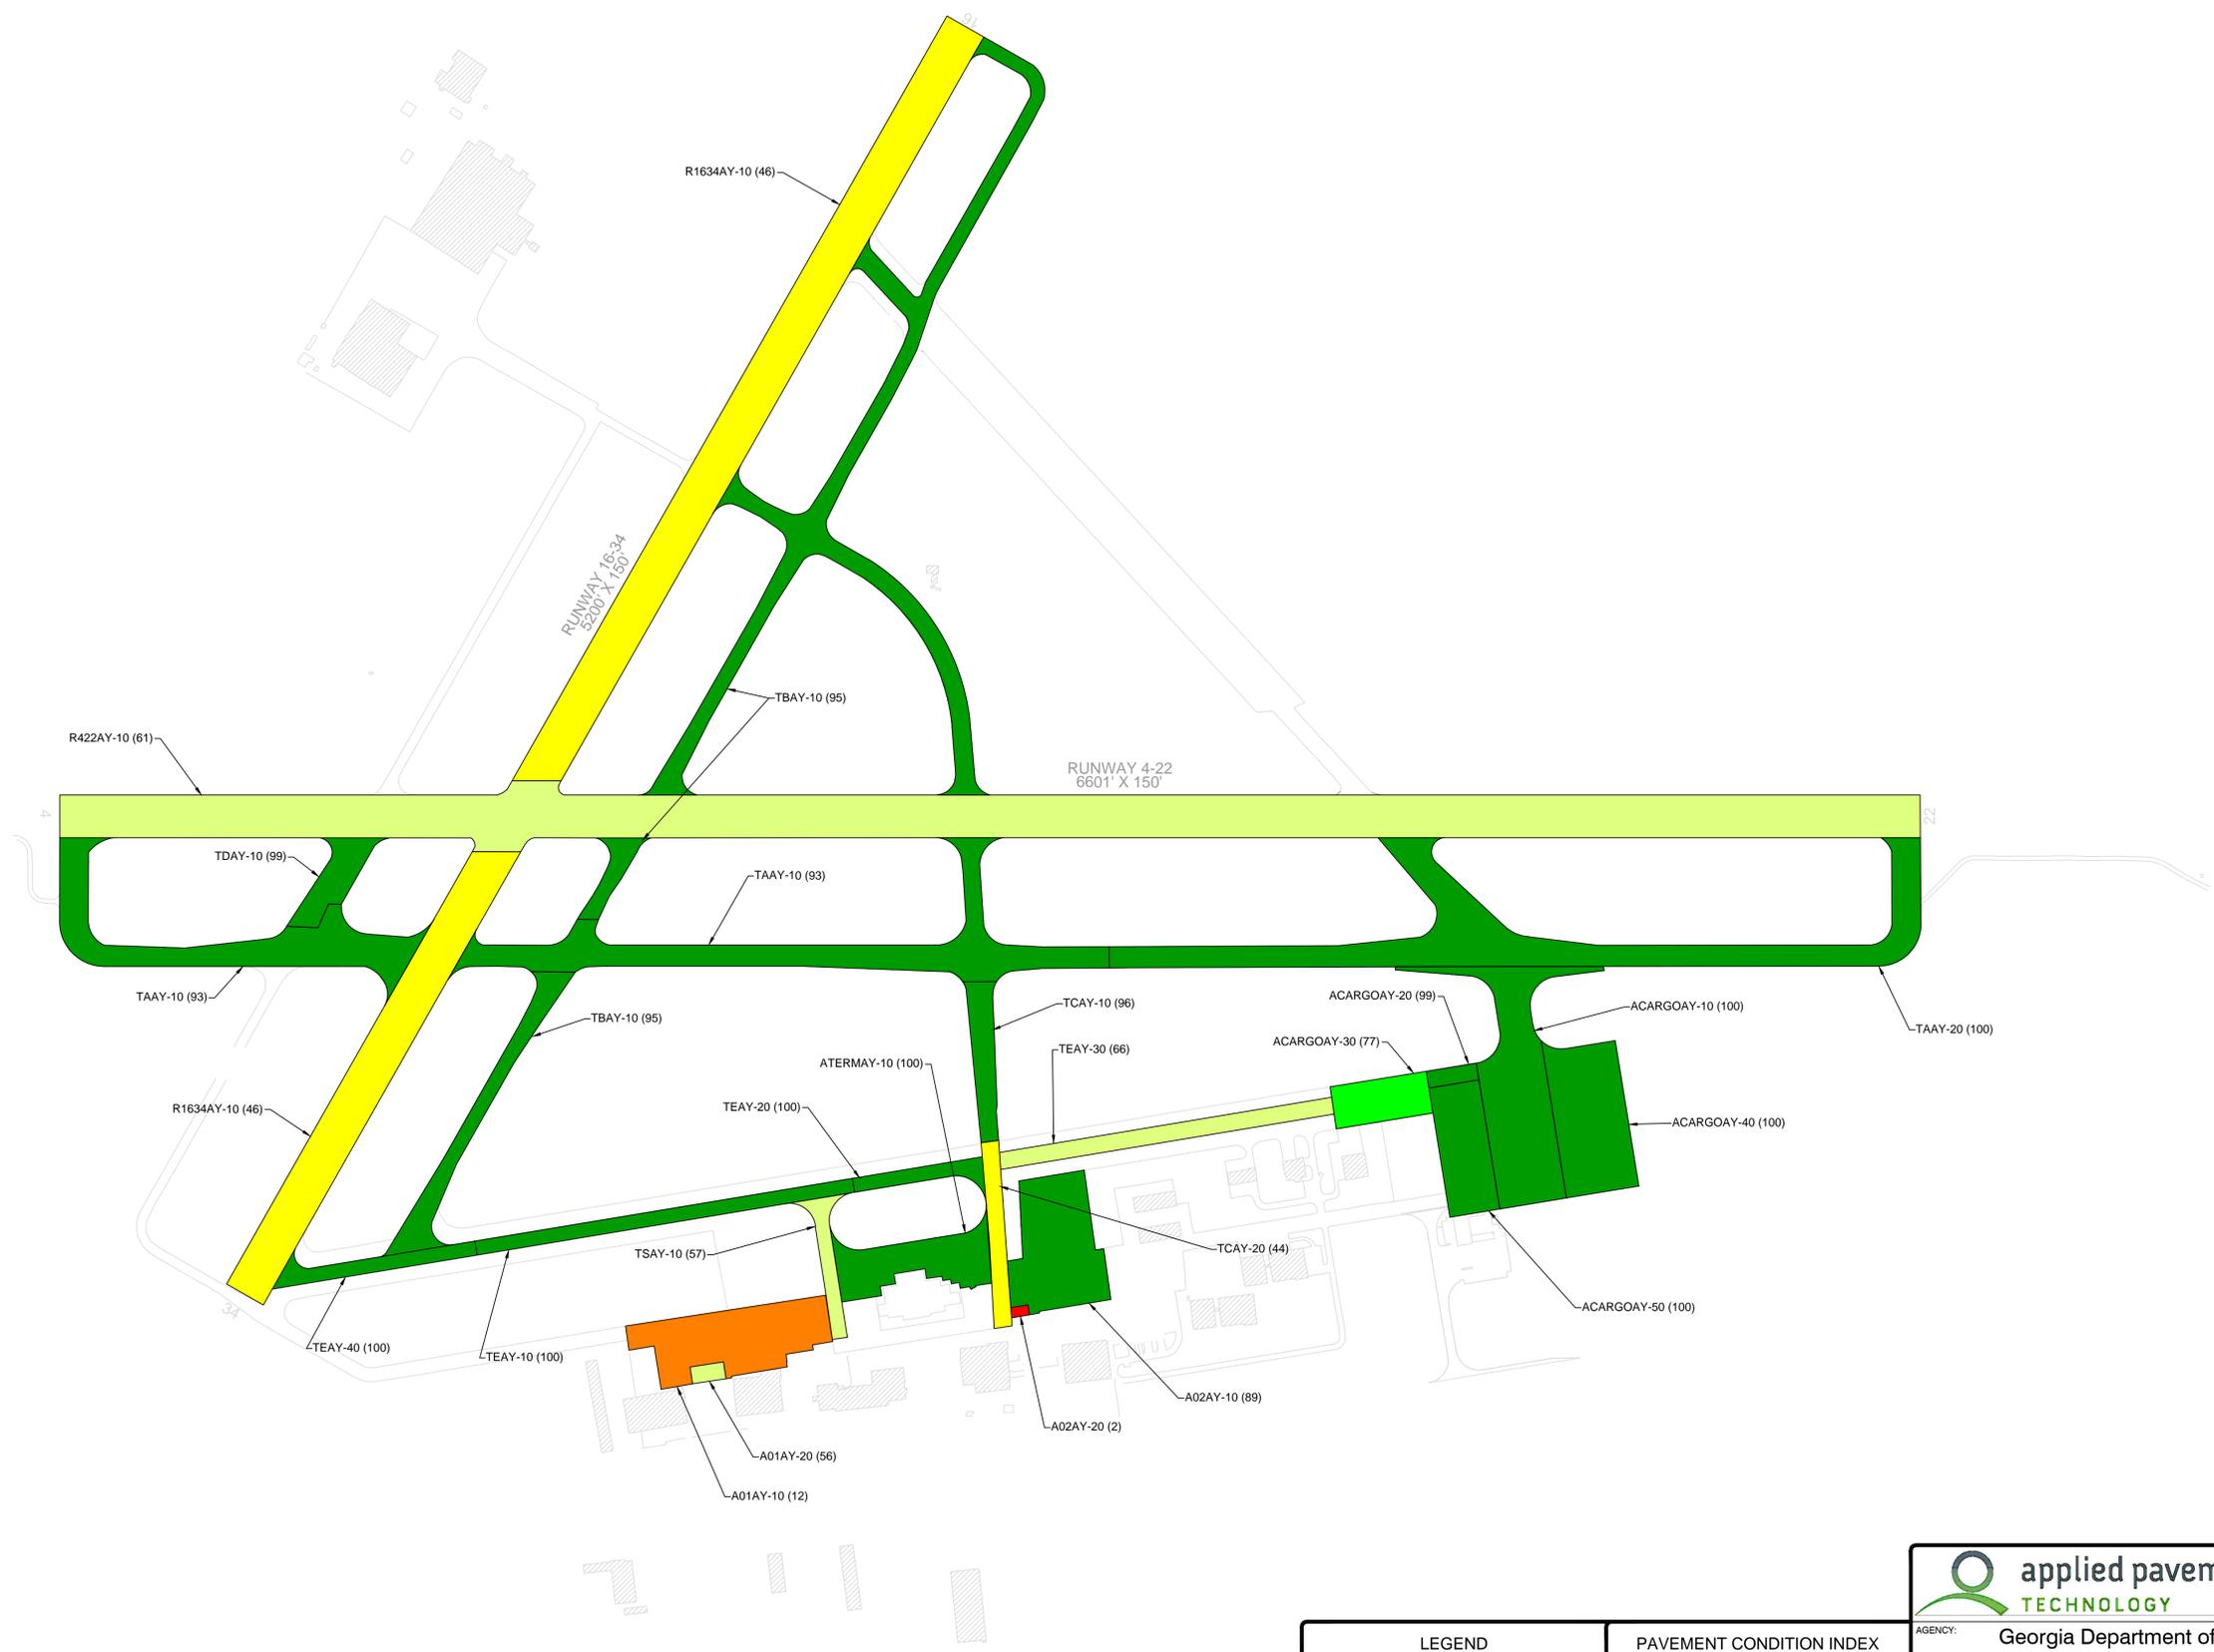
PAGE TITLE: PAVEMENT CONDITION INDEX MAP

Figures 6 and 7 provide graphs summarizing the overall condition of the pavements at Southwest Georgia Regional Airport. Figure 8 is a map that displays the condition of the pavements evaluated. Table 2 summarizes the results of the pavement evaluation and paint assessment and also presents both the 2007 and 2012 PCI values. Please note that modifications have been made to the PCI methodology since the time of the last pavement inspection in 2007, as detailed in ASTM 5340-11. These changes include the separation of the raveling and weathering distress type on asphalt-surfaced pavements into two distress types along with the addition of the alkali silica reaction (ASR) distress type on PCC pavements.

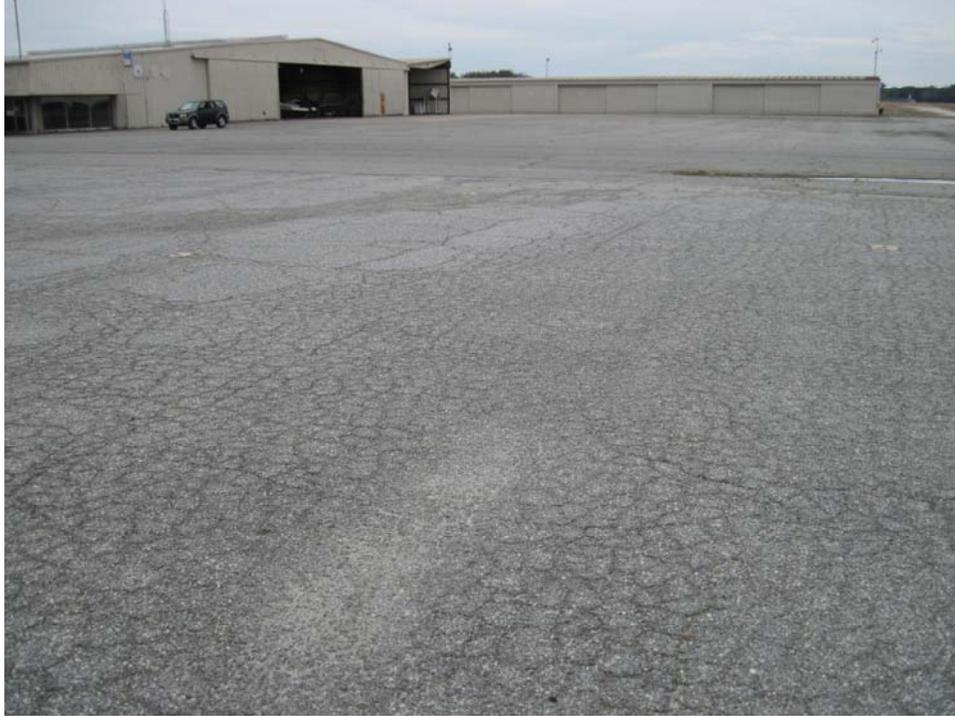
The apron area (A01AY) located to the southwest of the terminal apron was comprised of two sections. Section 10 was in poor condition with a PCI value of 12. Extensive amounts of medium-severity alligator cracking, medium-severity block cracking, and medium- and high-severity weathering were observed in this section. One additional sample unit was recorded, in accordance with ASTM D5340, which had low-severity depression and medium-severity patching. Section 20 had a PCI value of 56. Moderate to extensive quantities of low-severity longitudinal, transverse, and diagonal (LTD) cracking; shrinkage cracking; and high-severity joint seal damage were identified. Small amounts of low-severity scaling and shattered slabs were also observed.

A01AY-10. Overview.

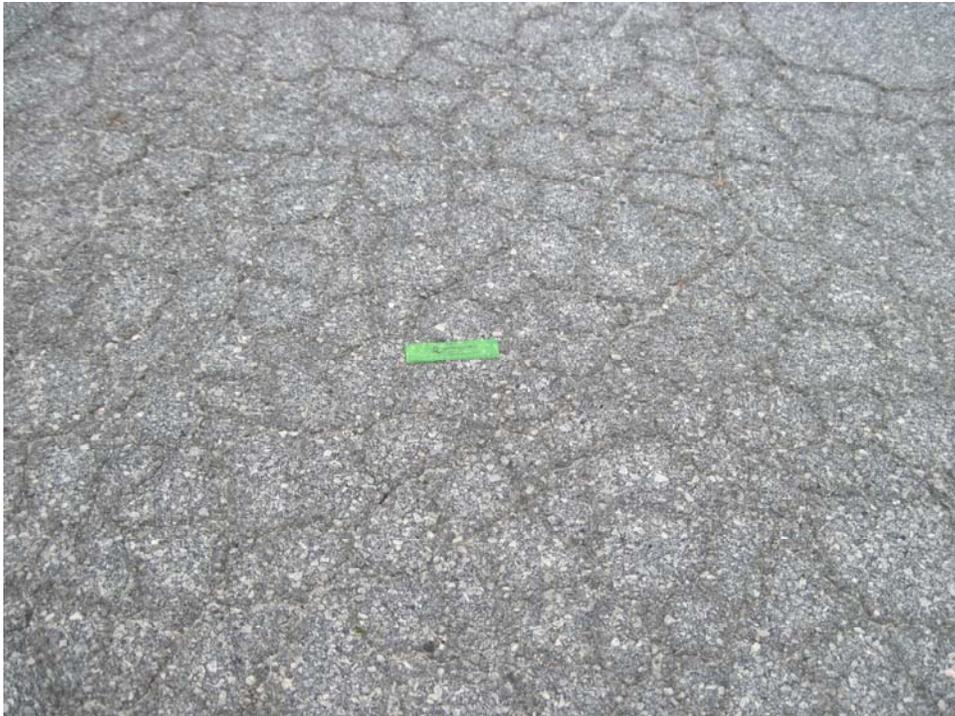
A01AY-10. Alligator Cracking and Weathering (Sample Unit #09).

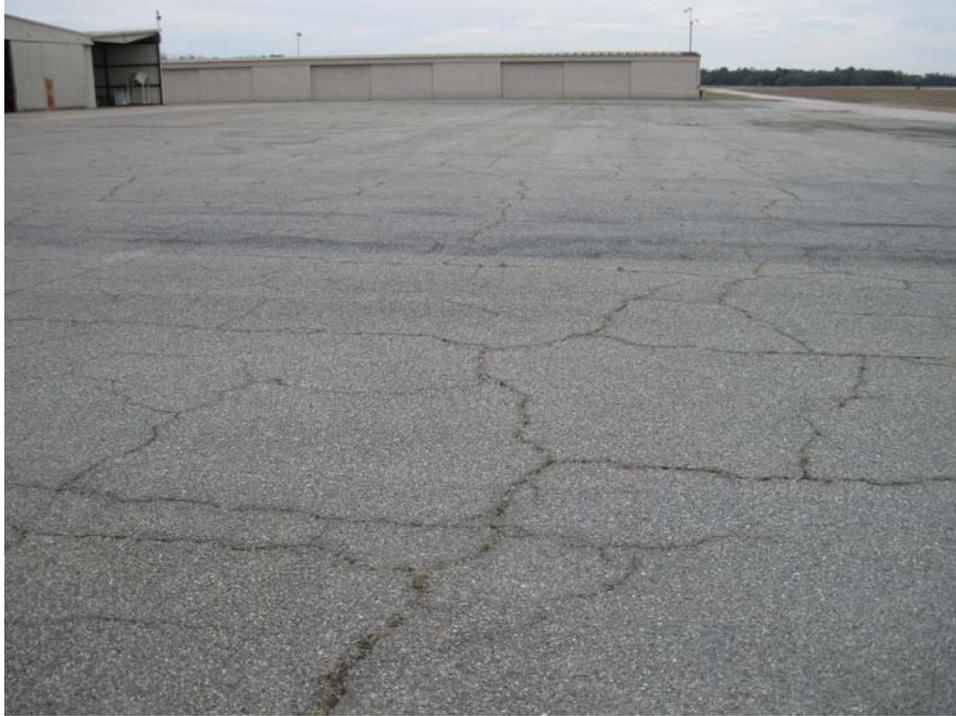
A01AY-10. Block Cracking (Sample Unit #11).

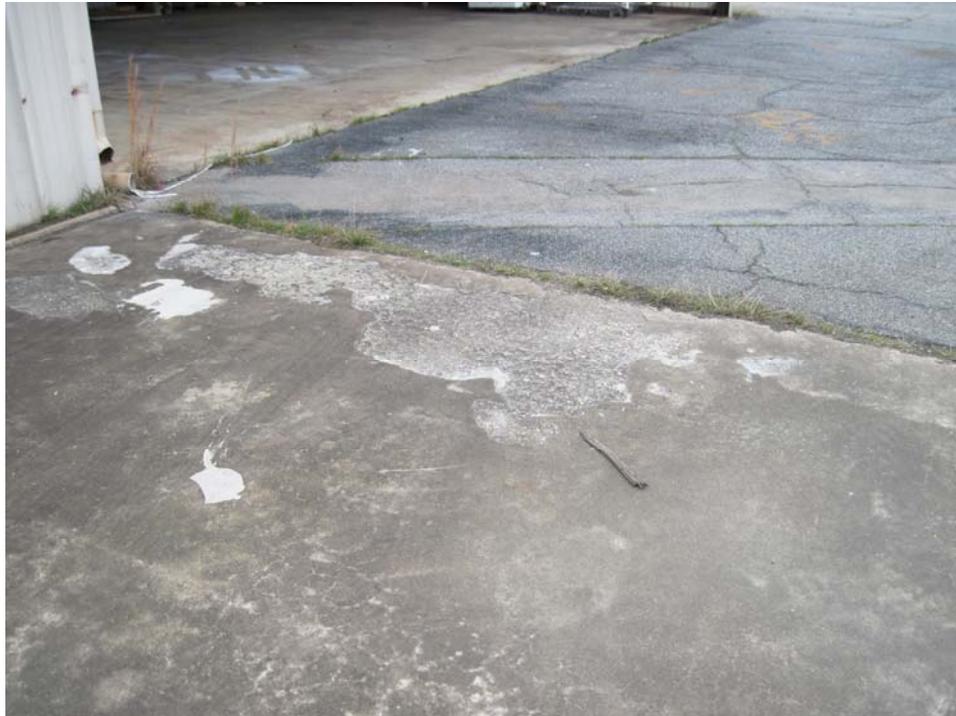
A01AY-10. Scaling (Sample Unit #1).

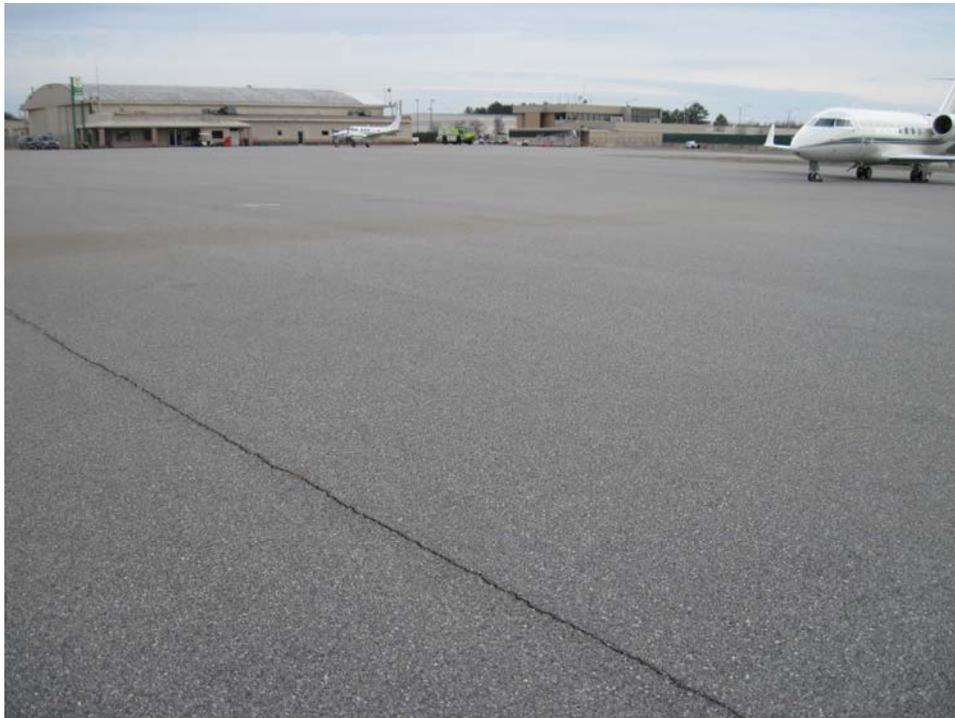
The FBO apron area (A02AY) located to the northeast of the terminal apron contained two sections. Section 10 had a PCI value of 89. Extensive amounts of low-severity L&T cracking were recorded along with smaller quantities of medium-severity L&T cracking. Section 20 was in poor condition with a PCI value of 2. Extensive quantities of medium-severity LTD cracking,

A02AY-10. Overview.

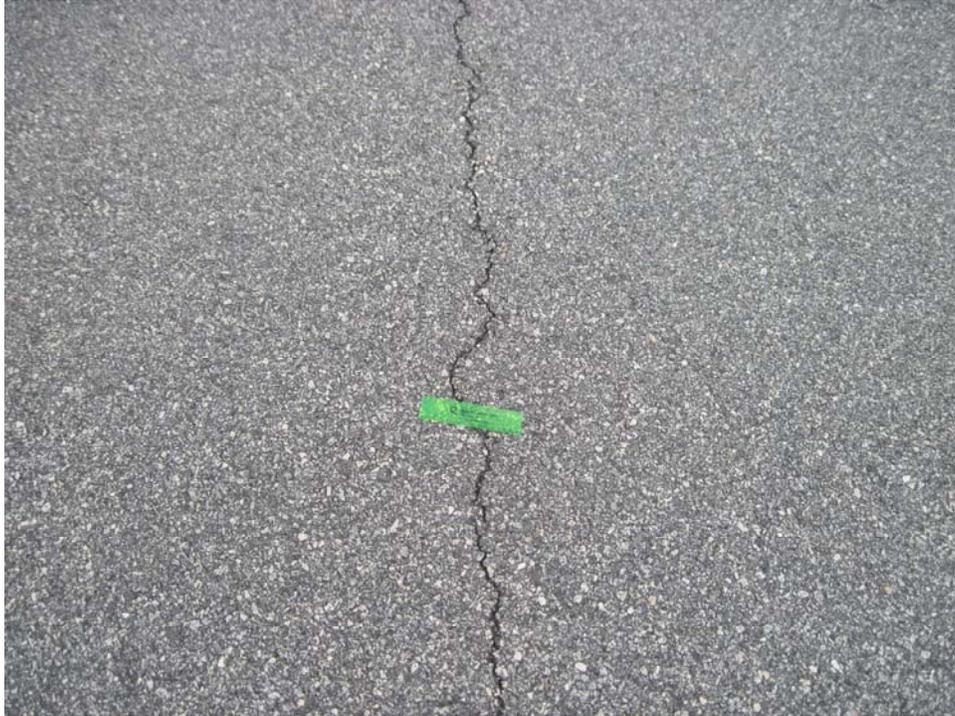
A02AY-10. Longitudinal and Transverse Cracking (Sample Unit #4).

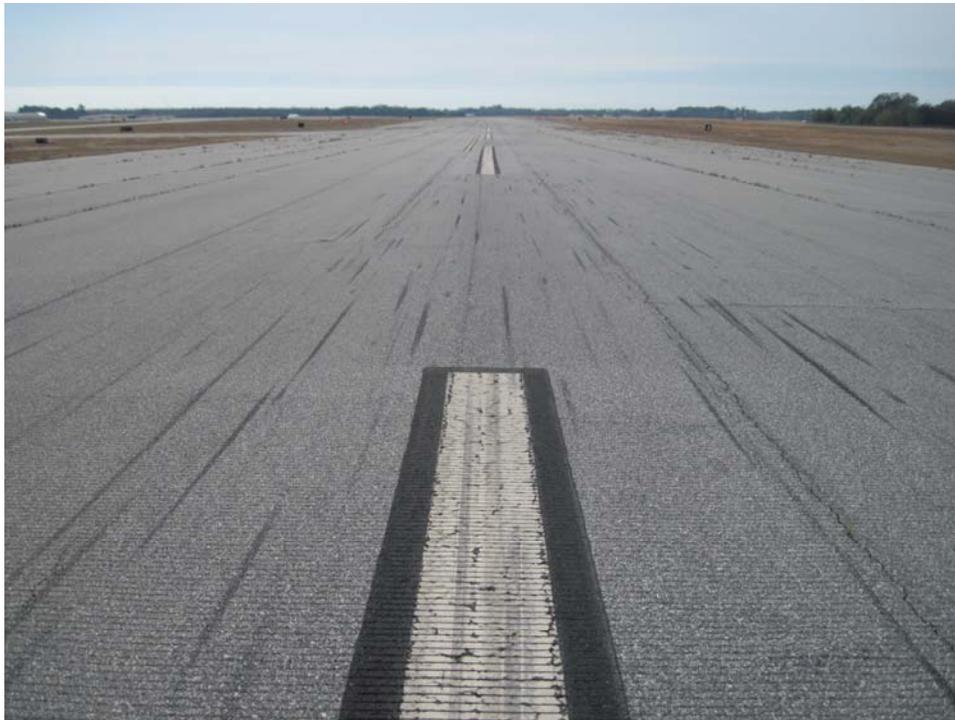
Runway 16-34 was defined by one section with a PCI value of 46. Substantial amounts of low- and medium-severity L&T cracking were recorded along with low- and medium-severity alligator cracking. Low-severity rutting and swelling were also observed, with most of the swelling occurring at the cracks. Low-severity weathering was identified throughout the runway along with small areas of medium- and high-severity weathering.

R1634AY-10. Overview.

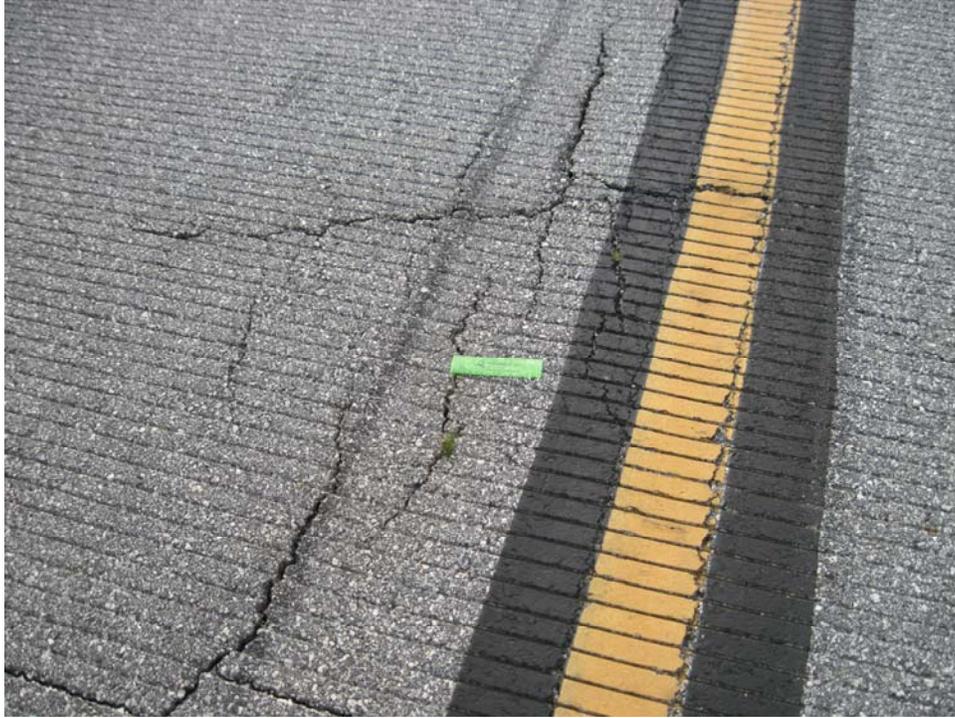
R1634AY-10. Alligator Cracking (Sample Unit #93).

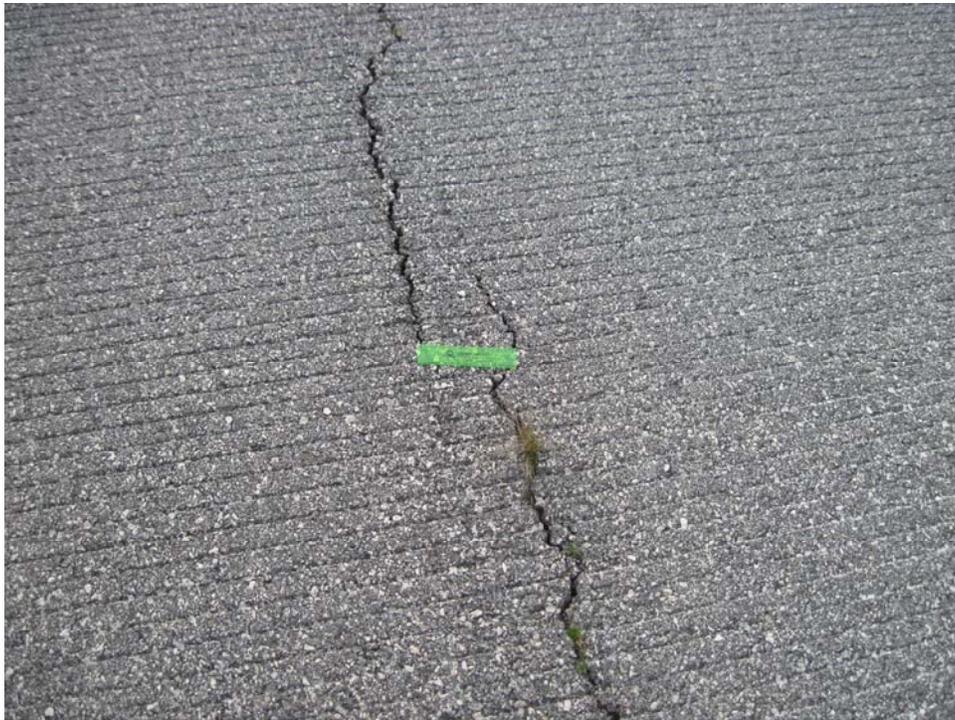
R1634AY-10. Longitudinal and Transverse Cracking and Weathering (Sample Unit #5).

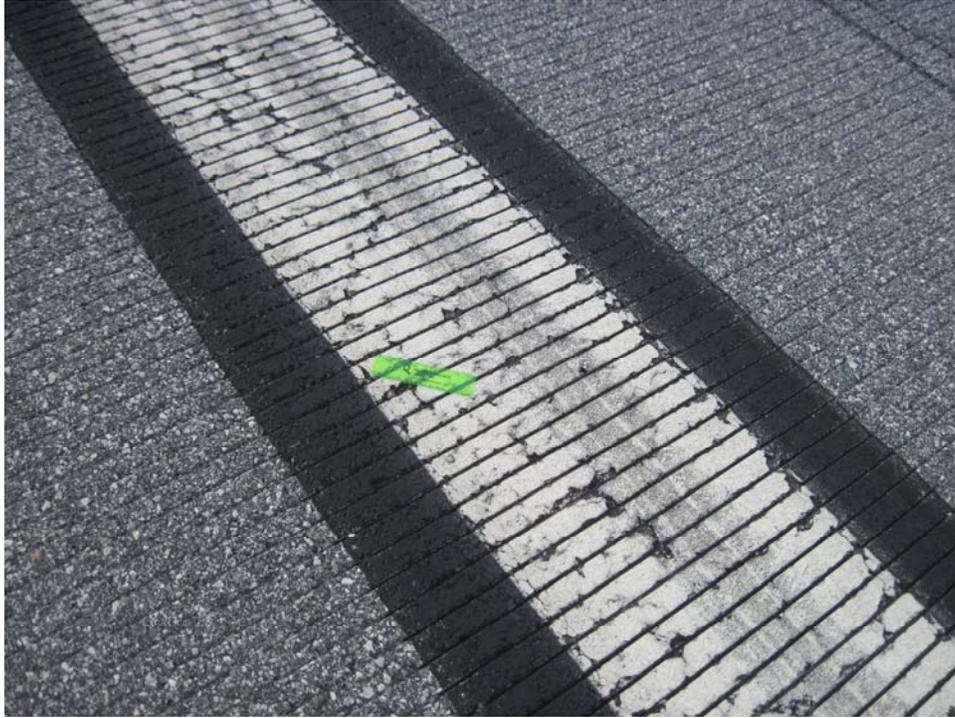
R1634AY-10. Paint Unsatisfactory.

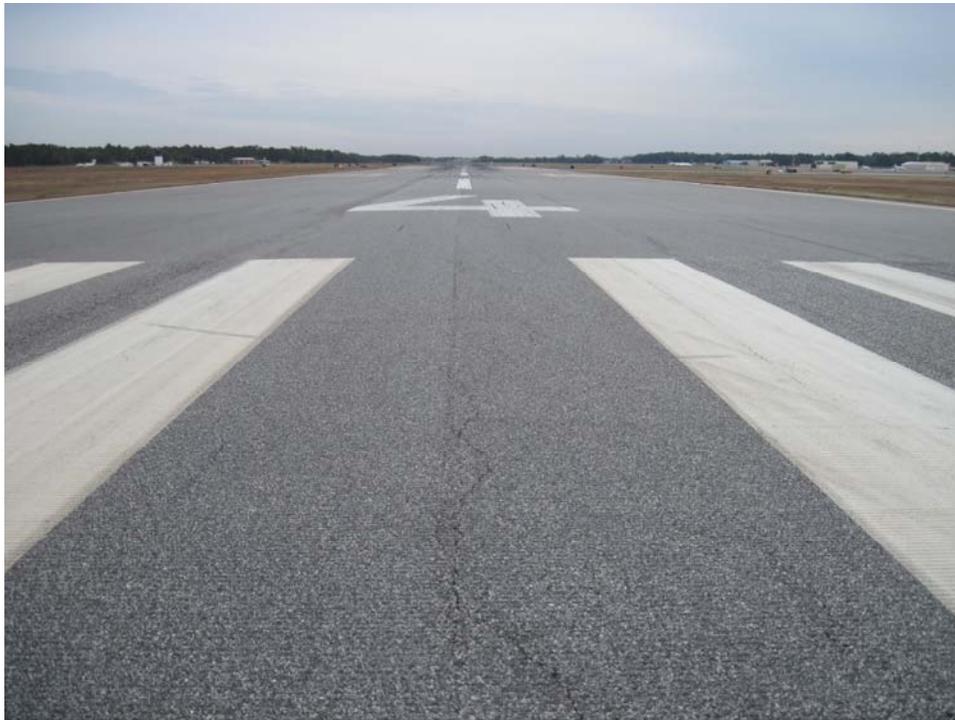
Runway 4-22 consisted of one section with a PCI value of 61. The primary distresses identified in Section 10 were low- and medium-severity longitudinal and transverse (L&T) cracking and medium-severity alligator cracking. Low-severity weathering was observed over the entire section, with areas of medium- and high-severity due to both natural pavement aging and paint removal. Isolated amounts of medium- and high-severity raveling were also noted.

R422AY-10. Overview.

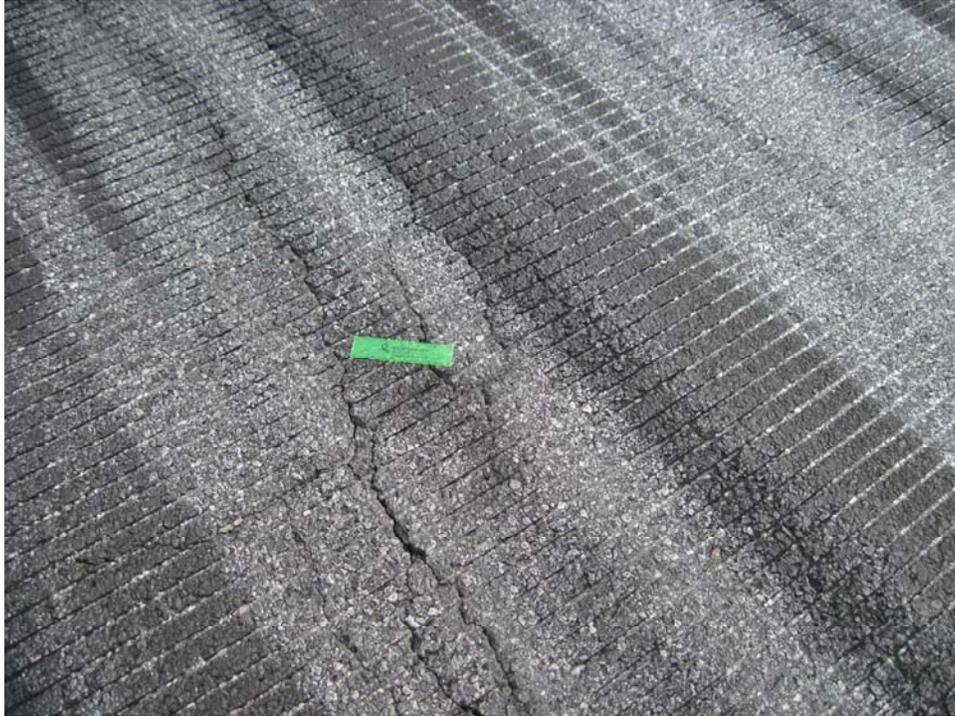
R422AY-10. Alligator Cracking (Sample Unit #120).

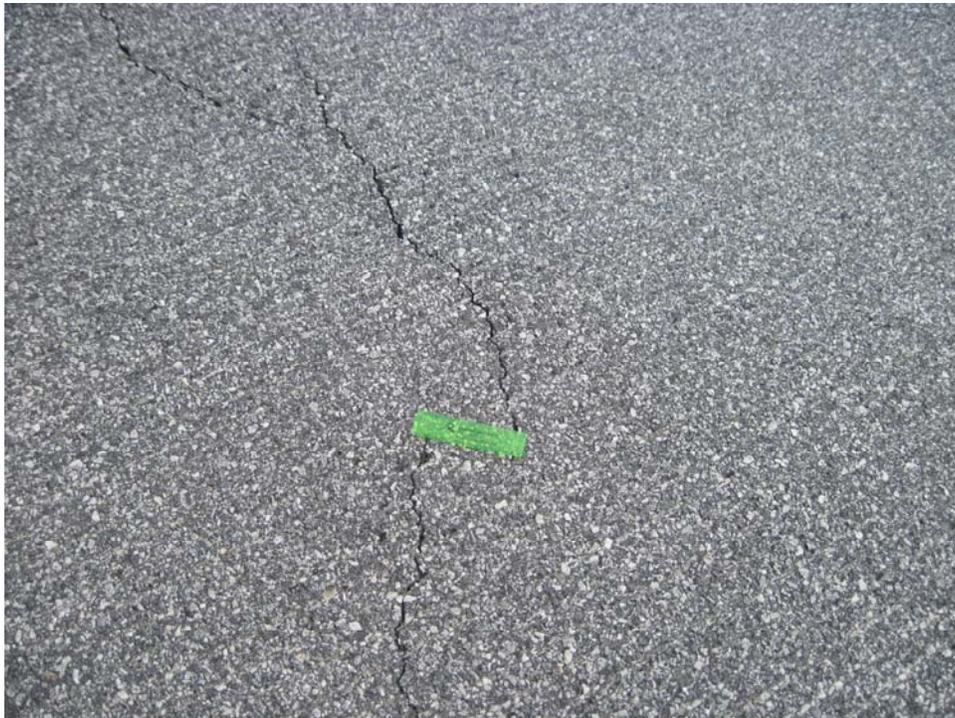
R422AY-10. Longitudinal and Transverse Cracking and Weathering (Sample Unit #134).

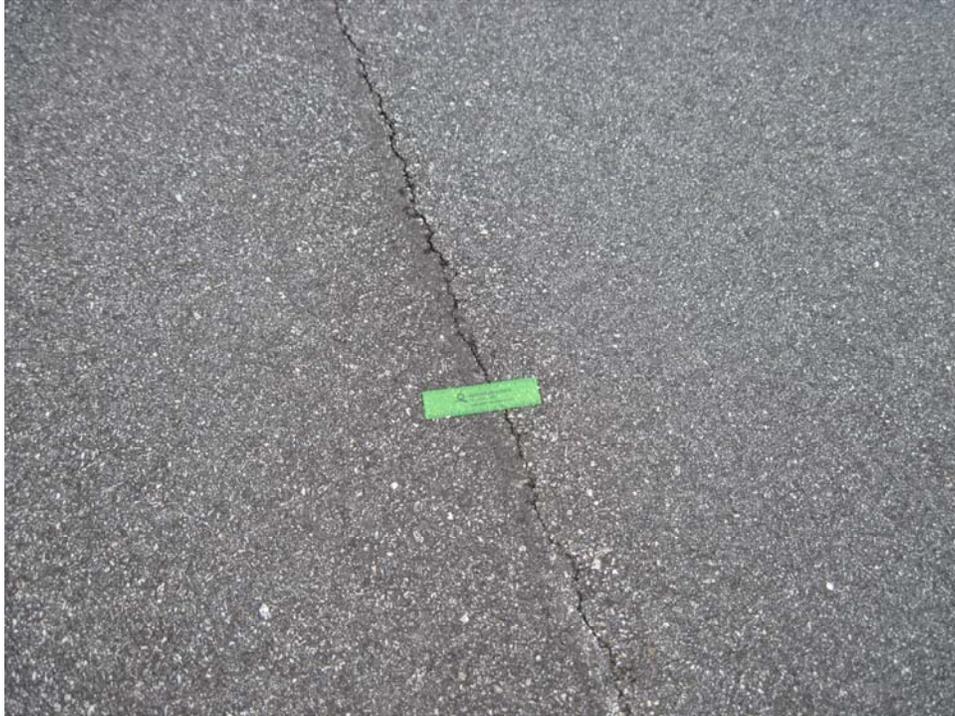
Taxiway A was comprised of two sections. Section 10 had a PCI of 93. The primary distress recorded was low-severity L&T cracking. A small area of bleeding was also noted. Section 20 was in excellent condition with a PCI of 100; only a small amount of low-severity L&T cracking was observed.

TAAY-10. Longitudinal and Transverse Cracking (Sample Unit #6).

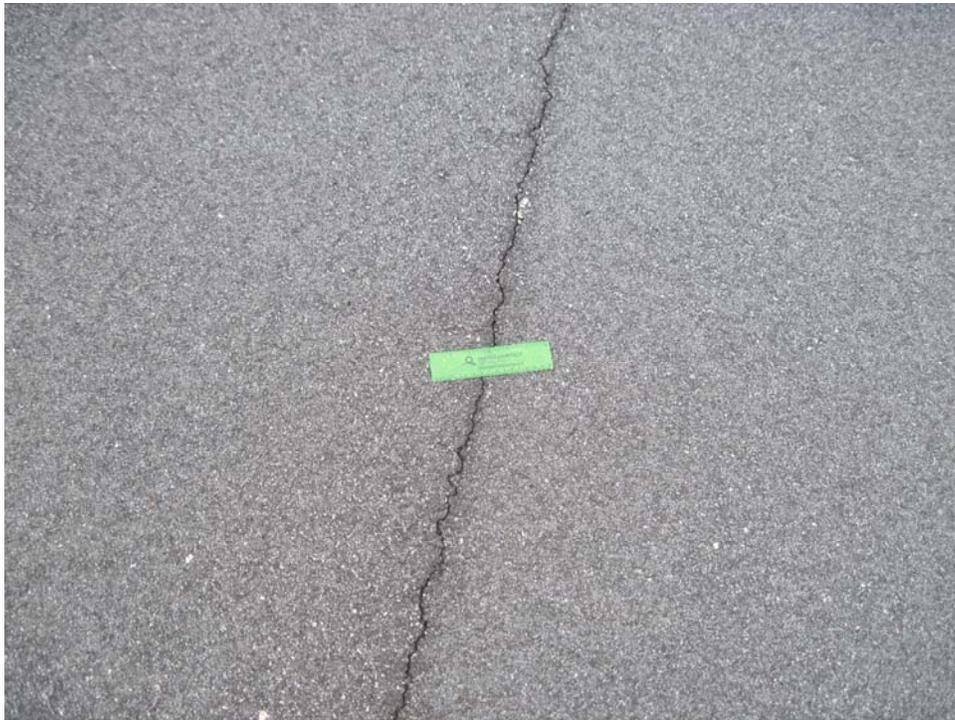
Taxiway B consisted of one section in excellent condition with a PCI of 95. The main distress identified in Section 10 was low-severity L&T cracking, with some areas of low-severity weathering. It should be noted that some areas of the section were exhibiting more cracking than others.

TBAY-10. Longitudinal and Transverse Cracking (Sample Unit # 12).

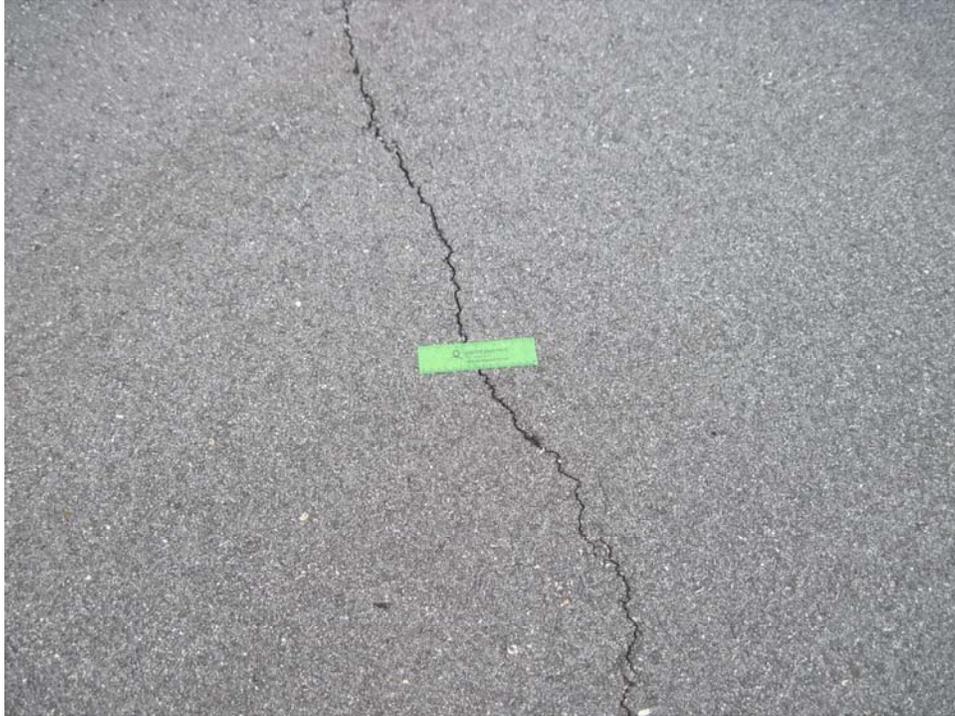
Taxiway C contained two sections. Section 10 was in excellent condition with a PCI value of 96. The only distress identified in this section was low-severity L&T cracking. Section 20 had a PCI value of 44. Block cracking was recorded on the entire section, with equal amounts of medium-severity and low-severity. Additionally, weathering was observed on the whole section; most of it was low-severity along with a smaller portion of it medium-severity.

TCAY-10. Longitudinal and Transverse Cracking (Sample Unit #3).

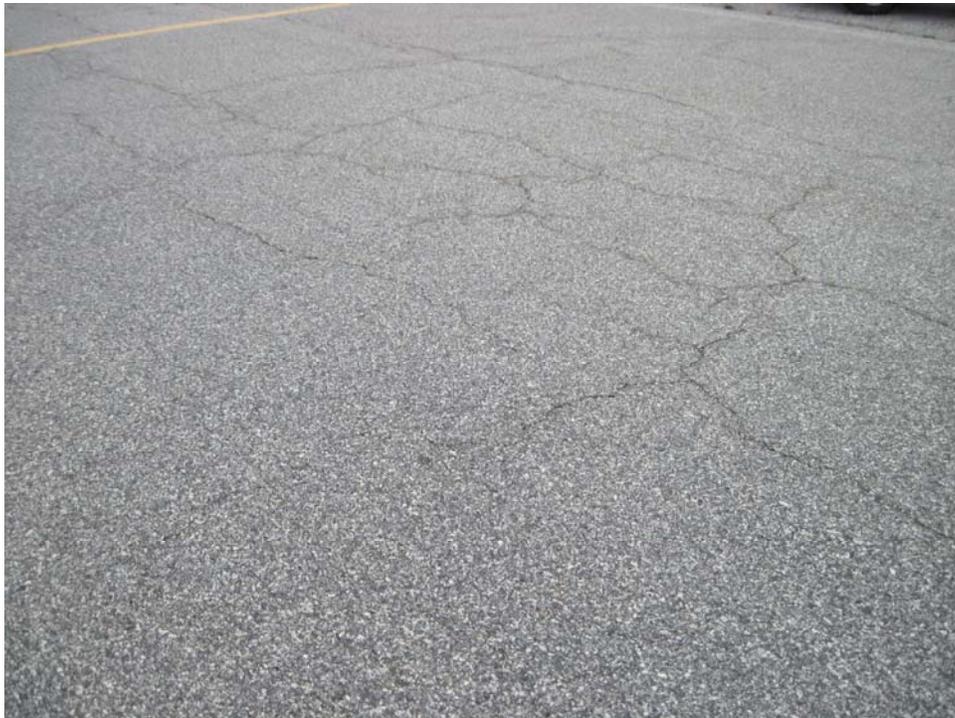
TCA Y-20. Block Cracking (Sample Unit #3).

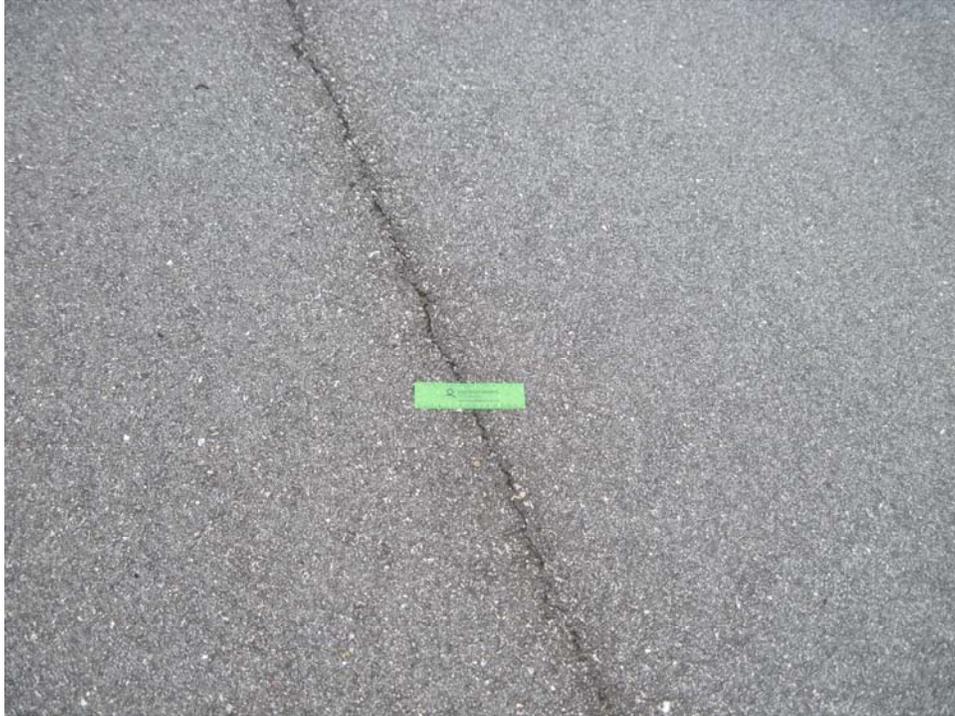
TEAY-10. Longitudinal and Transverse Cracking (Sample Unit #10).

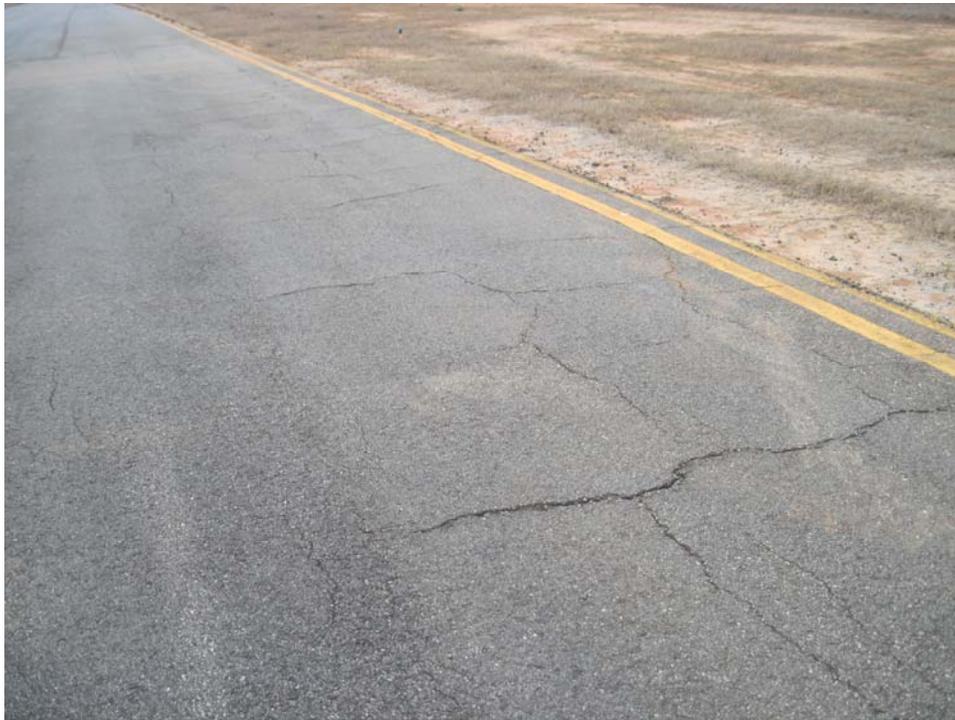
TEAY-20. Block Cracking (Sample Unit #3).

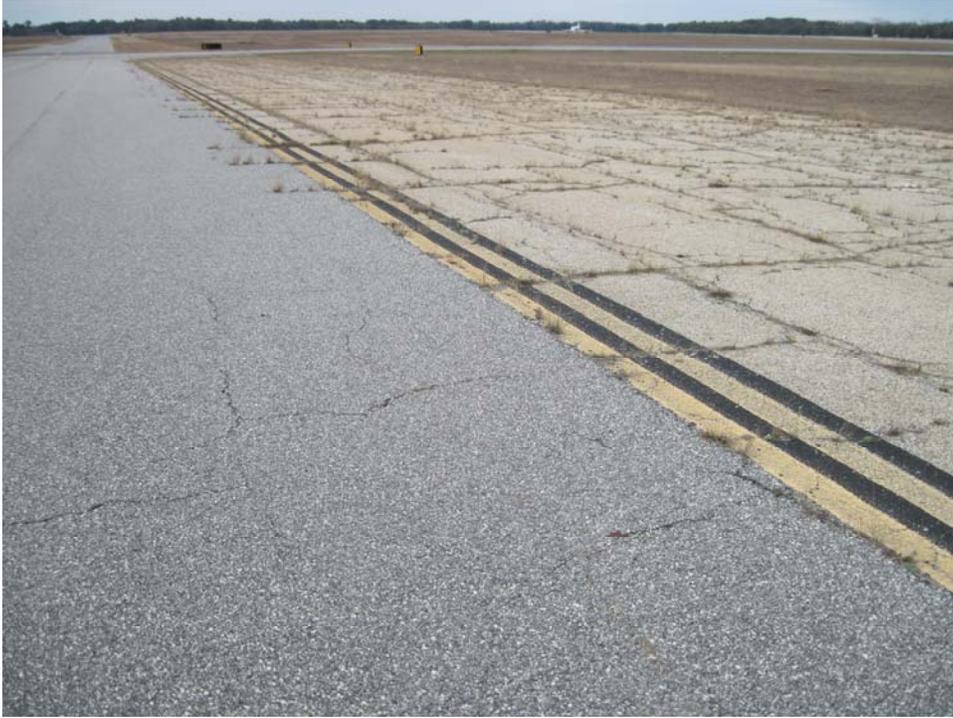
Taxiway E was defined by four sections. Sections 10, 20, and 40 were in excellent condition with PCI values of 100 and no recorded distresses. Section 30 had a PCI of 66 with a significant amount of low-severity L&T cracking and areas of low-severity block cracking, which were primarily located in the outer 10 feet of the taxiway. Low-severity weathering was recorded throughout the section along with smaller areas of medium-severity weathering.

TEAY-30. Block Cracking (Sample Unit #4).

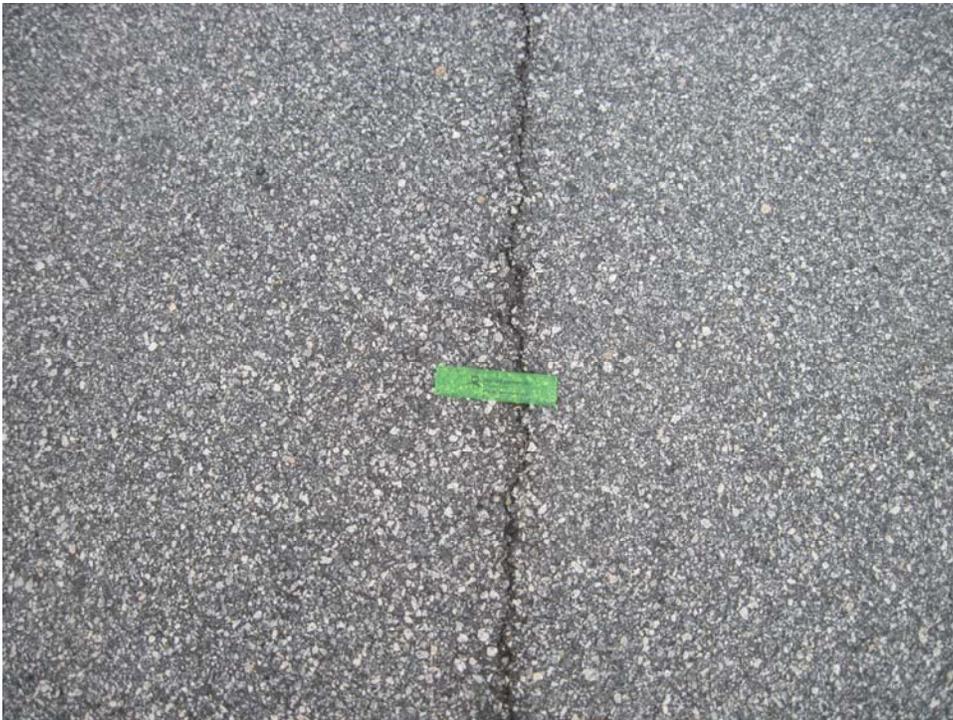
TEAY-30. Longitudinal and Transverse Cracking and Weathering (Sample Unit #2).

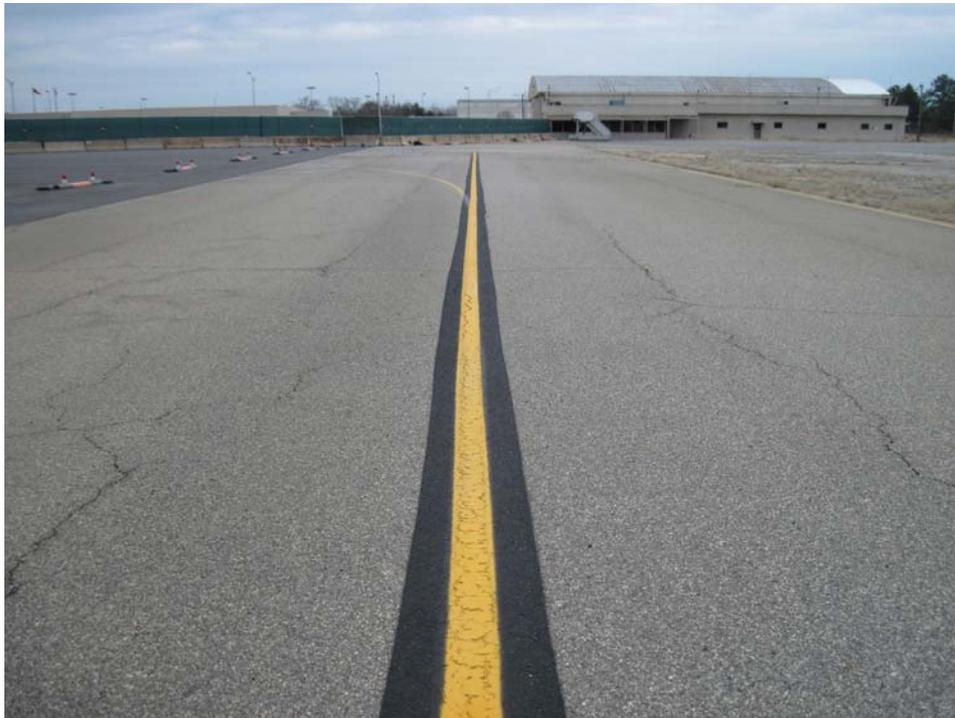
Taxiway S was comprised of one section with a PCI of 57. Typical distresses recorded were low- and medium-severity block cracking and L&T cracking. Medium-severity weathering was also identified throughout the entire section.

TSAY-10. Overview.

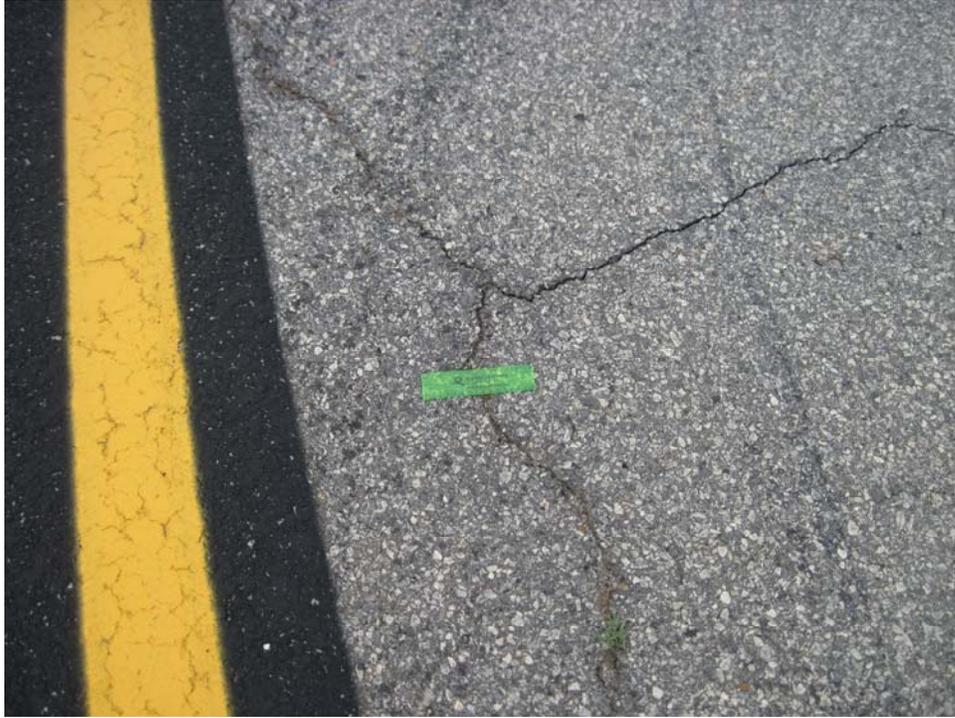
TSAY-10. Longitudinal and Transverse Cracking and Weathering (Sample Unit #1).
