2012 Cobb County- McCollum Field Pavement Management Plan

COBB COUNTY-MCCOLLUM FIELD

PAVEMENT MANAGEMENT REPORT

DECEMBER 2012

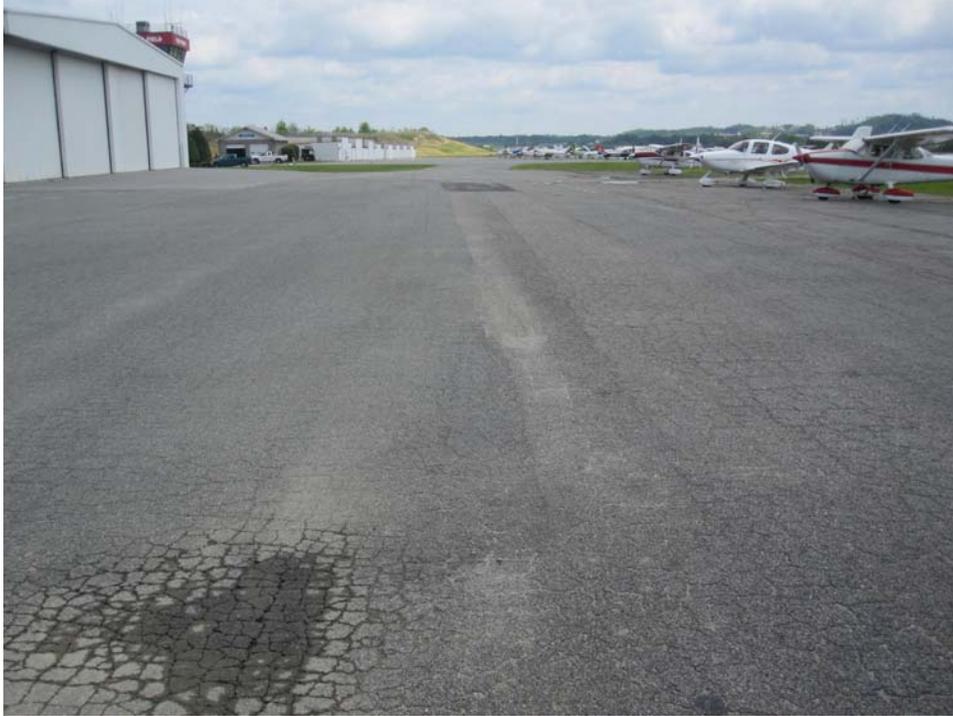
The north apron area (A01MR) consisted of seven sections. Section 10 was in poor condition with a PCI value of 28. Extensive amounts of medium-severity alligator cracking as well as low-severity block cracking and L&T cracking were observed. A small amount of high-severity alligator cracking was also identified. Additionally, low- and medium-severity weathering were recorded throughout. Section 20 had a PCI value of 90. The primary distress type observed on this section was low-severity weathering due to loss of fines and oxidation of the asphalt binder. A small amount of low-severity, unsealed L&T cracking was also noted. Section 30 had a PCI value of 70. Extensive low-severity block cracking was the primary distress identified on this section, along with smaller amounts of low-severity L&T cracking, bleeding, and medium-severity alligator cracking. None of the cracking in this section had been sealed. Low-severity weathering was also observed throughout. Section 40 had a PCI value of 66. The primary distress types observed in this section were low- and medium-severity L&T cracking and low-severity weathering. All of the cracking in this section was observed in an unsealed condition. Additionally, areas of medium-severity alligator cracking and low- and medium-severity raveling were identified. A small amount of bleeding was also noted. Section 50 had a PCI value of 89. Low-severity L&T cracking, along with small amounts of low-severity patching

A01MR-10. Overview.

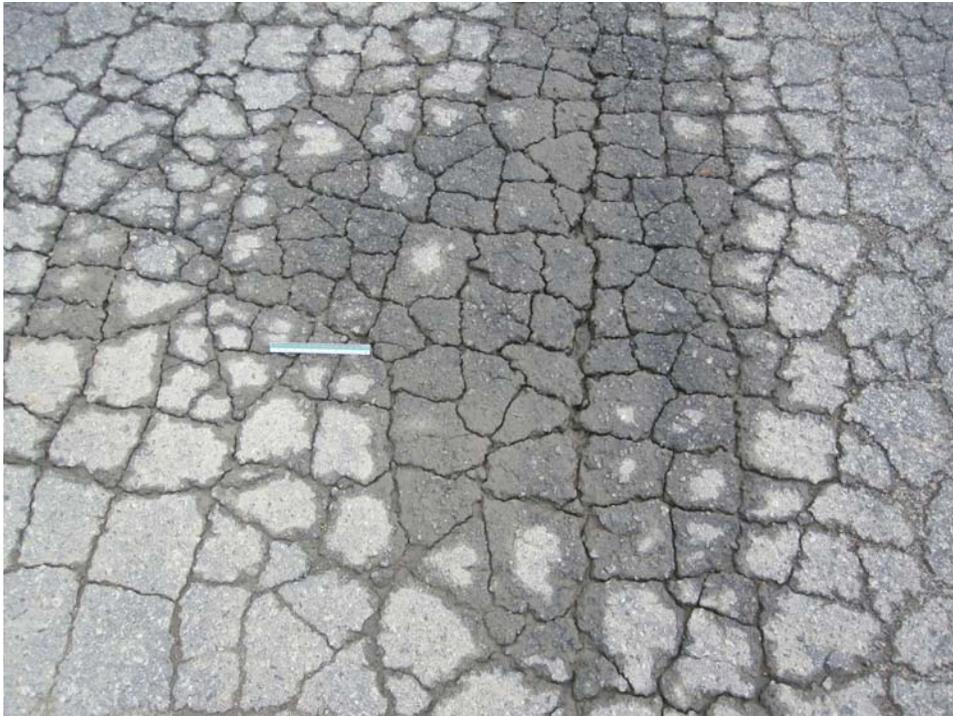
A01MR-10. Alligator Cracking (Sample Unit #01).

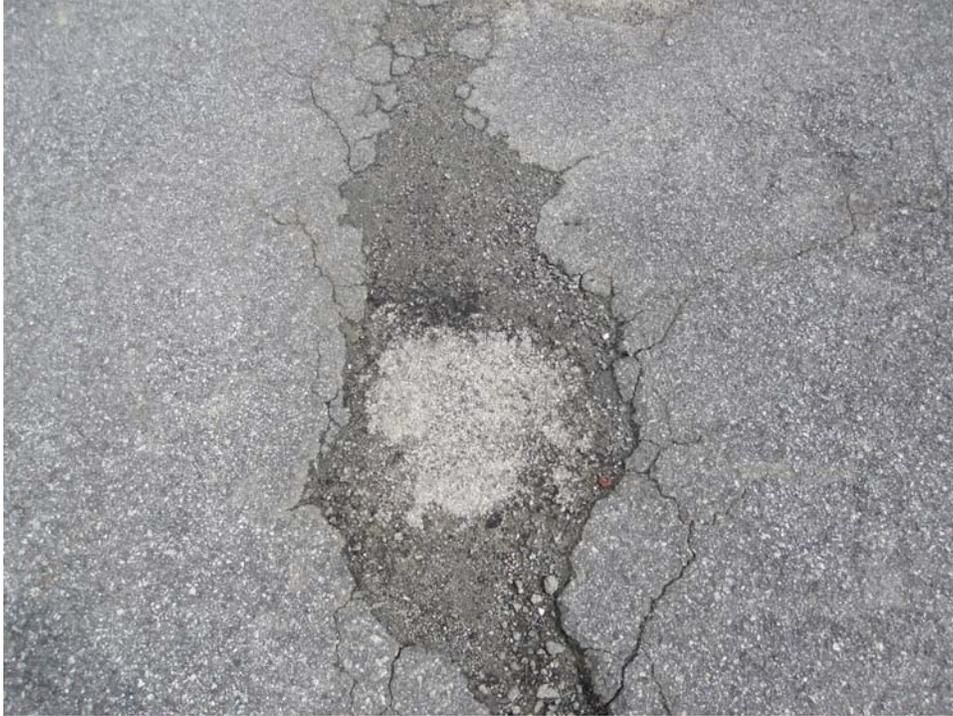
A01MR-10. Alligator Cracking (Sample Unit #04).

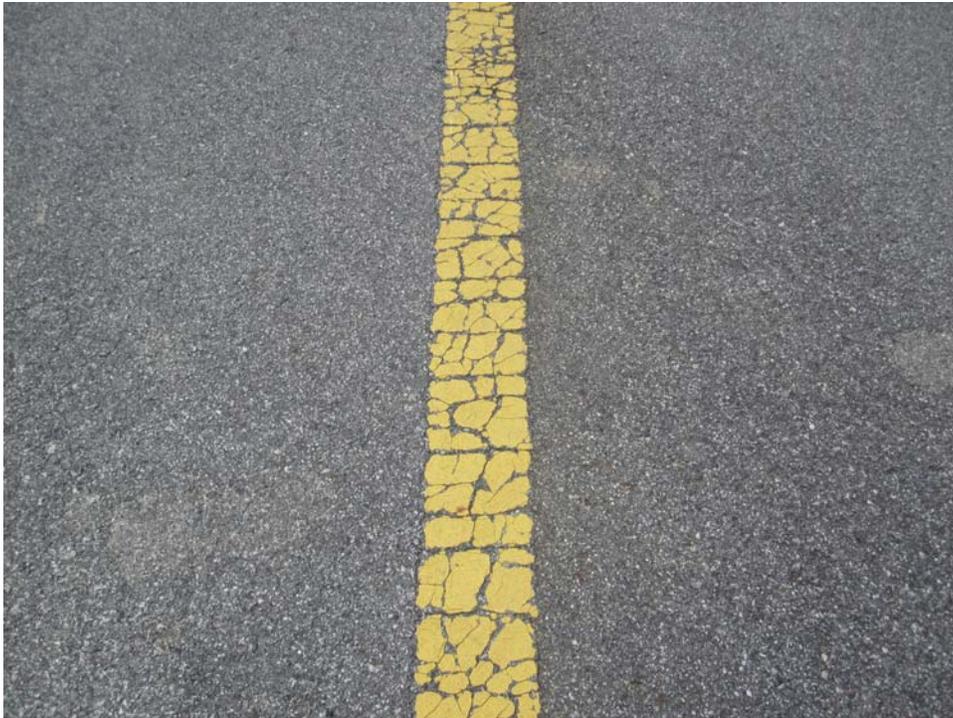
A01MR-10. Unsatisfactory Paint.

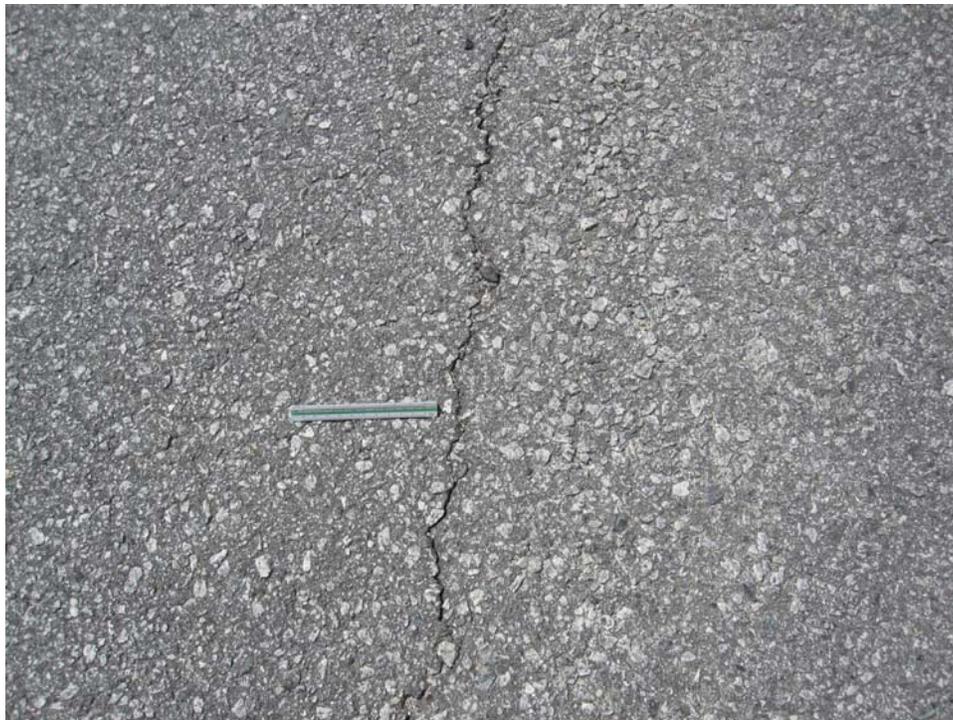
A01MR-20. Longitudinal and Transverse Cracking (Sample Unit #03).

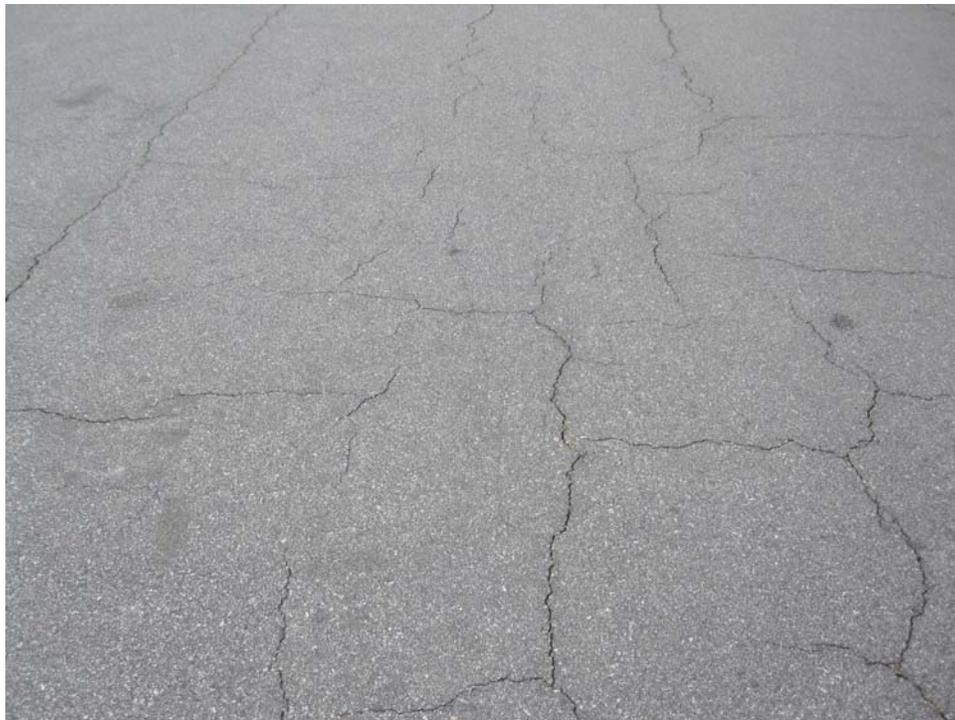
A01MR-30. Block Cracking (Sample Unit #04).

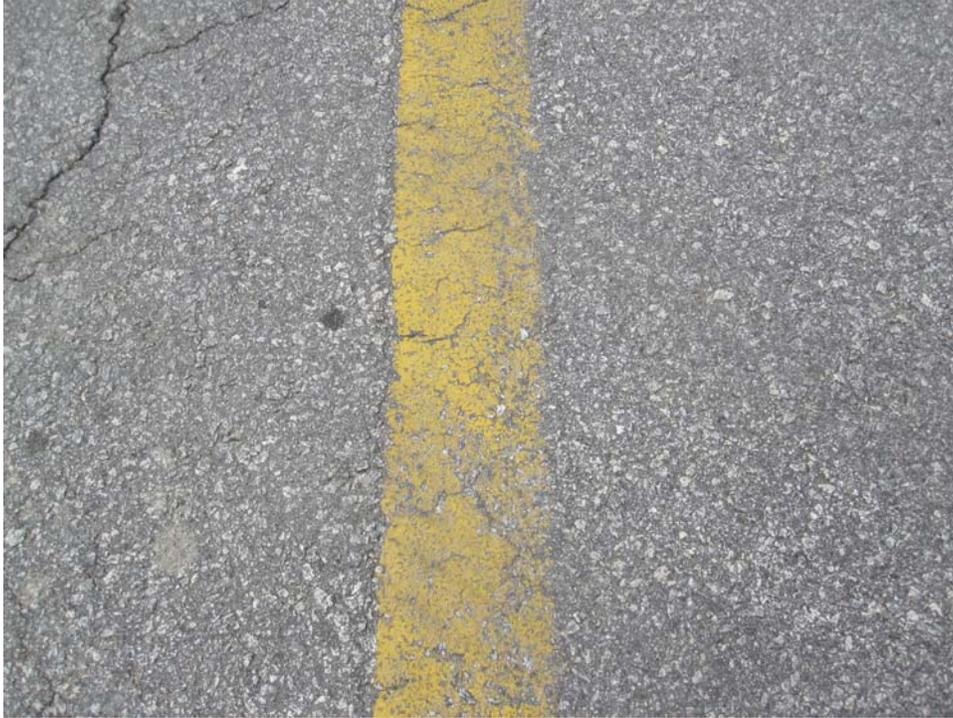
A01MR-30. Unsatisfactory Paint.

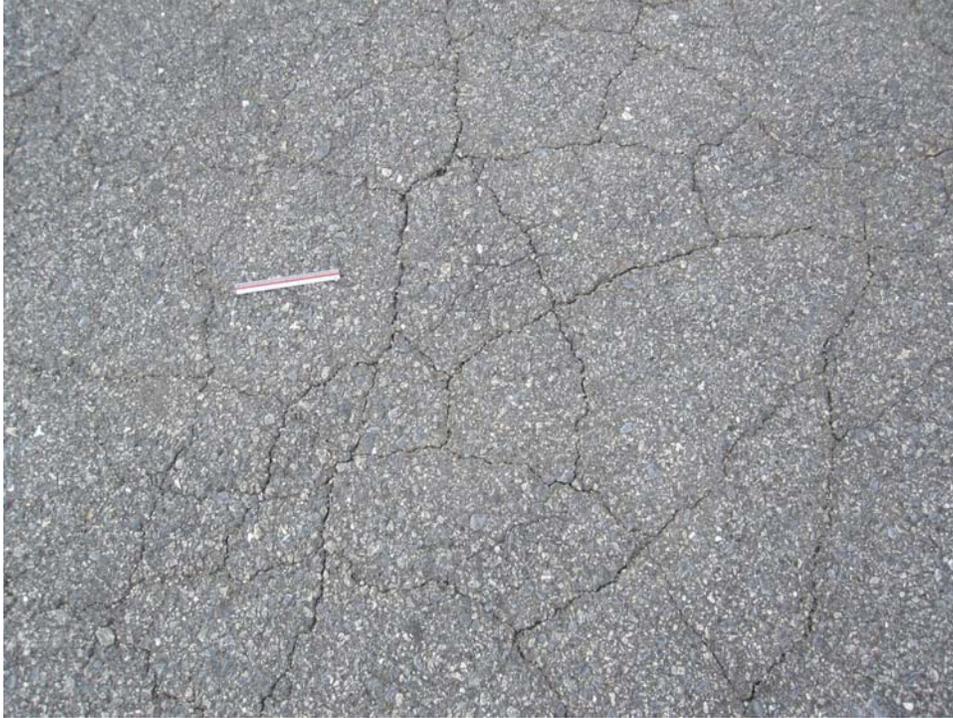
A01MR-40. Alligator Cracking (Sample Unit #56).

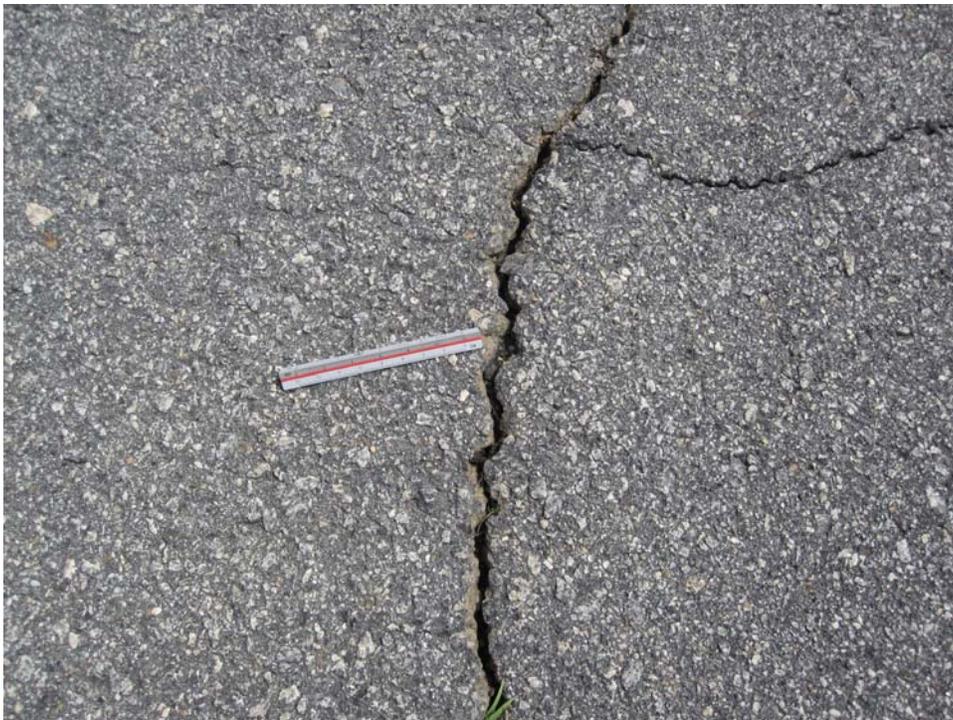
A01MR-40. Longitudinal and Transverse Cracking (Sample Unit #10).

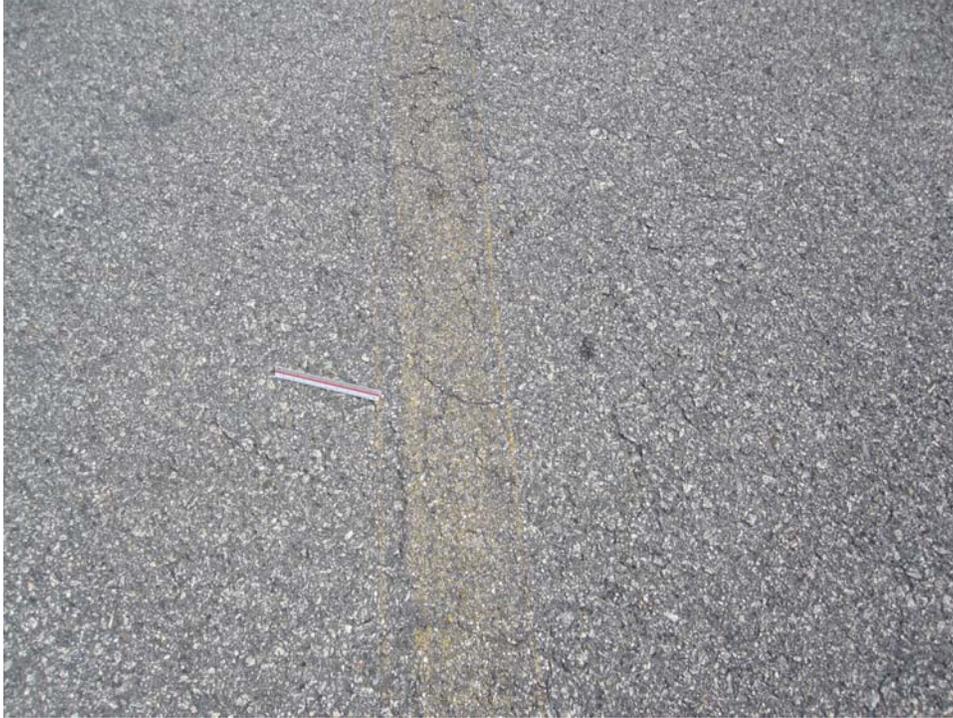
A01MR-40. Unsatisfactory Paint.

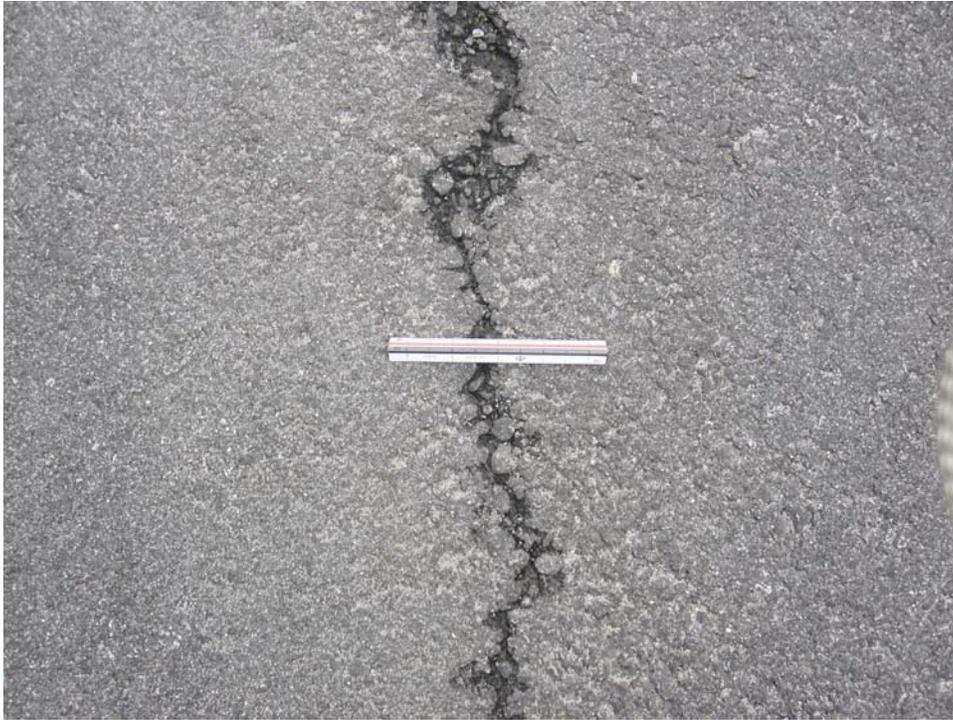
A01MR-50. Longitudinal and Transverse Cracking (Sample Unit #12).

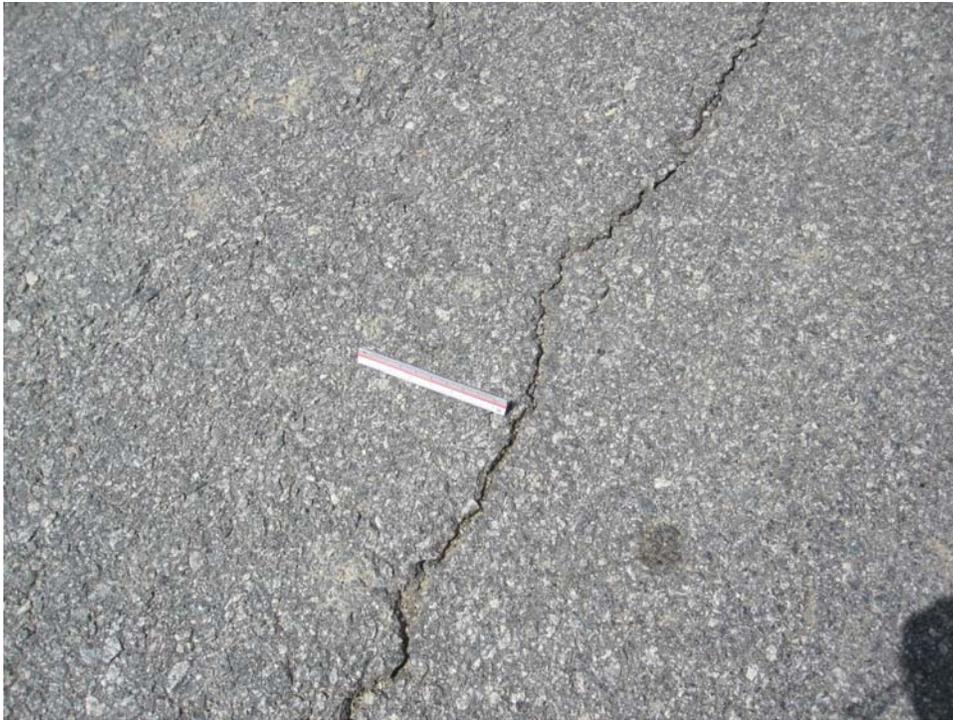
A01MR-60. Longitudinal and Transverse Cracking (Sample Unit #03).

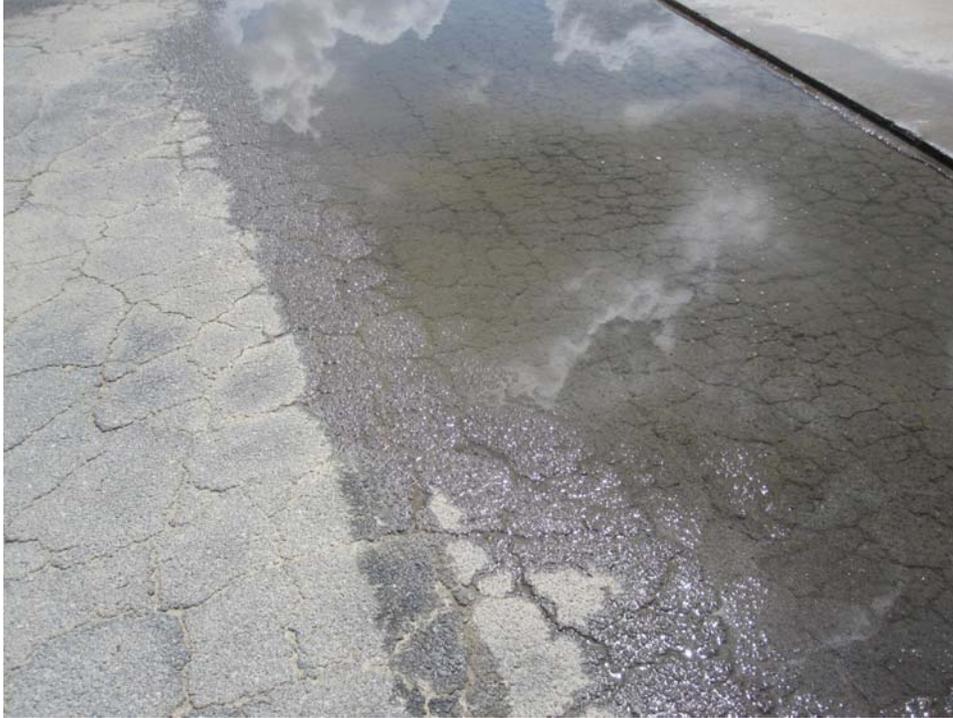
and low- and medium-severity alligator cracking were identified in this section. All of the cracking was observed in an unsealed condition. Section 60 had a PCI value of 52. Distresses identified on this section included amounts of medium-severity alligator cracking; low- and medium-severity L&T cracking, weathering, and patching; and low-severity depression. Additionally, an area of high-severity rutting was identified as an additional sample in an area trafficked by fuel trucks. Section 70 had a PCI value of 86. Distresses observed on this section included low-severity L&T cracking and weathering and small amounts of bleeding and medium-severity alligator cracking. All of the cracking in this section was unsealed.

A01MR-60. Rutting and Alligator Cracking (Additional Sample Unit #01).

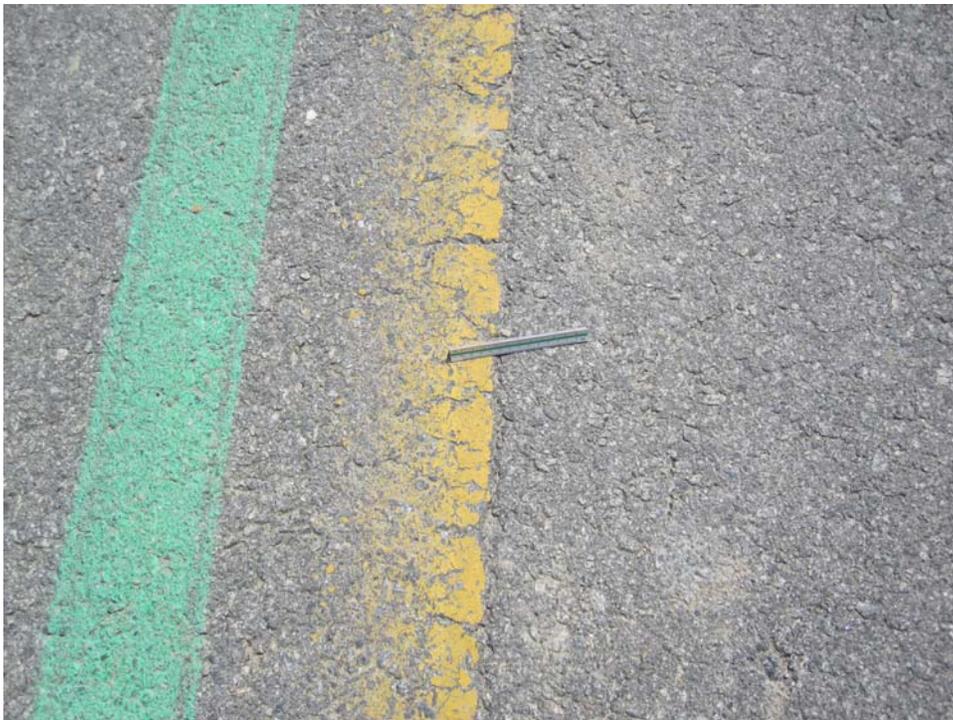
A01MR-60. Unsatisfactory Paint.

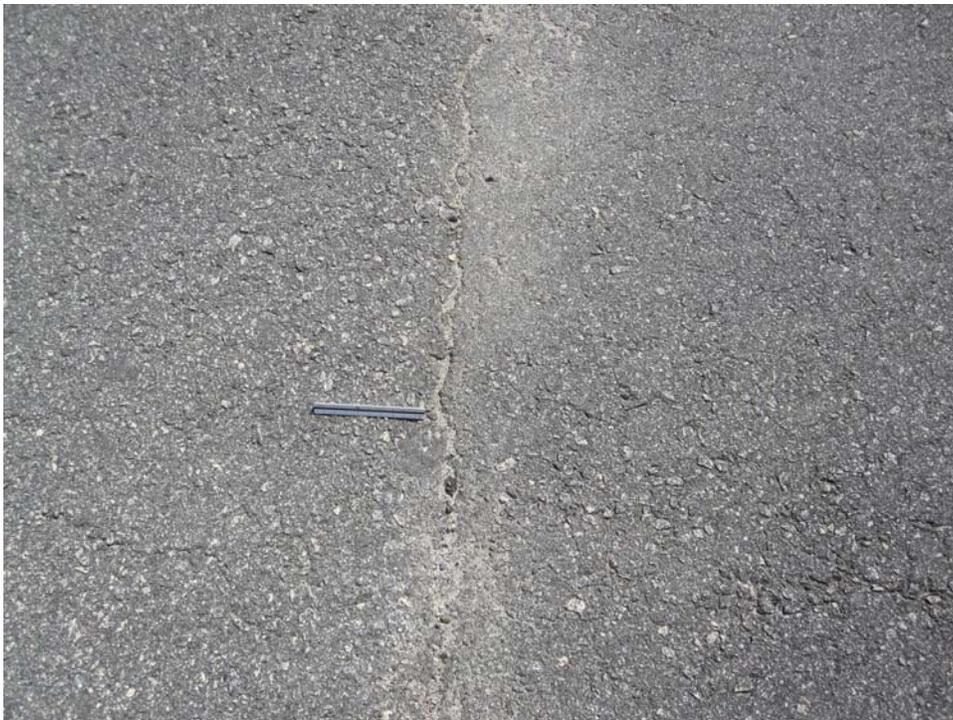
A01MR-70. Longitudinal and Transverse Cracking.

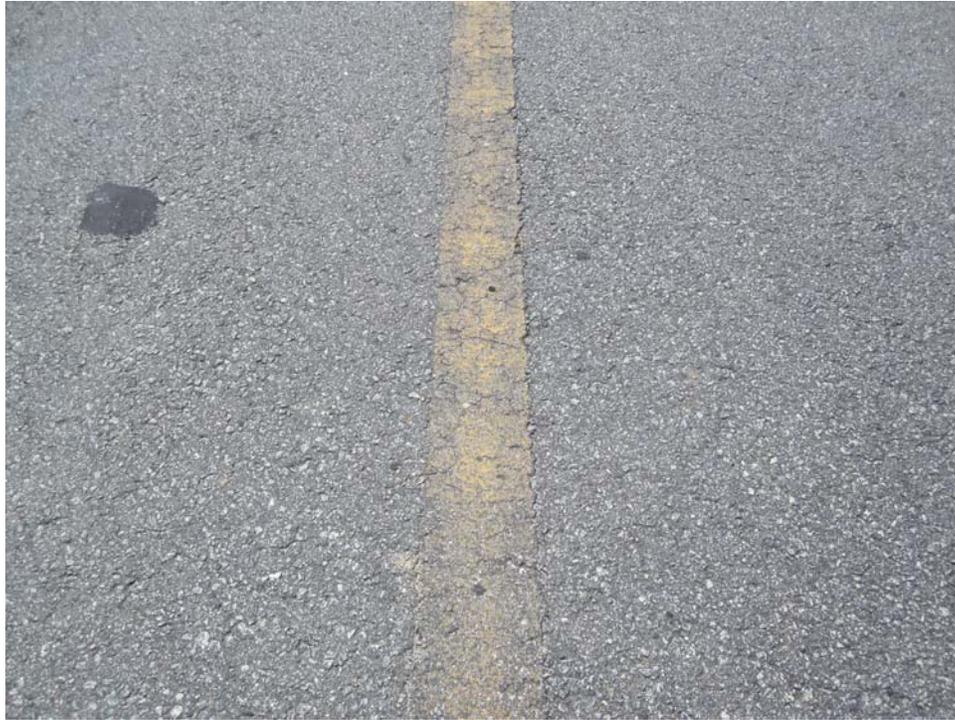
A01MR-70. Unsatisfactory Paint.

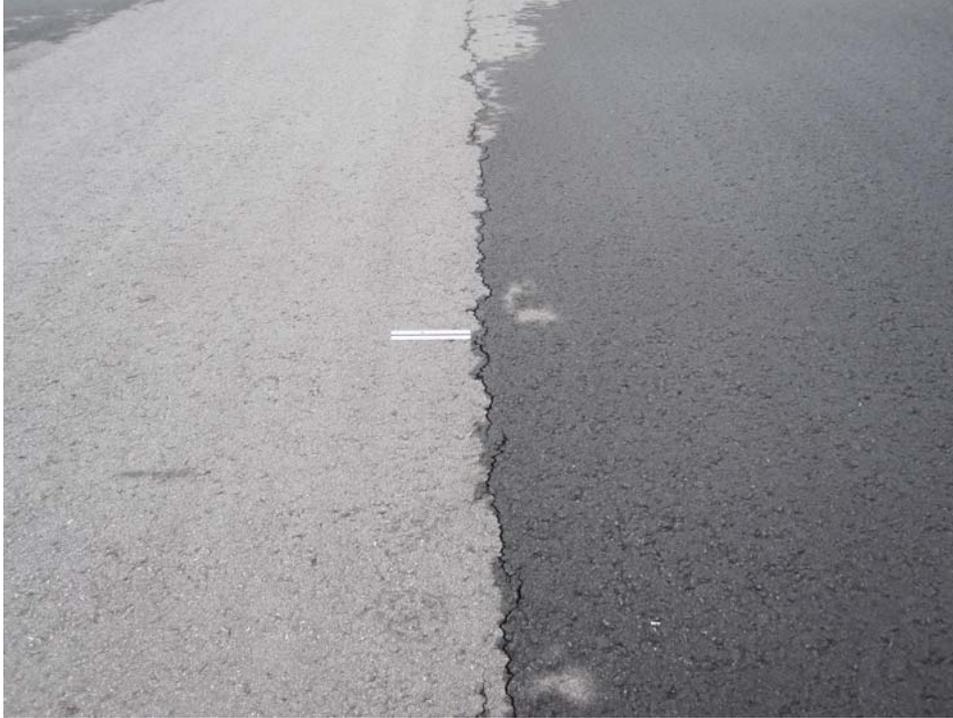
The south apron area (A02MR) was defined by one section. Section 10 was in excellent condition with a PCI value of 99. This section had been recently rehabilitated, and the only distress identified was a small amount of low-severity, unsealed L&T cracking.

A02MR-10. Longitudinal and Transverse Cracking.

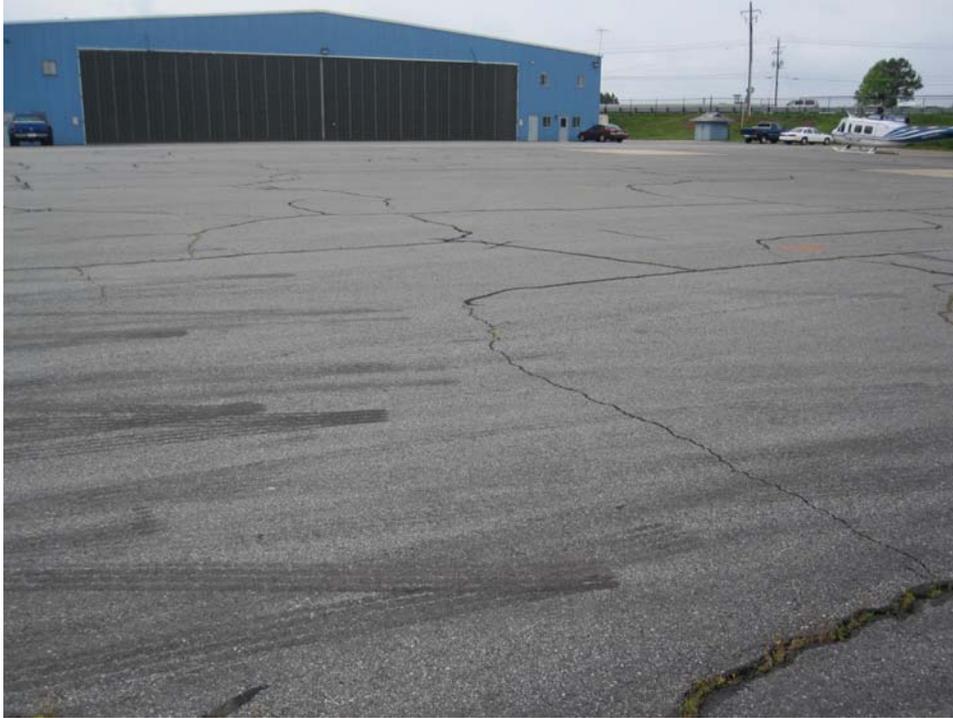
The state police apron area (A03MR) was comprised of one section. Section 10 was in poor condition with a PCI value of 37. Extensive quantities of low- and medium-severity L&T cracking and low-severity weathering along with significant amounts of medium-severity alligator cracking, rutting, and raveling were recorded in this section. Additionally, a large area of low-severity depression was observed. The crack sealant was no longer performing satisfactorily.

A03MR-10. Overview.

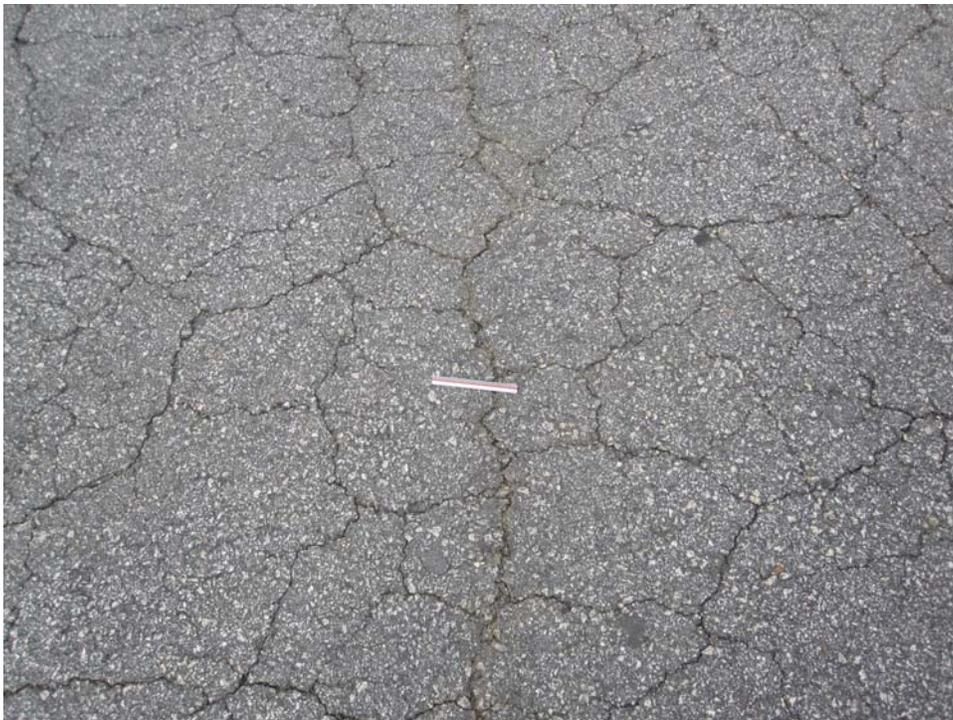
A03MR-10. Alligator Cracking (Sample Unit #14).

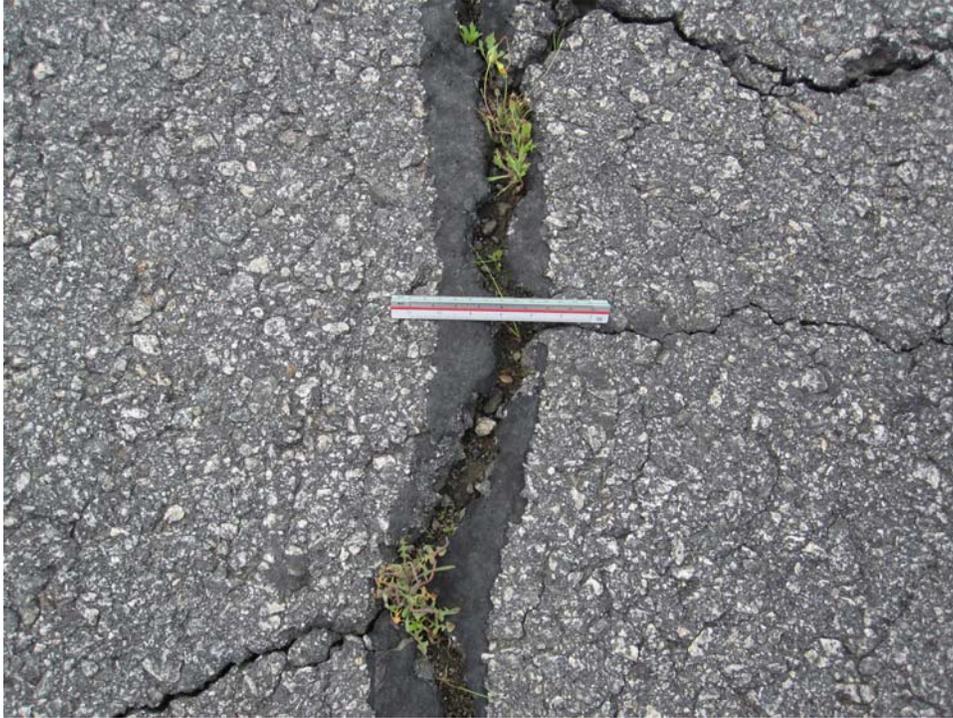
A03MR-10. Longitudinal and Transverse Cracking (Sample Unit #14).

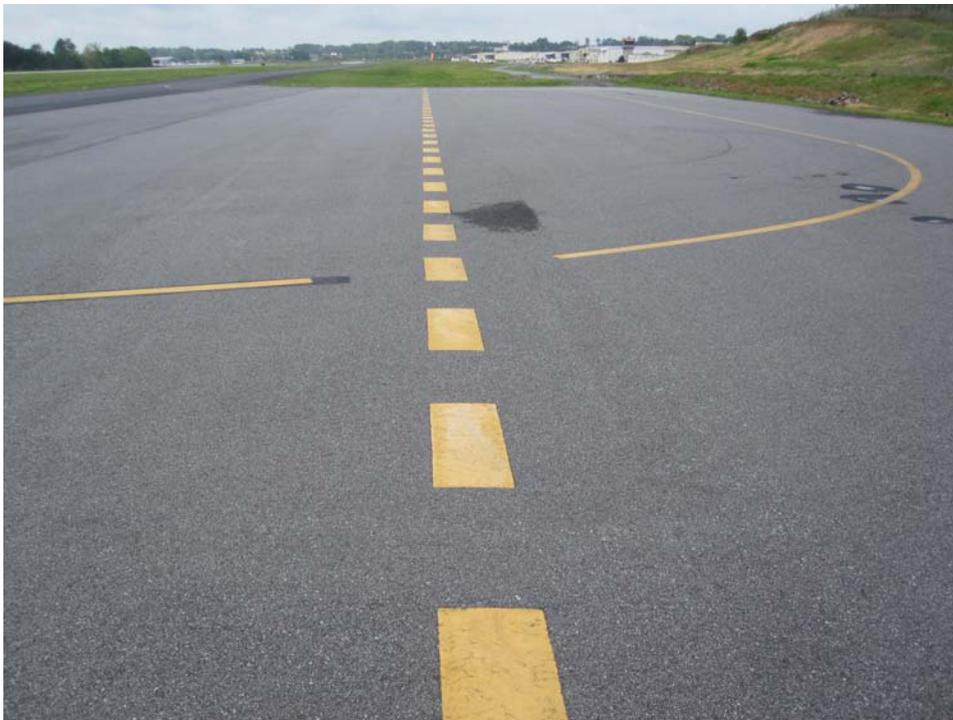
The run-up apron area (ARUNUPMR) contained one section. Section 10 had a PCI value of 93. Small amounts of low-severity, unsealed L&T cracking, along with a small amount of low-severity rutting were identified in this section.

ARUNUPMR-10. Overview.

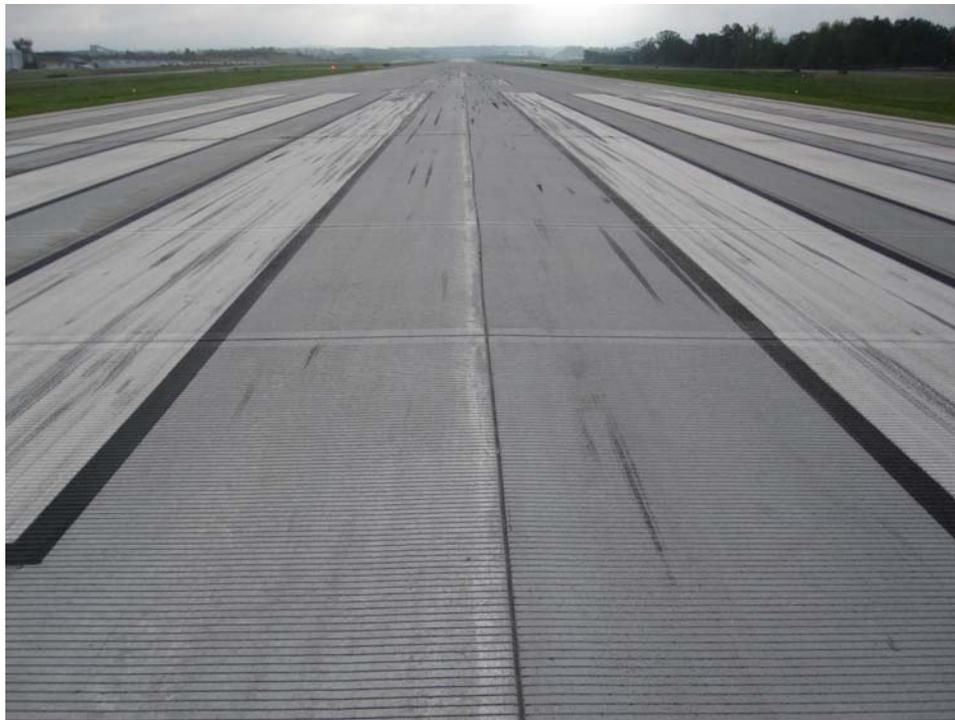
Runway 9-27 was comprised of one section. Section 10 had recently received a PCC overlay and was in excellent condition with a PCI value of 100. No distresses were observed.

R927MR-10. Overview.

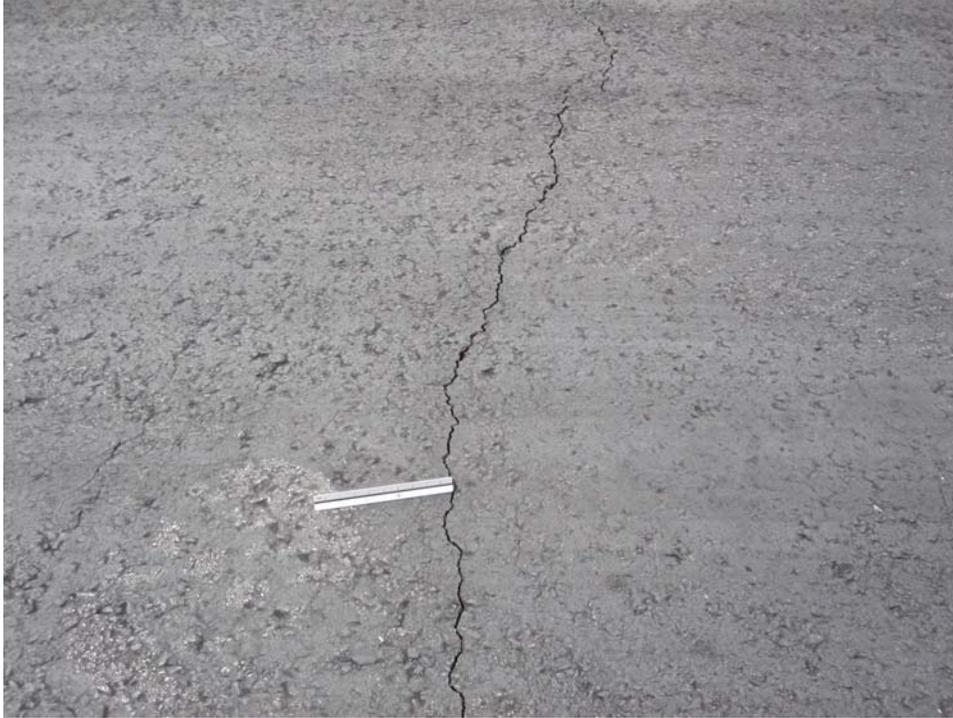
TAMR-20. Longitudinal and Transverse Cracking (Sample Unit #01).

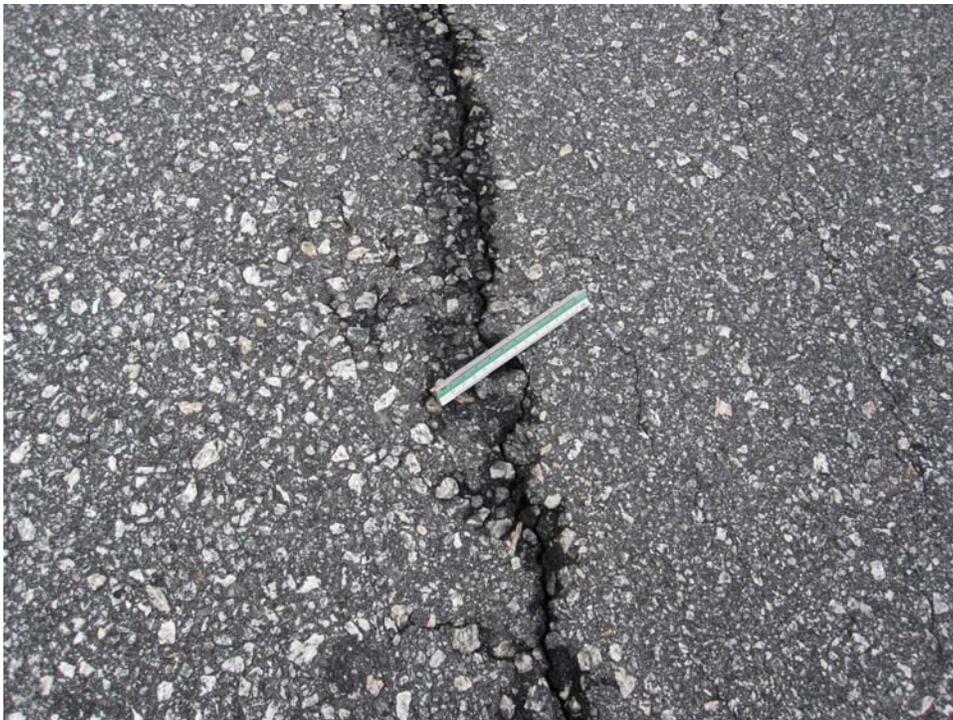
Taxiway B was comprised of two sections. Section 10 had a PCI value of 82. The primary distress type identified in this section was low-severity L&T cracking. Small amounts of medium-severity L&T cracking, bleeding, and low-severity patching were also recorded. Section 20 was recently constructed and had a PCI value of 100. No distresses were observed at the time of inspection.

TBMR-10. Longitudinal and Transverse Cracking (Sample Unit #17).
