2012 Newnan-Coweta County Airport Pavement Management Plan

NEWNAN-COWETA COUNTY AIRPORT

PAVEMENT MANAGEMENT REPORT

DECEMBER 2012

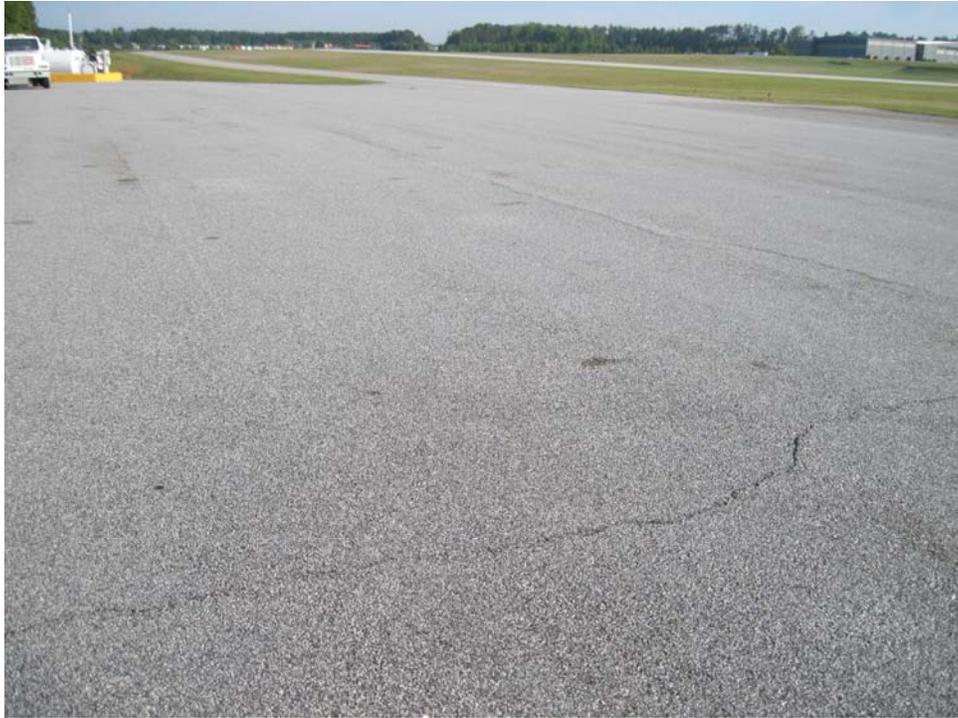
The southwest apron area (A01NW) was comprised of three sections. Section 10, located in front of the FBO, had a PCI value of 69. It contained a moderate amount of low-severity, unsealed L&T cracking, extensive areas of low-severity weathering, and smaller amounts of medium-severity weathering. Also noted was medium-severity swelling, located around a utility manhole. Section 20 had a PCI value of 44 with extensive amounts of low-severity, unsealed and medium-severity block cracking and moderate amounts of medium-severity alligator cracking. Also identified were low-severity, unsealed and medium-severity L&T cracking as well as low- and medium-severity rutting. Section 30 had a PCI value of 61. Low-severity weathering was recorded at varying amounts across the section along with smaller quantities of medium-severity weathering. Block cracking was extensive in about one-third of the section. In the remainder of the section, significant quantities of L&T cracking were recorded. The low-severity block cracking and L&T cracking were both sealed and unsealed, and medium-severity cracking was due to crack sealant that was no longer performing satisfactorily.

A01NW-10. Overview.

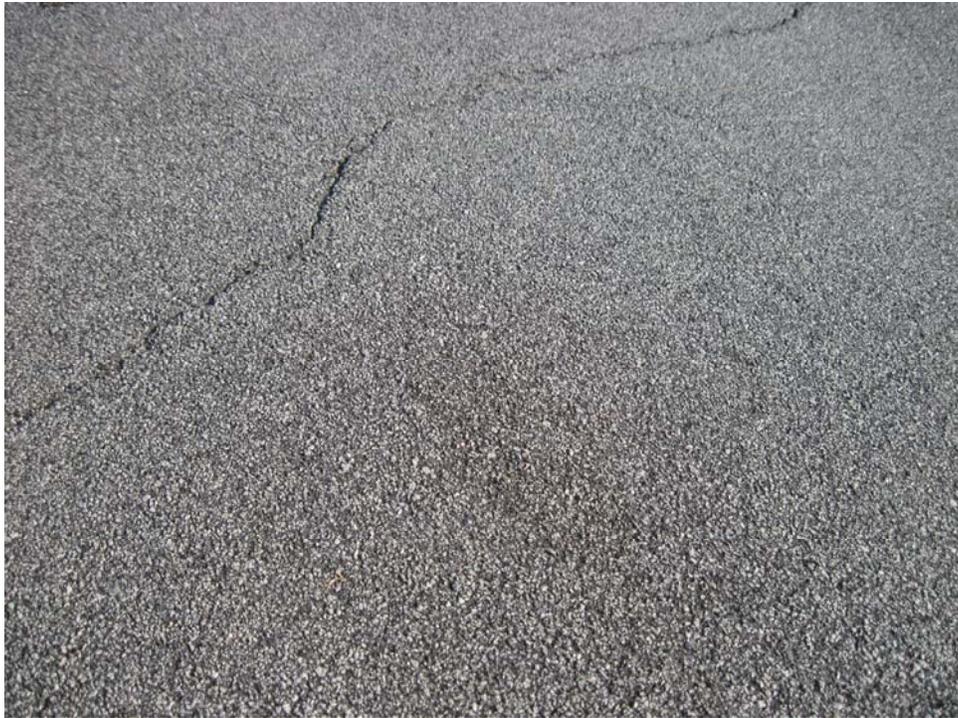
A01NW-10. Weathering (Sample Unit #06).

| Distress Type | Probable Cause of Distress | Feasible Maintenance Strategies |
|---|---|--|
| Weathering | Asphalt binder and/or fine aggregate may wear away as the pavement ages and hardens. | Patch if isolated. Consider a surface treatment if extensive. |

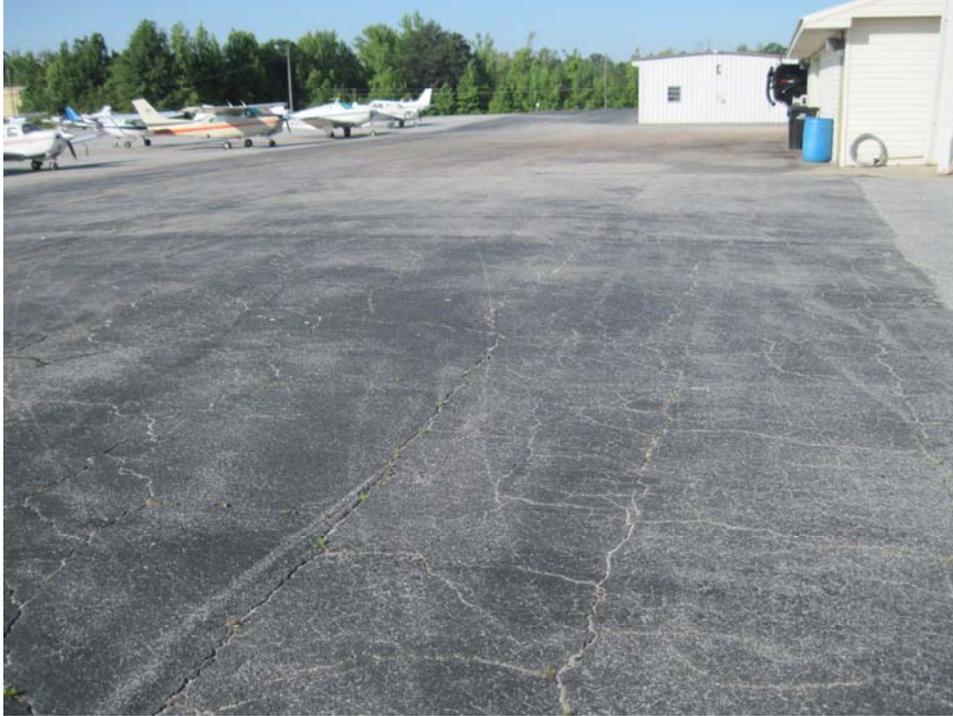
| Branch ¹ | Section ¹ | Surface Type ² | Section Area (sf) | LCD ³ | Paint Markings ⁴ | 2007 PCI | 2012 PCI | % Distress due to: | | Distress Types ⁷ |
|---|---|---|---|---|---|---|---|---|---|--|
| A01NW | 20 | AAC | 103,172 | 6/1/1990 | SAT | 48 | 44 | 54 | 46 | Alligator Cracking, Block Cracking, L&T Cracking, Rutting |

A01NW-20. Overview.

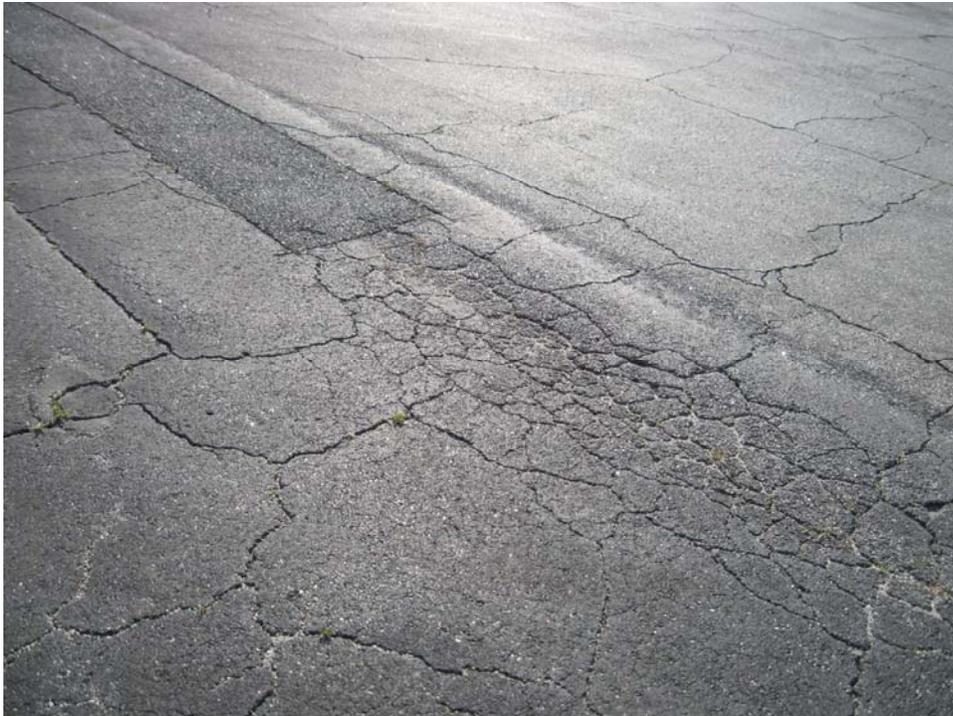
| Distress Type | Probable Cause of Distress | Feasible Maintenance Strategies |
|---|---|--|
| Alligator Cracking | Fatigue failure of the asphalt concrete surface under repeated traffic loading. | If localized, partial- or full-depth asphalt patch. If extensive, major rehabilitation needed. |

A01NW-20. Alligator Cracking (Sample Unit #17).

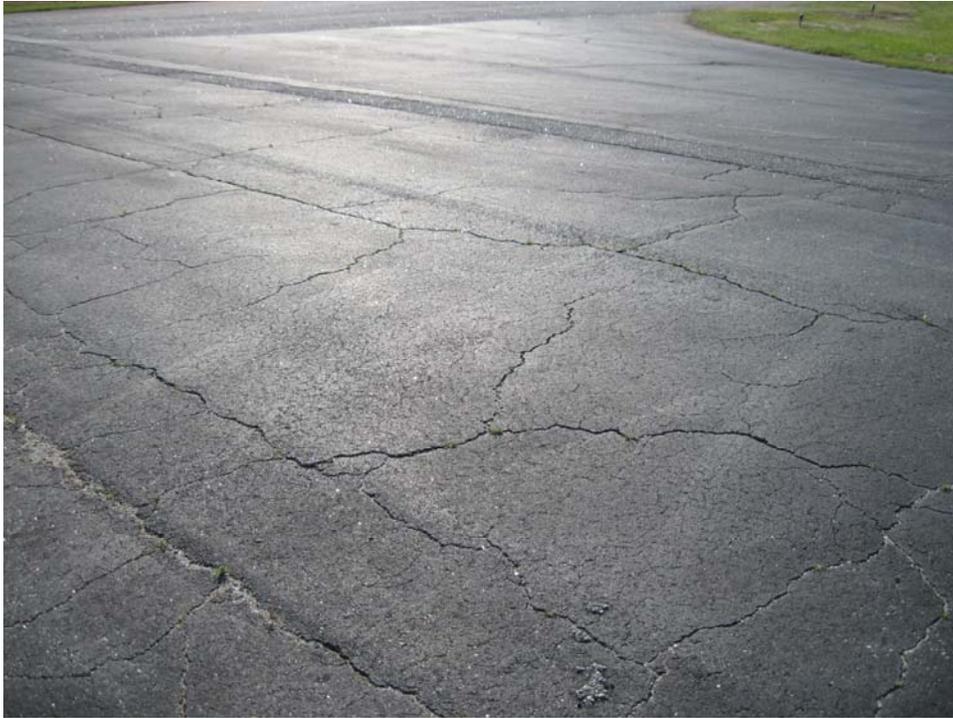
| Distress Type | Probable Cause of Distress | Feasible Maintenance Strategies |
|---|---|--|
| Block Cracking | Shrinkage of the asphalt concrete and daily temperature cycling; it is not load associated. | At low severity levels, crack seal and/or surface treatment. At higher severities, consider overlay. |

A01NW-20. Block Cracking (Sample Unit #17).

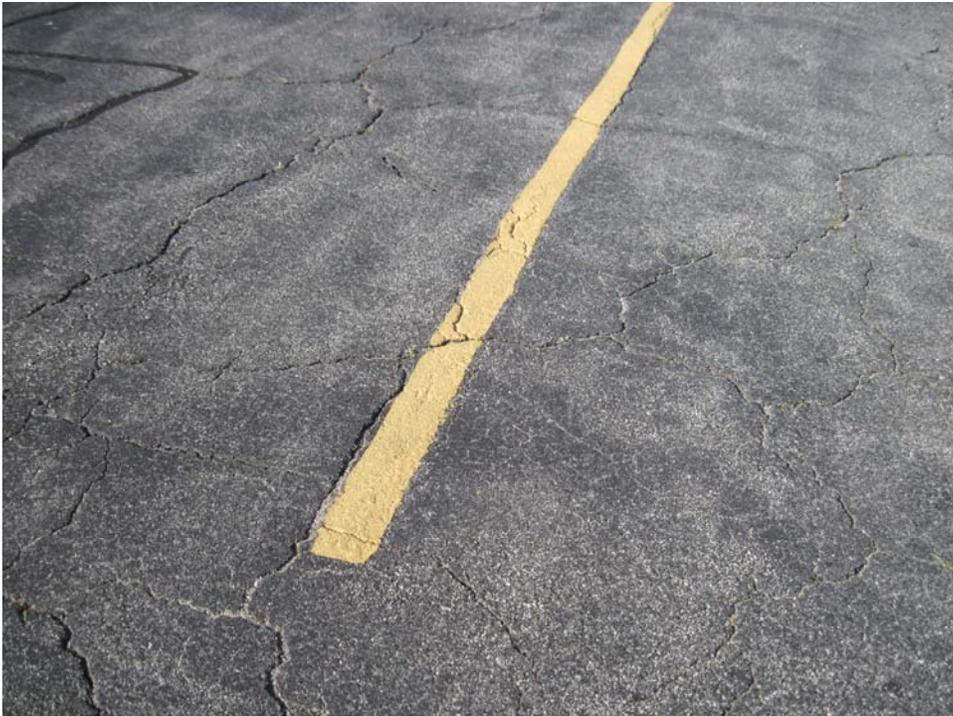
A01NW-20. Satisfactory Paint.

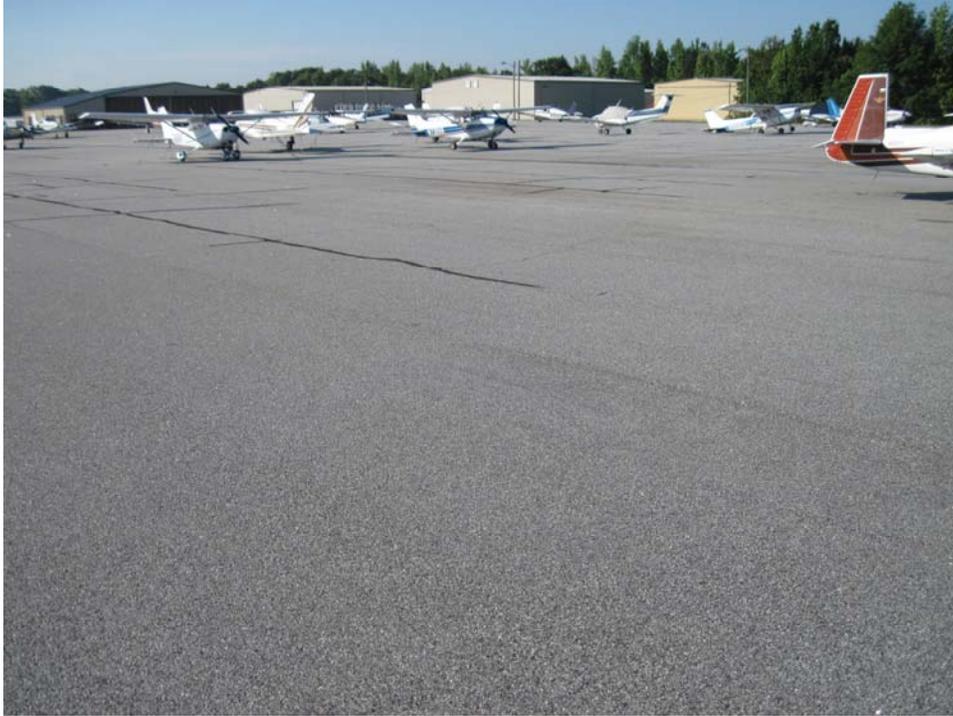
A01NW-30. Overview.

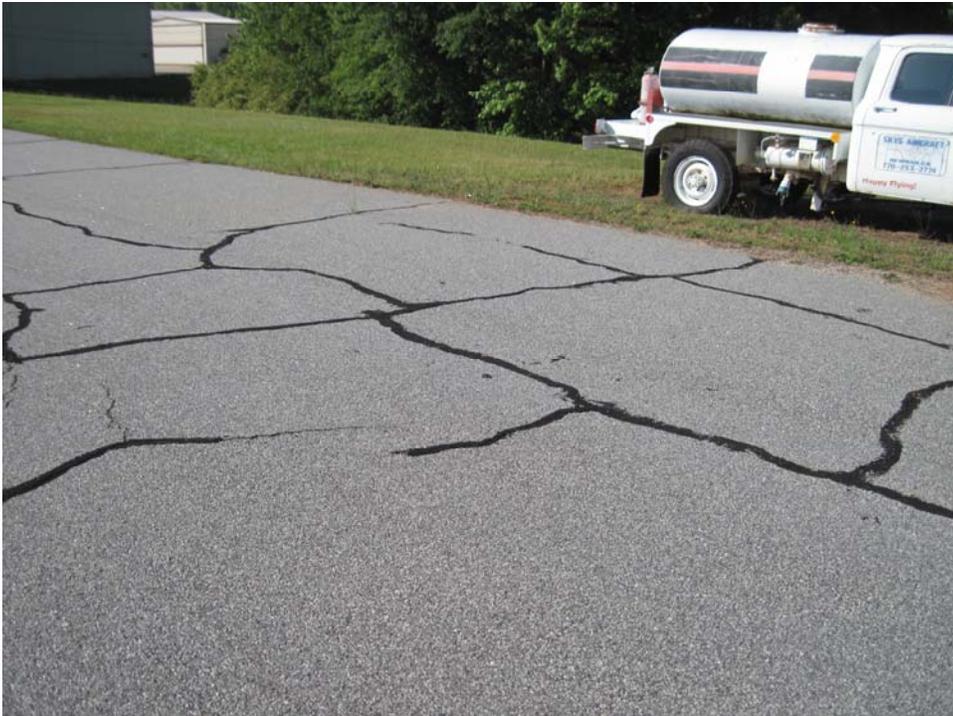
A01NW-30. Block Cracking (Sample Unit #19).

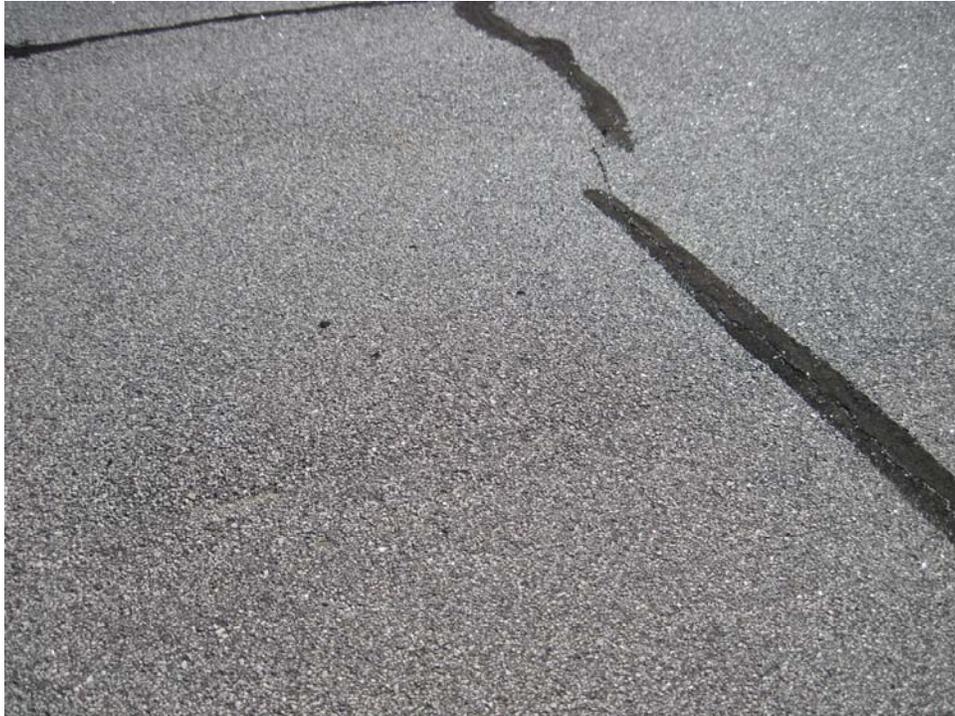
A01NW-30. Weathering (Sample Unit #23).

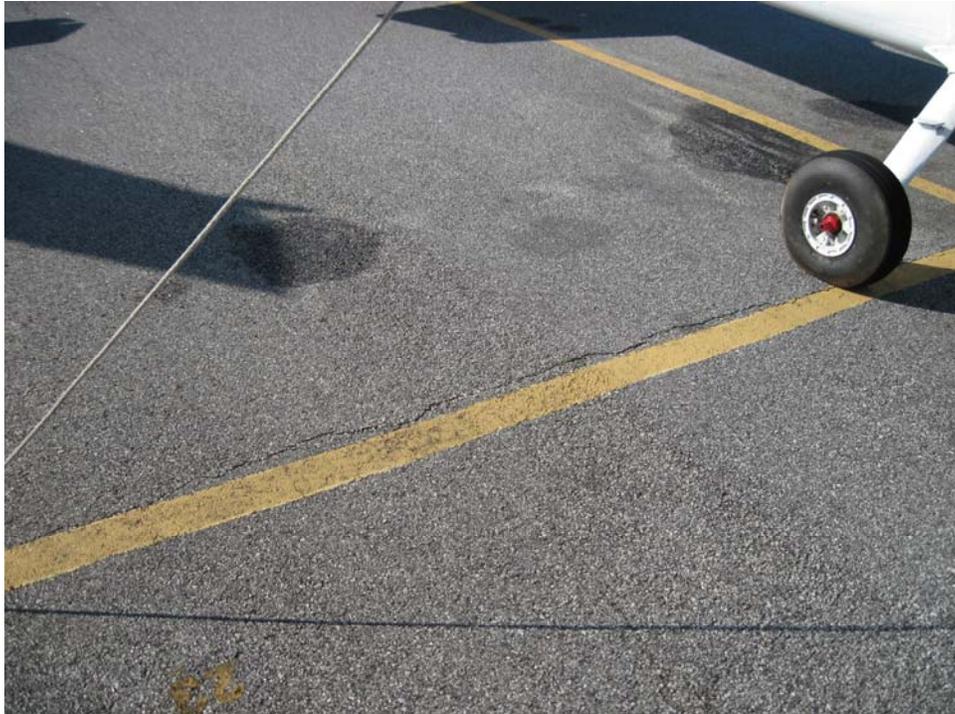
A01NW-30. Satisfactory Paint.

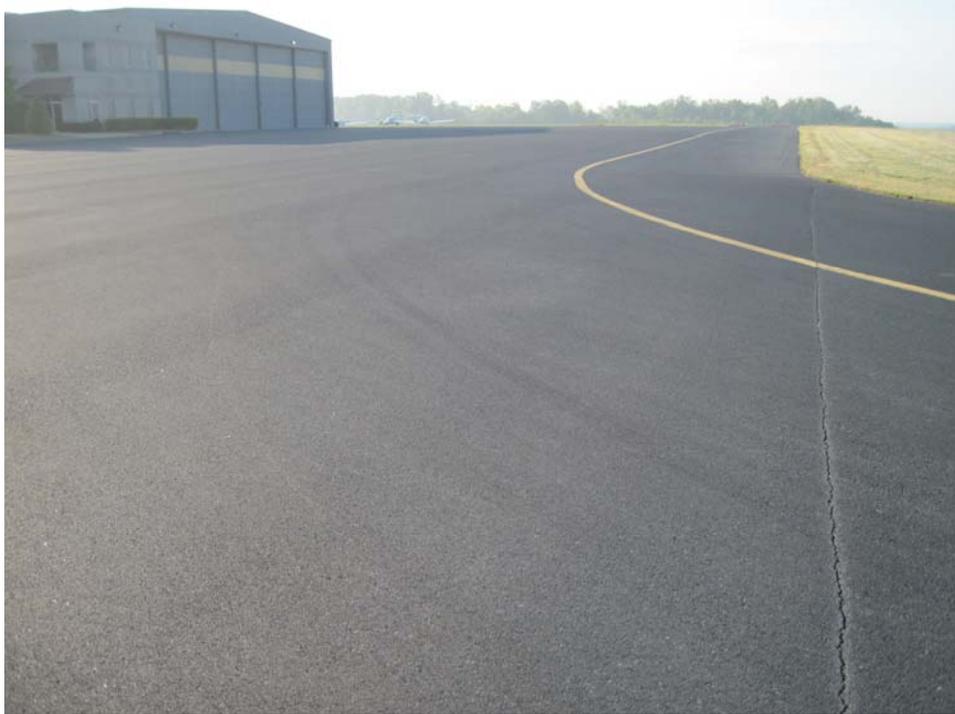
The northeast apron section (A02NW) contained two sections. Section 10 had a PCI value of 88, with relatively small amounts of low-severity, unsealed L&T cracking. However, several additional sample units were recorded due to localized areas of medium-severity alligator cracking and significant oil/fuel damage. An additional sample unit was identified near the runway where part of the section was not treated with a fog seal and was exhibiting low-severity

A02NW-10. Overview.

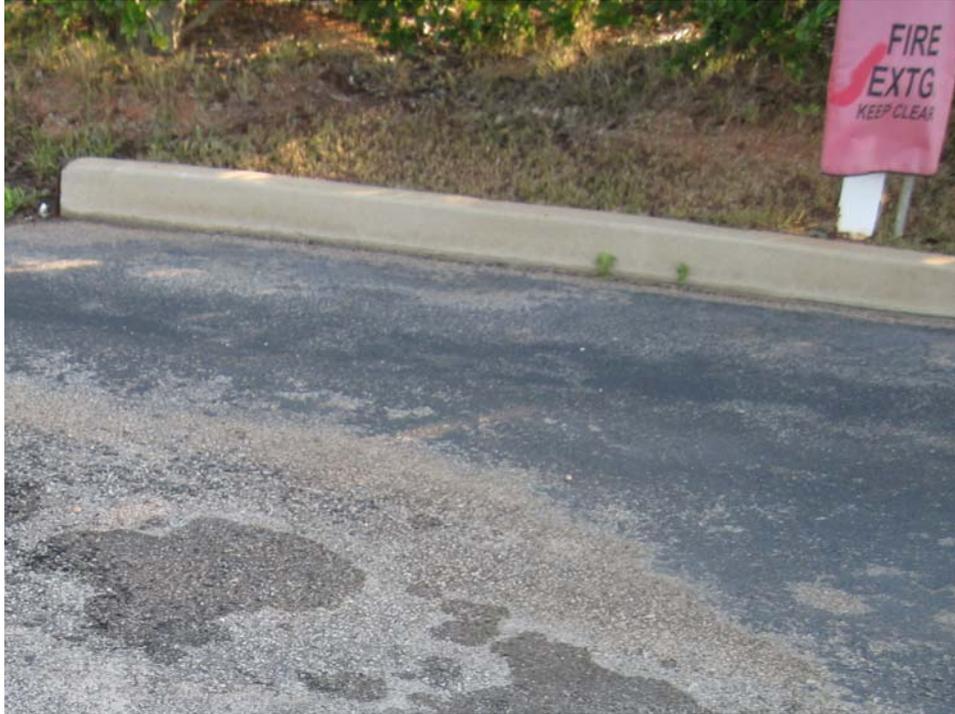
| Distress Type | Probable Cause of Distress | Feasible Maintenance Strategies |
|---|---|--|
| Oil Spillage | Deterioration or softening of the pavement surface caused by the spilling of oil, fuel, or other solvents. | Patch. |

A02NW-10. Oil/Fuel Damage (Additional Sample Unit #12).

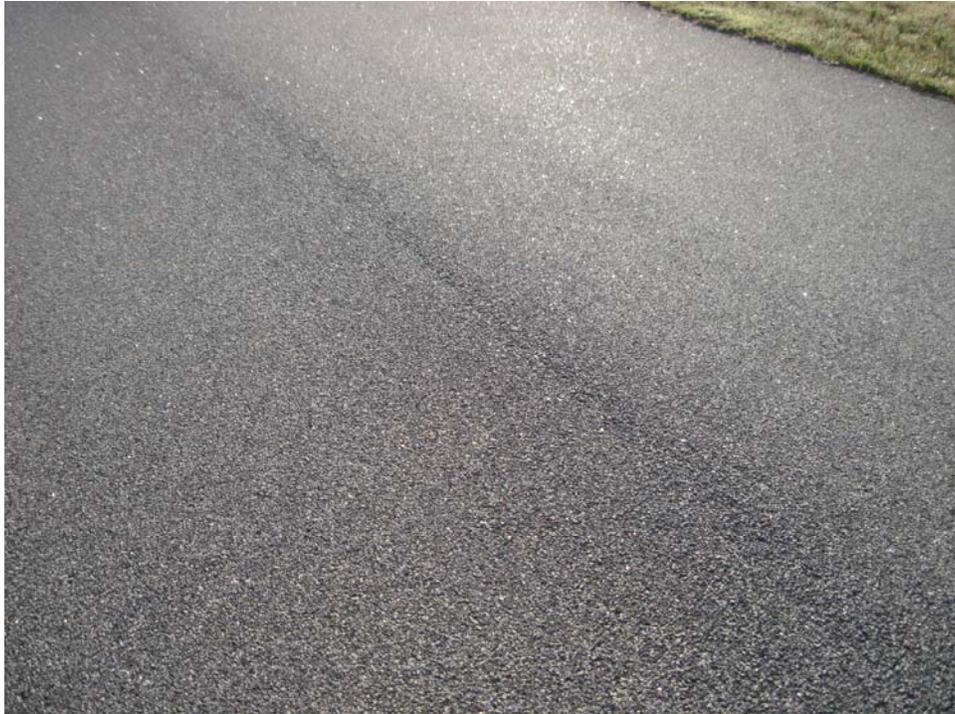
A02NW-10. Weathering (Additional Sample Unit #03).

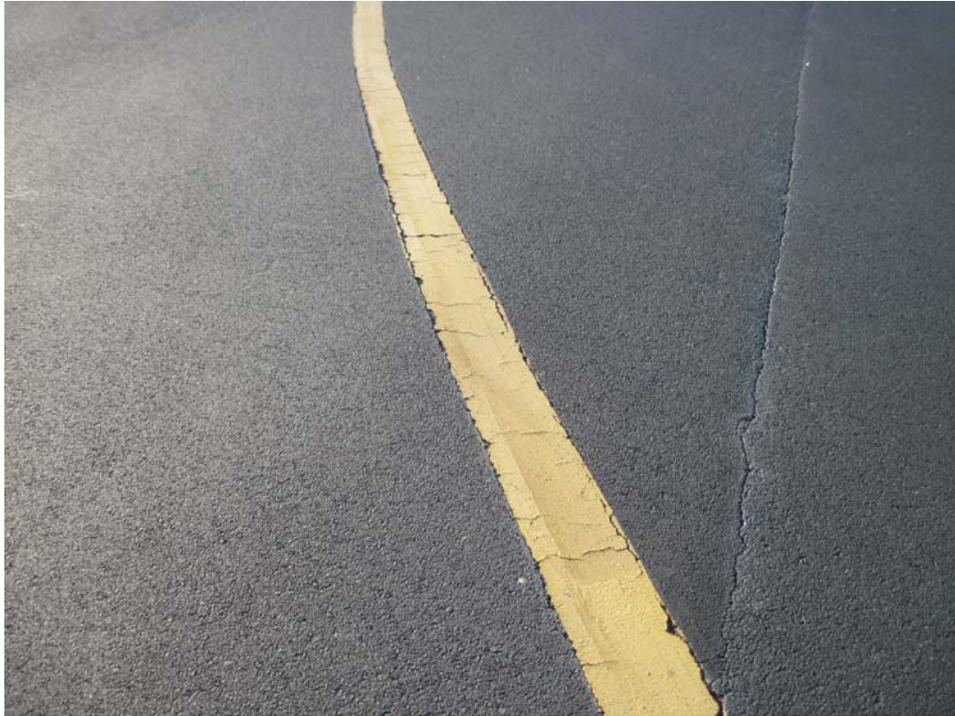
A02NW-10. Satisfactory Paint.

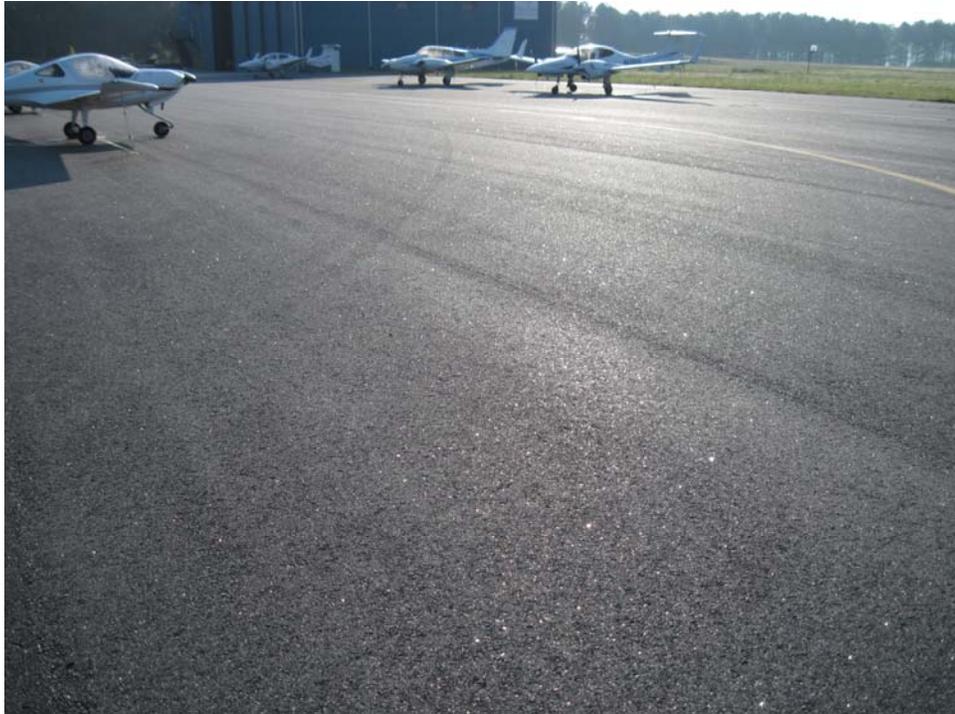
weathering. Section 20 was in excellent condition with a PCI of 98. Only very small amounts of oil/fuel damage and low-severity, unsealed L&T cracking were observed.

A02NW-20. Overview.

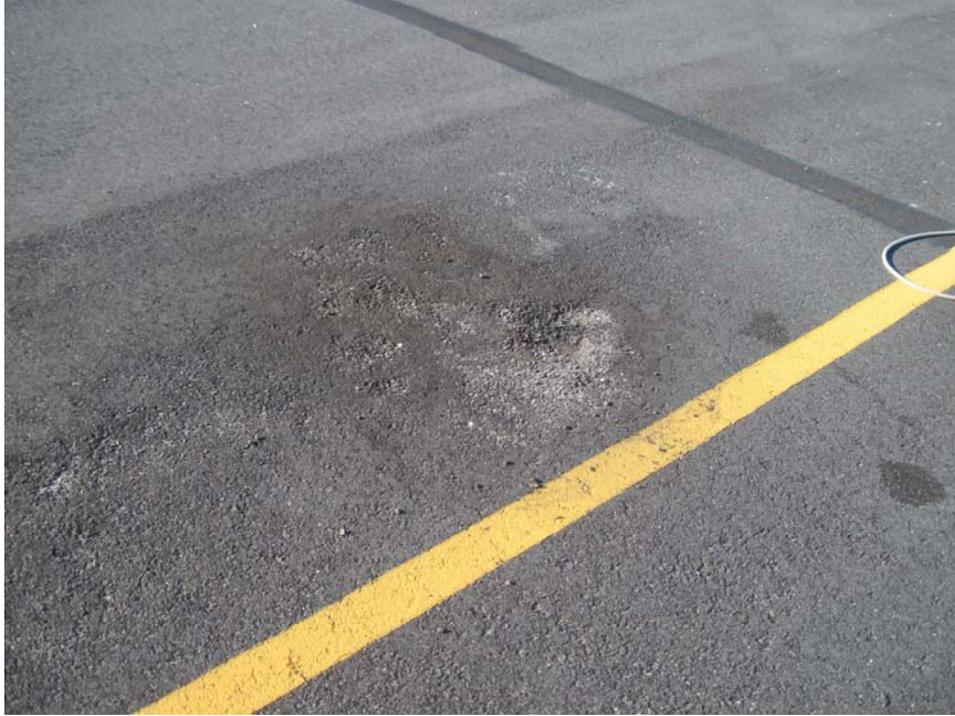
A02NW-20. Oil/Fuel Damage (Sample Unit #12).

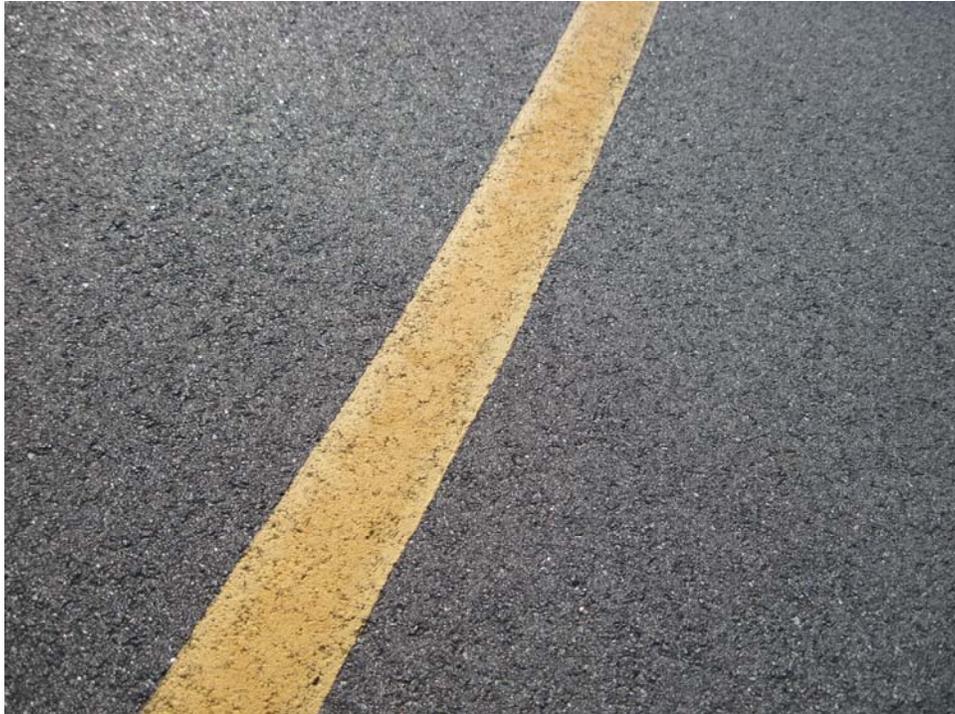
A02NW-20. Satisfactory Paint.

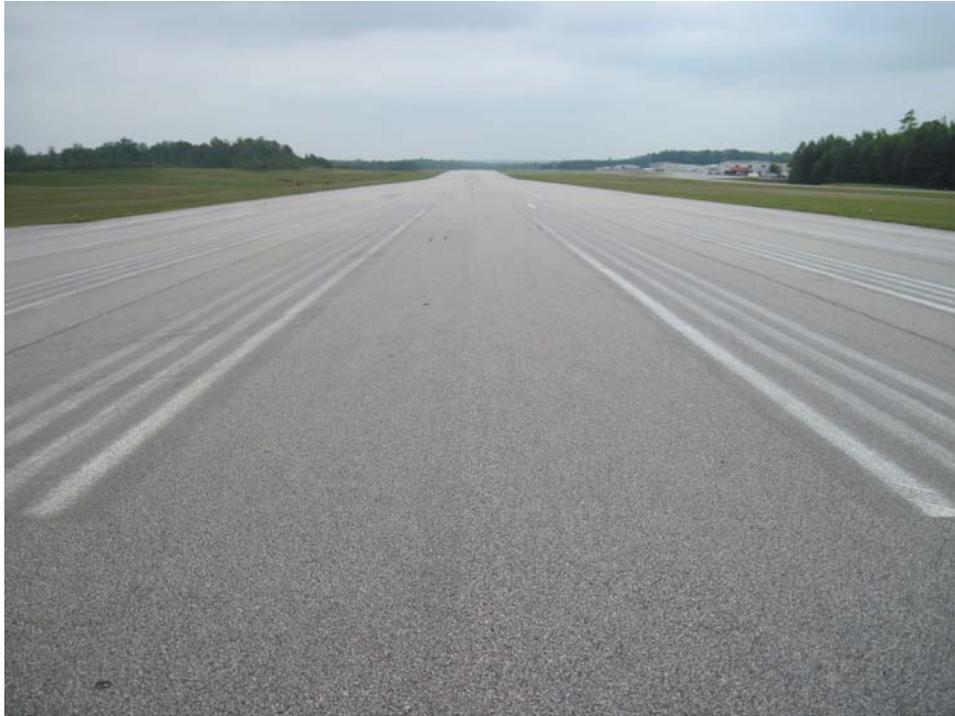
Runway 14-32 was defined by one section with a PCI value of 74. Moderate to extensive amounts of low- and medium-severity longitudinal and transverse (L&T) cracking were identified. All cracking was unsealed, with the medium-severity cracking having widths greater than ¼ in. Also observed was a small amount of low-severity swelling, most of which was located at the cracks. Low-severity weathering was recorded over about half of the area, and a small amount of medium-severity weathering was noted.

R1432NW-10. Overview.

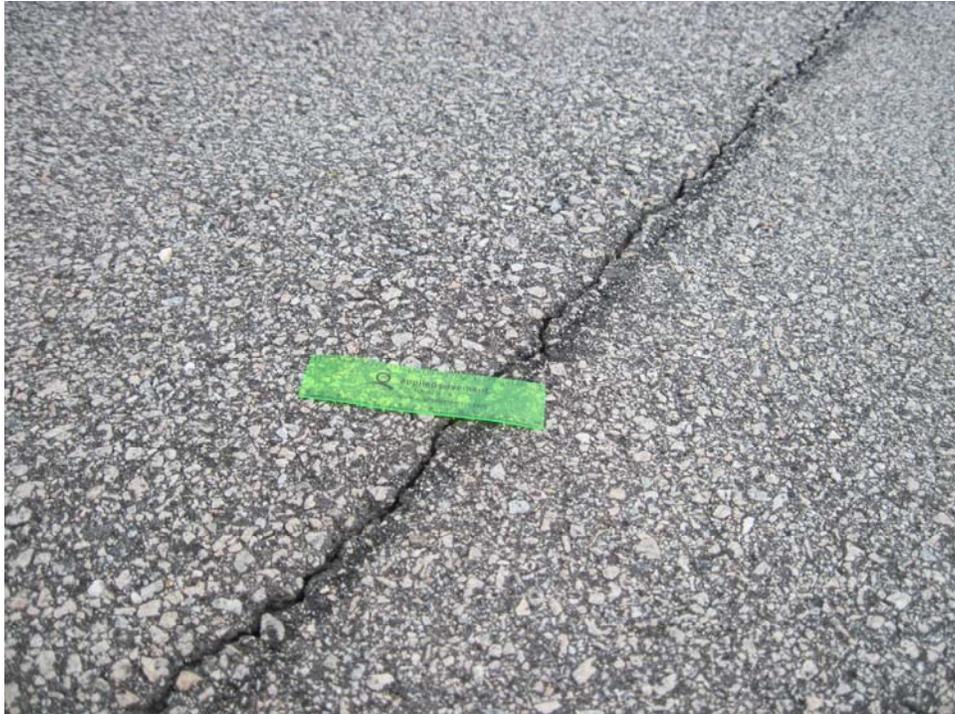
R1432NW-10. Longitudinal and Transverse Cracking and Weathering.

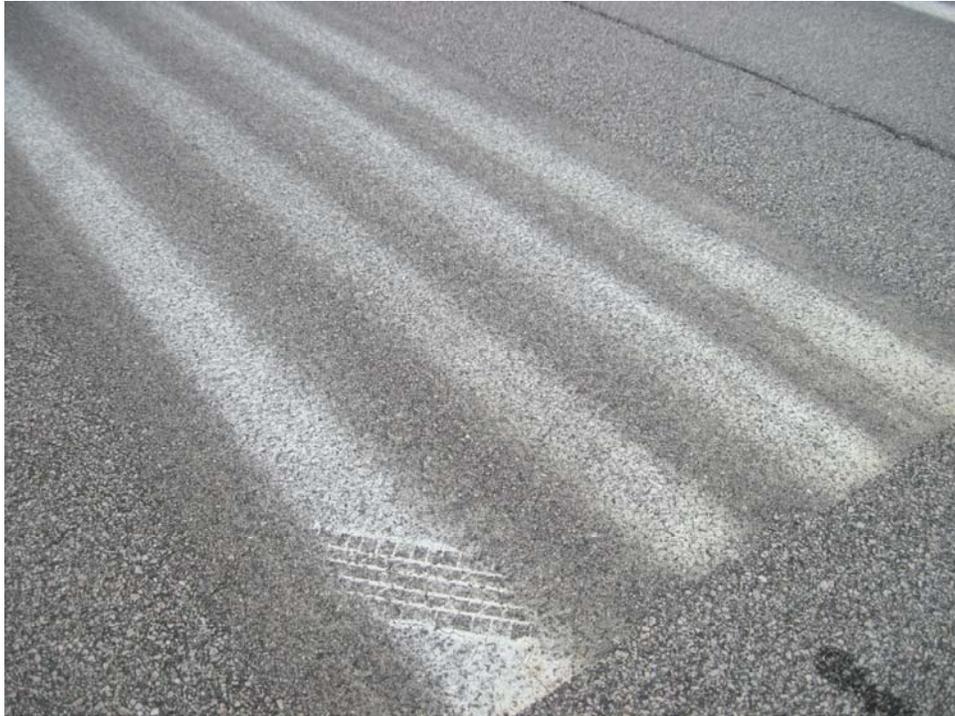
R1432NW-10. Unsatisfactory Paint (1).

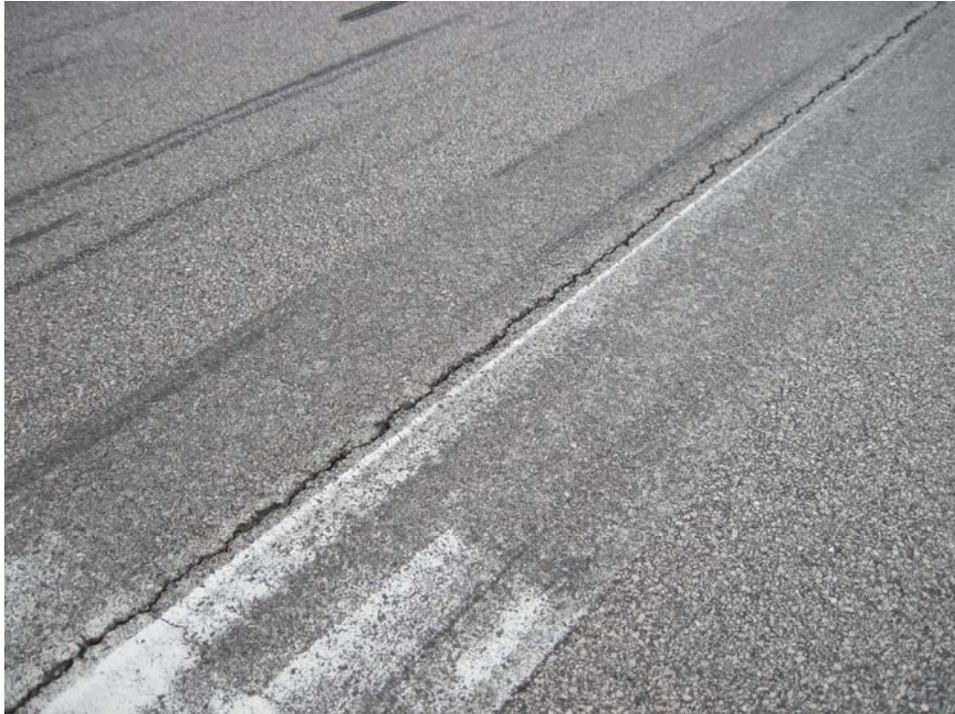
R1432NW-10. Unsatisfactory Paint (2).

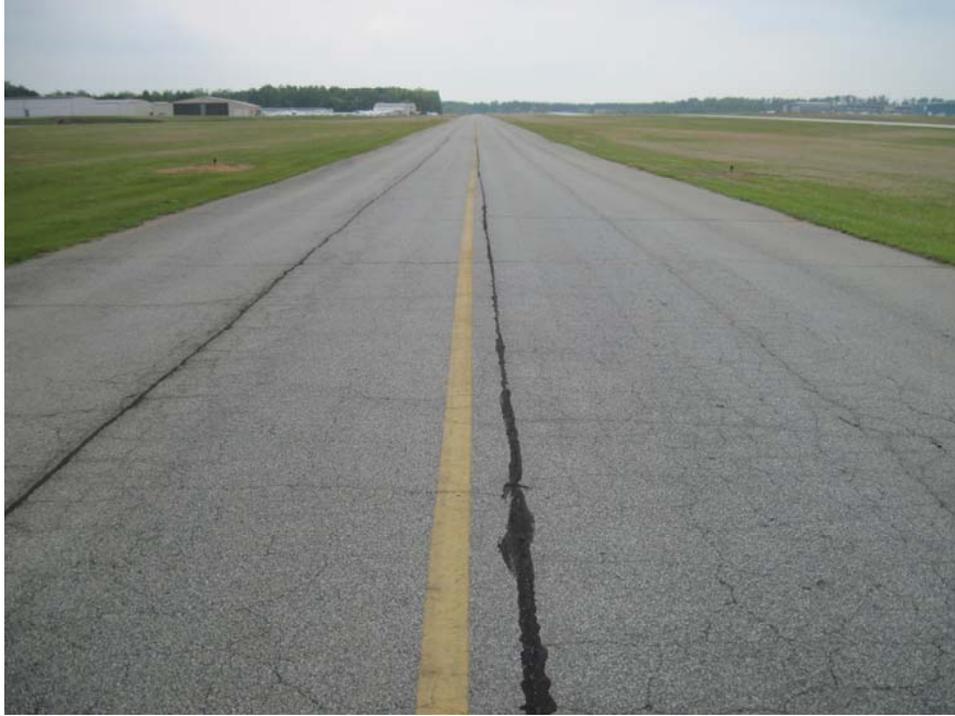
Taxiway A consisted of two sections. Section 10 comprised most of the taxiway and was scheduled to be rehabilitated shortly after the 2012 inspection. It was assumed that it will have a PCI value of 100 after rehabilitation. Section 20 was an extension near the 32 end of the runway and had a PCI value of 76 due to low- and medium-severity depressions. Moderate quantities of low-severity, unsealed L&T cracking and low-severity weathering were also observed, as well as a smaller amount of medium-severity weathering.

TANW-10. Overview.

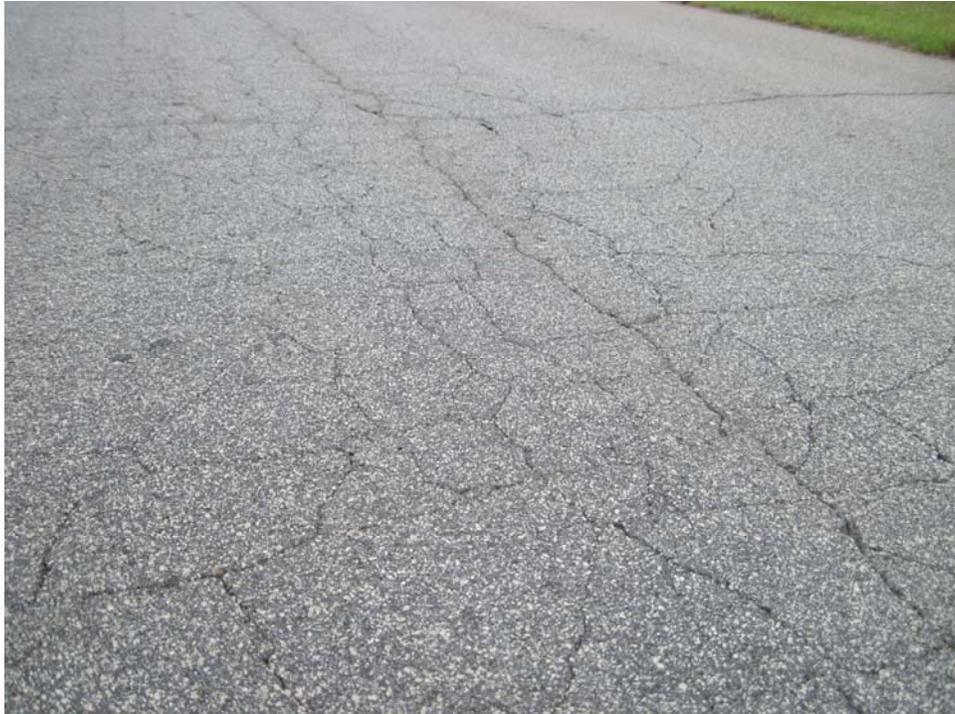
TANW-10. Alligator Cracking.

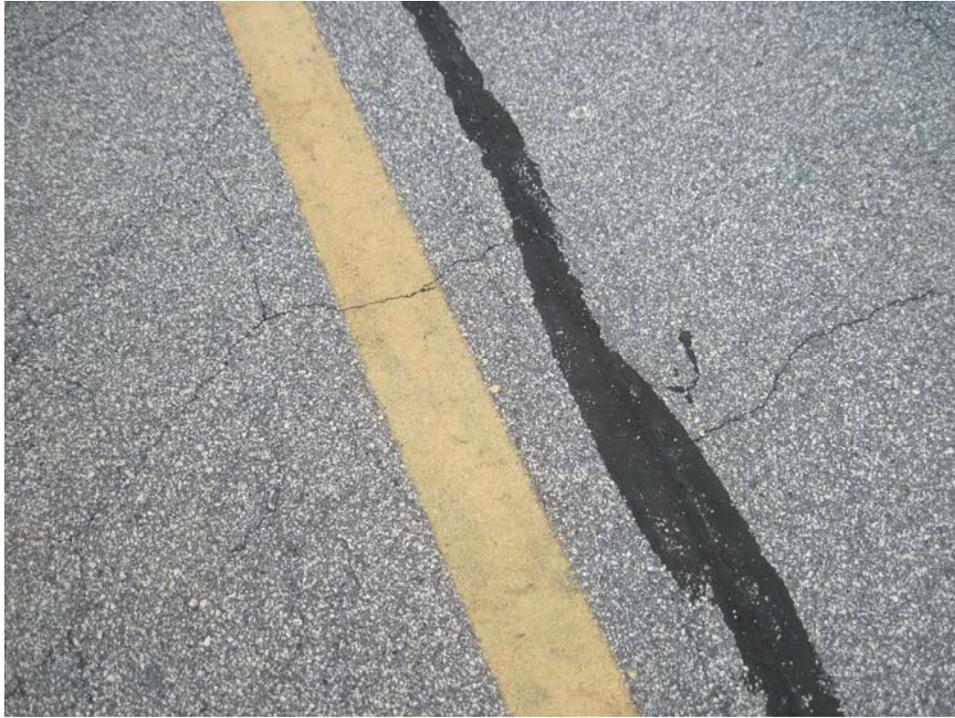
TANW-10. Satisfactory Paint.

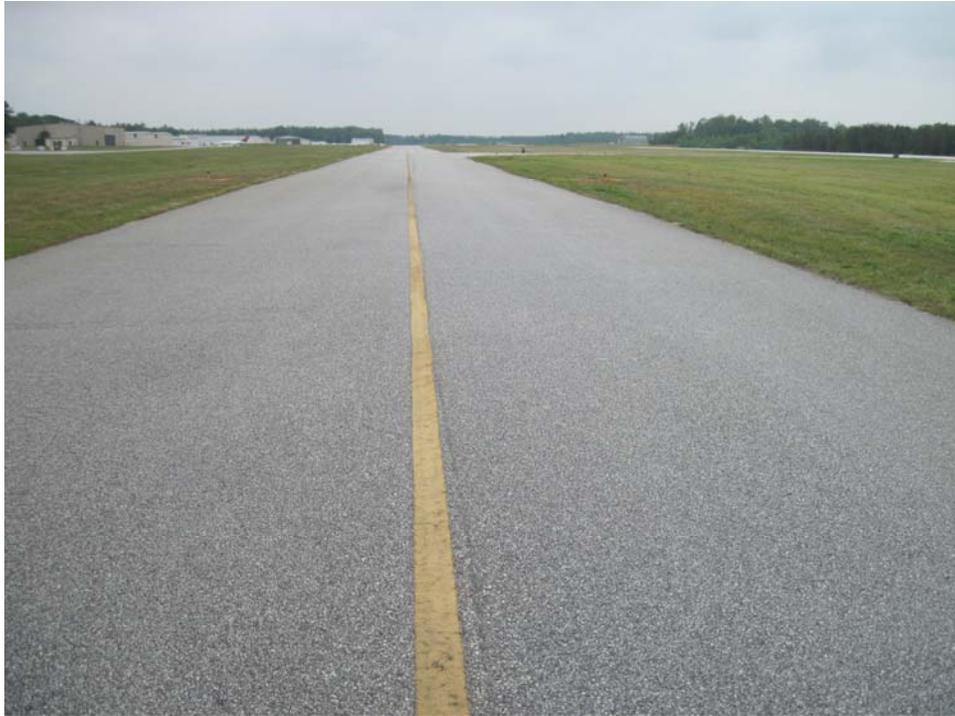
TANW-20. Overview.

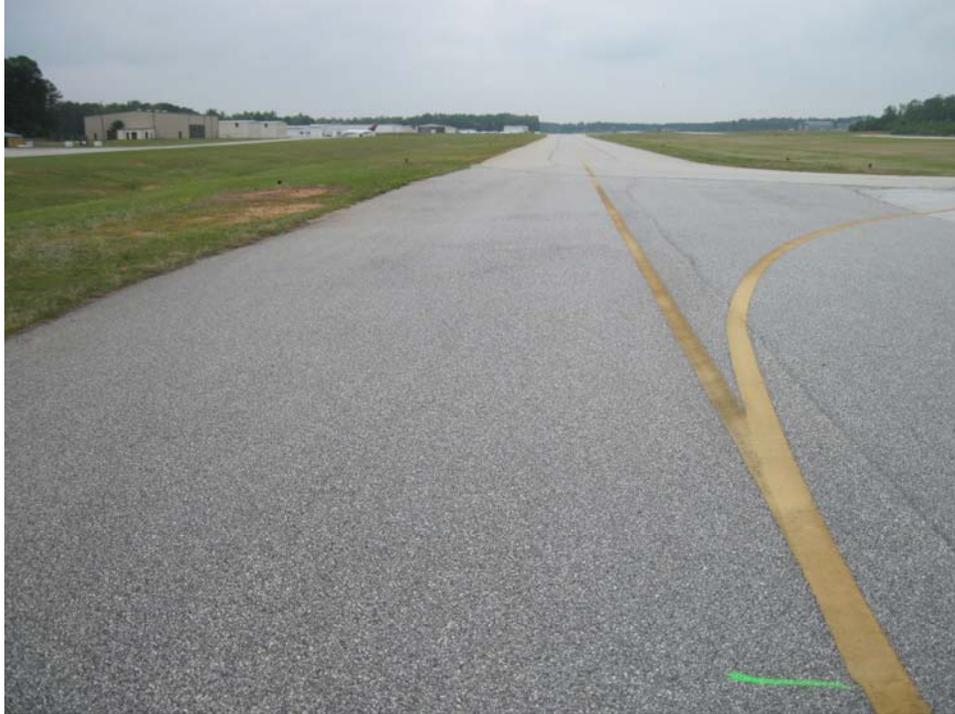
| Distress Type | Probable Cause of Distress | Feasible Maintenance Strategies |
|---|---|--|
| Depression | Settlement of the foundation soil or can be “built up” during construction. | Patch. |

TANW-20. Depression (Sample Unit #01).

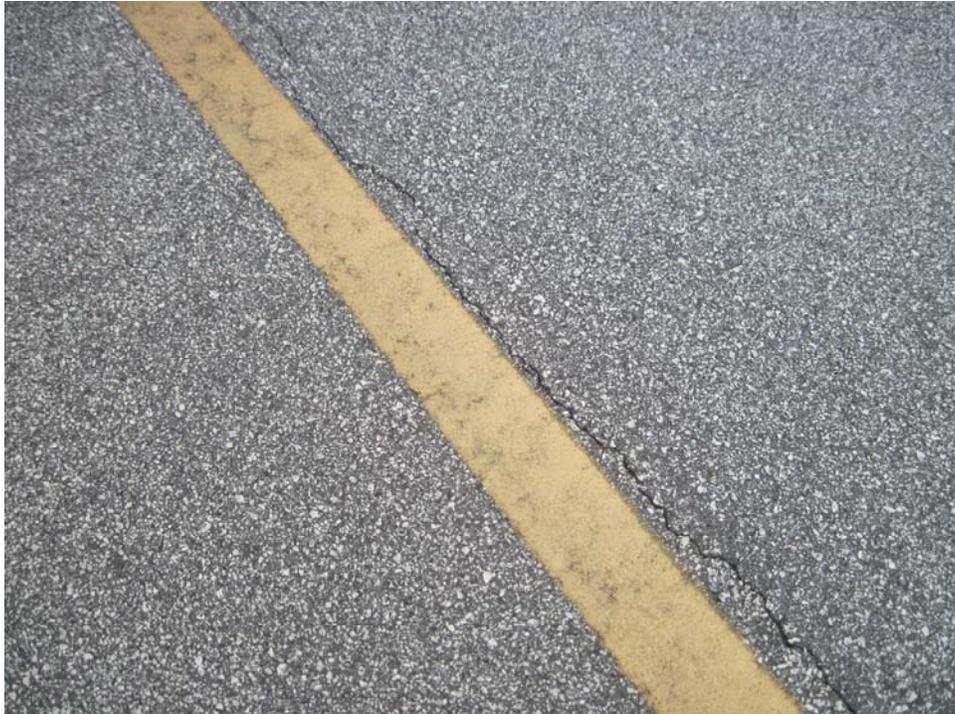
TANW-20. Satisfactory Paint.

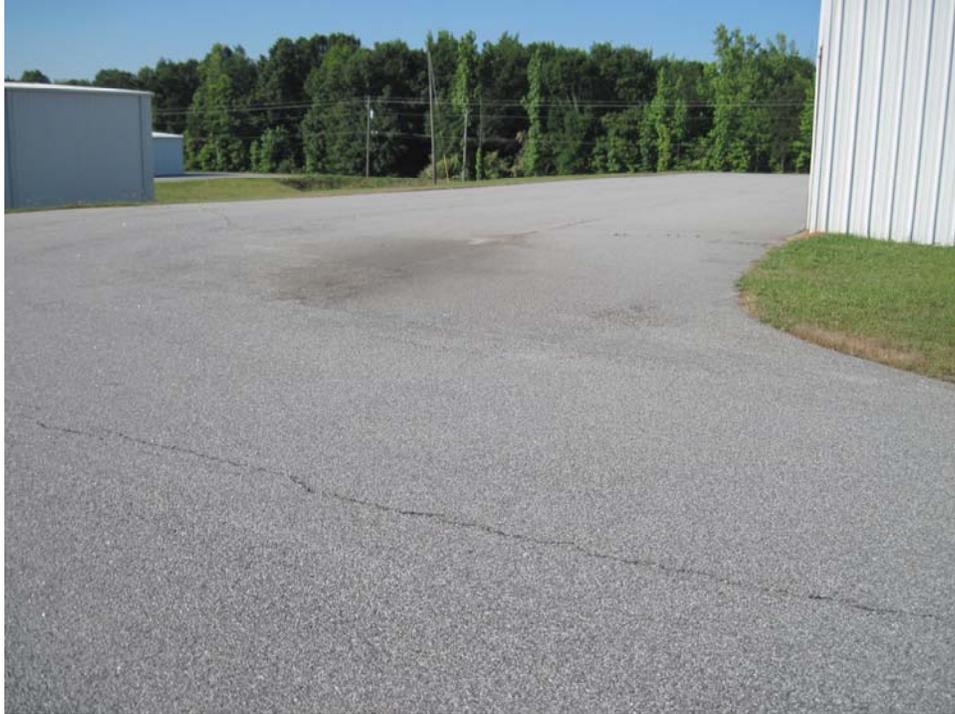
The T-Hangar pavement area consisted of three sections. Section 10 had a PCI value of 72, with extensive amounts of low-severity, unsealed L&T cracking and low-severity weathering. Areas of medium-severity weathering, medium-severity block cracking, and low-severity swelling were also recorded, as well as medium-severity L&T cracking. An additional sample unit was also identified, which contained small amounts of bleeding throughout and medium-severity alligator cracking. Section 20 had a PCI value of 70, with low-severity, unsealed L&T cracking, extensive amounts of low- and medium-severity weathering, and areas of medium- and high-severity raveling. One additional sample unit was recorded, which had medium-severity alligator cracking, low-severity depression, and high-severity weathering. Section 30 was in excellent condition with a PCI value of 100 and no distresses recorded.

THANGNW-10. Overview.

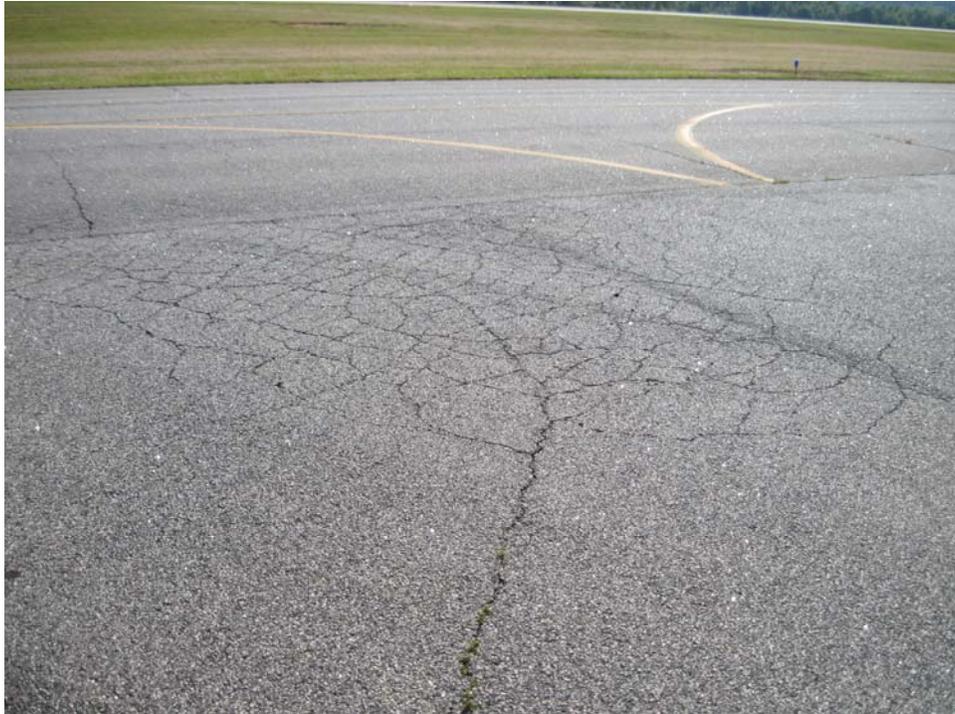
THANGNW-10. Alligator Cracking (Additional Sample Unit #01).

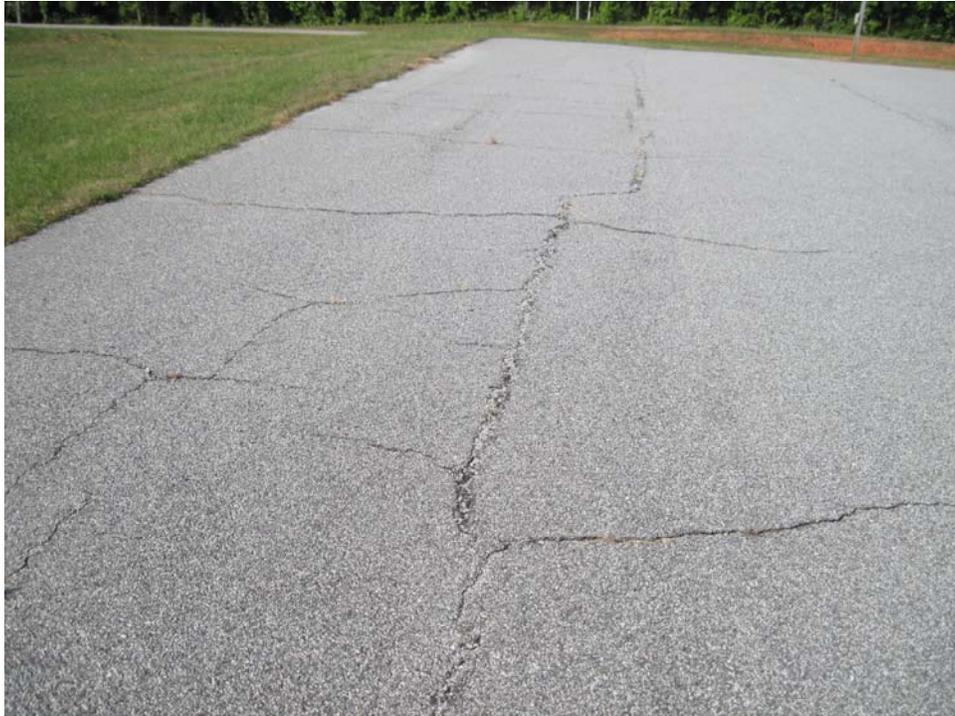
THANGNW-10. Block Cracking (Sample Unit #08).

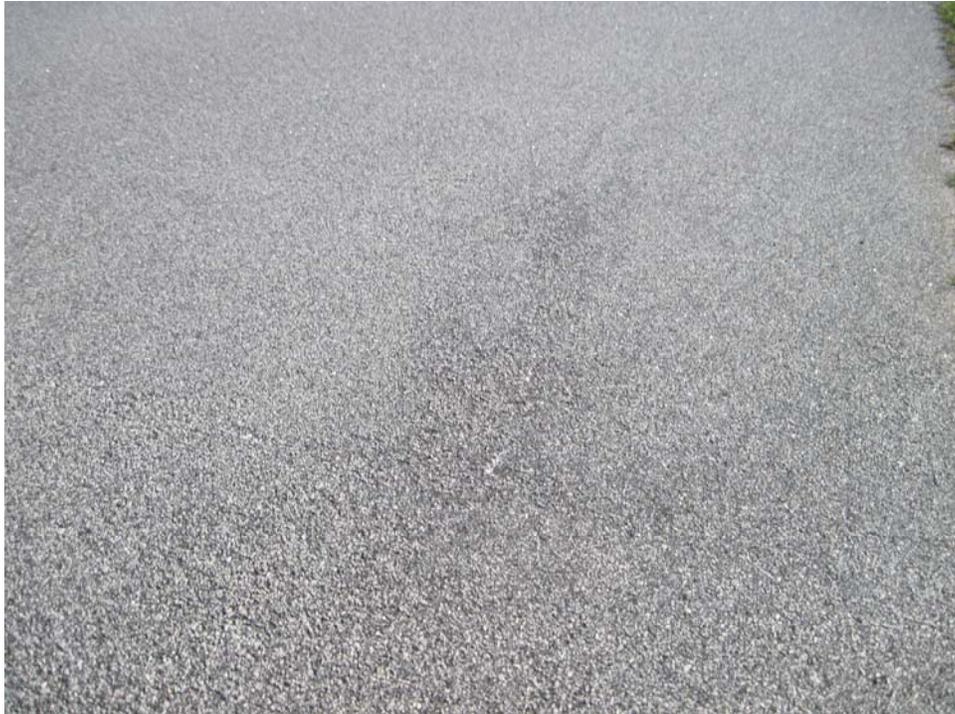
THANGNW-10. Weathering (Sample Unit #05).
