2012 Newnan-Coweta County Airport Pavement Management Plan

NEWNAN-COWETA COUNTY AIRPORT

PAVEMENT MANAGEMENT REPORT

DECEMBER 2012

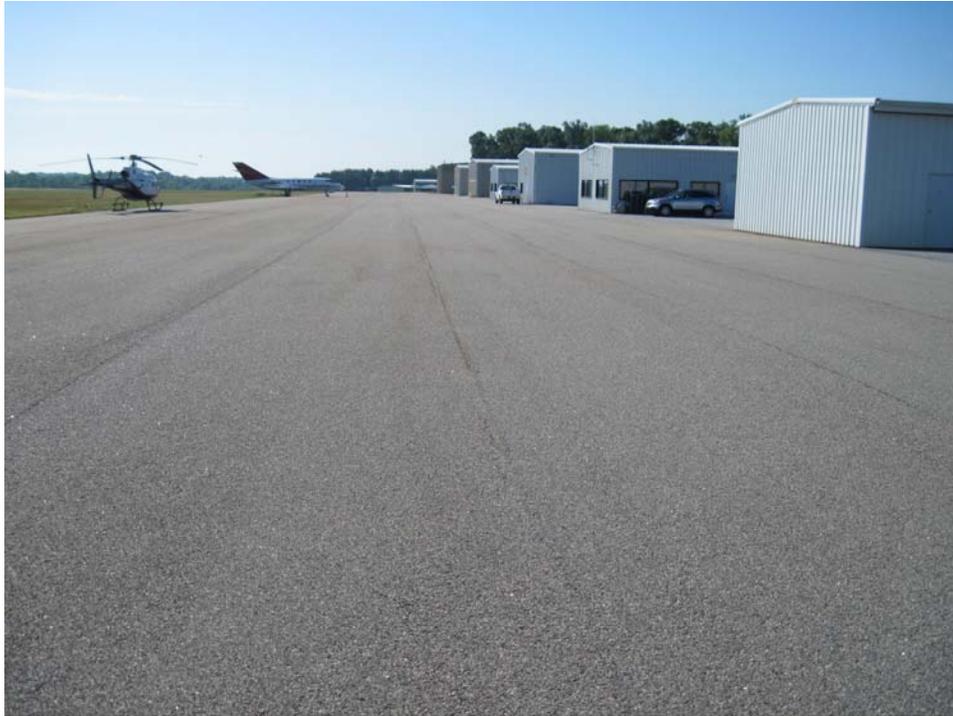
THANGNW-20. Overview.

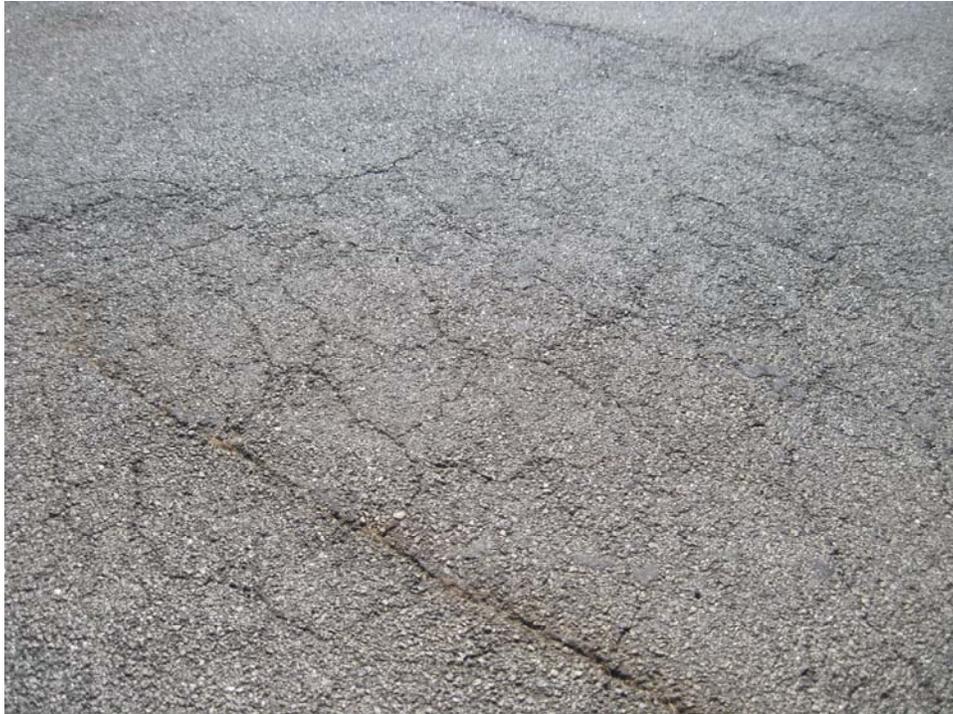
THANGNW-20. Alligator Cracking (Additional Sample Unit #03).

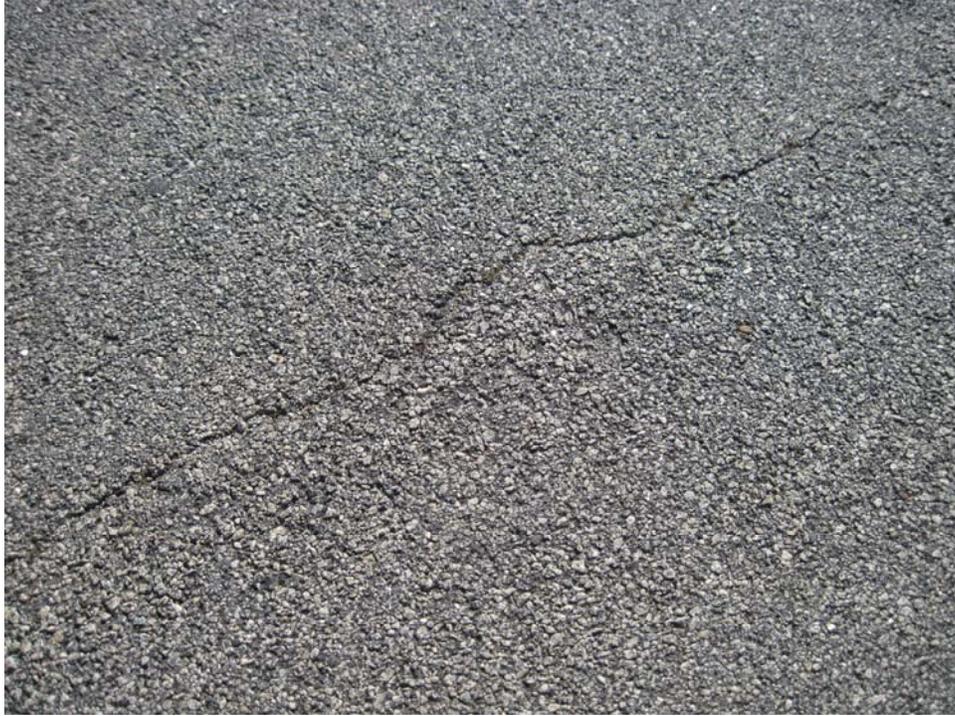
THANGNW-20. Weathering and Longitudinal and Transverse Cracking (Sample Unit #06).

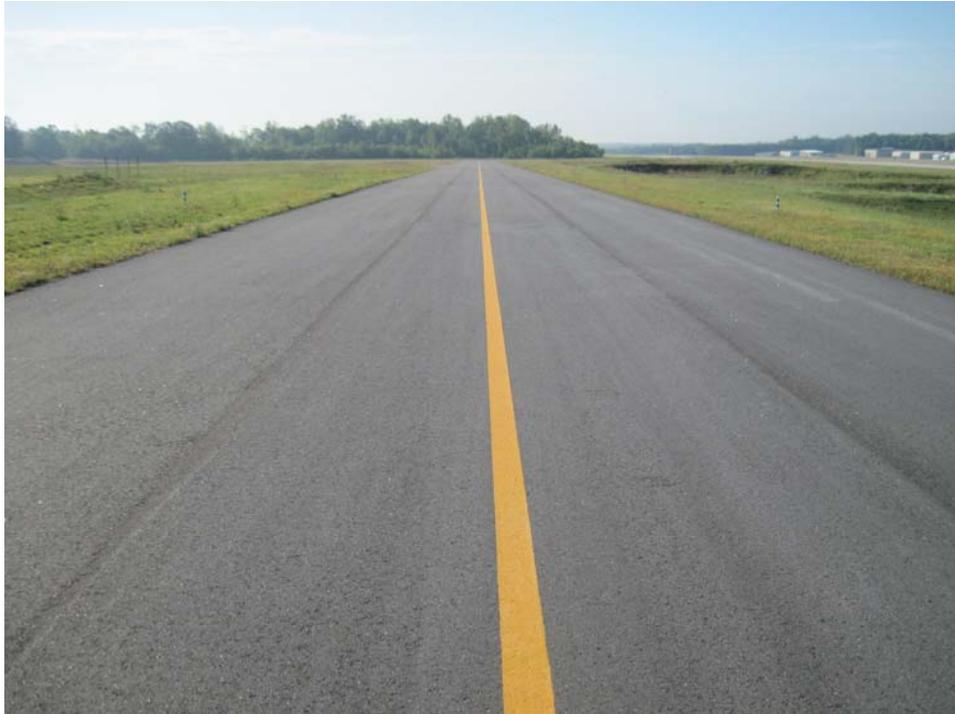
THANGNW-30. Overview.

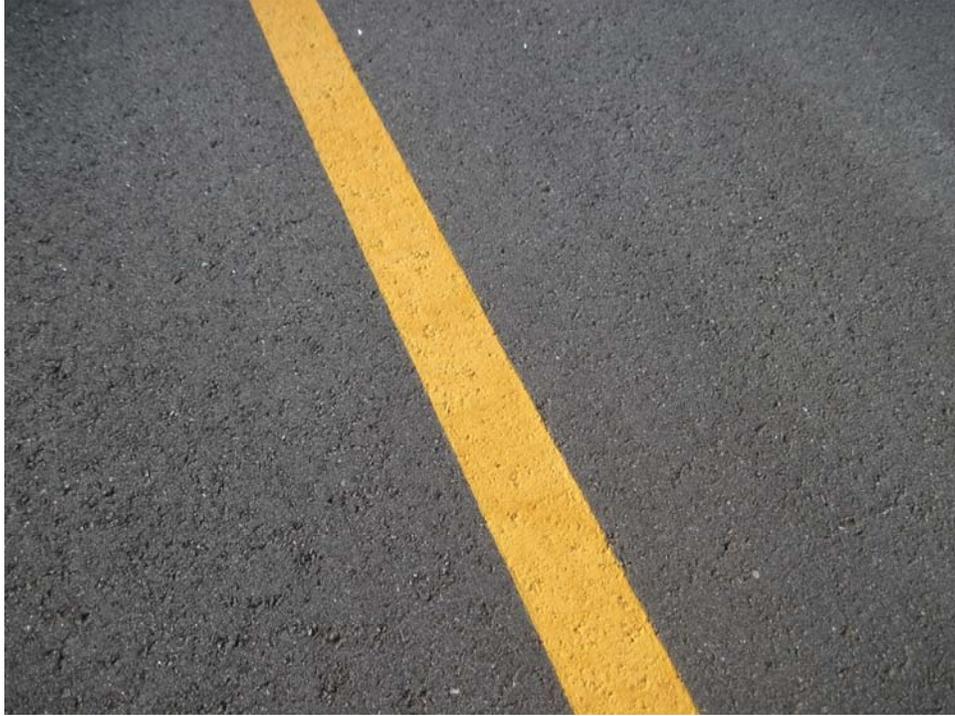
THANGNW-30. Satisfactory Paint.
