2012 Daniel Field Pavement Management Plan

DANIEL FIELD

PAVEMENT MANAGEMENT REPORT

DECEMBER 2012

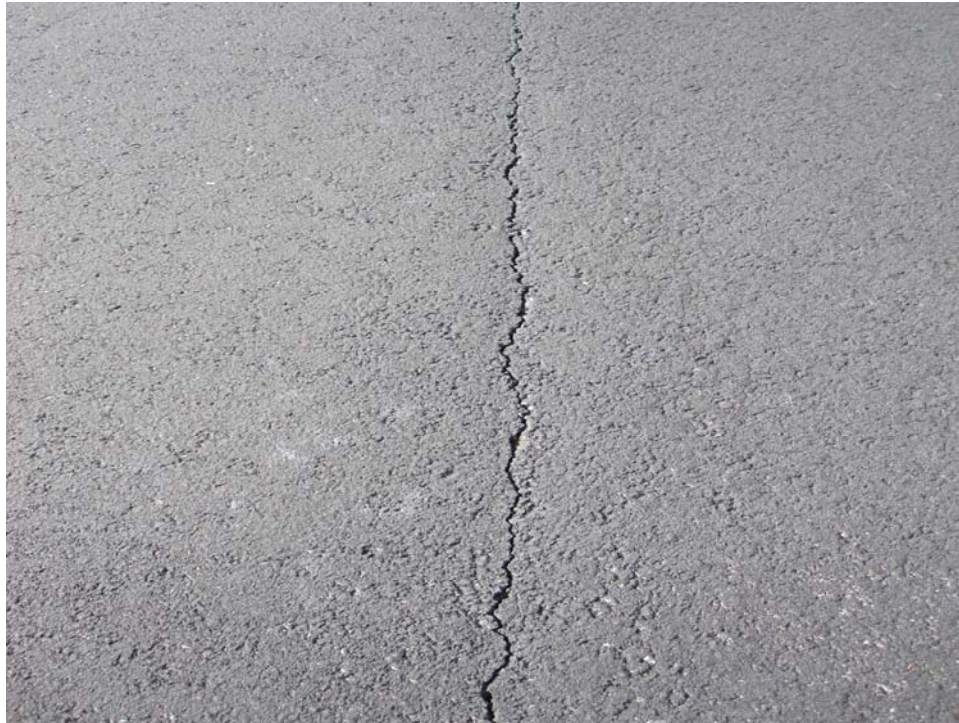
The terminal apron area (ATERMAG) consisted of seven sections. The low-severity cracking in these sections was both sealed and unsealed. The medium-severity cracking was primarily due to unsatisfactory crack sealant with small amounts due to unsealed crack widths greater than ¼ inch or development of secondary cracking. Section 10 had a PCI value of 84. The primary distress identified in this section was low-severity L&T cracking along with smaller quantities of low-severity patching and medium-severity L&T cracking. Section 20 had a PCI value of 88. Only small amounts of low-severity L&T cracking were recorded in this section. Section 30 had a PCI value of 60. Substantial amounts of low- and medium-severity L&T cracking, low-severity weathering, and low-severity raveling were observed throughout this section. Section 40 had a PCI value of 64. The only distresses identified were low- and medium-severity L&T cracking. Section 50 had a PCI value of 62. Moderate amounts of low- and medium-severity L&T cracking were recorded in this section. Section 60 had a PCI value of 90. Substantial amounts of low-severity weathering were identified in this section along with smaller quantities of low-severity L&T cracking. Section 70 had a PCI value of 49. Extensive amounts of low- and medium-severity block cracking were observed throughout.

ATERMAG-10. Longitudinal and Transverse Cracking (Sample Unit #13).

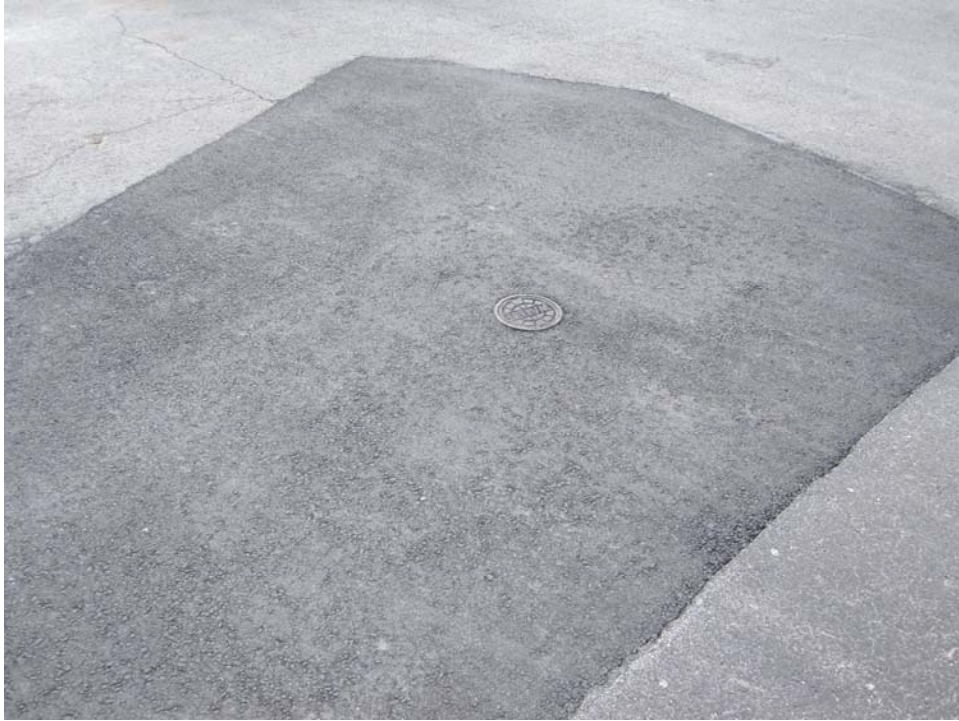
ATERMAG-10. Patching (Sample Unit #01).

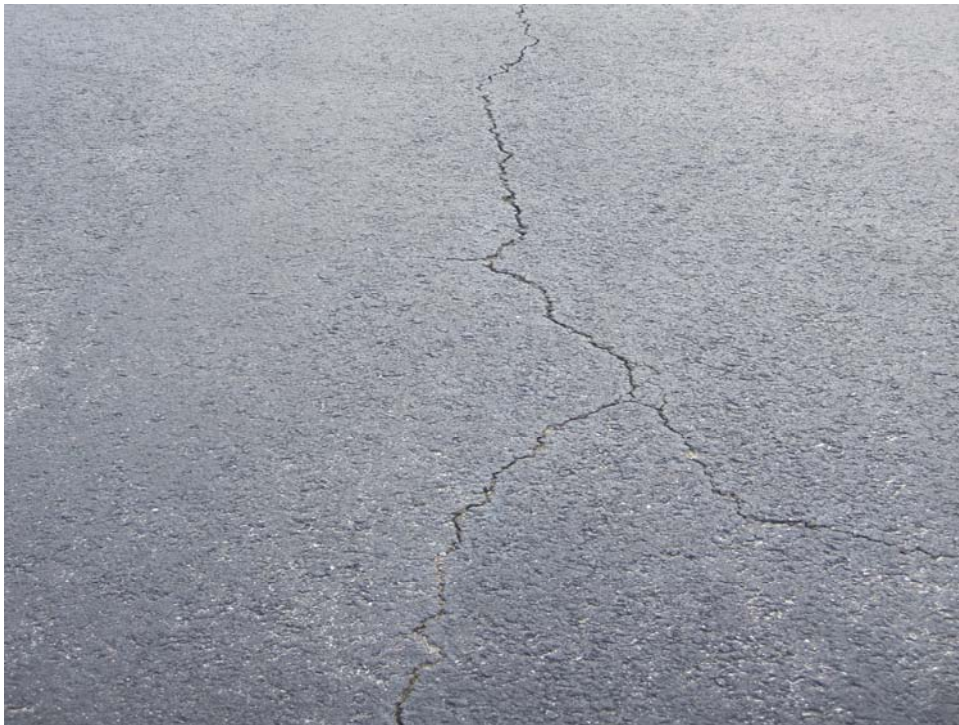
ATERMAG-20. Longitudinal and Transverse Cracking (Sample Unit #05).

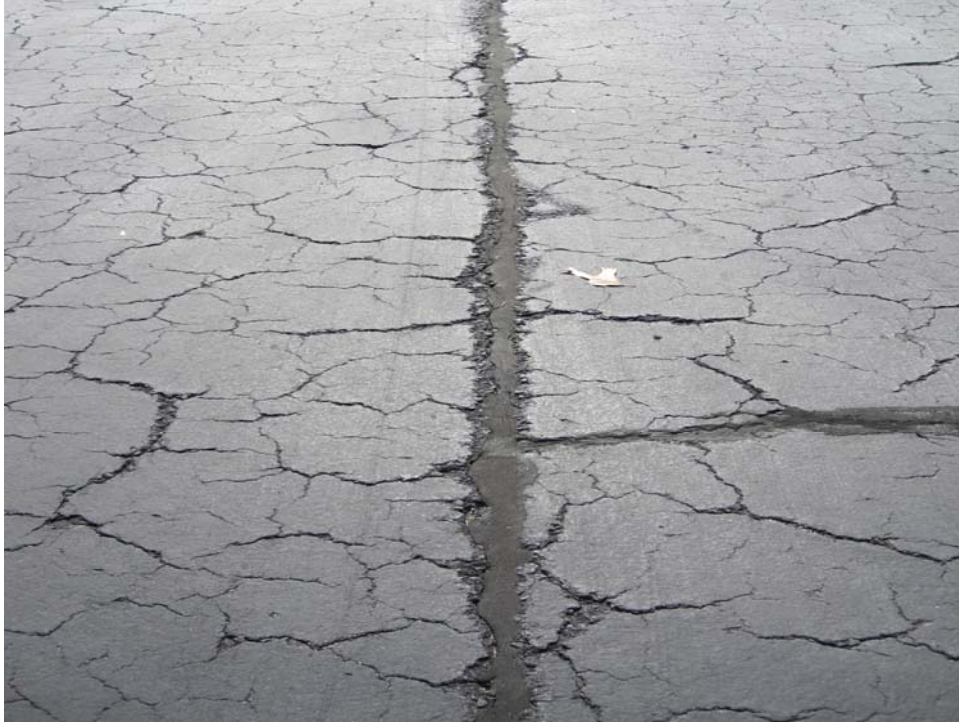
ATERMAG-30. Longitudinal and Transverse Cracking (Sample Unit #19).

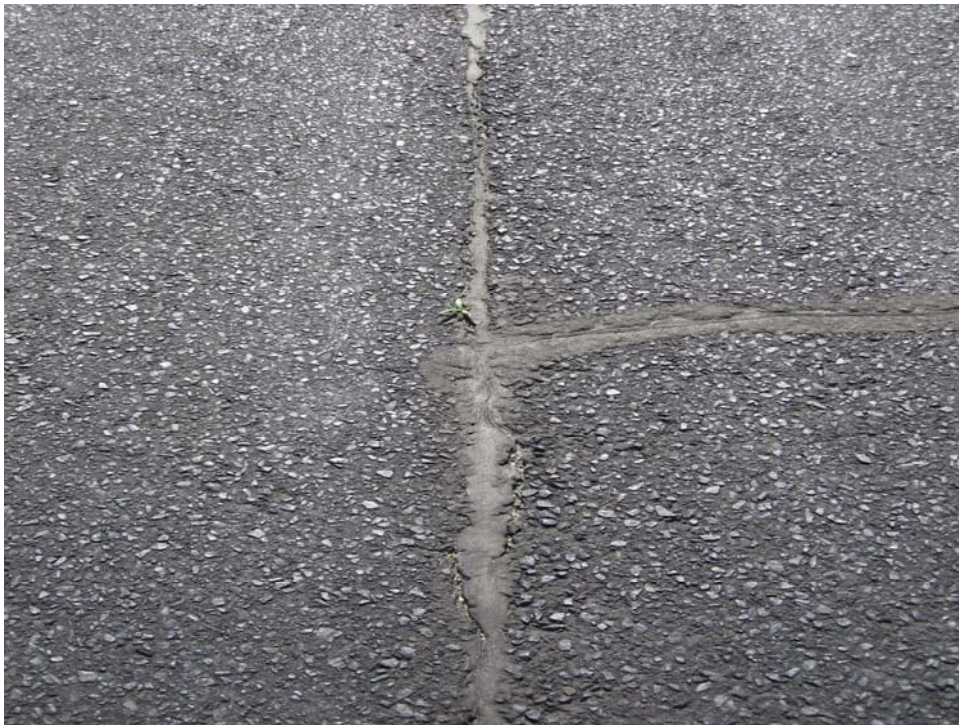
ATERMAG-30. Longitudinal and Transverse Cracking (Sample Unit #33).

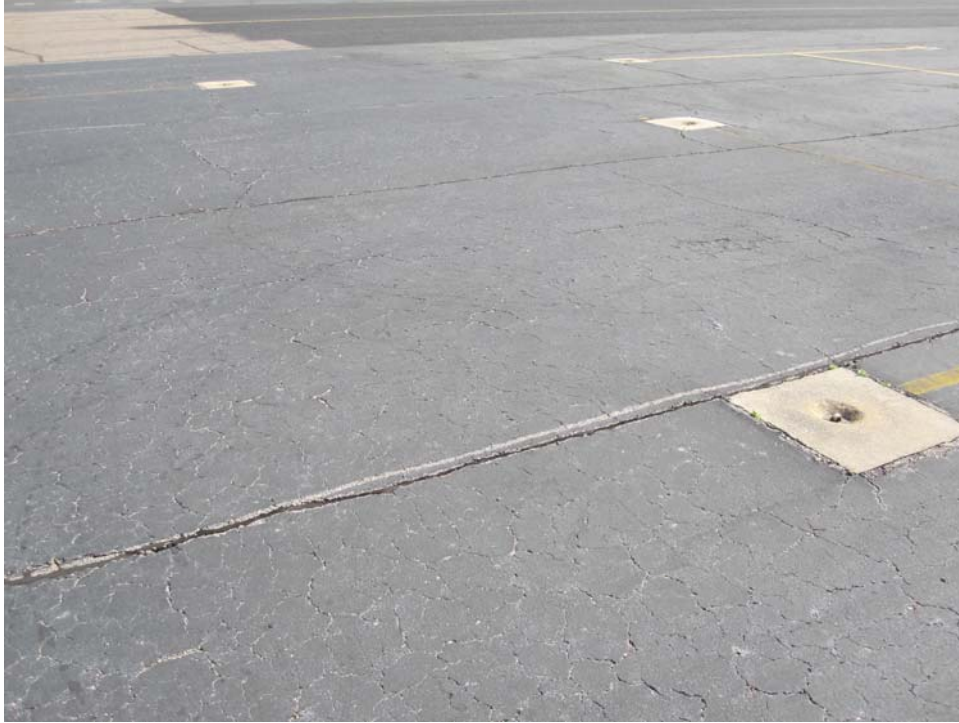
ATERMAG-30. Raveling (Sample Unit #39).

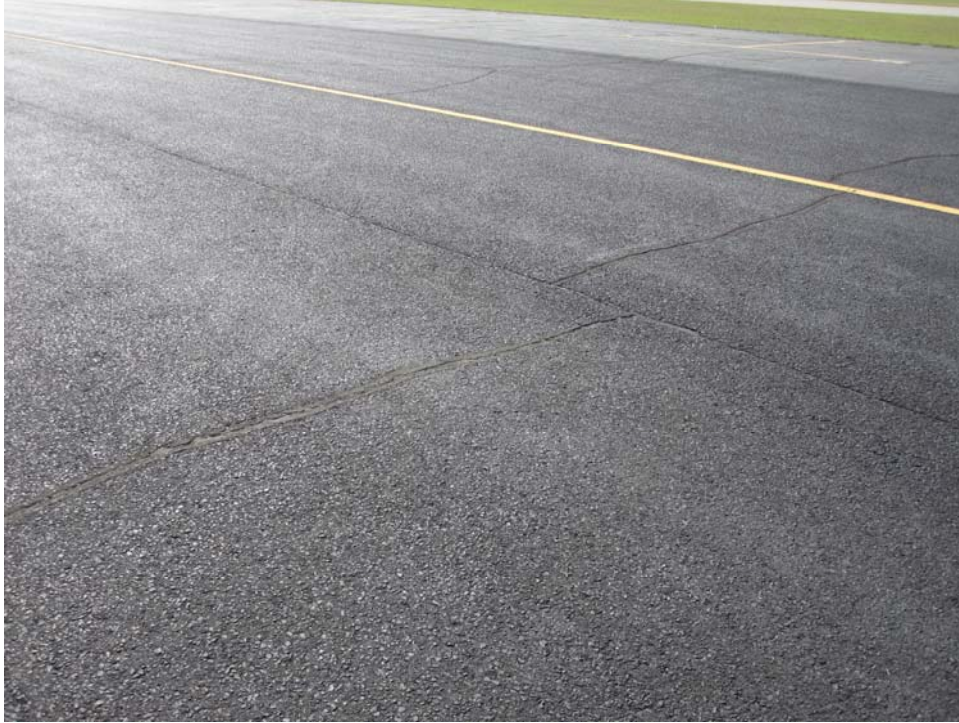
ATERMAG-30. Seal Coat (Sample Unit #49).

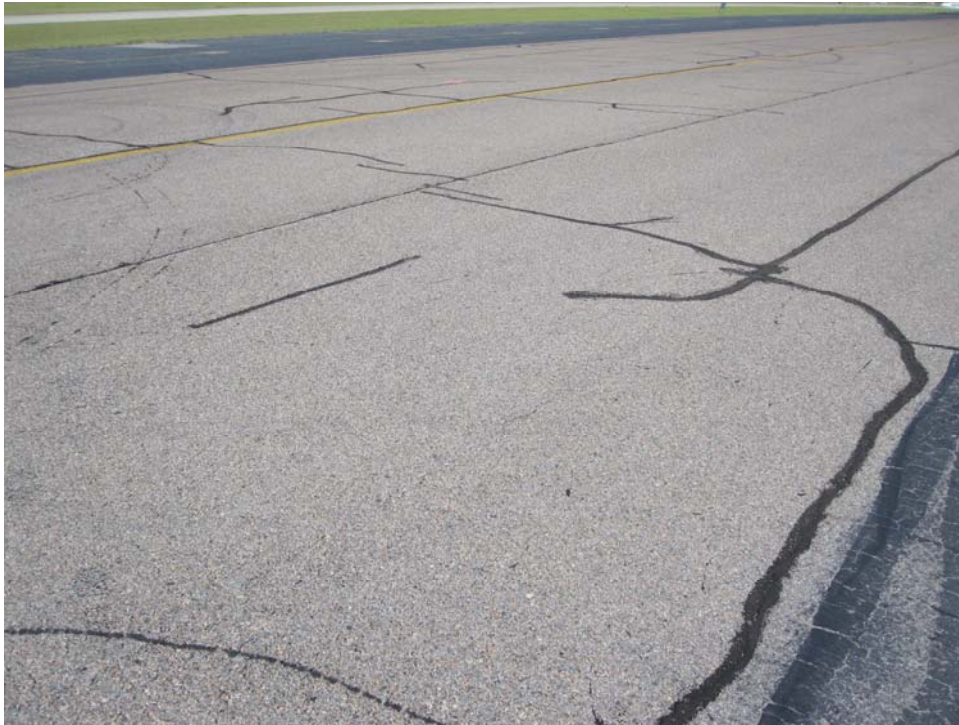
ATERMAG-30. Weathering (Sample Unit #49).

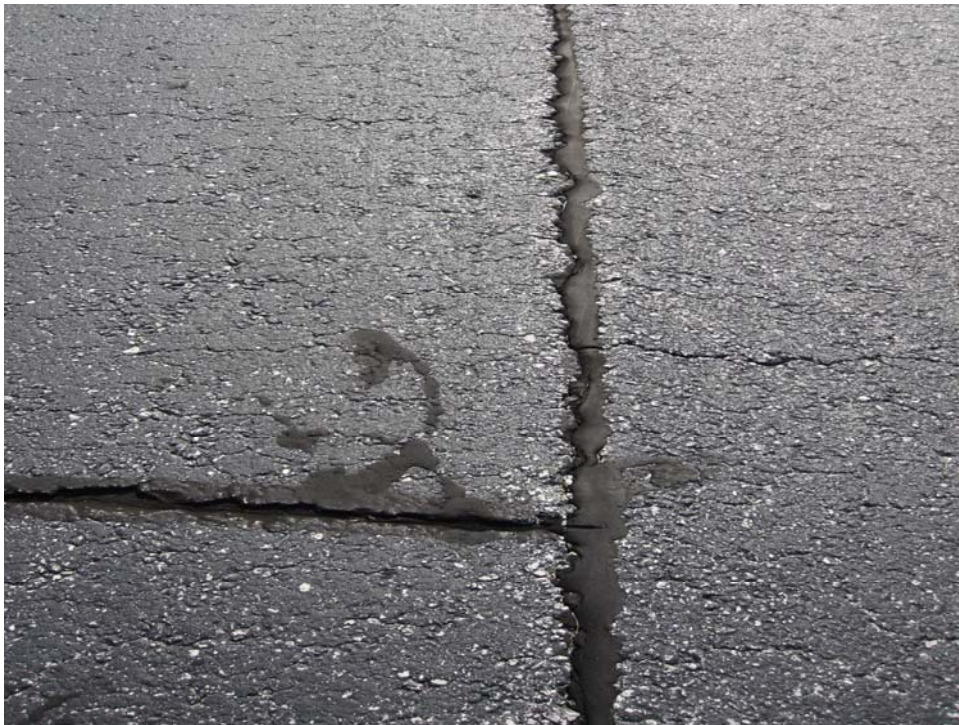
ATERMAG-40. Longitudinal and Transverse Cracking (Sample Unit #11).

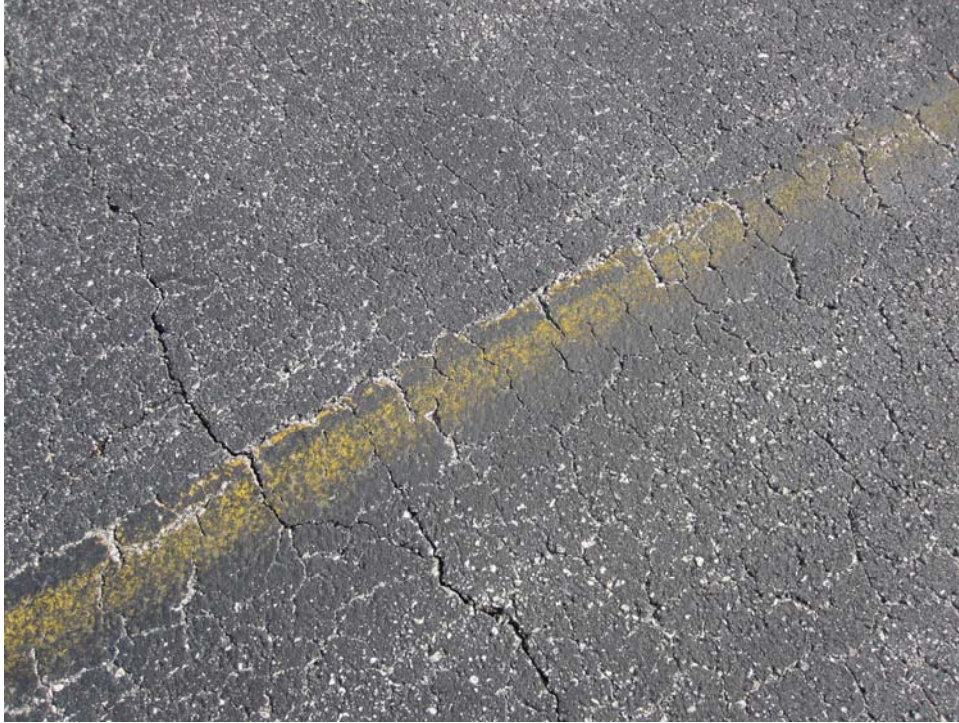
ATERMAG-40. Unsatisfactory Paint.

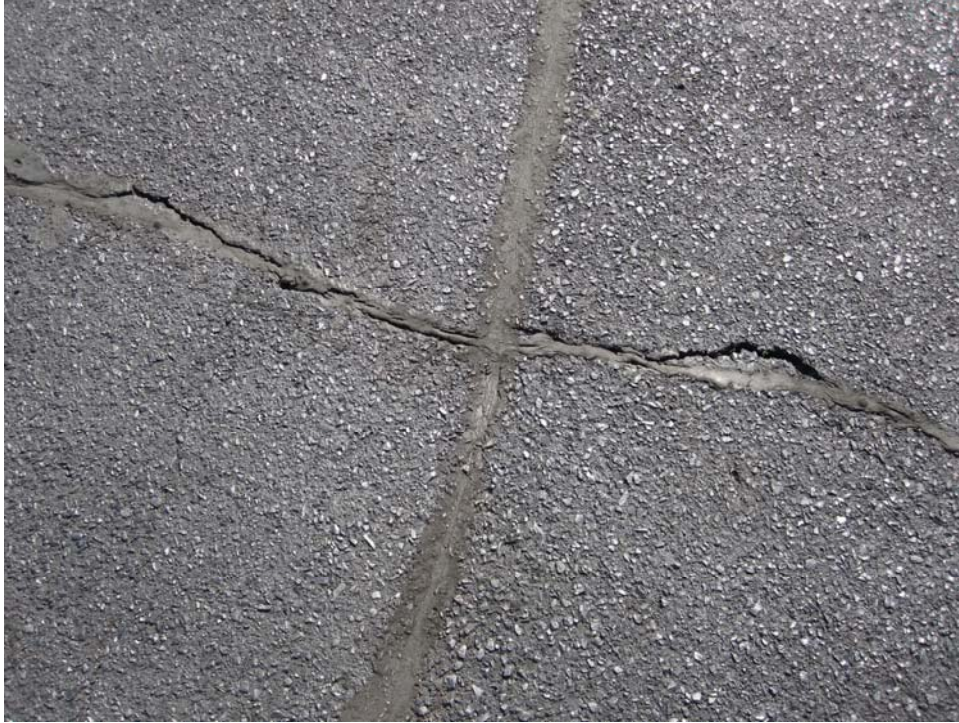
ATERMAG-50. Longitudinal and Transverse Cracking (Sample Unit #10).

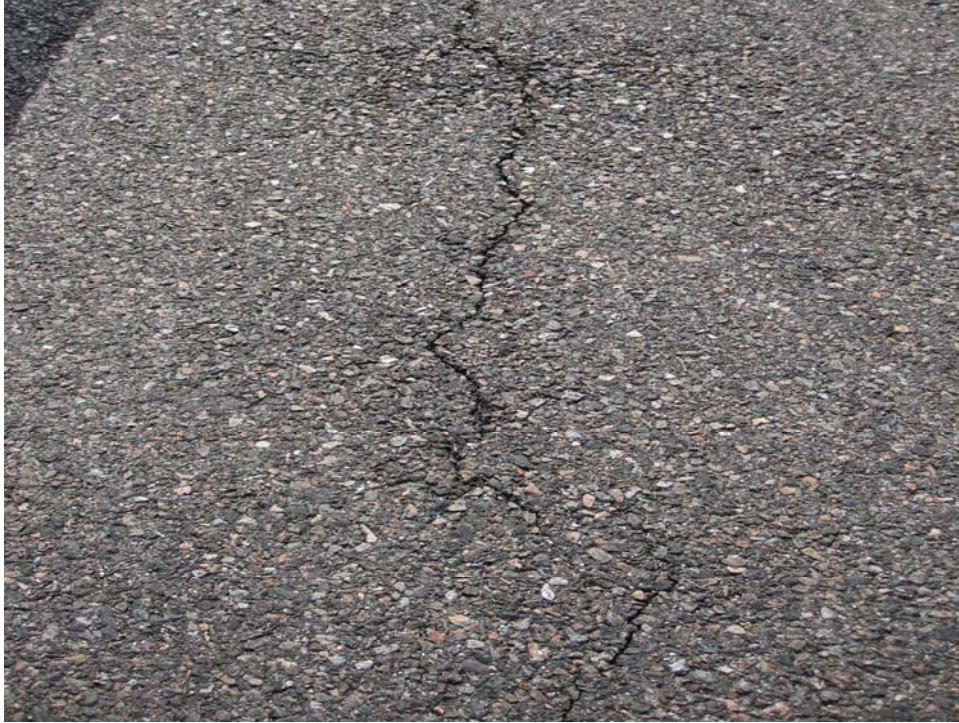
ATERMAG-60. Longitudinal and Transverse Cracking (Sample Unit #03).

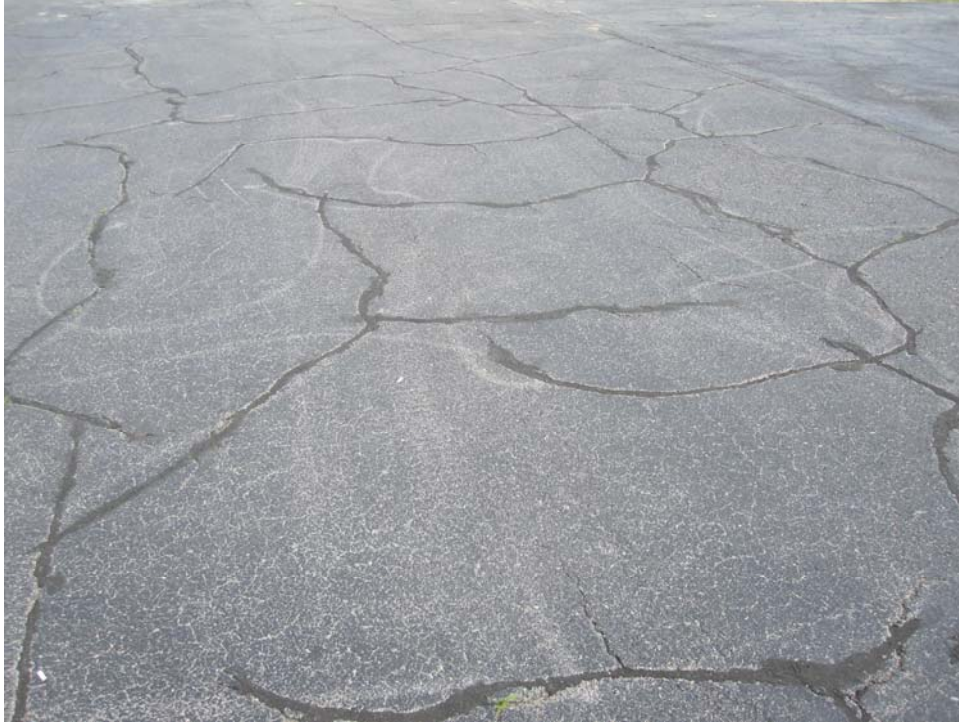
ATERMAG-70. Block Cracking (Sample Unit #01).

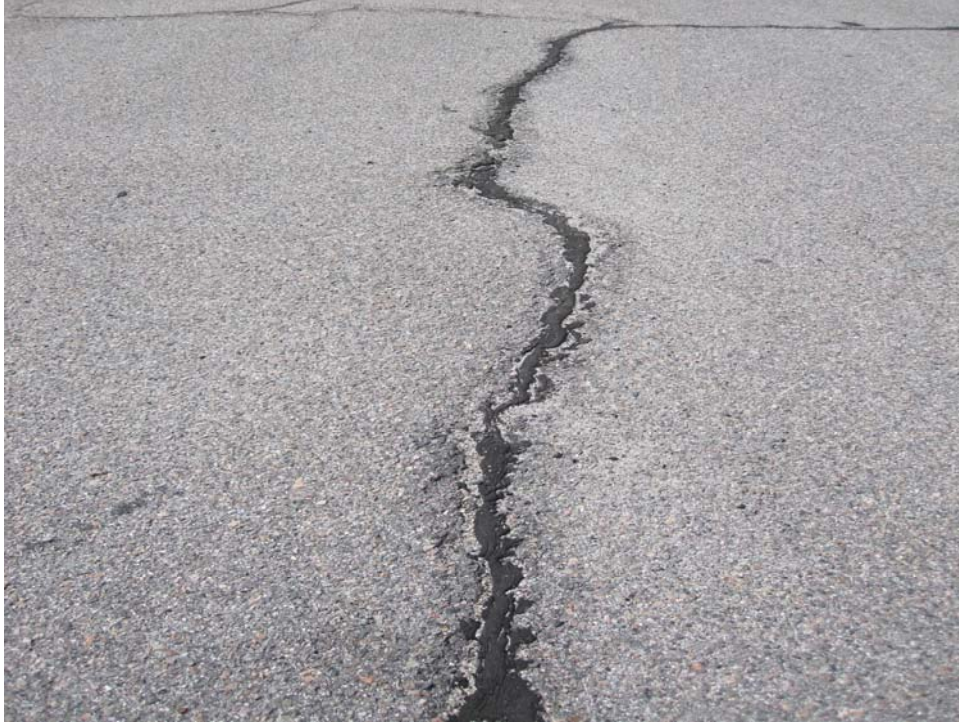
The tower apron area (ATOWERAG) contained two sections. All low-severity cracking was unsealed; all medium-severity cracking was due to unsatisfactory crack sealant. Section 10 had a PCI value of 48. The primary distresses identified in this section were medium-severity L&T cracking and weathering. Low-severity L&T cracking was also recorded. Section 20 had a PCI value of 53. The main distresses observed in this section were medium-severity L&T cracking and low-severity weathering. Moderate amounts of low-severity L&T cracking and block cracking were also identified along with smaller quantities of low-severity patching.

ATOWERAG-10. Longitudinal and Transverse Cracking (Sample Unit #01).

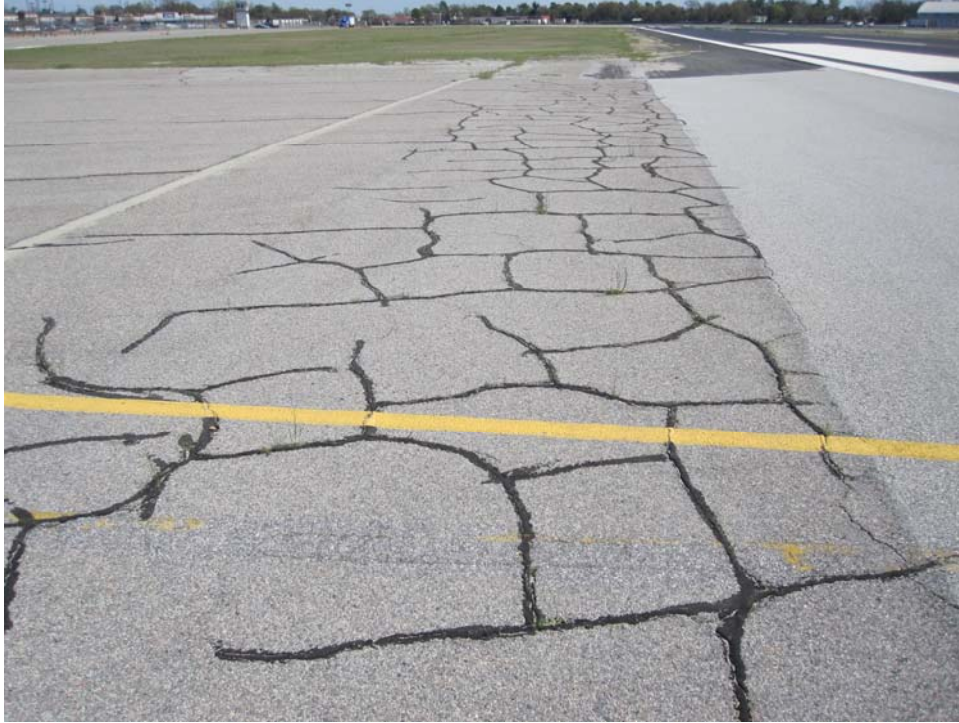
ATOWERAG-20. Block Cracking (Sample Unit #03).

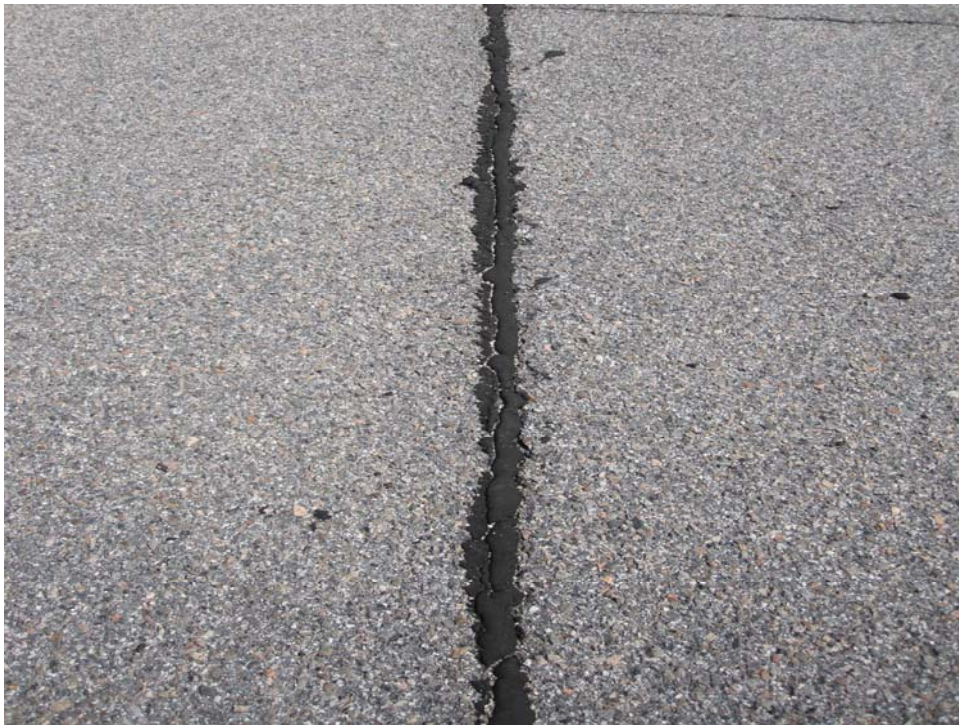
ATOWERAG-20. Longitudinal and Transverse Cracking (Sample Unit #23).

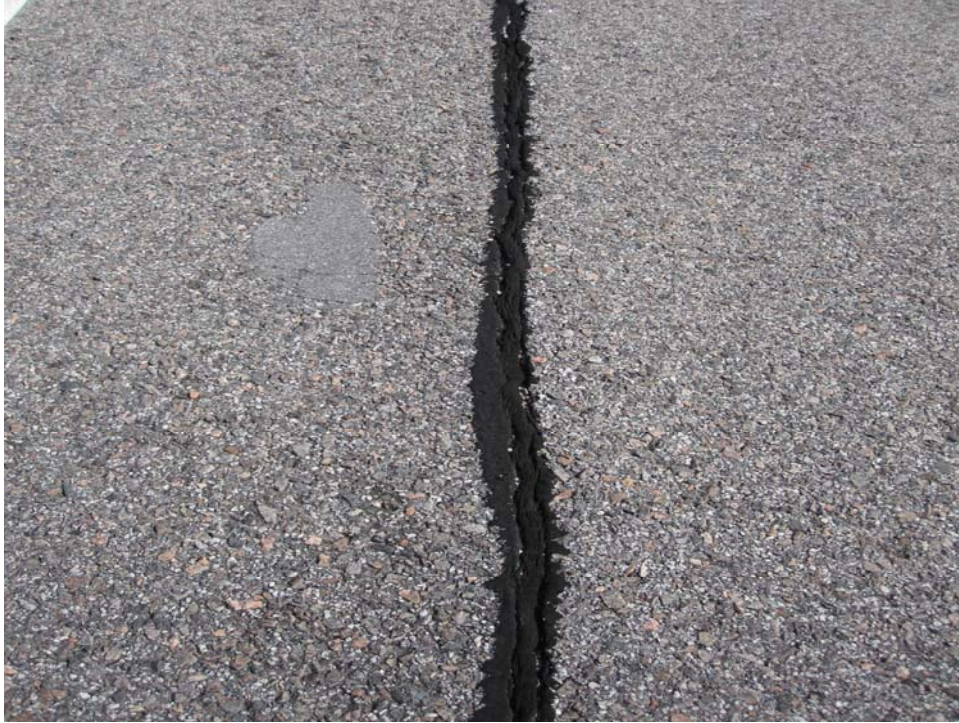
Runway 5-23 consisted of two sections. Section 10 had a PCI value of 52. The only distresses identified in this section were low- and medium-severity L&T cracking and low-severity weathering along with smaller quantities of medium-severity weathering. All low-severity cracking was unsealed, and medium-severity cracking was due to unsatisfactory crack sealant. An additional sample unit that included several areas of low- and medium-severity patching unique to that location of the runway was recorded in accordance with ASTM D5340. Section 20 consisted of the intersection of both runways and had a PCI value of 91. Moderate amounts of low-severity weathering were observed in this section along with low-severity, unsealed L&T cracking.

R0523AG-10. Longitudinal and Transverse Cracking (Sample Unit #06).

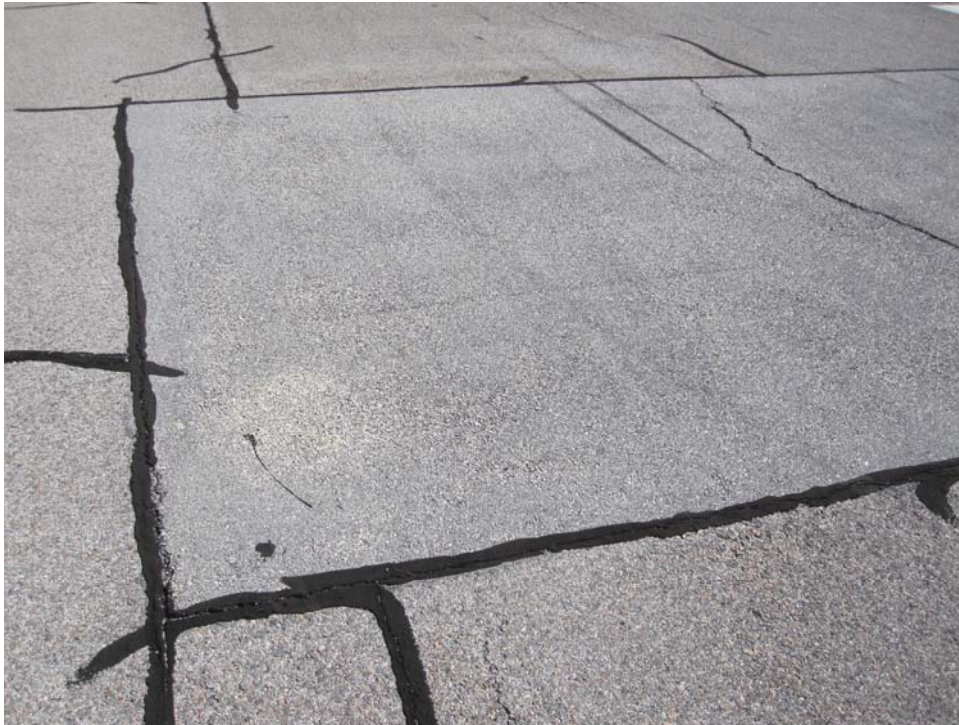
R0523AG-10. Patching (Sample Unit #15).

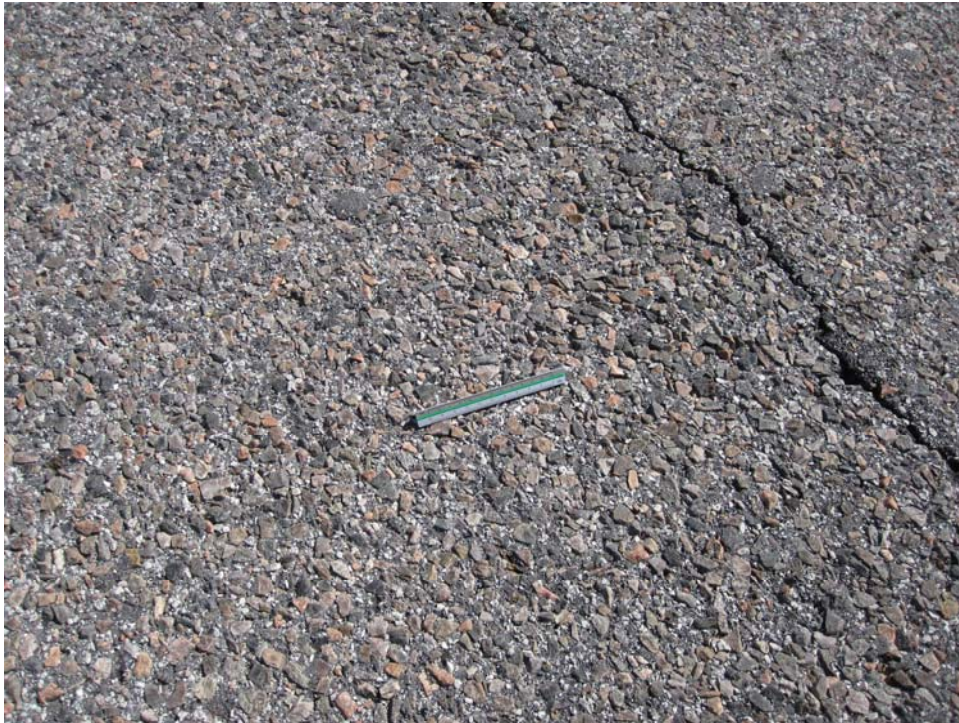
R0523AG-10. Weathering (Sample Unit # 06).

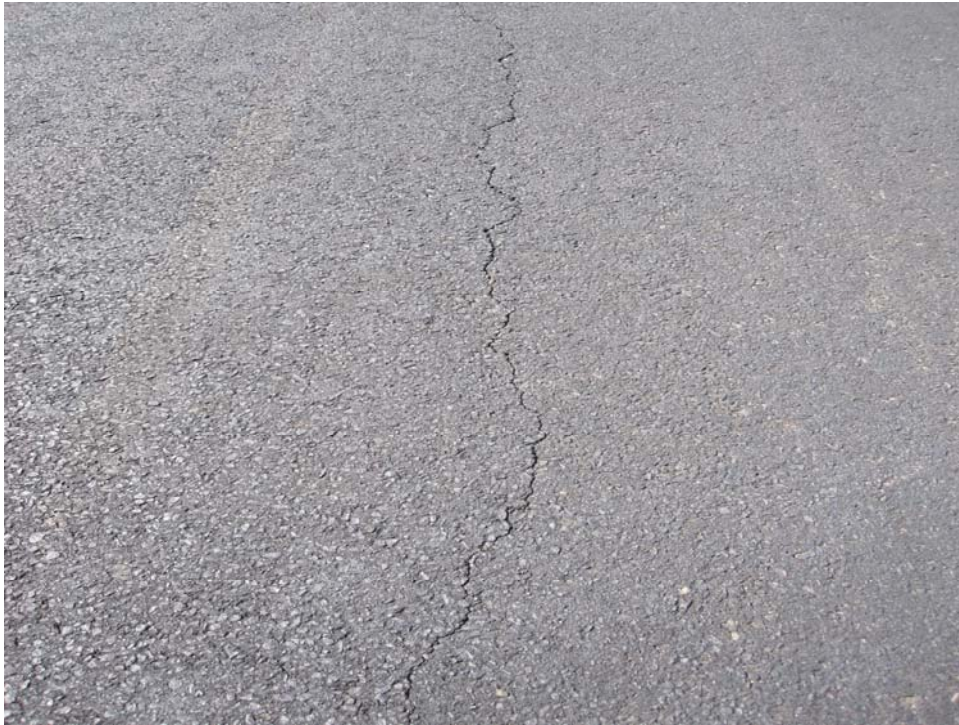
R0523AG-20. Longitudinal and Transverse Cracking (Sample Unit #04).

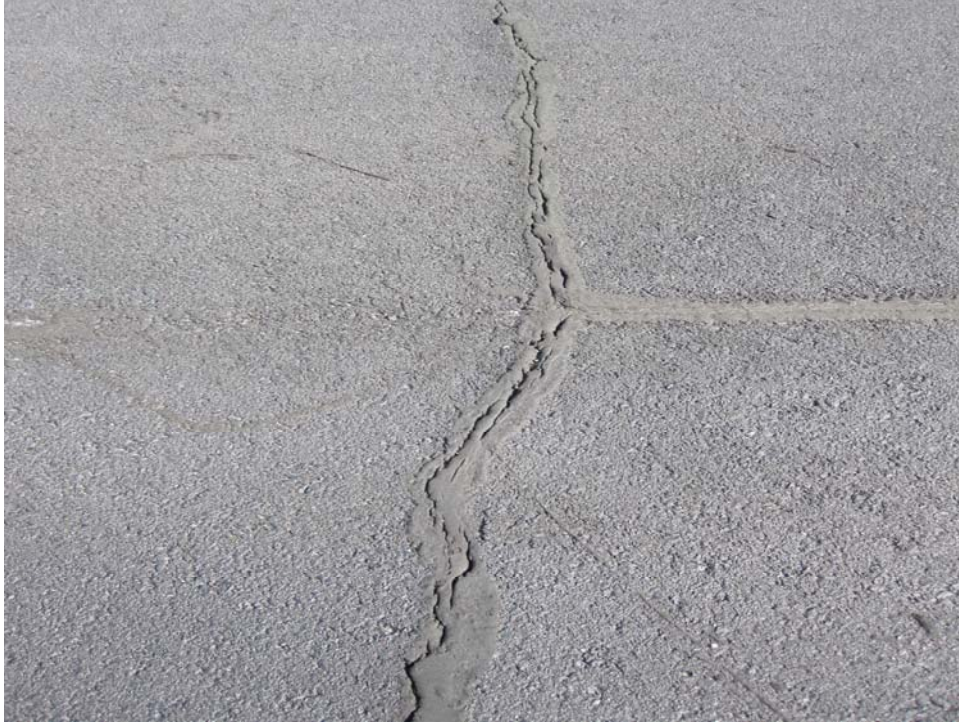
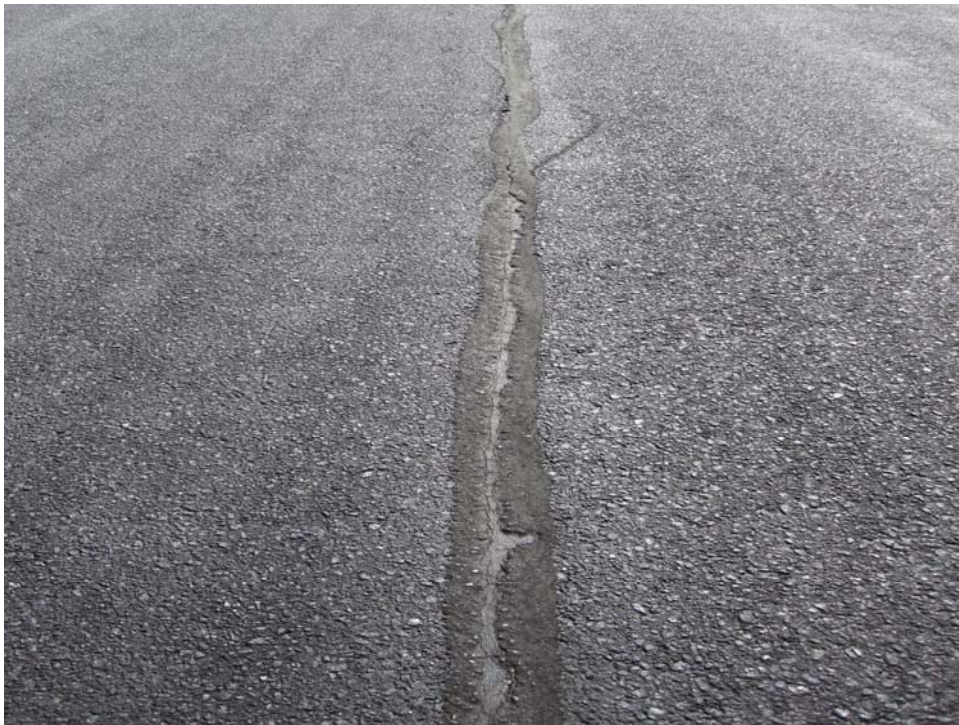
Runway 11-29 was comprised of one section with a PCI value of 70. A surface treatment project was completed on this runway in 2010. Substantial amounts of low- and medium-severity longitudinal and transverse (L&T) cracking were observed throughout this section. The low-severity cracking was both sealed and unsealed, and the medium-severity cracking was due to unsatisfactory crack sealant.

R1129AG-10. Longitudinal and Transverse Cracking (Sample Unit #09).

R1129AG-10. Longitudinal and Transverse Cracking (Sample Unit #22).

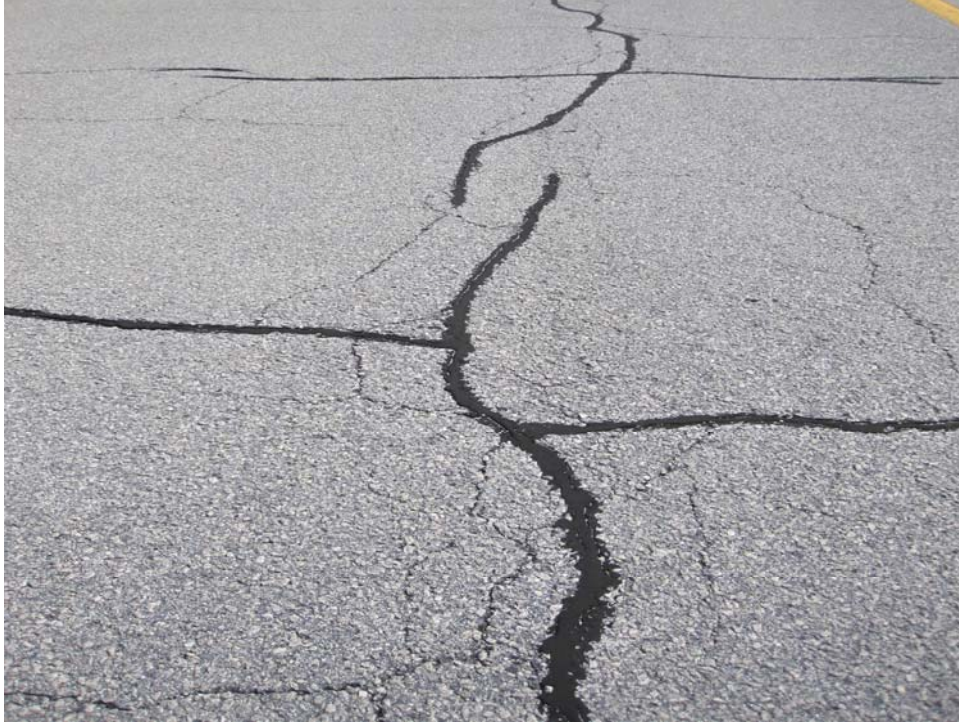
Taxiway A was defined by one section with a PCI value of 52. The primary distresses identified in Section 10 were medium-severity L&T cracking and low-severity weathering. In addition, moderate amounts of low-severity L&T cracking, medium-severity alligator cracking, and medium-severity weathering were also observed. All low-severity cracking was unsealed and medium-severity cracking was due to unsatisfactory crack sealant.

TAAG-10. Alligator Cracking (Sample Unit #05).

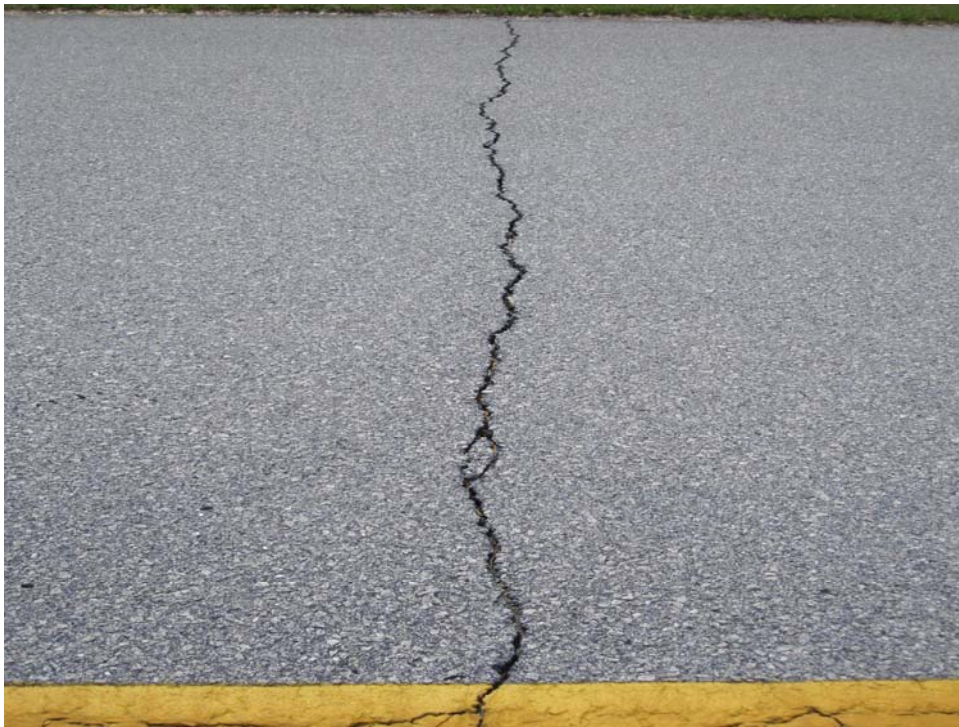
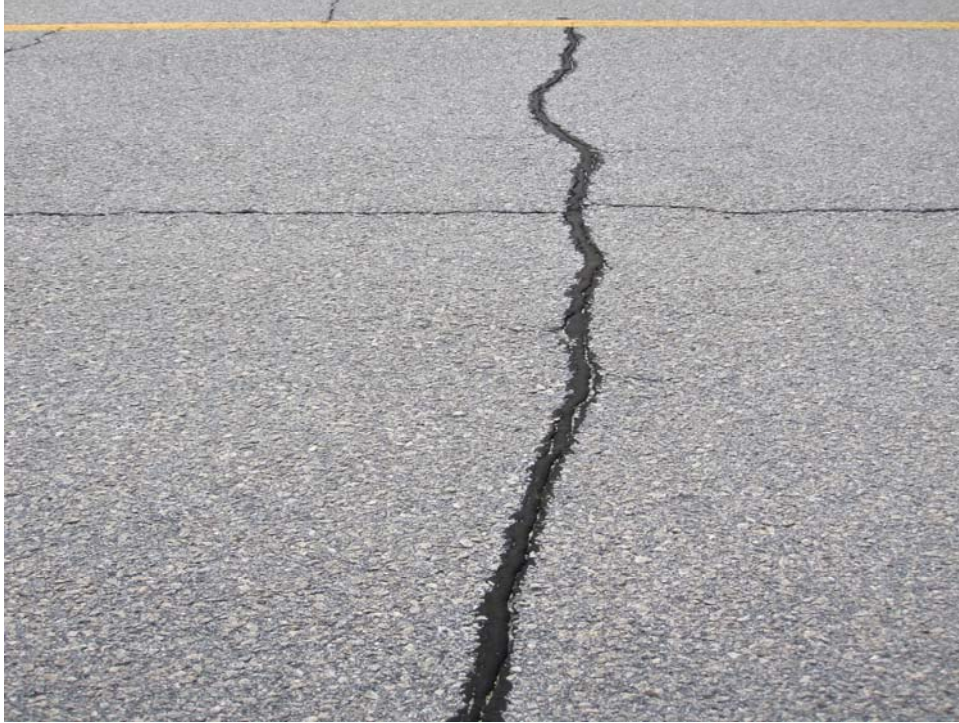
TAAG-10. Longitudinal and Transverse Cracking (Sample Unit #05).

TAAG-10. Longitudinal and Transverse Cracking (Sample Unit #16).

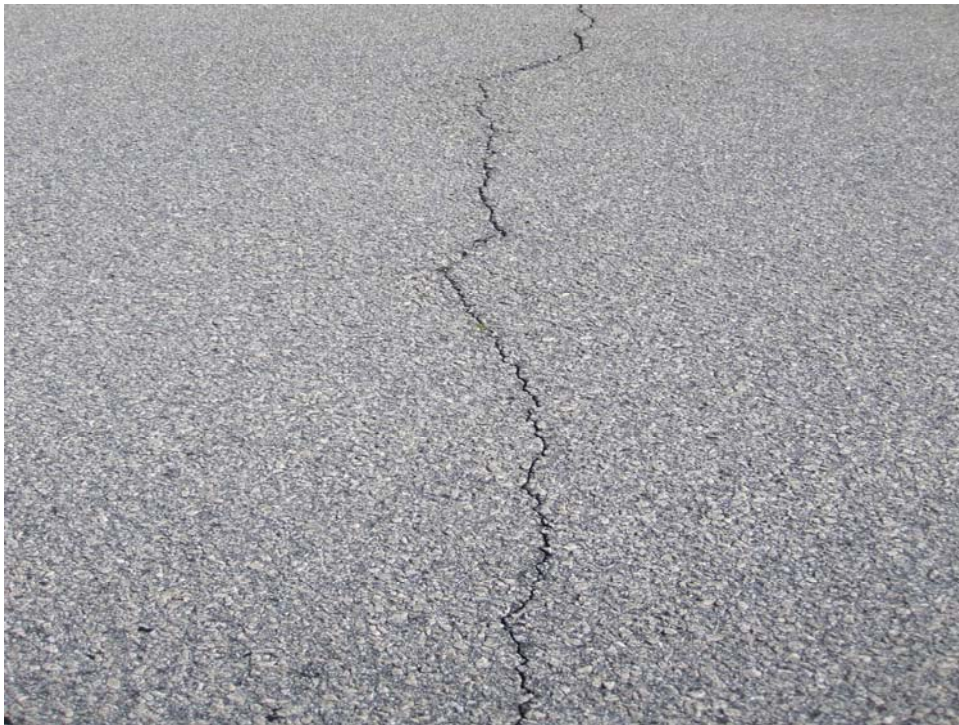
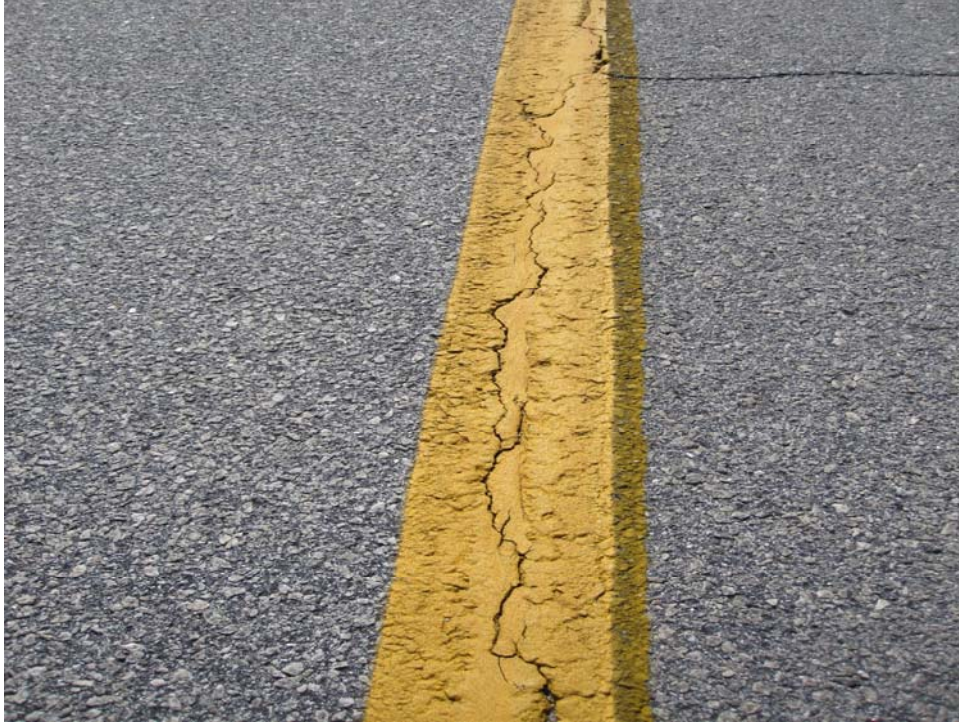
Taxiway D was comprised of one section with a PCI value of 76. Substantial quantities of low-severity weathering were recorded throughout Section 10 along with moderate amounts of low- and medium-severity L&T cracking and medium-severity weathering. All low-severity cracking was unsealed and medium-severity cracking was due to unsatisfactory crack sealant.

TDAG-10. Longitudinal and Transverse Cracking (Sample Unit #18).

TDAG-10. Longitudinal and Transverse Cracking (Sample Unit #22).

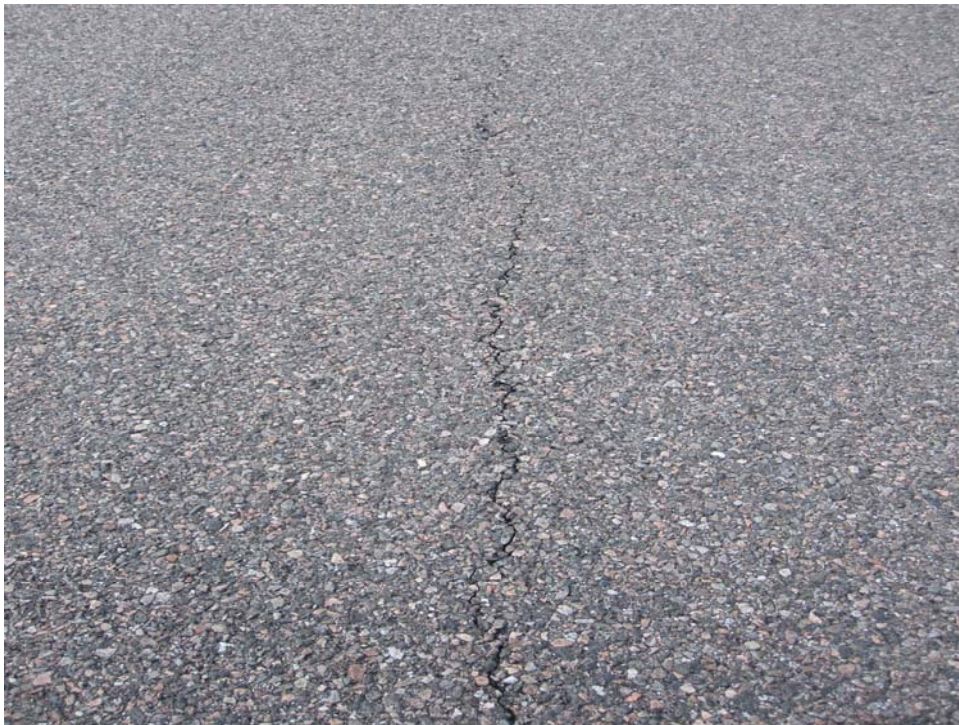
Taxiway E was defined by one section with a PCI value of 89. The primary distress identified in Section 10 was low-severity weathering. Additionally, low-severity, unsealed L&T cracking and medium-severity weathering were observed in smaller quantities.

TEAG-10. Longitudinal and Transverse Cracking (Sample Unit #01).

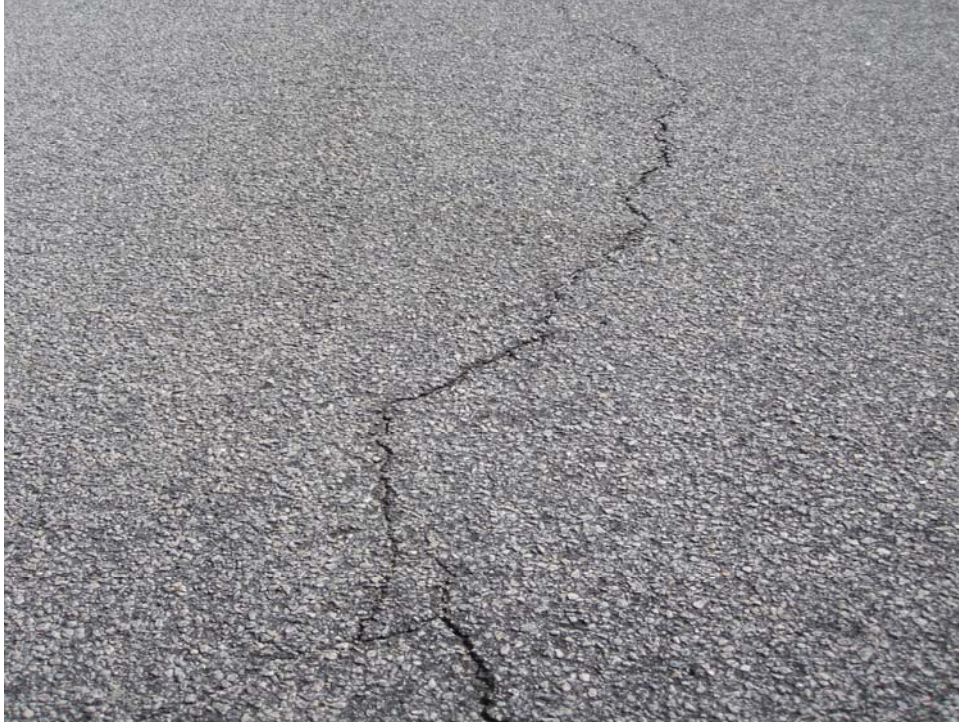
The T-Hangar area was comprised of one section with a PCI value of 74. The primary distresses identified in Section 10 were low-severity block cracking and weathering. Smaller quantities of low-severity L&T cracking and raveling were also observed. All low-severity cracking was unsealed.

THANGAG-10. Longitudinal and Transverse Cracking (Sample Unit #08).

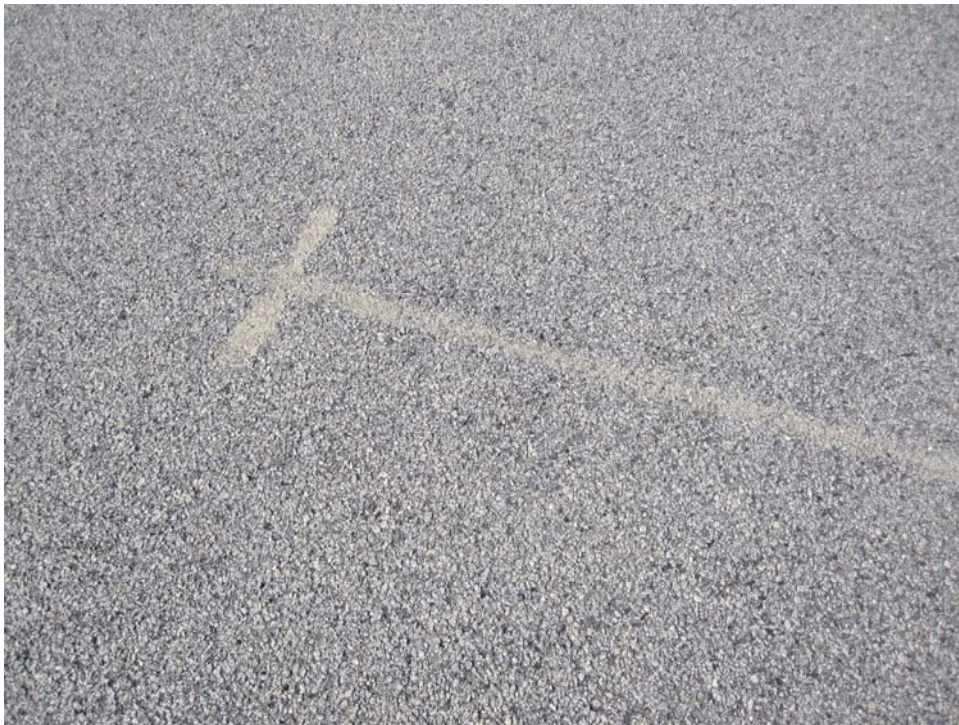
THANGAG-10. Unsatisfactory Paint.
