2012 Columbus Airport Pavement Management Plan

COLUMBUS AIRPORT

PAVEMENT MANAGEMENT REPORT

DECEMBER 2012

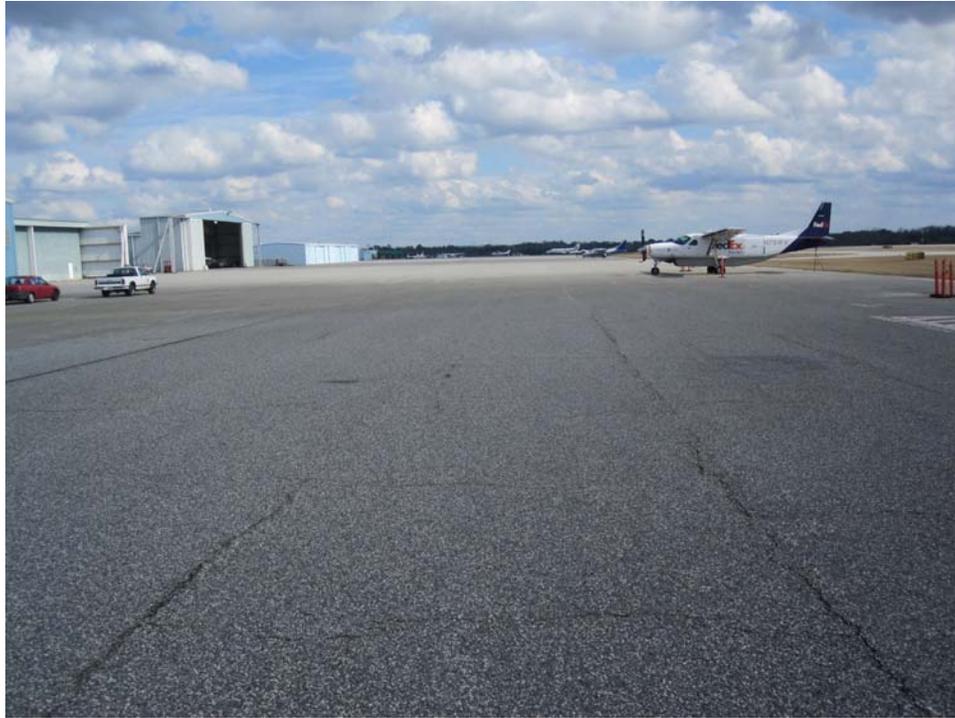
A01CS-10. Overview.

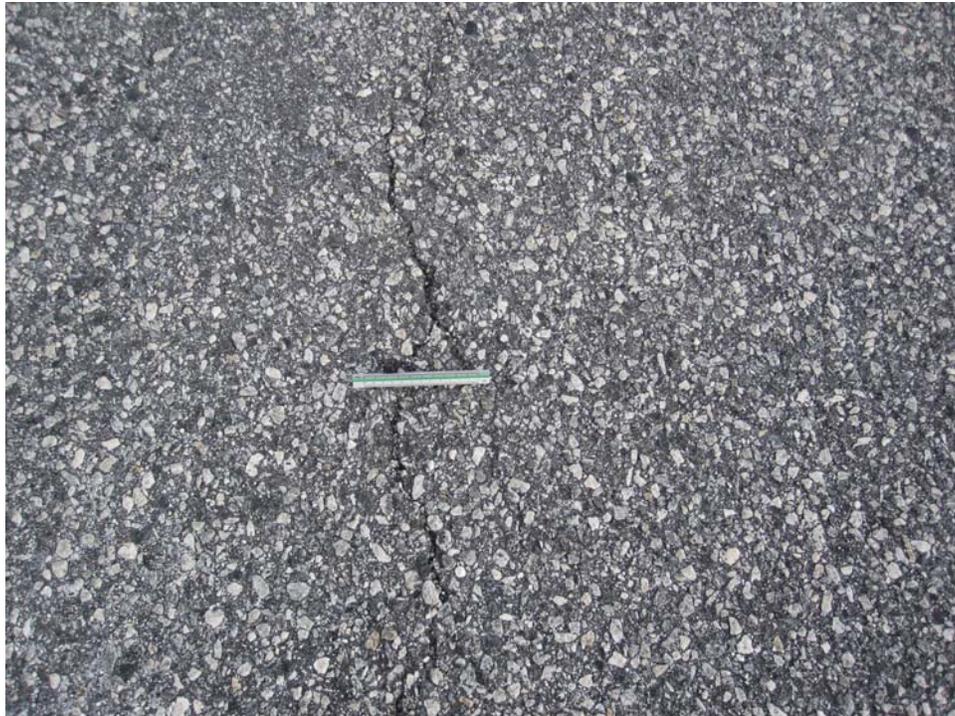
A01CS-10. Longitudinal and Transverse Cracking (Sample Unit #71).

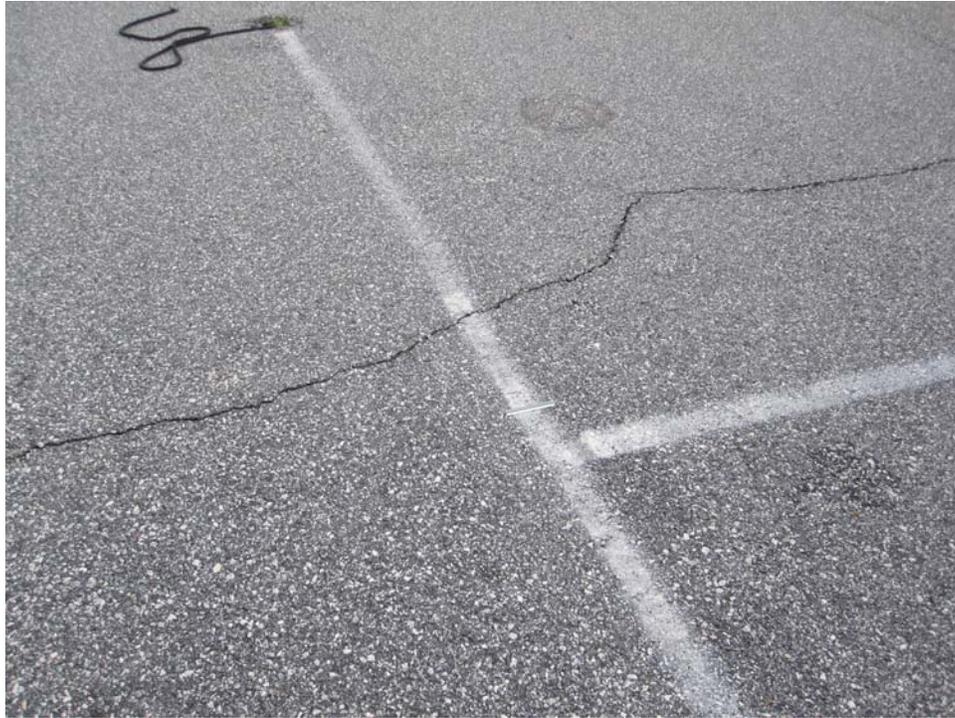
A01CS-10. Unsatisfactory Paint.

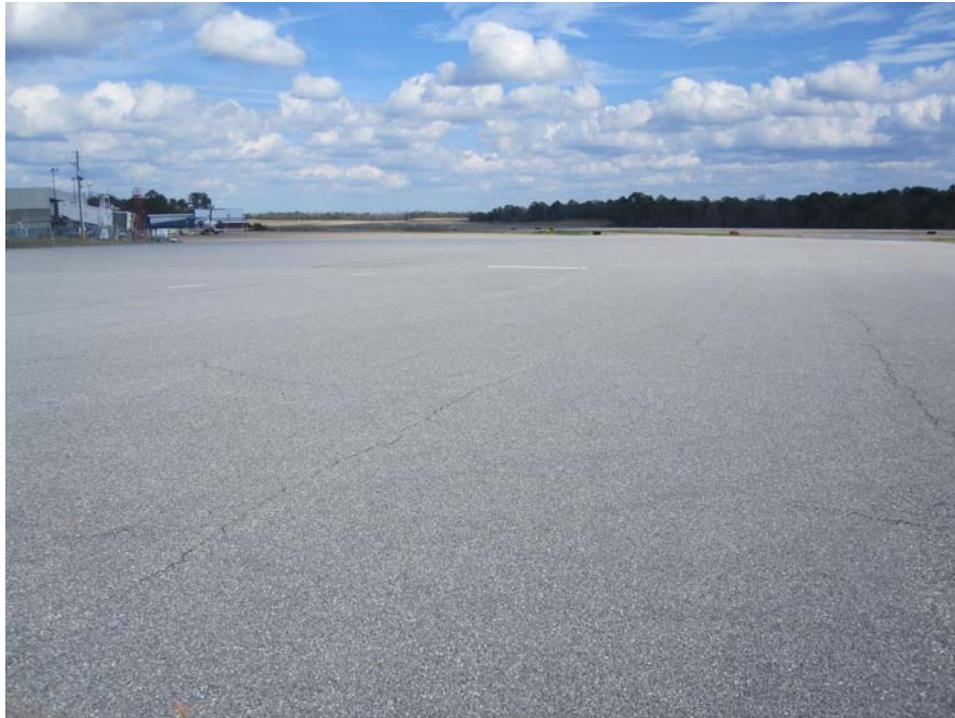
A01CS-20. Overview.

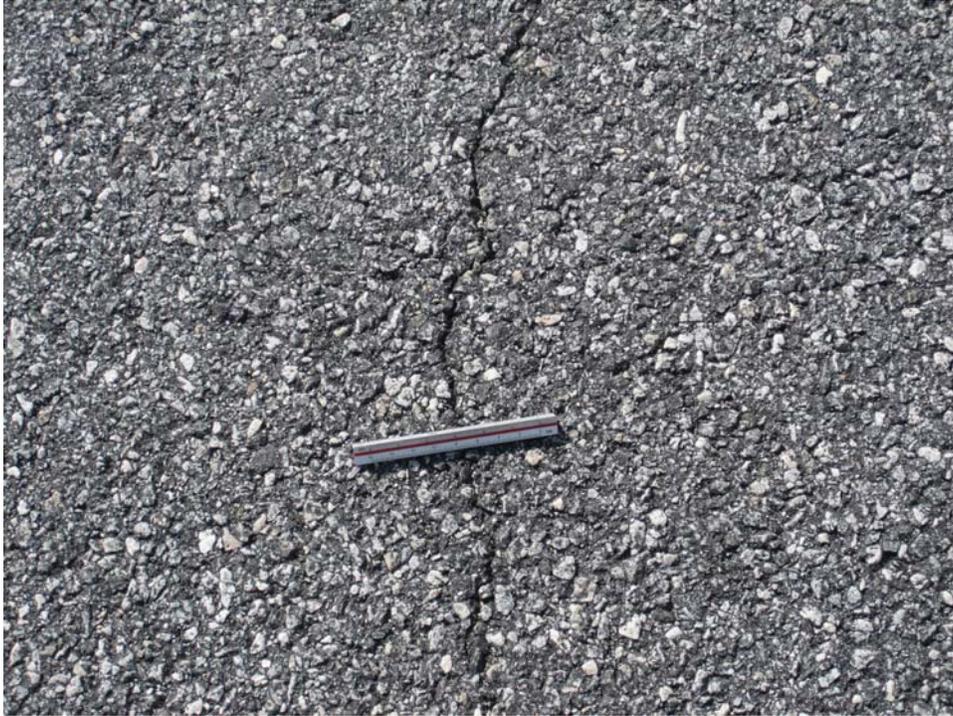
A01CS-20. Longitudinal and Transverse Cracking (Sample Unit #21).

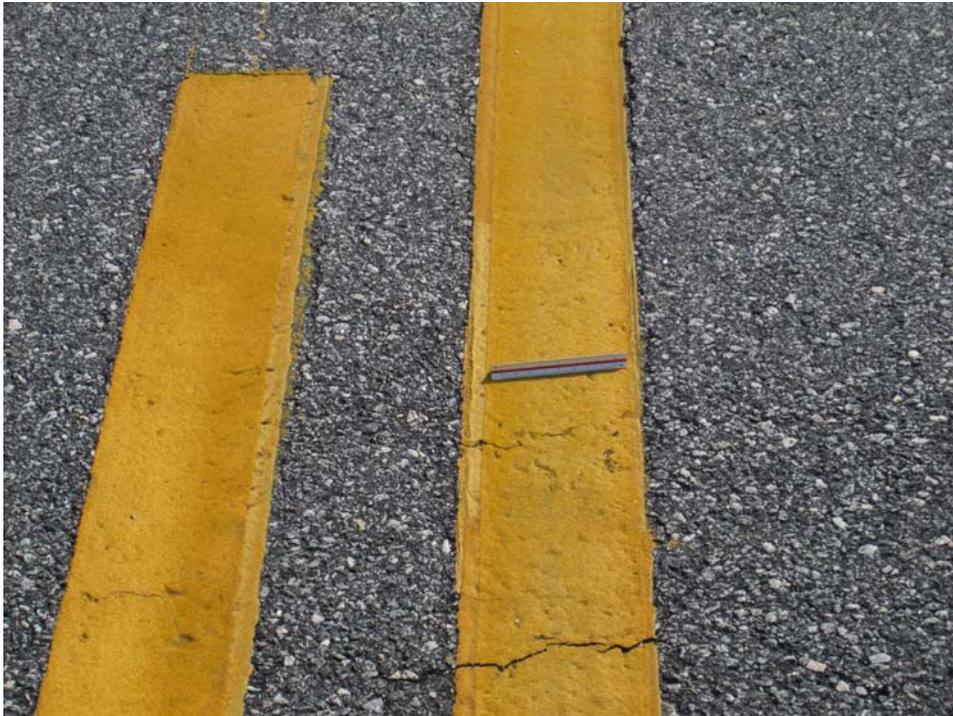
A01CS-20. Satisfactory Paint.

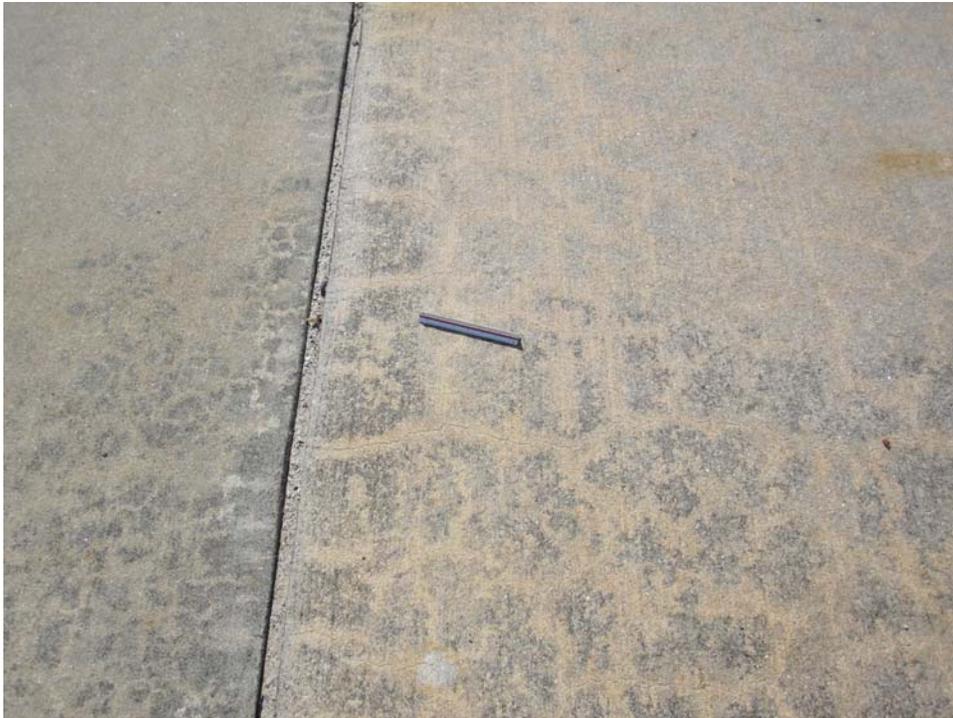
The terminal apron area (ATERMCS) contained two sections. Section 10 consists of the majority of the apron area with a PCI value of 86. Low-severity alkali silica reaction (ASR) was the only distress observed in this section. Section 20 was in excellent condition with a PCI value of 100. No distresses were identified in this section during the inspection.

ATERMCS-10. ASR (Sample Unit #05).

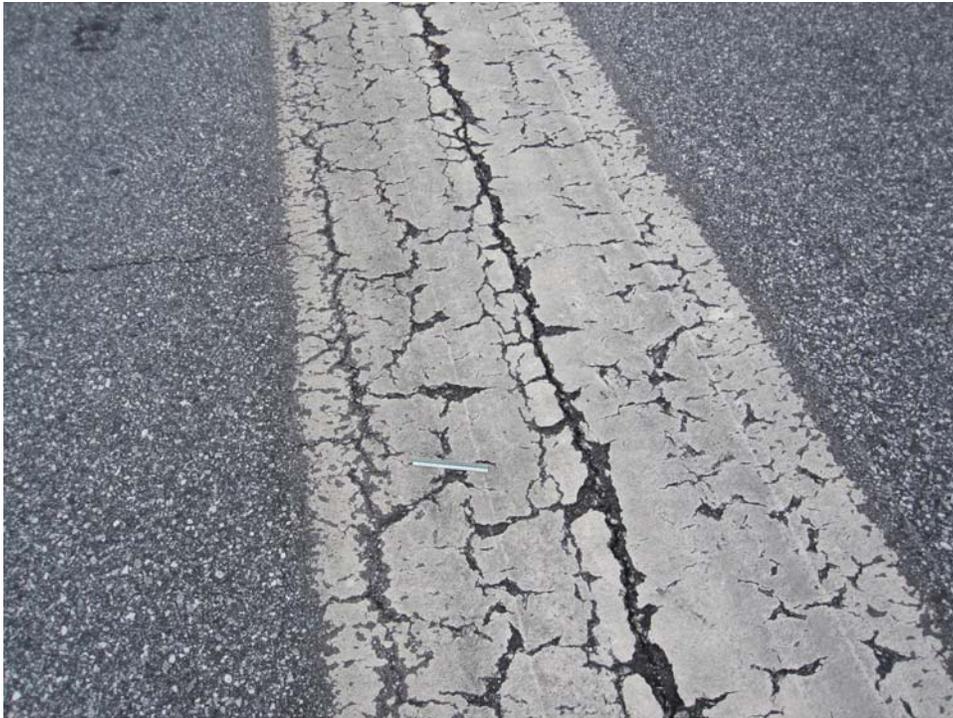
R1331CS-10C. Unsatisfactory Paint.

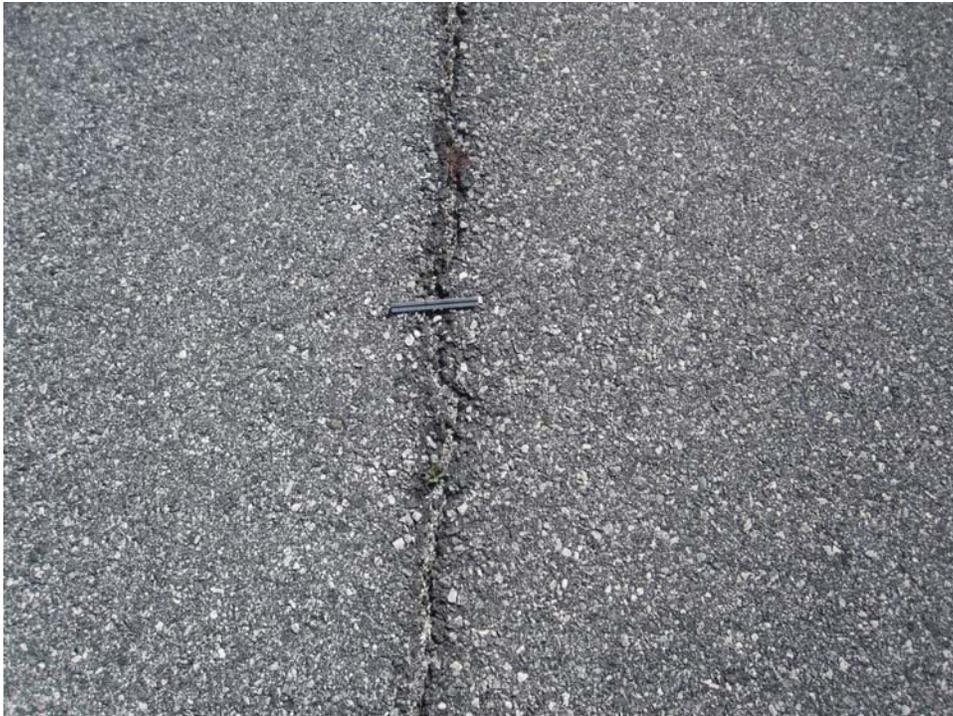
R1331CS-10N. Longitudinal and Transverse Cracking (Sample Unit #14).

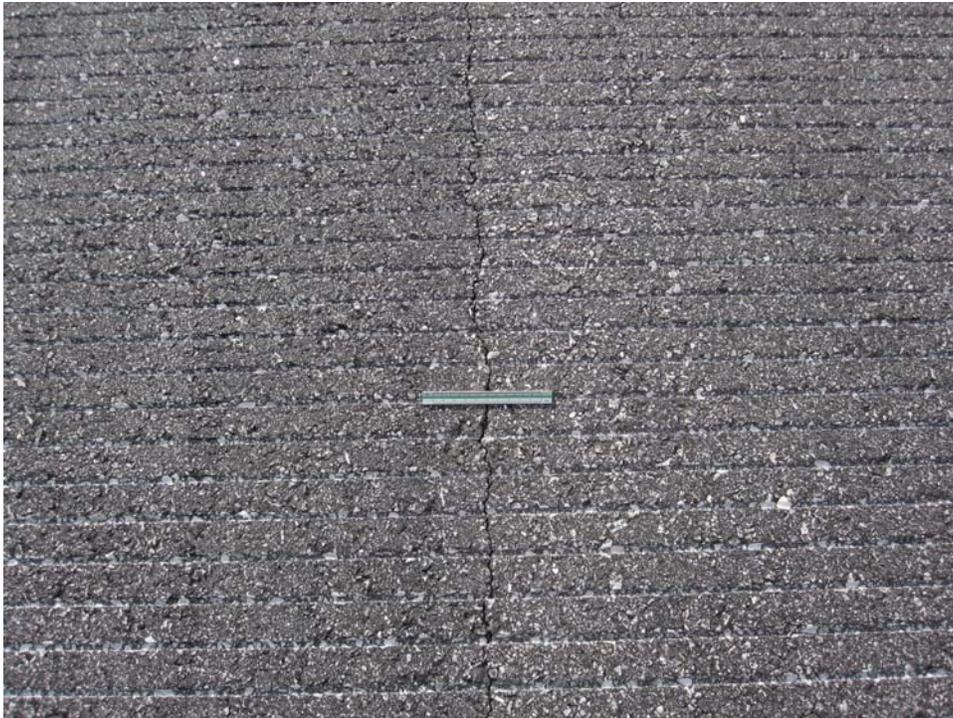
R624CS-10C. Longitudinal and Transverse Cracking (Sample Unit #35).

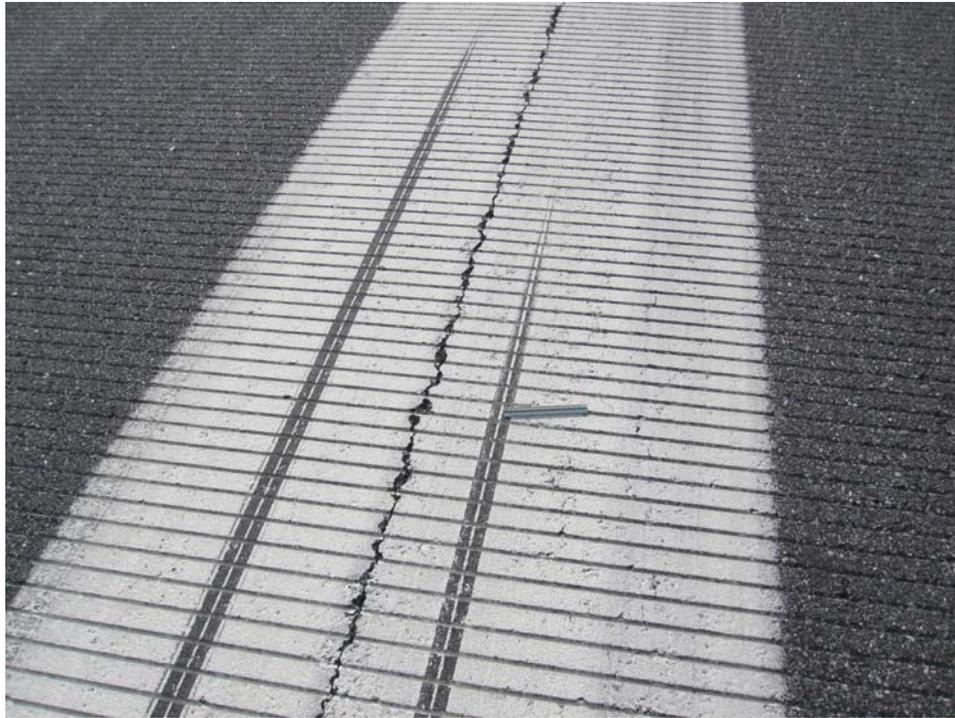
R624CS-10C. Satisfactory Paint.

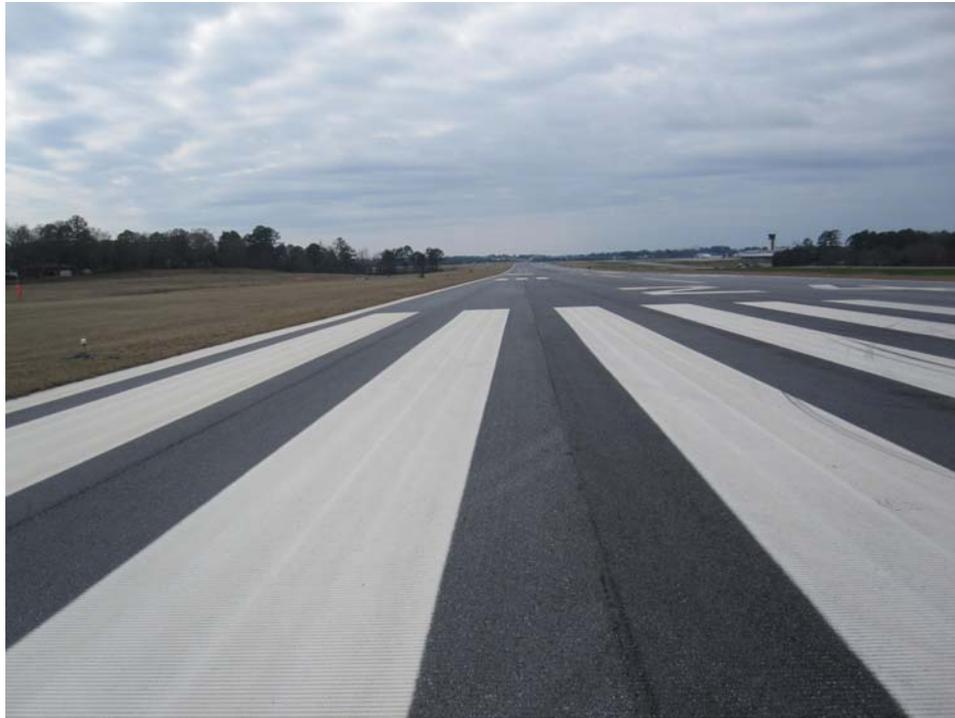
R624CS-10E. Overview.

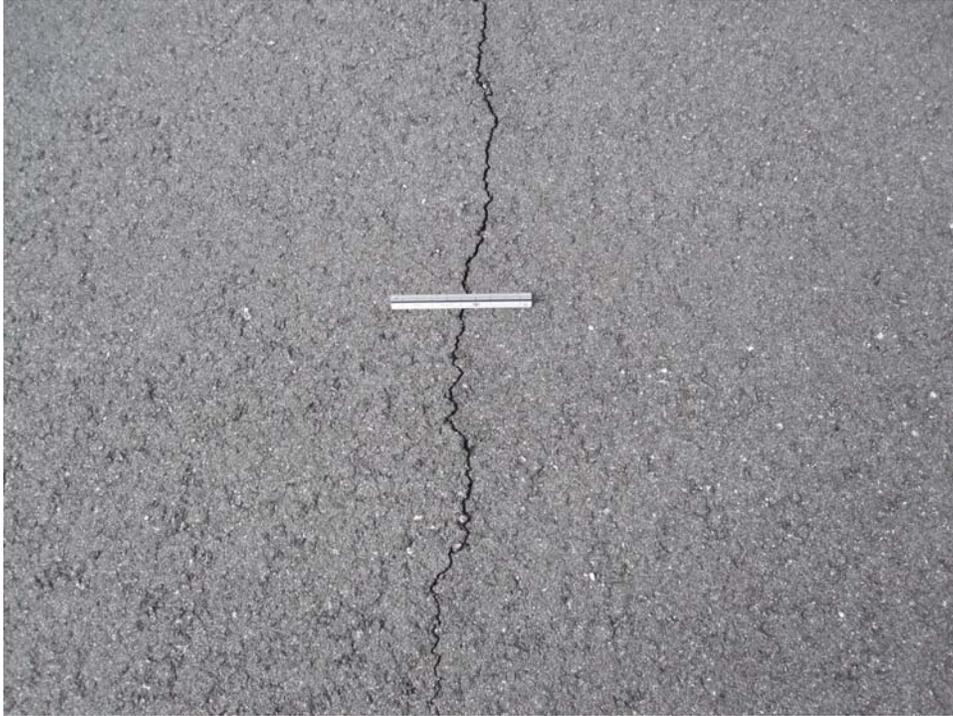
R624CS-10E. Longitudinal and Transverse Cracking (Sample Unit #46).

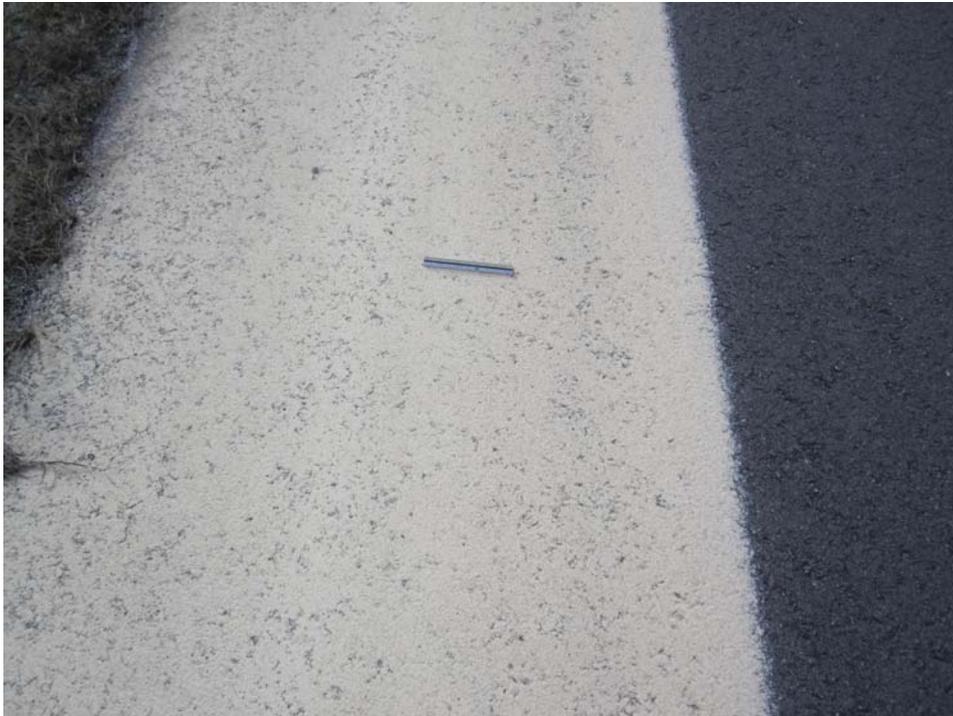
R624CS-10E. Satisfactory Paint.

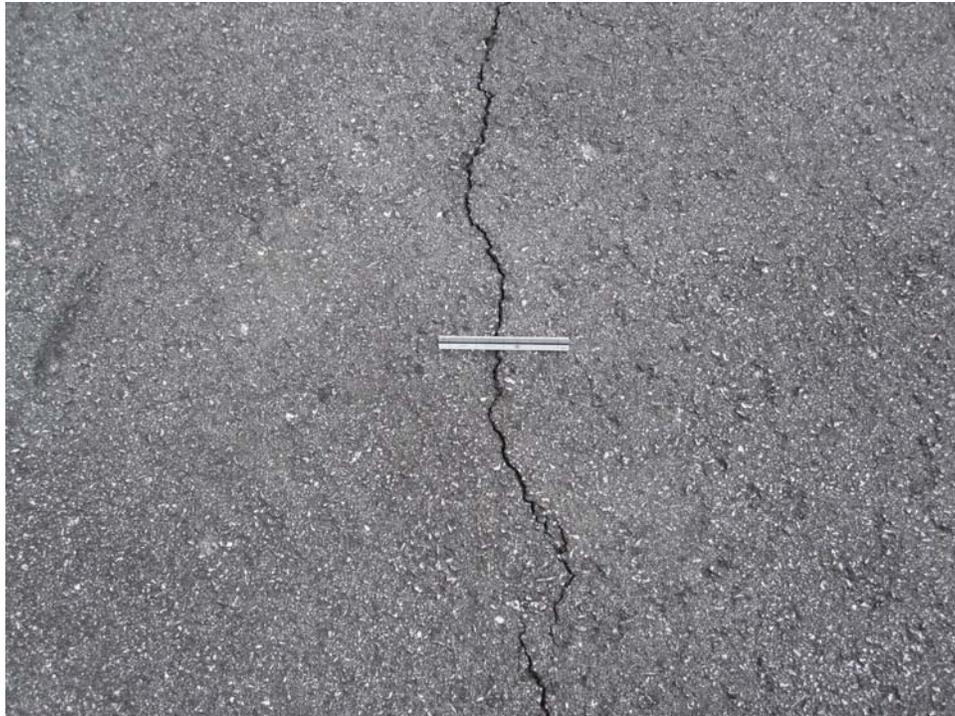
R624CS-10W. Longitudinal and Transverse Cracking (Sample Unit #44).

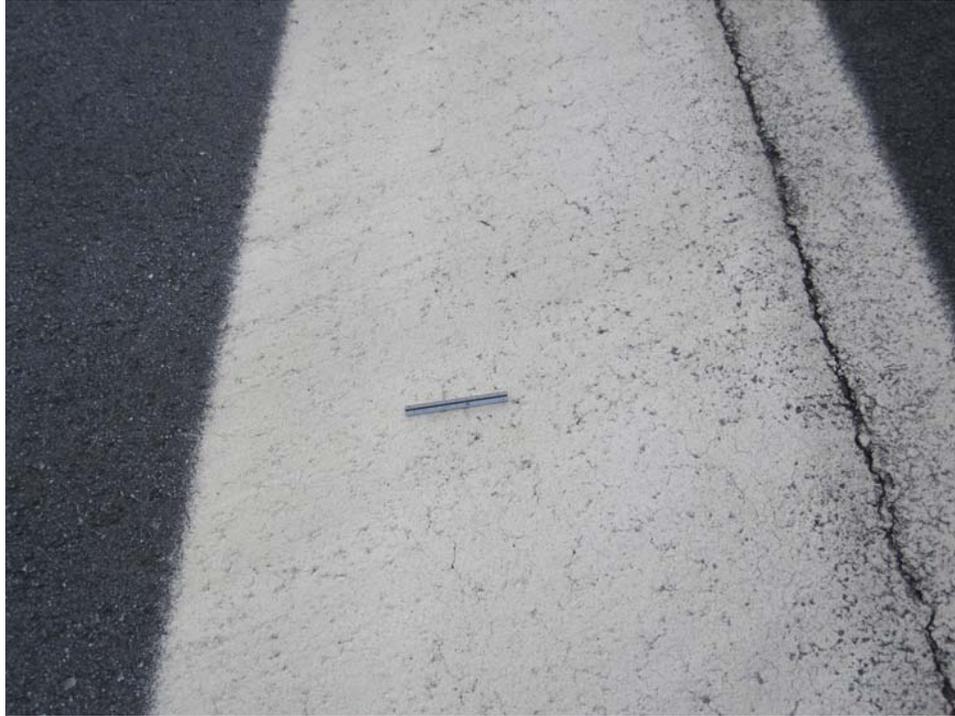
R624CS-10W. Satisfactory Paint.

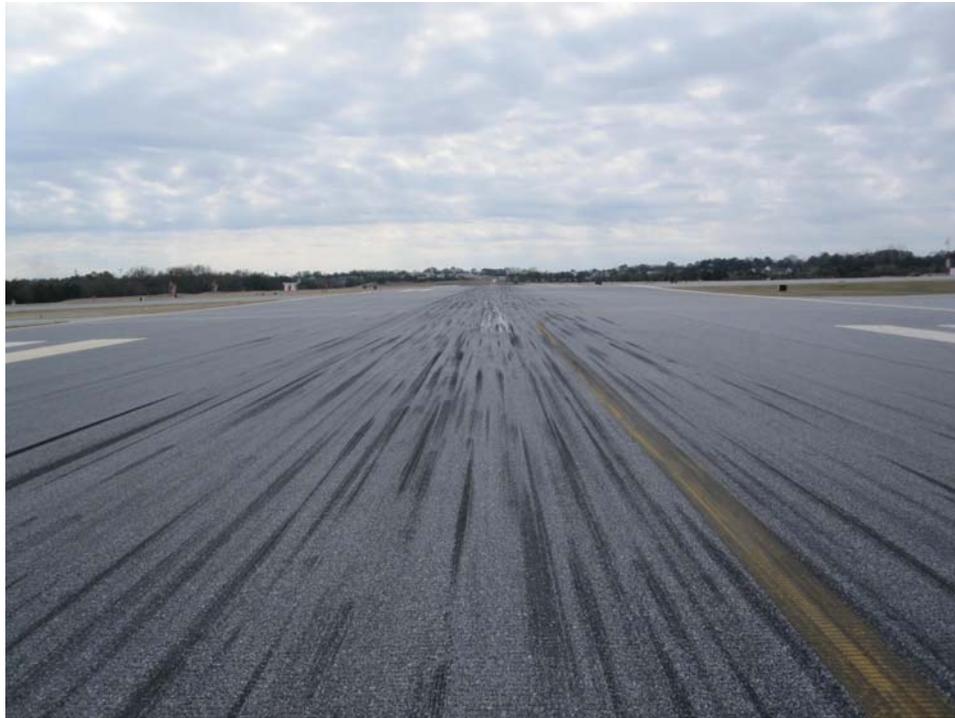
R624CS-20C. Overview.

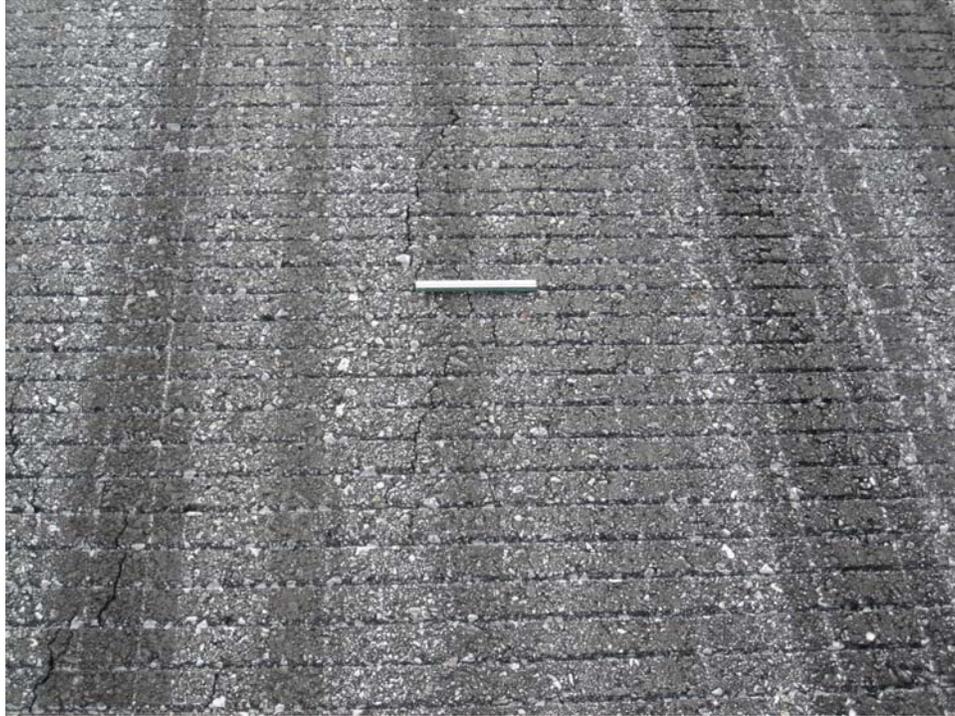
R624CS-20C. Alligator Cracking (Sample Unit #06).

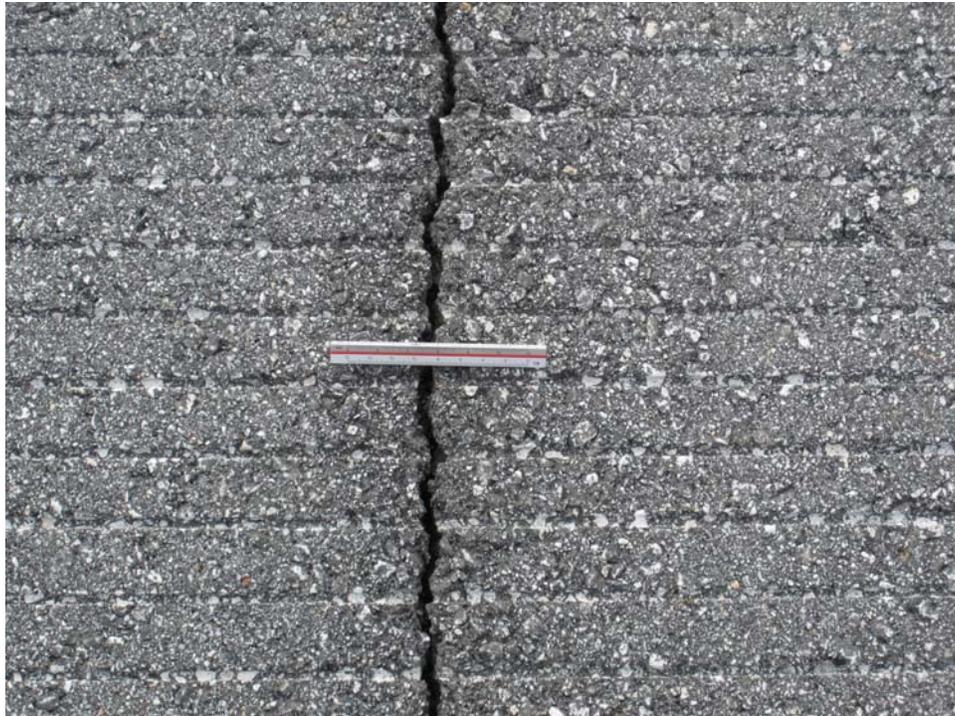
R624CS-20C. Longitudinal and Transverse Cracking (Sample Unit #06).

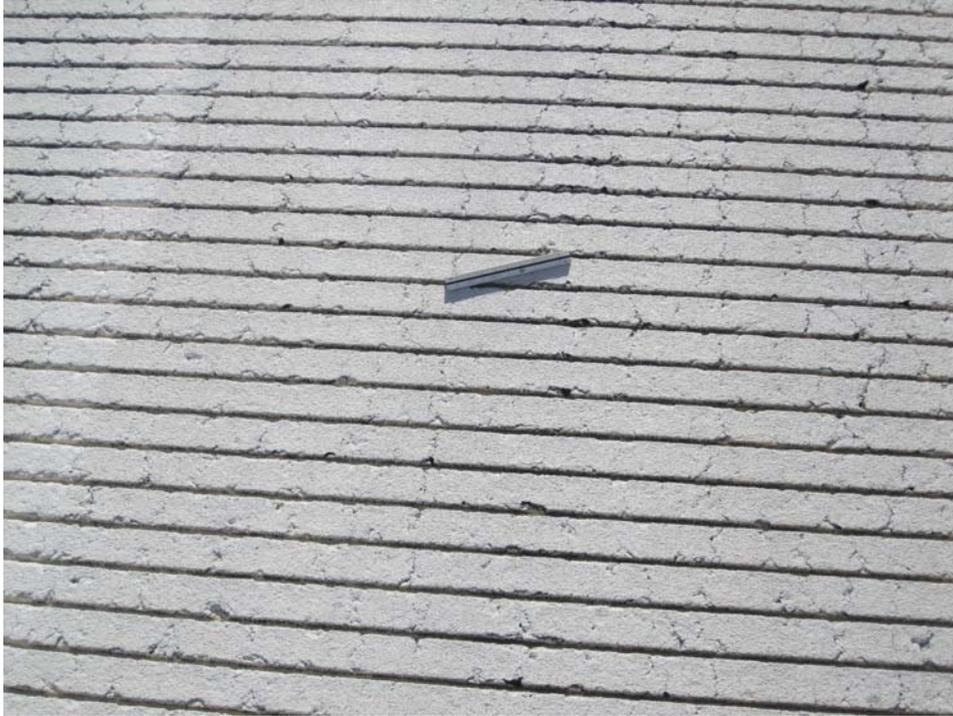
R624CS-20C. Satisfactory Paint.

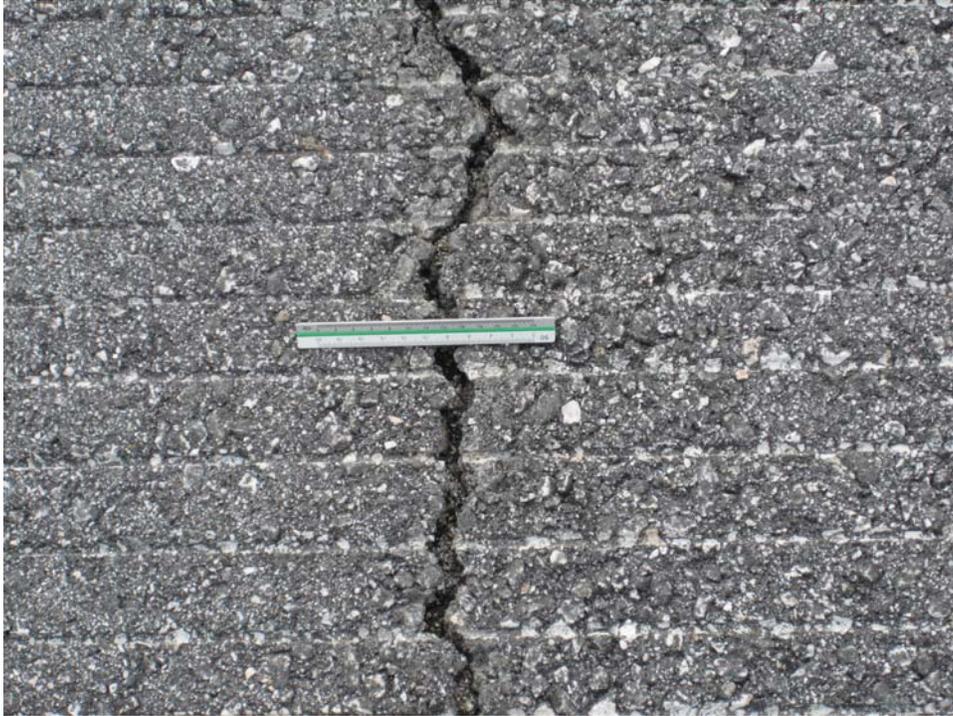
R624CS-20E. Longitudinal and Transverse Cracking (Sample Unit #01).

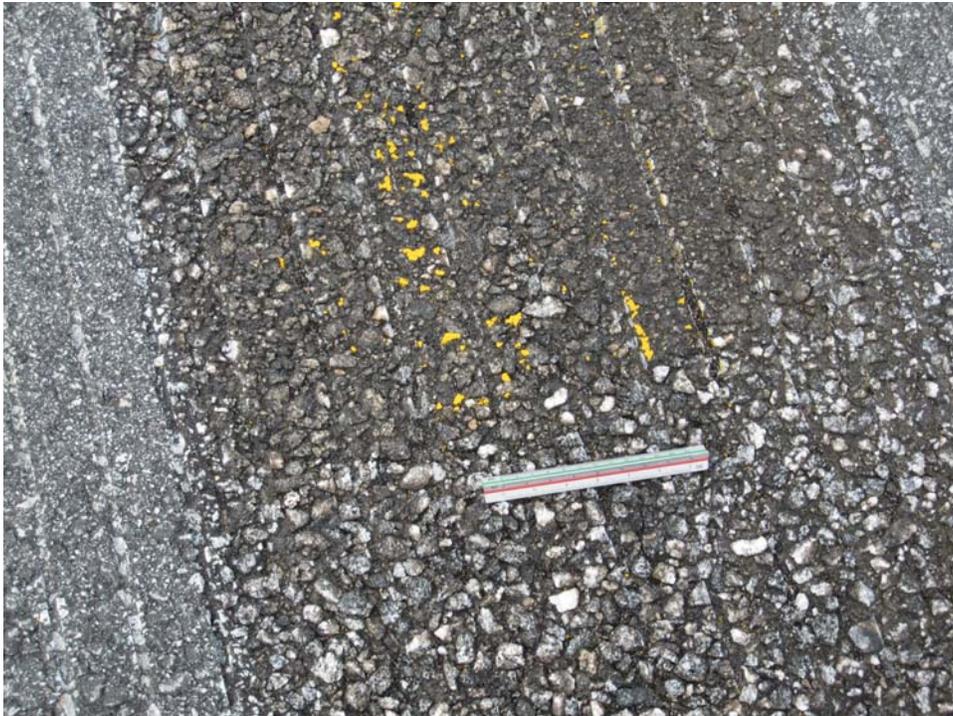
R624CS-20E. Raveling (Sample Unit #01).

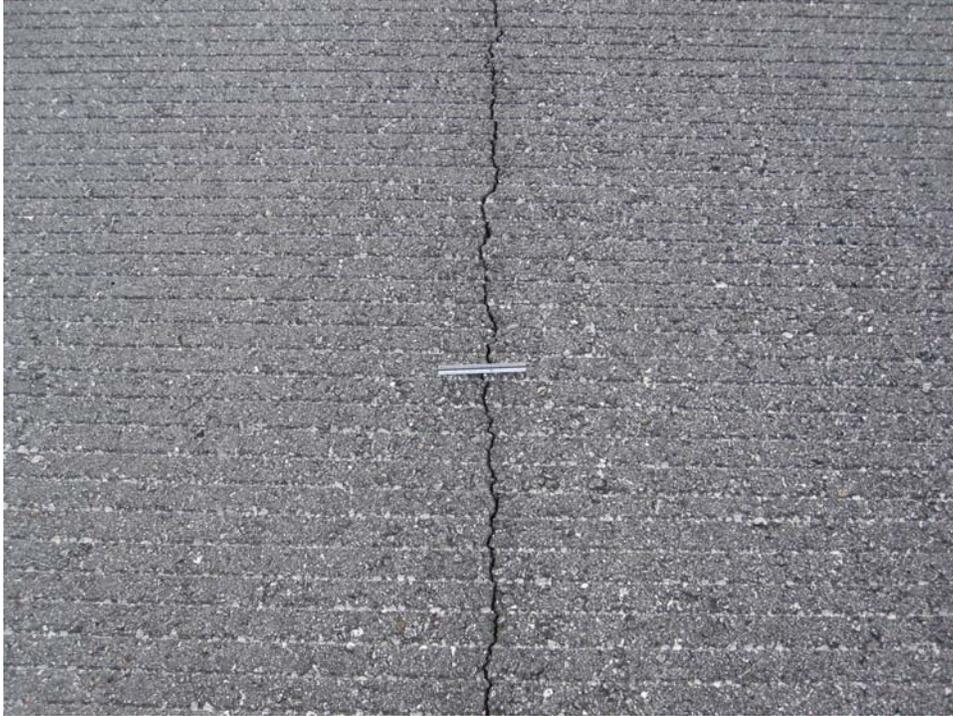
R624CS-20W. Longitudinal and Transverse Cracking (Sample Unit #15).

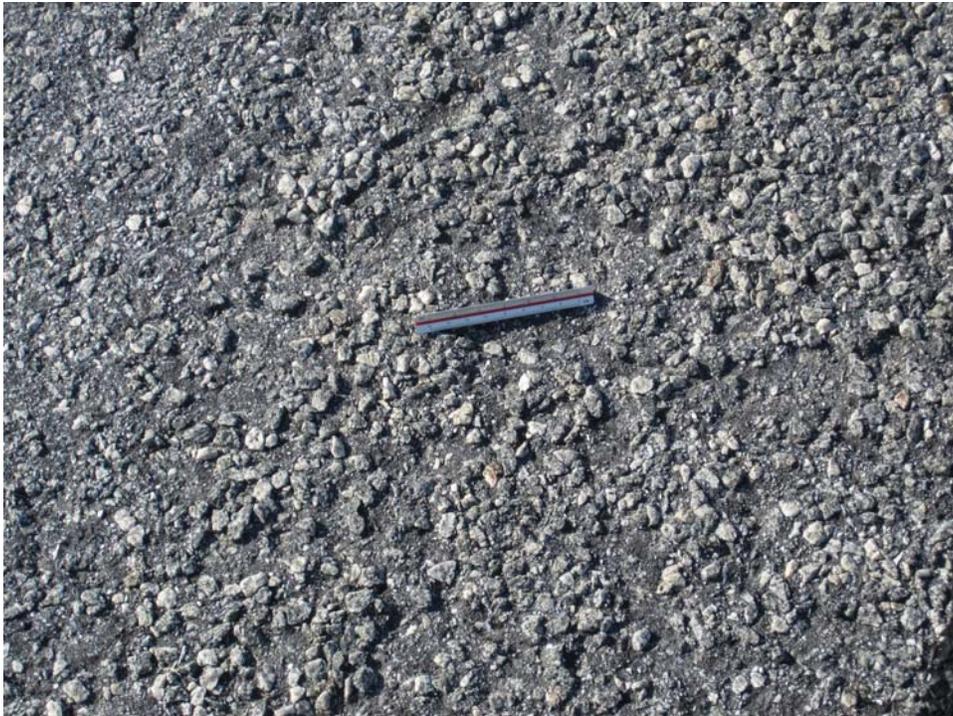
R624CS-20W. Raveling (Sample Unit #19).

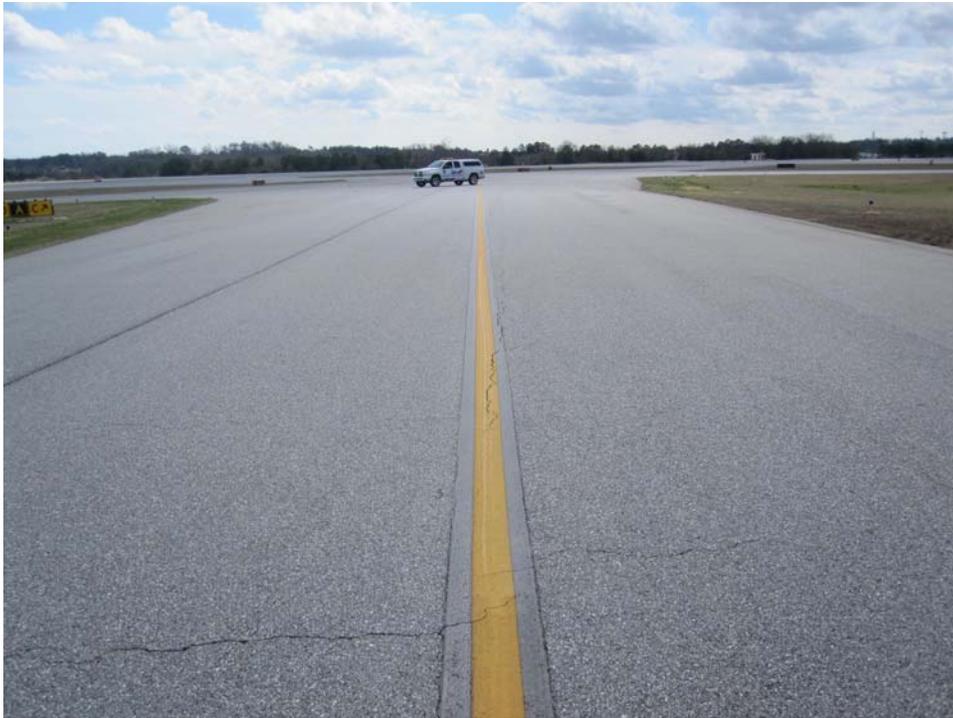
TACS-10. Overview.

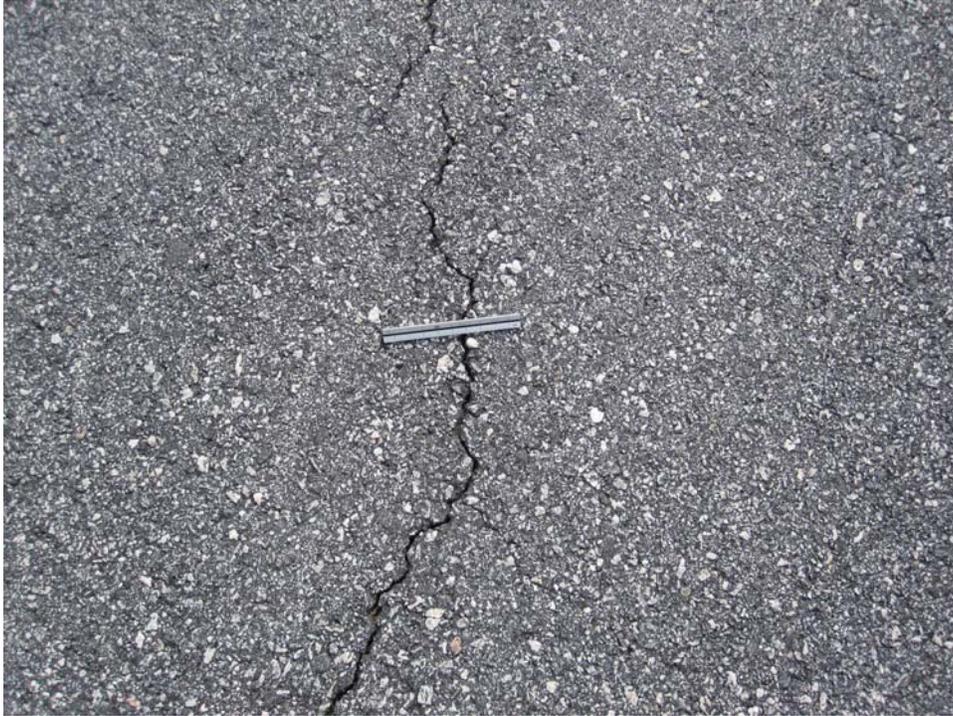
Taxiway A was comprised of one section located between Taxiway C and the FBO apron. Section 10 had a PCI value of 81 with the primary distresses observed being low- and medium-severity L&T cracking. Medium-severity patching was also identified.

TACS-10. Longitudinal and Transverse Cracking (Sample Unit #02).

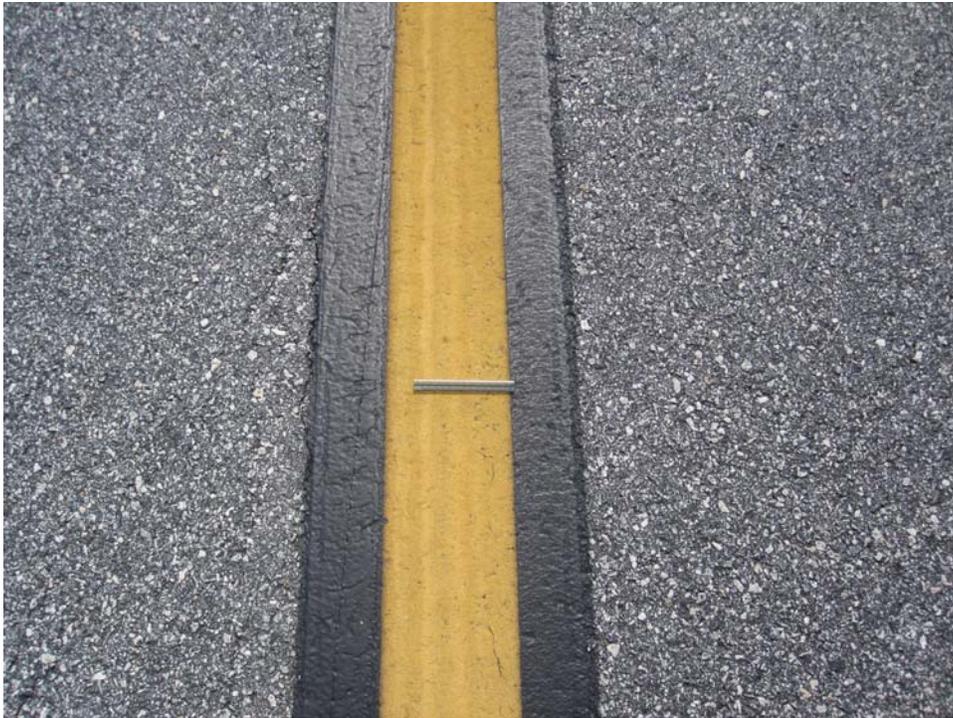
TACS-10. Satisfactory Paint.

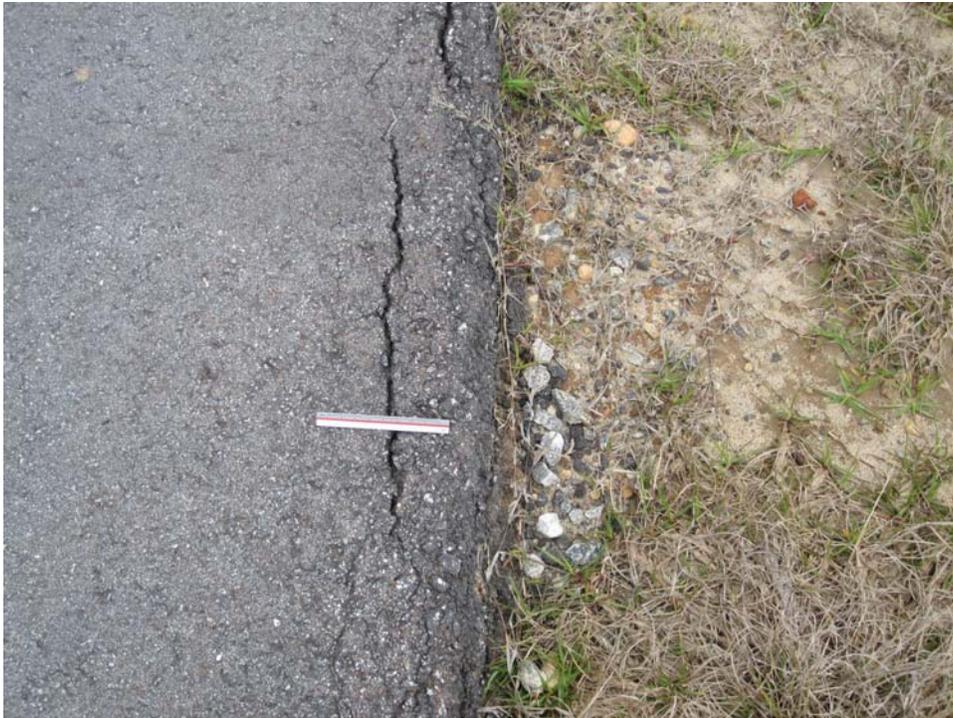
TCCS-10. Longitudinal and Transverse Cracking (Sample Unit #68).

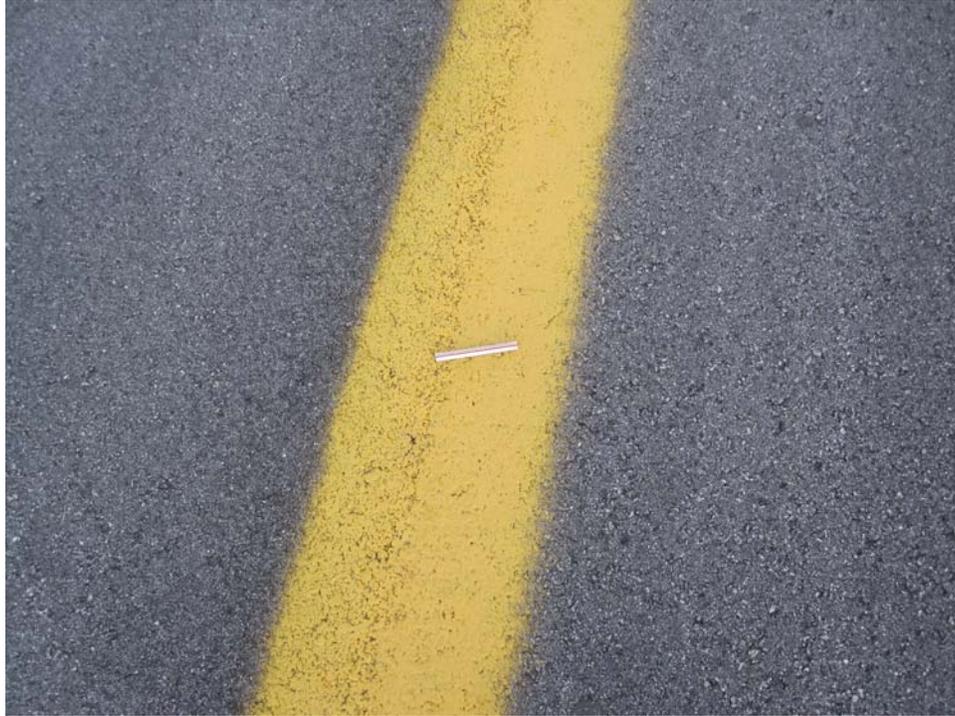
TCCS-10. Satisfactory Paint.

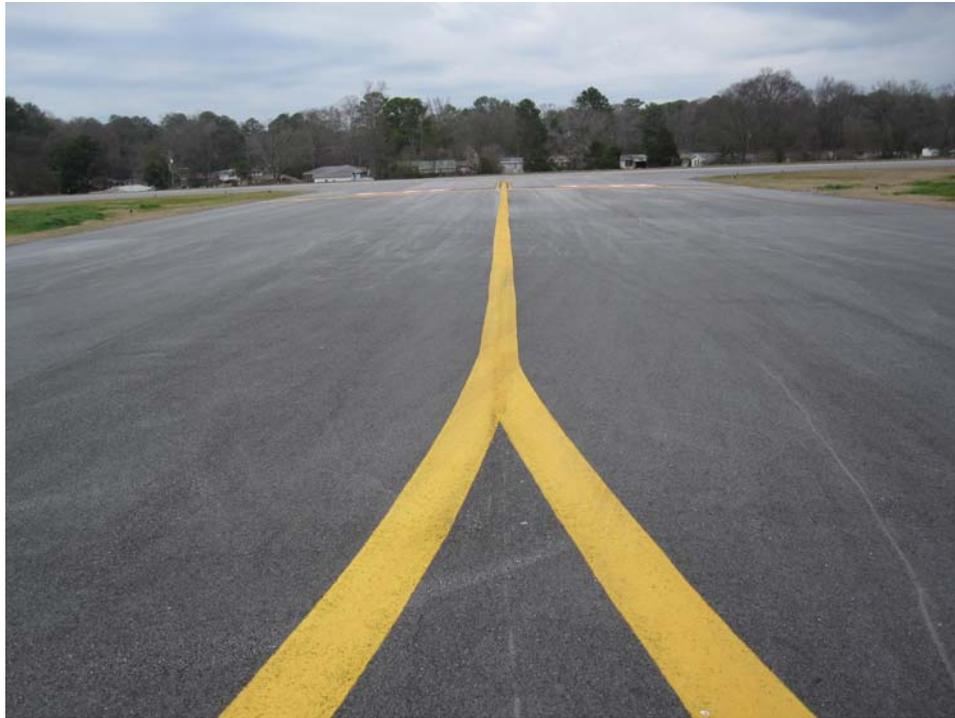
TCCS-20. Overview.

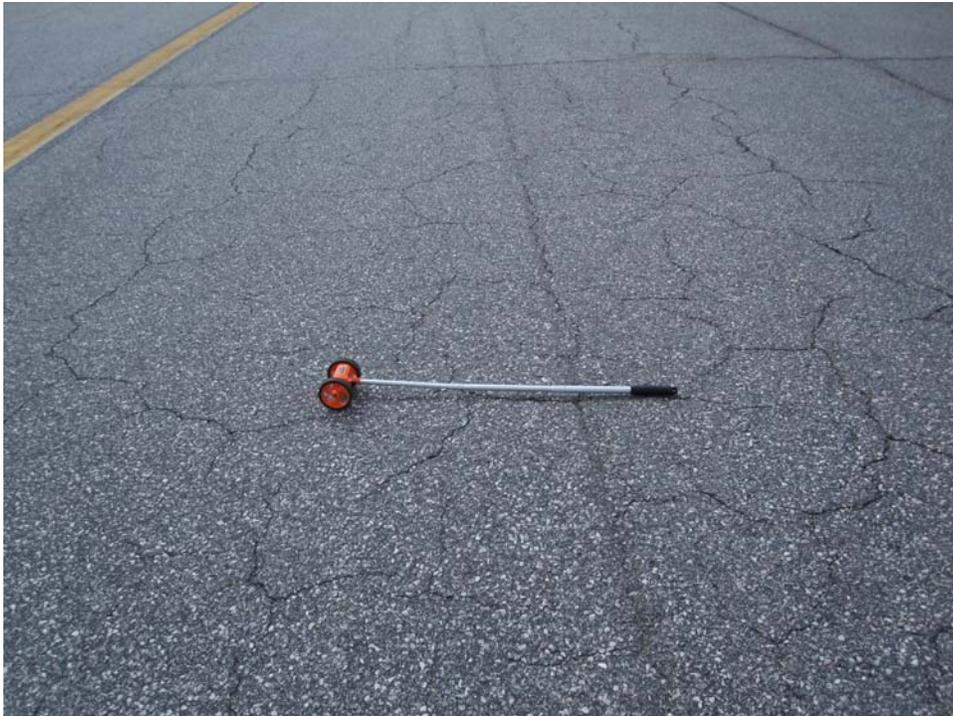
TCCS-30. Block Cracking (Sample Unit #01).

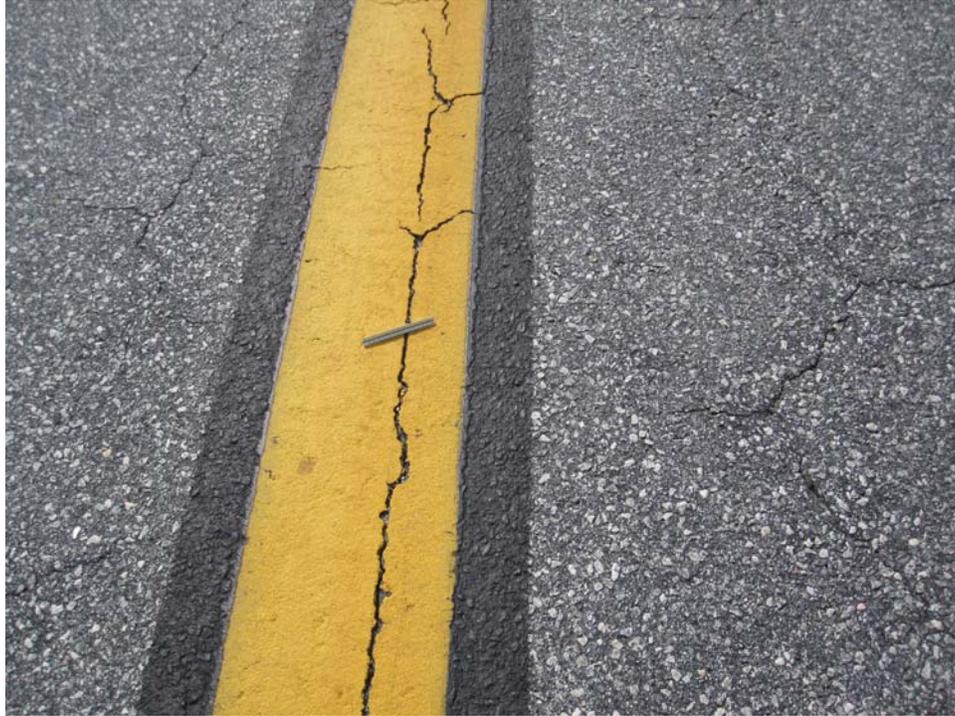
TCCS-30. Satisfactory Paint.

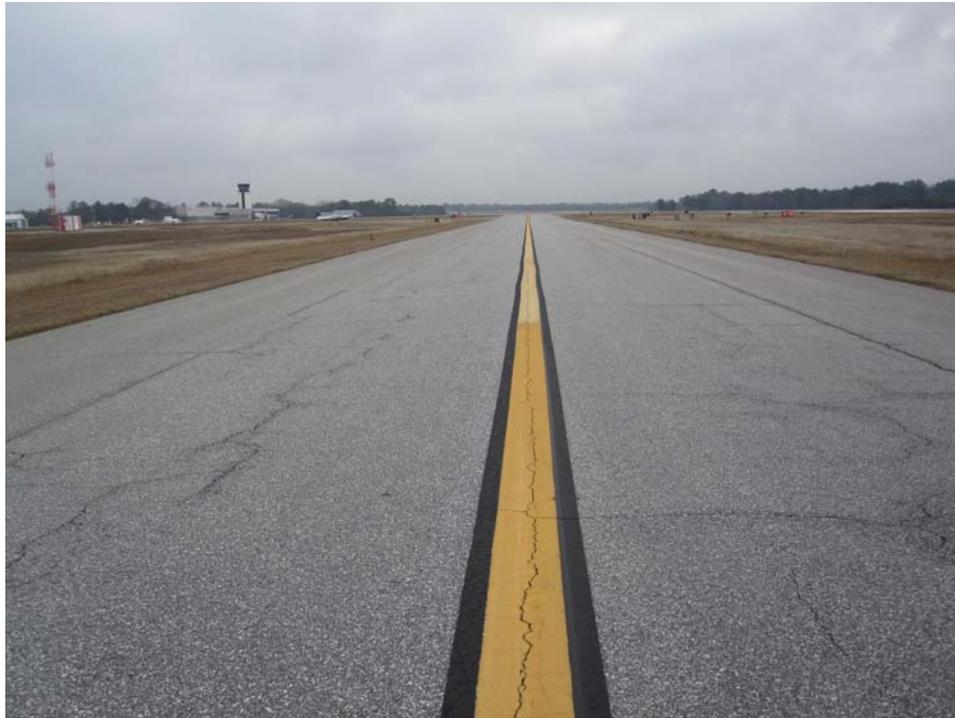
TCCS-40. Overview.
