2012 Columbus Airport Pavement Management Plan

COLUMBUS AIRPORT

PAVEMENT MANAGEMENT REPORT

DECEMBER 2012

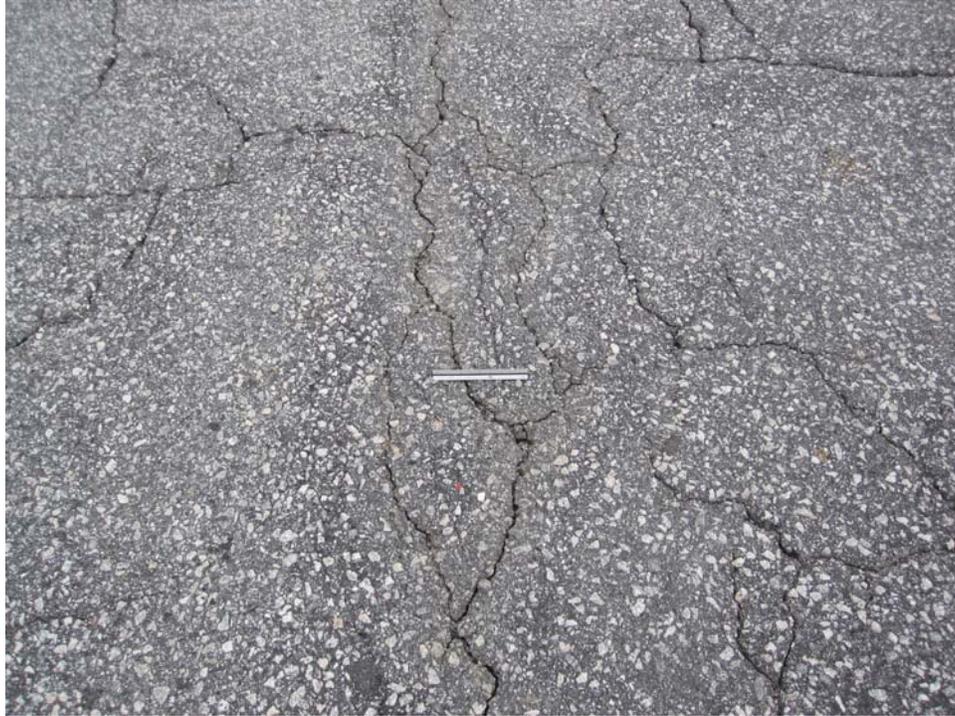
TCCS-40. Alligator Cracking (Additional Sample Unit #02).

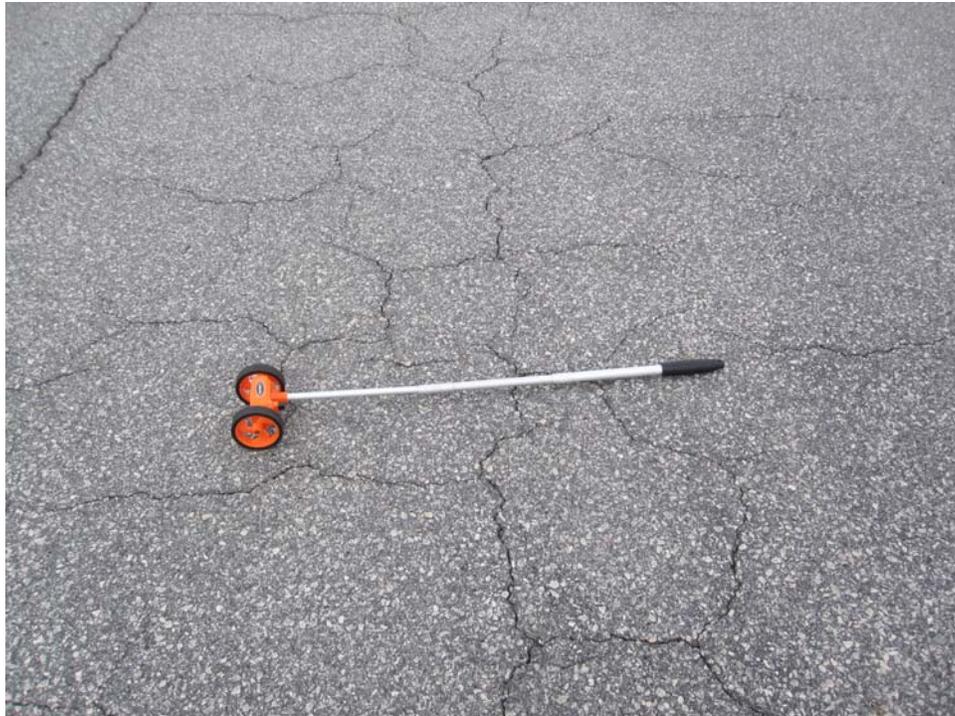
TCCS-40. Block Cracking (Sample Unit #14).

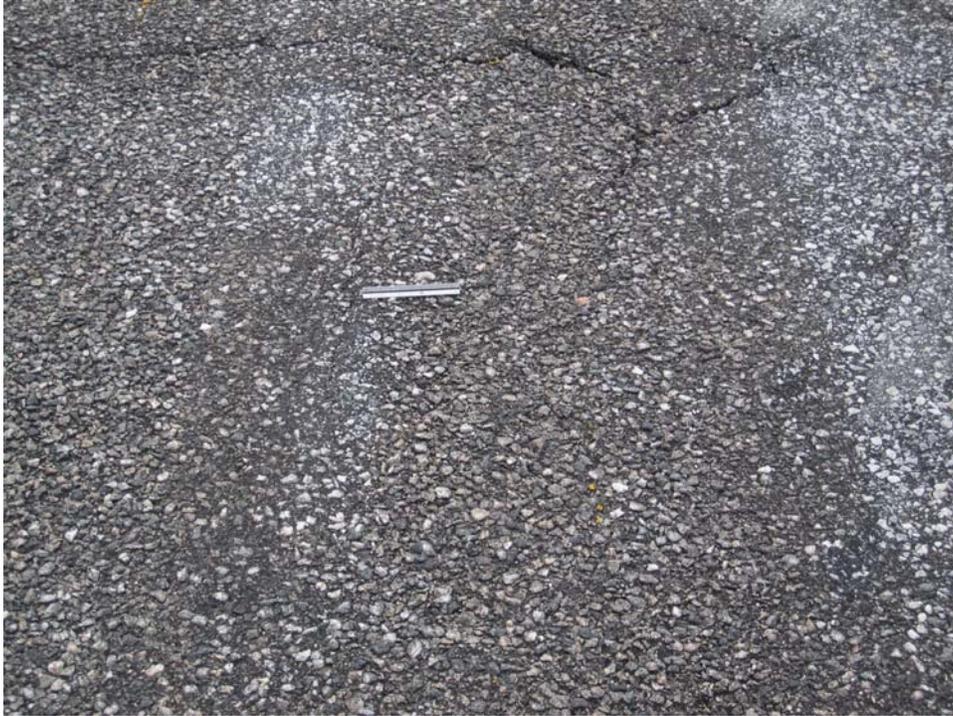
TCCS-40. Raveling (Additional Sample Unit #02).

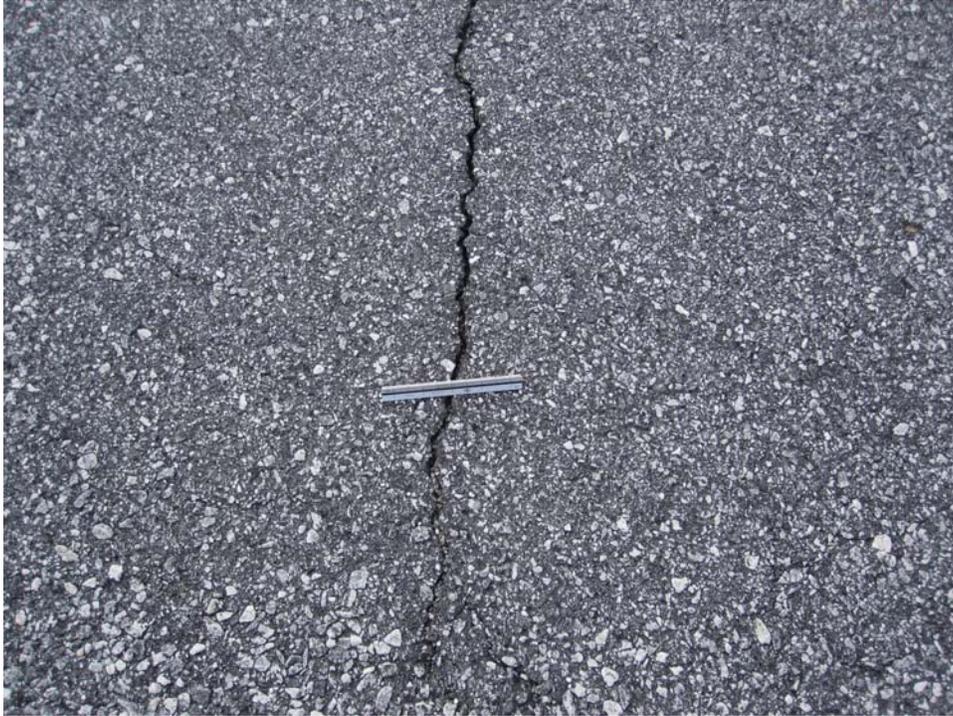
Taxiway D2 was comprised of one section between Taxiway D and the FBO apron. Section 10 had a PCI value of 79 with the primary distresses observed being low- and medium-severity L&T cracking. Small amounts of low- and medium-severity weathering were also identified in this section.

TD2CS-10. Longitudinal and Transverse Cracking (Sample Unit #02).

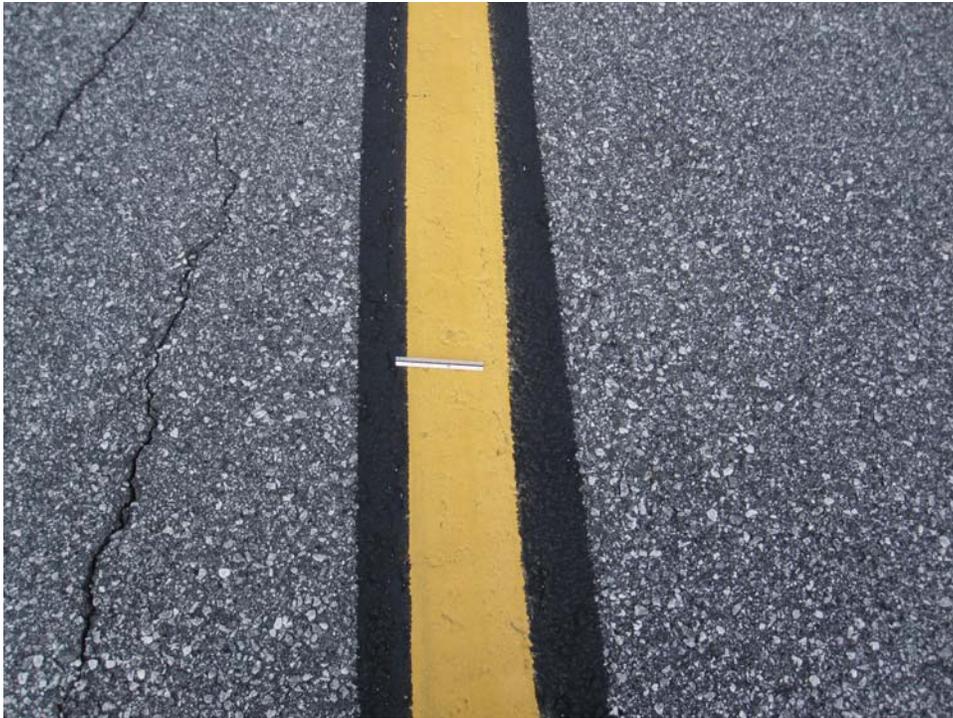
TD2CS-10. Satisfactory Paint.

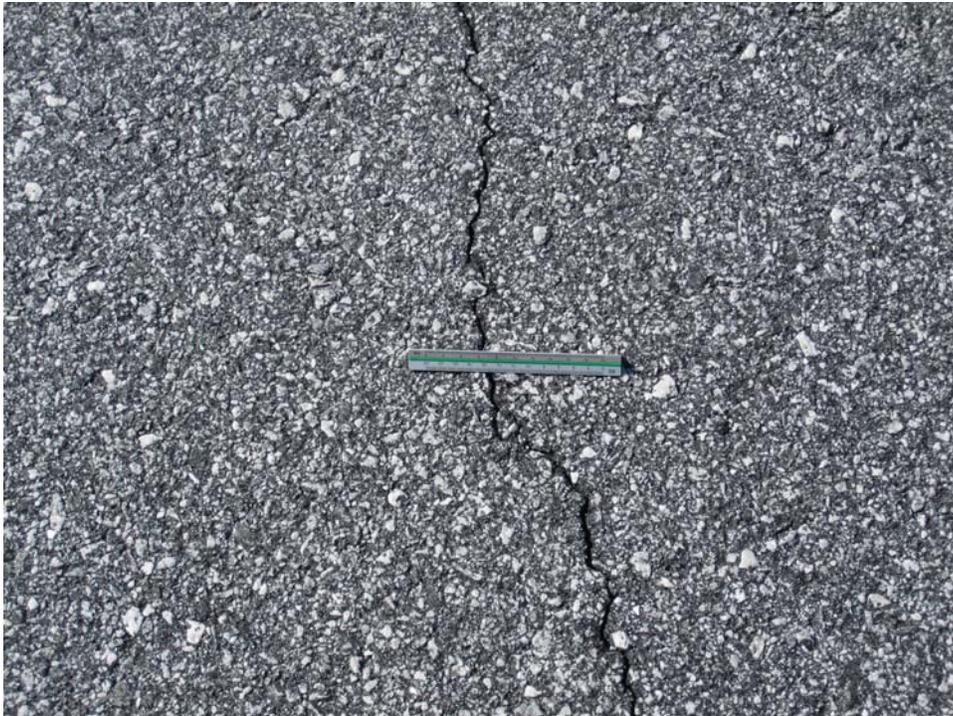
Taxiway D3 contained one section with a PCI value of 91. Small amounts of low- and medium-severity L&T cracking were the only distresses recorded throughout Section 10.

TD3CS-10. Longitudinal and Transverse Cracking (Sample Unit #03).

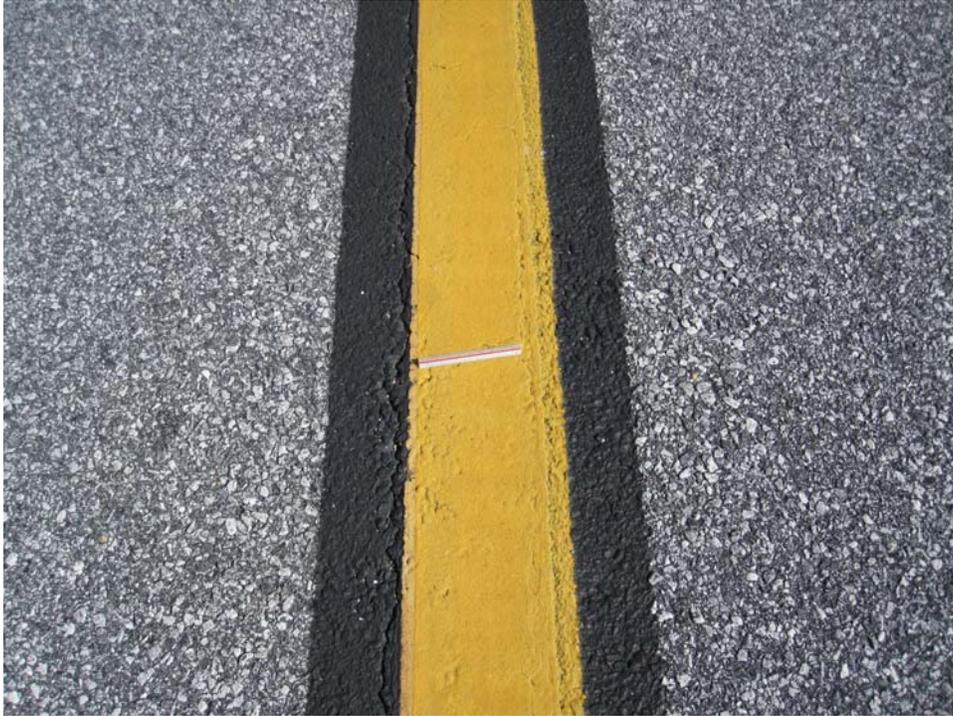
TD3CS-10. Satisfactory Paint.

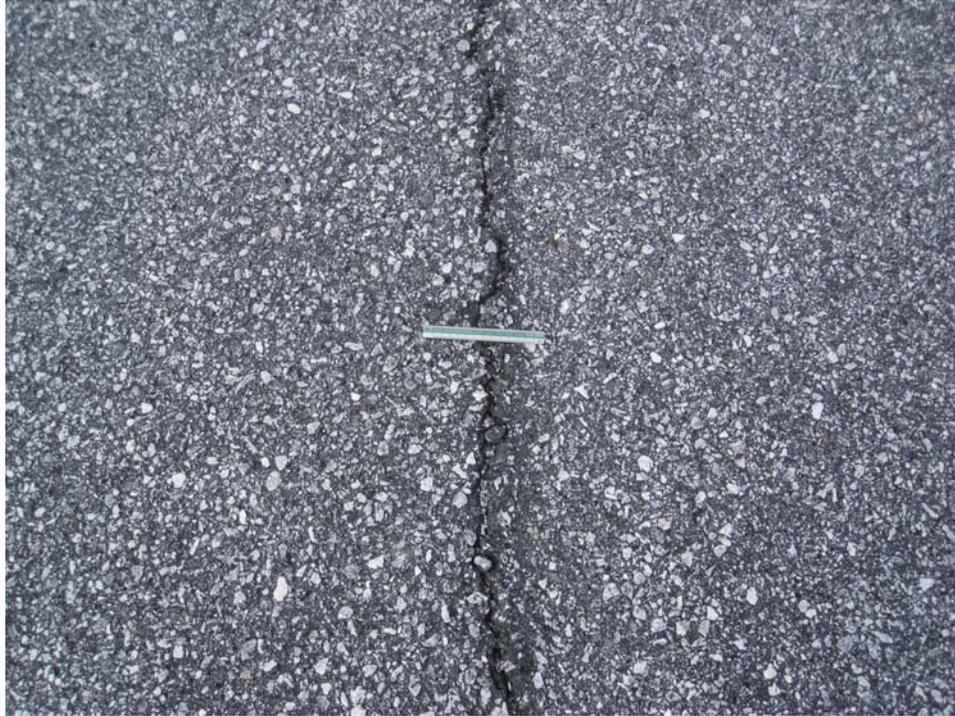
TDCS-10. Longitudinal and Transverse Cracking (Sample Unit #16).

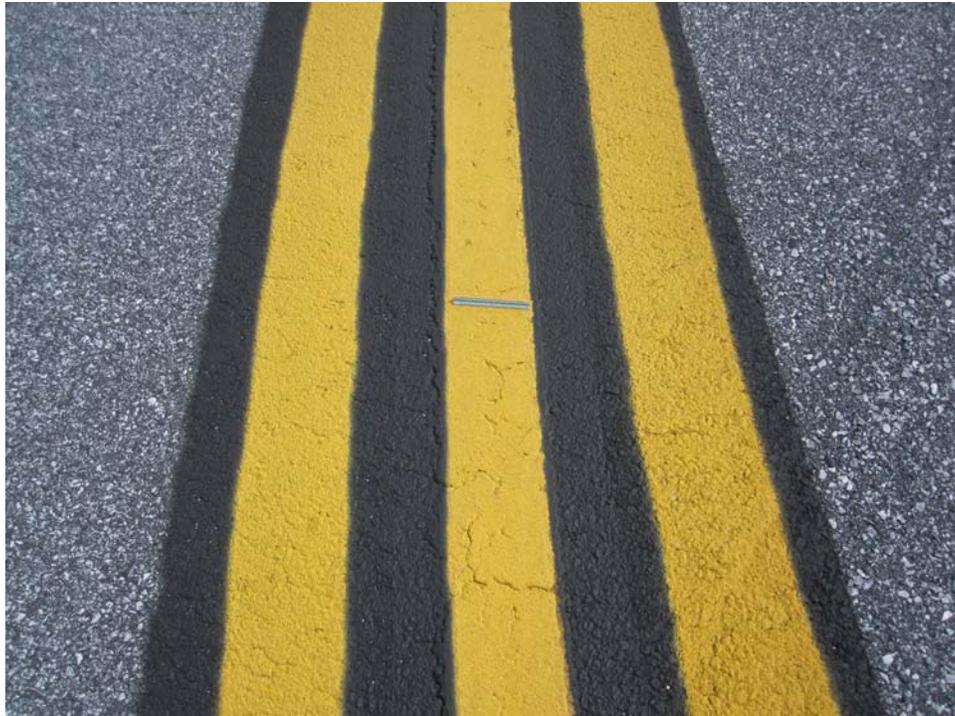
TDCS-10. Satisfactory Paint.

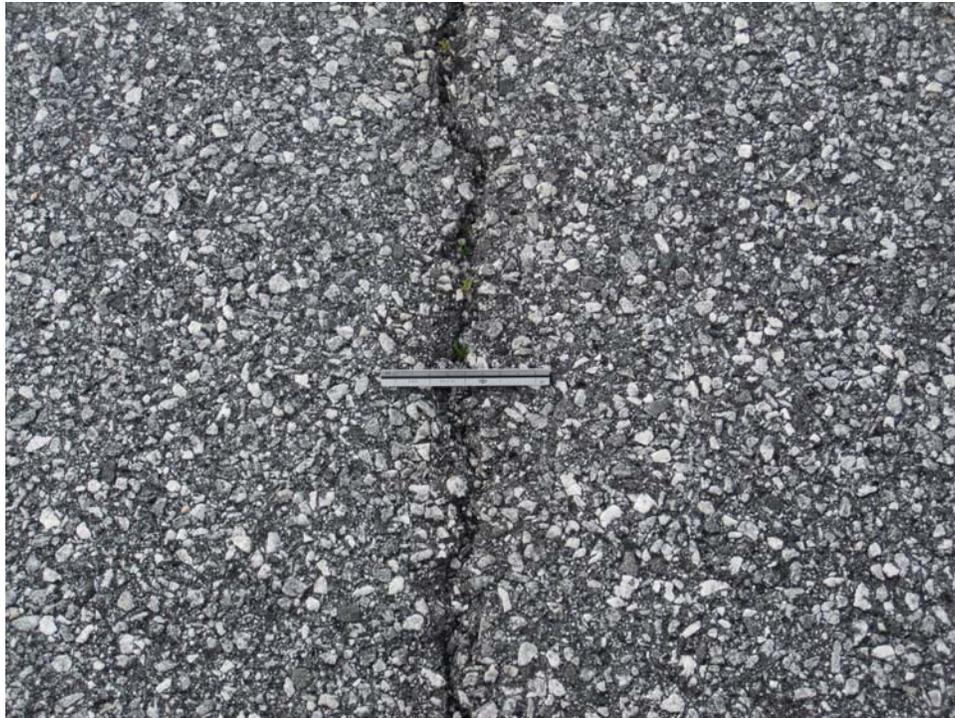
TDCS-20. Longitudinal and Transverse Cracking (Sample Unit #08).

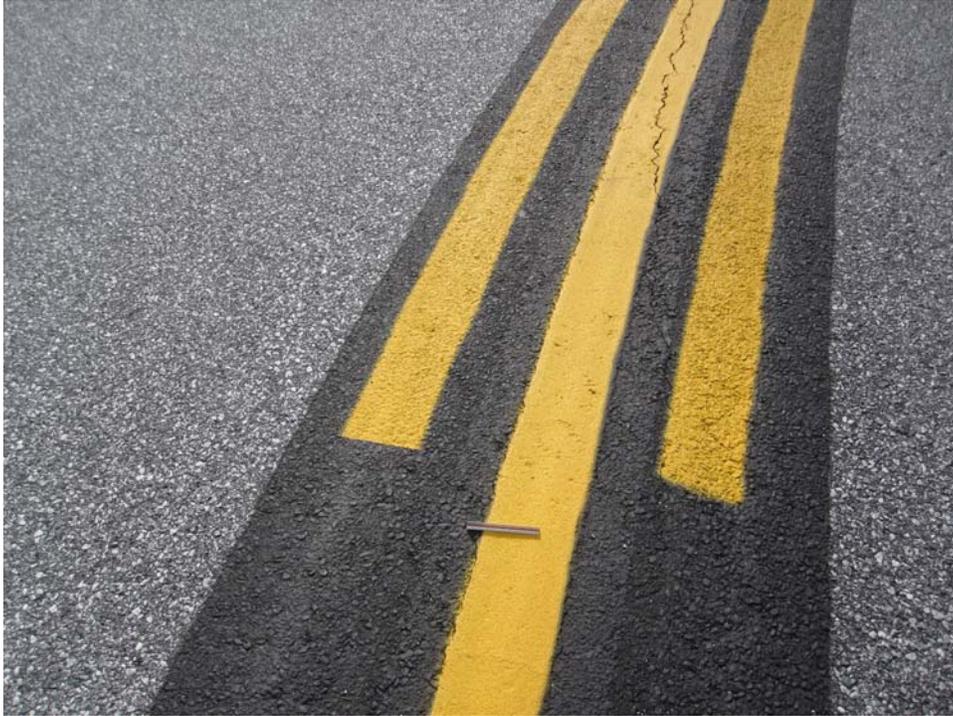
TDCS-20. Satisfactory Paint.

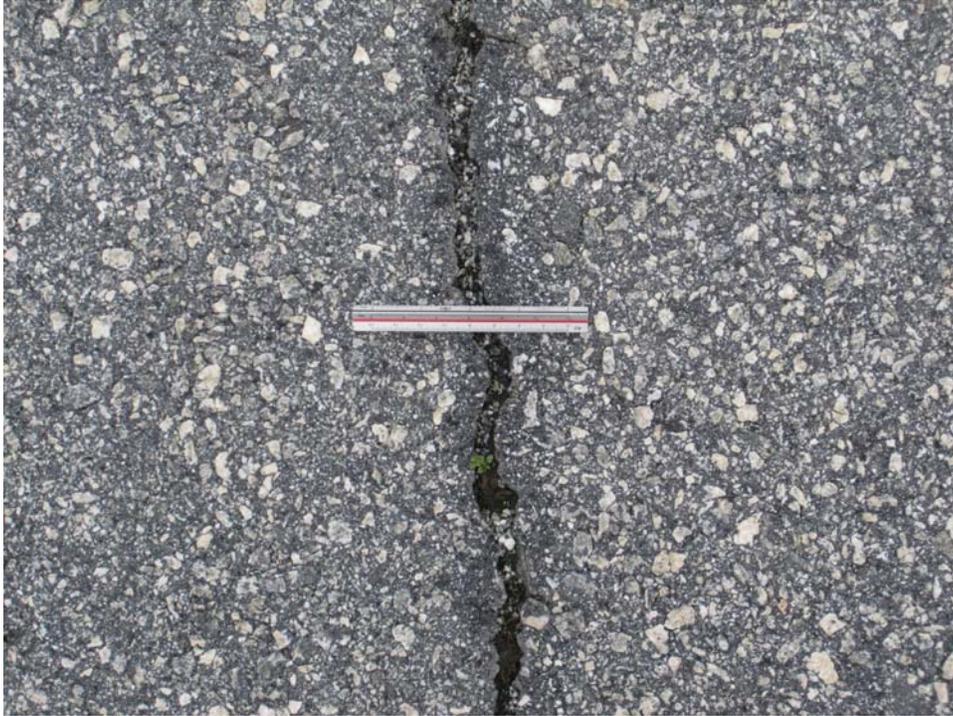
TFCS-10. Longitudinal and Transverse Cracking (Sample Unit #08).

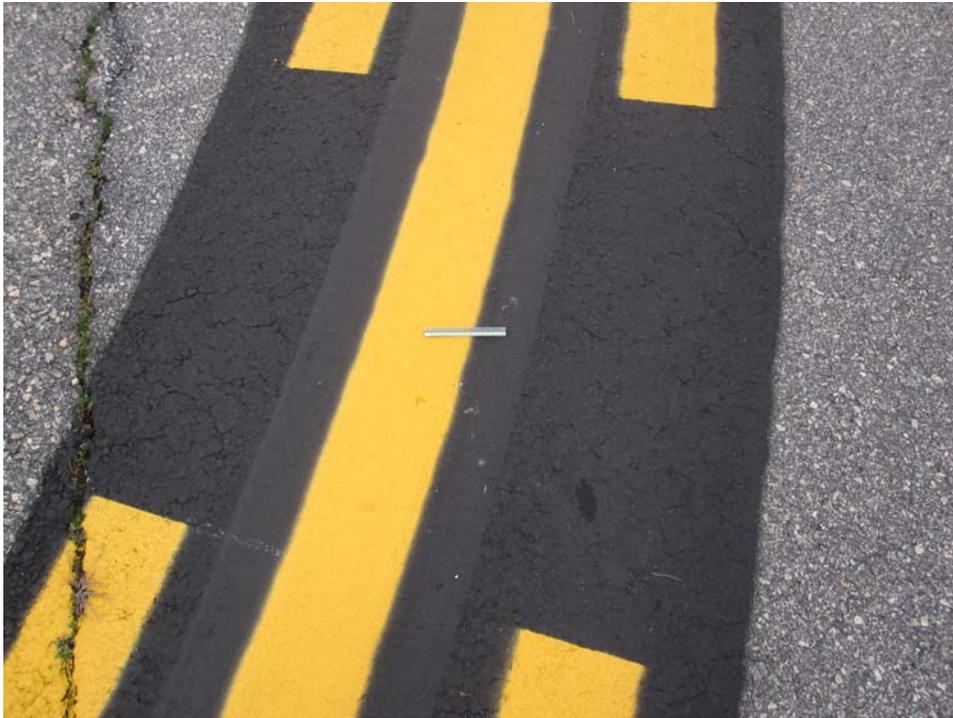
TFCS-10. Satisfactory Paint.

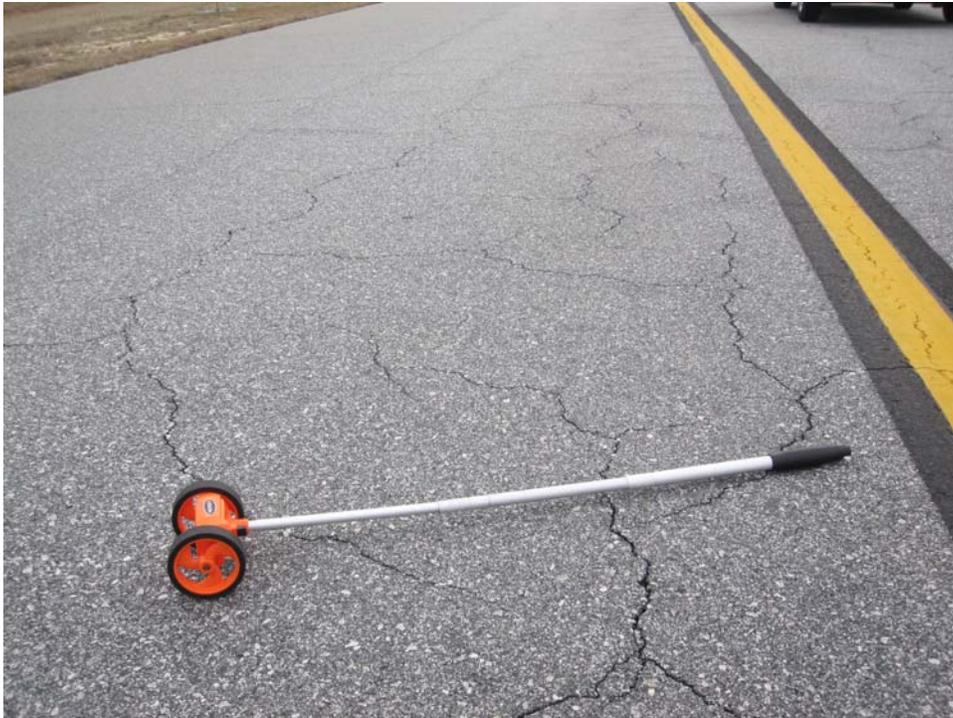
TFCS-20. Block Cracking (Sample Unit #11).

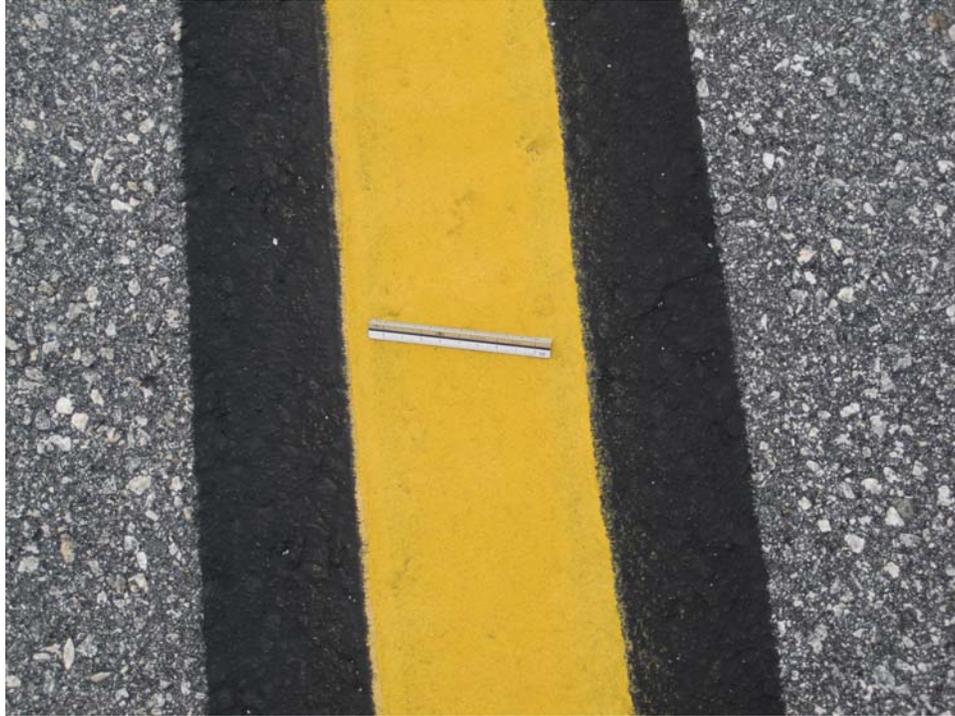
TFCS-20. Satisfactory Paint.

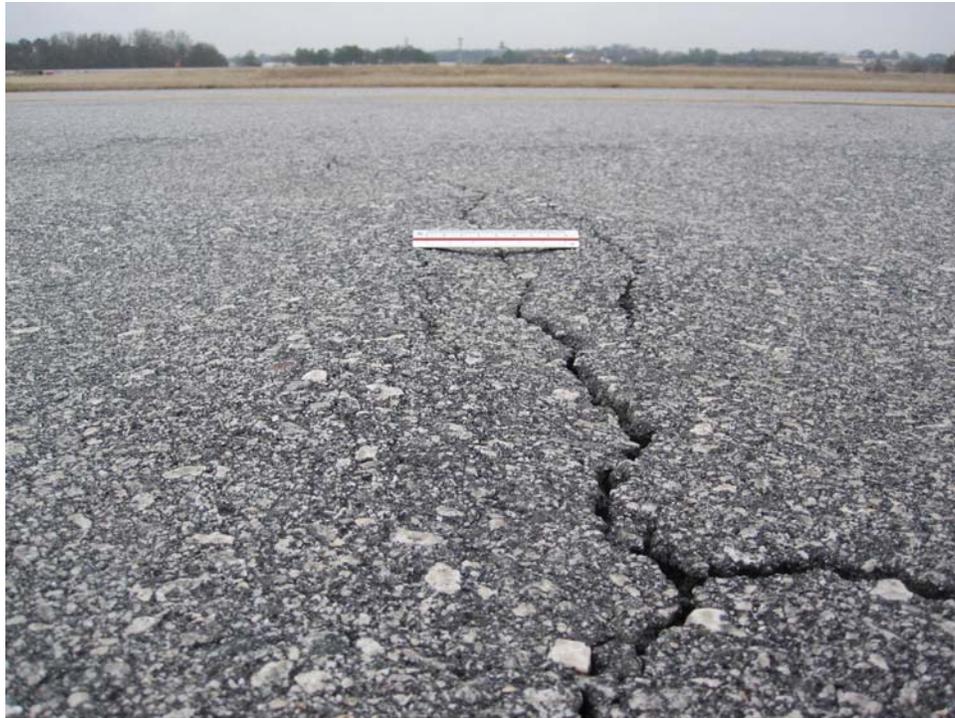
TFCS-20. Swelling (Sample Unit #12).

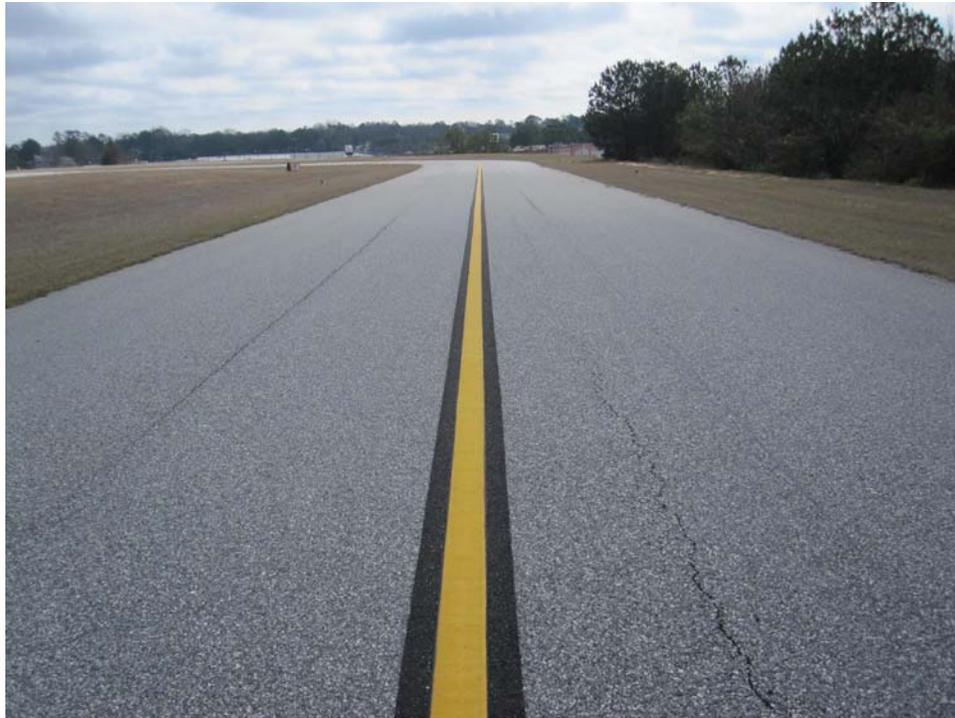
TFCS-40. Overview.

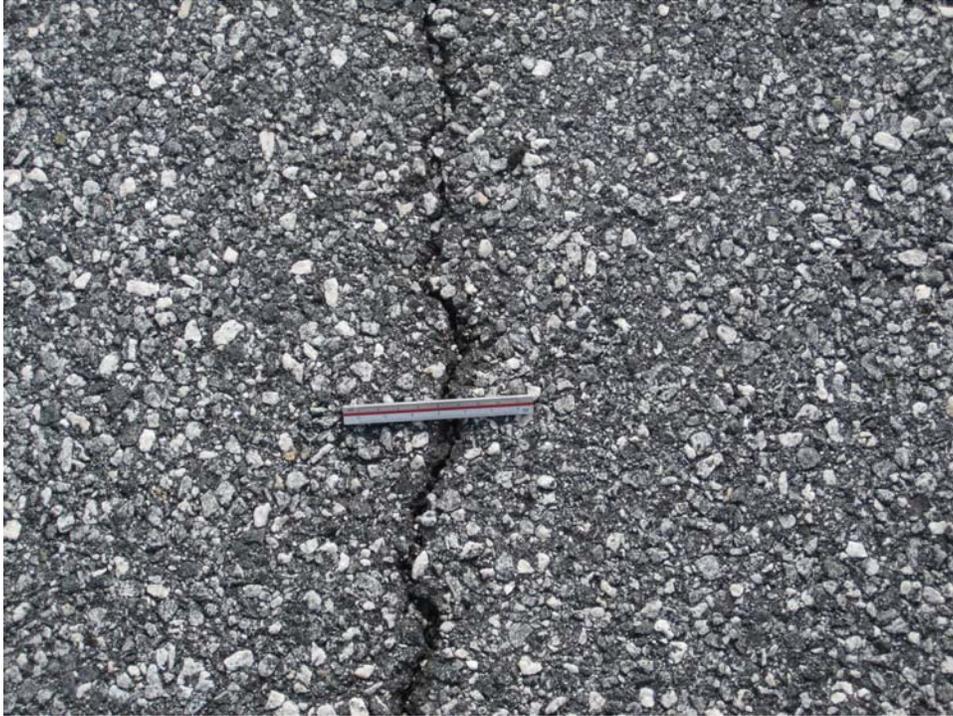
Section 40 had a PCI value of 76 with large quantities of low-severity L&T cracking and raveling. Smaller quantities of medium-severity L&T cracking were also identified.

TFCS-40. Longitudinal and Transverse Cracking (Sample Unit #03).

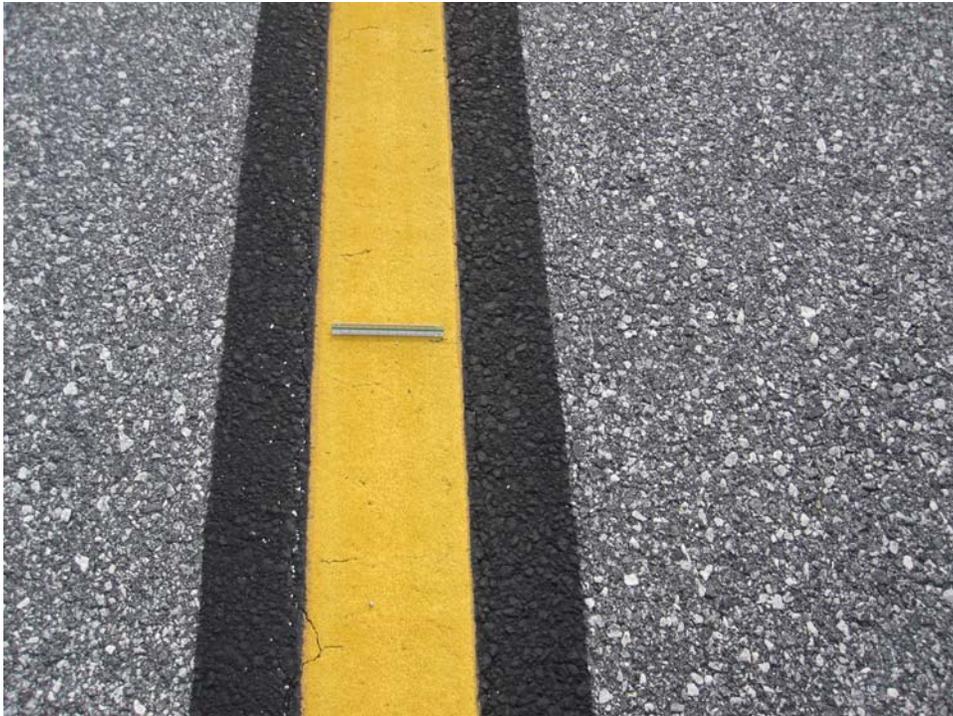
TFCS-40. Satisfactory Paint.

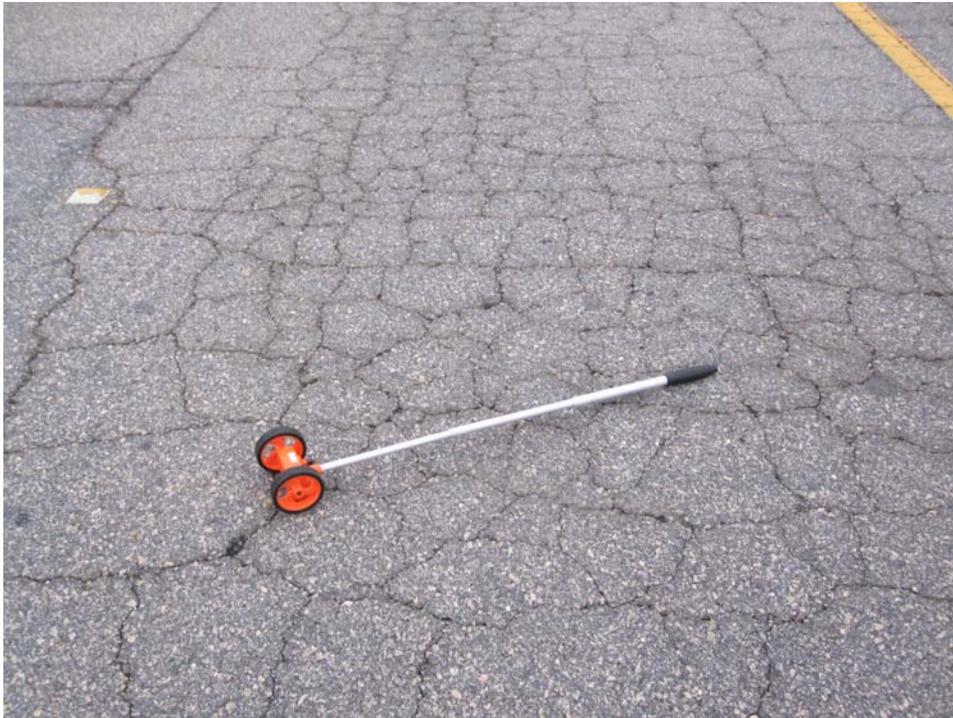
The T-Hangar area consisted of one section with a PCI value of 48. Extensive quantities of low- and medium-severity alligator cracking, L&T cracking, and weathering were observed. Additionally, small quantities of bleeding were identified.

THANGCS-10. Alligator Cracking (Sample Unit #04).

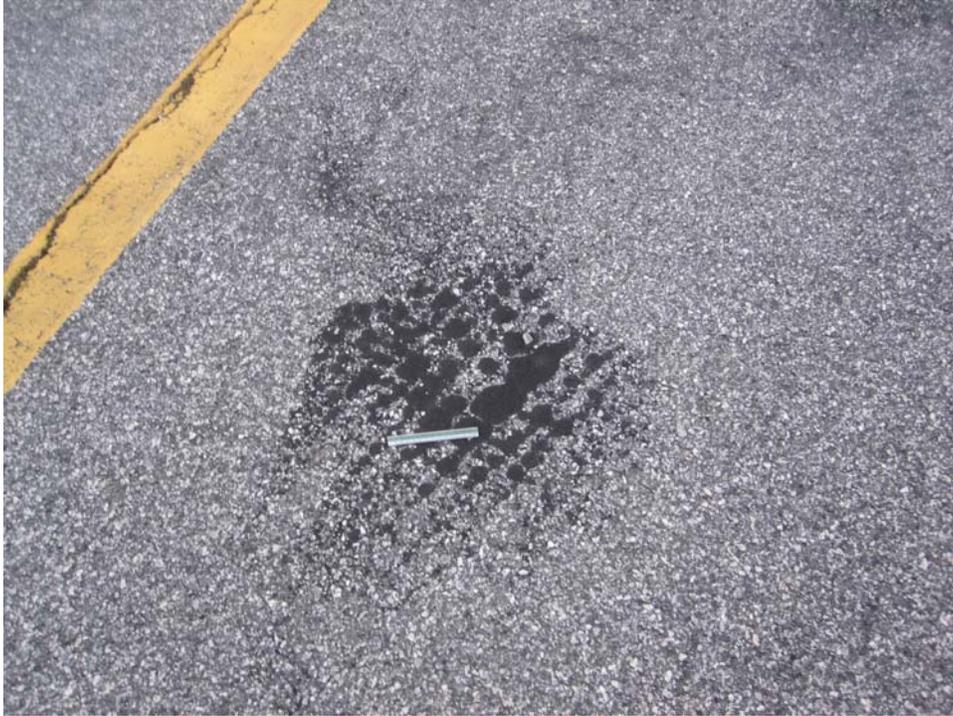
THANGCS-10. Bleeding (Sample Unit #06).
