2012 Greene County Regional Airport Pavement Management Plan

GREENE COUNTY REGIONAL AIRPORT

PAVEMENT MANAGEMENT REPORT

DECEMBER 2012

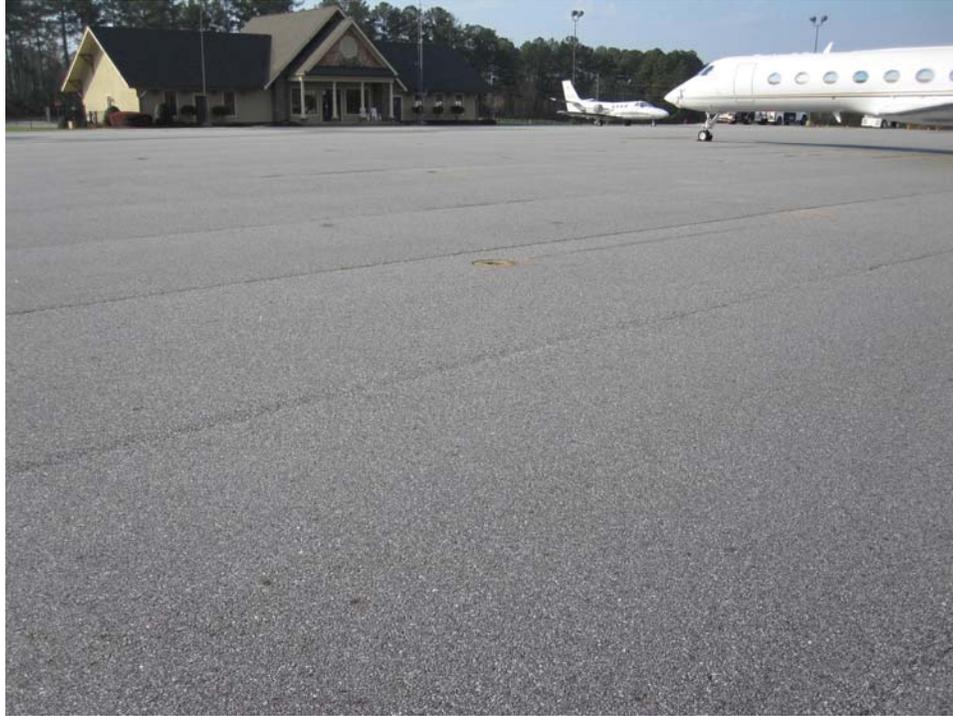
The apron area consisted of two sections. Section 10 had a PCI value of 86. Low-severity L&T cracking and weathering were identified throughout the section. Section 20 had a PCI value of 84. Moderate amounts of low-severity L&T cracking and weathering were observed.

A01GB-10. Overview.

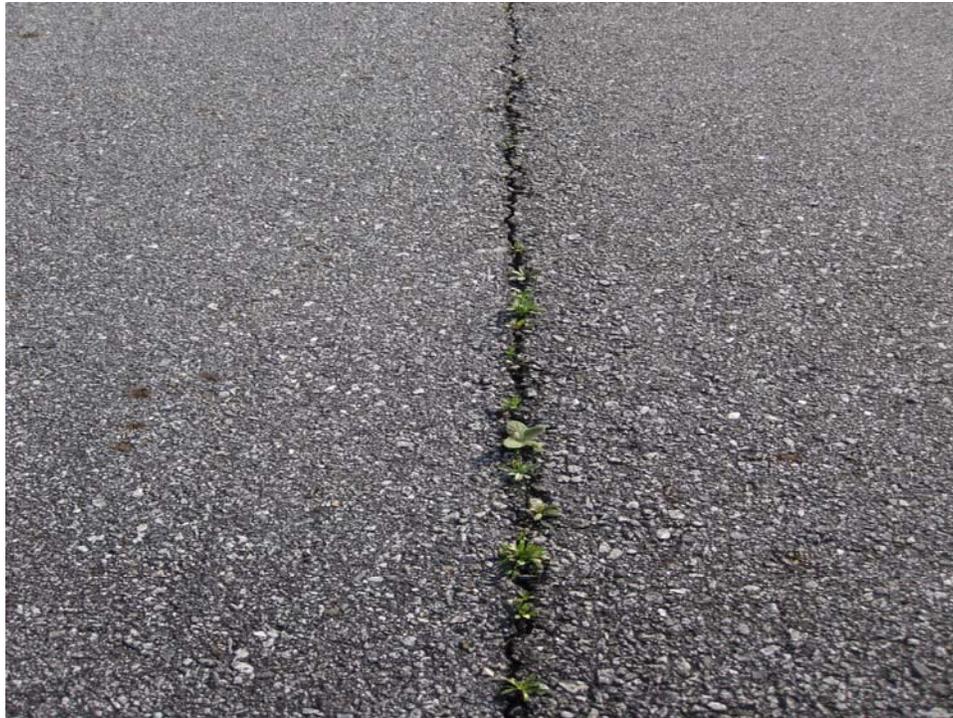
A01GB-10. Longitudinal and Transverse Cracking (Sample Unit #09).

Sample Number: 09 Type: R Area: 6,500.00SqFt PCI = 86
Sample Comments:
57 WEATHERING L 3,250.00 SqFt Comments:
48 LONGITUDINAL/TRANSVERSE CRACKING L 183.00 Ft Comments:

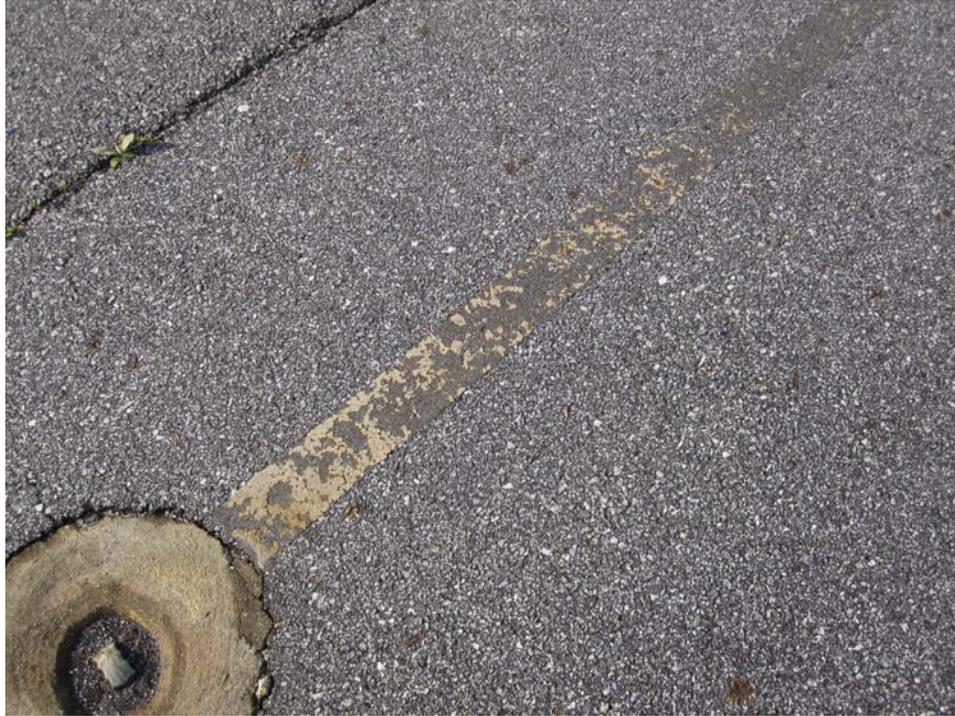
A01GB-10. Unsatisfactory Paint.

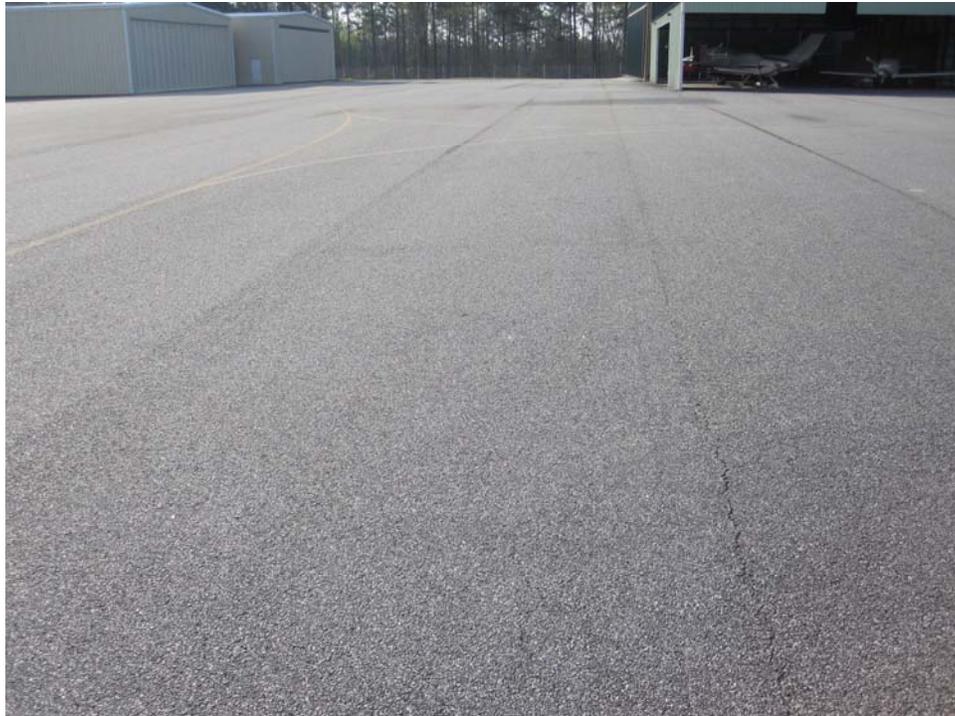
A01GB-20. Overview.

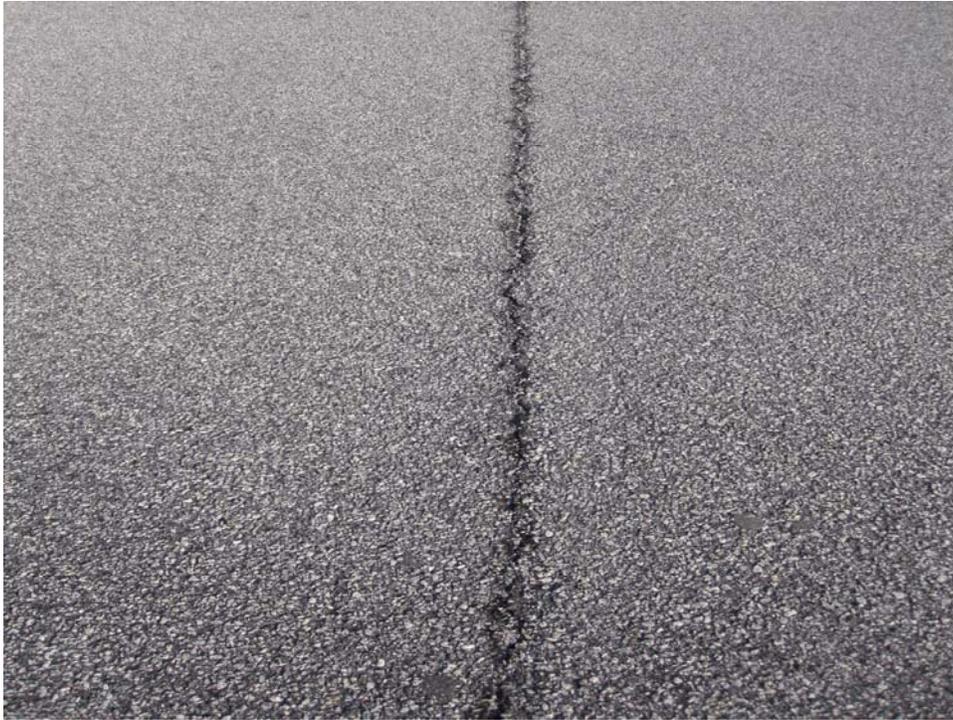
A01GB-20. Longitudinal and Transverse Cracking (Sample Unit #03).

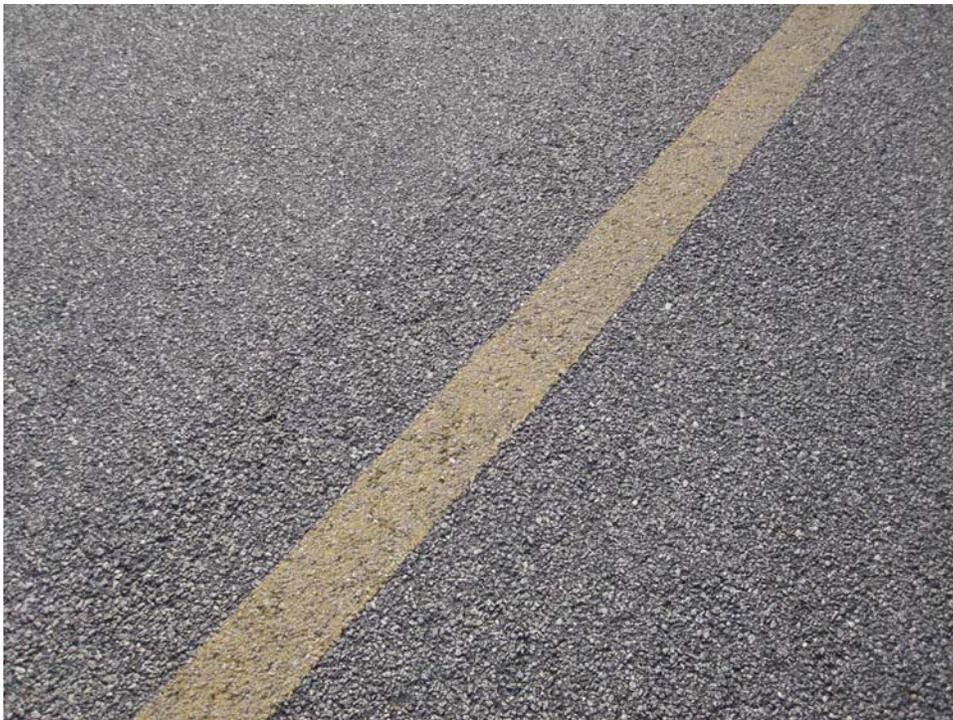
A01GB-20. Unsatisfactory Paint.

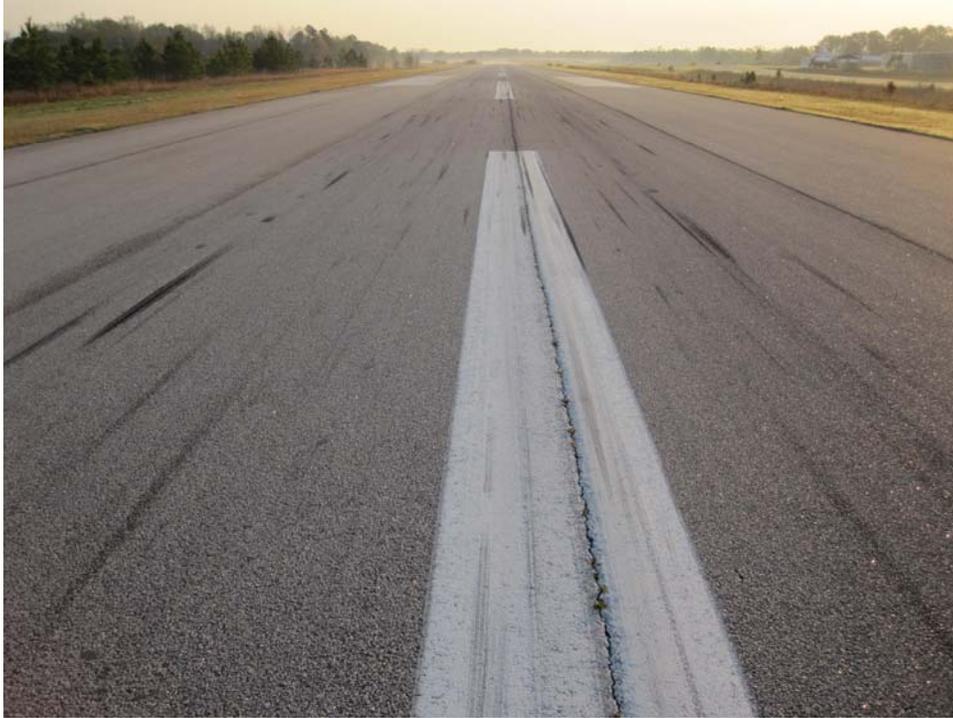
Runway 7-25 was comprised of two sections. Section 10 had a PCI value of 69. The primary distresses identified in this section were low- and medium-severity longitudinal and transverse (L&T) cracking and low-severity weathering. In addition, moderate amounts of low- and medium-severity alligator cracking and low-severity patching were recorded. Section 20 consisted of a new extension constructed in 2009 that was in excellent condition with a PCI value of 100. No distresses were observed in this section at the time of inspection.

R725GB-10. Overview.

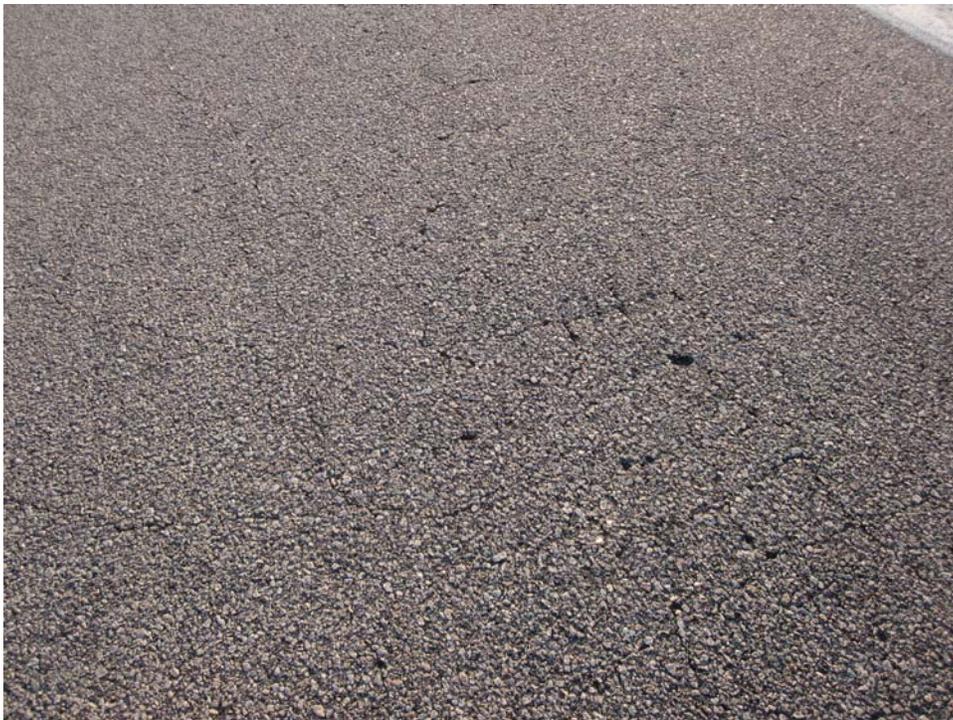
R725GB-10. Alligator Cracking (Sample Unit #48).

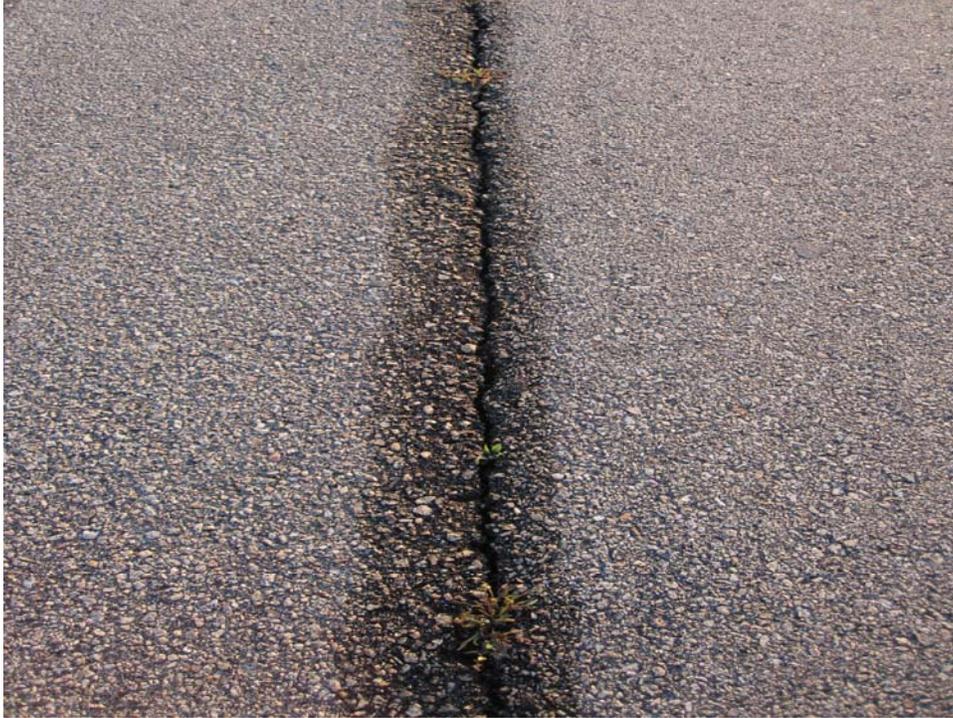
R725GB-10. Longitudinal and Transverse Cracking (Sample Unit #16).

Sample Number: 16 Type: R Area: 5,625.00SqFt PCI = 72
Sample Comments:
48 LONGITUDINAL/TRANSVERSE CRACKING L 223.00 Ft Comments:
48 LONGITUDINAL/TRANSVERSE CRACKING M 150.00 Ft Comments:
57 WEATHERING L 5,625.00 SqFt Comments:

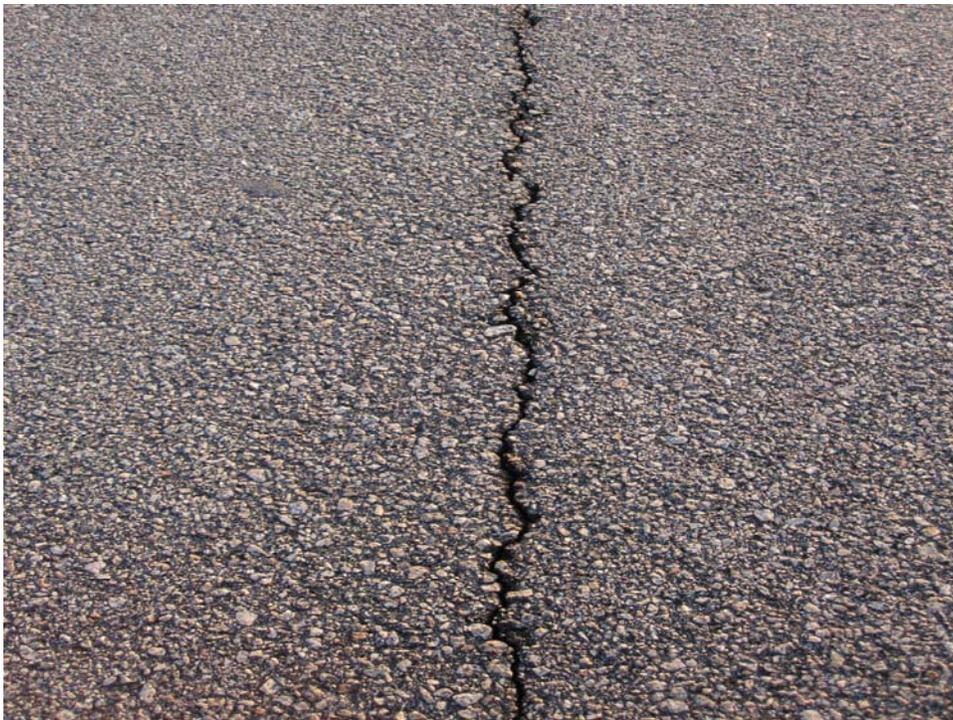
R725GB-10. Longitudinal and Transverse Cracking (Sample Unit #24).

Sample Number: 24 Type: R Area: 5,625.00SqFt PCI = 75
Sample Comments:
57 WEATHERING L 5,625.00 SqFt Comments:
48 LONGITUDINAL/TRANSVERSE CRACKING L 283.00 Ft Comments:
48 LONGITUDINAL/TRANSVERSE CRACKING M 75.00 Ft Comments:

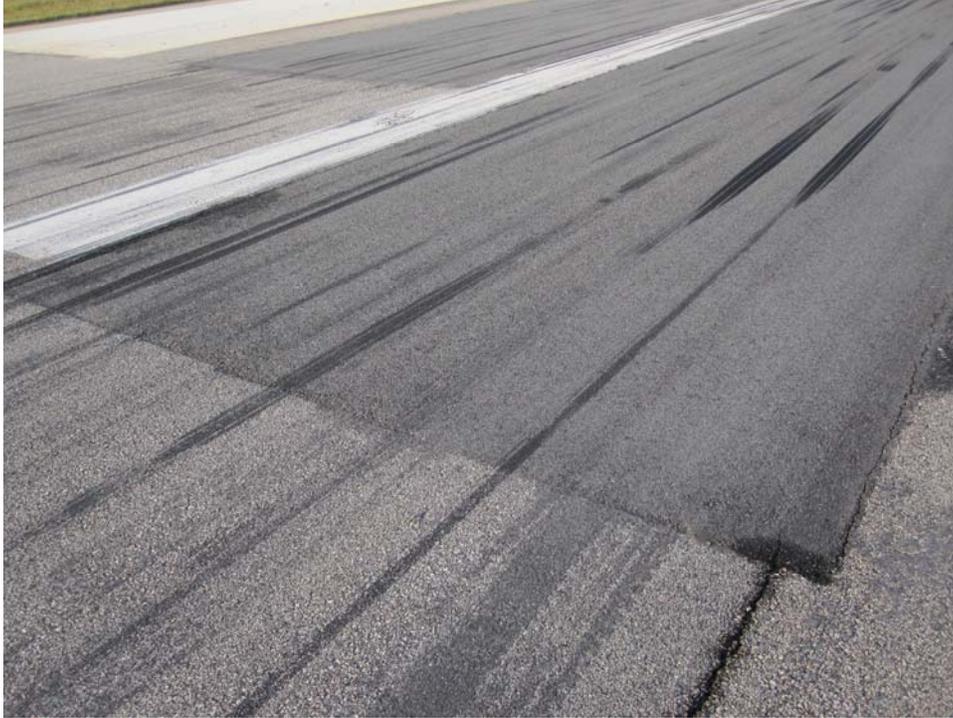
R725GB-10. Patching (Sample Unit #64).

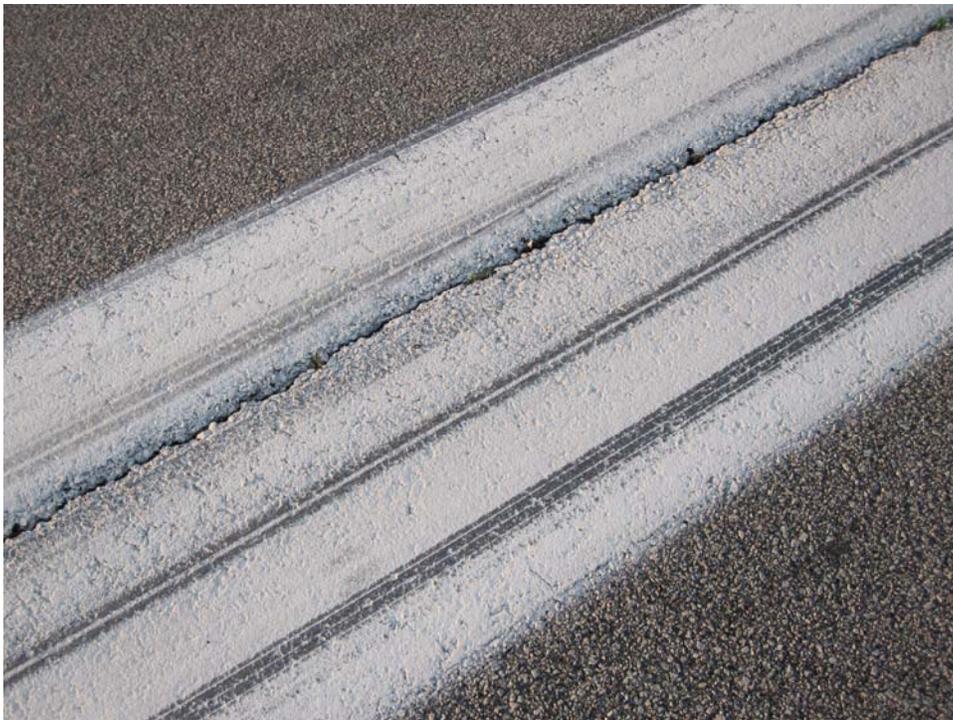
R725GB-10. Satisfactory Paint.

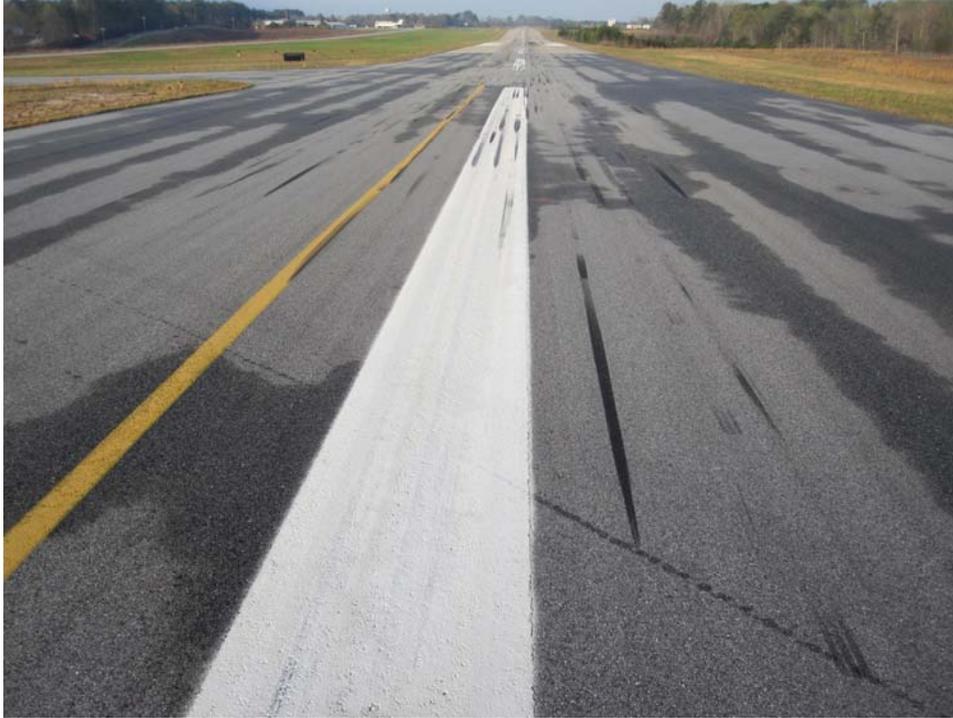
R725GB-20. Overview.

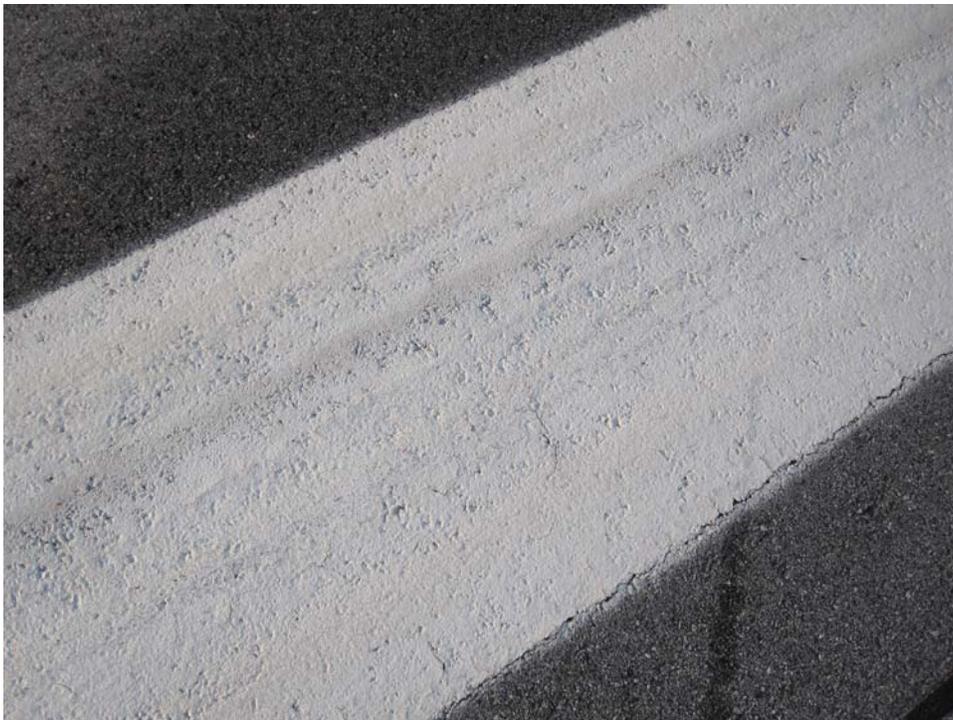
R725GB-20. Satisfactory Paint.

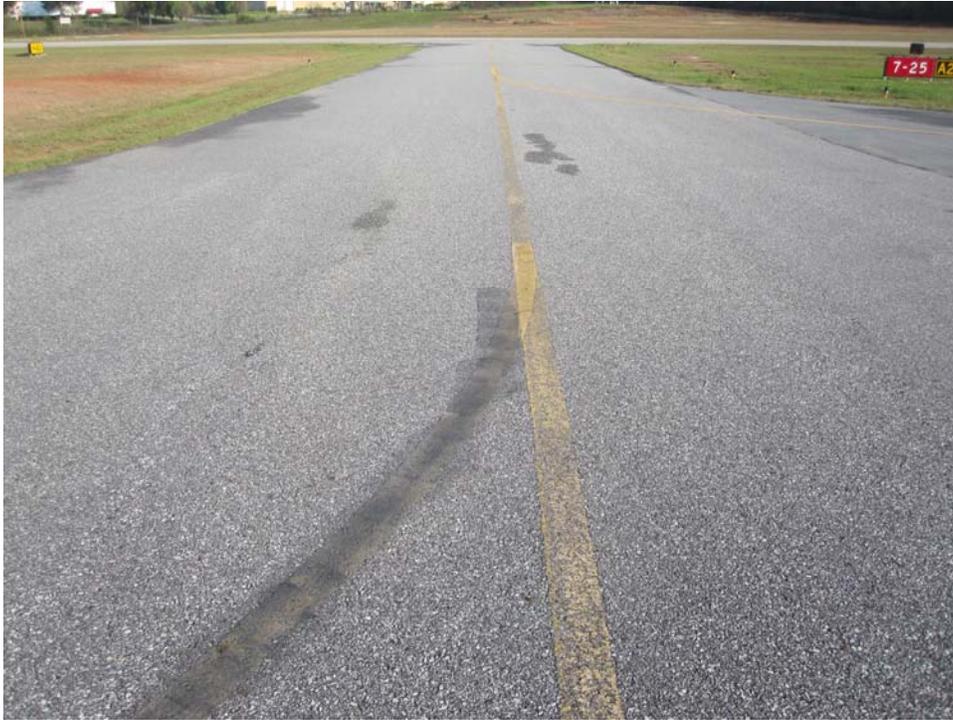
Taxiway A2 consisted of one section with a PCI value of 89. Moderate quantities of low- and medium-severity weathering were identified throughout Section 10 along with smaller quantities of low- and medium-severity L&T cracking.

TA2GB-10. Overview.

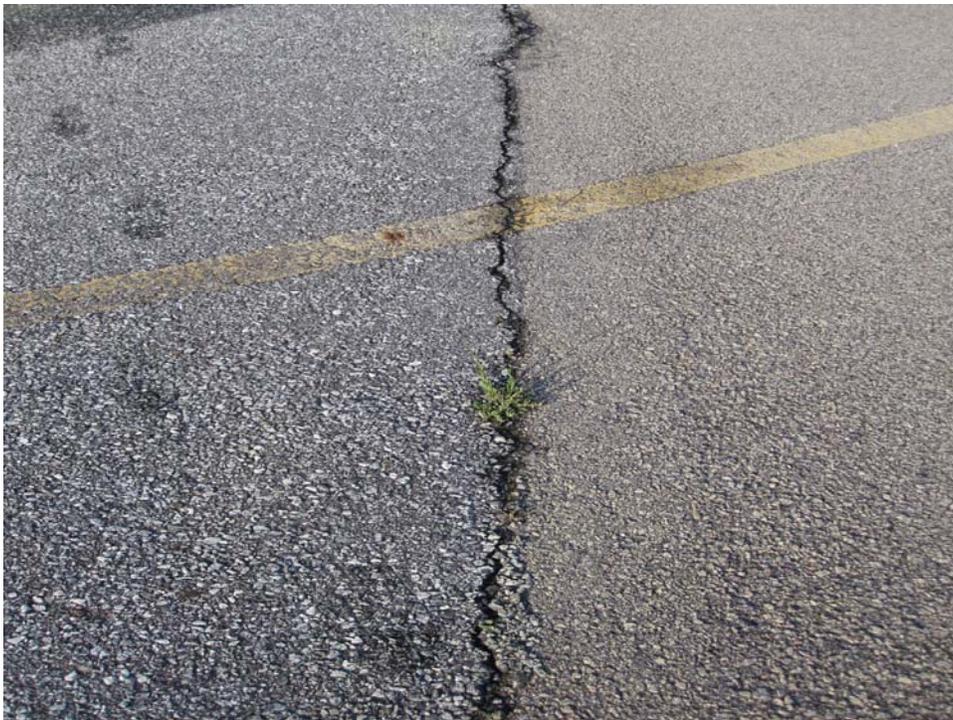
TA2GB-10. Longitudinal and Transverse Cracking (Sample Unit #01).

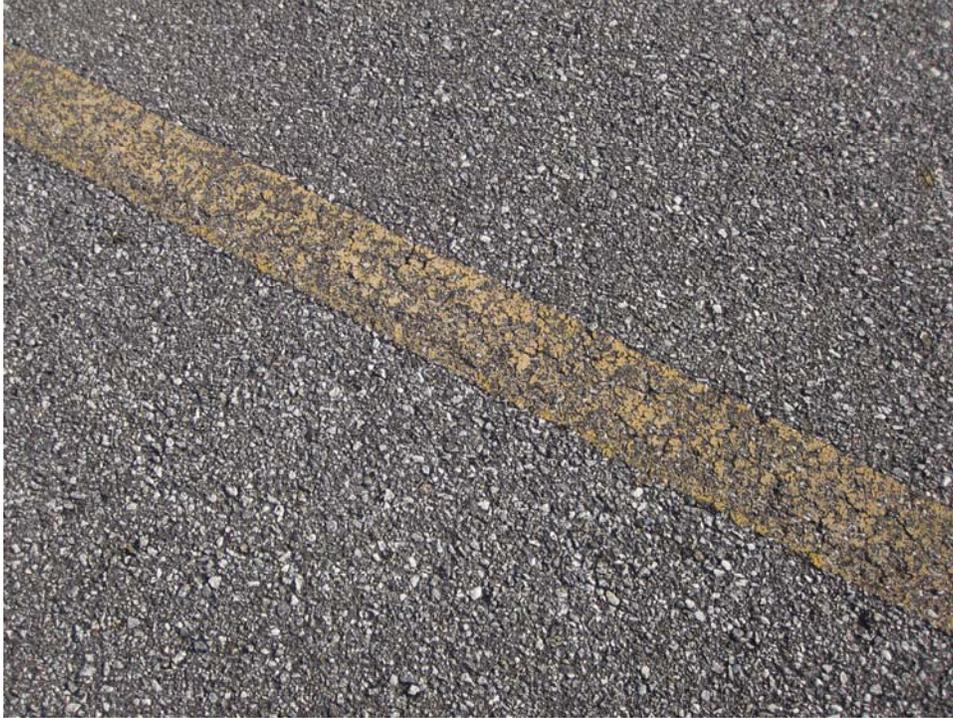
TA2GB-10. Unsatisfactory Paint.

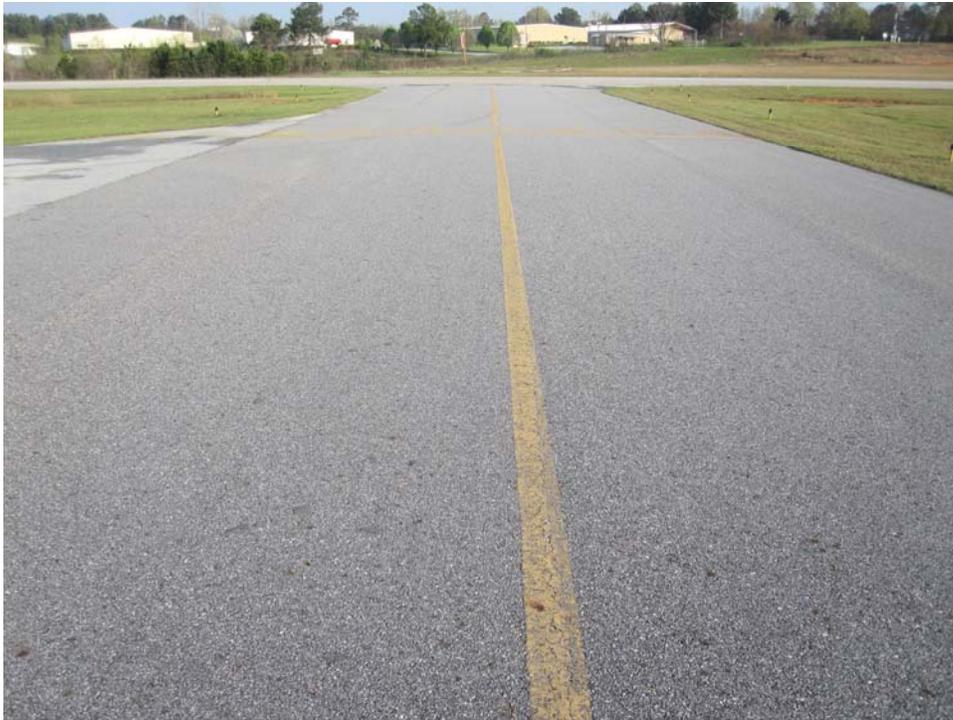
Taxiway A3 was defined by one section with a PCI value of 86. Only low- and medium-severity L&T cracking were recorded in Section 10.

TA3GB-10. Overview.

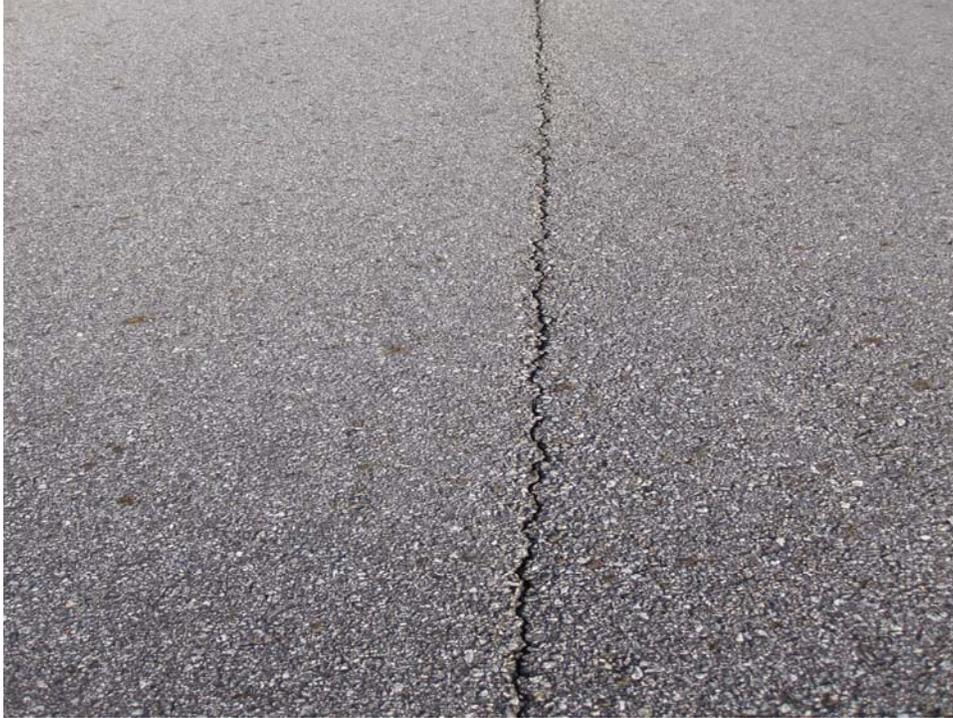
TA3GB-10. Longitudinal and Transverse Cracking (Sample Unit #03).

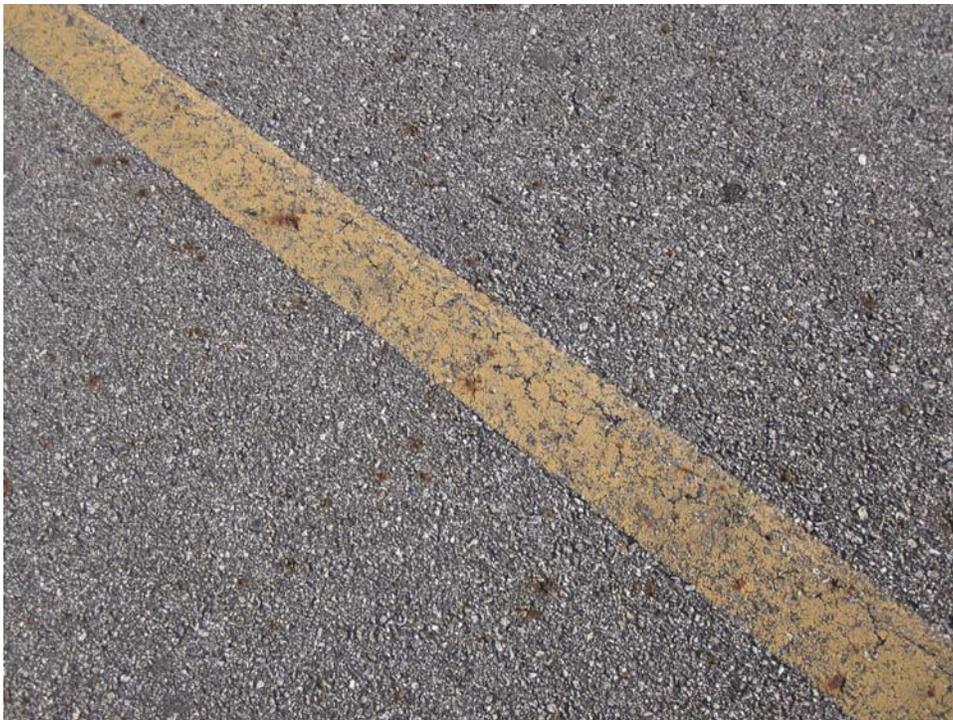
TA3GB-10. Satisfactory Paint.

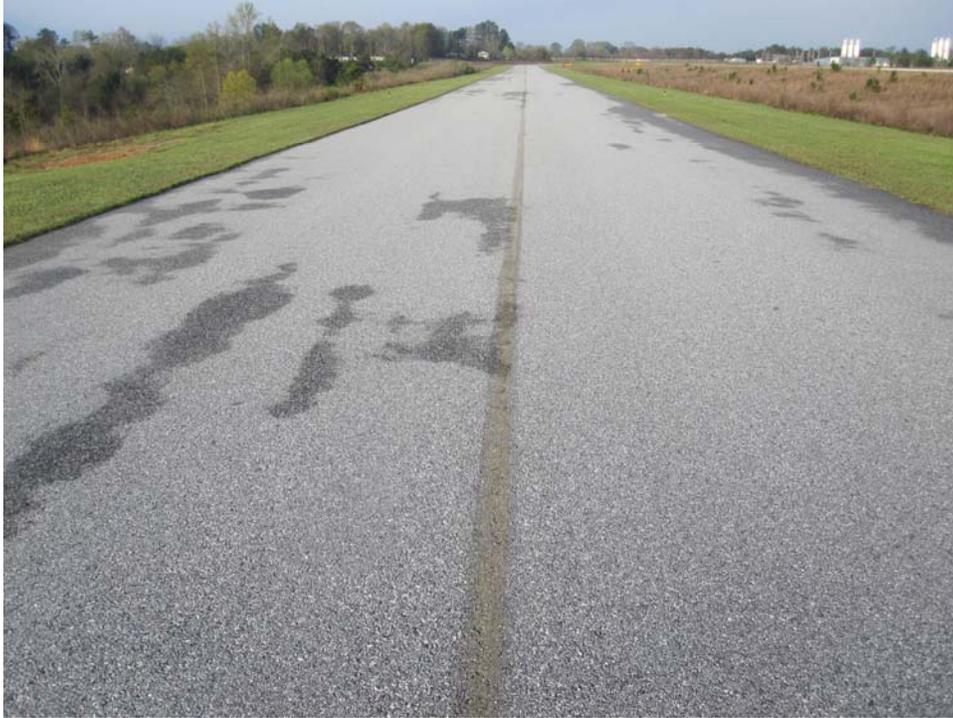
Taxiway A was defined by two sections. Section 10 had a PCI value of 89. Moderate amounts of low-severity L&T cracking and weathering were recorded in this section. Section 20 consisted of a new extension constructed in 2009 that was in excellent condition with a PCI value of 100. No distresses were observed at the time of inspection.

TAGB-10. Overview.

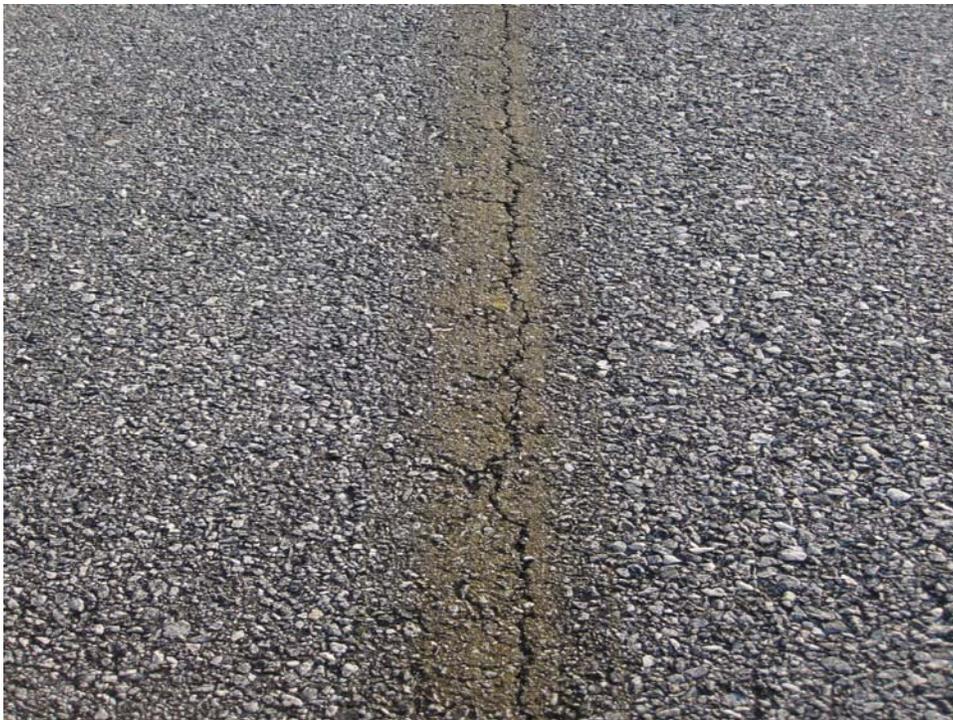
TAGB-10. Longitudinal and Transverse Cracking (Sample Unit #08).

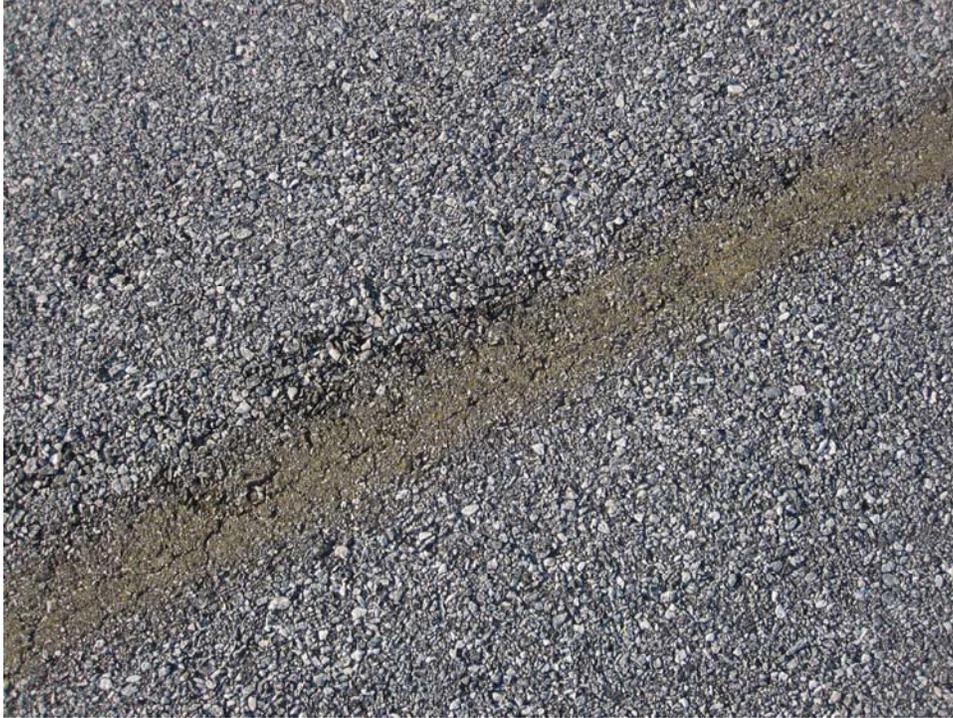
TAGB-10. Unsatisfactory Paint.

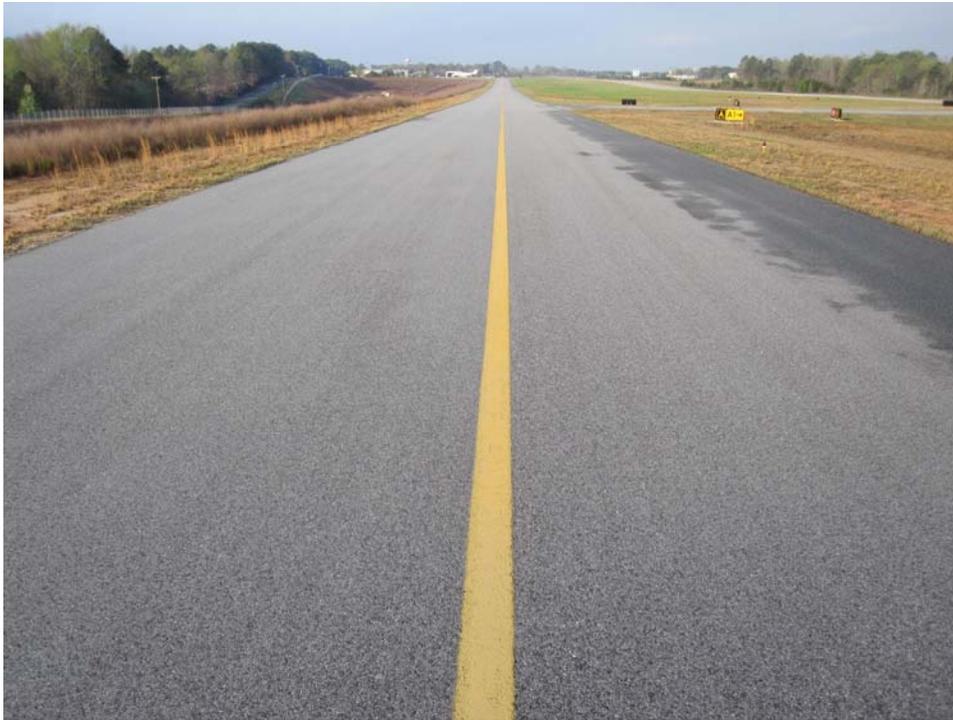
TAGB-20. Overview.

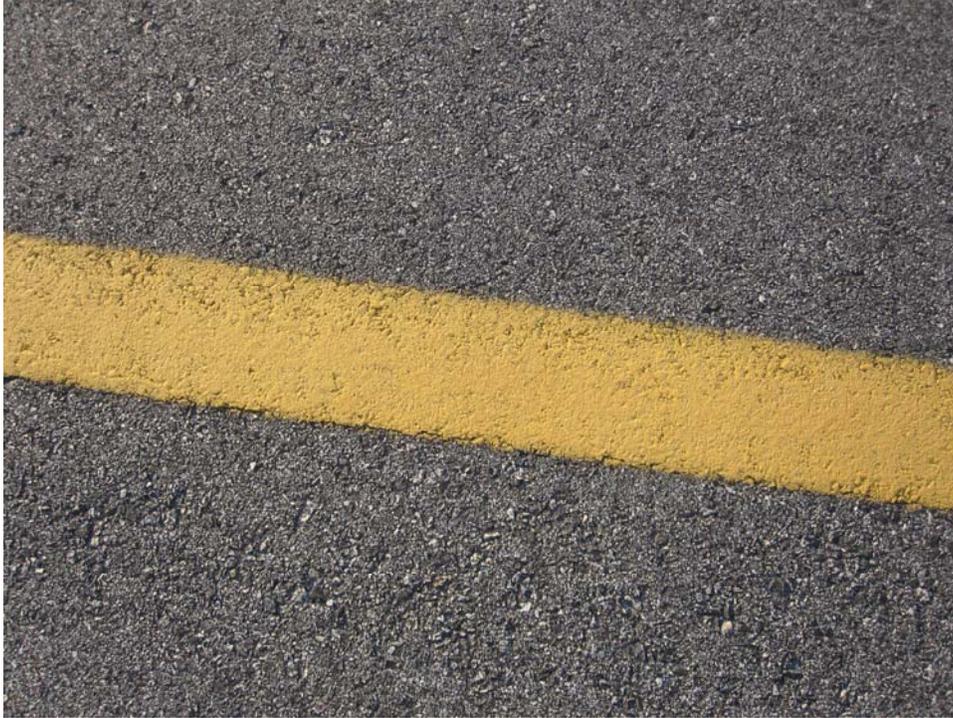
TAGB-20. Satisfactory Paint.

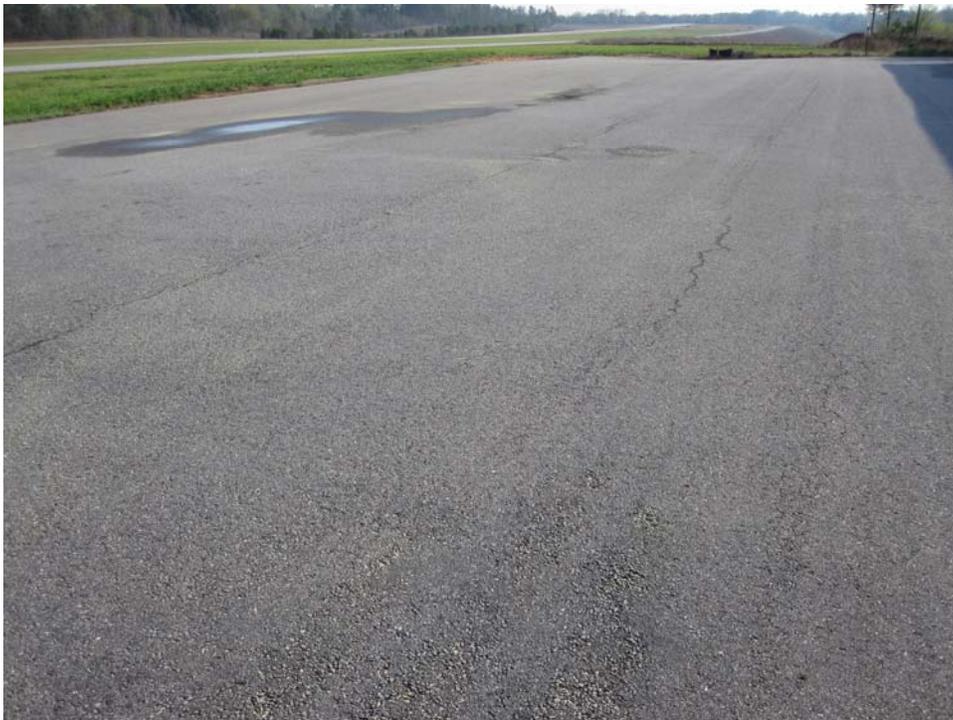
The T-Hangar area was comprised of one section with a PCI value of 79. The primary distresses identified in this section were low-severity L&T cracking and weathering. Moderate quantities of low-severity patching and medium-severity weathering were also observed. An additional sample unit was identified in accordance with ASTM D5340 that included small quantities of medium-severity raveling.

THANGGB-10. Overview.

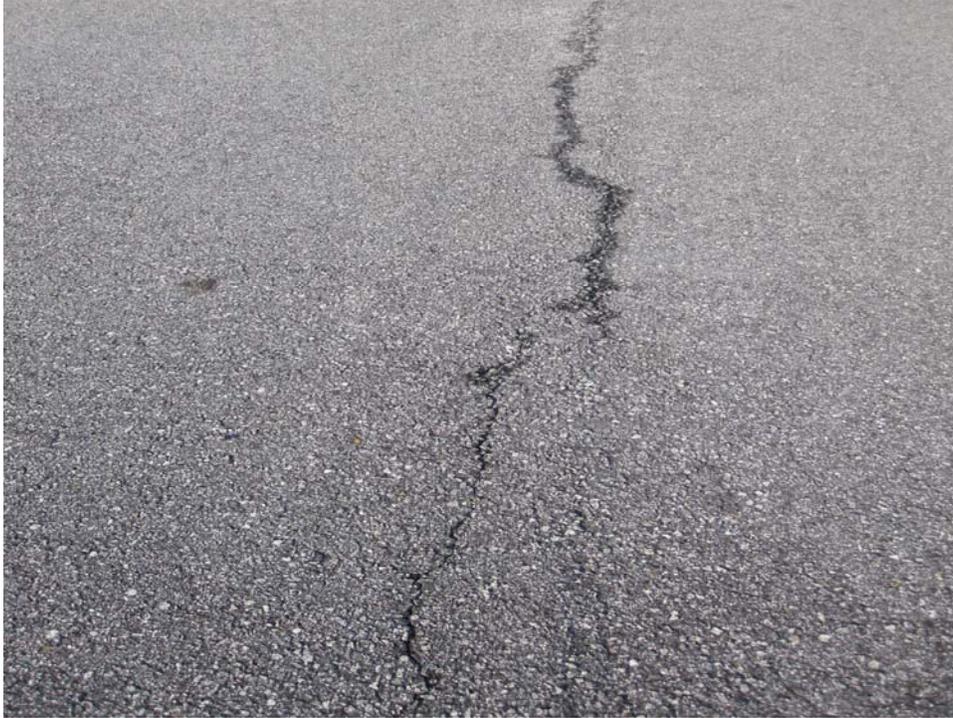
THANGGB-10. Longitudinal and Transverse Cracking (Sample Unit #01).

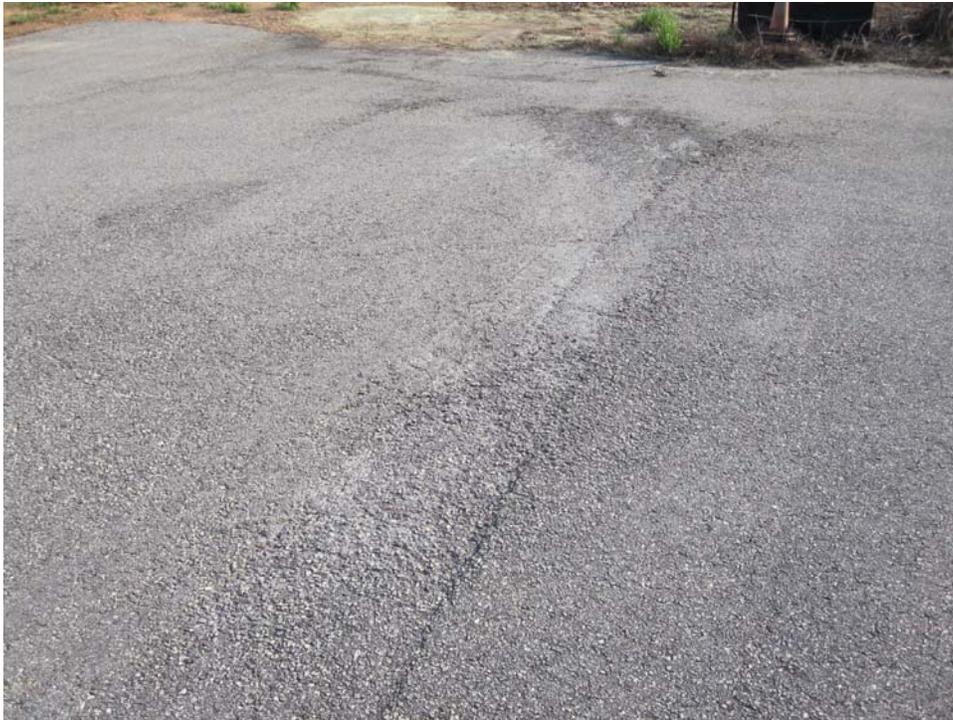
THANGGB-10. Raveling (Sample Unit #03).

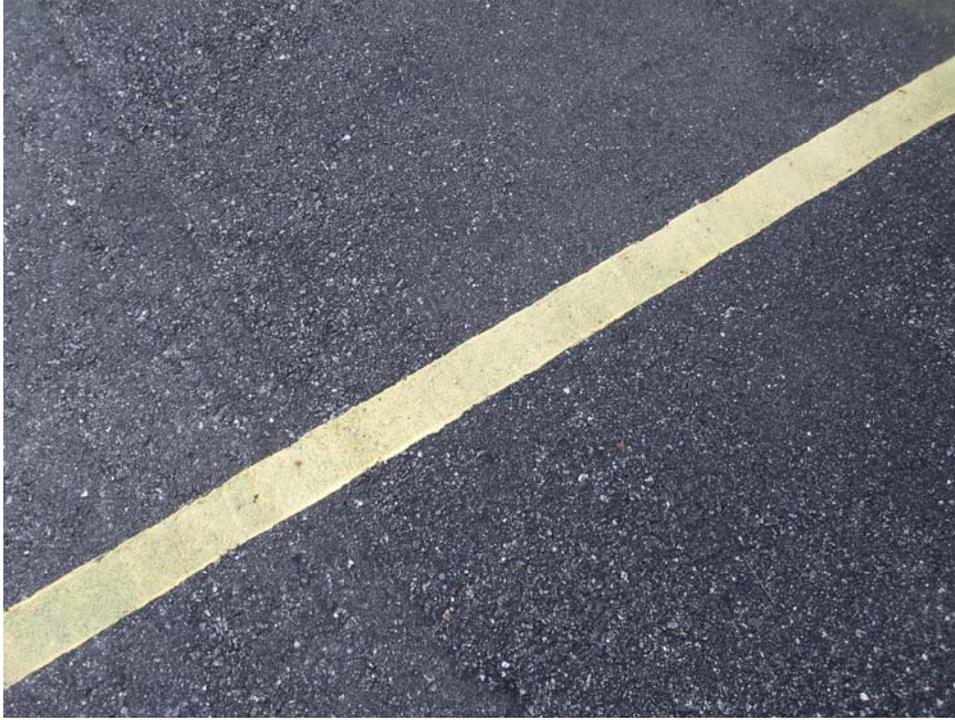
THANGGB-10. Satisfactory Paint.
