2012 Gwinnett County- Briscoe Field Pavement Management Plan

GWINNETT COUNTY-BRISCOE FIELD

PAVEMENT MANAGEMENT REPORT

DECEMBER 2012

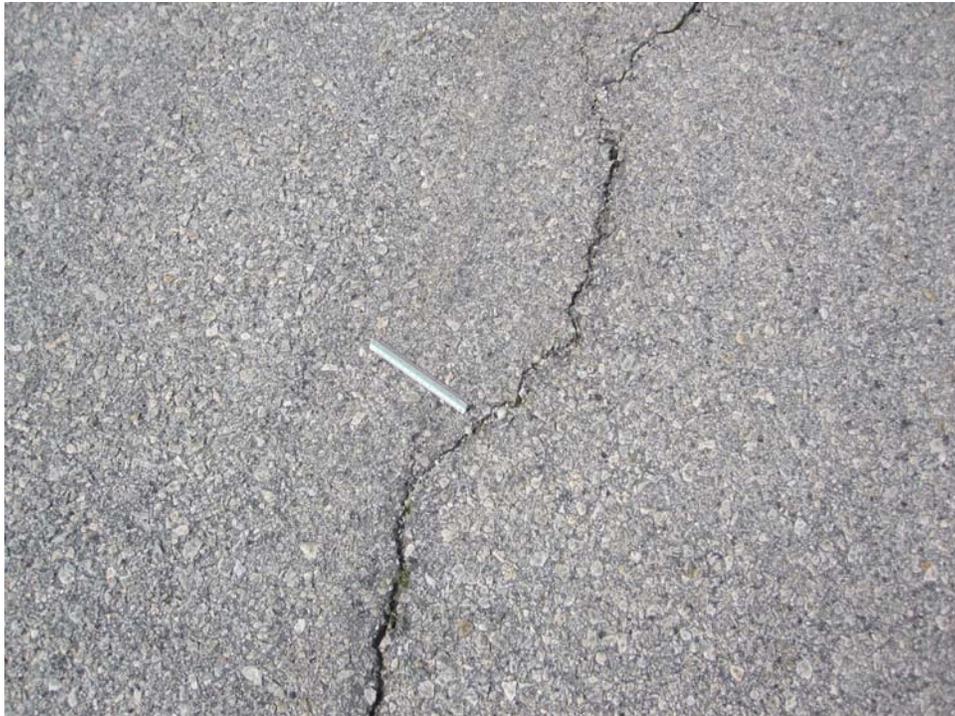
A01LW-10. Longitudinal and Transverse Cracking (Sample Unit #12).

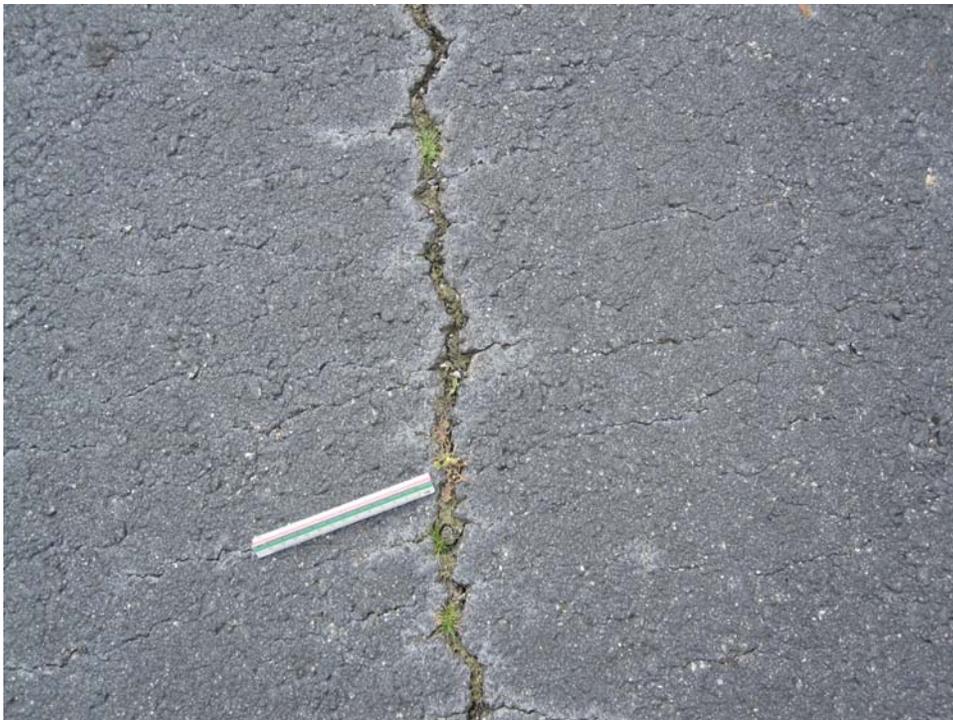
A01LW-20. Longitudinal and Transverse Cracking (Sample Unit #35).

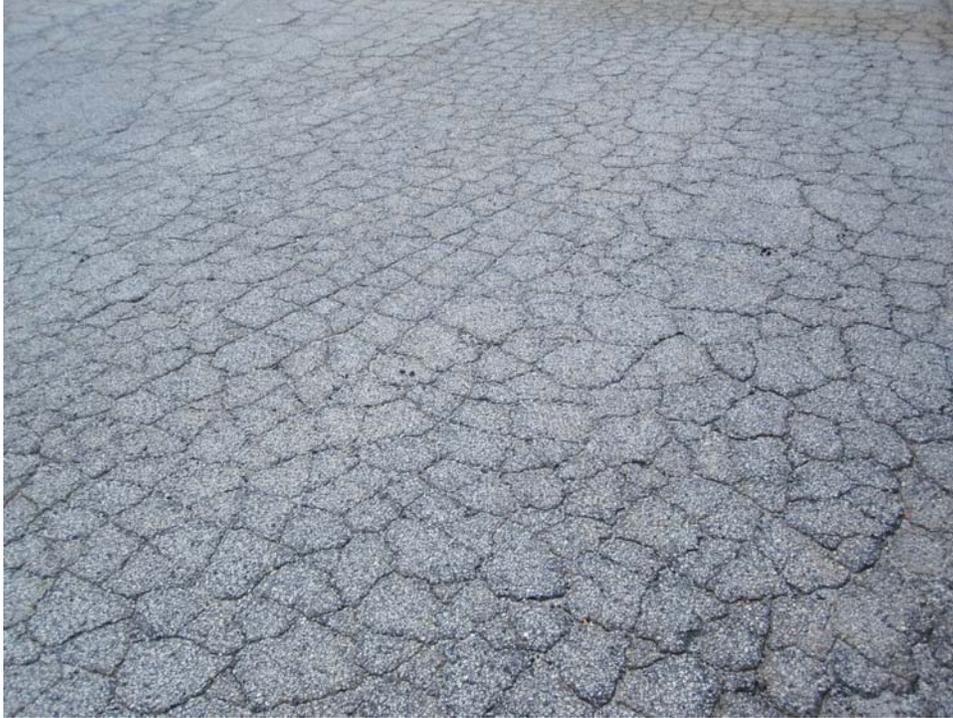
A01LW-30. Alligator Cracking (Sample Unit #02).

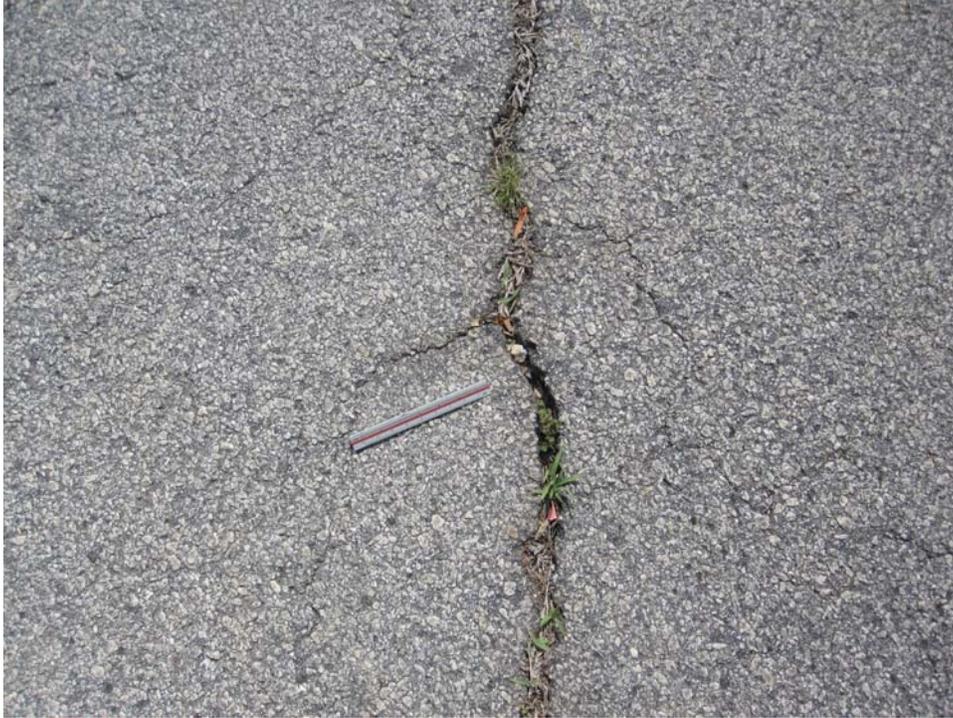
A01LW-50. Longitudinal and Transverse Cracking (Sample Unit #01).

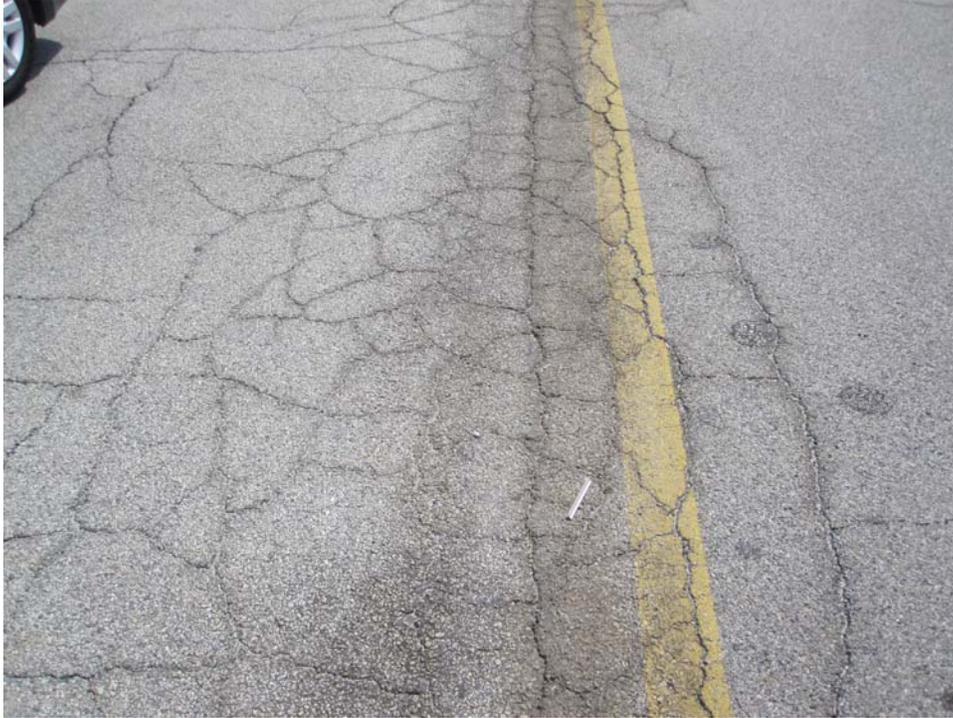
A01LW-60. Alligator Cracking (Sample Unit #05).

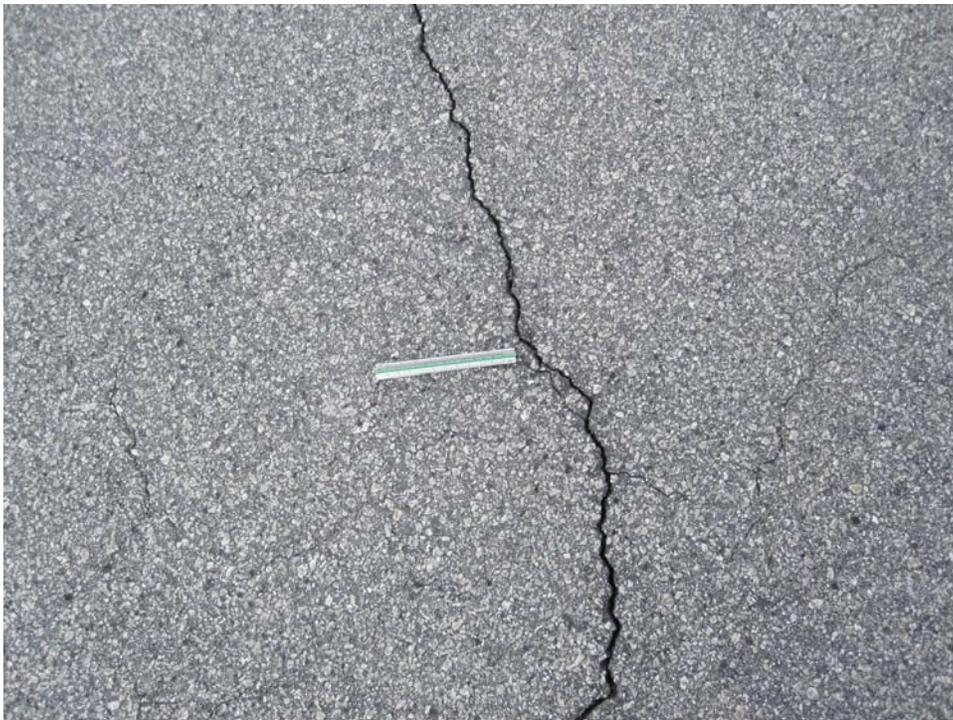
A01LW-60. Longitudinal and Transverse Cracking (Sample Unit #07).

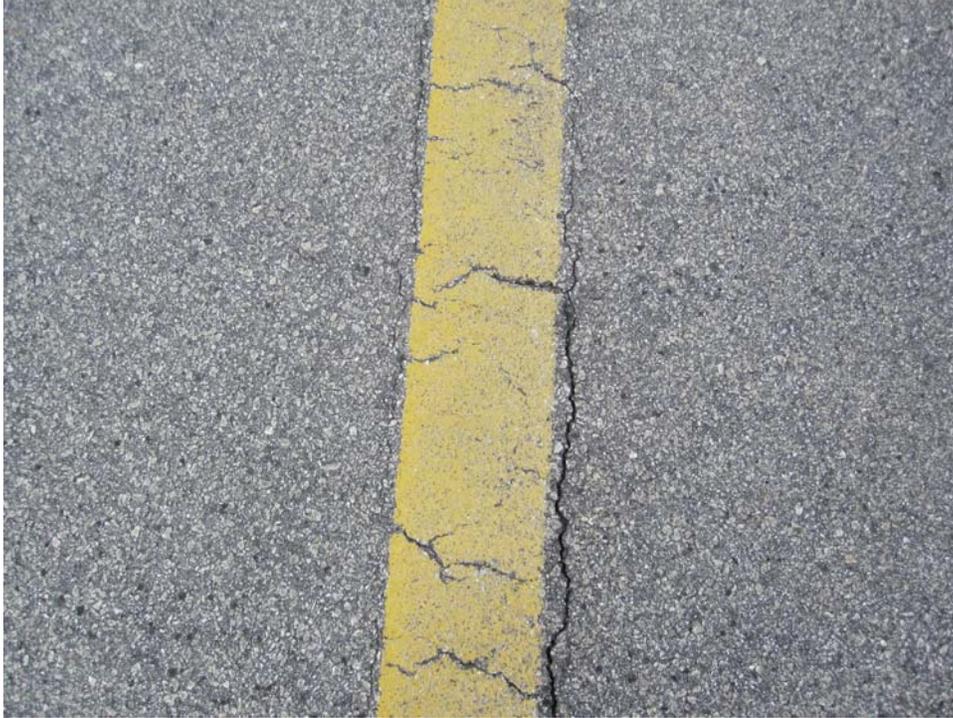
A01LW-60. Unsatisfactory Paint.

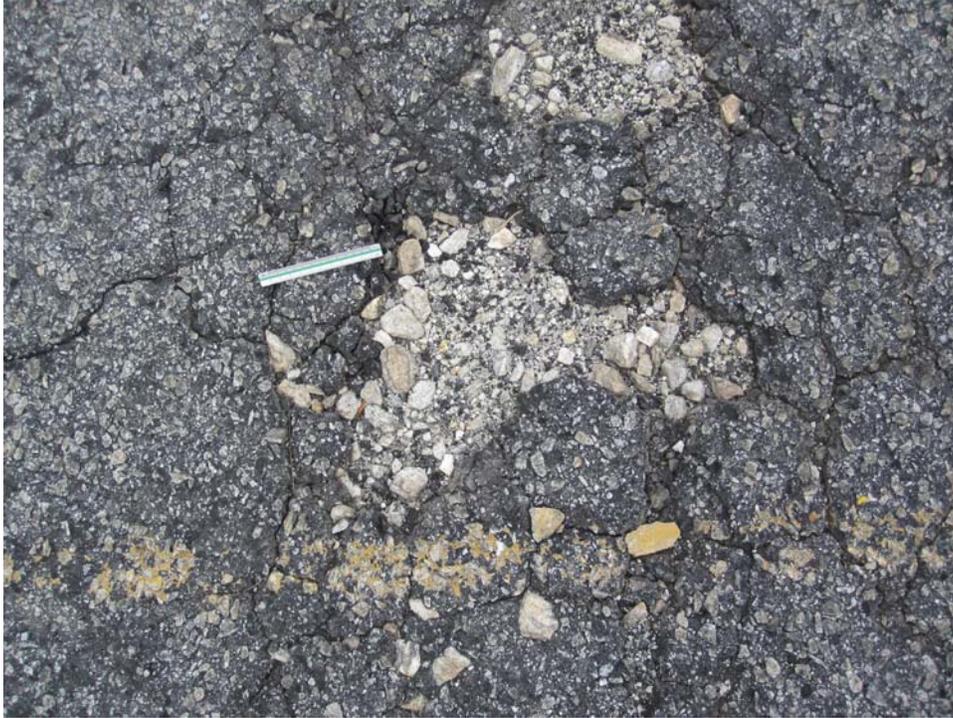
A01LW-70. Alligator Cracking (Sample Unit #03).

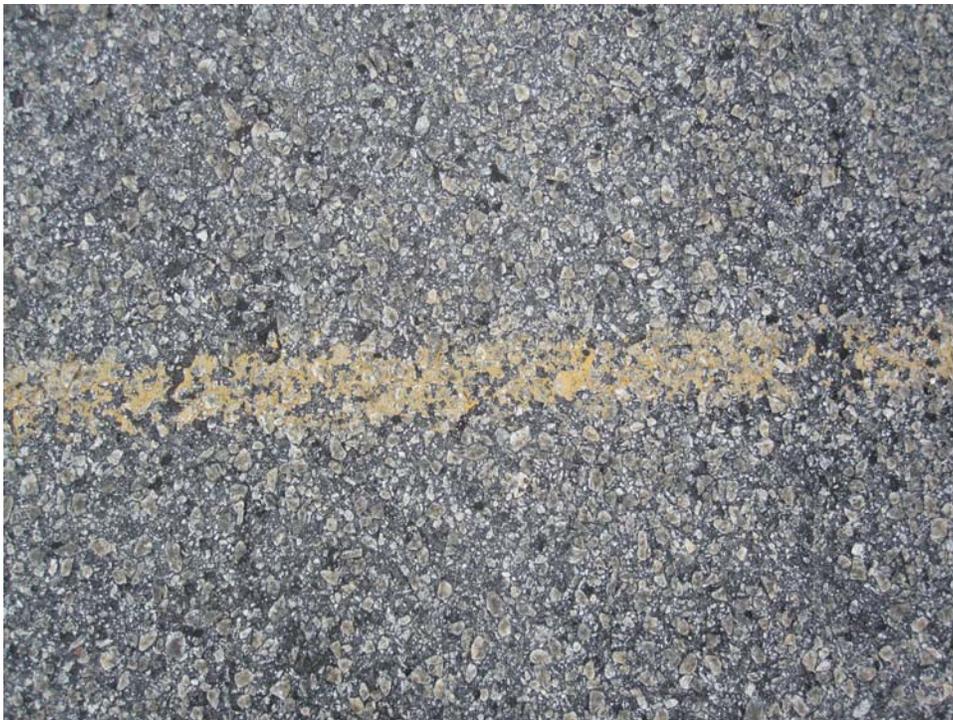
A01LW-70 Unsatisfactory Paint

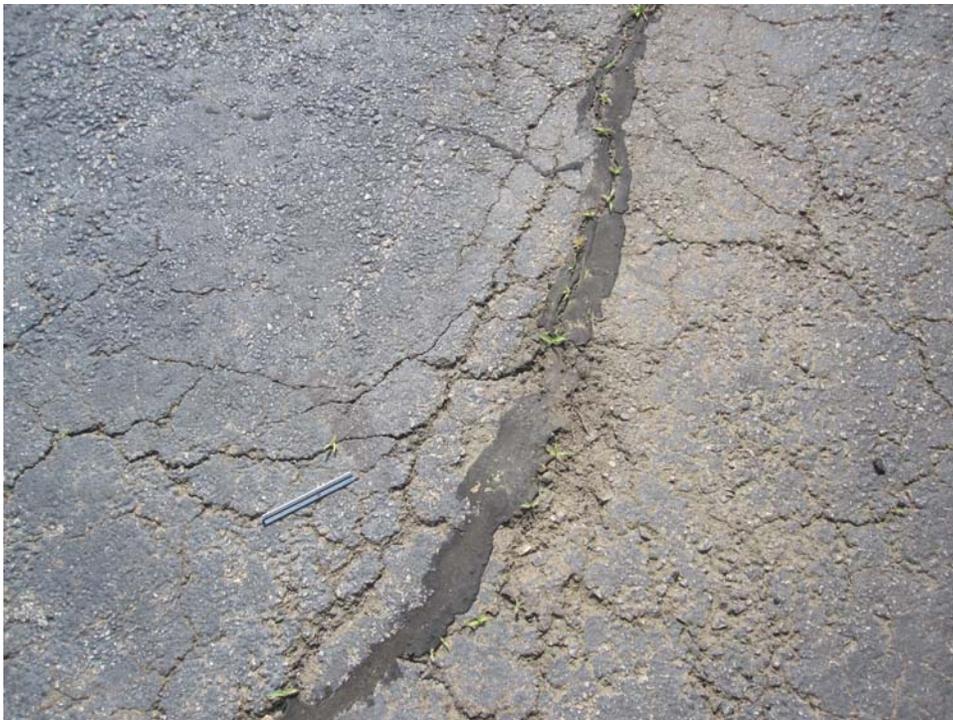
A02LW-10. Alligator Cracking (Sample Unit #10).

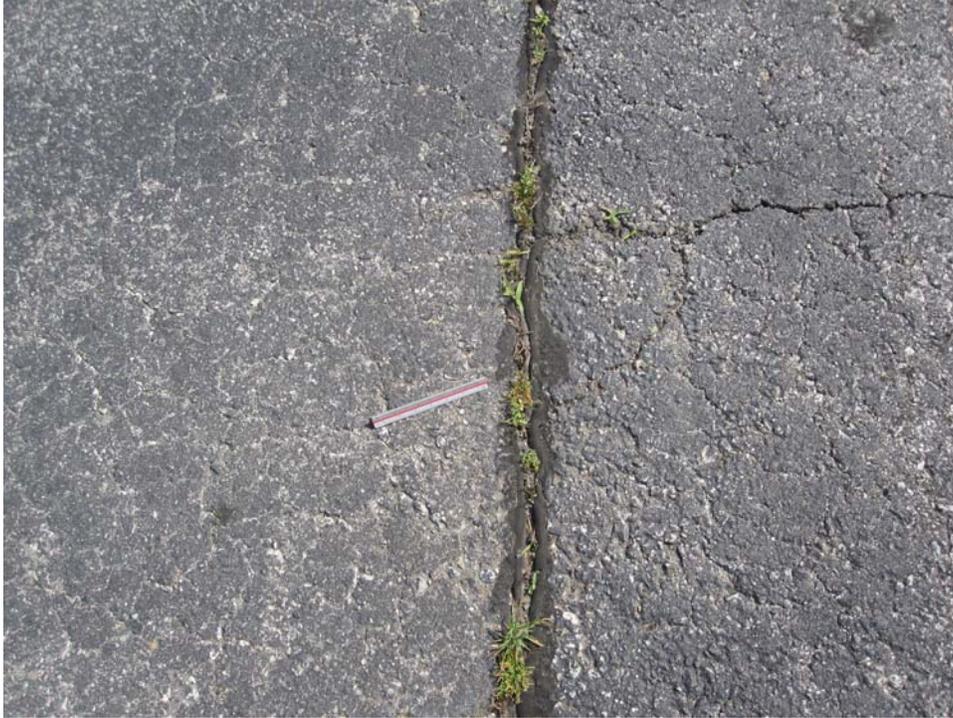
A02LW-10. Longitudinal and Transverse Cracking (Sample Unit #10).

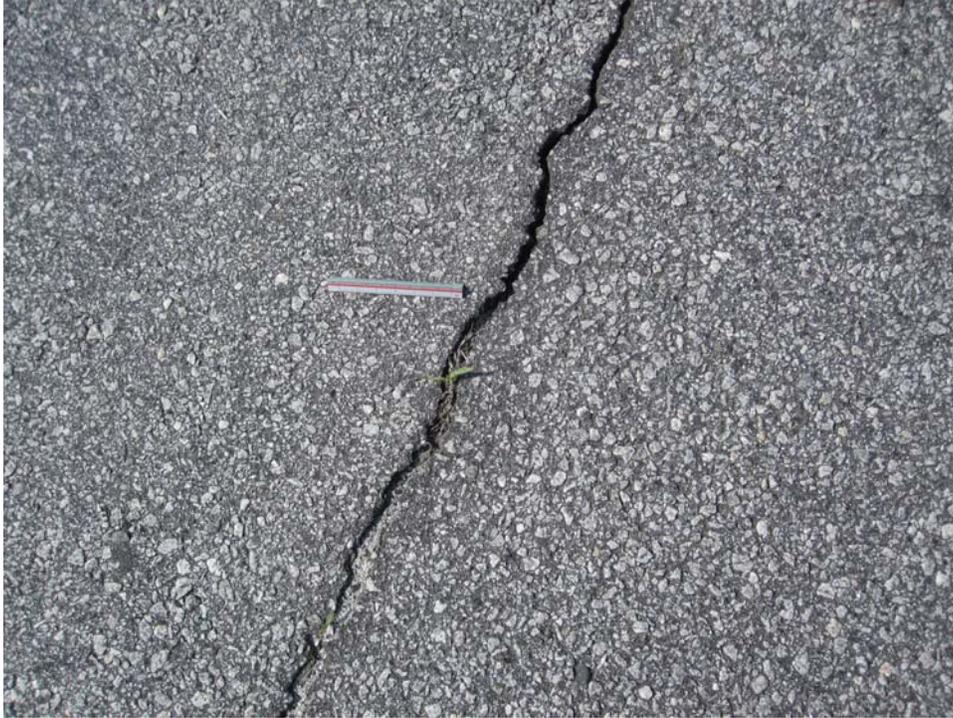
A02LW-20. Longitudinal and Transverse Cracking (Sample Unit #25).

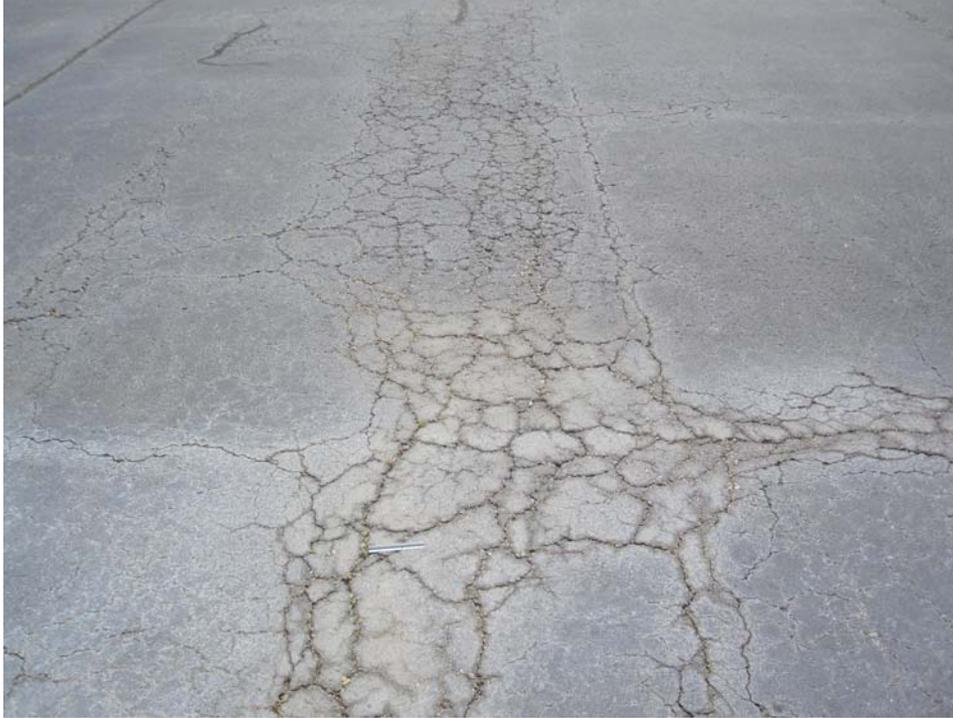
A03LW-10. Alligator Cracking (Sample Unit #11).

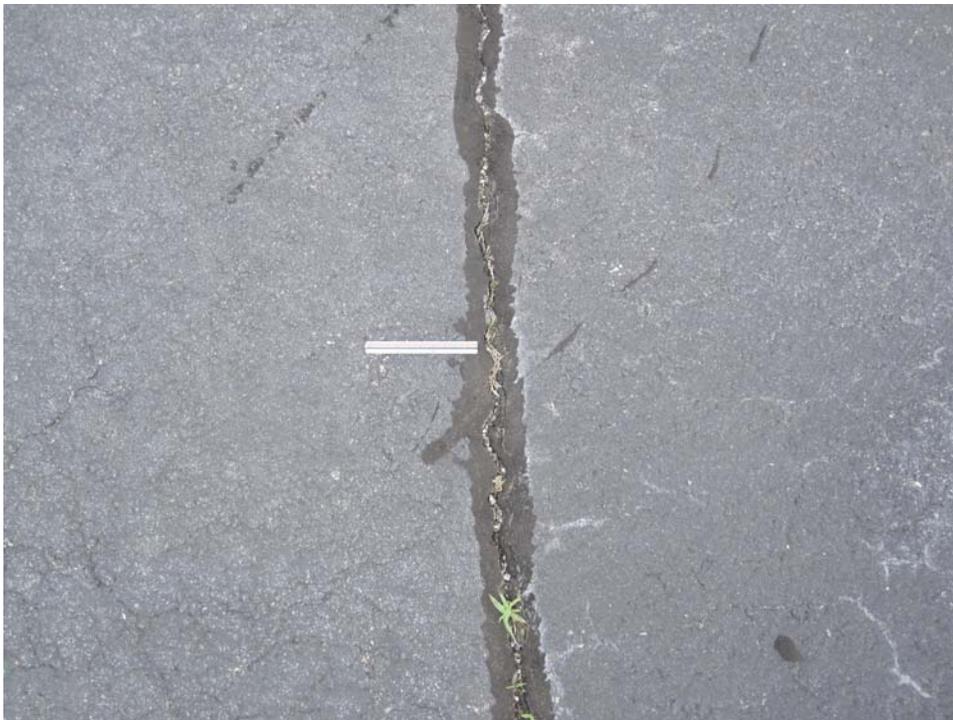
A03LW-10. Longitudinal and Transverse Cracking (Sample Unit #22).

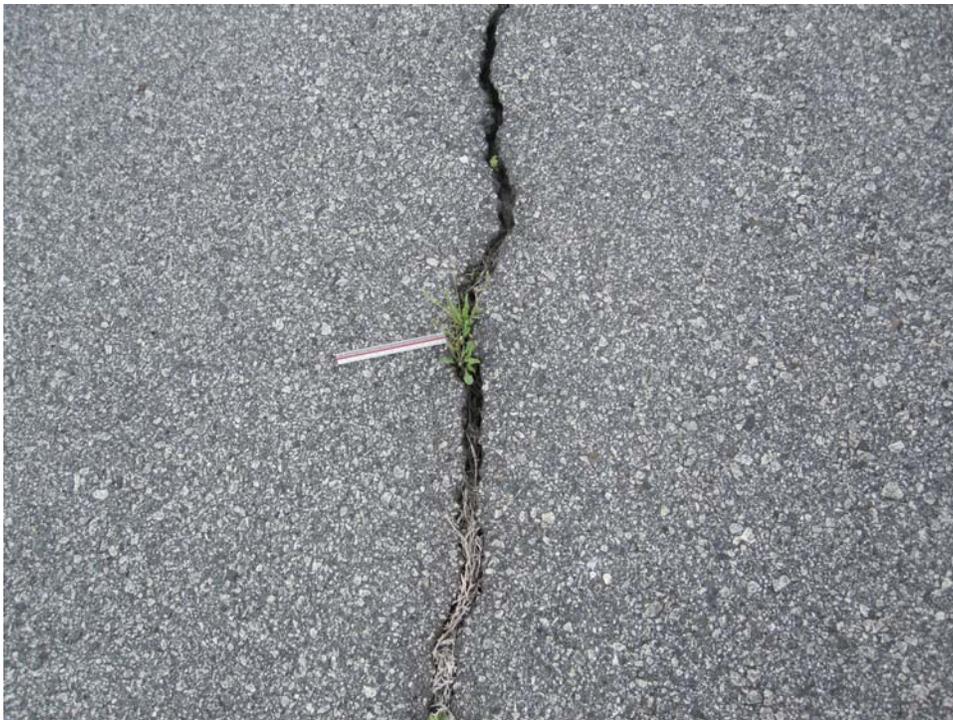
A03LW-20. Longitudinal and Transverse Cracking (Sample Unit #06).

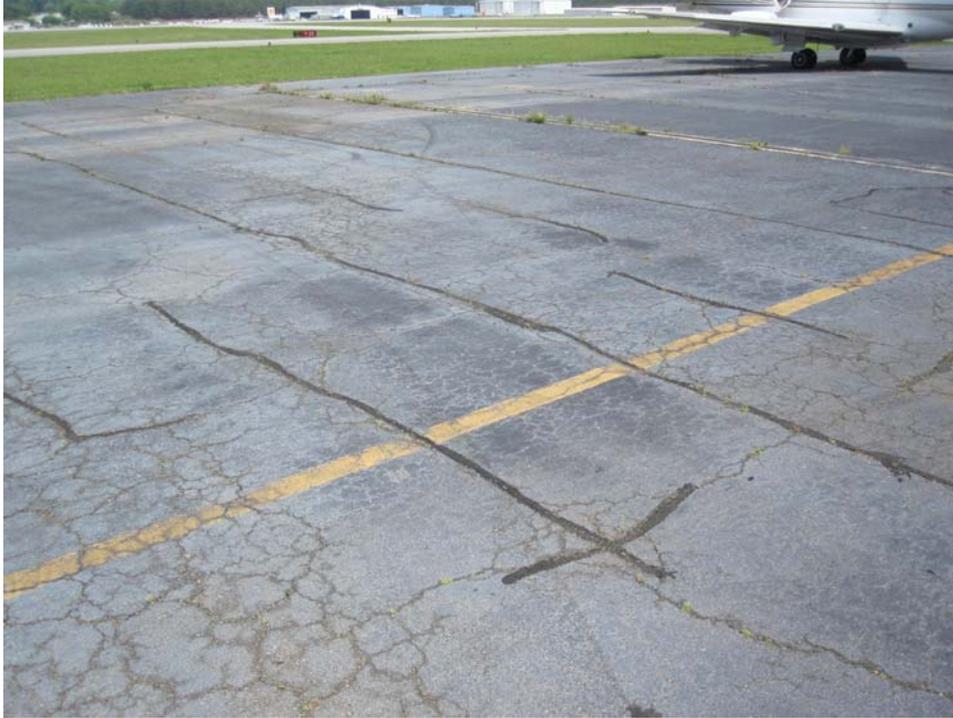
A03LW-20. Alligator and Block Cracking (Sample Unit #26).

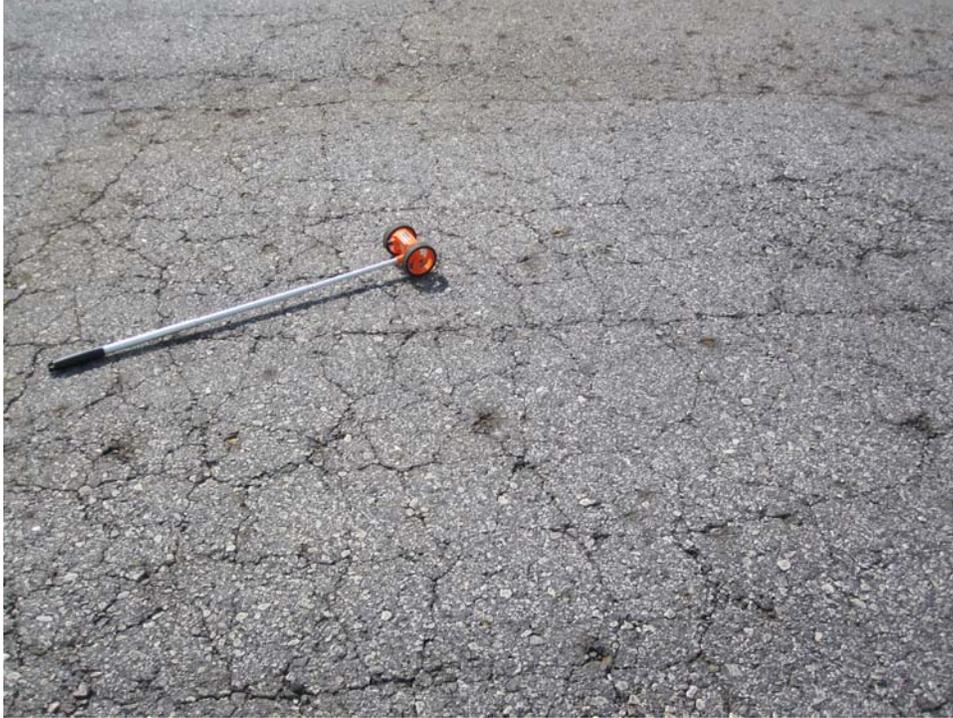
A04LW-10. Alligator Cracking (Sample Unit #03).

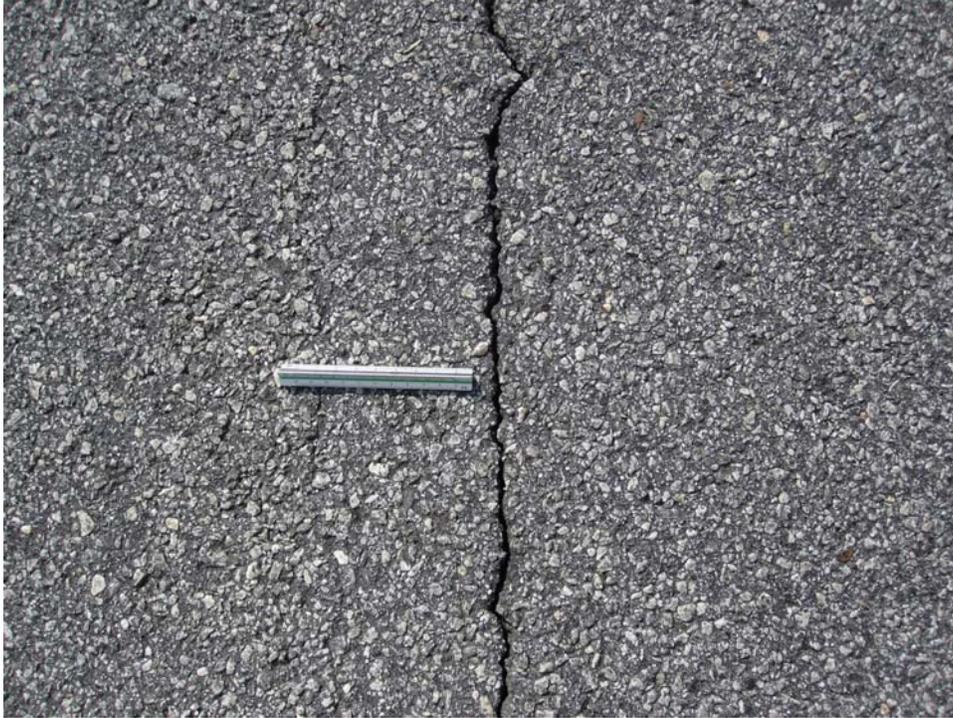
A04LW-20. Longitudinal and Transverse Cracking (Sample Unit #01).

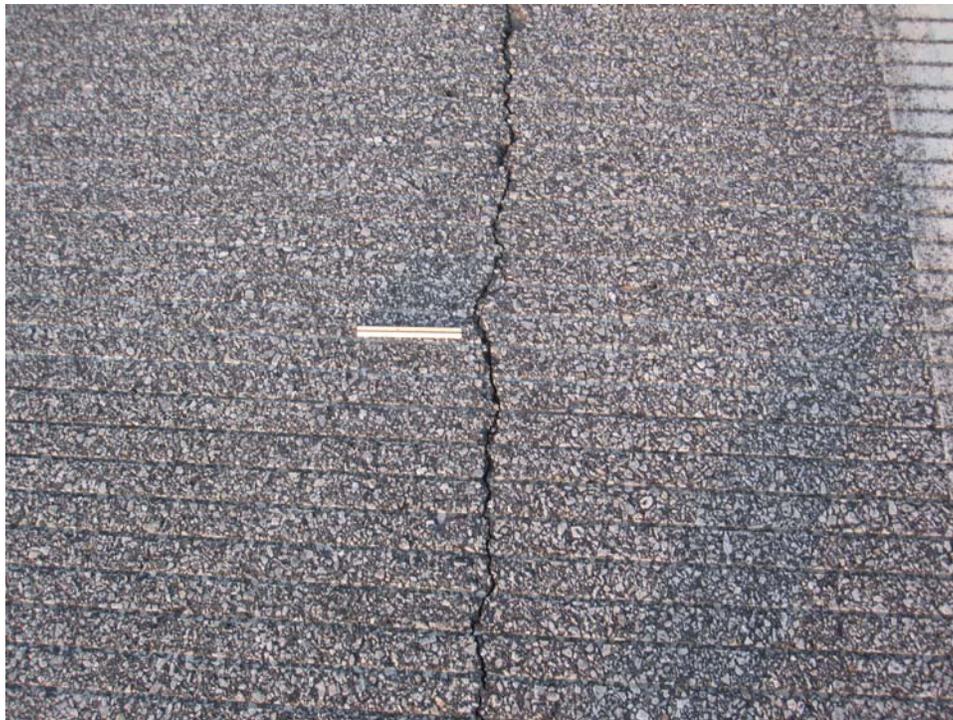
R725LW-10. Longitudinal and Transverse Cracking (Sample Unit #117).

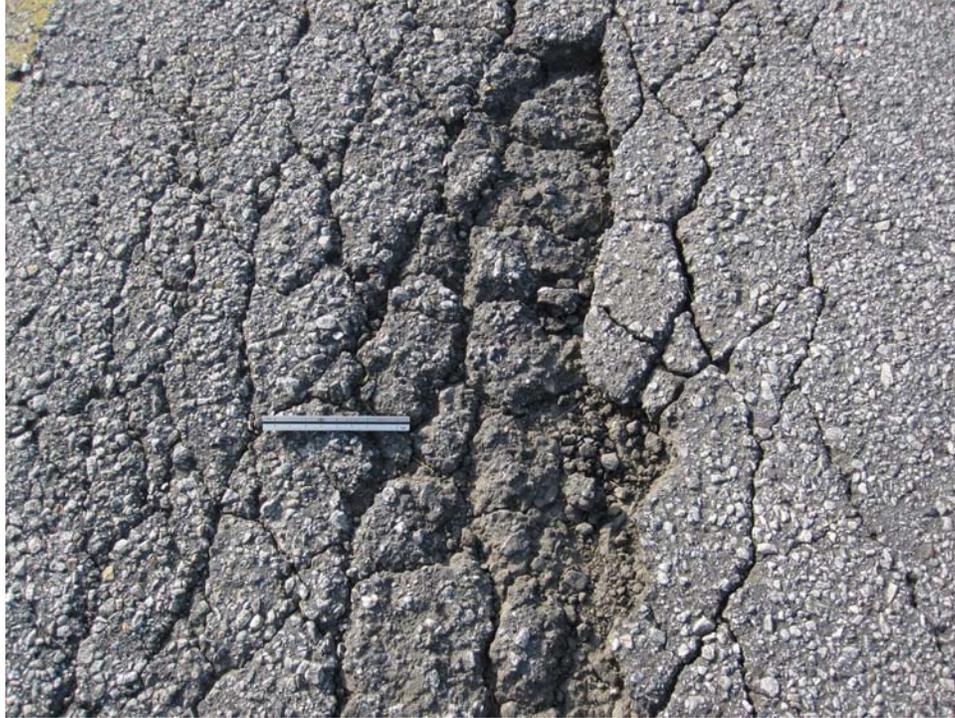
TBLW-10. Alligator Cracking (Sample Unit #01).

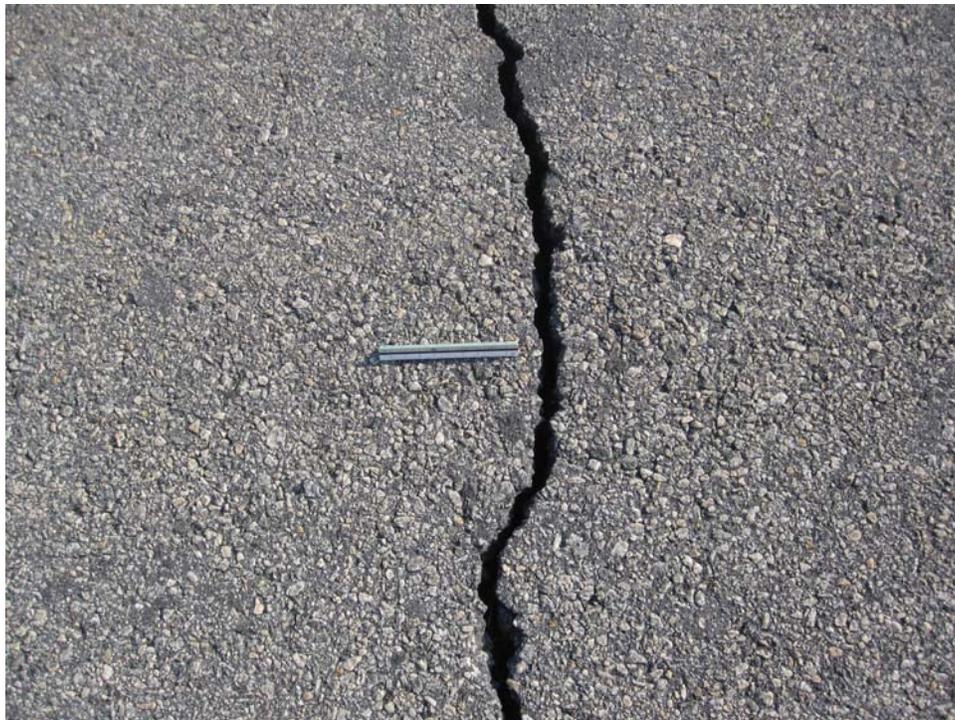
TBLW-10. Longitudinal and Transverse Cracking (Sample Unit #03).

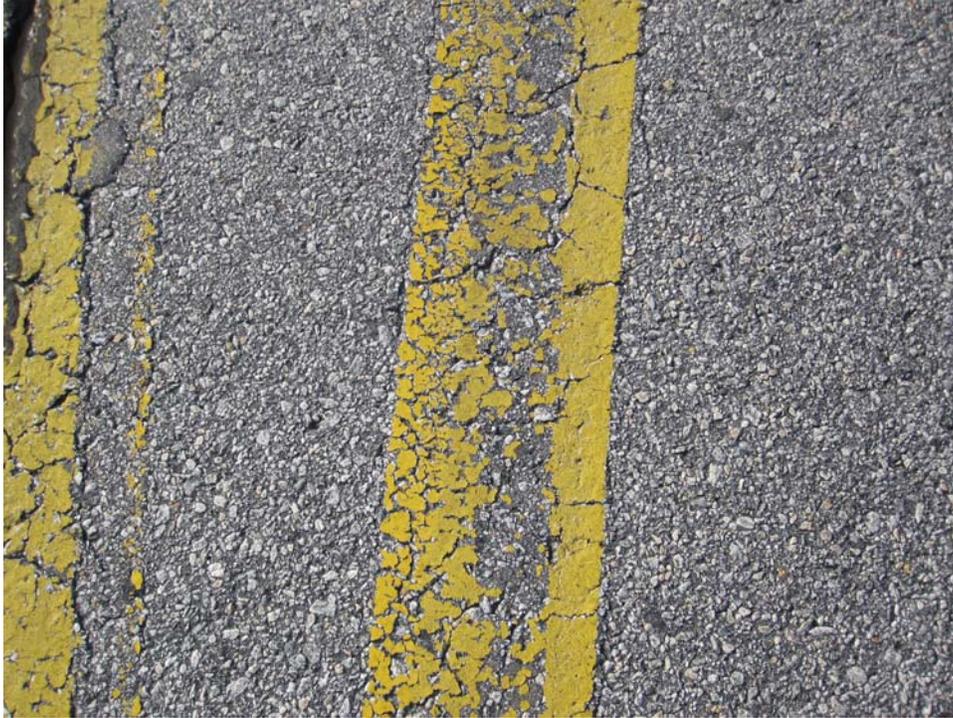
TBLW-10. Unsatisfactory Paint.

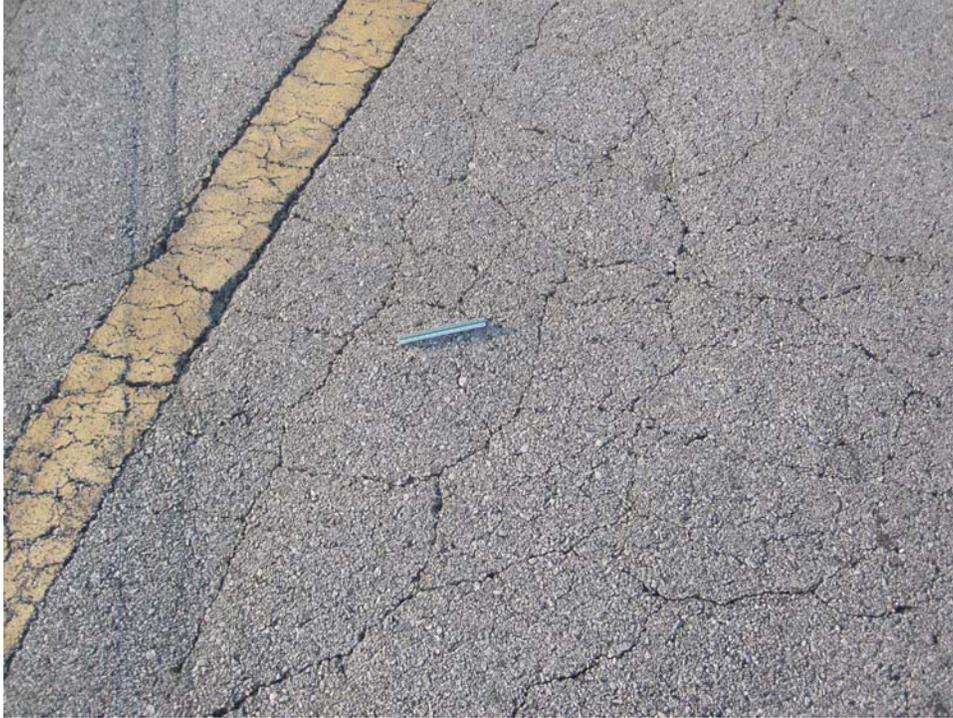
TCLW-10. Alligator Cracking (Sample Unit #04).

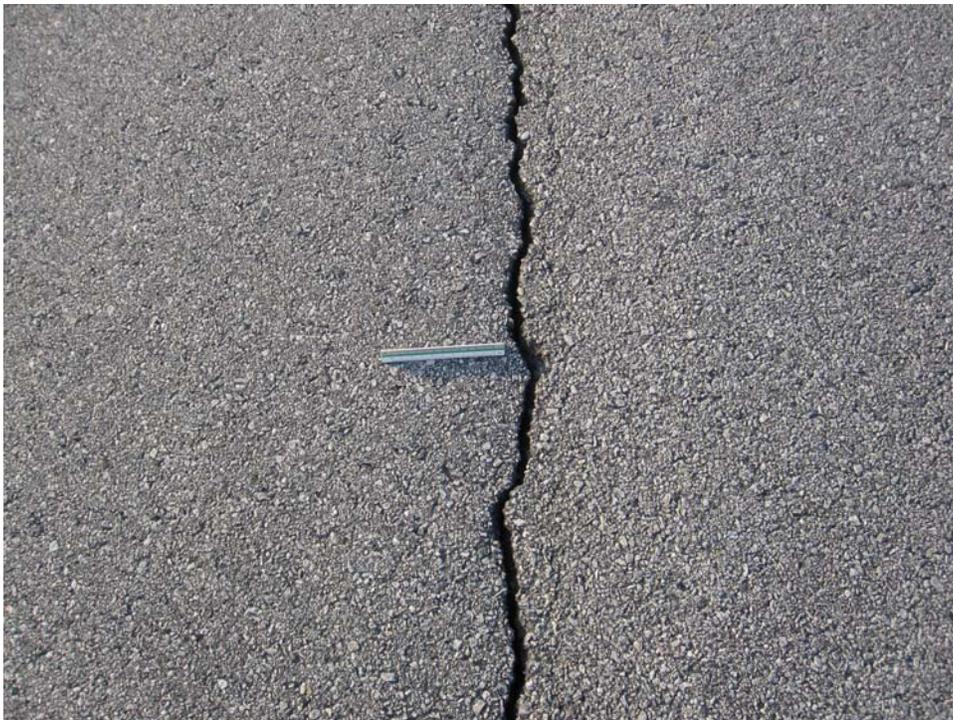
TCLW-10. Longitudinal and Transverse Cracking (Sample Unit #02).

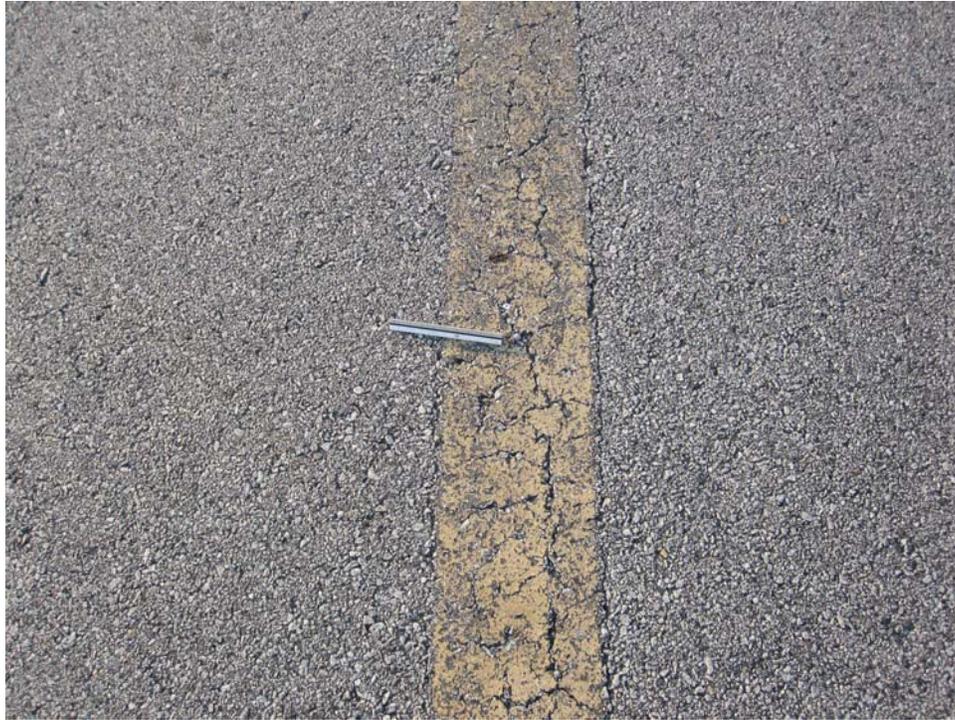
TCLW-10. Unsatisfactory Paint.

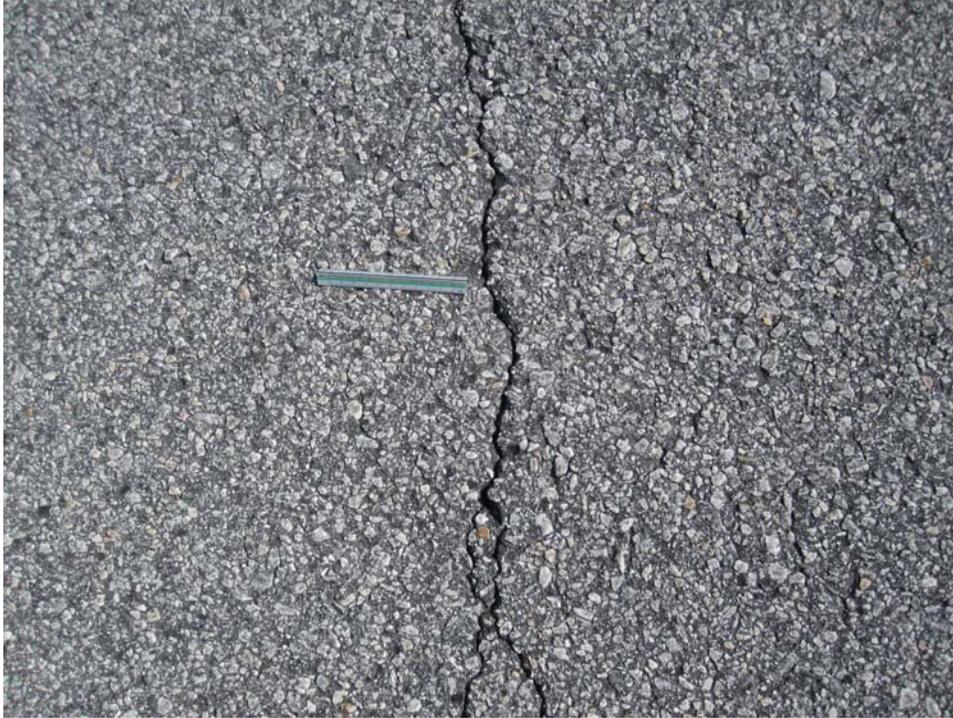
TDLW-10. Longitudinal and Transverse Cracking (Sample Unit #01).

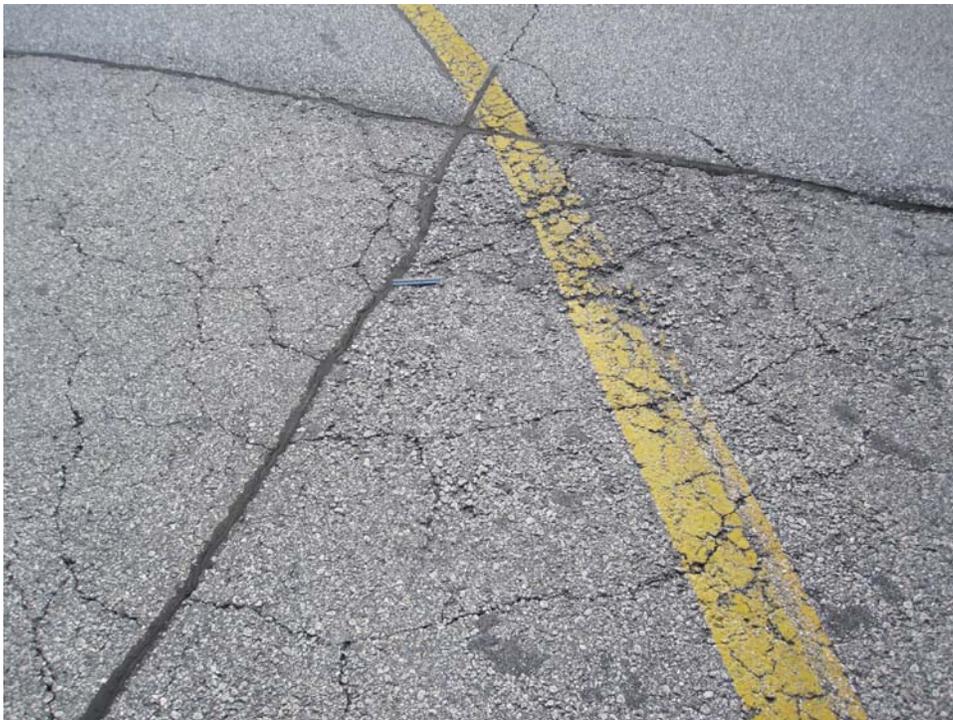
TDLW-10. Rutting and Alligator Cracking (Sample Unit #01).

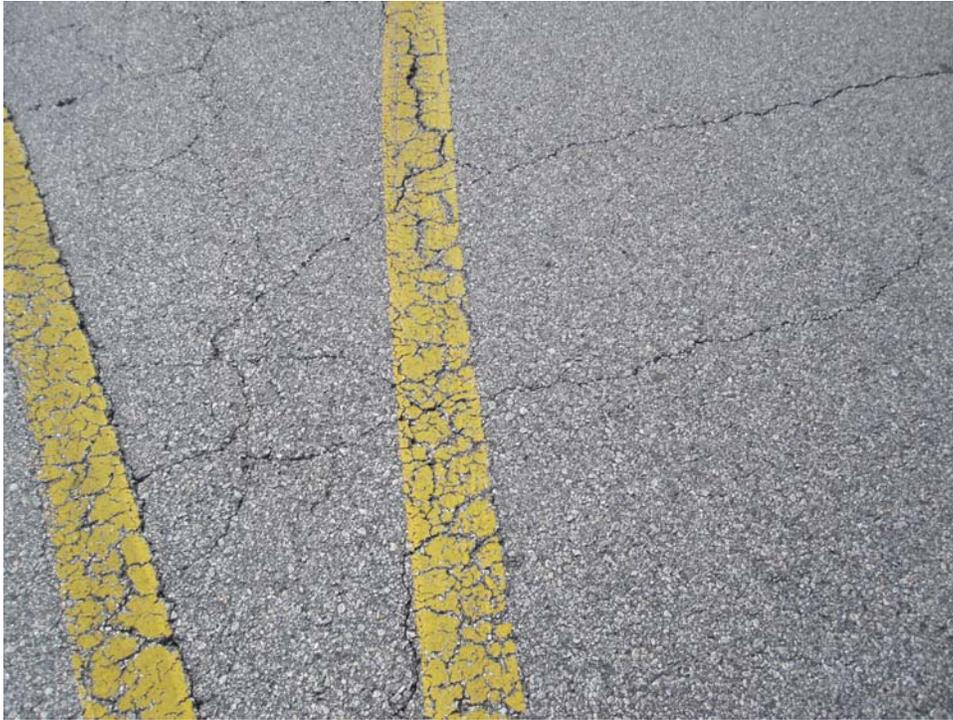
TDLW-10. Unsatisfactory Paint.

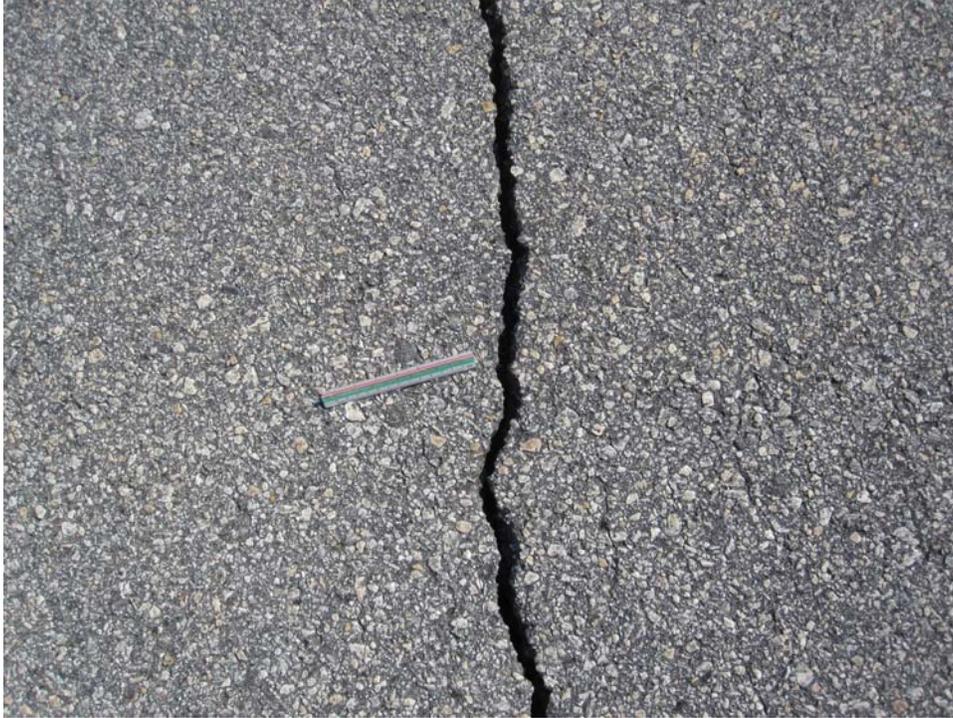
TELW-10. Longitudinal and Transverse Cracking (Sample Unit #01).

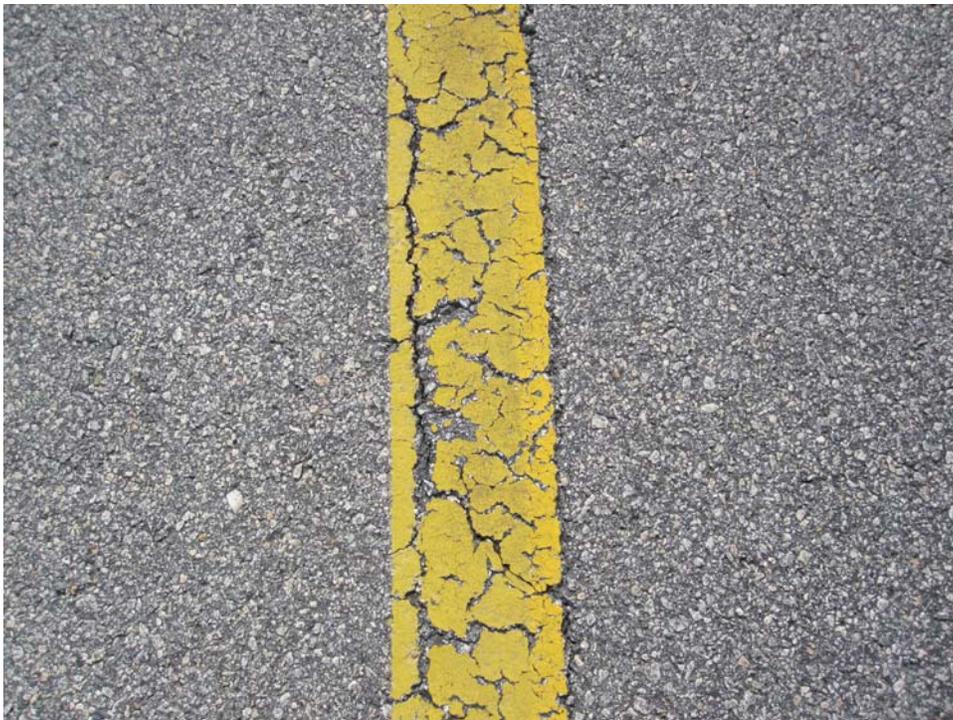
TELW-10. Unsatisfactory Paint.

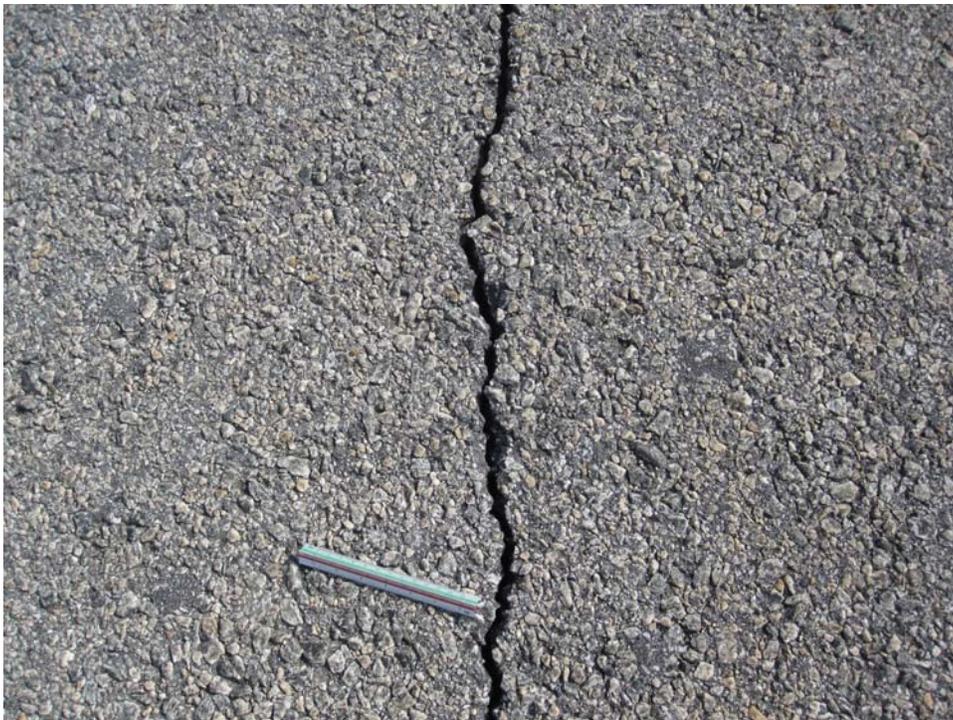
TFLW-10. Longitudinal and Transverse Cracking (Sample Unit #01).

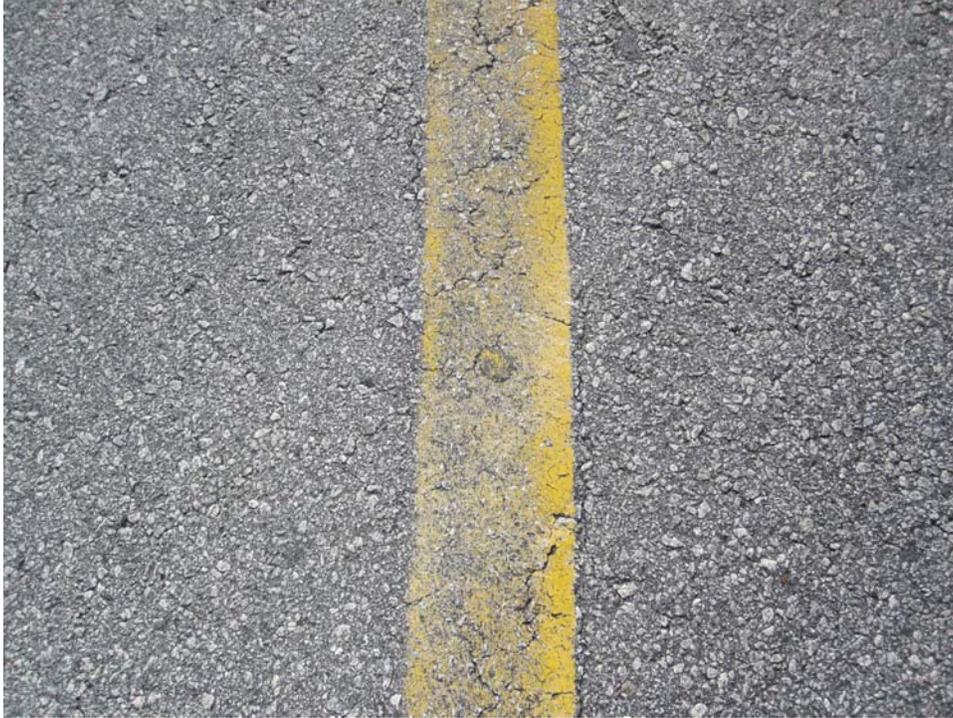
TFLW-10. Unsatisfactory Paint.

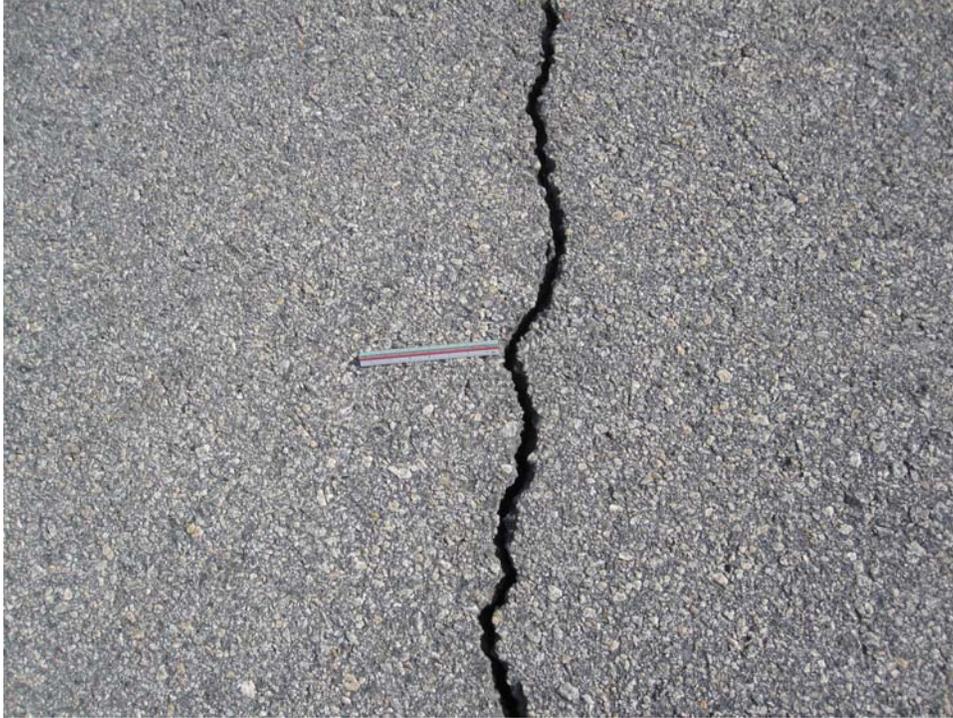
TGLW-10. Longitudinal and Transverse Cracking (Sample Unit #01).
