2012 Gwinnett County- Briscoe Field Pavement Management Plan

GWINNETT COUNTY-BRISCOE FIELD

PAVEMENT MANAGEMENT REPORT

DECEMBER 2012

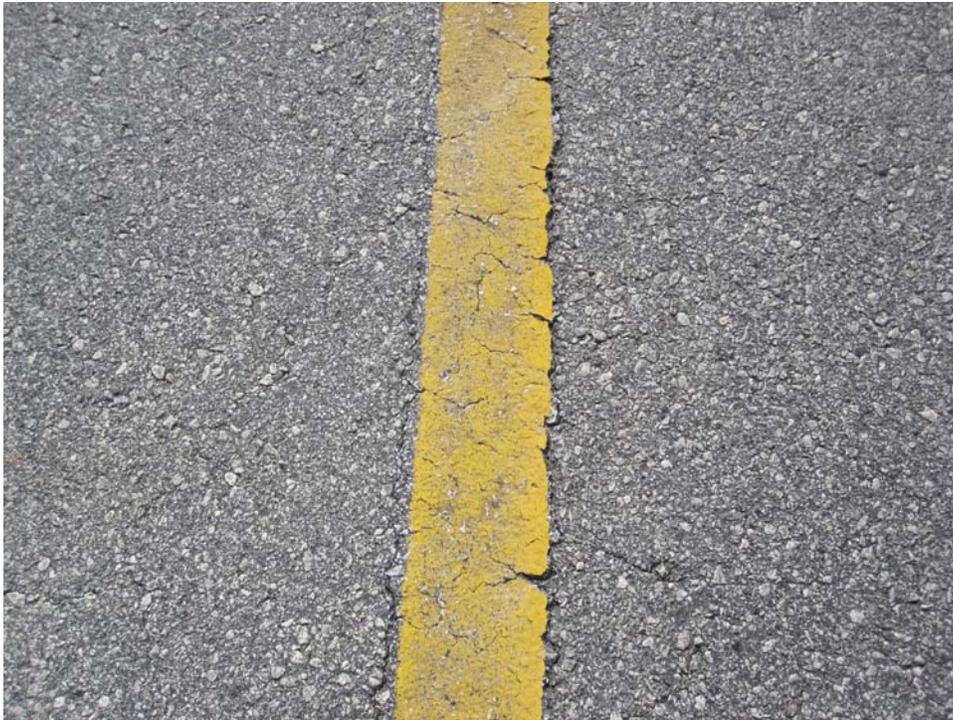
TGLW-10. Unsatisfactory Paint.

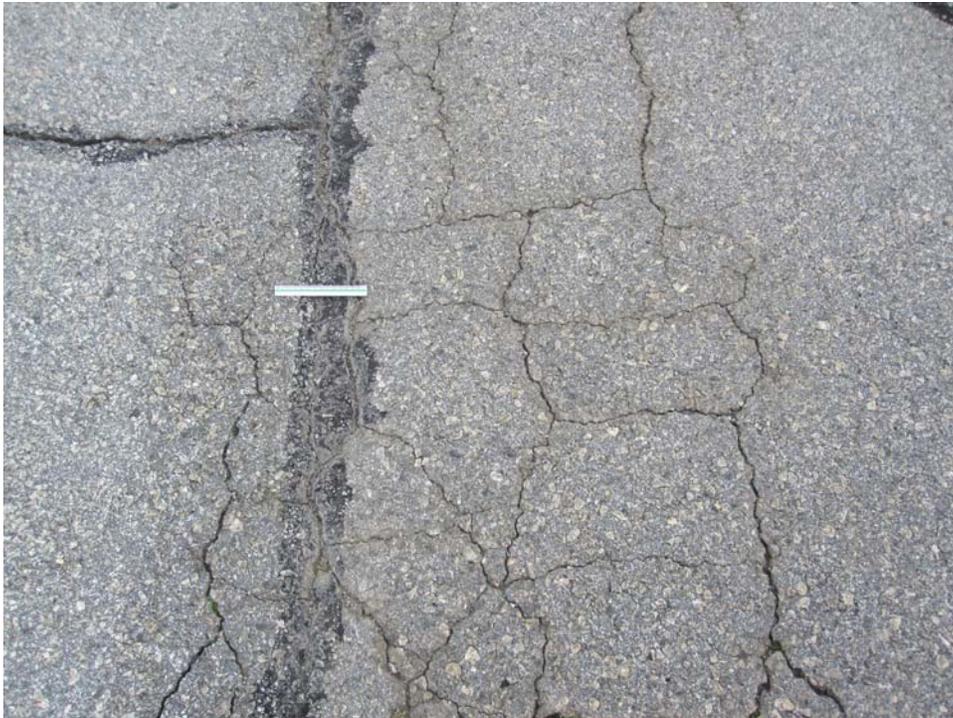
THLW-20. Alligator Cracking (Sample Unit #03).

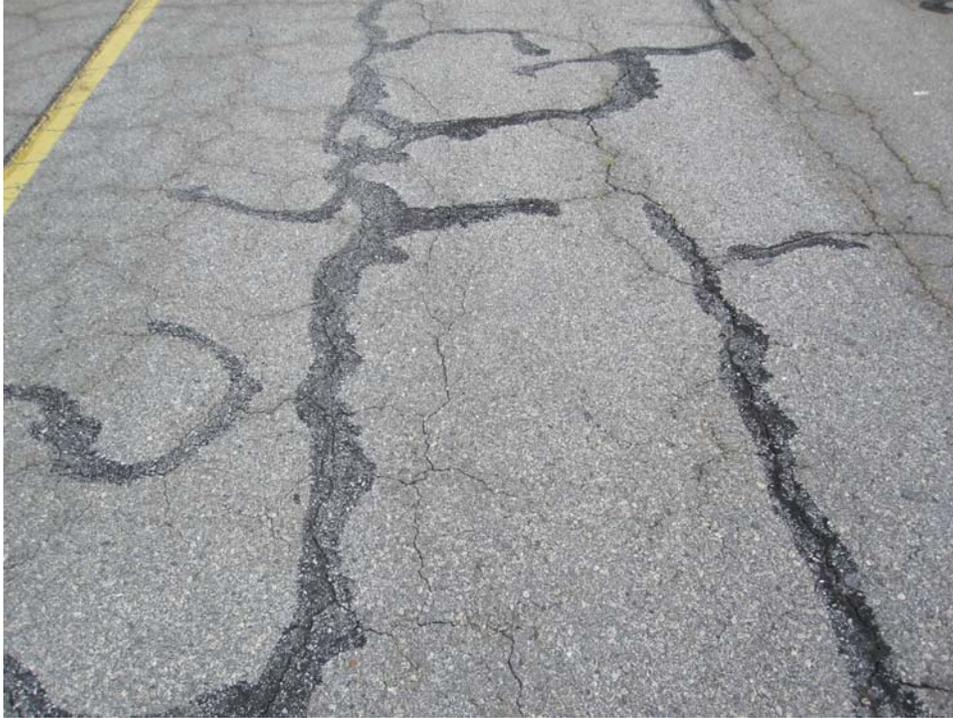
THLW-20. Block Cracking (Sample Unit #01).

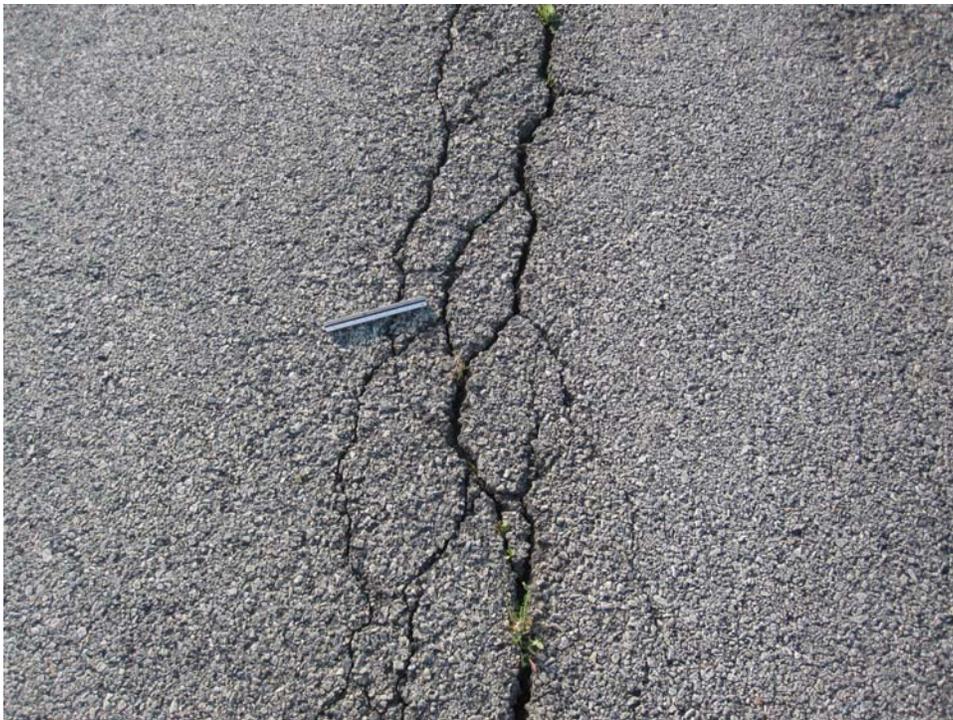
TWLW-10. Alligator Cracking (Sample Unit #04).

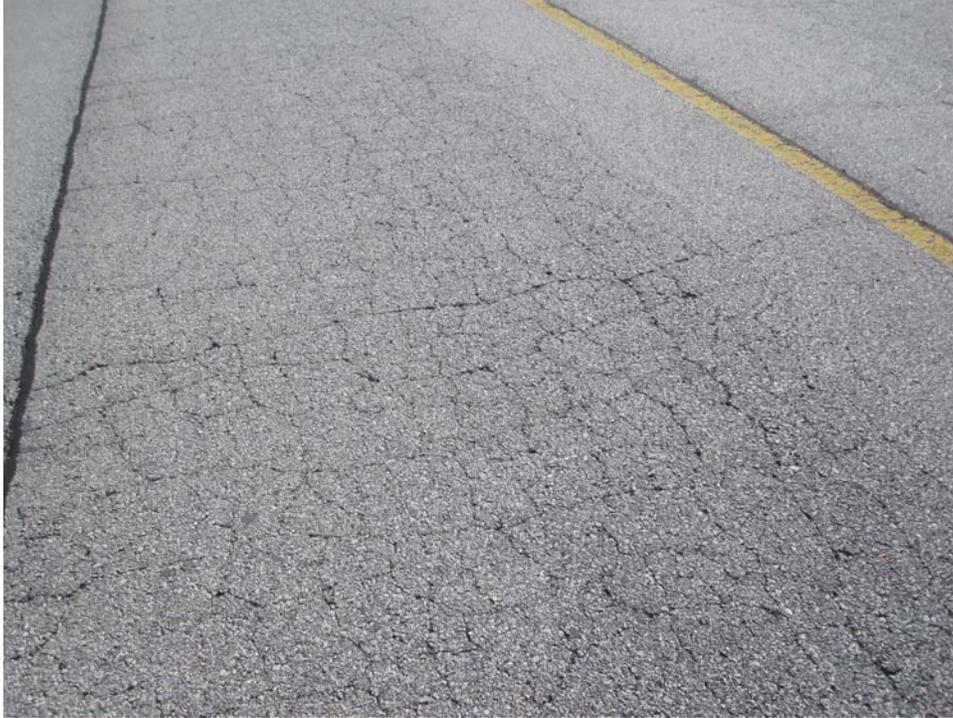
TWLW-10. Alligator Cracking (Sample Unit #09).

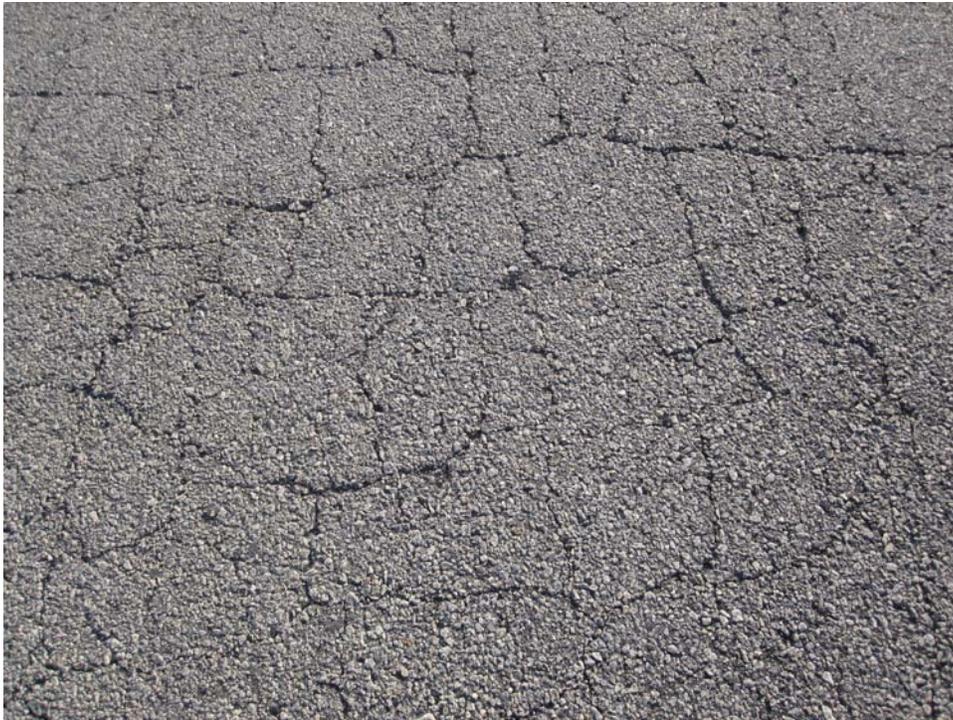
TWLW-10. Alligator Cracking (Sample Unit #51).

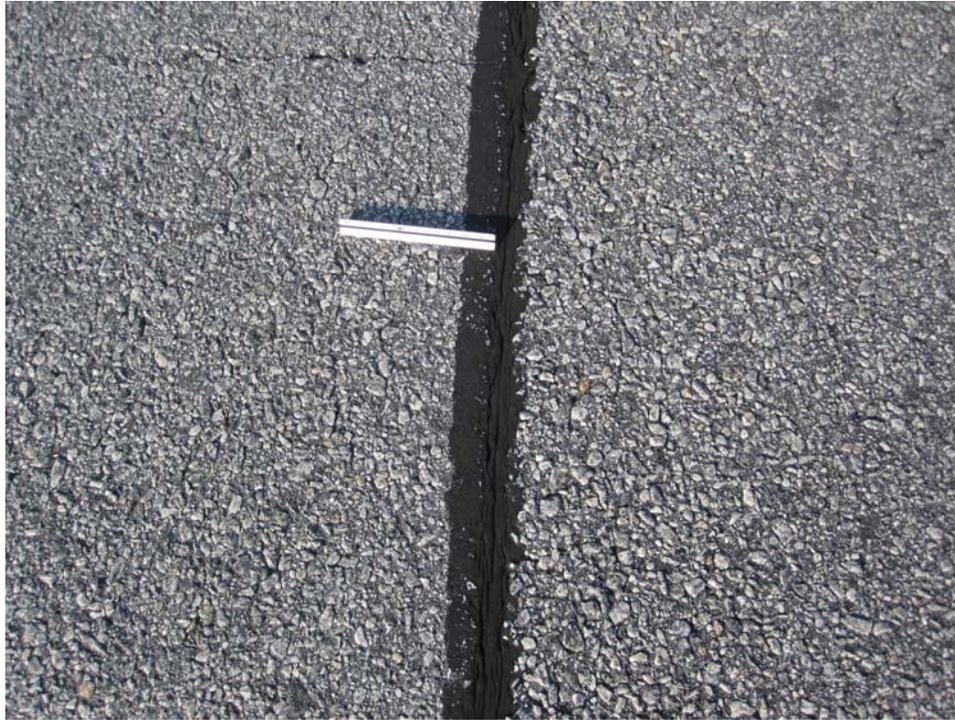
TWLW-10. Longitudinal and Transverse Cracking (Sample Unit #03).

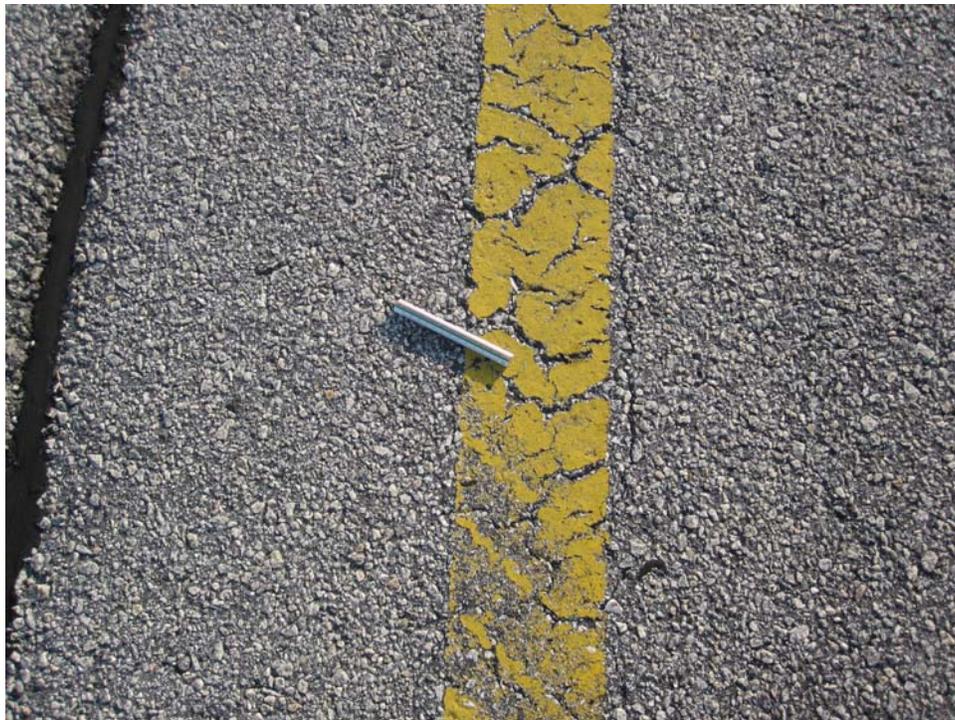
TWLW-10. Unsatisfactory Paint.

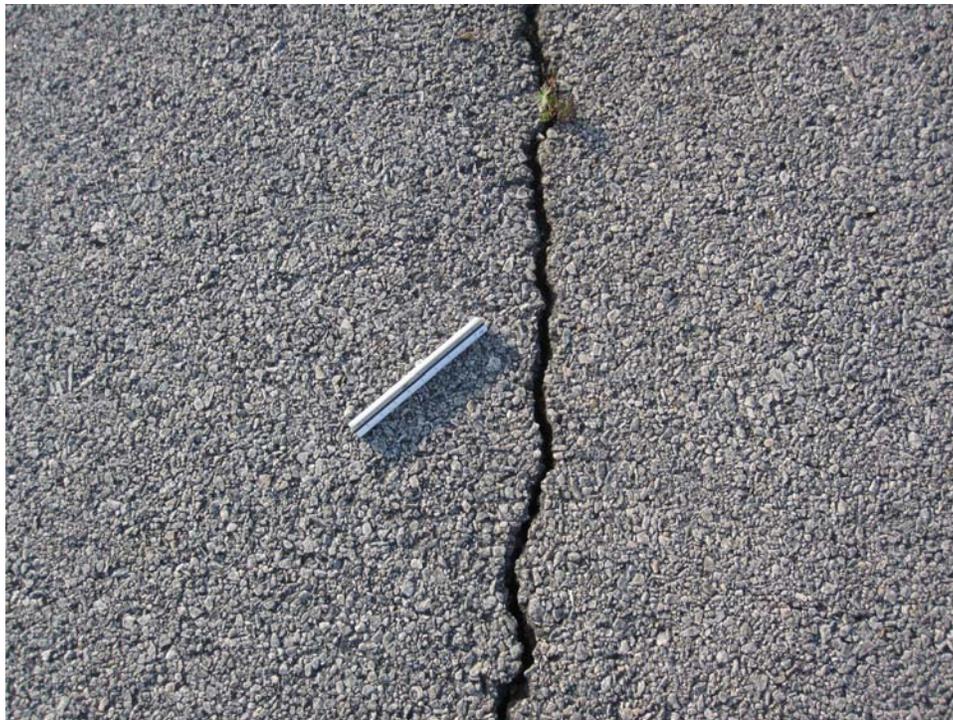
TWLW-20. Longitudinal and Transverse Cracking (Sample Unit #02).

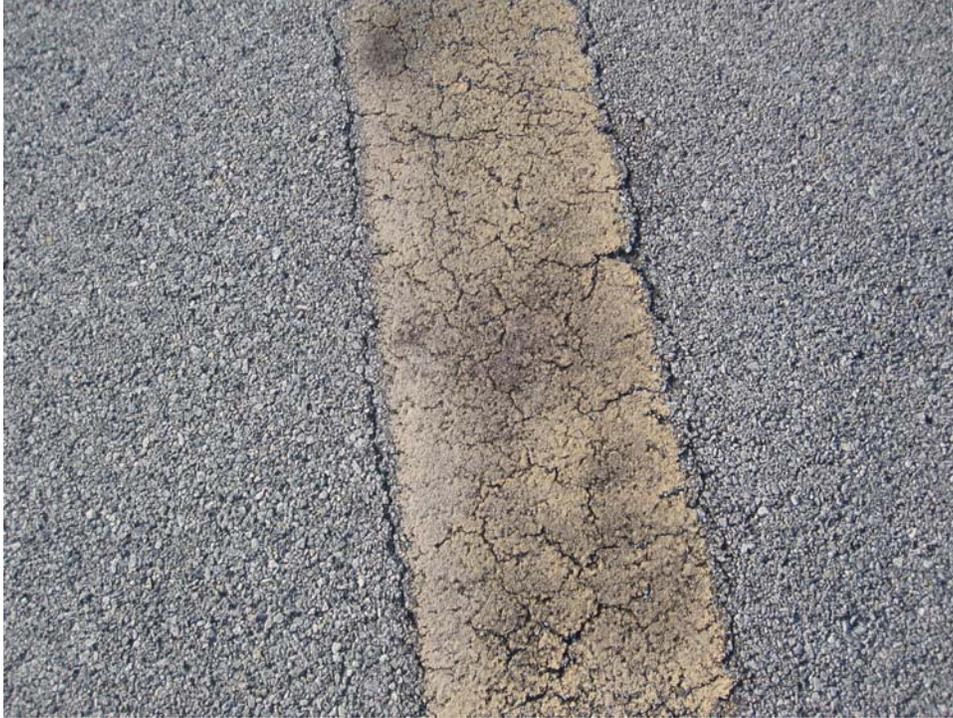
TWLW-20. Unsatisfactory Paint.

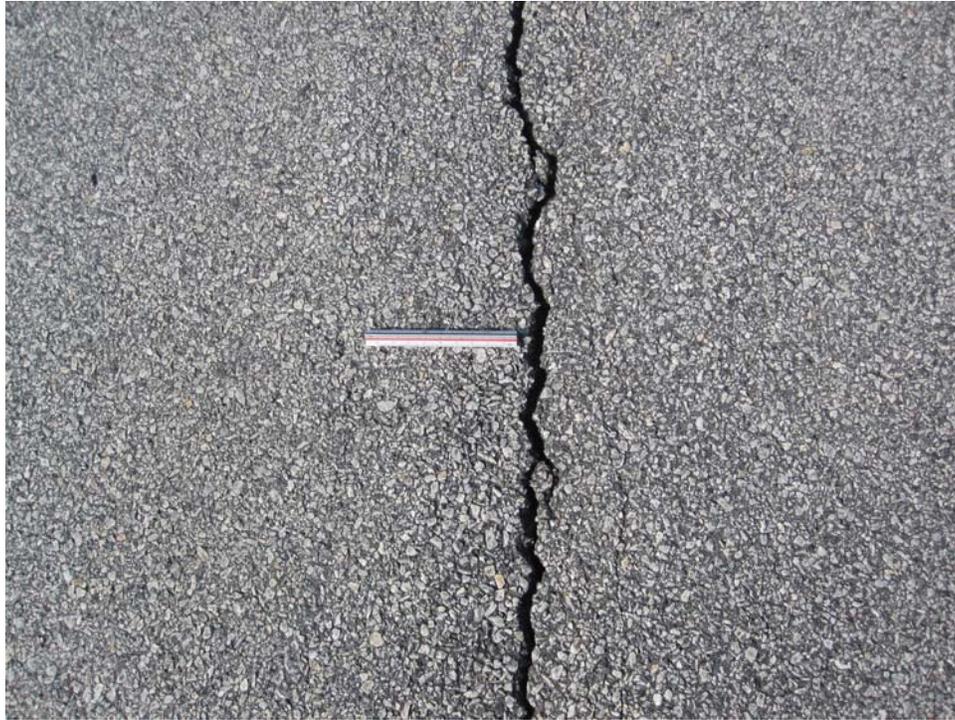
TWLW-30. Longitudinal and Transverse Cracking (Sample Unit #06).

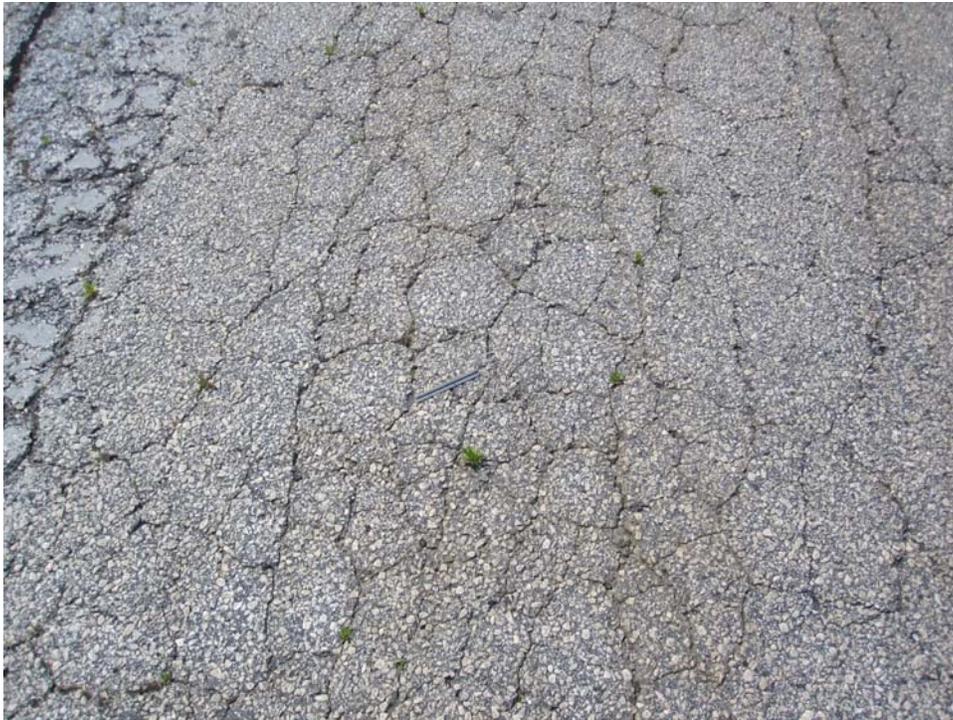
TYLW-10. Alligator Cracking (Sample Unit #20).

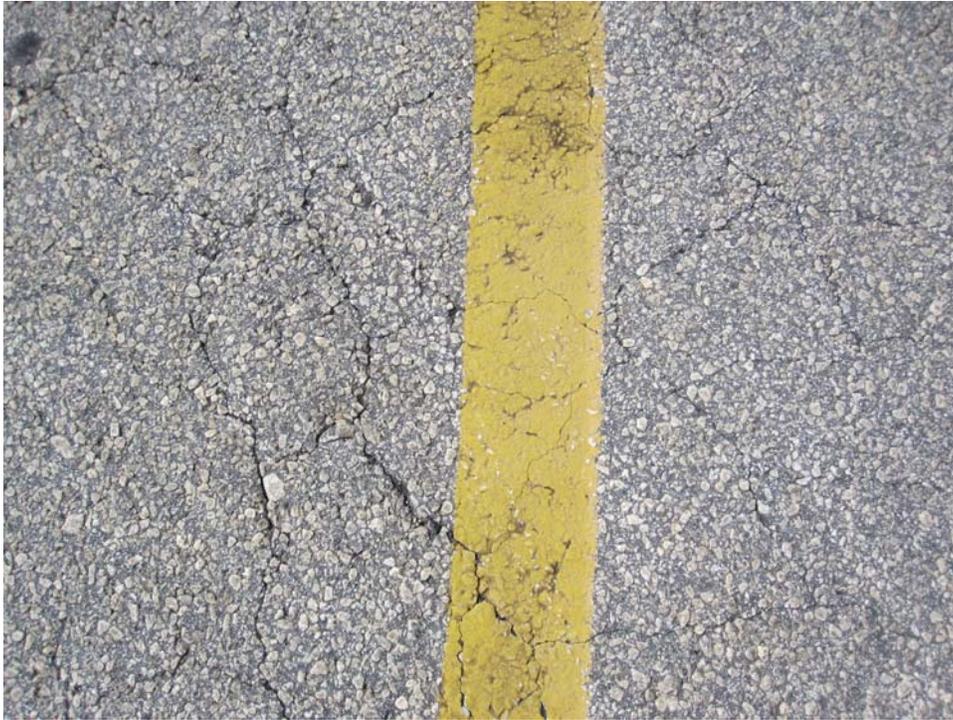
TYLW-10. Unsatisfactory Paint.

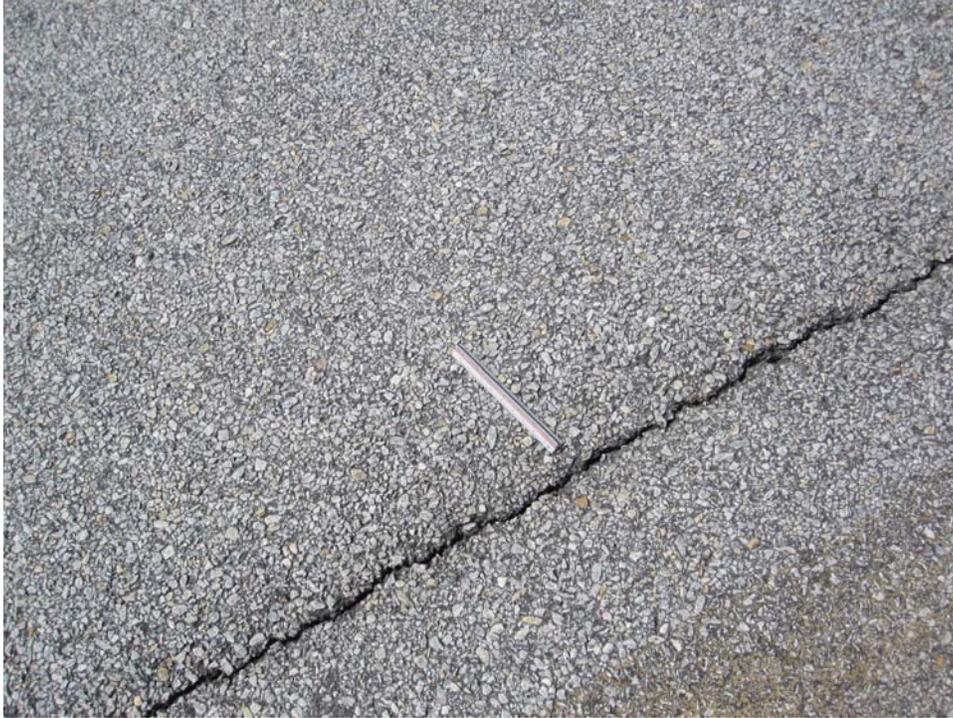
TZLW-10. Longitudinal and Transverse Cracking (Sample Unit #03).

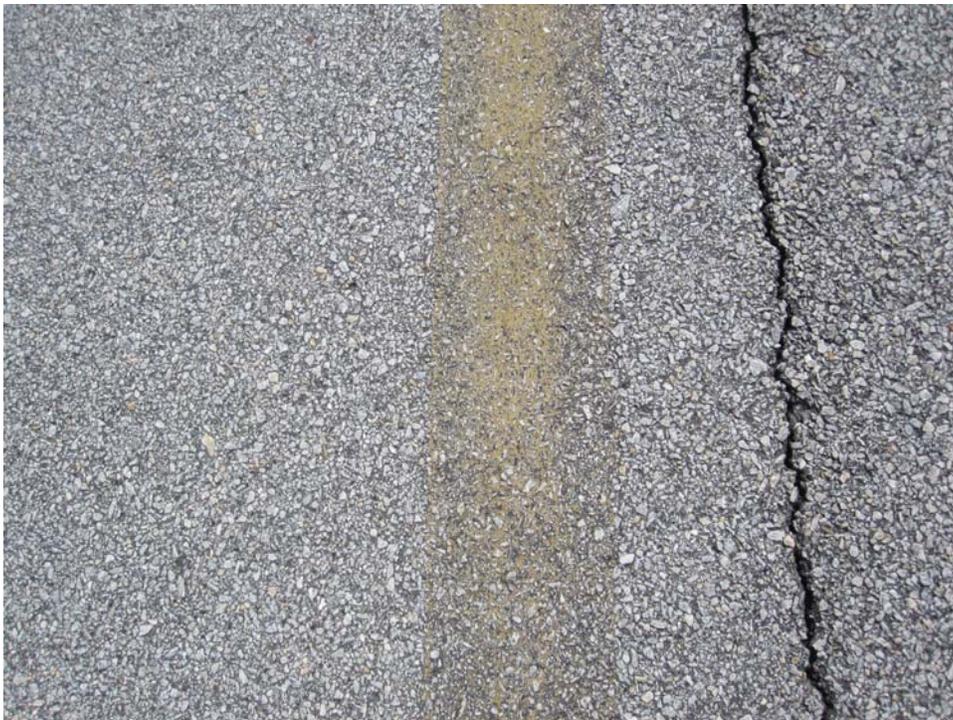
TZLW-10. Unsatisfactory Paint.

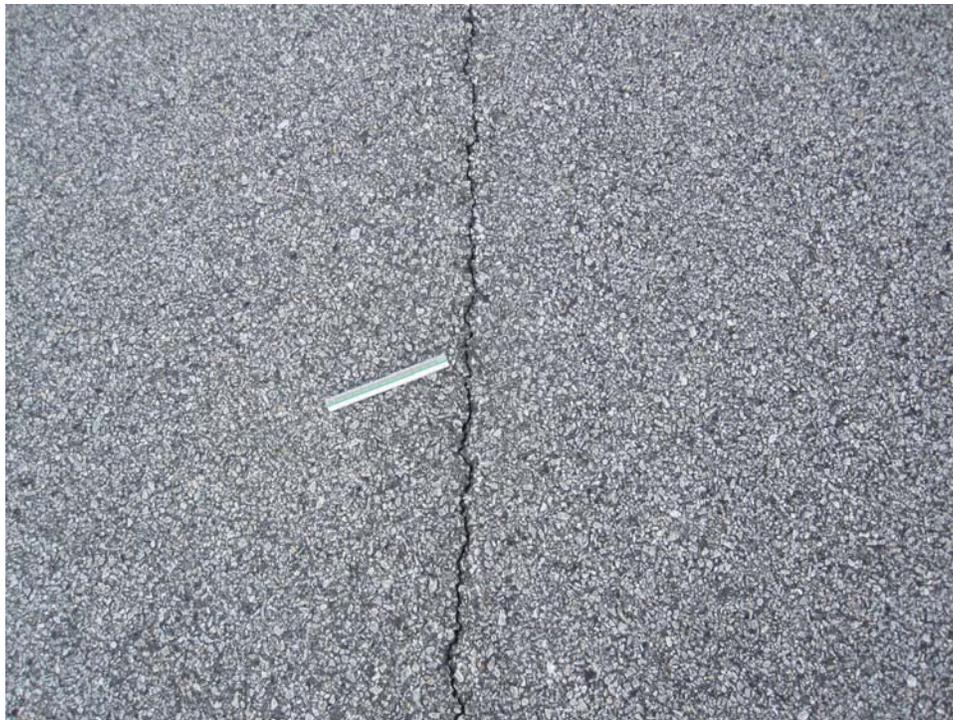
TZLW-20. Longitudinal and Transverse Cracking (Sample Unit #03).

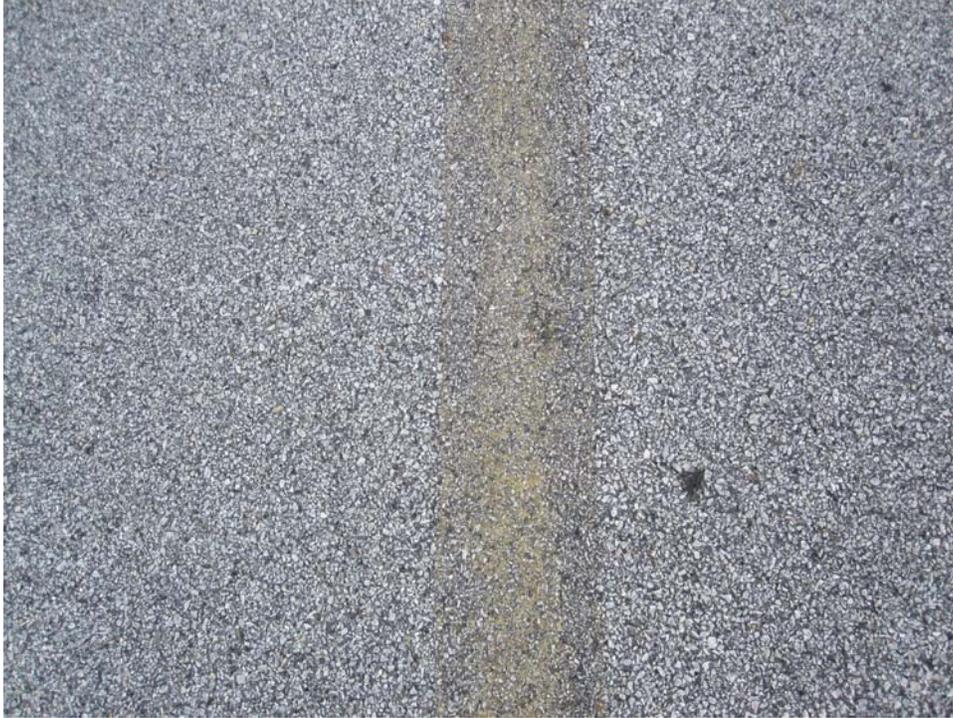
TZLW-20. Unsatisfactory Paint.

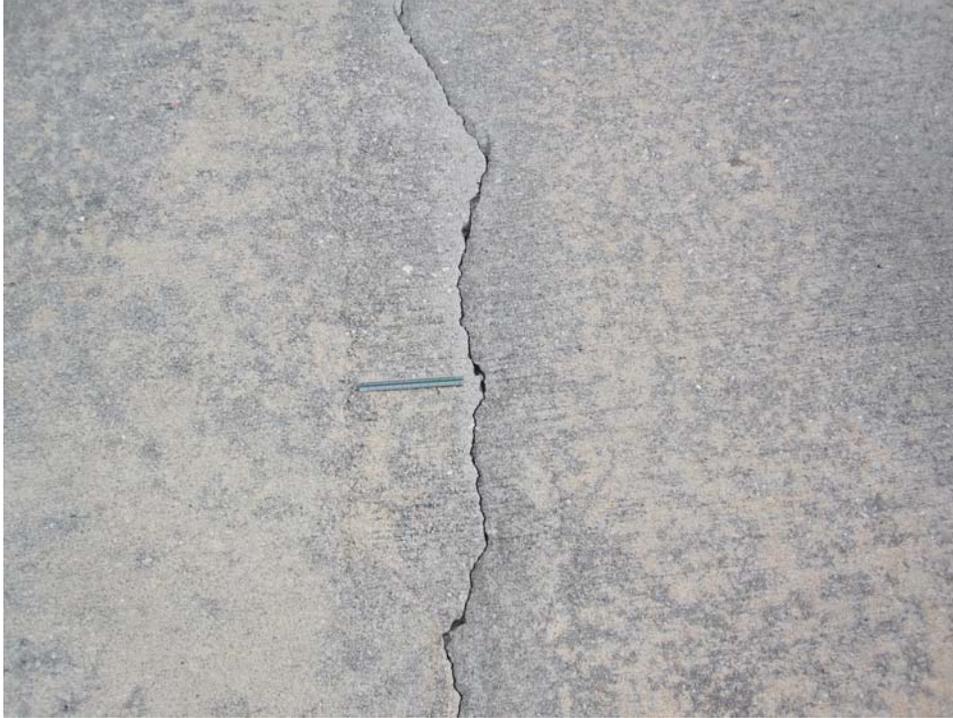
THANGLW-10. LTD Cracking (Sample Unit #04).

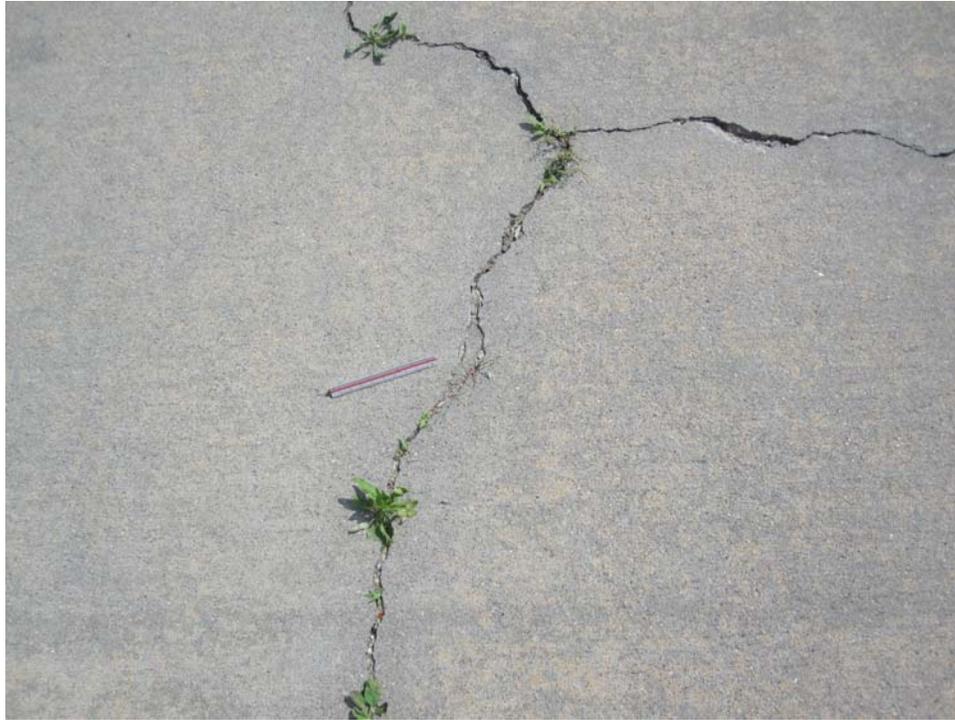
THANGLW-20. LTD Cracking (Sample Unit #01).
