# 2012 Savannah-Hilton Head International Airport Pavement Management Plan

# SAVANNAH-HILTON HEAD INTERNATIONAL AIRPORT

## PAVEMENT MANAGEMENT REPORT

**DECEMBER 2012**

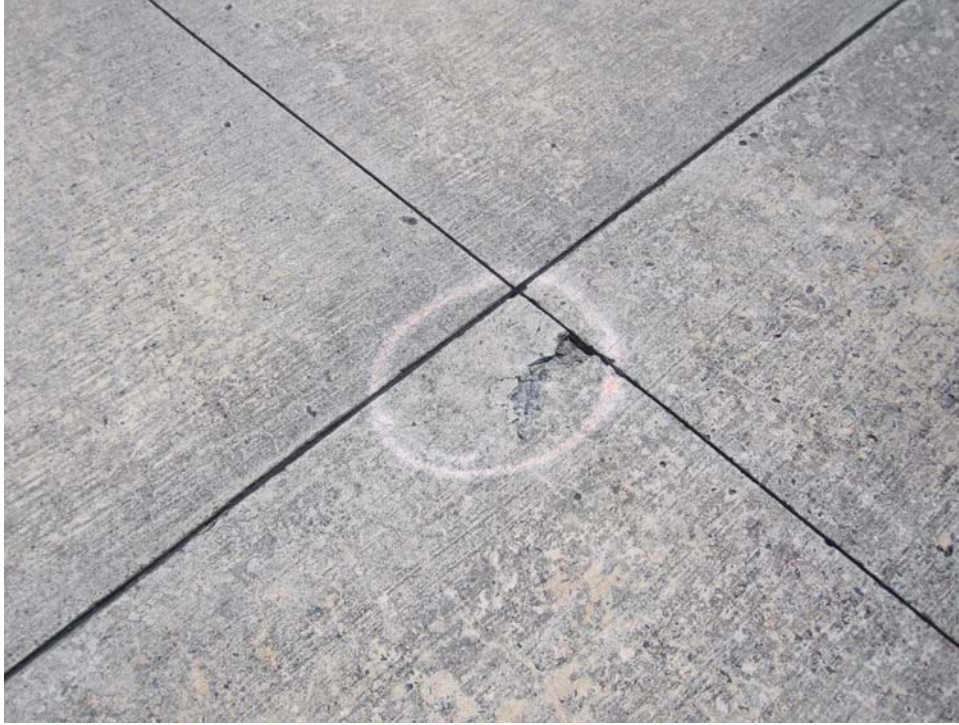
AOLDTERMSV-10 . Corner Spalling (Sample Unit #72).

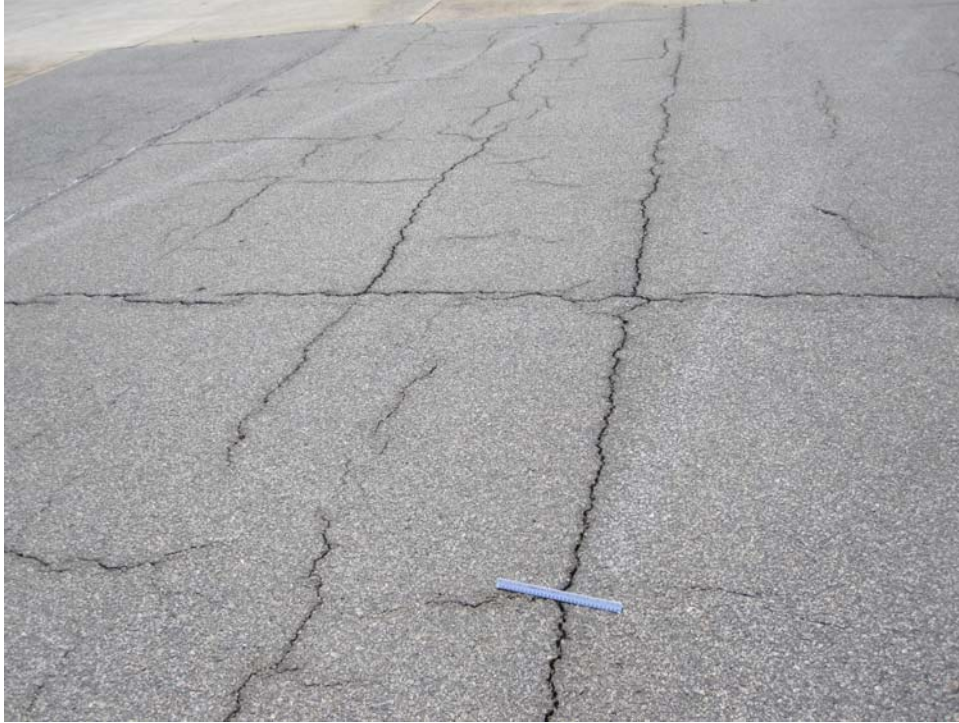
ASIGNORSV-10. Block Cracking (Sample Unit #15).

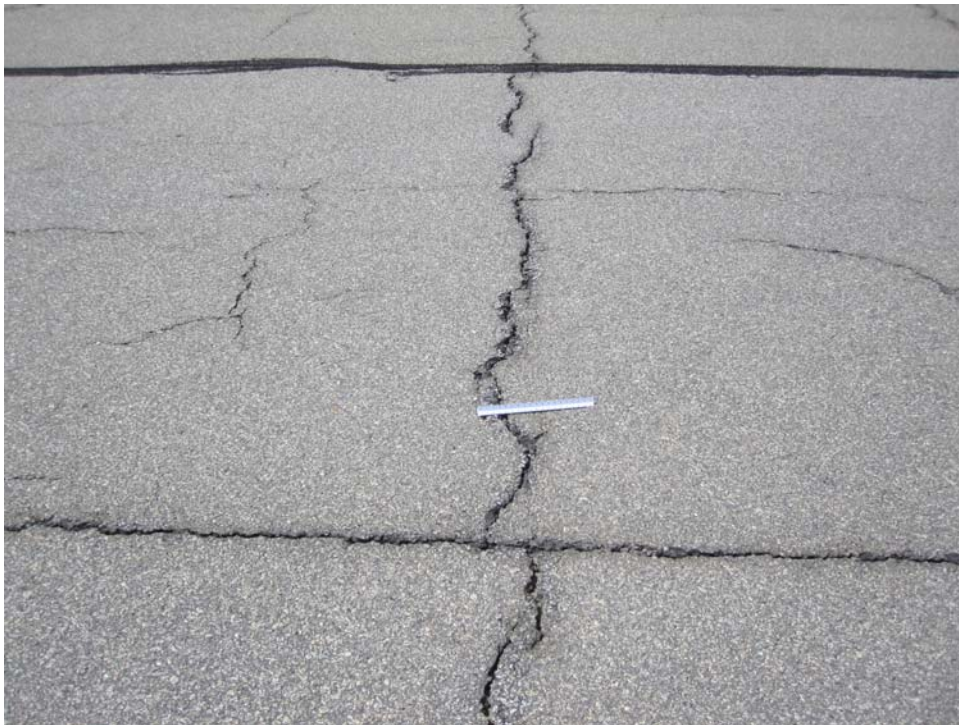
ASIGNORSV-10. Swelling (Sample Unit #18).

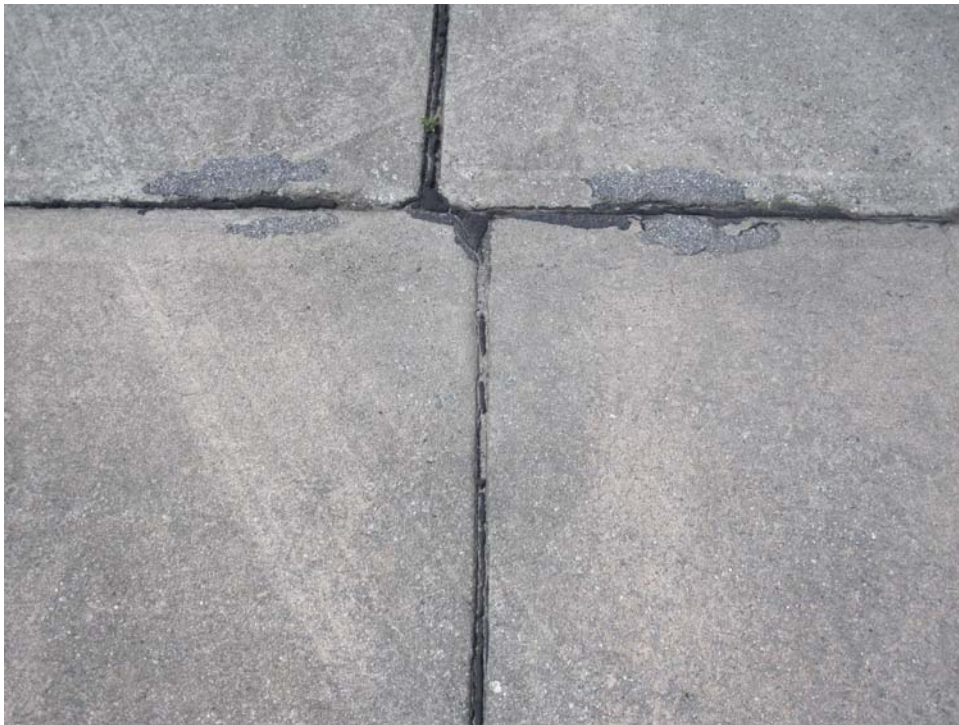
ASIGNORSV-20. Joint Seal Damage (Sample Unit #15).

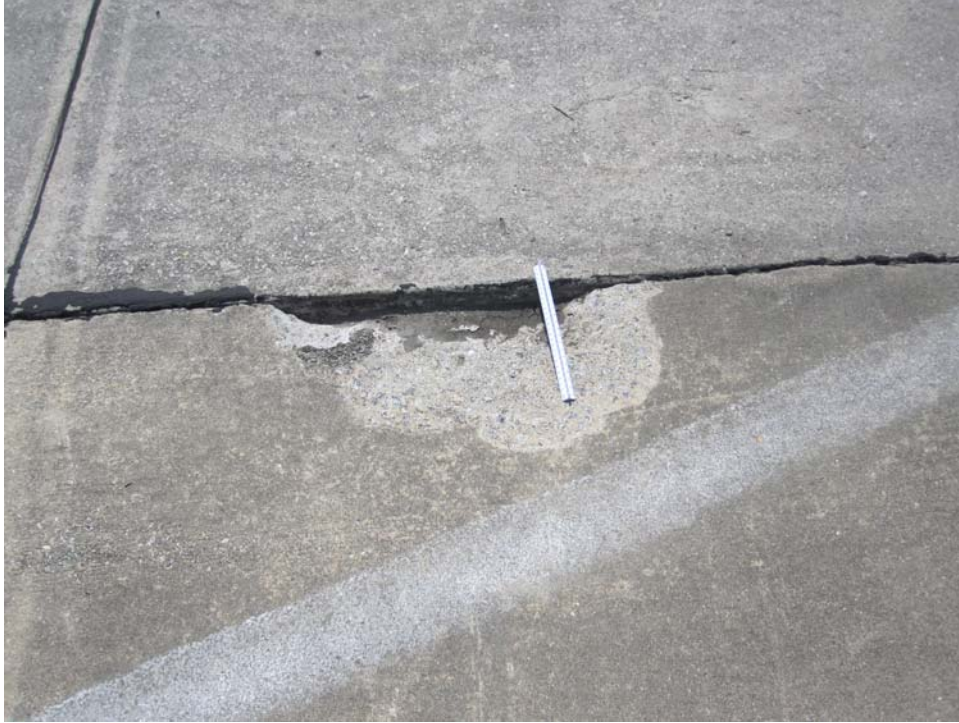
ASIGNORSV-20. Joint Spalling (Sample Unit #12).

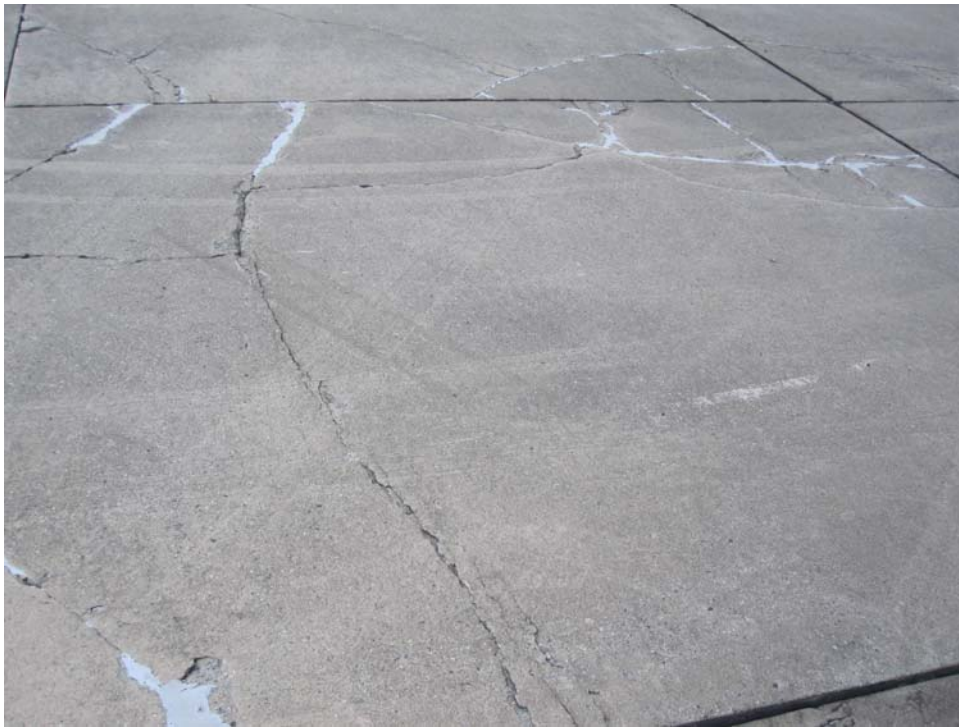
ASIGNORSV-20. Shattered Slab (Sample Unit #31).

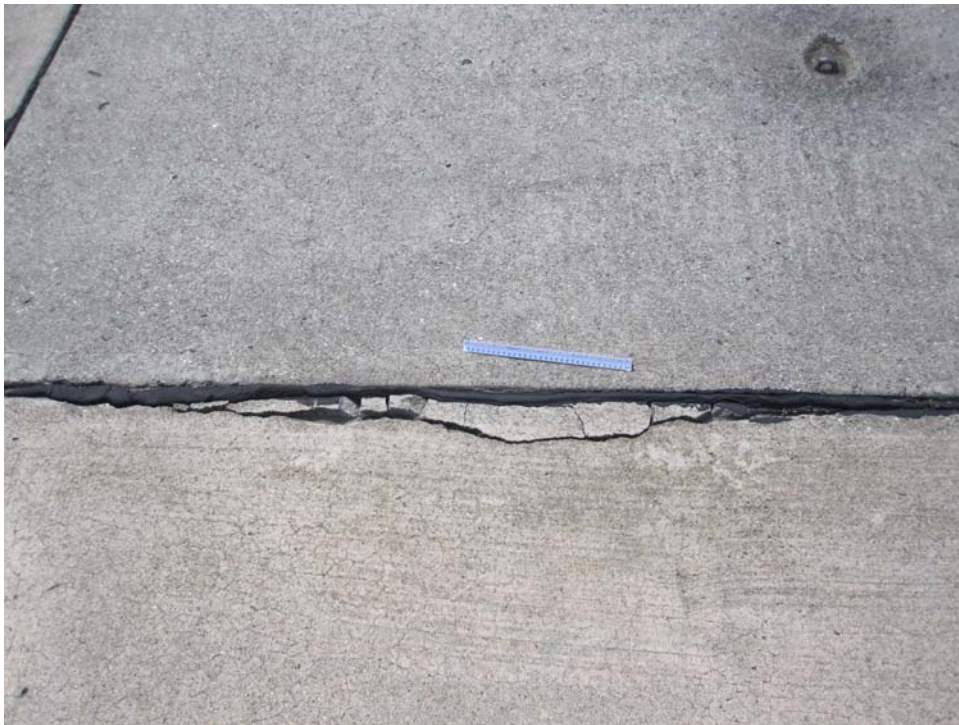
ASIGSTHSV-10. Joint Spalling (Sample Unit #16).

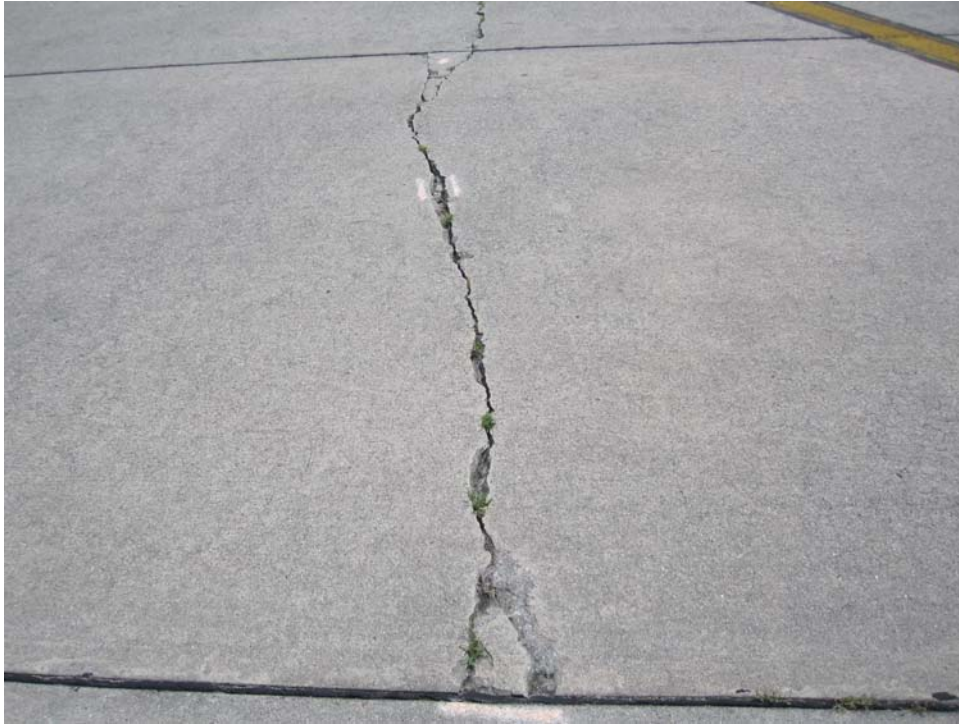
ASIGSTHSV-10. LTD Cracking (Sample Unit #02).

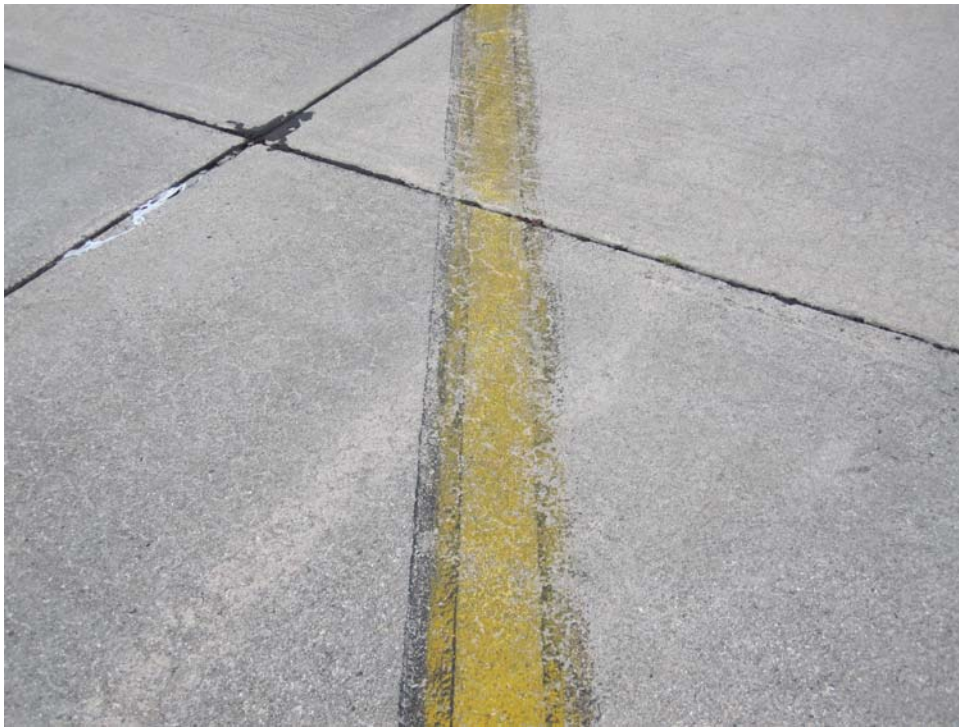
ASIGSTHSV-10. Unsatisfactory Paint.

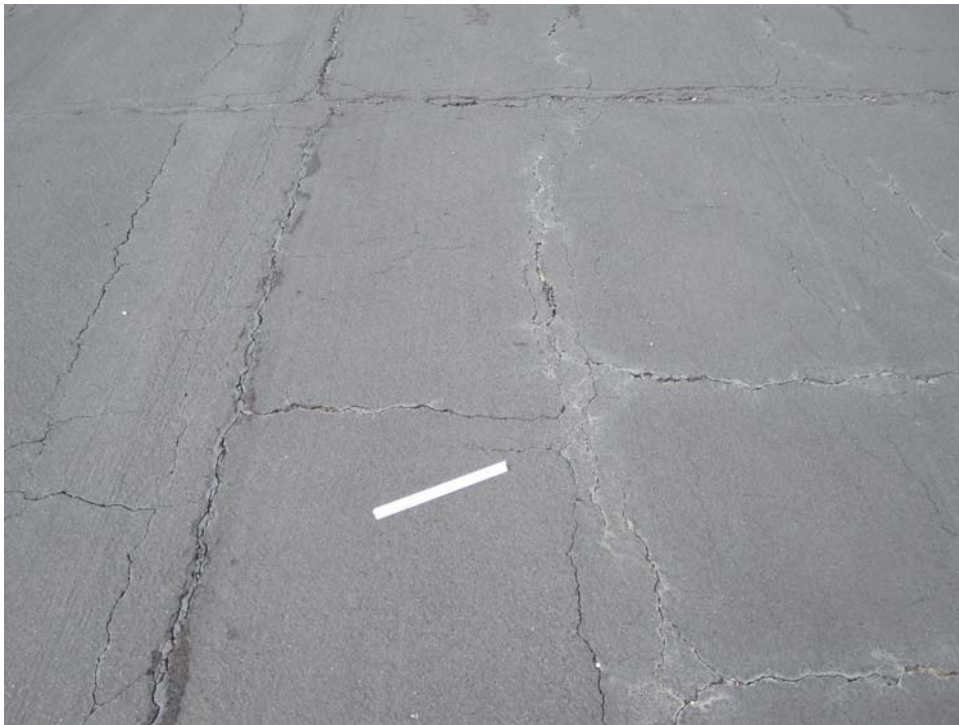
ASIGSTHSV-20. Block Cracking (Sample Unit #15).

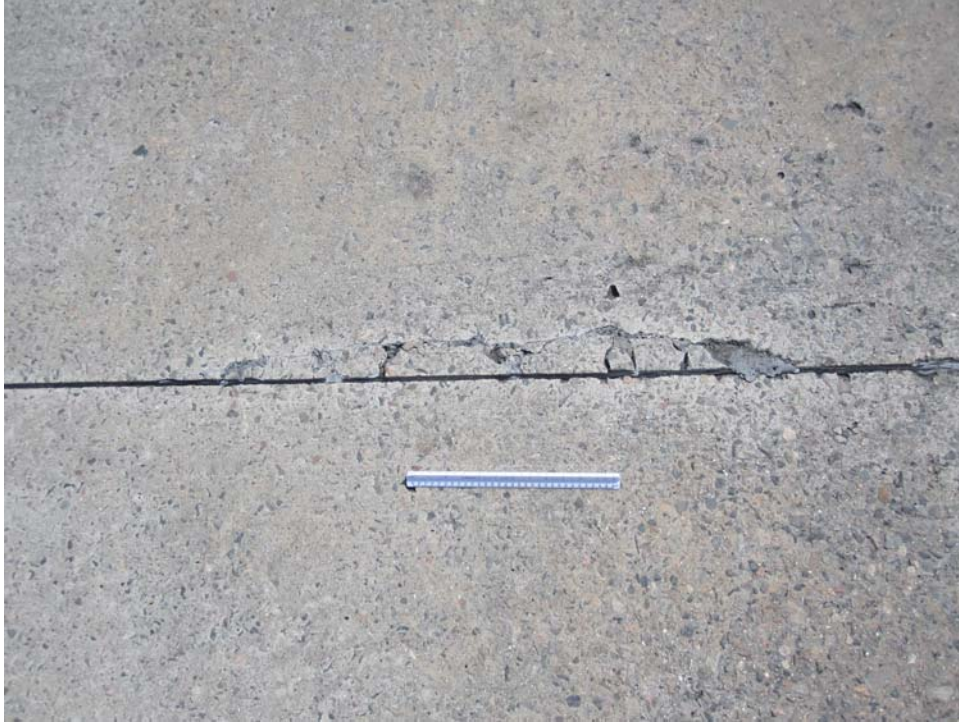
ATERMSV-10. Joint Spalling (Sample Unit #33).

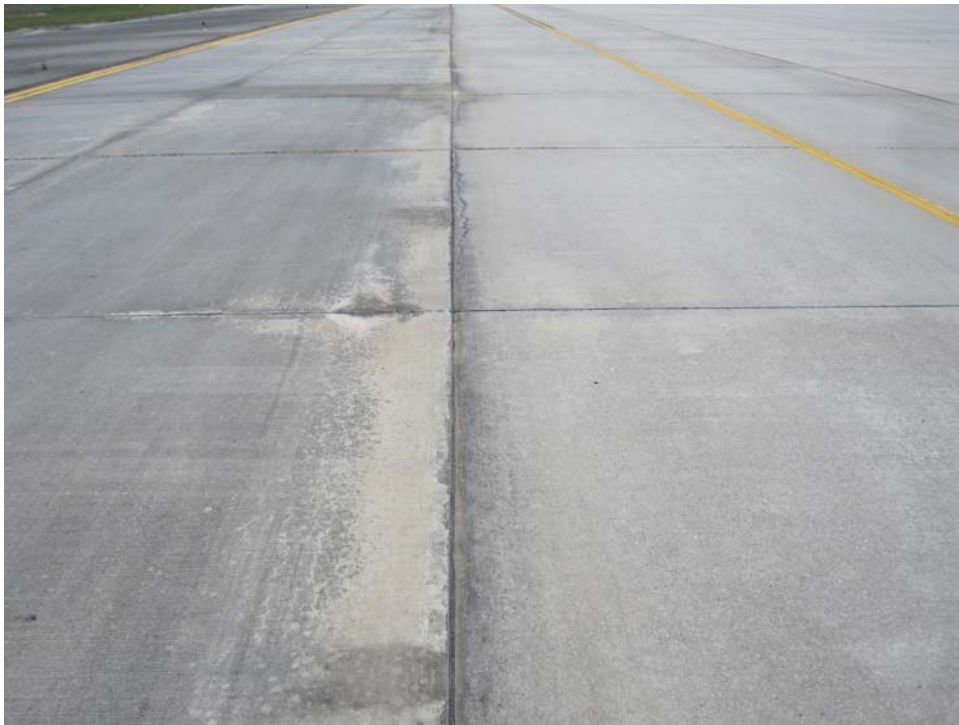
ATERMSV-10. Pumping (Sample Unit #01).

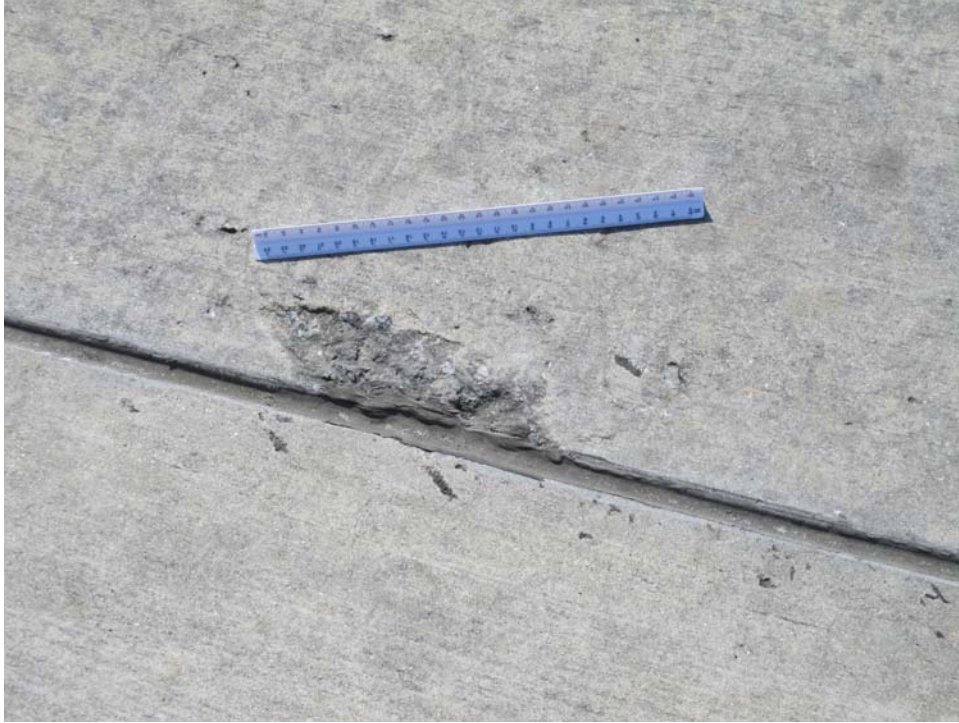
ATERMSV-20. Joint Spalling (Sample Unit #23).

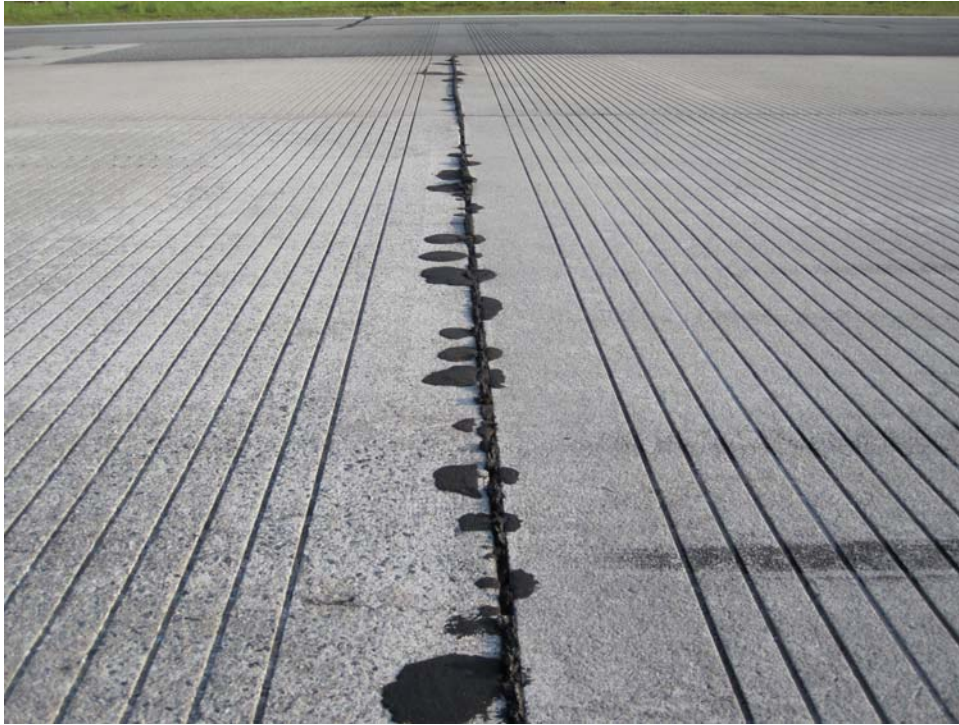
Runway 10-28 was defined by three sections. Section 10C consisted of the center PCC pavement and had a PCI value of 94. The majority of the joint sealant was in good condition. Small amounts of various severity small patching, low-severity large patching, shrinkage cracking, medium-severity joint spalling, and medium-severity corner spalling were also observed. An area with medium-severity joint seal damage and low-severity faulting was inspected as an additional sample unit according to PCI procedure. It was also noted that the intersection with Runway 1-19 had slightly higher deterioration with more patching and some high-severity joint seal damage.

R1028SV-10C. Joint Seal Damage (Additional Sample Unit #26).

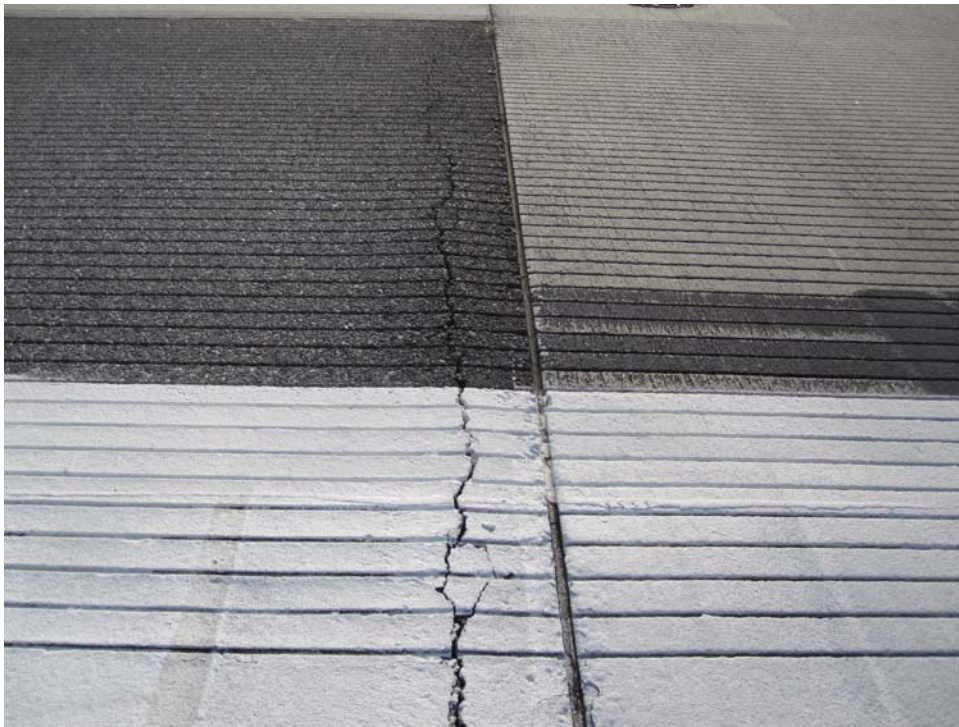
R1028SV-10C. Shoving (Sample Unit #10).

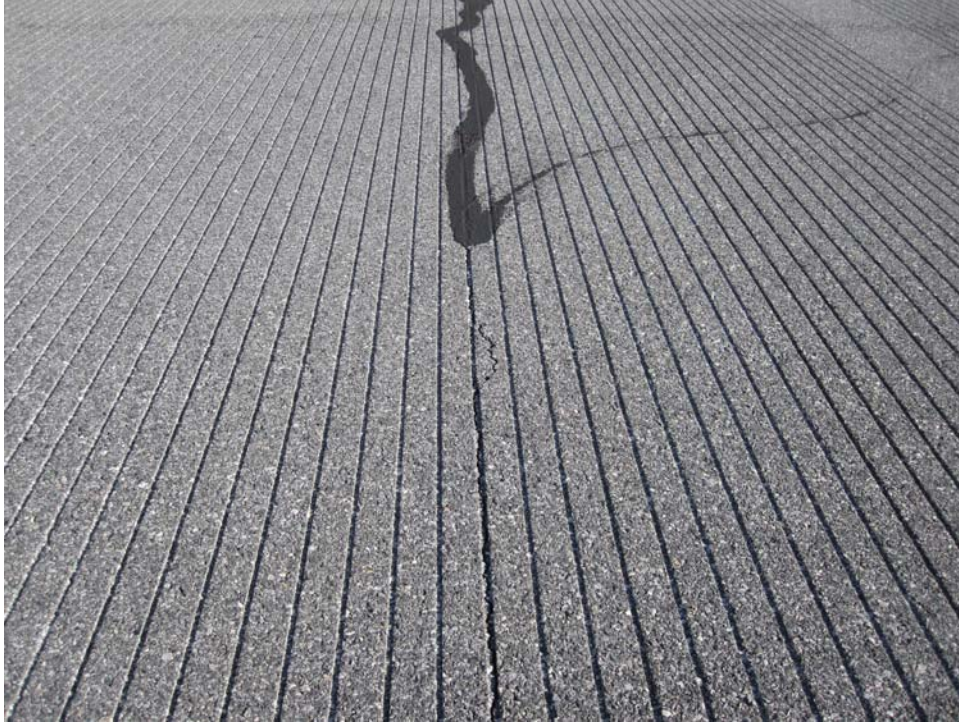
Sections 10N and 10S consisted of the northern and southern AC portions of the runway, respectively. Sections 10N and 10S were in similar condition with PCI values of 73 and 69, respectively. Low-severity shoving was observed along some of the section edges adjacent to the center PCC pavement section. Medium-severity weathering and low-severity, sealed longitudinal and transverse (L&T) cracking were observed primarily along the paving lane seams. Additionally, small amounts of medium-severity depression, low- and medium-severity L&T cracking, high-severity patching, high-severity raveling, low-severity swelling, and low-severity weathering were observed in these sections.

R1028SV-10N. Longitudinal and Transverse Cracking (Sample Unit #46).

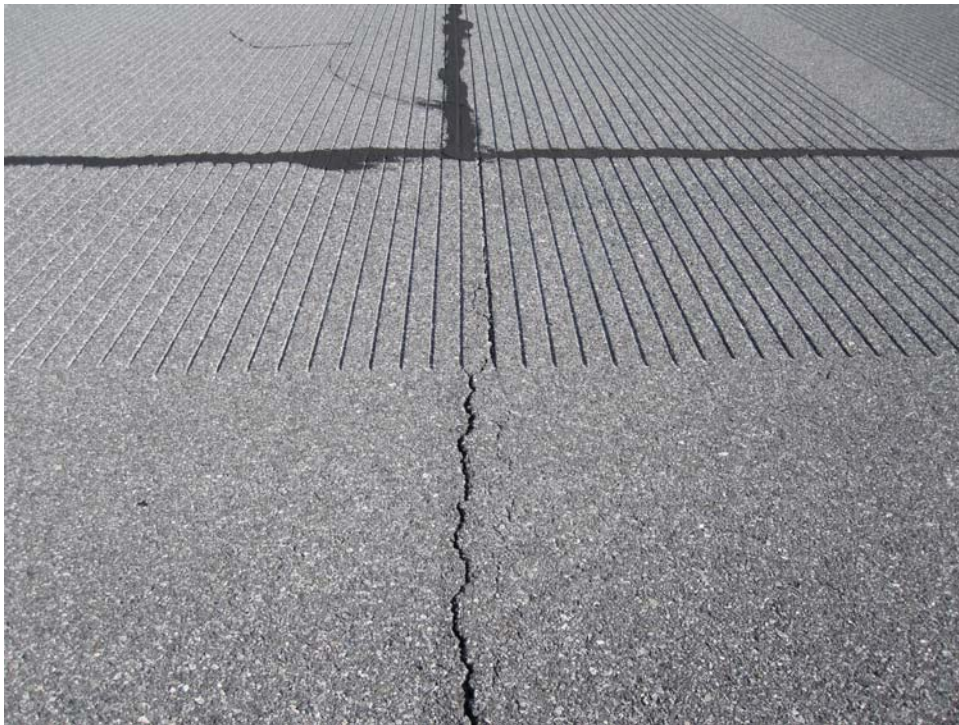
R1028SV-10S. Longitudinal and Transverse Cracking (Sample Unit #44).

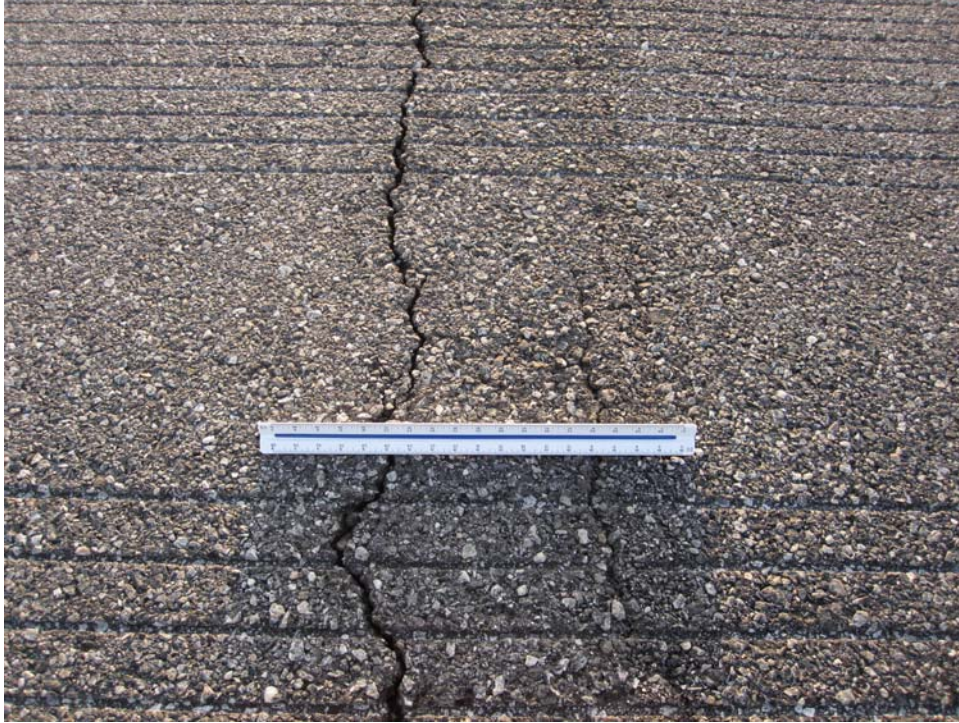
R1028SV-10S. Raveling (Sample Unit #23).

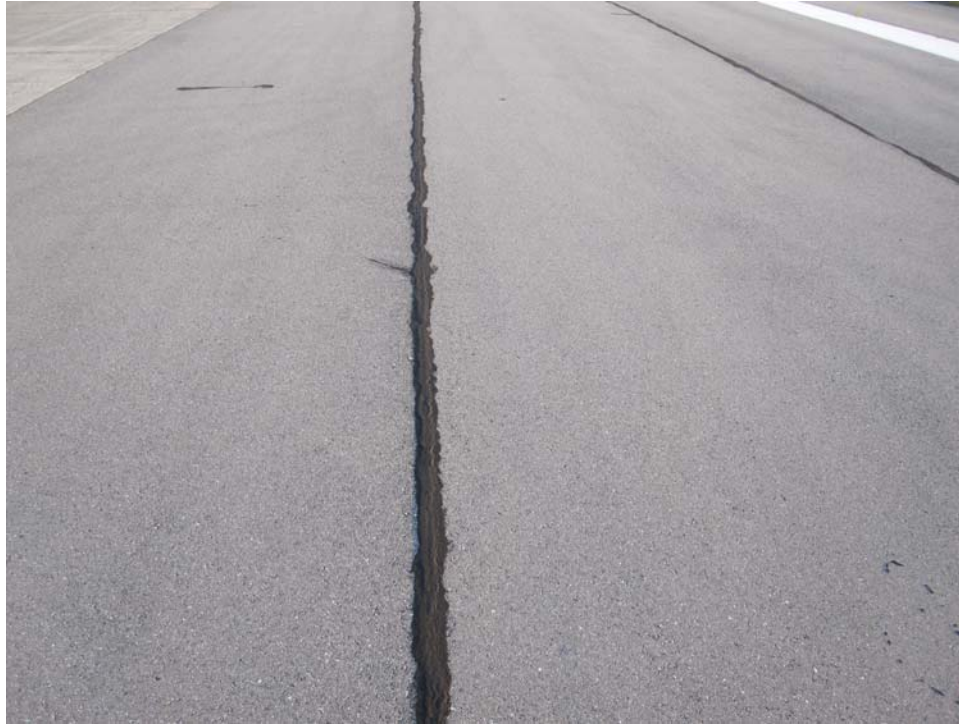
Sections 10E and 10W were in similar condition with PCI values of 88. Moderate quantities of sealed, low-severity joint reflection cracking were the predominant distress observed. In addition, low-severity patching was observed in Section 10E.

R119SV-10E. Longitudinal and Transverse Cracking (Sample Unit #24).

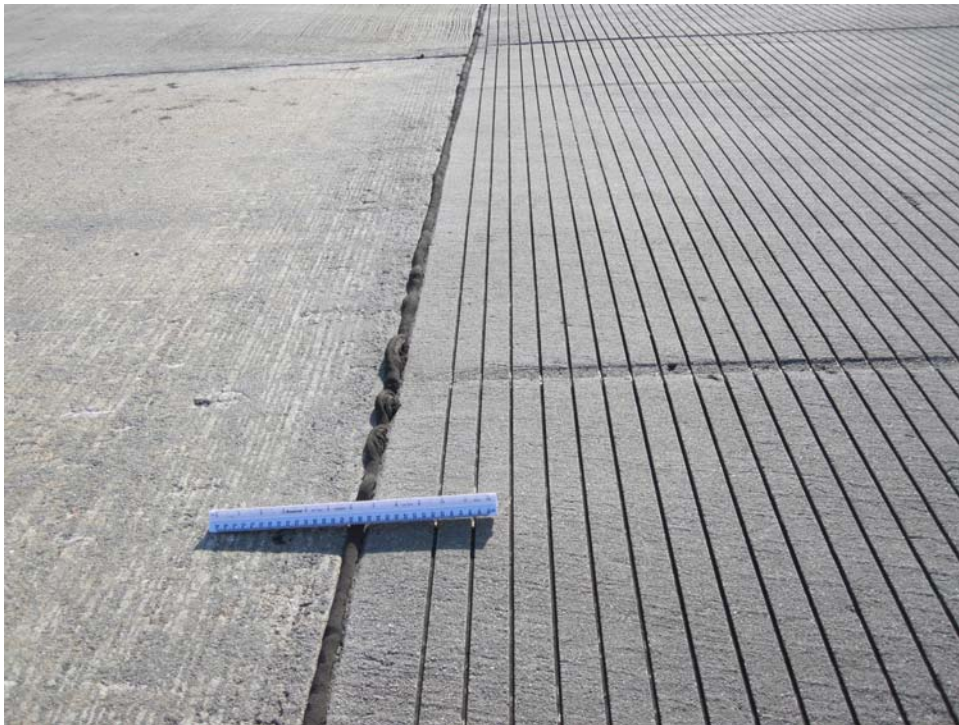
Sections 20C, 20E, and 20W were in excellent condition with PCI values of 97, 95, and 96, respectively. Medium-severity joint seal damage was observed adjacent to Runway 10-28 where crack sealant was extruding from the joint. In addition, small amounts of low-severity small patching, low-severity large patching, medium-severity joint spalling, and low-severity corner spalling were observed.

R119SV-20E. Joint Seal Damage (Sample Unit #01).

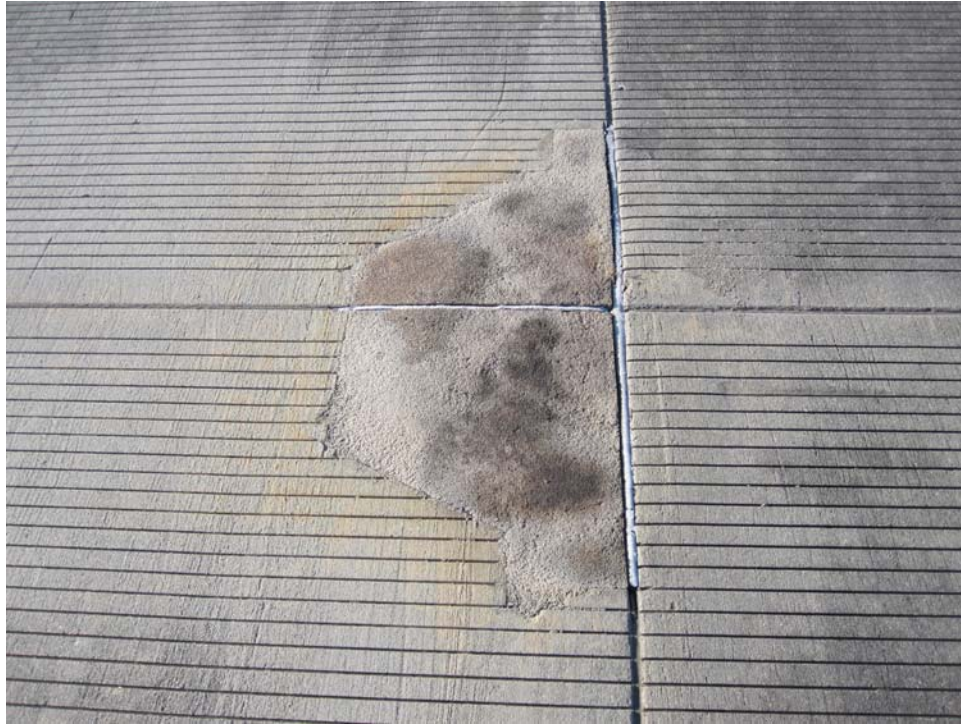
R119SV-20E. Small Patching (Sample Unit #04).

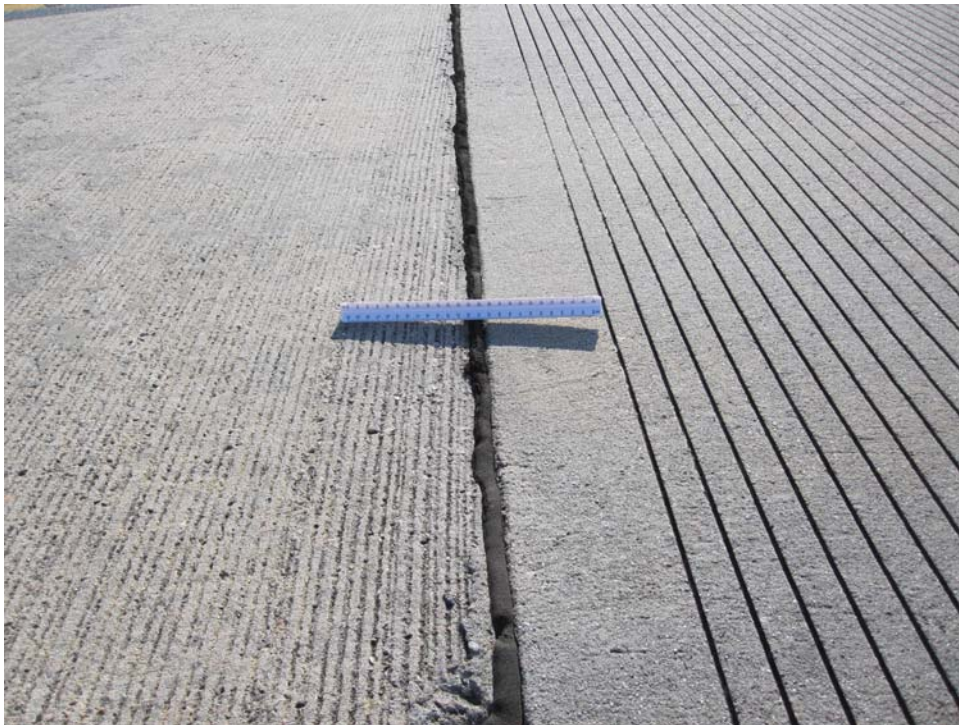
R119SV-20W. Joint Seal Damage (Sample Unit #01).

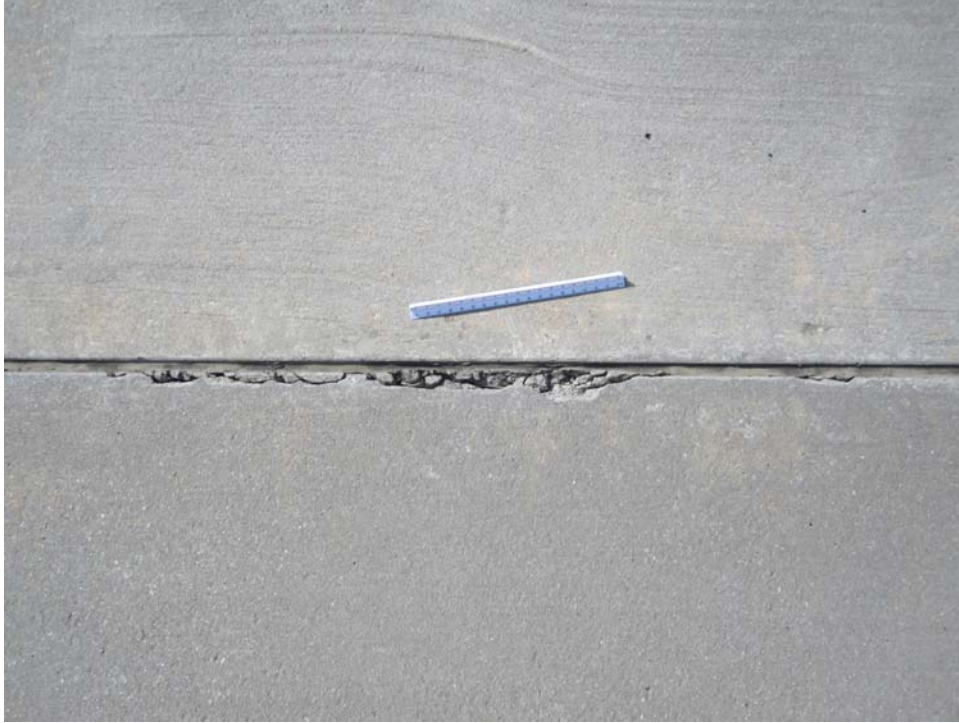
Taxiway A1 was defined by one section with a PCI value of 96. The joint sealant was in fair condition with minor deterioration. Small amounts of low-severity patching, medium-severity joint spalling, and medium-severity corner spalling were observed in this section.

TA1SV-10. Joint Spalling (Sample Unit #04).

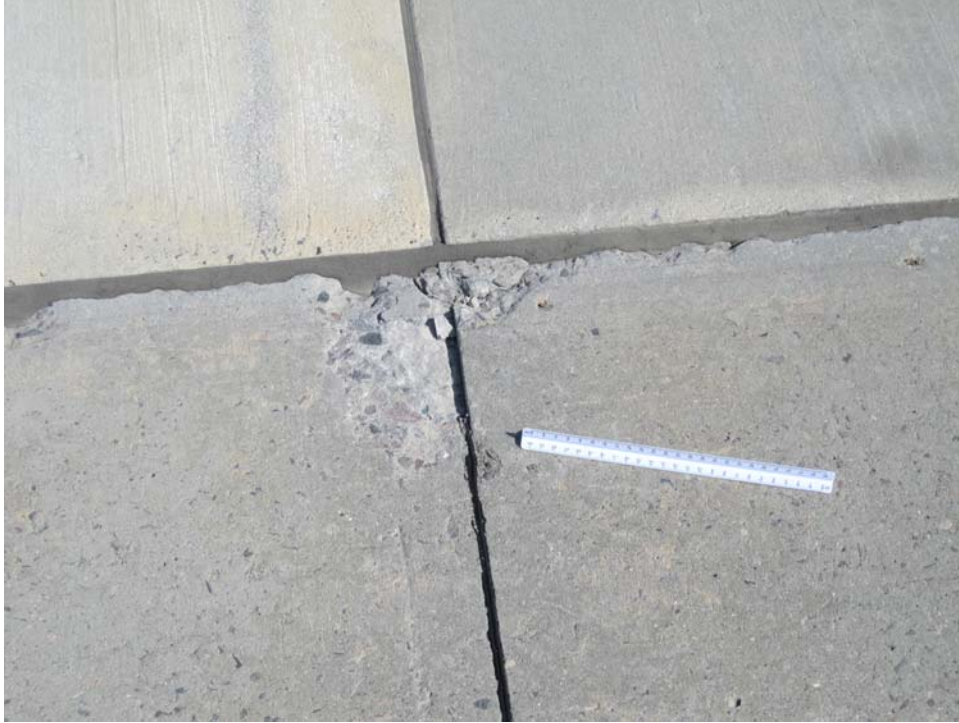
TA2SV-10. Corner Spalling (Sample Unit #04).

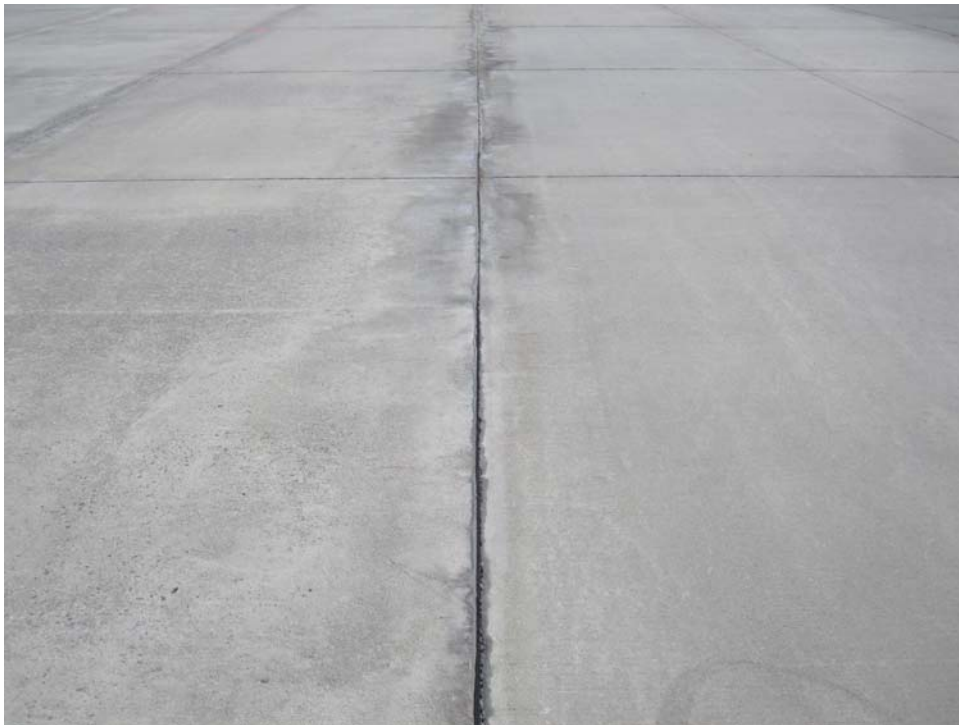
TA2SV-10. Pumping (Sample Unit #02).

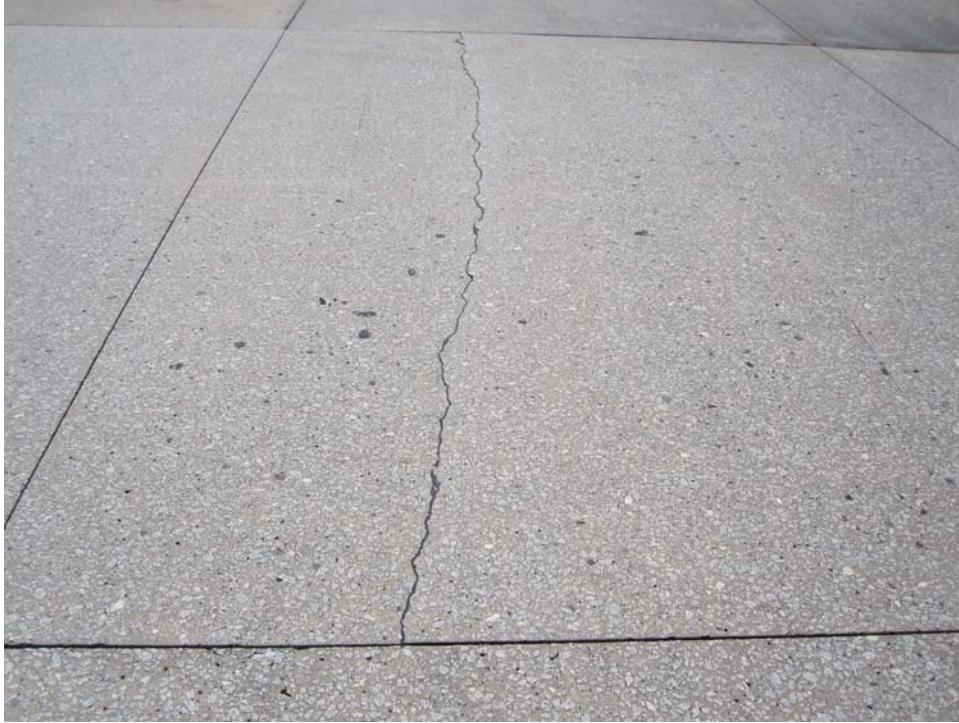
TASV-20. LTD Cracking (Sample Unit #26).

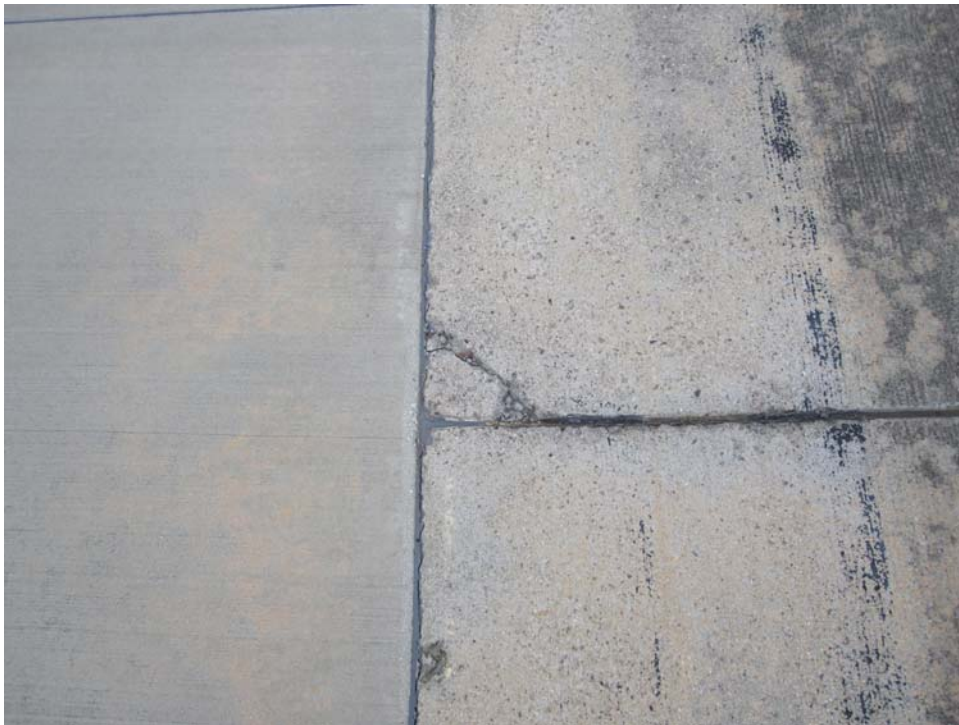
Section 50 defined the majority of Taxiway A south of Taxiway C. This section was in excellent condition with a PCI value of 99. Small amounts of joint and corner spalling were observed in this section.

TASV-50. Corner Spalling (Sample Unit #29).

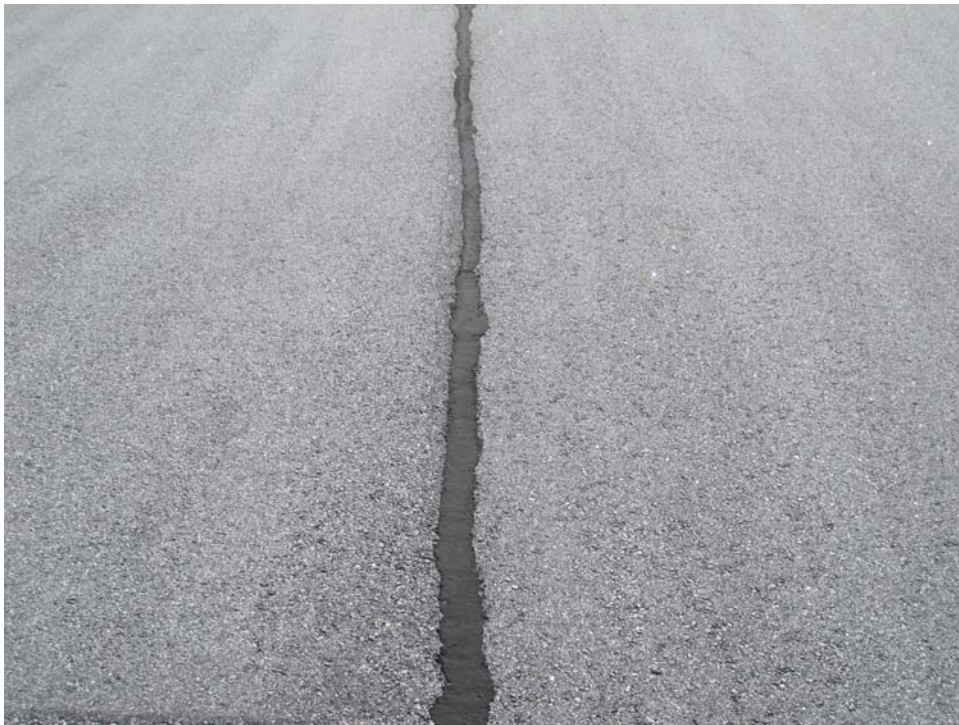
Section 10 was in excellent condition with a PCI value of 97. Sealed and unsealed, low-severity L&T cracking was the only distress observed in this section.

TBSV-10. Longitudinal and Transverse Cracking (Sample Unit #15).

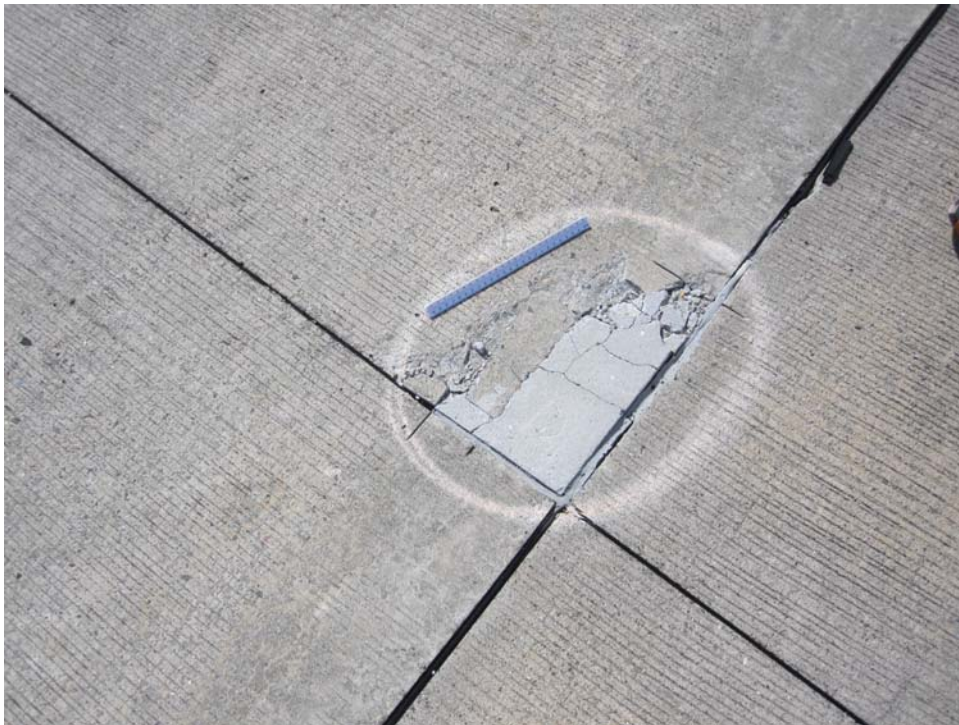
TBSV-20. Corner Spalling (Sample Unit #101).

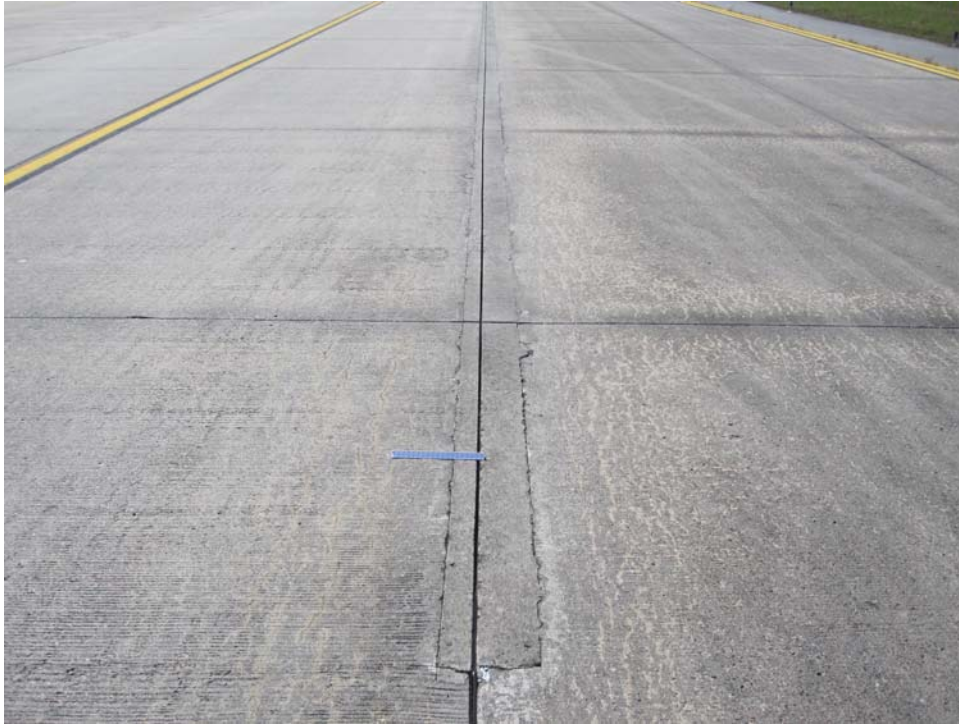
TBSV-20. Large Patching (Sample Unit #71).

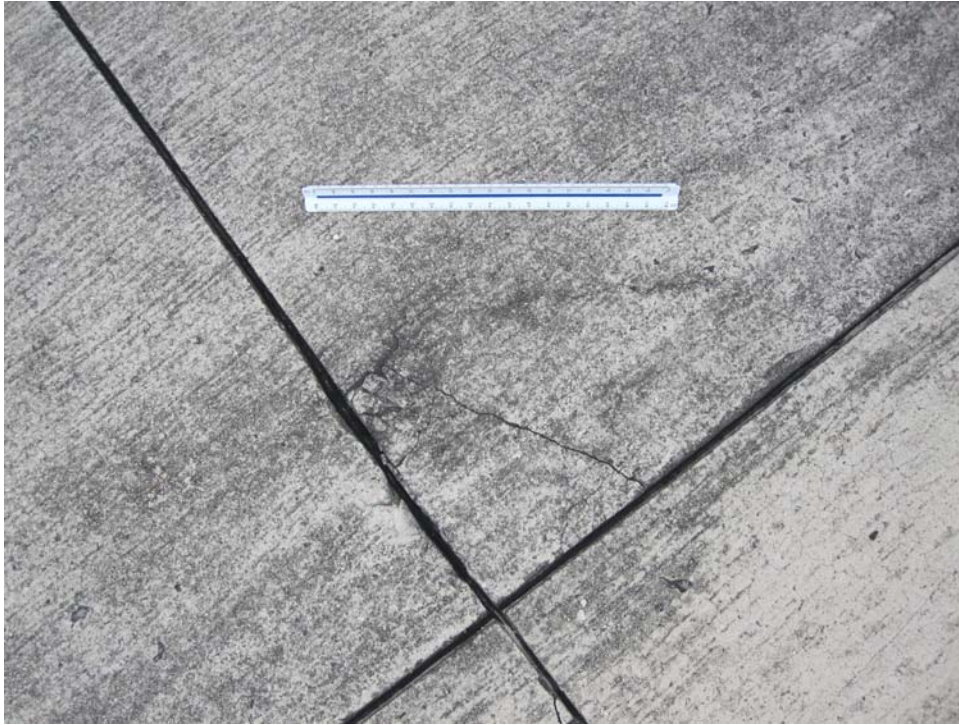
TC1SV-10. Corner Spalling (Sample Unit #20).
