# 2012 Savannah-Hilton Head International Airport Pavement Management Plan

# SAVANNAH-HILTON HEAD INTERNATIONAL AIRPORT

## PAVEMENT MANAGEMENT REPORT

**DECEMBER 2012**

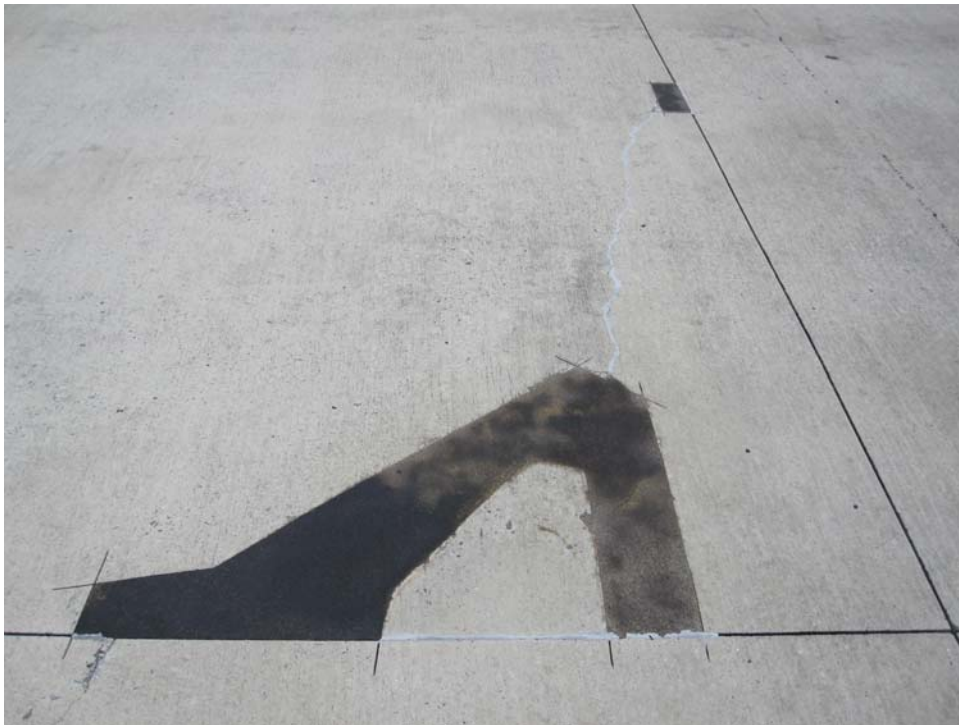
TC1SV-10. Longitudinal and Transverse Cracking (Sample Unit #25).

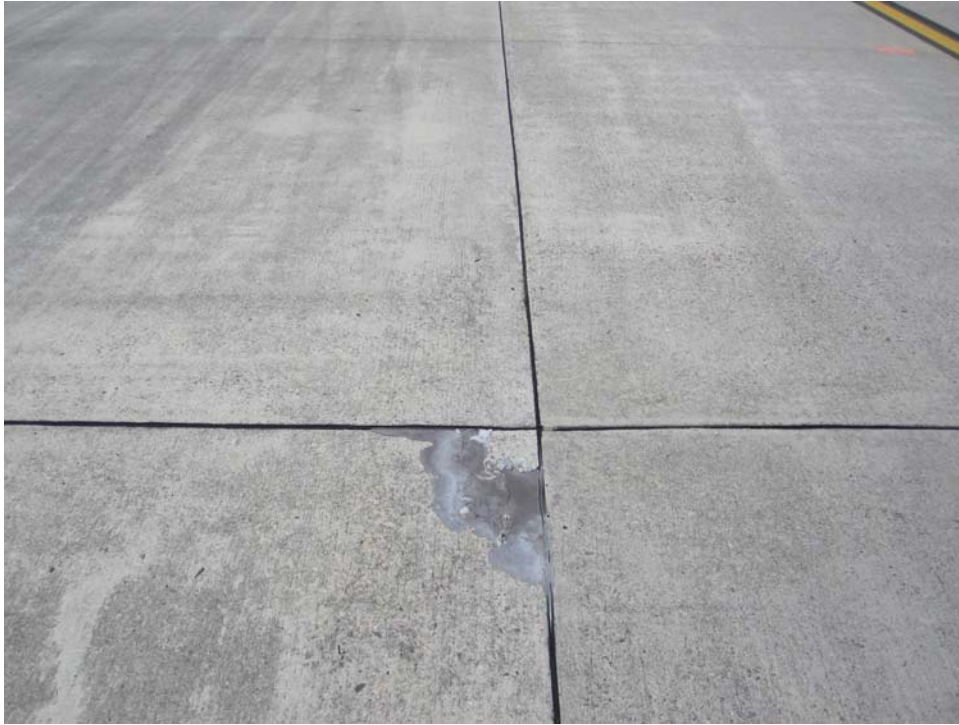
TCSV-20. Corner Spalling (Sample Unit #40).

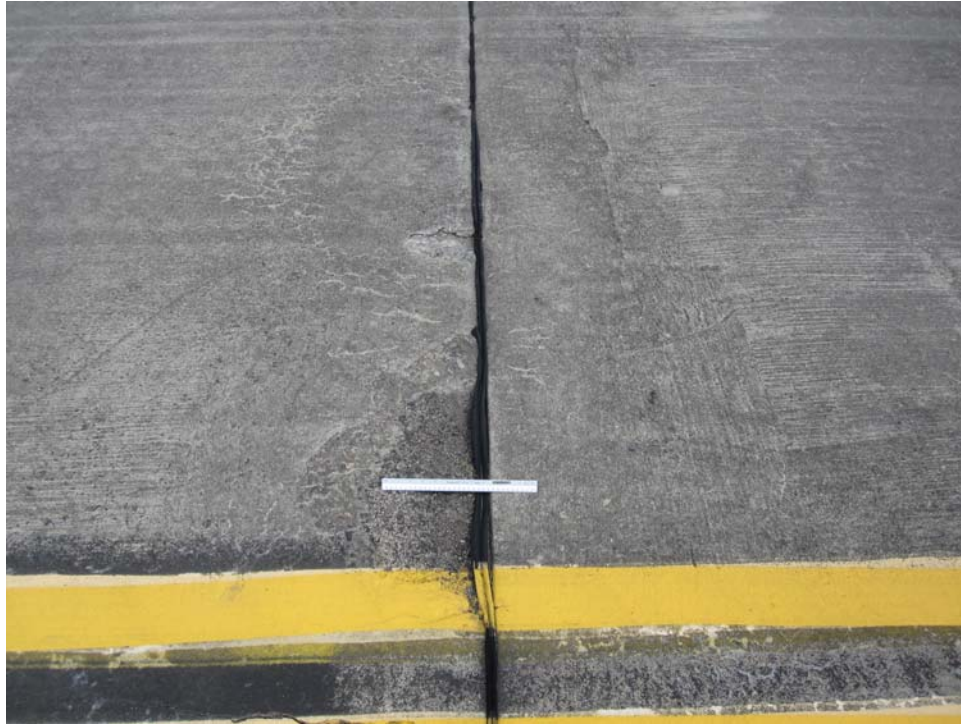
TCSV-30. Joint Spalling (Sample Unit #08).

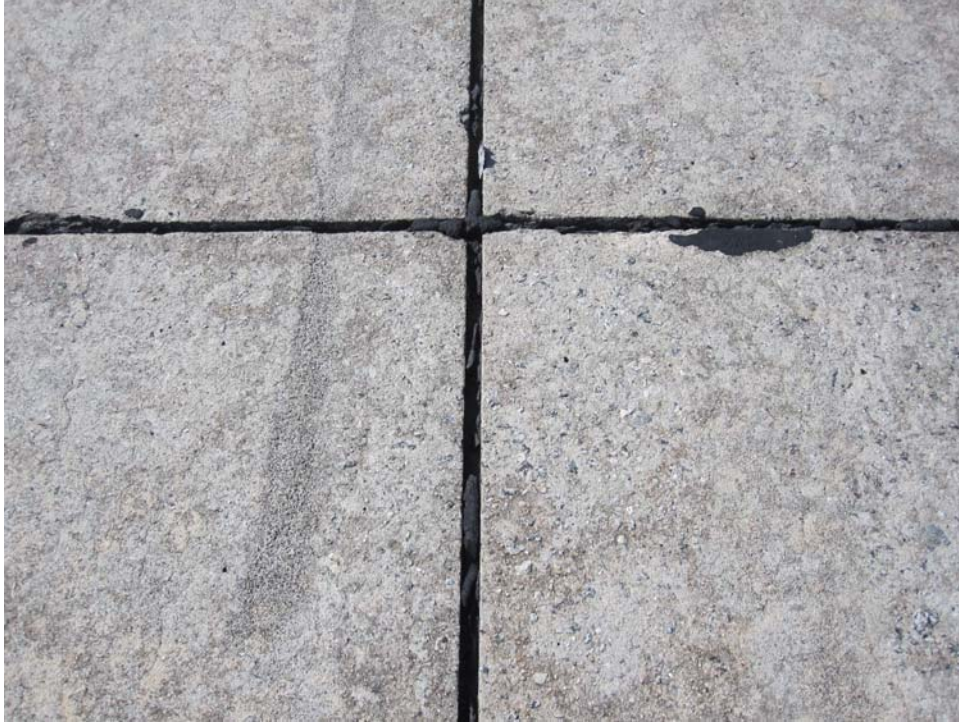
Section 60, located near the approach end of Runway 28, had a PCI value of 87. The majority of the joint sealant had deteriorated significantly or was missing in this section. In addition, small amounts of low-severity small patching were observed.

TCSV-60. Joint Seal Damage (Sample Unit # 05).

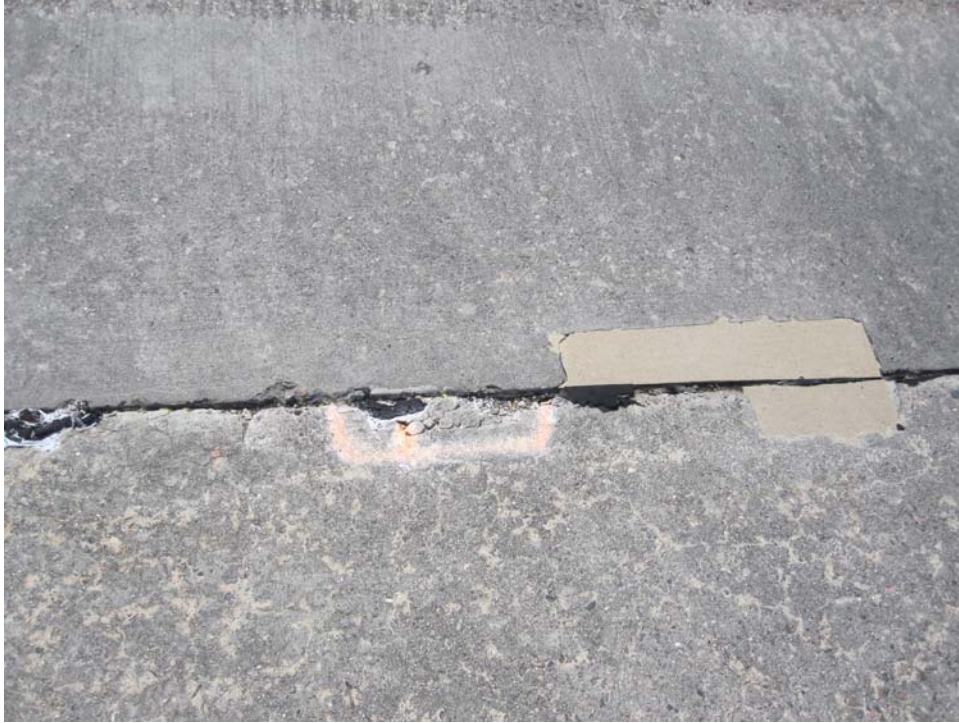
TE1SV-10. Joint Spalling (Sample Unit #01).

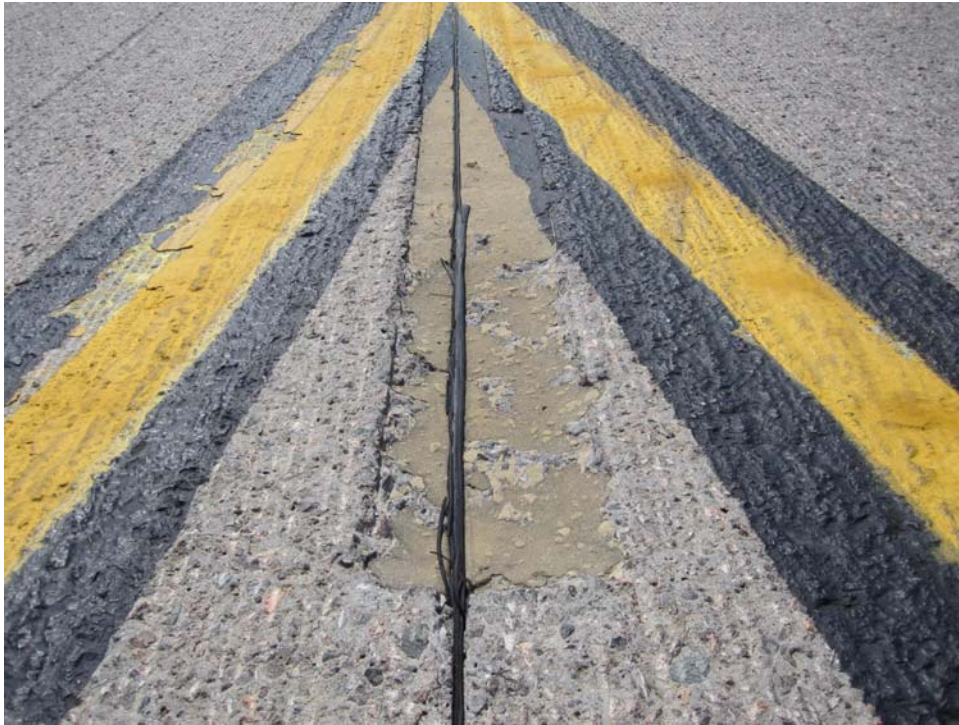
TE1SV-10. Large Patching (Sample Unit #03).

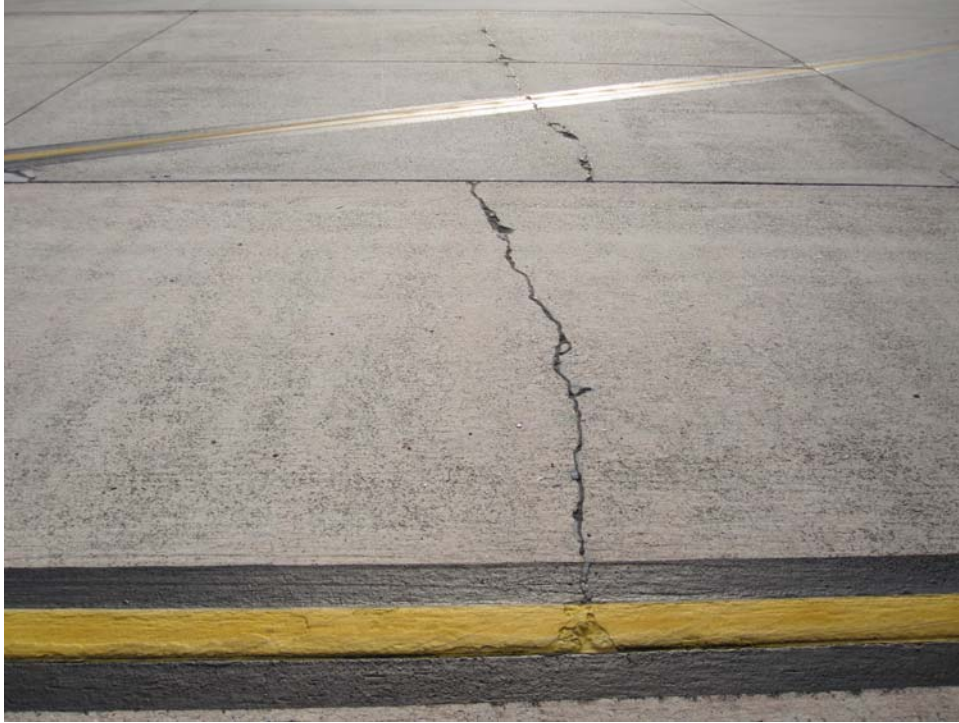
TE1SV-10. LTD Cracking (Sample Unit #10).

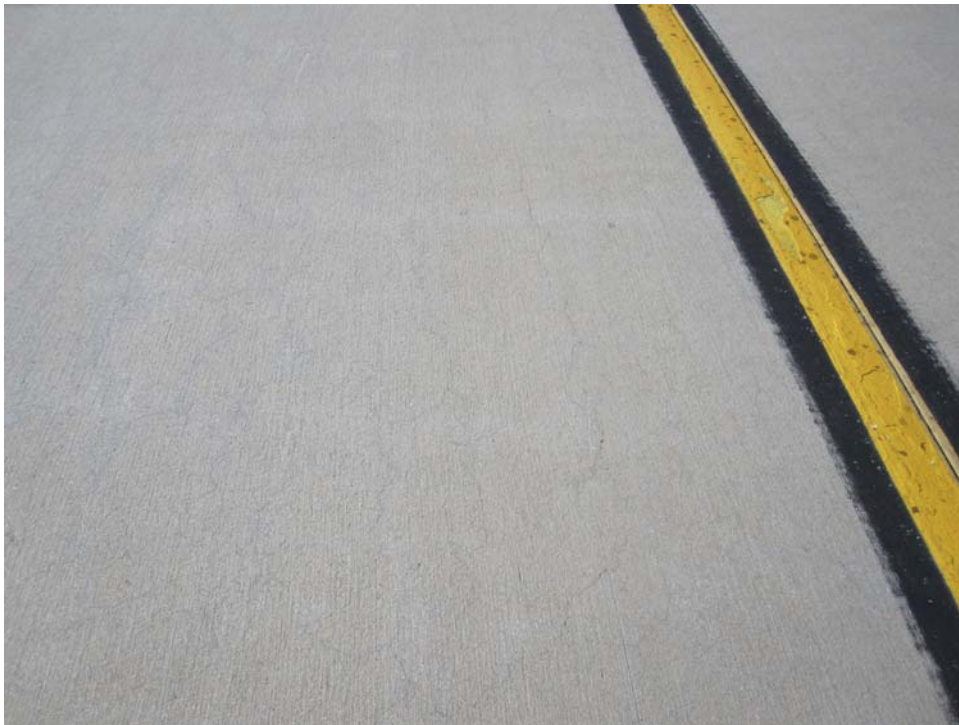
TESV-10. Shrinkage Cracking (Sample Unit #03).

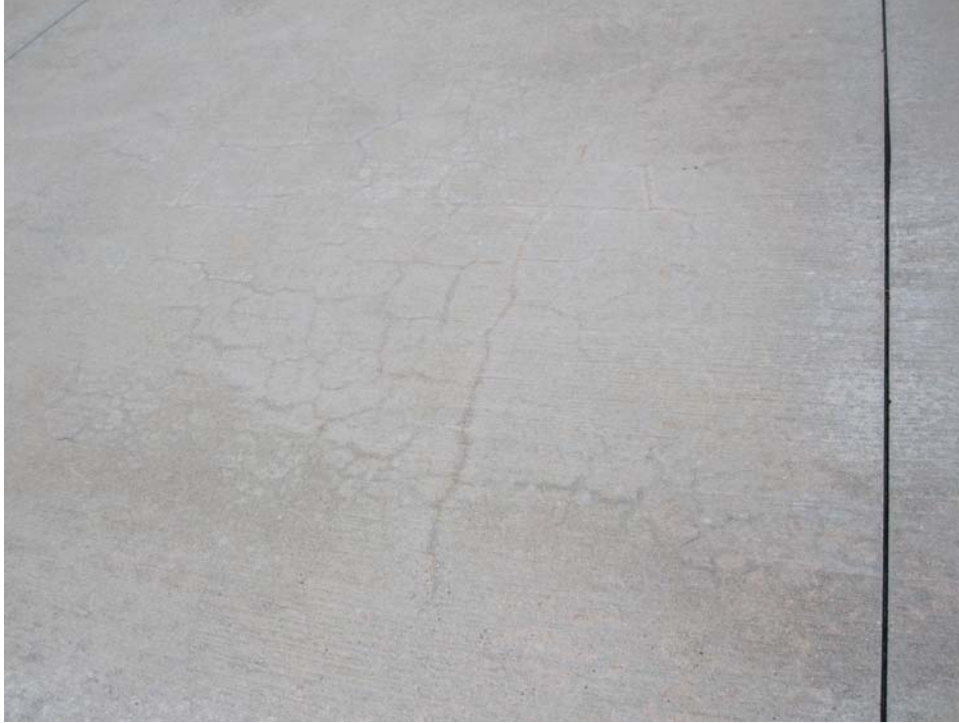
TESV-10. Shrinkage Cracking (Sample Unit #09).

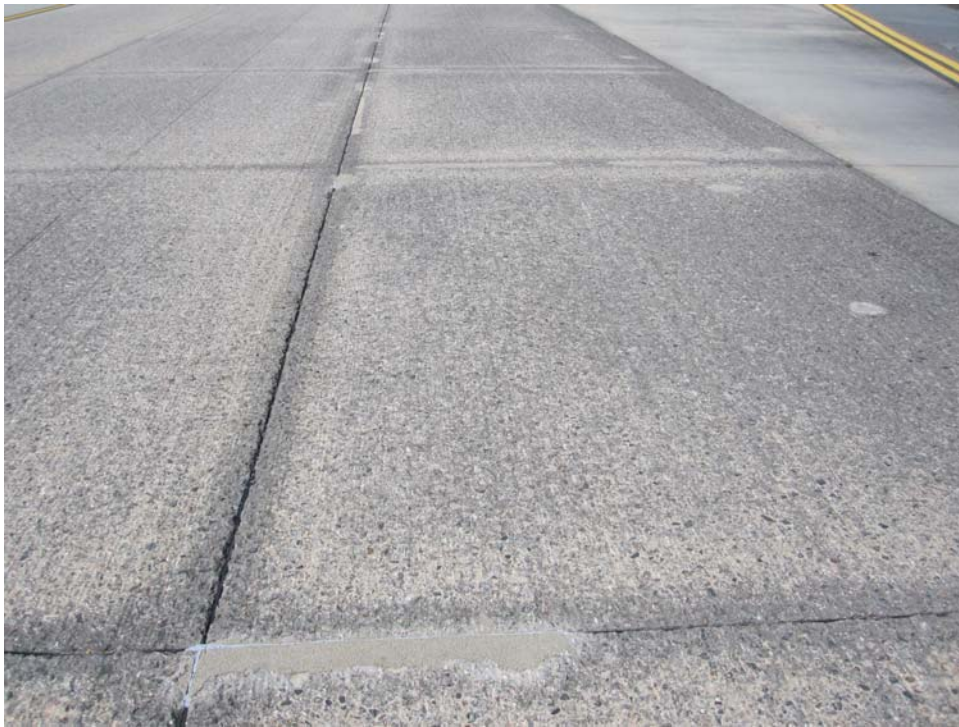
TESV-20. Small Patching (Sample Unit #18).

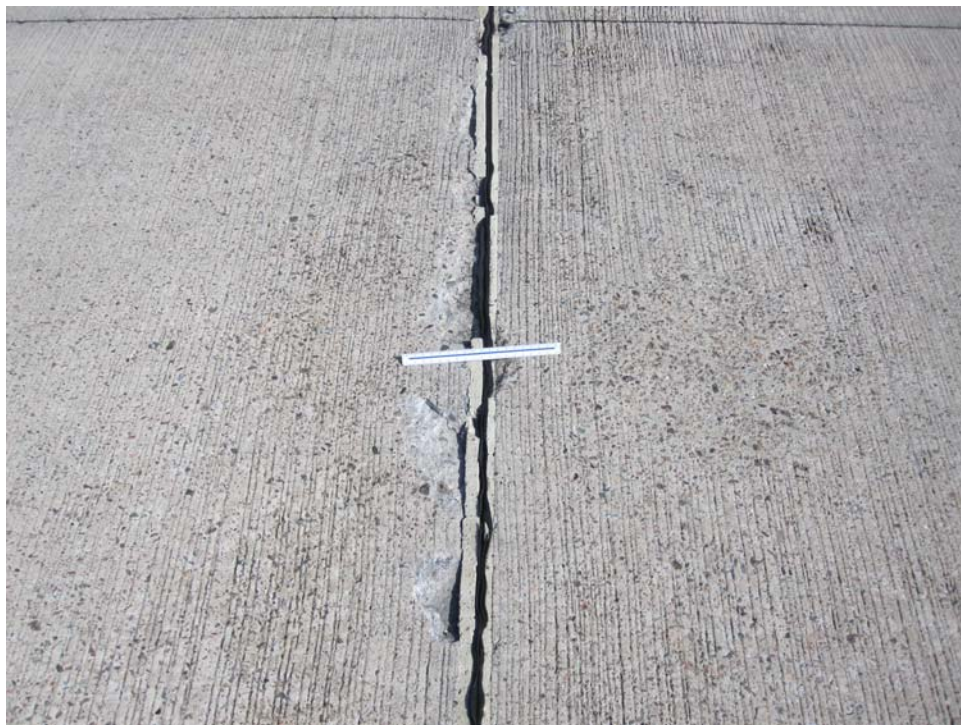
TESV-30. Joint Spalling (Sample Unit #26).

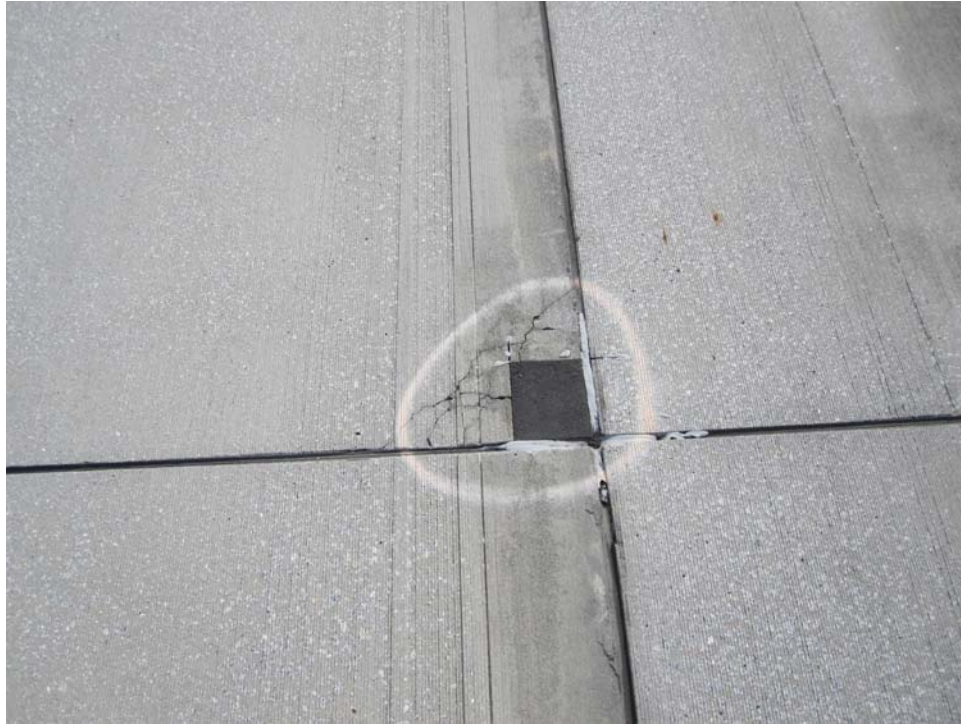
TESV-40. Corner Spalling (Sample Unit #19).

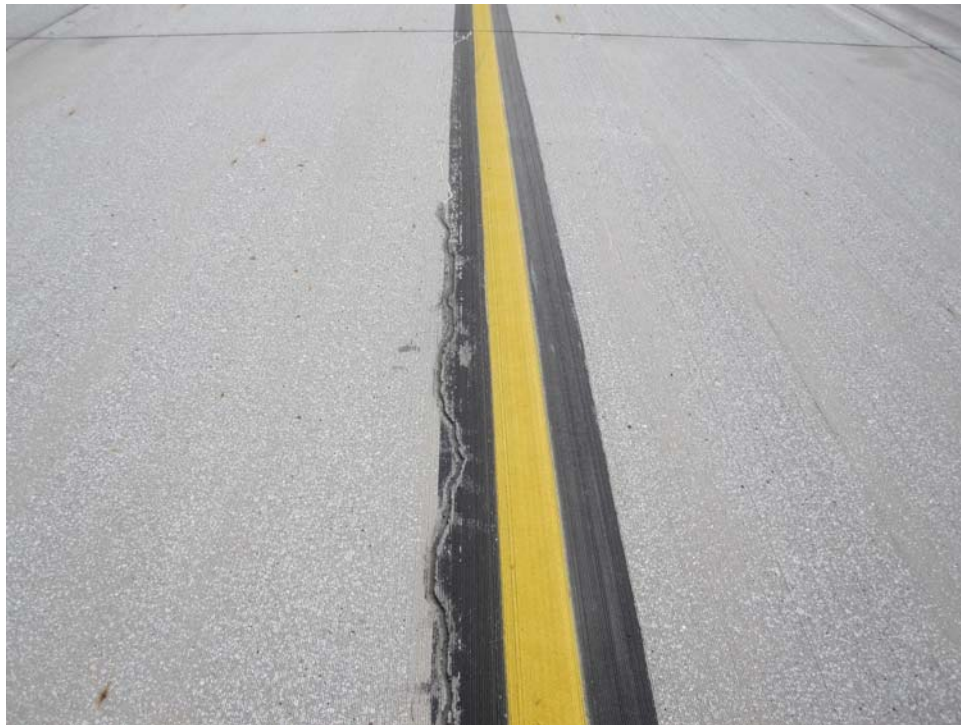
TESV-40. LTD Cracking (Sample Unit #16).

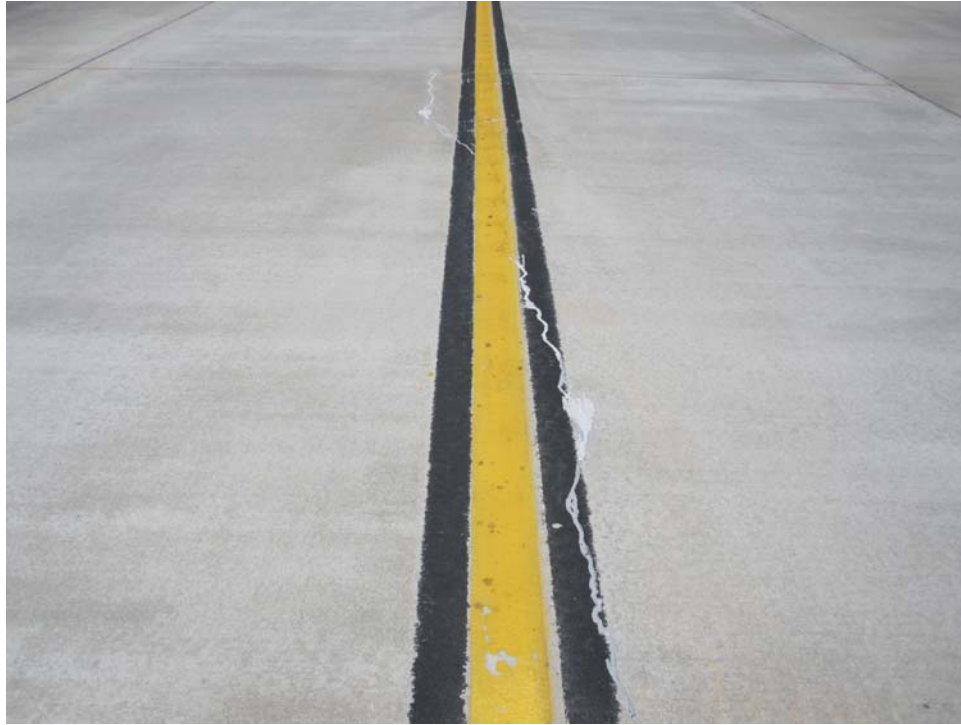
TFSV-10. LTD Cracking (Sample Unit #13).

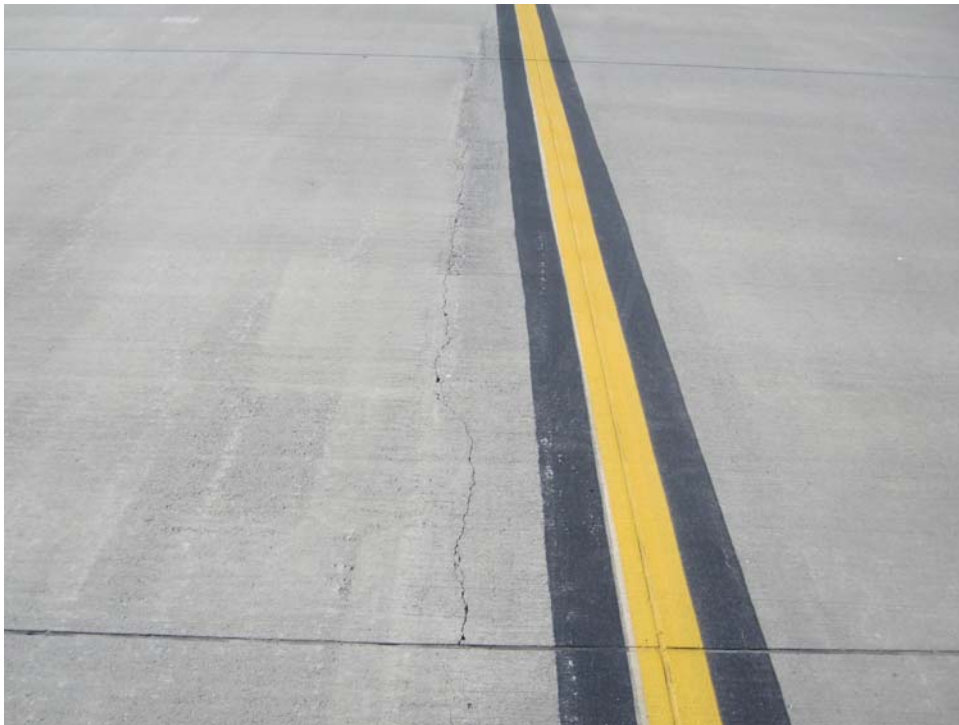
TGA4SV-20. LTD Cracking (Sample Unit #01).
