# 2012 Valdosta Regional Airport Pavement Management Plan

# VALDOSTA REGIONAL AIRPORT

## PAVEMENT MANAGEMENT REPORT

**DECEMBER 2012**

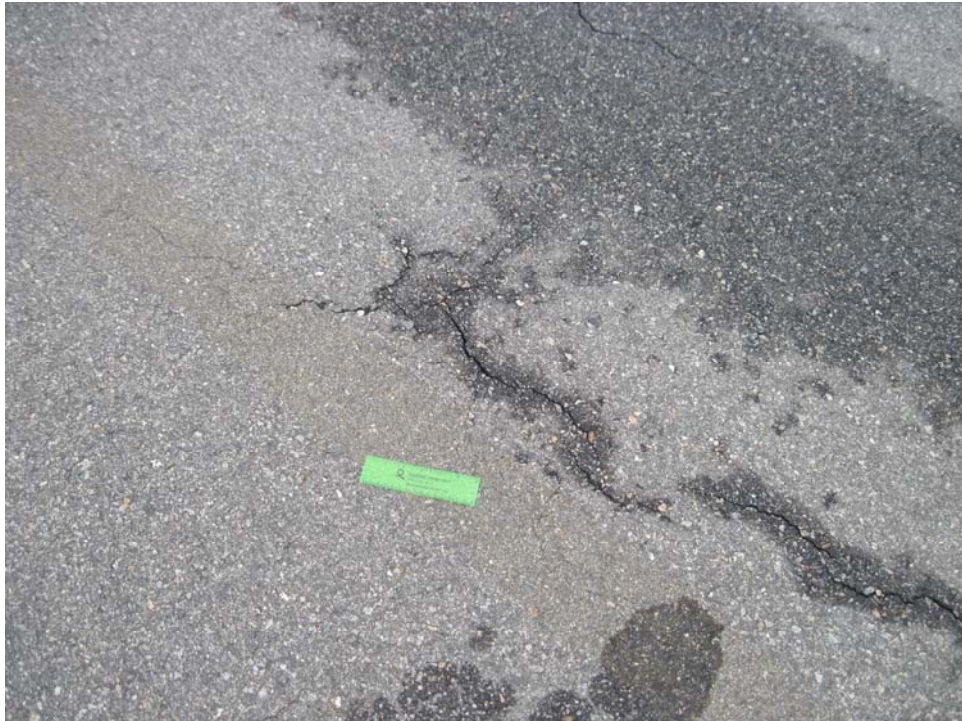
A01VL-10. Longitudinal and Transverse Cracking (Sample Unit #13).

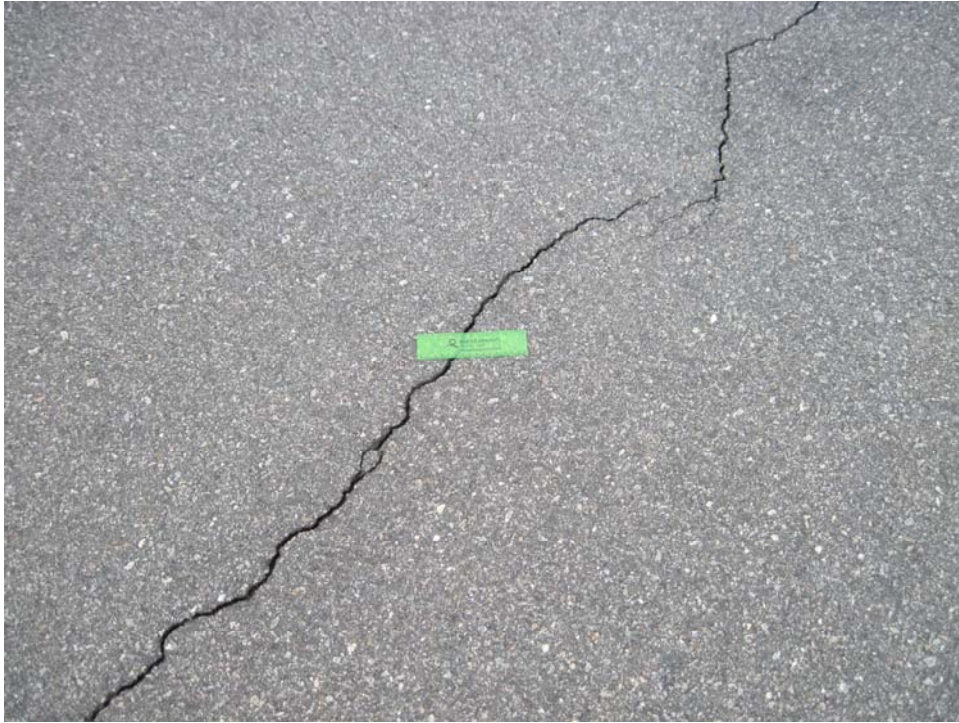
A01VL-20. Longitudinal and Transverse Cracking (Sample Unit #16).

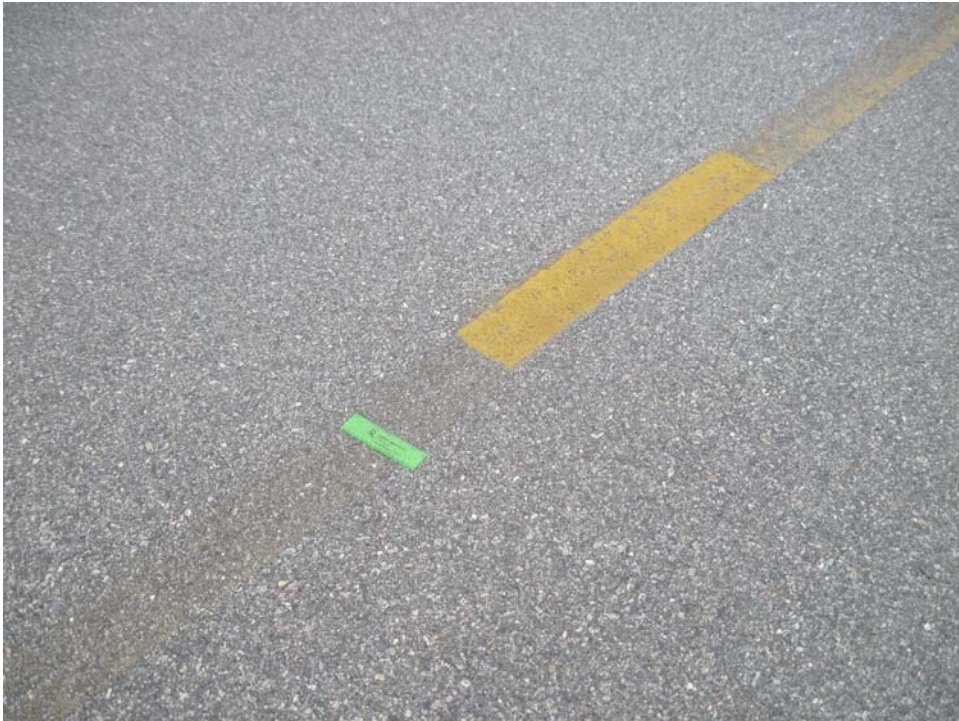
A01VL-20. Unsatisfactory Paint.

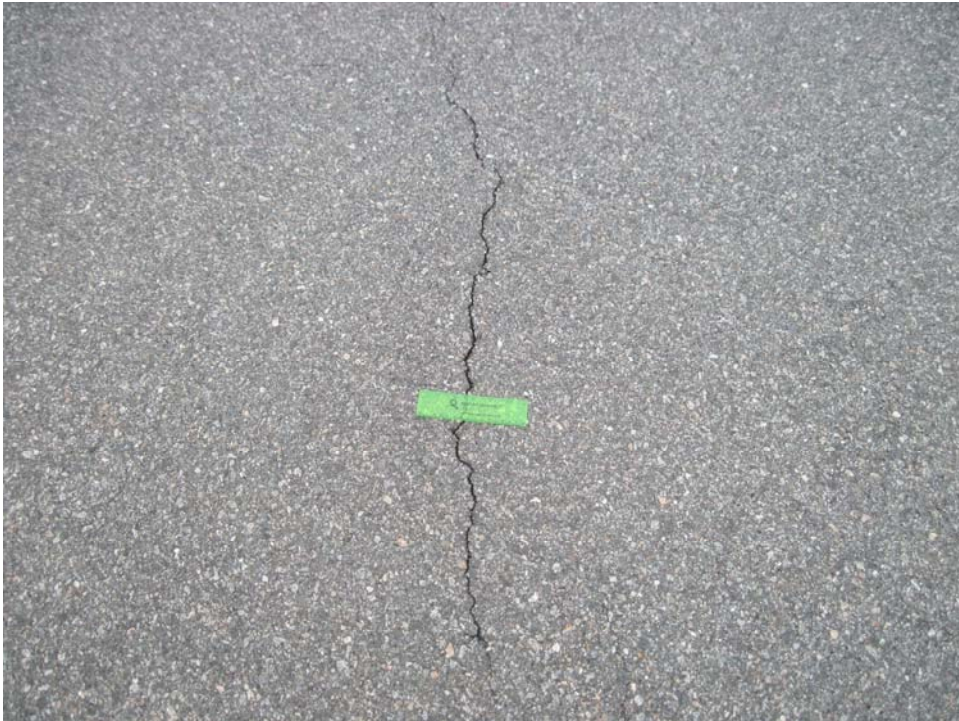
A01VL-25. Longitudinal and Transverse Cracking (Sample Unit #02).

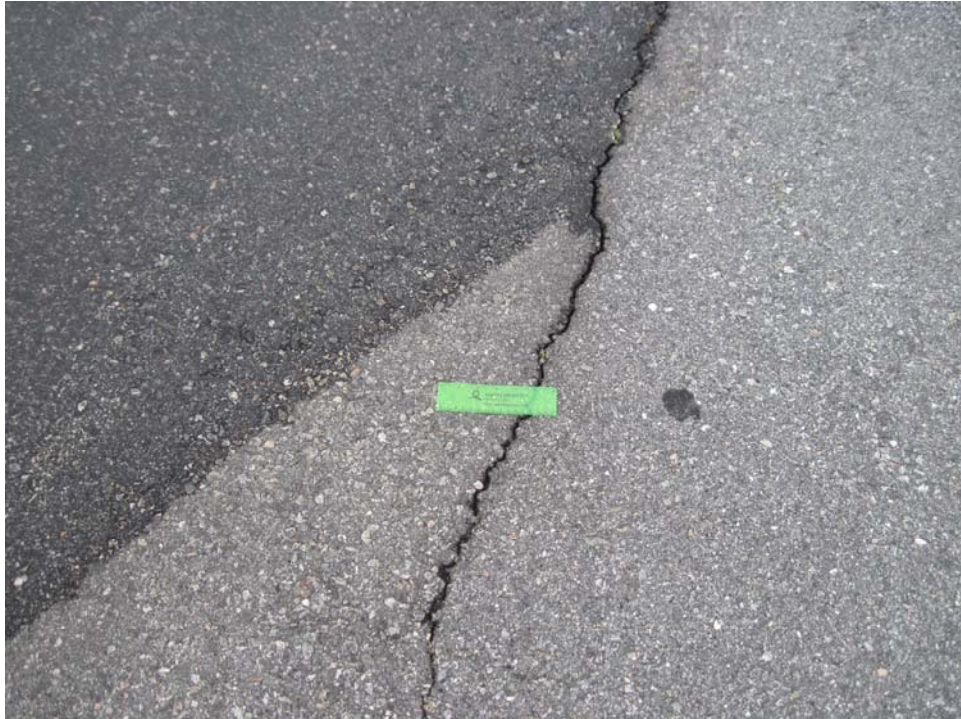
A01VL-30. Longitudinal and Transverse Cracking (Sample Unit #01).

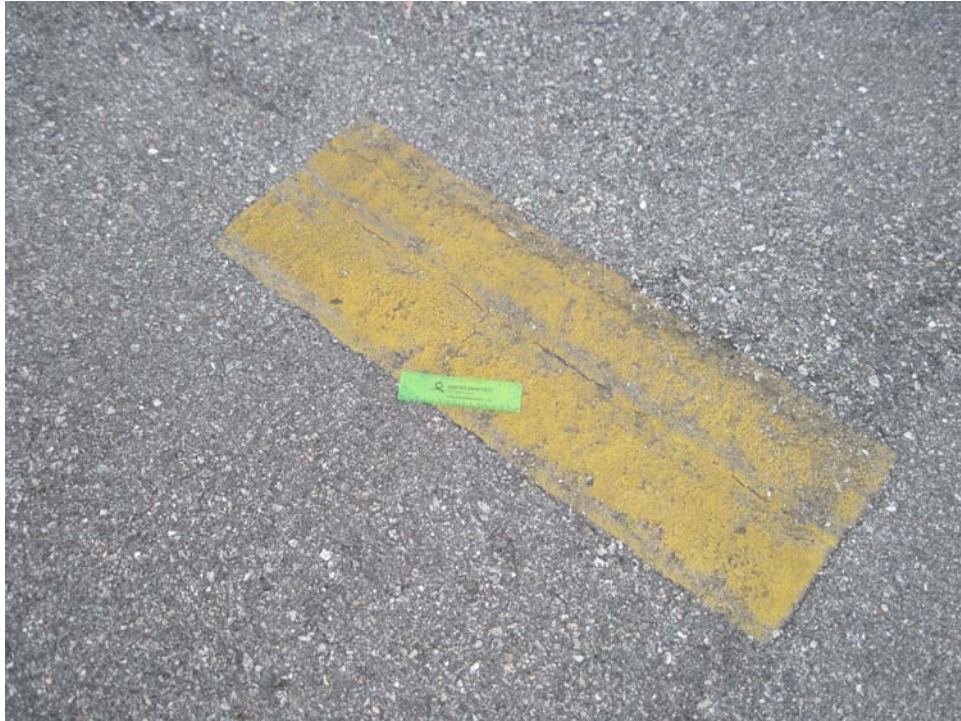
A01VL-30. Unsatisfactory Paint.

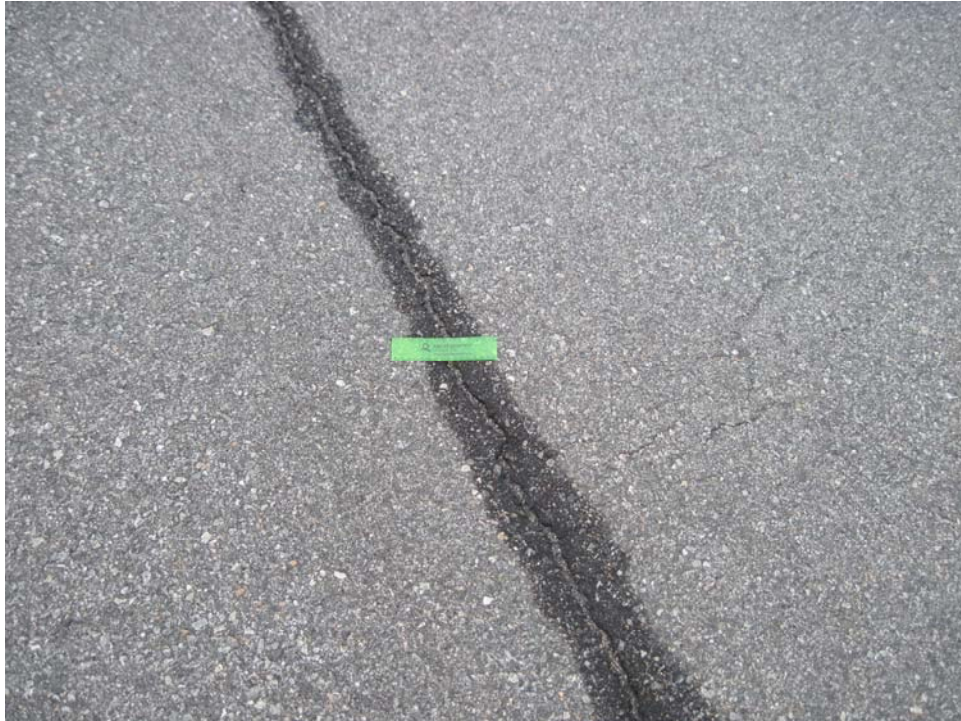
A01VL-40. Longitudinal and Transverse Cracking (Sample Unit #2).

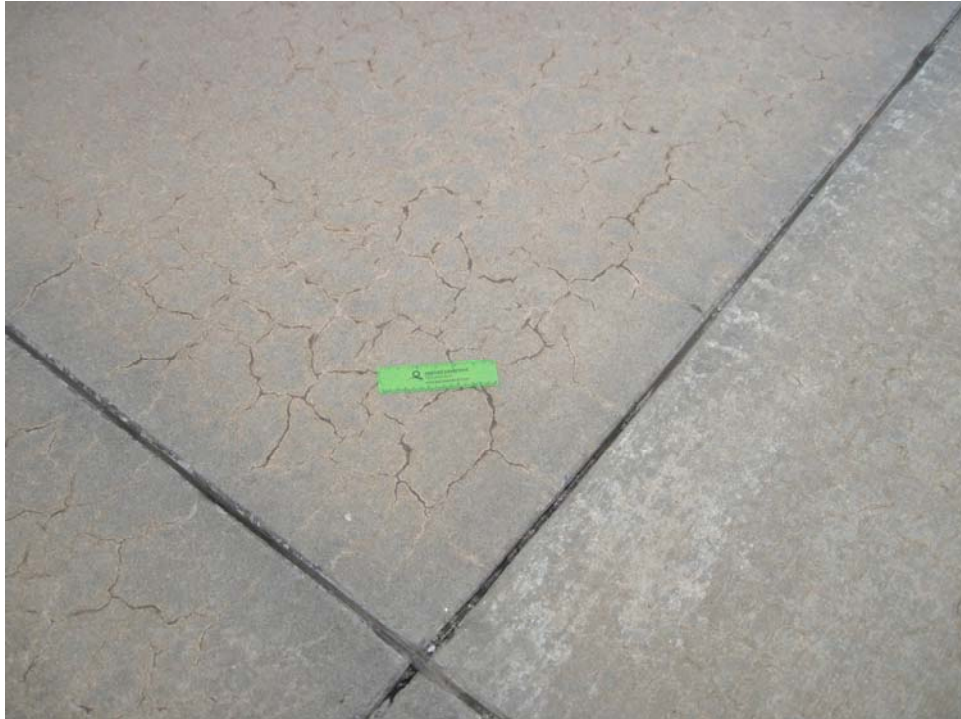
The terminal apron (ATERMVL) was defined by one section with a PCI of 78. Distresses recorded in Section 10 included low-severity alkali silica reaction (ASR), shrinkage cracking, and low-severity joint seal damage.

ATERMVL-10. ASR (Sample Unit #6).

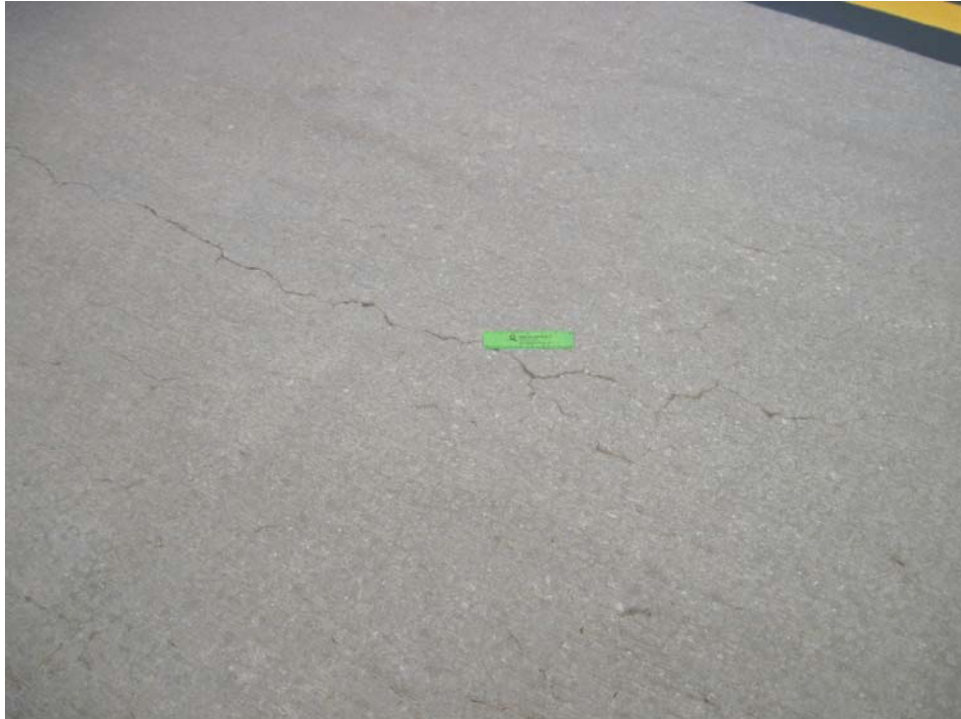
ATERMVL-10. Shrinkage Cracking (Sample Unit #5).

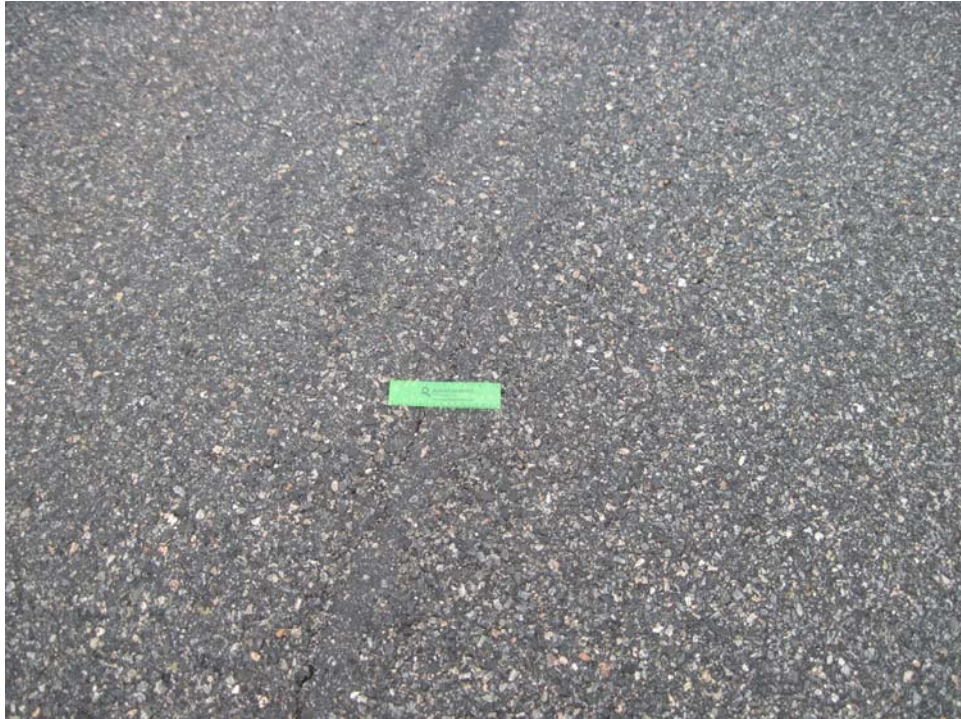
Runway 13-31 consisted of one section with a PCI value of 77. The primary distress identified in Section 10 was low-severity longitudinal and transverse (L&T) cracking, with a smaller amount of medium-severity L&T cracking. Low-severity weathering was recorded throughout the entire section. Significant amounts of roller checking were also noted, and much of the cracking recorded was roller checking that had opened up. One additional sample unit was identified in accordance with ASTM D5340 that contained a low-severity depression and an isolated area of bleeding.

R1331VL-20. Longitudinal and Transverse Cracking.

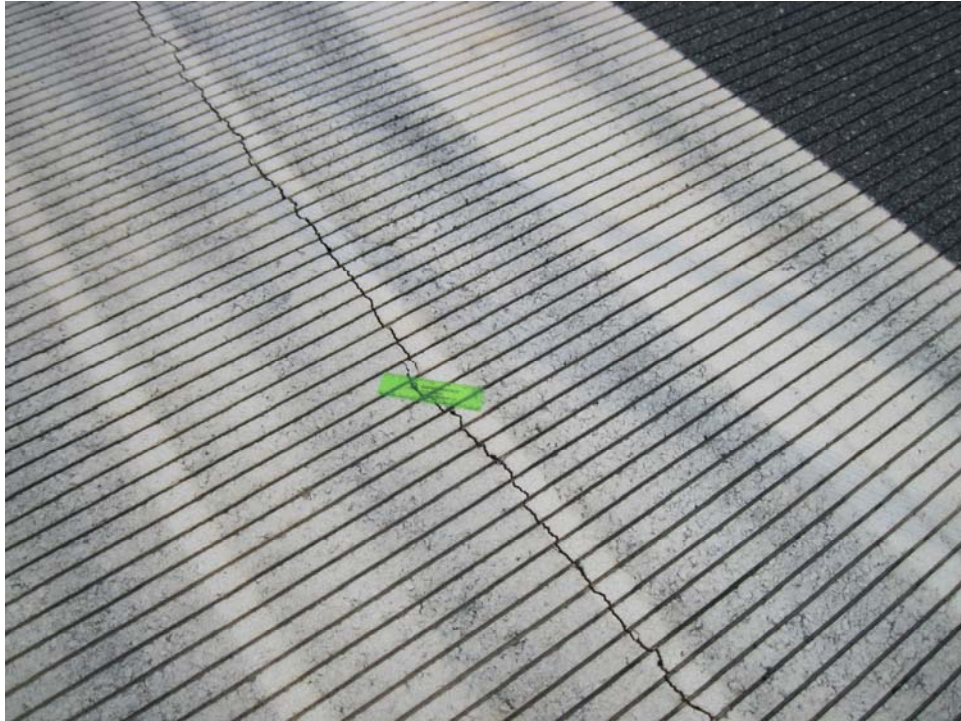
R1735VL-10. Longitudinal and Transverse Cracking and Satisfactory Paint (Sample Unit #60).

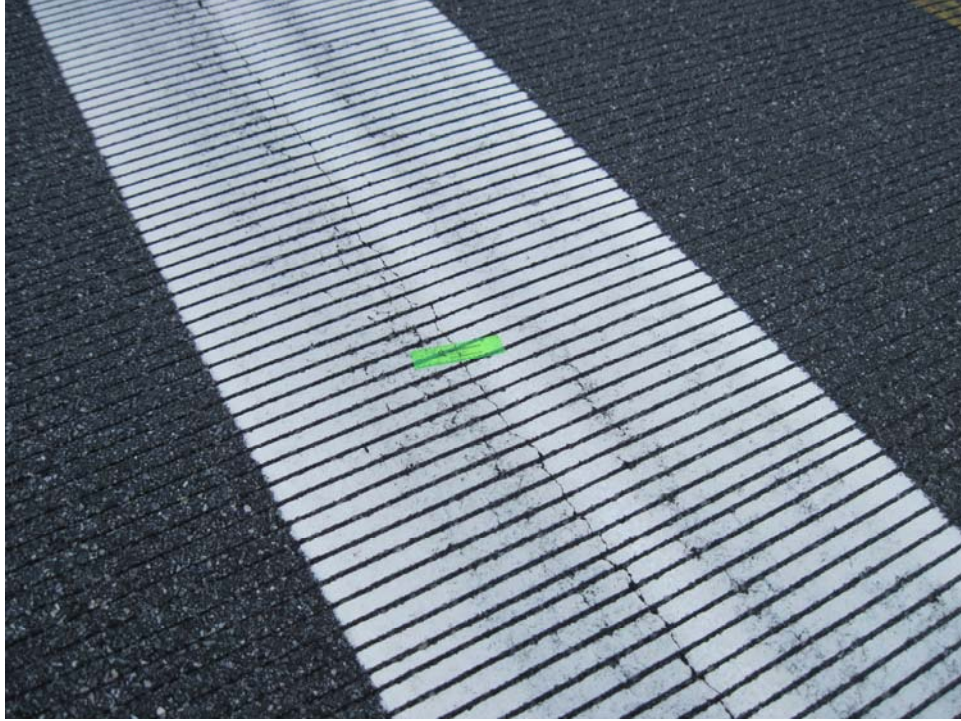
R1735VL-20. Longitudinal and Transverse Cracking and Satisfactory Paint (Sample Unit #31).

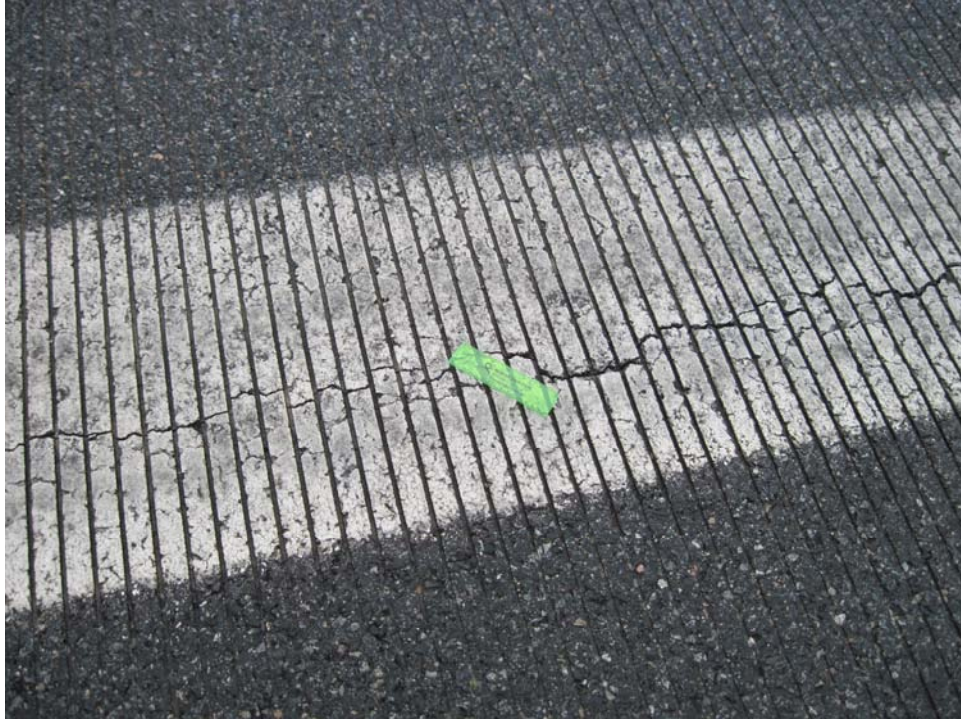
Runway 4-22 contained one section with a PCI value of 92. Moderate amounts of low-severity L&T cracking and weathering were recorded along with small amounts of bleeding and medium-severity weathering. At the south end of the runway, an area of depression was noted which was not deep enough to be recorded.

R422VL-10. Longitudinal and Transverse Cracking.

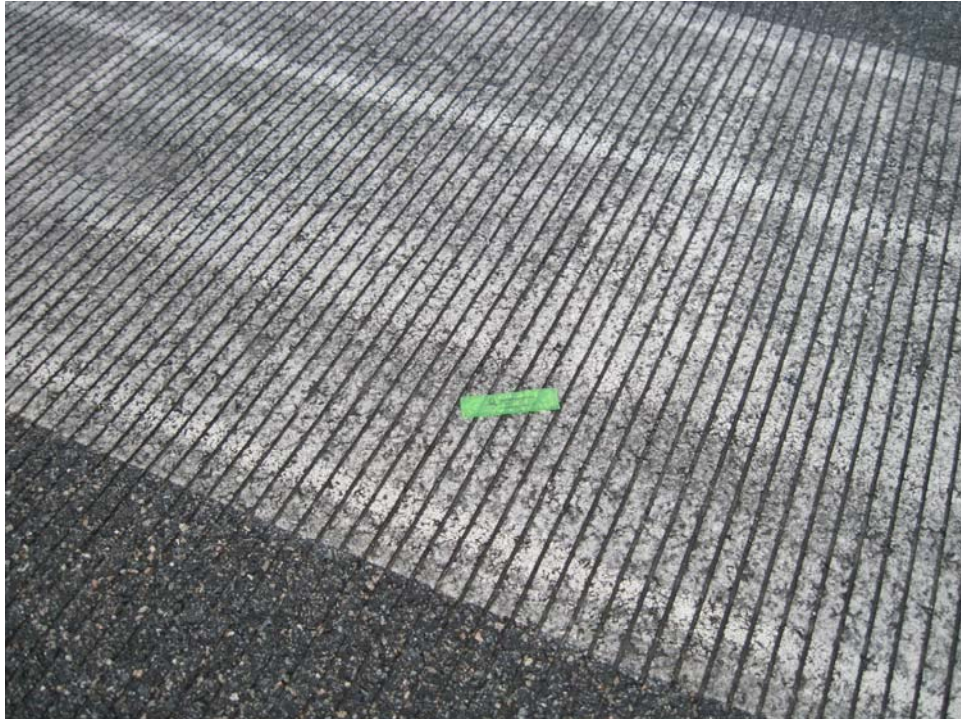
R422VL-10. Unsatisfactory Paint.

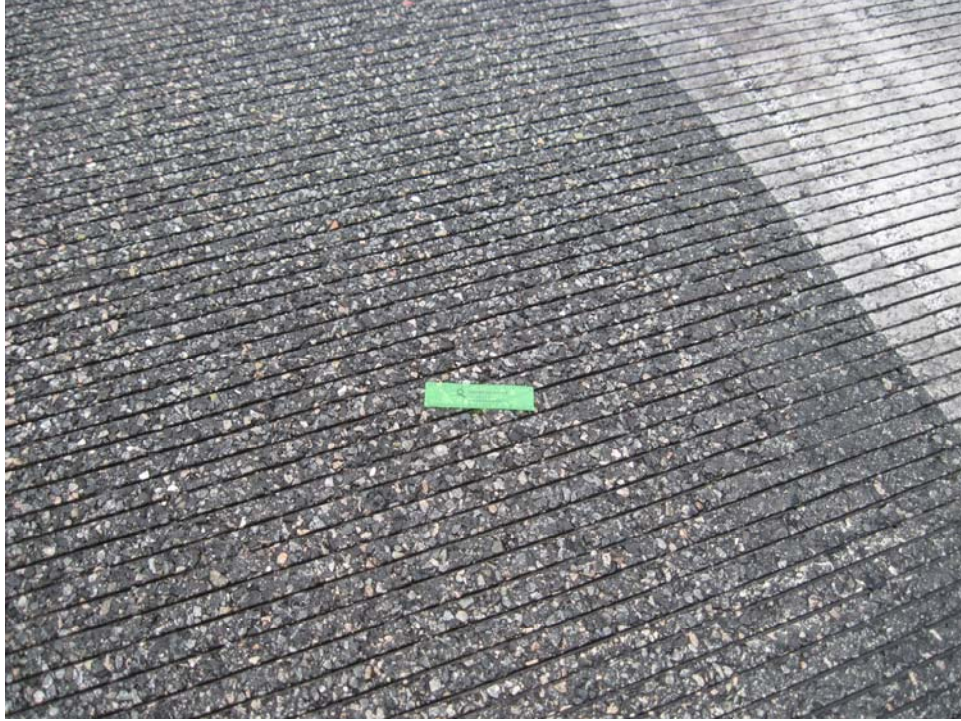
R422VL-10. Weathering (sample unit #55).

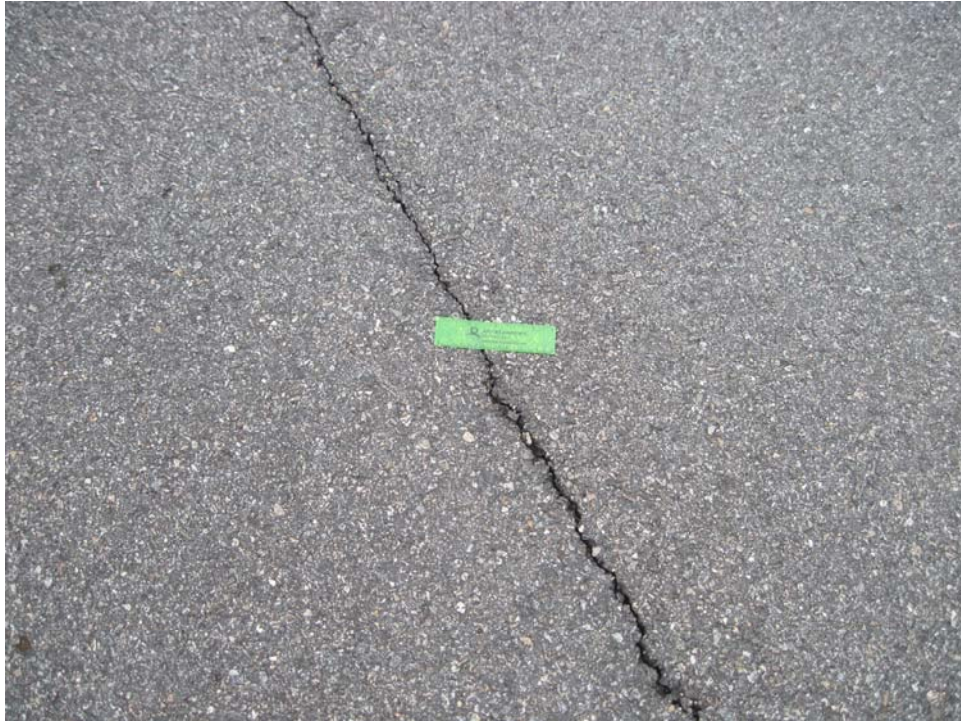
Taxiway A was comprised of two sections. Section 10 had a PCI of 92 with the primary distress recorded being low-severity L&T cracking. A moderate amount of low-severity weathering was also observed, as well as small areas of bleeding and medium-severity weathering. Section 20 had a PCI of 93. A small amount of low-severity L&T cracking was identified along with moderate quantities of low-severity weathering.

TAVL-10. Longitudinal and Transverse Cracking (Sample Unit #20).

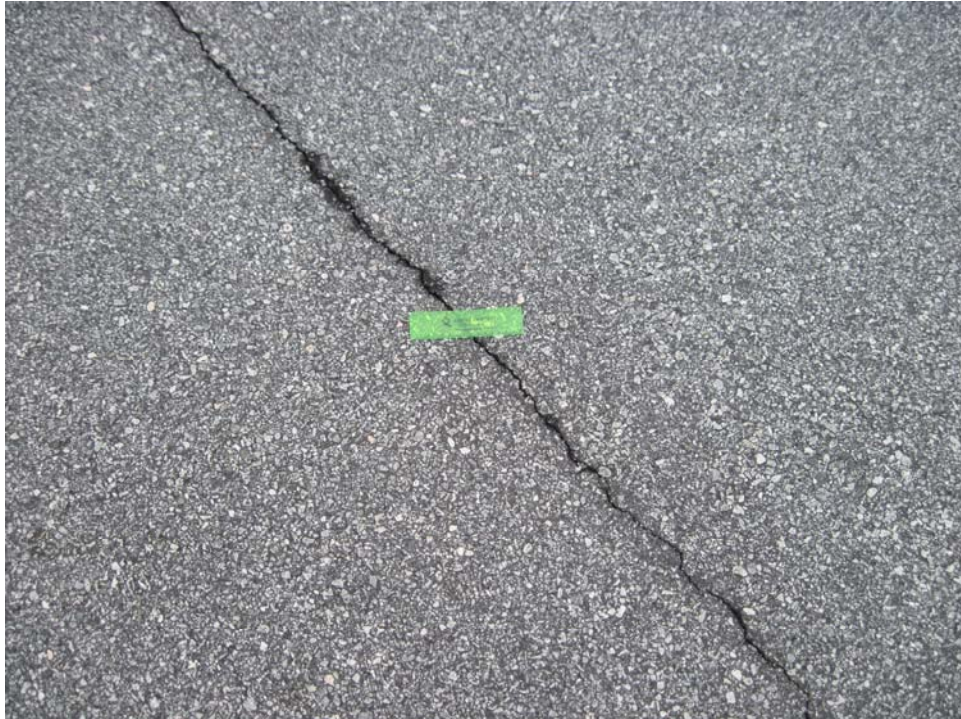
TAVL-20. Longitudinal and Transverse Cracking (Sample Unit #2).

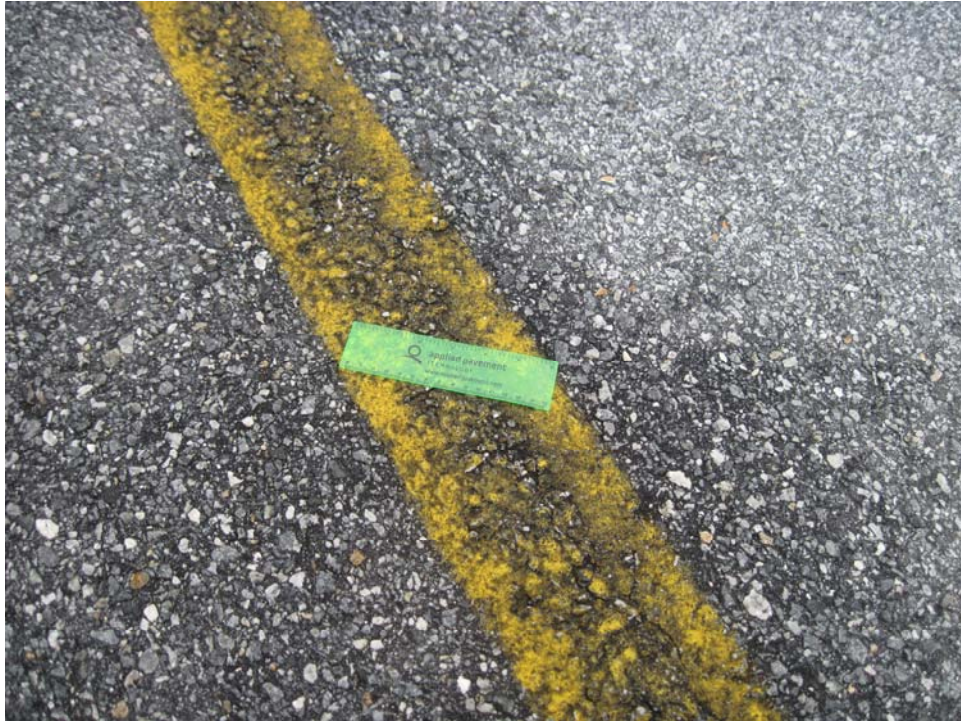
TCVL-10. Unsatisfactory Paint.

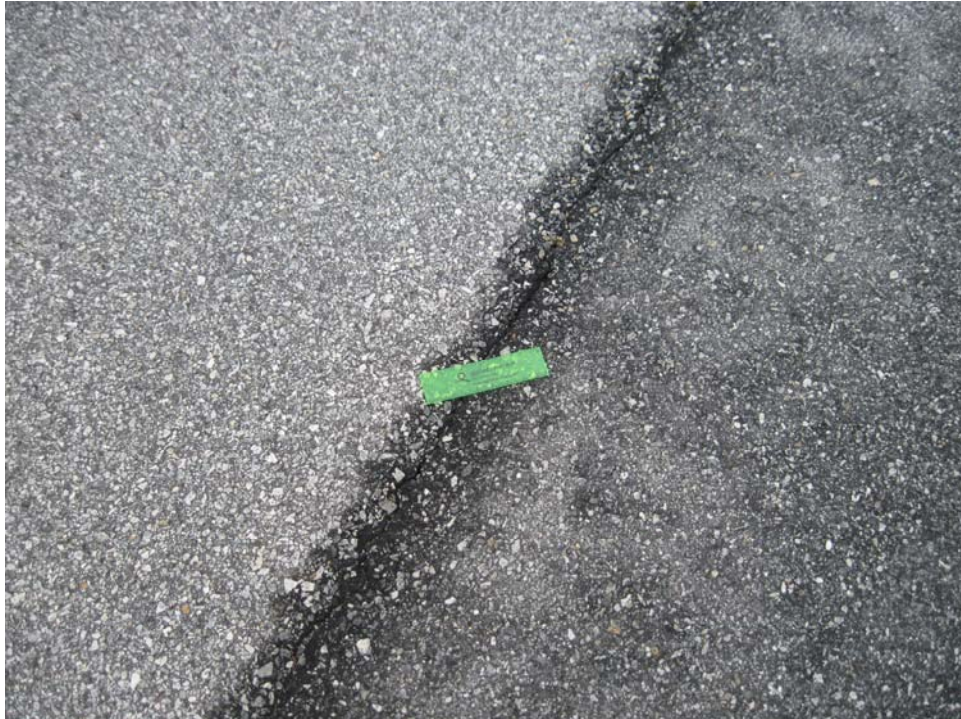
Taxiway C consisted of one section with a PCI value of 83. Moderate quantities of low-severity L&T cracking were recorded. Low-severity weathering was observed over half of the area along with a small area of medium-severity weathering. A small amount of low-severity patching was also noted.

TCVL-10. Longitudinal and Transverse Cracking (sample unit #30).

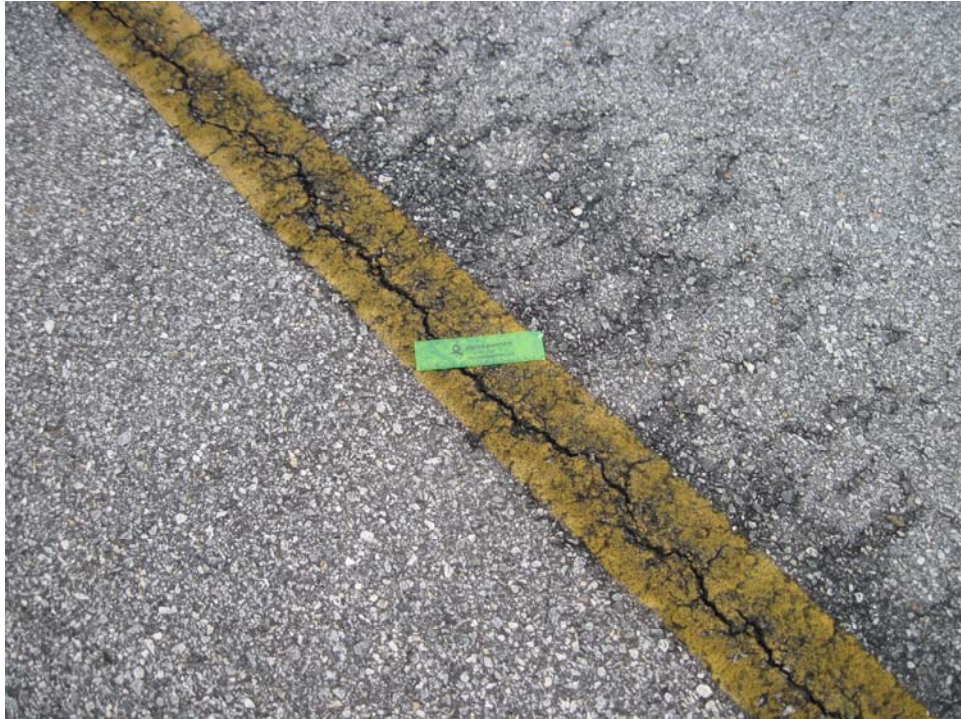
Taxiway F was comprised of one section. Section 10 had a PCI of 83. Moderate amounts of low-severity L&T cracking and a small amount of medium-severity L&T cracking were identified in this section. Low-severity weathering was also recorded. Roller checking was noted in parts of Section 10.

TFVL-10. Unsatisfactory Paint and Longitudinal and Transverse Cracking (Sample Unit #3).

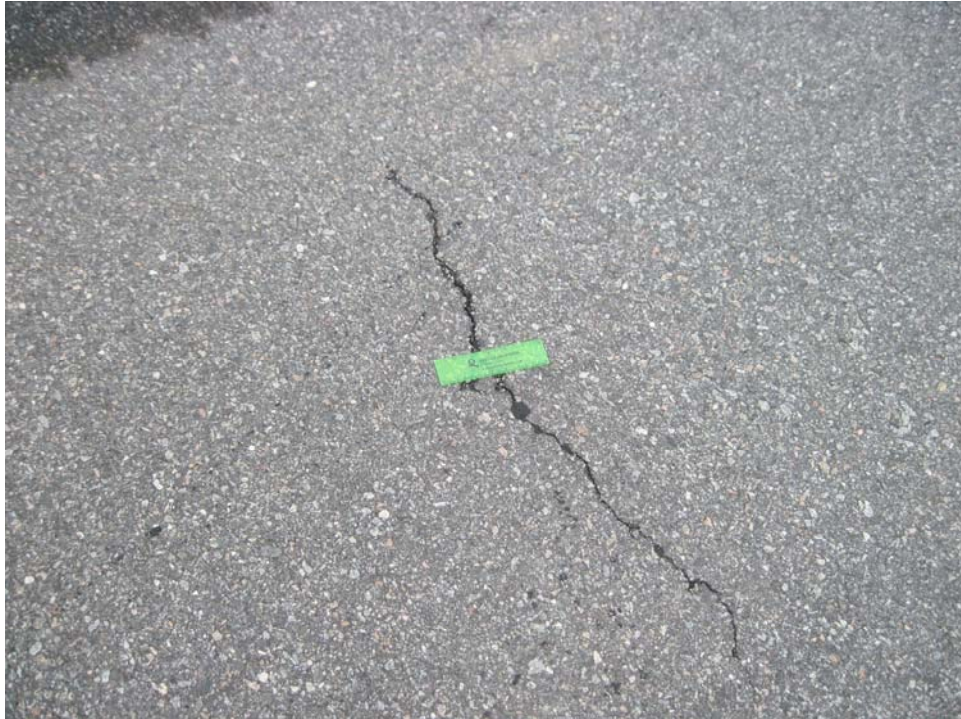
TLVL-10. Longitudinal and Transverse Cracking.

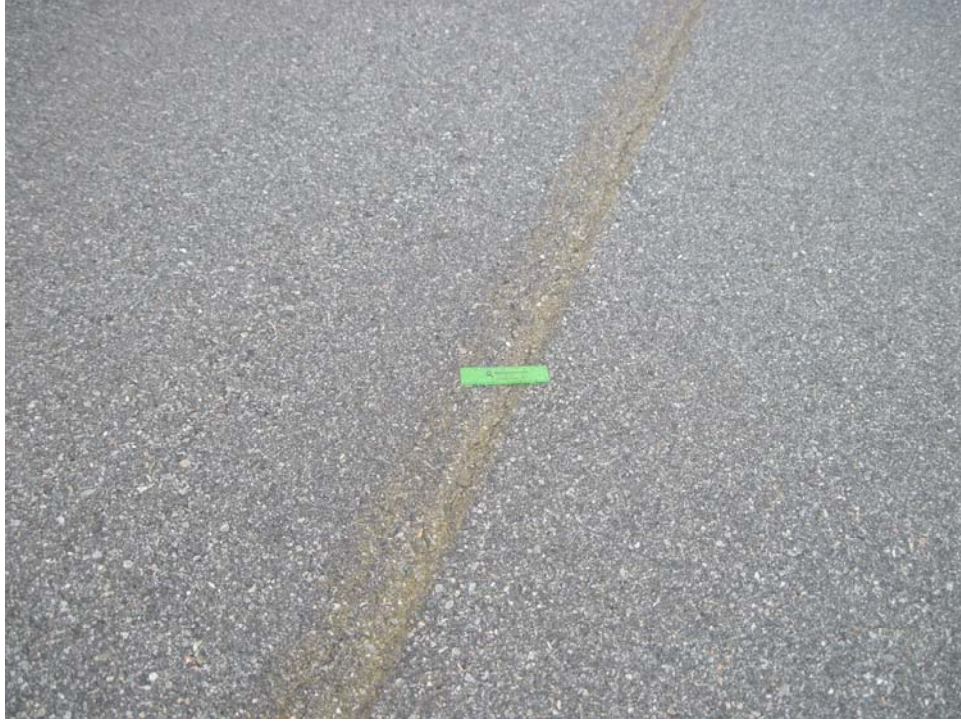
TLVL-20. Longitudinal and Transverse Cracking and Unsatisfactory Paint (Sample Unit #2).

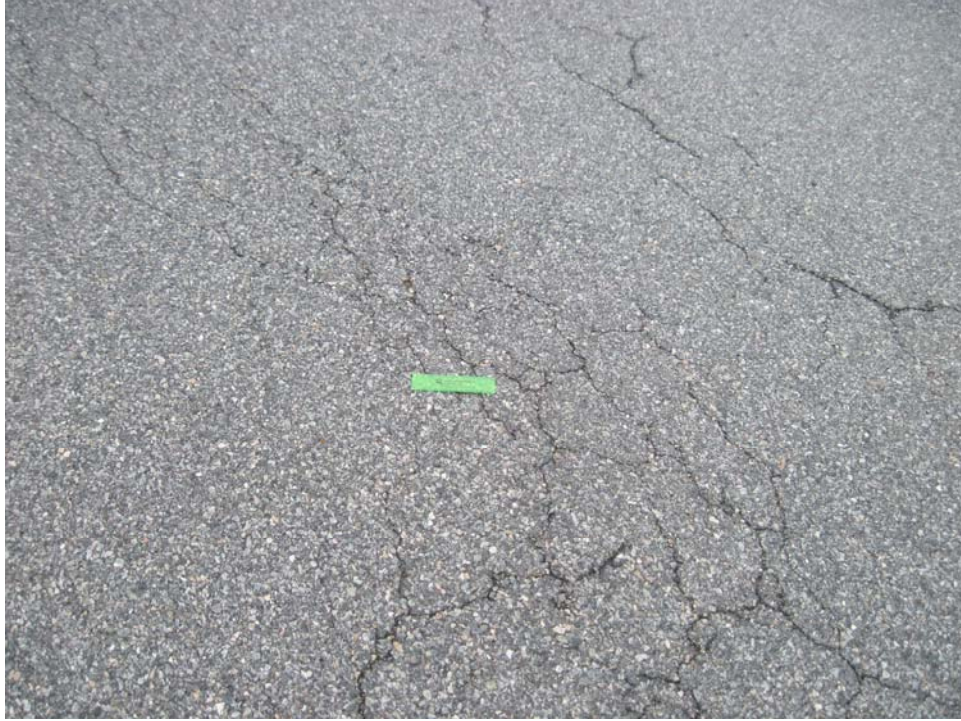
Taxiway M consisted of one section. Section 10 had a PCI of 69. Typical distresses recorded in this section were low-severity L&T cracking and weathering. At the south end of Section 10, there were moderate amounts of both low- and medium-severity alligator cracking.

TMVL-10. Alligator Cracking (sample unit #2).

<b>Branch<sup>1</sup></b>	<b>Section</b>	<b>Year</b>	<b>Type of Repair<sup>2</sup></b>	<b>Estimated Cost<sup>3</sup></b>
TLVL	20	2013	Rejuvenator	\$2,431
		2017	Preventive Maintenance	\$401
TMVL	10	2013	Major M&R	\$136,473
TNVL	10	2013	Major M&R	\$63,603

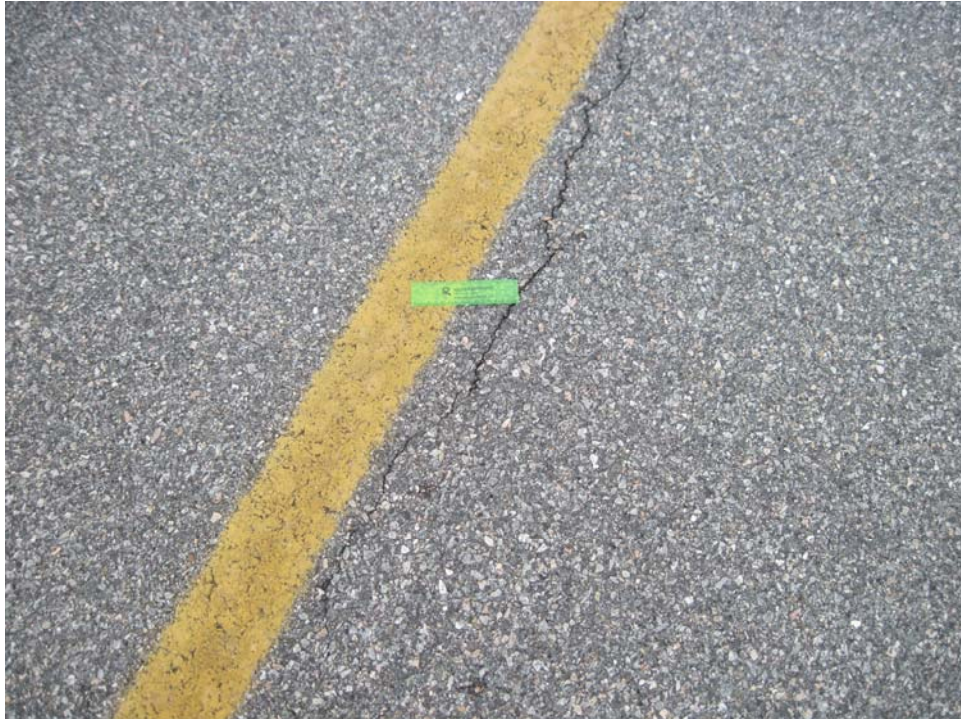
TMVL-10. Longitudinal and Transverse Cracking and Satisfactory Paint (Sample Unit #9).

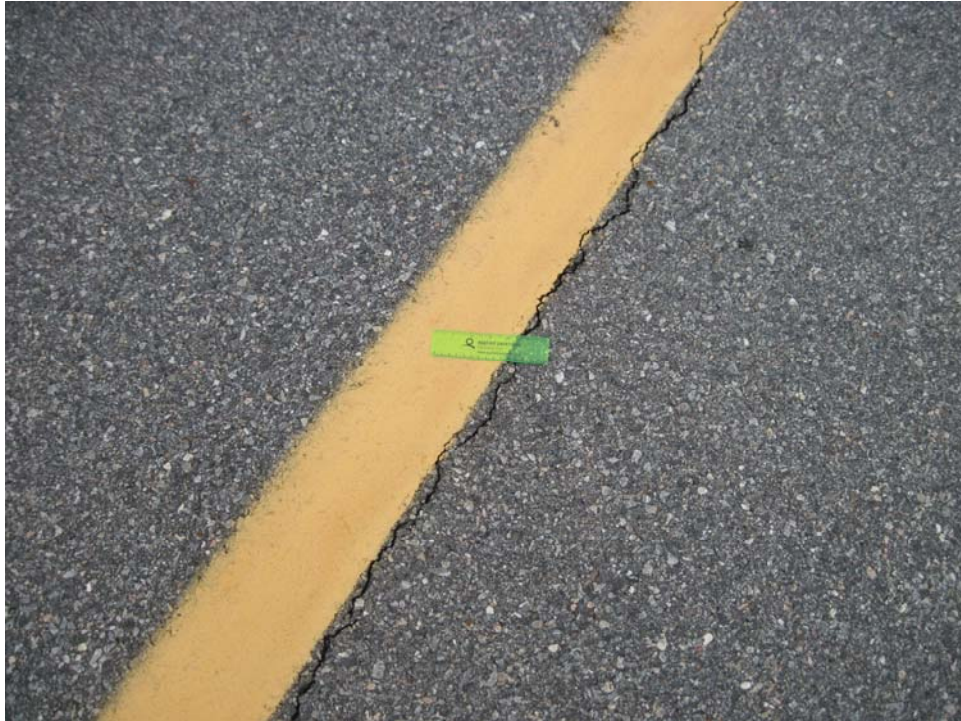
Taxiway N was comprised of one section with a PCI of 61. Extensive quantities of low-severity L&T cracking were observed along with a moderate amount of medium-severity L&T cracking. Low-severity weathering was recorded over approximately half of the section. A small area of medium-severity weathering was also identified, as well as a small area of bleeding.

TNVL-10. Longitudinal and Transverse Cracking and Satisfactory Paint.

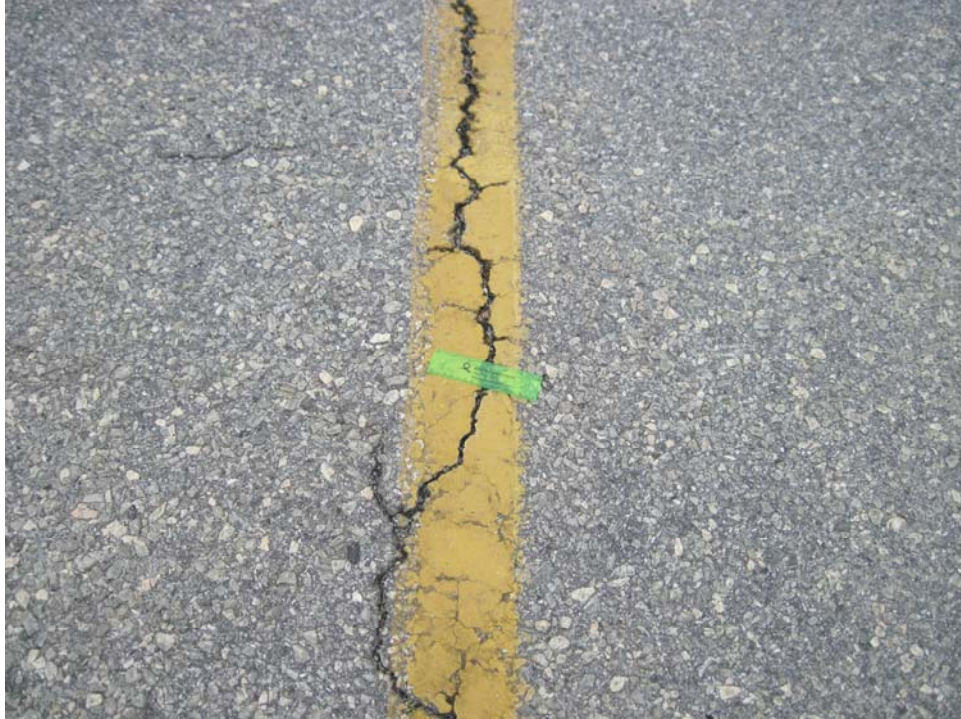
THANG01VL-10. Longitudinal and Transverse Cracking and Satisfactory Paint (Sample Unit #1).

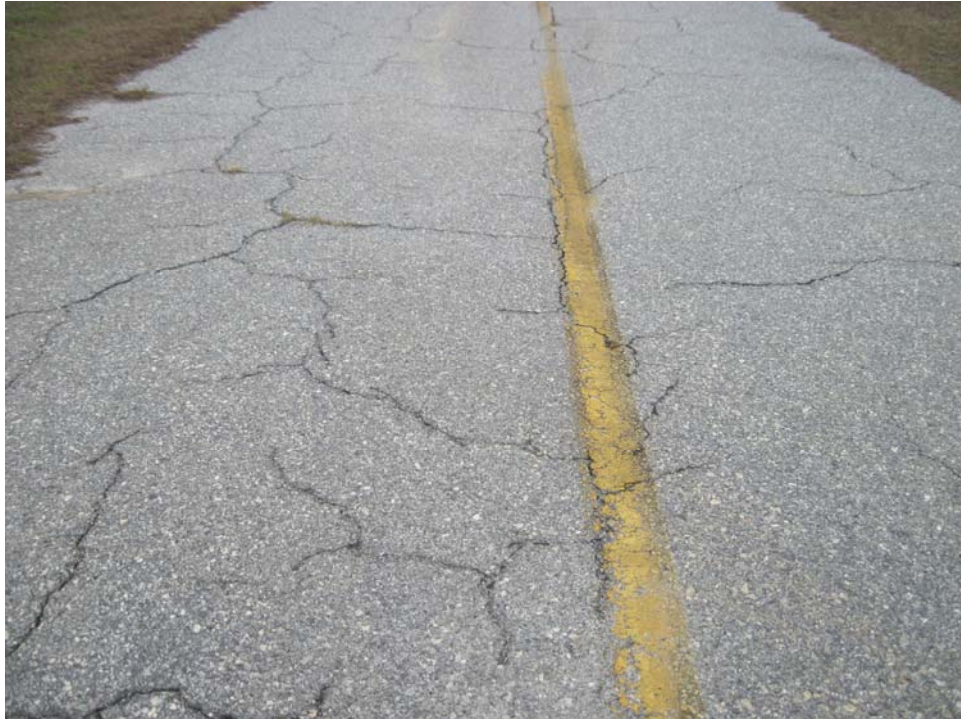
This T-Hangar area (THANG01VL) was comprised of three sections and was located at the north end of the FBO apron. Section 10 had a PCI of 42 with medium-severity block cracking and low- and medium-severity weathering recorded throughout. Section 20 had a PCI of 94. A moderate amount of low-severity weathering and a very small amount of low-severity L&T cracking were observed. Section 30 had a PCI of 89 with low-severity weathering identified over the entire section along with a small amount of low-severity L&T cracking.

THANG01VL-10. Block Cracking (Sample Unit #02).

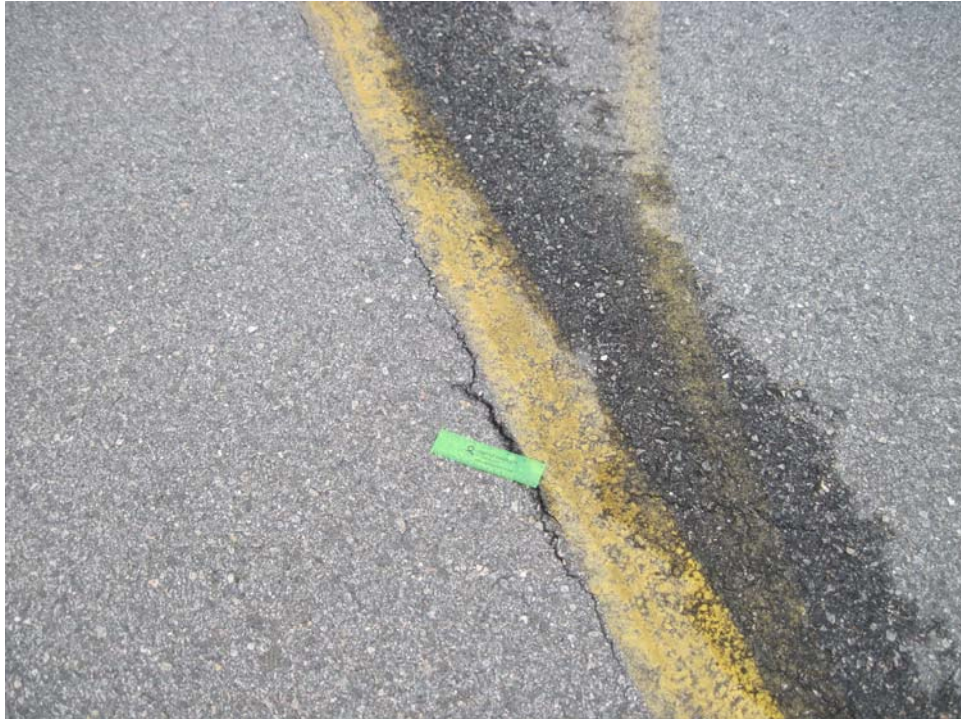
THANG01VL-30. Longitudinal and Transverse Cracking (Sample Unit #01).

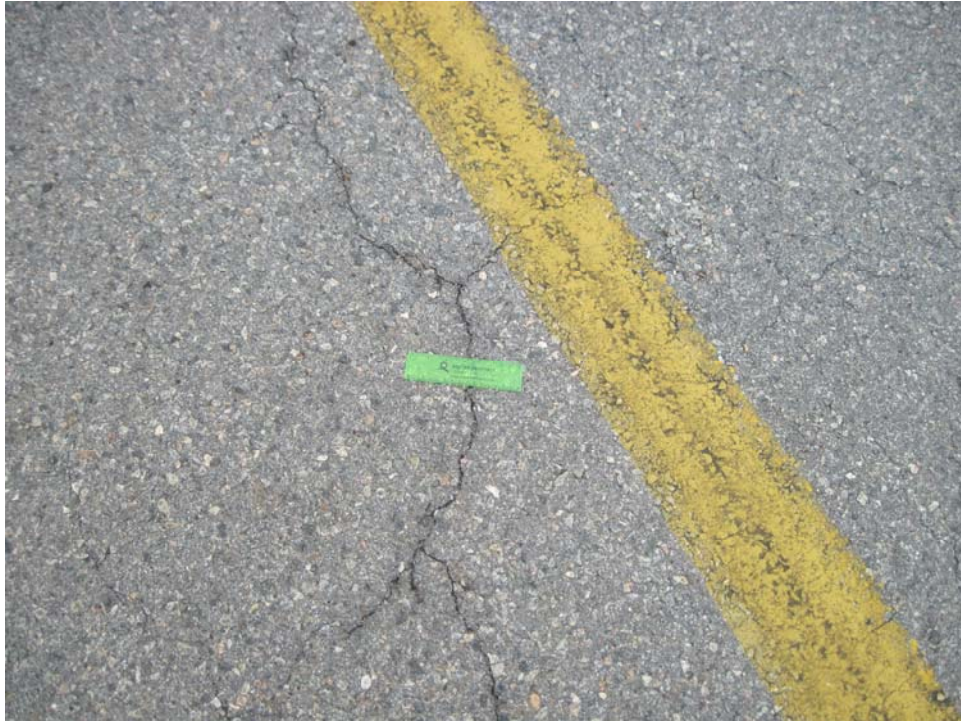
This area of T-Hangar taxiways (THANG02VL) consisted of four sections and was located at the south end of the FBO apron. Section 10 had a PCI of 77 with low-severity weathering, L&T cracking, and patching recorded. Section 20 was in excellent condition with a PCI of 96. A moderate amount of low-severity weathering was identified along with a small quantity of low-severity L&T cracking. Section 30, with a PCI of 91, had both extensive areas of low-severity weathering and a small amount of low-severity L&T cracking. Section 40 was in excellent condition with a PCI of 100. No distresses were observed at the time of inspection.

THANG02VL-10. Longitudinal and Transverse Cracking (Sample Unit #02).
