NEWNAN-COWETA COUNTY AIRPORT
PAVEMENT MANAGEMENT REPORT

2007 GEORGIA AIRPORT PAVEMENT MANAGEMENT REPORT

NEWNAN-COWETA COUNTY AIRPORT

PAVEMENT MANAGEMENT REPORT

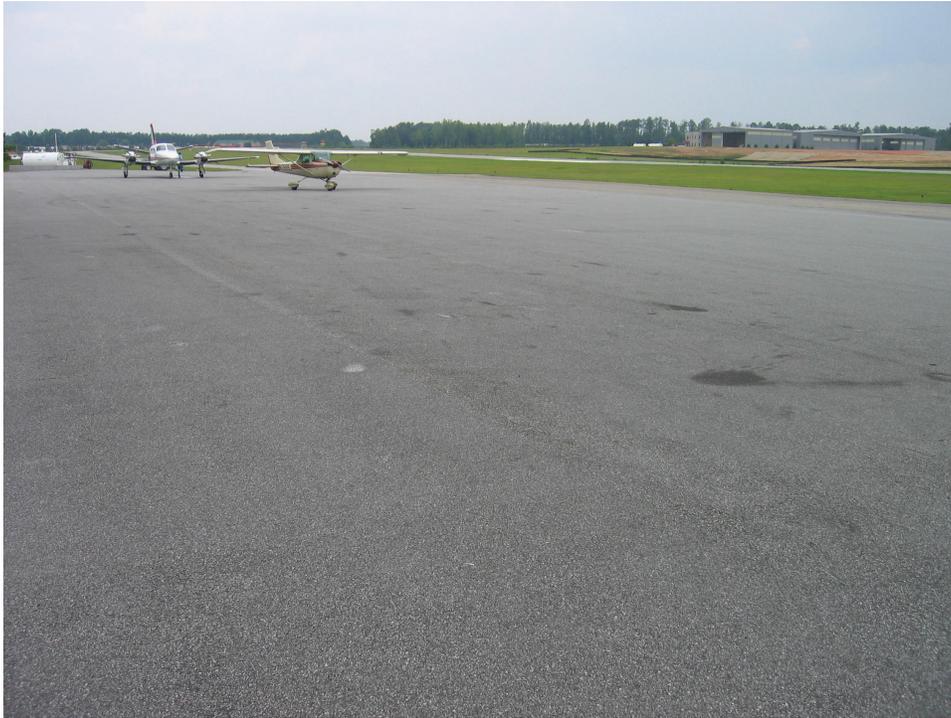
A01NW-10. Overview.

Three sections were identified in the main apron. A01NW-10 is in good condition with a PCI value of 88. Significant quantities of low-severity, unsealed, L&T cracking were observed throughout the section. Section A01NW-20 is in poor condition with a PCI value of 48 due to high amounts of low and medium-severity block and L&T cracking, along with medium-severity alligator cracking, and rutting also being recorded. A01NW-30 is in similar condition to A01NW-10 with a PCI value of 81. Higher amounts of L&T cracking were observed, however. All cracks were recorded as low-severity sealed due to a crack sealing project scheduled for this section before the end of summer 2007.

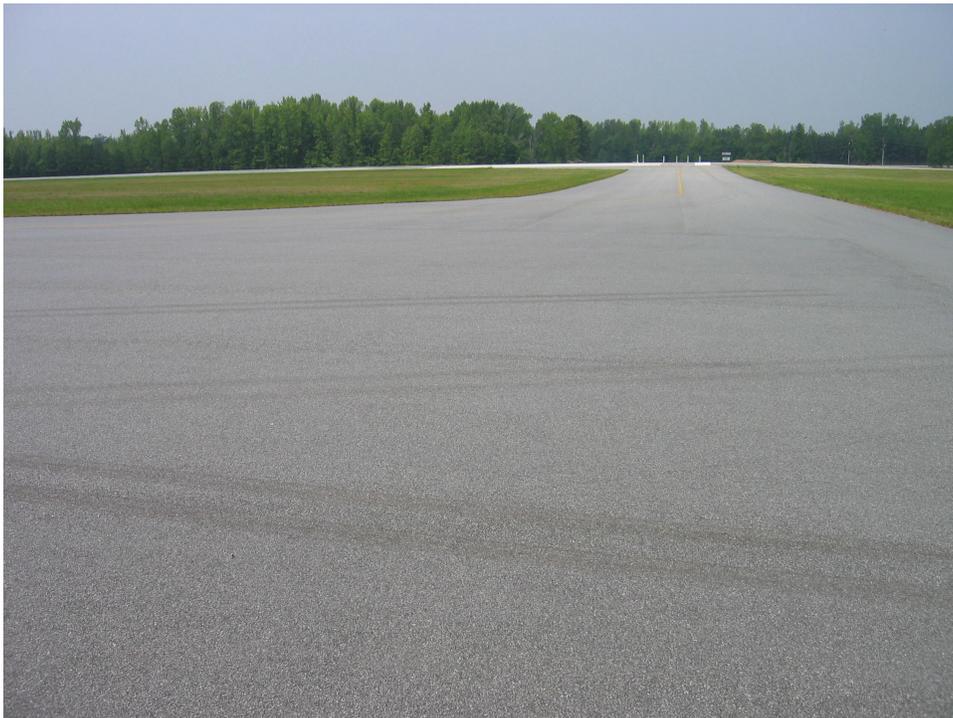
A02NW-10. Overview.

A second apron area is located at the northern end of Runway 14-32. This apron area is defined by one recently constructed section, A02NW-10, that is in excellent condition with a PCI value of 100. No distress was identified in this section at the time of inspection.

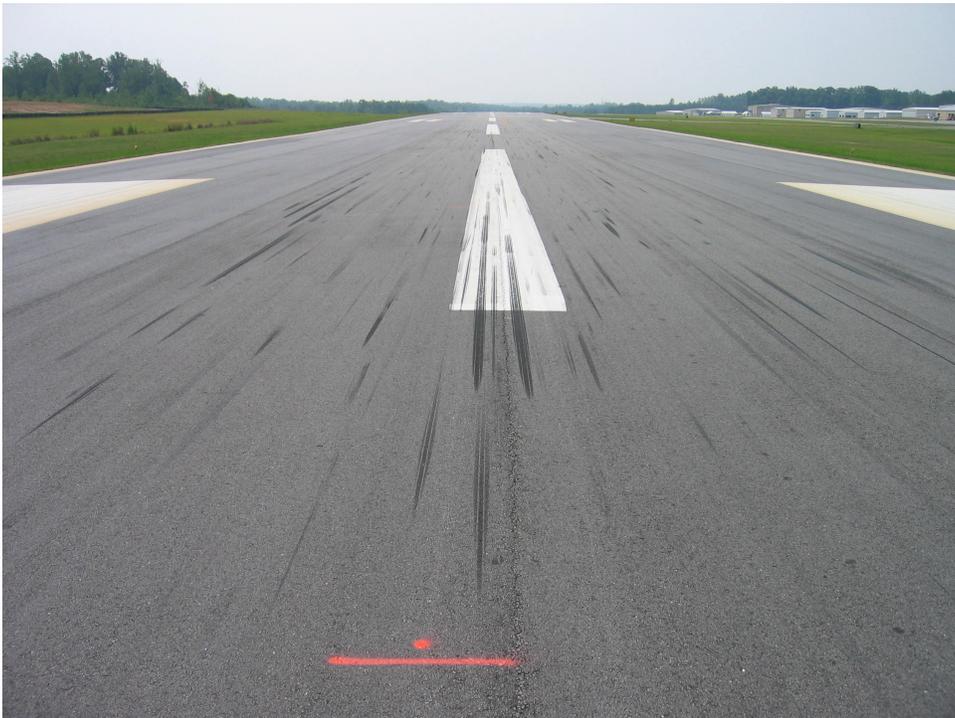
R1432NW-10. Overview.

Runway 14-32 consists of one recently rehabilitated section, R1432NW-10, and is in excellent condition with a PCI value of 96. Moderate amounts of low-severity, unsealed, longitudinal and transverse (L&T) cracking were identified throughout the section.

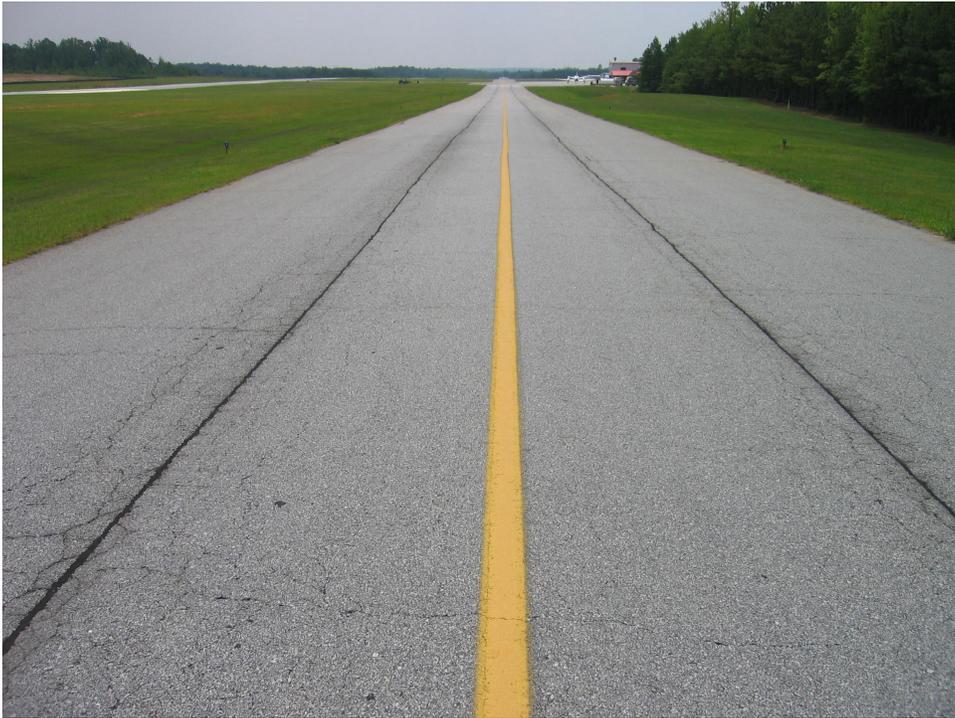
TANW-10. Overview.

Two sections are defined in Taxiway A. TANW-10 is in poor condition with a PCI value of 35. Significant amounts of low-severity, sealed and unsealed, L&T cracking were observed. Isolated amounts of raveling and weathering, medium-severity L&T cracking, and rutting were also identified throughout the section. Significant quantities of medium-severity alligator cracking were observed throughout the section. The taxiway was recently extended to the south along with the runway extension and defines section TANW-20. TANW-20 is in excellent condition with a PCI value of 96. No distresses were observed except for a small area at the north end which was identified as an additional sample unit due to a moderate amount of depression that was atypical of the condition of the pavement section as a whole.

Branch¹	Section	Year	Type of Repair²	Estimated Cost³
A01NW	20	2008	Major M&R	\$182,151
A01NW	30	2008	Preventive Maintenance	\$114
A02NW	10	2008	Rejuvenator	\$15,608
TANW	10	2008	Major M&R	\$770,947
TANW	20	2008	Preventive Maintenance	\$404
THANGNW	20	2008	Rejuvenator	\$26,470
A01NW	10	2012	Preventive Maintenance	\$2,466
A01NW	30	2012	Preventive Maintenance	\$15,664
R1432NW	10	2012	Preventive Maintenance	\$5,753
THANGNW	10	2012	Preventive Maintenance	\$1,031
THANGNW	20	2012	Preventive Maintenance	\$4,777

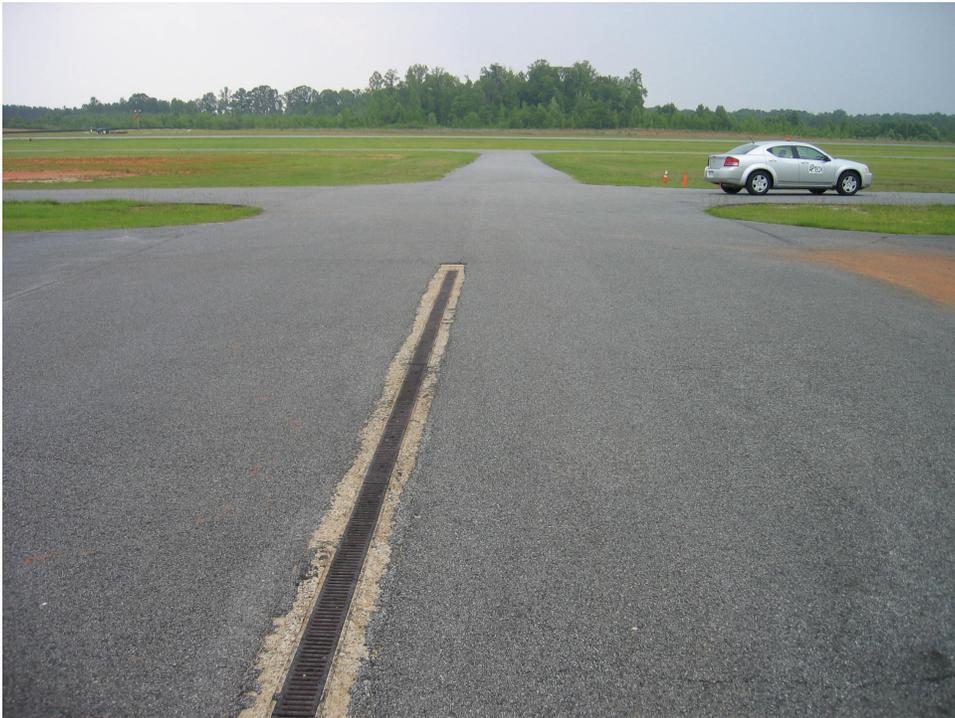
THANGNW-10. Overview.

The T-hanger area is defined by two sections. THANGNW-10 is in good condition with a PCI value of 94. Only small quantities of low-severity, unsealed, L&T cracking were observed throughout the section. THANGNW-20 was recently constructed and is in good condition with a PCI value of 93. Only minor amounts of low-severity, unsealed, L&T cracking were identified and recorded in this section.
