DANIEL FIELD
PAVEMENT MANAGEMENT REPORT

2007 GEORGIA AIRPORT PAVEMENT MANAGEMENT REPORT

DANIEL FIELD

PAVEMENT MANAGEMENT REPORT

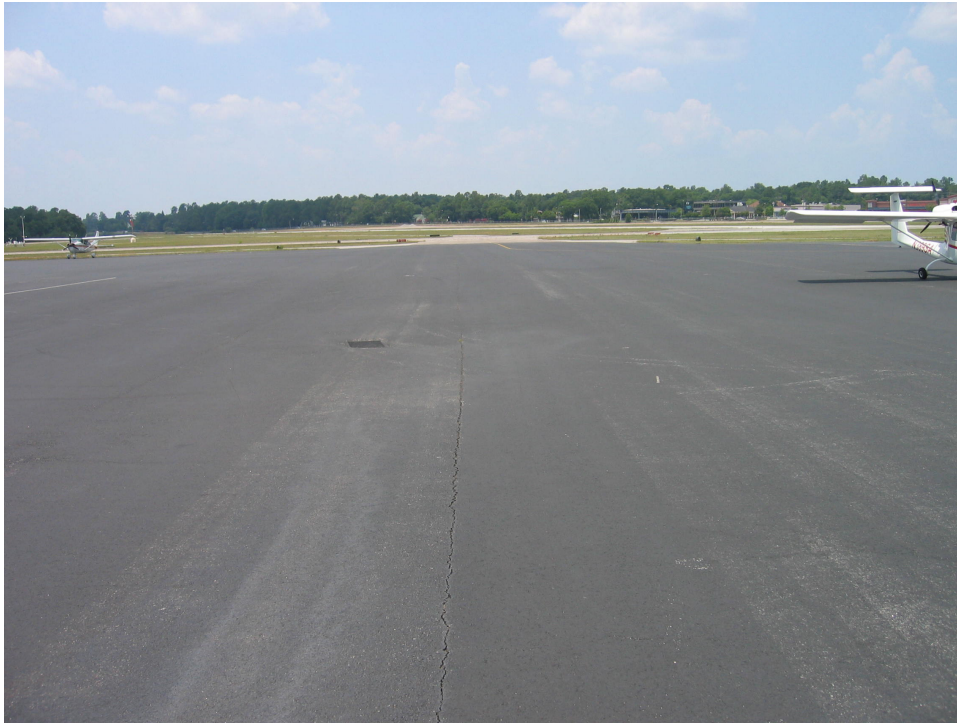
ATERMAG-10. Overview.

The terminal apron area is defined by seven sections. Section ATERMAG-10 is in good condition with a PCI value of 92. A small amount of unsealed, low-severity L&T cracking was the only distress observed in this section.

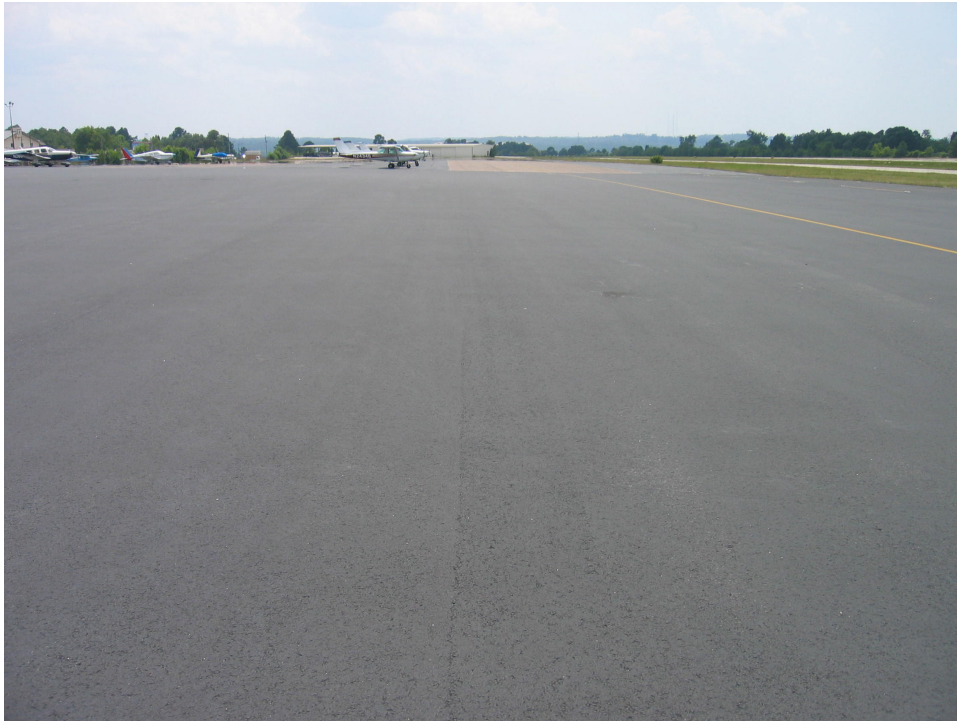
ATERMAG-20. Overview.

Section ATERMAG-20 is in excellent condition with a PCI value of 100. No distress was observed in this section.

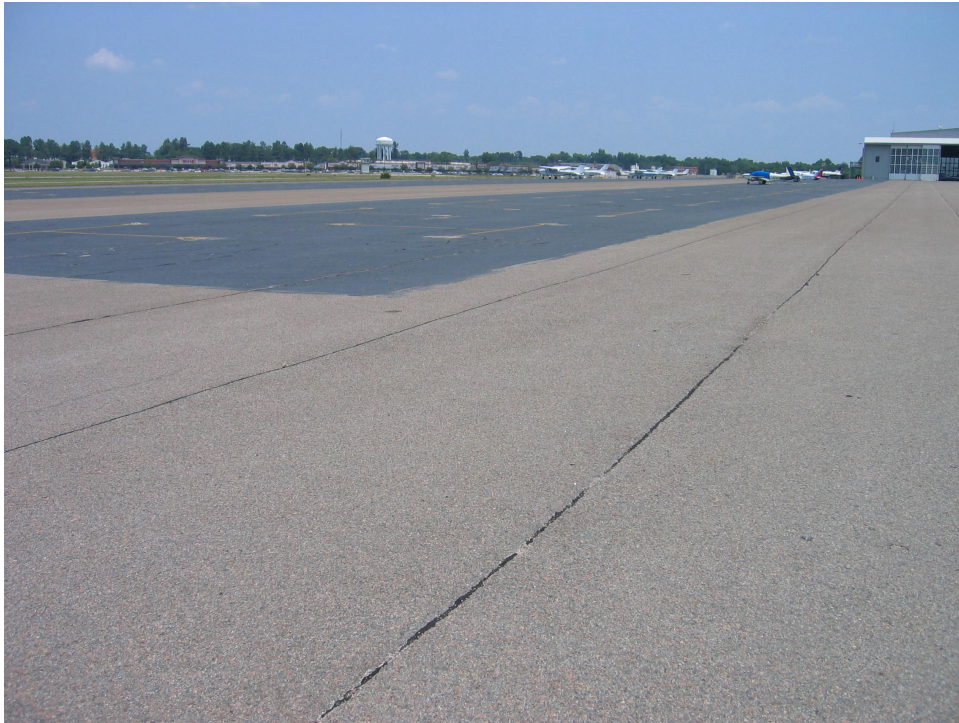
ATERMAG-30. Overview.

Section ATERMAG-30 is in fair condition with a PCI value of 74. A large amount of low-severity L&T cracking was observed, mainly on the paving seams which have opened in

multiple locations. These paving seams have been sealed but a fair amount of the sealant has failed resulting in medium-severity cracking.

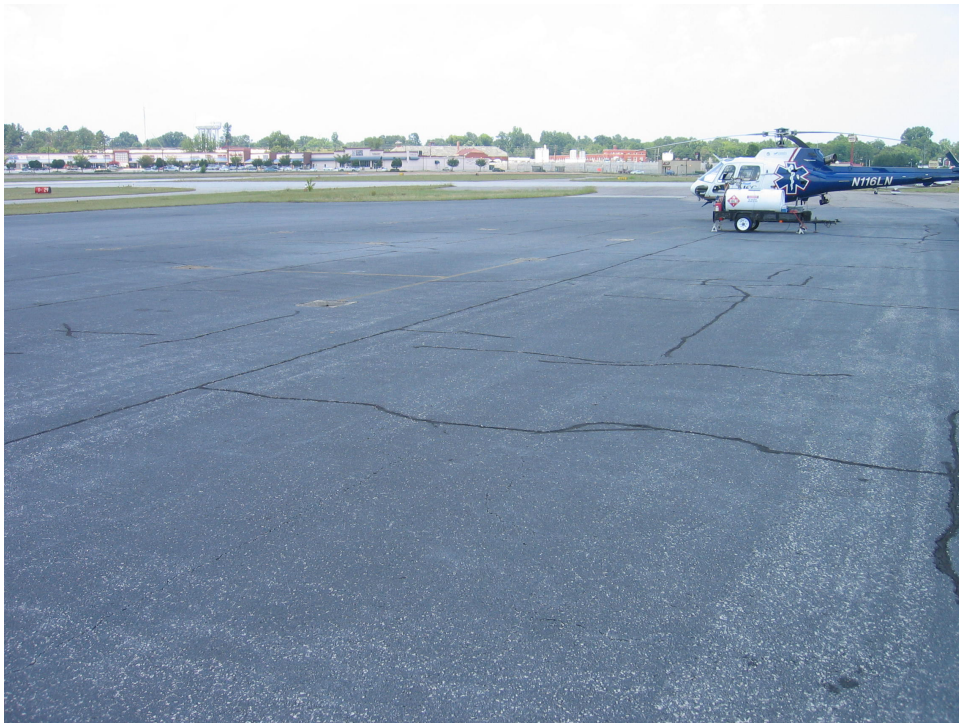
ATERMAG-40. Overview.

Section ATERMAG-40 is in fair condition with a PCI value of 79. Low-severity L&T cracking was the only distress identified in this section. Sealant in satisfactory condition was observed in approximately fifty percent of the cracks.

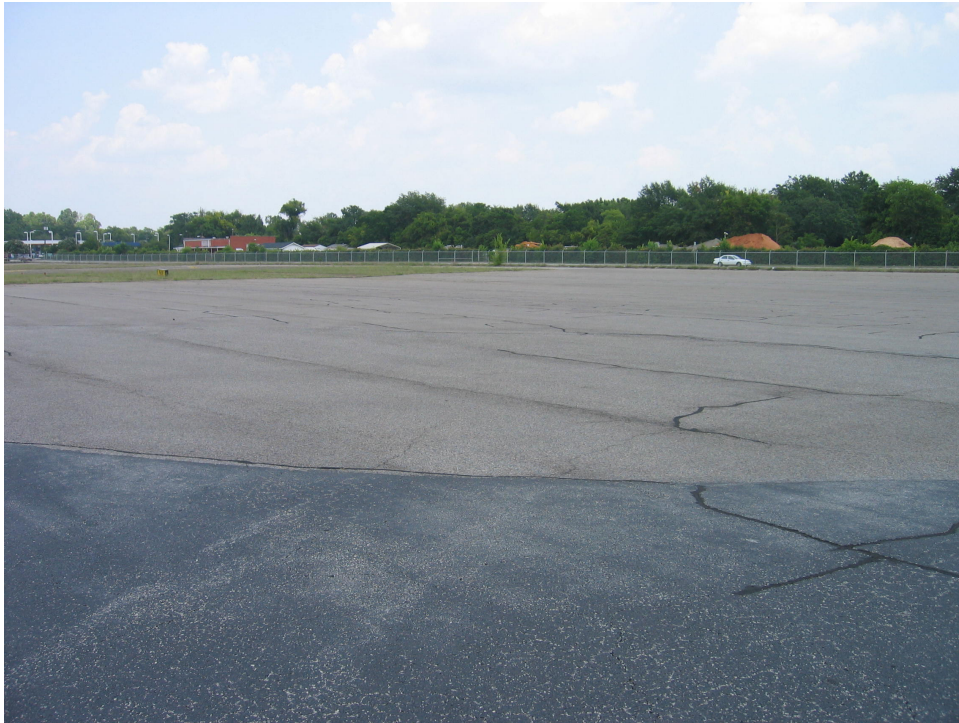
ATERMAG-50. Overview.

Section ATERMAG-50 is in fair condition with a PCI value of 70. A substantial amount of low-severity L&T cracking was observed, most in a sealed condition. A small amount of medium-severity L&T cracking was also recorded in this section.

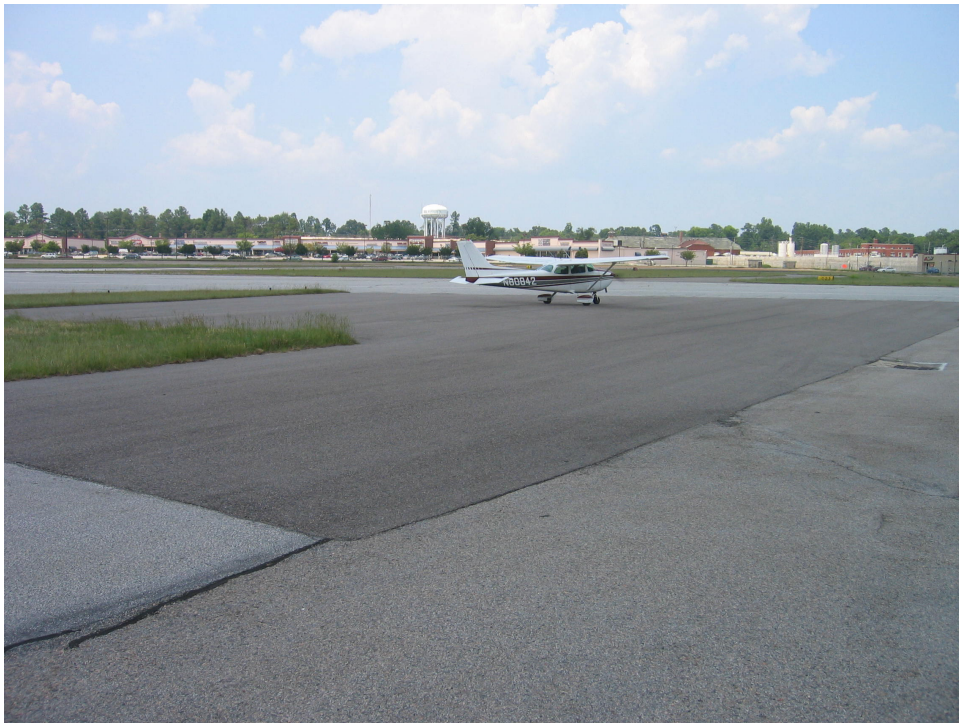
ATERMAG-60. Overview.

Section ATERMAG-60 was recently rehabilitated and is in excellent condition with a PCI value of 100. No distresses were observed in this section.

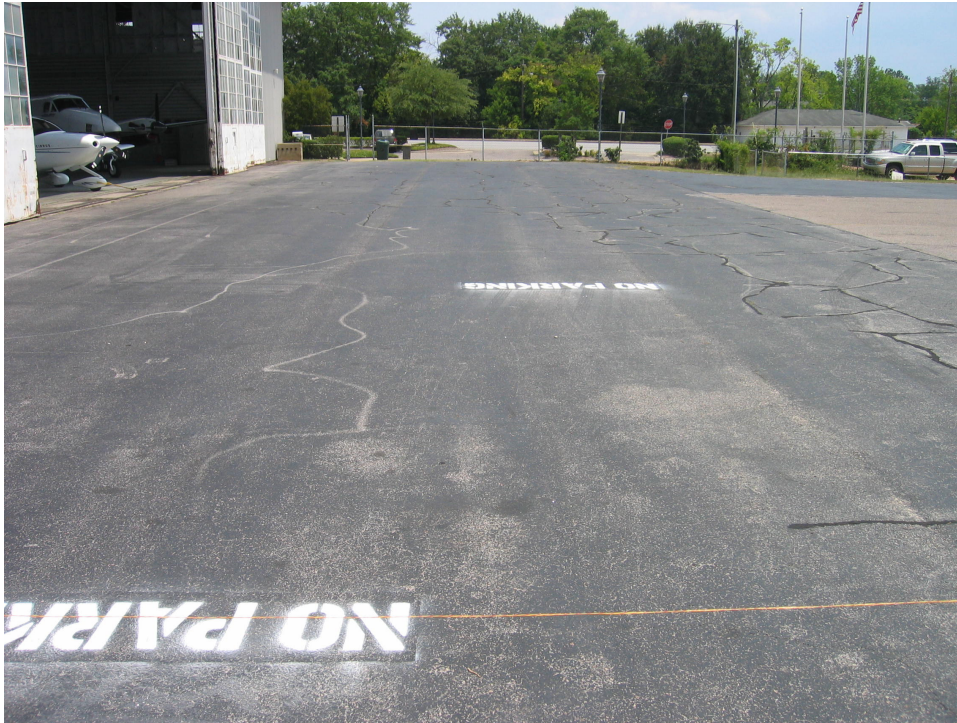
ATERMAG-70. Overview.

Section ATERMAG-70 is in fair condition with a PCI value of 71. A significant quantity of low-severity block cracking was observed in this section. The majority of the cracking was sealed with satisfactory crack sealant.

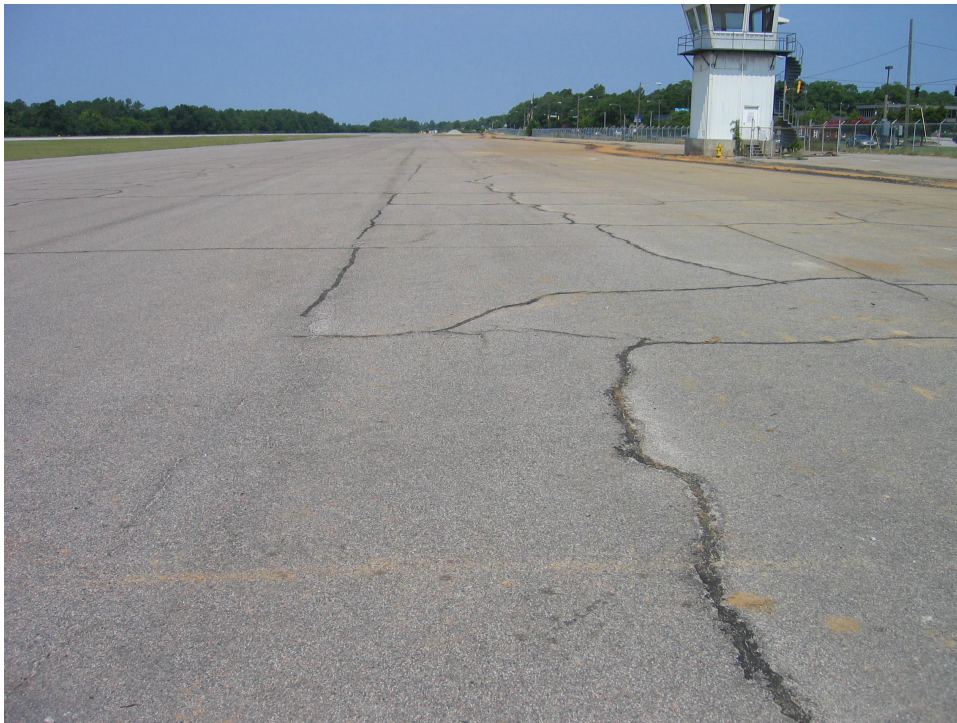
ATOWERAG-10. Overview.

The tower apron area consists of two sections. Section ATOWERAG-10 is in fair condition with a PCI value of 61. Substantial amounts of low and medium-severity L&T cracking were observed in this section. A small amount of raveling and weathering was also noted.

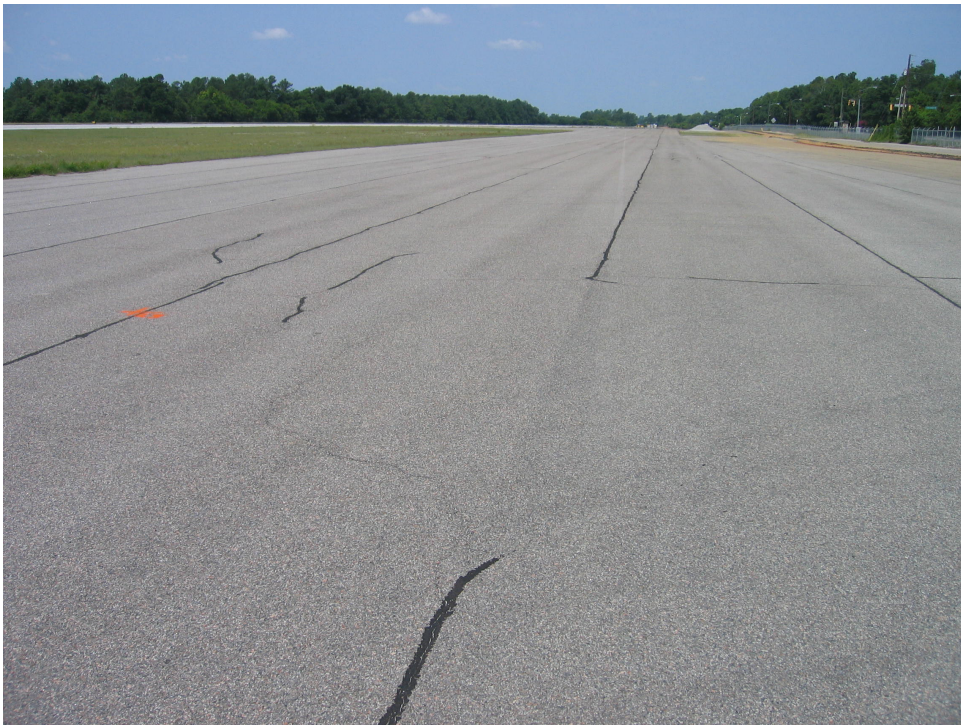
ATOWERAG-20. Overview.

Section ATOWERAG-20 is in fair condition with a PCI value of 77. Areas of low-severity block cracking and a significant amount of low-severity L&T cracking were observed in this section. A small amount of L&T cracking had progressed to a level of medium-severity.

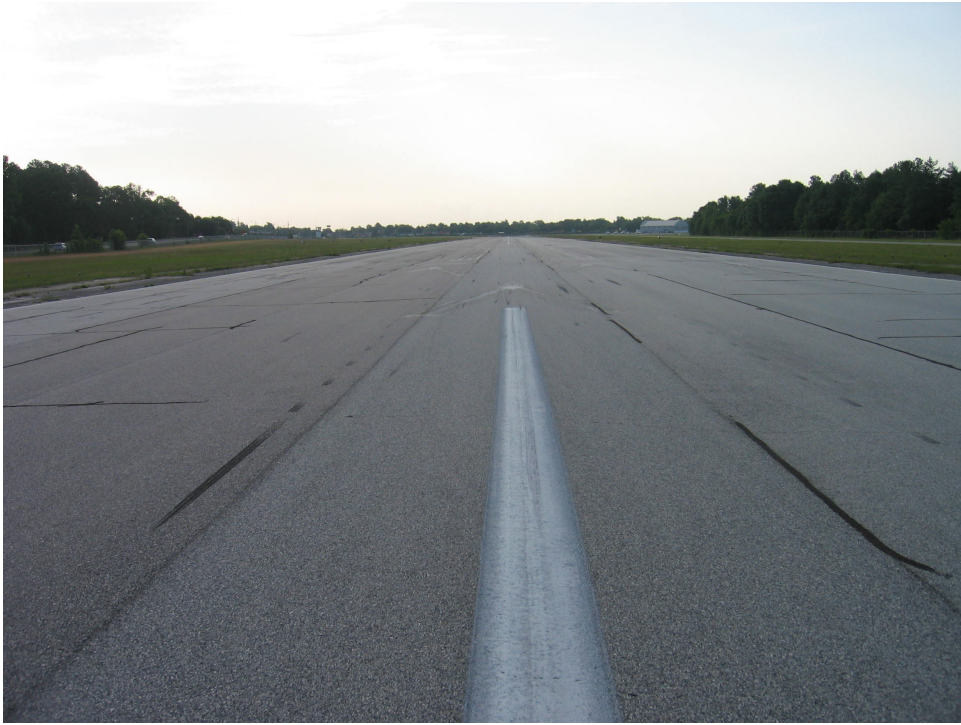
R1129AG-10. Overview.

Runway 11-29 at Daniel Field is comprised of a single pavement section. Section R1129AG-10 is in good condition with a PCI value of 82. A fair amount of longitudinal and transverse (L&T) cracking was observed in this section, almost all of which had been recently sealed with the sealant being in good condition. A small amount of swelling was also observed in this section.

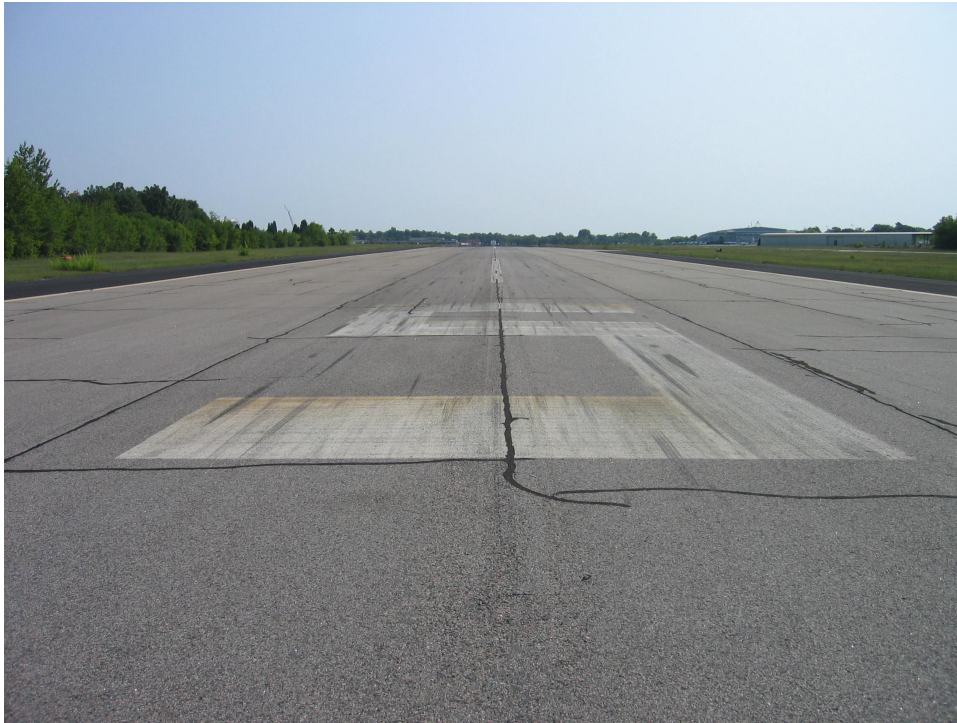
R523AG-10. Overview.

Runway 5-23 consists of two pavement sections. Section R523AG-10 comprises approximately 94 percent of the runway surface area and is in fair condition with a PCI value of 75. A substantial amount of low-severity L&T cracking was observed in this section. Most of this cracking was in the paving seams and has been sealed. In some areas, the sealant has hardened and failed resulting in the progression of these cracks to a level of medium-severity. A small amount of low-severity patching was also recorded in this section.

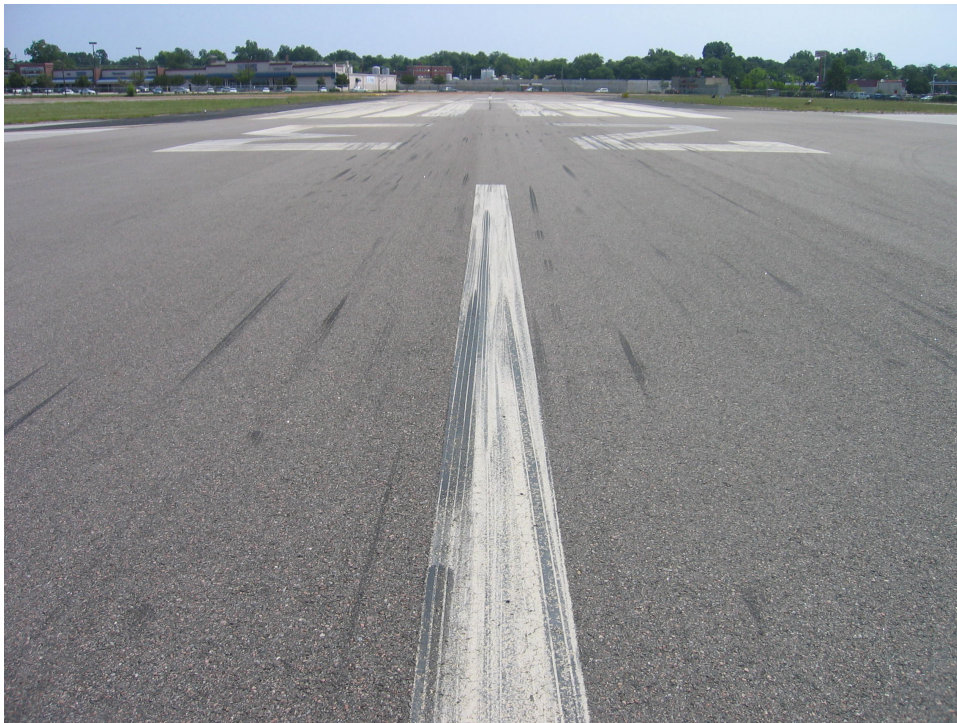
R523AG-20. Overview.

Section R523AG-20 is a recently rehabilitated pavement section located at the intersection of Runway 5-23 and Runway 11-29. This section is in excellent condition with a PCI value of 100. No distresses were observed in this section.

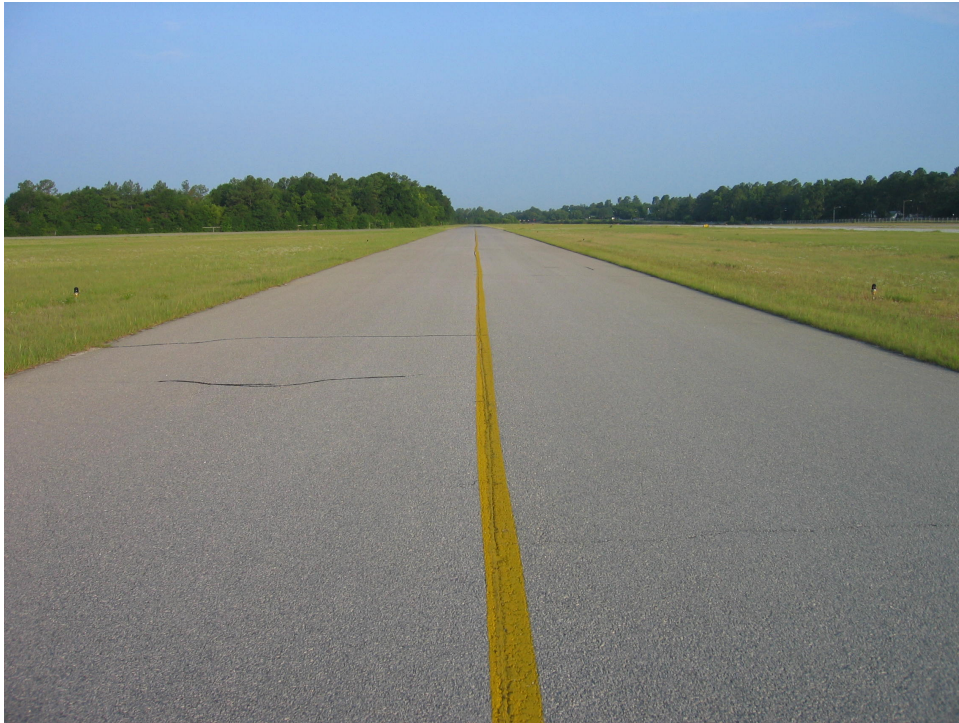
TAAG-10. Overview.

Taxiway A consists of a single section. Section TAAG-10 is in fair condition with a PCI value of 77. A significant amount of sealed, low-severity L&T cracking was observed in this section. In some areas, the sealant has hardened and failed resulting in medium-severity L&T cracking.

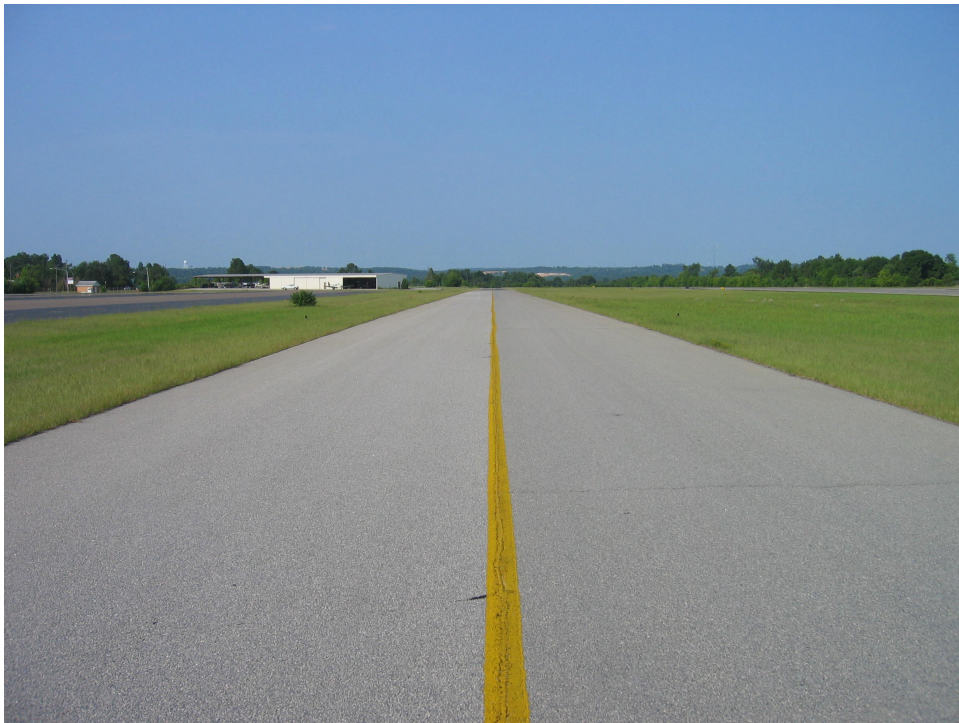
TDAG-10. Overview.

Taxiway D consists of a single section. Section TDAG-10 is in good condition with a PCI value of 86. A fair amount of low-severity L&T cracking, most of which was in a sealed condition, was observed in this section. A small amount of low-severity raveling and weathering was also noted.

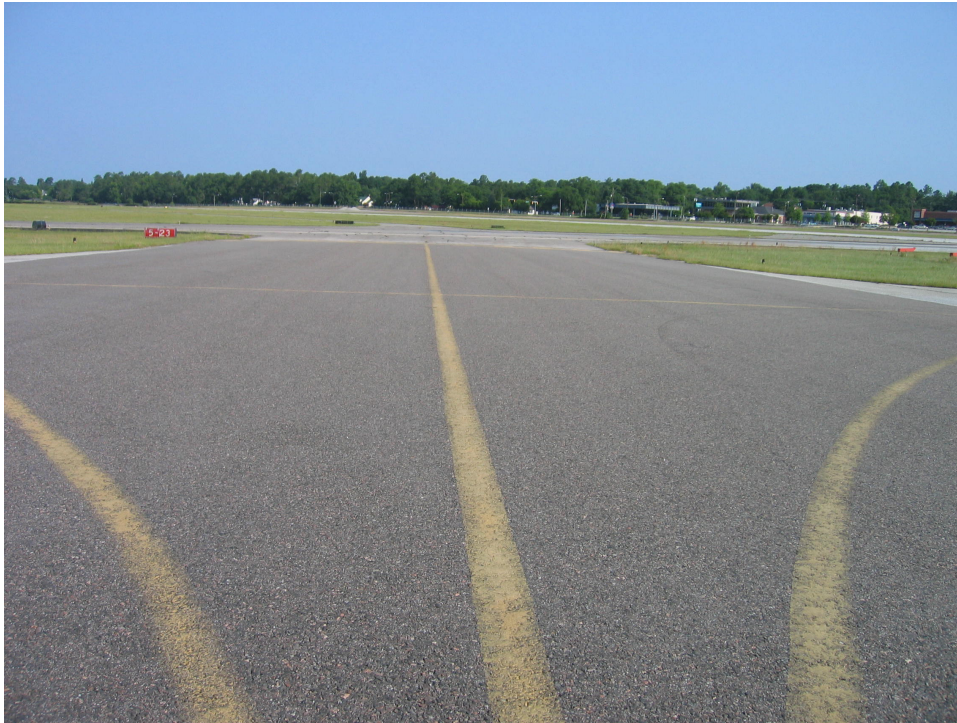
TEAG-10. Overview.

Taxiway E consists of a small connector taxiway providing access from Runway 5-23 to the apron area. Section TEAG-10 was recently rehabilitated and is in excellent condition with a PCI value of 100. No distresses were observed in this section.

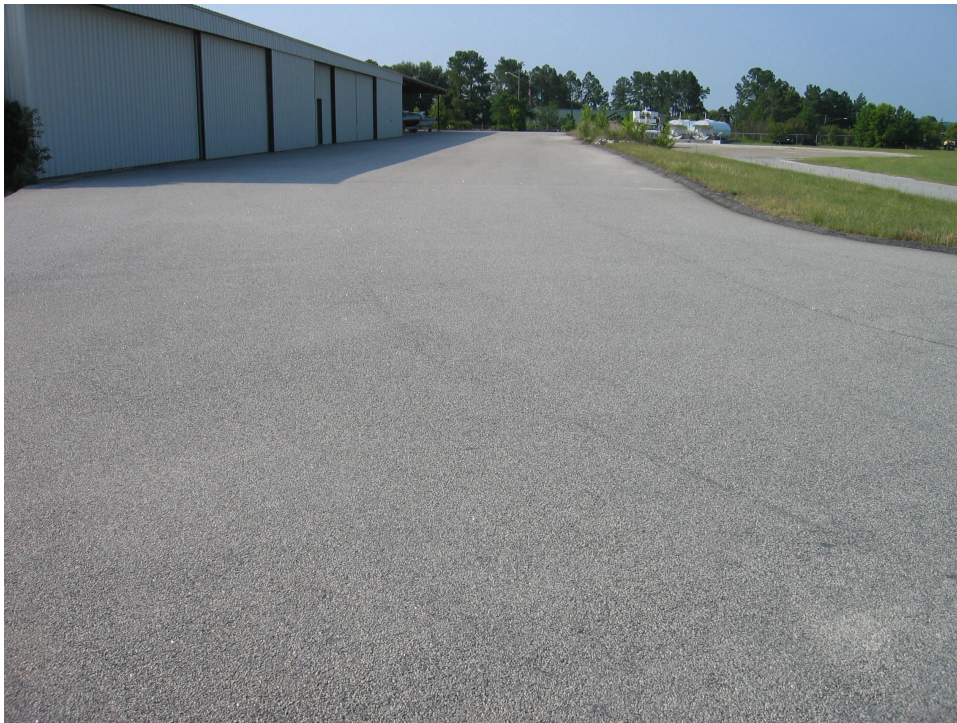
THANGAG-10. Overview.

The T-hangar area at Daniel field consists of a single section. Section THANGAG-10 was recently rehabilitated and is in excellent condition with a PCI value of 97. A small amount of unsealed, low-severity L&T cracking was the only distress observed in this section.
