**COOK COUNTY AIRPORT
PAVEMENT MANAGEMENT REPORT**

**2007 GEORGIA AIRPORT
PAVEMENT MANAGEMENT REPORT**

COOK COUNTY AIRPORT

PAVEMENT MANAGEMENT REPORT

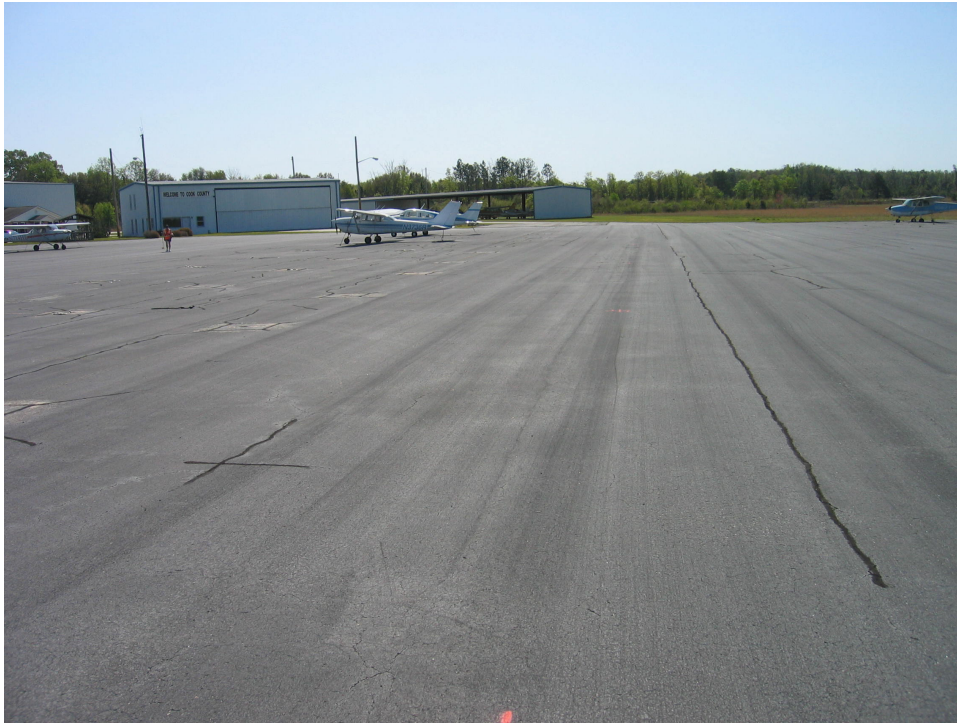
The apron area consists of one section and is in fair condition with a PCI value of 67. Significant amounts of low and medium-severity L&T cracking were observed. The majority of the low-severity cracking was not sealed at the time of inspection. The majority of the medium-severity cracking was due to failed crack sealant.

A01AD-10. Overview.

Branch	Section	Distress Type	Severity	Work Description	Work Quantity	Work Unit	Unit Cost	Work Cost
A01AD	10	Longitudinal and transverse cracking	Medium	Crack Sealing - AC	5,855	Ft	\$0.85	\$4,976
R523AD	10	Longitudinal and transverse cracking	Medium	Crack Sealing - AC	131	Ft	\$0.85	\$111

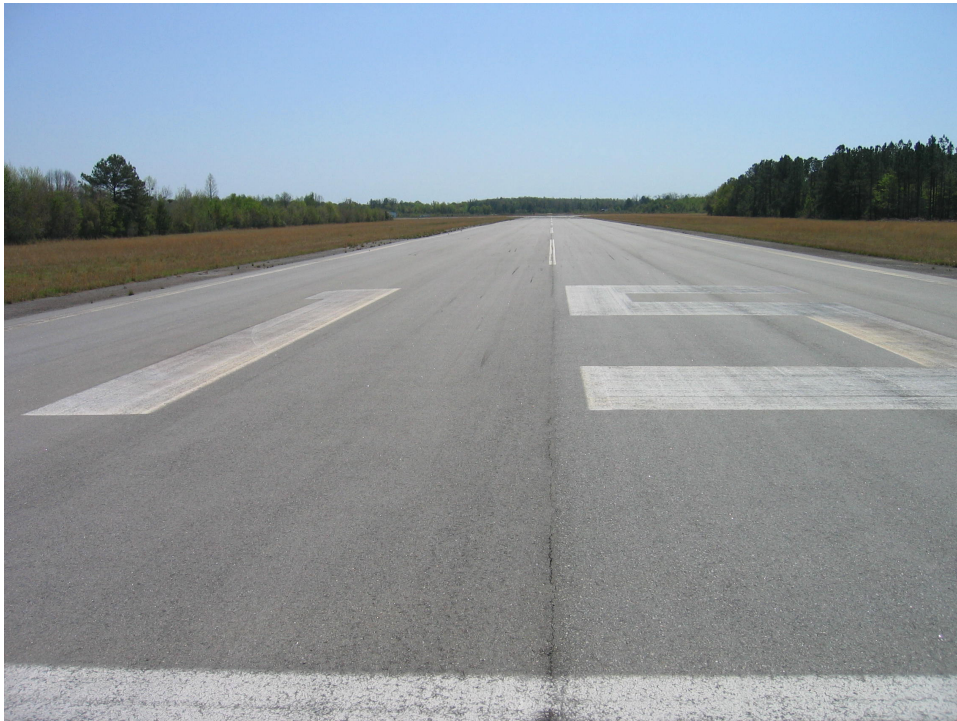
One section is defined in Runway 15-33. Section R1533AD-10 is in good condition with a PCI value of 95. Moderate amounts of low-severity longitudinal and transverse (L&T) cracking were observed with an isolated amount of low-severity swelling also recorded at the north end along the centerline.

R1533AD-10. Overview.

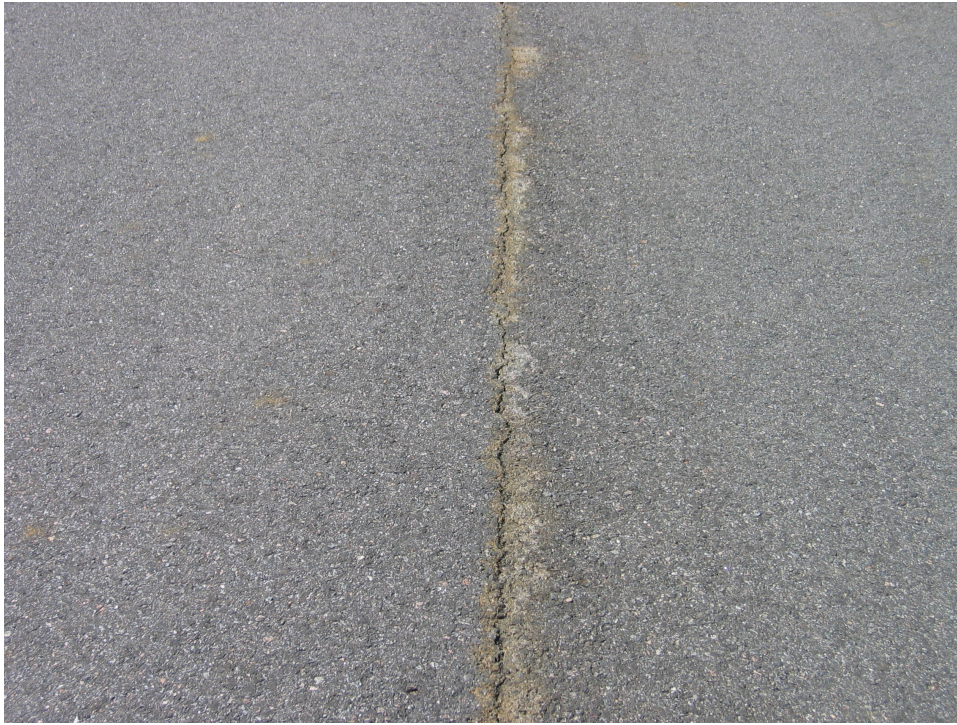
Two sections are defined in Runway 5-23. Section R523AD-10 is in good condition with a PCI value of 90. Significant amounts of low-severity L&T cracking were recorded along the paving lane joints along with small quantities of medium-severity L&T cracking. Section R523AD-20 is an extension to the approach end of Runway 5 that was constructed after the inspection in March of 2007. It is assumed that the pavement is in excellent condition with a PCI value of 100.

R523AD-10. L&T cracking.

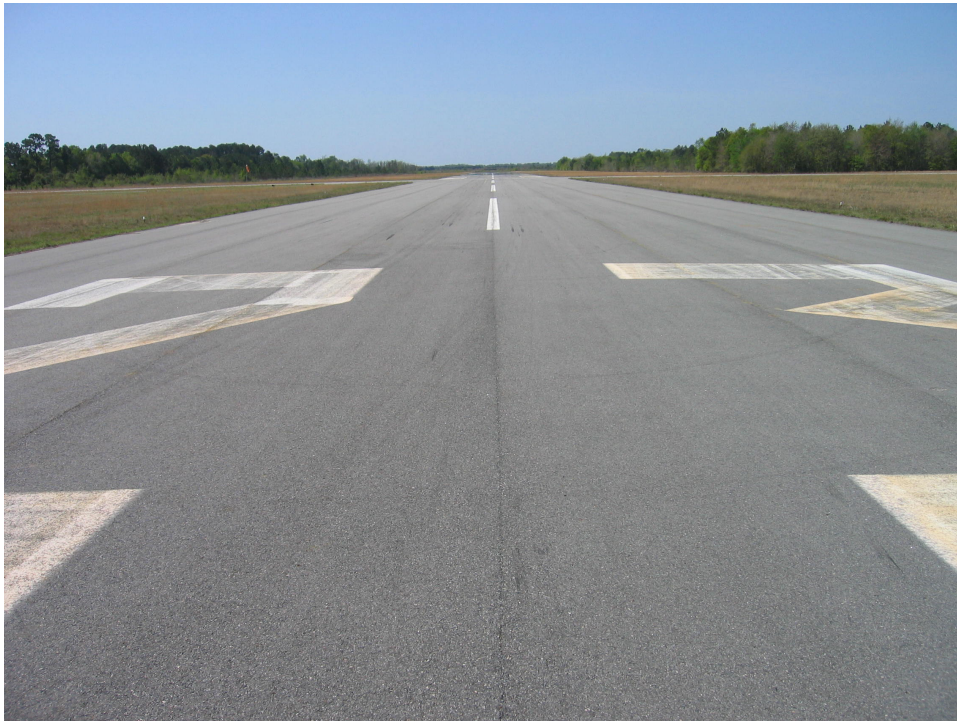
R523AD-10. Overview.

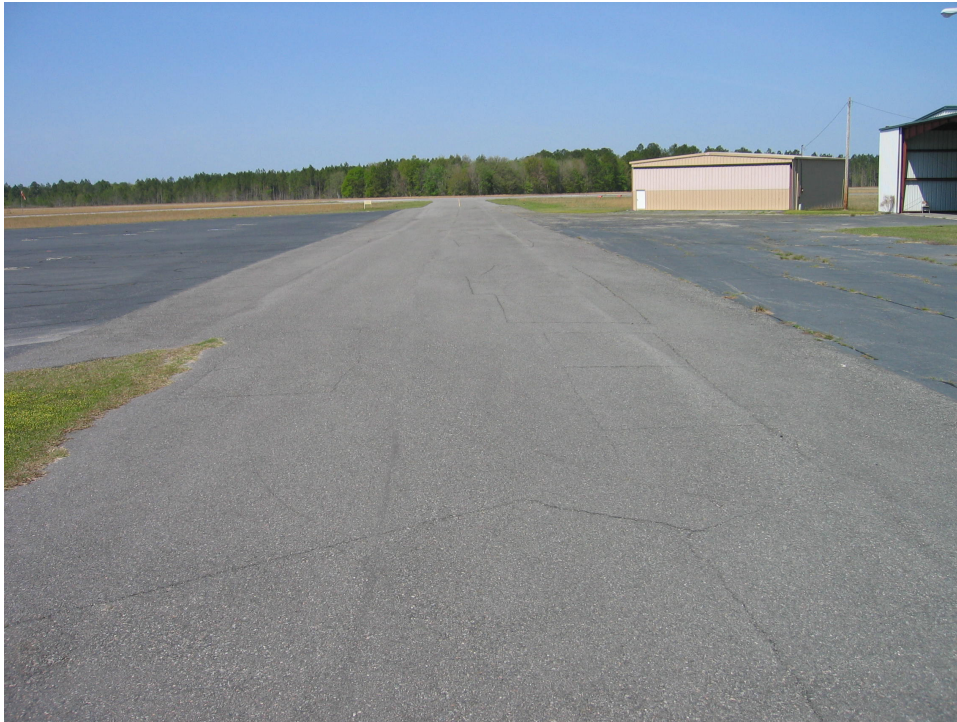
Taxiway A has one section defined and is in good condition with a PCI value of 90. Moderate amounts of low-severity L&T cracking and raveling and weathering were observed at the time of inspection.

TAAD-10. Overview.

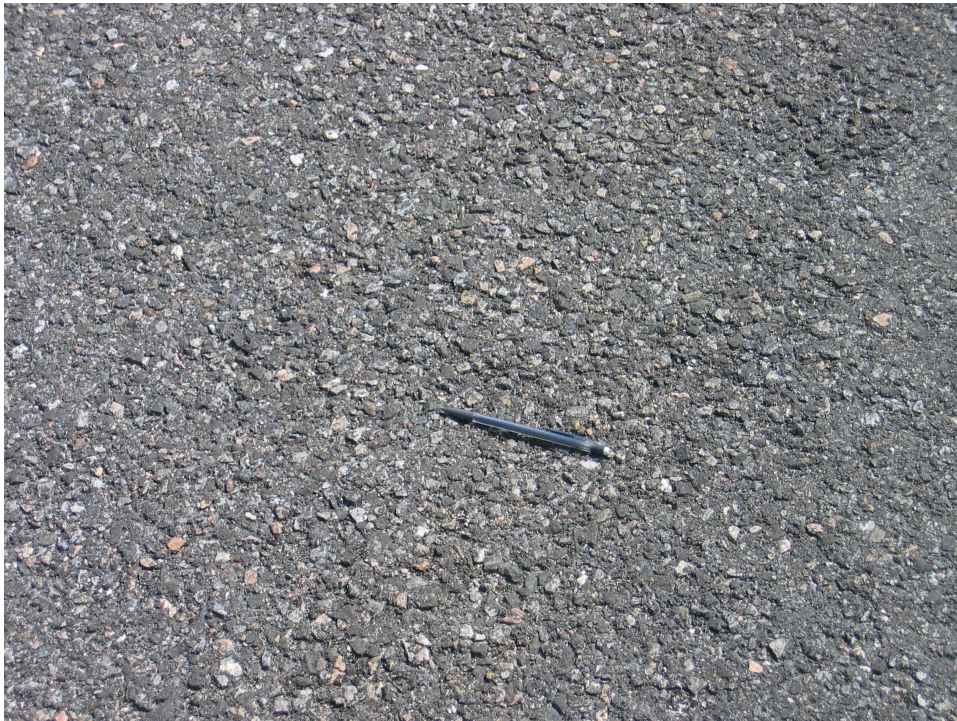
TAAD-10. Raveling and weathering.
