SOUTHWEST GEORGIA REGIONAL PAVEMENT EVALUATION REPORT

JULY 2002

SOUTHWEST GEORGIA REGIONAL AIRPORT

PAVEMENT EVALUATION REPORT

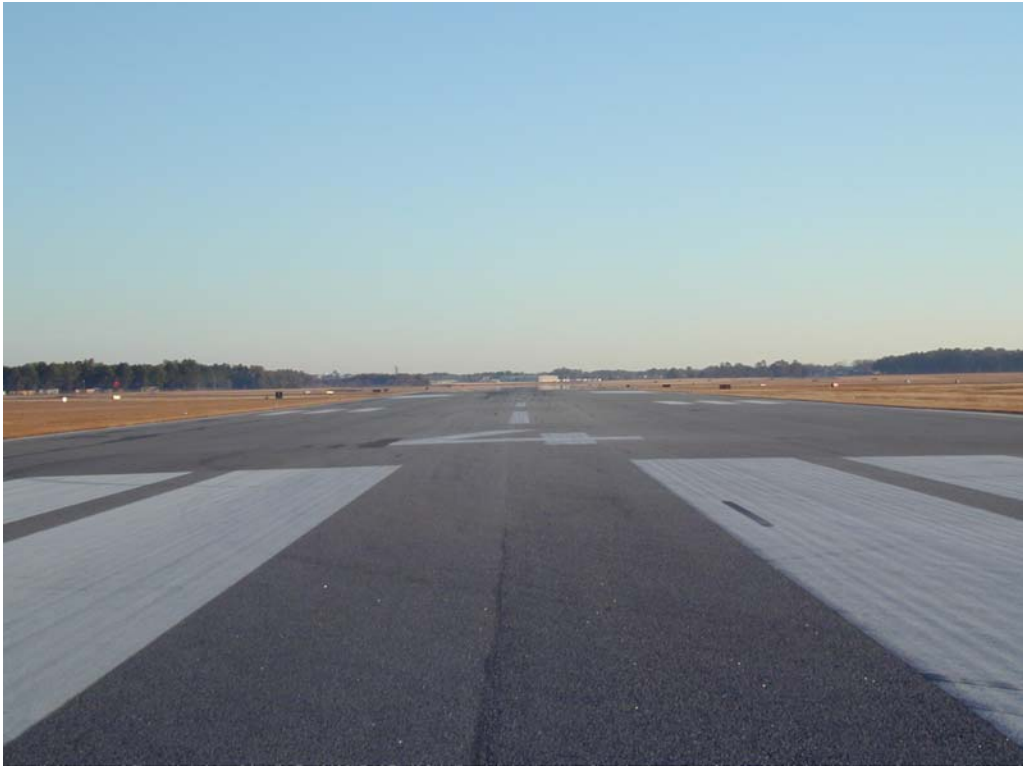
Runway 4-22, section R422AB-10, is in very good condition with unsealed, low-severity longitudinal and transverse (L&T) cracking as the predominant distress. Also observed in the section include low-severity weathering and raveling.

Overview of section R422AB-10.

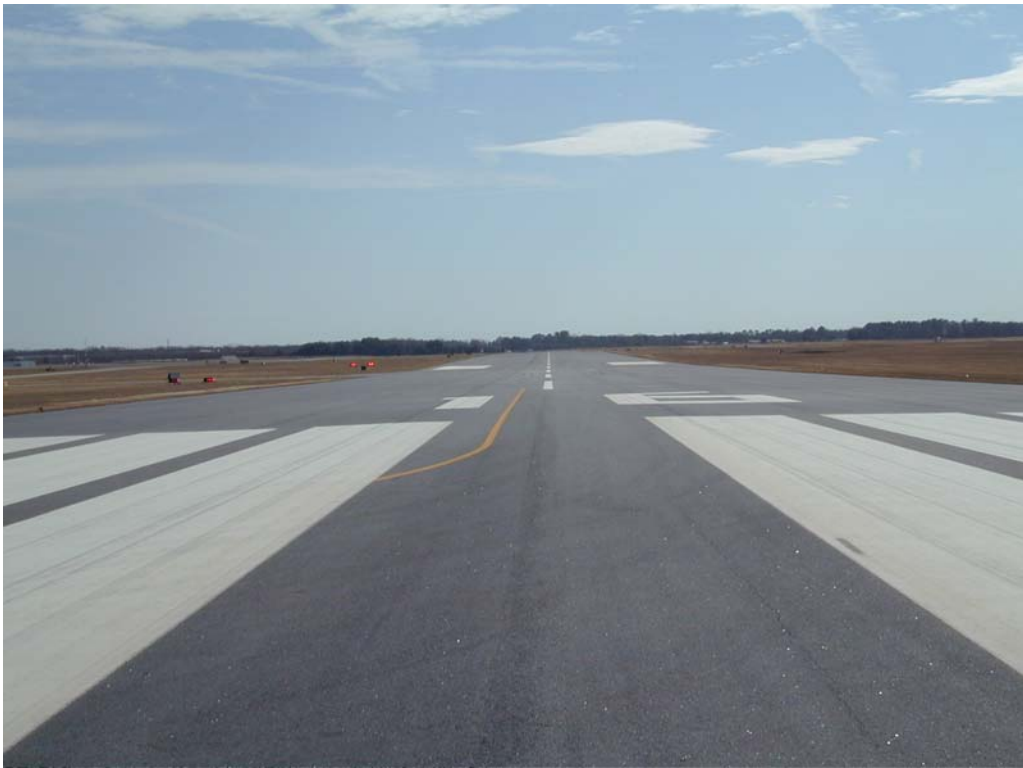
Runway 16-34, section R1634AB-10, is in good condition with the only observed distress being unsealed, low-severity L&T cracking.

Overview of section R1634AB-10.

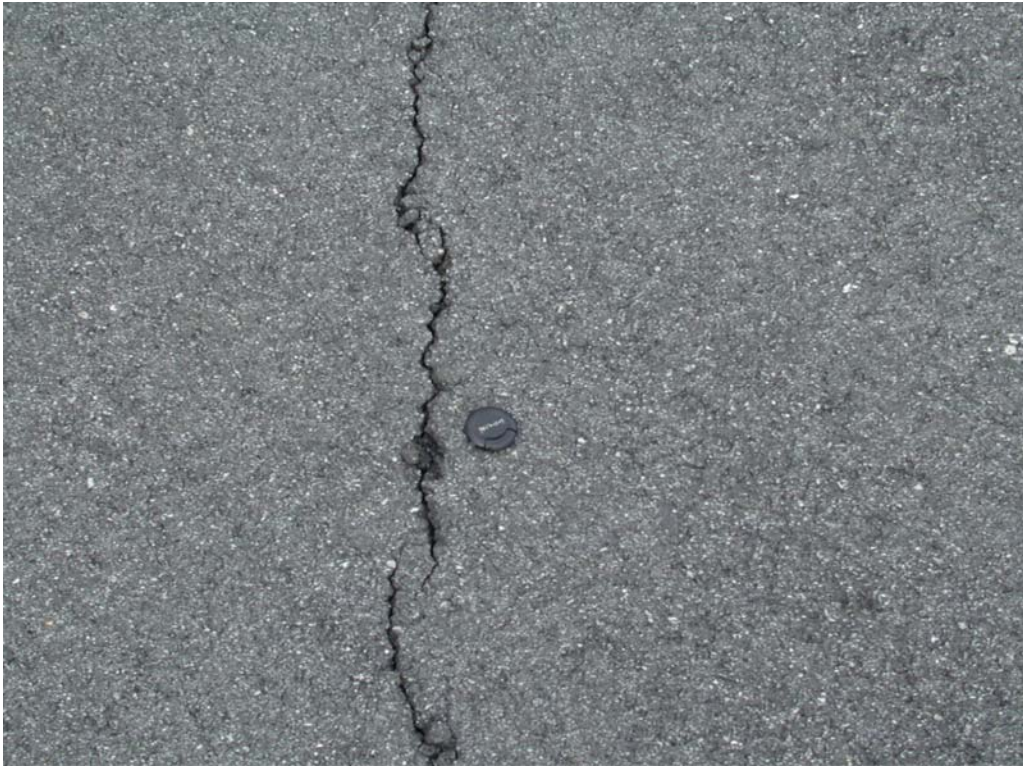
L&T cracking in section R1634AB-10.

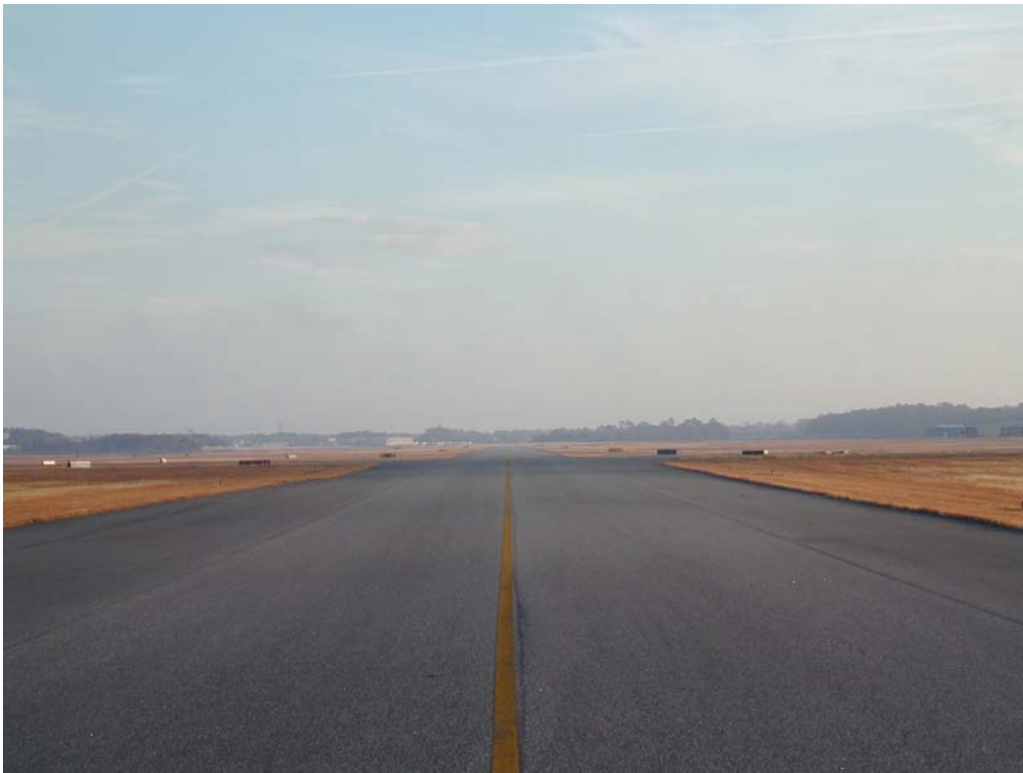
Taxiway A runs parallel to Runway 4-22 and is composed of one section, TAAB-10. This pavement is in good condition with the only noted distress being low to moderate amounts of unsealed, low-severity L&T cracking.

Overview of section TAAB-10.

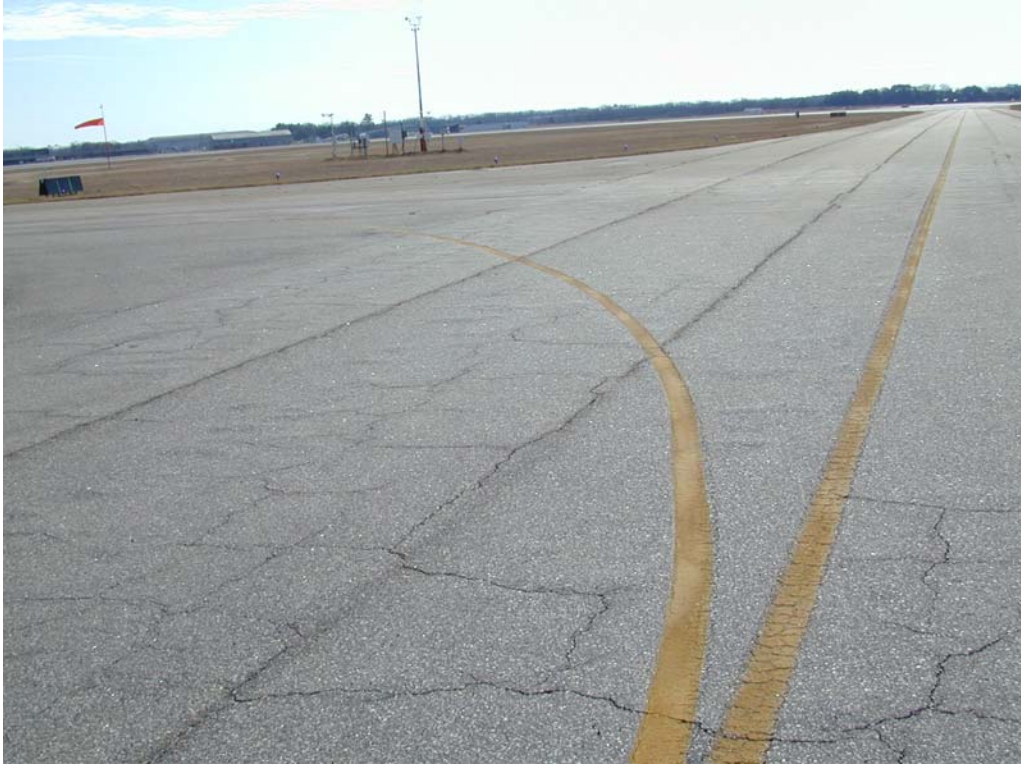
Taxiway B is composed of two sections, TBAB-10 and TBAB-20, and it runs parallel to Runway 16-34. The pavement in section TBAB-10 is in fair condition with moderate amounts of unsealed, low and medium-severity L&T cracking. The pavement in TBAB-20 also has moderate amounts of low- and medium-severity L&T cracking, and it also contains significant areas of unsealed, low-severity block cracking. An area of low-severity swelling was also noted within section TBAB-20.

Block cracking in section TBAB-10.

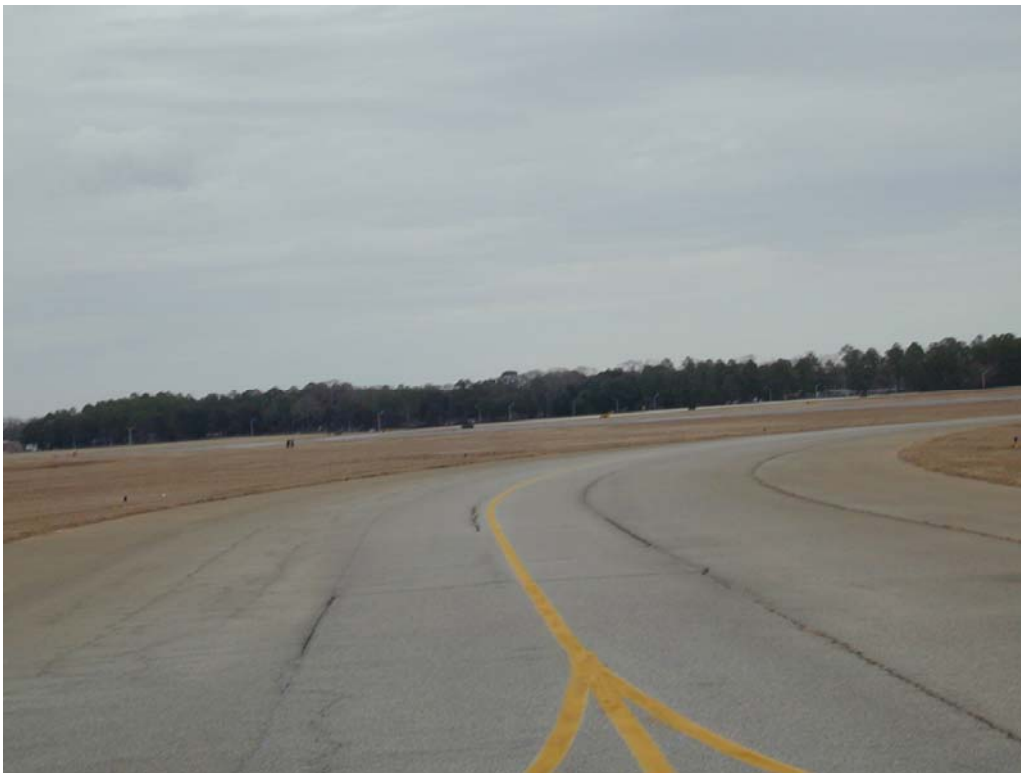
Taxiway C connects the terminal apron with the midpoint of Runway 16-34 and is composed of three sections: TCAB-10, TCAB-20, and TCAB-30. Section TCAB-10 is in fair condition and contains moderate amounts of unsealed, low-severity block cracking, low and medium-severity L&T cracking, and limited areas of low-severity swelling. Sections TCAB-20 and TCAB-30 are both in very good condition with relatively small quantities of unsealed, low-severity L&T cracking.

Overview of section TCAB-10.

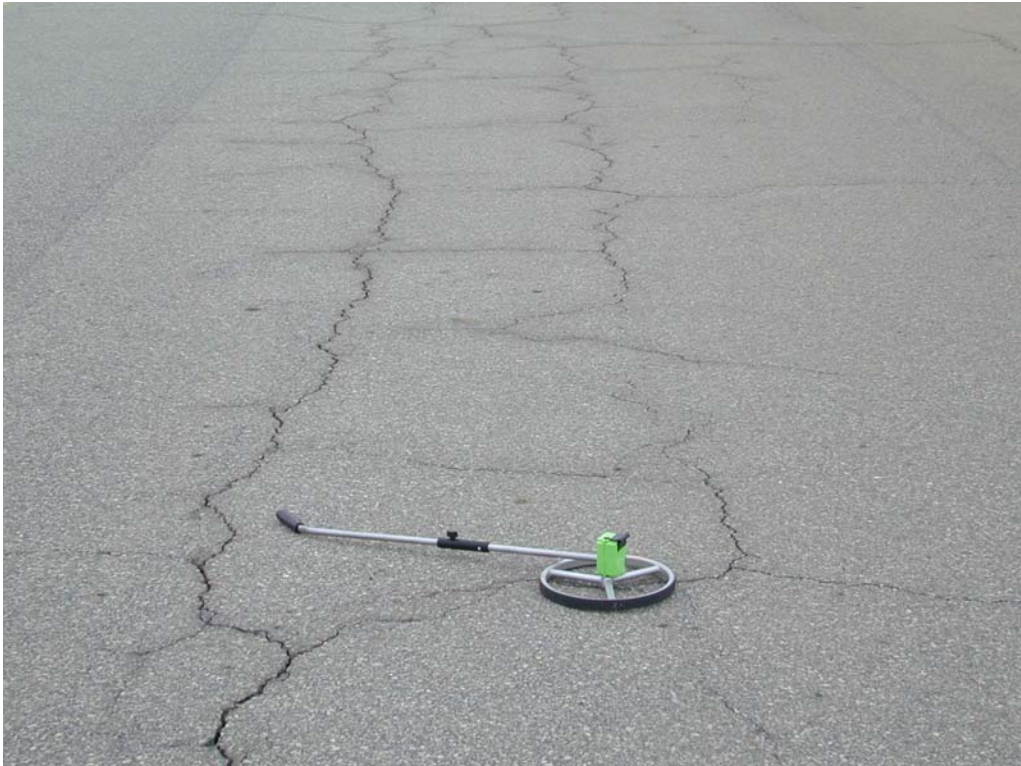
Block cracking in section TCAB-10.

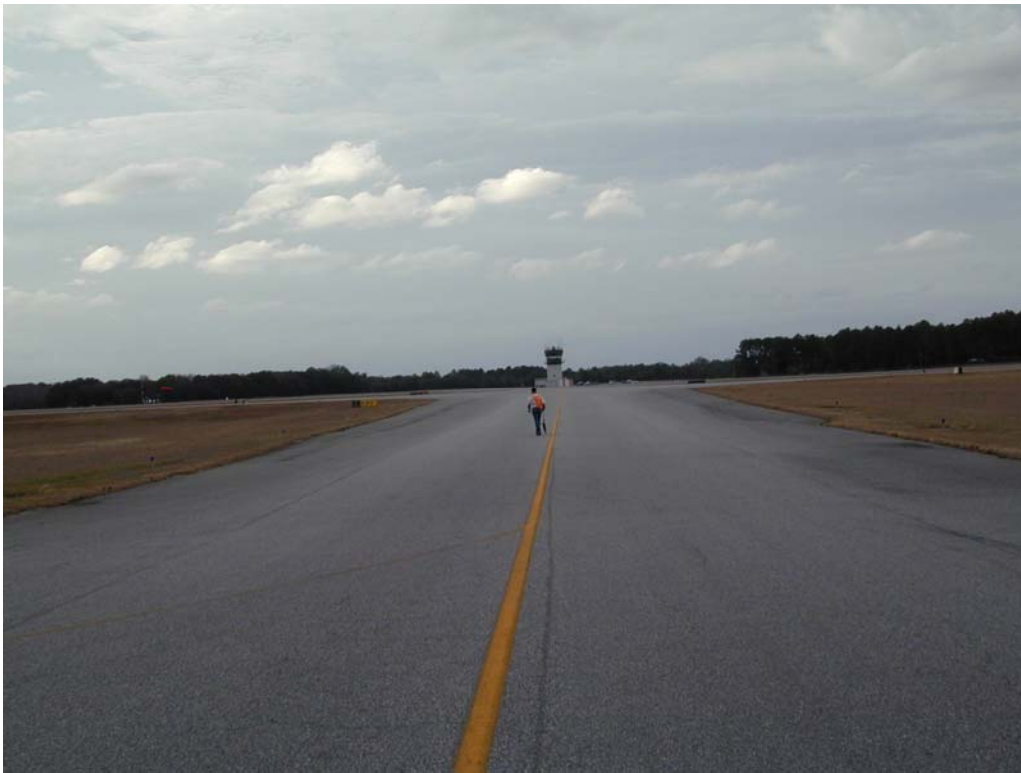
Overview of section TCAB-20.

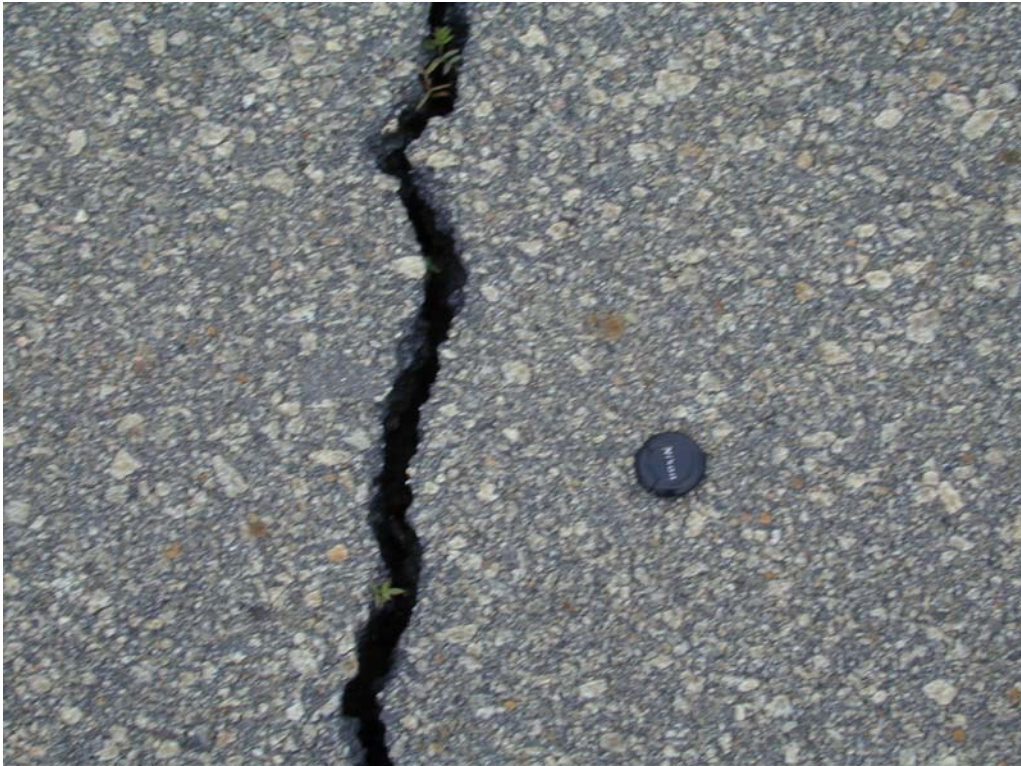
L&T cracking in section TCAB-20.

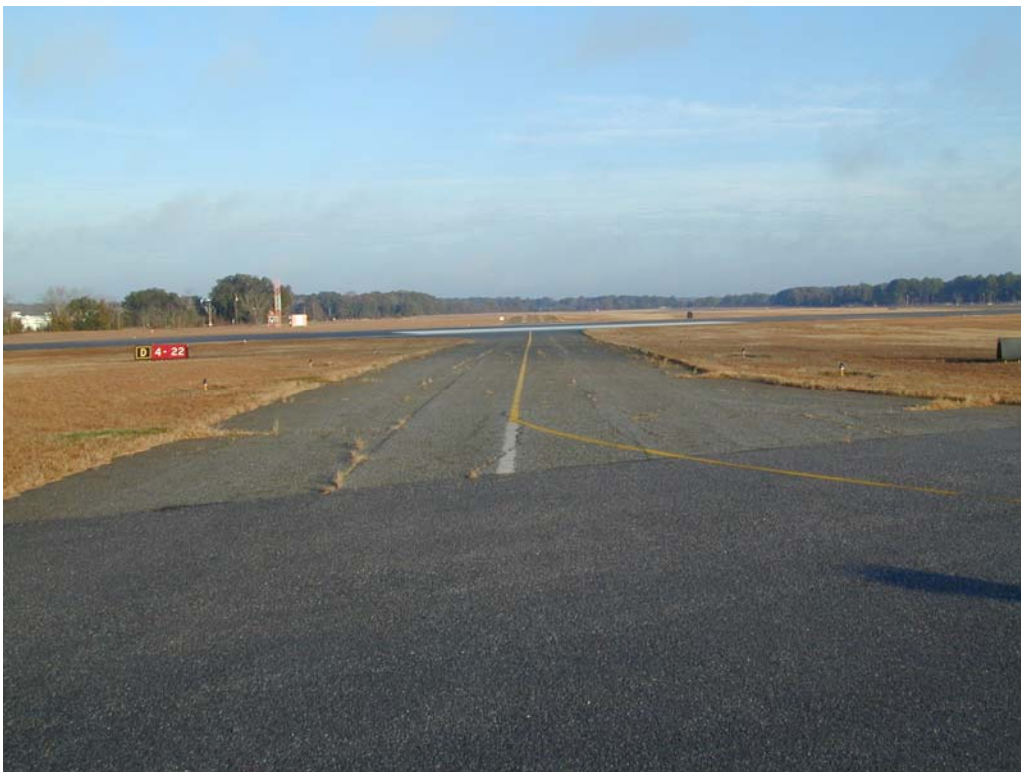
Taxiway D has been inspected as one section, TDAB-10, and it is in poor condition. The entire section is experiencing unsealed, low and medium-severity block cracking. Limited areas of low-severity weathering are also noted on this section.

Overview of section TDAB-10.

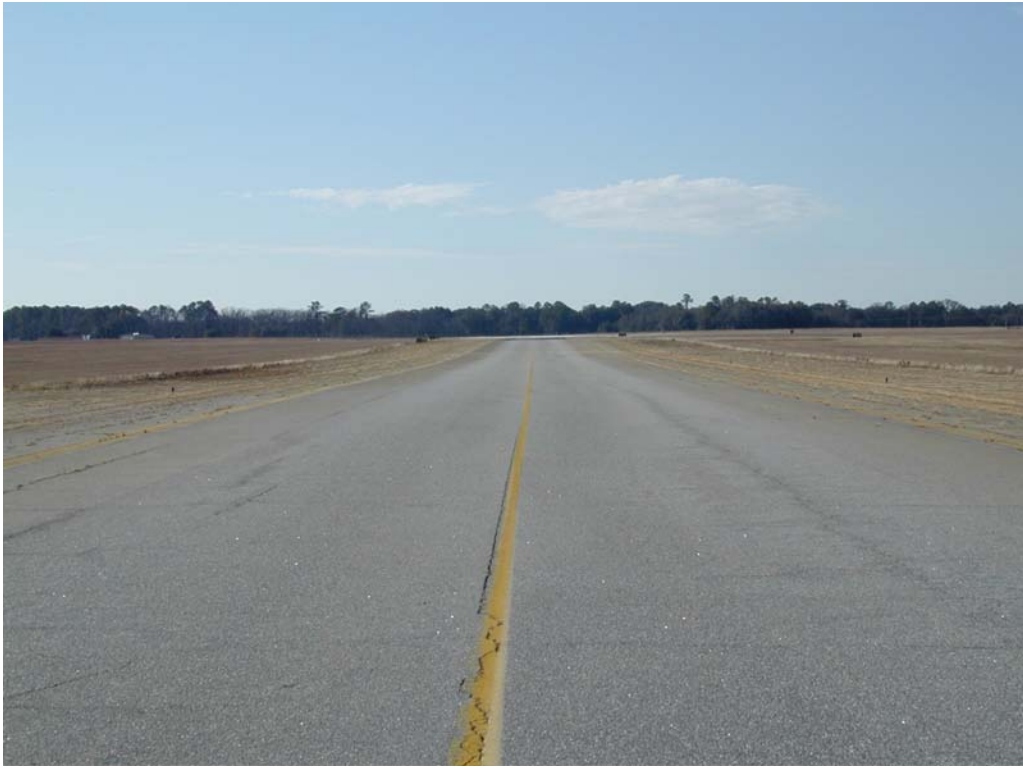
Taxiway E is comprised of sections TEAB-10 and -20, and it connects Runway 34 with the terminal apron. The condition of TEAB-10 is fair with moderate amounts of unsealed, low and medium-severity L&T cracking and small quantities of low and medium-severity swelling. Section TEAB-20 is in fair condition with nearly total coverage of medium-severity block cracking. The areas not exhibiting medium-severity block cracking contained unsealed, low-severity block cracking and medium-severity patching.

Overview of section TEAB-10.

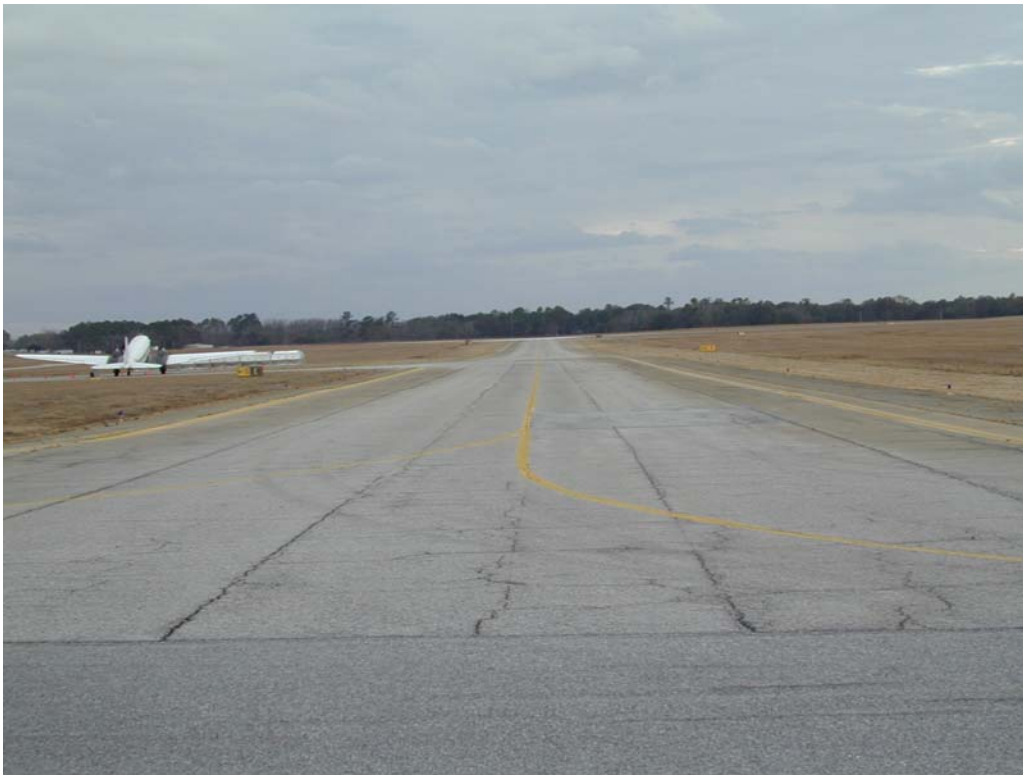
Overview of section TEAB-20.

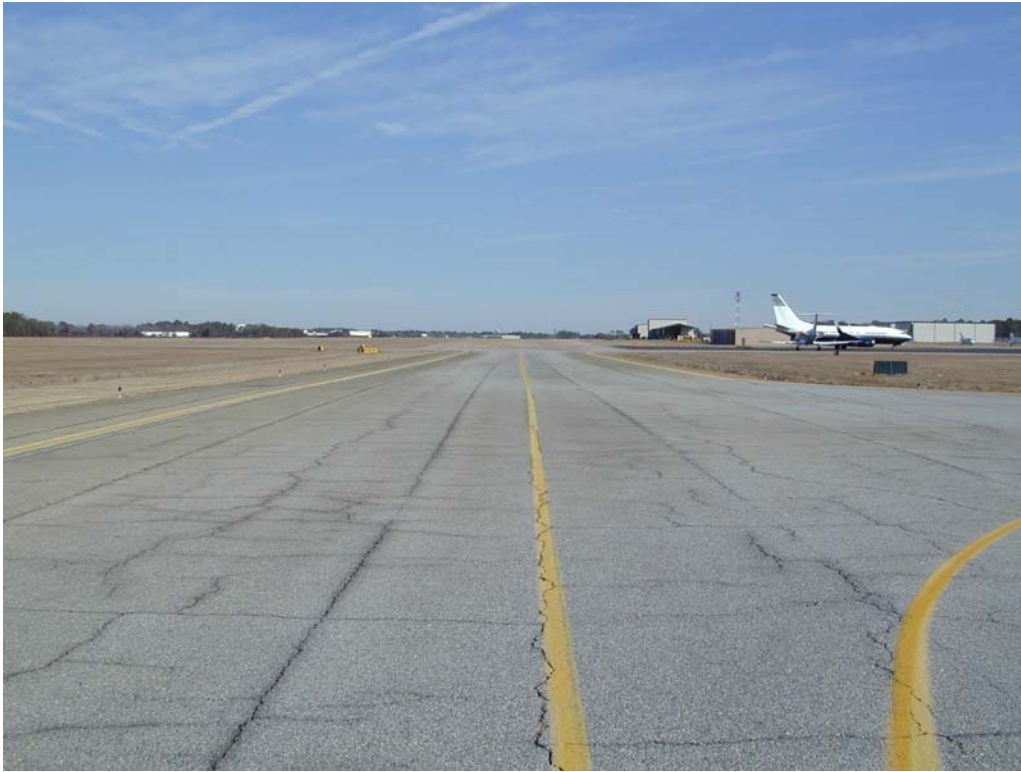
Block cracking in section TEAB-20.

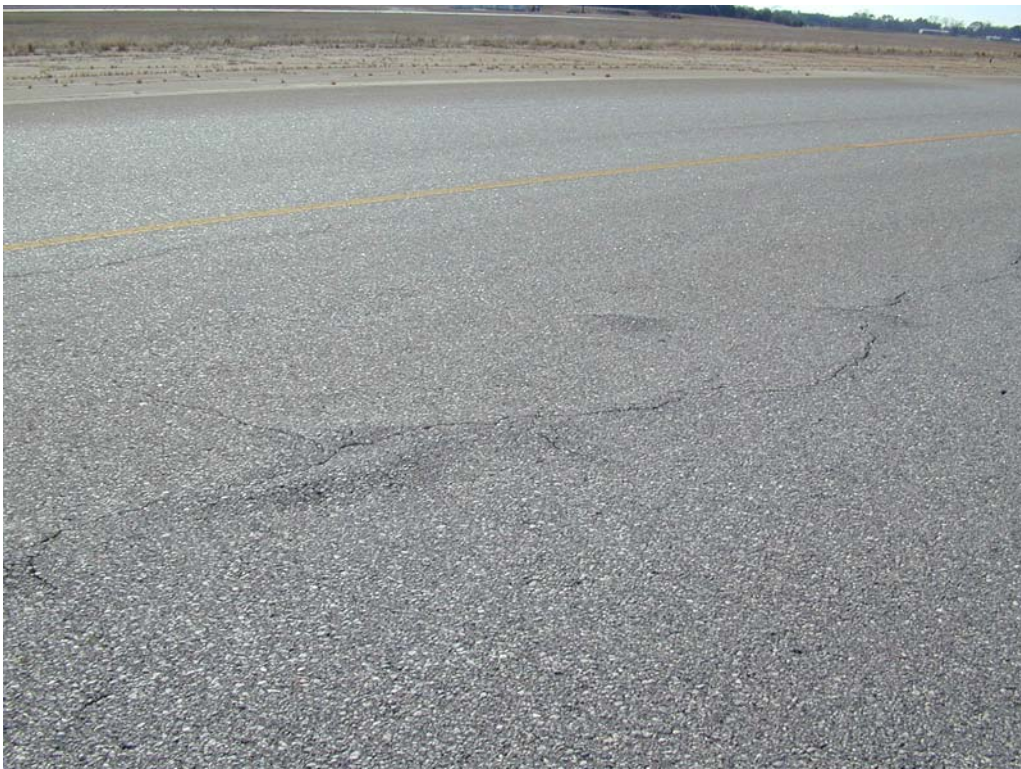
L&T cracking with swelling in section TEAB-20.

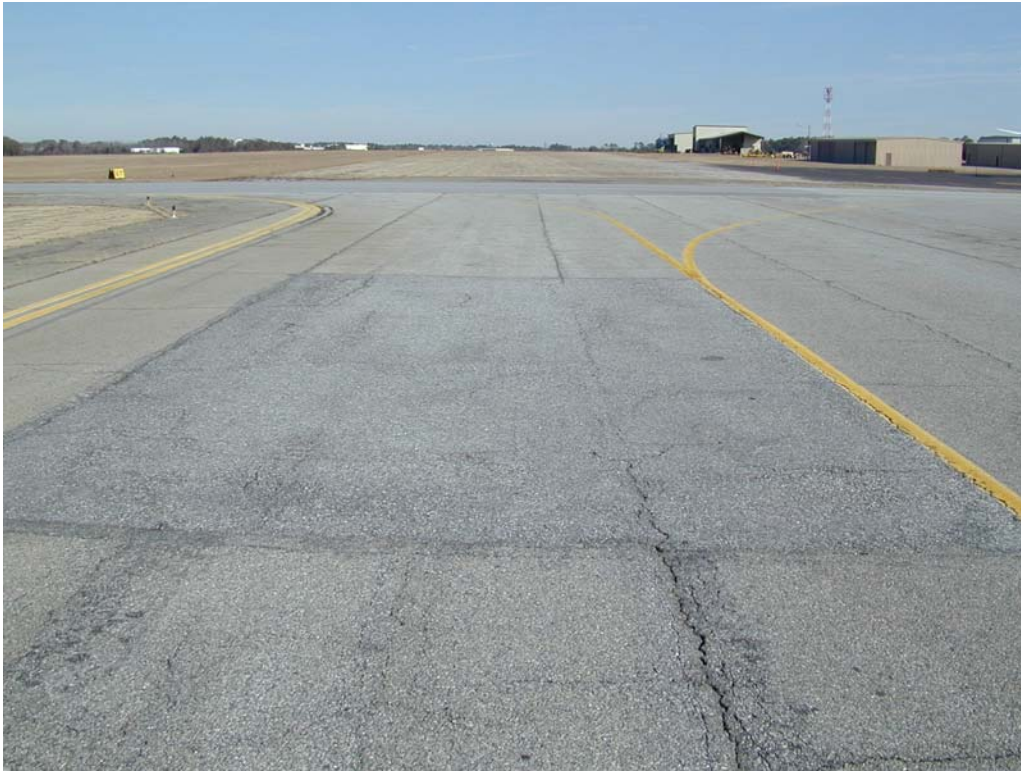
Patch in an additional sample unit in section TEAB-20.

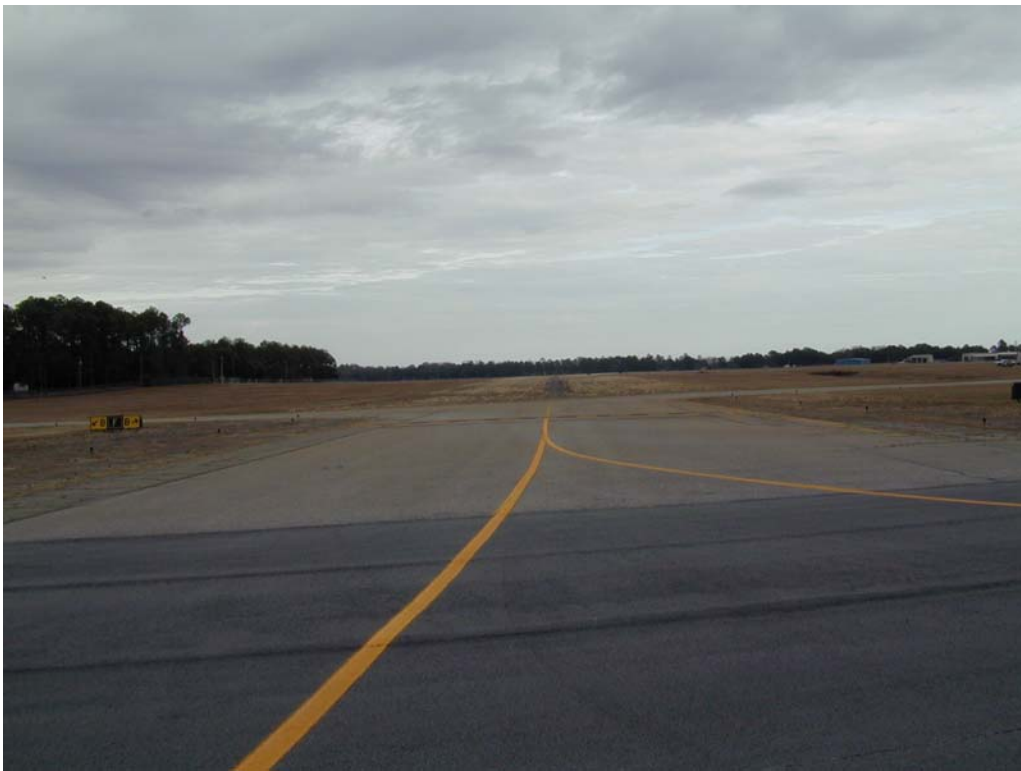
Taxiway F connects Runway 16 with Taxiway B and is composed of one section, TFAB-10. The pavement is in good condition with relatively small quantities of unsealed, low and medium-severity L&T cracking. Limited areas of medium-severity block cracking were also noted along the edges of the section.

Overview of section TFAB-10.

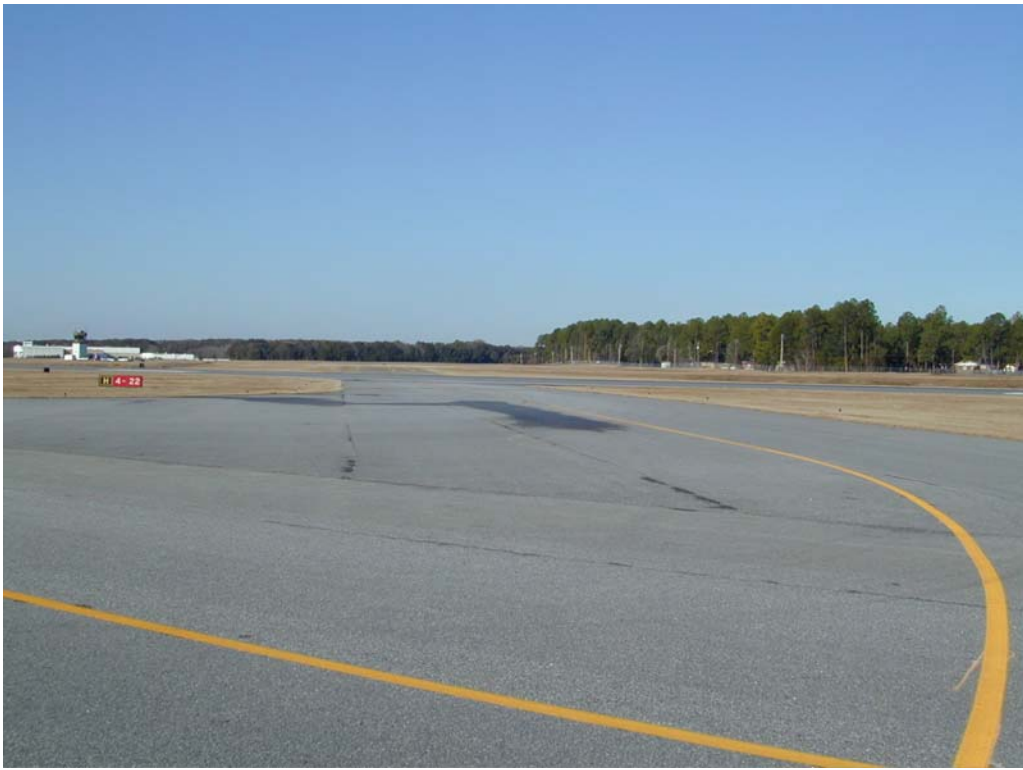
Taxiway H is composed of one section, THAB-10, and is good condition. The only noted distress on the section is relatively small quantities of unsealed, low-severity L&T cracking.

Overview of section THAB-10.

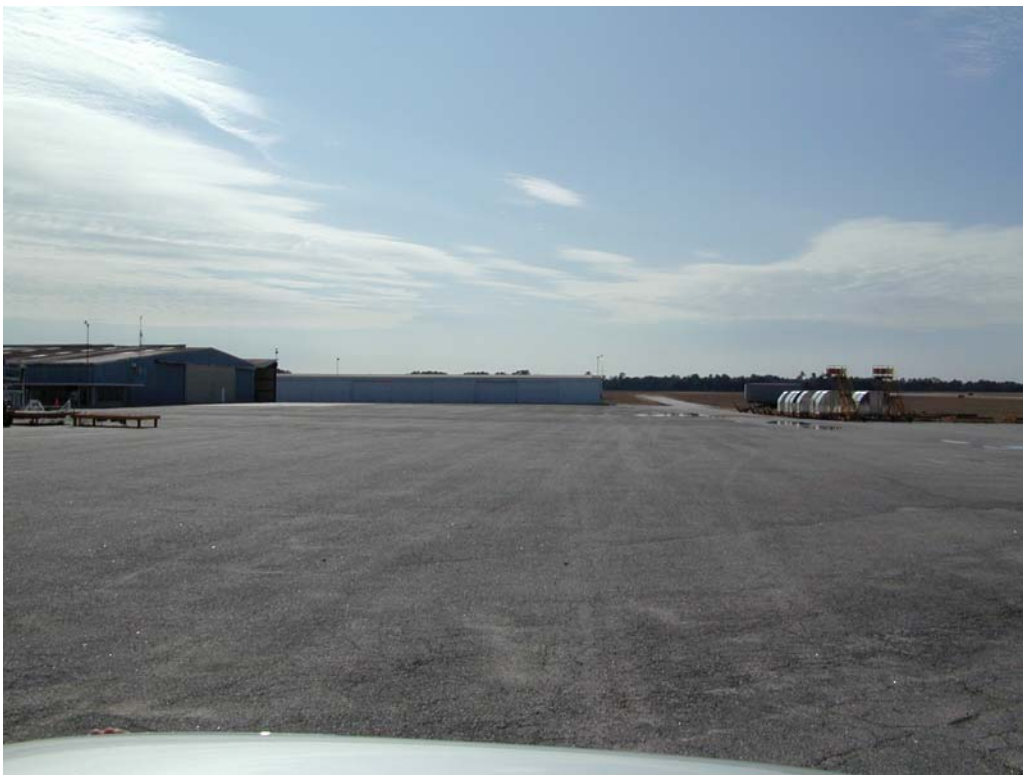
Section A01AB-10 is poor condition with the entire section experiencing medium-severity block cracking and weathering and raveling. One area also contained a medium-severity depression and a large low-severity patch. The depression contained standing watering and was exhibiting areas of high-severity weathering.

Overview of section A01AB-10.

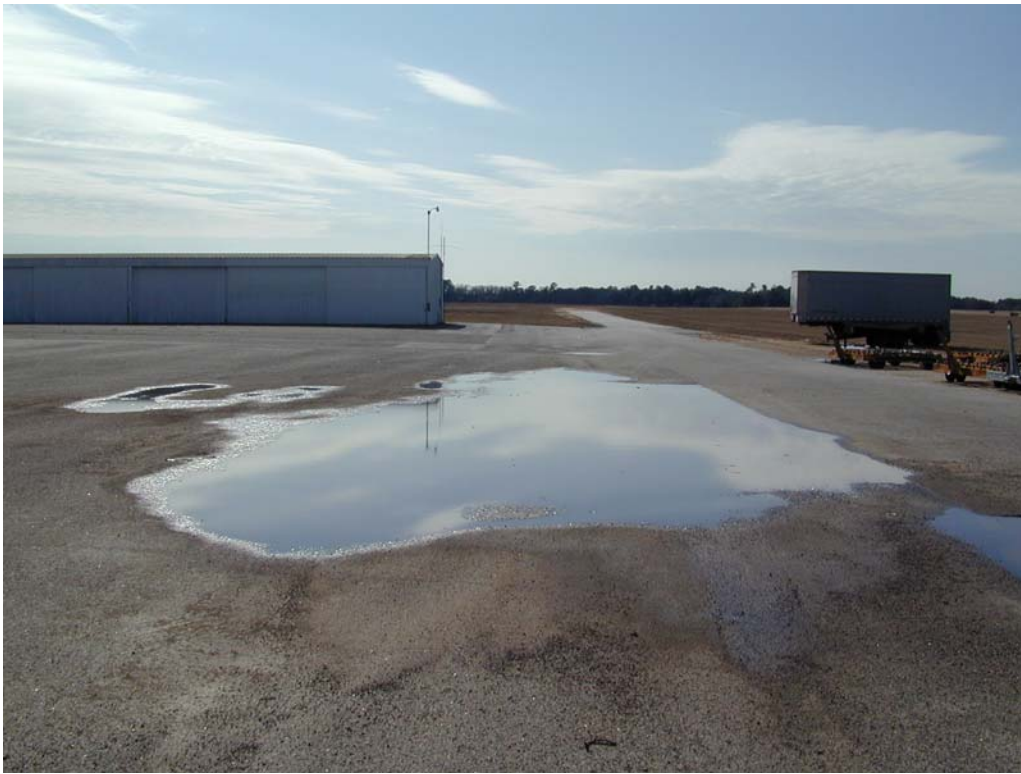
Depression in an additional sample unit in section A01AB-10.

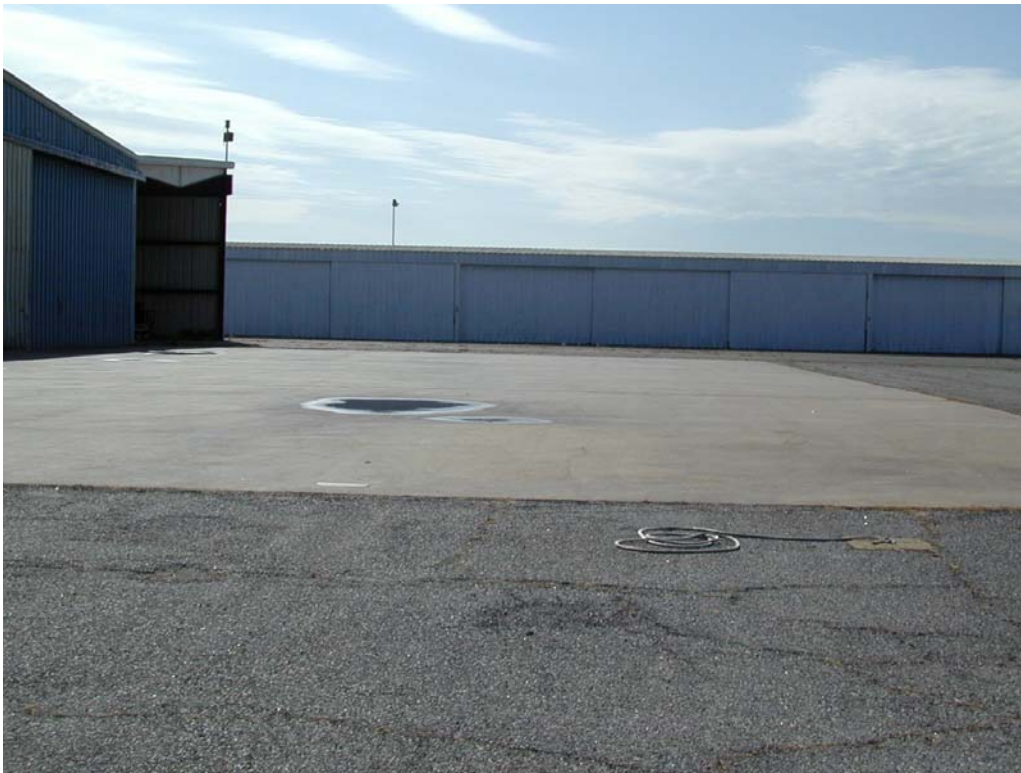
Section A01AB-20 is a PCC pad located near the entrance to a hangar, and the pavement is in good condition. The PCC was experiencing moderate quantities of low-severity linear cracking and medium-severity joint seal damage.

Overview of section A01AB-20.

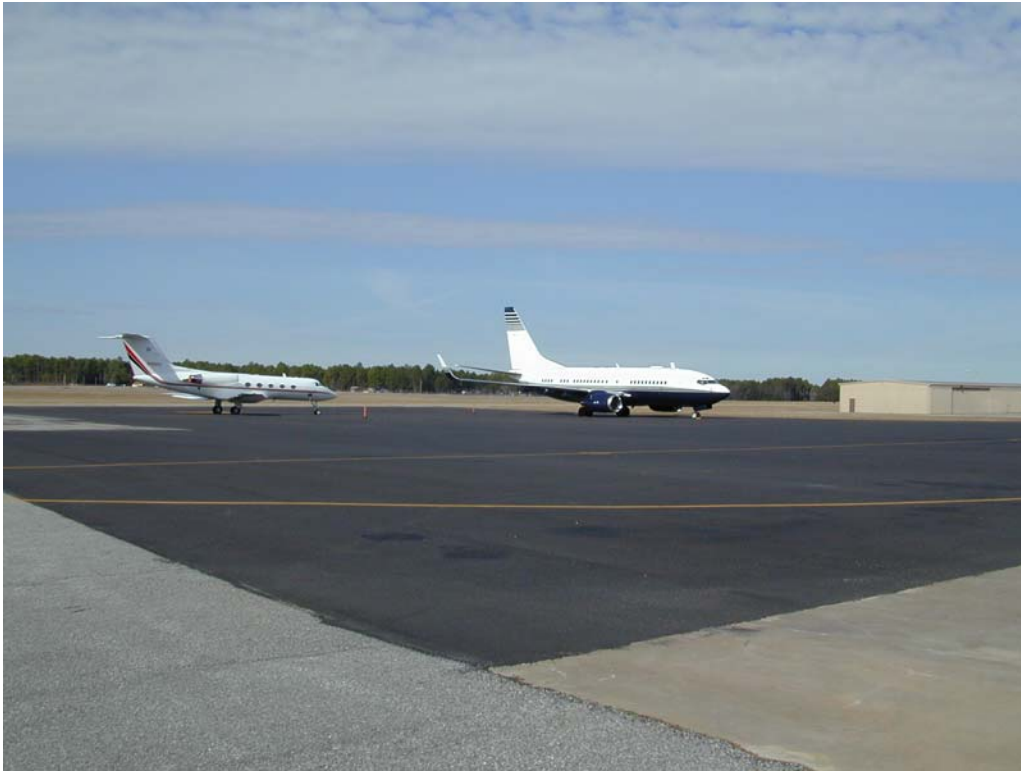
Overview of section A02AB-10.

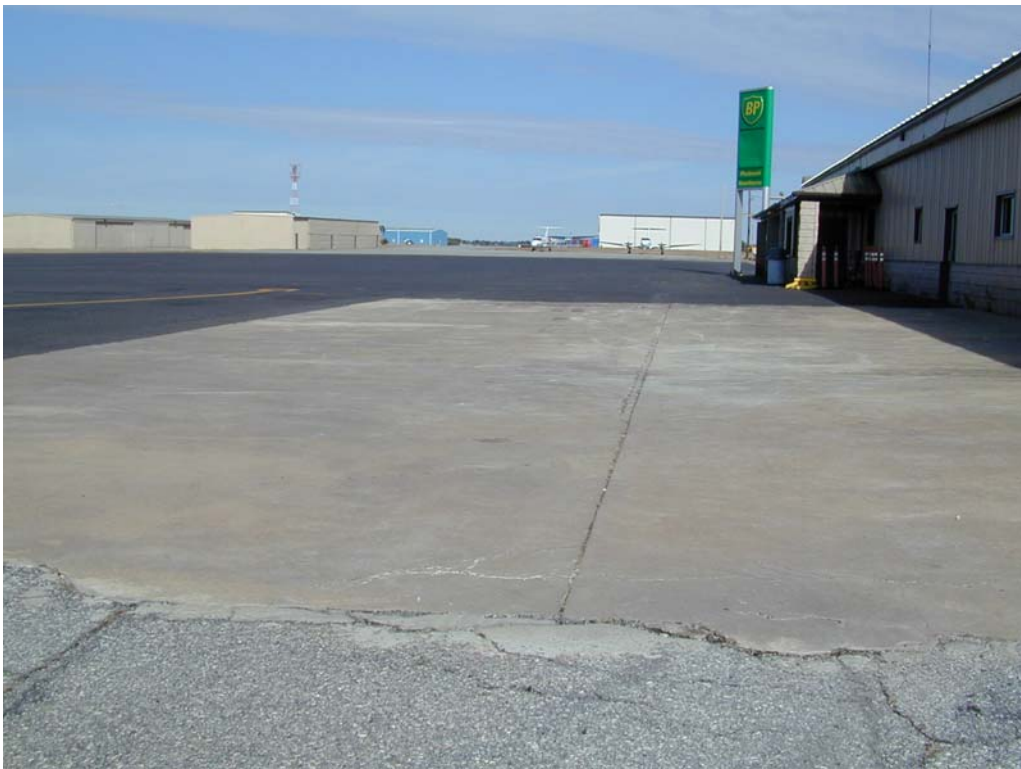
Section A02AB-10 is an asphalt-surfaced section and is in excellent condition with no noted distresses. Section A02AB-20 is a PCC section in poor condition. This small section is experiencing medium-severity joint seal damage, low and medium-severity corner breaking, low-severity linear cracking, and all severity levels of corner spalling.

Overview of section A02AB-20.

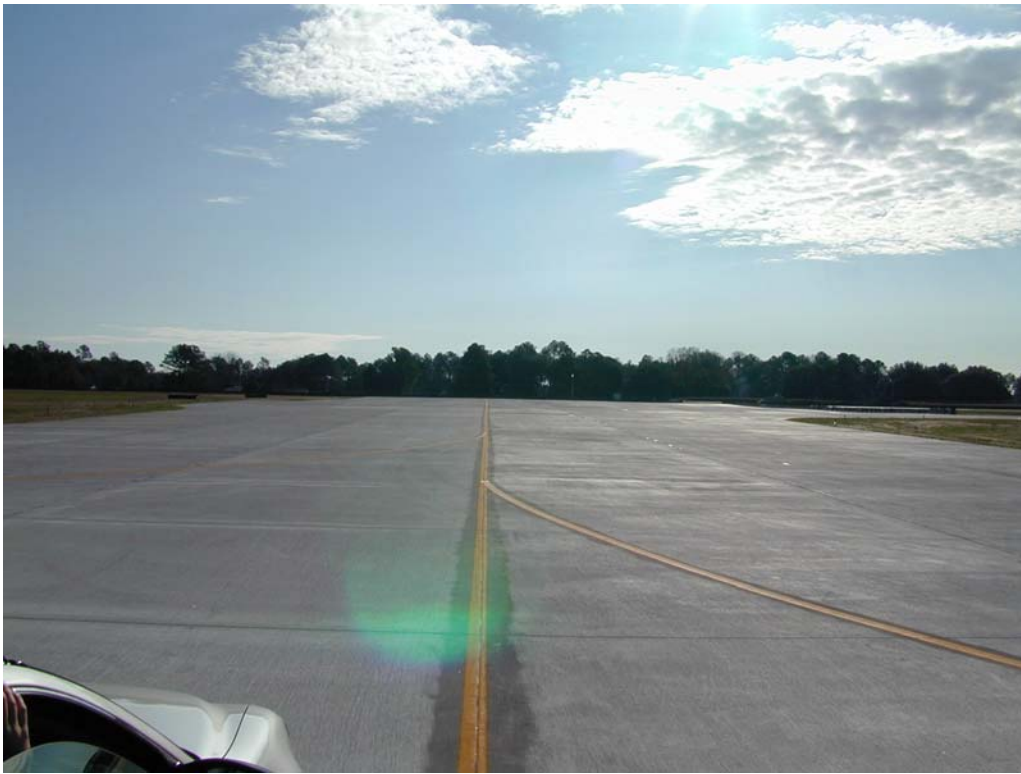
A new cargo apron has been recently constructed along Taxiway A and it is composed of two PCC sections and one asphalt surfaced section. ACARGOAB-10 and ACARGOAB-20 are the PCC sections and ACARGOAB-30 is the asphalt section. All three sections were in excellent condition with no noted distresses.

Overview of section ACARGOAB-10.

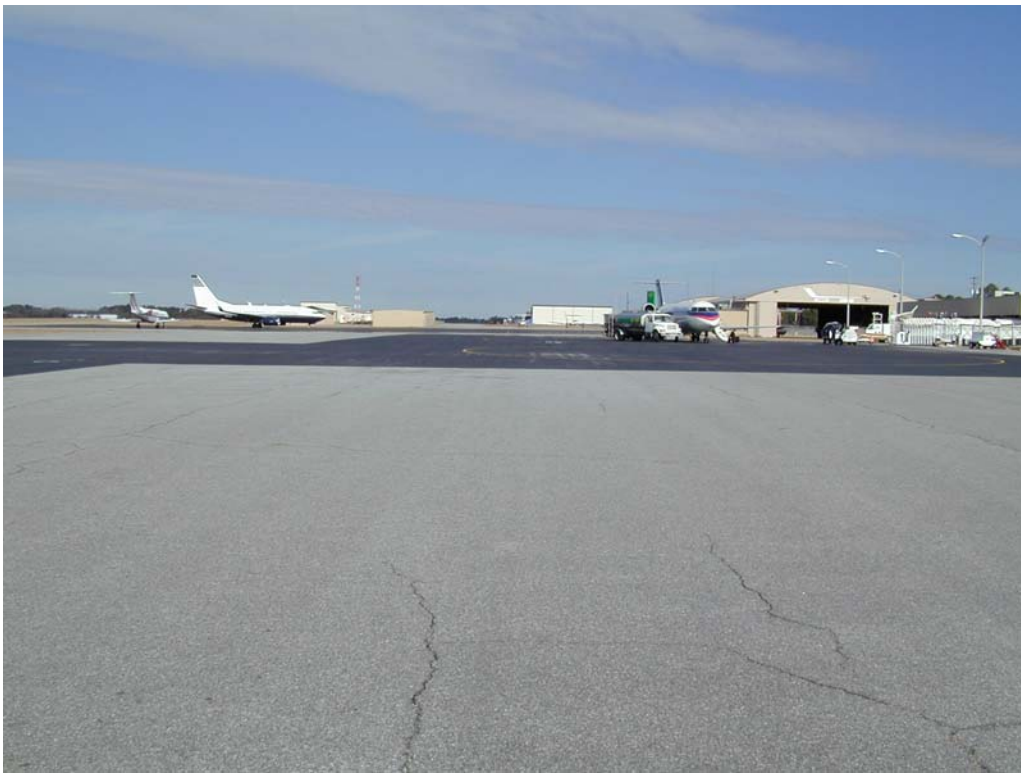
The terminal apron is composed of one section, ATERMAB-10, and it is in fair condition with. There are moderate quantities of unsealed, low and medium-severity block and L&T cracking. Also noted was an isolated low-severity depression.

Overview of section ATERMAB-10.

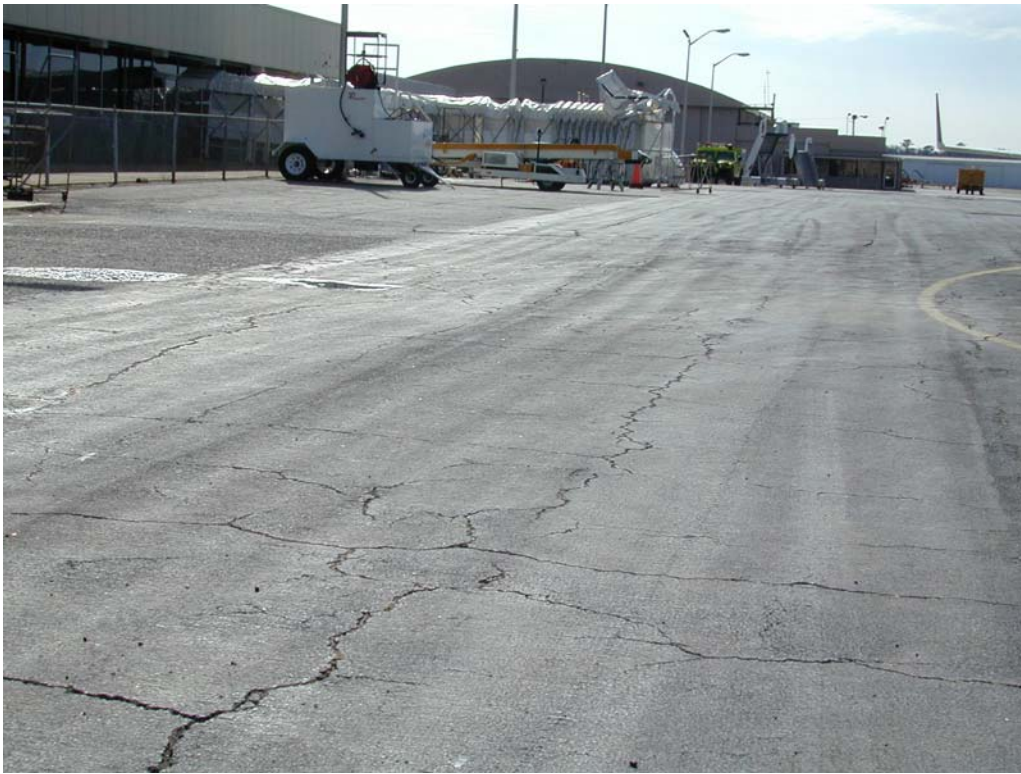
Block cracking in section ATERMAB-10.
