AUGUSTA REGIONAL AIRPORT AT BUSH FIELD

PAVEMENT EVALUATION REPORT

JULY 2002

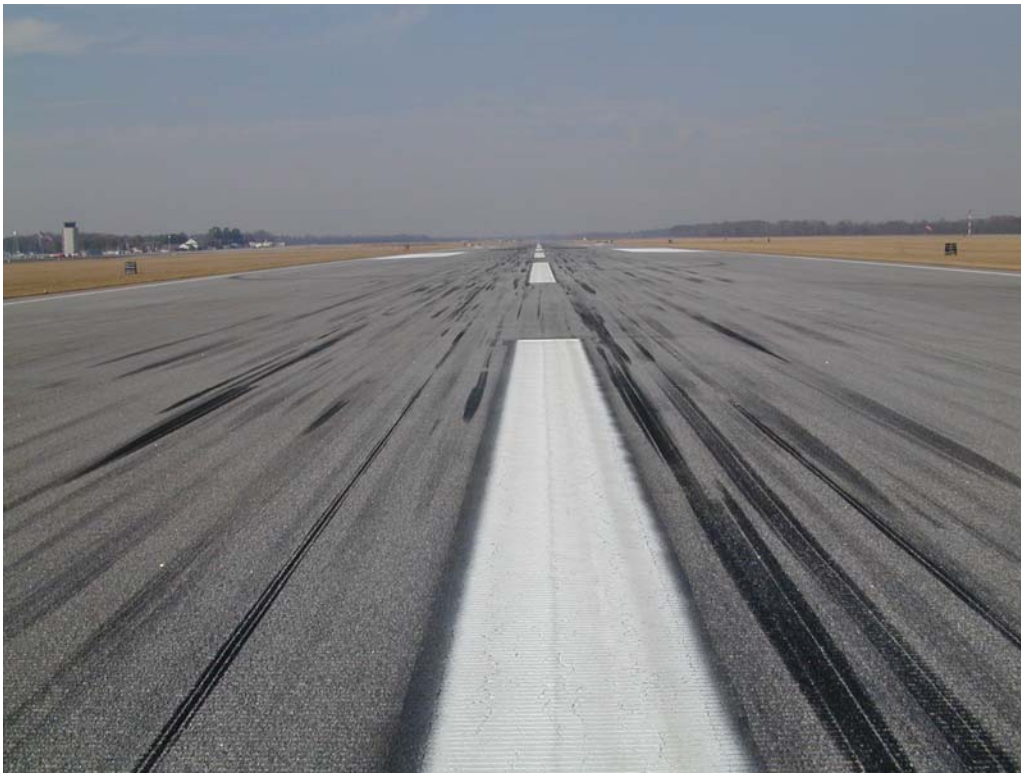
Sections R1735AGR-10W, R1735AGR-10C, and R1735AGR-10E are all in good condition. Moderate amounts of low-severity longitudinal and transverse (L&T) cracking were found throughout the sections primarily at paving lane joints. Smaller quantities of L&T cracking were observed at medium-severity due to the existence of secondary cracking associated with the primary L&T cracks. Swelling was found throughout the sections associated with L&T cracking. In many areas early stages of raveling and weathering were observed that did not yet meet the ASTM criteria for recording the distress.

Overview of section R1735AGR-10C.

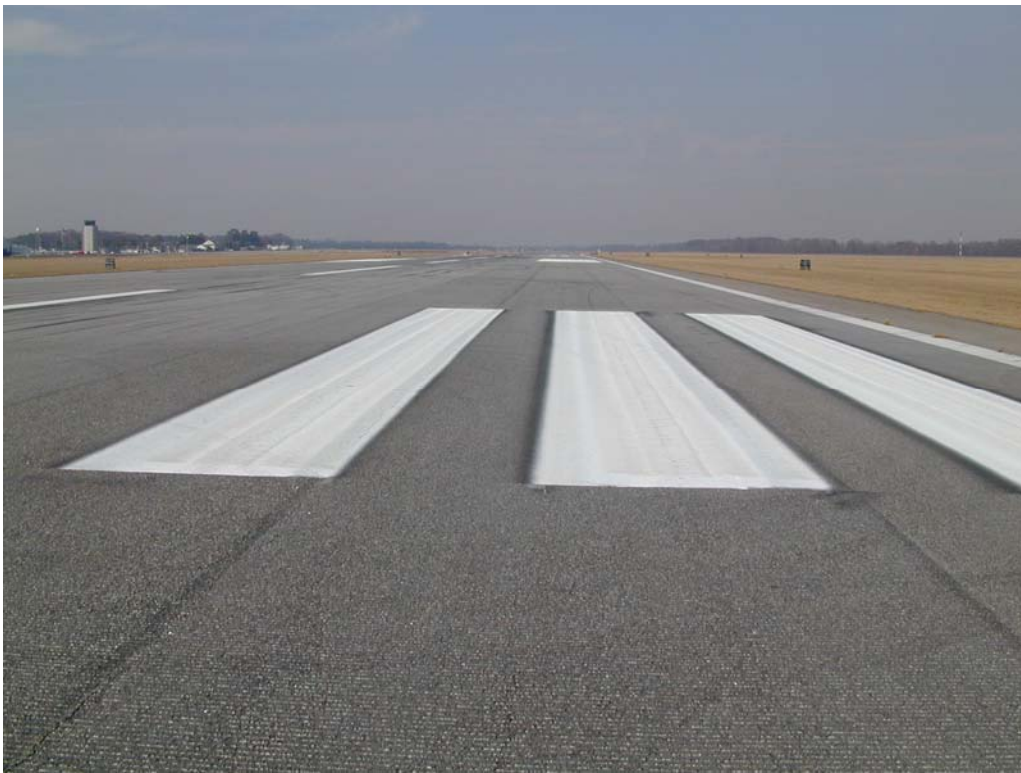
Overview of section R1735AGR-10E.

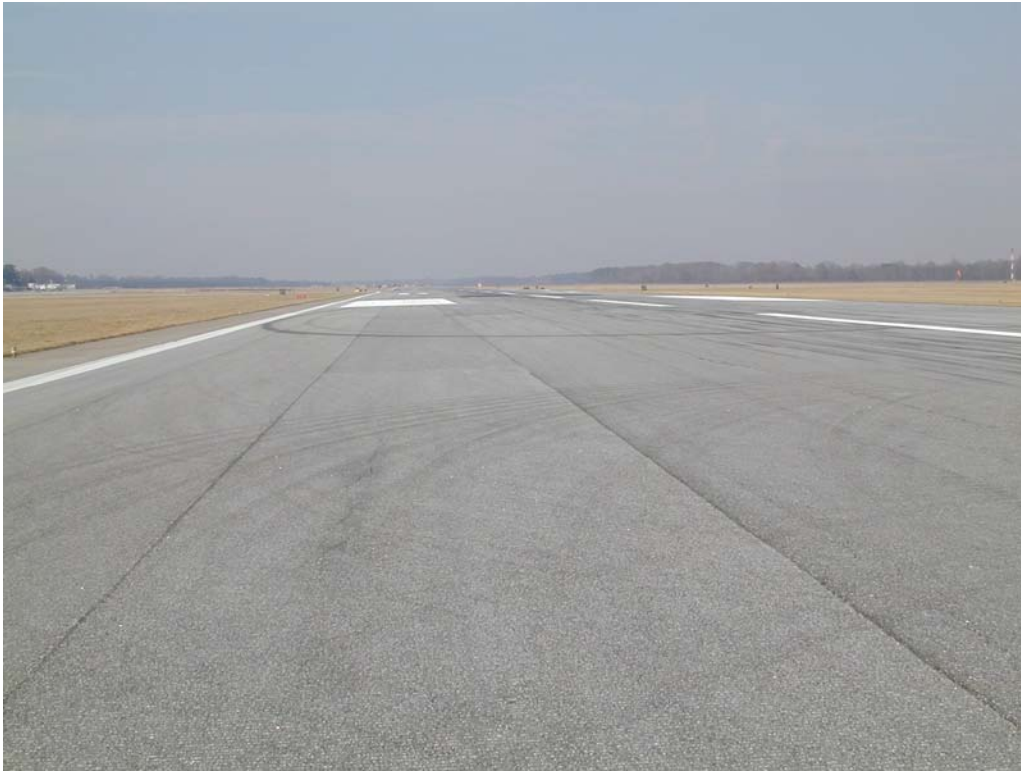
Overview of section R1735AGR-10W.

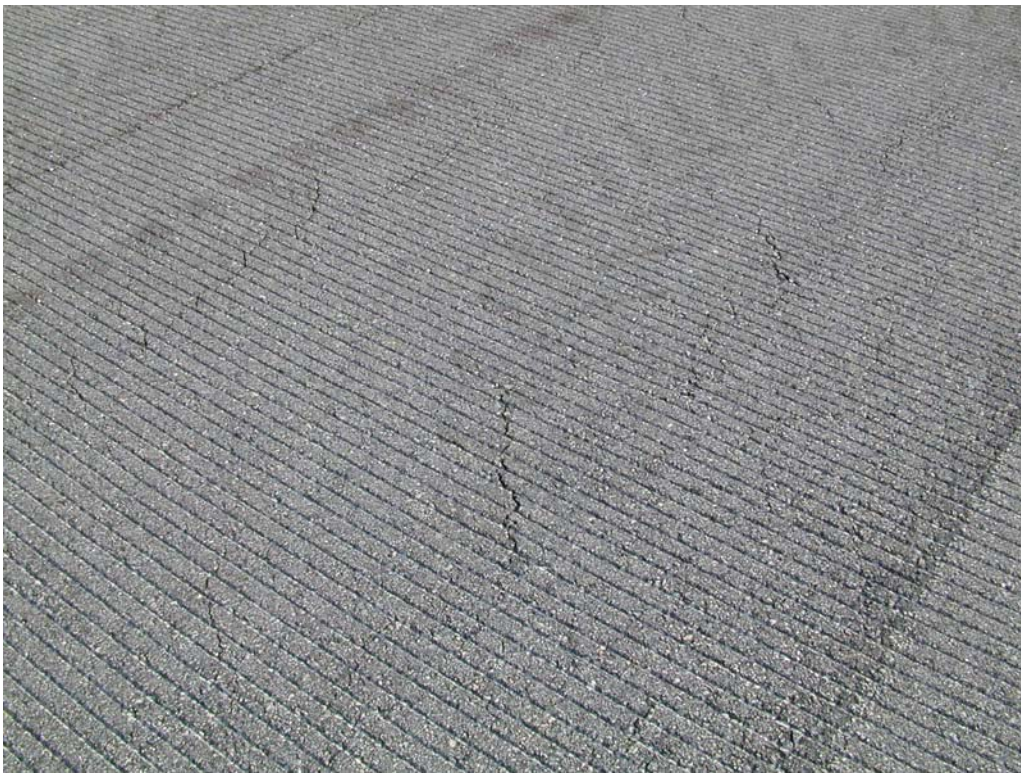
L&T cracking in section R1735AGR-10W.

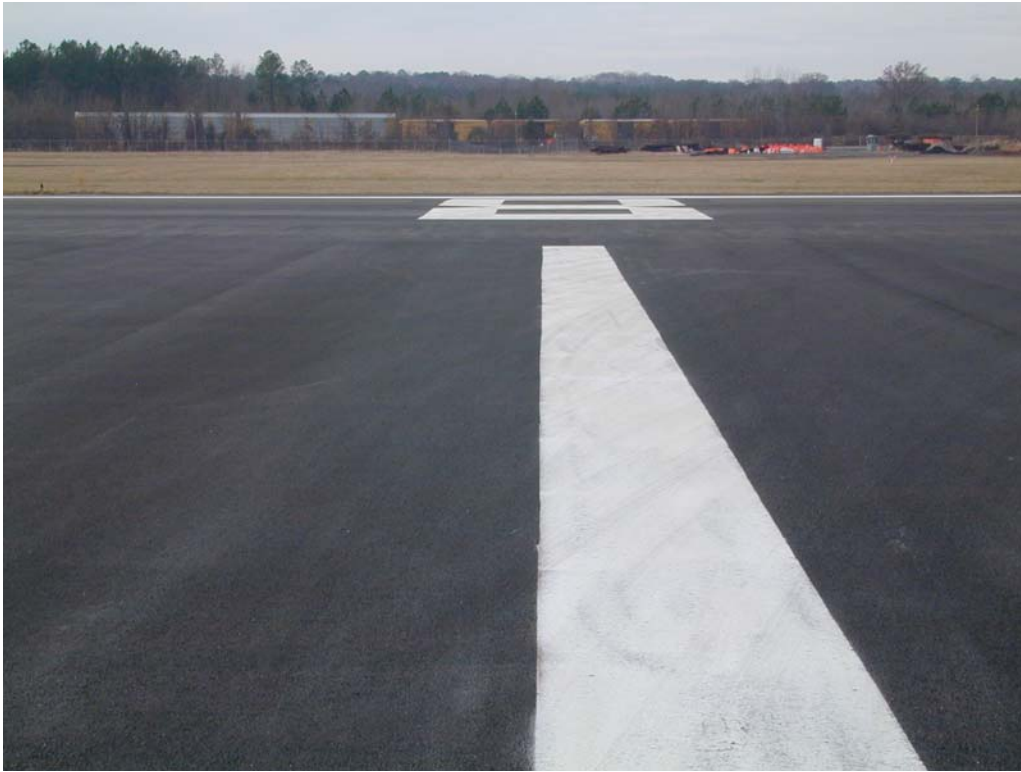
Sections R0826AGR-10N, R0826AGR-10C, and R0826AGR-10S are located on the western end of the runway near Taxiway C. All three sections were recently rehabilitated and found to be free from any distress.

Overview of section R826AGR-10C.

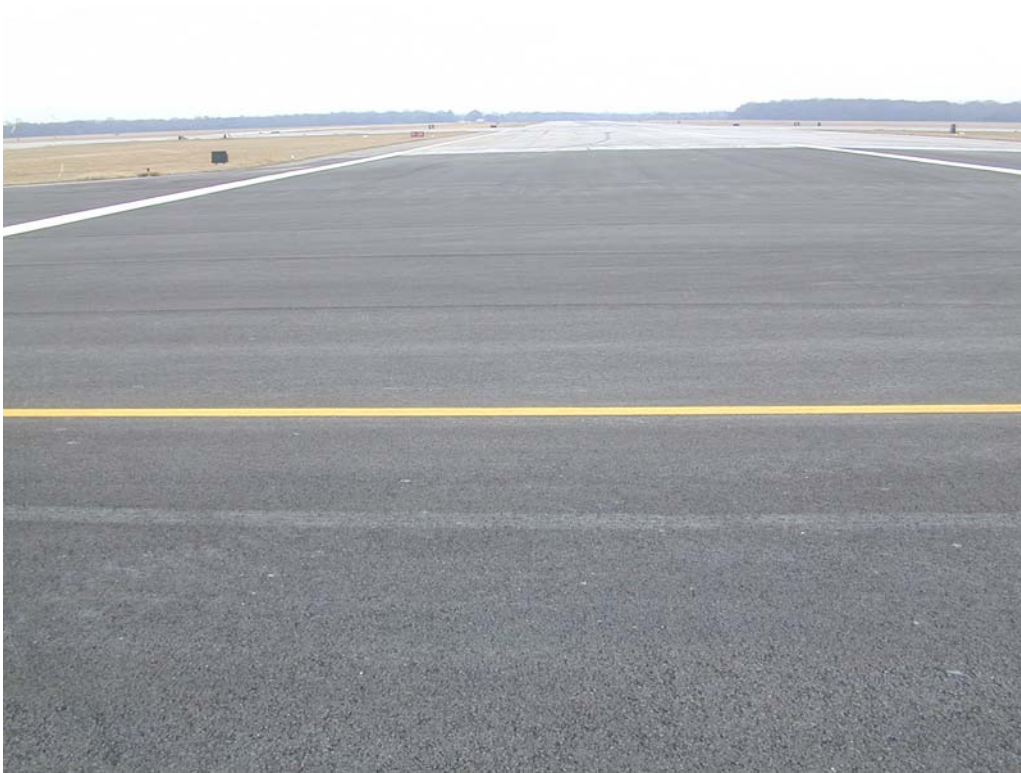
Overview of section R826AGR-10N.

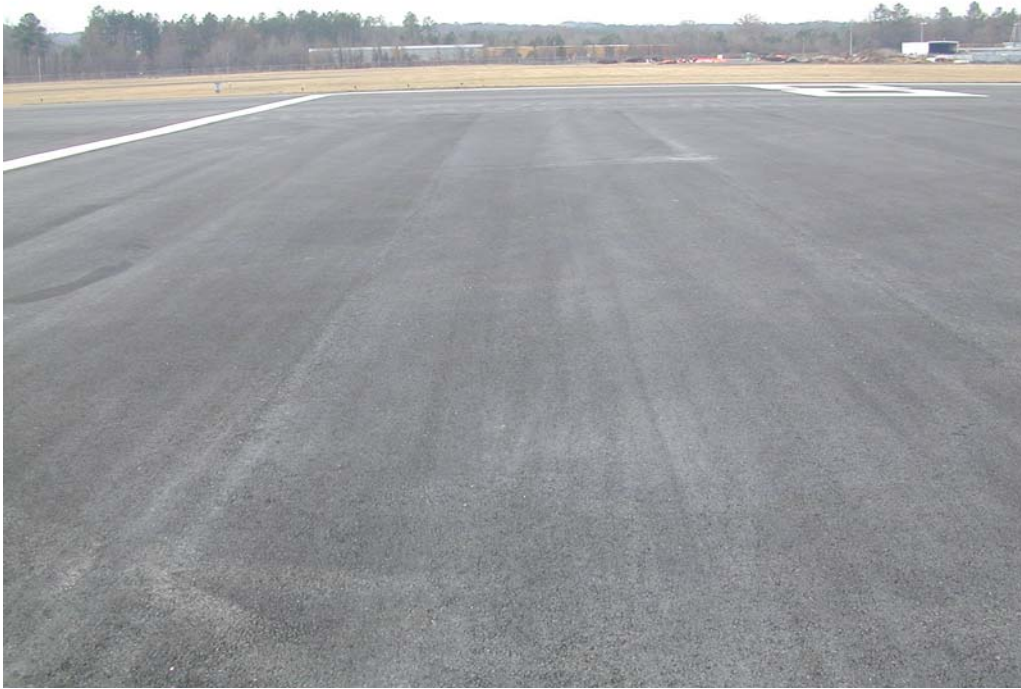
Overview of section R826AGR-10S.

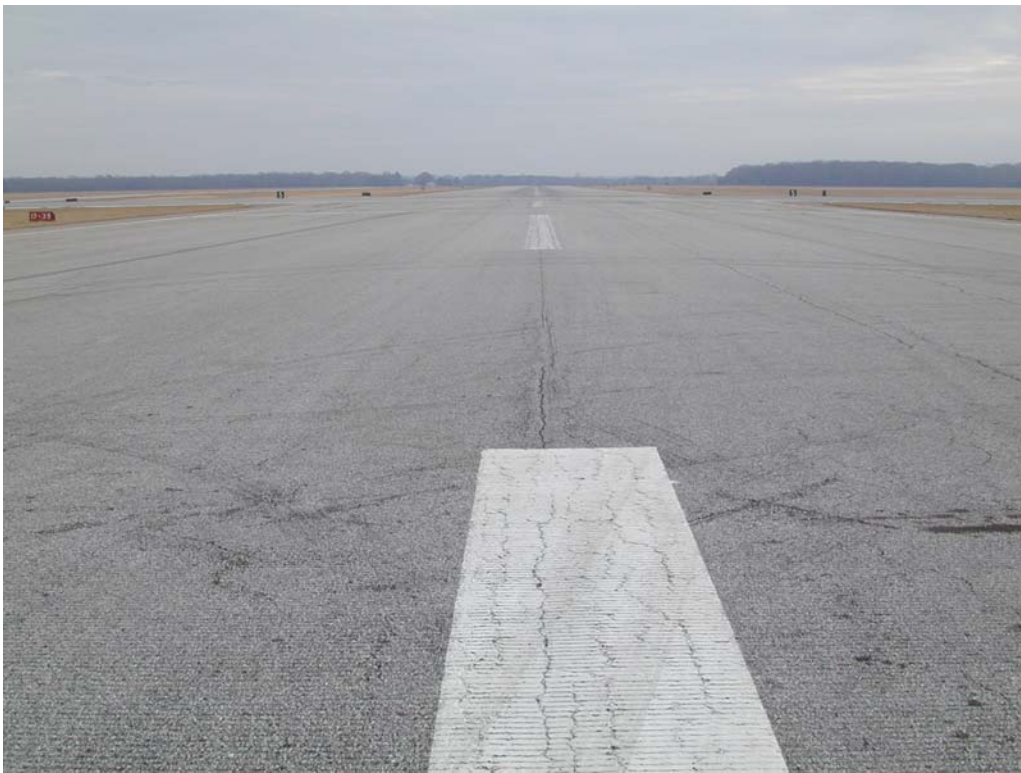
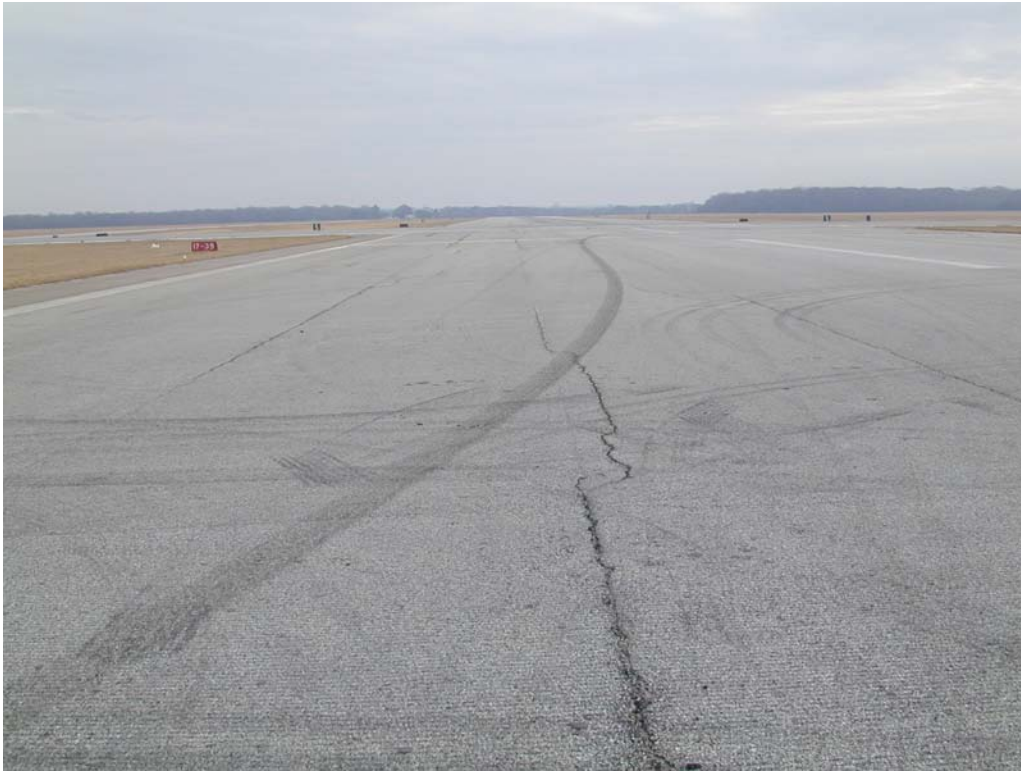
Sections R0826AGR-20N, R0826AGR-20C, and R0826AGR-20S are located between Runway 17-35 and Taxiway C. These sections are in fair condition with significant quantities of low and medium-severity L&T cracking observed. Raveling and weathering was found at low-severity over nearly the entire pavement surface. Finally, areas were found on the centerline where secondary cracking patterns formed an area greater than one foot in width. When this situation exists, the pavement is essentially failed and alligator cracking was recorded.

Overview of section R826AGR-20N.

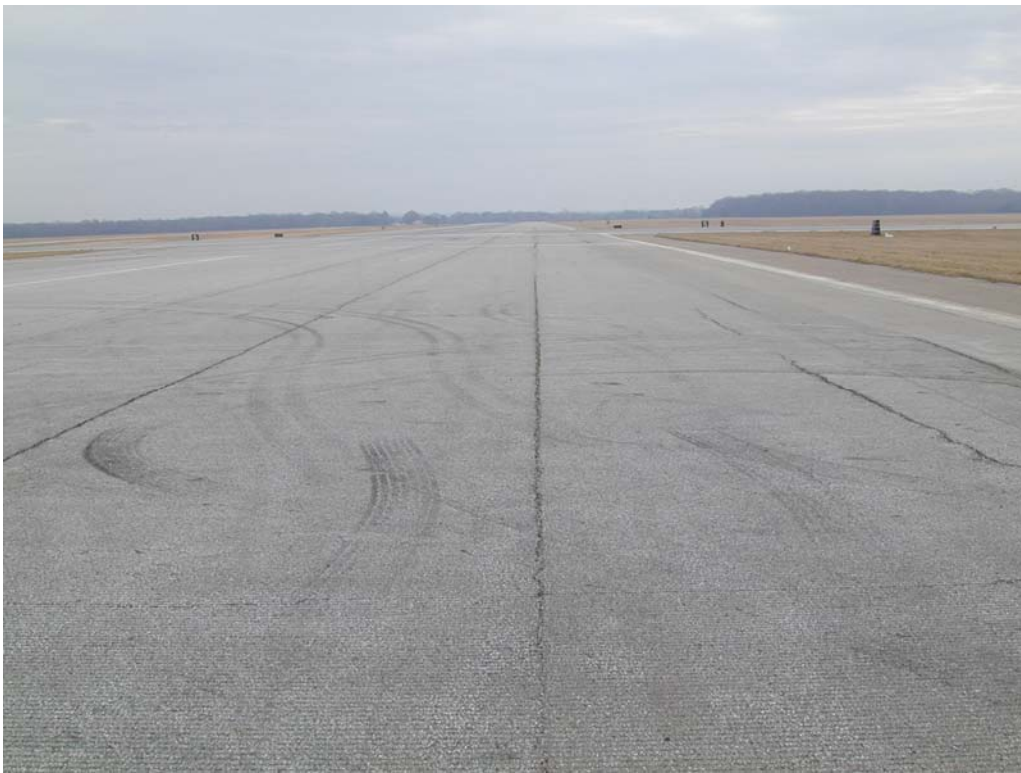
Overview of section R826AGR-20S.

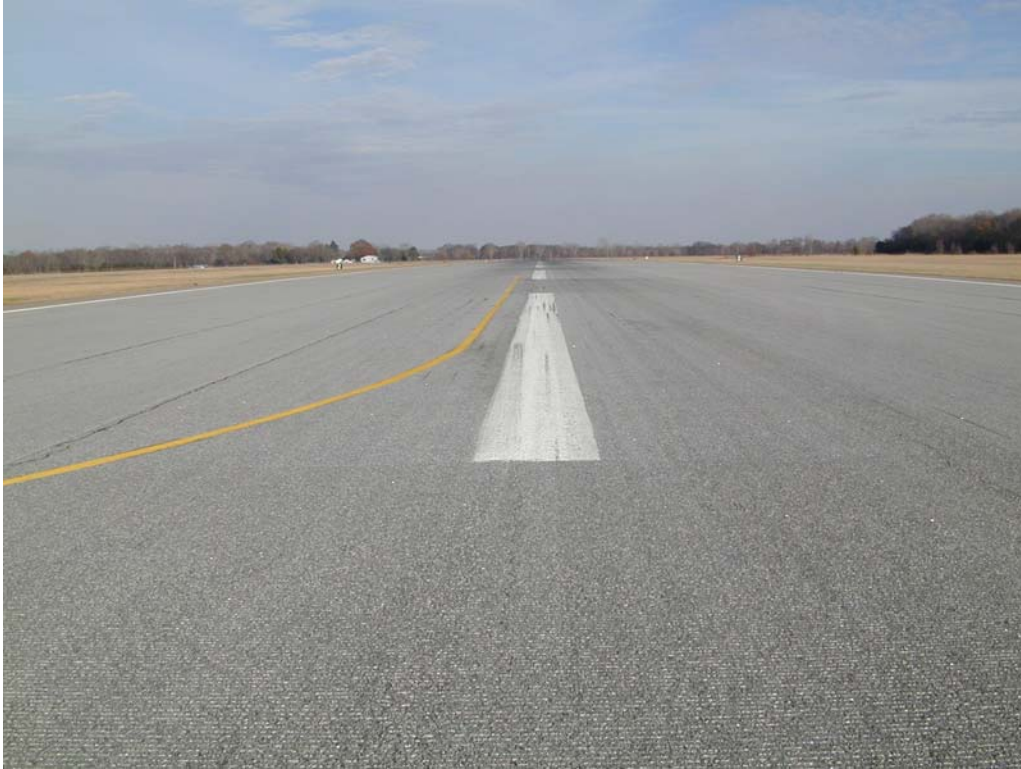
Sections R0826AGR-30N, R0826AGR-30C, and R0826AGR-30S are located east of Runway 17-35. These sections are in similar condition to sections R0826AGR-20N, R0826AGR-20C, and R0826AGR-20S with smaller amounts of raveling and weathering being found.

Overview of section R826AGR-30C.

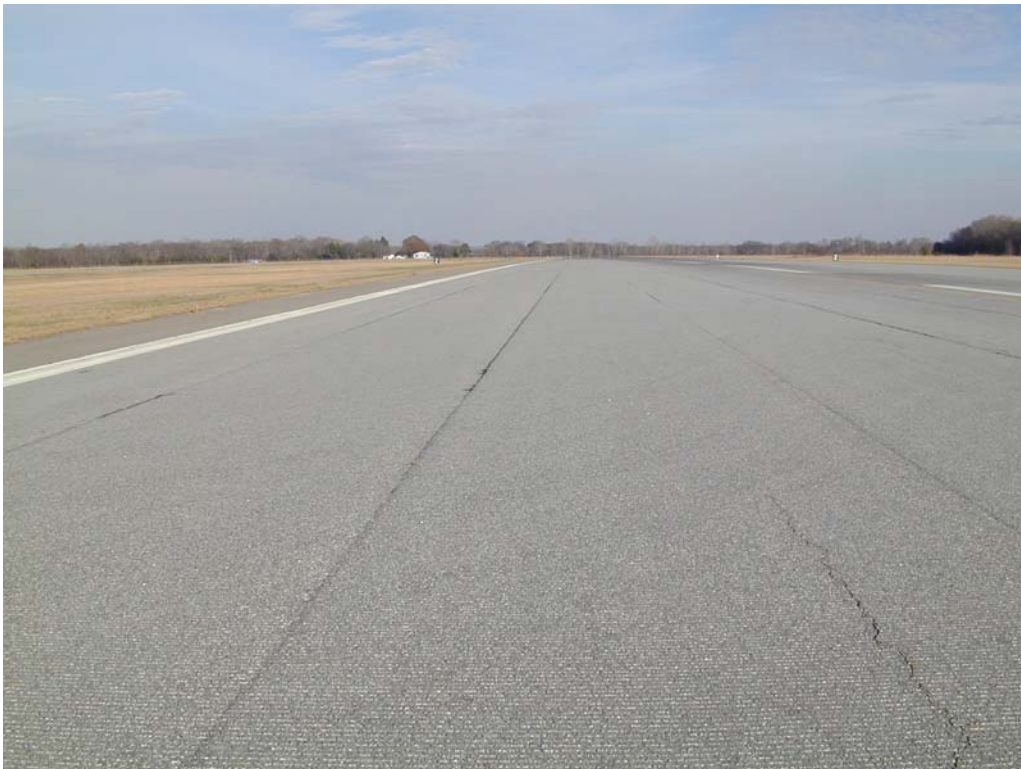
Overview of section R826AGR-30N.

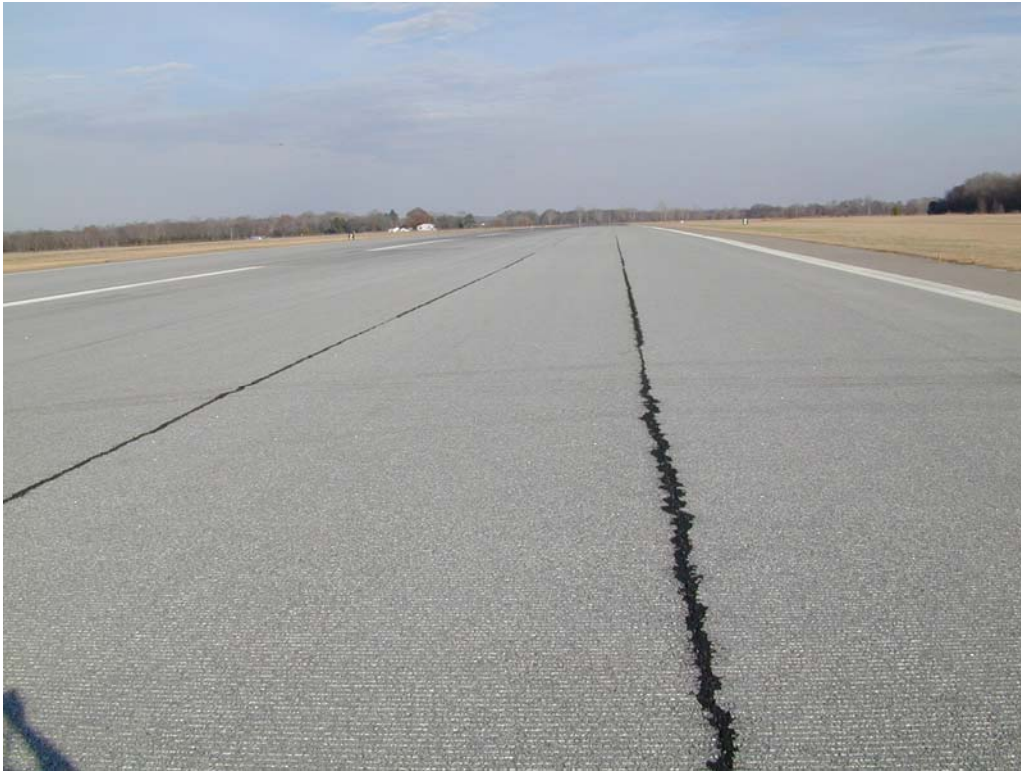
Overview of section R826AGR-30S.

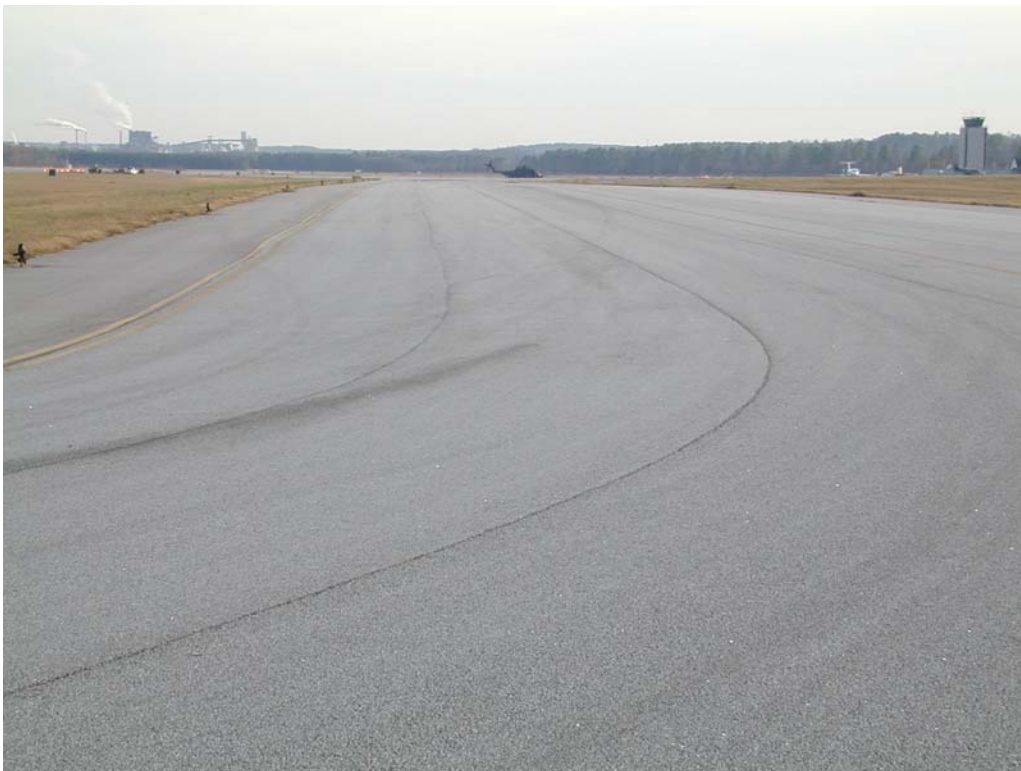
Two sections were defined in Taxiway A. TAAGR-10 is located adjacent to Runway 17-35 and was in the process of being rehabilitated during the inspection. It assumed that when finished the section will be free of any distress. TAAGR-20 runs from the approach end of Runway 17 to Taxiway B. This section is in good condition with moderate amounts of low-severity L&T cracking and raveling and weathering observed. Isolated amounts of swelling were found associated with L&T cracking. It appears that the paving lane edges were rolled over creating a vertical displacement at the paving lane joints. These areas were not very wide and were not recorded as depressions. Approximately 35 percent of the L&T cracking observed was associated with the paving lane joints.

Overview of section TAAGR-20.

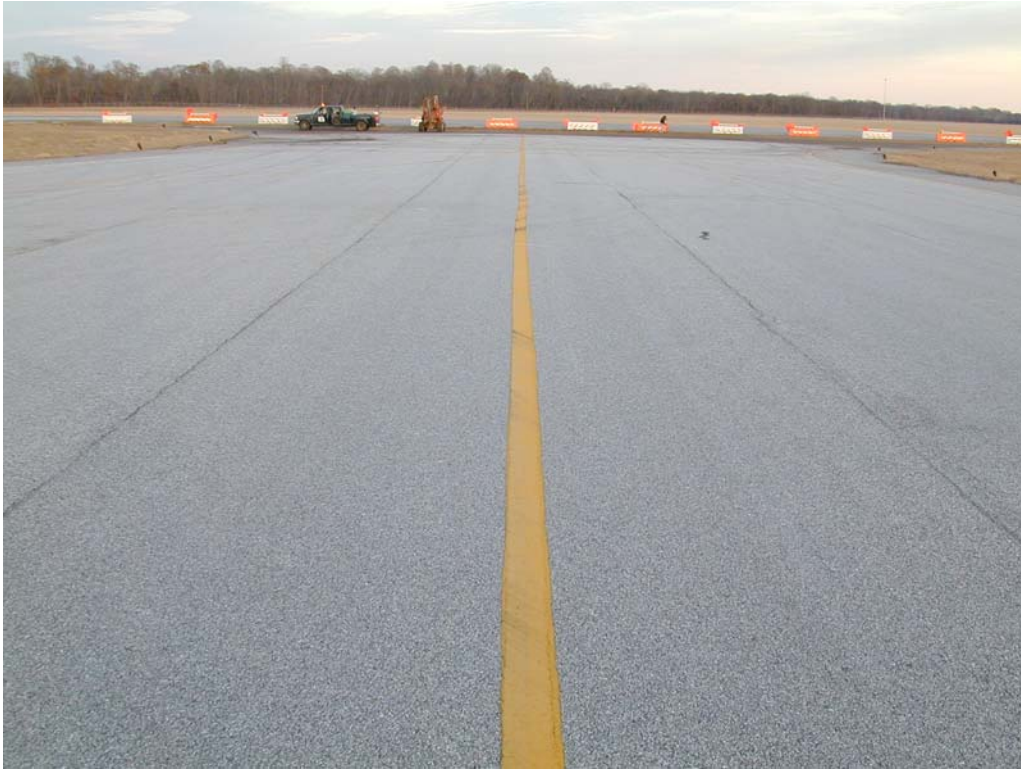
TBAGR-20 is located adjacent to Runway 17-35 and was in the process of being rehabilitated during the inspection. It assumed that when finished the section will be free of any distress.

Overview of section TBAGR-20.

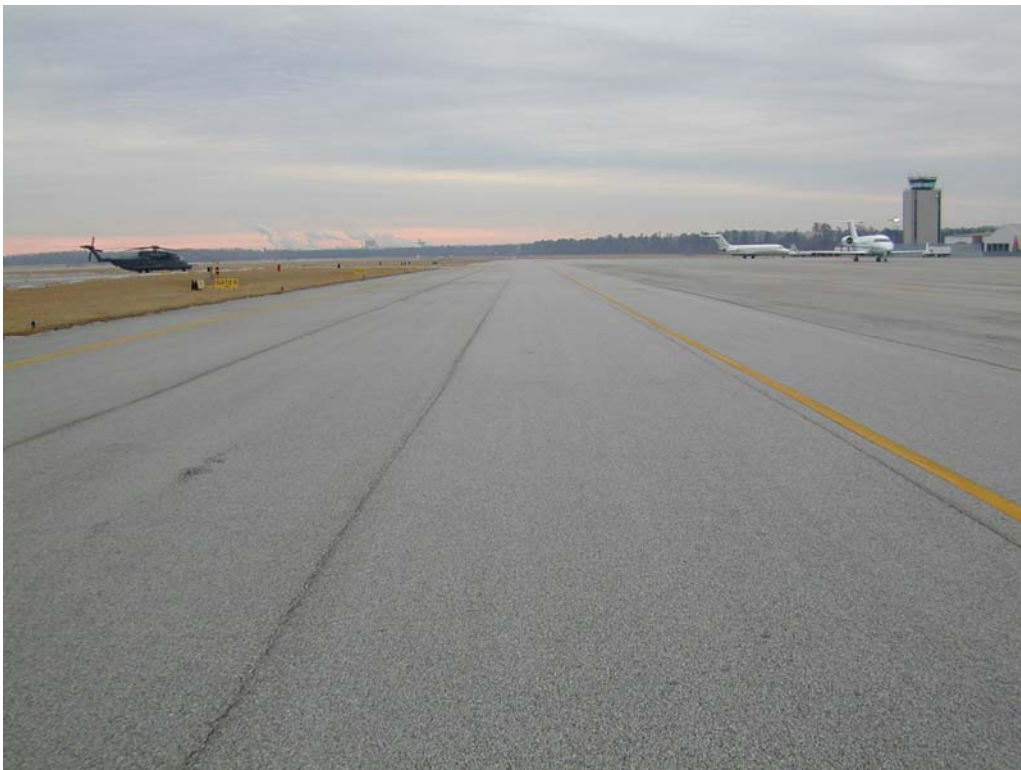
Two sections were defined in Taxiway C. TCAGR-10 runs from Taxiway B south to a point just past Taxiway D. This section is good condition with moderate amounts of low-severity L&T cracking found throughout the section. Alligator cracking was observed at the western edge of the taxiway. It appears that the area of alligator cracking exists at the point where the edge of the taxiway overlaps the edge of older apron pavement. Nearly all of the L&T cracking found in the section is associated with paving lane joints. TCAGR-20 runs from the point where TCAGR-10 stops to the approach end of Runway 35. This pavement was recently rehabilitated and was found to be free of any distress.

Overview of section TCAGR-10.

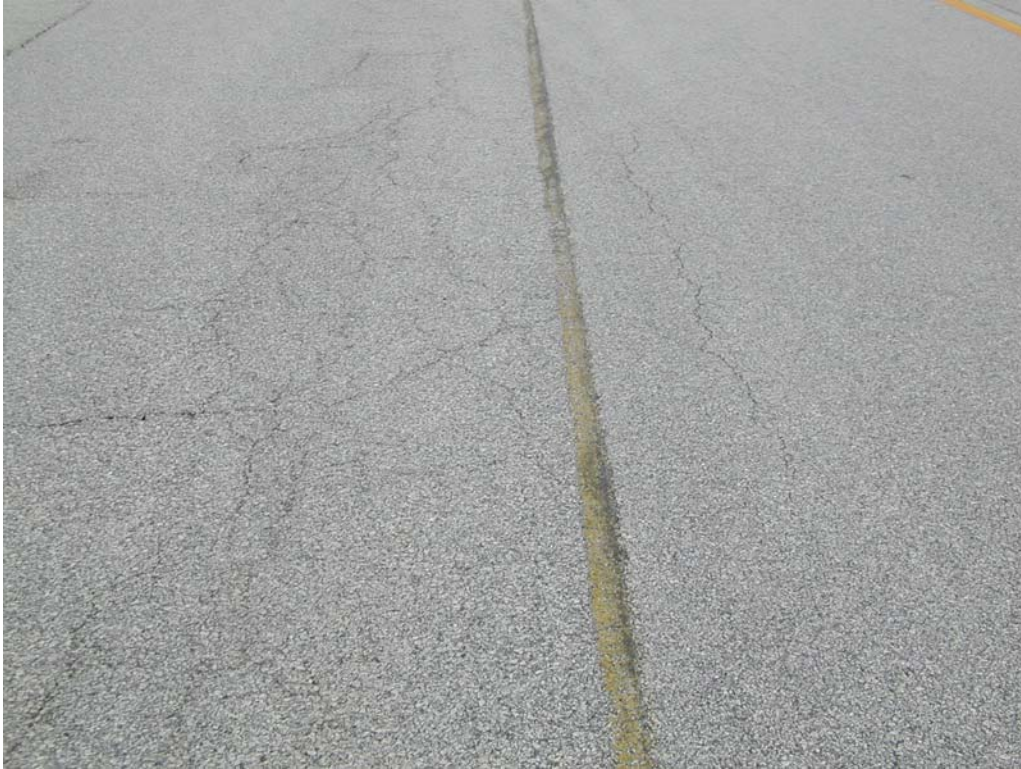
Alligator cracking in section TCAGR-10.

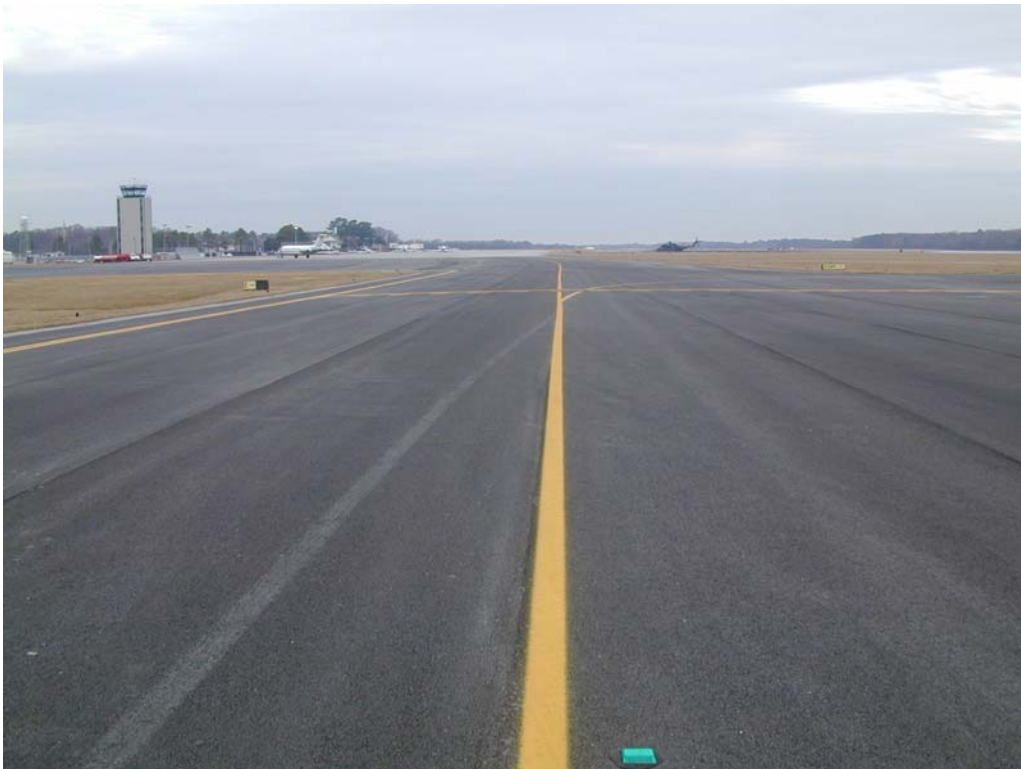
Overview of section TCAGR-20.

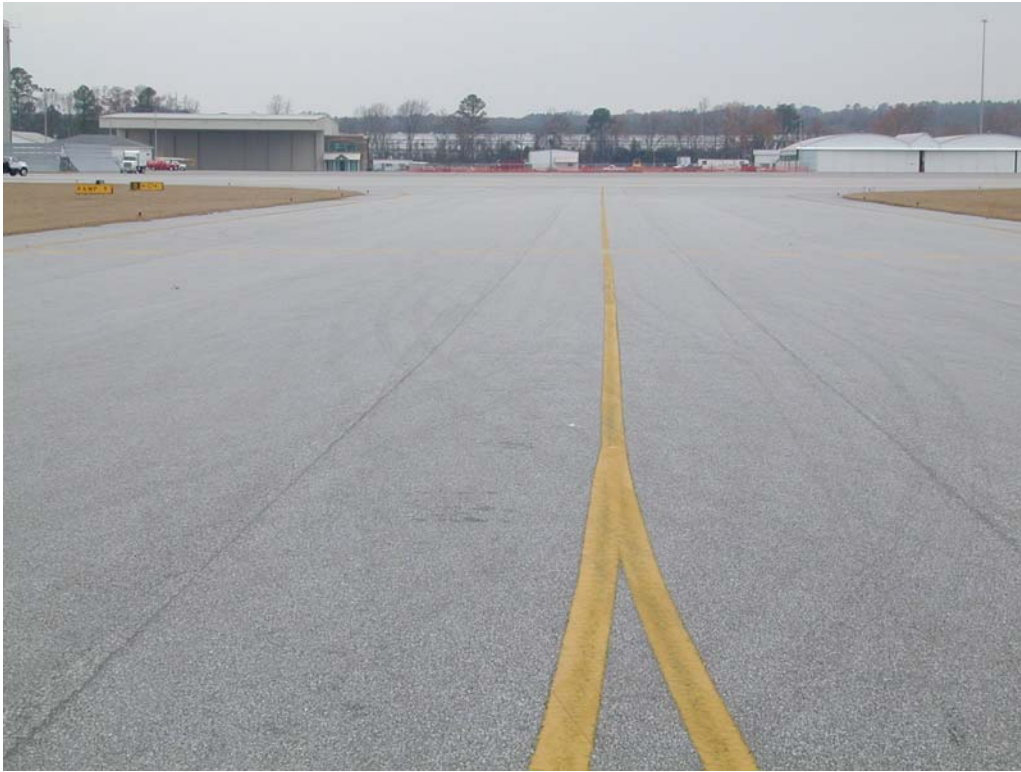
One section was defined in Taxiway D. TDAGR-10 is in excellent condition with small quantities of low-severity raveling and weathering being found throughout the section. This distress was found primarily at the paving lane joints. Isolated small amounts of low-severity L&T cracking were also found.

Overview of section TDAGR-10.

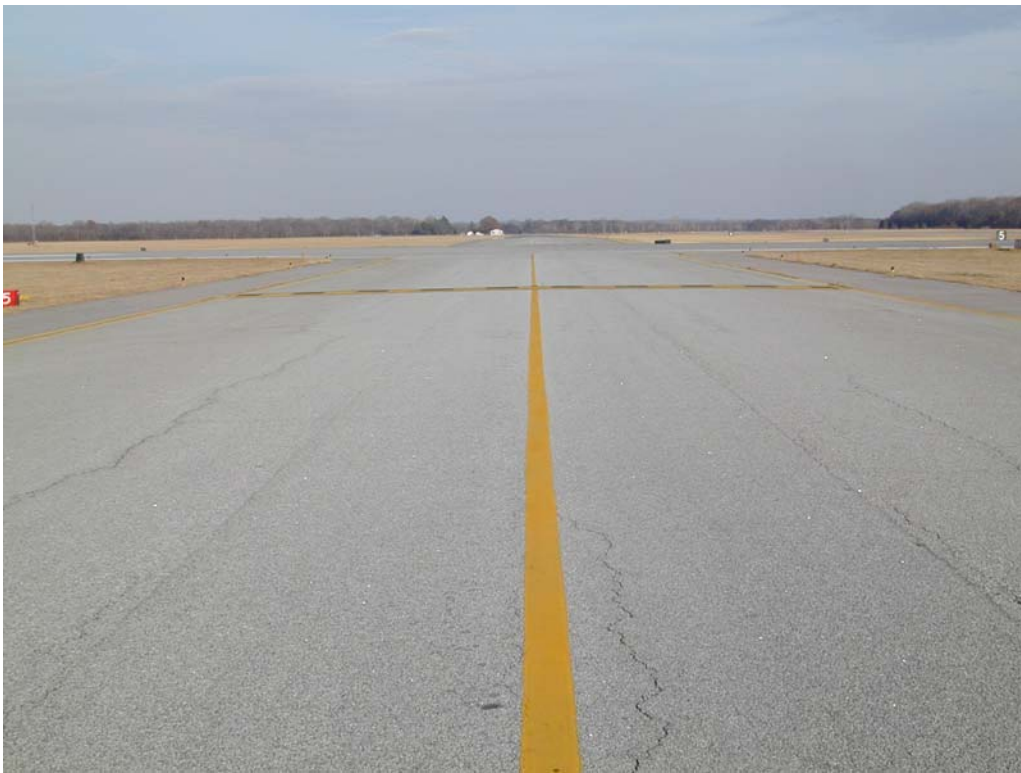
Two sections were defined in Taxiway E. TEAGR-10 is located between Taxiway C and Runway 17-35 and is in poor condition. Large amounts of low and medium-severity L&T and block cracking were observed. Medium-severity raveling and weathering was also found covering nearly the entire sections surface. TEAGR-20 is located east of Runway 17-35 and is in excellent condition. Moderate amounts of low-severity L&T cracking were found throughout the section.

Overview of section TEAGR-10.

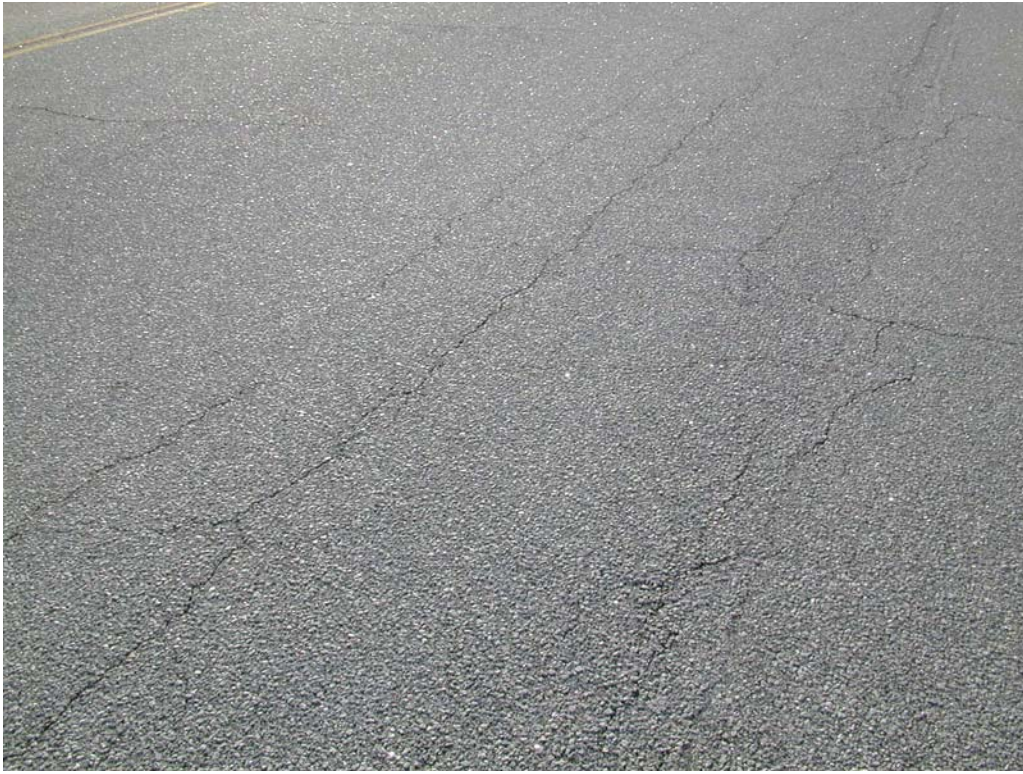
L&T cracking in section TEAGR-10.

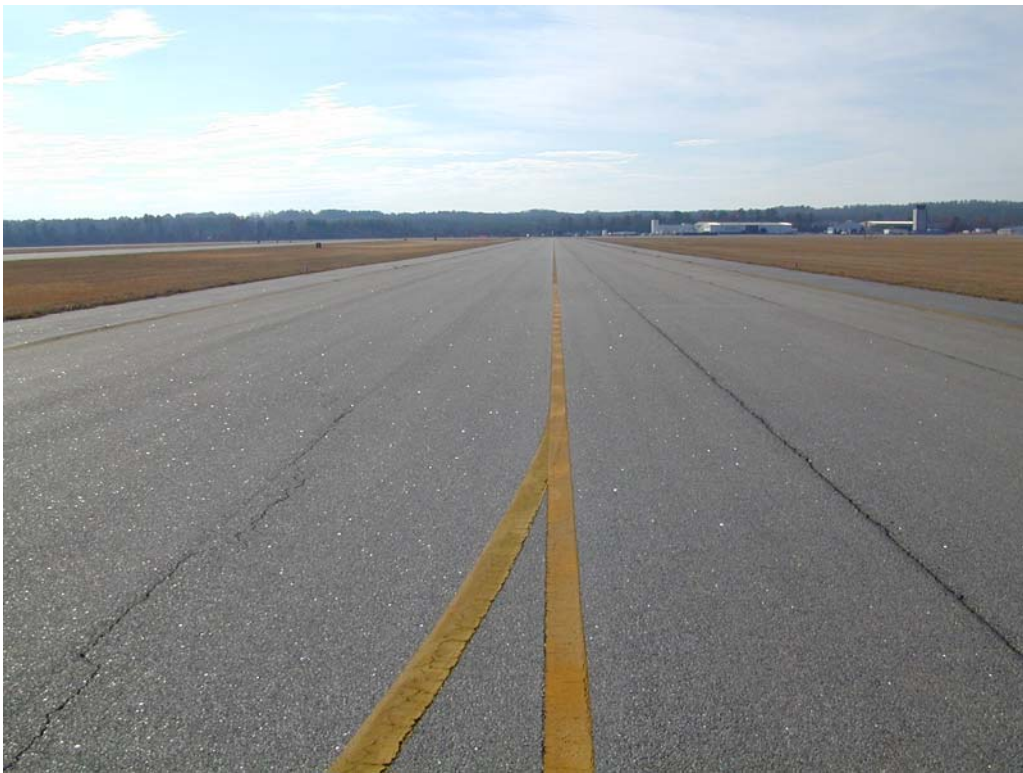
Overview of section TEAGR-20.

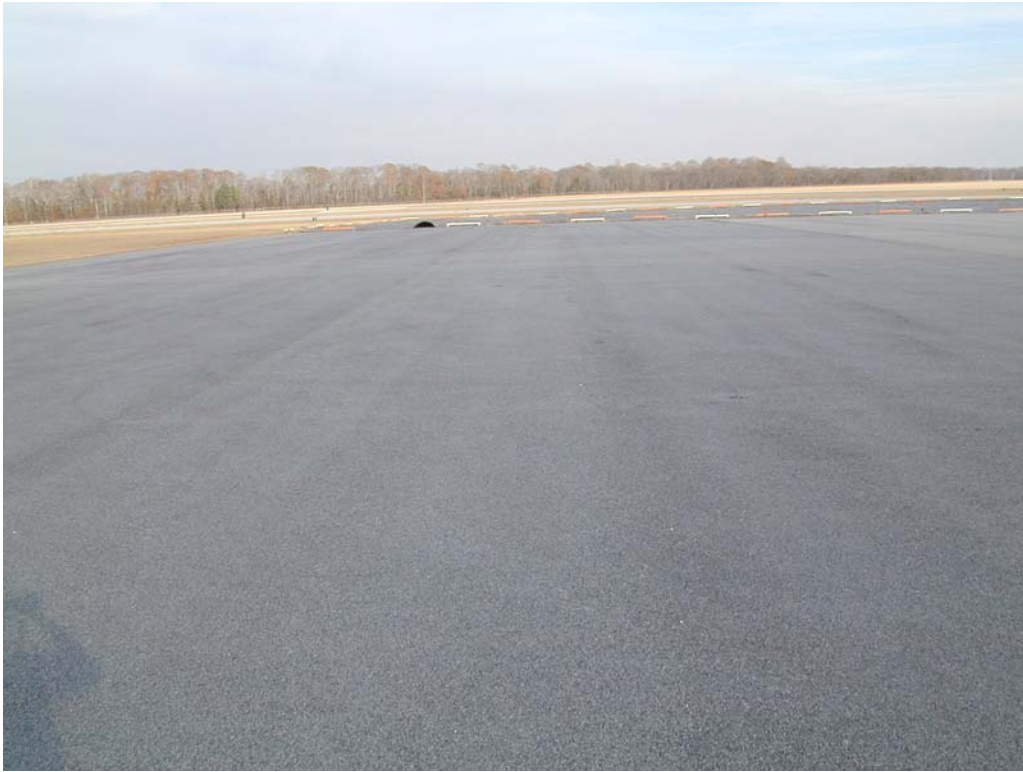
The Main Apron was divided into five sections. Both A01AGR-10 and A01AGR-20 are located at the northern end and are in excellent condition. Small amounts of low-severity L&T cracking were observed in these sections. A01AGR-30 is in fair condition with substantial amounts of low-severity L&T and block cracking observed throughout the section. Low-severity raveling and weathering was found over the entire surface of the section. Finally, significant quantities of swelling were observed. Periodically, PCC hard stands have been placed in the pavement for the purpose of parking commercial traffic on during loading and unloading. These hard stands are exhibiting signs of failure with multiple distresses evident in them. Since these areas are not large enough to define a separate section under ASTM criteria, they were recorded as high-severity patching in an additional sample unit. A01AGR-40 is in excellent condition with moderate amounts of low-severity L&T cracking found. Isolated areas of swelling were also observed in the section. A01AGR-50 was recently constructed and found to be free of any distress.

Overview of section A01AGR-10.

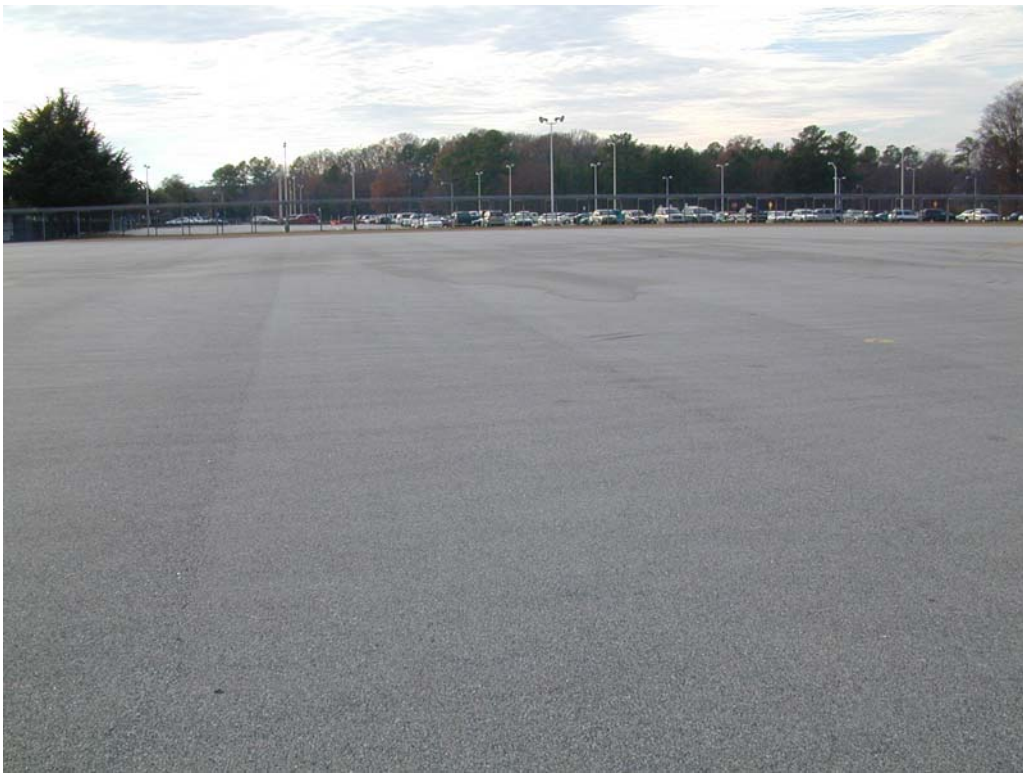
Overview of section A01AGR-20.

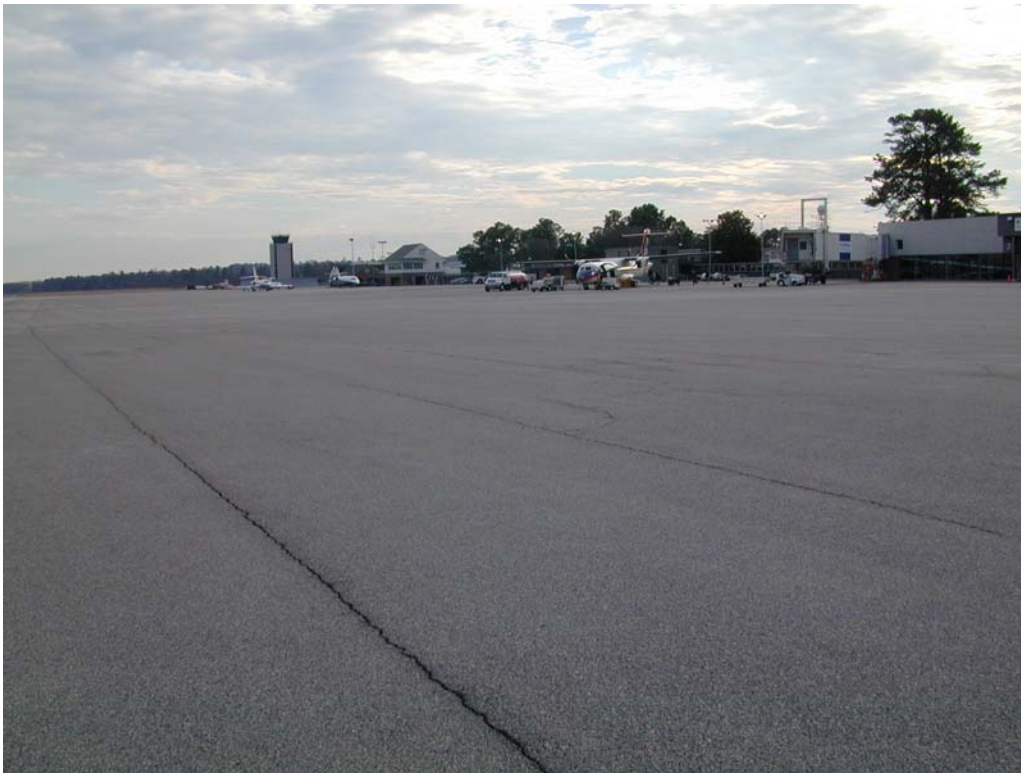
Overview of section A01AGR-30.

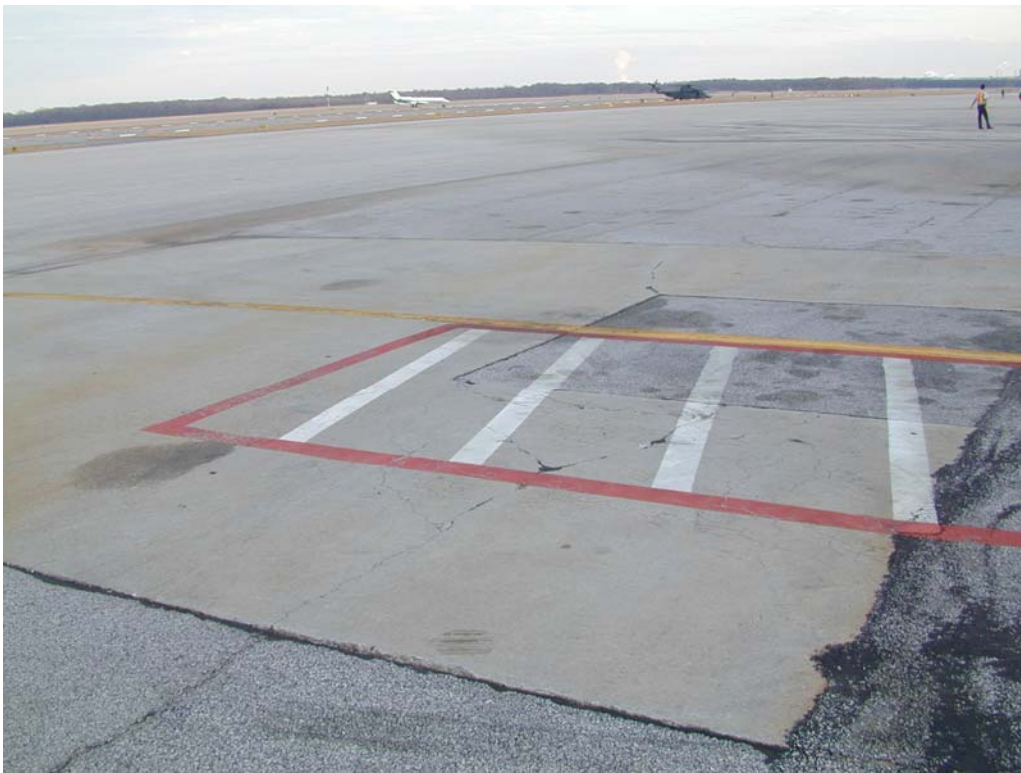
Overview of an additional sample unit with a PCC patch in section A01AGR-30.

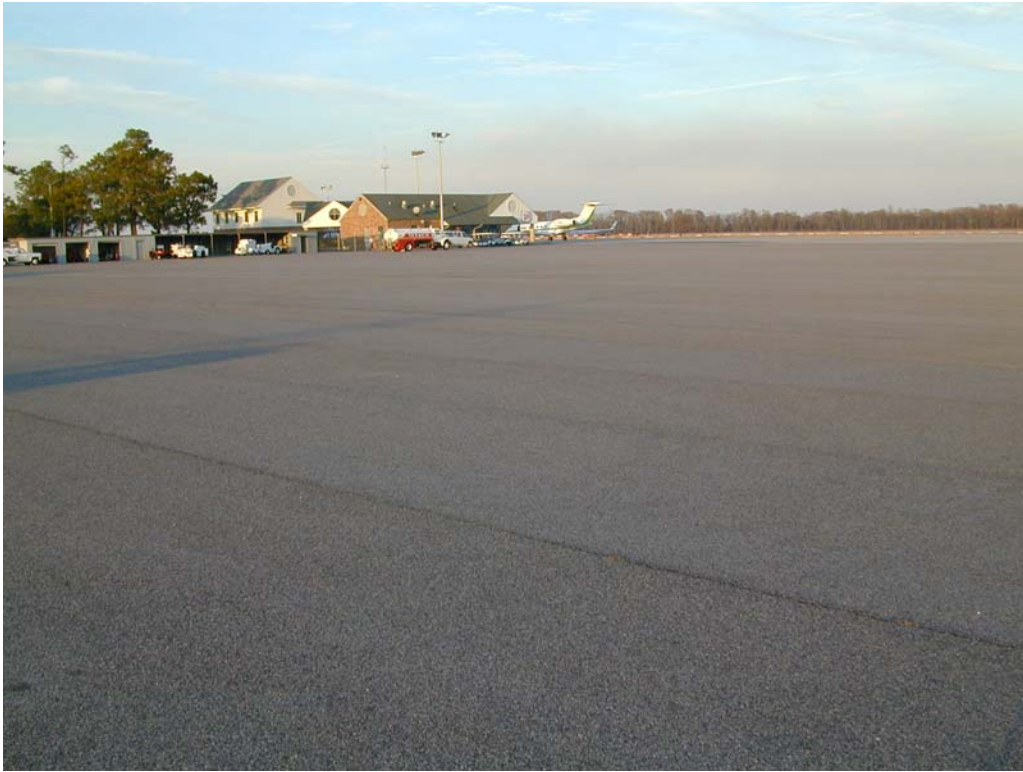
Overview of section A01AGR-40.
