AUGUSTA REGIONAL AIRPORT AT BUSH FIELD

PAVEMENT EVALUATION REPORT

JULY 2002

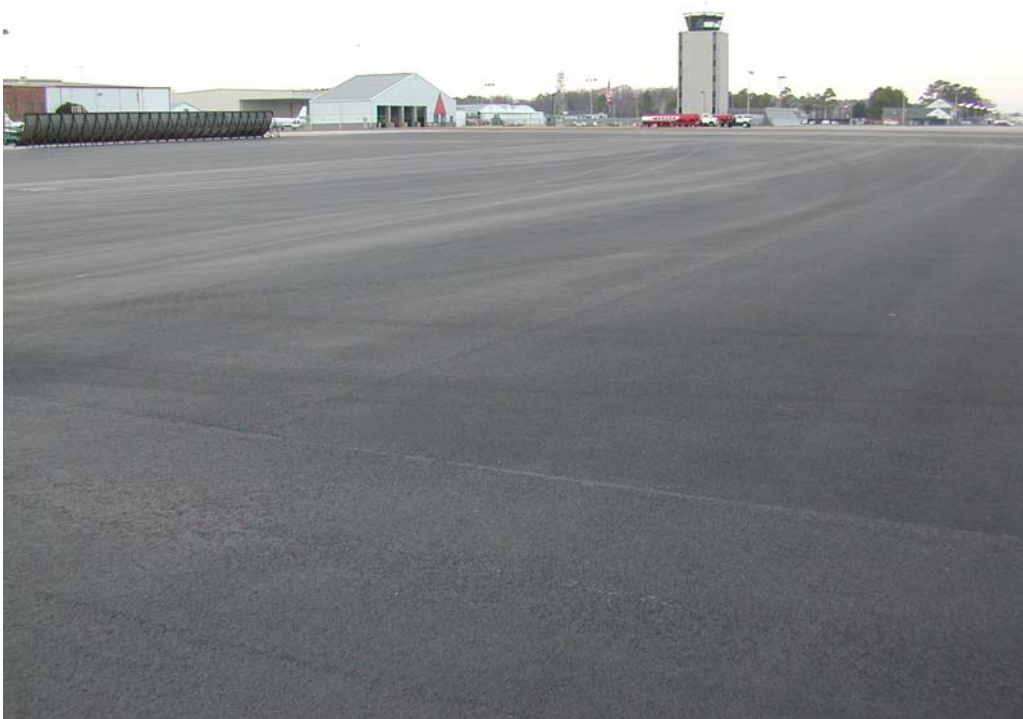
The Main Apron was divided into five sections. Both A01AGR-10 and A01AGR-20 are located at the northern end and are in excellent condition. Small amounts of low-severity L&T cracking were observed in these sections. A01AGR-30 is in fair condition with substantial amounts of low-severity L&T and block cracking observed throughout the section. Low-severity raveling and weathering was found over the entire surface of the section. Finally, significant quantities of swelling were observed. Periodically, PCC hard stands have been placed in the pavement for the purpose of parking commercial traffic on during loading and unloading. These hard stands are exhibiting signs of failure with multiple distresses evident in them. Since these areas are not large enough to define a separate section under ASTM criteria, they were recorded as high-severity patching in an additional sample unit. A01AGR-40 is in excellent condition with moderate amounts of low-severity L&T cracking found. Isolated areas of swelling were also observed in the section. A01AGR-50 was recently constructed and found to be free of any distress.

Overview of section A01AGR-50.

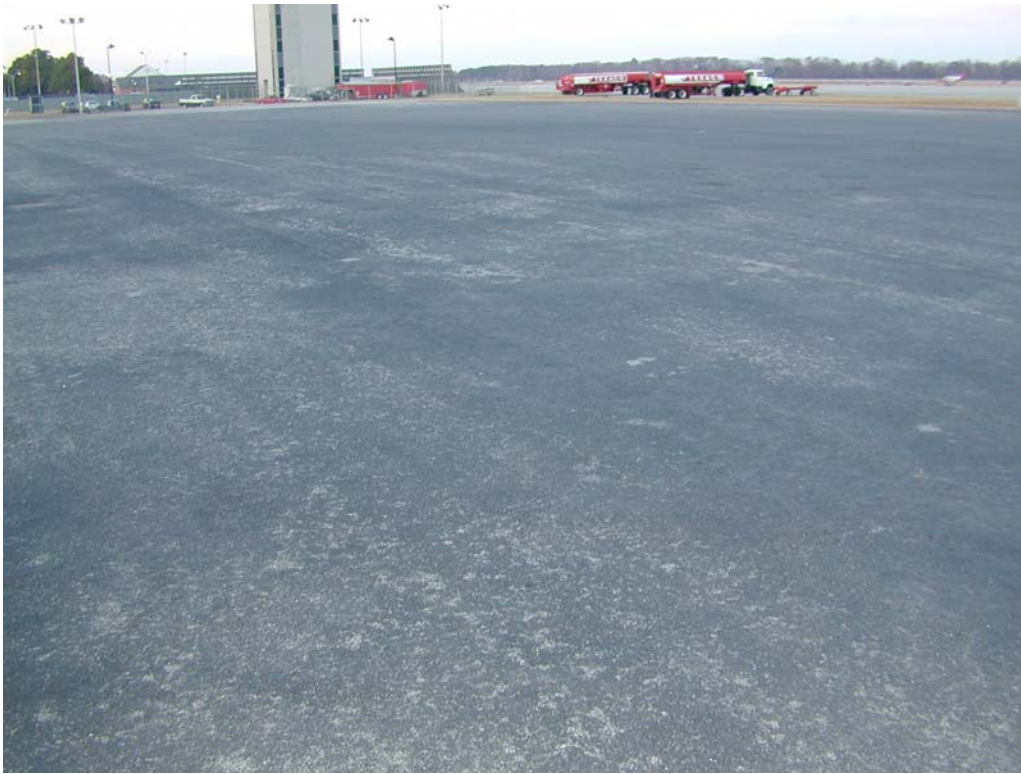
Two sections were defined in the Garrett Aviation Apron. AGARRETAGR-10 consists of the apron area adjacent to the Garrett Aviation main hangar. Large quantities of low-severity block and L&T cracking were found throughout the section. Smaller quantities of swelling were also observed. AGARRETAGR-20 used to be the access taxiway into the Garrett Aviation area but is now considered part of the apron area. This section was recently rehabilitated and was found to be free of any distress.

Overview of section AGARRETAGR-10.

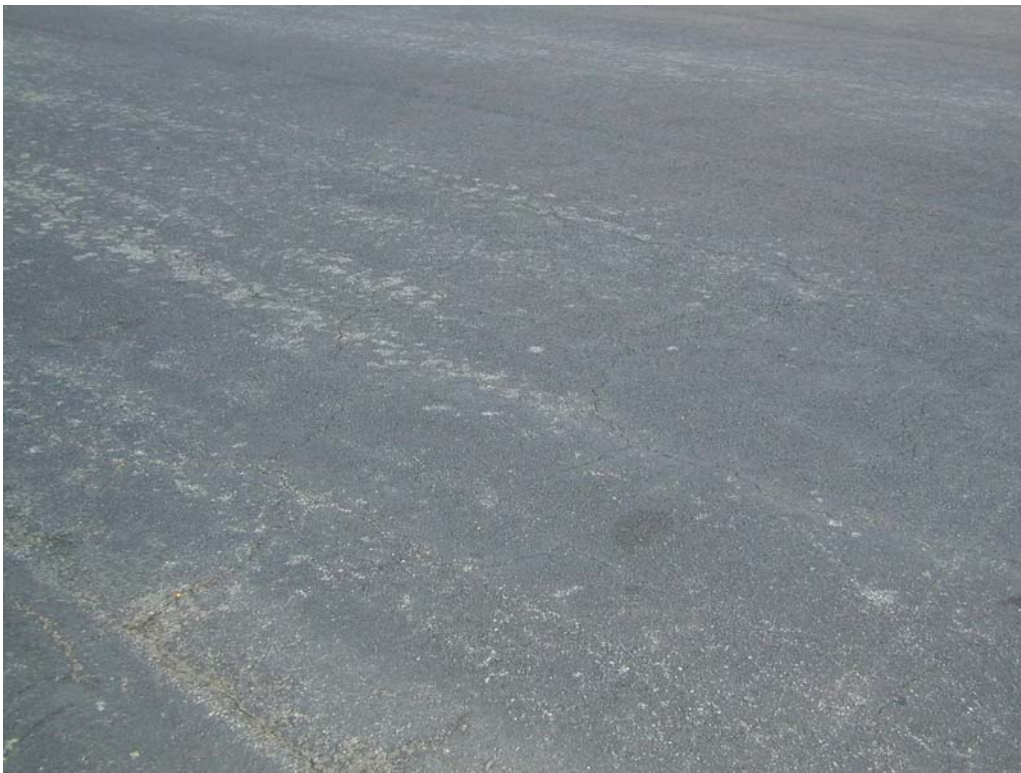
Block cracking in section AGARRETAGR-10.

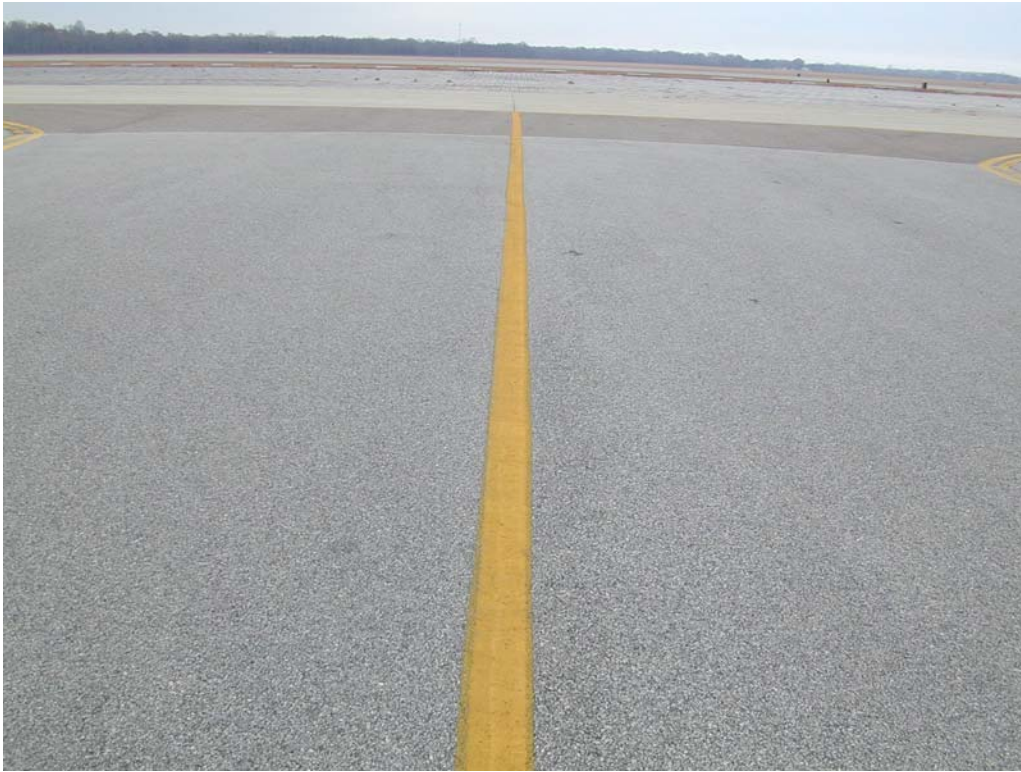
Two sections were defined in the Helipad. AHELIAGR-10 consists of the small asphalt pavement joining the Helipad and the Main Apron. This section is in poor condition with significant amounts of medium-severity raveling and weathering found throughout. Substantial quantities of L&T cracking and depression as well as isolated amounts of swelling and bleeding were also observed. AHELIAGR-20 consists of a PCC pavement and comprises the main portion of the Helipad. This section is in excellent condition with only medium-severity joint seal damage being found.

Overview of section AHELIAGR-10.

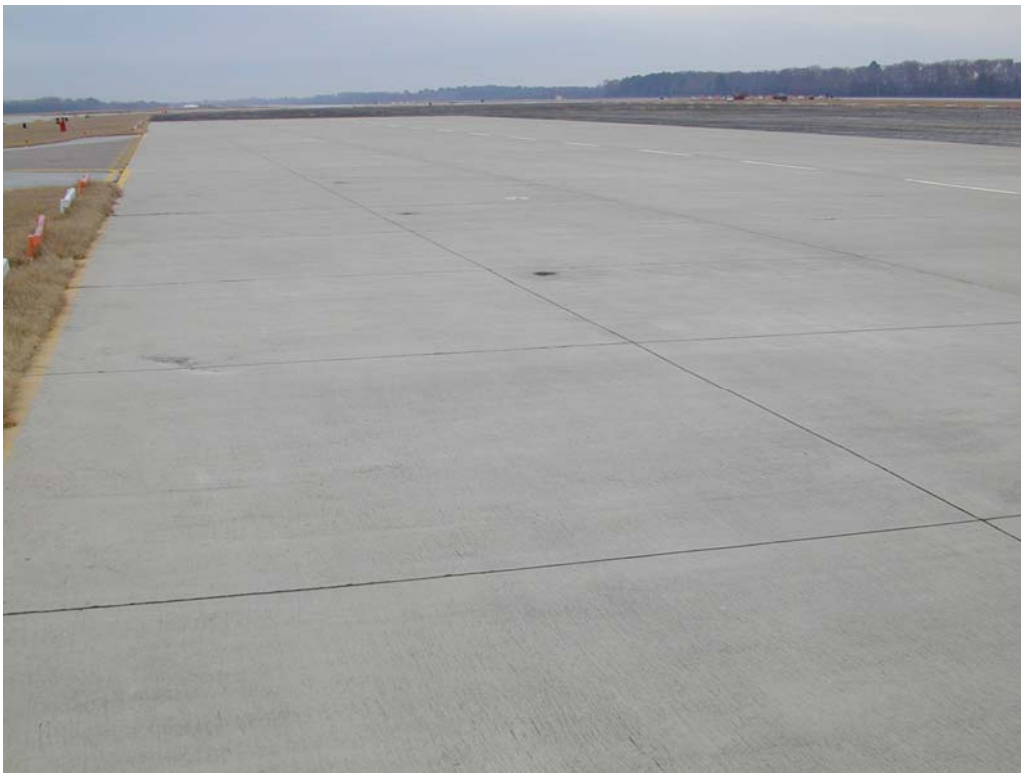
Overview of section AHELIAGR-20.
