COLUMBUS METROPOLITAN AIRPORT

PAVEMENT EVALUATION REPORT

JULY 2002

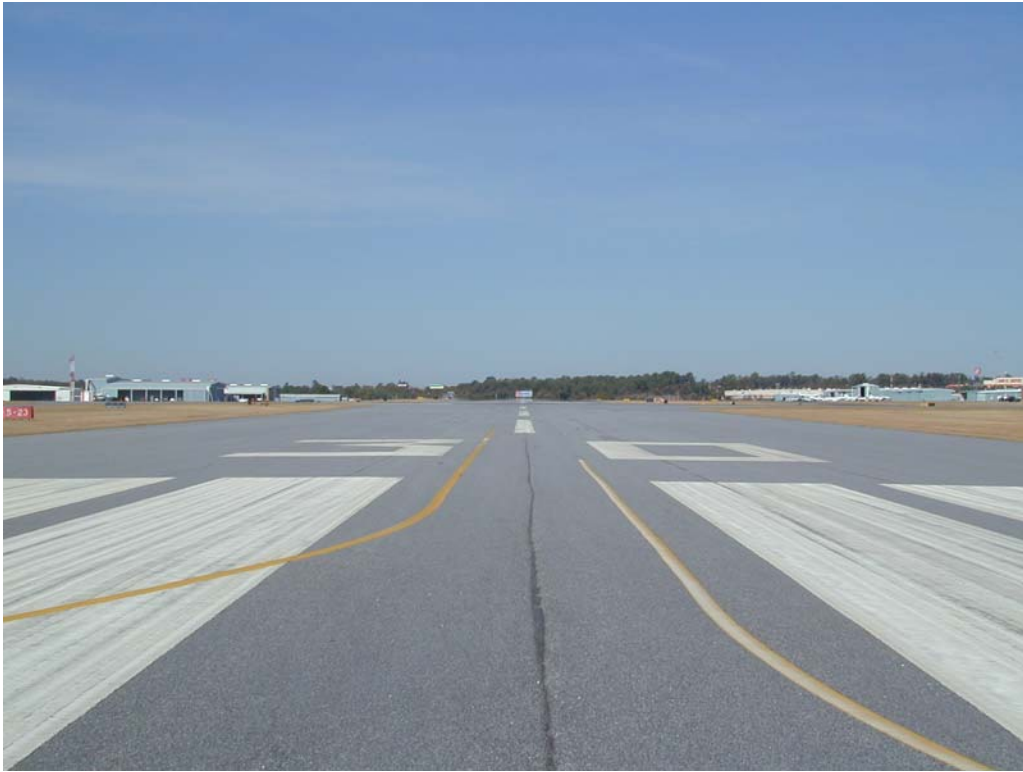
Runway 12-30 is also divided into three sections, section R1230CL-10C, 10N, and 10S, across its width due to variations in traffic. All three sections are in good condition with the primary distress type is unsealed, low-severity, L&T cracking. Small quantities of low-severity patching are also noted in all three sections.

Overview of section R1230CL-10C.

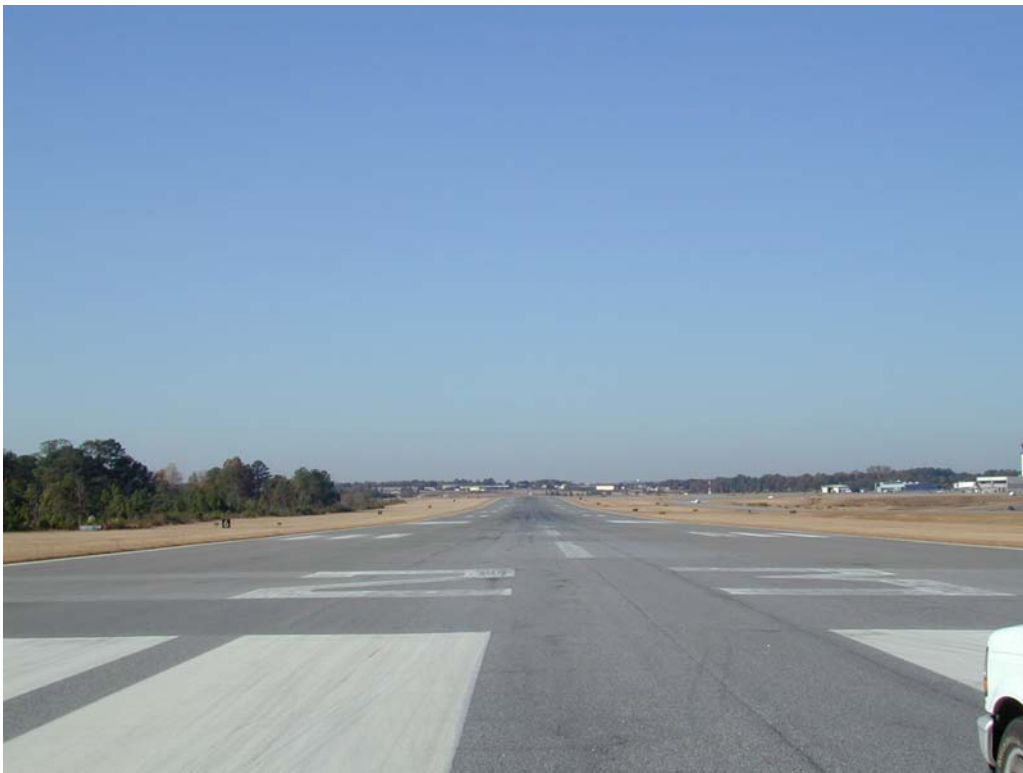
Runway 5-23 is divided into three sections, R523CL-10C, R523CL -10E, R523CL -10W, across its width to account for variations in traffic and condition on the pavement. Section R523CL-10C is in fair condition with significant quantities of low-severity alligator cracking, low-severity rutting, and low and medium-severity longitudinal and transverse (L&T) cracking.

Lesser amounts of low and medium-severity swelling and weathering and raveling are also observed on the pavement. Sections R523CL-10E and R523CL10W are both in good condition with moderate amounts of low and medium-severity L&T cracking and weathering. The latter two sections also have relatively small quantities of low-severity swelling.

Overview of section R523CL-10C.

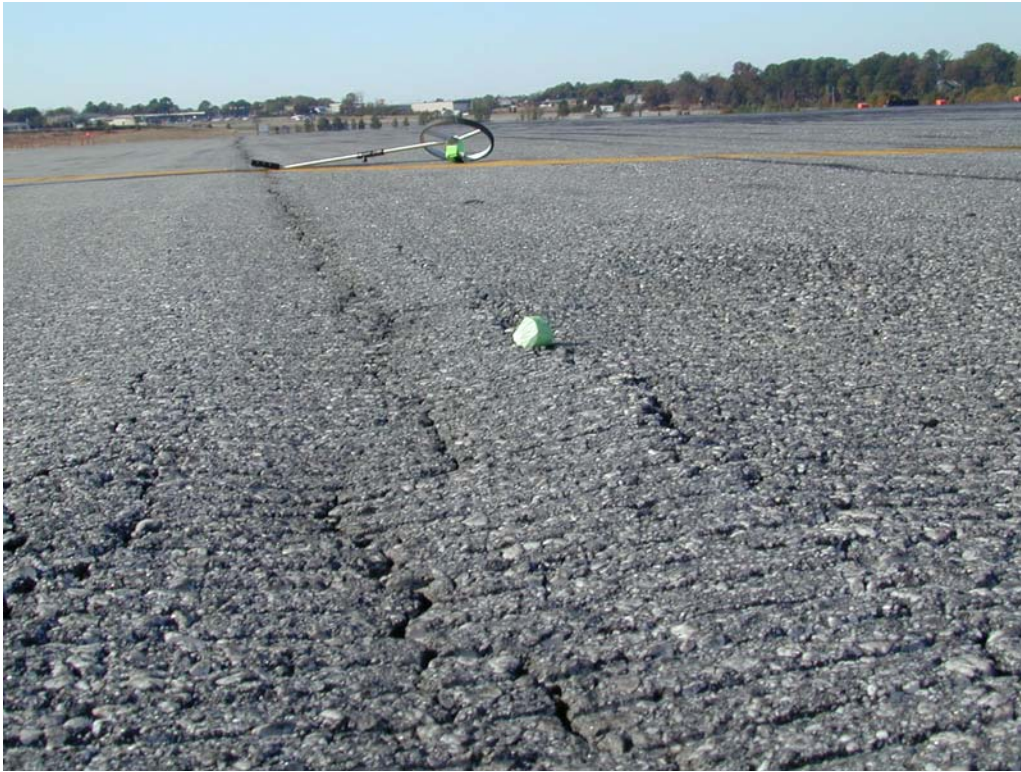
L&T cracking with swell in section R523CL-10.

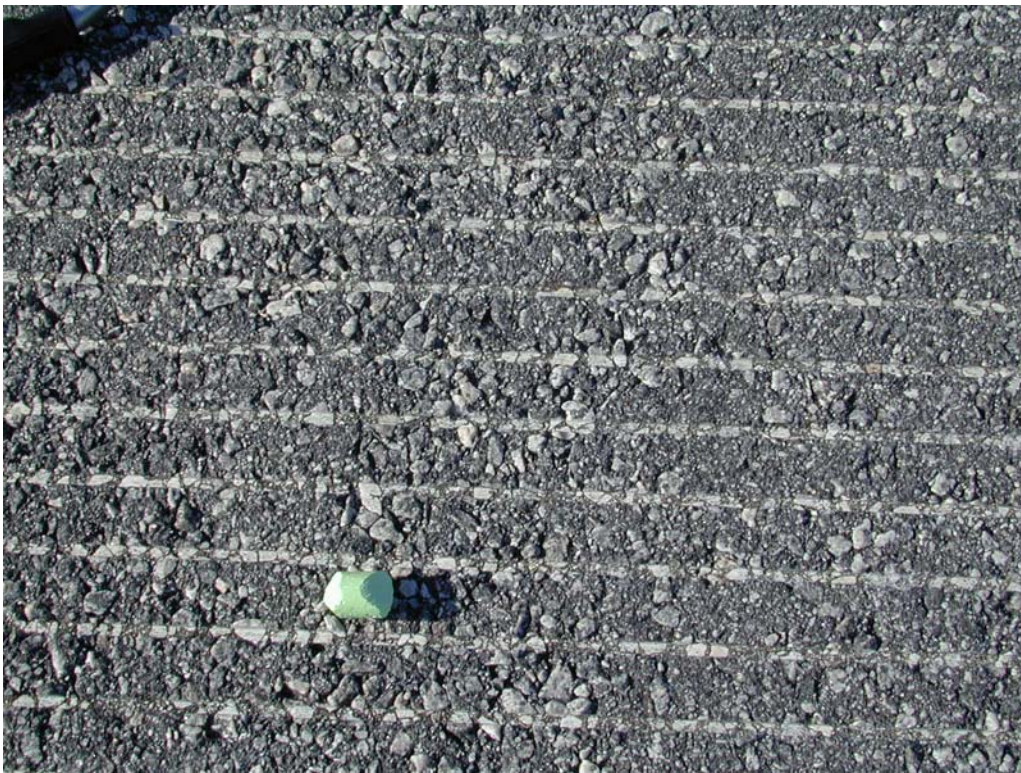
Weathering in section R523CL-10C.

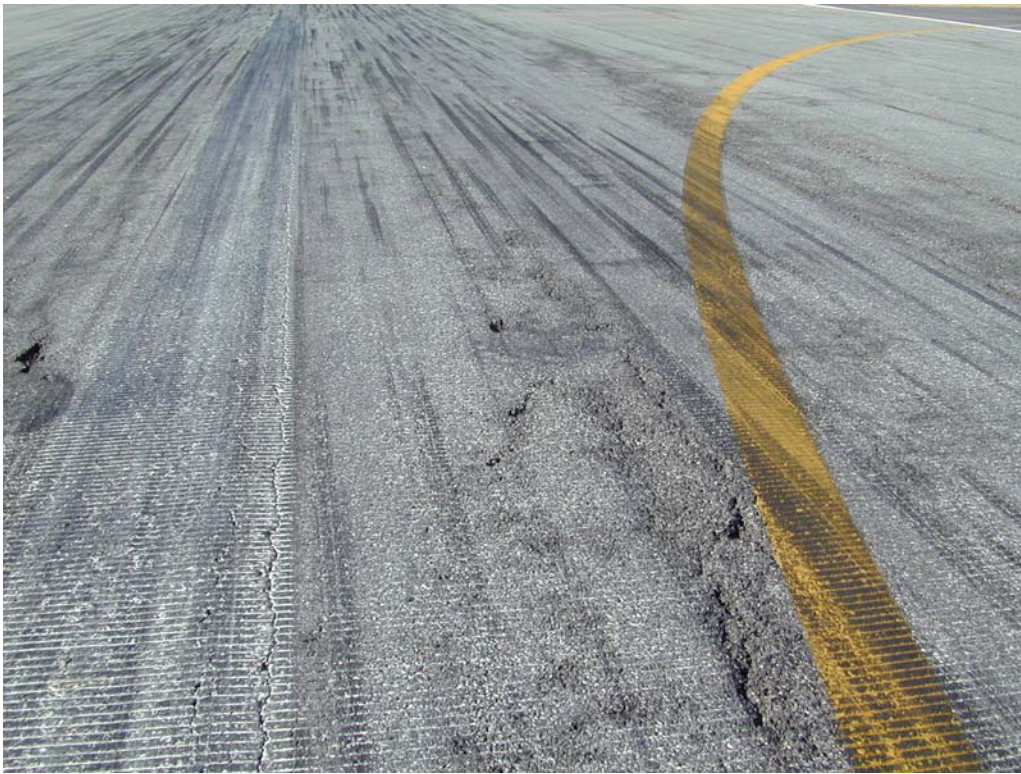
Overview of spring 2002 rehabilitation in section R523CL-10C.

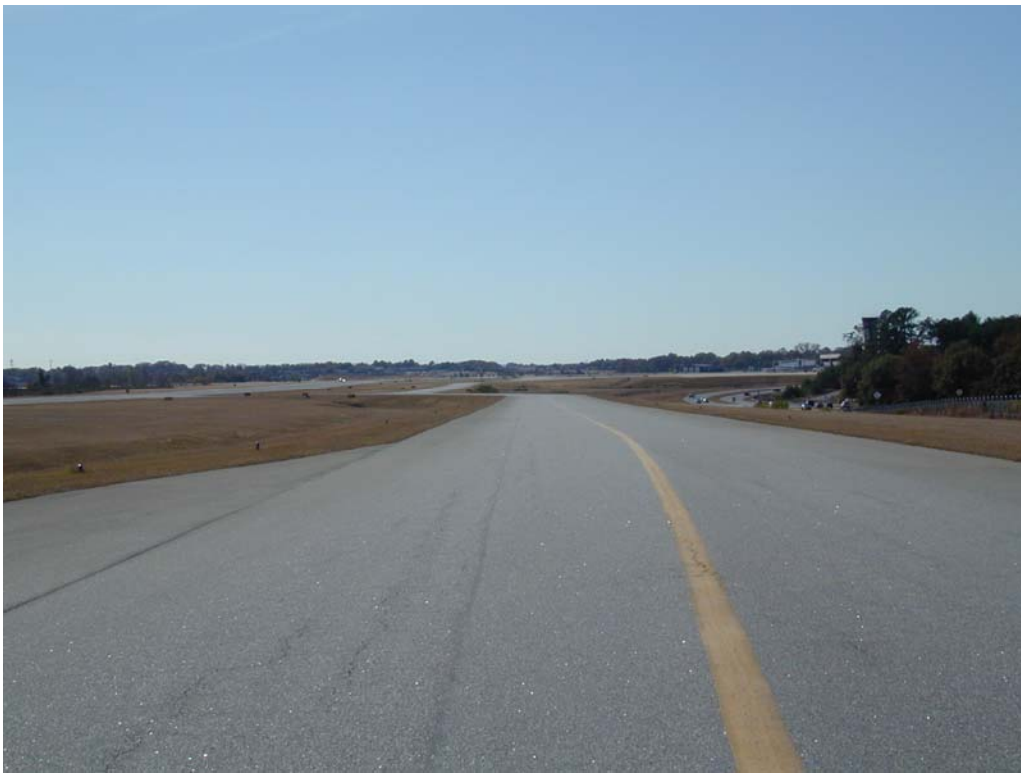
Taxiway C is the parallel taxiway for Runway 5-23, and it is composed of sections TCCL-10, TCCL-20, TCCL-30, and TCCL-40. Sections TCCL-10 and TCCL-20 are in good condition with both exhibiting moderate amounts of unsealed, low-severity, block cracking and small quantities of unsealed, low-severity, L&T cracking. Section TCCL-30 and TCCL-40 are also in slightly better condition but they are also exhibiting significant amounts of low-severity block and L&T cracking.

Overview of section TCCL-10.

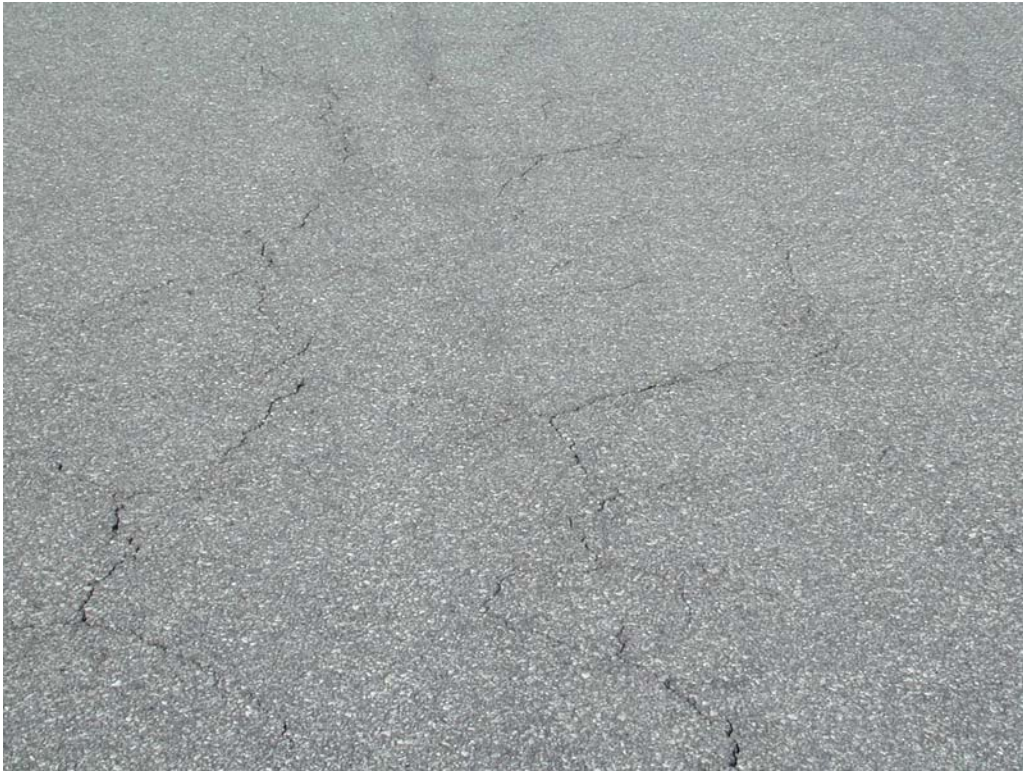
Block cracking in section TCCL-10.

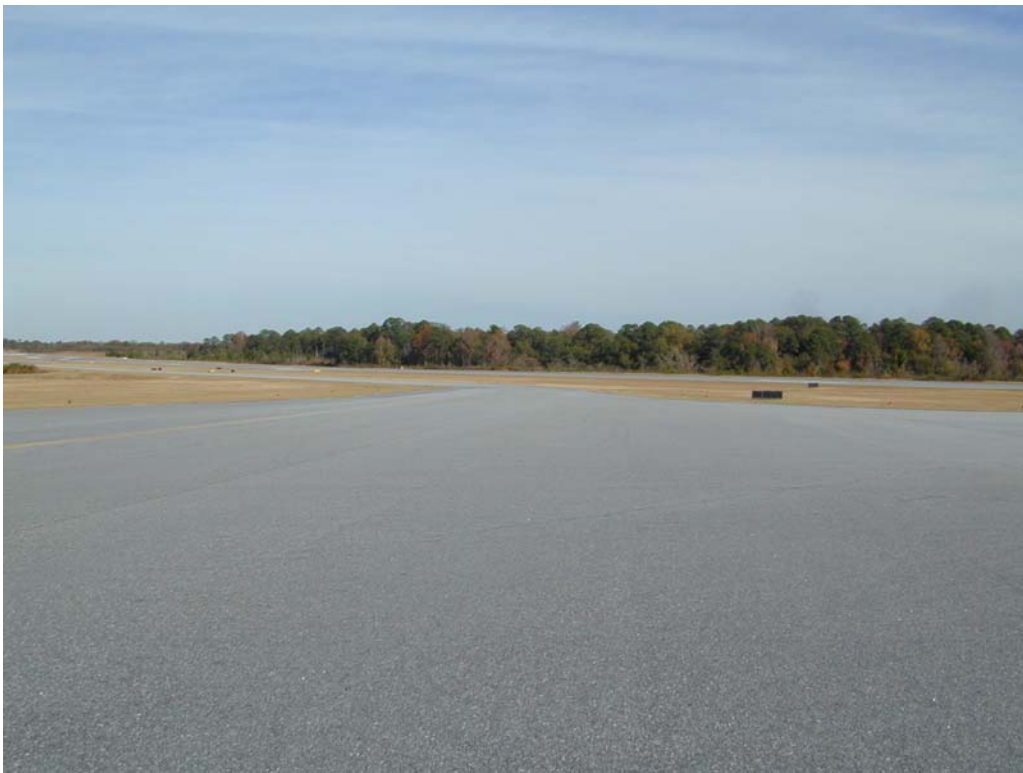
Overview of section TCCL-30.

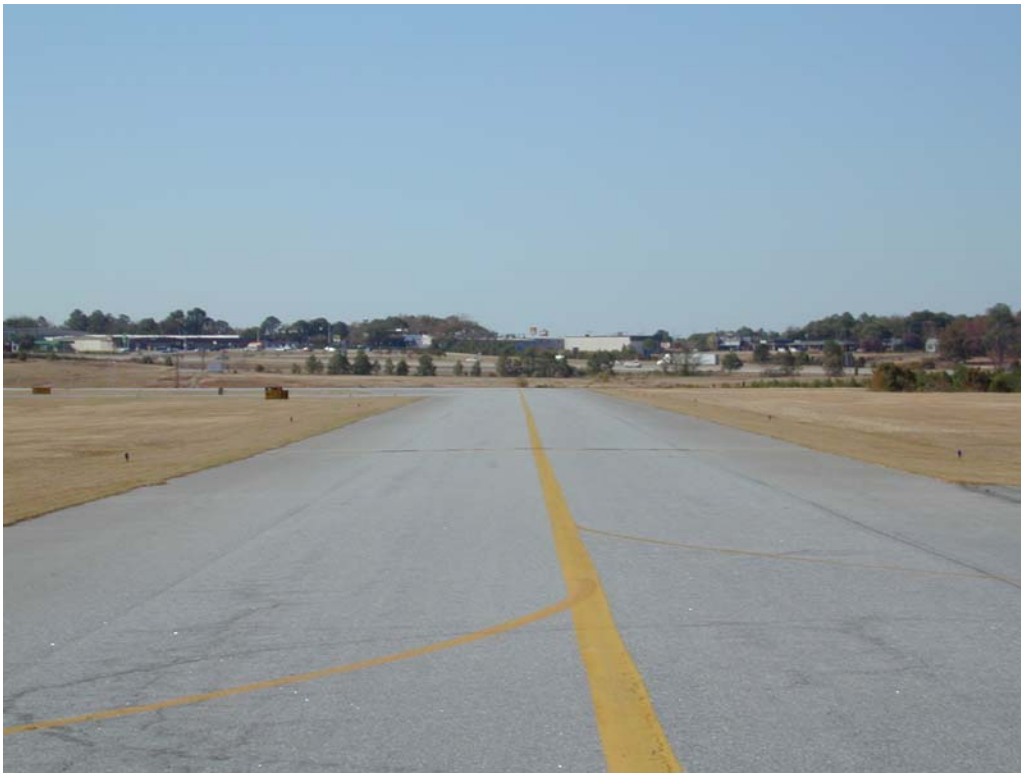
Overview of section TCCL-40.

Plan Year	Network	Branch	Section	Distress Description	Severity	Work Description	Work Qty.	Work Unit	Unit Cost	Work Cost
2002	COLUMBUS	R523CL	10E	L & T CR	M	Crack Sealing	7,504	LF	\$3.20	\$24,014
2002	COLUMBUS	TCCL	40	L & T CR	M	Crack Sealing	278	LF	\$3.20	\$890

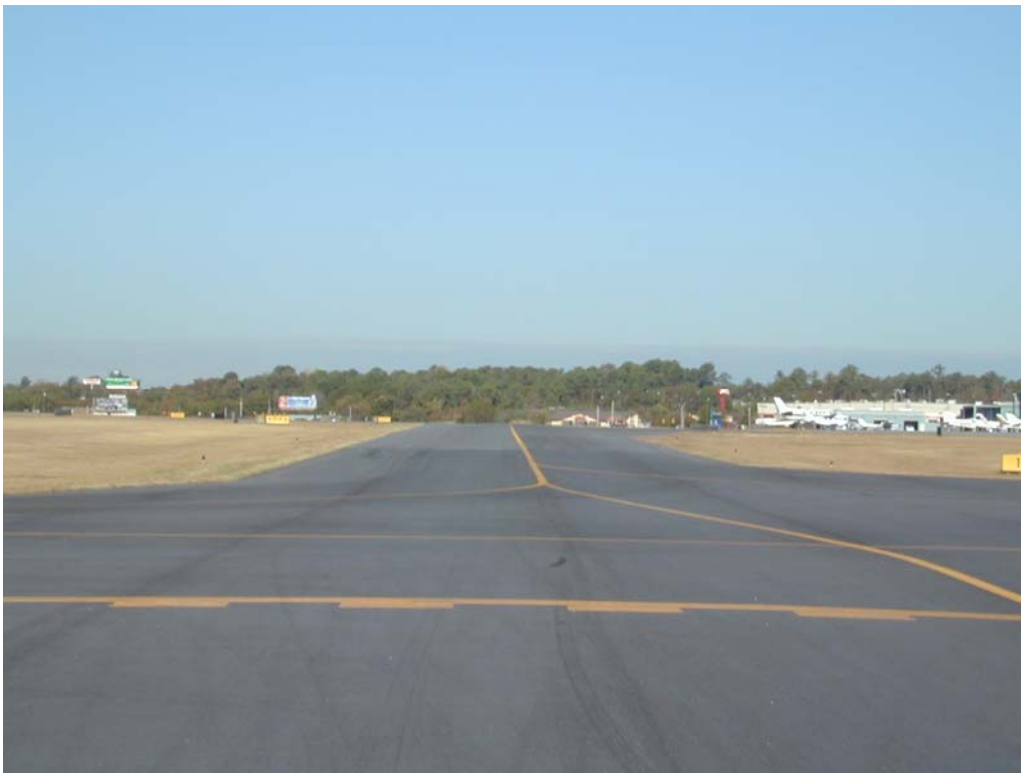
Taxiway D runs parallel to Runway 12-30 along the runways east side, and it is divided into two sections along its length, TDCL-10 and TDCL-20. Both sections are in excellent condition with no observed distresses.

Overview of section TDCL-10.

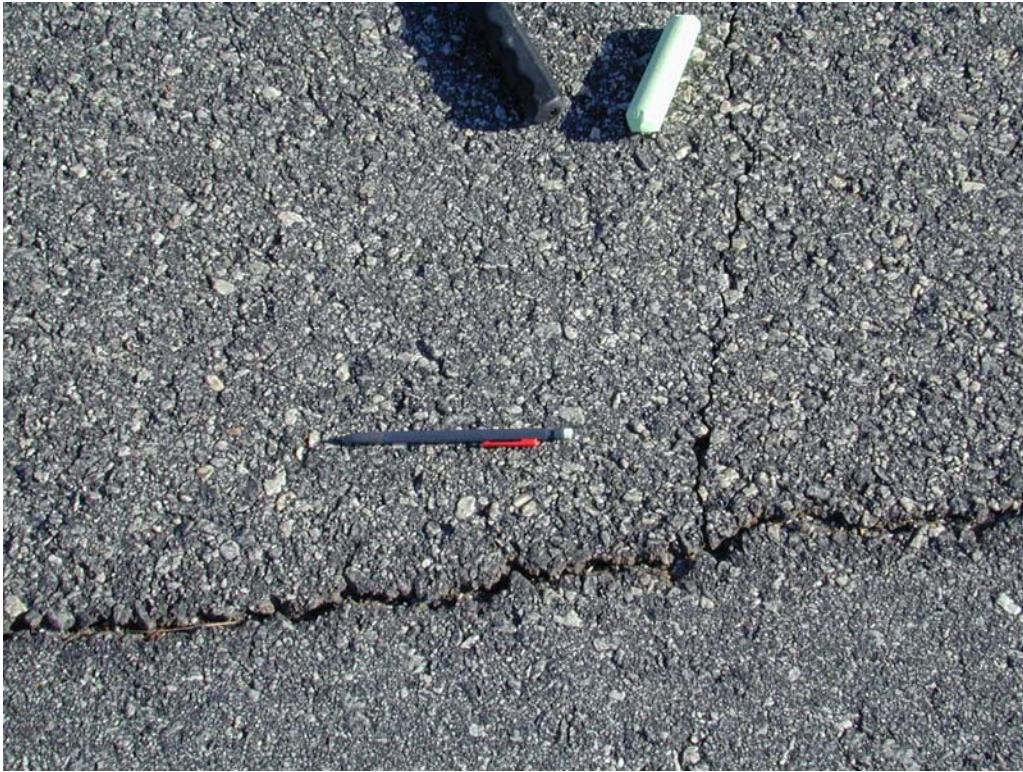
Taxiway F runs parallel to Runway 12-30 along the runways west side, and it is divided into 4 sections, TFCL-10, TFCL-20, TFCL-30, and TFC -40. Sections TFCL-10 is in good condition with moderate amounts of unsealed, low-severity, L&T cracking. Section TFCL-20 is also in good condition with the predominant distress being low-severity alligator cracking. Sections TFCL-30 and TFCL -40 are in excellent condition with no noted distresses in either section.

L&T cracking in section TFCL-10.

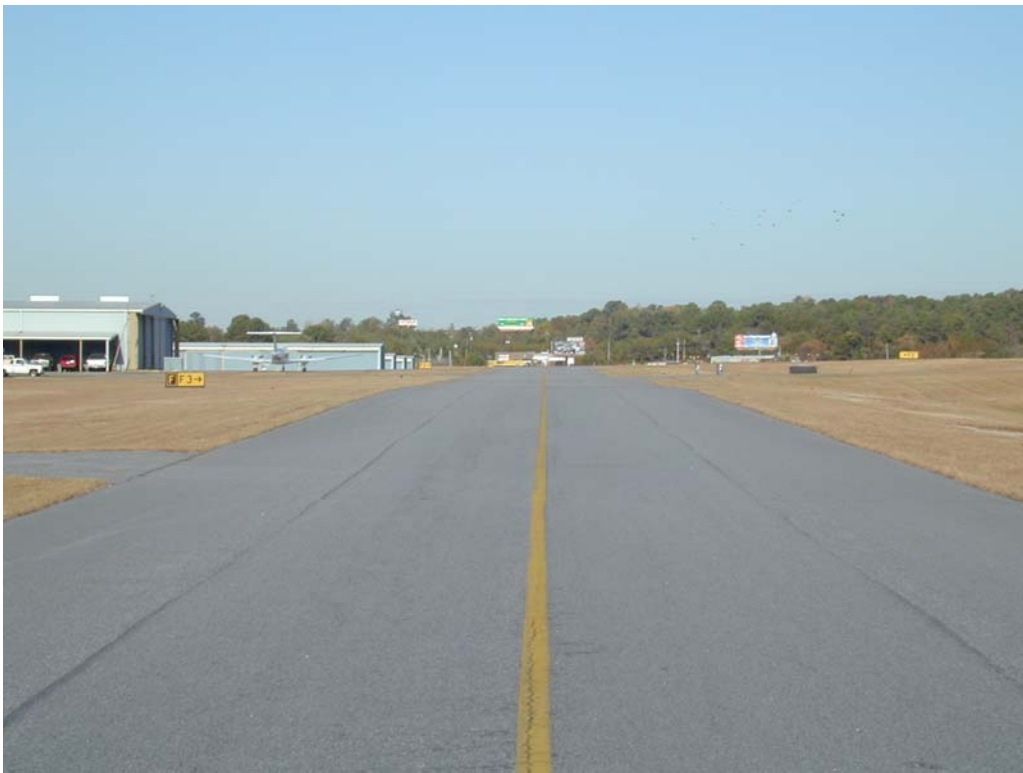
Overview of section TFCL-20.

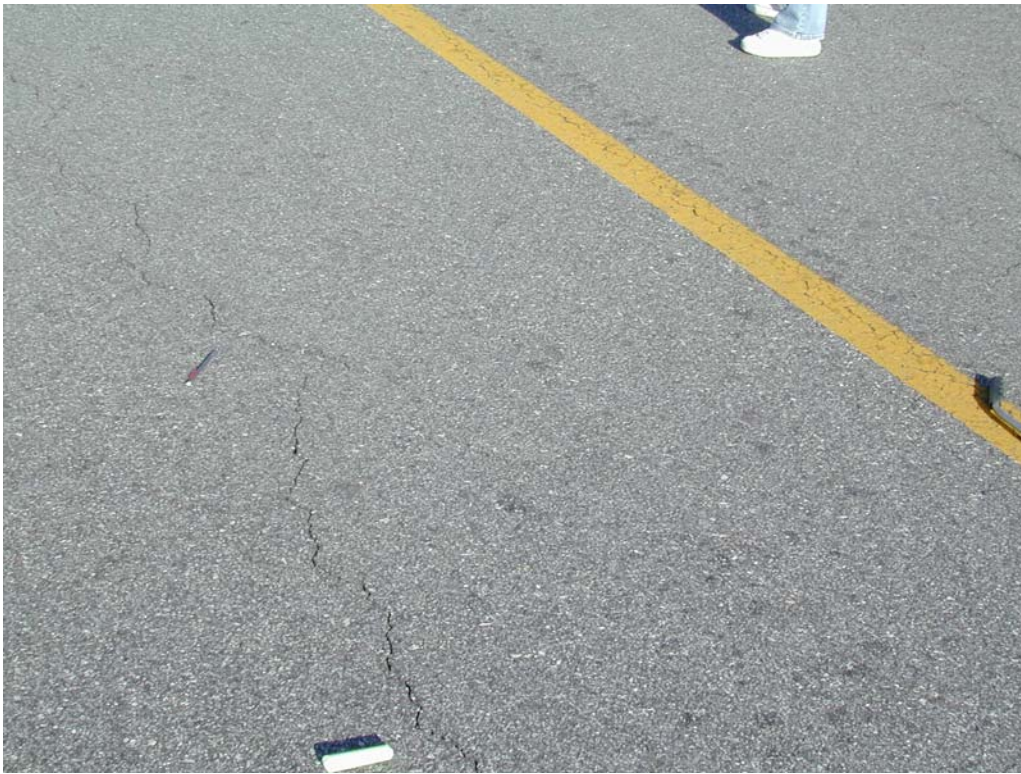
Alligator cracking in section TFCL-20.

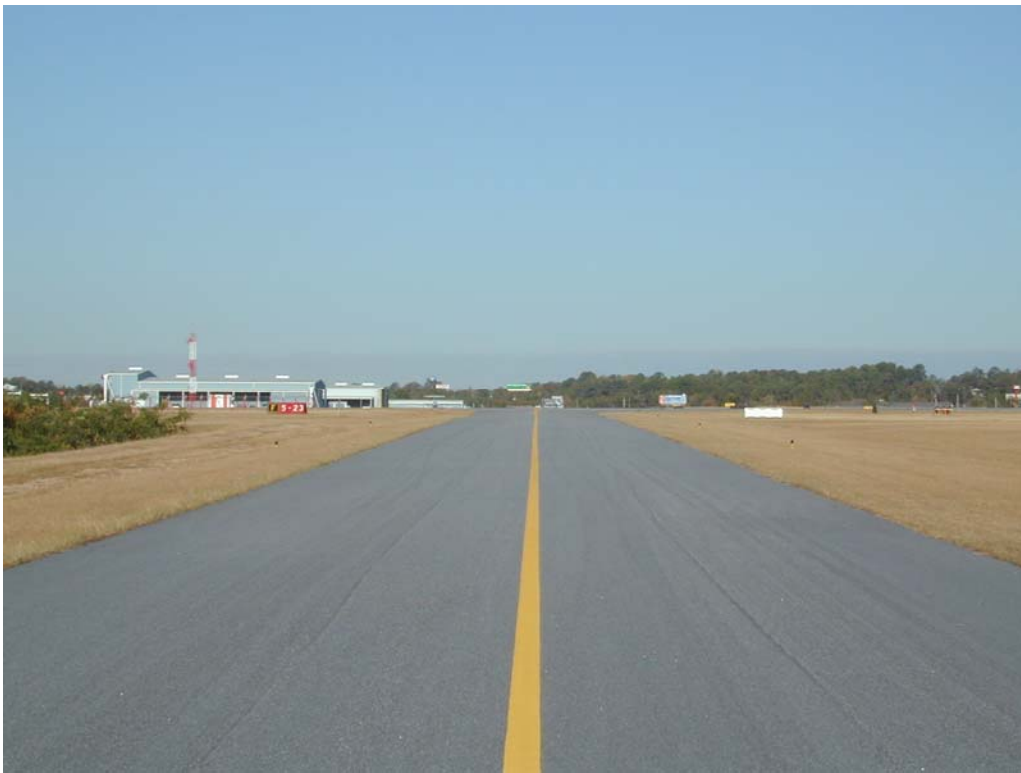
Overview of section TFCL-40.

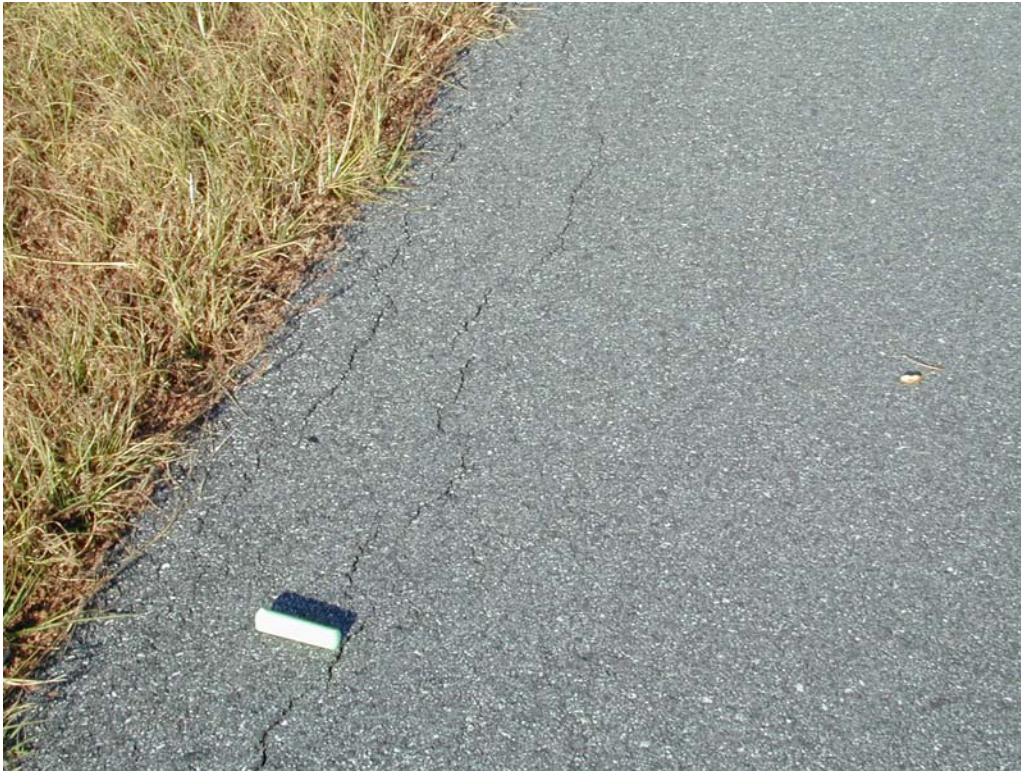
Edge cracking in section TFCL-40.

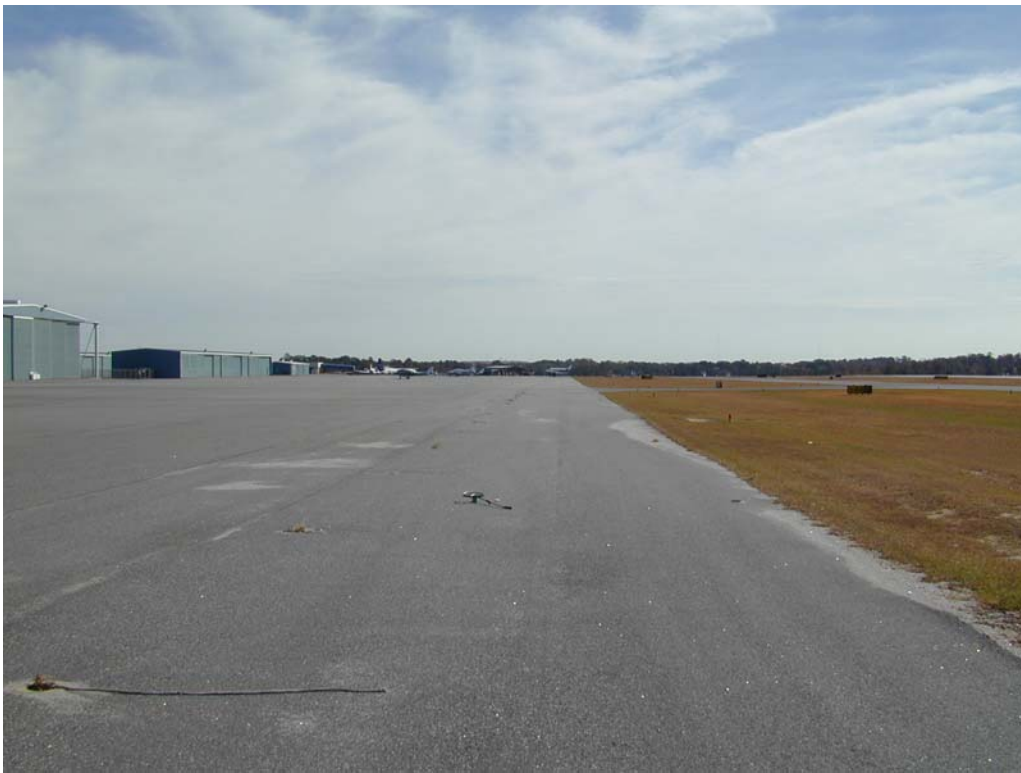
Section A01CL-10 is in very good condition with limited amounts of low-severity L&T cracking. Section A01CL-20 was closed to aircraft and surrounded by fencing in preparation for rehabilitation to occur in the spring of 2002.

Overview of section A01CL-10.

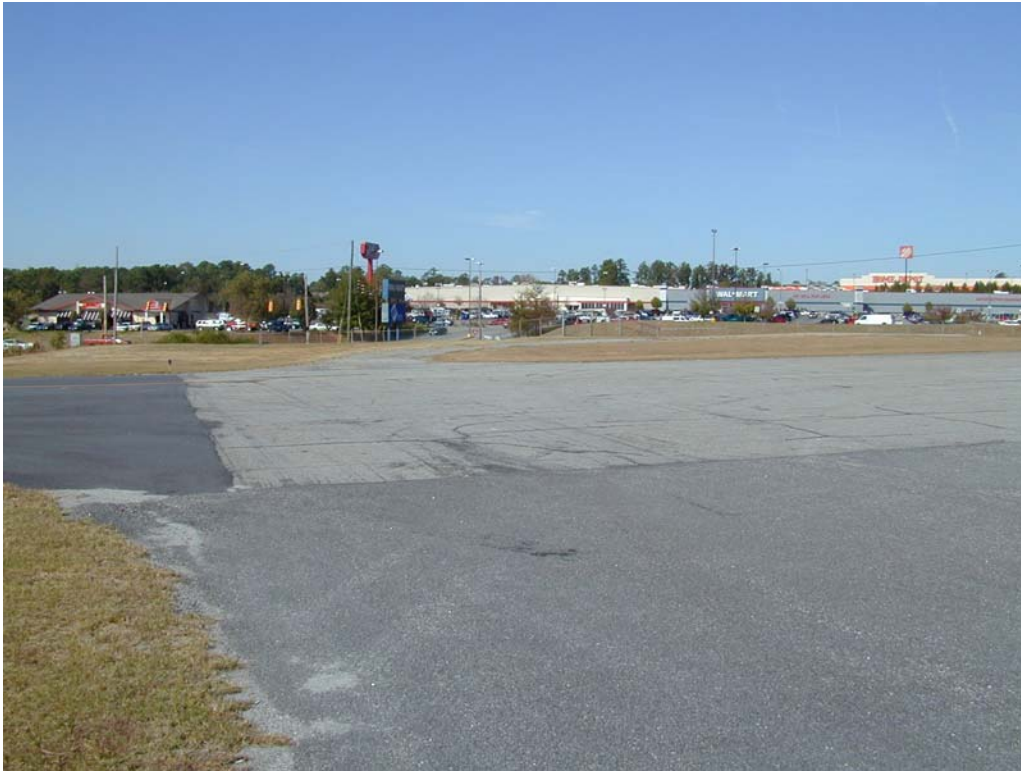
Overview of end of section A01CL-10.

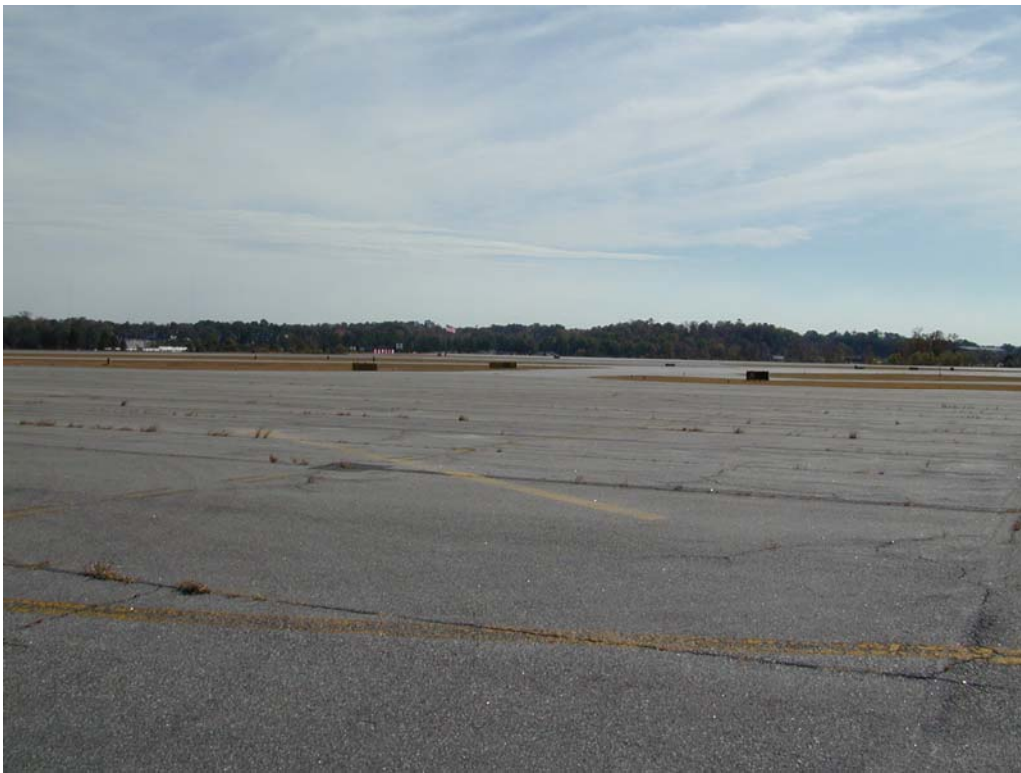
Overview of section A01CL-20 prior to rehabilitation.

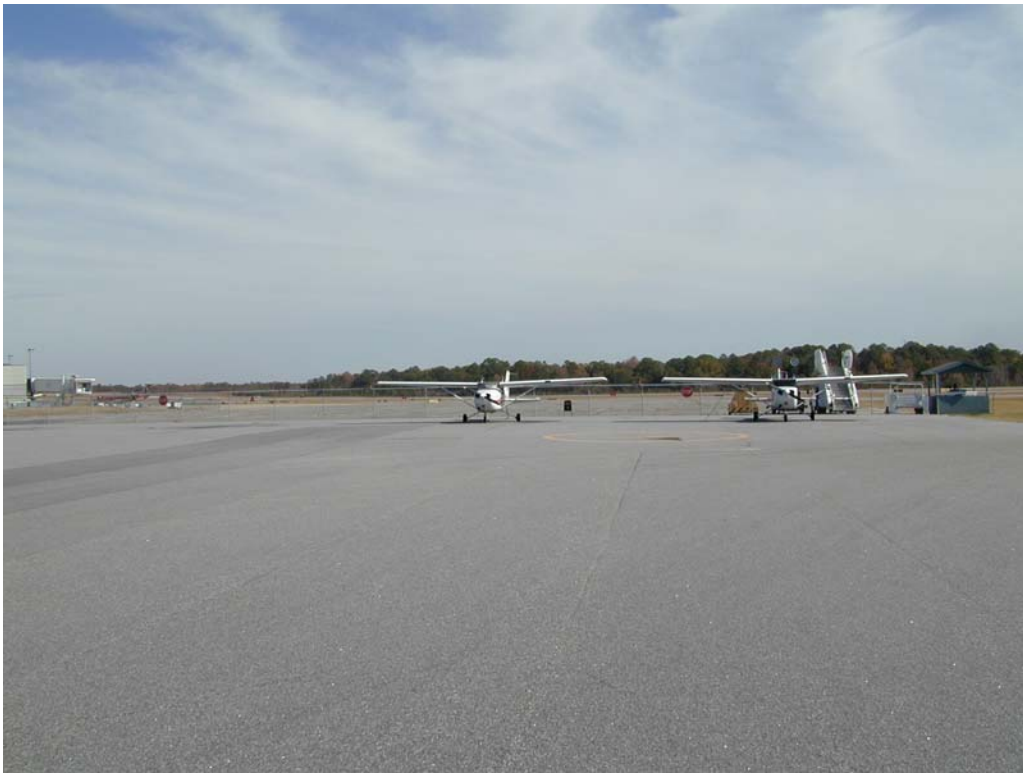
Overview of section A02CL-10.

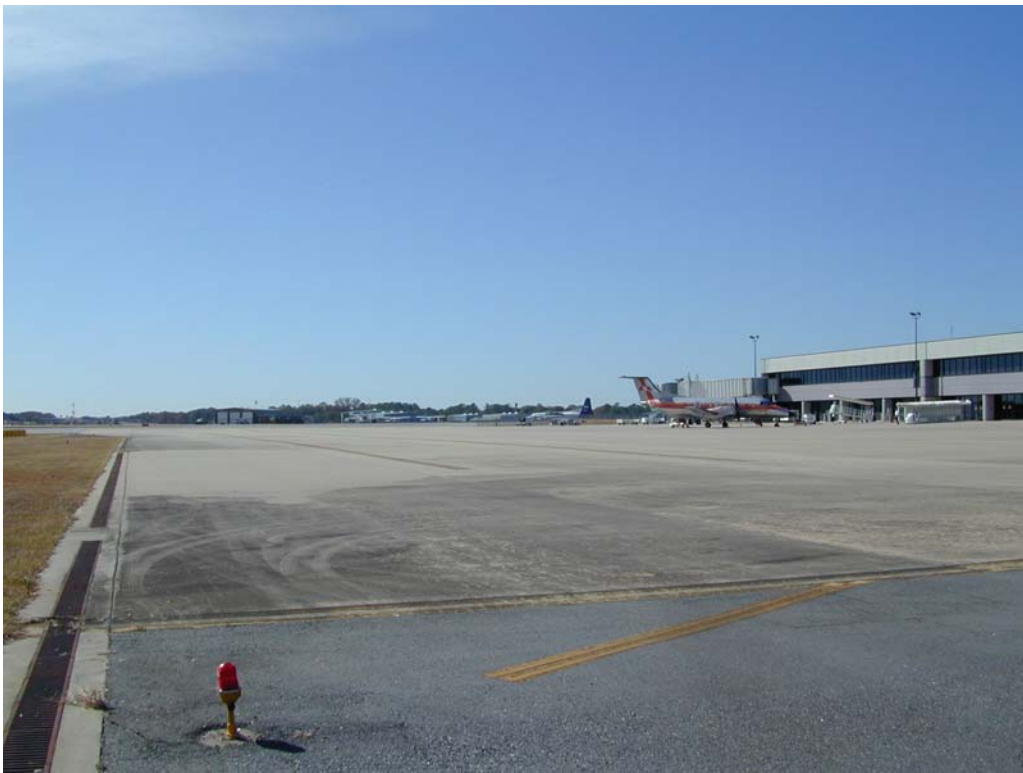
The terminal apron, ATERMVL-10, is in excellent condition with only sporadic low-severity corners spalls identified.

Overview of section ATERMCL-10.

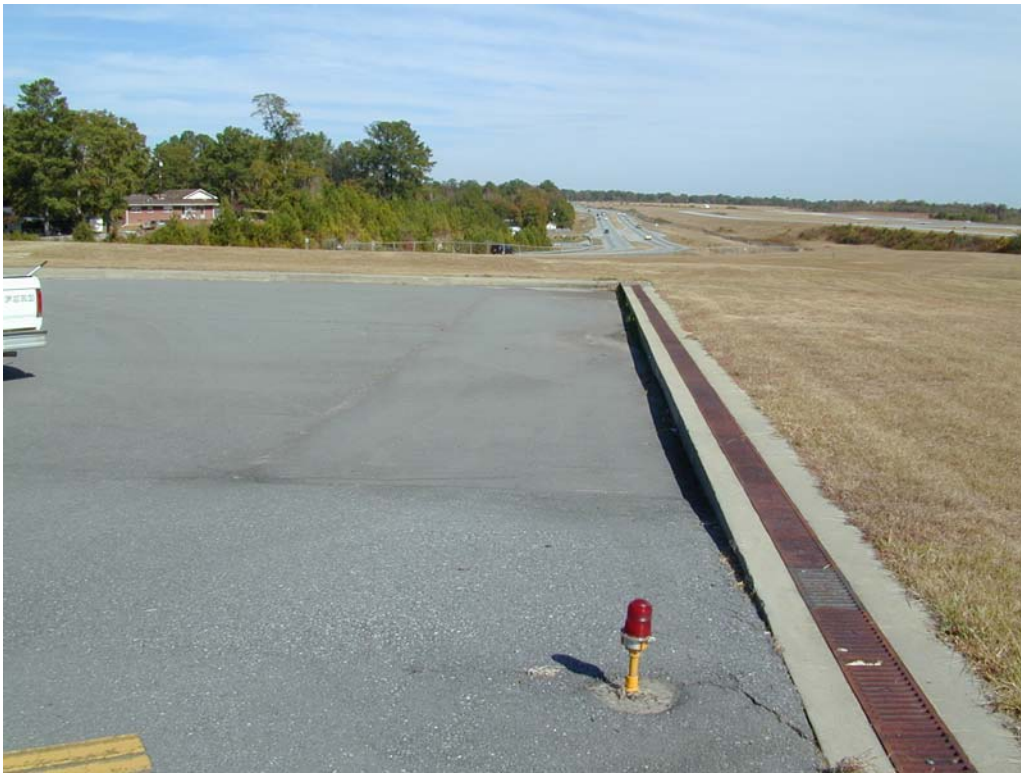
Overview of shoulder and edge drains in section ATERMCL-10.

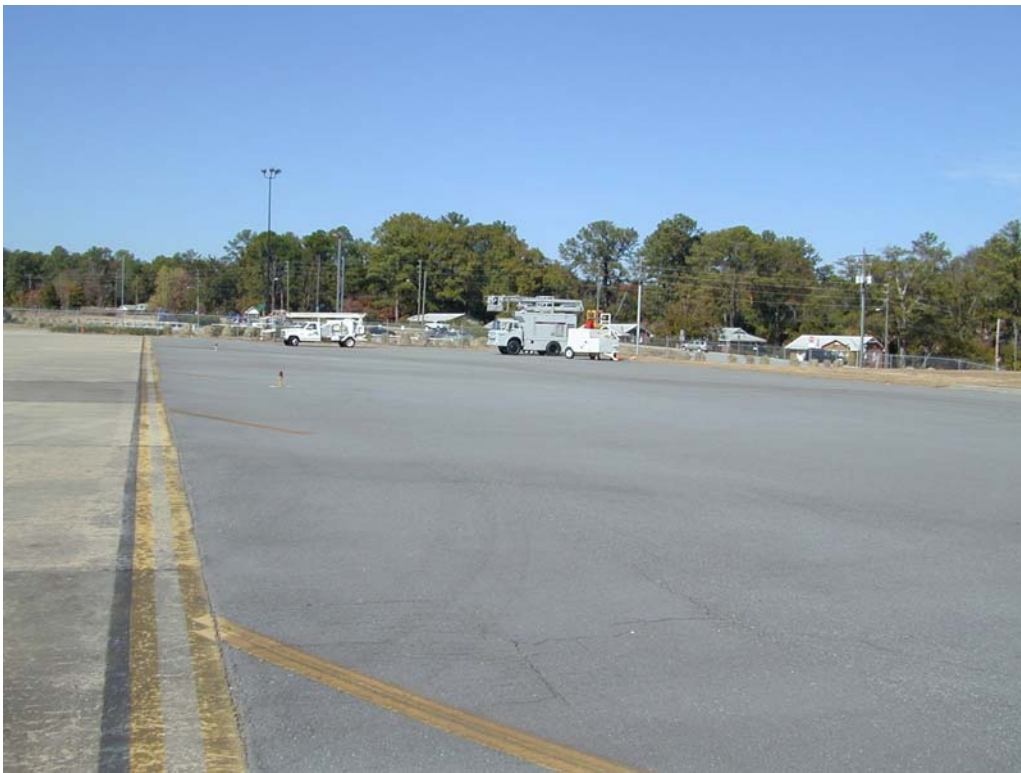
Overview of shoulder in section ATERMCL-10.

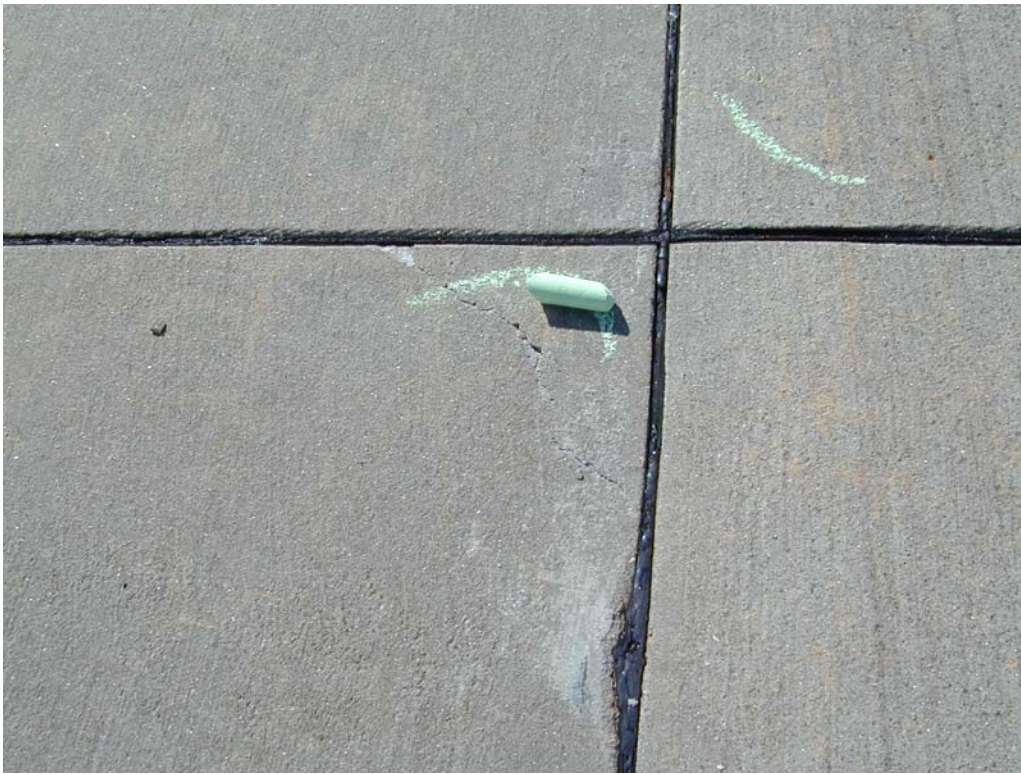
Corner spall in section ATERMCL-10.

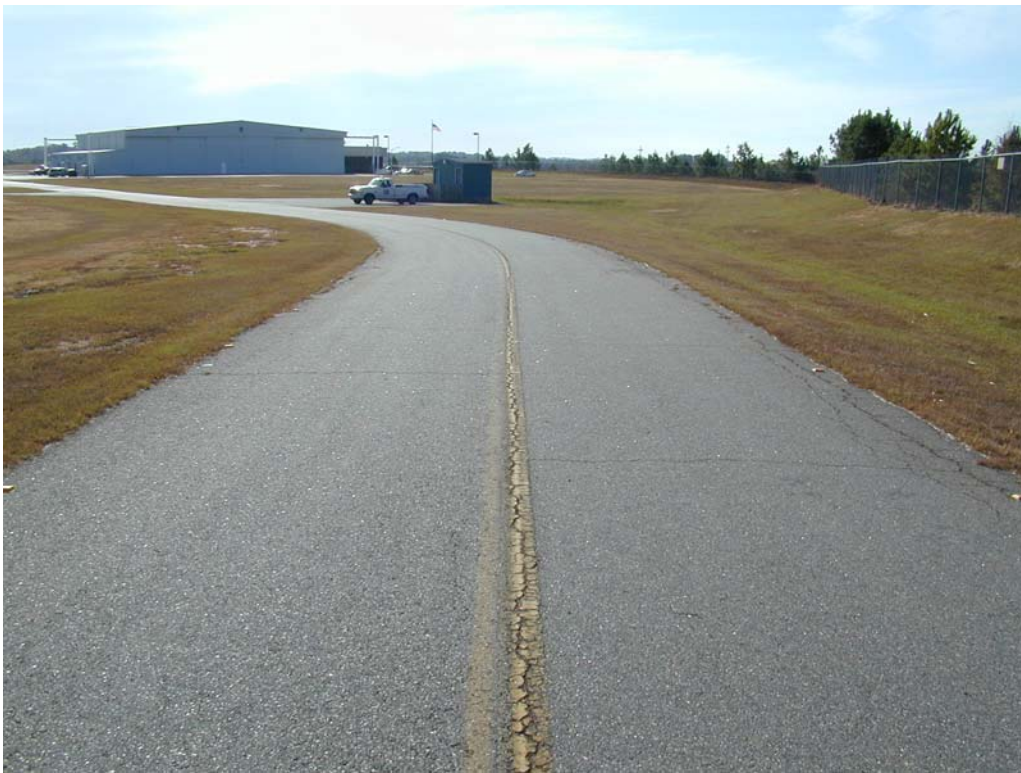
The T-Hanger area is located in the northwestern portion of the airport and it is composed of one section, THANGCL-10. The pavement is in fair condition with areas of low and medium-severity alligator cracking and unsealed, low-severity, L&T cracking.

Overview of section THANGCL-10.
