FULTON COUNTY - BROWN FIELD

PAVEMENT EVALUATION REPORT

JULY 2002

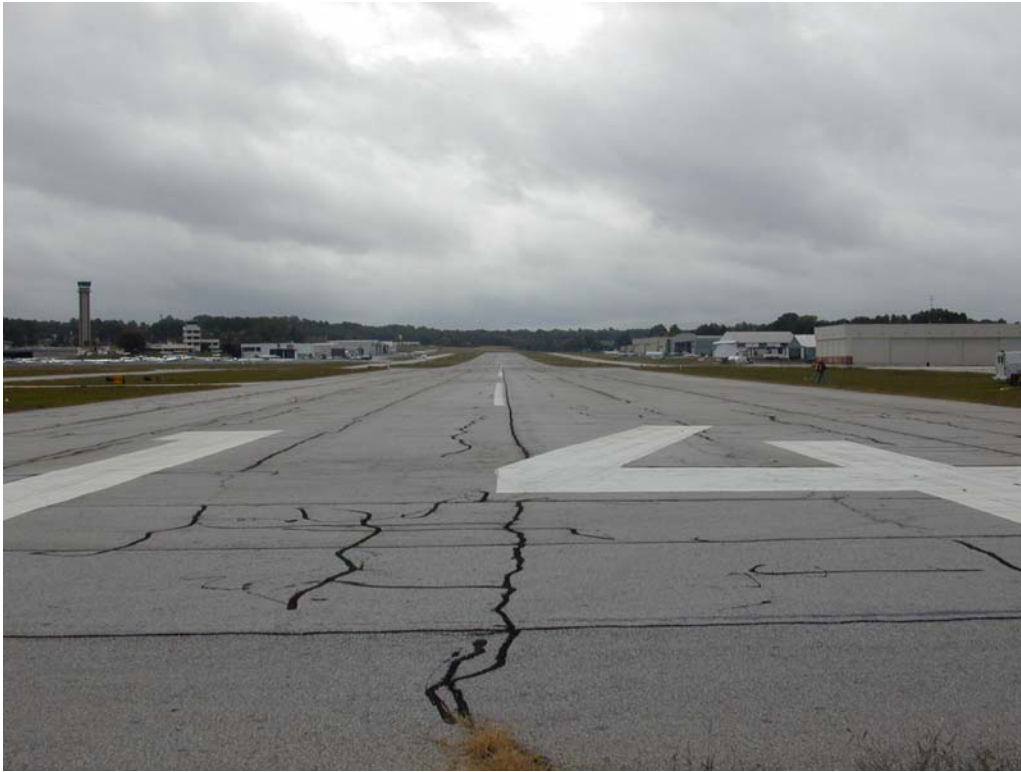
Runway 14-32, defined by one section, is in fair condition. Moderate amounts of low-severity block and L&T cracking were found throughout the runway. In addition, isolated areas of alligator cracking, and medium-severity L&T cracking were observed. Most of the cracks were sealed.

Overview of section R1432AB-10.

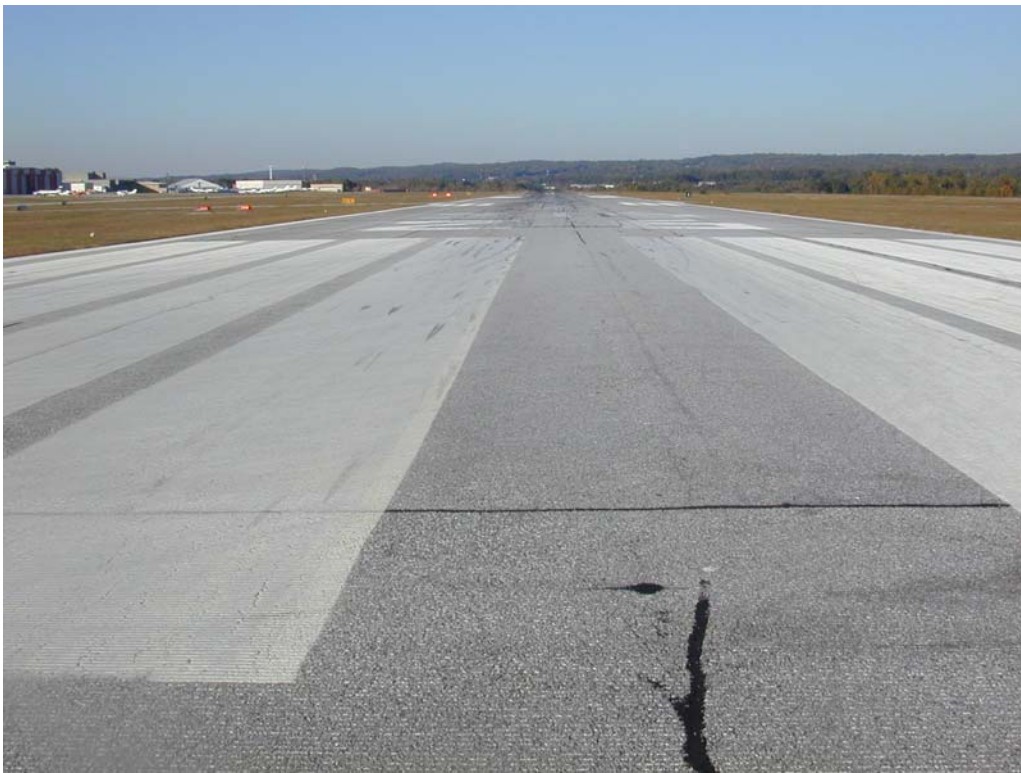
Runway 8-26 was defined by one section and is in fair condition. The primary distresses on RW826AB-10 were low-severity longitudinal and transverse (L&T) cracking, alligator cracking, and raveling and weathering. In addition, small quantities of medium-severity alligator and L&T cracking were also observed. Most of the cracks were sealed and were found along paving lane joints. Isolated areas of high-severity raveling and weathering were also found.

Overview of section R826AB-10.

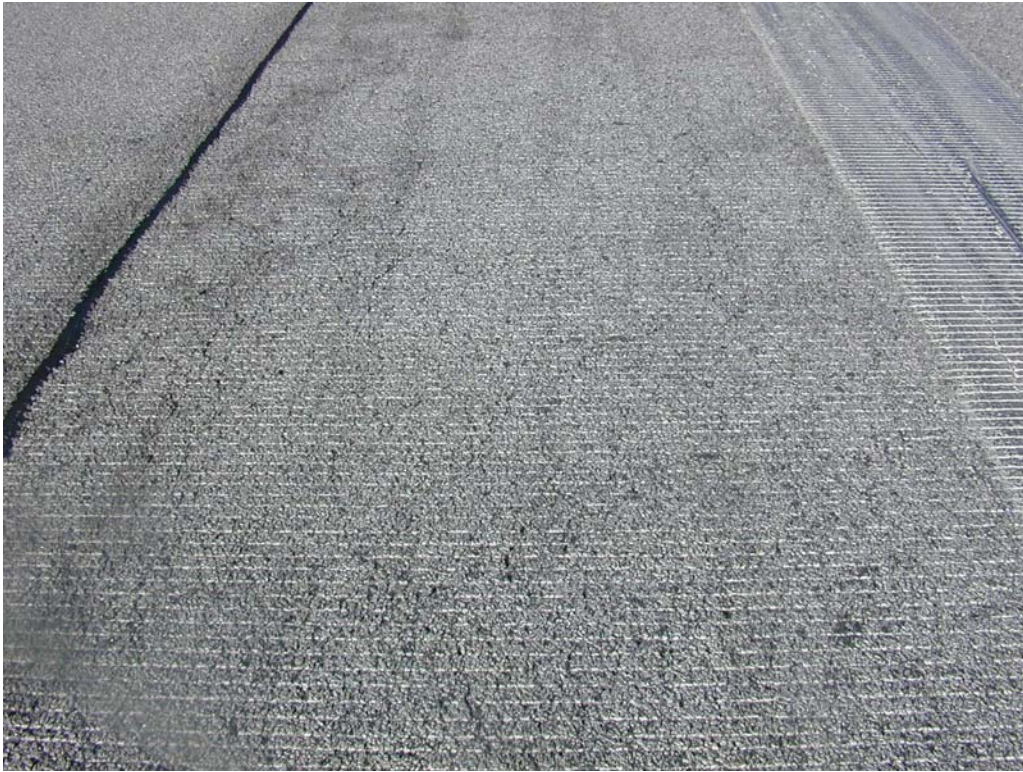
Alligator cracking in section R826AB-10.

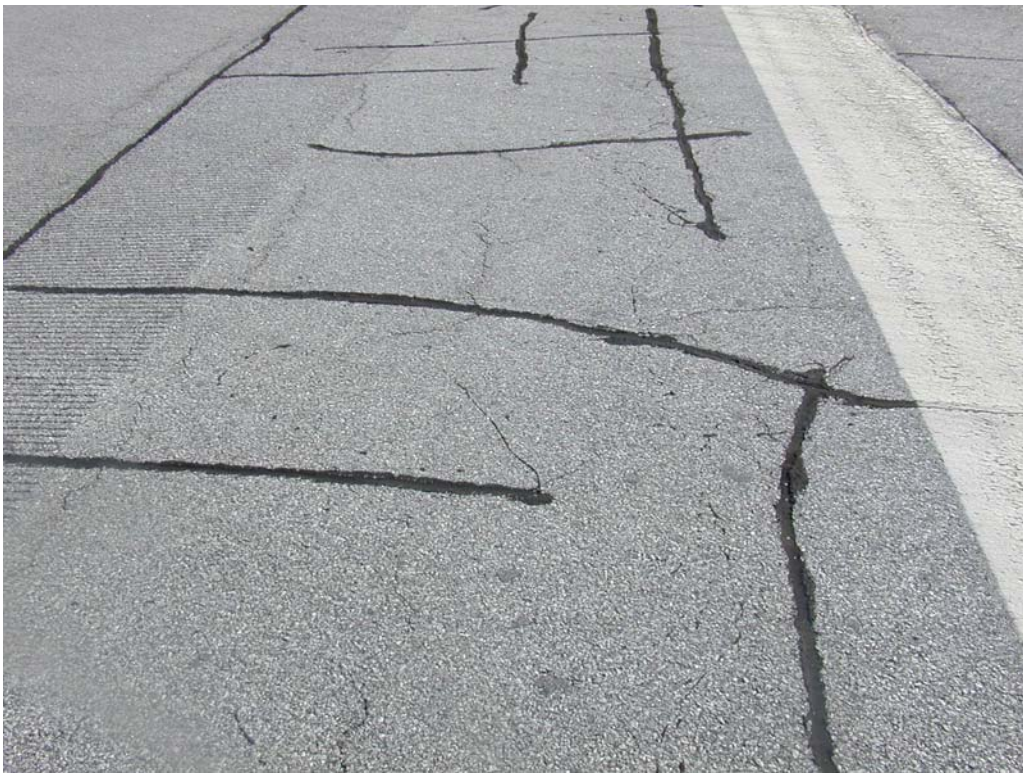
Block cracking in section R826AB-10.

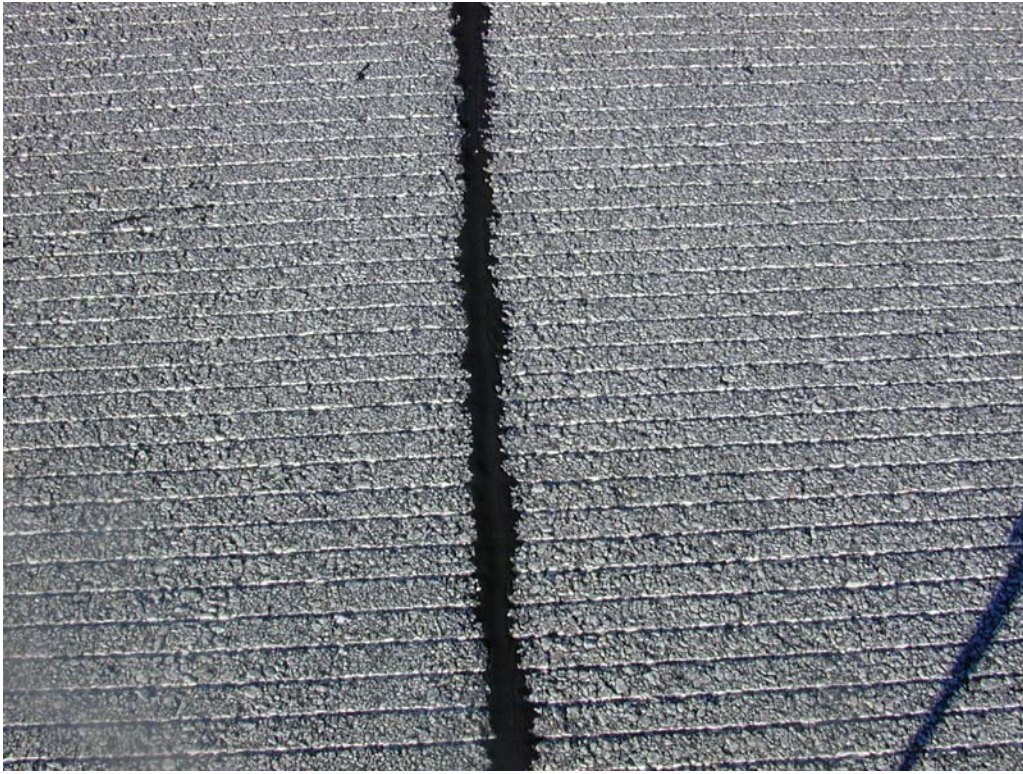
L&T cracking in section R826AB-10.

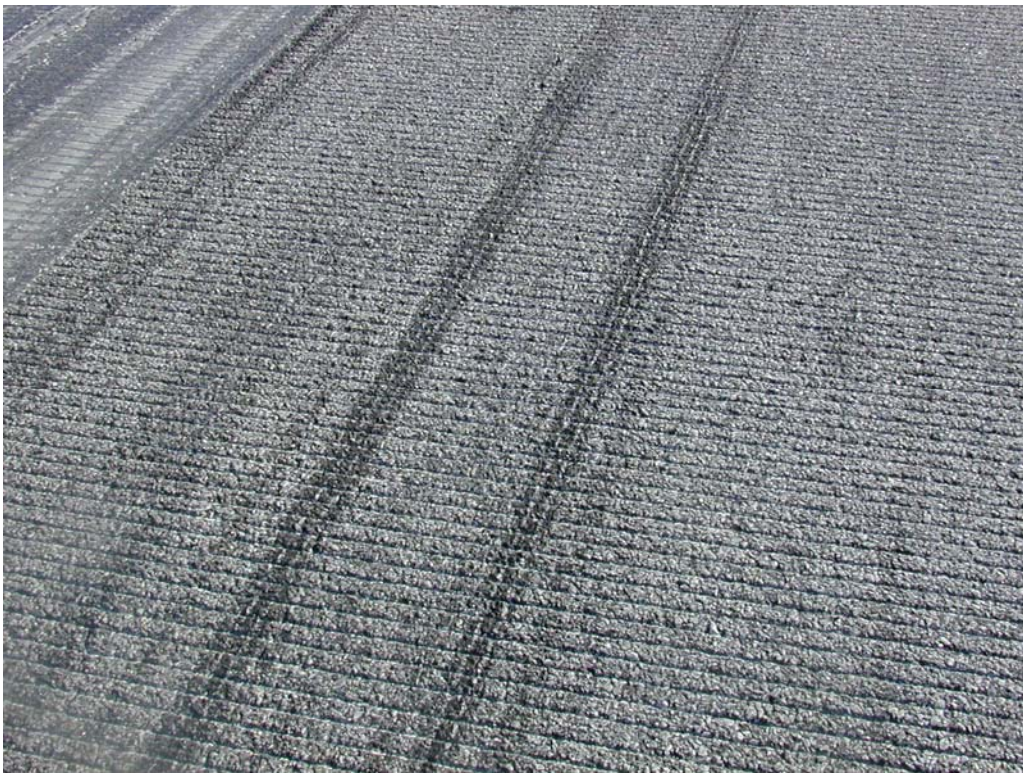
Weathering in section R826AB-10.

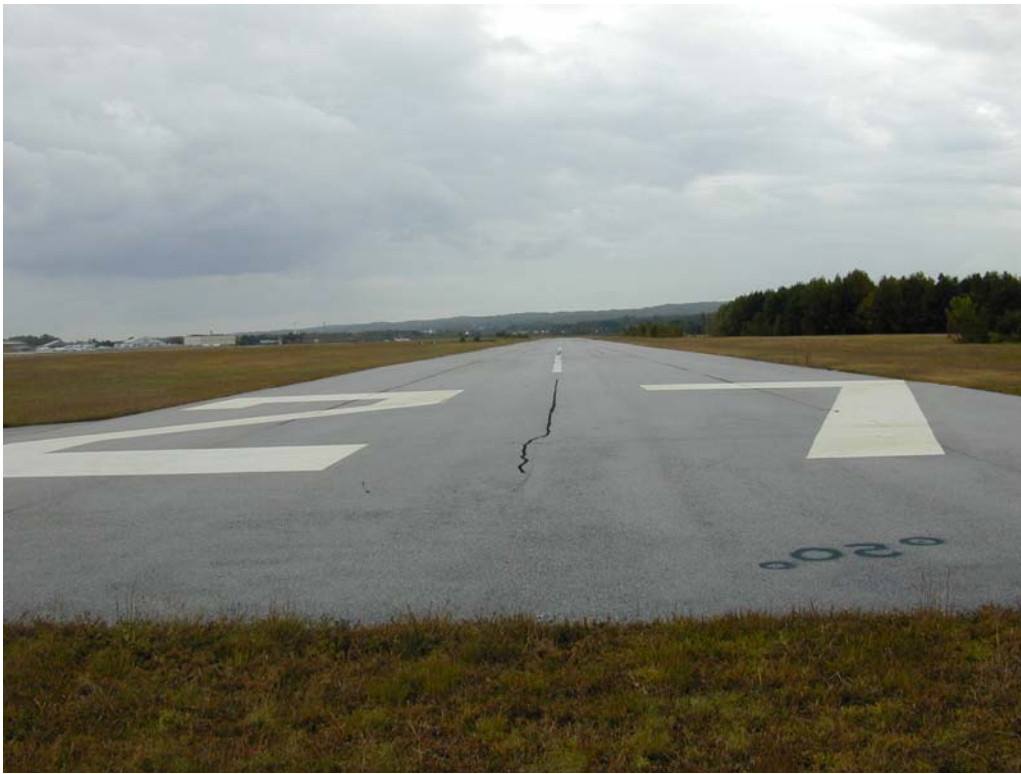
Runway 9-27 also consisted of one section and was in fair condition. The primary distress found on the runway was low severity, sealed, L&T cracking. Small quantities of medium-severity L&T cracking were also found due to sealant that had failed. In addition, isolated areas of raveling and weathering were observed.

Overview of section R927AB-10.

Plan Year	Network	Branch	Section	Distress Description	Severity	Work Description	Work Qty.	Work Unit	Unit Cost	Work Cost
2002	ATL-FTY	A01AB	10	L & T CR	M	Crack Sealing	1,824	LF	\$1.28	\$2,334
2002	ATL-FTY	R927AB	10	L & T CR	M	Crack Sealing	2,280	LF	\$1.28	\$2,918

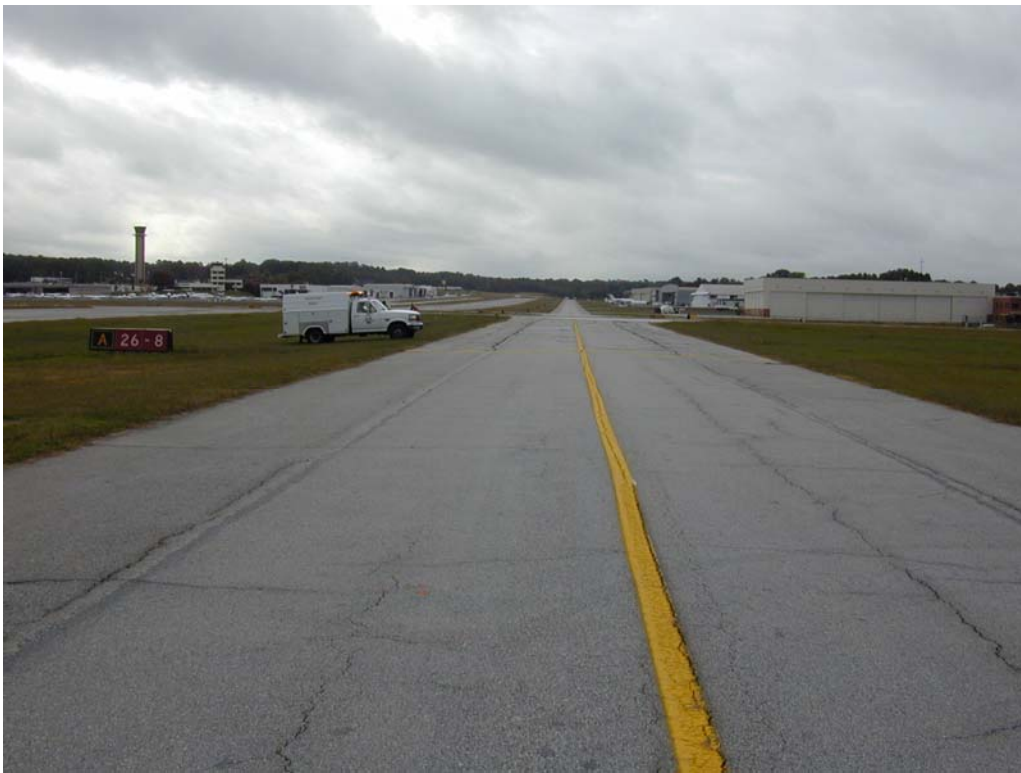
One section, running full length parallel to the Runway 14-32 on its west side, defines Taxiway A. TAAB-10 is in fair condition with moderate amounts of low-severity block and medium-severity L&T cracking. The majority of the cracking was found unsealed. Small quantities of medium-severity block cracking were also found.

Overview of section TAAB-10.

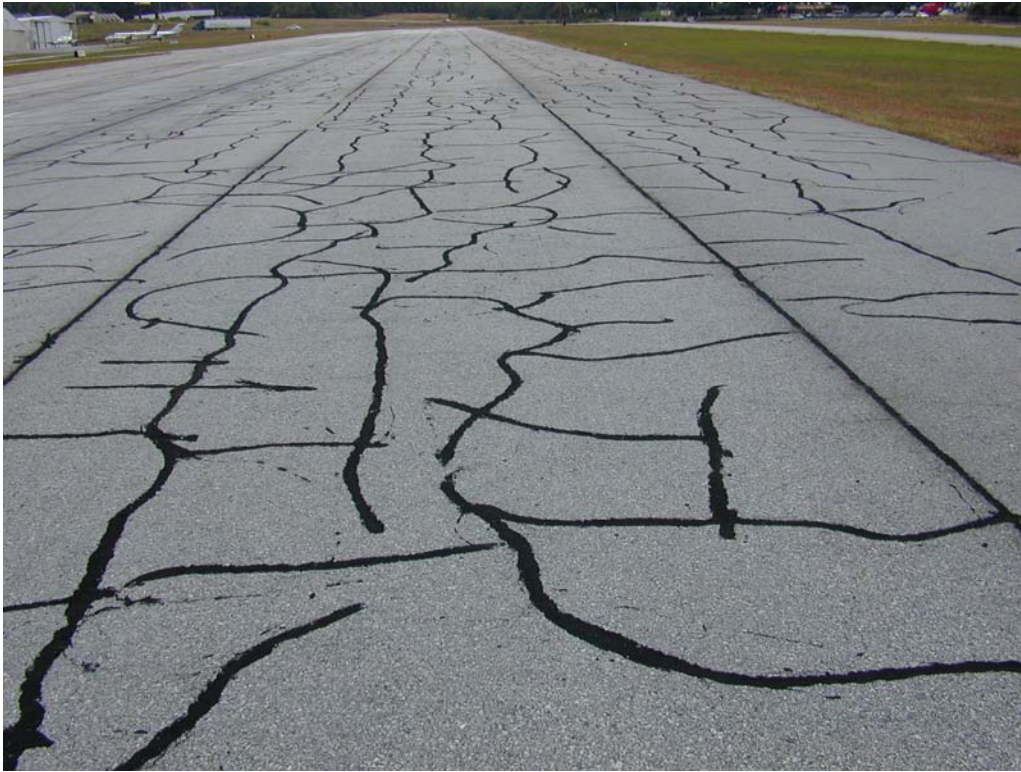
Block cracking in section TAAB-10.

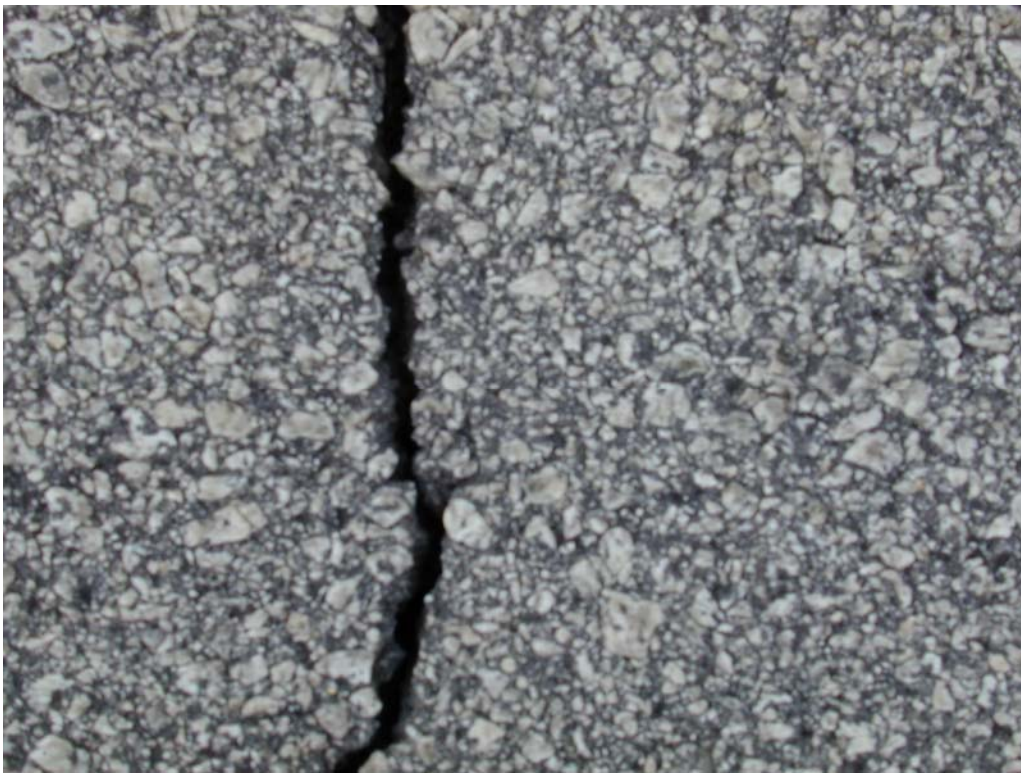
L&T cracking in section TAAB-10.

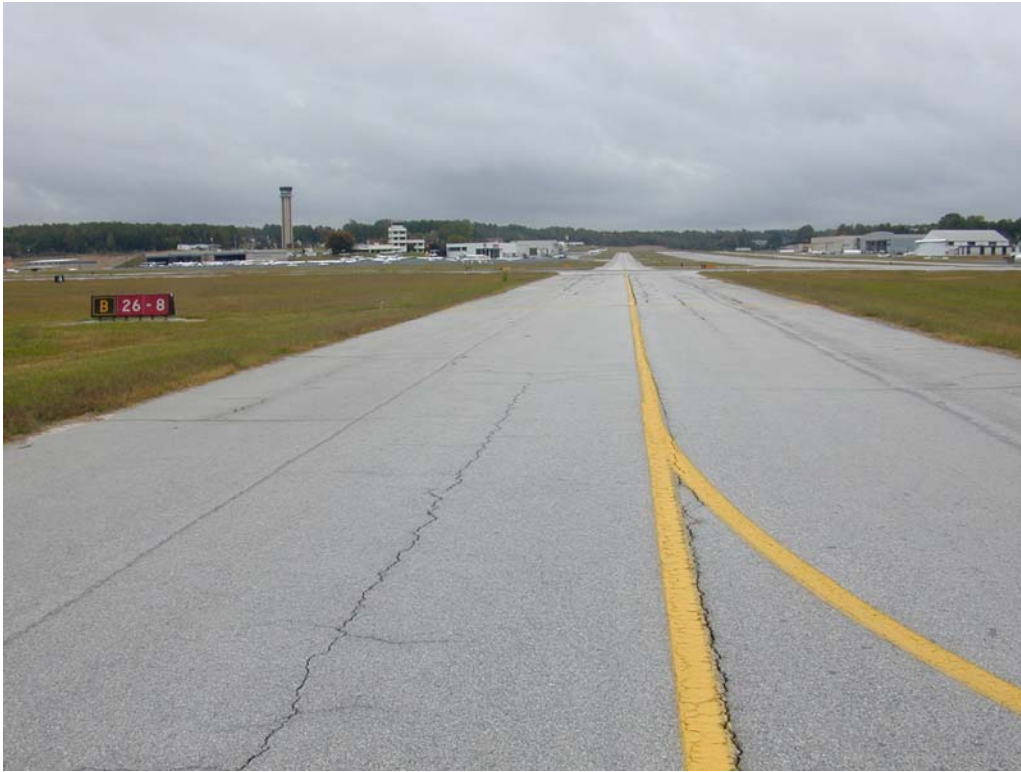
Similar to Taxiway A, Taxiway B runs parallel to the Runway 14-32 on its east side and is in fair condition. Moderate amounts of low and medium-severity block cracking, L&T cracking, and alligator cracking were found on this taxiway. The majority of all of the cracking was unsealed.

Overview of section TBAB-10.

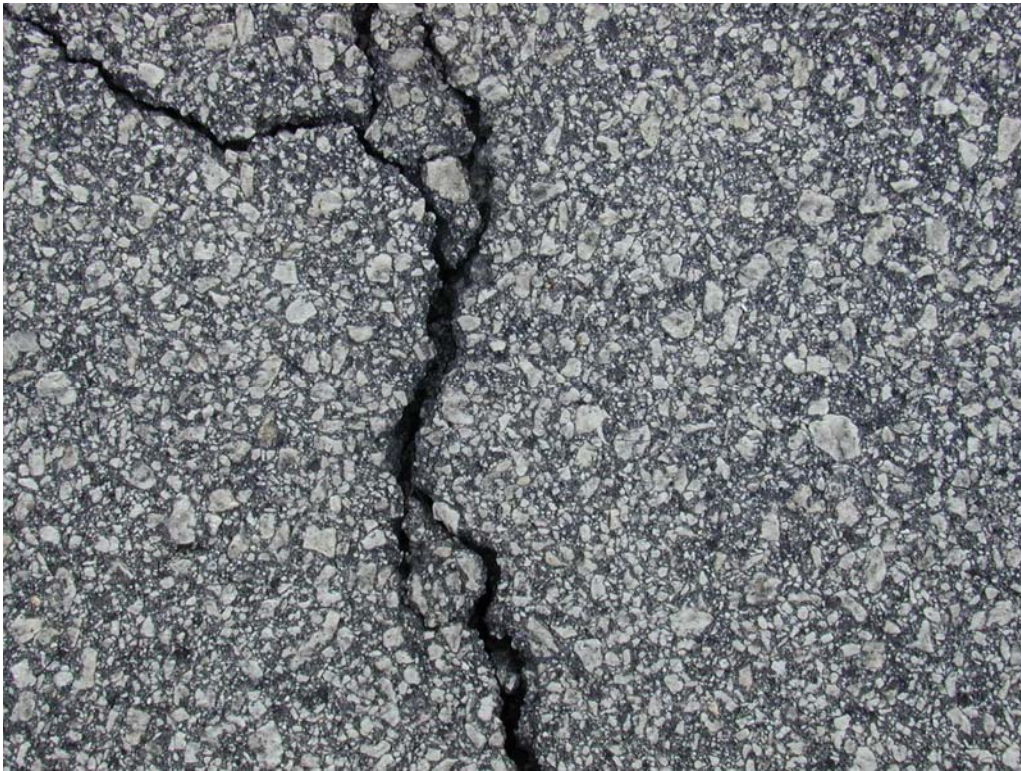
L&T cracking in section TBAB-10.

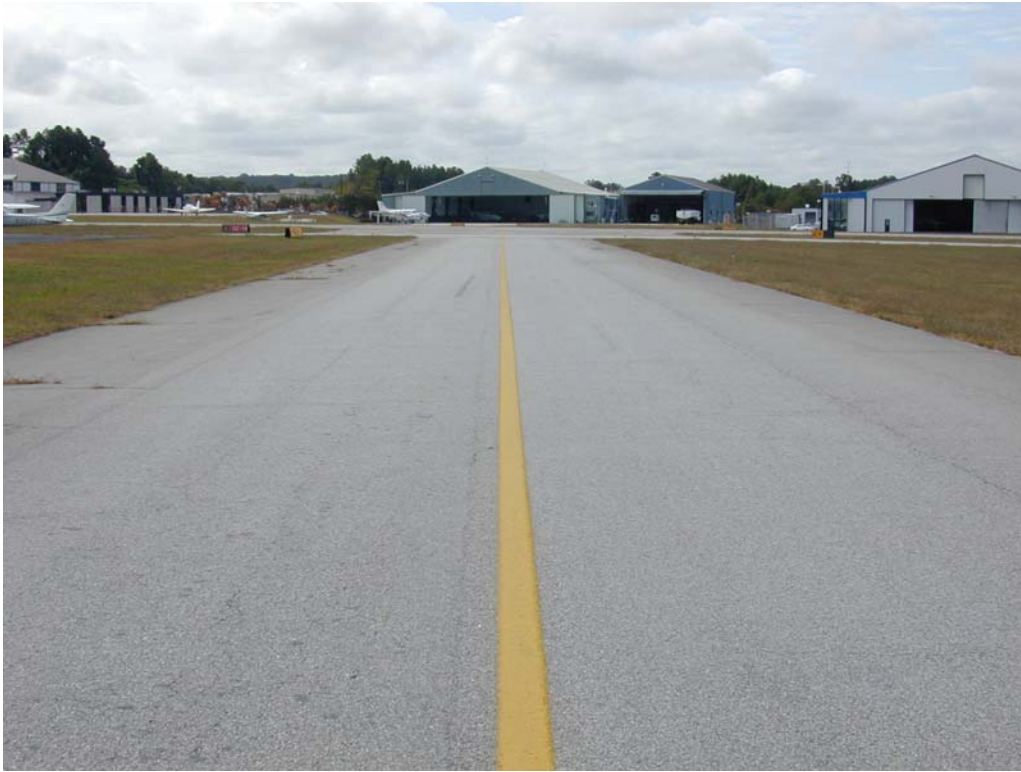
Taxiway G consists of one section connecting Taxiway B and Taxiway I. TGAB-10 is in poor condition with significant amounts of low-severity, unsealed, block cracking found throughout. Isolated quantities of medium-severity block, L&T, as well as alligator cracking were also present on this taxiway. Vegetation growth was present in some of the cracks.

Overview of section TGAB-10.

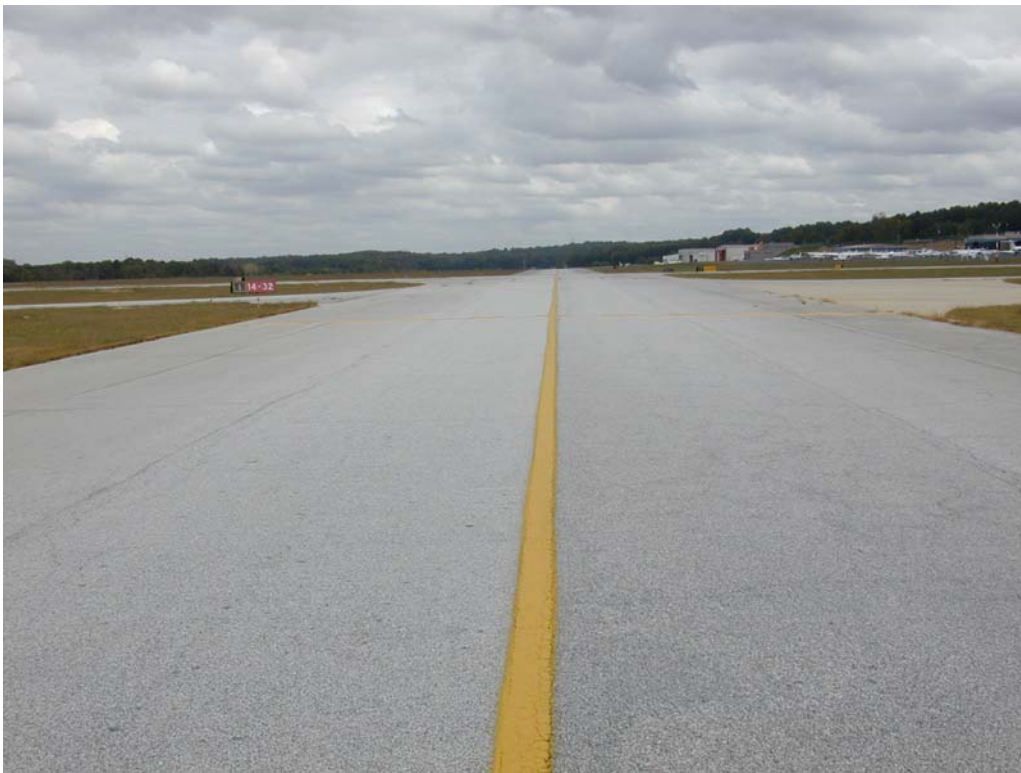
Taxiway I consists of one section and runs parallel to the Runway 8-26. This taxiway is in fair condition. Moderate amounts of low and medium-severity L&T, block, and alligator cracking were found. In addition, isolated areas of raveling and weathering, rutting, and oil spillage were observed. All cracks were unsealed. Medium-severity cracking was recorded due to the presence of secondary cracking.

Overview of section TIAB-10.

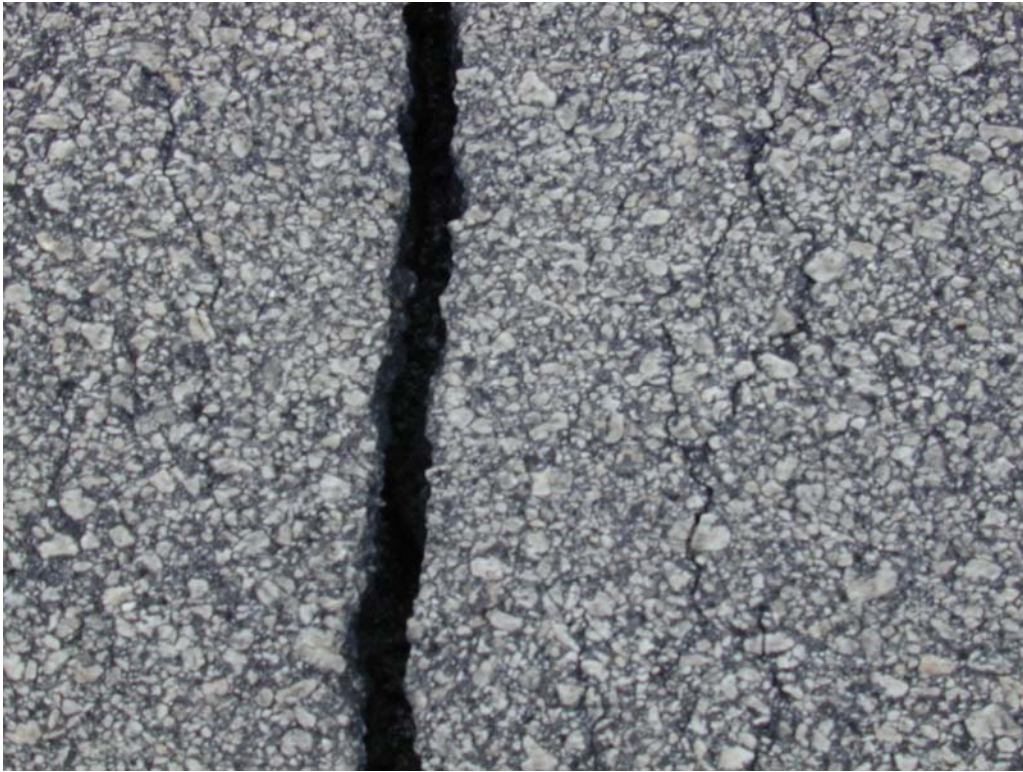
L&T cracking in section TIAB-10.

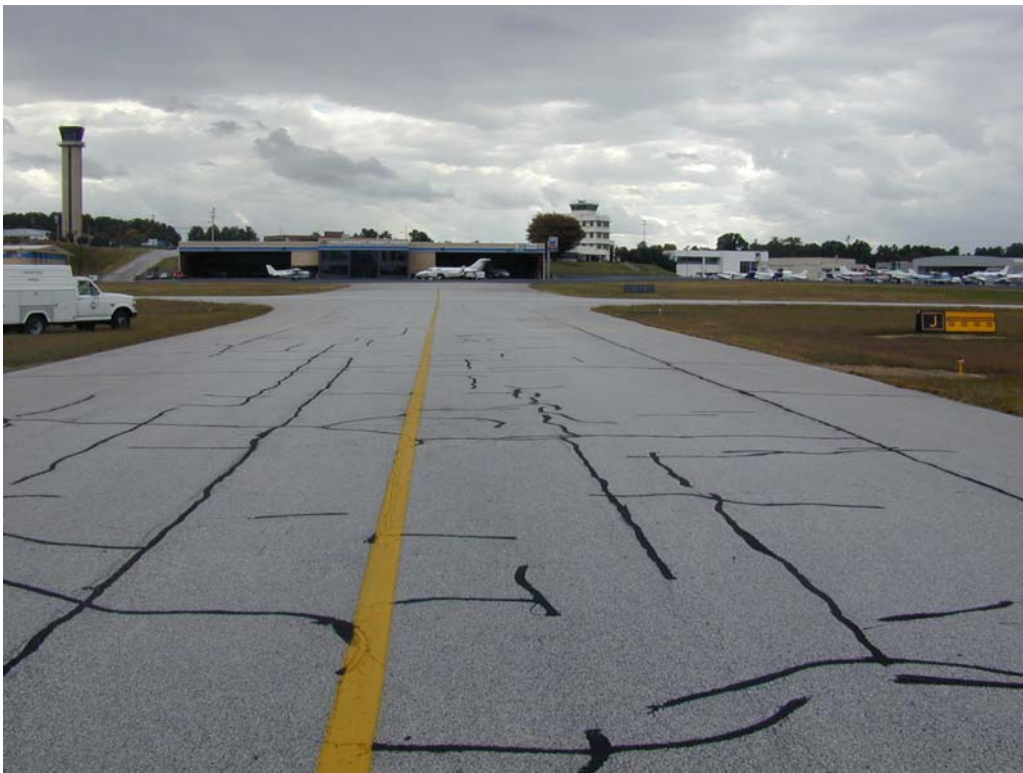
Taxiway 9-27 was defined by one section. T927AB-10 connects Runway 9-27 and Runway 8-26, and is in fair condition with moderate amounts of low and medium-severity L&T cracking observed throughout. The majority of cracking was sealed and medium-severity cracks were noted due to failed sealant. In addition, isolated areas of alligator cracking were found.

Overview of section T927AB-10.

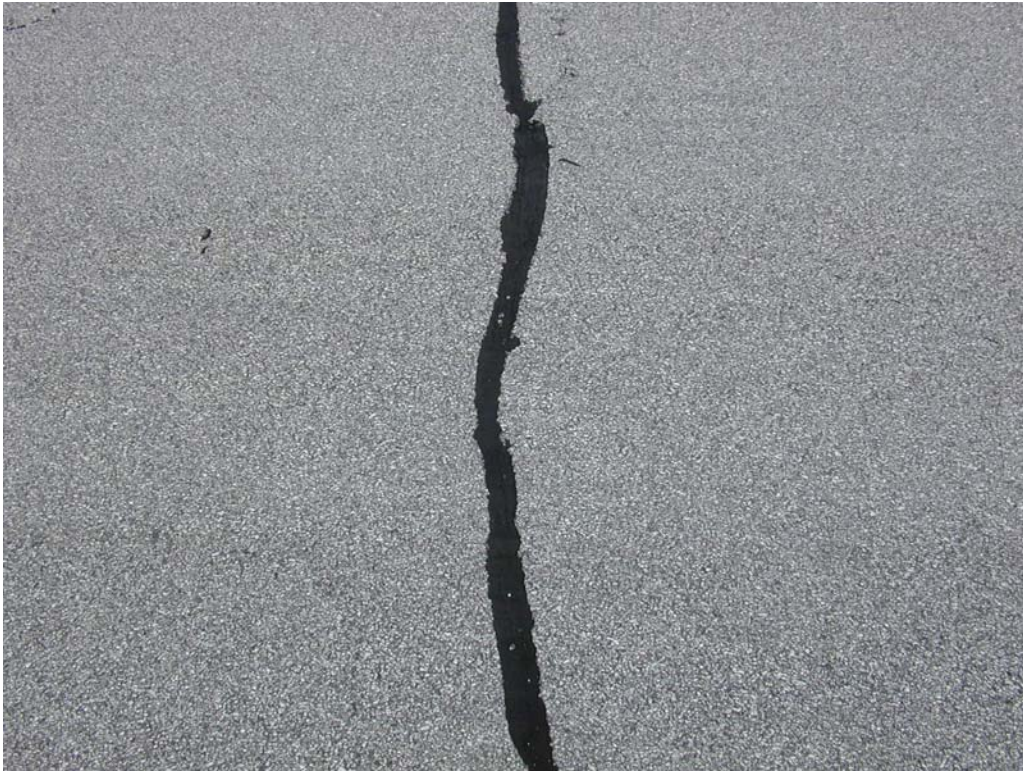
L&T cracking in section T927AB-10.

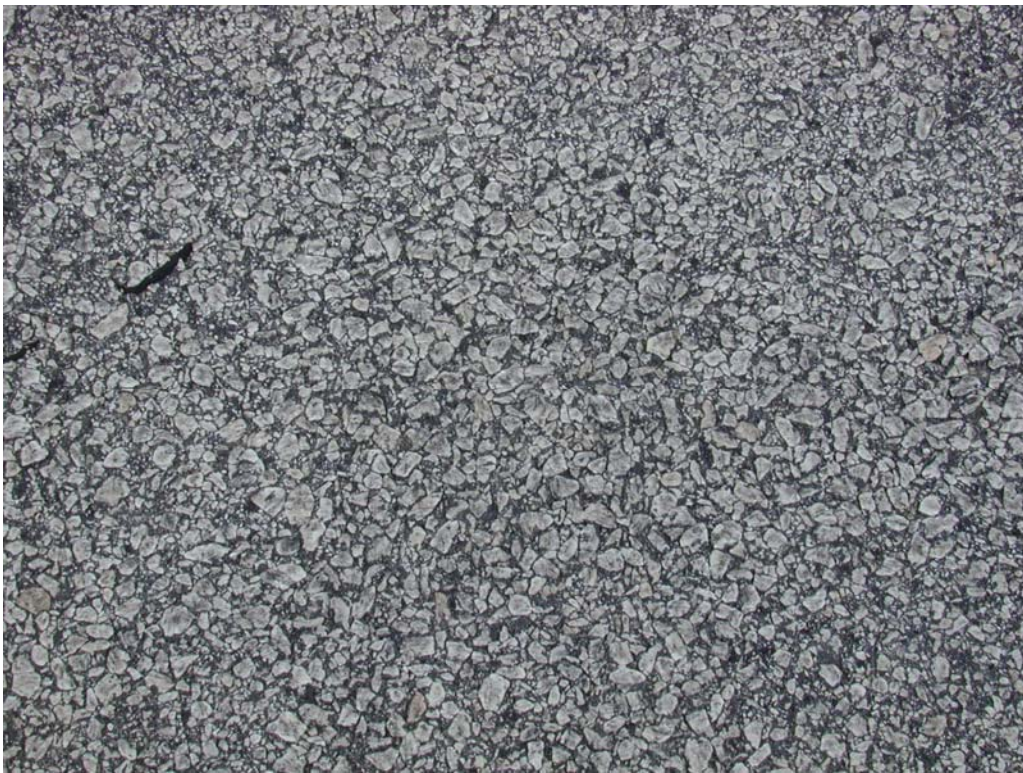
Raveling and weathering in section T927AB-10.

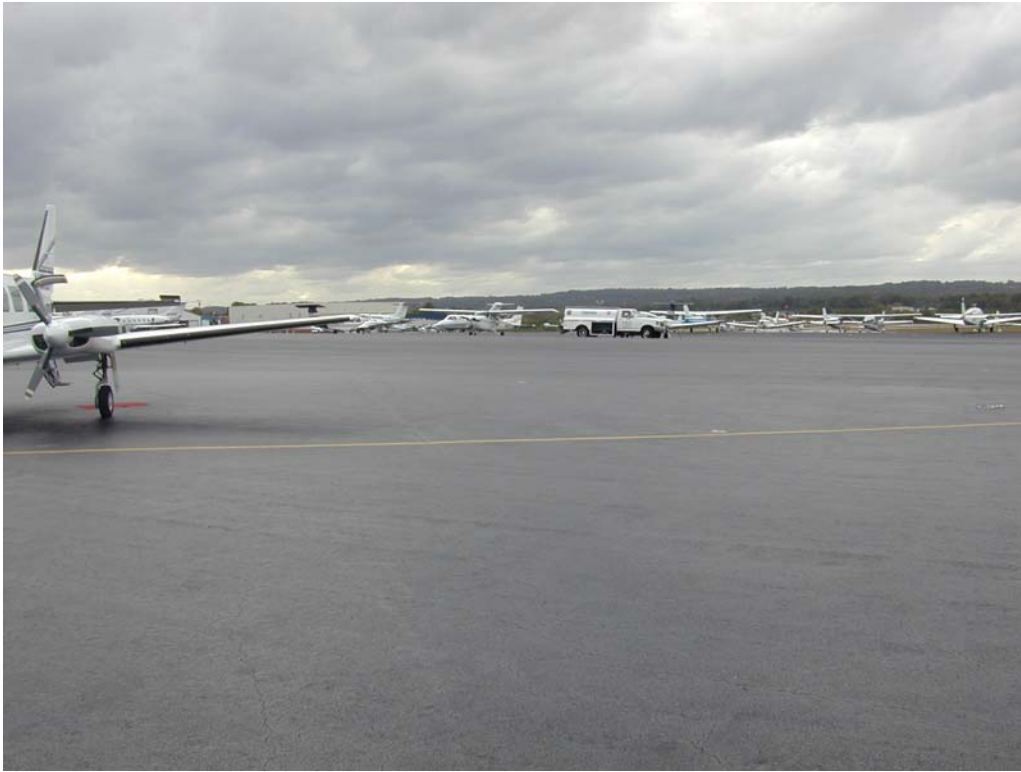
One section was defined in the apron. A01AB-10 is in fair condition with low-severity block, and L&T cracking being found. Small quantities of medium-severity block and L&T cracking were also observed in this section. In addition, isolated areas of alligator cracking, raveling and weathering and bleeding were also noted. All cracks were unsealed.

Overview of section A01AB-10.

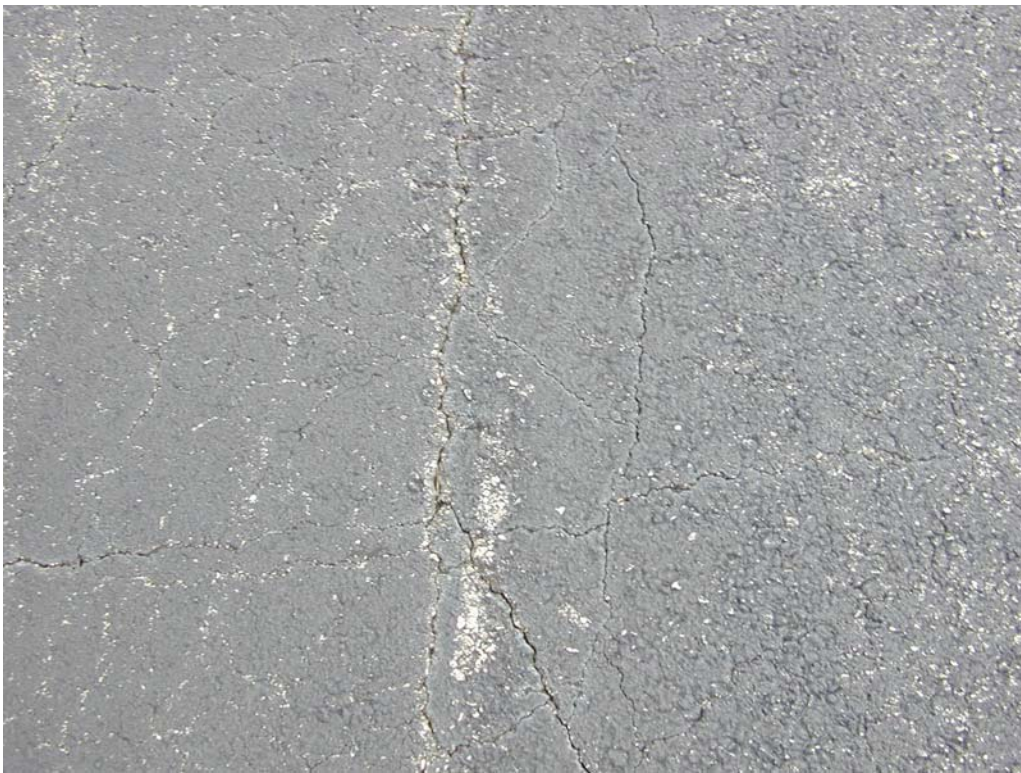
Alligator cracking in section A01AB-10.

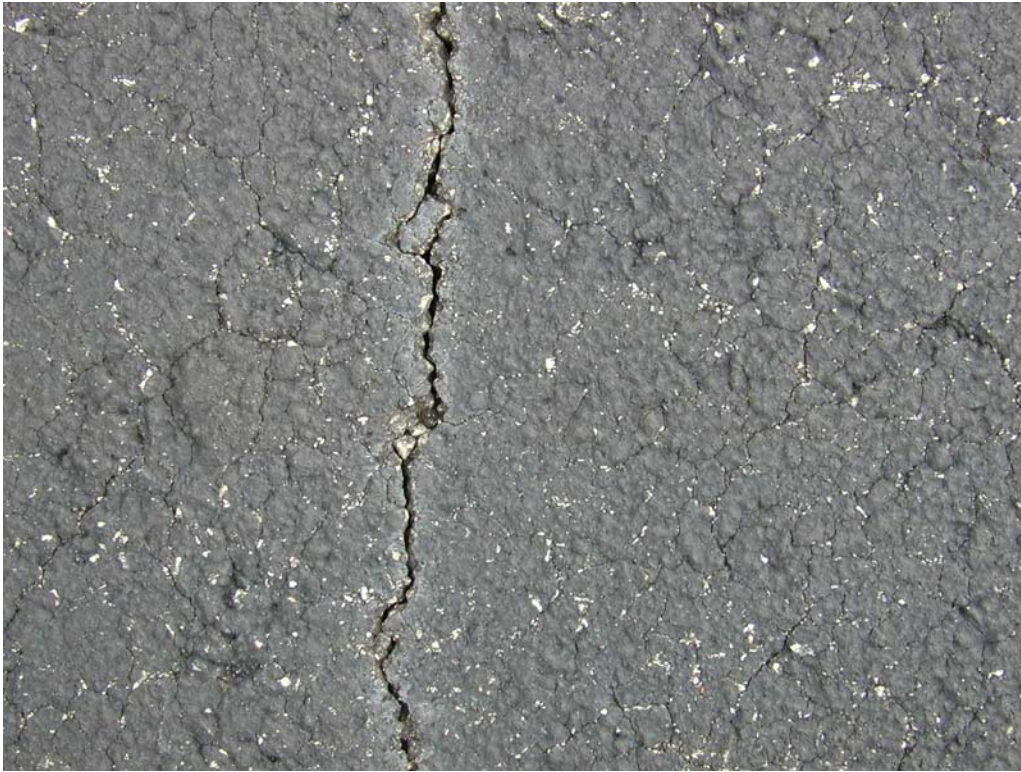
L&T cracking in section A01AB-10.
