DEKALB - PEACHTREE AIRPORT

PAVEMENT EVALUATION REPORT

JULY 2002

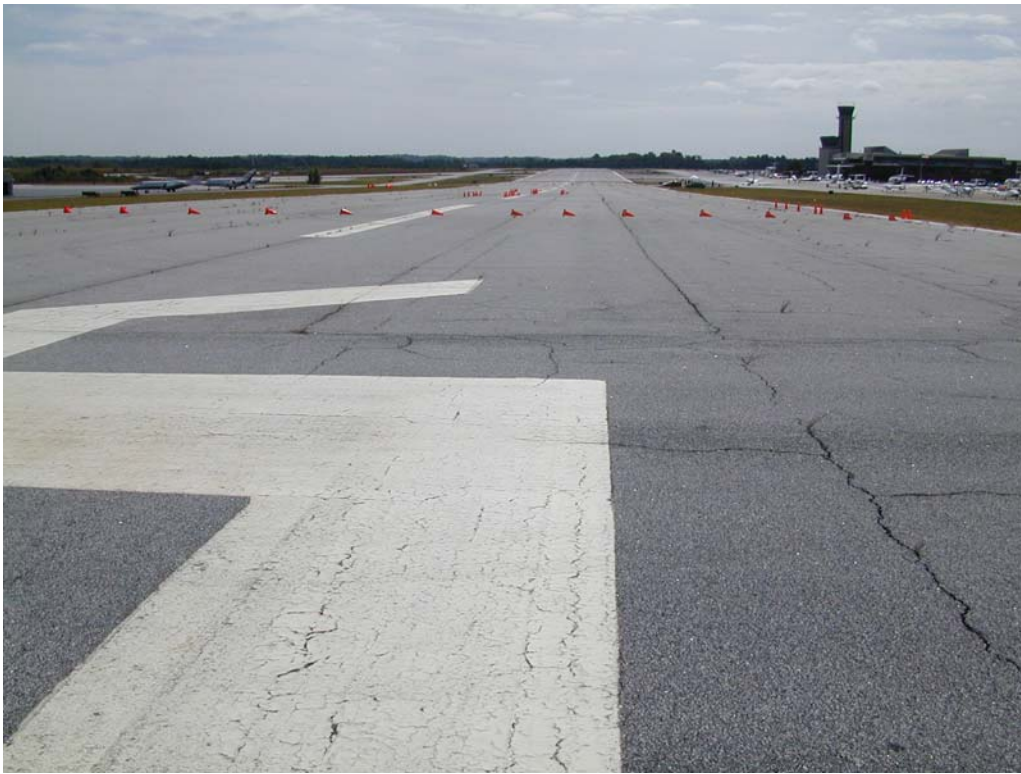
One section was defined in Runway 16-34. R1634AP-10 is in good condition with large amounts of L&T and block cracking being observed throughout the section. Quantities of swelling and isolated areas of rutting and alligator cracking were also found but will be repaired upon the completion of the crack sealing/surface treatment project.

Overview of section R1634AP-10.

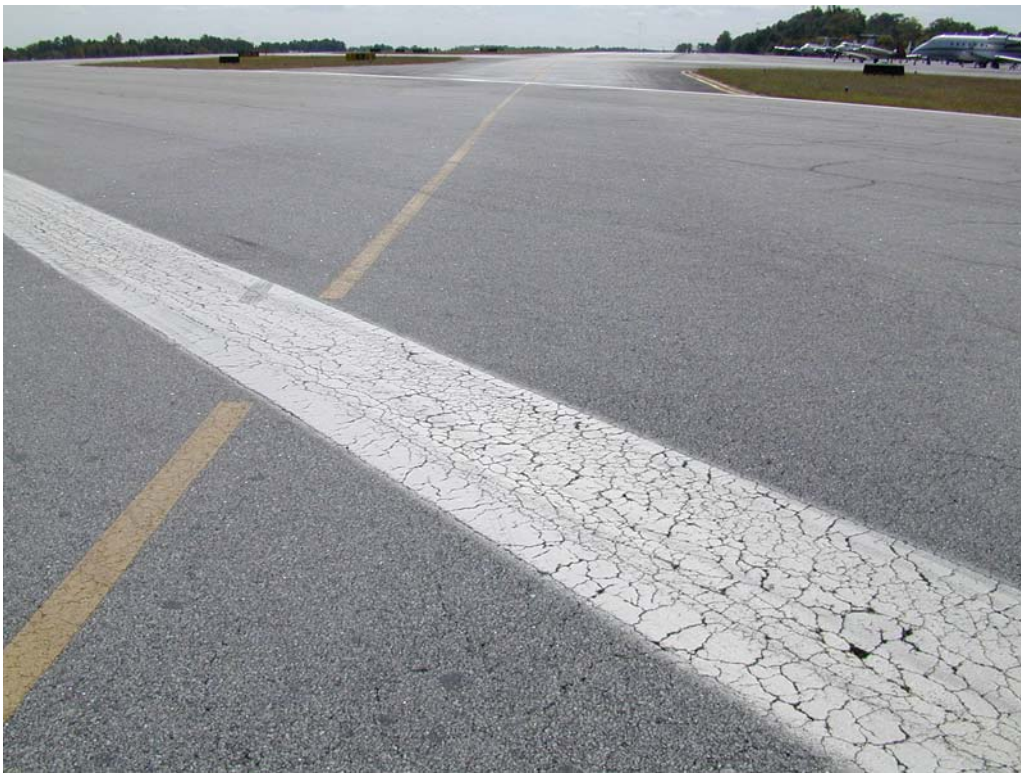
Overview of area being replaced in section R1634AP-10.

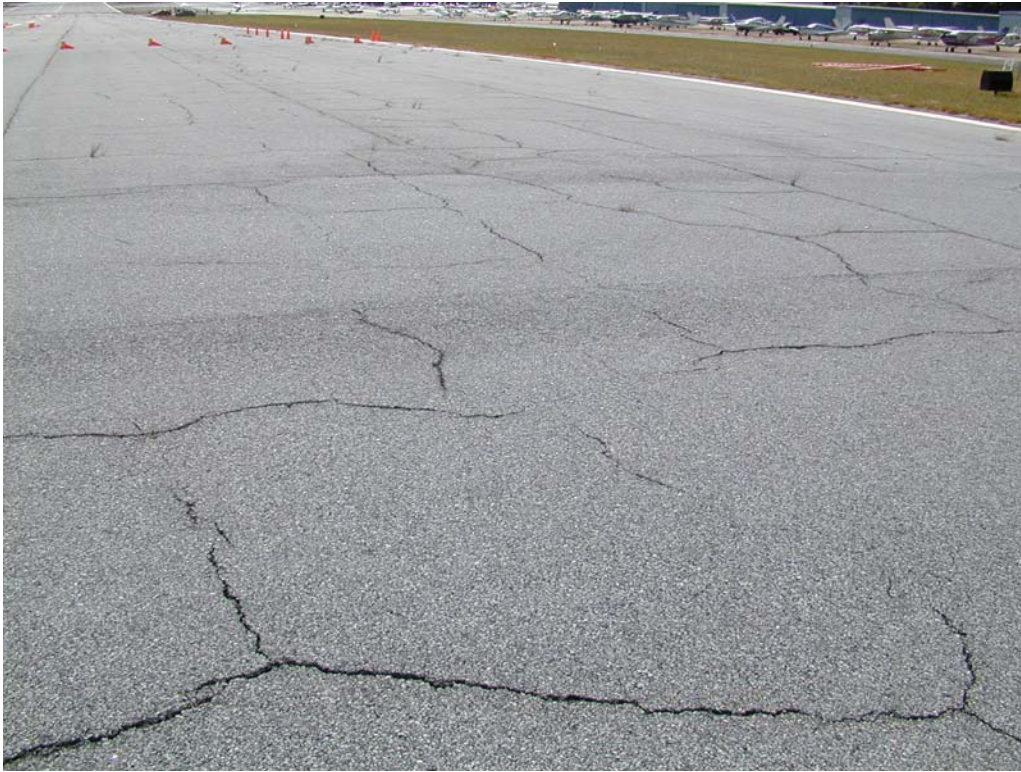
Block cracking in section R1634AP-10.

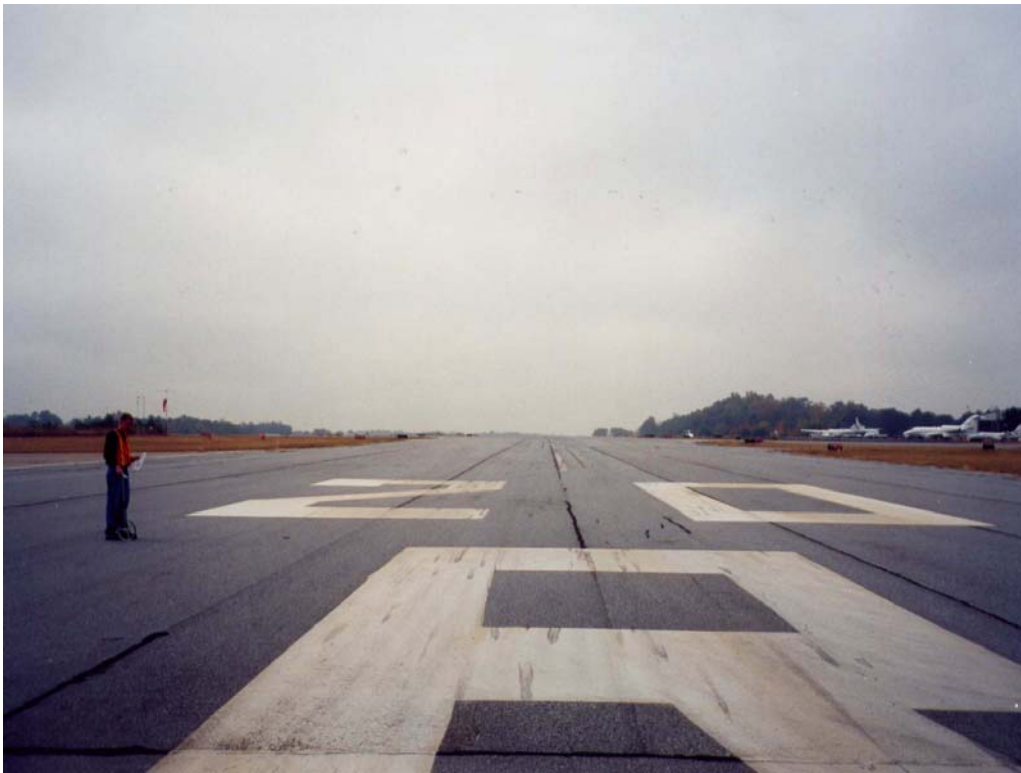
Section R2L20RAP-10 is the only section defined in Runway 2L-20R. The section is in good condition with moderate amounts of L&T cracking being observed. In addition, small quantities of block and alligator cracking were found throughout the section. A couple of areas were found that were atypical in condition to the rest of the runway. In these areas, large quantities of patching, rutting, and alligator cracking were found.

Overview of section R2L20RAP-10.

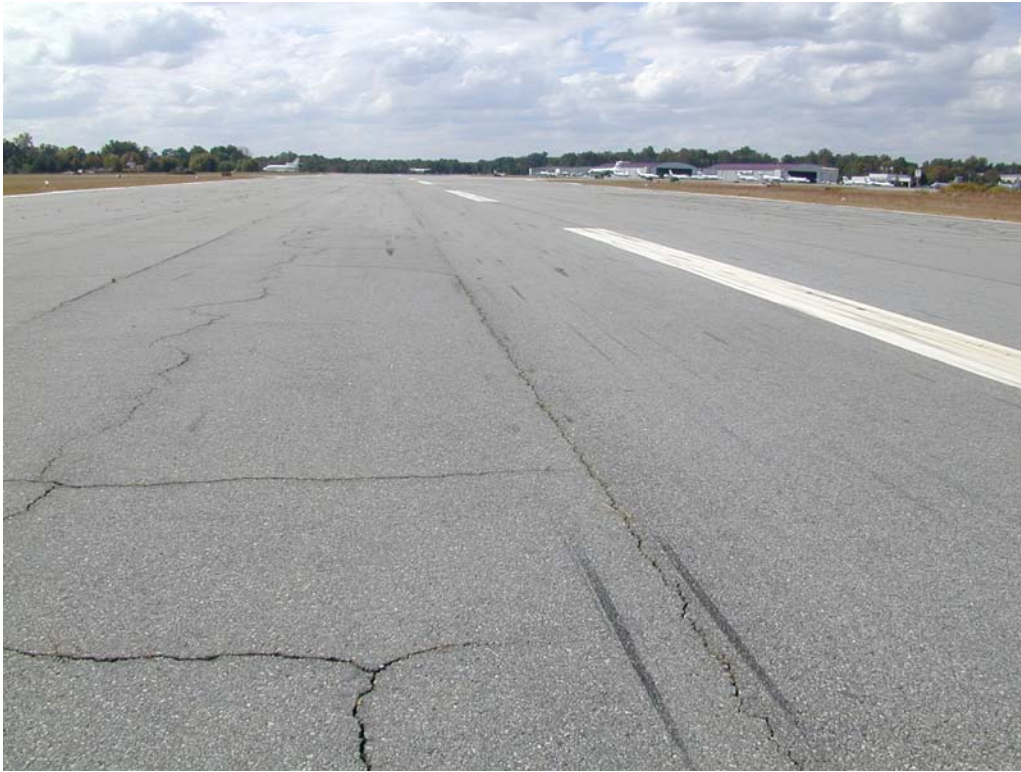
Overview of section R927AP-10.

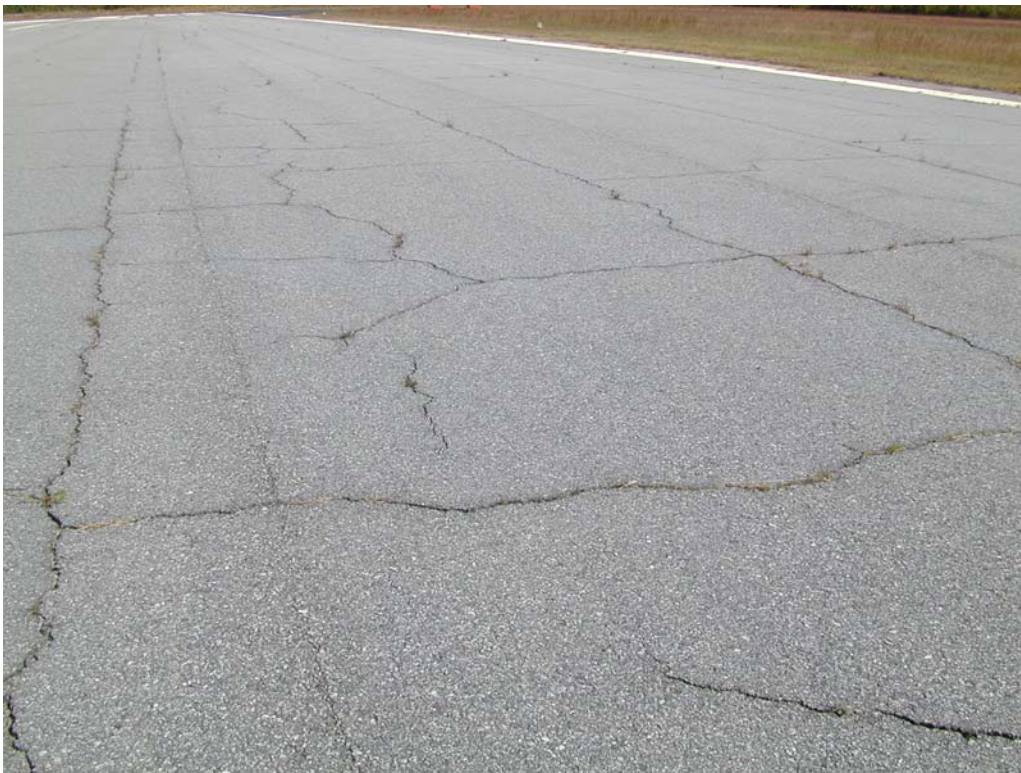
Block cracking in section R927AP-10.

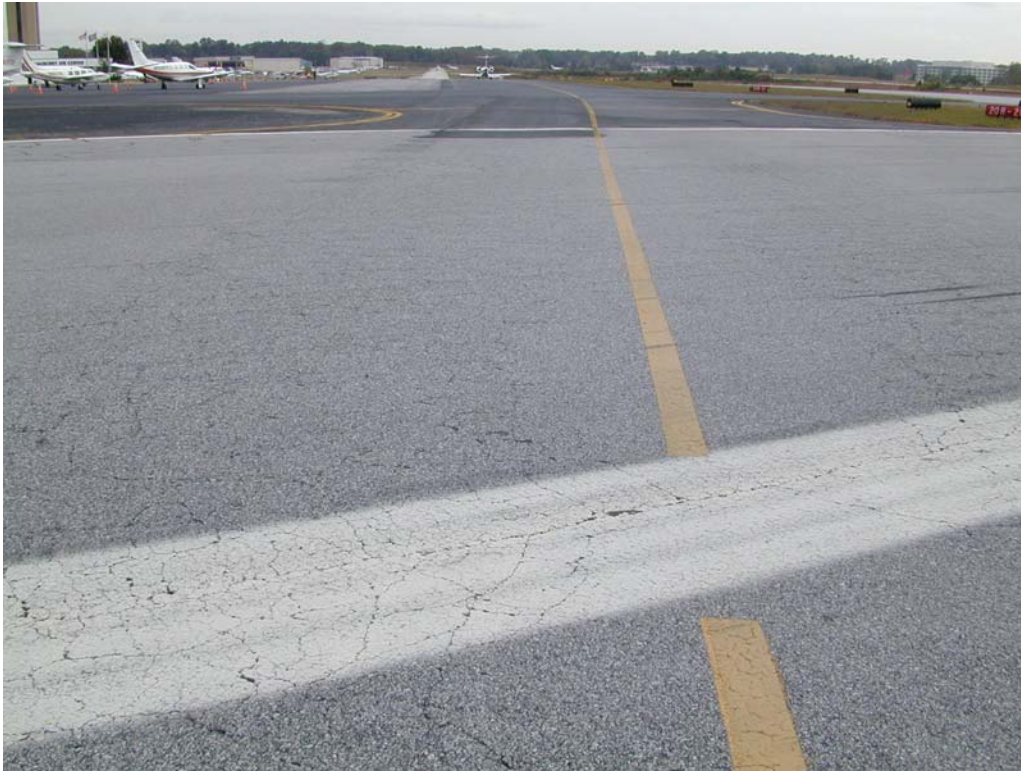
Two sections were defined during the inspection of Runway 9-27. R927AP-10 is in similar condition to Runway 16-34 with larger quantities of block cracking found in the section. R927AP-20 is located where Taxiway A crosses the runway. This area, although similar in condition to the rest of Runway 9-27, was found to be failing. Large amounts of medium and high-severity alligator cracking along with rutting were found throughout the section. These load related distresses were located in the wheel paths of traffic using Taxiway A. This area was not identified for complete repair in the scope of the crack sealing/surface treatment project.

Overview of section R927AP-20.

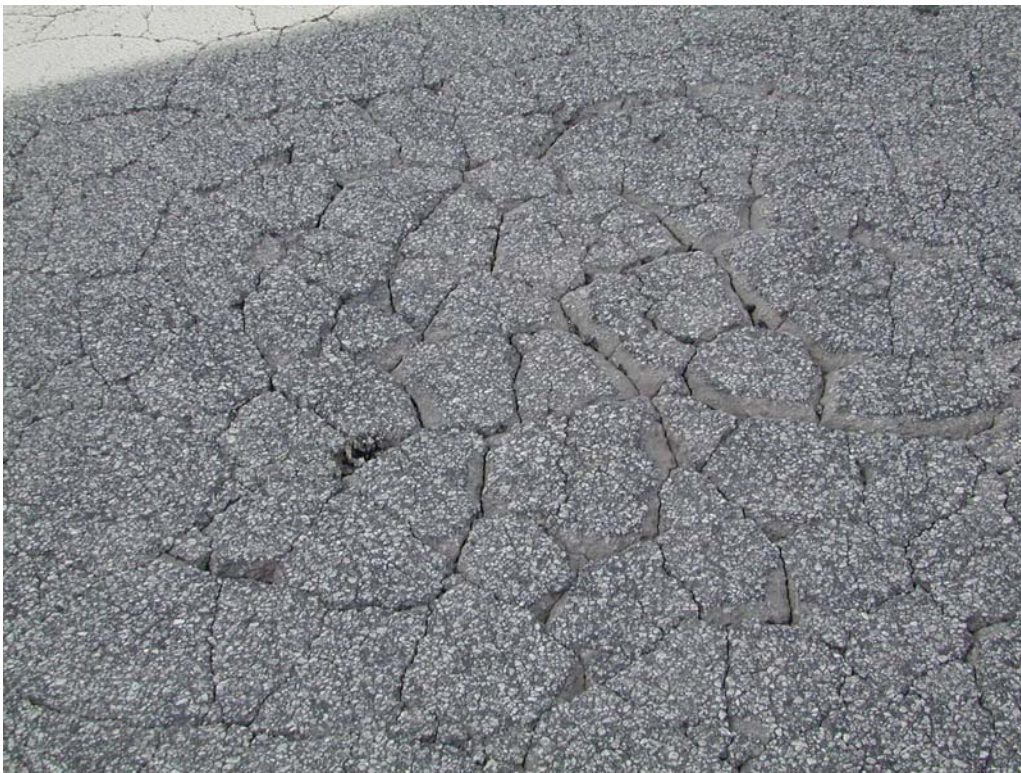
Alligator cracking in section R927AP-20.

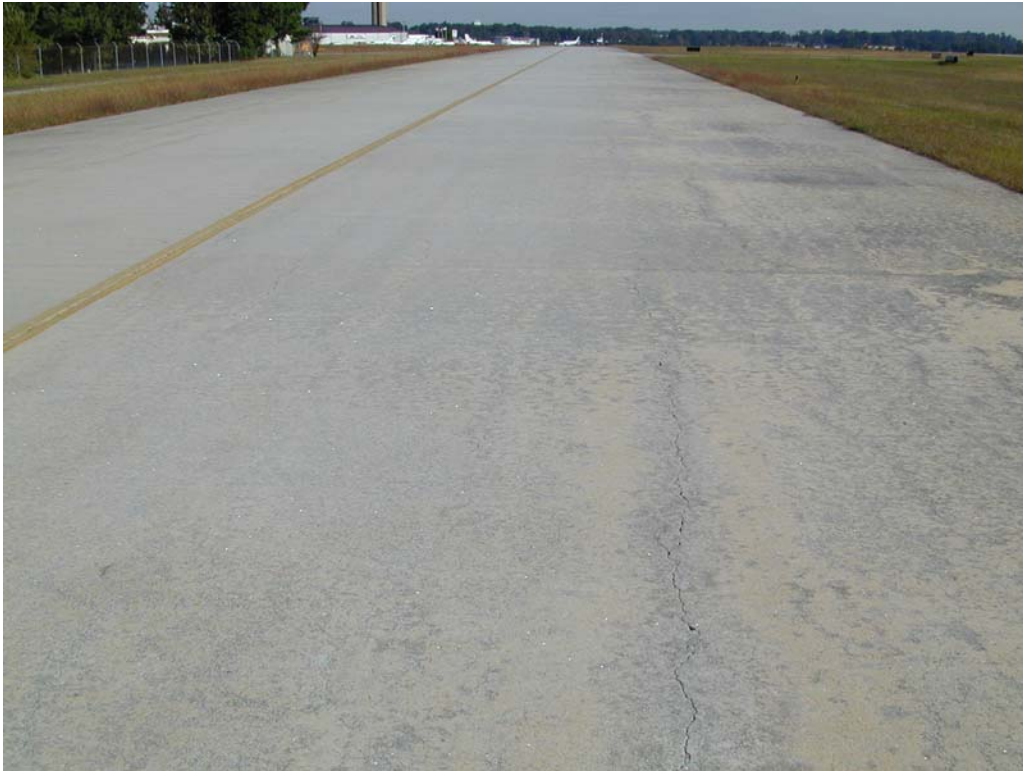
Three sections exist in Taxiway A. TAAP-10 runs from the approach end of Runway 2R to Runway 9-27. This section is in fair condition with significant quantities of LTD, shrinkage, and map cracking observed throughout the section. In addition to the cracking, joint seal damage at medium and high-severity was found. The holding apron area at the south end of the taxiway was found to be in better condition and inspected as an additional sample unit. TAAP-20 consists of the asphalt pavement between Runway 9-27 and Runway 16-34. It is in poor condition with large amounts of alligator and block cracking being observed. Additionally, significant amounts of rutting and patching were found in the section. TAAP-30 is in similar condition to TAAP-10 with only slightly lower quantities of the same distresses being found throughout the section.

Overview of section TAAP-10.

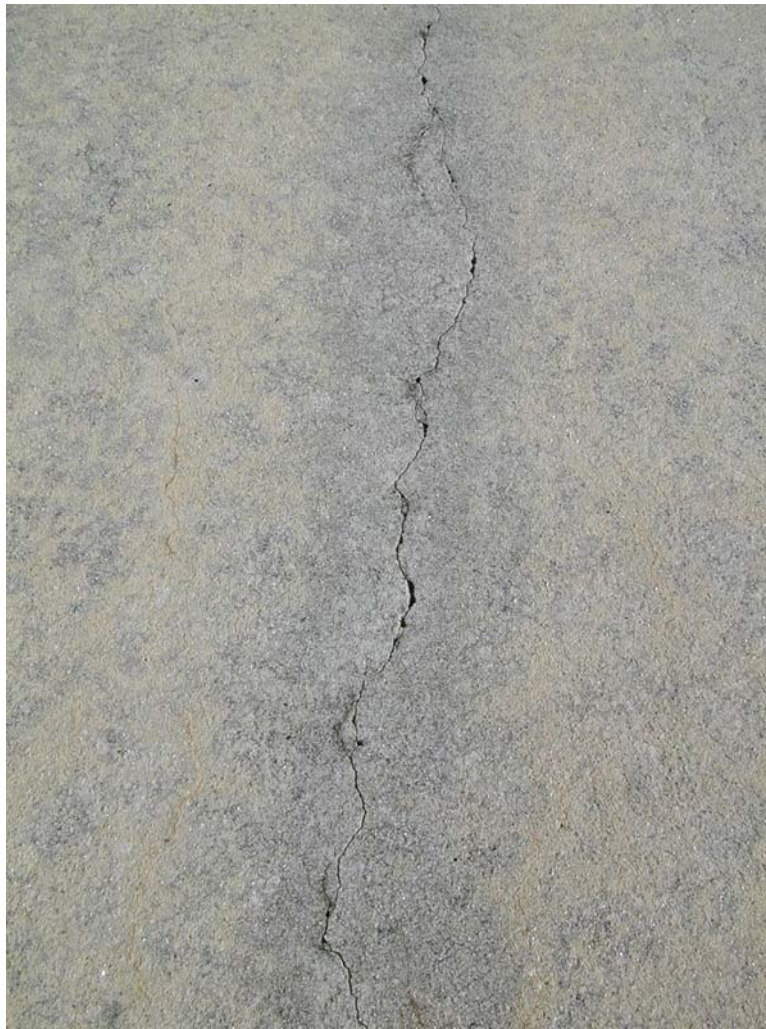
LTD cracking in section TAAP-10.

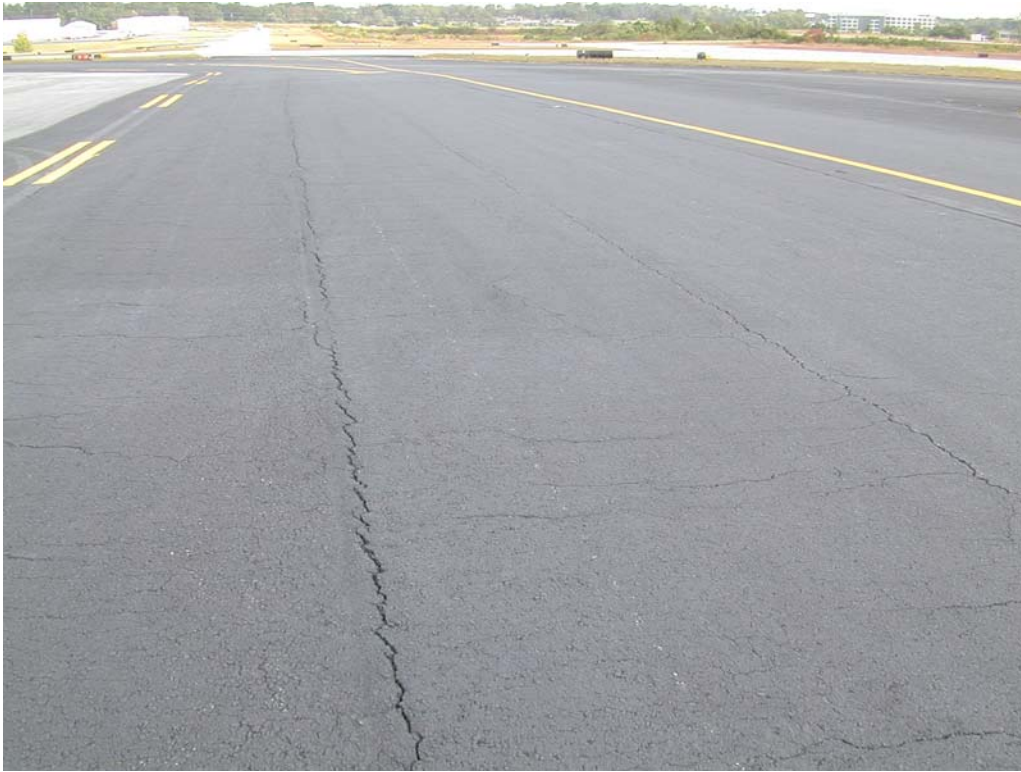
Overview of section TAAP-20.

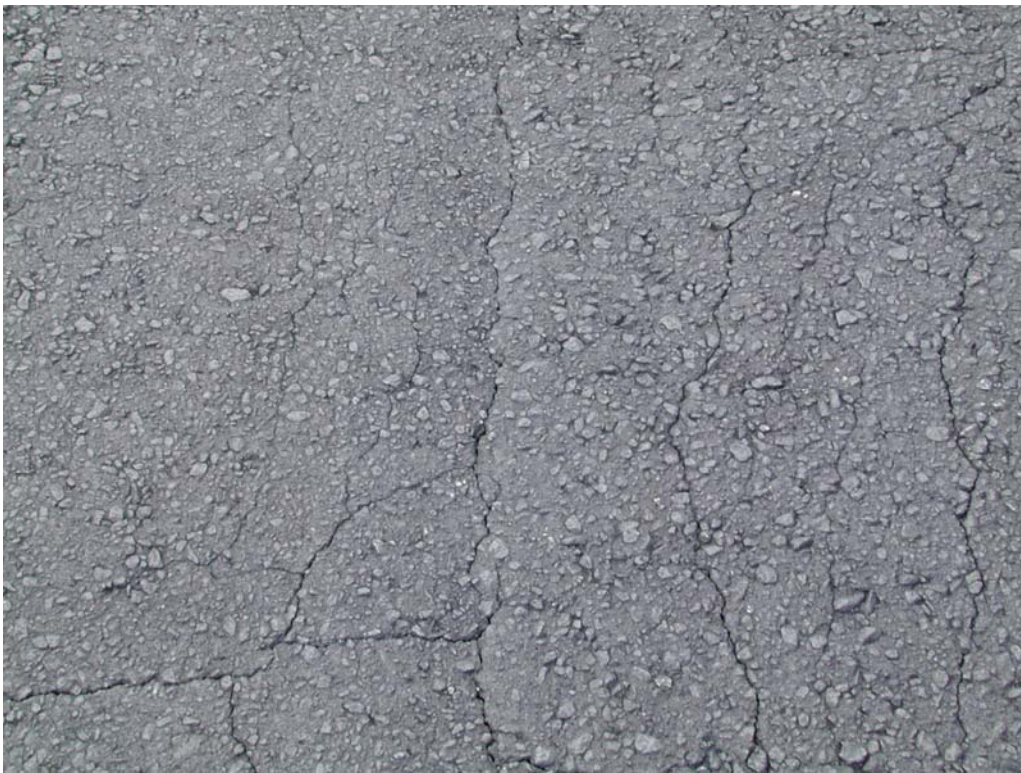
Alligator cracking in section TAAP-20.

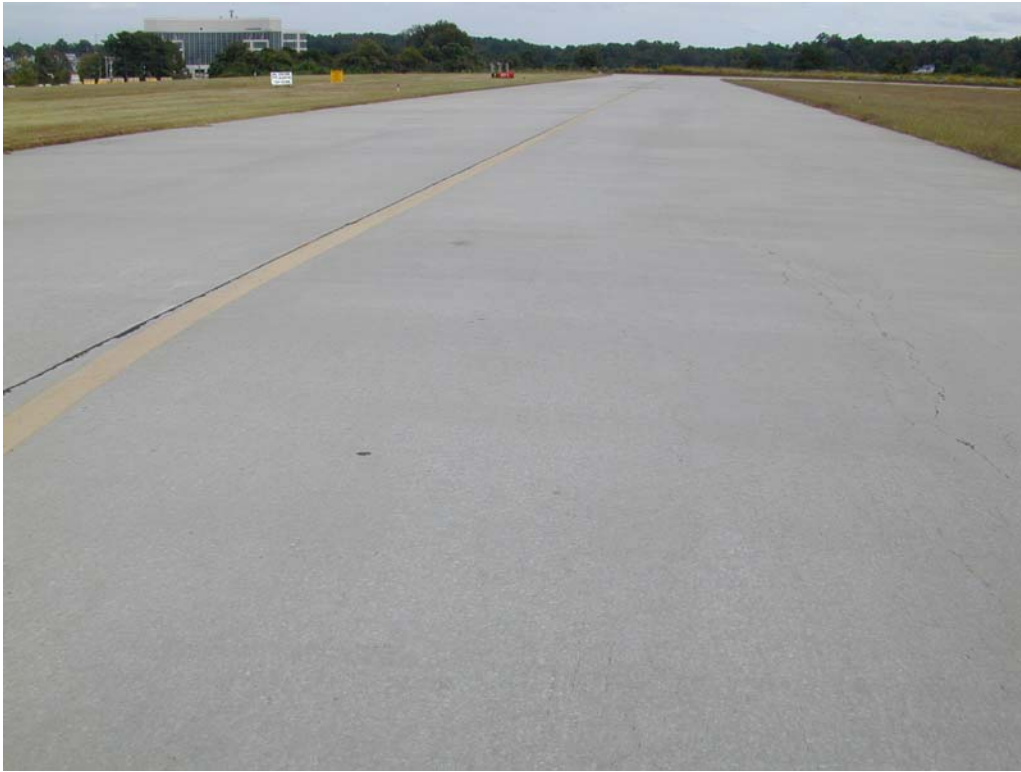
Overview of section TAAP-30.

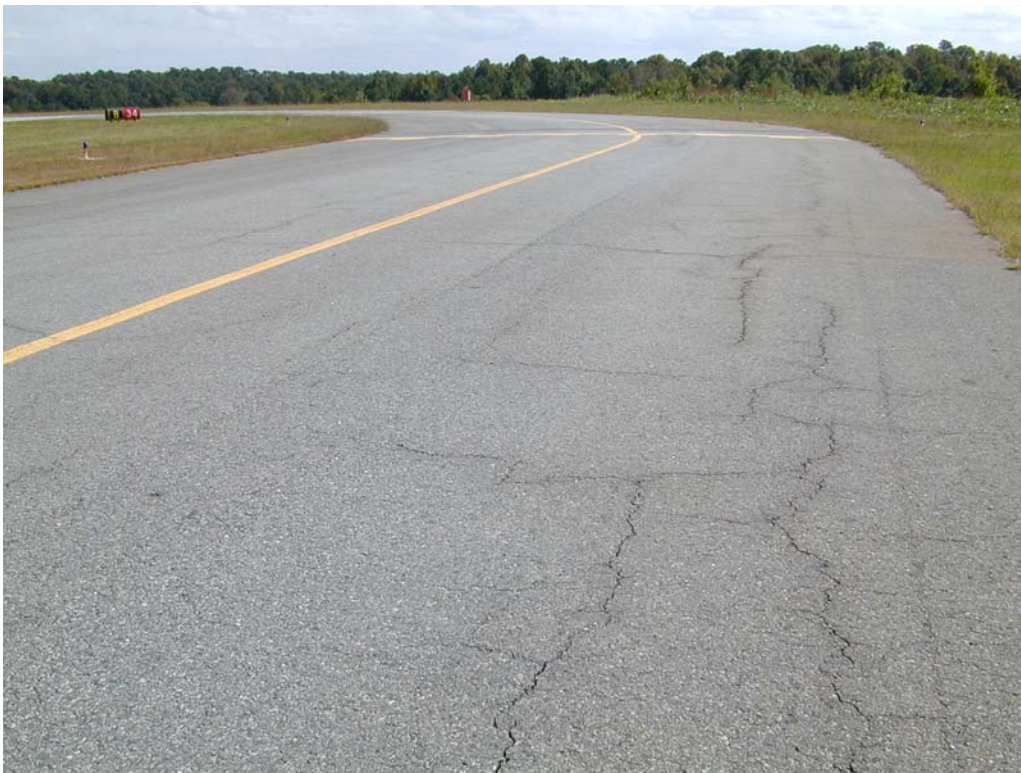
One section was defined in Taxiway B. TBAP-10 is in fair condition with significant amounts of L&T, block, and alligator cracking being observed throughout the section. Occasional quantities of rutting and patching were also found.

Overview of section TBAP-10.

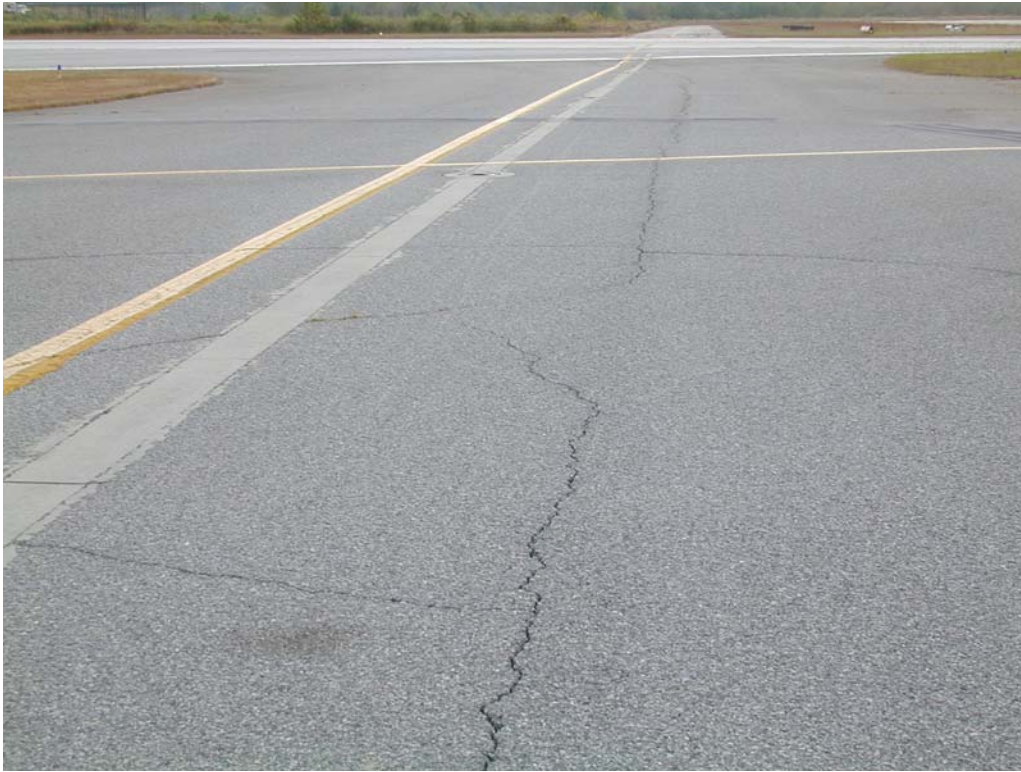
Overview of section TBAP-10 at section TCAP-10.

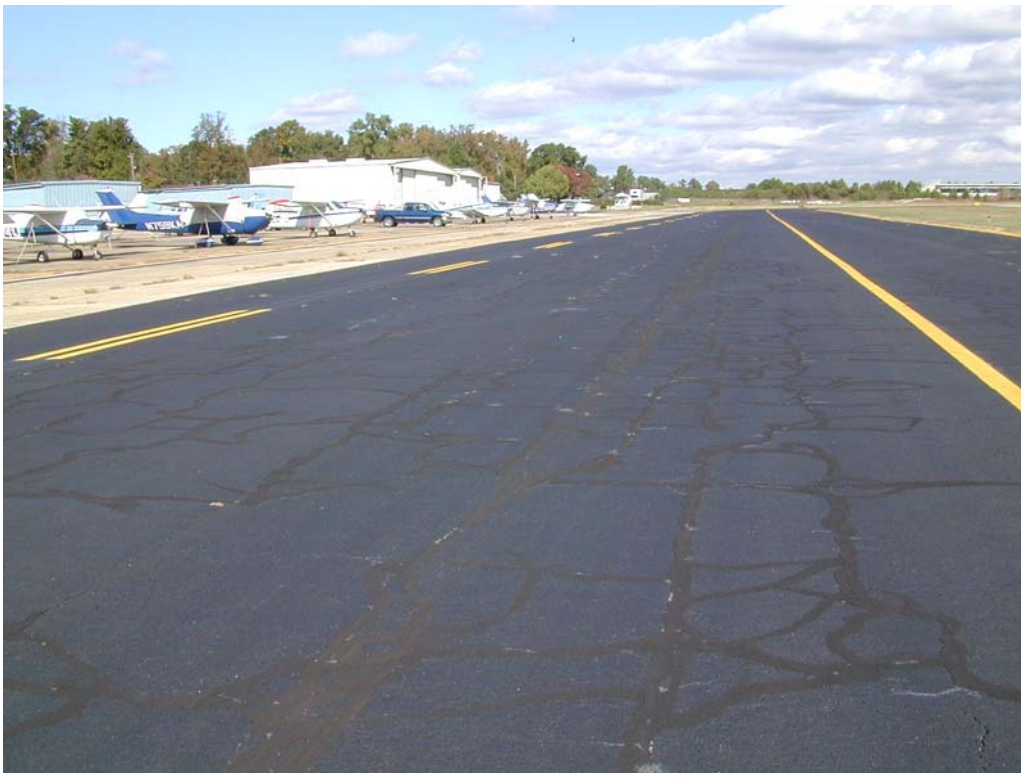
Block cracking in section TBAP-10.

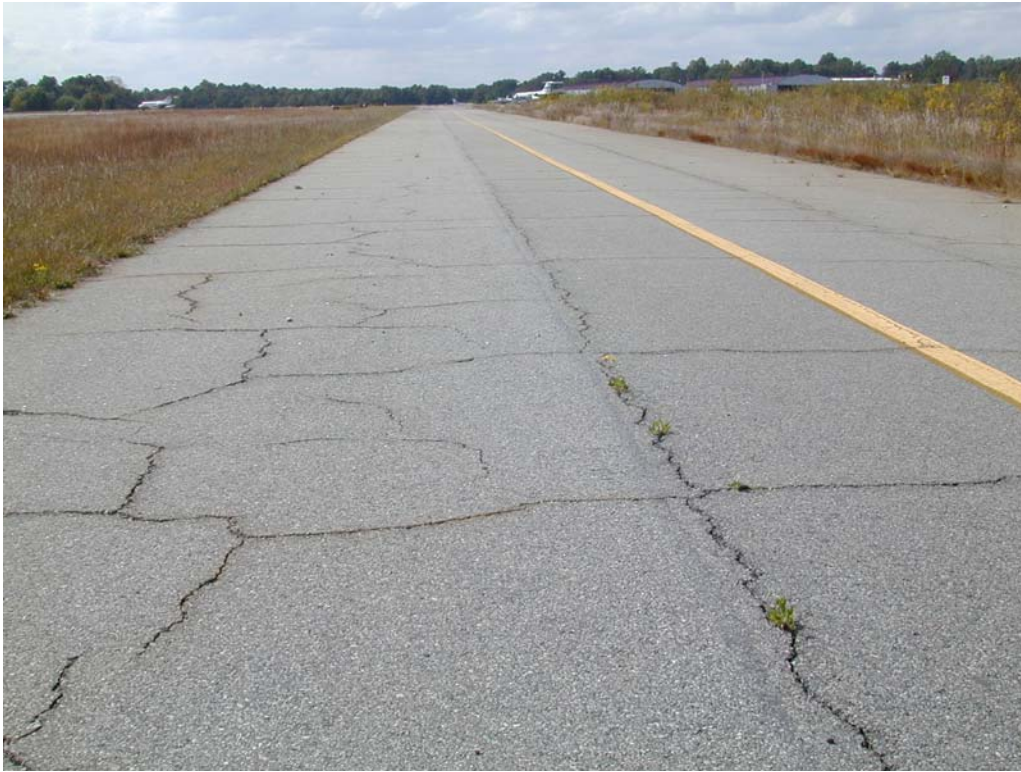
Three sections are defined in Taxiway C. TCAP-10 is in fair condition with low-severity block cracking covering nearly 100 percent of the section's surface. Both TCAP-20 and TCAP-30 are in poor condition with large quantities of block and alligator cracking found throughout the sections. Additionally, significant quantities of rutting were observed in TCAP-20.

Overview of section TCAP-10.

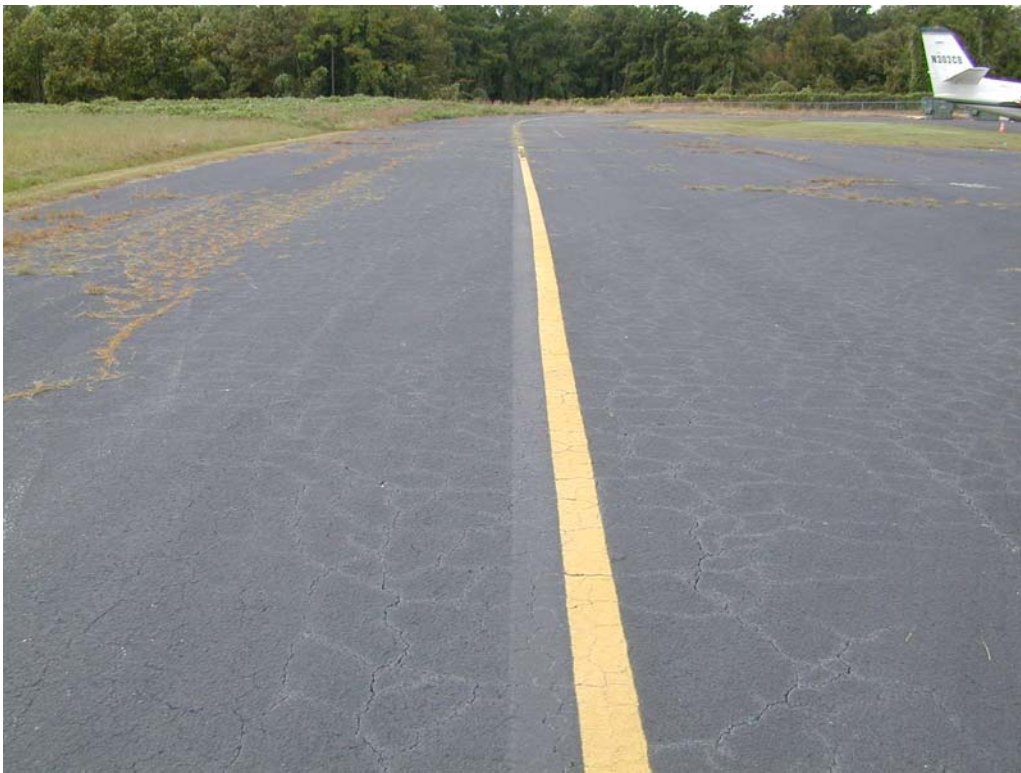
Overview of section TCAP-20.

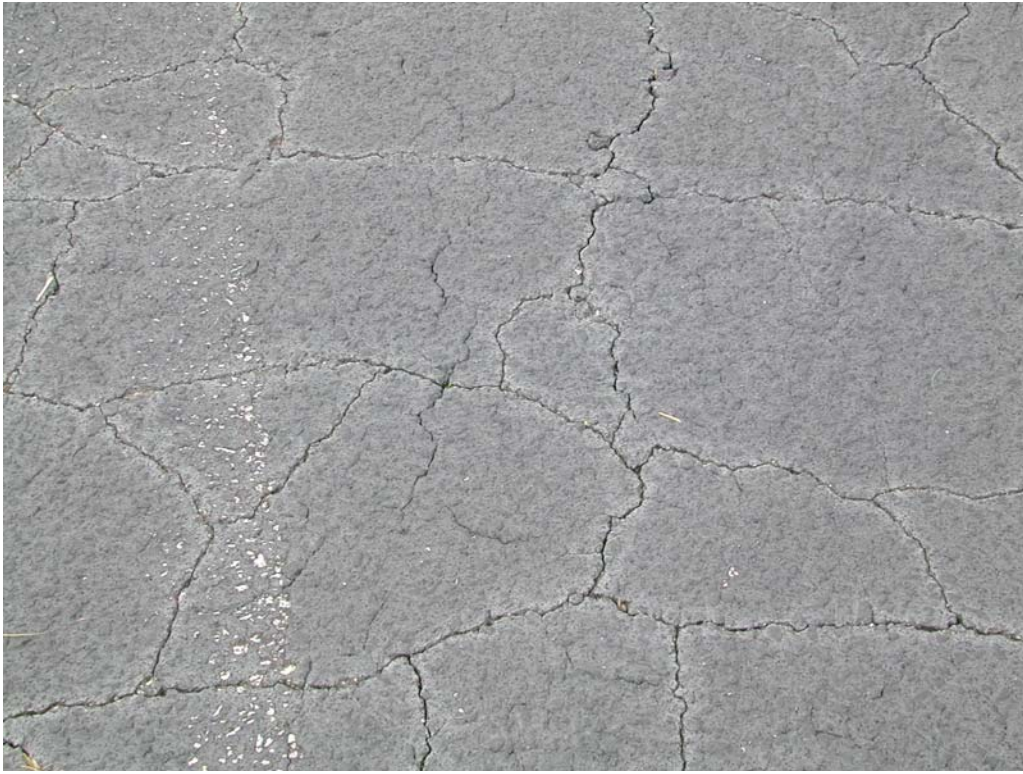
Alligator cracking in section TCAP-20.

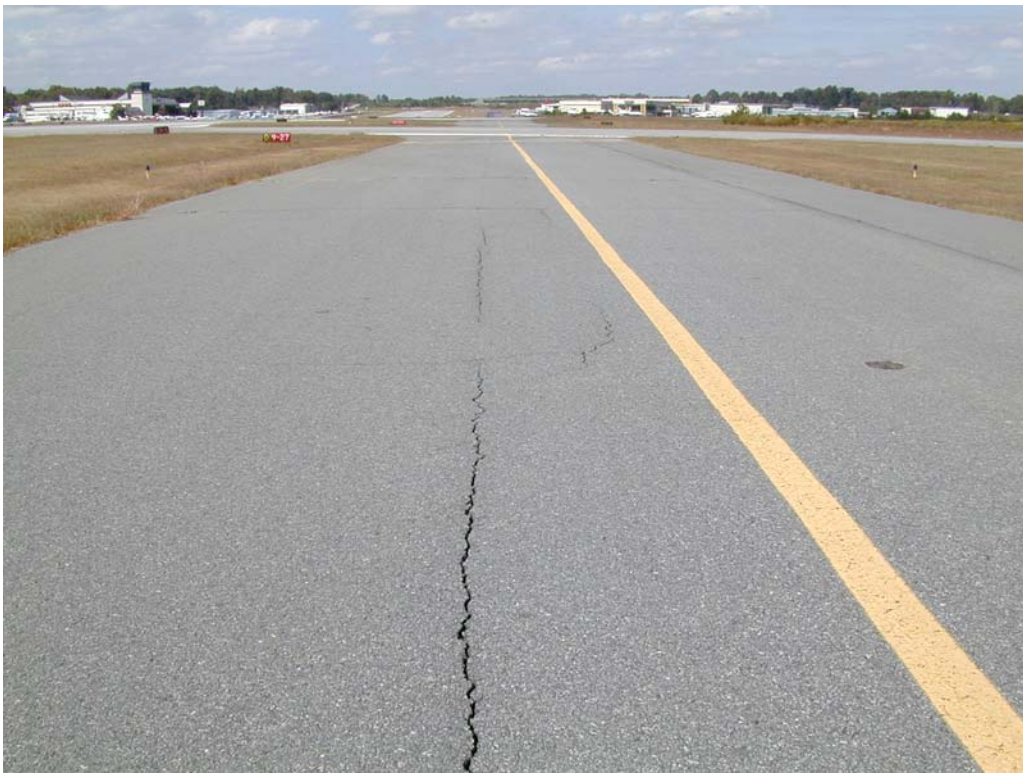
One section was defined in Taxiway D. TDAP-10 is in poor condition with significant amounts of L&T, block, and alligator cracking being observed. Rutting was also found in moderate quantities throughout the section. The sample units in the intersection with Taxiway E were inspected as additional sample units. Although the distresses found here are similar to those found throughout the section, much higher densities were observed.

Overview of section TDAP-10.

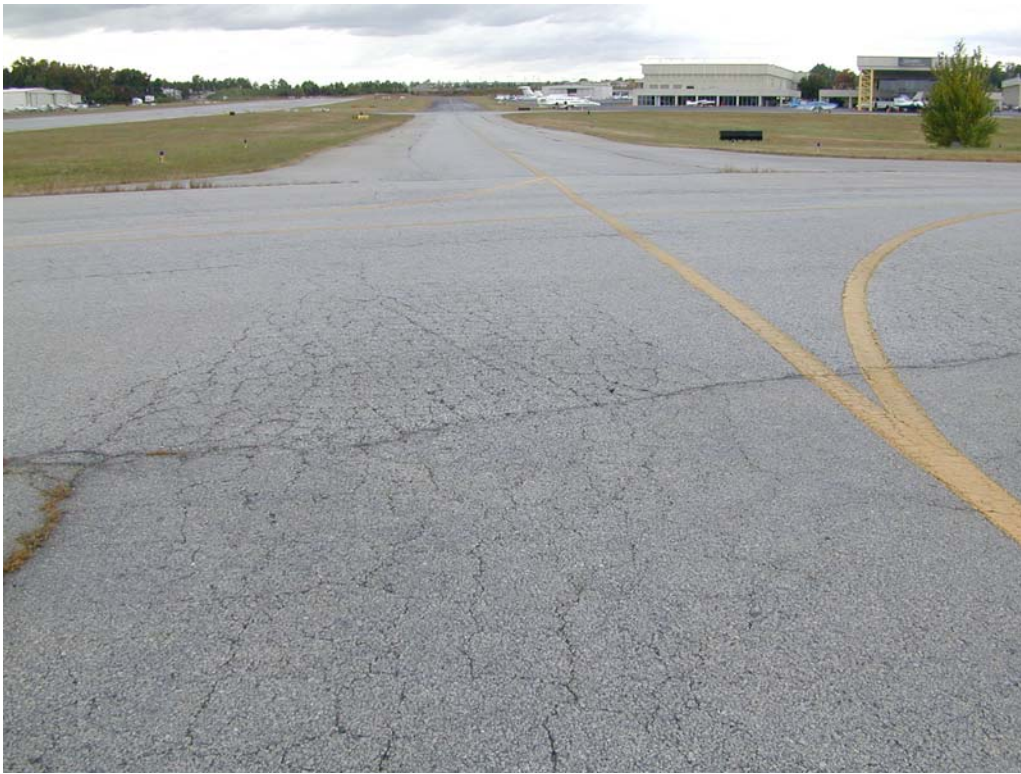
Alligator cracking (additional sample unit) in section TDAP-10.

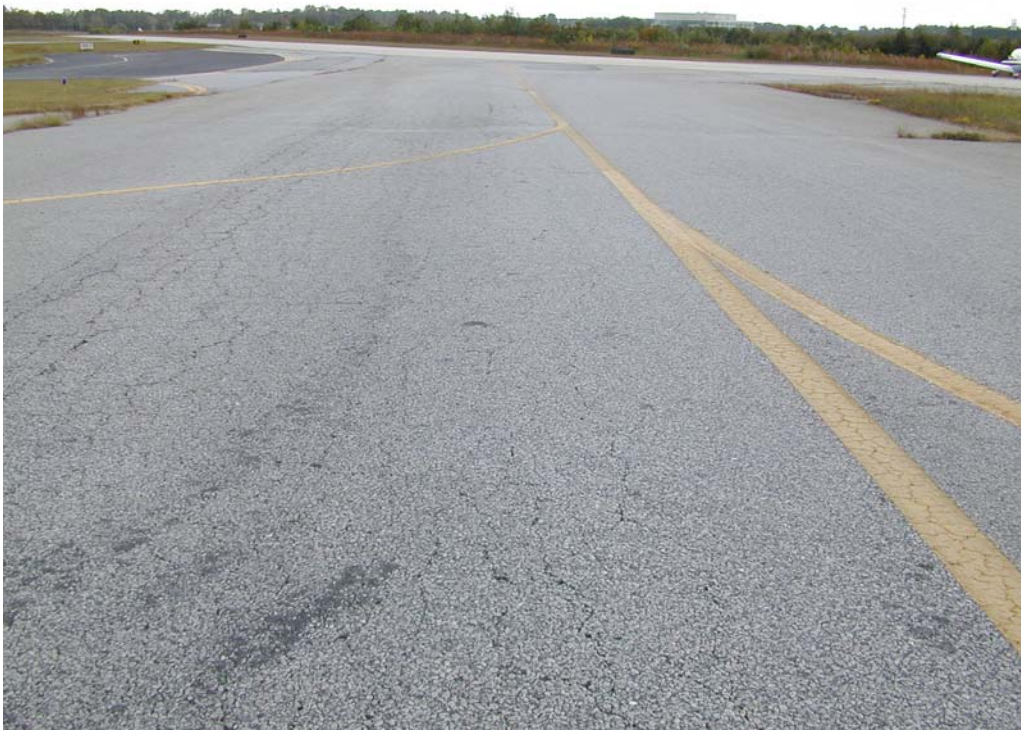
One section, TEAP-10, was defined during the inspection. This section is failed with extensive amounts of alligator cracking and rutting being found throughout the pavement. Additionally, raveling and weathering was found over the entire surface of the section.

Overview of section TEAP-10.

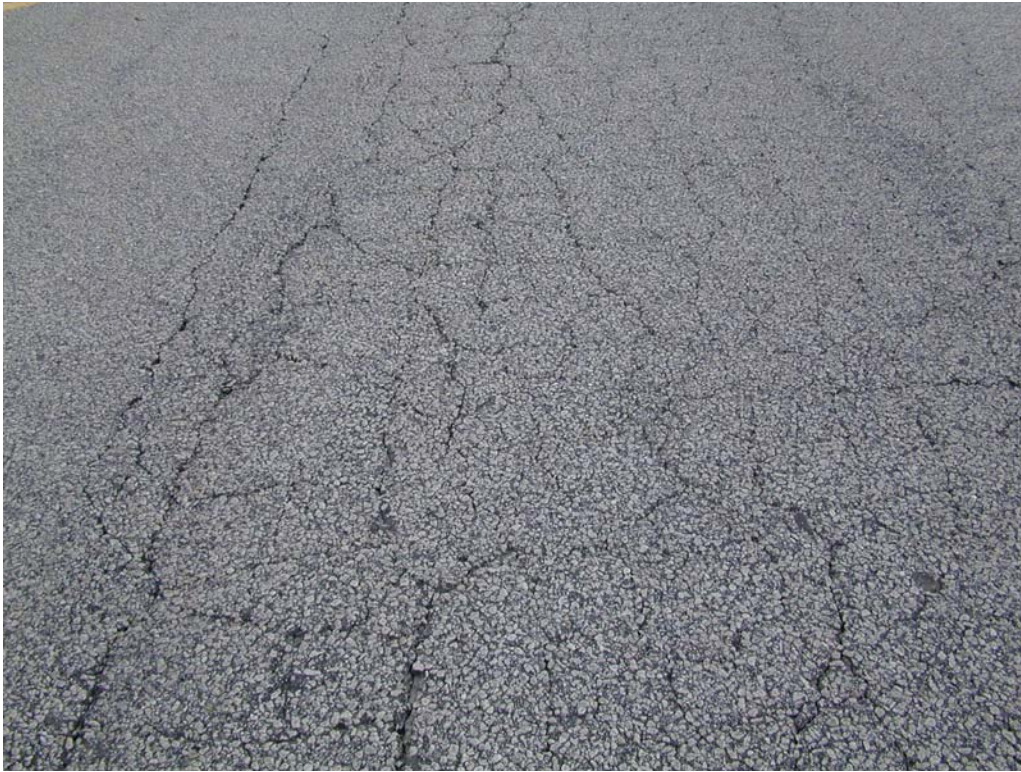
Alligator cracking in section TEAP-10.

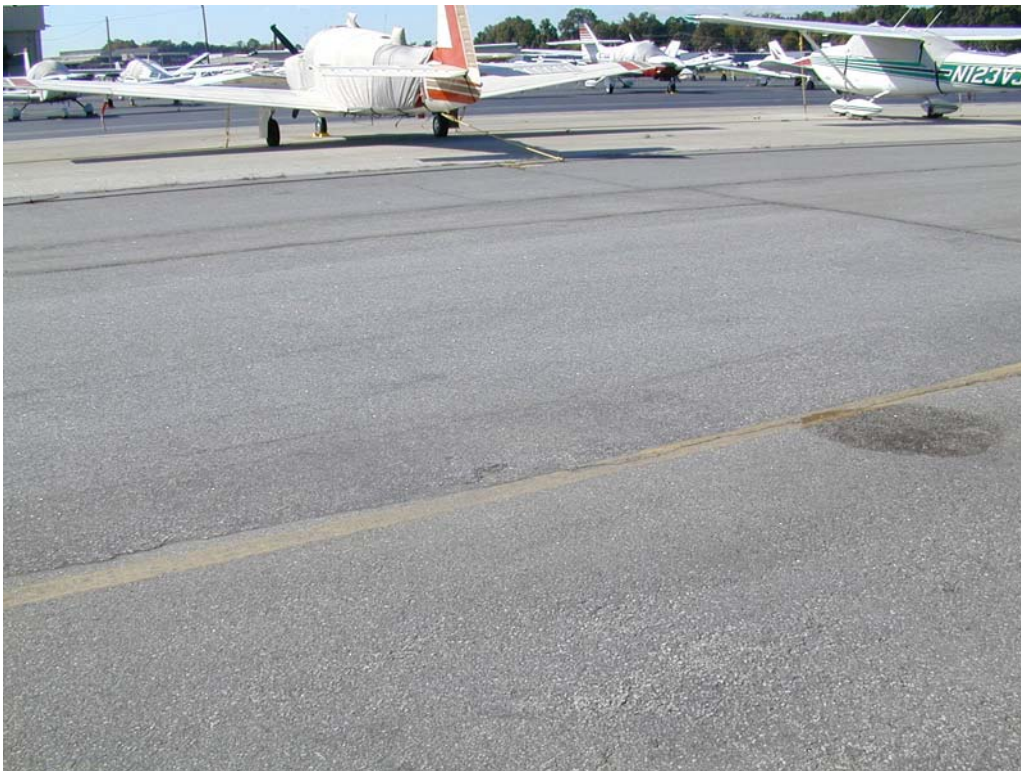
Again, one section was defined in Taxiway F. TFAP-10 is in poor condition with significant amounts of medium-severity alligator cracking, low-severity L&T cracking, rutting being observed.

Overview of section TFAP-10.

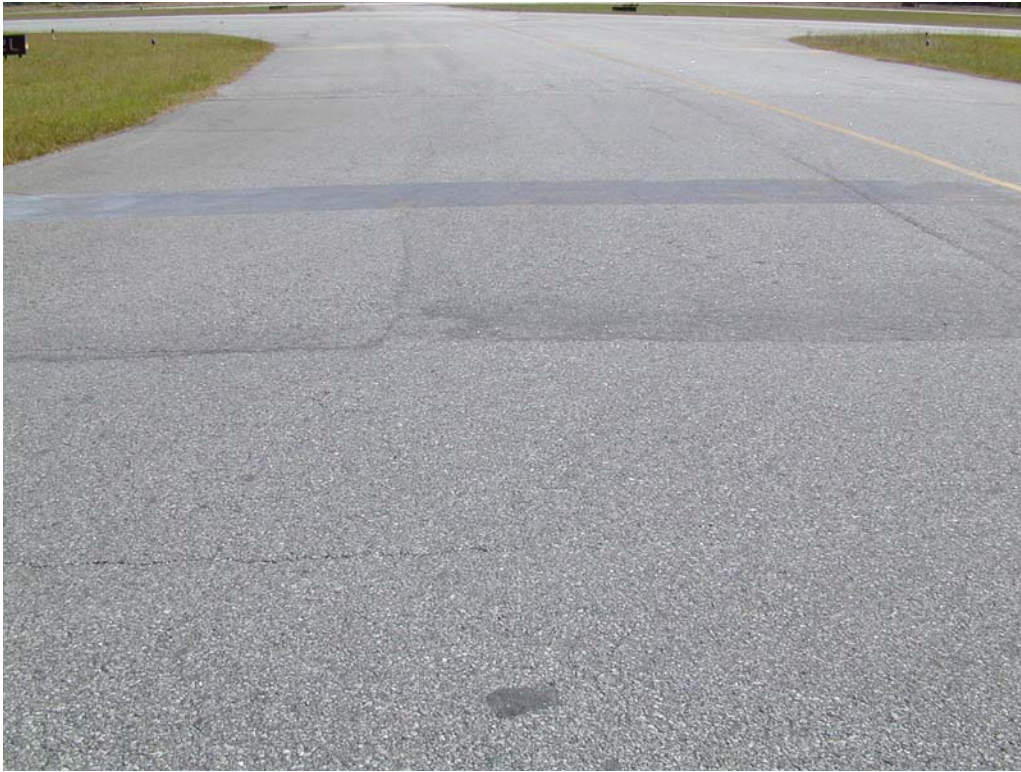
One section was defined in Taxiway G. TGAP-10 is in good condition with moderate amounts of block and L&T cracking found throughout the section.

Overview of section TGAP-10.

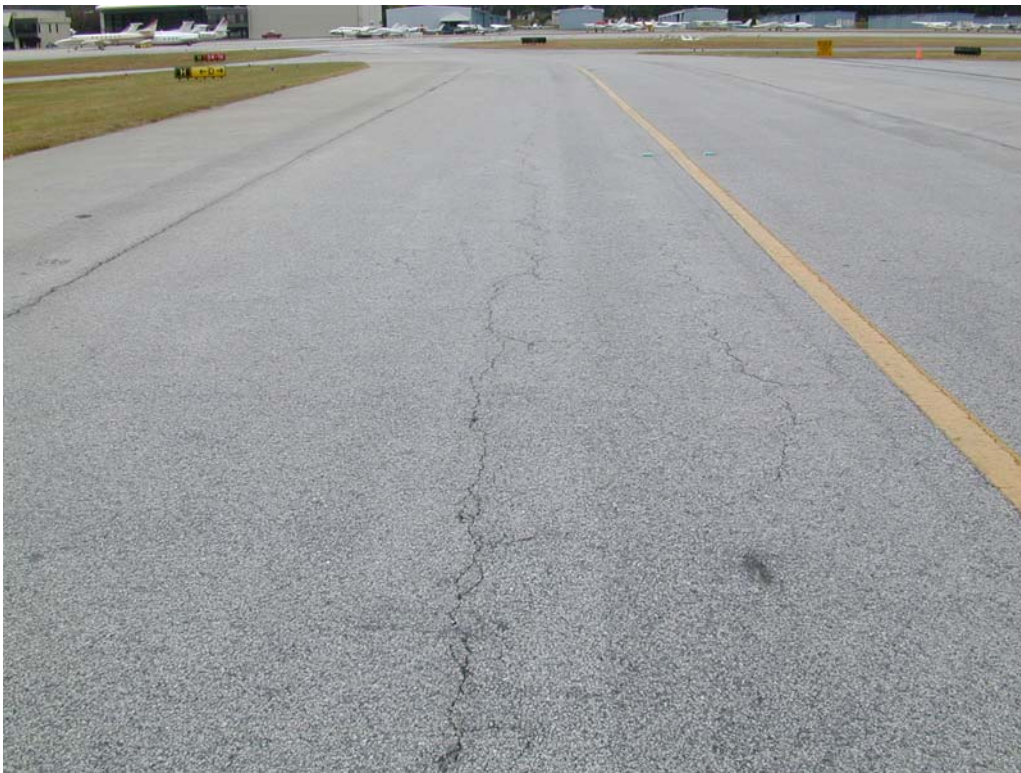
One section exists in Taxiway H. THAP-10 is in poor condition with extensive amounts of alligator cracking and raveling and weathering being observed. Moderate amounts of L&T cracking were also found. Finally, isolated quantities of rutting were observed in the section.

Overview of section THAP-10.

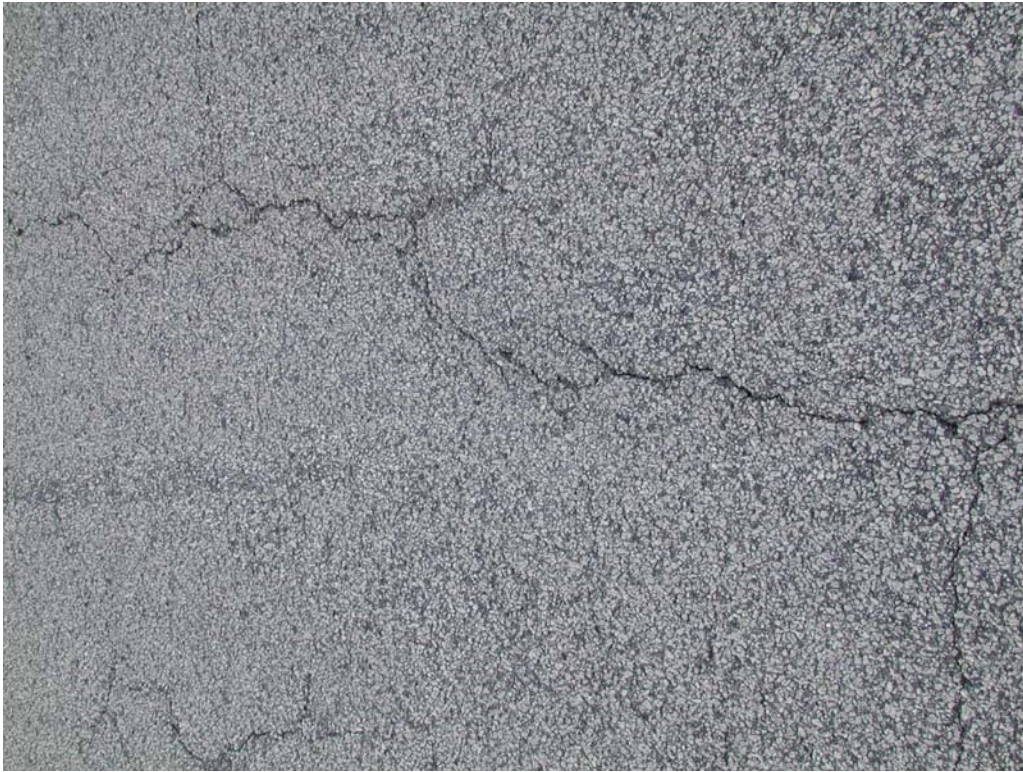
Alligator cracking in section THAP-10.
