DEKALB - PEACHTREE AIRPORT

PAVEMENT EVALUATION REPORT

JULY 2002

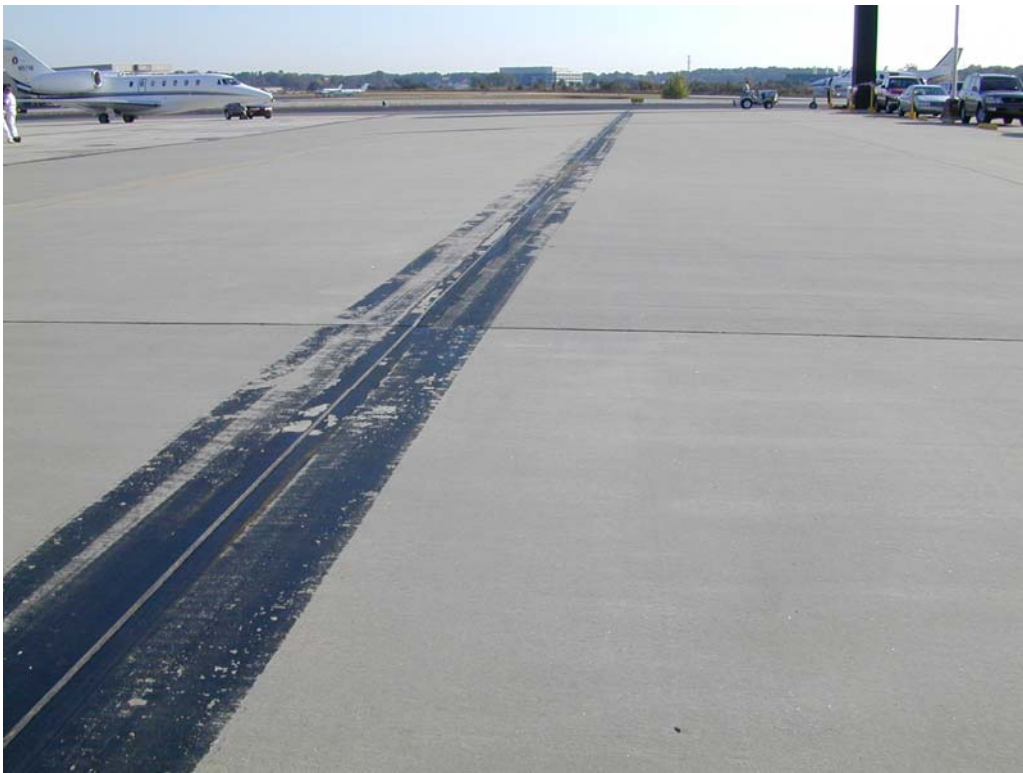
Overview of section TKAP-10.

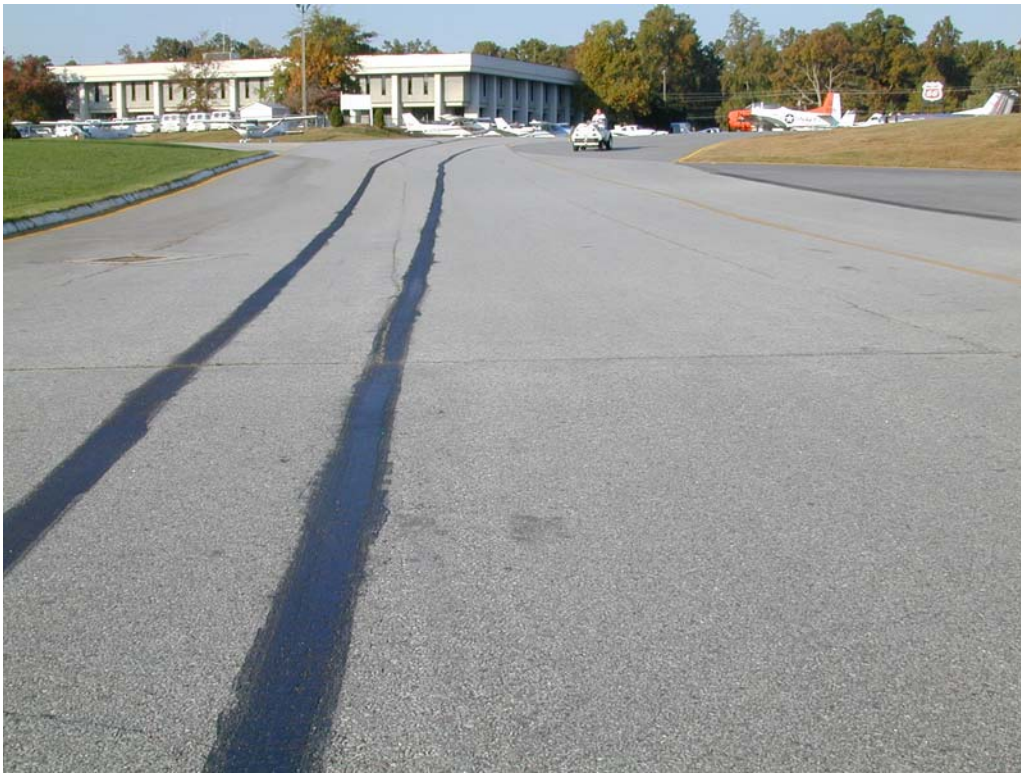
Two sections are defined in Taxiway K. TKAP-10 is newer PCC pavement and was found to be free of any distress. TKAP-20 is in good condition with moderate quantities of L&T cracking and raveling and weathering being observed in the section. In addition, isolated quantities of alligator cracking were found. An area at the western end of Taxiway K was found to be failed but was scheduled to be replaced and was not identified during the inspection.

Overview of section TKAP-20.

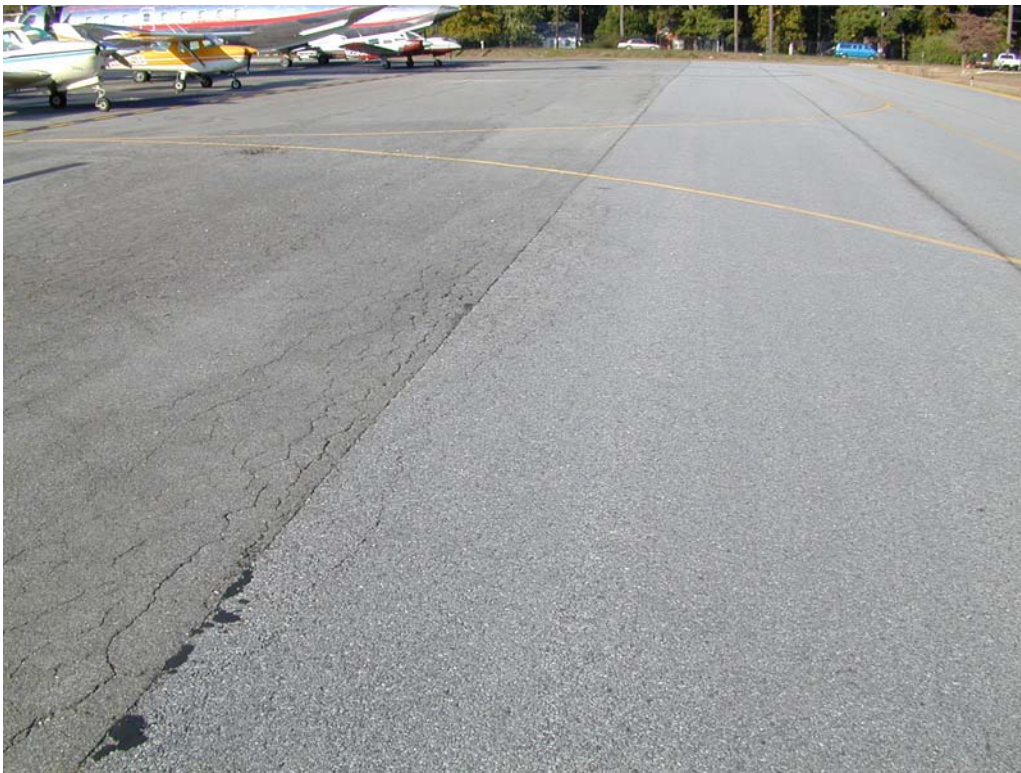
Overview of area being replaced in section TKAP-20.

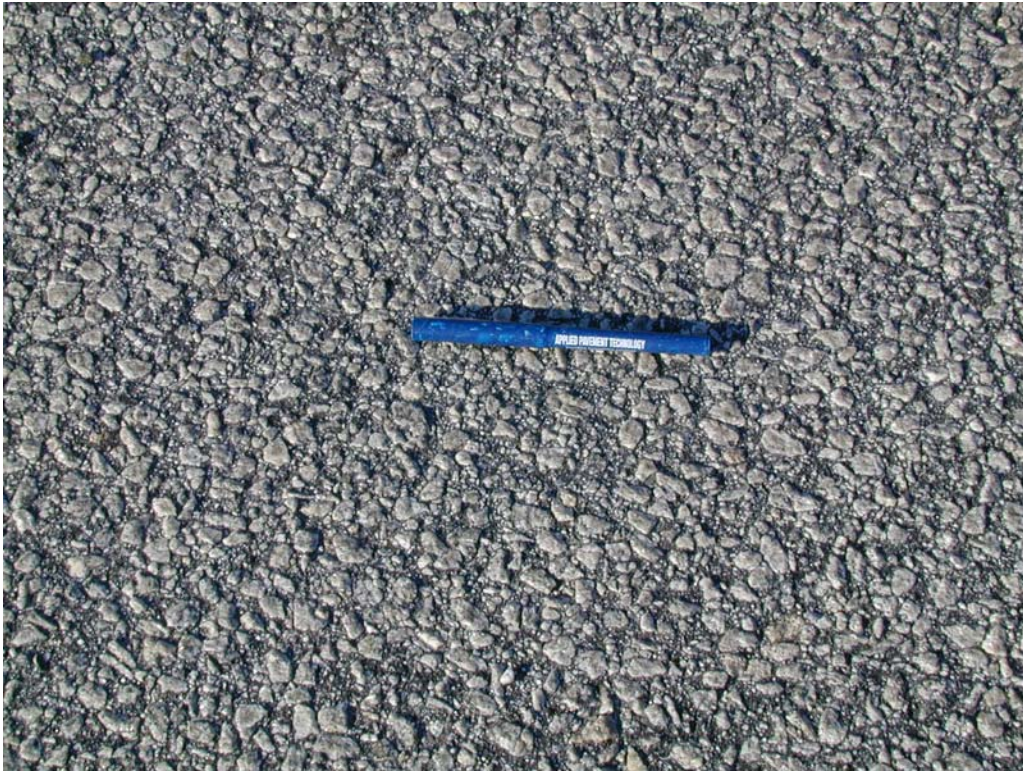
Raveling and weathering in section TKAP-20.

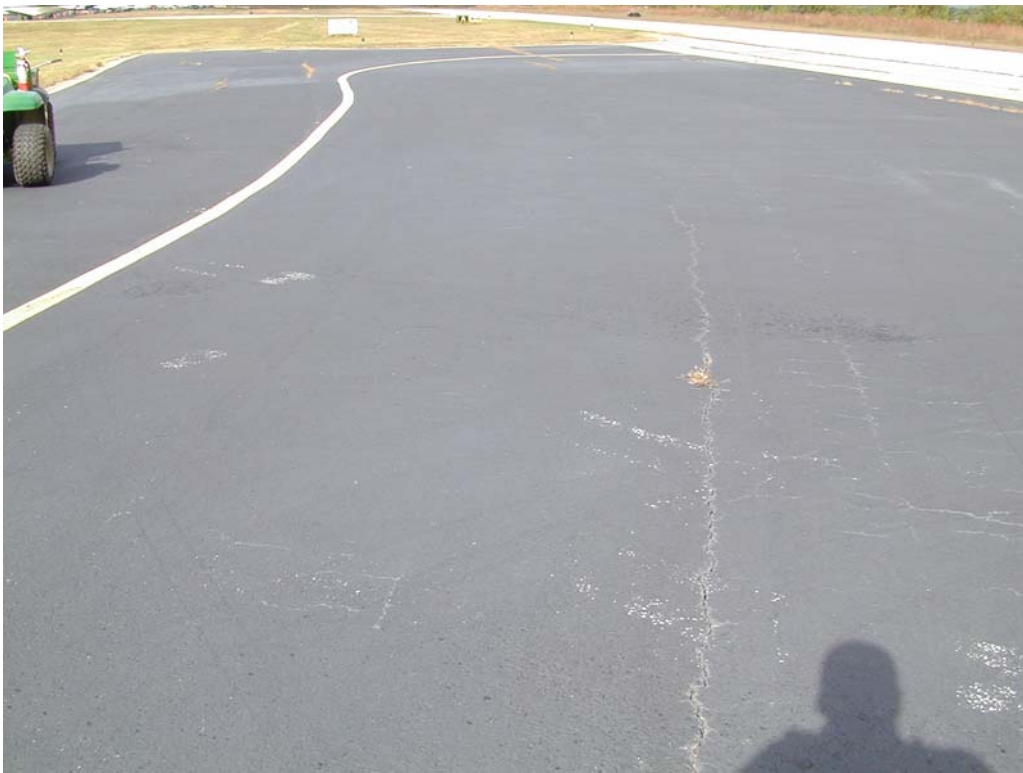
One section defines the apron adjacent to Taxiway A and E that serves as a runup apron for Runway 20R. A20RUNUPAP-10 is in good condition with significant quantities of low-severity, unsealed, L&T cracking being observed throughout the section. An isolated area of alligator cracking was also found in the section.

Overview of section A20RUNUPAP-10.

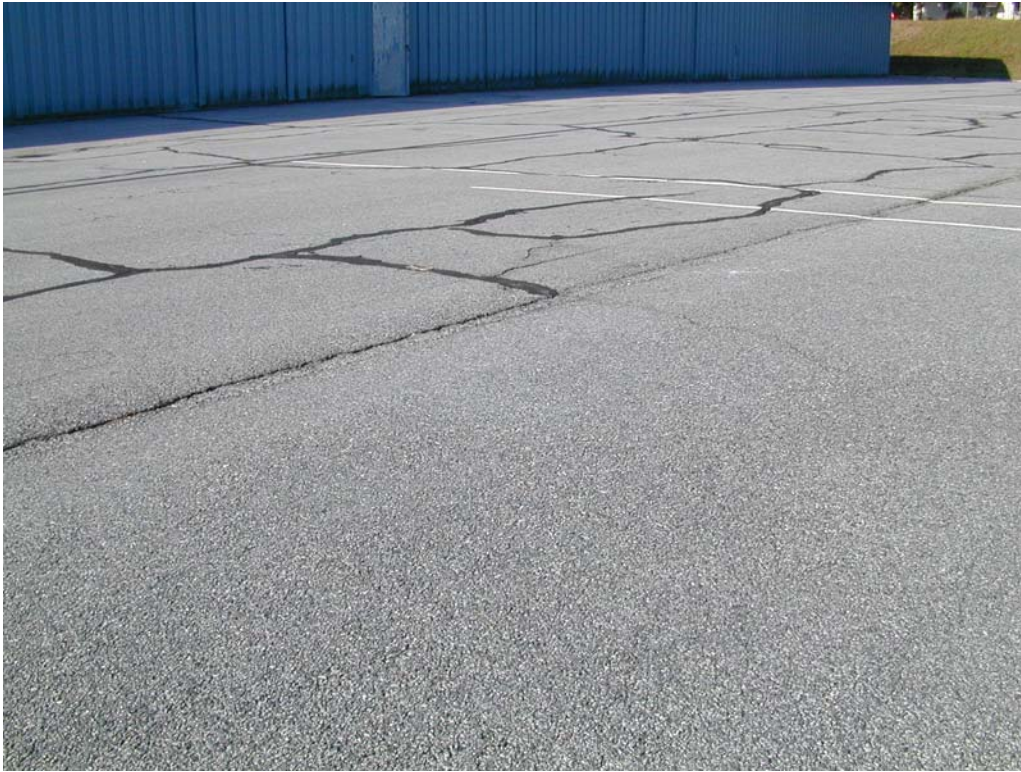
Two sections are defined in the Northwest Ramp. ANWRAMPAP-10 is in poor condition with significant amounts of alligator, block, and L&T cracking observed throughout the section. Swelling was found in isolated areas associated with the cracking. Finally, raveling and weathering was found in areas throughout the section. ANWRAMPAP-20 is also in poor condition with significant quantities of spalling, faulting, LTD cracking, and patching observed in the section. Additionally, high-severity joint seal damage was found throughout the section.

Overview of section ANWRAMPAP-10.

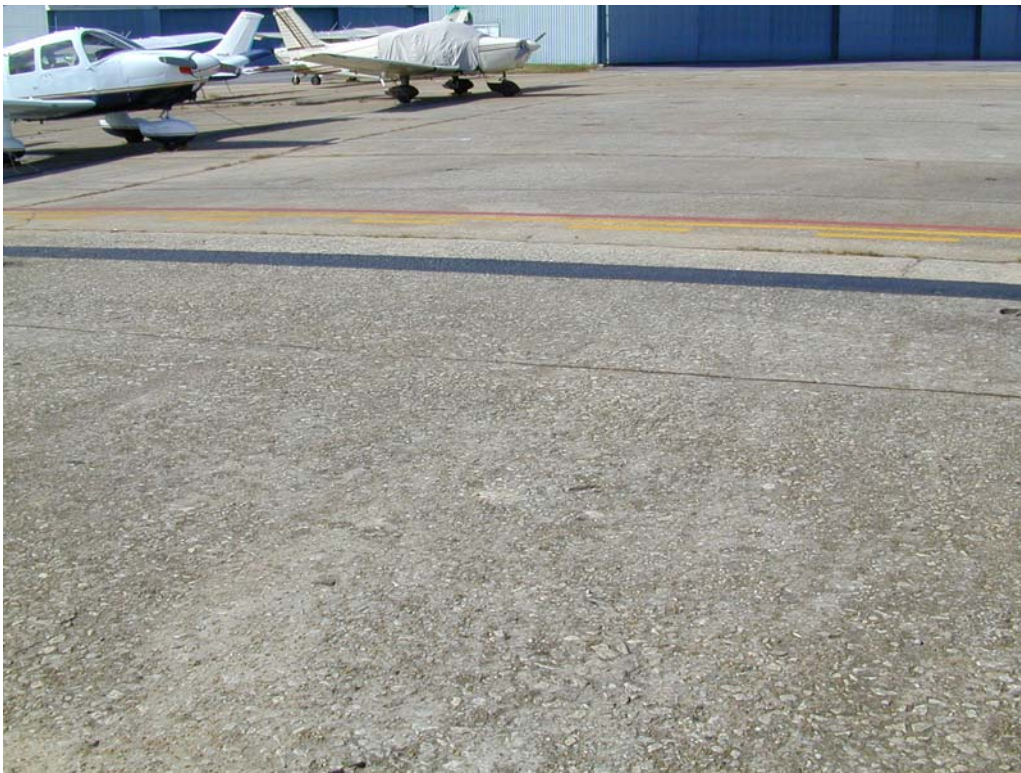
Overview of section ANWRAMPAP-20.

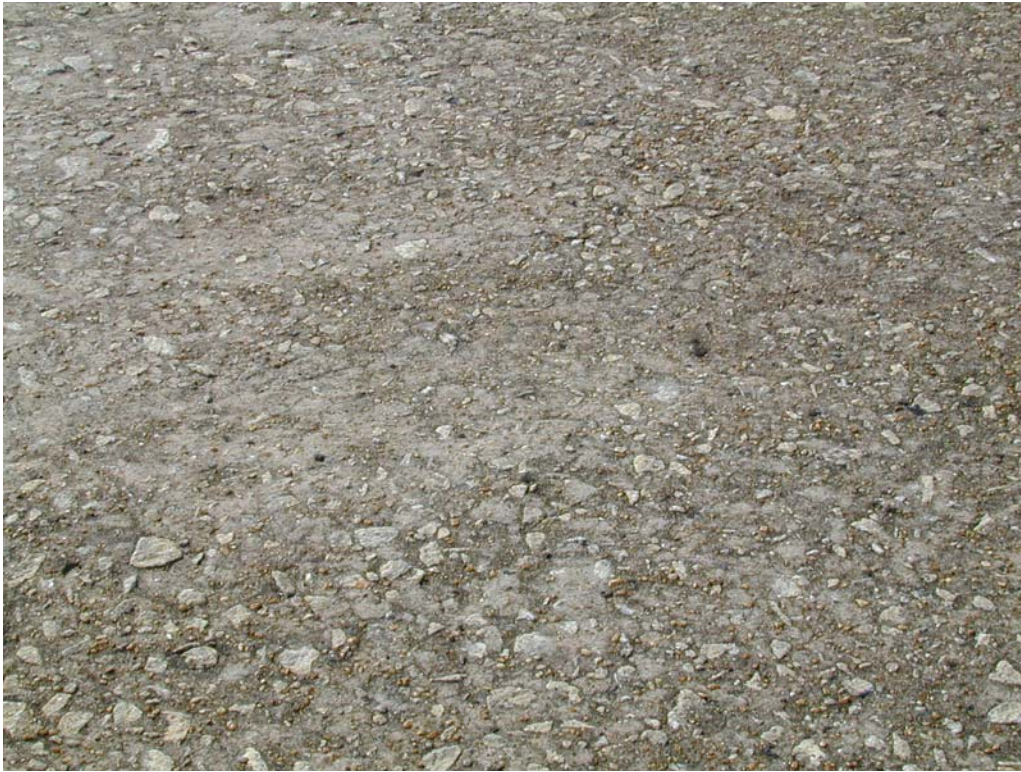
Scaling in section ANWRAMPAP-20.

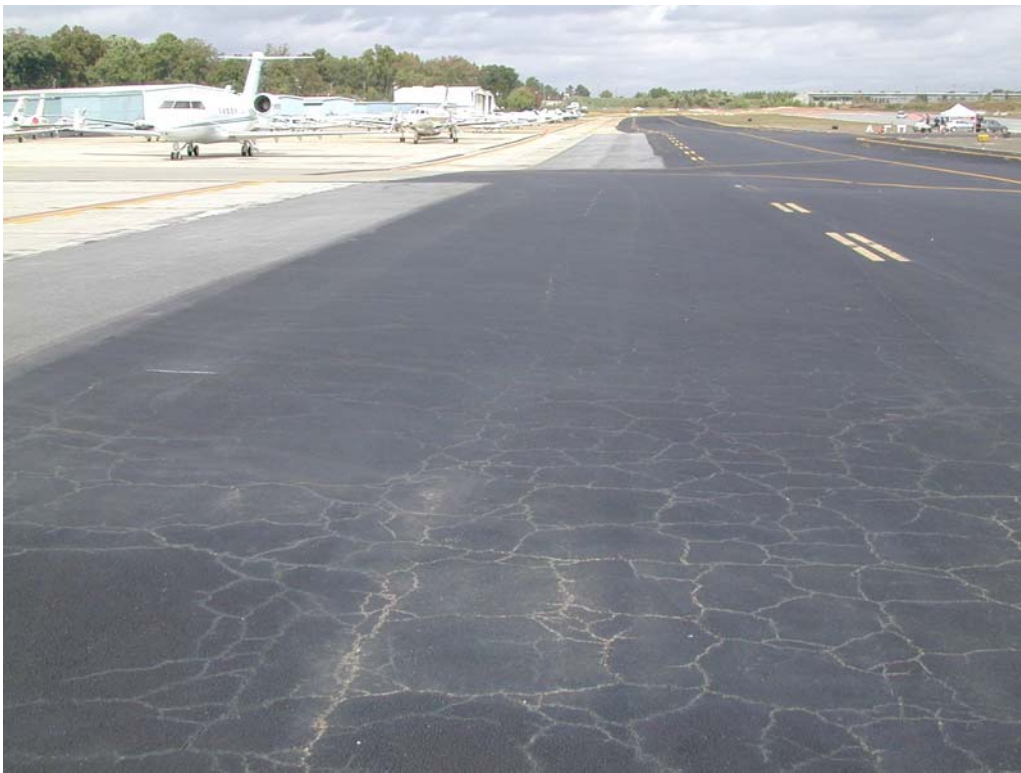
The Perimeter Apron consists of two sections. APERIMAP-10 is failed with large quantities of alligator and block cracking being found throughout the section. APERIMAP-20 is in excellent condition having been recently rehabilitated. Only small quantities of L&T cracking were found in the section.

Overview of section APERIMAP-10.

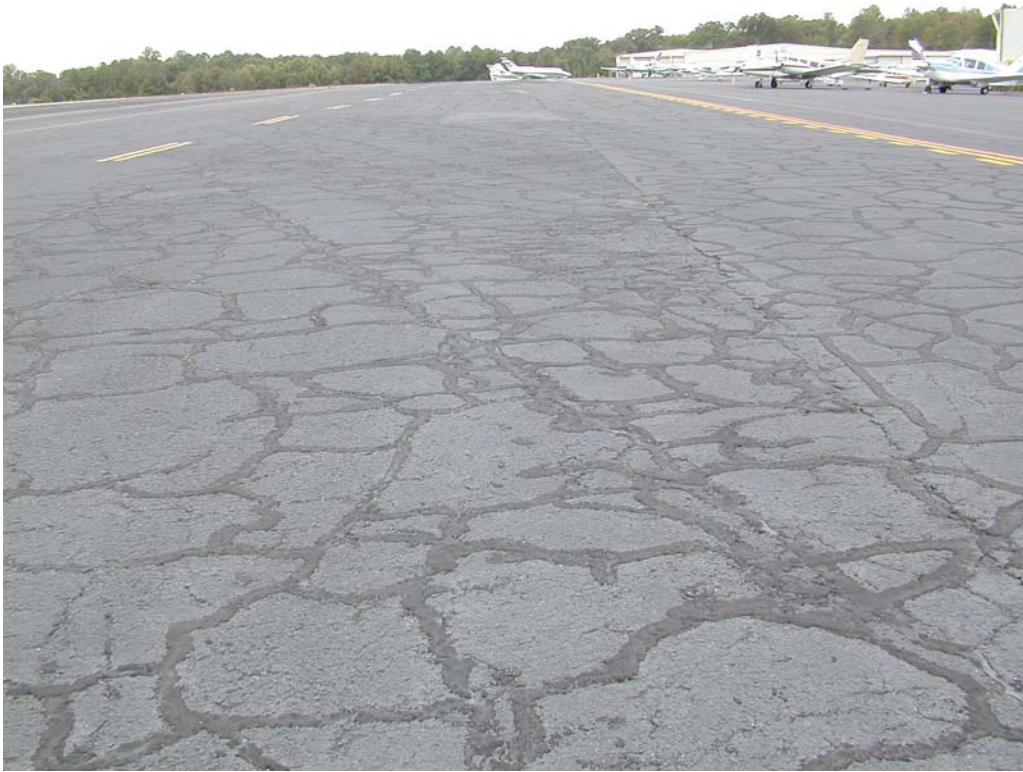
Block cracking in section APERIMAP-10.

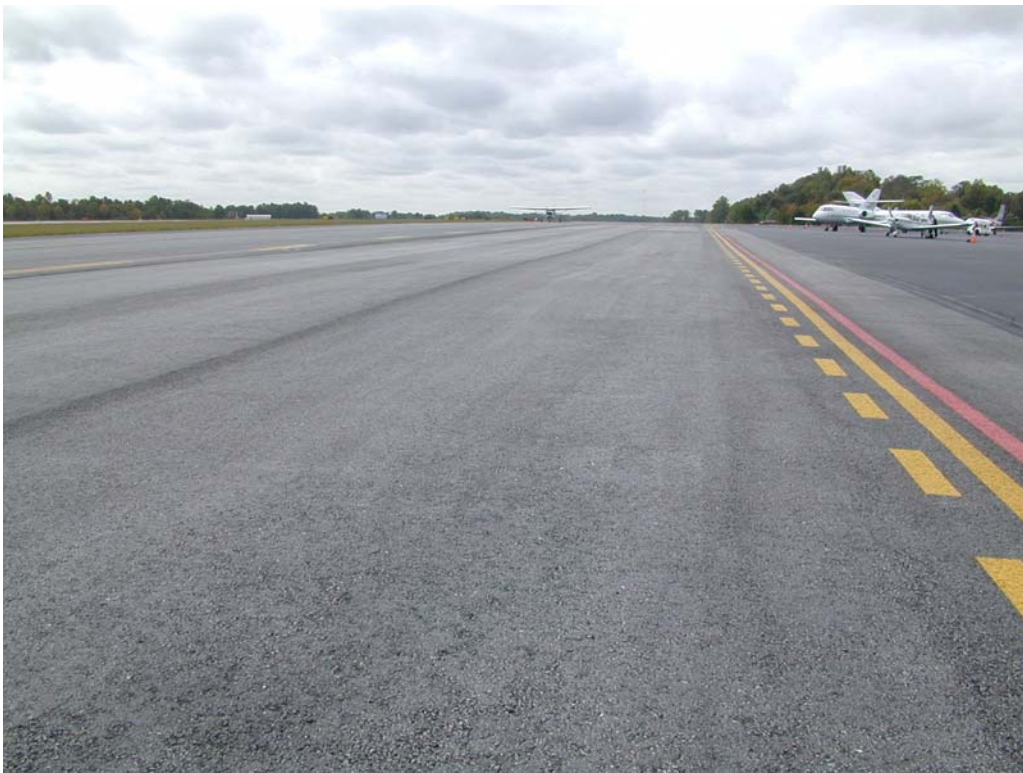
Overview of section APERIMAP-20.

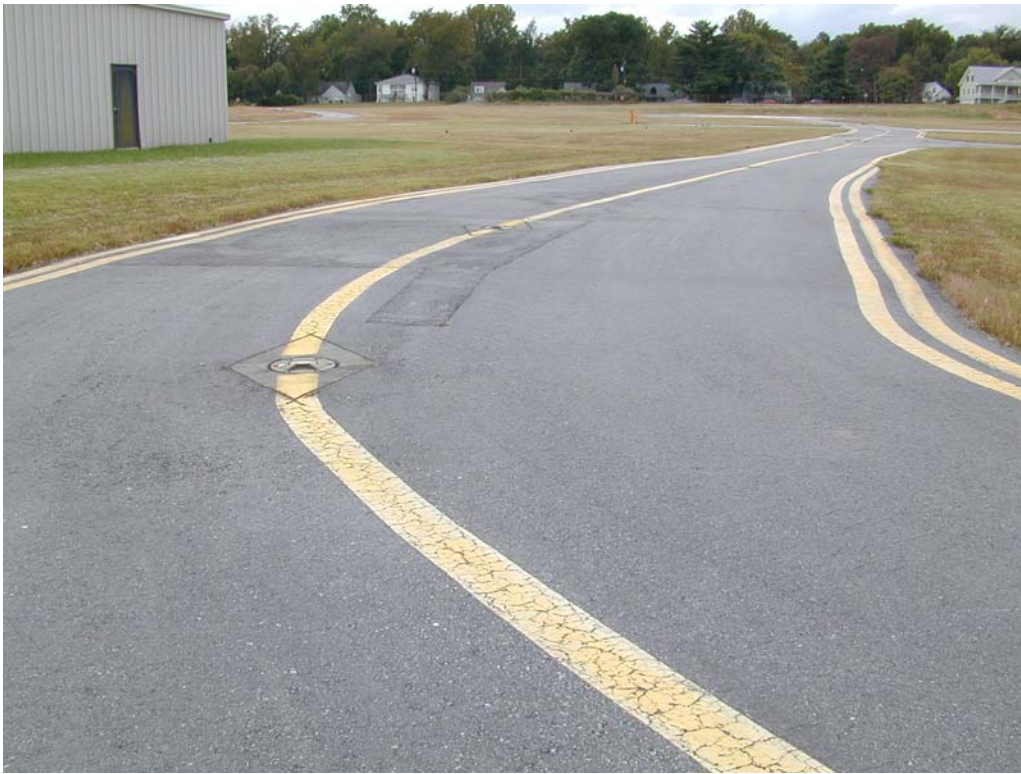
Two sections are defined in the Helipad. HELIAP-10 is in excellent condition with significant amounts of patching and small amounts of L&T cracking being found throughout the section. HELIAP-20 is also in excellent condition and was found to be free from any distress.

Overview of section HELIAP-10.

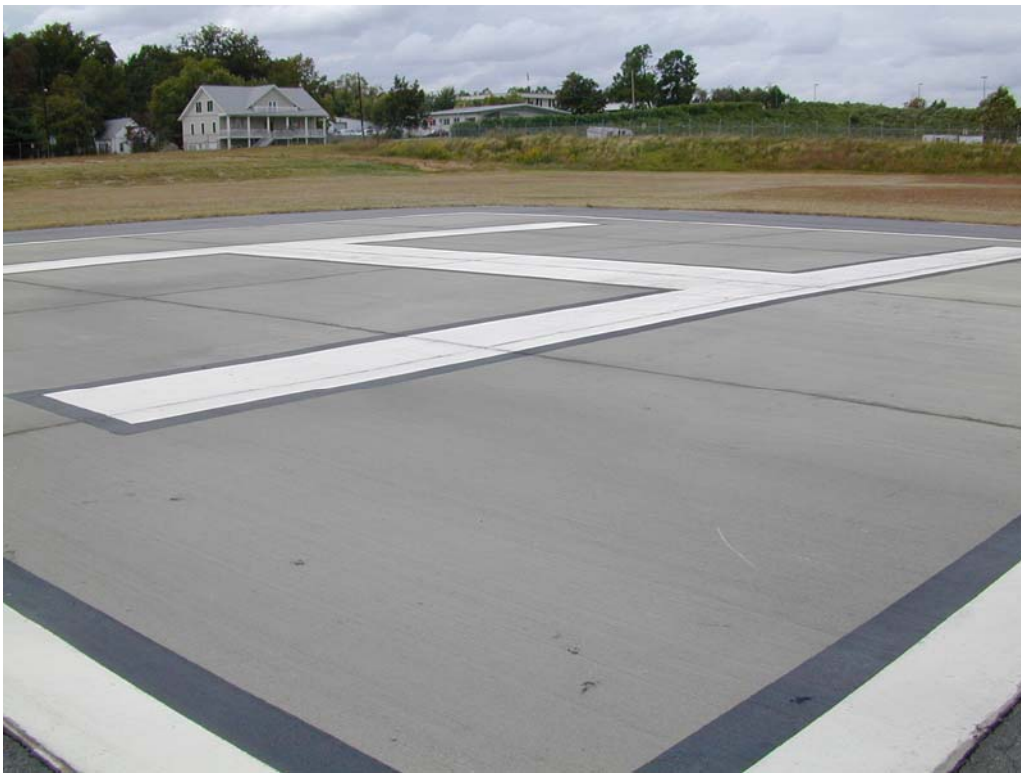
Overview of section HELIAP-20.
