# 2012 Cook County Airport Pavement Management Plan

# COOK COUNTY AIRPORT

## PAVEMENT MANAGEMENT REPORT

**DECEMBER 2012**

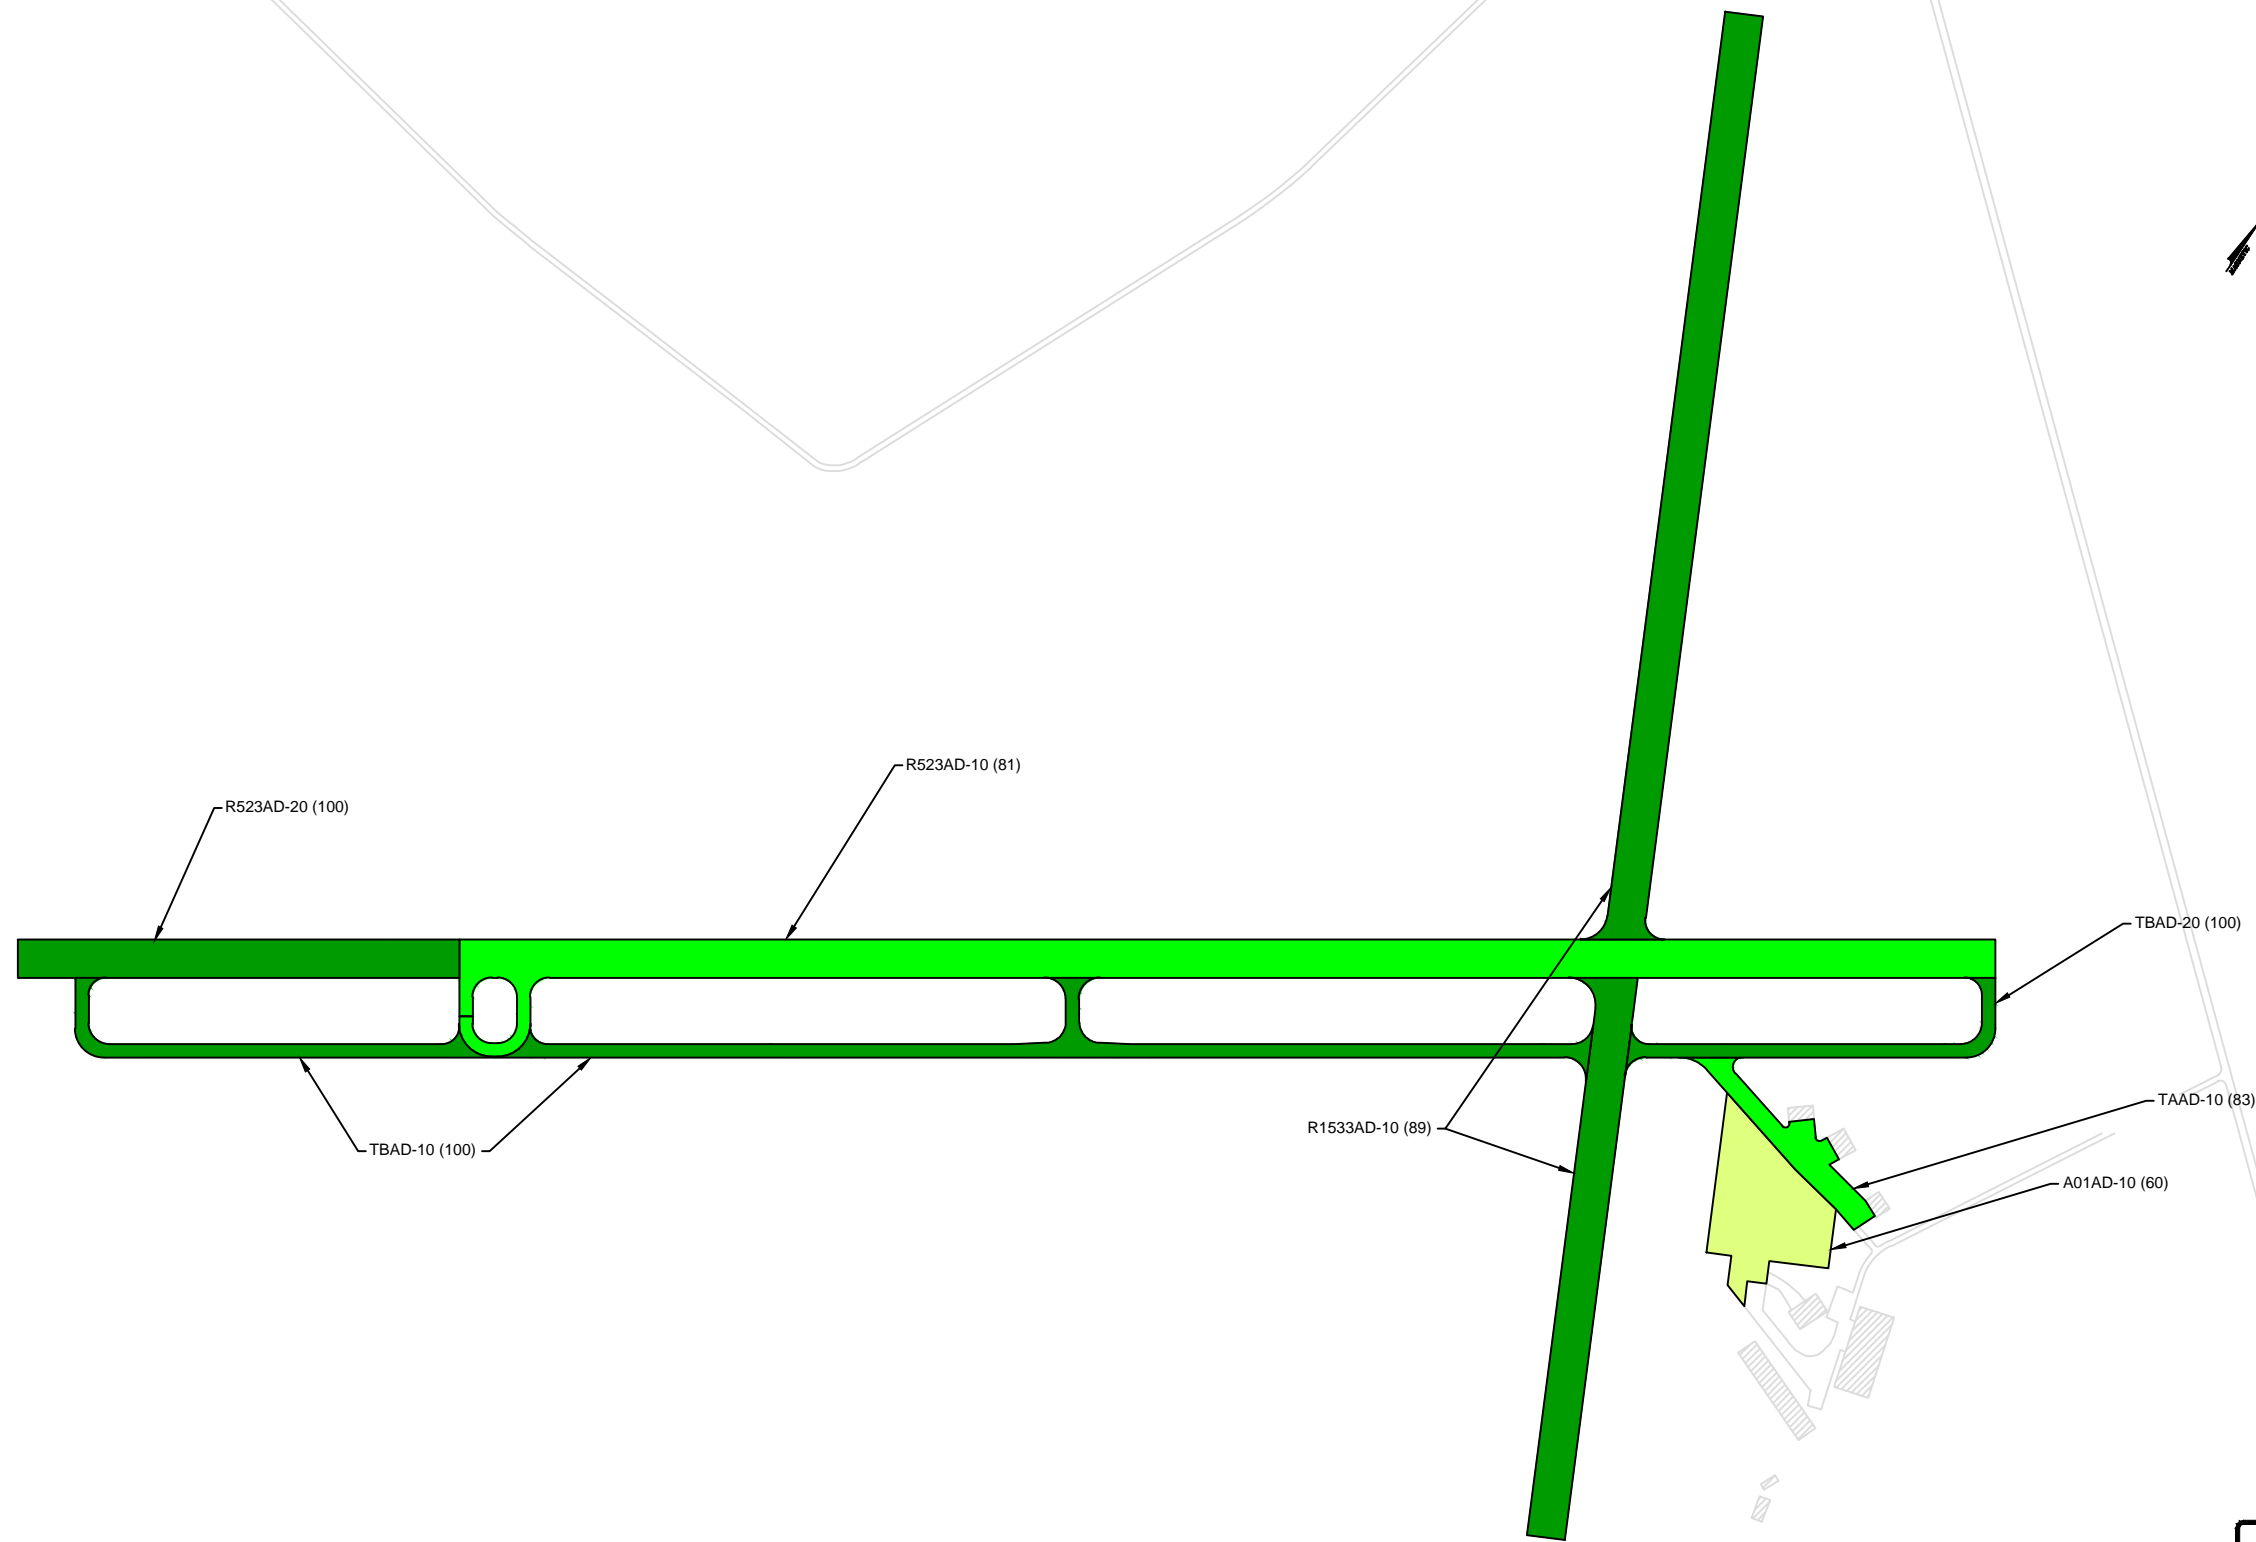
The 2012 area-weighted condition of Cook County Airport is 86, with conditions ranging from 60 to 100 [on a scale of 0 (failed) to 100 (excellent)]. This compares to a 2007 PCI of 91.

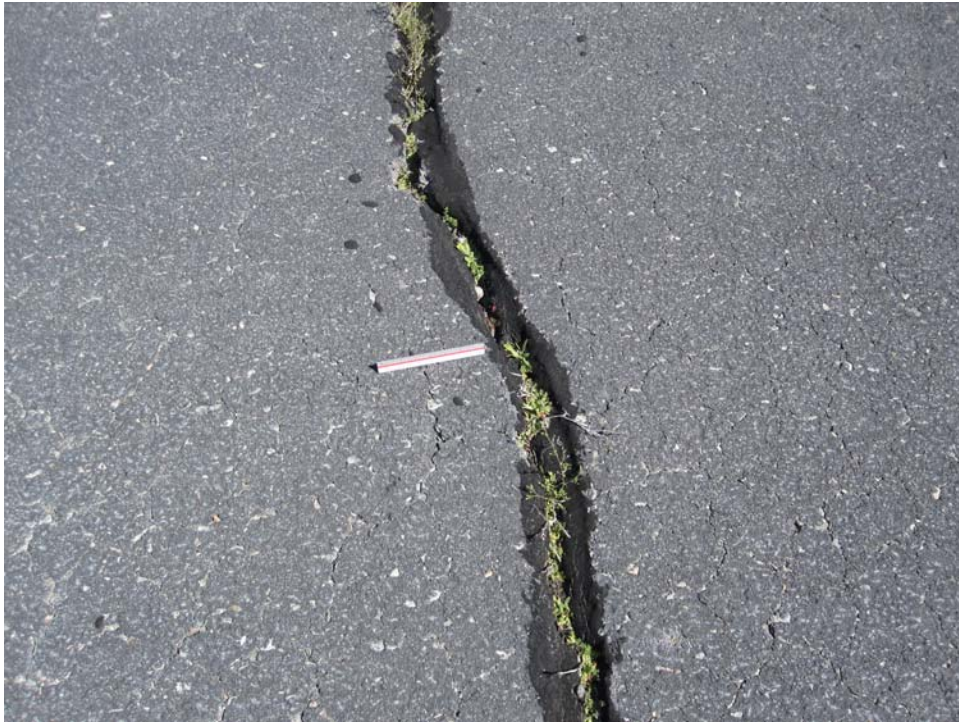
The apron area was defined by one section with a PCI value of 60. Large quantities of medium-severity L&T cracking were recorded where crack sealant had failed and no longer prevented water from penetrating the pavement surface. Low-severity, unsealed L&T cracking was also observed along with medium-severity L&T cracking identified in areas where unsealed crack widths exceeded ¼ in.

A01AD-10. Longitudinal and Transverse Cracking (Sample Unit #14).

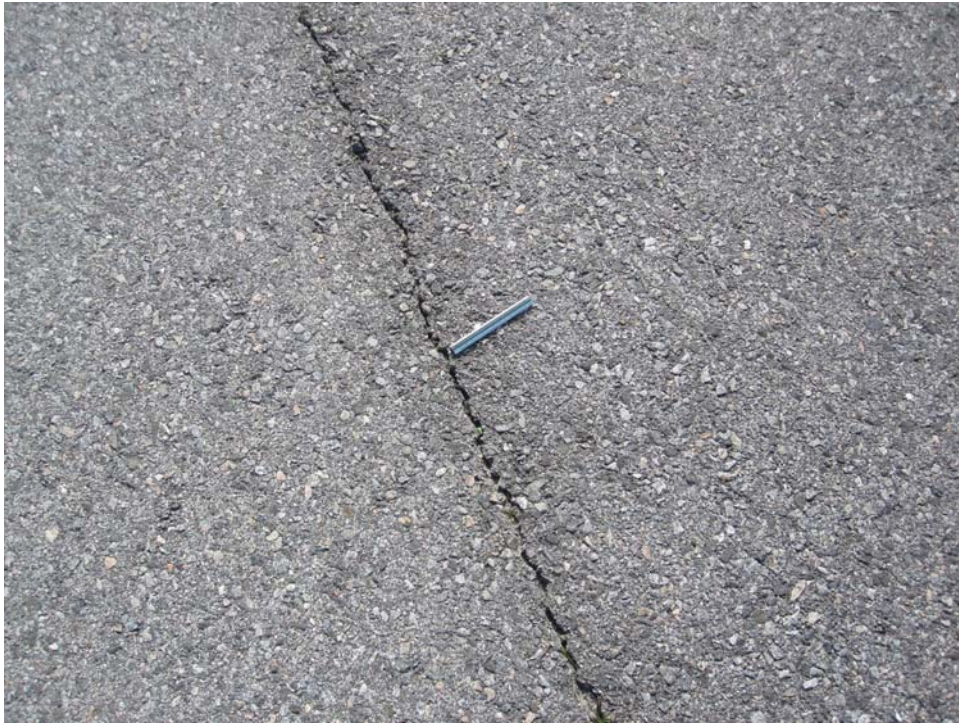
Runway 15-33 was comprised of one section with a PCI value of 89. Low-severity, unsealed L&T cracking was observed along some of the paving lanes.

R1533AD-10. Longitudinal and Transverse Cracking (Sample Unit #03).

Sample Number: 03 Type: R Area: 5,000.00SqFt PCI = 85  
Sample Comments:  
48 LONGITUDINAL/TRANSVERSE CRACKING L 250.00 Ft Comments:lu

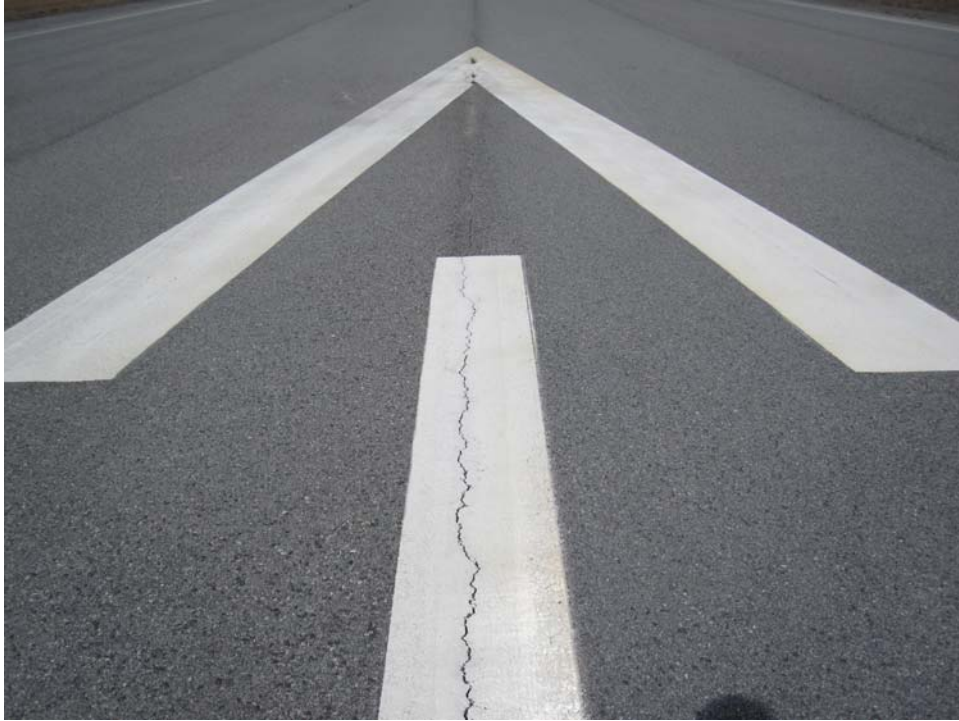
R1533AD-10. Satisfactory Paint.

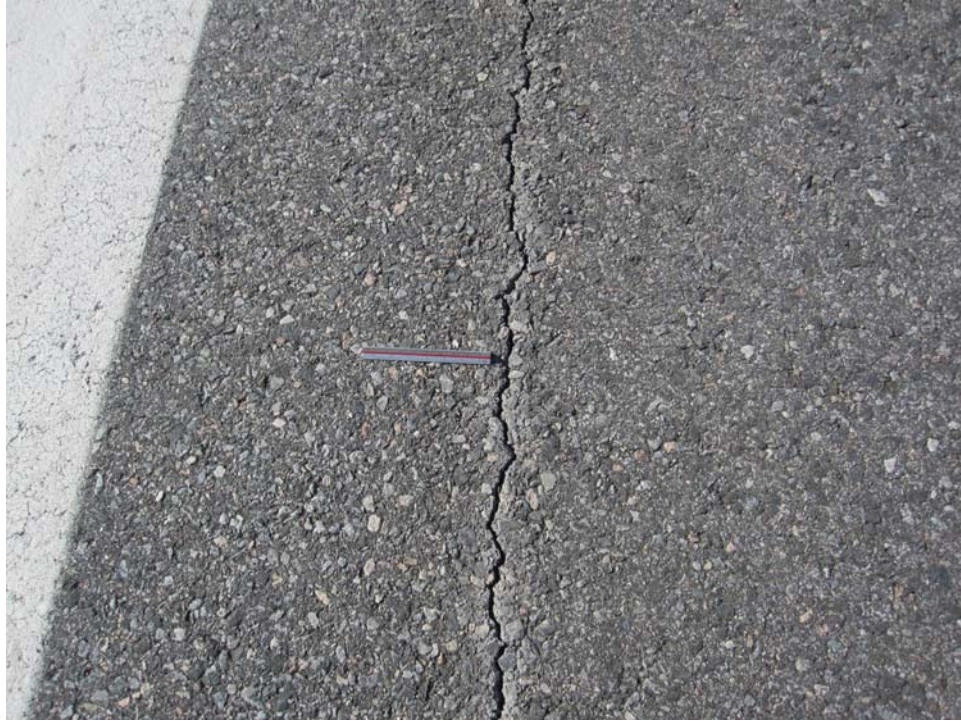
Runway 5-23 consisted of two sections. Section 10 had a PCI value of 81. The predominant distress identified was low-severity, unsealed longitudinal and transverse (L&T) cracking. Medium-severity L&T cracking was also recorded along the paving seams where the unsealed crack widths were greater than ¼ in. Section 20, located on the west end of Runway 5-23, had a PCI value of 100 with no distresses observed at the time of inspection.

R523AD-10. Longitudinal and Transverse Cracking (Sample Unit #76).

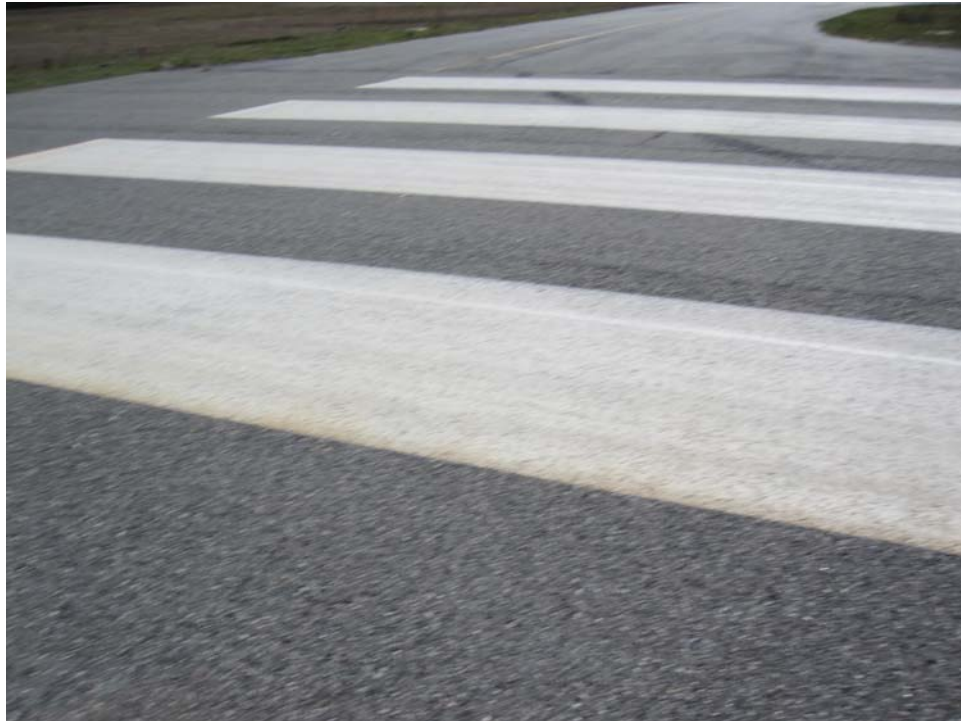
R523AD-10. Satisfactory Paint.

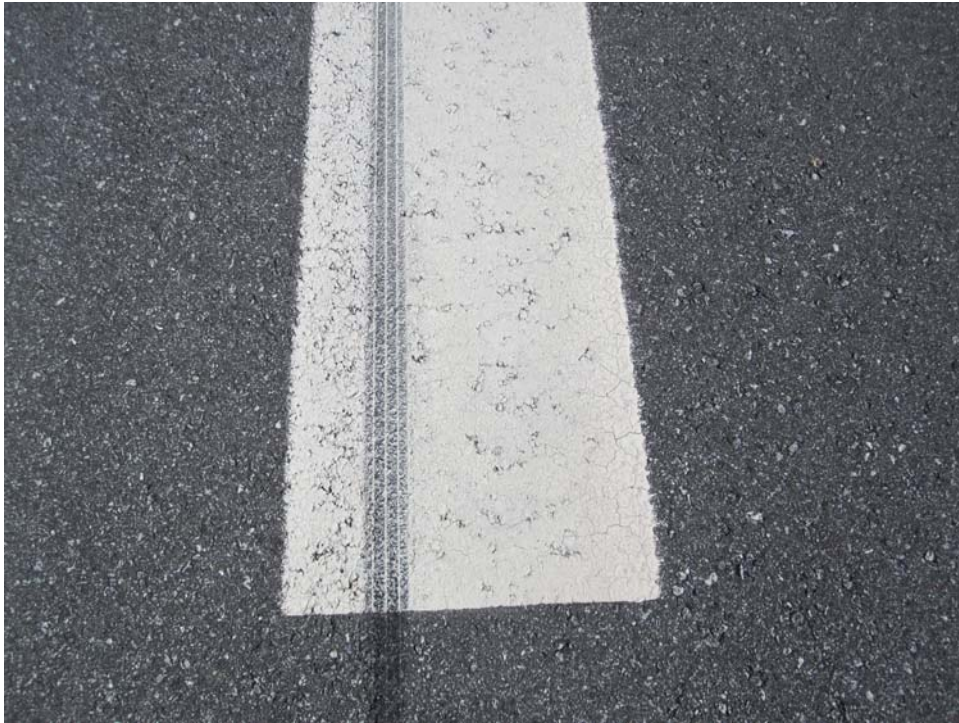
R523AD-20. Satisfactory Paint.

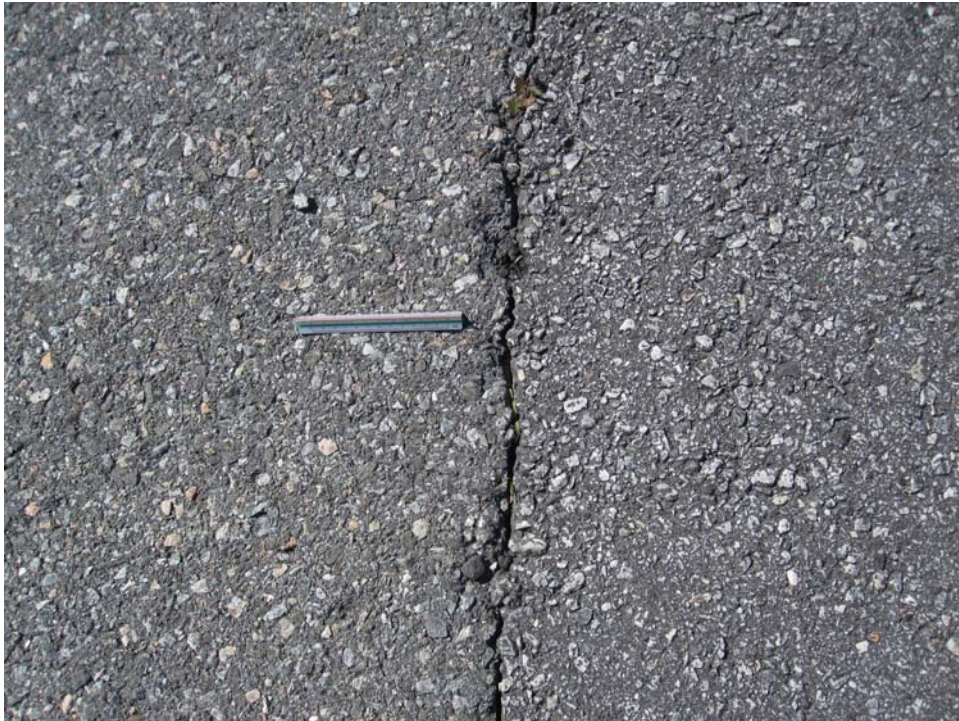
Taxiway A was defined by one section with a PCI value of 83. Large amounts of low-severity weathering were recorded where fine aggregate was missing from the pavement surface. Low-severity, unsealed L&T cracking and low-severity swelling were also identified.

TAAD-10. Longitudinal and Transverse Cracking (Sample Unit #01).

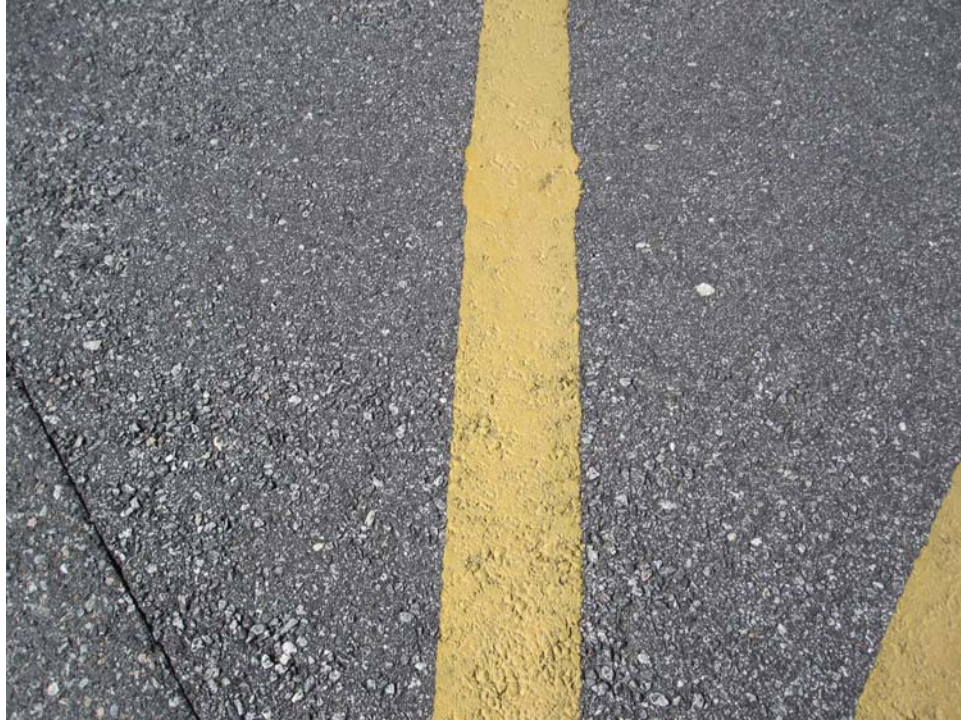
TAAD-10. Satisfactory Paint.

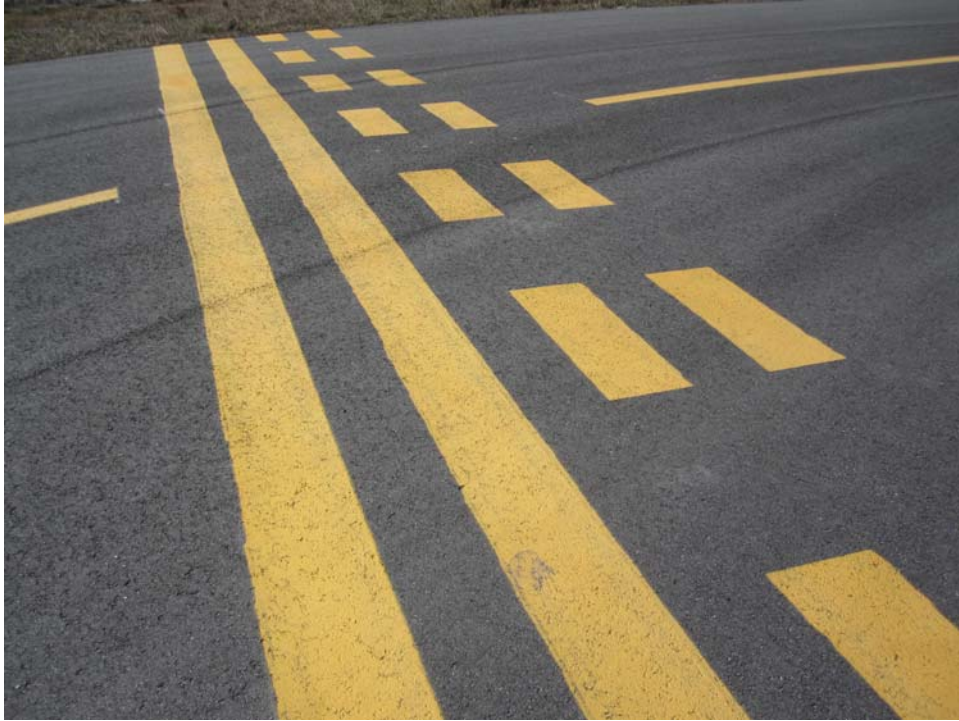
TBAD-10. Satisfactory Paint.

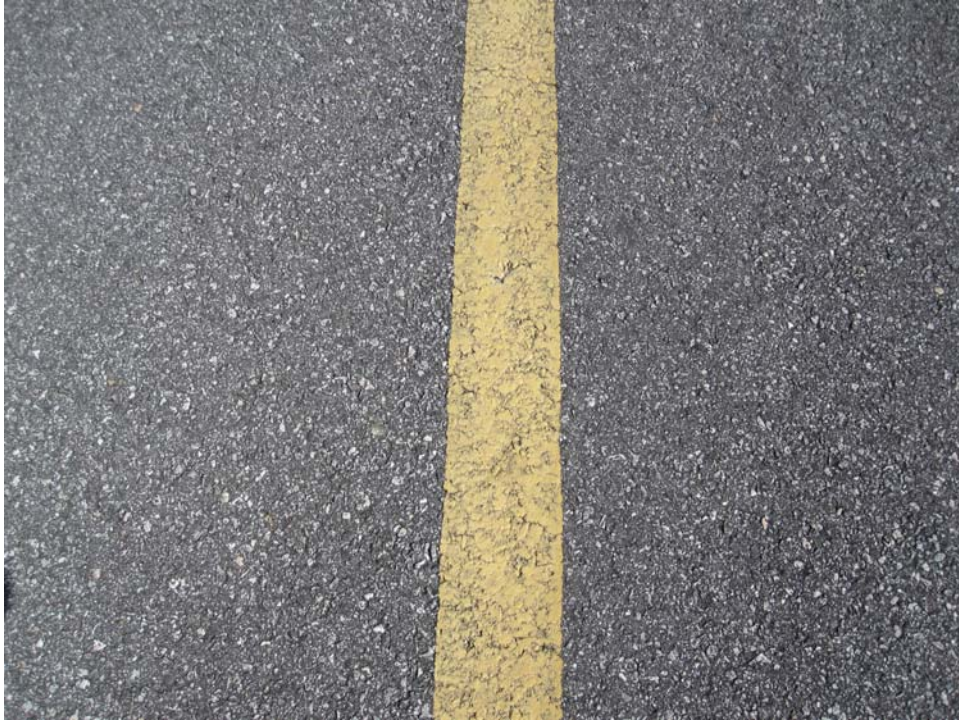
TBAD-20. Satisfactory Paint.
