2012 Athens-Ben Epps Field Pavement Management Plan

ATHENS-BEN EPPS FIELD

PAVEMENT MANAGEMENT REPORT

DECEMBER 2012

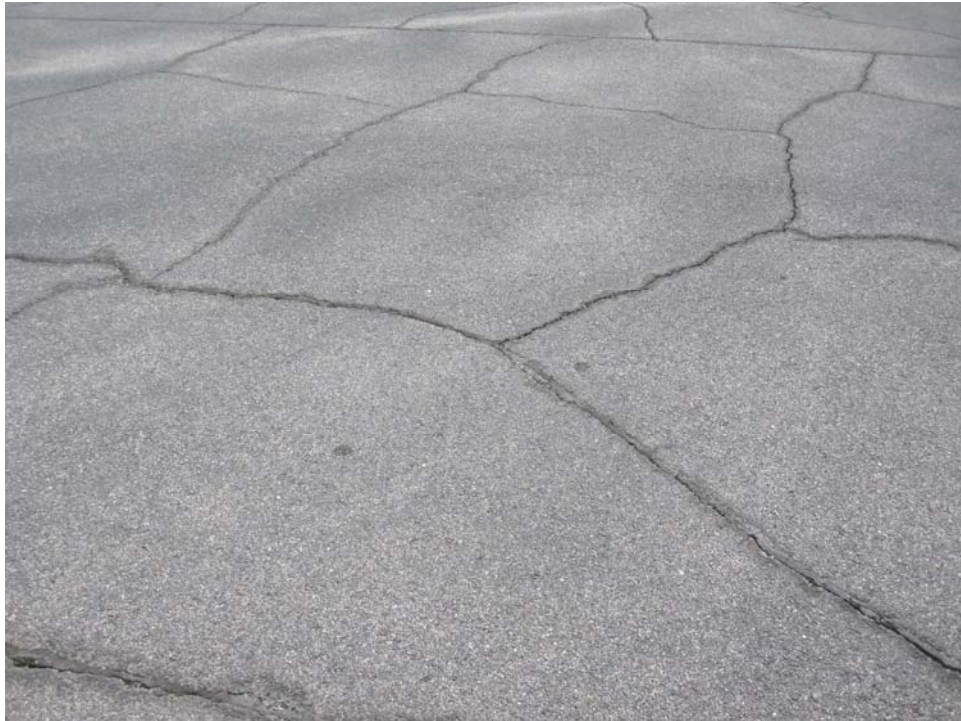
A01AT-10. Block Cracking (Sample Unit #03).

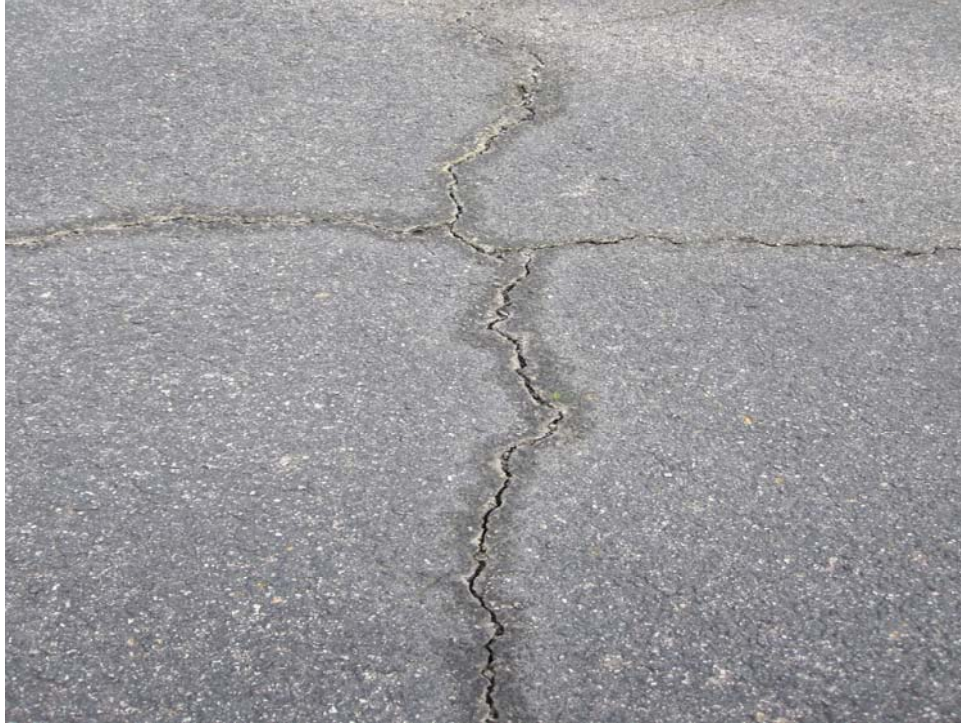
A01AT-10. Longitudinal and Transverse Cracking (Sample Unit #12).

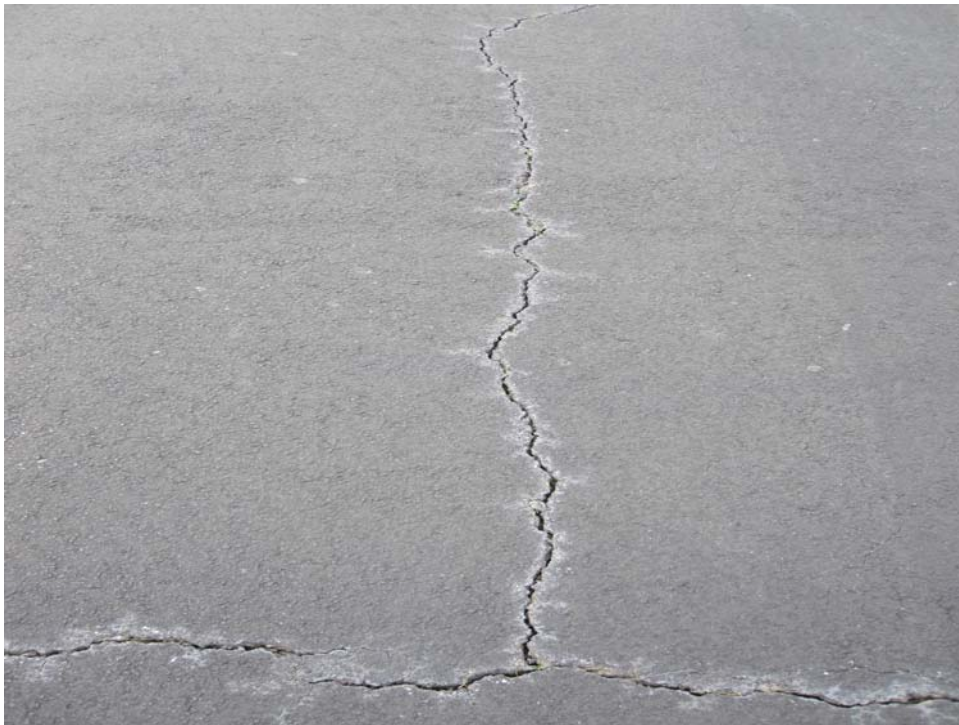
A01AT-20. Longitudinal and Transverse Cracking (Sample Unit #02).

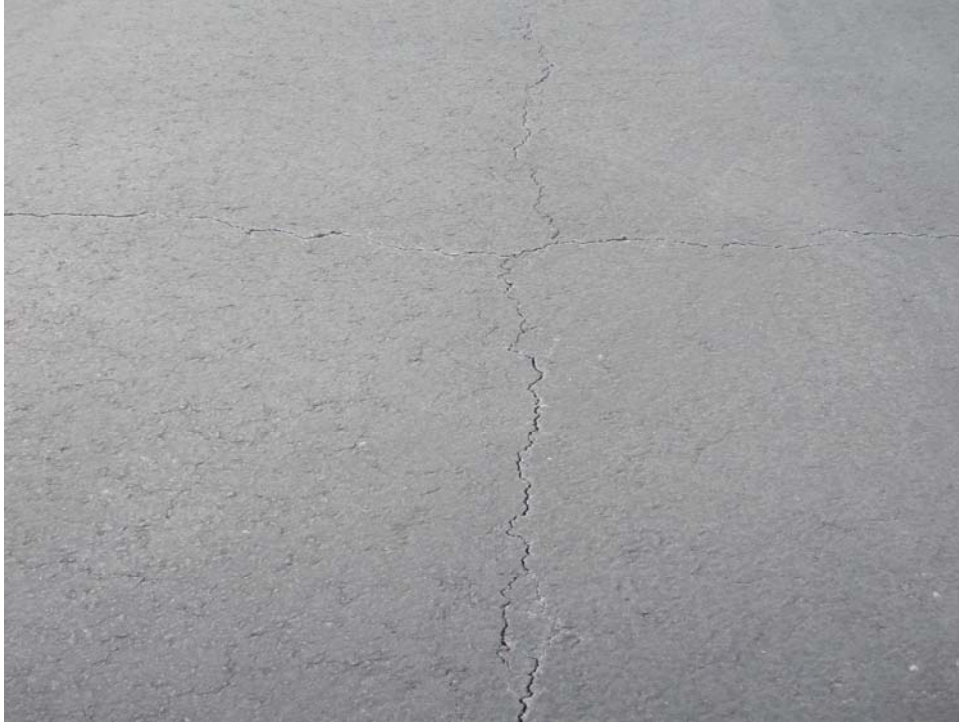
A01AT-20. Longitudinal and Transverse Cracking (Sample Unit #20).

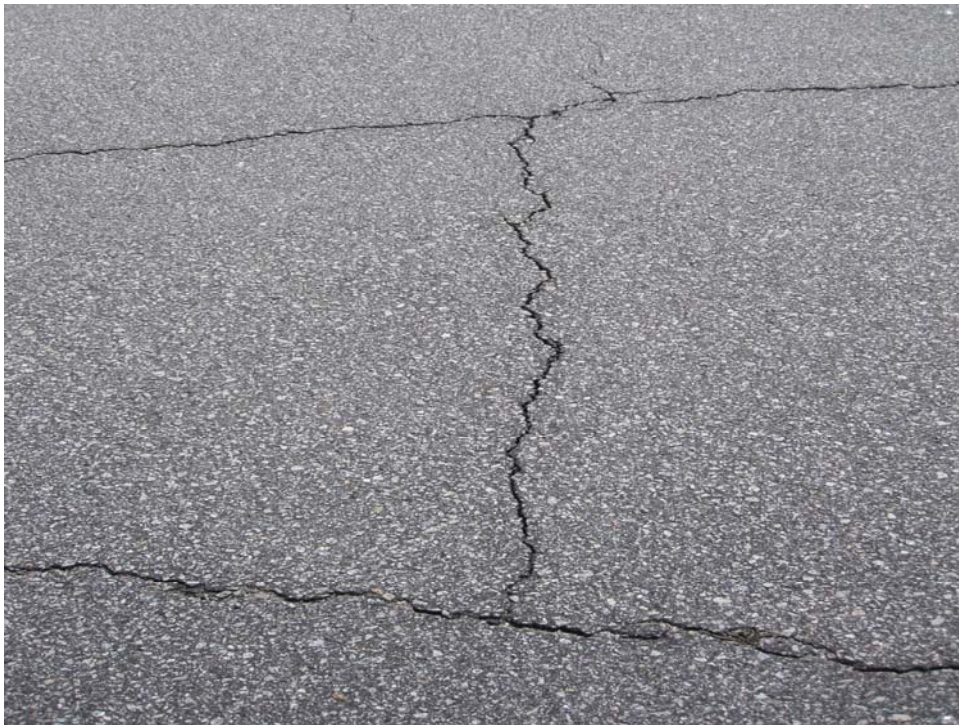
A01AT-20. Longitudinal and Transverse Cracking (Sample Unit #28).

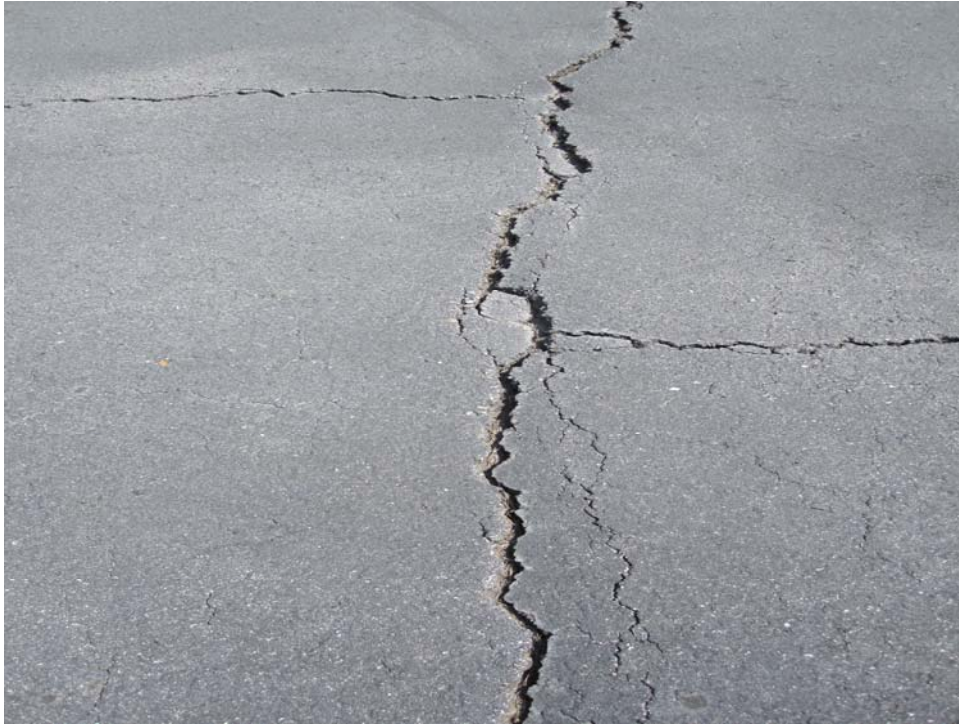
A01AT-30. Longitudinal and Transverse Cracking (Sample Unit #02).

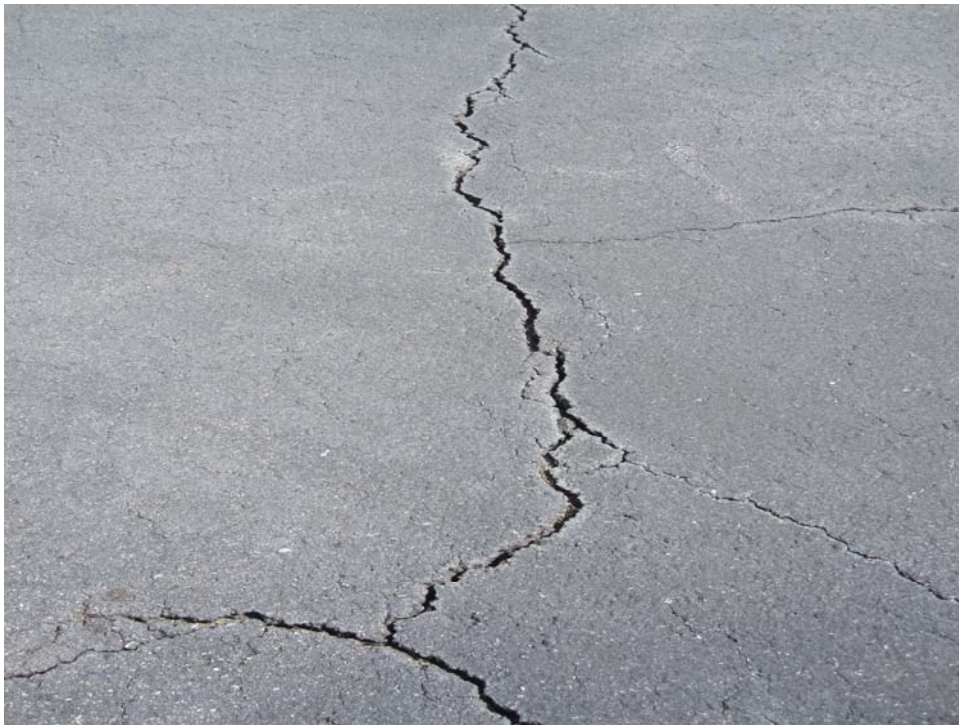
A01AT-30. Longitudinal and Transverse Cracking (Sample Unit #05).

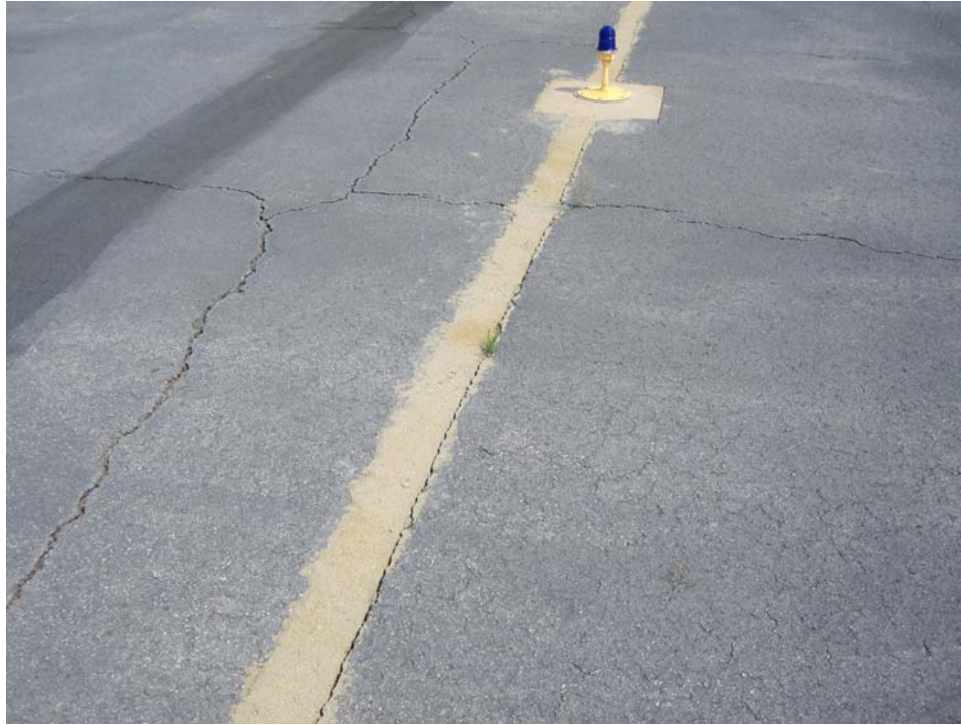
A01AT-30. Patching (Sample Unit #07).

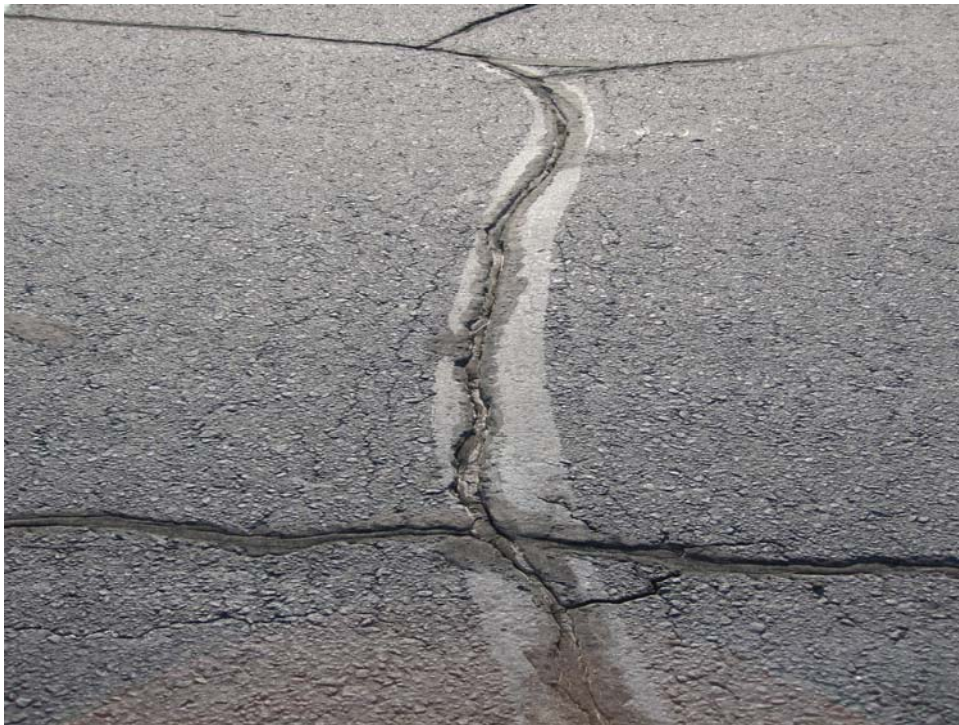
R220AT-10. Longitudinal and Transverse Cracking (Sample Unit #07).

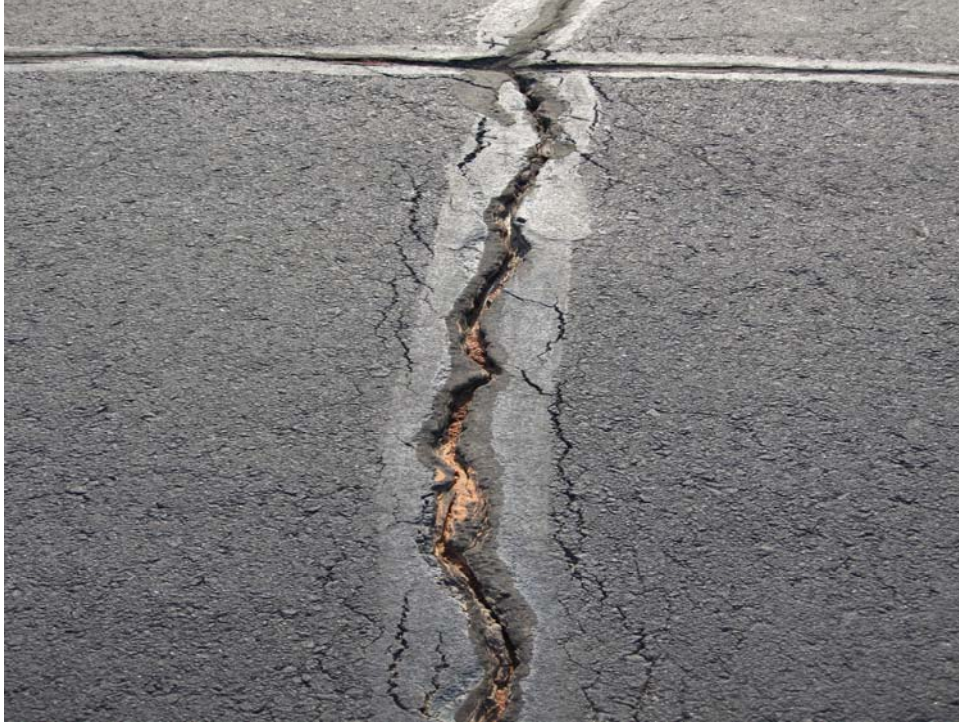
R220AT-10. Longitudinal and Transverse Cracking (Sample Unit #11).

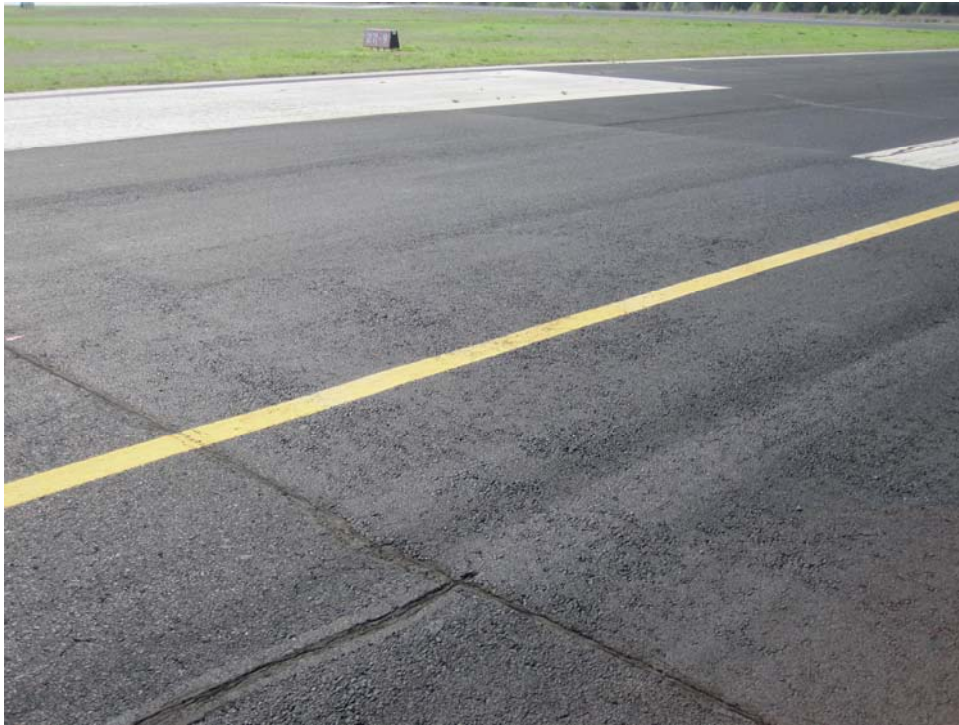
R220AT-10. Patching (Additional Sample Unit #23).

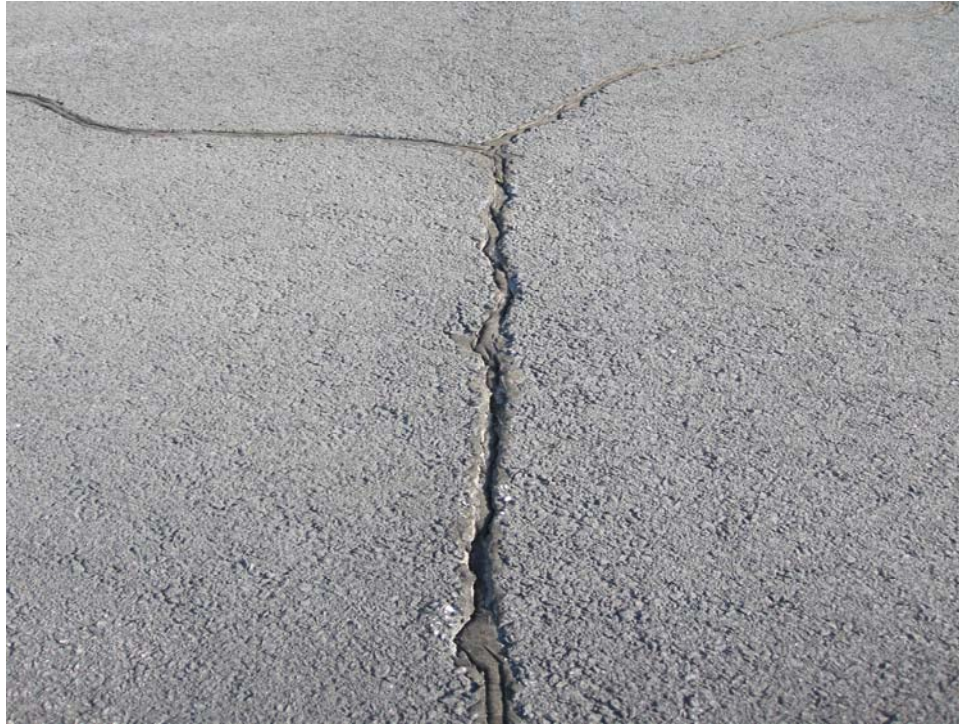
R220AT-20. Longitudinal and Transverse Cracking (Sample Unit #02).

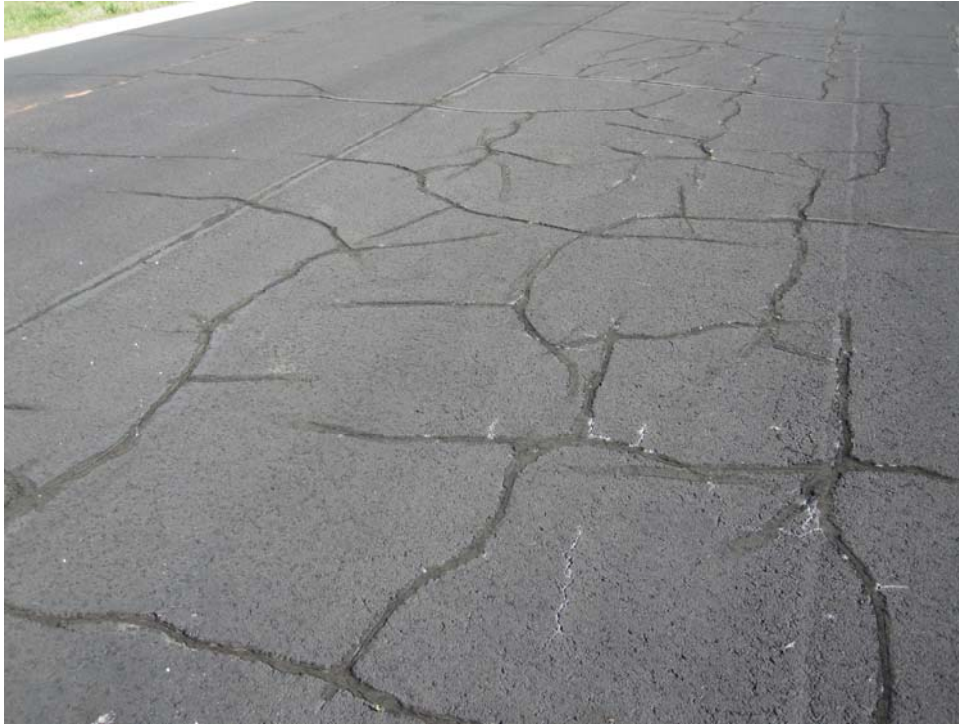
R220AT-30. Block Cracking (Sample Unit #32).

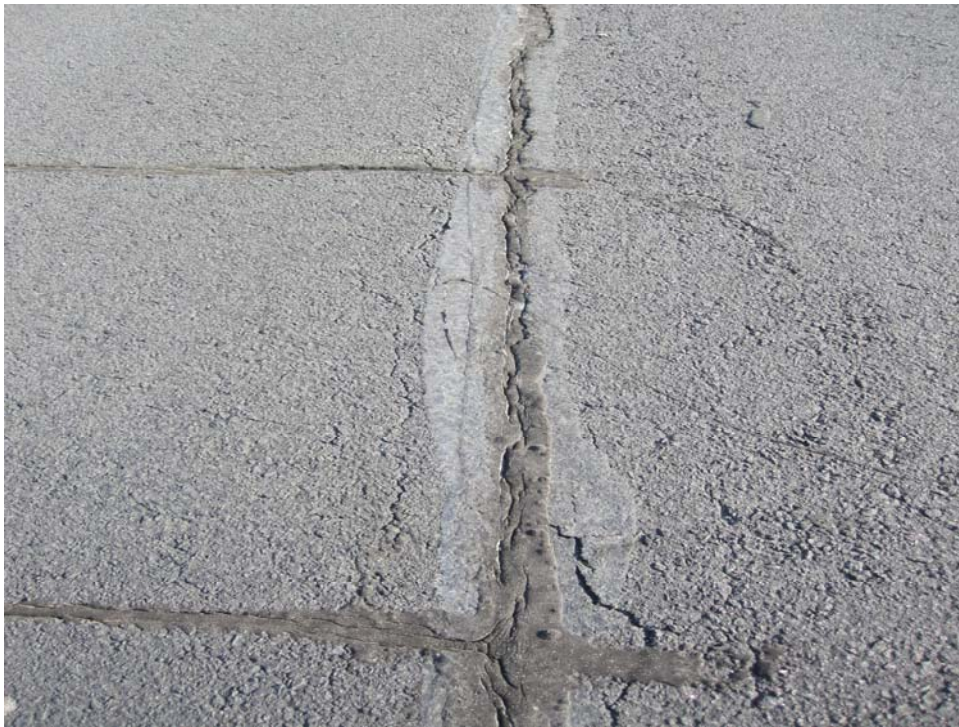
R220AT-30. Longitudinal and Transverse Cracking (Sample Unit #04).

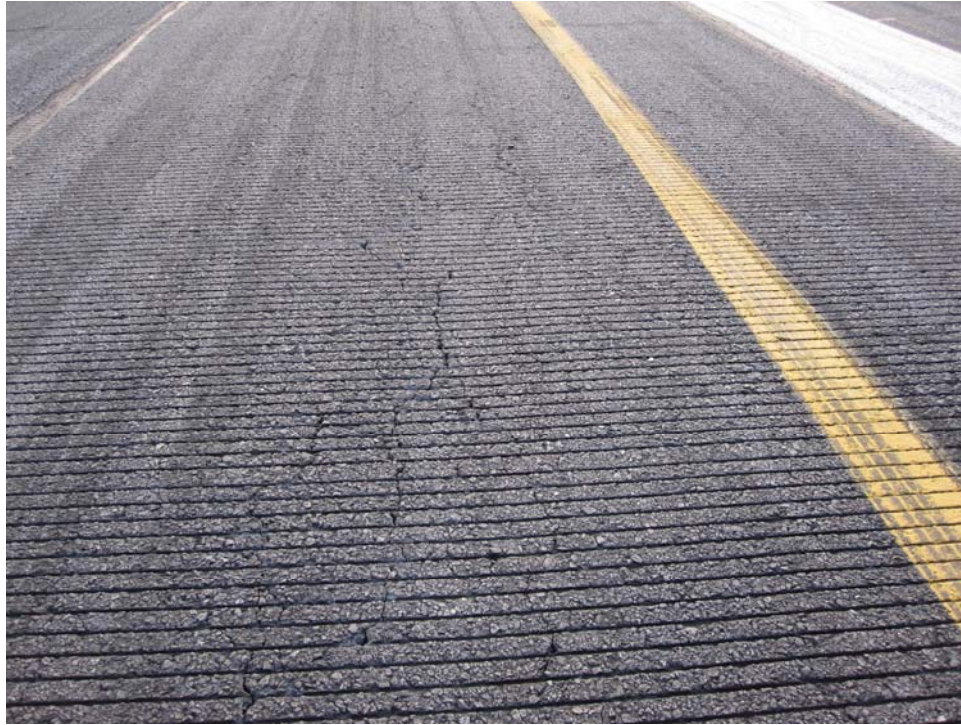
R927AT-10. Alligator Cracking (Sample Unit #25).

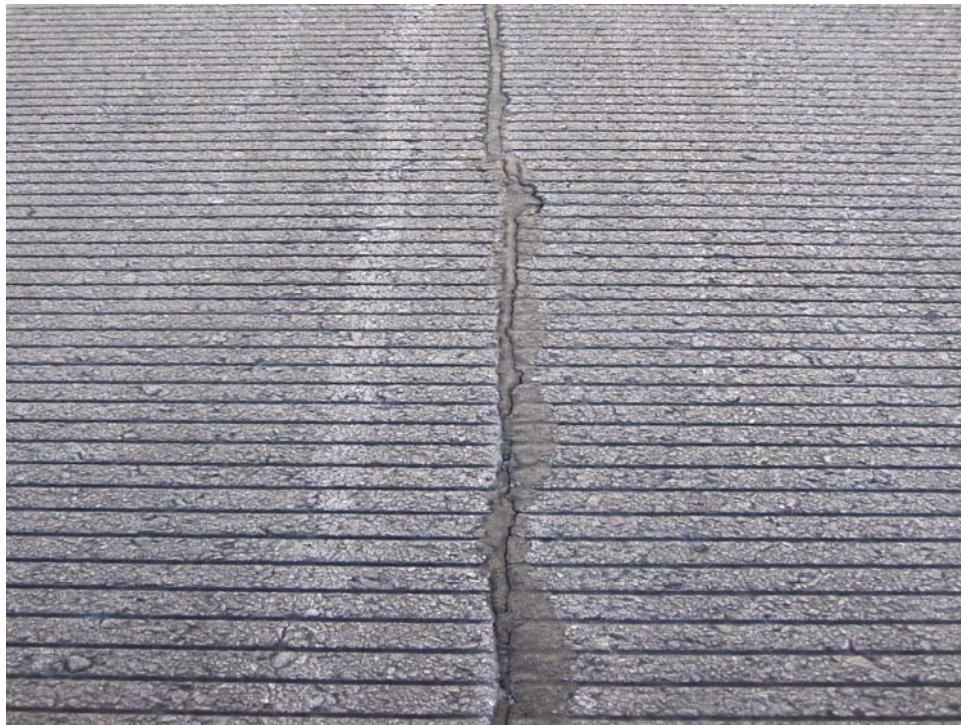
R927AT-10. Longitudinal and Transverse Cracking (Sample Unit #16).

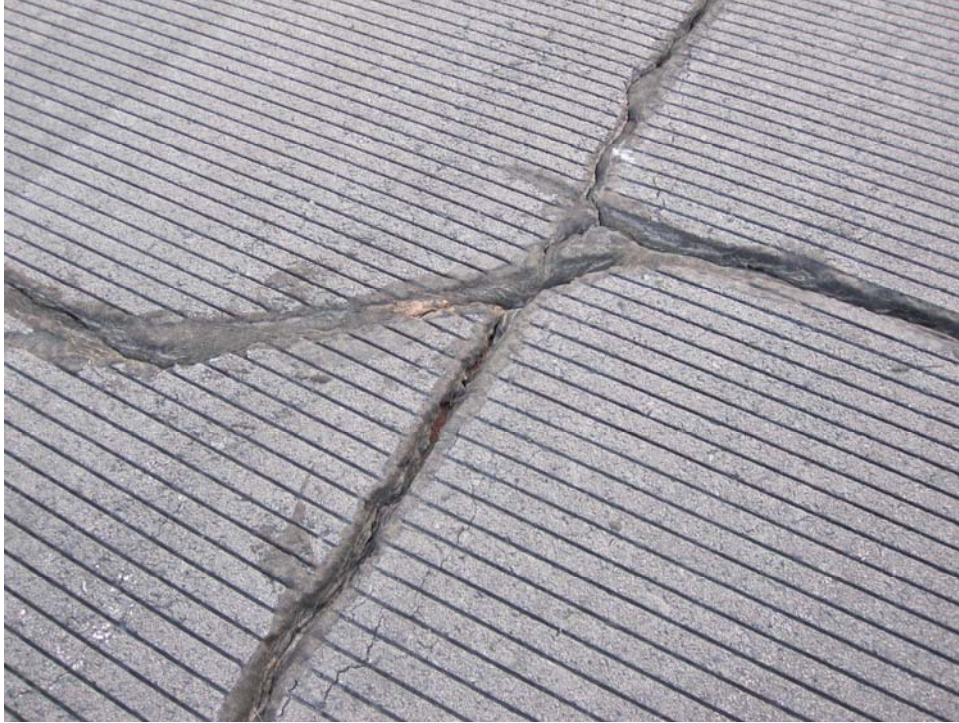
R927AT-10. Longitudinal and Transverse Cracking (Sample Unit #34).

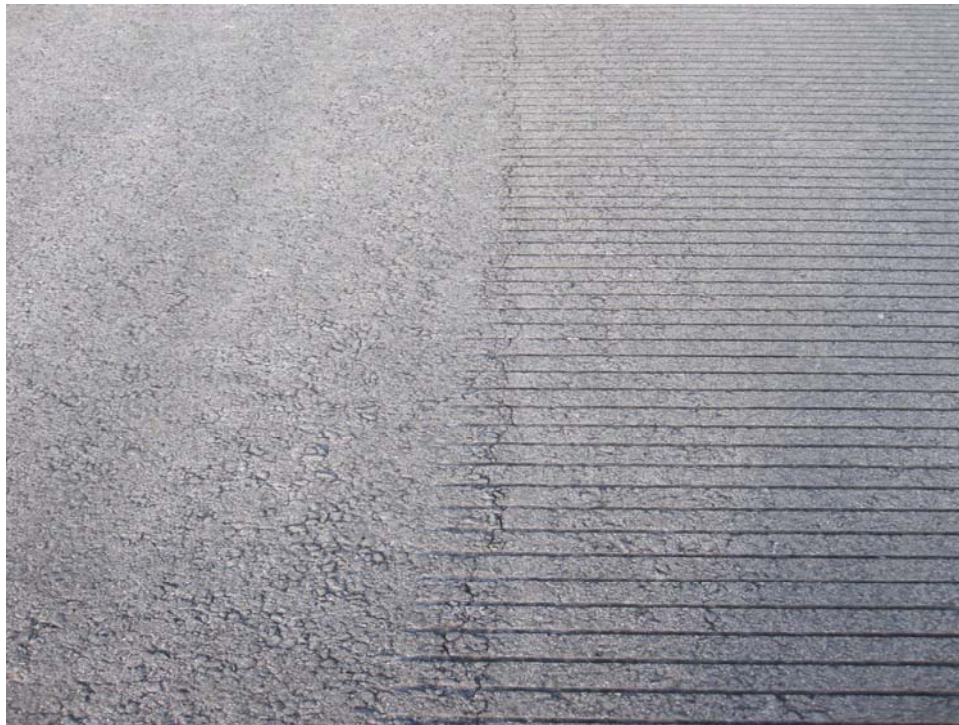
R927AT-20. Longitudinal and Transverse Cracking (Sample Unit #07).

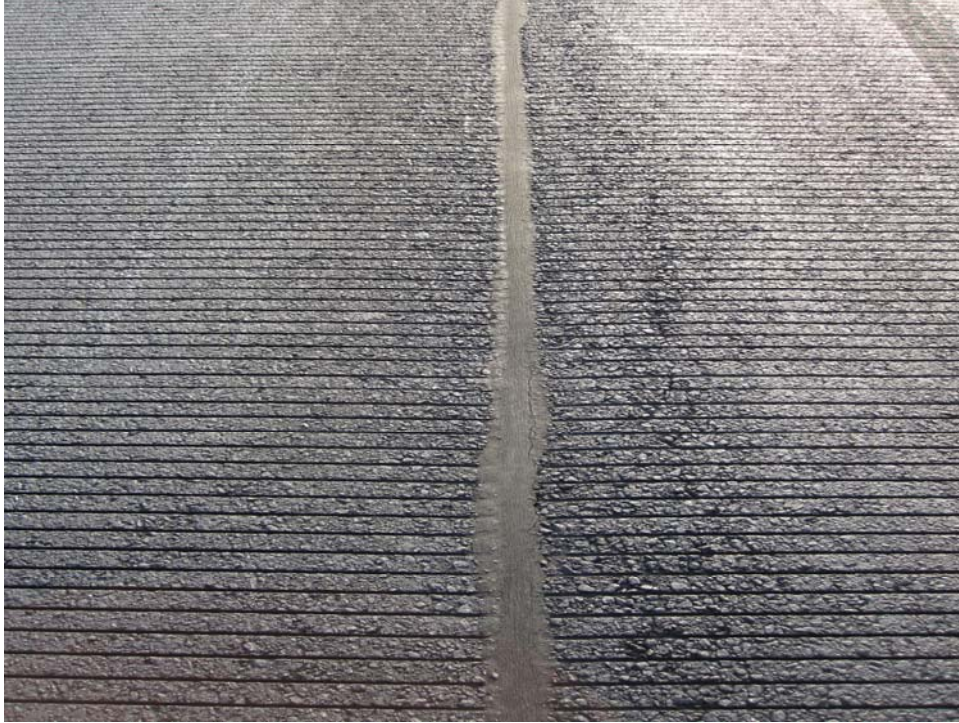
R927AT-20. Longitudinal and Transverse Cracking (Sample Unit #13).

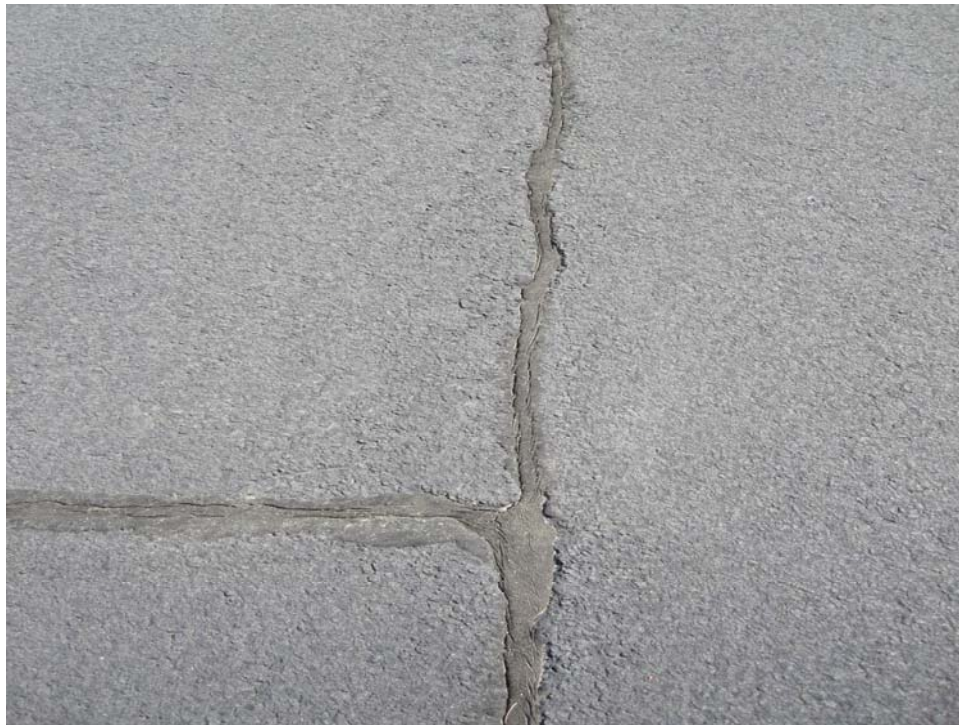
TAAT-10. Longitudinal and Transverse Cracking (Sample Unit #05).

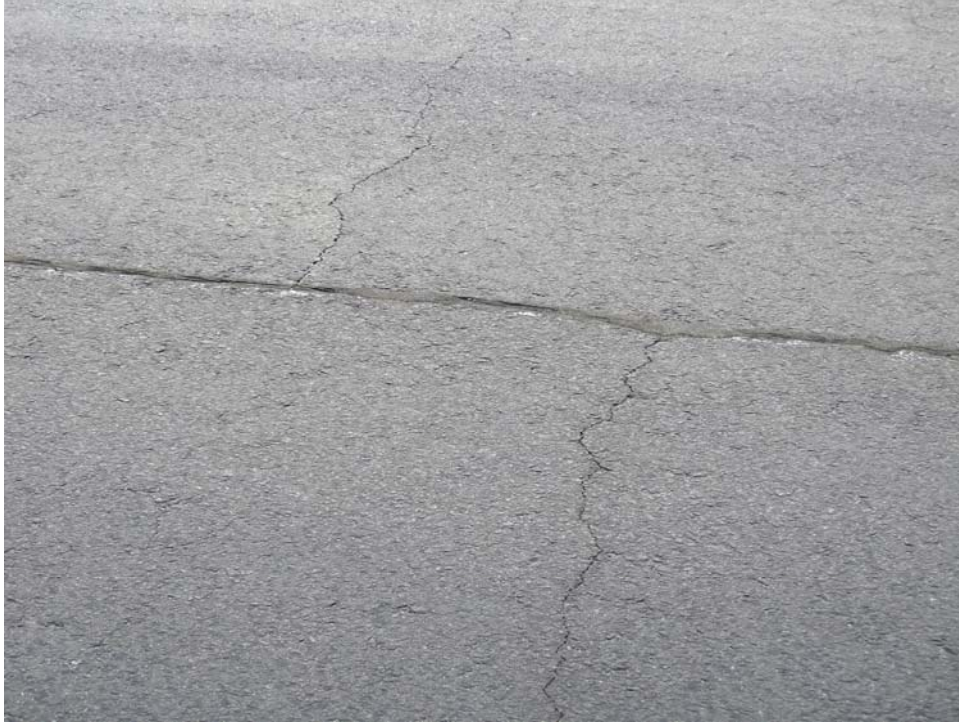
TAAT-10. Longitudinal and Transverse Cracking (Sample Unit #14).

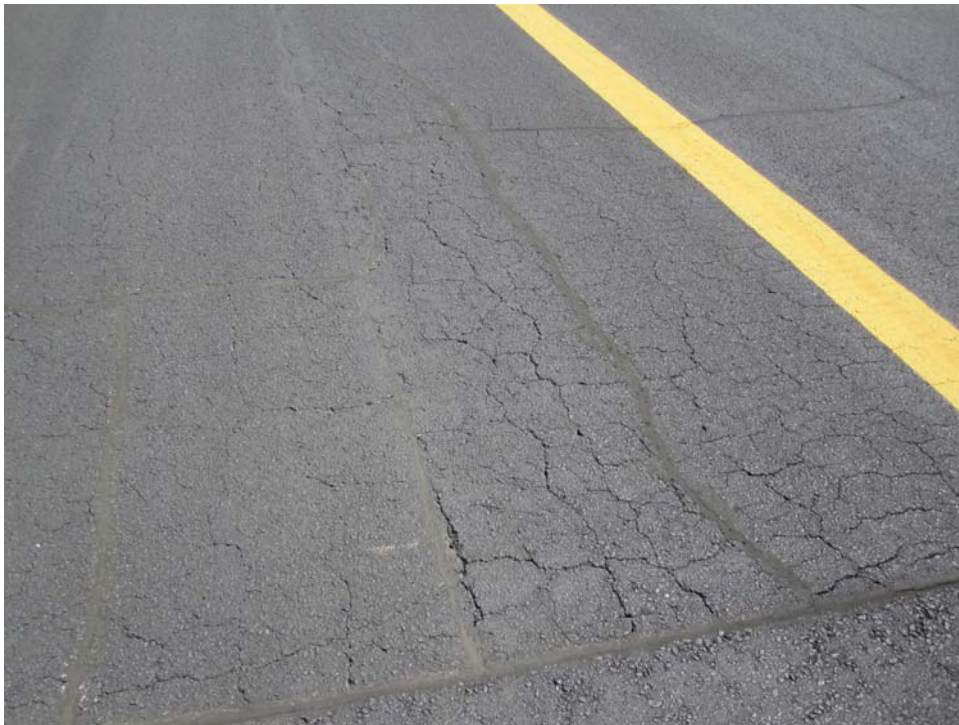
TAAT-20. Alligator Cracking (Sample Unit #24).

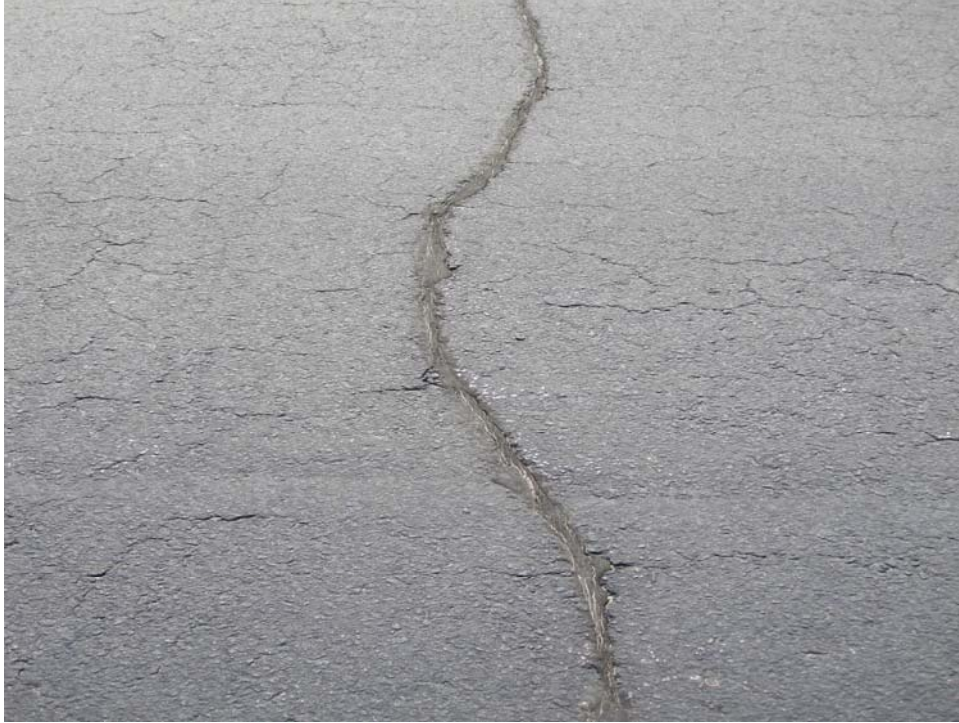
TAAT-20. Longitudinal and Transverse Cracking (Sample Unit #08).

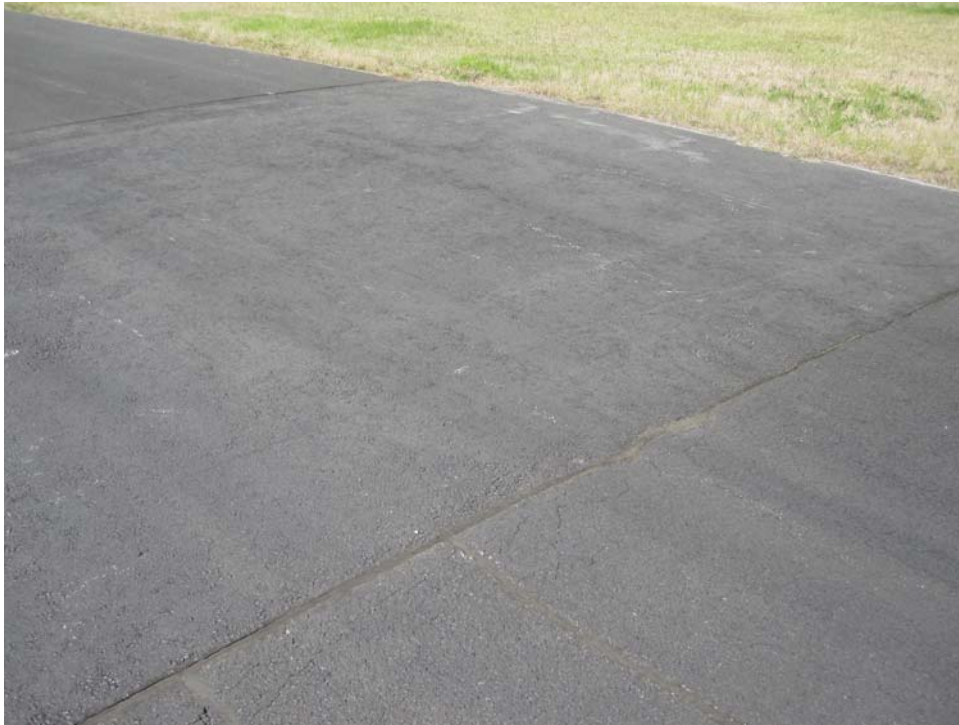
TAAT-20. Patching (Sample Unit #24).

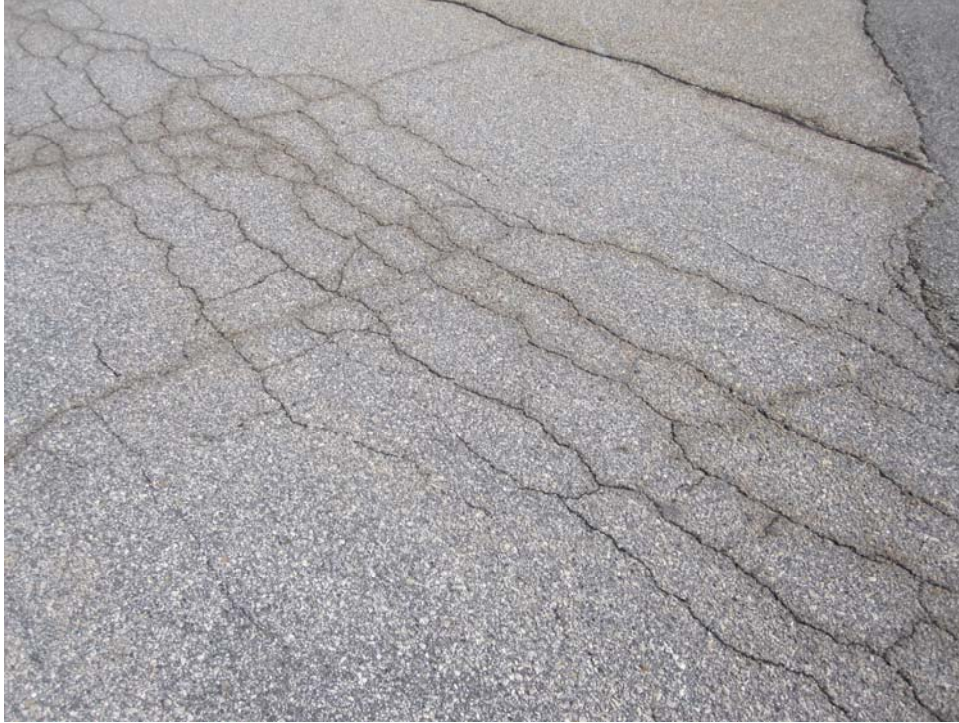
TAAT-30. Alligator Cracking (Sample Unit #06).

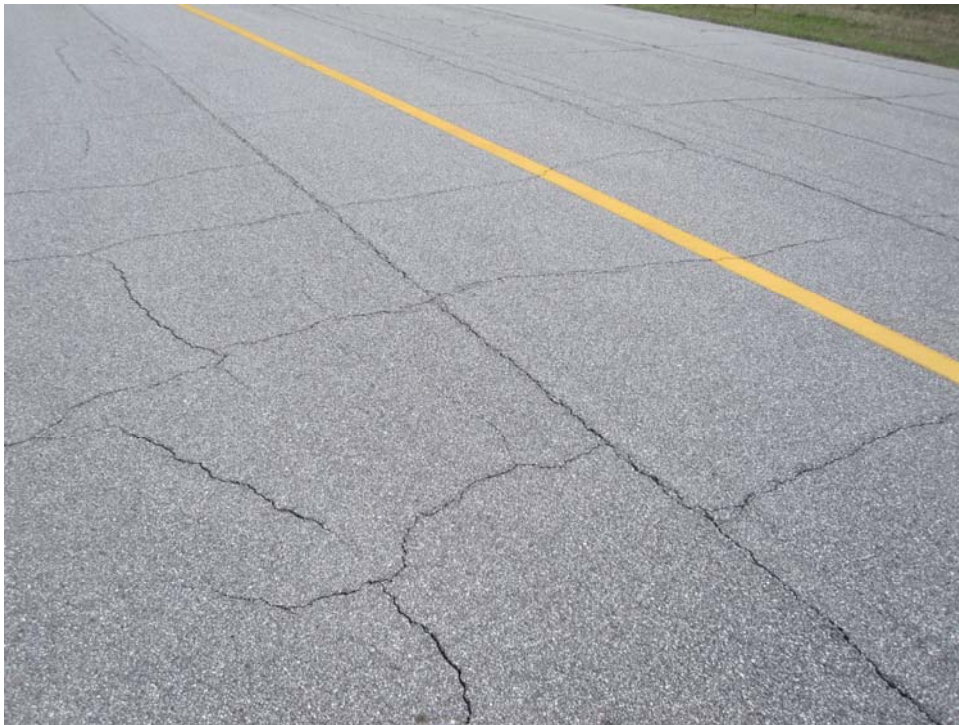
TAAT-30. Block Cracking (Sample Unit #13).

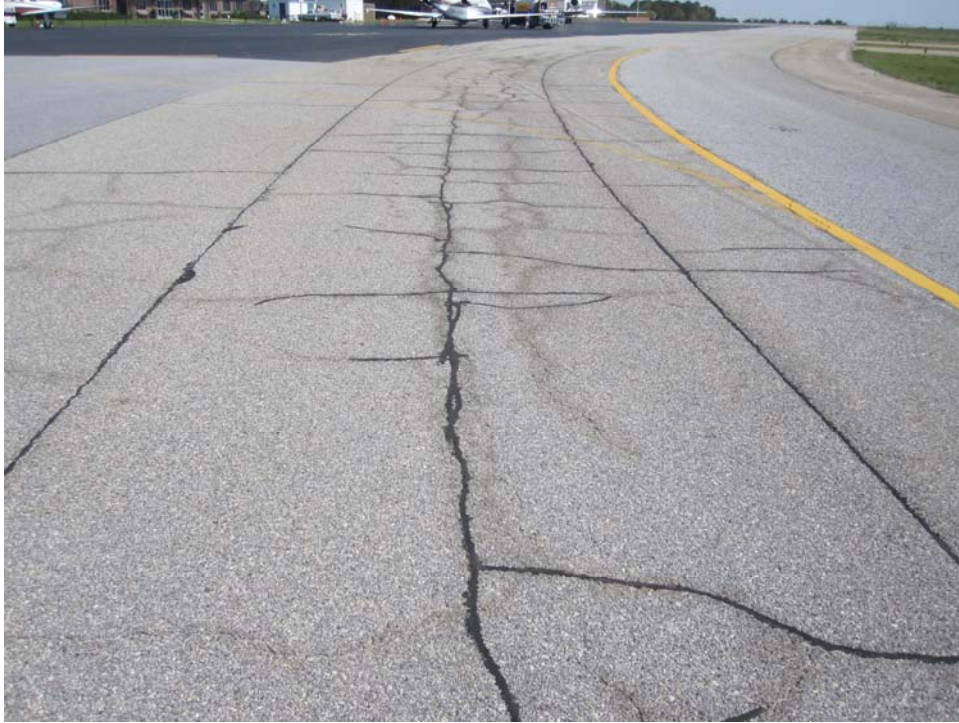
TAAT-30. Block Cracking (Sample Unit (09)).

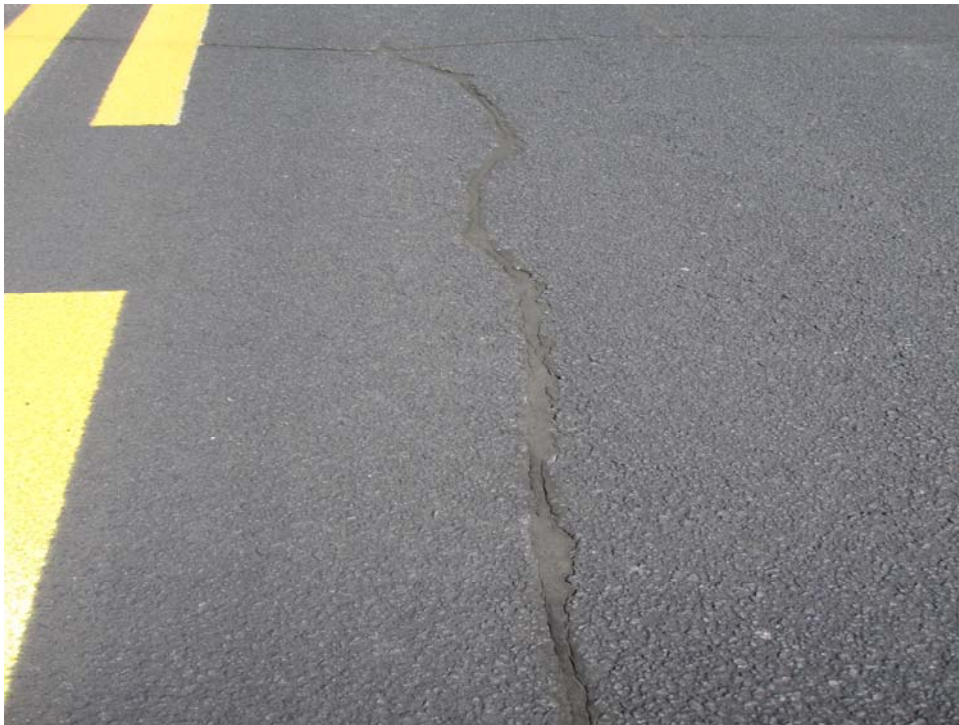
TAAT-30. Longitudinal and Transverse Cracking (Sample Unit #03).

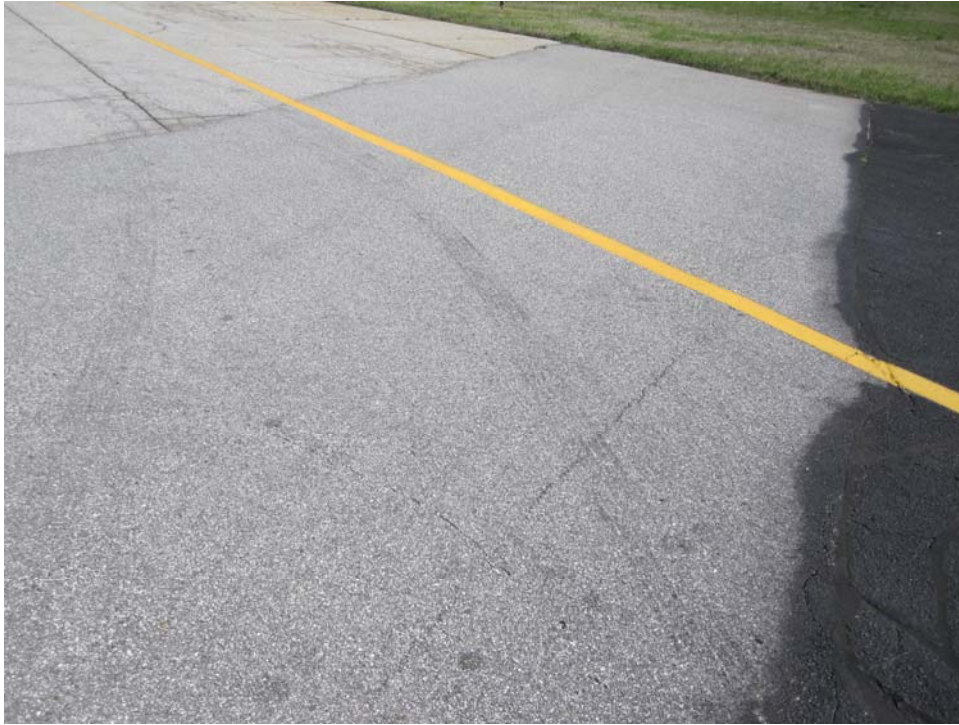
TAAT-30. Patching (Sample Unit #06).

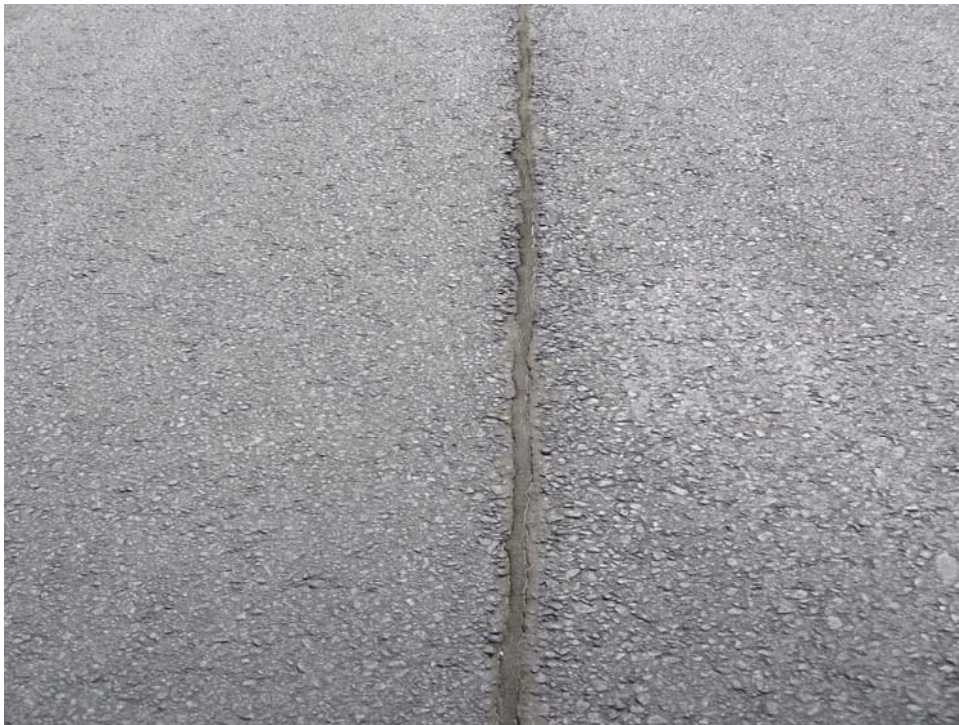
TAAT-40. Longitudinal and Transverse Cracking (Sample Unit #07).

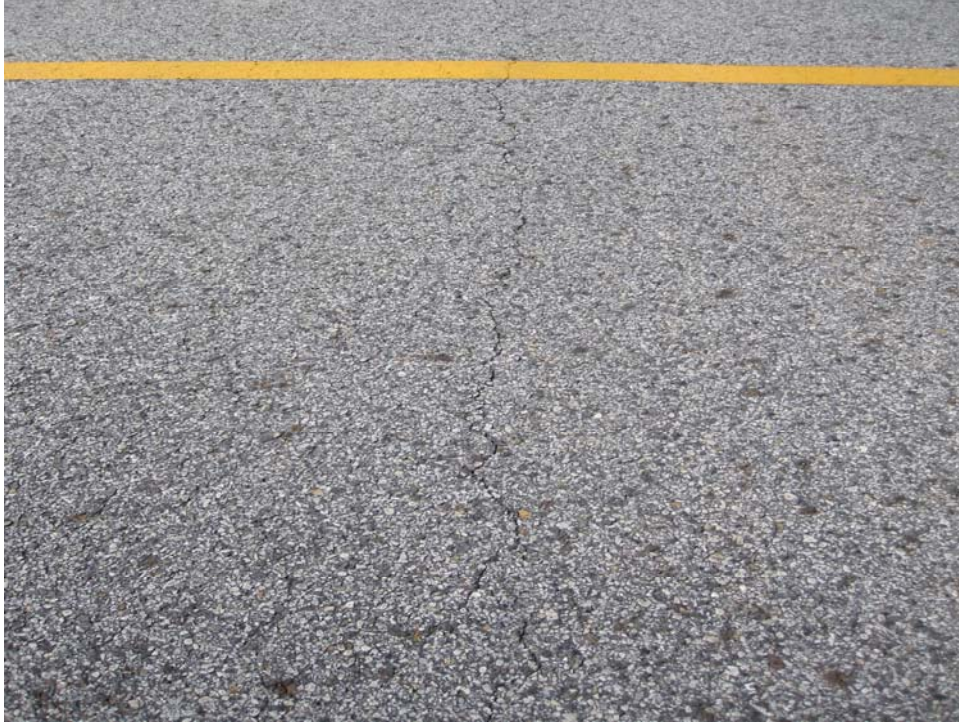
TAAT-50. Longitudinal and Transverse Cracking (Sample Unit #02).

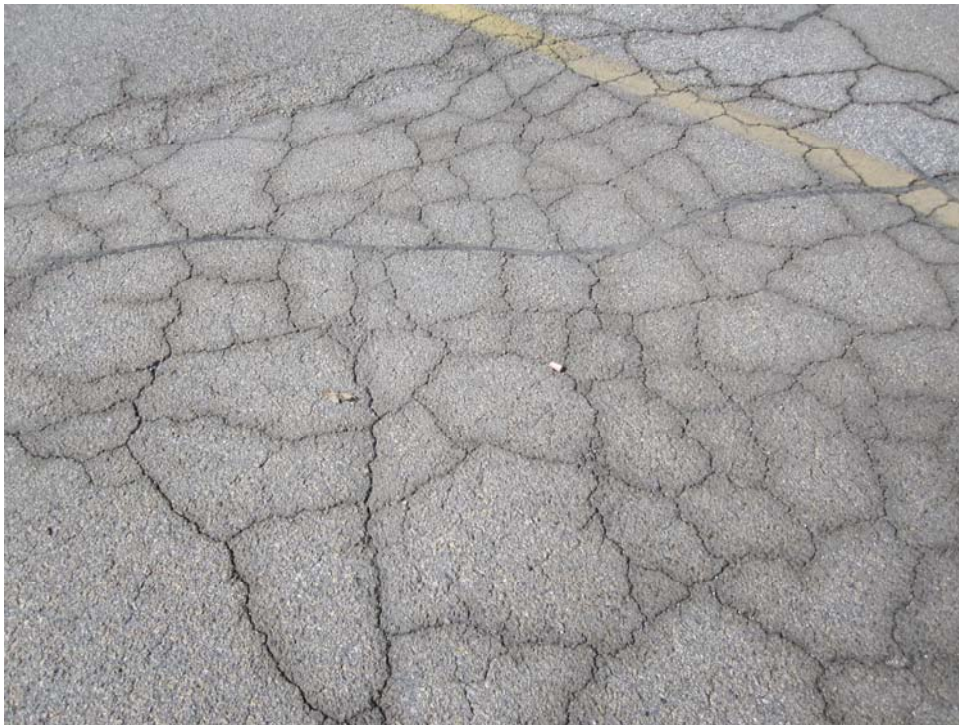
TBAT-10. Alligator Cracking (Sample Unit #08).
