2012 Athens-Ben Epps Field Pavement Management Plan

ATHENS-BEN EPPS FIELD

PAVEMENT MANAGEMENT REPORT

DECEMBER 2012

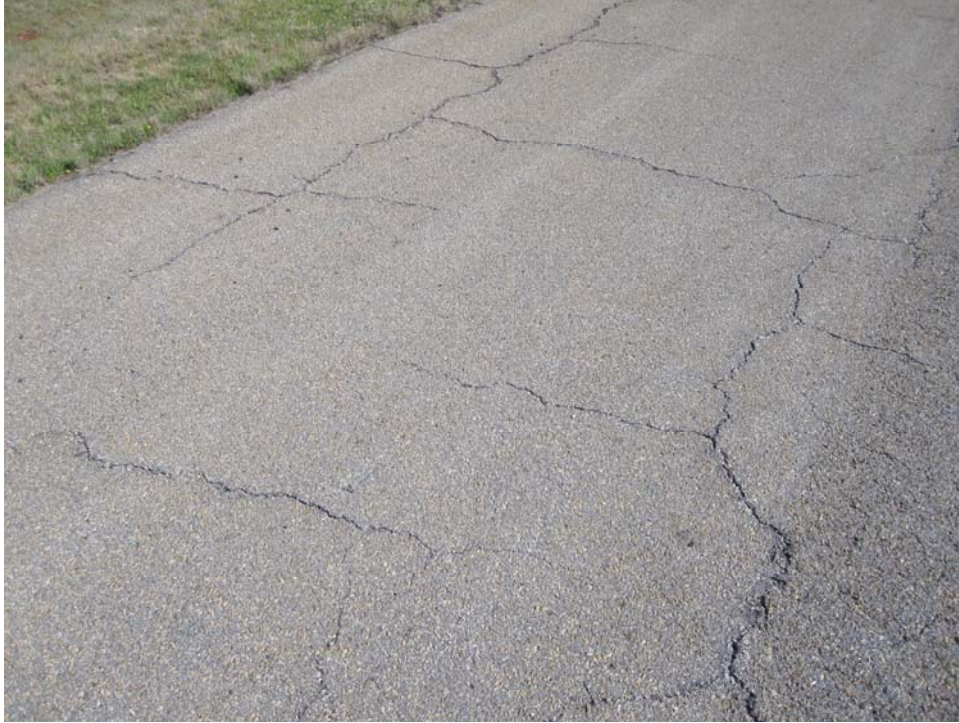
TBAT-10. Block Cracking (Sample Unit #02).

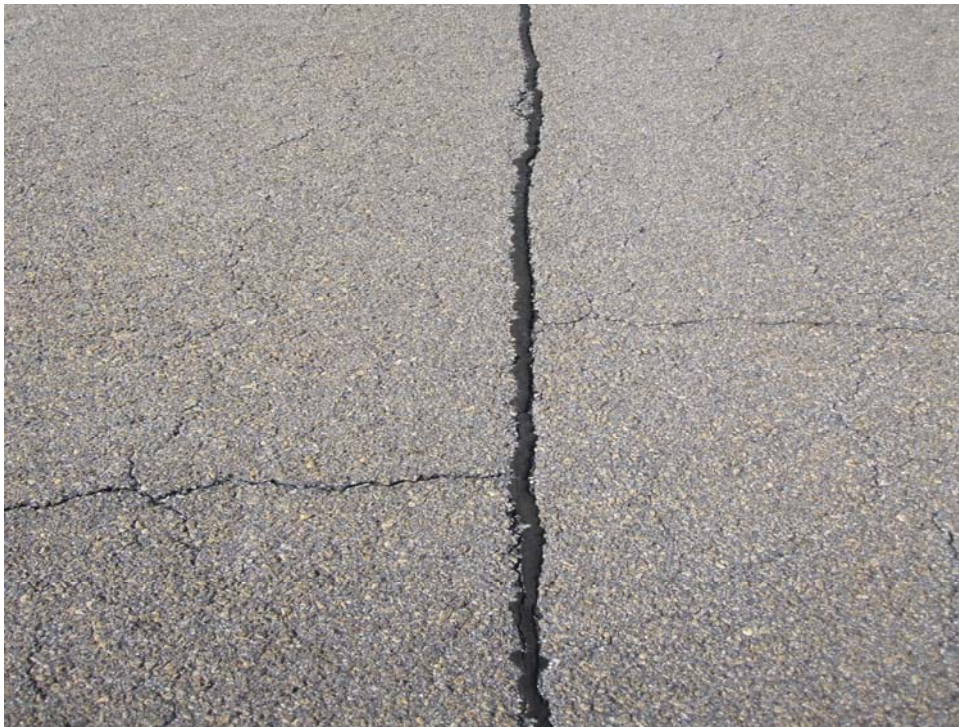
TBAT-10. Longitudinal and Transverse Cracking (Sample Unit #02).

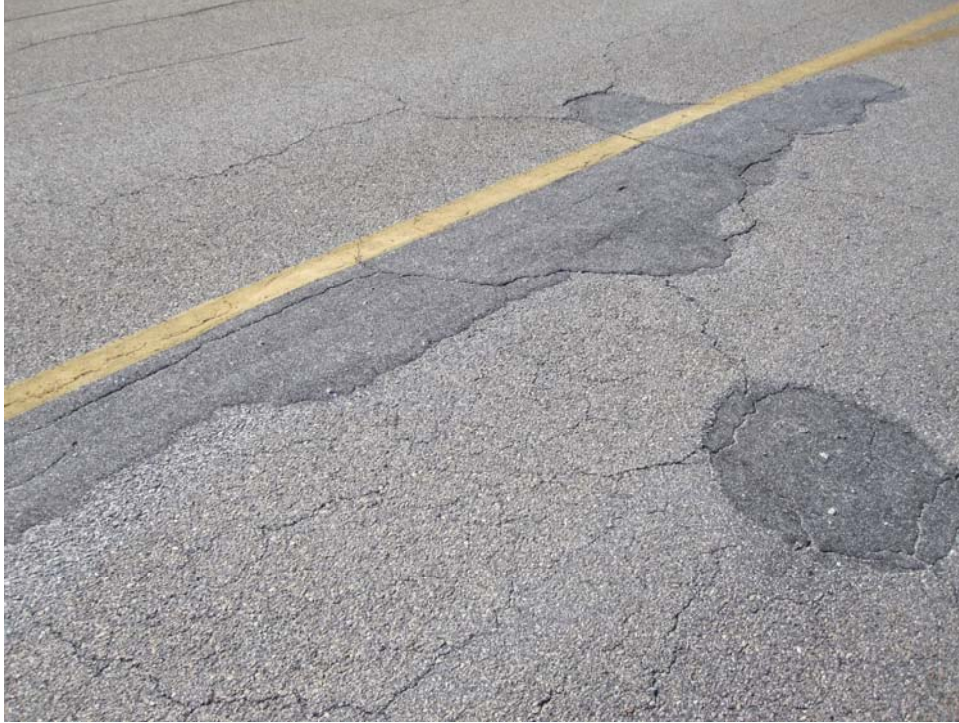
TBAT-10. Patching (Sample Unit #06).

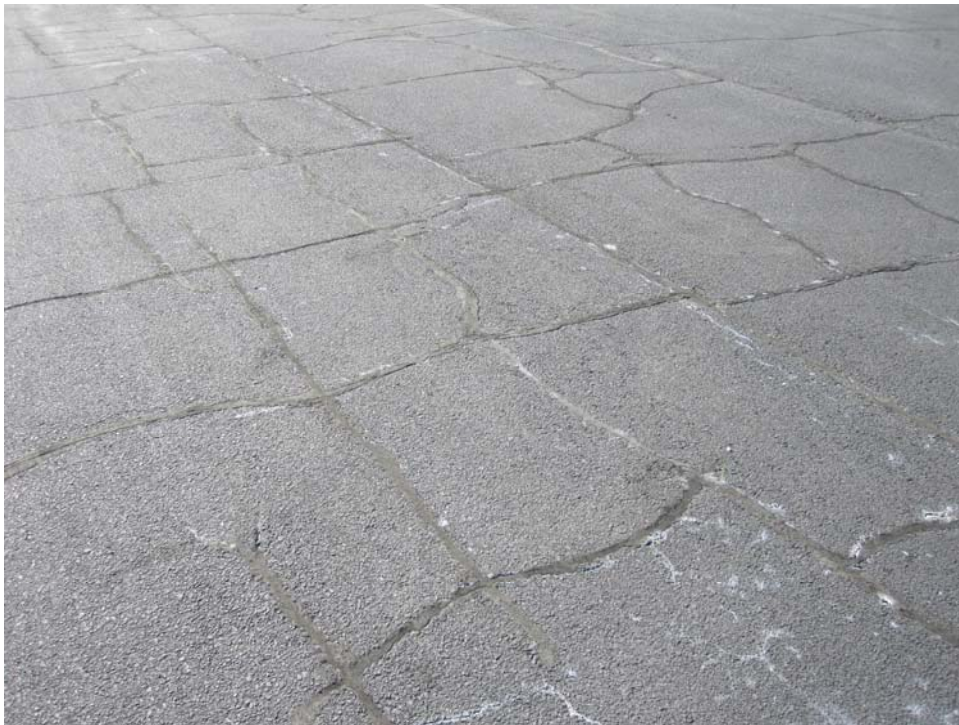
TBAT-15 Block Cracking (Sample Unit #04).

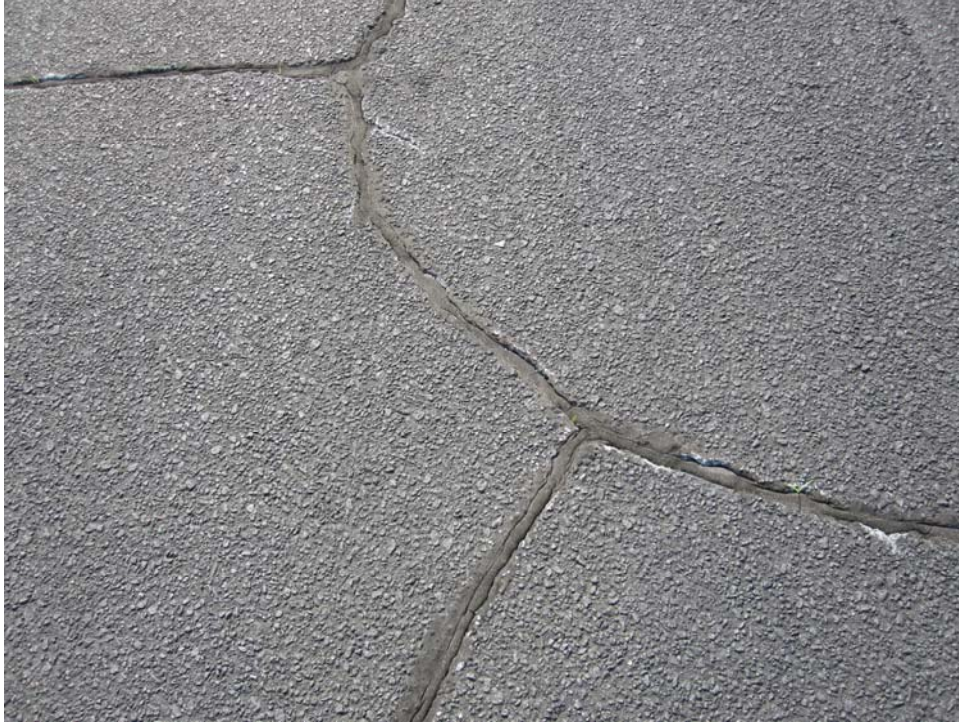
TBAT-15. Longitudinal and Transverse Cracking (Sample Unit #03).

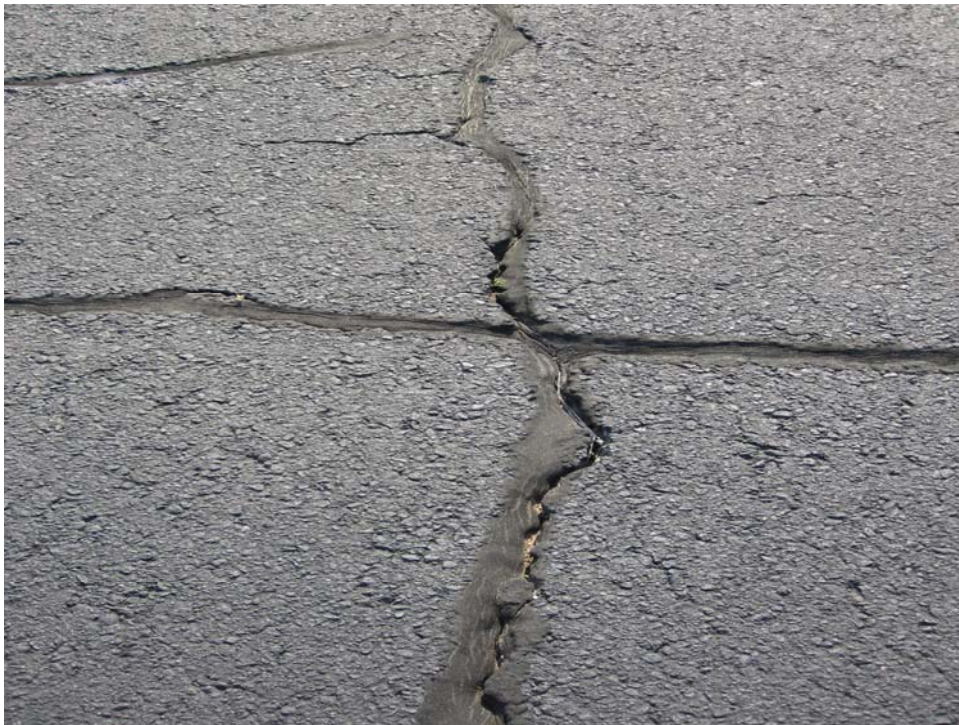
TBAT-20. Longitudinal and Transverse Cracking (Sample Unit #24).

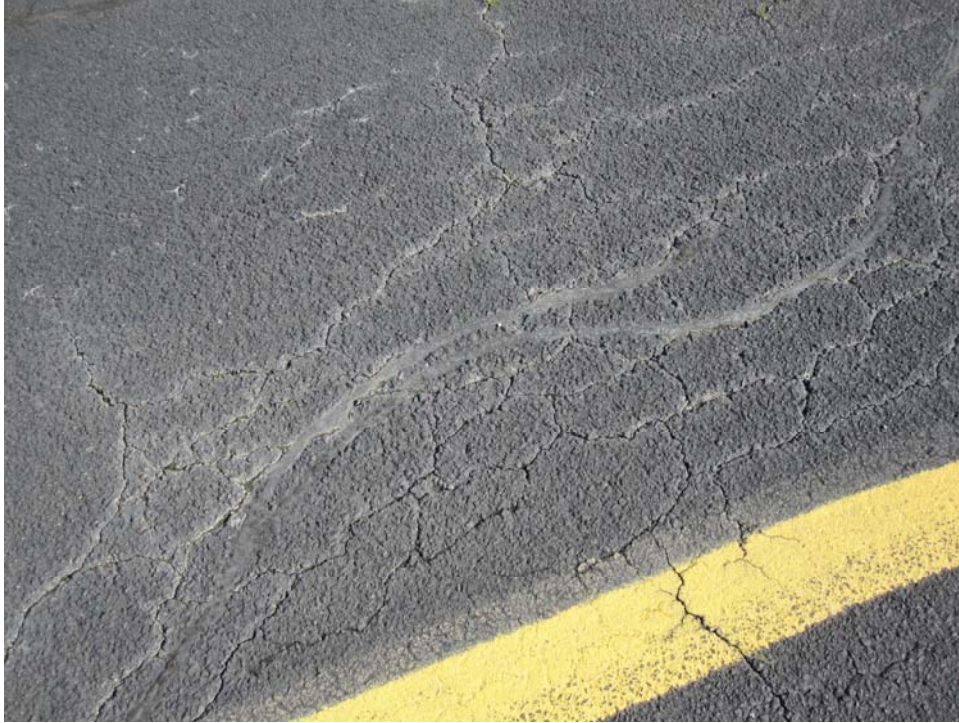
TBAT-30. Alligator Cracking (Sample Unit #02).

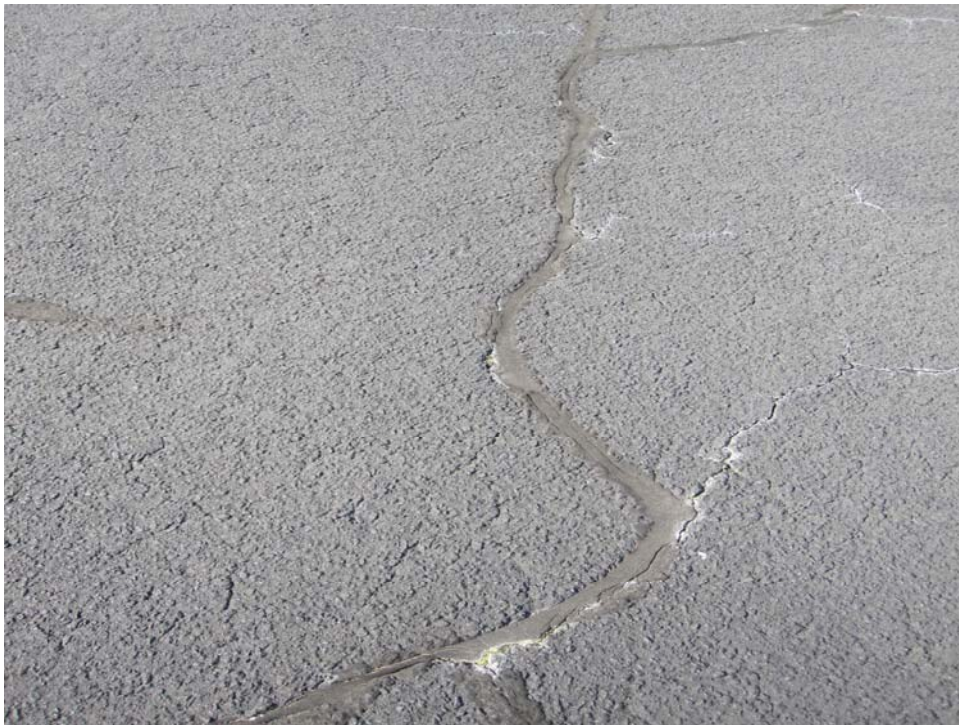
TBAT-30. Longitudinal and Transverse Cracking (Sample Unit #03).

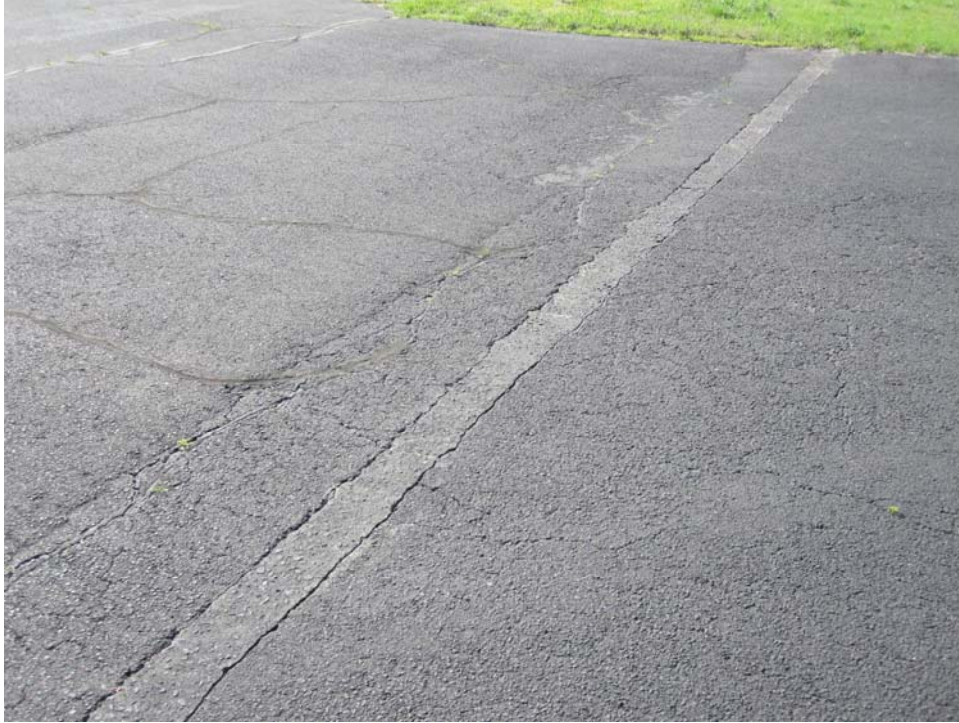
TBAT-30. Patching (Sample Unit #02).

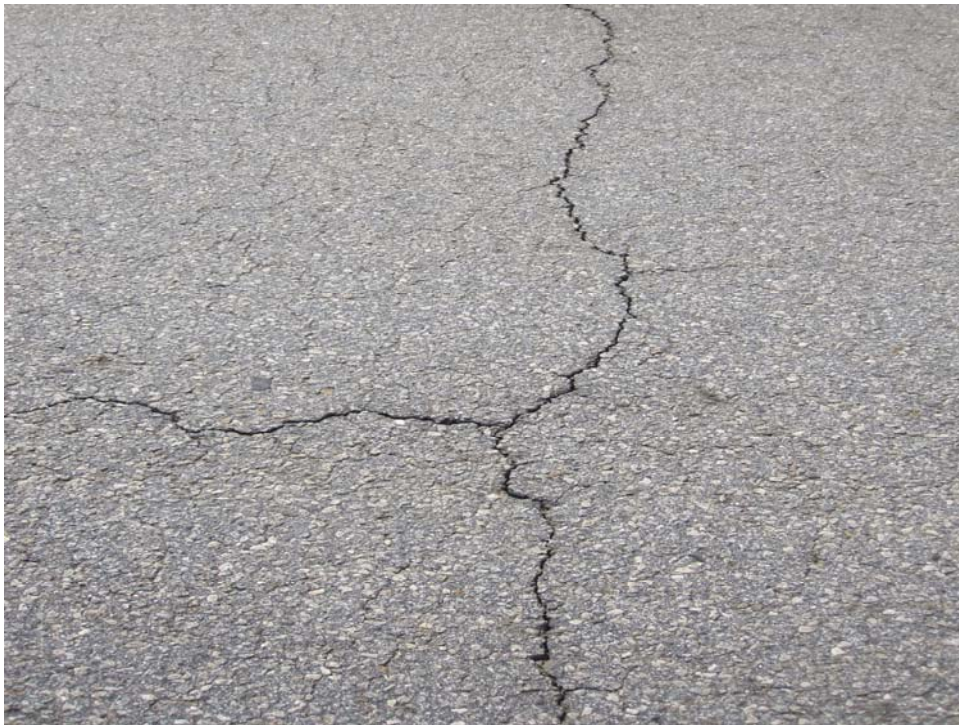
THANGAT-10. Longitudinal and Transverse Cracking (Sample Unit #02).
