2012 Fulton County-Brown Field Pavement Management Plan

FULTON COUNTY-BROWN FIELD

PAVEMENT MANAGEMENT REPORT

DECEMBER 2012

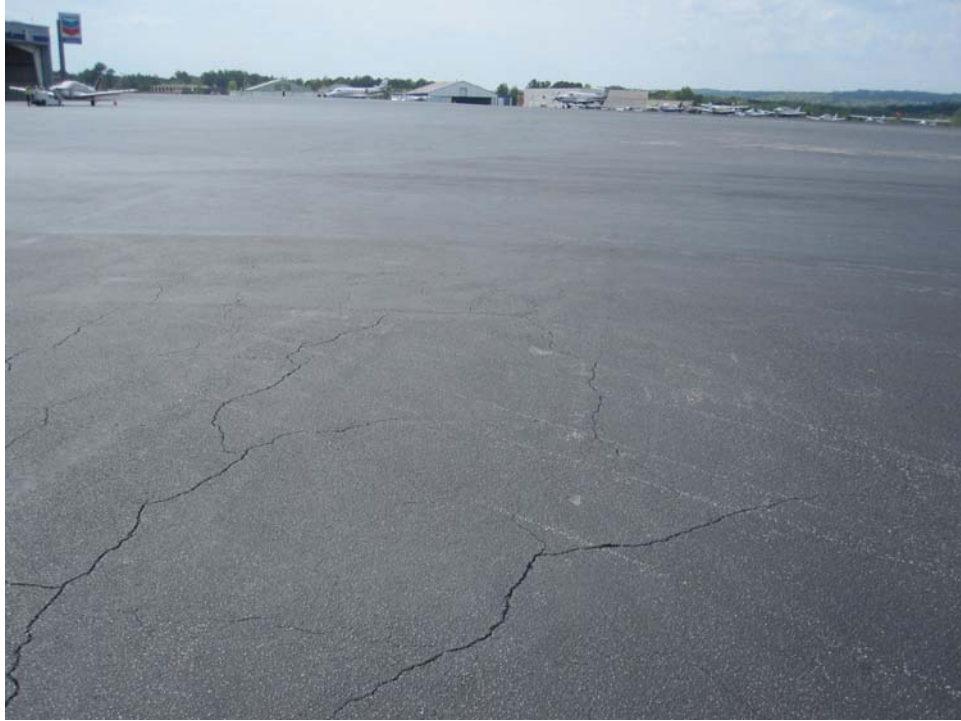
The apron area was comprised of one section. Section 10 had a PCI value of 56. The main distresses identified were low- and medium-severity L&T cracking and block cracking. There were also areas of medium-severity alligator cracking noted. Small amounts of low-severity, alligator cracking, bleeding, low-severity depression and swelling, and low- and medium-severity patching were also observed. Few cracks on the apron had been sealed. The seal coat that covered this section was in good condition.

A01AB-10. Overview.

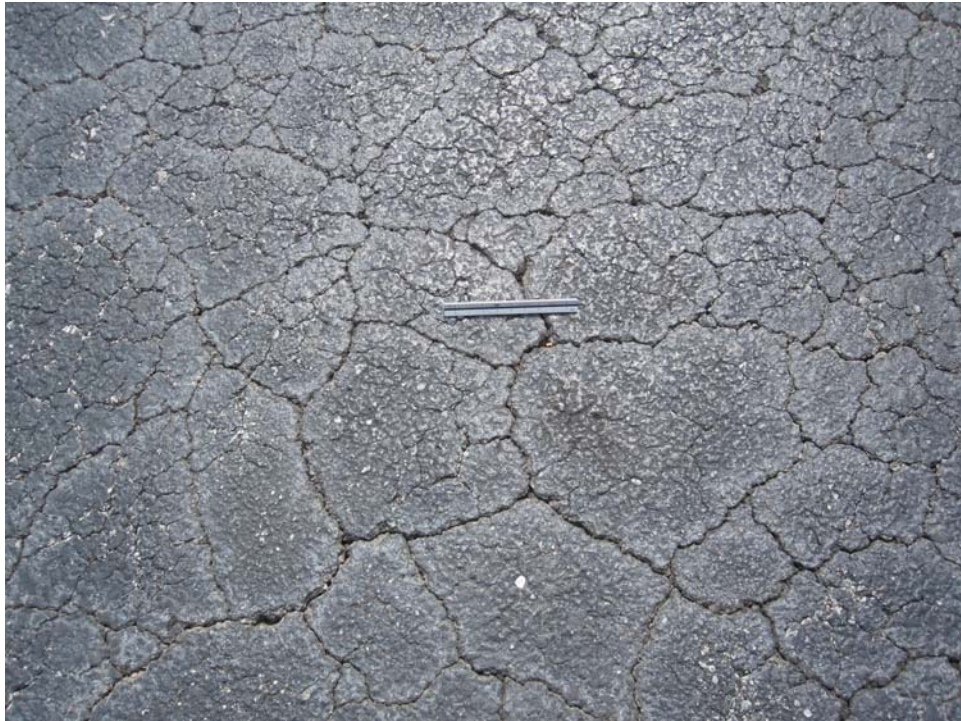
A01AB-10. Alligator Cracking (Sample Unit #58).

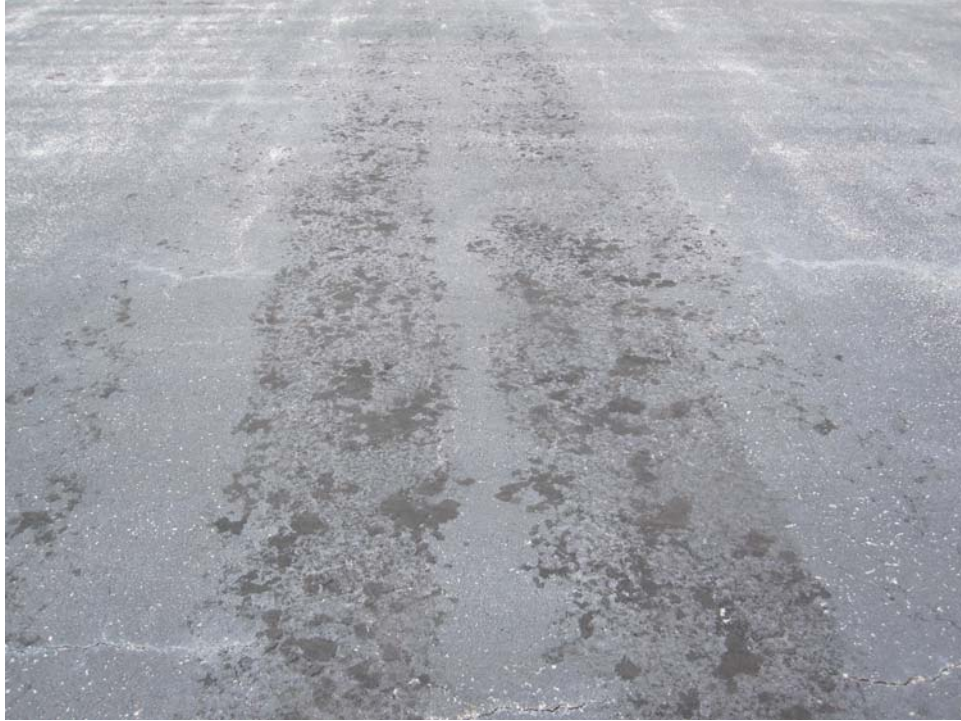
A01AB-10. Bleeding (Sample Unit #04).

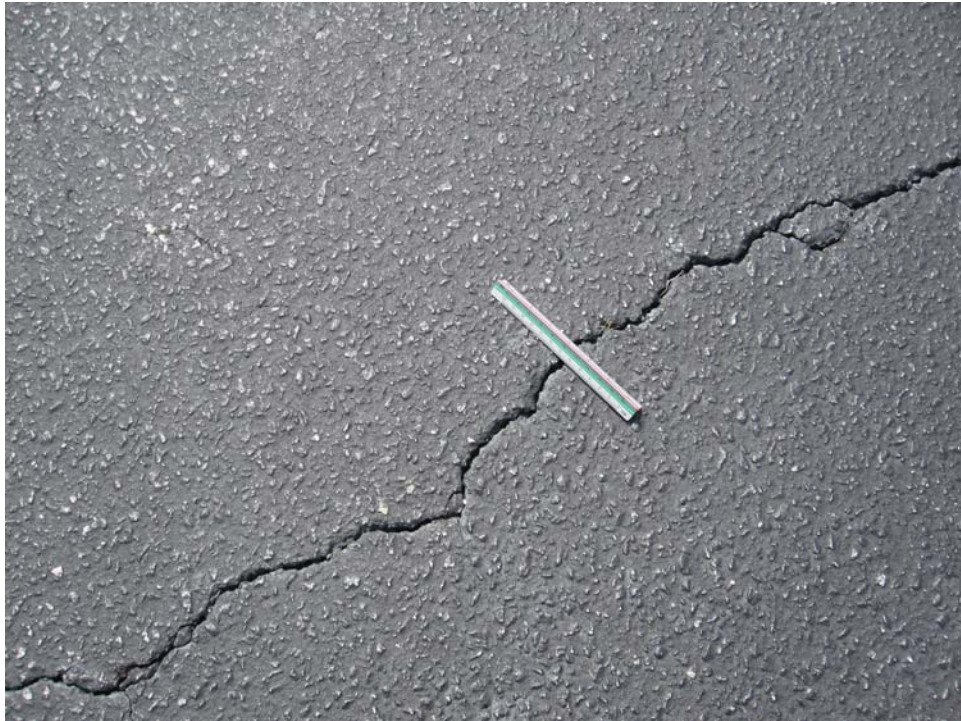
A01AB-10. Longitudinal and Transverse Cracking (Sample Unit #04).

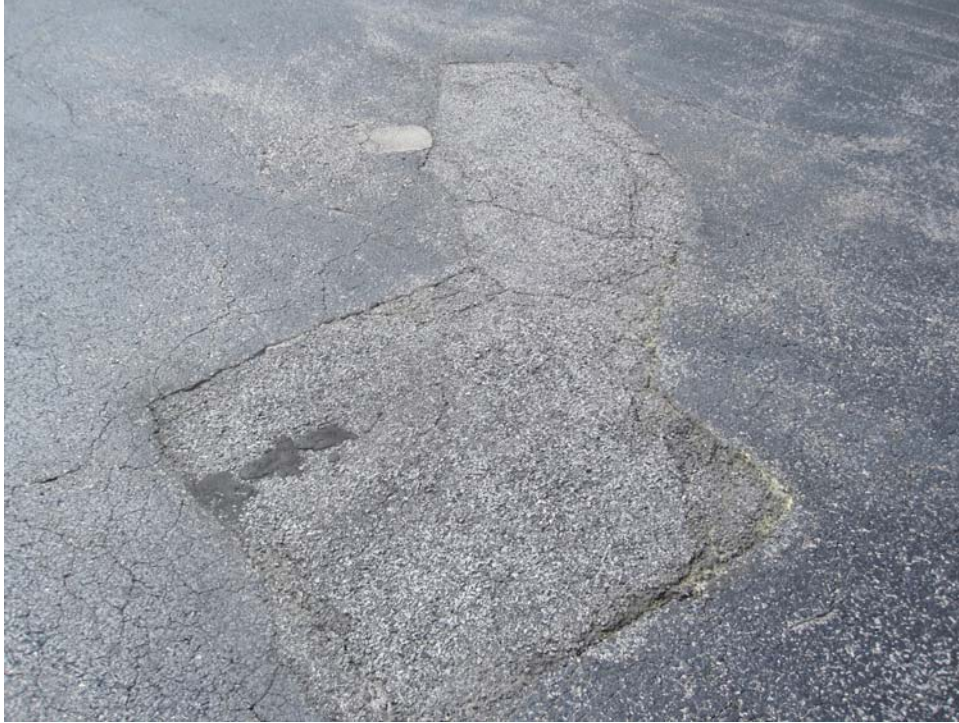
A01AB-10. Patching (Sample Unit #118).

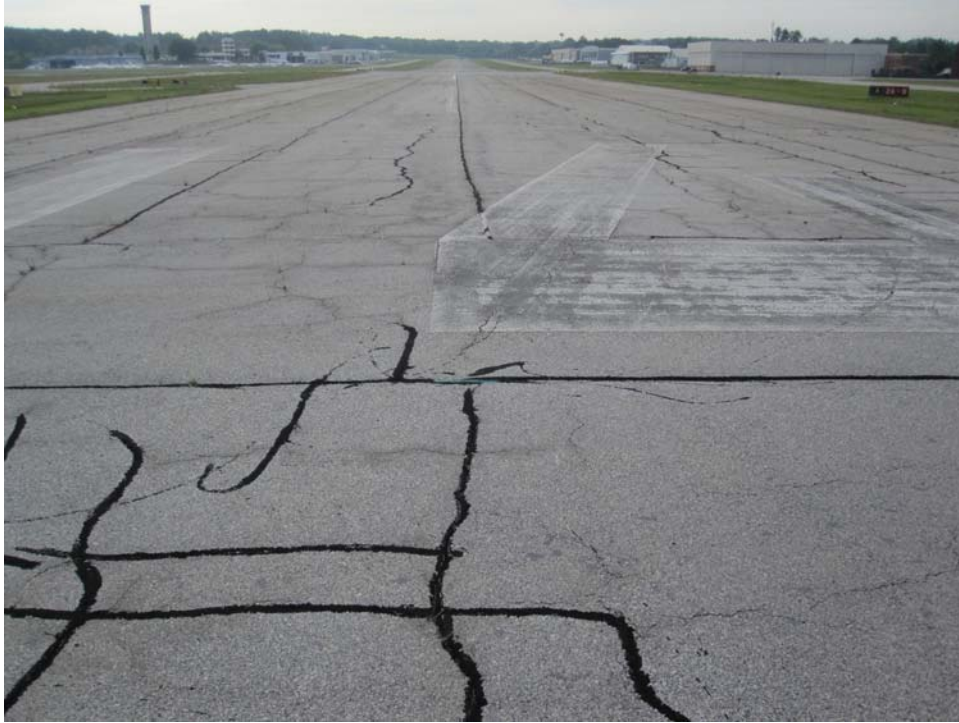
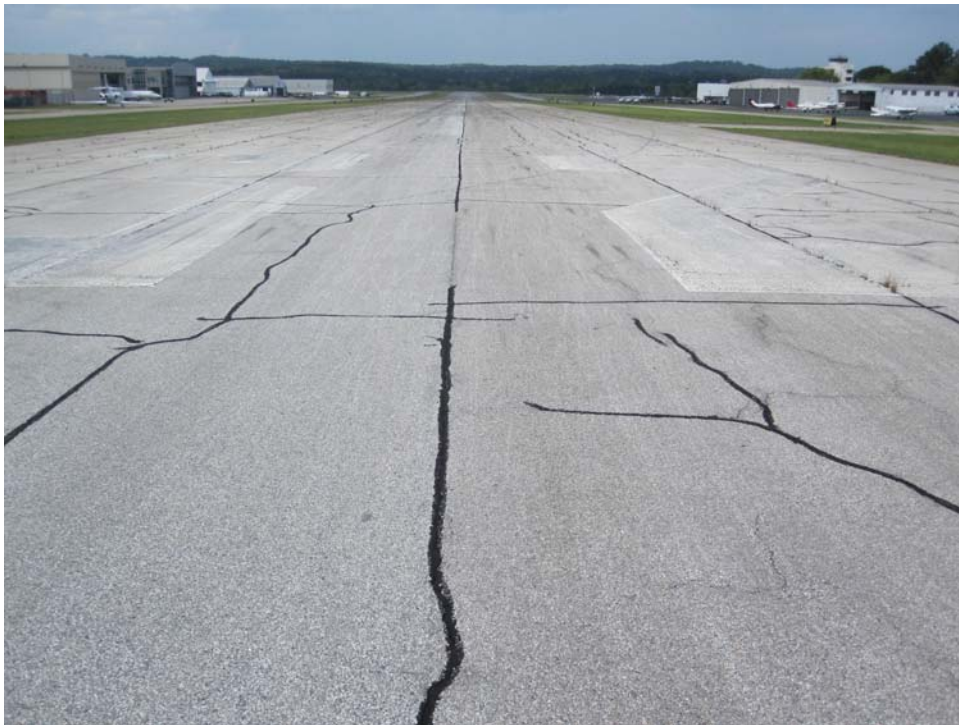
Runway 14-32 contained one section. Section 10 had a PCI value of 39. Extensive amounts of both low- and medium-severity block cracking and low- and medium-severity weathering were the primary distress types observed on this section. Most of the medium-severity cracks were due to failed crack sealant. Areas of low- and medium-severity L&T cracking, bleeding, and low-severity swelling were also recorded.

R1432AB-10. Overview (1).

R1432AB-10. Overview (2).

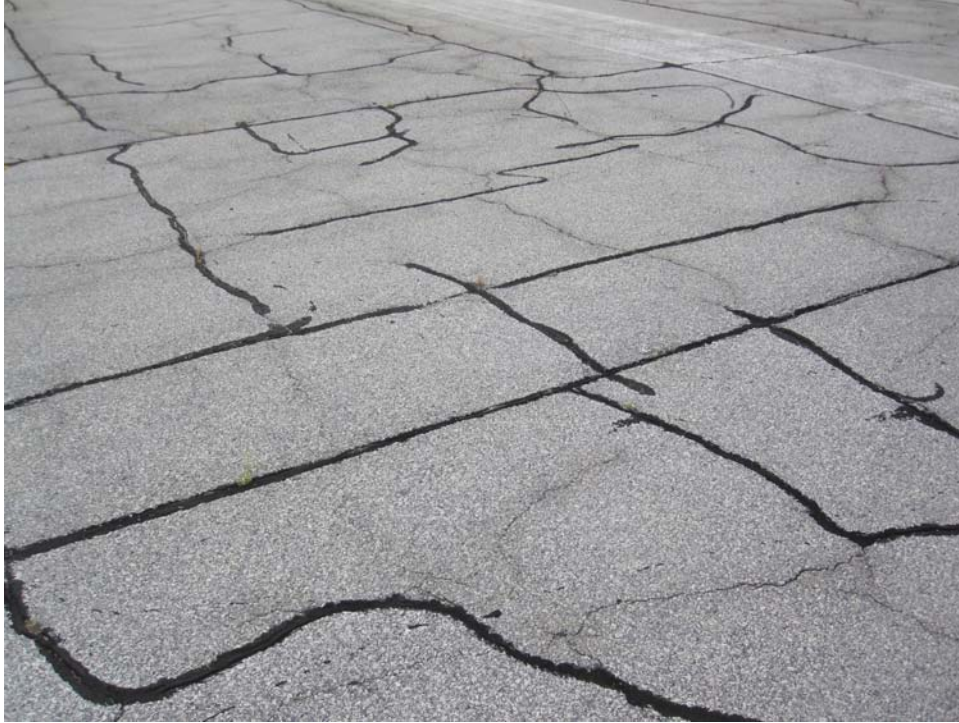
R1432AB-10. Block Cracking (Sample Unit #01).

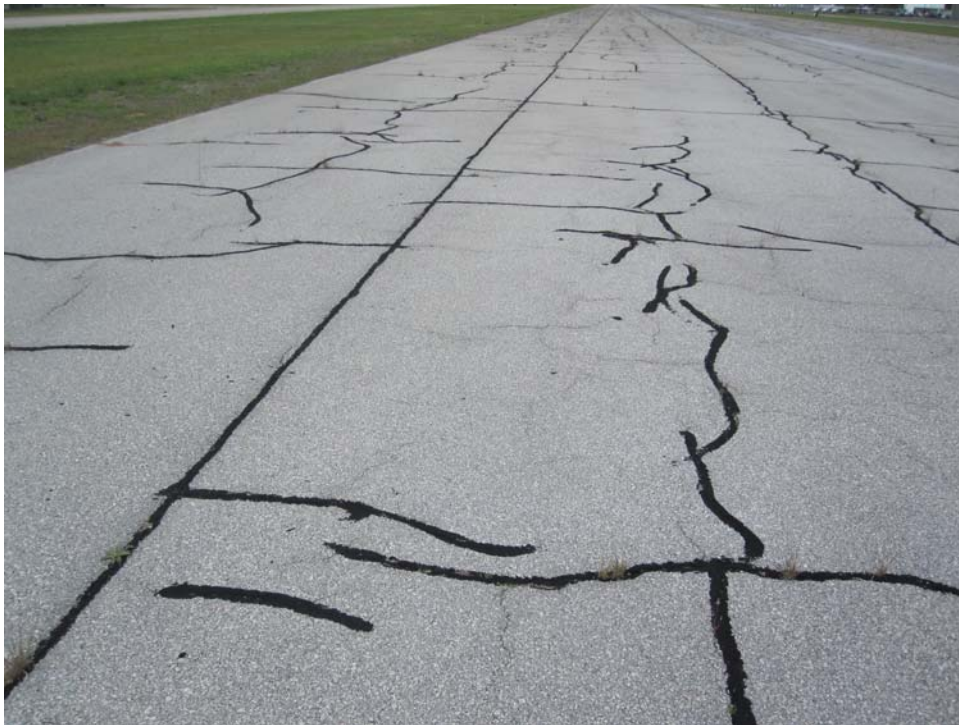
R1432AB-10. Block Cracking (Sample Unit #43).

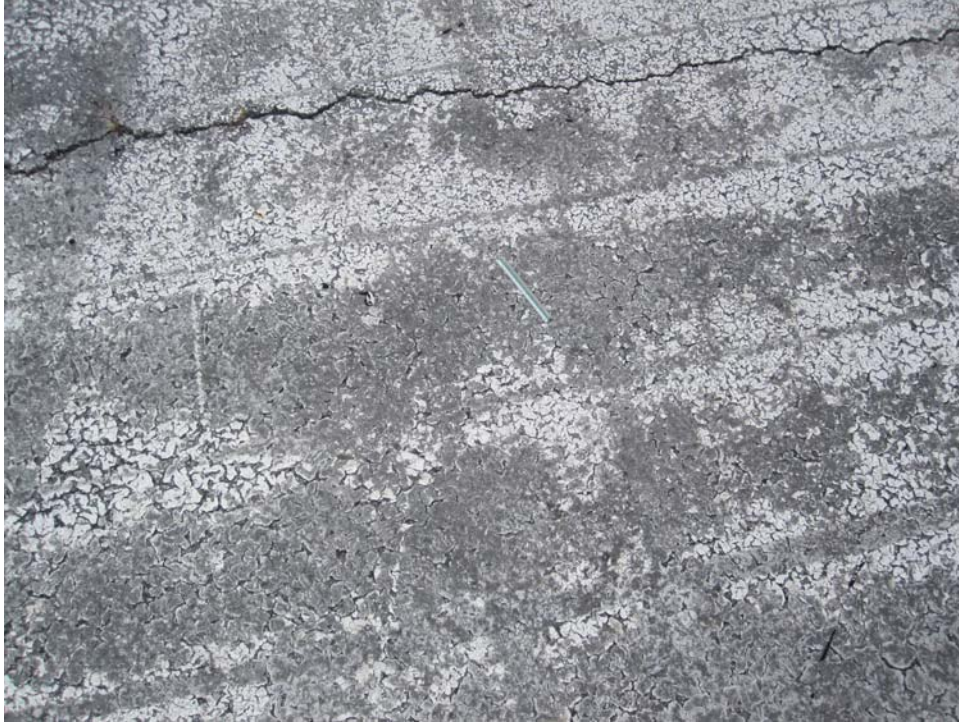
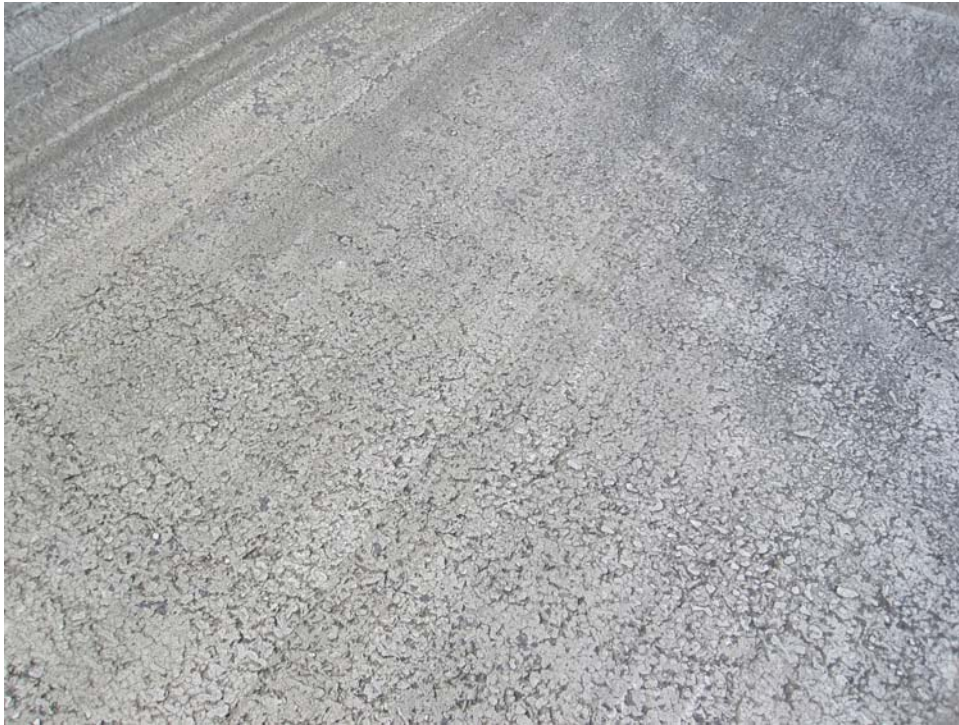
R1432AB-10. Unsatisfactory Paint (1).

R1432AB-10. Unsatisfactory Paint (2).

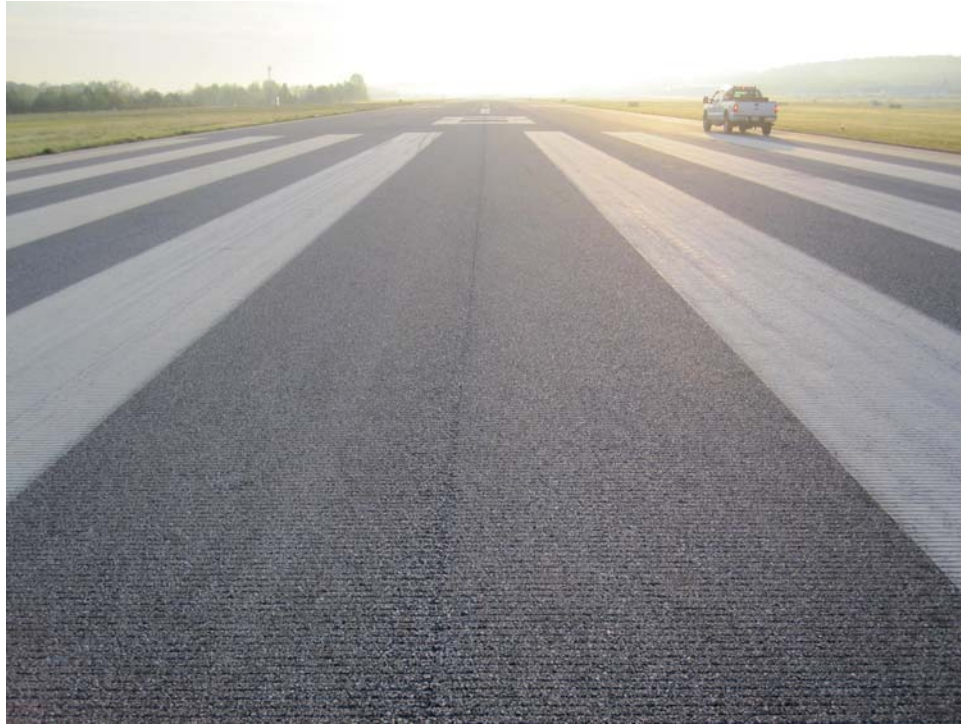
Runway 8-26 was comprised of one section. Section 10 has a PCI of 85. The primary distress identified in this section was low-severity longitudinal and transverse (L&T) cracking along with smaller amounts of medium-severity L&T cracking. In addition, isolated areas of medium-severity weathering and low-severity swelling, alligator cracking, and rutting were observed.

R826AB-10. Overview.

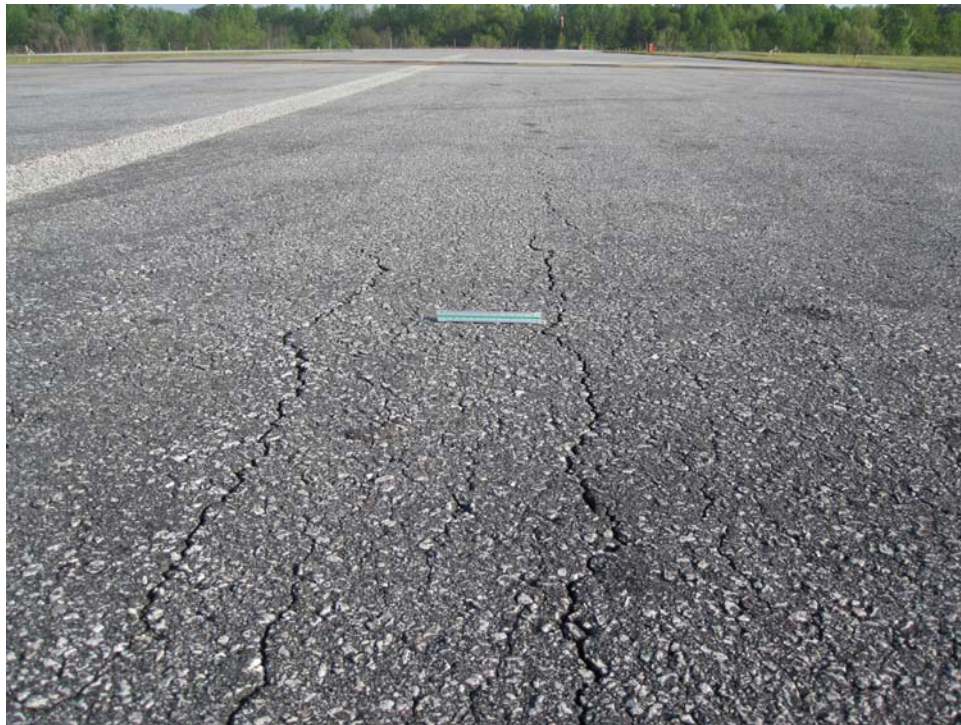
R826AB-10. Alligator Cracking and Rutting (Sample Unit #119).

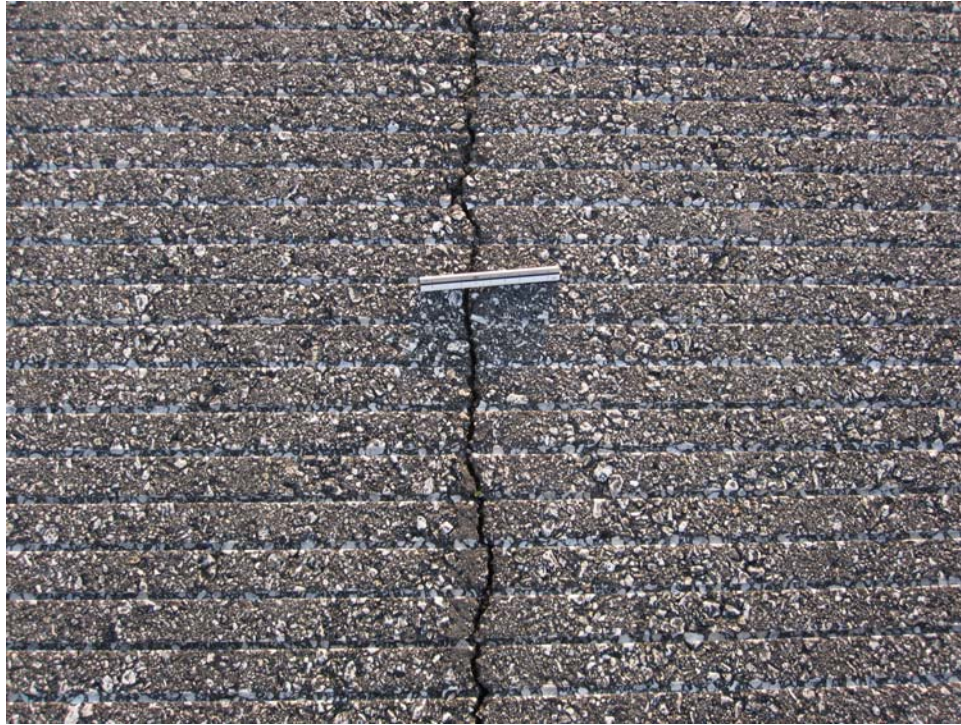
R826AB-10. Longitudinal and Transverse Cracking (Sample Unit #01).

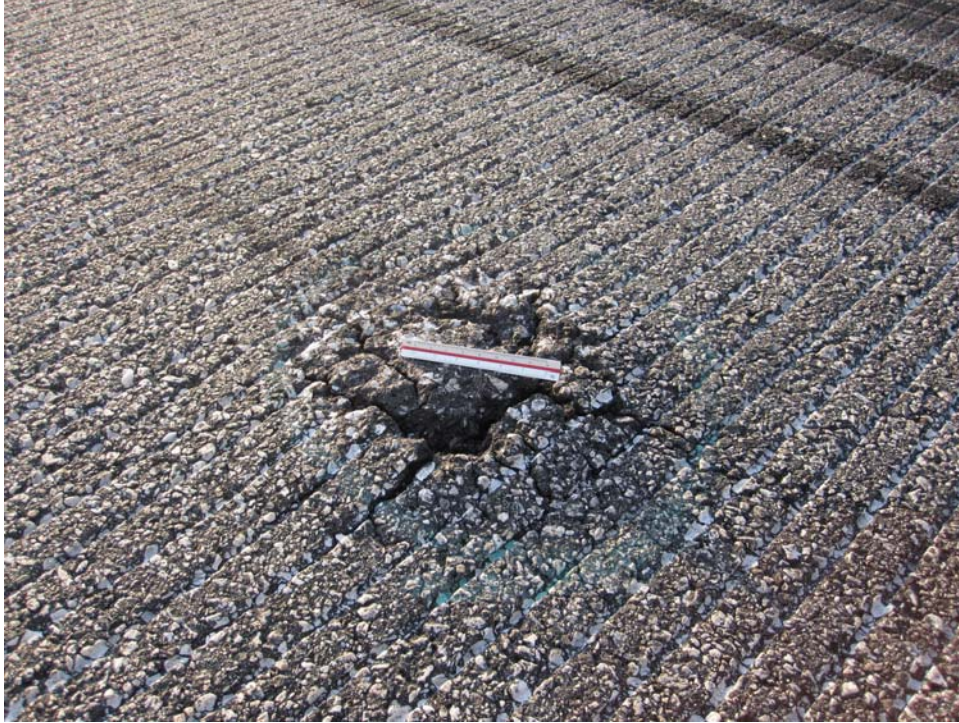
R826AB-10. Swelling (Sample Unit #23).

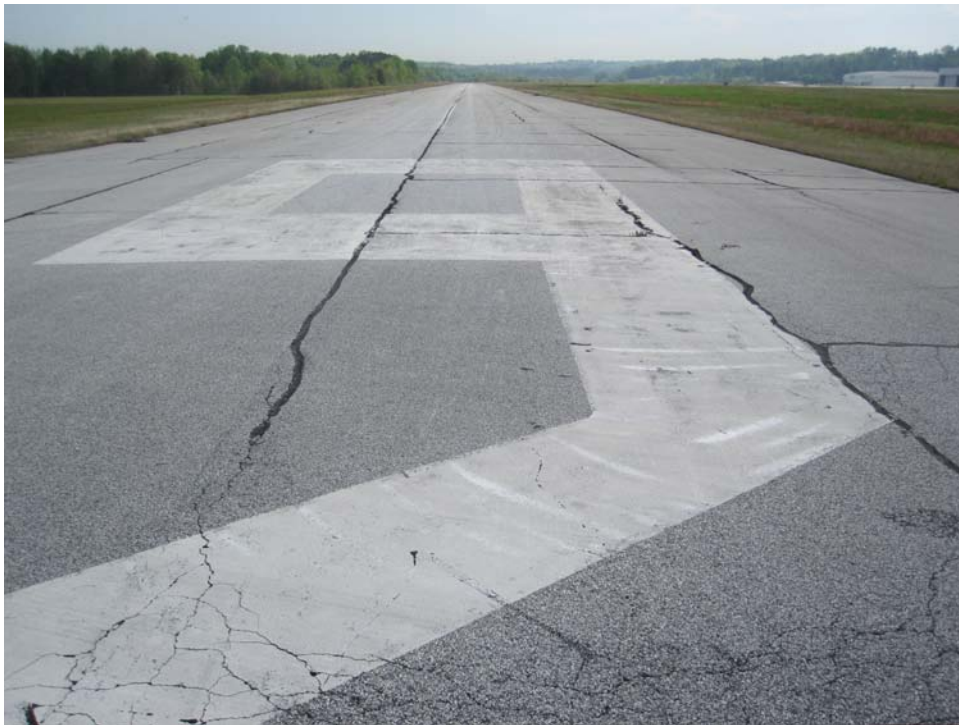
Runway 9-27 consisted of one section. Section 10 had a PCI value of 46. Substantial amounts of low- and medium-severity L&T cracking were recorded in this section. This section was also extensively weathered, with low- and medium-severity weathering recorded throughout. Significant areas of low-severity swelling were also recorded in this section. A small amount of high-severity L&T cracking was also observed. A large area of medium-severity alligator cracking was also observed at the 9 approach end and recorded as an additional sample unit in accordance with ASTM D5340.

R927AB-10. Overview.

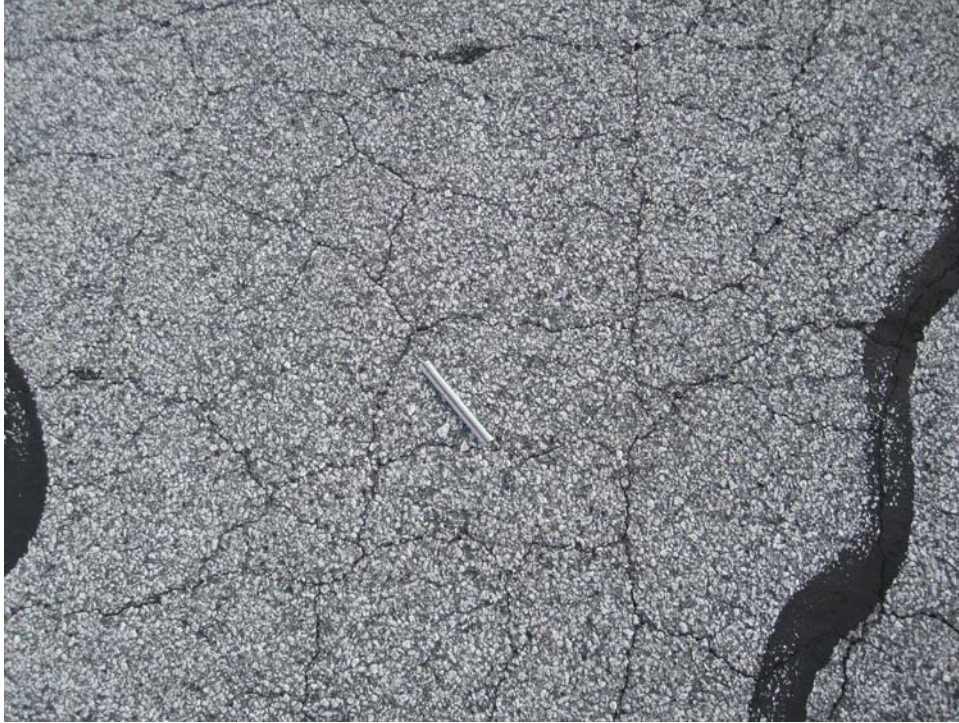
R927AB-10. Alligator Cracking (Additional Sample Unit #01).

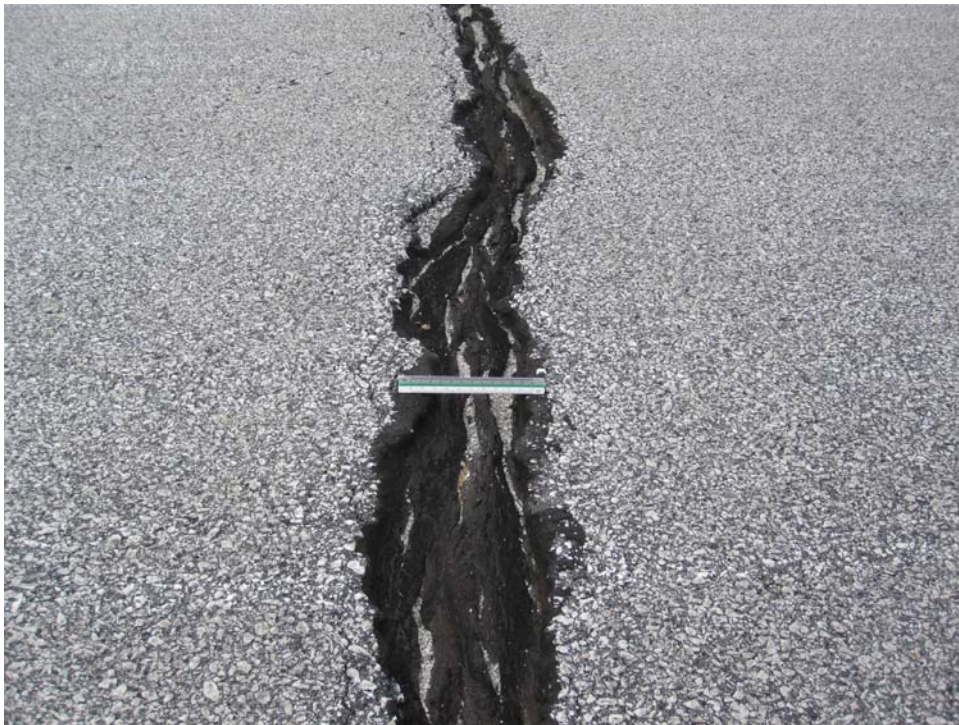
R927AB-10. High Severity Crack (Sample Unit #06).

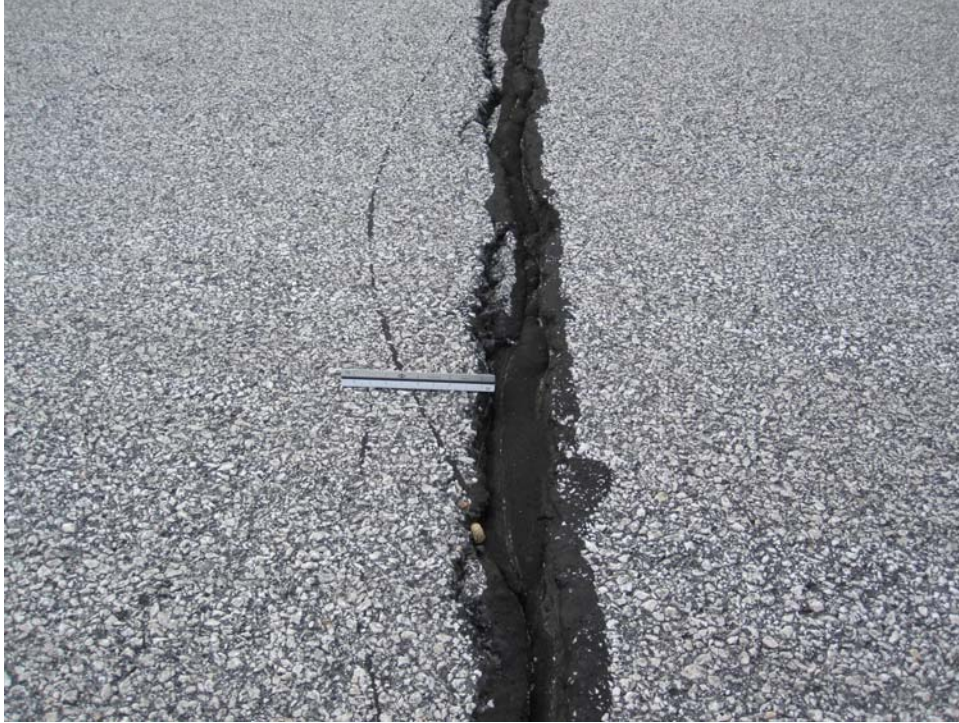
R927AB-10. Longitudinal and Transverse Cracking (Sample Unit #02).

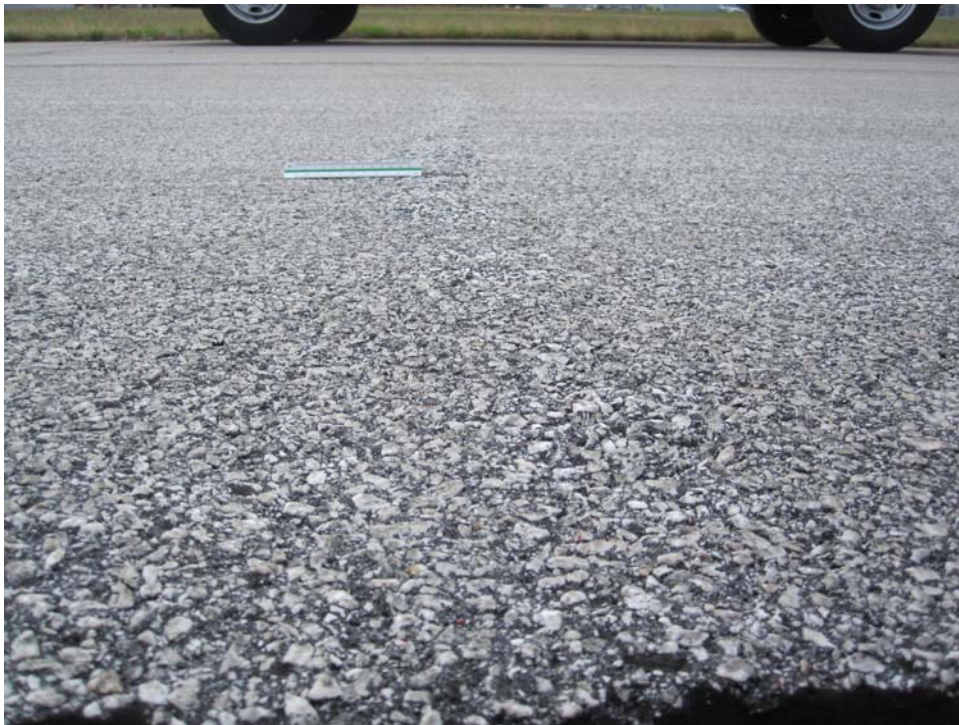
R927AB-10. Swelling (Sample Unit #06).

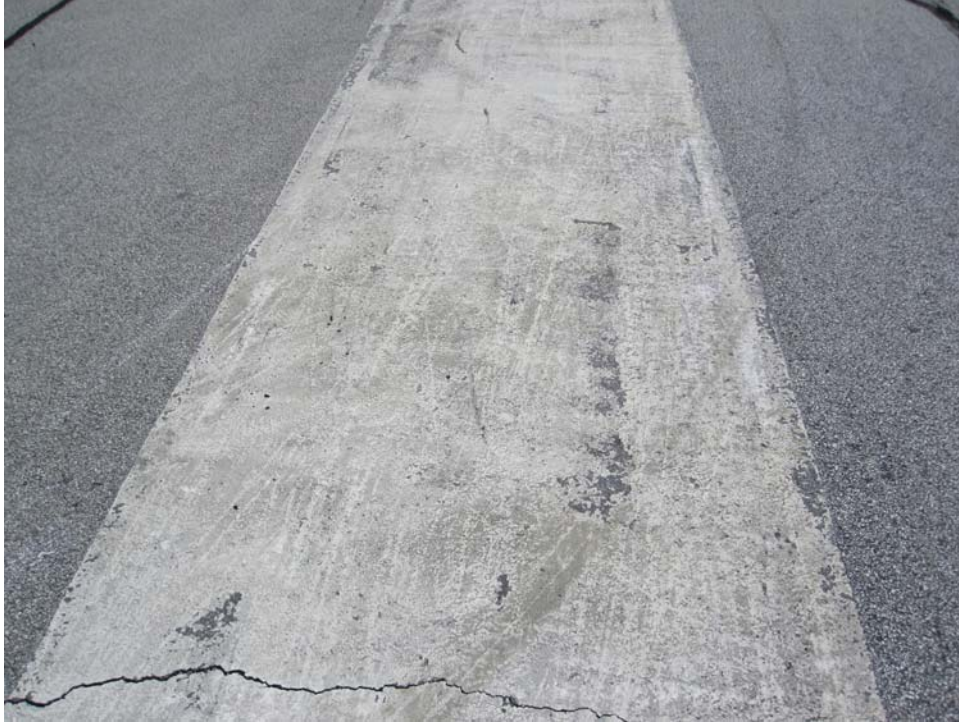
R927AB-10. Unsatisfactory Paint.

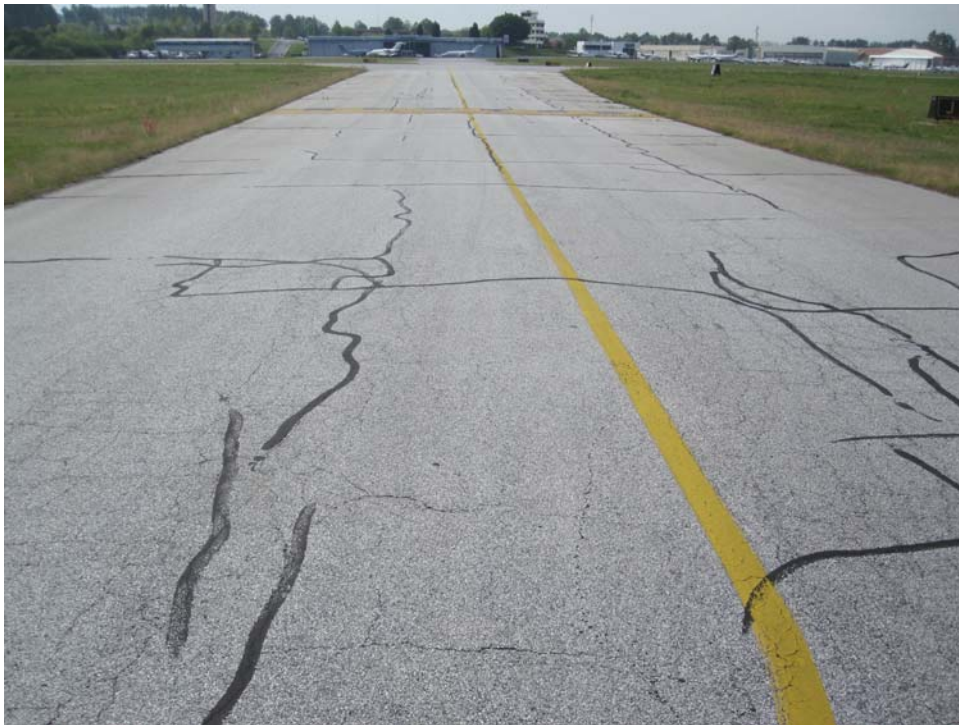
Taxiway 9-27 consisted of two sections. Section 10 included the portions of Taxiways J, K, and L located between Runways 8-26 and 9-27. These pavements were managed as a single pavement section. Section 10 had a PCI value of 46. Low- and medium-severity L&T cracking, medium-severity alligator cracking, and low-severity weathering were identified in this section. Most of the medium-severity cracking was due to failed crack sealant. Section 20 was defined by the portion of Taxiway J located north of Runway 9-27 as well as the maintenance apron to which it is connected. The PCI of this section was 70. The distresses observed included moderate amounts of both low- and medium-severity L&T cracking. Additionally, low-severity weathering was identified throughout this section along with a small amount of bleeding.

T927AB-10. Overview.

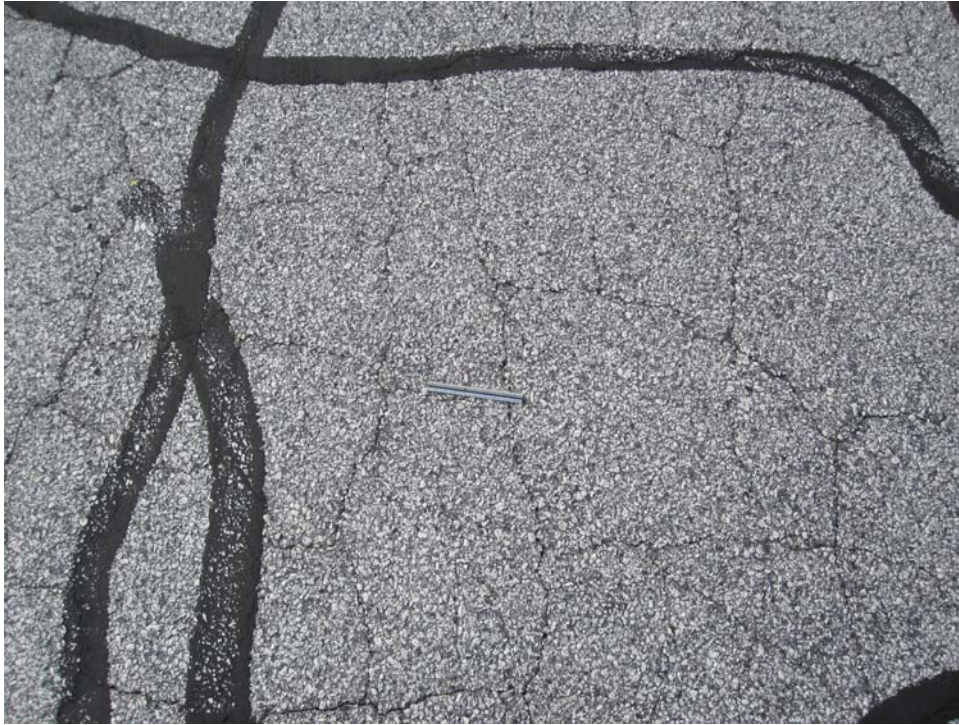
T927AB-10. Alligator Cracking (Sample Unit #02).

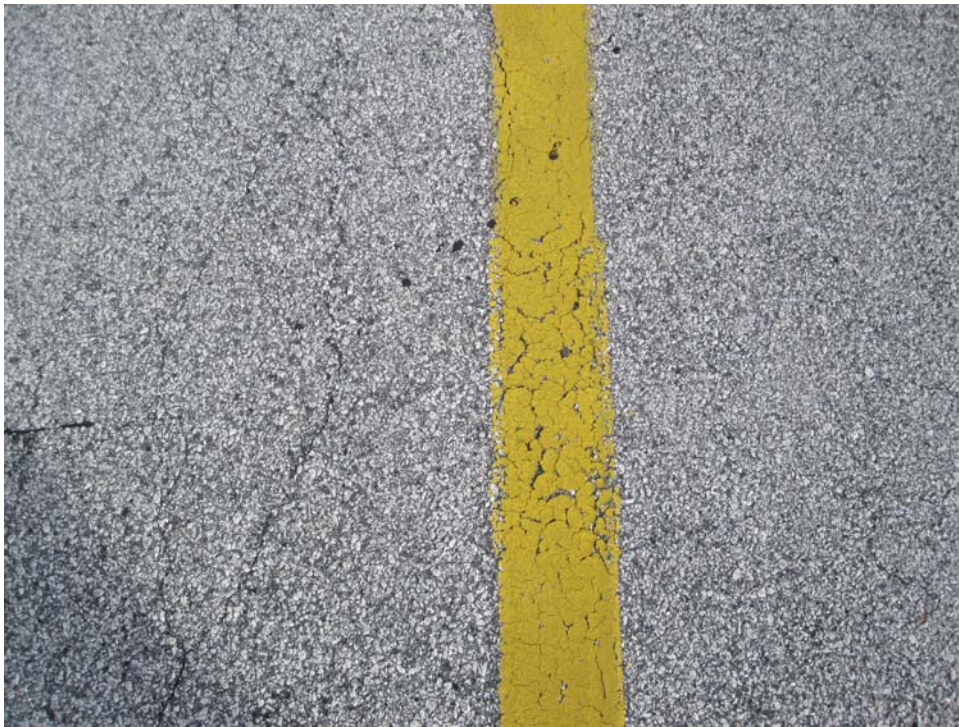
T927AB-10. Unsatisfactory Paint.

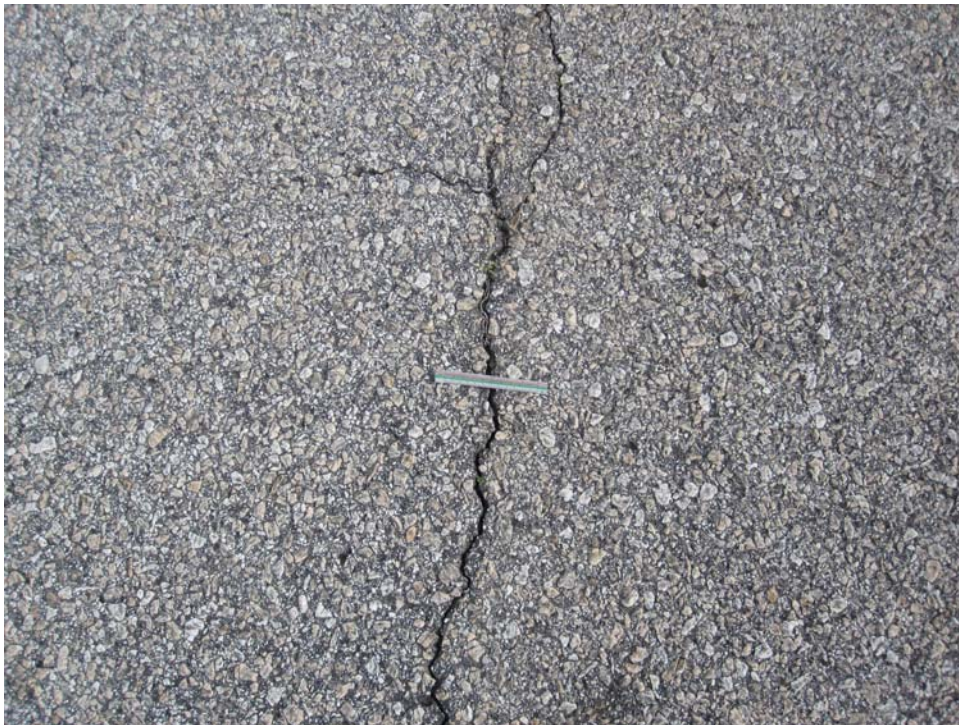
T927AB-20. Longitudinal and Transverse Cracking (Sample Unit #02).

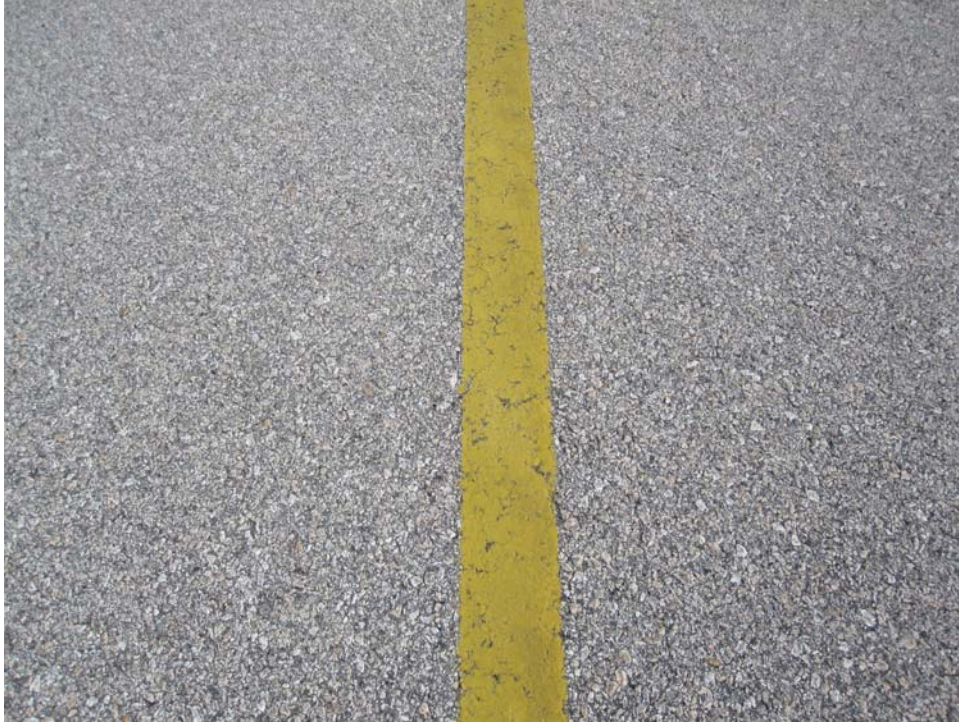
T927AB-20. Unsatisfactory Paint.

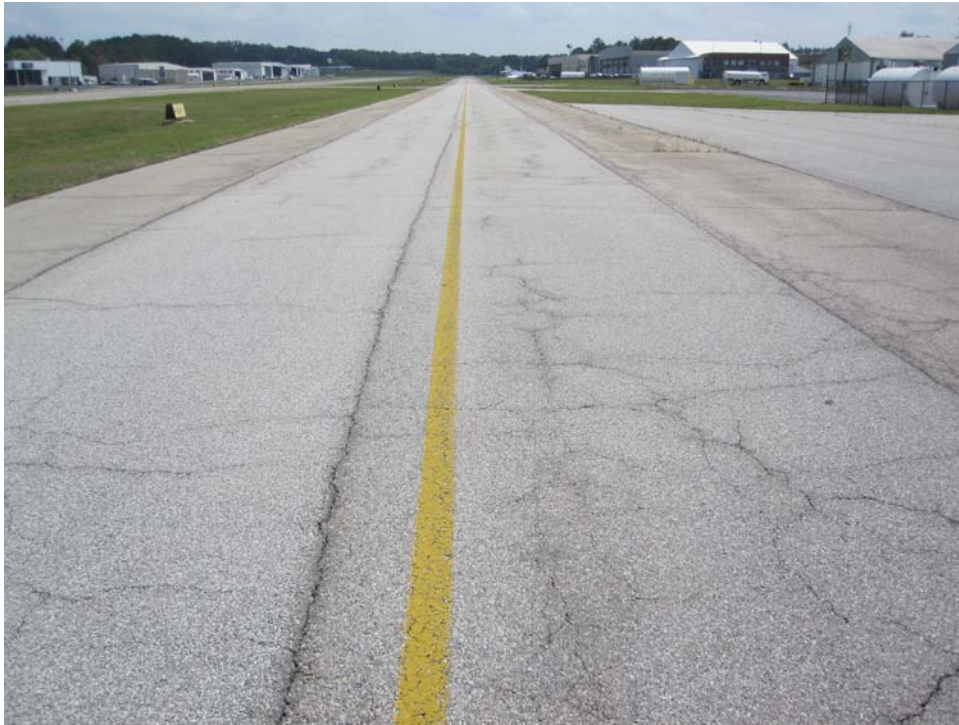
Taxiway A was defined by one section. Section 10 had a PCI value of 32. The primary distress identified in this section was low- and medium-severity block cracking. Many of the cracks north of Runway 8-26 had been sealed, but the sealant was no longer performing satisfactorily. Significant areas of medium-severity alligator cracking located in the wheelpaths were also noted in this section. Low-severity weathering was recorded throughout along with a small amount of bleeding.

TAAB-10. Overview.

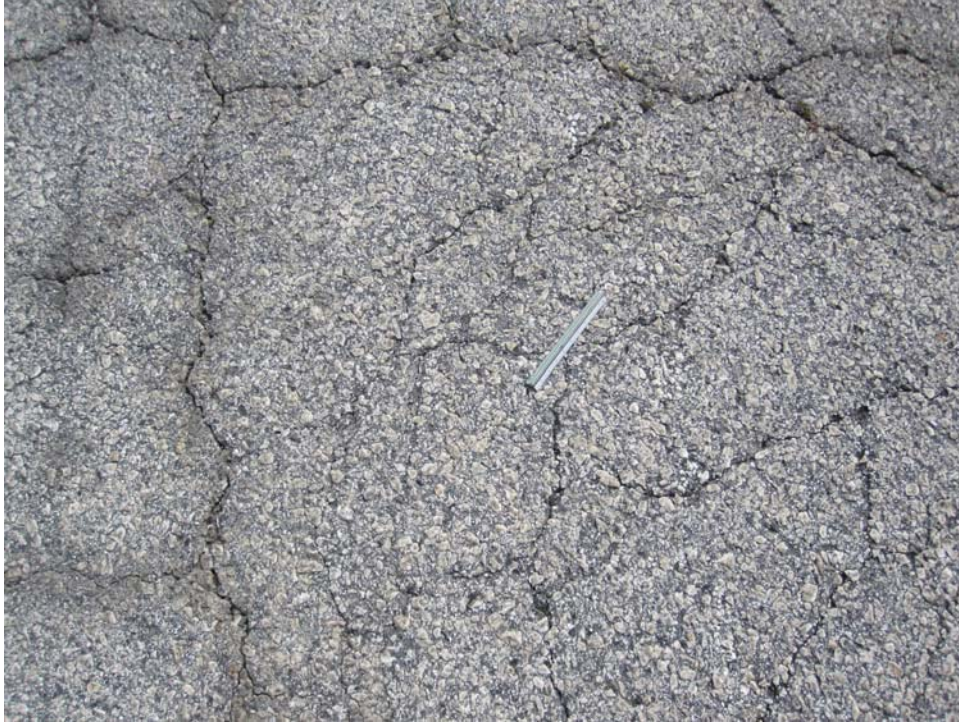
TAAB-10. Alligator Cracking (Sample Unit #07).

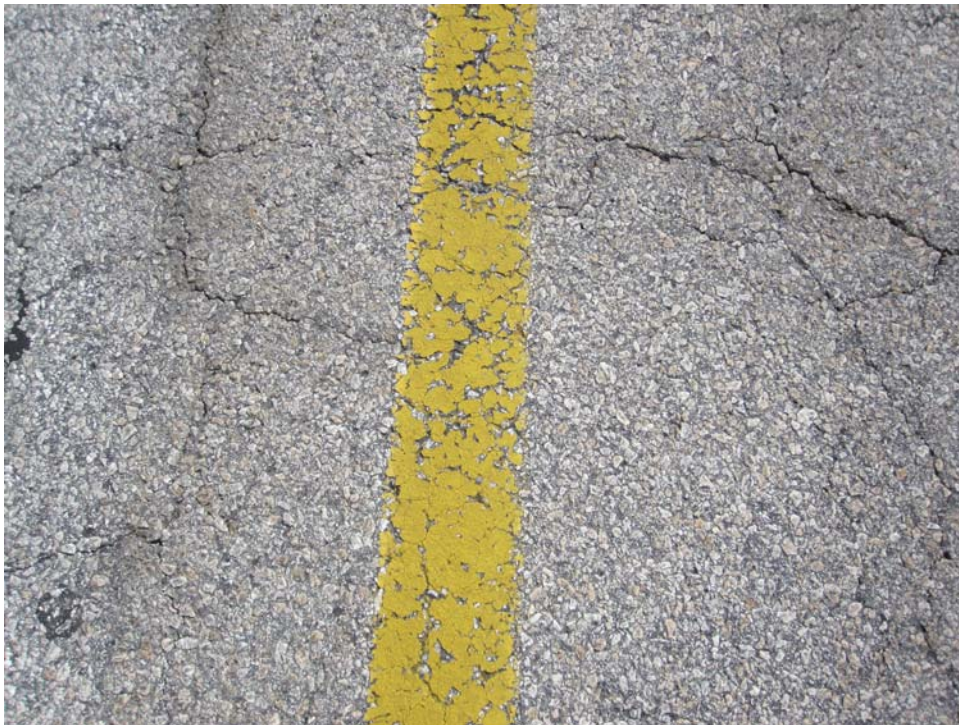
TAAB-10. Unsatisfactory Paint.

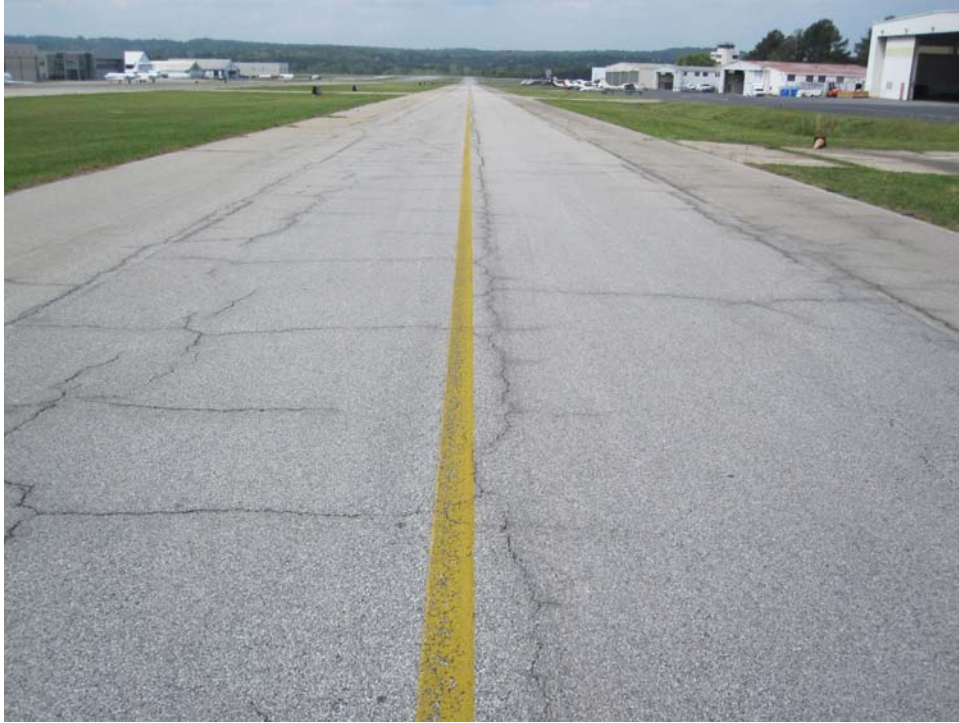
Taxiway B was comprised of one section. Section 10 had a PCI value 32. Extensive amounts of low- and medium-severity block cracking and low-severity weathering were recorded throughout. Most of the cracking observed on this section was in an unsealed condition.

Additionally, areas of medium-severity alligator cracking, low- and medium-severity L&T cracking and bleeding were identified on this section.

TBAB-10. Overview.

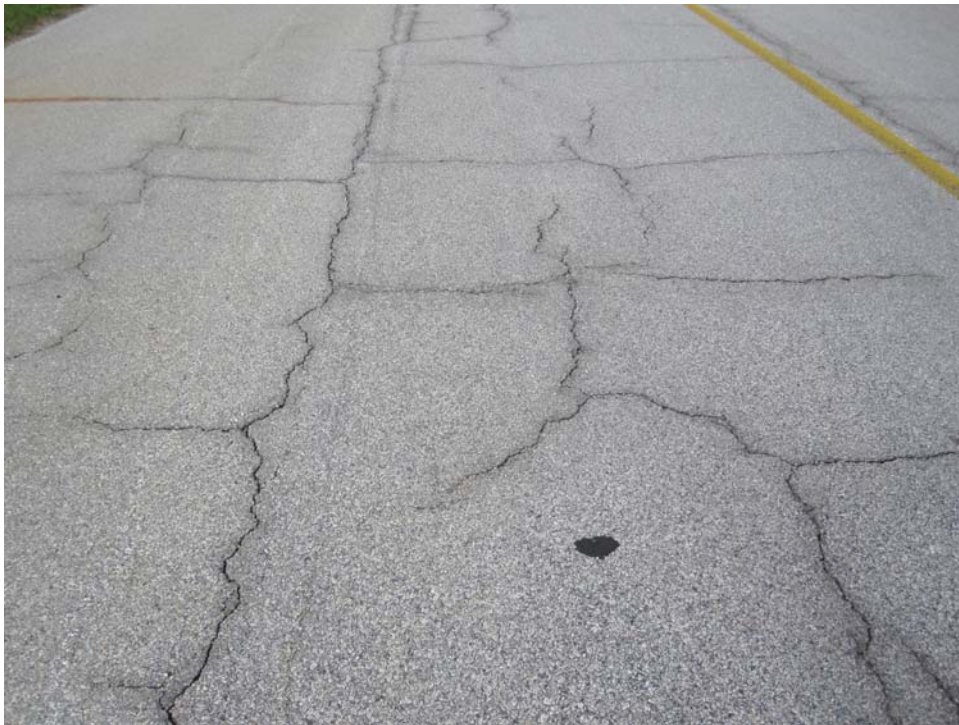
TBAB-10. Block Cracking (Sample Unit #34).
