2012 Fulton County-Brown Field Pavement Management Plan

FULTON COUNTY-BROWN FIELD

PAVEMENT MANAGEMENT REPORT

DECEMBER 2012

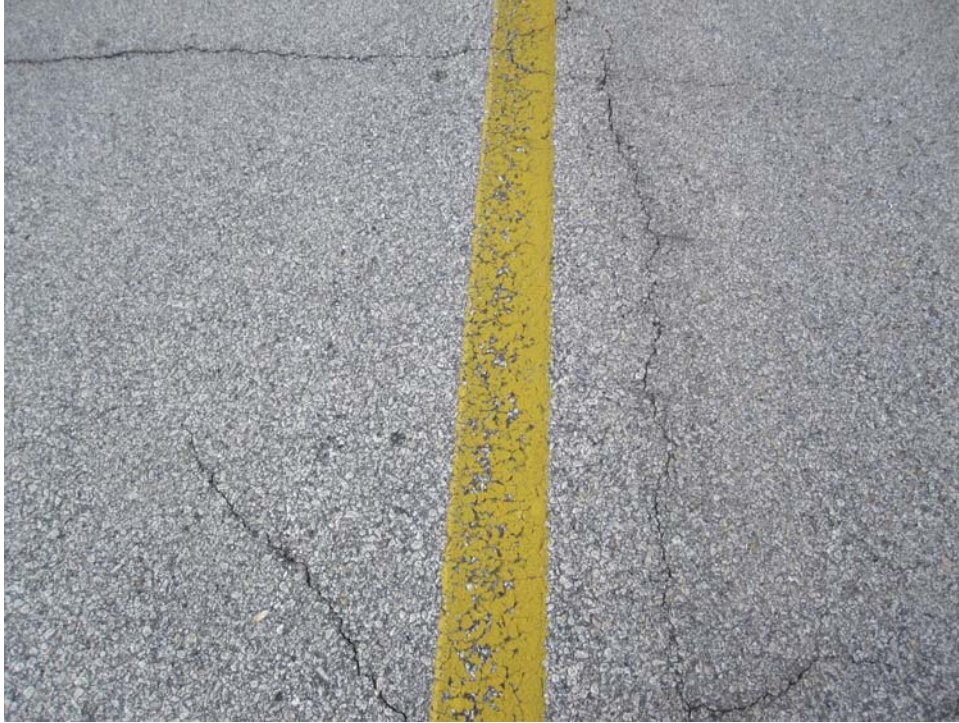
TBAB-10. Unsatisfactory Paint.

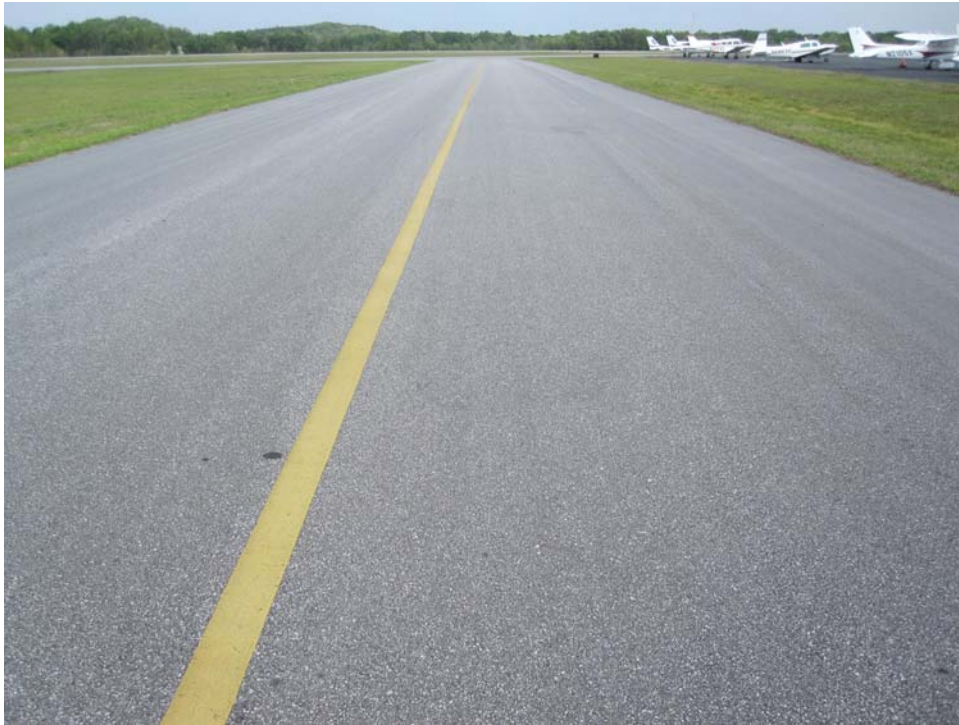
Taxiway G was defined by one section. Section 10 was recently rehabilitated and had a PCI value of 99. A small amount of low-severity, unsealed cracking and a small area of low-severity swelling were recorded in this section.

TGAB-10. Overview.

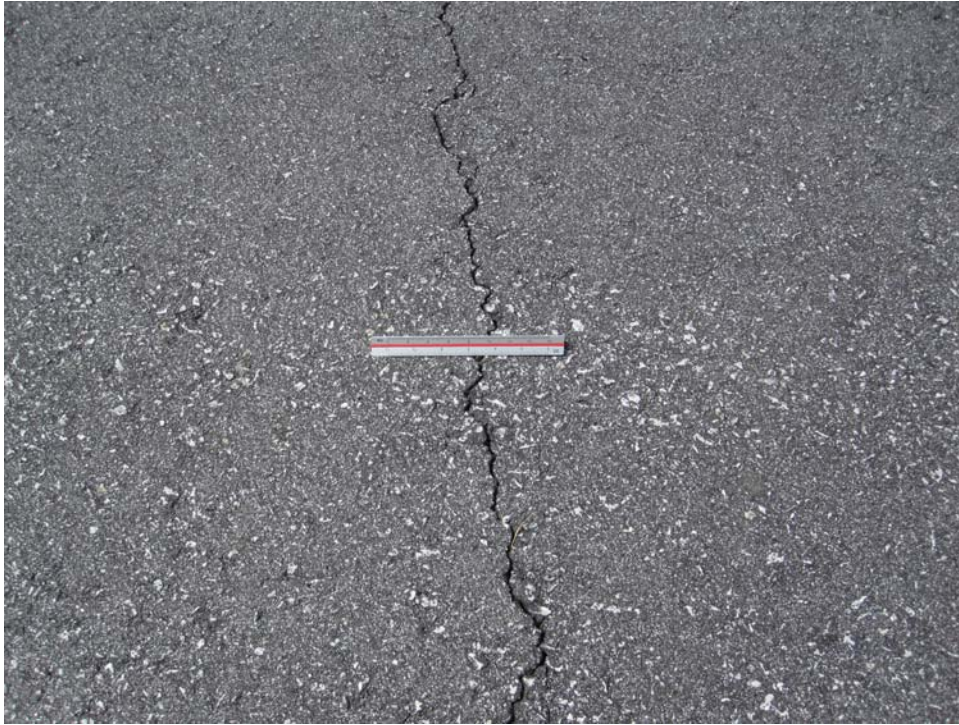
TGAB-10. Longitudinal and Transverse Cracking (Sample Unit #04).

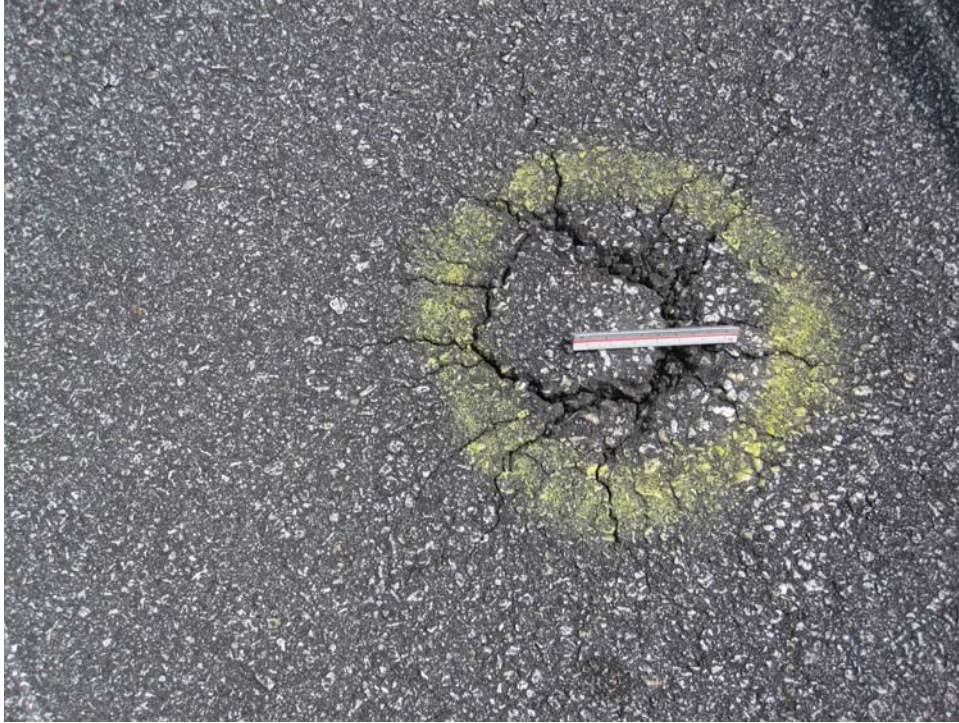
TGAB-10. Swelling (Sample Unit #04).

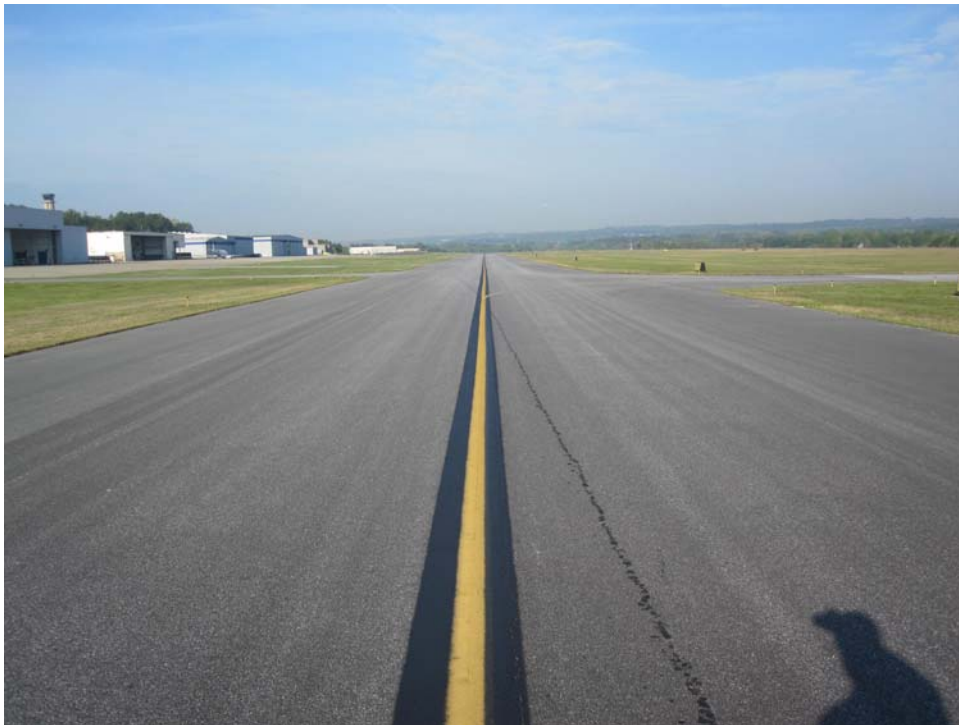
Taxiway I contained one section. Section 10 was recently rehabilitated and had a PCI value of 93. A small amount of low-severity, unsealed cracking was recorded in this section. Most of the cracking observed in this section was occurring in the paving lane seams. Additionally, an isolated area bleeding was also noted.

TIAB-10. Overview.

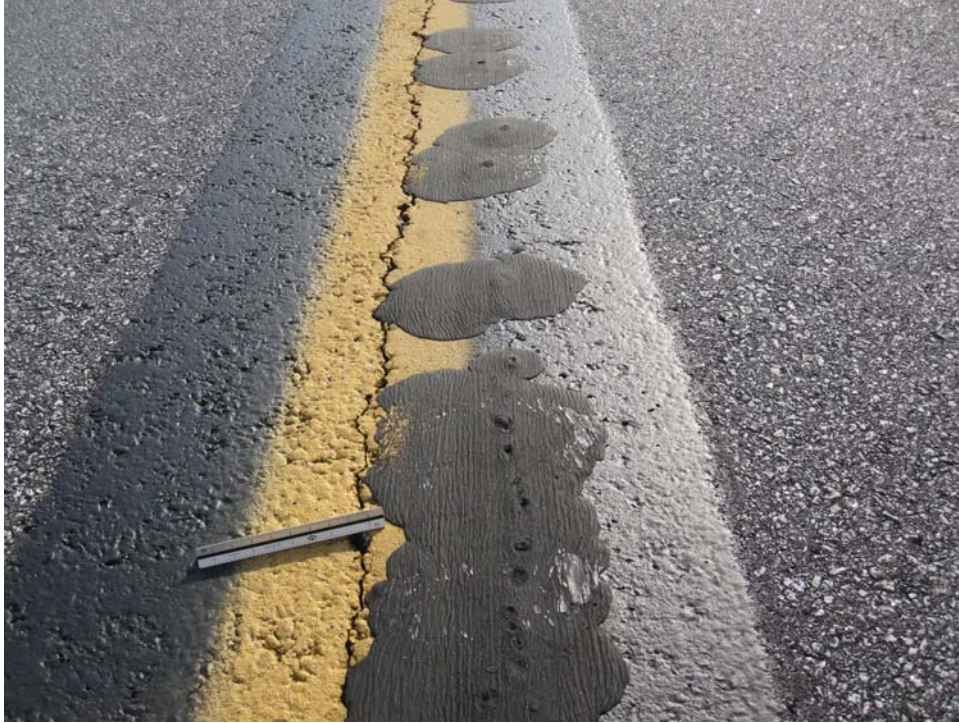
TIAB-10. Bleeding (Sample Unit #20).

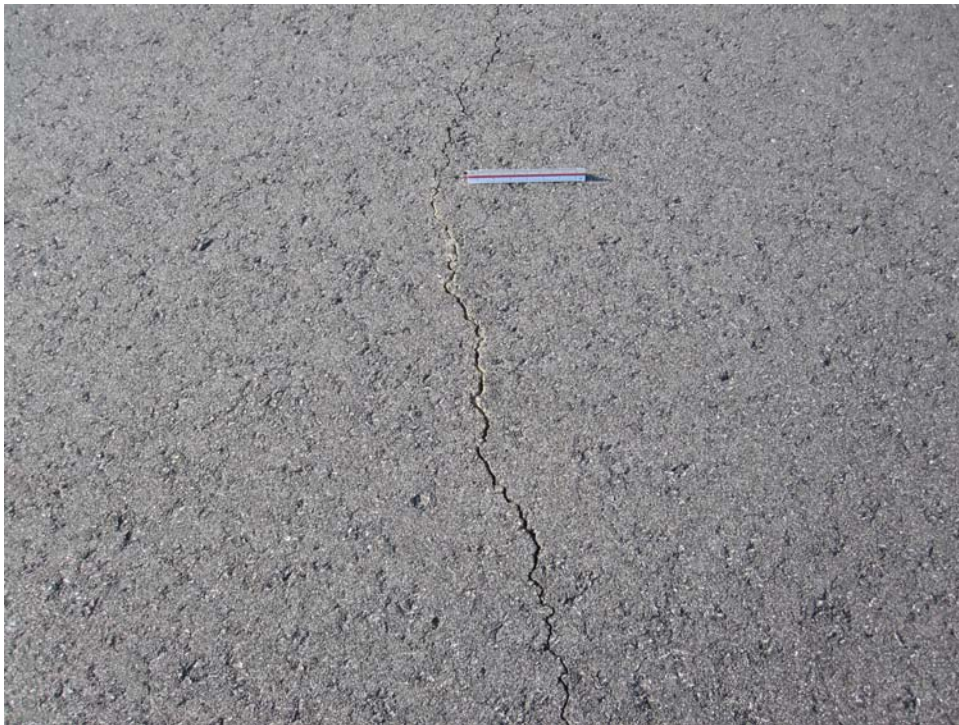
TIAB-10. Longitudinal and Transverse Cracking (Sample Unit #67).
