2012 DeKalb-Peachtree Airport Pavement Management Plan

DEKALB-PEACHTREE AIRPORT

PAVEMENT MANAGEMENT REPORT

DECEMBER 2012

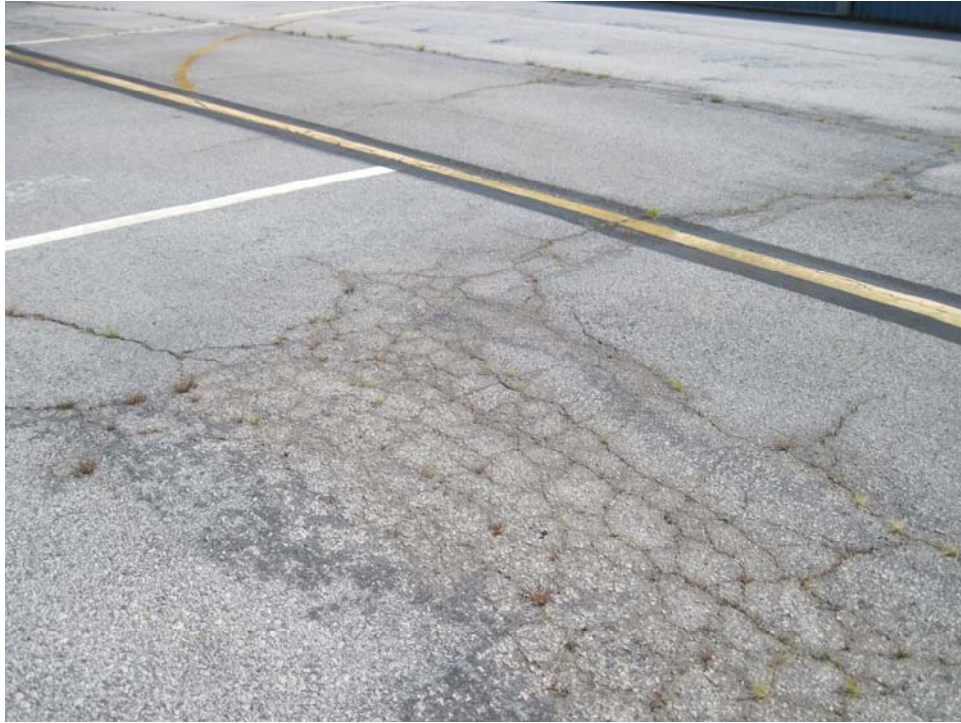
The northeast apron was defined by one section in poor condition with a PCI of 27. It contained extensive areas of alligator cracking, L&T cracking, and block cracking, all mostly medium-severity with some low-severity. Low-severity depression, medium-severity patching, and low- and medium-severity rutting were also observed. Finally, a moderate quantity of medium-severity raveling was recorded along with extensive amounts of low-, medium-, and high-severity weathering.

ANERAMPAP-10. Alligator Cracking.

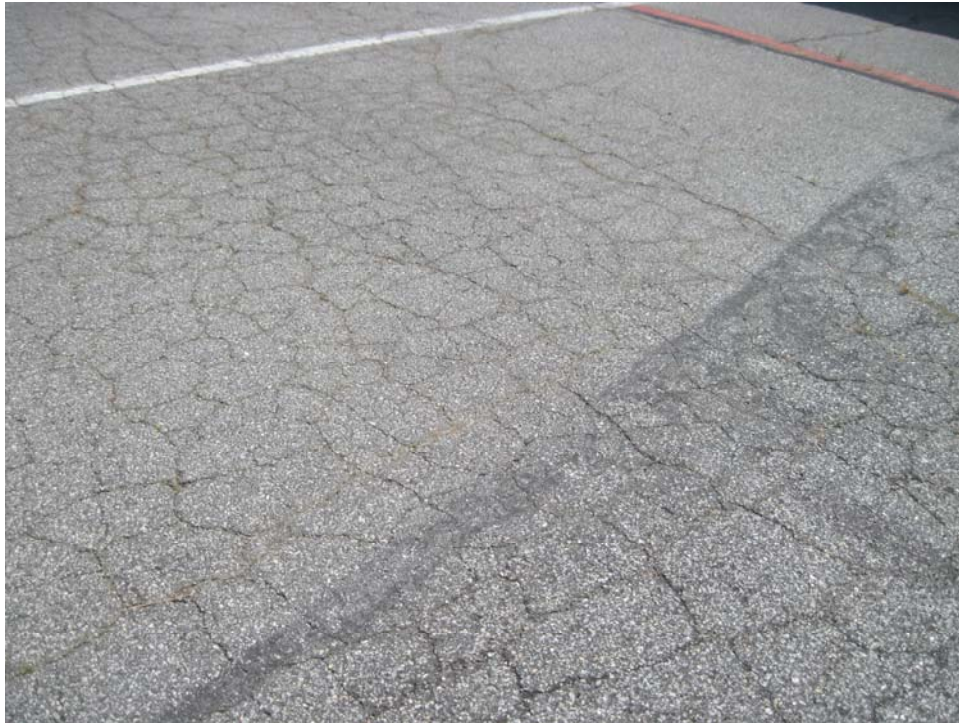
The north apron contained one section in poor condition with a PCI of 40. Alligator cracking existed over nearly all of the section, mostly medium-severity with some low- and high-severity. Also noted were medium-severity block cracking, low-severity depression, low- and medium-severity L&T cracking, high-severity patching, medium-severity swelling, and low- and medium-severity weathering.

ANRAMPAP-10. Alligator Cracking (Sample Unit #64).

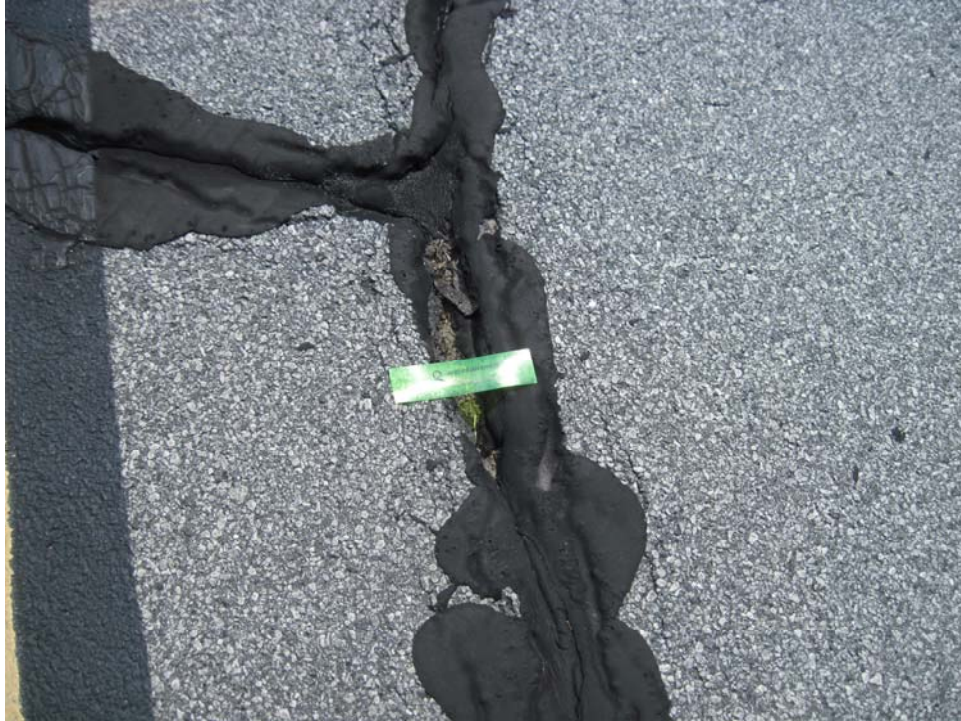
The northwest apron was comprised of three sections. Section 10 contained the asphalt sections between the T-Hangars and was in poor condition with a PCI of 28. The section had extensive areas of alligator cracking and block cracking, as well as smaller areas of swelling. Low-severity weathering was observed throughout the section with areas of medium-severity weathering. Section 20 was in poor condition with a PCI of 2. High-severity joint seal damage was noted throughout, along with high-severity corner breaks, joint and corner spalls, LTD cracks, and large and small patches. High-severity shattered slabs, medium-severity LTD cracks and

ANWRAMPAP-10. Block Cracking (Sample Unit #04).

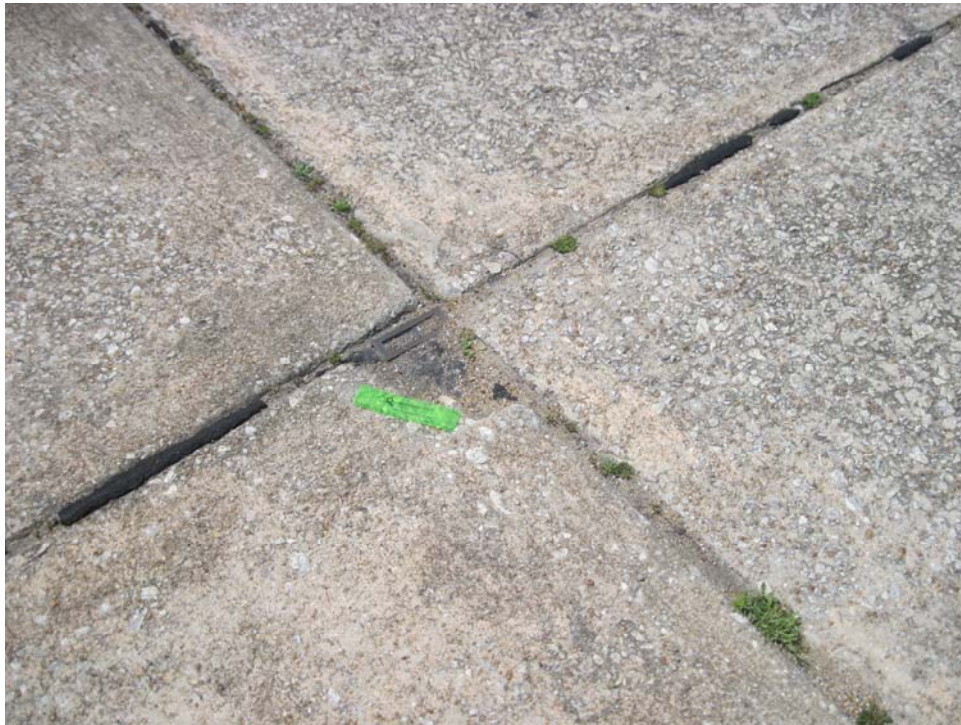
ANWRAMPAP-20. Corner Spalling (Sample Unit #22).

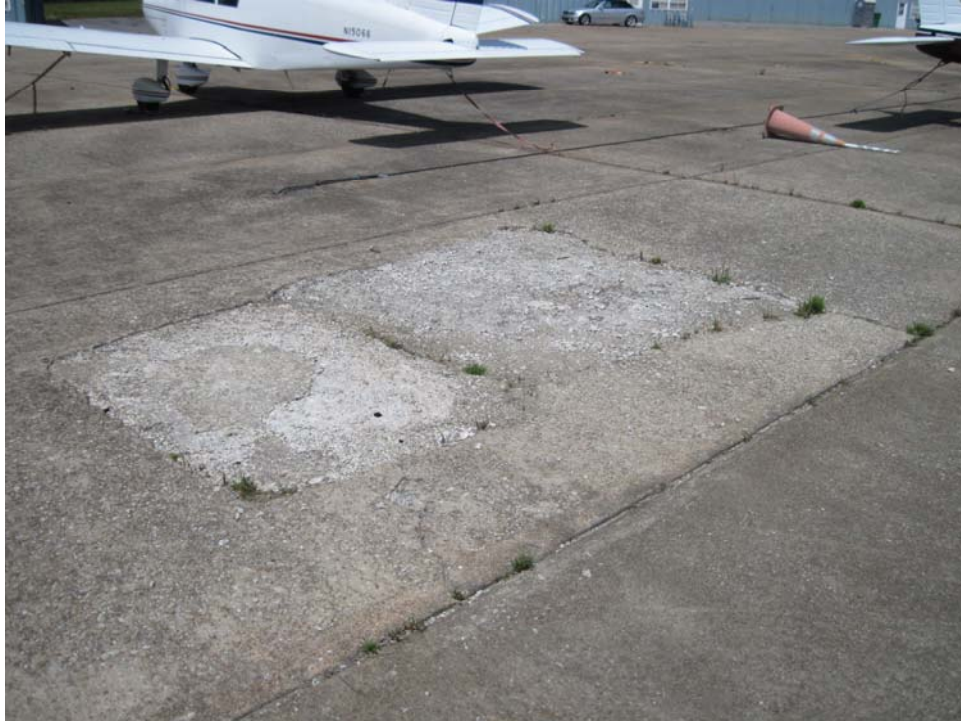
ANWRAMPAP-20. Shattered Slab and Scaling (Sample Unit #22).

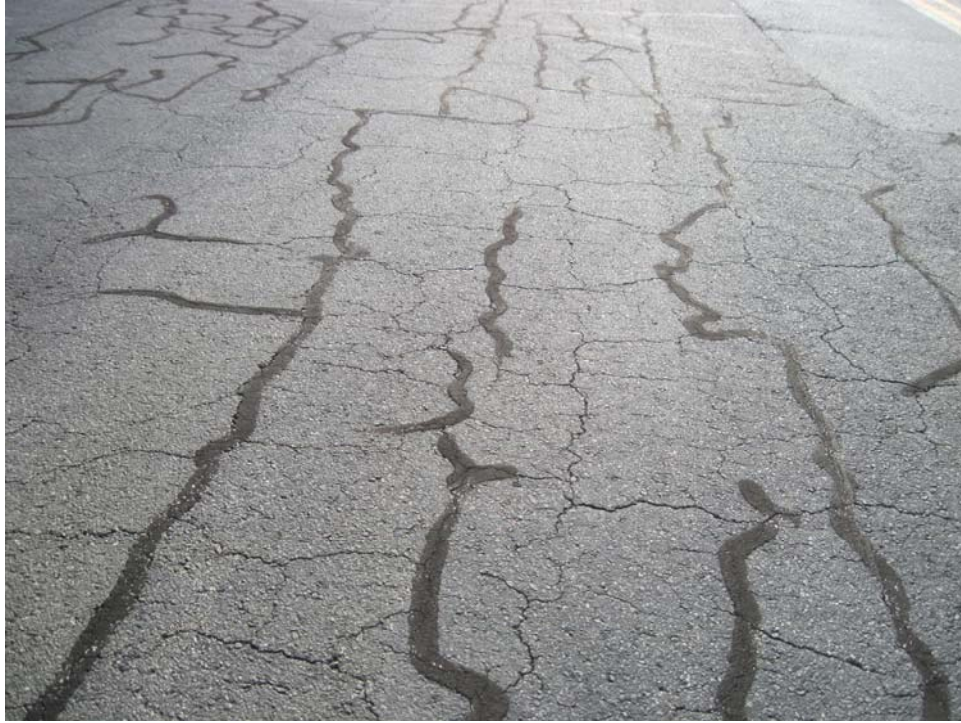
APERIMAP-10. Alligator Cracking (Sample Unit #05).

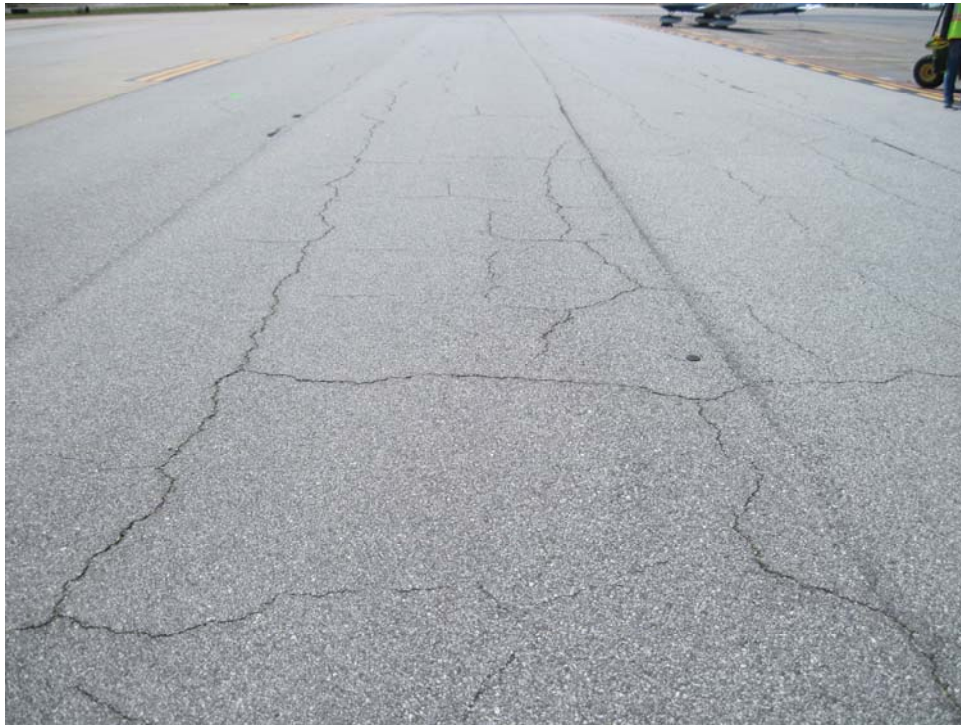
APERIMAP-20. Block Cracking (Sample Unit #05).

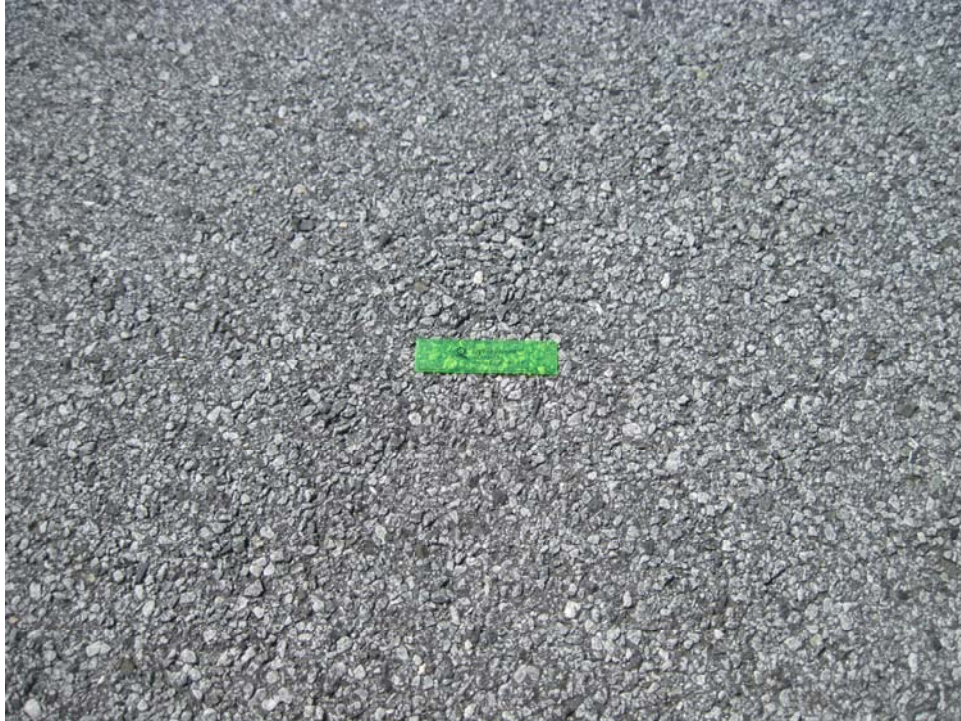
APERIMAP-20. Weathering (Sample Unit #14).

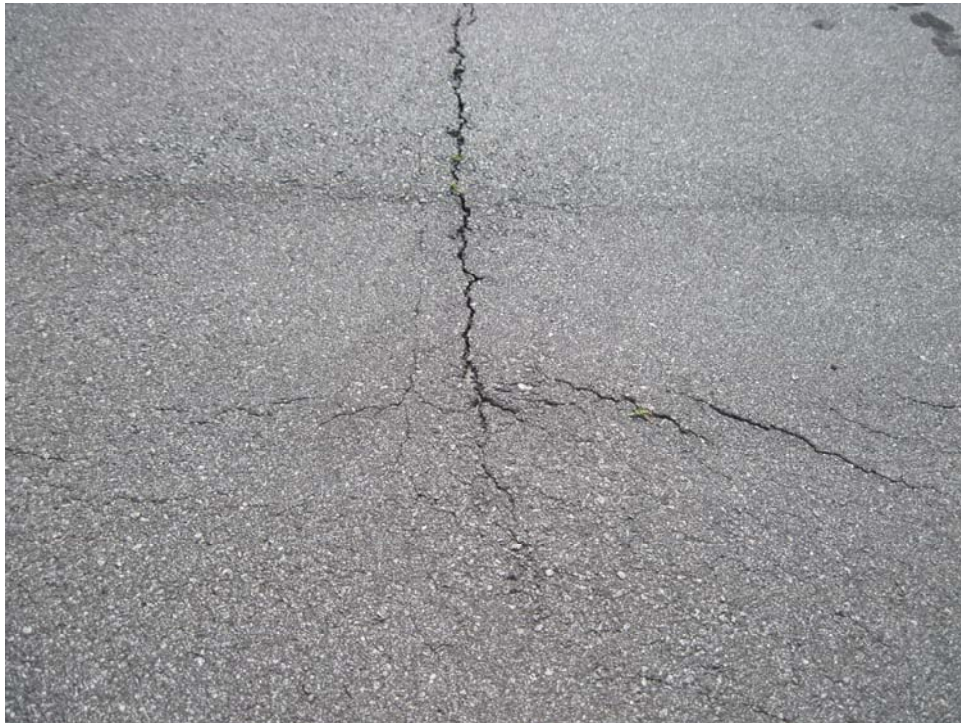
APERIMAP-30. Longitudinal and Transverse Cracking.

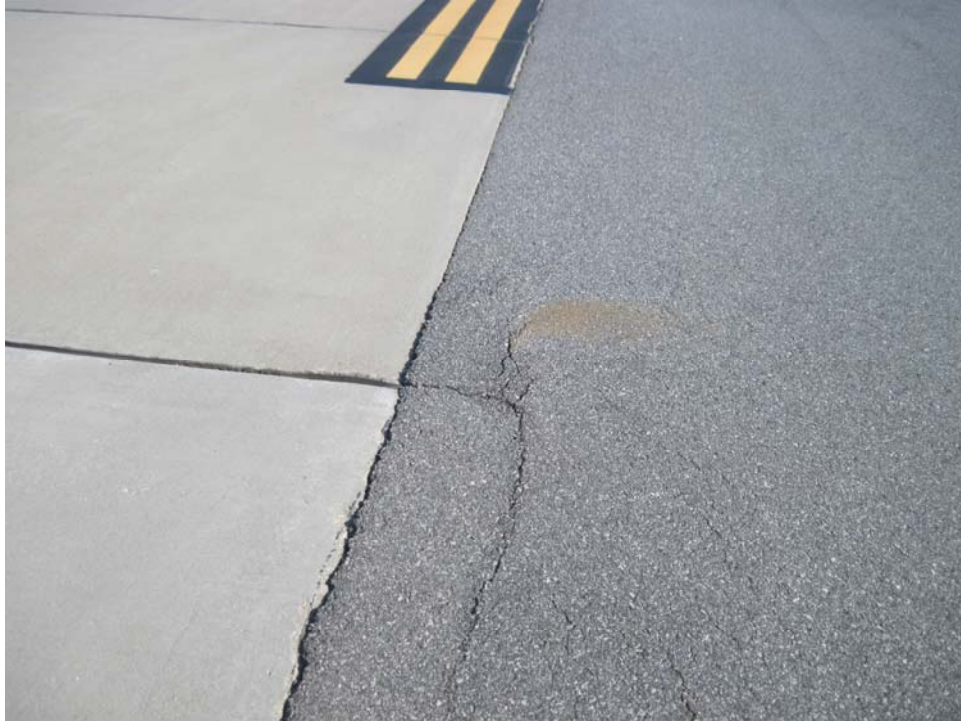
APERIMAP-30. Shoving.

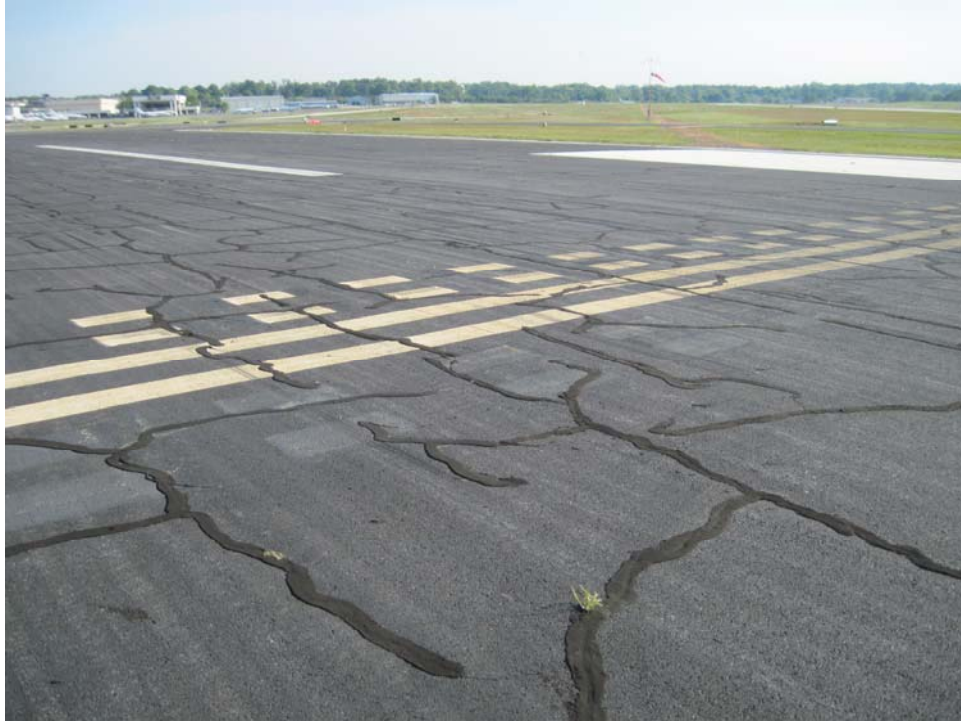
Runway 16-34 was defined by two sections. Section 10 had a PCI of 48. Extensive block cracking was present, with more medium-severity than low-severity. The low-severity cracking was unsealed. Extensive low- and medium-severity L&T cracking were also observed, as well as low-severity swelling.

R1634AP-10. Block Cracking (Sample Unit #42).

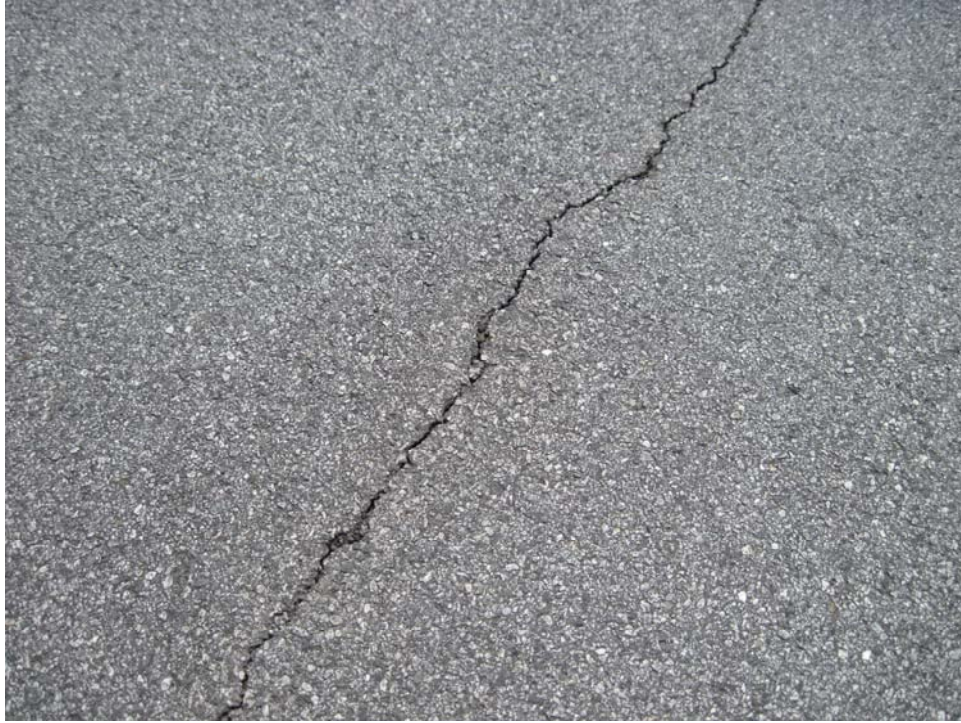
Section 20 had a PCI of 73. It contained moderate amounts of low-severity, unsealed block cracking; low-severity, unsealed L&T cracking; and low-severity weathering; as well as small amounts of medium-severity L&T cracking and patching.

R2L20RAP-20. Longitudinal and Transverse Cracking (Sample Unit #02).

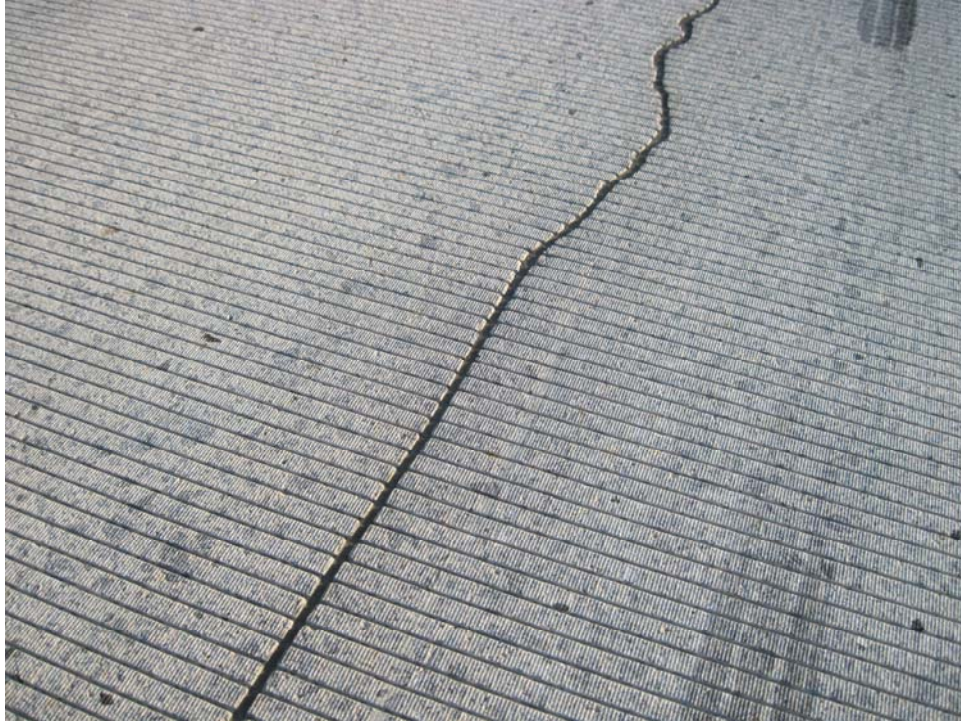
Runway 2R-20L consisted of one section with a PCI of 73. Low-severity alkali silica reaction (ASR) was recorded in about one-third of the slabs. Longitudinal, transverse, and diagonal (LTD) cracking was recorded in a significant portion of the slabs, mostly low-severity and sealed, with a smaller portion of medium-severity LTD cracks due to failed crack sealant or spalling along the crack. Also observed at a low rate were low- and medium-severity small patches, low-severity large patches, medium-severity joint spalls, and medium-severity ASR.

R2R20LAP-10. LTD Cracking (Sample Unit #12).

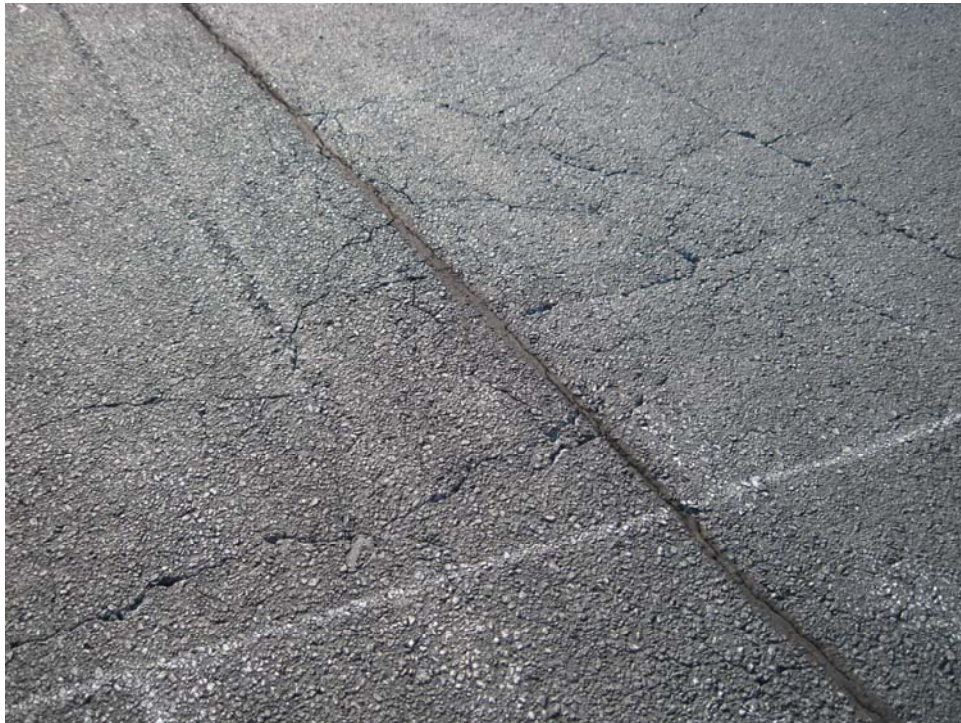
Runway 9-27 consisted of one section in poor condition with a PCI value of 36. Nearly the entire area contained block cracking, mostly medium-severity with a smaller portion that was low-severity and unsealed. The remainder of the area contains extensive low-severity, unsealed longitudinal and transverse (L&T) cracking, with a moderate amount of medium-severity L&T cracking. Low- and medium-severity weathering, medium-severity raveling, and low- and medium-severity swelling were noted throughout the section. Also recorded were low- and medium-severity patching and medium-severity alligator cracking.

R927AP-10. Alligator Cracking (Sample Unit #51).

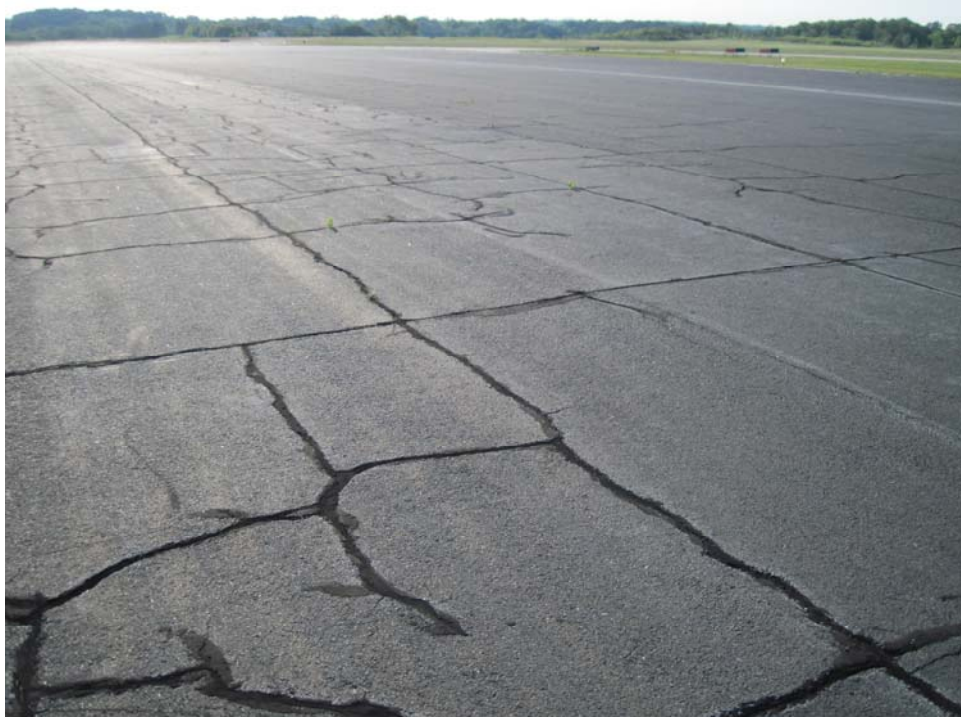
R927AP-10. Block Cracking (Sample Unit #64).

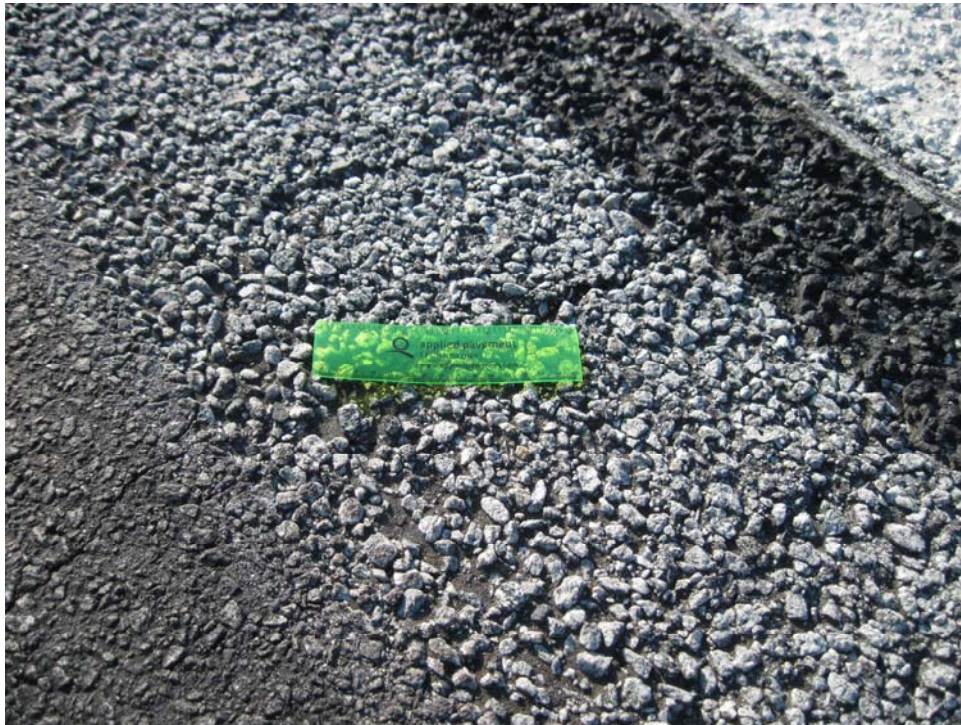
R927AP-10. Raveling (Sample Unit #51).

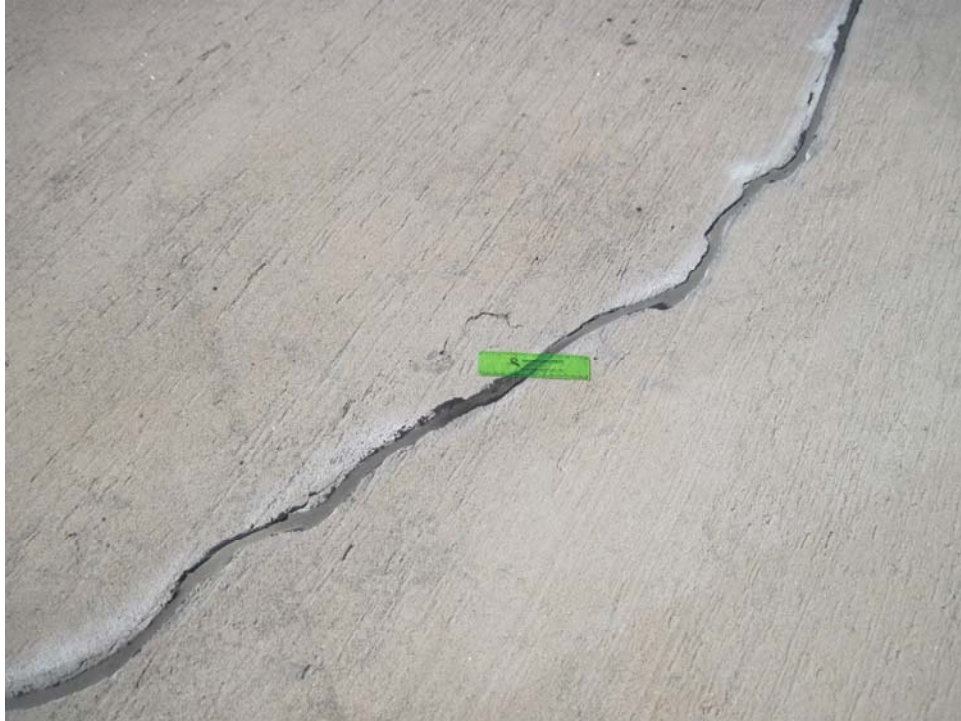
Taxiway A was comprised of four sections. Section 10 had a PCI of 56. LTD cracking was present in a little over half of the slabs, with most of it being low-severity and sealed with a small portion of medium-severity. ASR was observed in about two-thirds of the slabs, with most of it being low-severity and some being medium-severity. A moderate amount of shrinkage cracking was recorded. Primarily in and next to the holding pads, low-severity faulting and low- and medium-severity shattered slabs were recorded. The shattered slabs existed where the original 25 foot by 25 foot slabs were left in place. Most of the section's slabs were recently saw-cut into halves or quarters, and a number of slabs were recently replaced.

TAAP-10. LTD Cracking (Sample Unit #12).

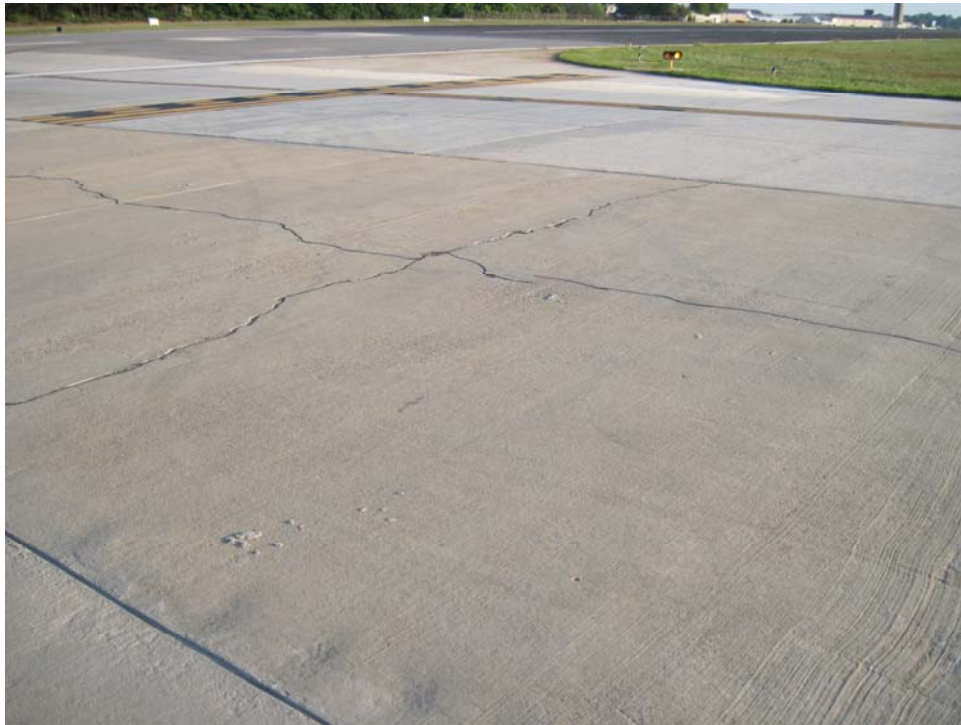
TAAP-10. Shattered Slab (Sample Unit #04).

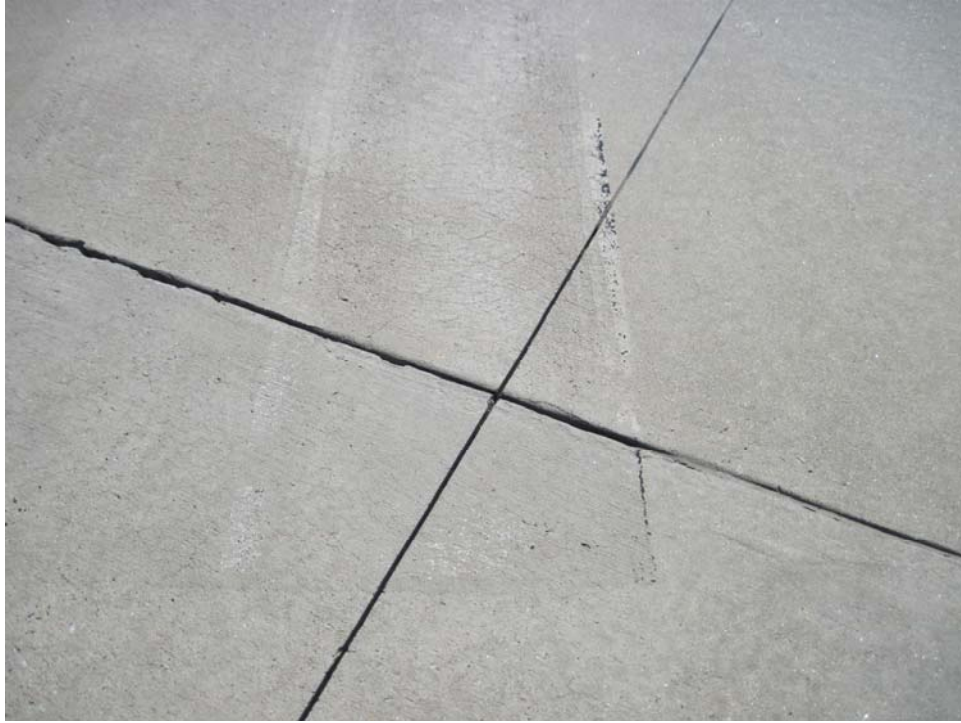
Section 20 had a PCI of 94. Joint seal damage was noted across the entire section, mostly low-severity with a moderate amount of high-severity. The high-severity joint seal damage was primarily due to where joint seal had been removed completely as part of paint removal. A small amount of high-severity small patches and medium-severity joint spalls were also observed.

TAAP-20. Joint Seal Damage (Sample Unit #02).

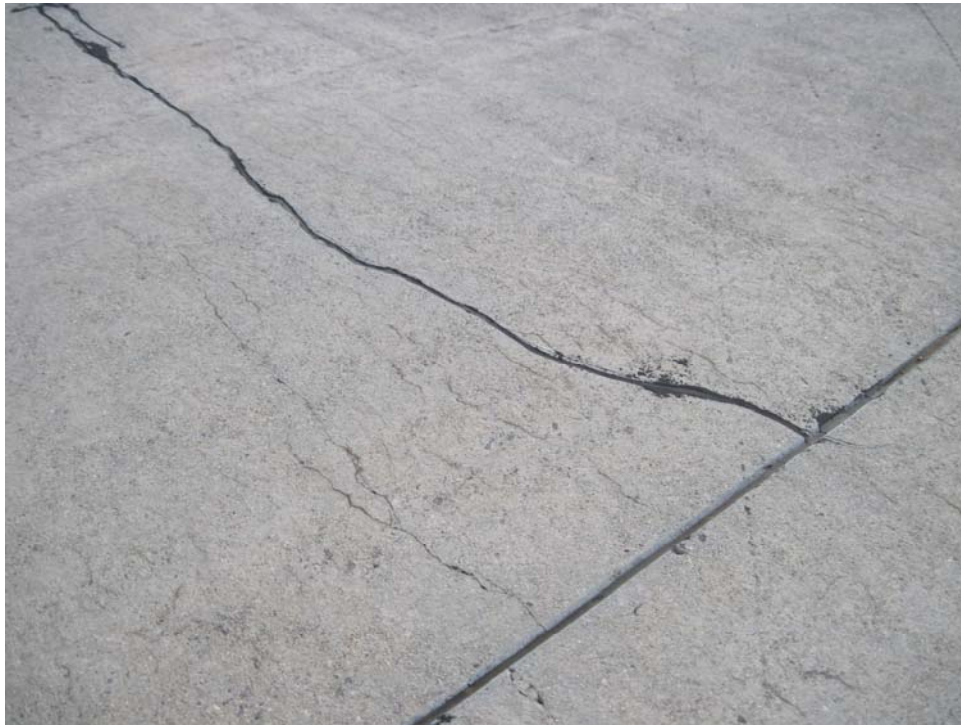
Section 30 had a PCI of 58. Over two-thirds of the section was showing signs of ASR, mostly low-severity with some medium-severity. Low- and medium-severity LTD cracks were recorded in about a third of the slabs, with most of them being low-severity. A large number of slab replacements were recently completed in this section.

TAAP-30. LTD Cracking and ASR (Sample Unit #04) (1).

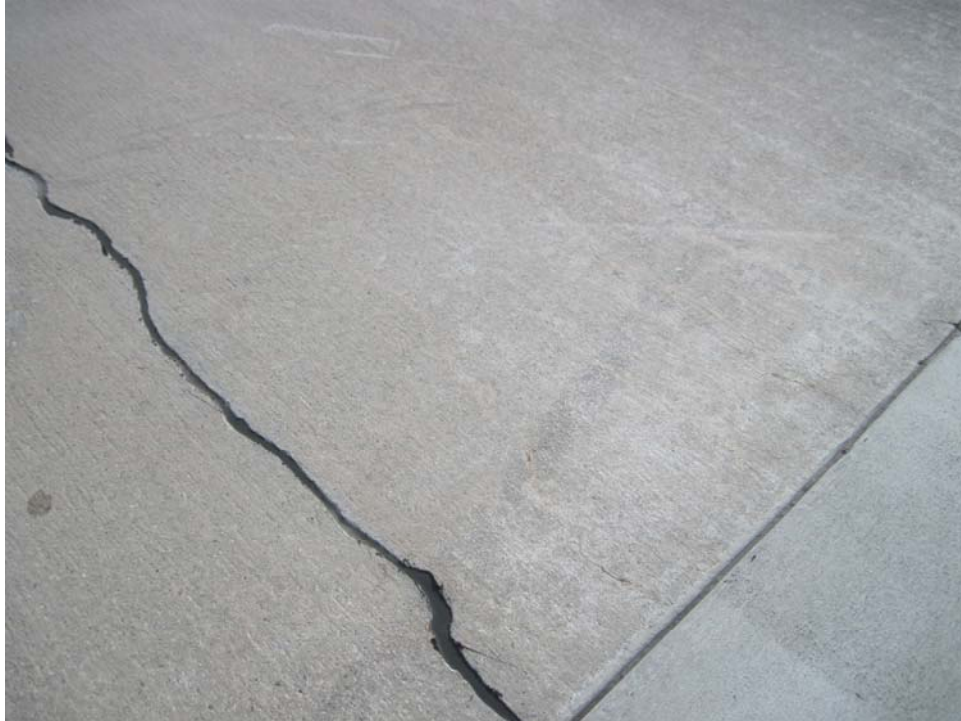
TAAP-30. LTD Cracking and ASR (Sample Unit #29) (2).

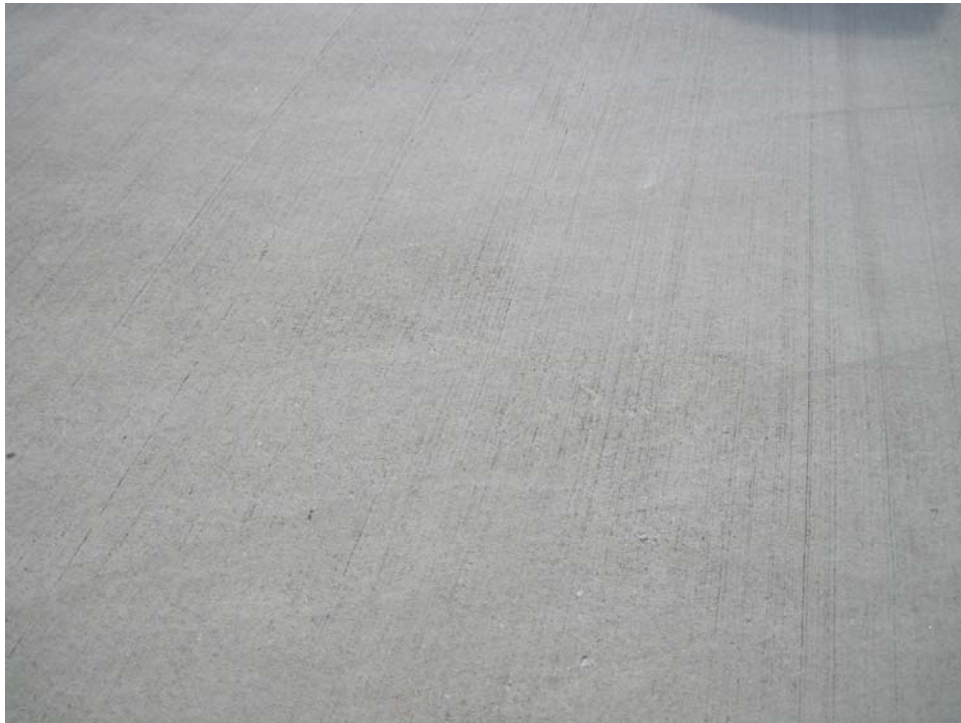
TARUNUPAP-10. Shrinkage Cracking (Sample Unit #02).

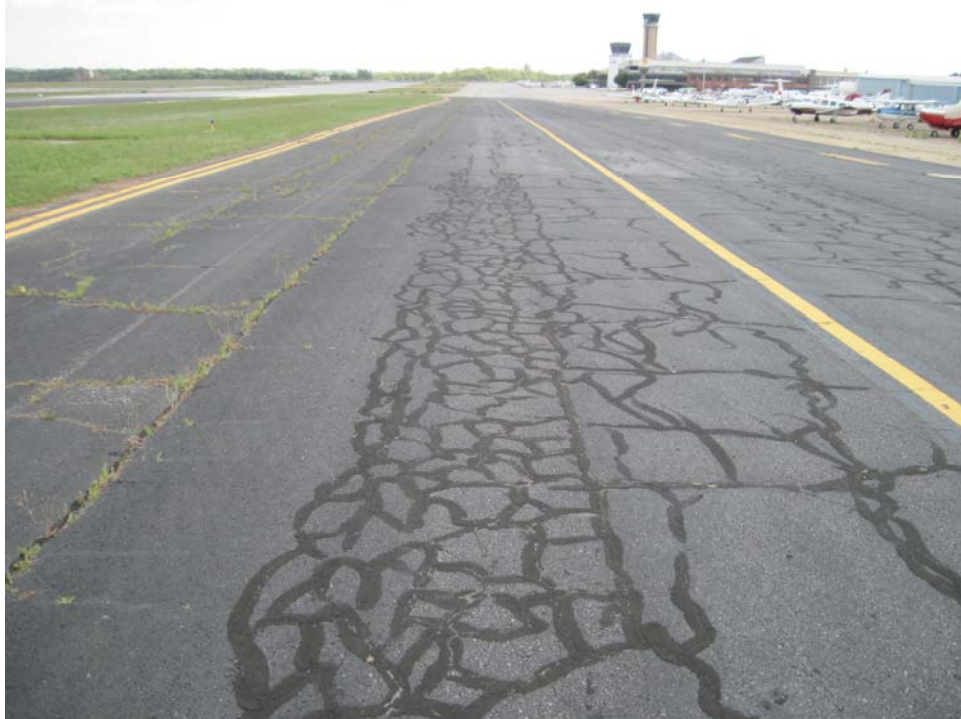
Taxiway B consisted of four sections. Section 10 was in poor condition with a PCI of 33. Low- and medium-severity block cracking were observed over most of the section, with the remainder being medium-severity alligator cracking. Also noted were low-severity depression, low- and medium-severity rutting, and low-severity swelling.

TBAP-10. Alligator Cracking (Sample Unit #07).

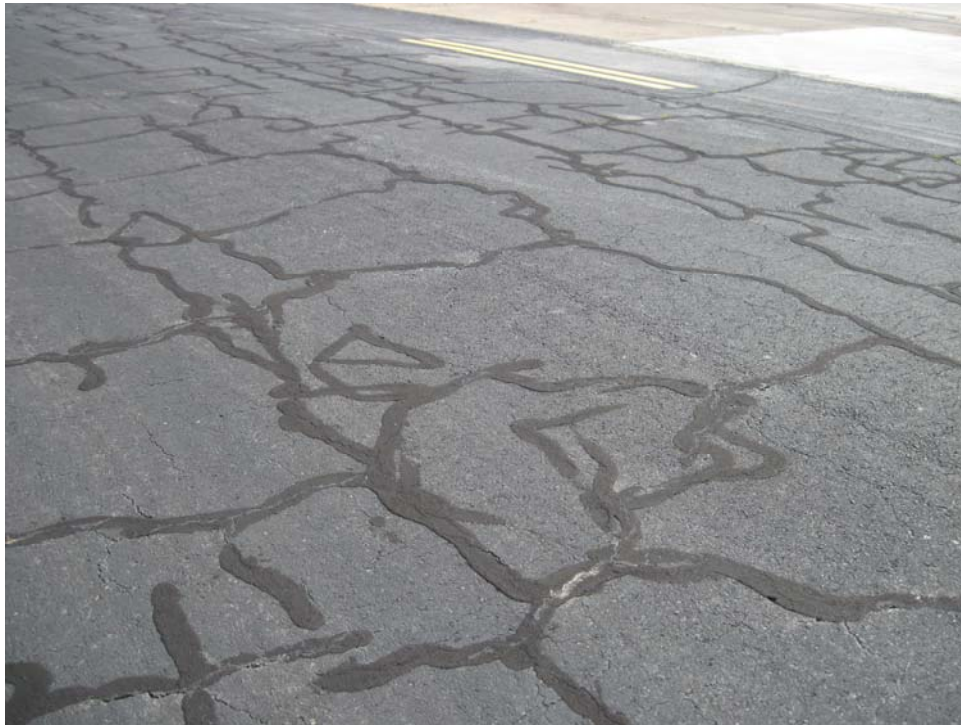
TBAP-10. Block Cracking (Sample Unit #04).

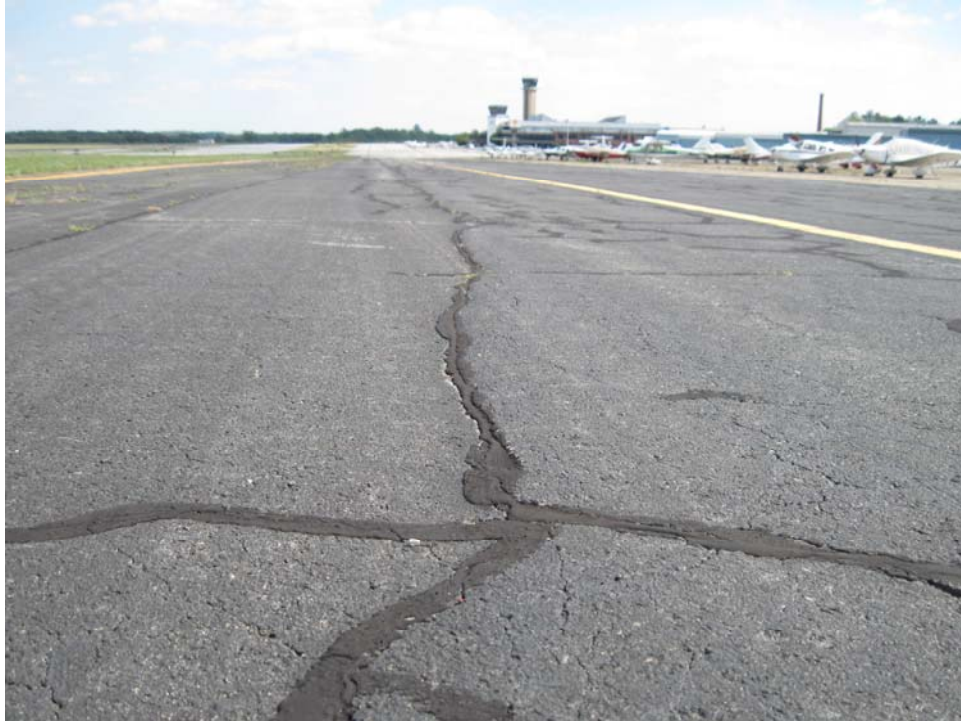
TBAP-10. Rutting (Sample Unit #03).

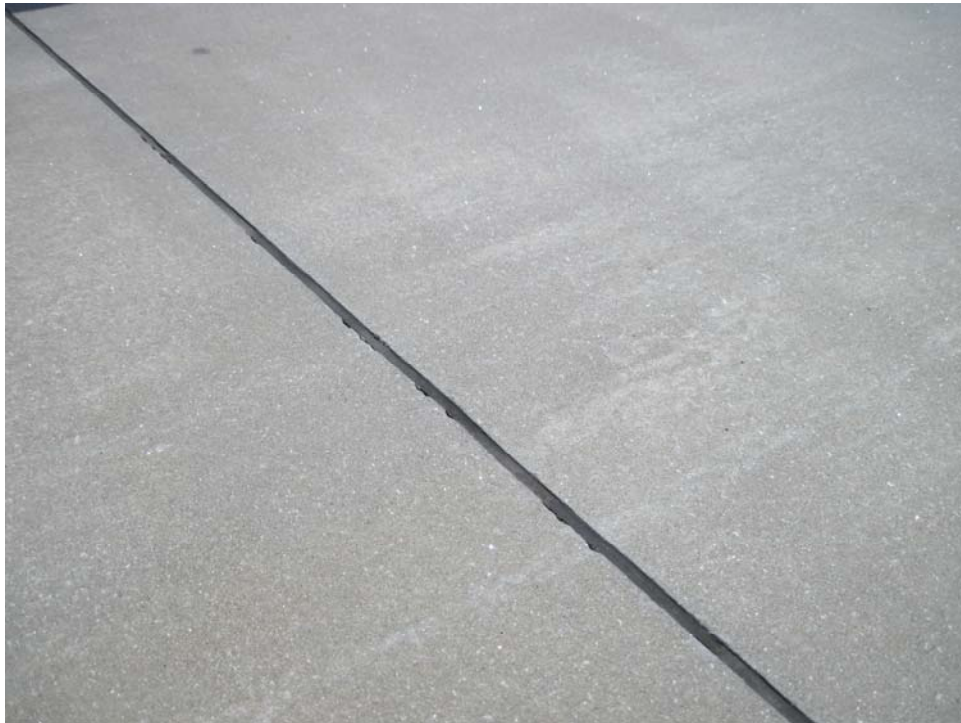
Section 20 was in excellent condition with a PCI of 98. Low-severity joint seal damage was recorded in half of the slabs, along with small amounts of low-severity scaling and medium-severity joint spalls.

TBAP-20. Joint Seal Damage (Sample Unit #16).

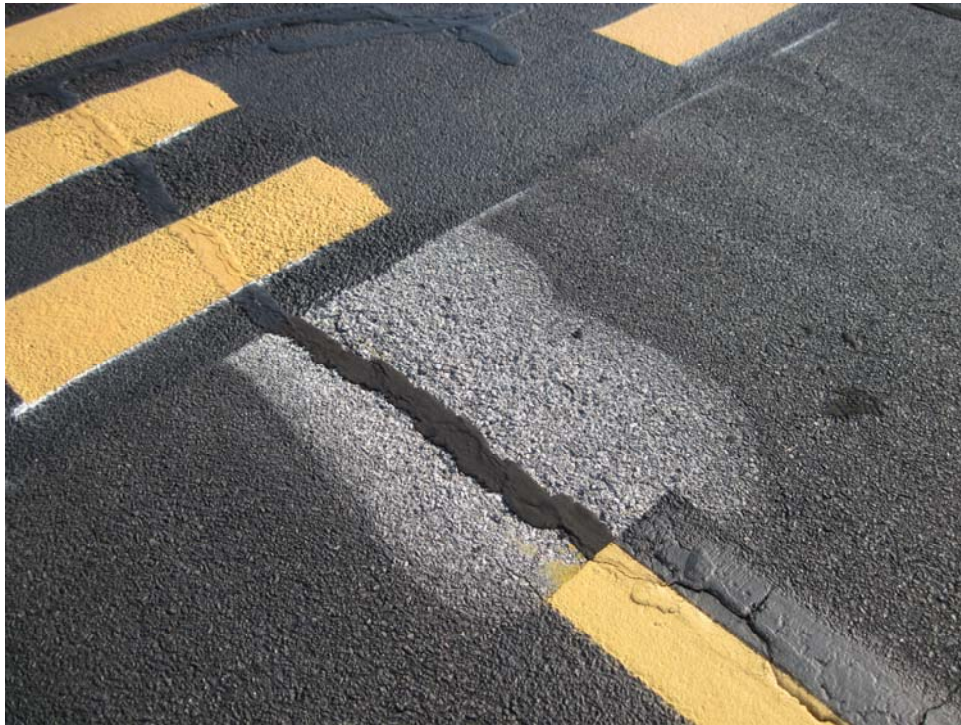
Section 40 had a PCI of 63. It contained significant amounts of low-severity, unsealed and medium-severity block cracking and L&T cracking. It also contained a significant amount of low-severity patching and small amounts of low-severity swelling and medium-severity weathering due to paint removal.

TBAP-40. Weathering and Longitudinal and Transverse Cracking (Sample Unit #4).

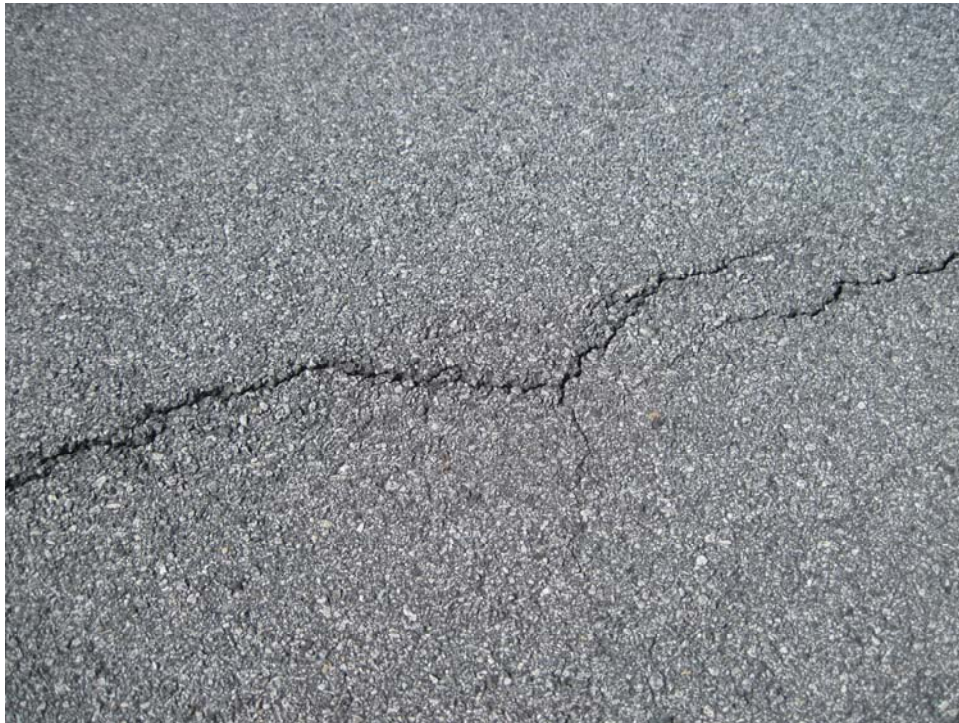
Taxiway C was defined by three sections. Section 10 had a PCI value of 72. It contained moderate amounts of low-severity weathering and low-severity, unsealed L&T cracking, as well as smaller amounts of medium-severity L&T cracking, low- and medium-severity swelling, and bleeding.

TCAP-10. Longitudinal and Transverse Cracking and Weathering (Sample Unit #02).

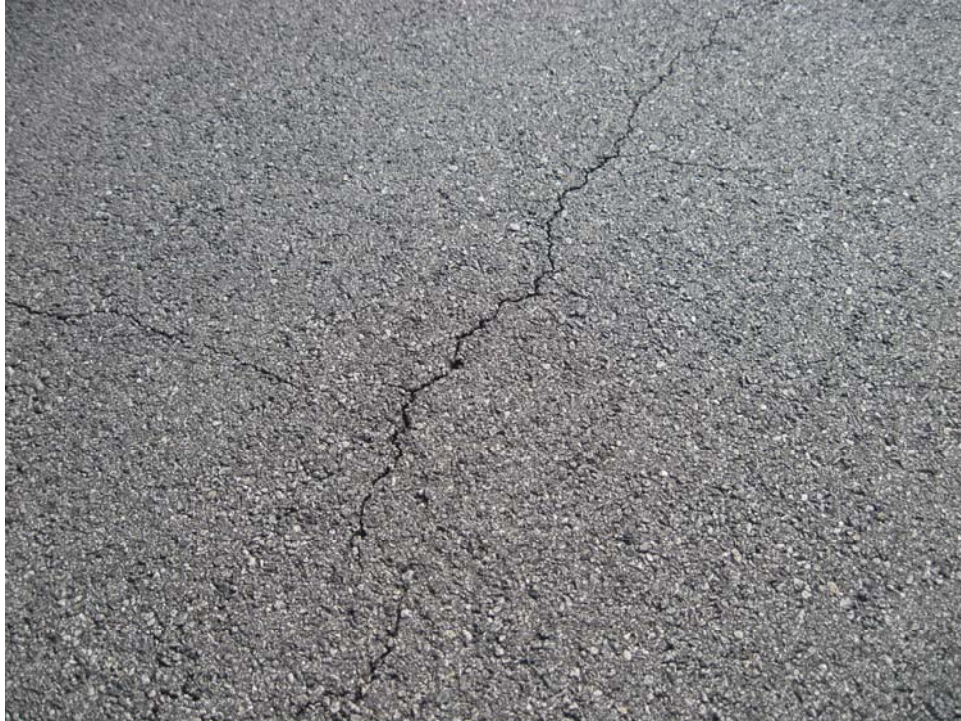
Section 20 had a PCI of 65 and contained a variety of distresses. Moderate amounts of low- and medium-severity weathering; low-severity, unsealed and medium-severity L&T cracking; and low-severity, unsealed block cracking were most common. Also observed were low-severity swelling, low-severity depression, low-severity alligator cracking, and bleeding.

TCAP-20. Weathering and Longitudinal and Transverse Cracking (Sample Unit #01).

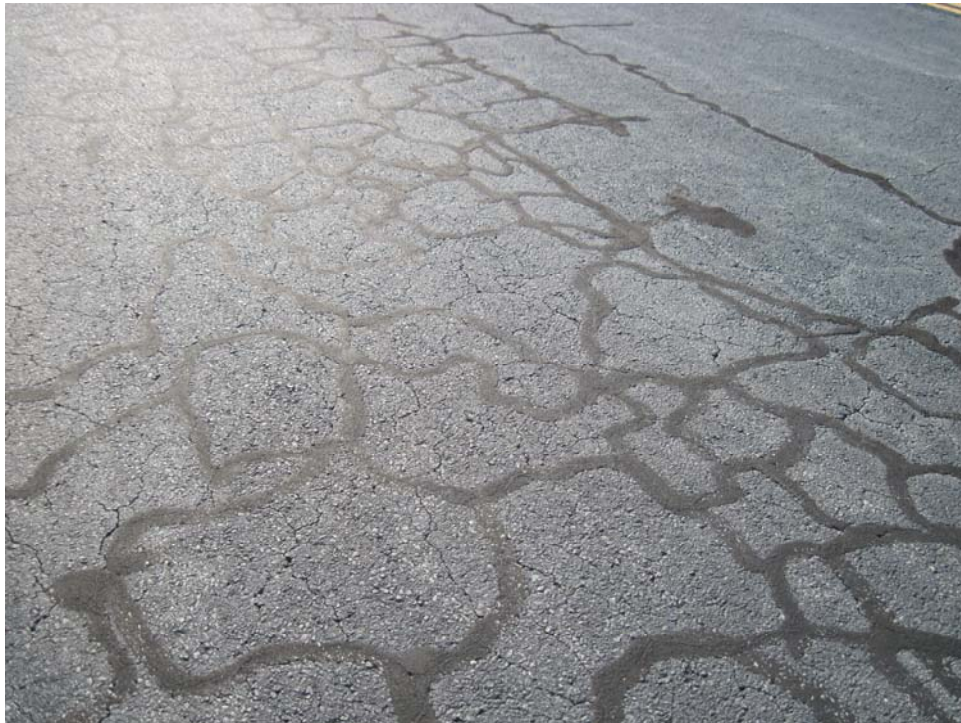
Section 30 was in poor condition with a PCI of 16. It contained a significant amount of patching, and the remainder of the pavement consisted of medium-severity alligator cracking as well as low-severity, sealed and medium-severity block cracking. Significant amounts of low-severity rutting were also present.

TCAP-30. Alligator Cracking (Sample Unit #01).
