2012 DeKalb-Peachtree Airport Pavement Management Plan

DEKALB-PEACHTREE AIRPORT

PAVEMENT MANAGEMENT REPORT

DECEMBER 2012

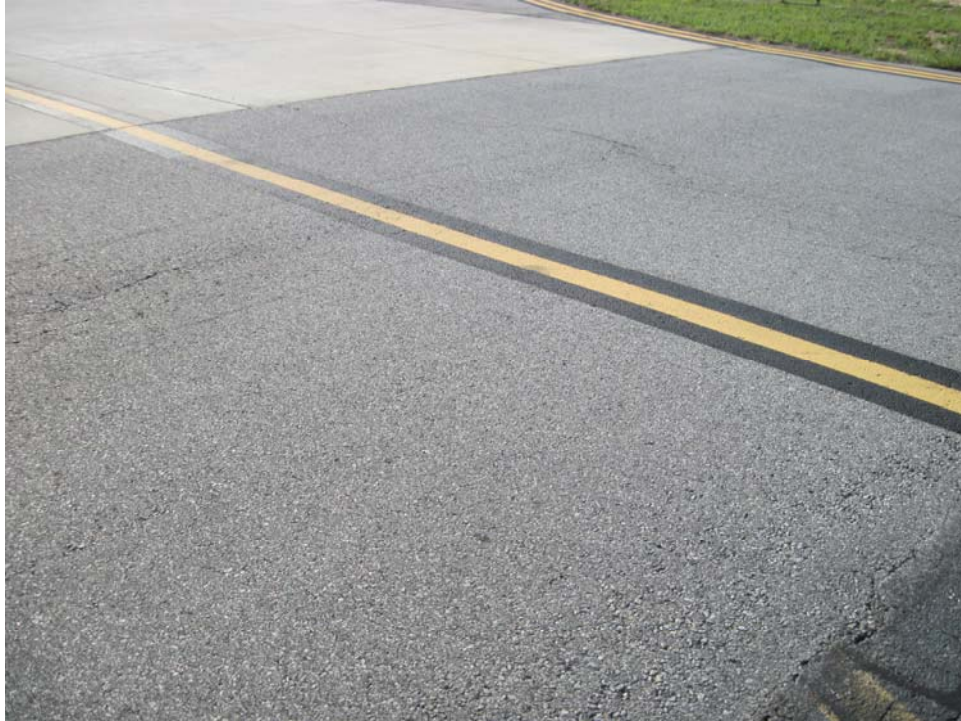
TCAP-30. Patching (Sample Unit #01).

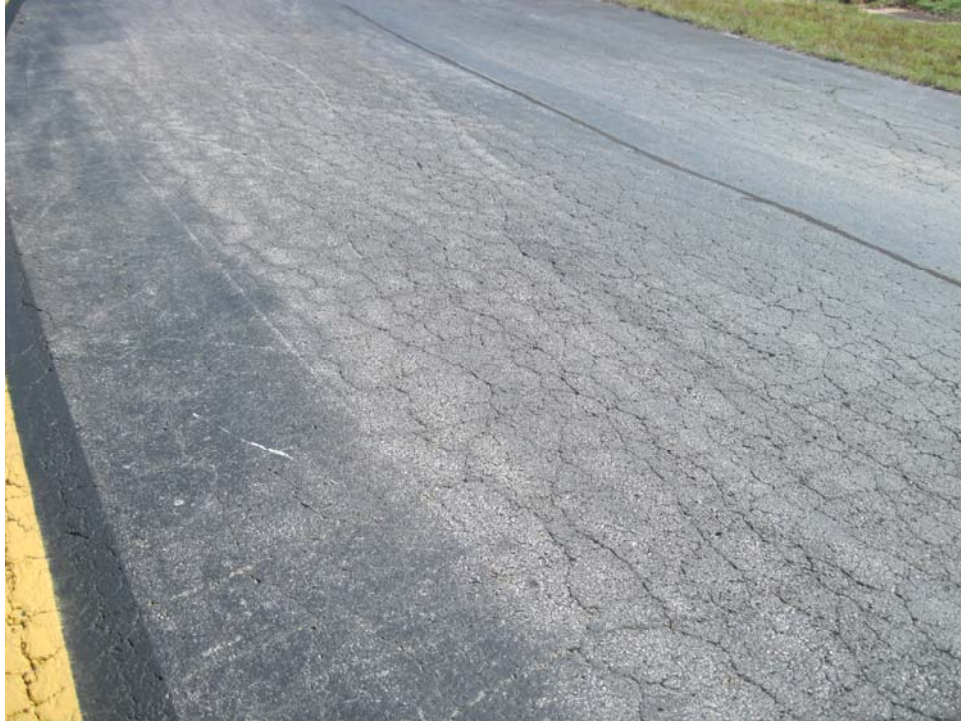
Taxiway D was comprised of three sections. Section 10 was in poor condition with a PCI of 20, with medium-severity, and a small portion of low-severity, alligator cracking present over nearly a quarter of the section. Low-severity, sealed and unsealed, and medium-severity L&T cracking were extensive, as well as high-severity patching. Low-, medium-, and high-severity rutting were present, with the majority of it being low-severity.

TDAP-10. Alligator Cracking (Sample Unit #16).

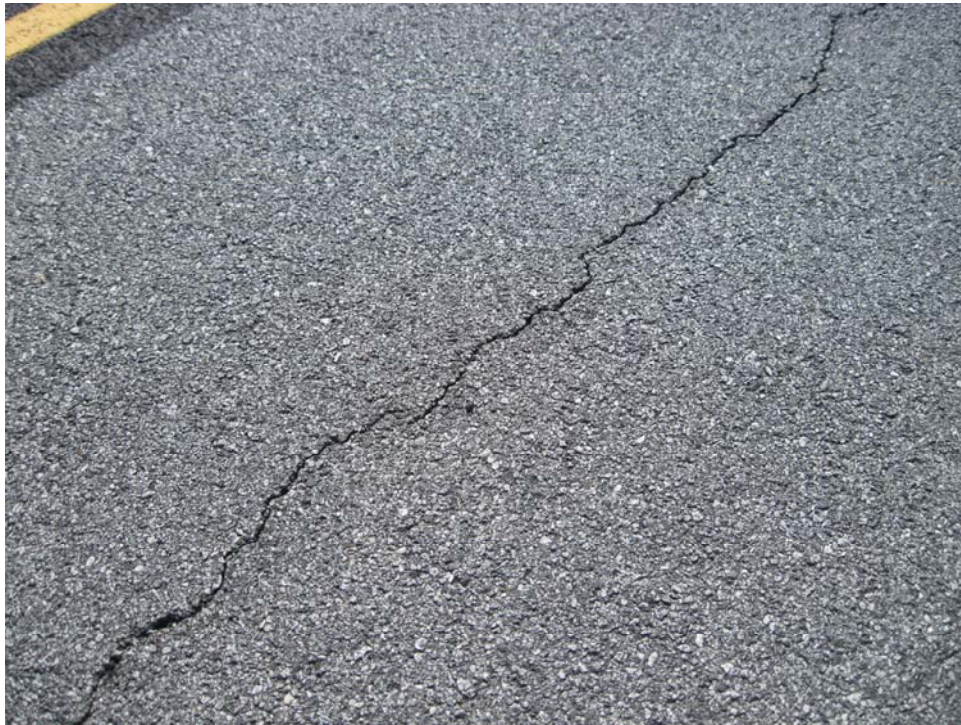
Section 20 had a PCI of 75. It contained moderate amounts of low-severity, unsealed L&T cracking and low-severity weathering. A small amount of medium-severity L&T cracking was also recorded.

TDAP-20. Longitudinal and Transverse Cracking and Weathering (Sample Unit #06).

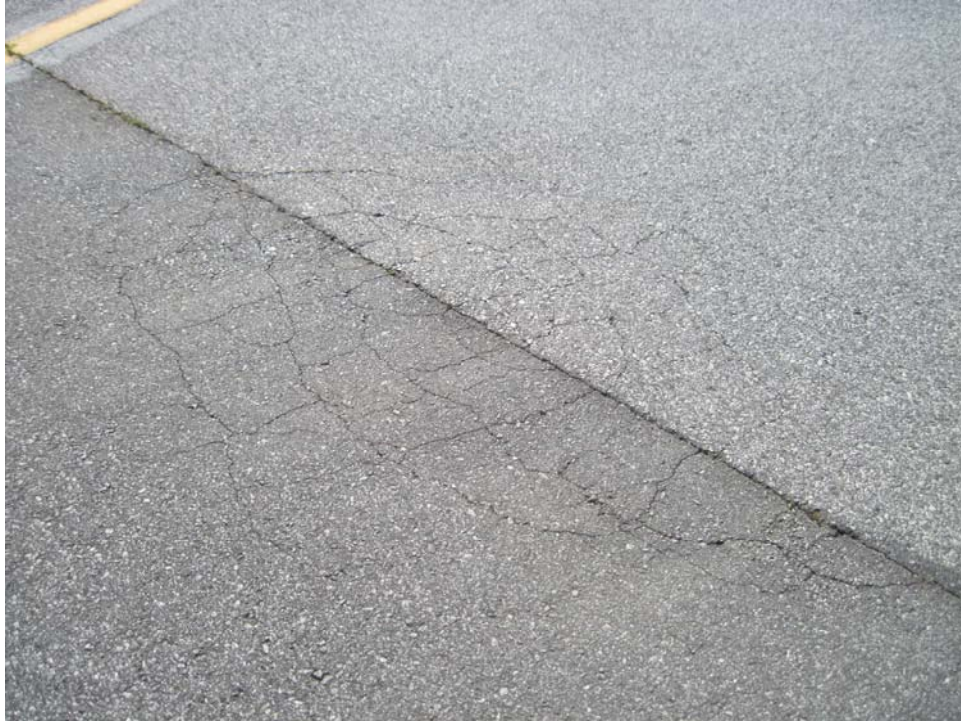
Section 30 had a PCI of 72, with moderate amounts of low-severity, unsealed L&T cracking and low-severity weathering were recorded, along with minor amounts of low- and medium-severity alligator cracking and low-severity rutting.

TDAP-30. Alligator Cracking (Sample Unit #03).

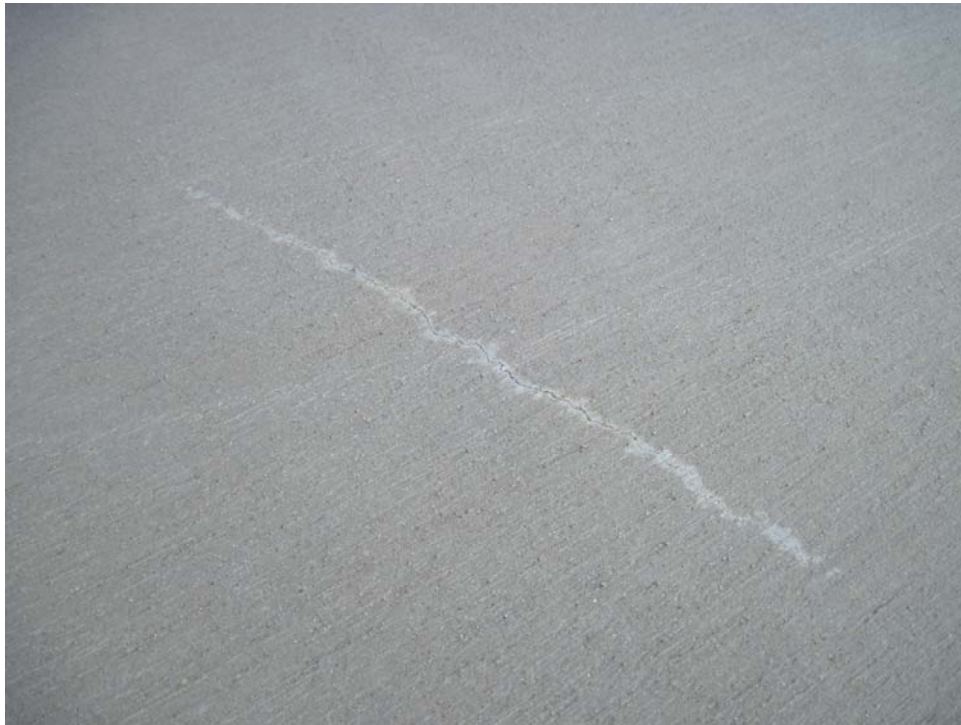
TEAP-10. Shrinkage Cracking.

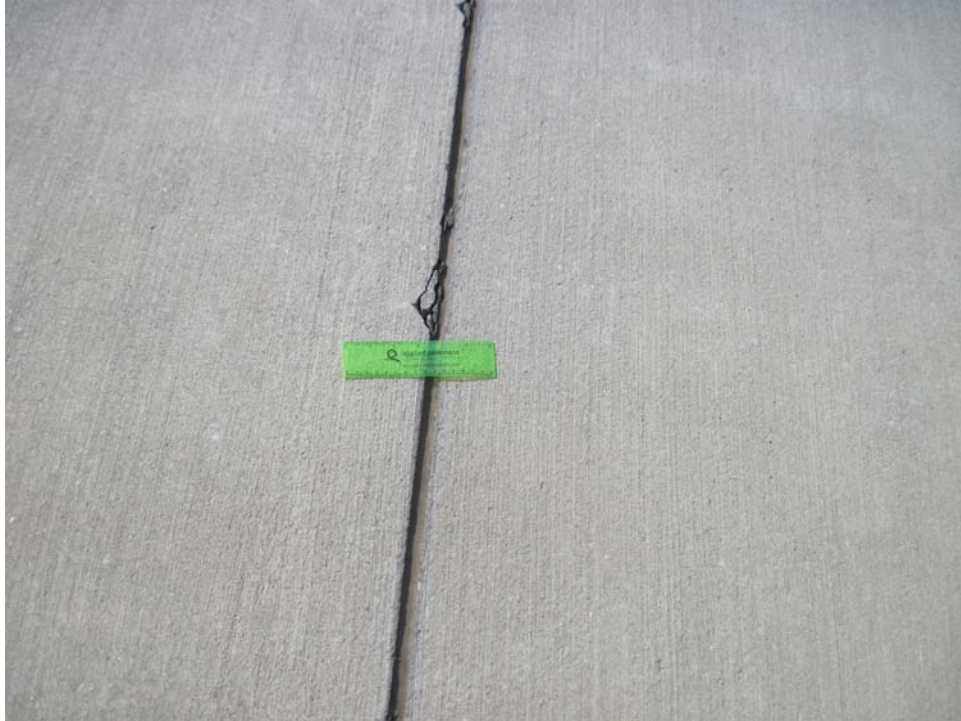
Taxiway E was defined by two sections. Sections 10 and 20 were both in excellent condition with PCI values of 98 and 97, respectively. In section 10, one low-severity corner spall and several shrinkage cracks were noted. Section 20 had low-severity joint seal damage in most slabs and a few shrinkage cracks.

TEAP-20. Joint Seal Damage (Sample Unit #07).

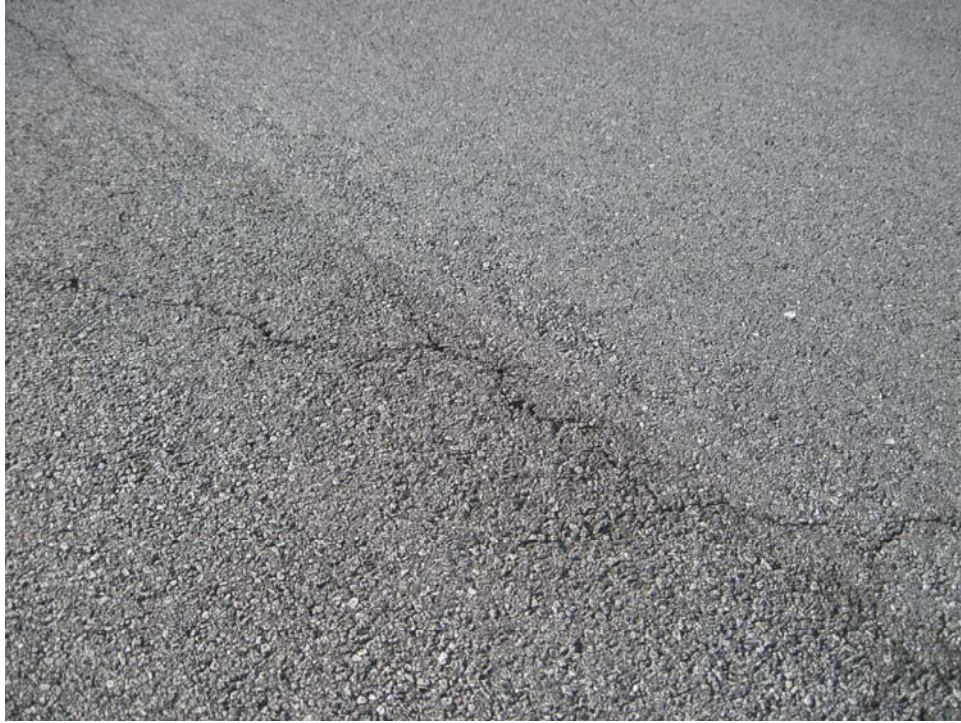
Taxiway F was comprised of one section with a PCI of 84. Moderate amounts of low-severity, unsealed L&T cracking and low-severity weathering were recorded, as well as small amounts of medium-severity L&T cracking and alligator cracking.

TFAP-10. Longitudinal and Transverse Cracking and Weathering (Sample Unit #04).

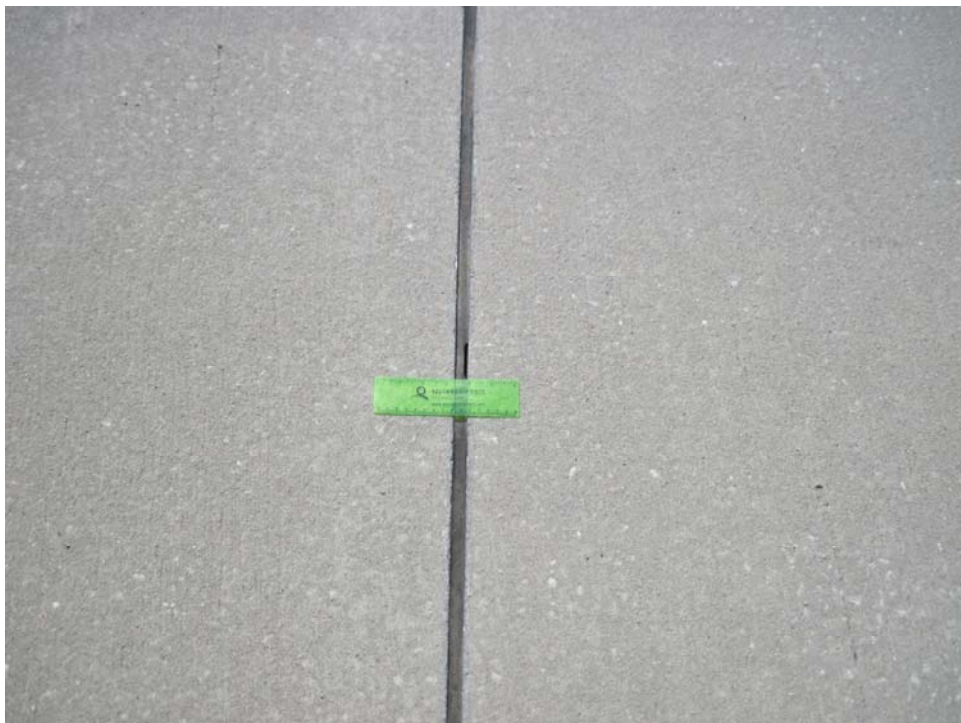
Taxiway H was comprised of one section in excellent condition with a PCI of 96. Mostly low-severity with a smaller amount of medium-severity joint seal damage was recorded for the whole section. It also contained a small amount of low-severity LTD cracking and shrinkage cracking.

THAP-10. Joint Seal Damage (Sample Unit #02).

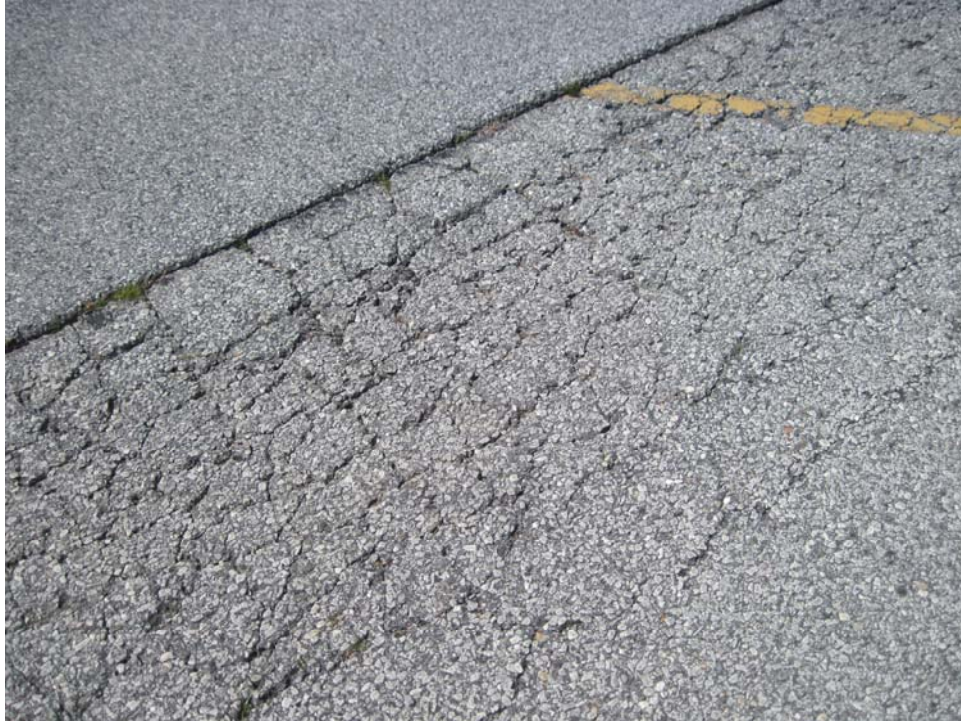
Section 20 had a PCI of 37. Low- and medium-severity weathering were present over most of the section, except for areas which had been patched or treated with a surface treatment. A small amount of low-severity raveling was also recorded. A significant amount of low-severity patching was present, as well as a very small amount of high-severity patching. Significant amounts of low-severity block cracking, low- and medium-severity L&T cracking, and low-, medium-, and high-severity alligator cracking were recorded. The low-severity cracking was unsealed. Medium- and high-severity rutting and a small amount of oil/fuel damage were also noted.

TKAP-20. Alligator Cracking and Rutting (Sample Unit #19).
