# 2012 Augusta Regional at Bush Field Pavement Management Plan

# AUGUSTA REGIONAL AT BUSH FIELD

## PAVEMENT MANAGEMENT REPORT

**DECEMBER 2012**

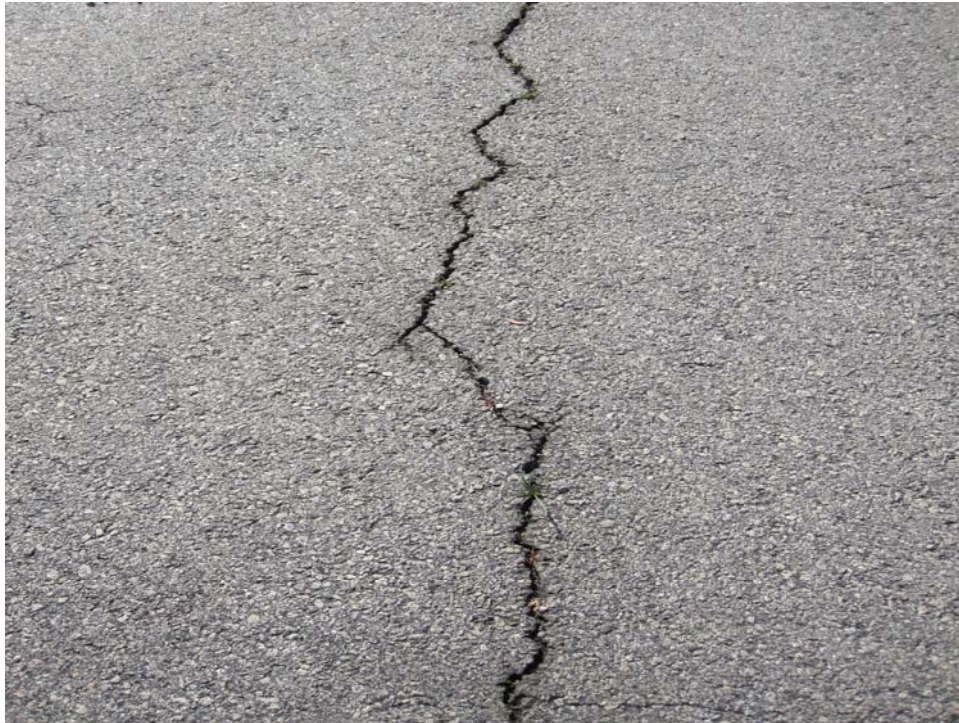
A01AGR-10. Longitudinal and Transverse Cracking (Sample Unit #05).

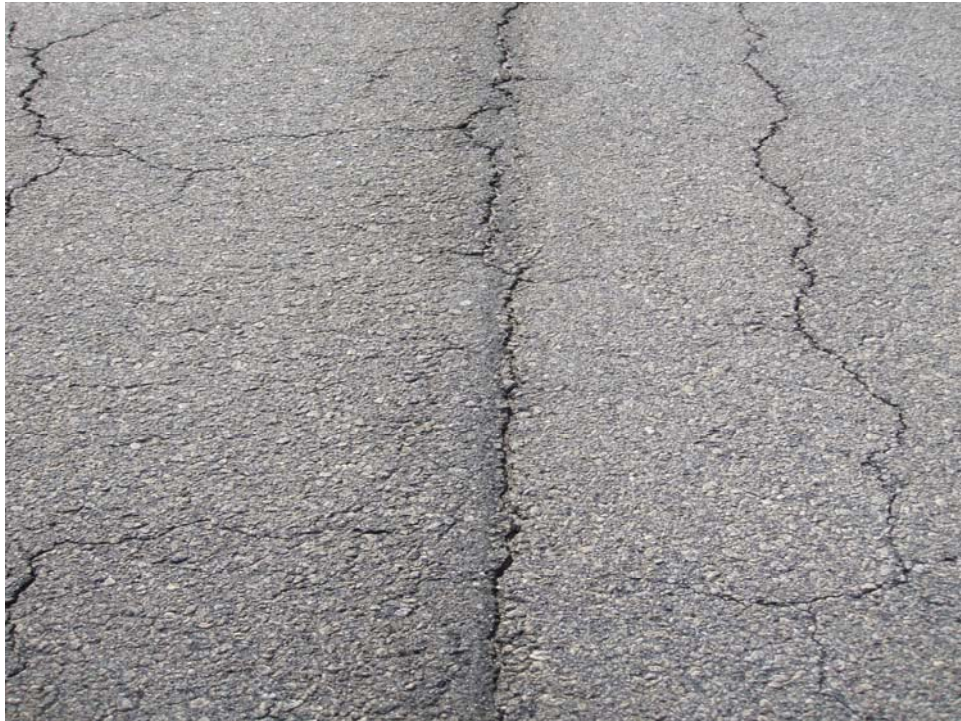
A01AGR-20. Longitudinal and Transverse Cracking (Sample Unit #12).

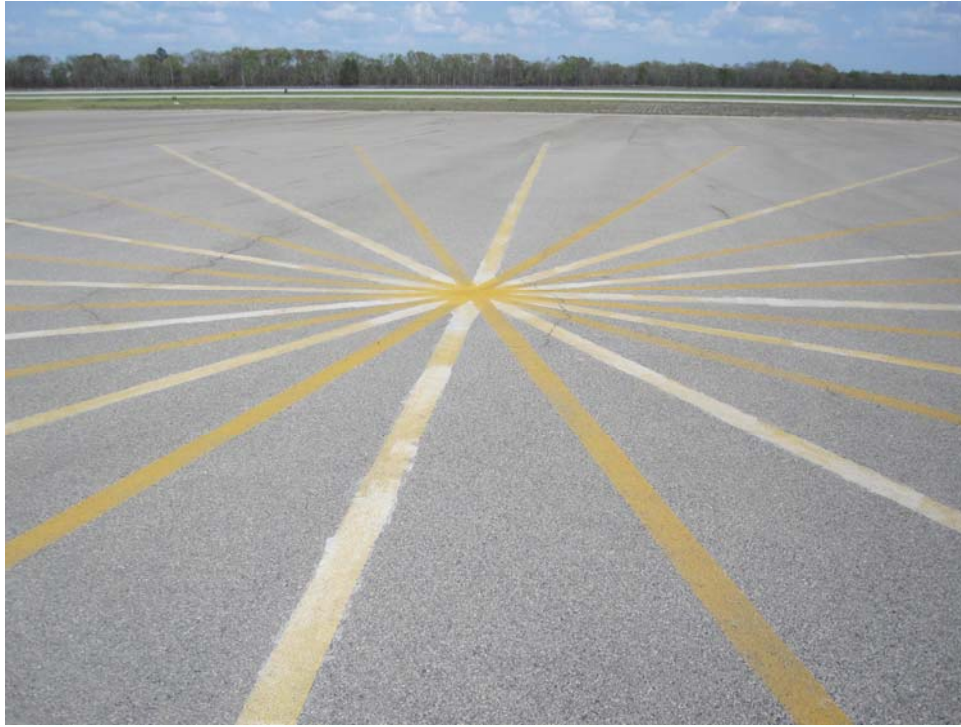
A01AGR-20. Unsatisfactory Paint.

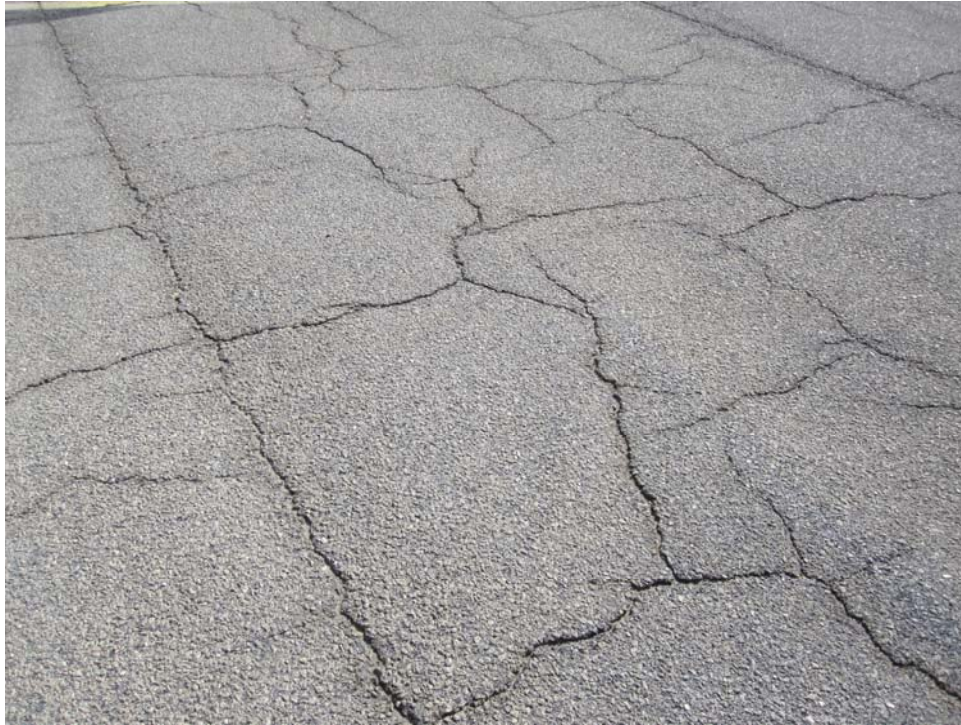
A01AGR-30. Block Cracking (Sample Unit #17).

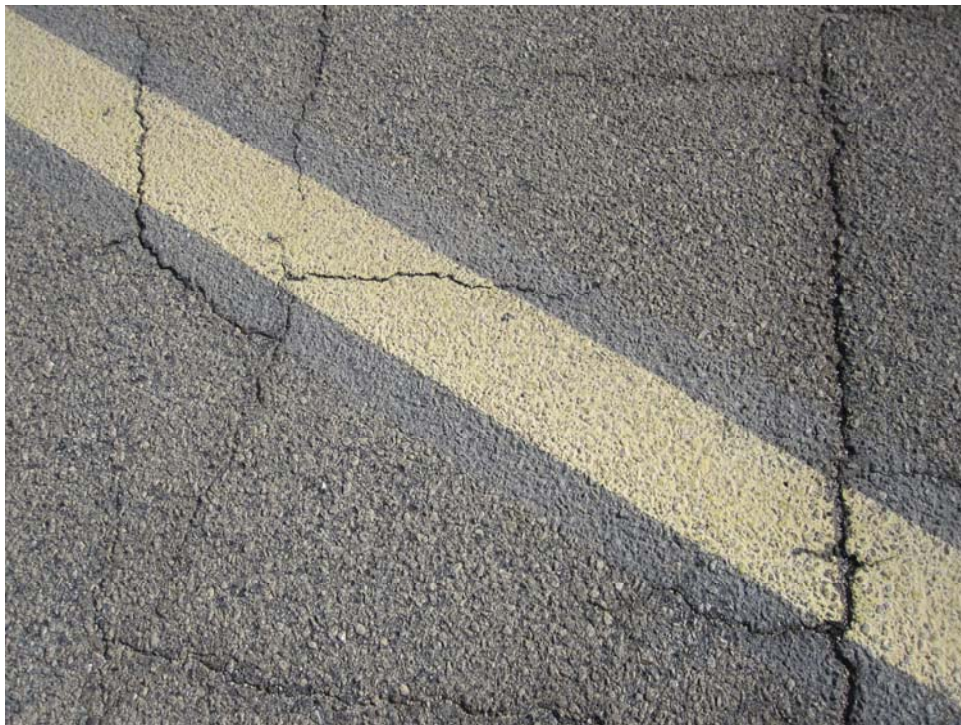
A01AGR-30. Unsatisfactory Paint.

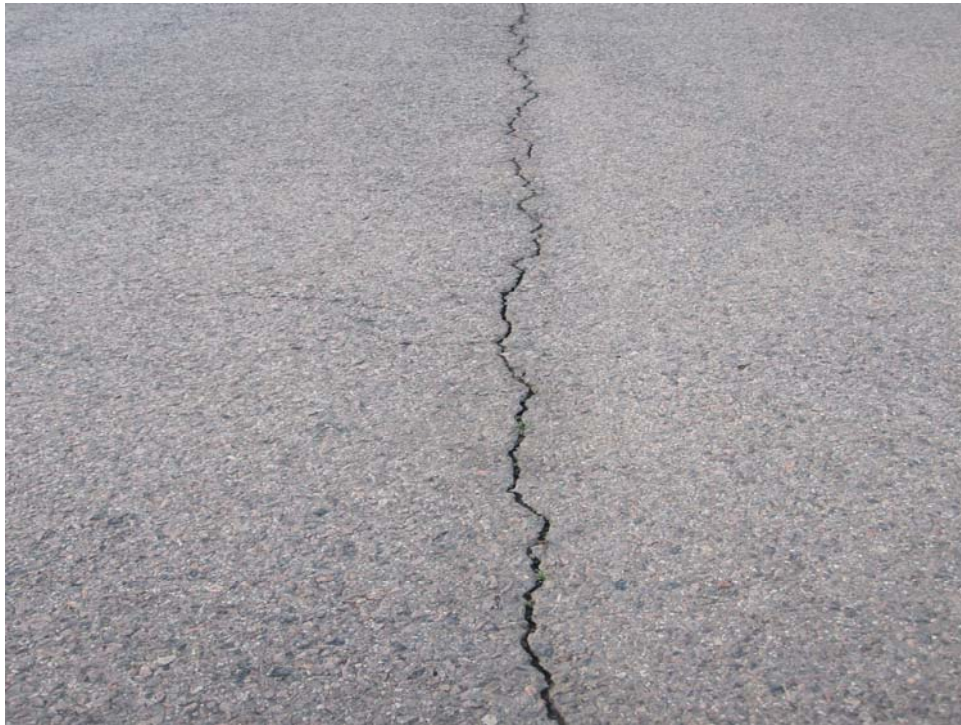
A01AGR-40. Longitudinal and Transverse Cracking (Sample Unit #15).

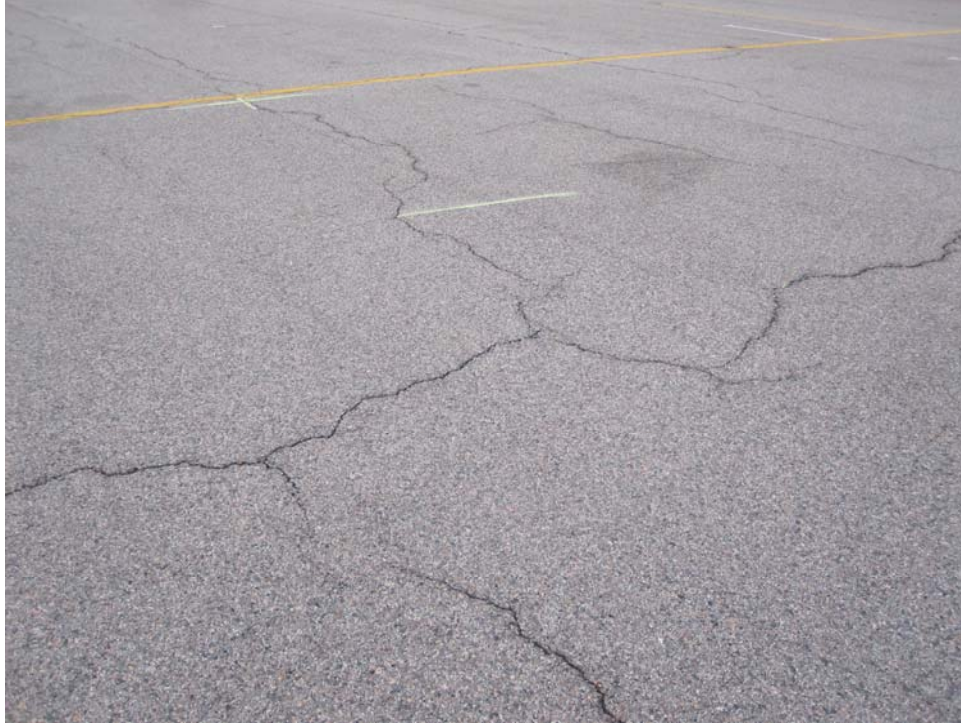
A01AGR-40. Longitudinal and Transverse Cracking (Sample Unit #41).

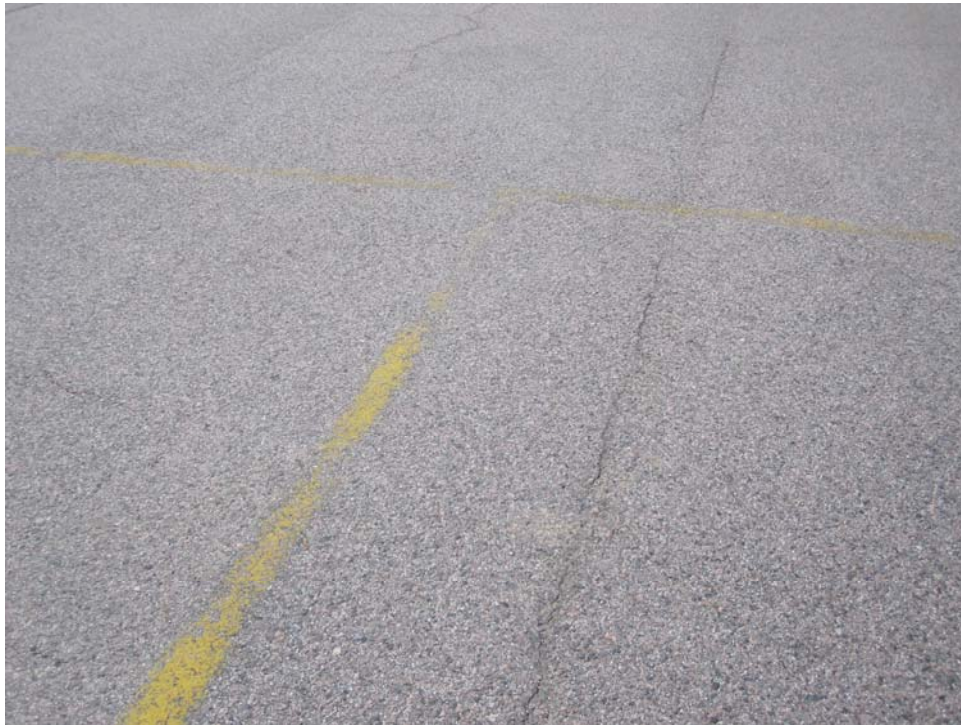
A01AGR-40. Unsatisfactory Paint.

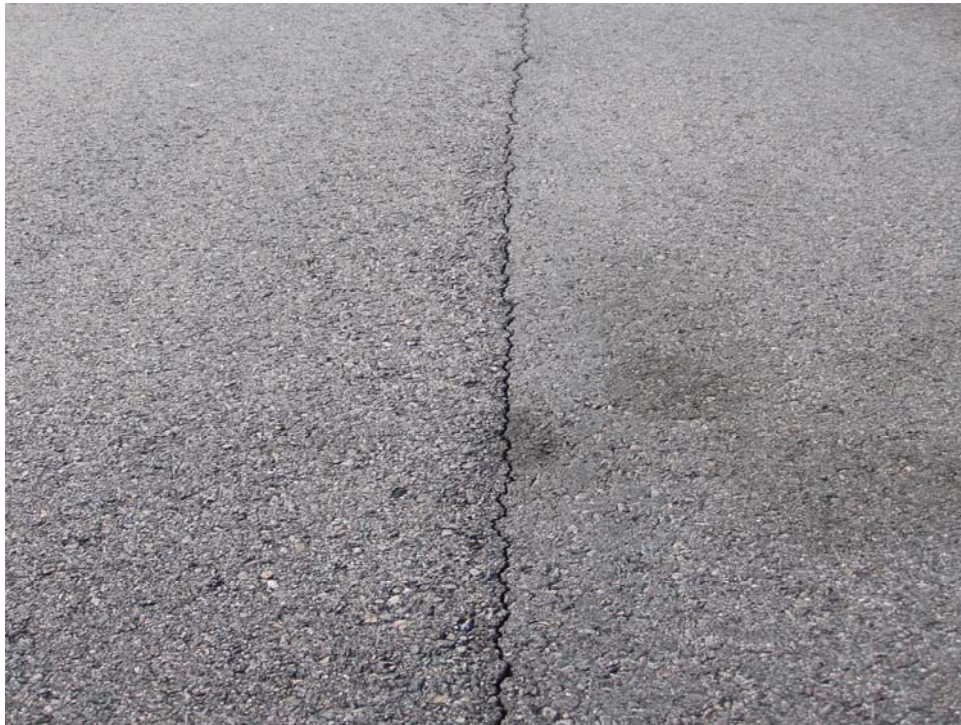
A01AGR-50. Longitudinal and Transverse Cracking (Sample Unit #08).

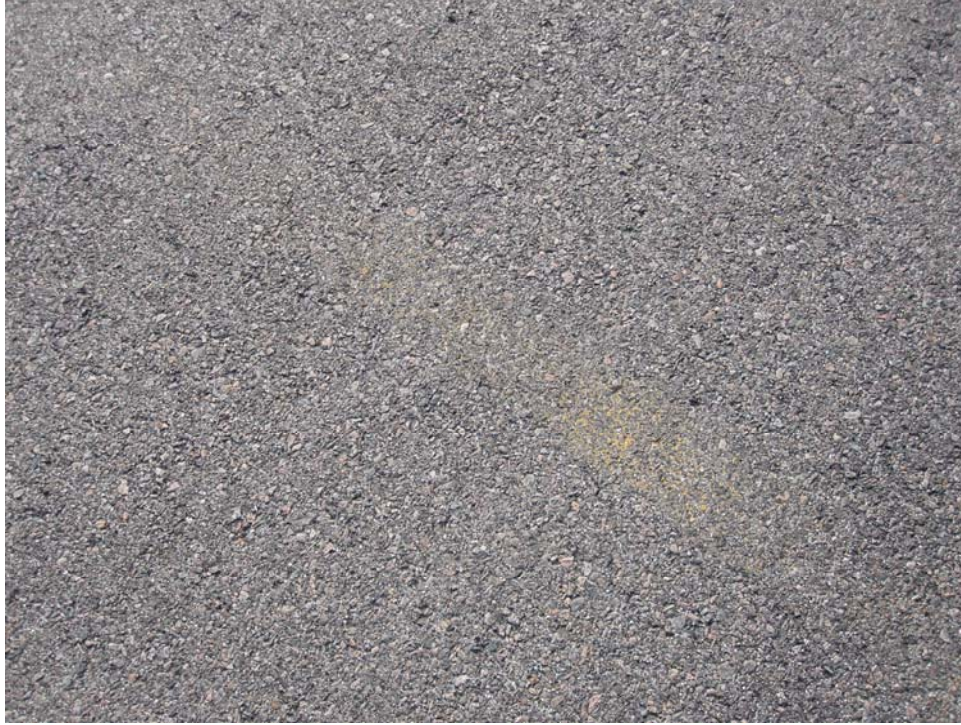
A01AGR-50. Unsatisfactory Paint.

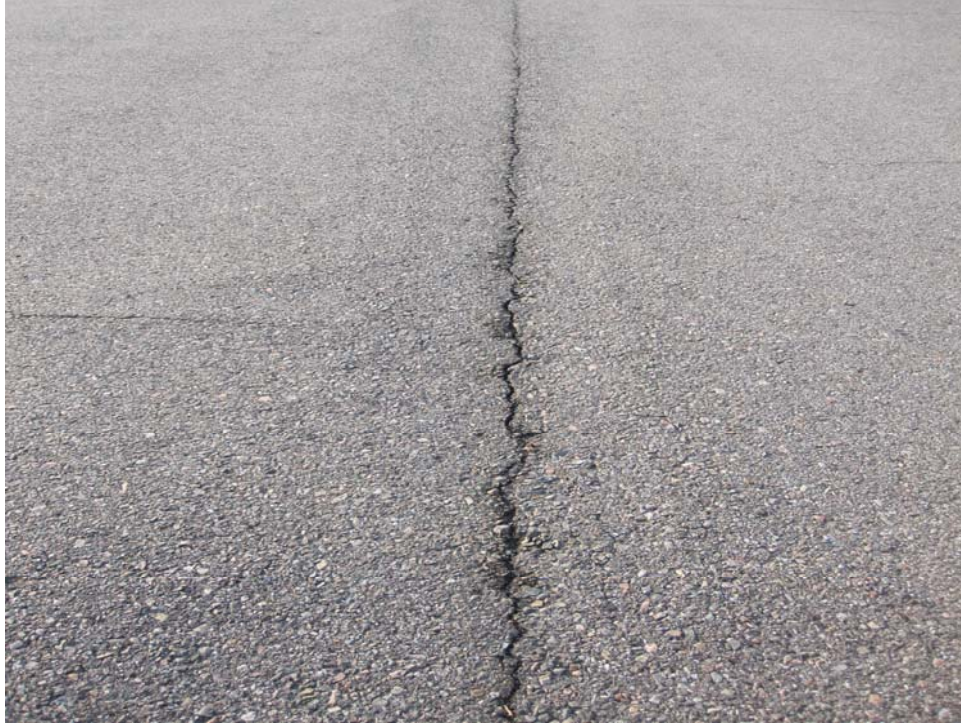
A01AGR-60. Longitudinal and Transverse Cracking (Sample Unit #13).

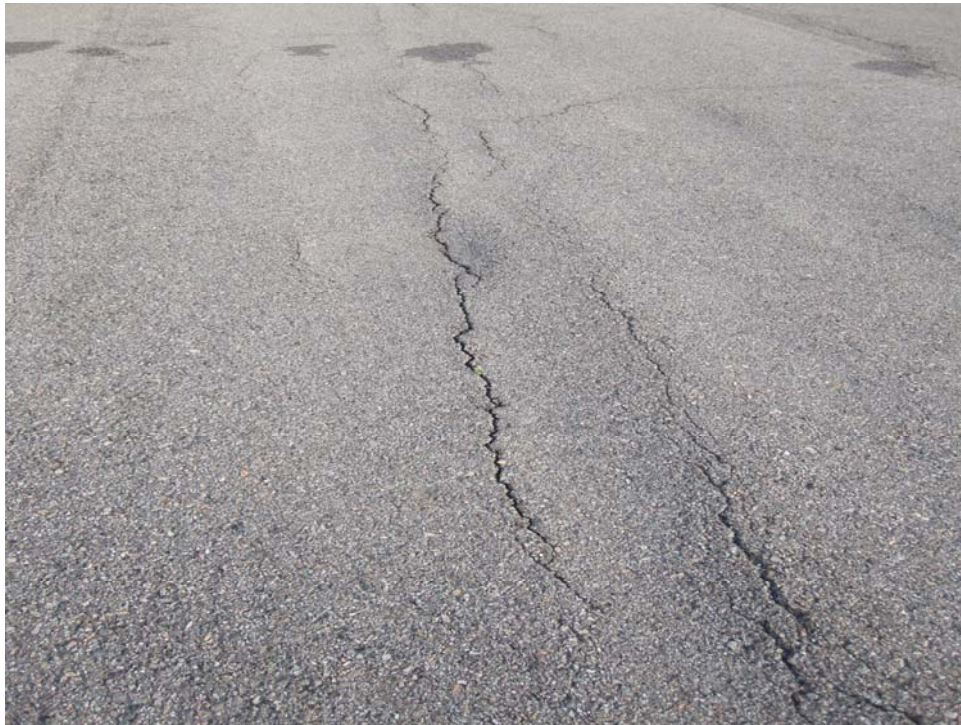
A01AGR-60. Rutting (Sample Unit #09).

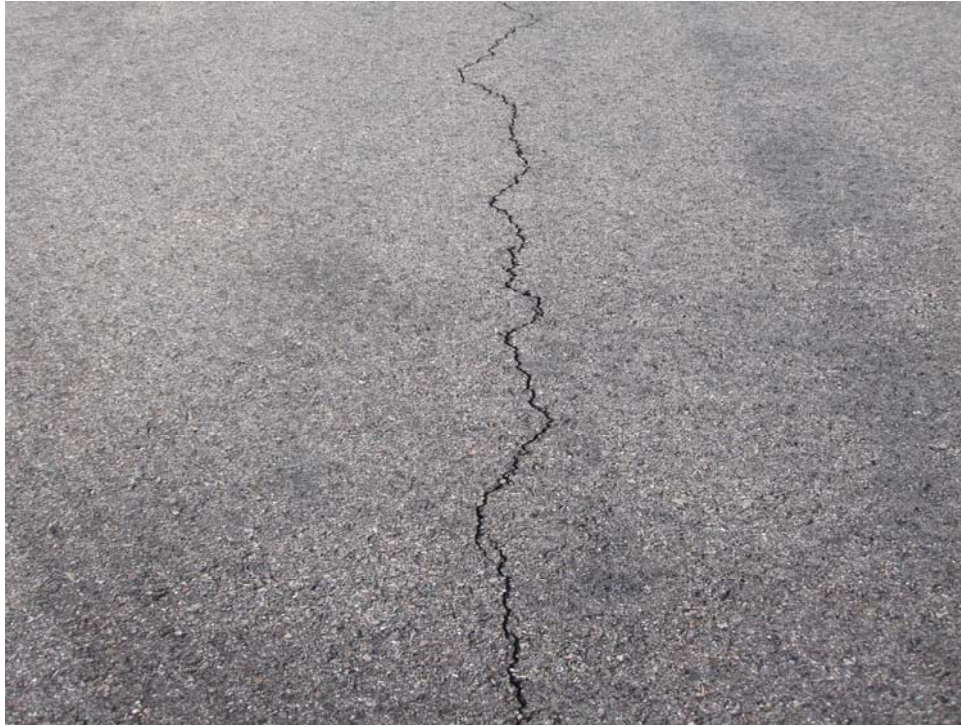
A01AGR-70. Longitudinal and Transverse Cracking (Sample Unit #03).

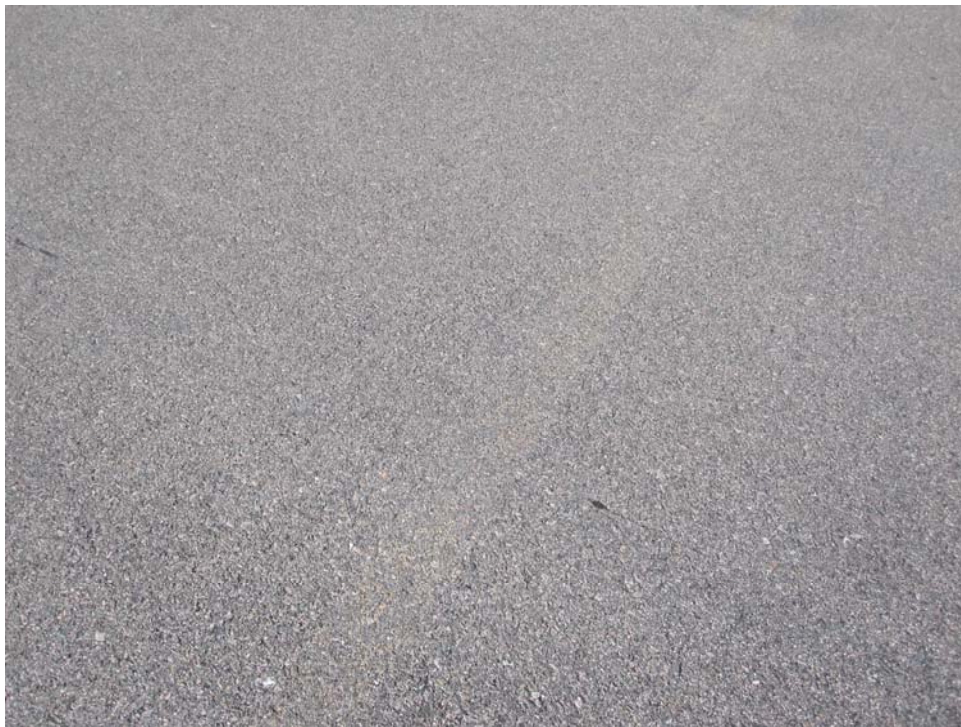
A01AGR-70. Unsatisfactory Paint.

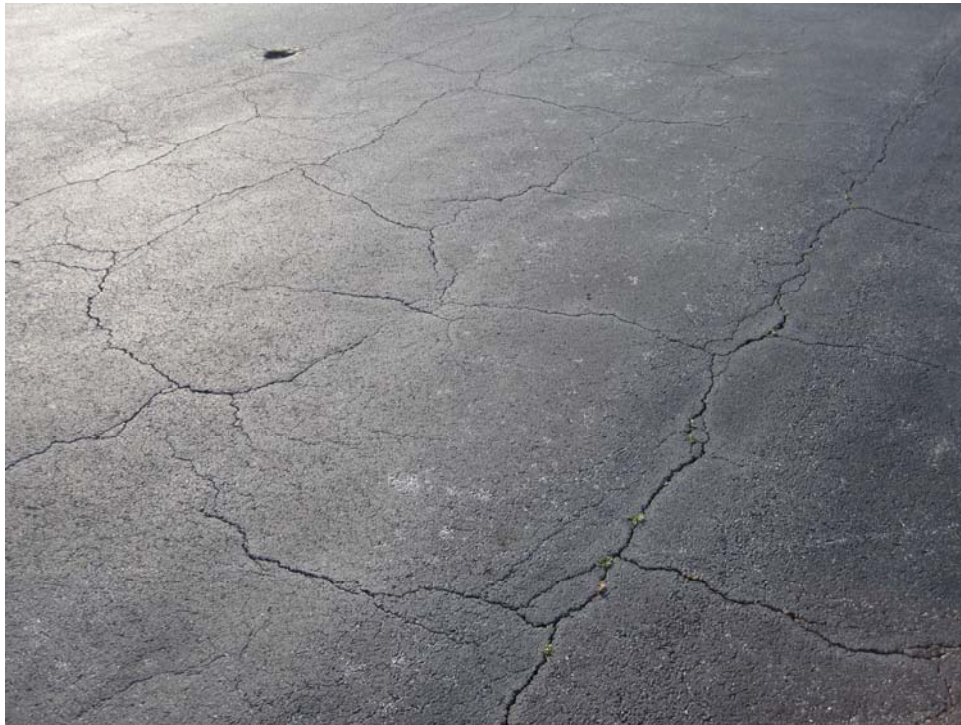
AGARRETAGR-10. Block Cracking (Sample Unit #06).

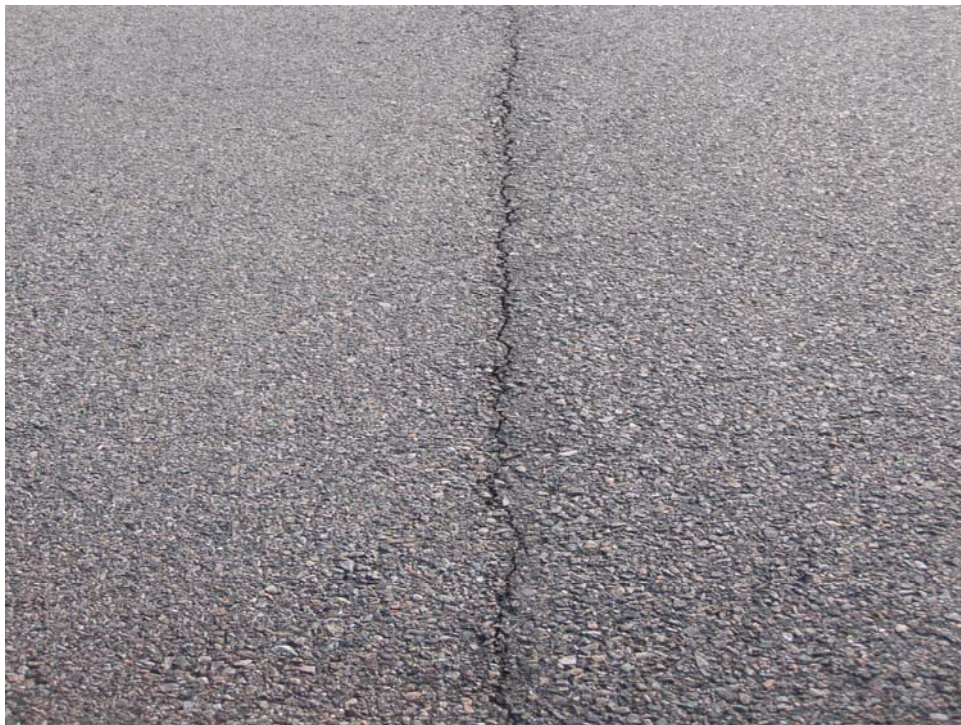
AGARRETAGR-20. Longitudinal and Transverse Cracking (Sample Unit #02).

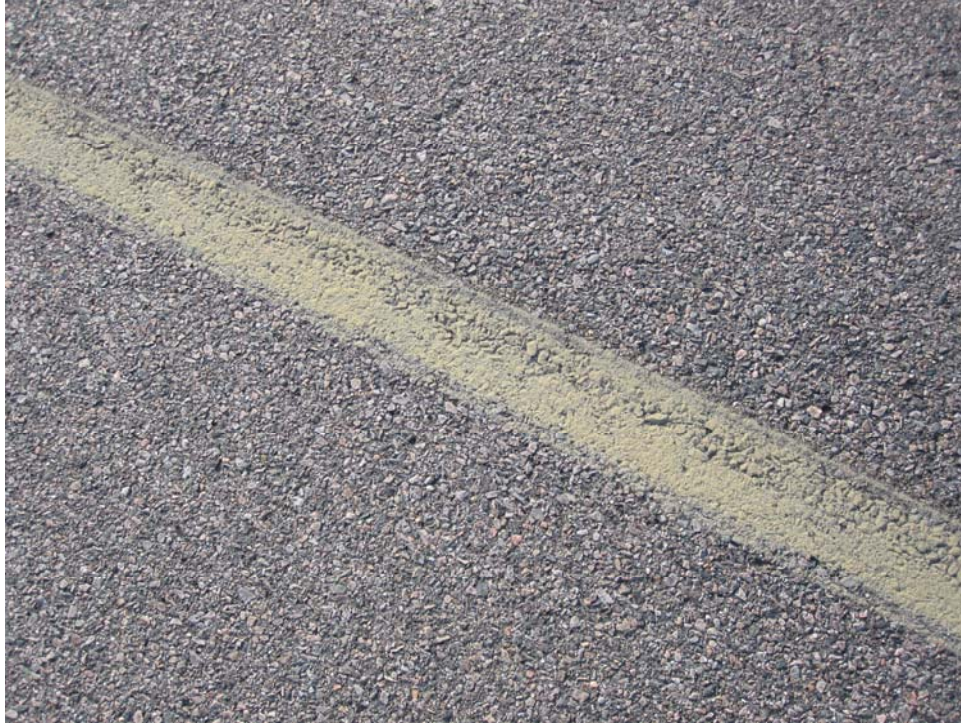
AGARRETAGR-20. Unsatisfactory Paint.

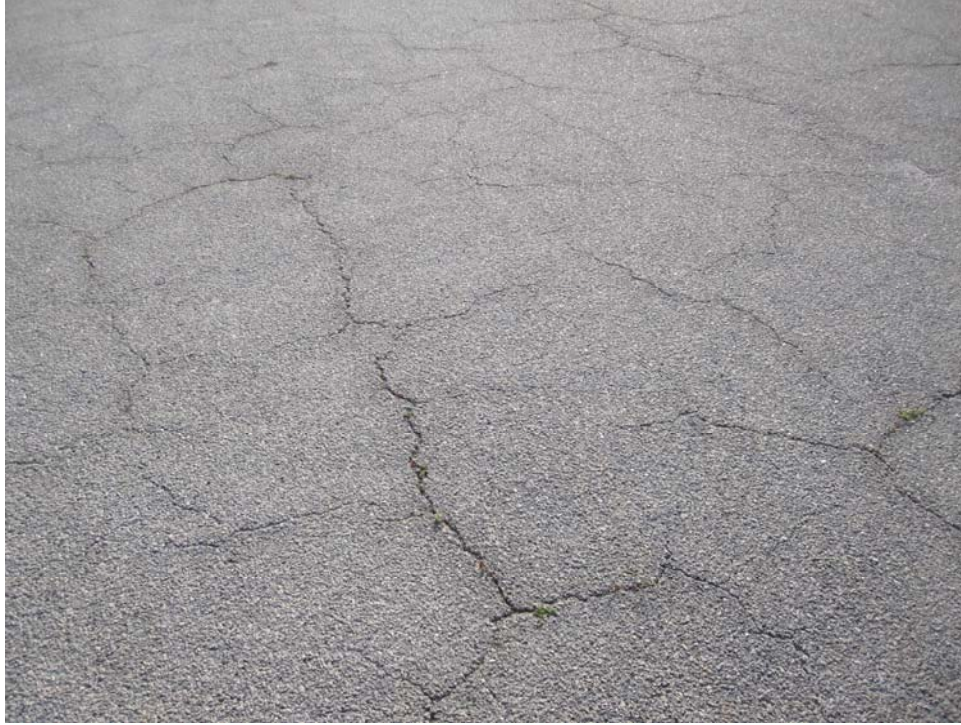
AGARRETAGR-30. Block Cracking (Sample Unit #05).

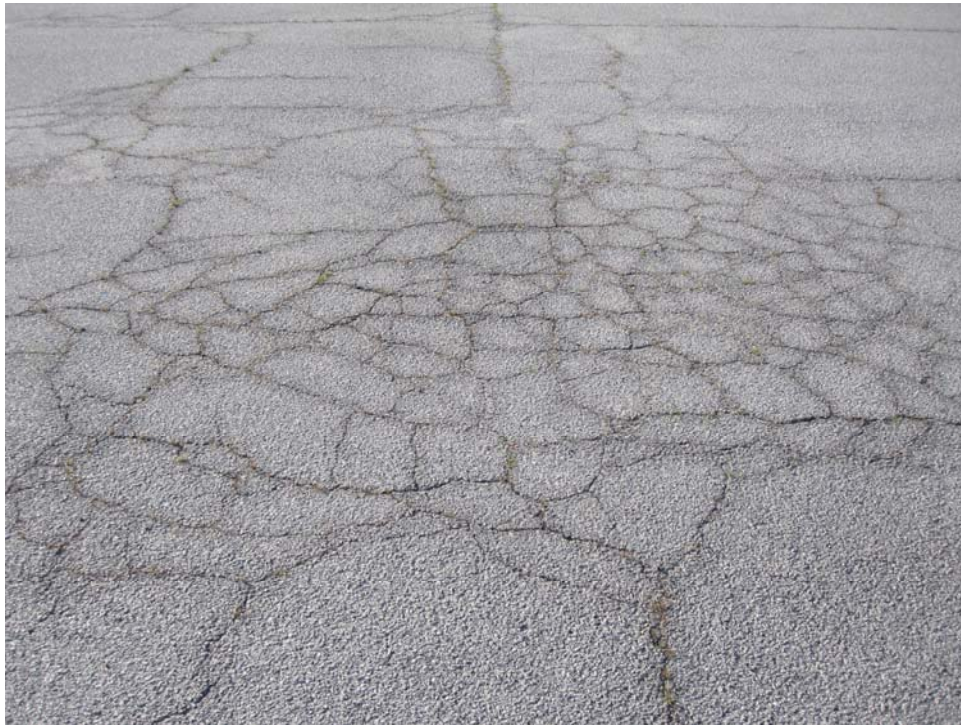
AGARRETAGR-40. Alligator Cracking (Sample Unit # 08).

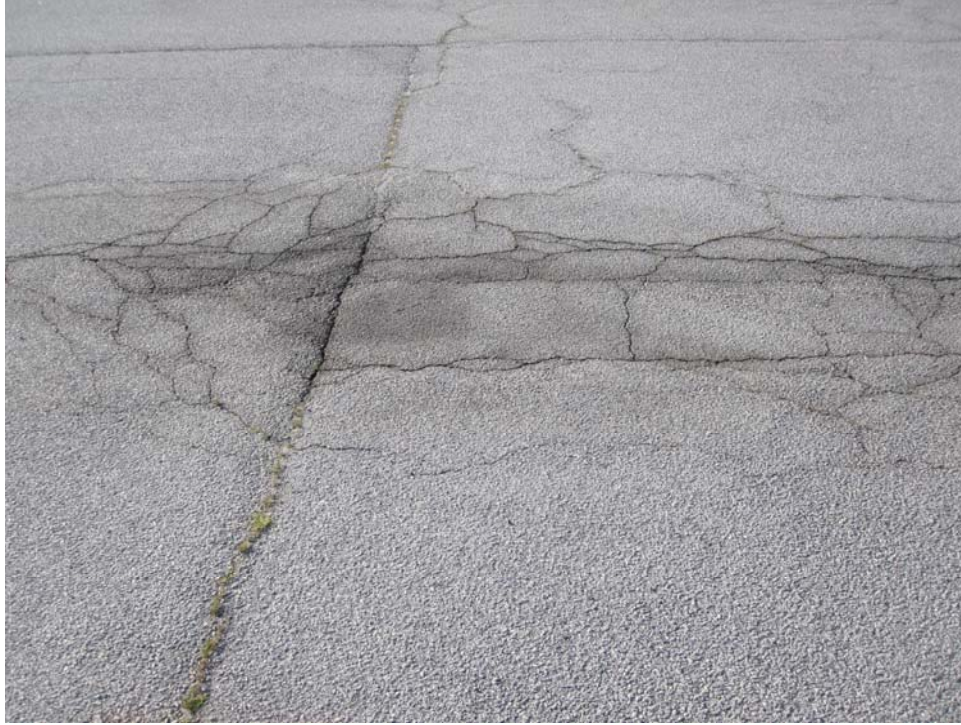
AGARRETAGR-40. Depression (Sample Unit #11).

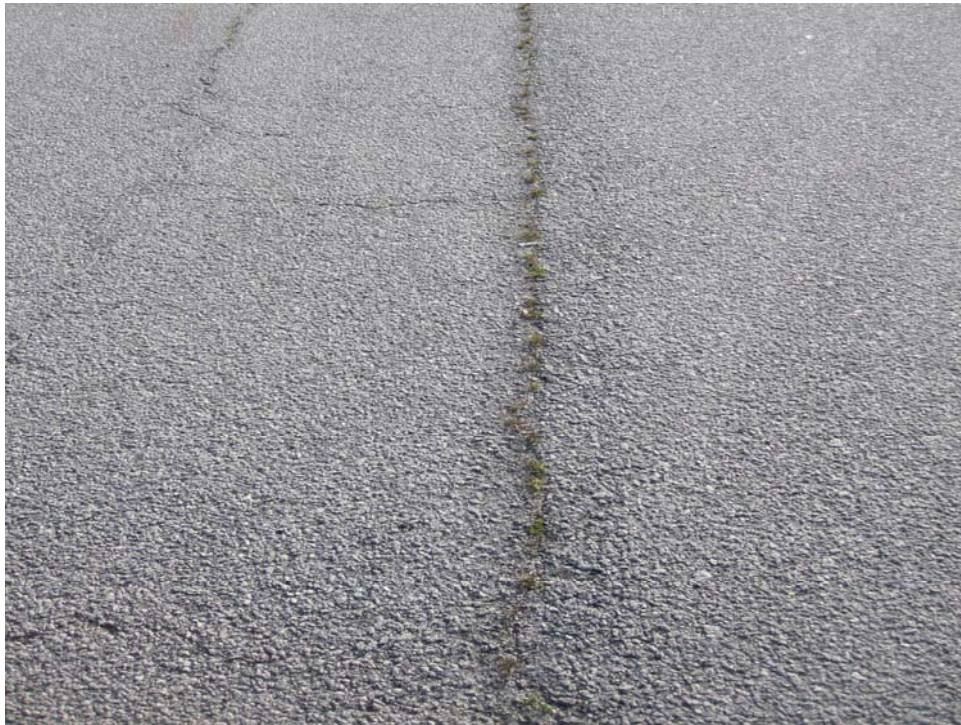
AGARRETAGR-40. Longitudinal and Transverse Cracking (Sample Unit #11).

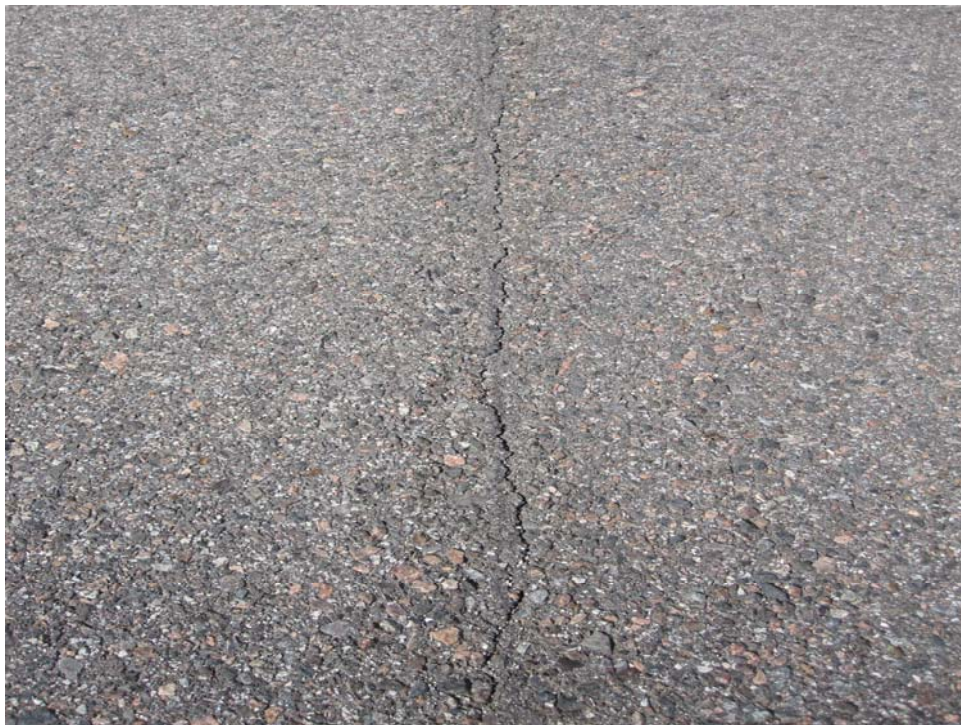
HELIAGR-10. Longitudinal and Transverse Cracking (Sample Unit #03).

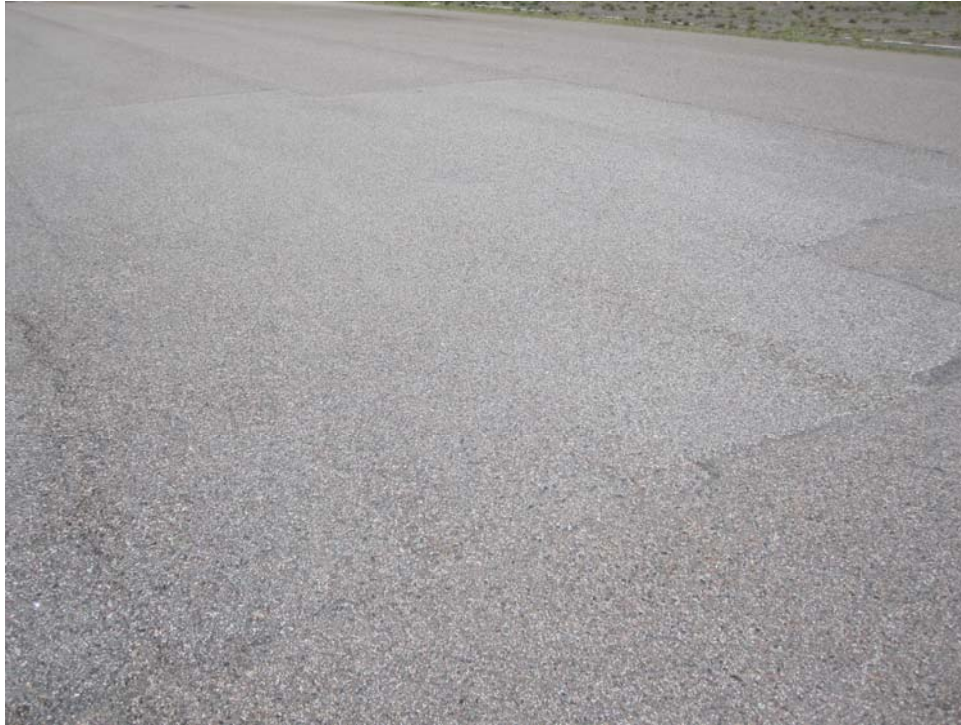
HELIAGR-10. Patching (Sample Unit #05).

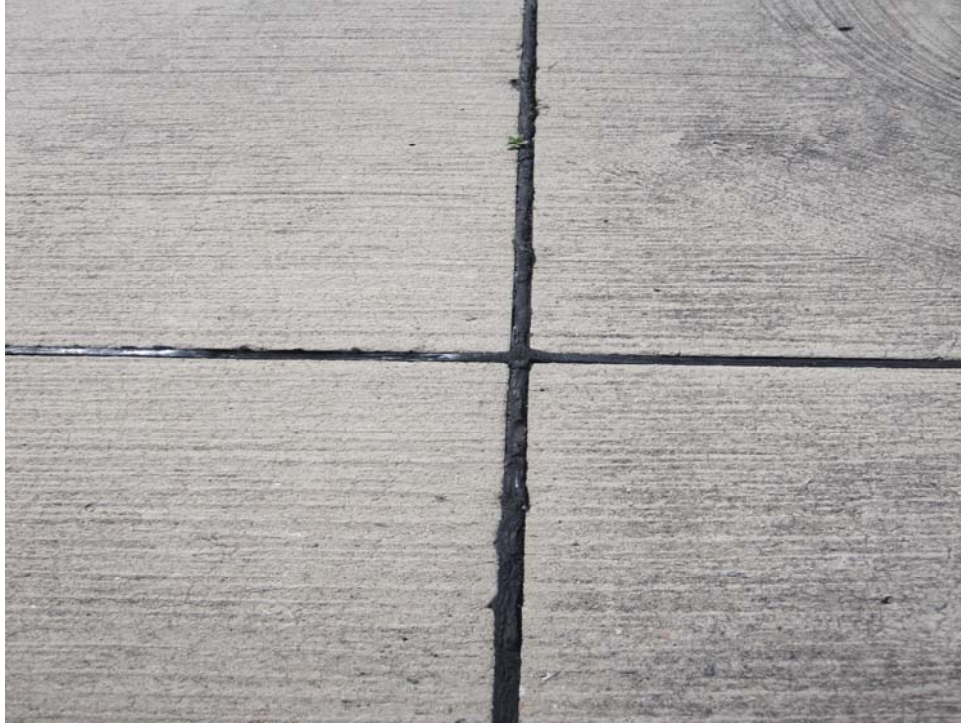
HELIAGR-20. Joint Seal Damage (Sample Unit #01).

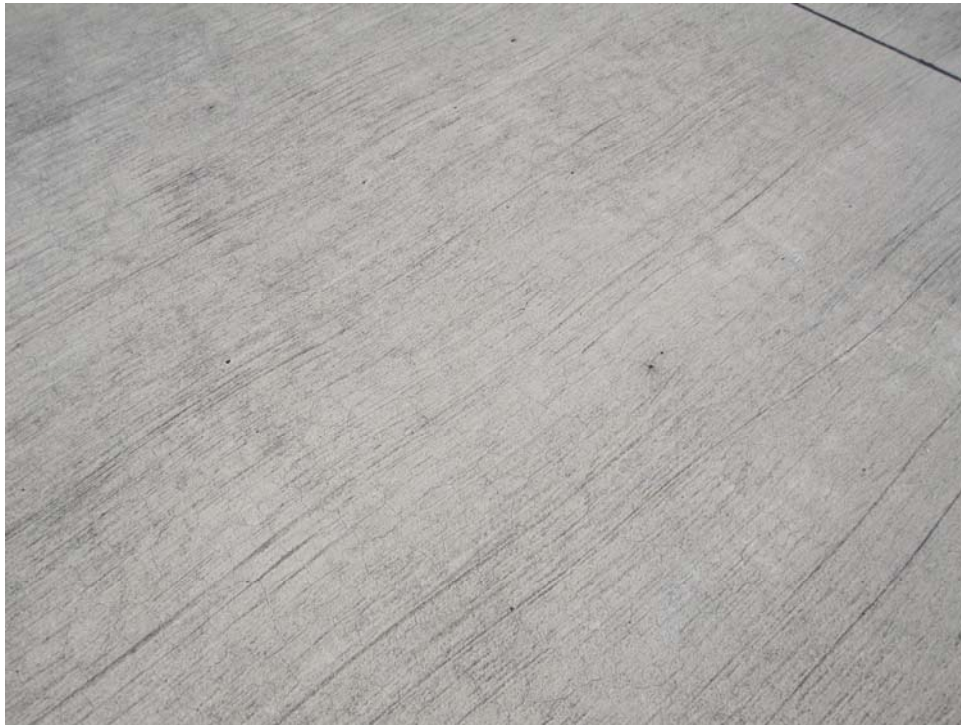
HELIAGR-20. Shrinkage Cracking (Sample Unit #02).

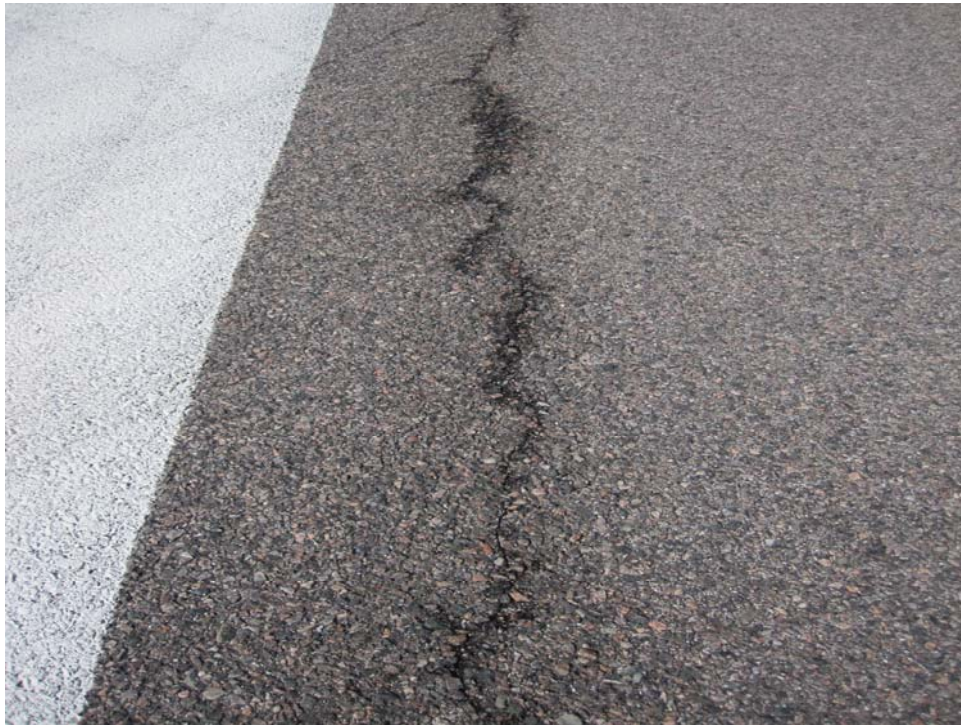
R0826AGR-10. Longitudinal and Transverse Cracking (Sample Unit #02).

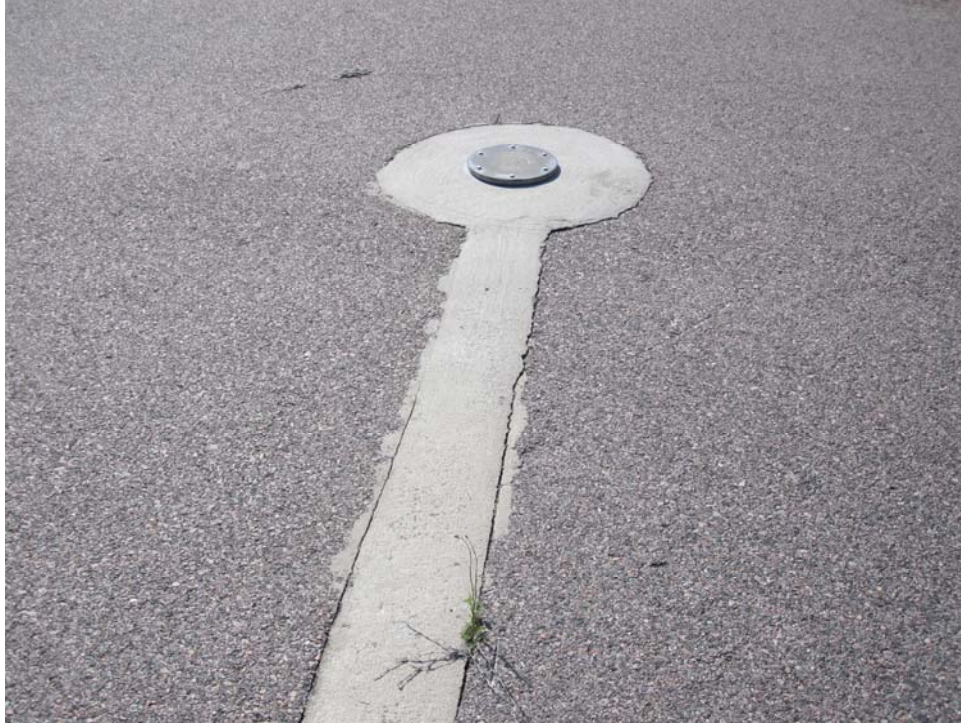
R0826AGR-10. Patching (Sample Unit #02).

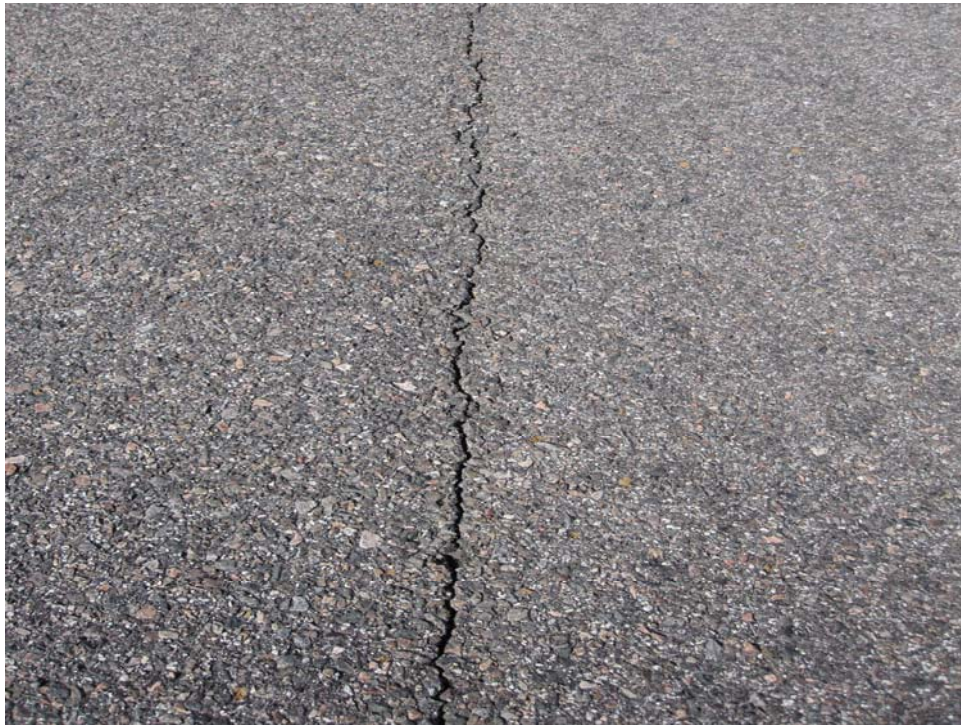
R0826AGR-20. Longitudinal and Transverse Cracking (Sample Unit #02).

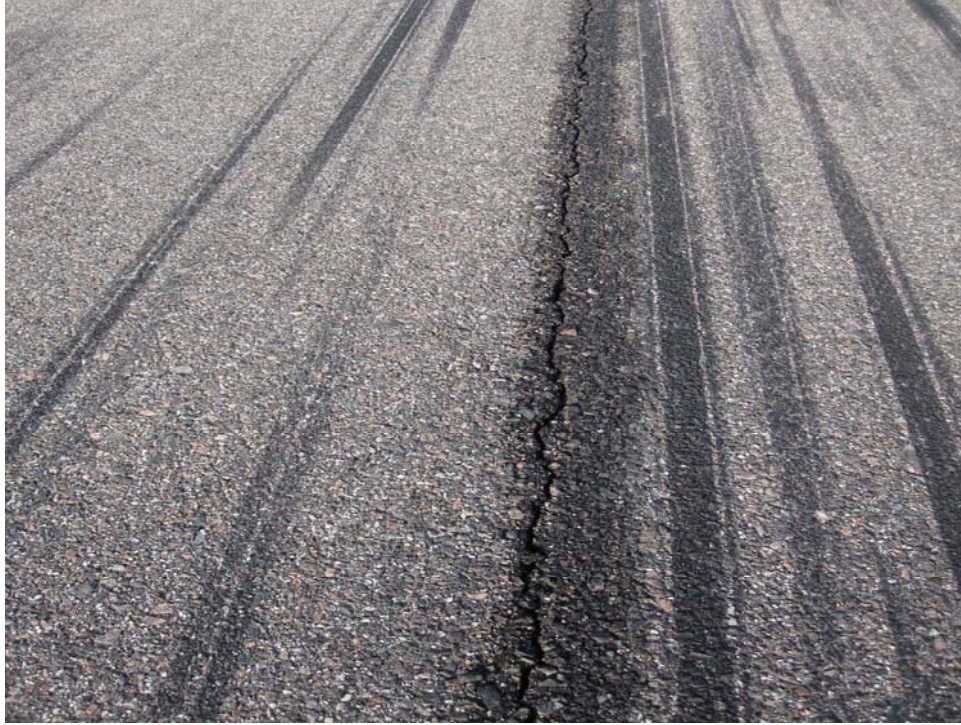
R0826AGR-30. Longitudinal and Transverse Cracking (Sample Unit #44).

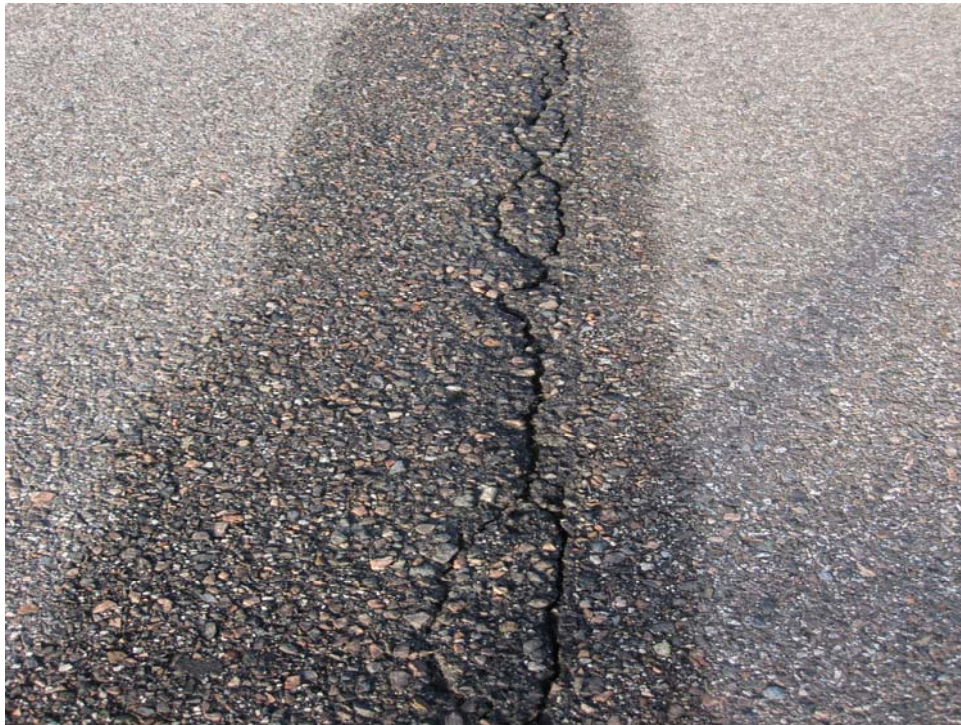
R0826AGR-30. Longitudinal and Transverse Cracking (Sample Unit #66).

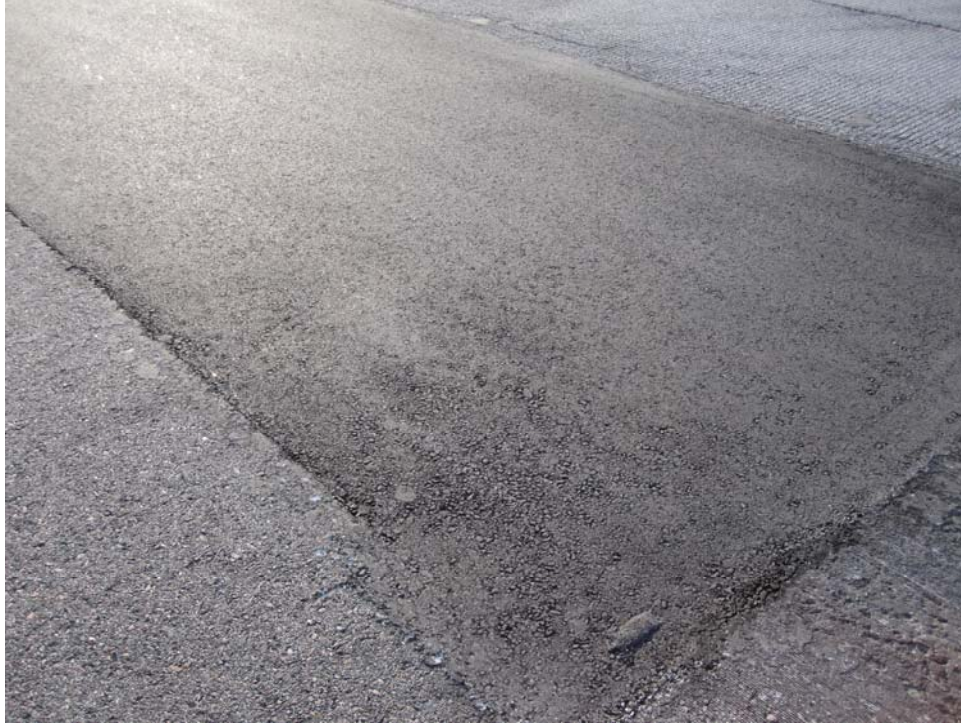
R0826AGR-30. Patching (Sample Unit #68).

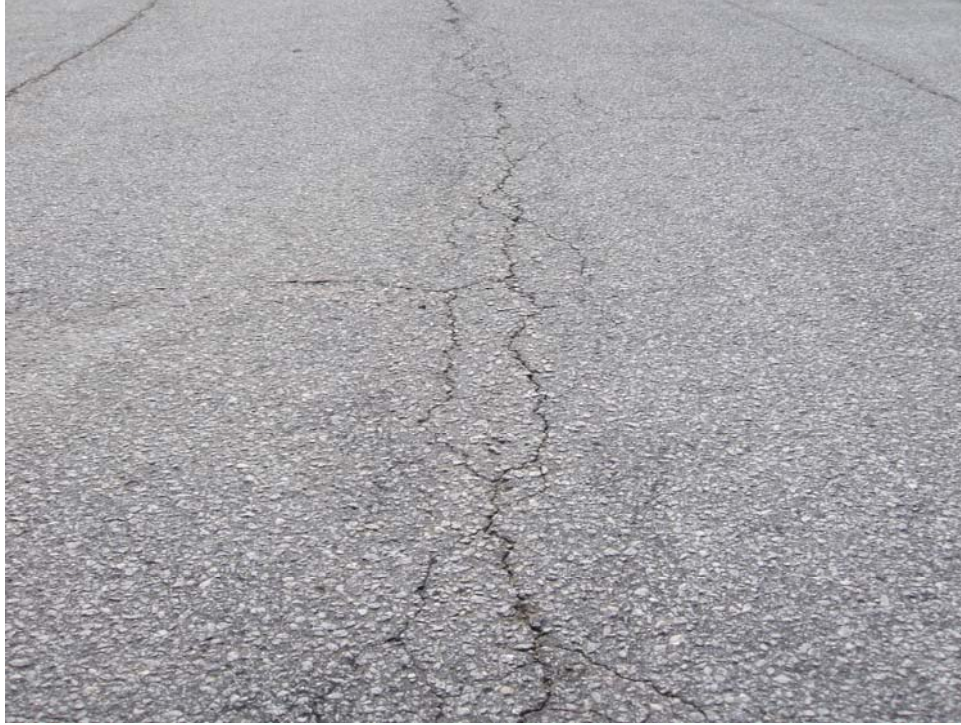
TAAGR-20. Alligator Cracking (Sample Unit #37).
