# 2012 Augusta Regional at Bush Field Pavement Management Plan

# AUGUSTA REGIONAL AT BUSH FIELD

## PAVEMENT MANAGEMENT REPORT

**DECEMBER 2012**

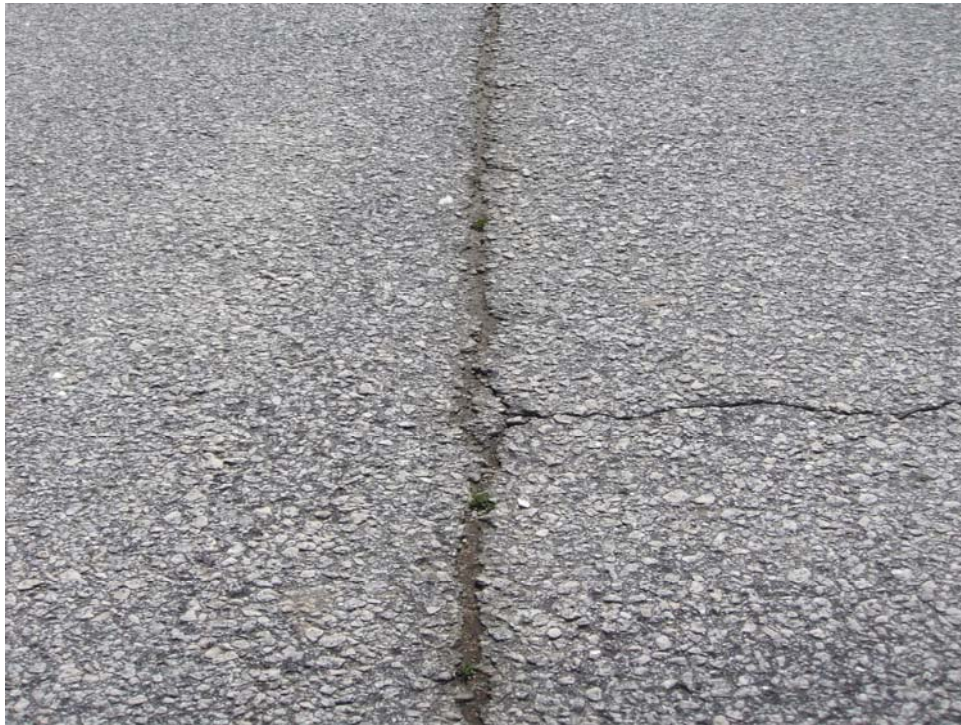
TAAGR-20. Longitudinal and Transverse Cracking (Sample Unit #32).

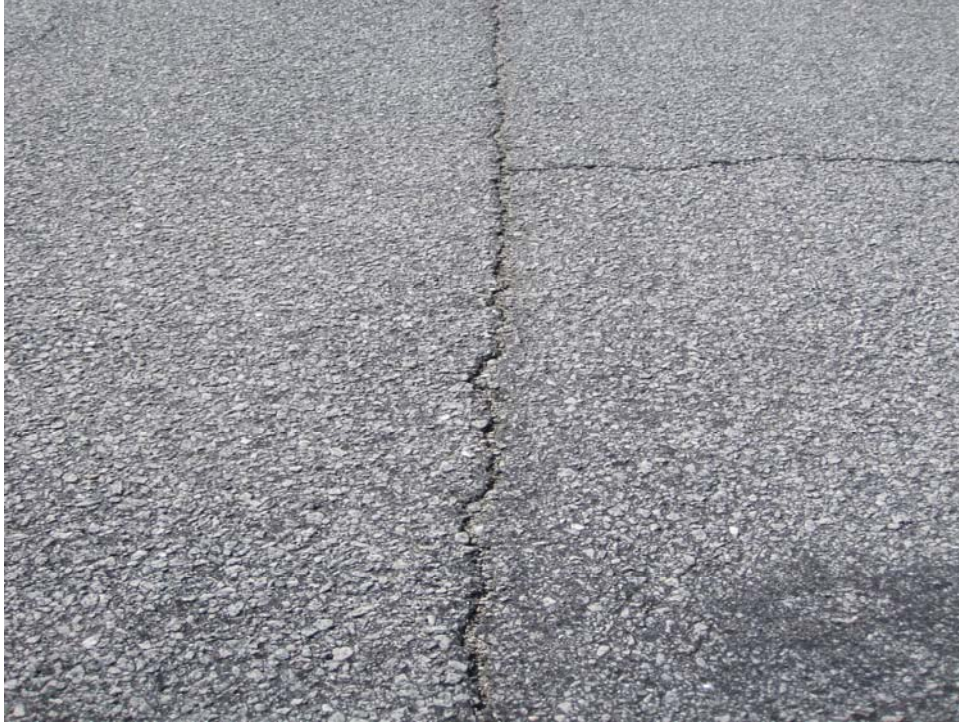
TBAGR-10. Longitudinal and Transverse Cracking (Sample Unit #06).

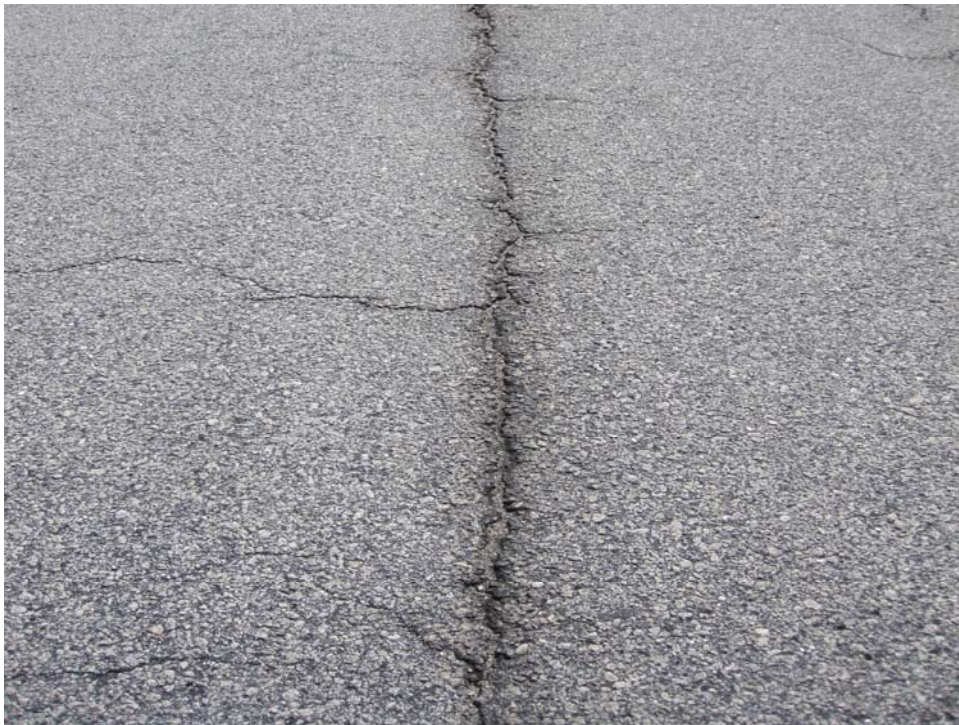
TCAGR-10. Longitudinal and Transverse Cracking (Sample Unit #01).

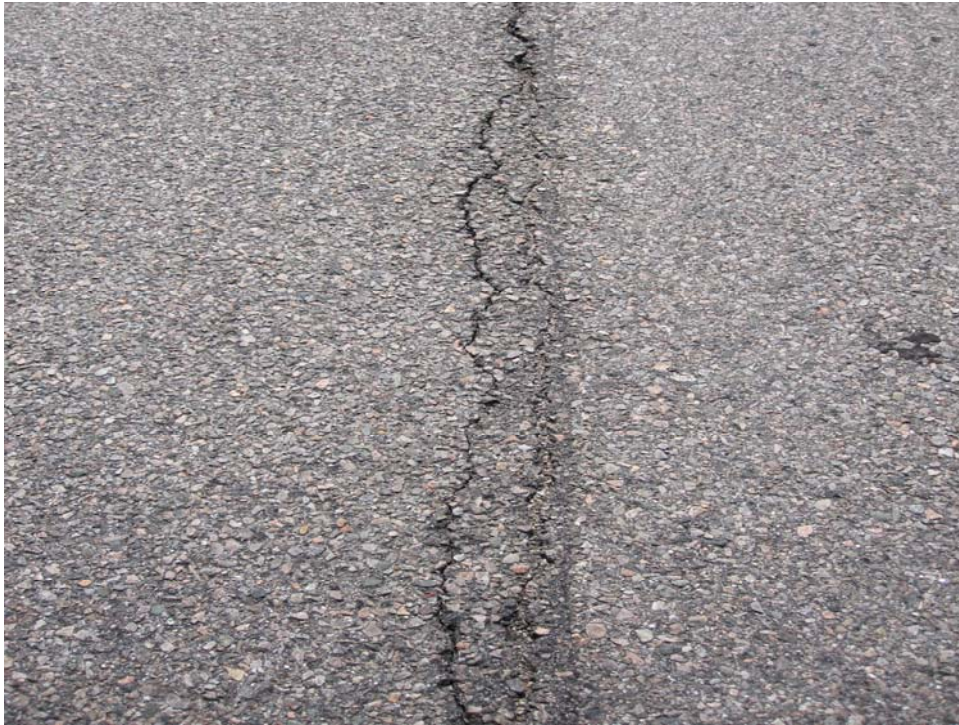
TCAGR-20. Longitudinal and Transverse Cracking (Sample Unit #25).

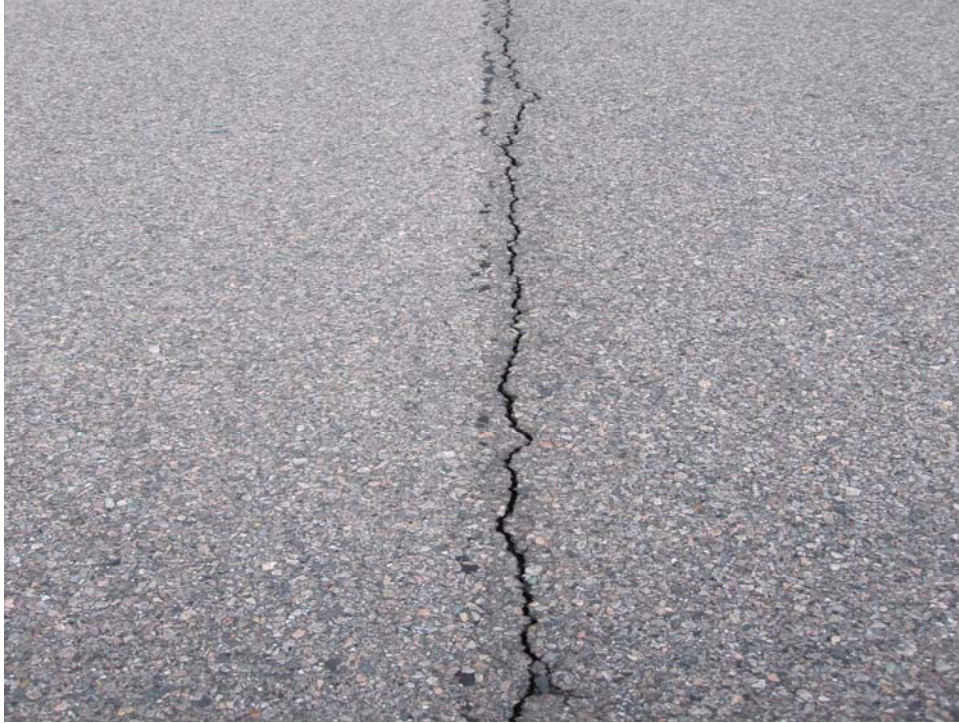
TCAGR-20. Longitudinal and Transverse Cracking (Sample Unit #35).

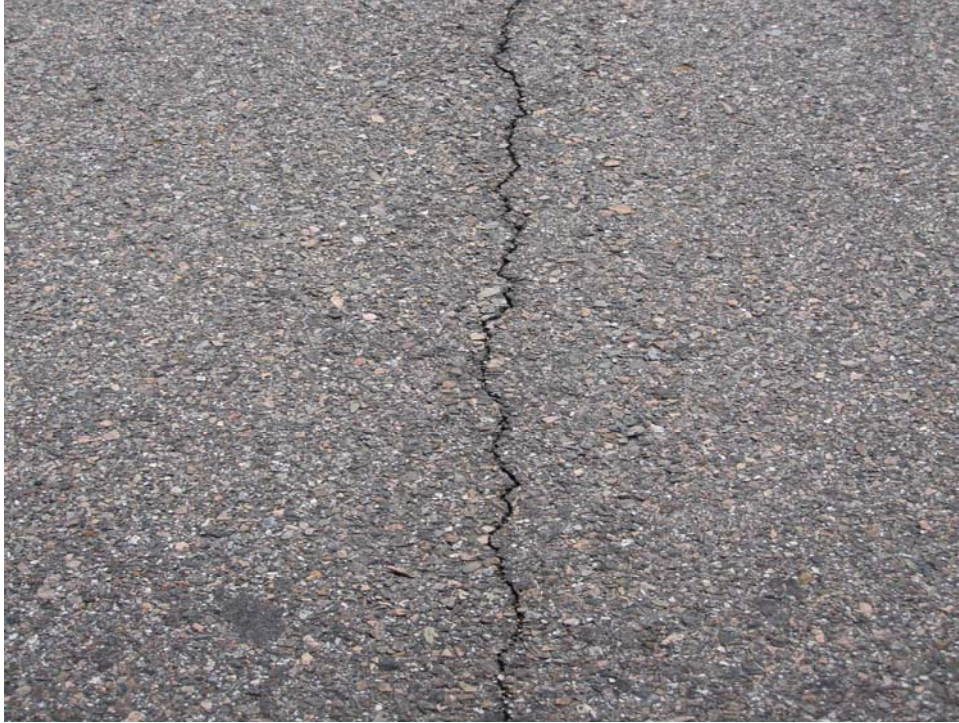
TCAGR-30. Longitudinal and Transverse Cracking (Sample Unit #22).

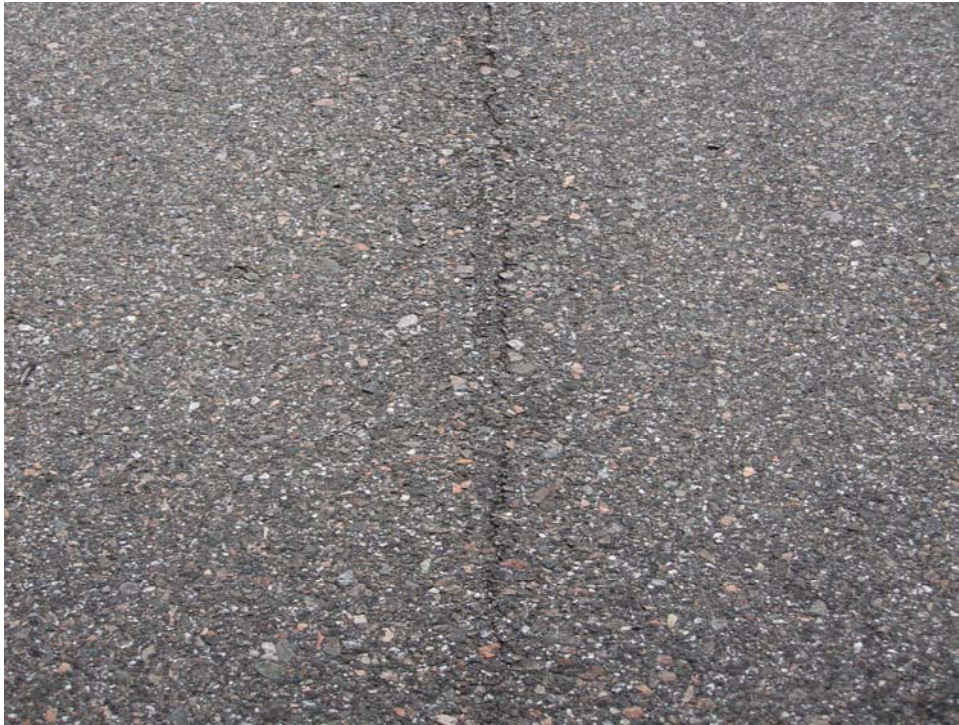
TCAGR-30. Longitudinal and Transverse Cracking (Sample Unit #26).

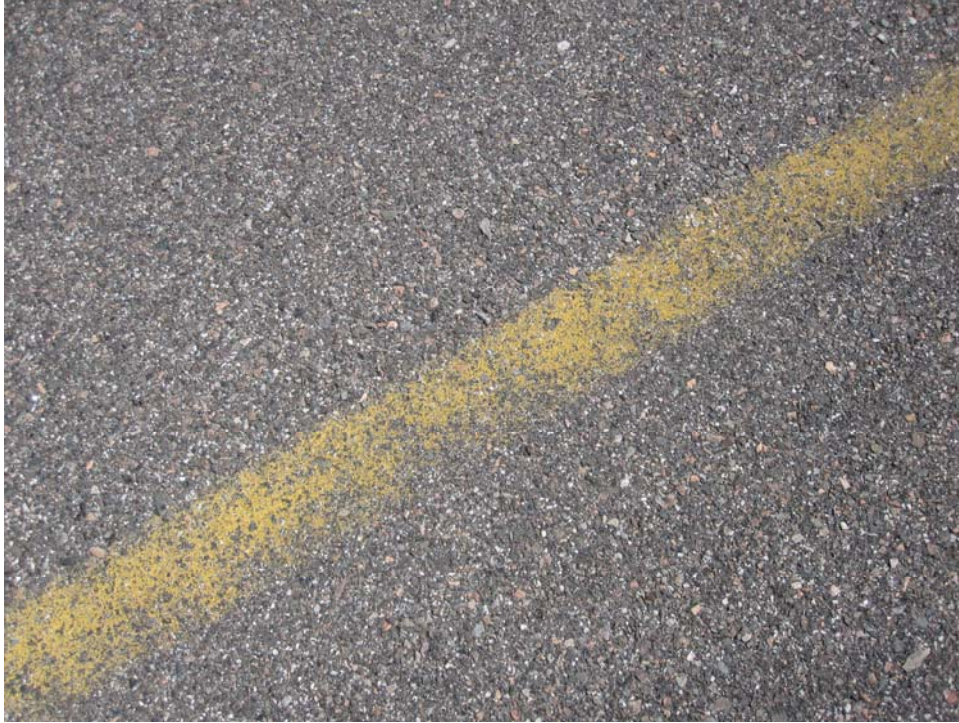
TCAGR-30. .Unsatisfactory Paint.

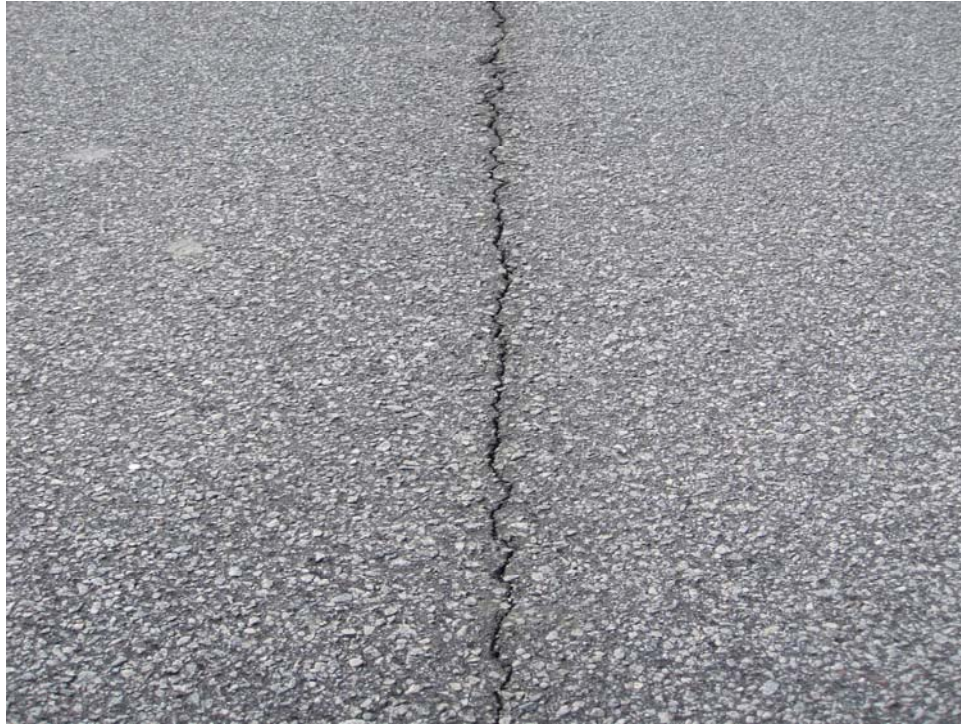
TDAGR-10. Longitudinal and Transverse Cracking (Sample Unit #07).

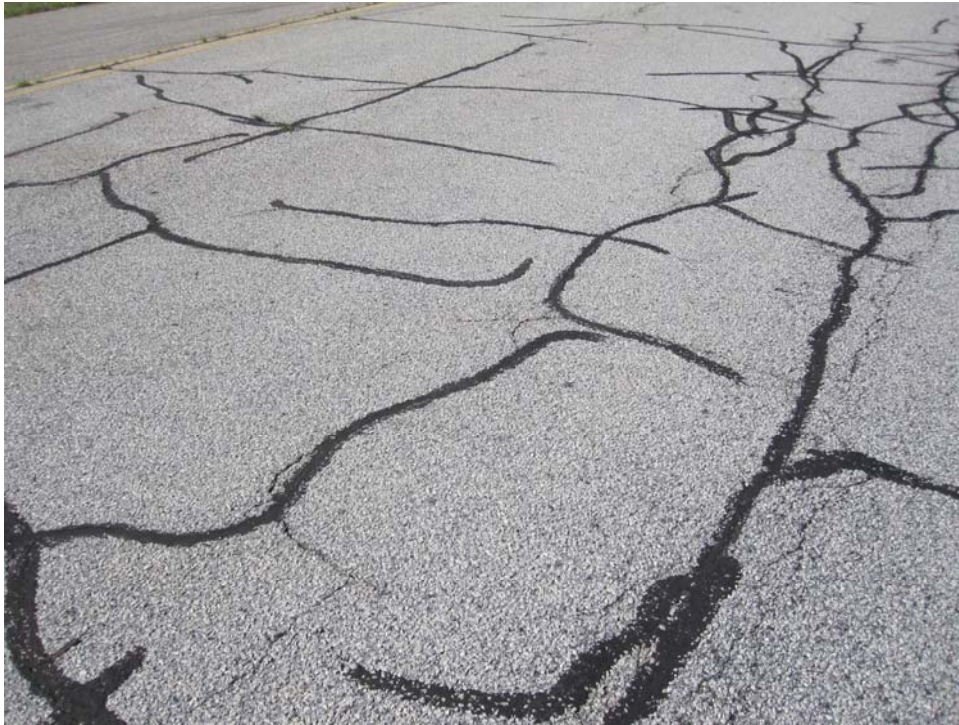
TEAGR-10. Block Cracking (Sample Unit #03).

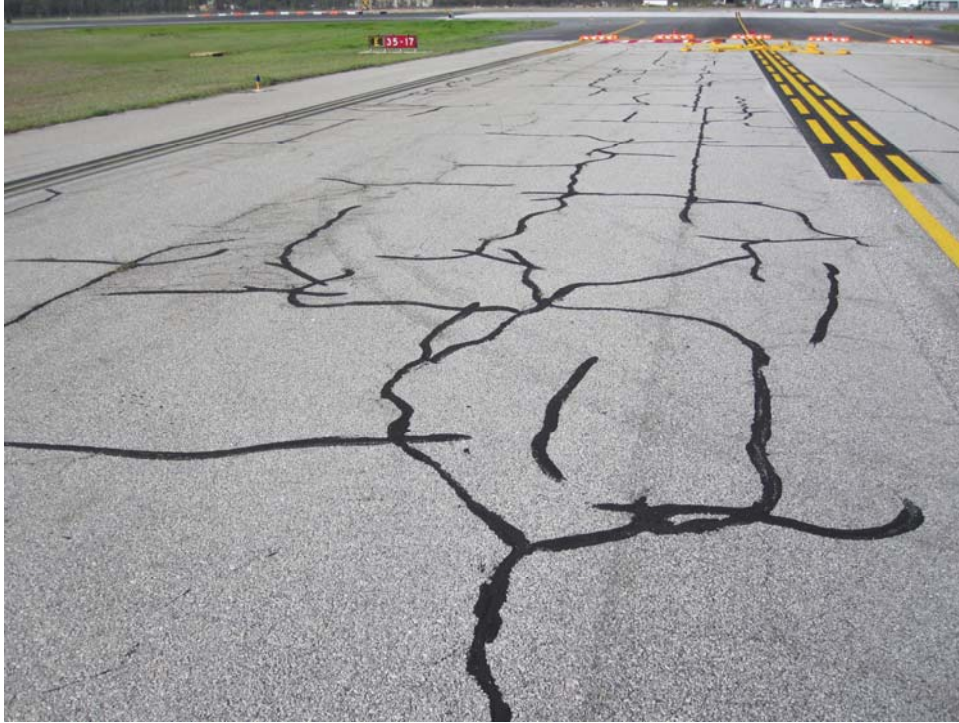
TEAGR-20. Longitudinal and Transverse Cracking (Sample Unit # 02).

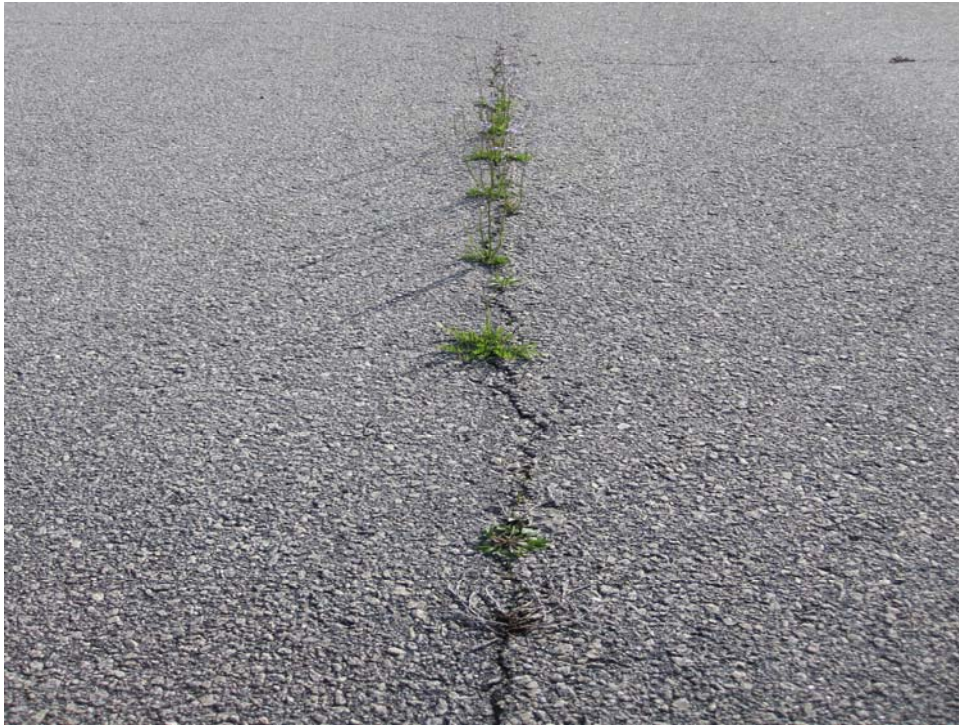
TEAGR-20. Longitudinal and Transverse Cracking (Sample Unit #36).

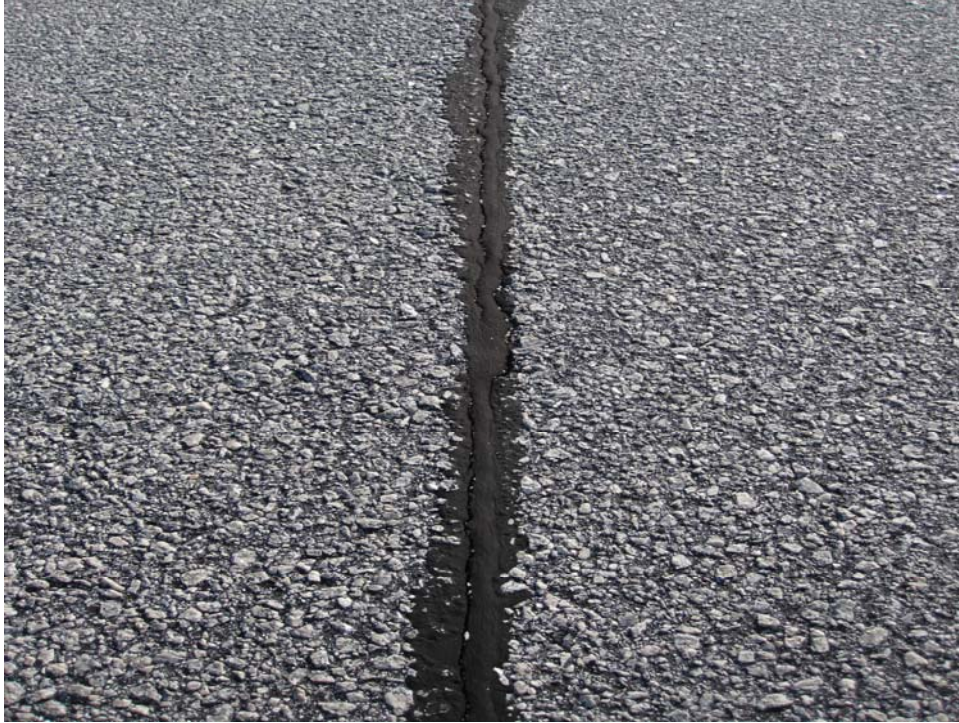
TEAGR-20. Longitudinal and Transverse Cracking (Sample Unit #44).

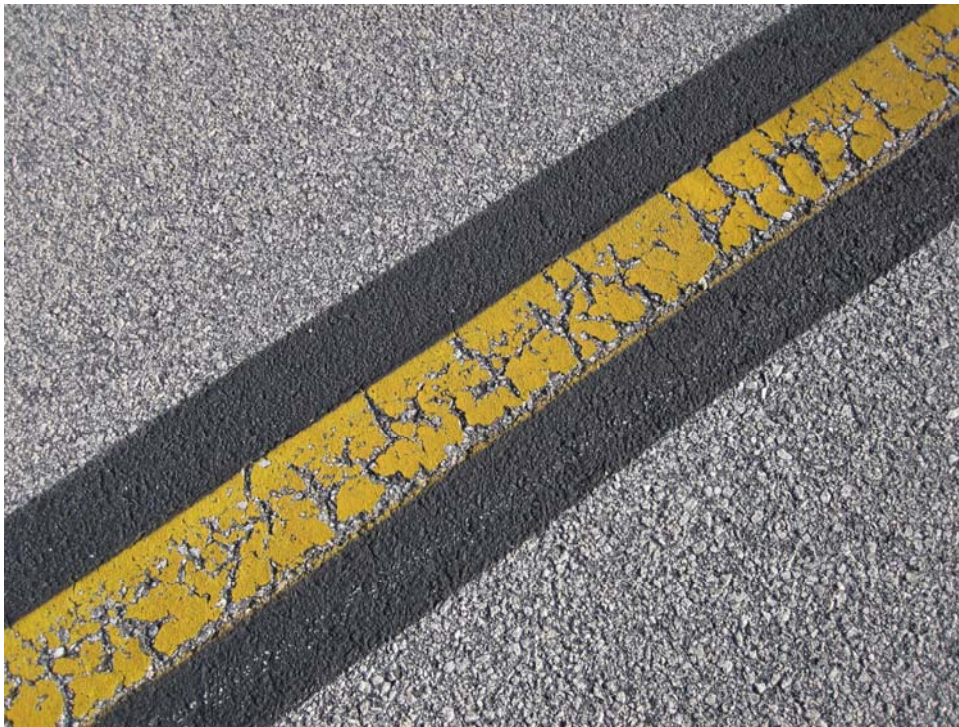
TEAGR-20. Unsatisfactory Paint.
