# 2012 Brunswick-Golden Isles Airport Pavement Management Plan

## **BRUNSWICK-GOLDEN ISLES AIRPORT**

### PAVEMENT MANAGEMENT REPORT

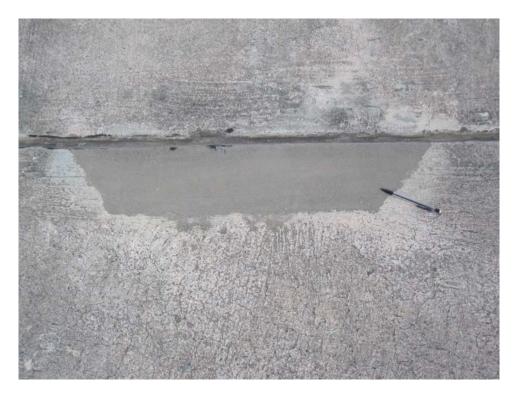
The terminal apron area (A01BQ) contained one section with a PCI value of 97. Low-severity small patching, large patching, corner spalling, and joint spalling were recorded throughout Section 10.

A01BQ-10. Small Patching (Sample Unit #10).

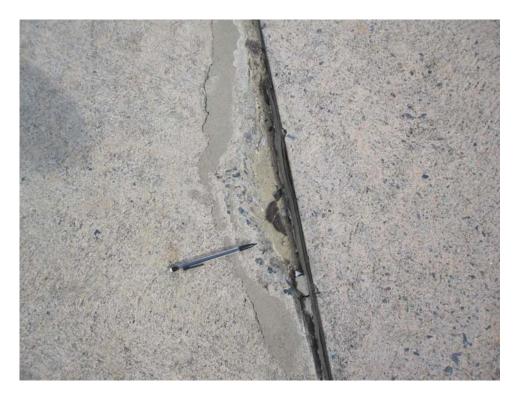
The north apron area (A02BQ) was defined by one section with a PCI value of 89. Medium-severity joint seal damage was recorded where the joint sealant had deteriorated significantly with visible openings or oxidized sealant. Low-severity corner spalling and low- and medium-severity joint spalling were observed throughout the section. Small amounts of low- and medium-severity small patching and isolated quantities of low- and medium-severity scaling were also observed.

A02BQ-10. Joint Spalling (Sample Unit #03).

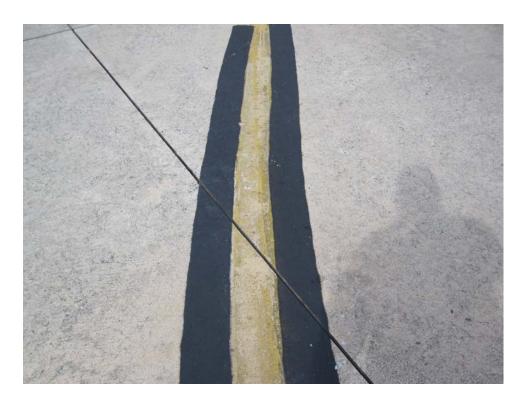
A02BQ-10. Unsatisfactory Paint.

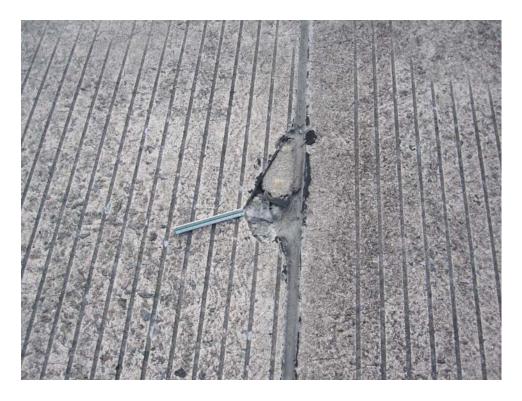
R725BQ-10C. Joint Spalling (Sample Unit #04).

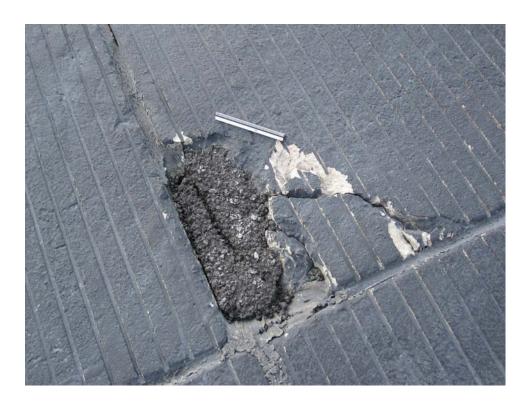
R725BQ-10S. Corner Spalling (Additional Sample Unit #02).

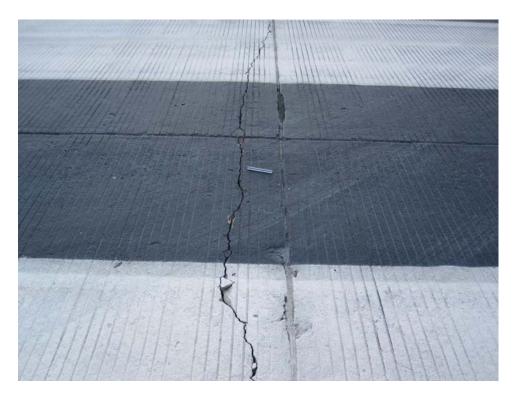
R725BQ-10S. Joint Spalling (Additional Sample Unit #02).

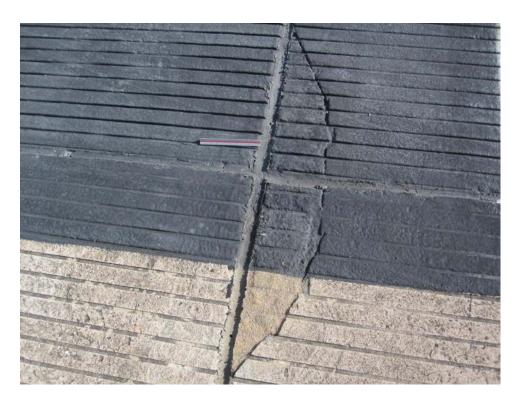
R725BQ-10S. Joint Spalling (Sample Unit #01).

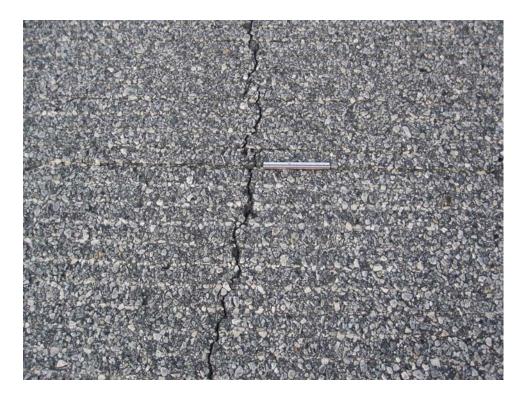
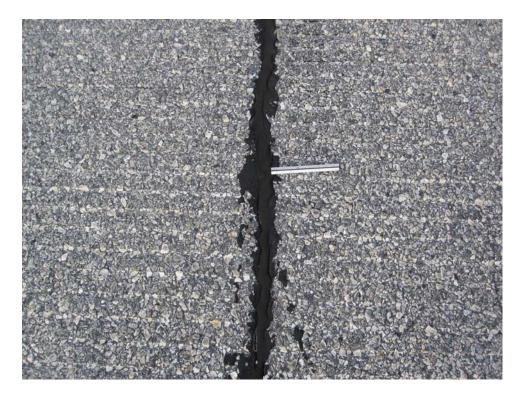
R725BQ-20C. Longitudinal and Transverse Cracking (Sample Unit #64) (1).

R725BQ-20C. Longitudinal and Transverse Cracking (Sample Unit #64) (2).

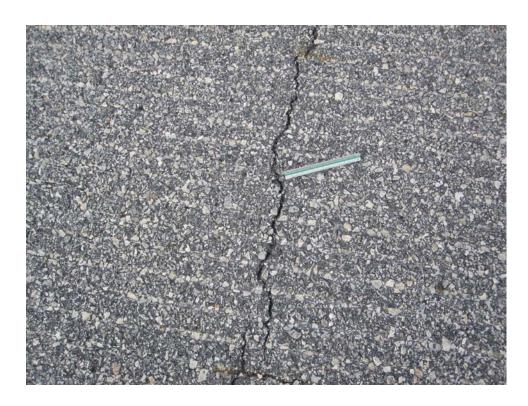
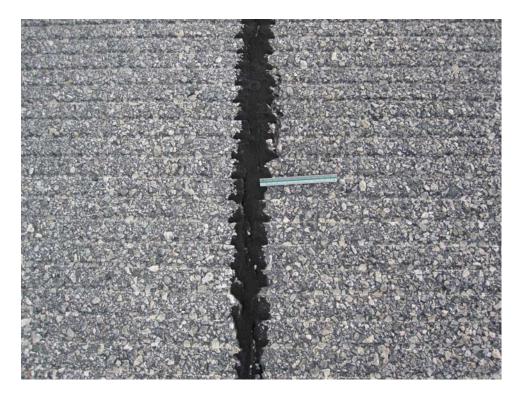
R725BQ-20N. Longitudinal and Transverse Cracking (Sample Unit #63) (1).

R725BQ-20N. Longitudinal and Transverse Cracking (Sample Unit #63) (2).

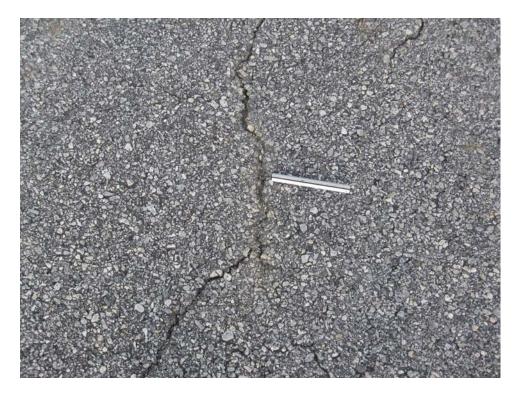
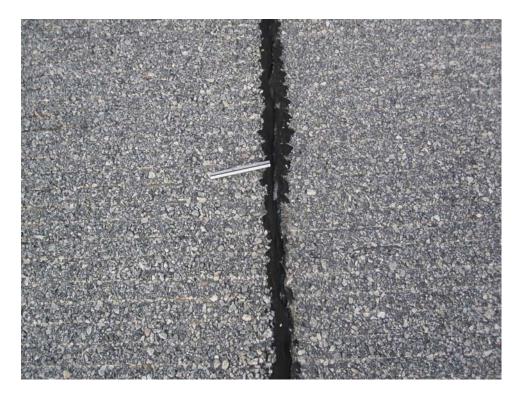
R725BQ-20S. Longitudinal and Transverse Cracking (Sample Unit #65) (1).

R725BQ-20S. Longitudinal and Transverse Cracking (Sample Unit #65) (2).

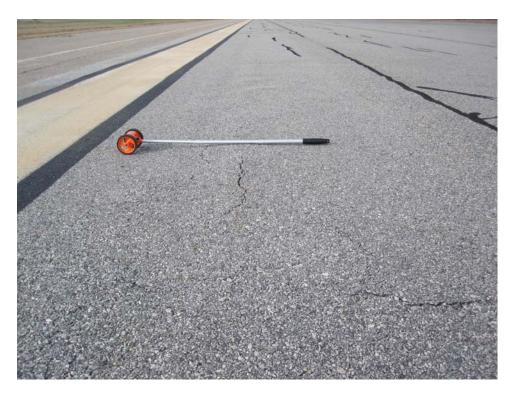
R725BQ-20S. Swelling (Sample Unit #55).

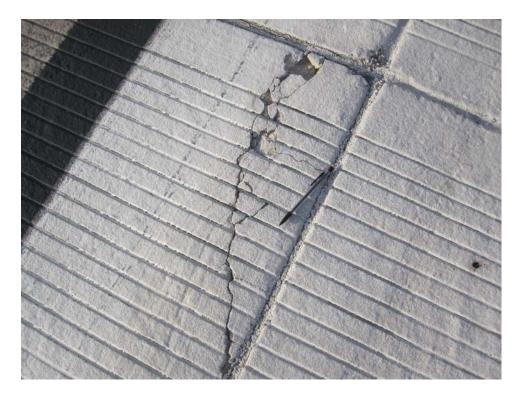
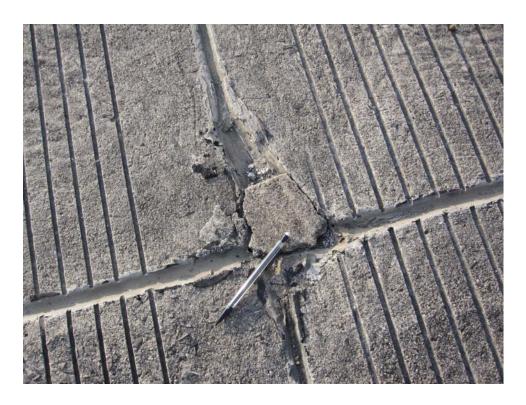
R725BQ-30C. Corner Spalling (Sample Unit #02) (1).

R725BQ-30C. Corner Spalling (Sample Unit #02) (2).

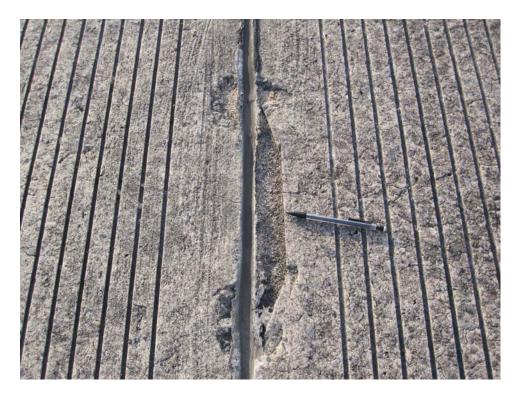
R725BQ-30C. Joint Spalling (Sample Unit #04).

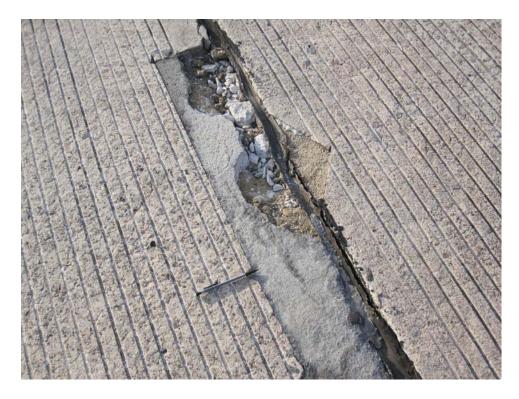
R725BQ-30C. Small Patching (Sample Unit #04).

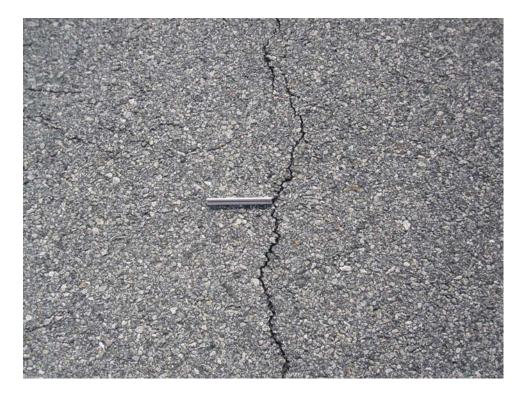
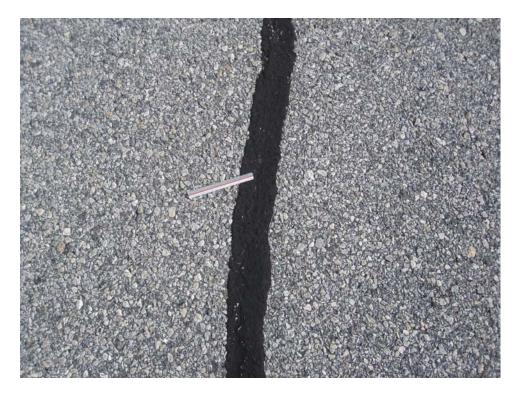
Taxiway A was defined by three sections. Section 10 had a PCI value of 67. Substantial quantities of low-severity, sealed L&T cracking were observed throughout the section. Additional amounts of low-severity, unsealed L&T cracking and low-severity swelling were identified. Section 20 had a PCI value of 96. Low- and medium-severity joint spalling and corner spalling were identified during the inspection. Low-severity patching was also identified, while medium-severity small patching was recorded where cracks were visible in the patching material. Section 30 had a PCI value of 89. Medium-severity joint seal damage was recorded where the joint sealant was observed to be in an unsatisfactory condition, either allowing water to penetrate the pavement surface or not being pliable. In addition, low- and medium-severity joint spalling and corner spalling were identified throughout the section. An area with two low-severity large patches along with several spalls was inspected as an additional sample unit in accordance with ASTM D5340.

TABQ-10. Longitudinal and Transverse Cracking (Sample Unit #04) (1).

TABQ-10. Longitudinal and Transverse Cracking (Sample Unit #04) (2).

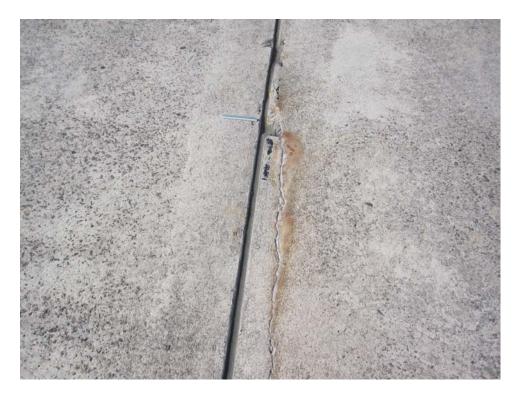
TABQ-20. Joint Spall (Sample Unit #09).

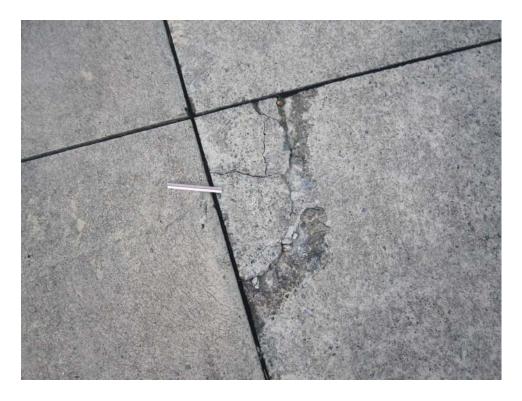
TABQ-30. Corner Spall (Sample Unit #18).

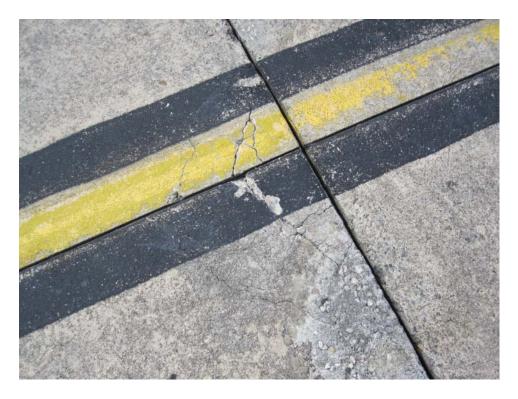
TABQ-30. Corner Spalling (Additional Sample Unit #17).

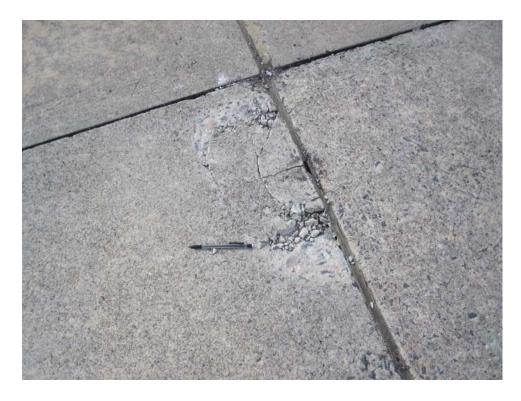
TABQ-30. Joint Spalling (Additional Sample Unit #17).

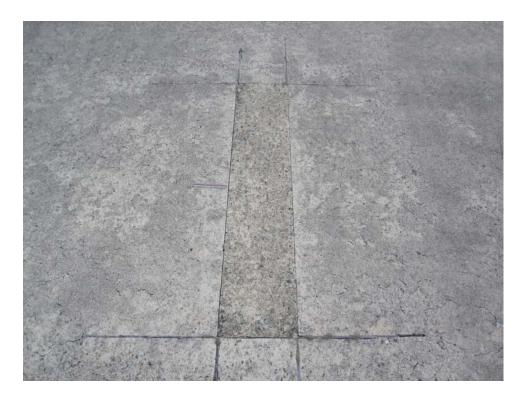
TABQ-30. Small Patch (Sample Unit #18).

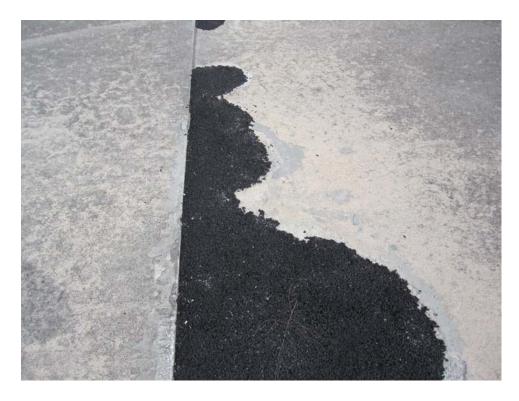
TABQ-30. Small Patching (Additional Sample Unit #17).
