# 2012 Middle Georgia Regional Airport Pavement Management Plan

# MIDDLE GEORGIA REGIONAL AIRPORT

## PAVEMENT MANAGEMENT REPORT

**DECEMBER 2012**

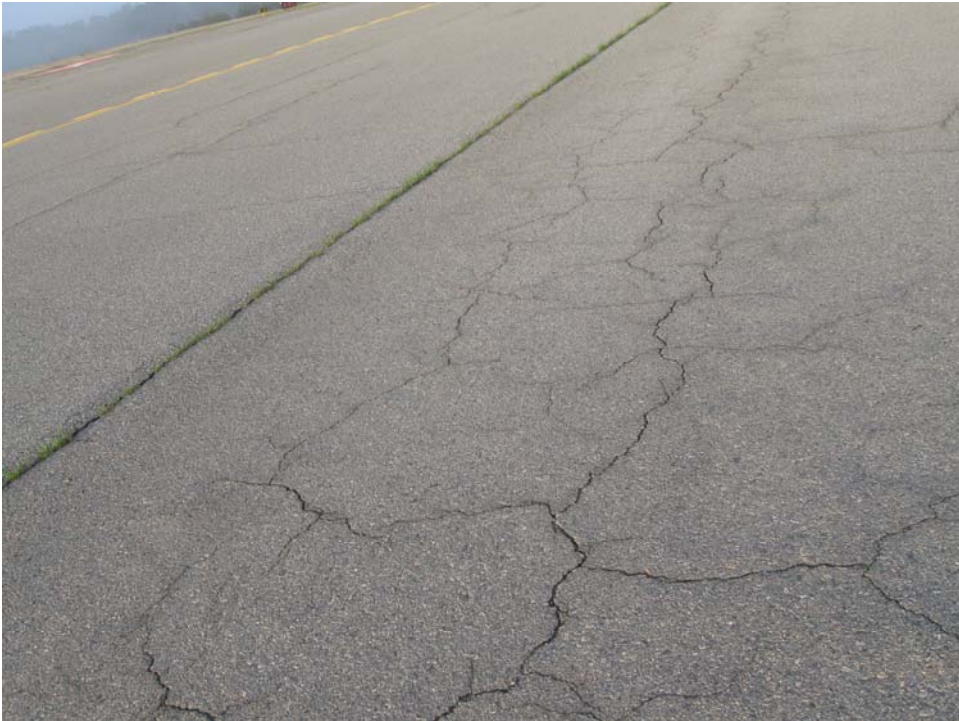
A01MGRA-10. Block Cracking (Sample Unit #26).

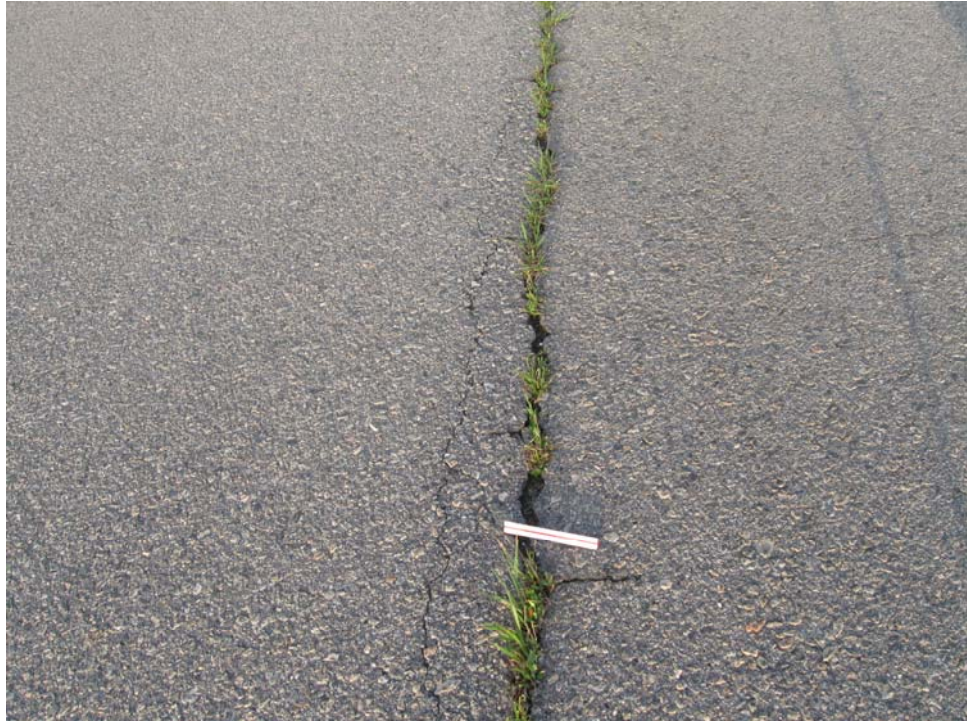
A01MGRA-10. Longitudinal and Transverse Cracking (Sample Unit #26).

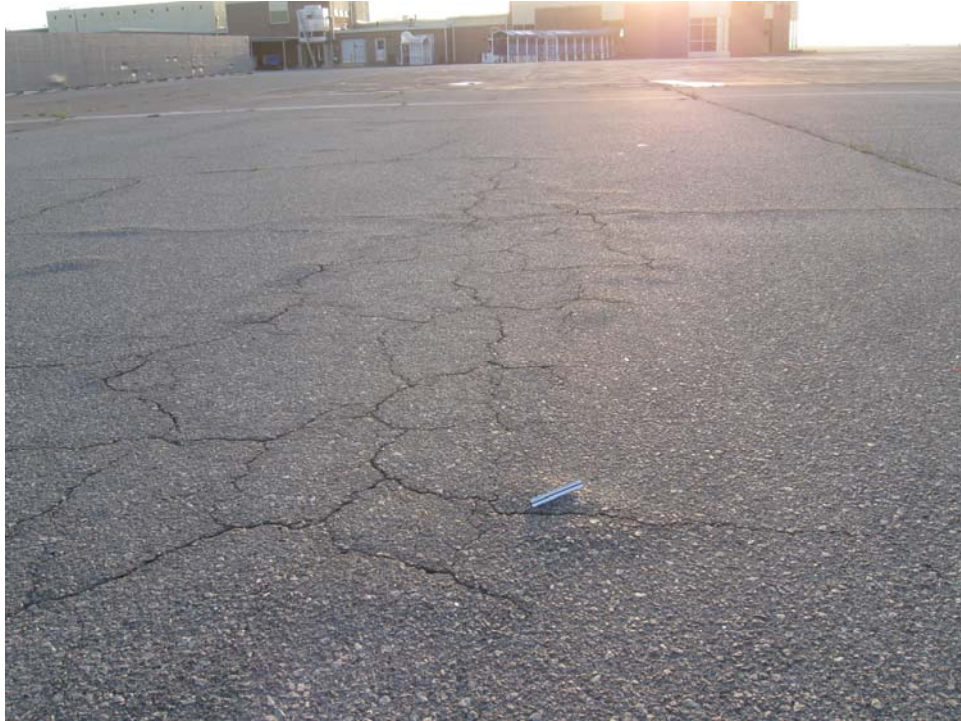
A01MGRA-10. Swelling (Sample Unit #02).

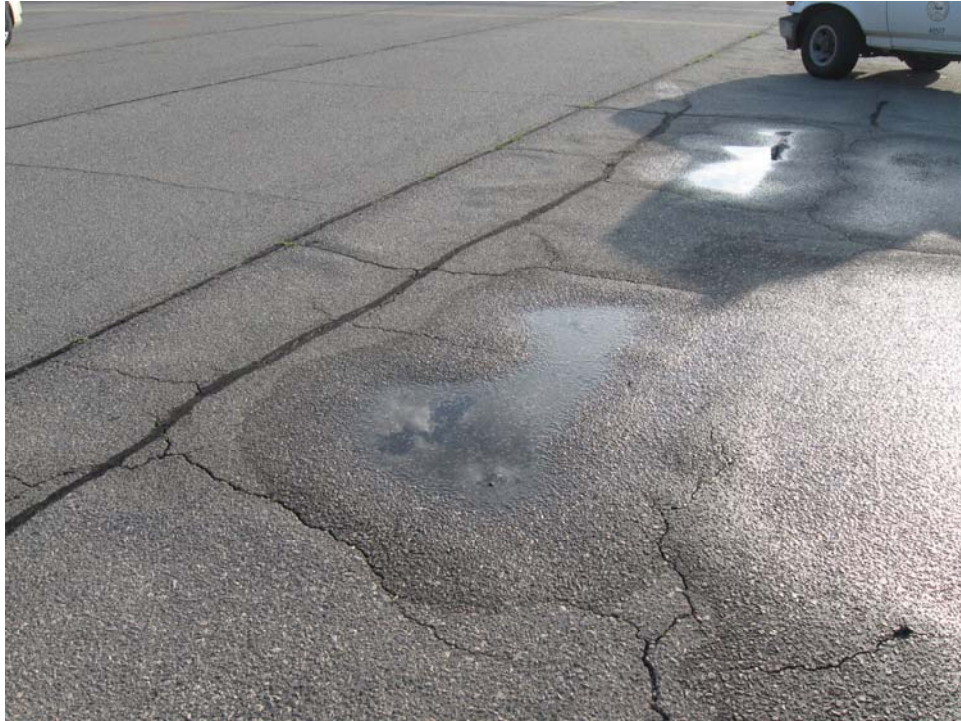
A01MGRA-20. Depression (Sample Unit #41).

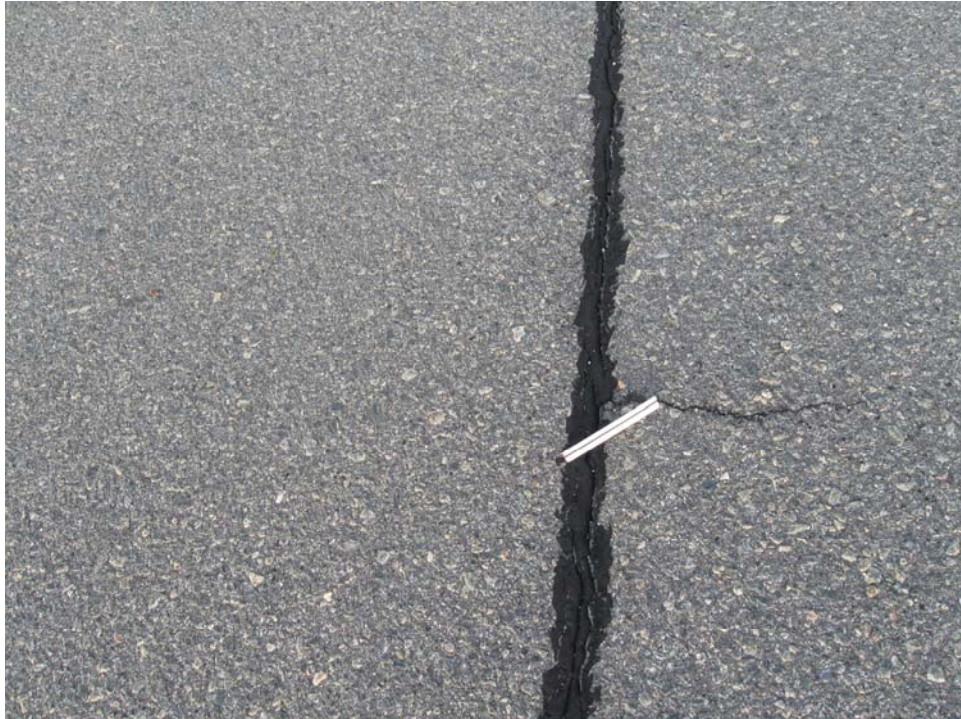
A01MGRA-20. Longitudinal and Transverse Cracking (Sample Unit #41).

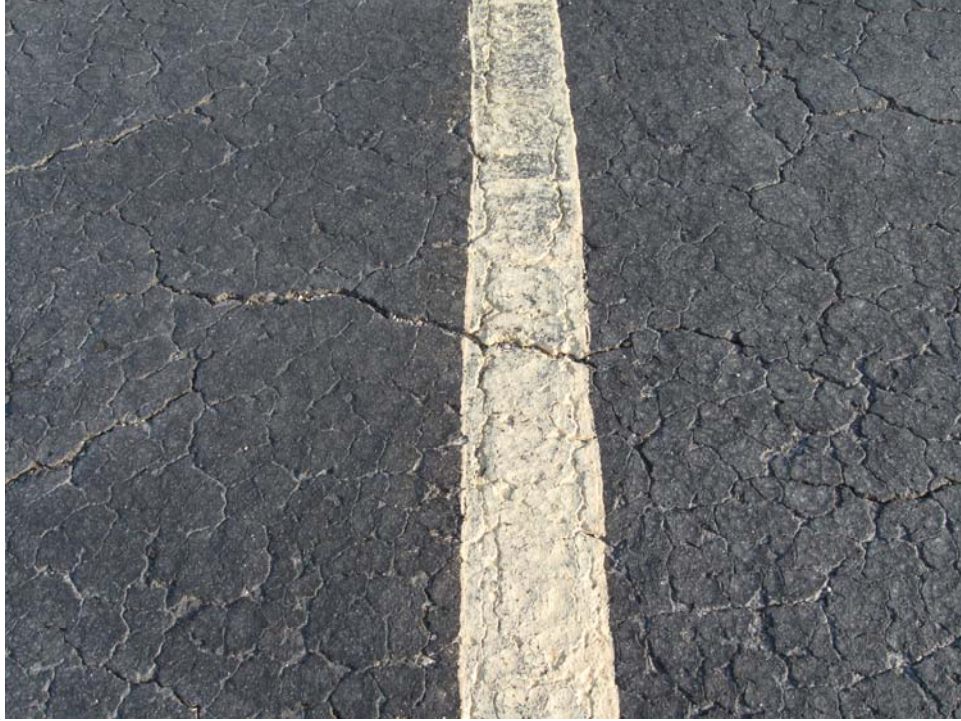
A01MGRA-20. Unsatisfactory Paint.

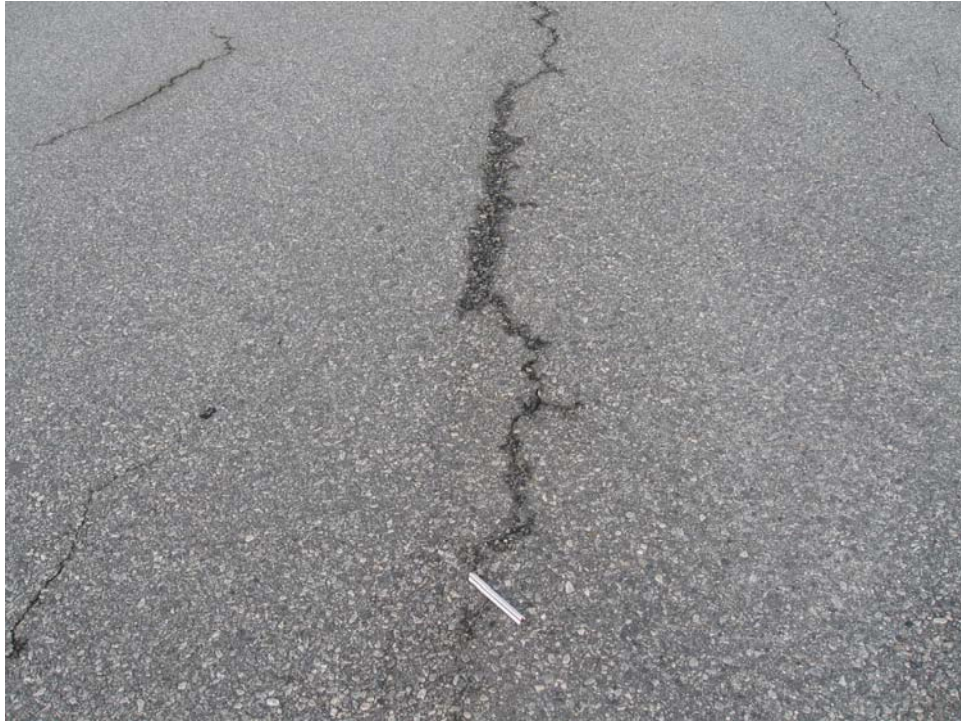
A01MGRA-30. Longitudinal and Transverse Cracking (Sample Unit #01).

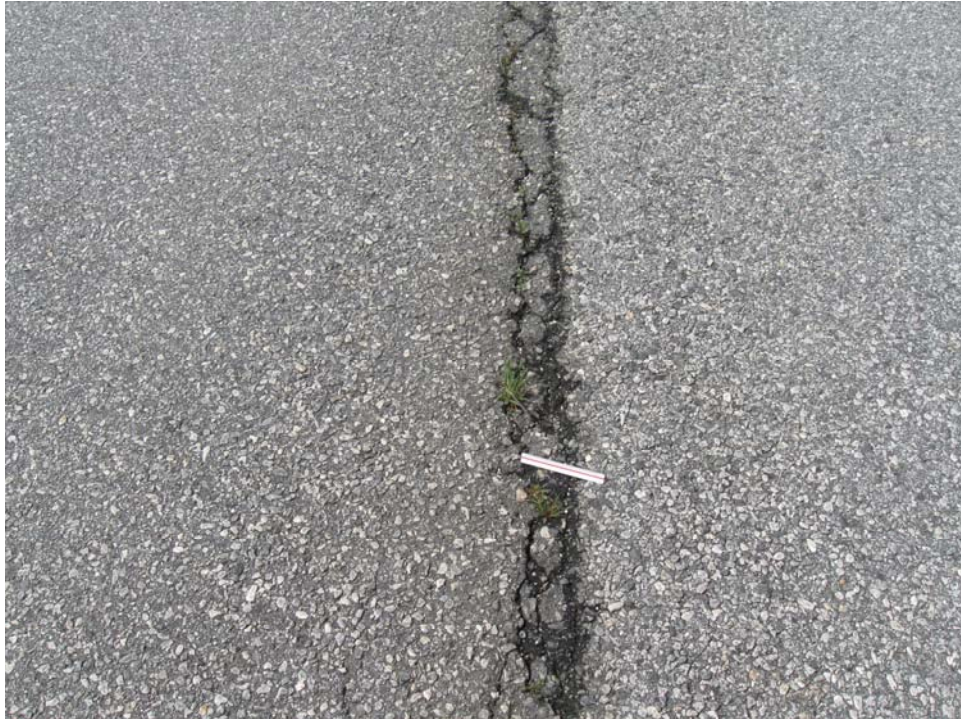
A01MGRA-40. Longitudinal and Transverse Cracking (Sample Unit #14).

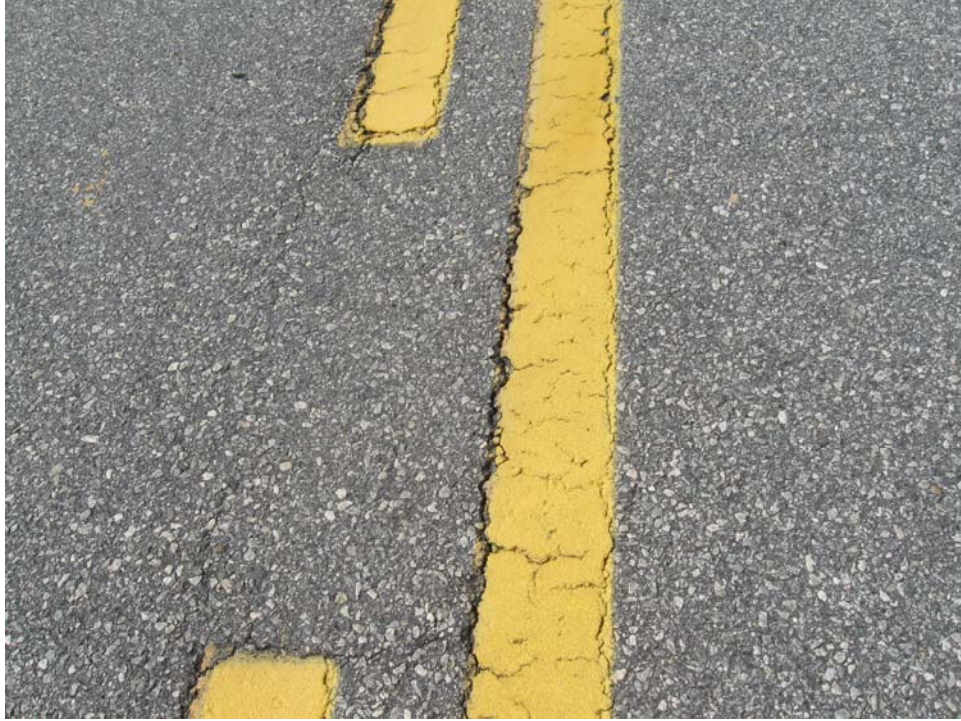
A01MGRA-40. Unsatisfactory Paint.

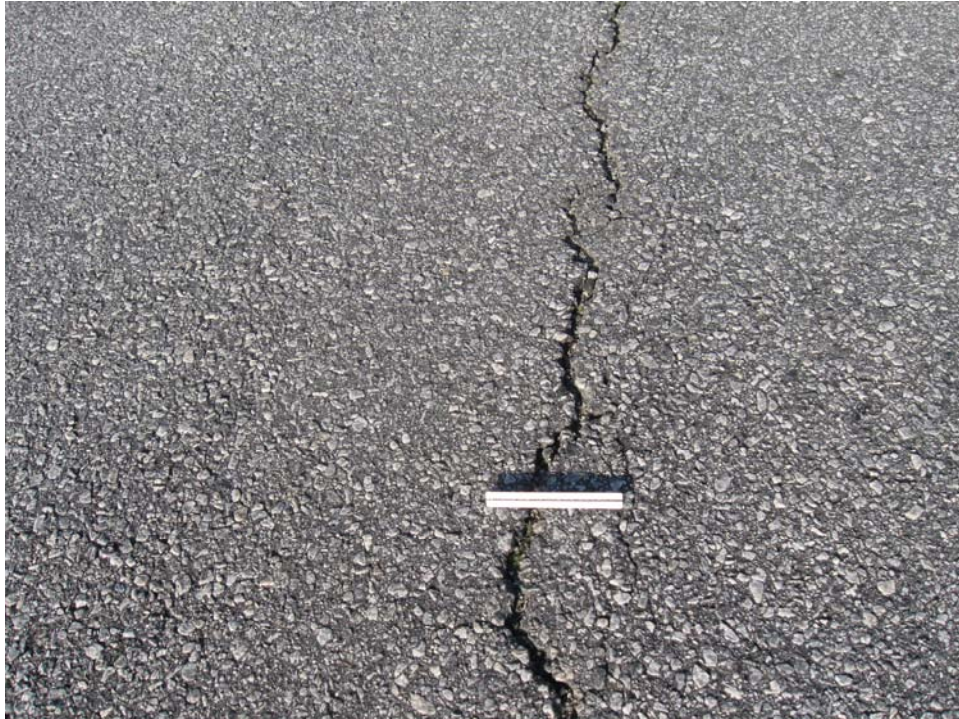
A01MGRA-50. Longitudinal and Transverse Cracking (Sample Unit #16).

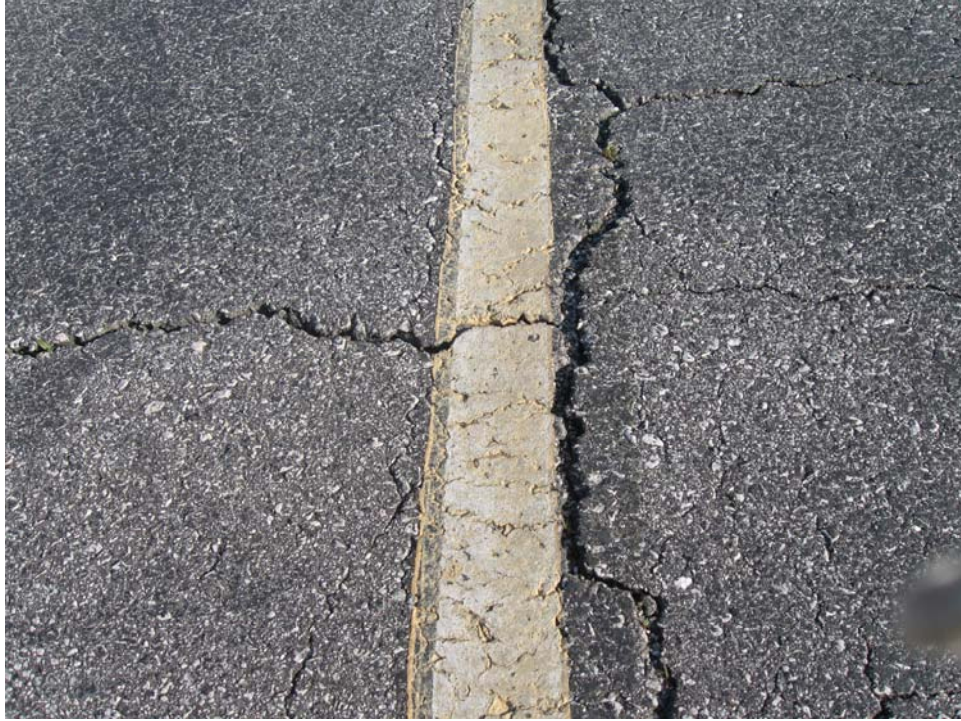
A01MGRA-50. Unsatisfactory Paint.

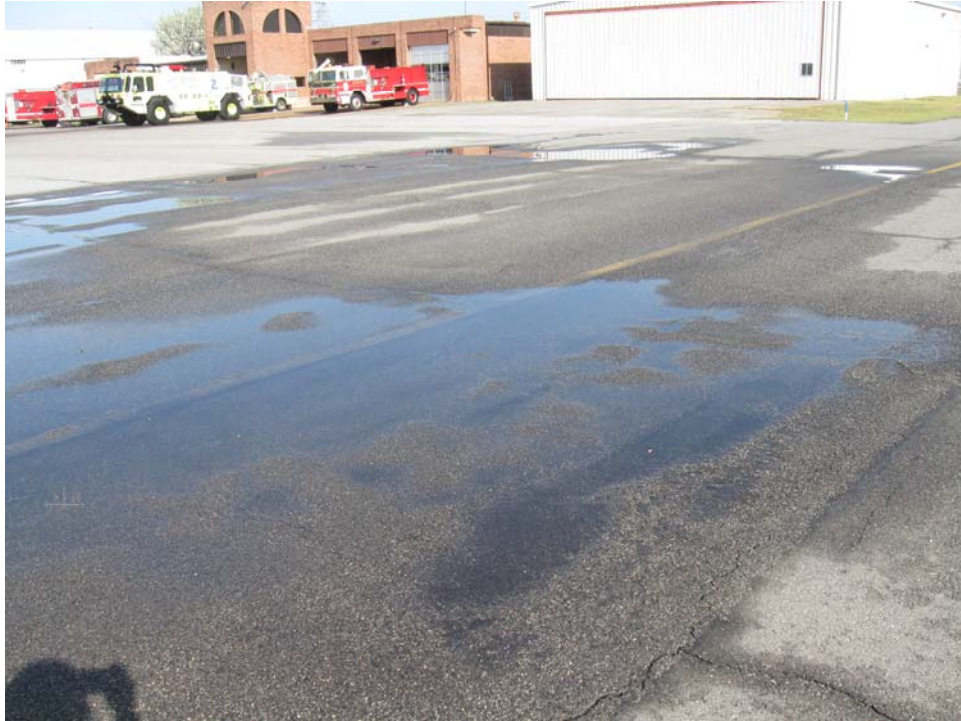
A01MGRA-60. Depression (Sample Unit #02).

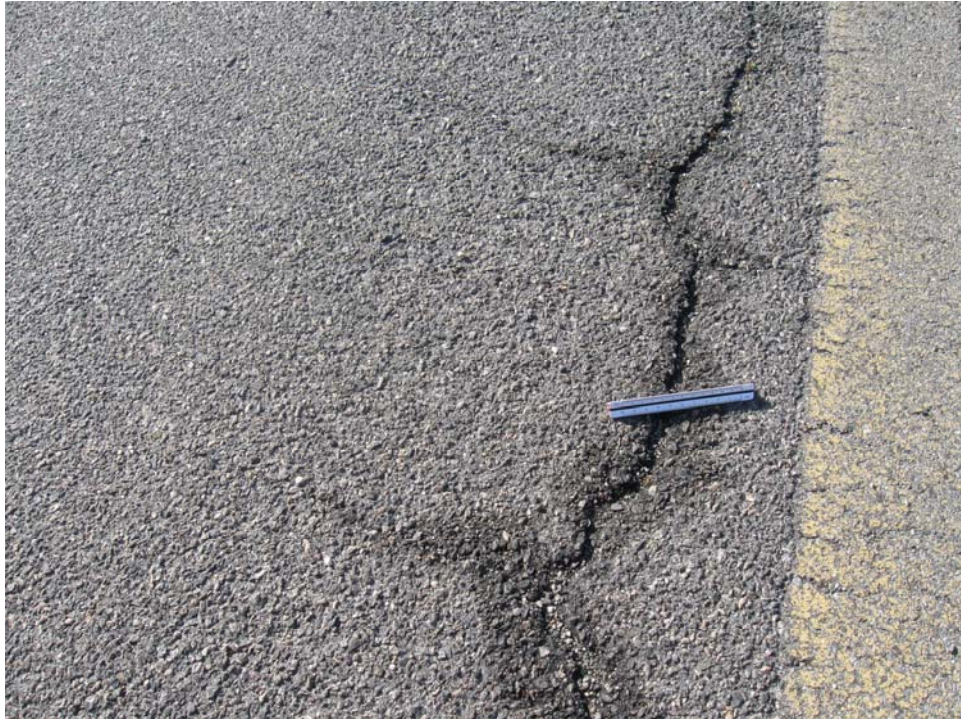
A01MGRA-60. Longitudinal and Transverse Cracking (Sample Unit #03).

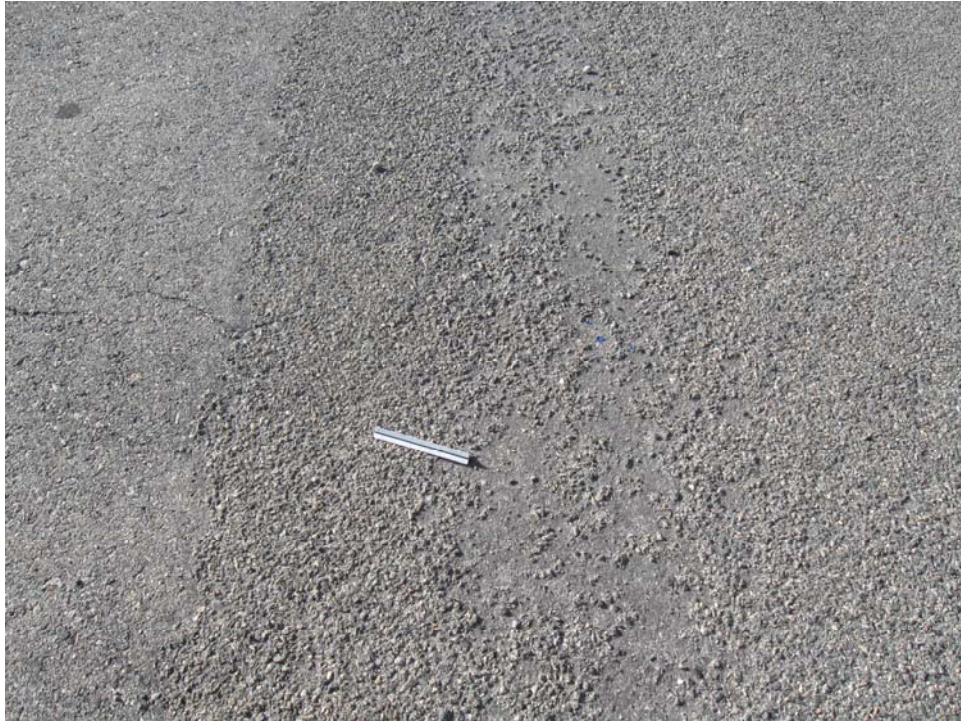
A01MGRA-60. Raveling (Sample Unit #03).

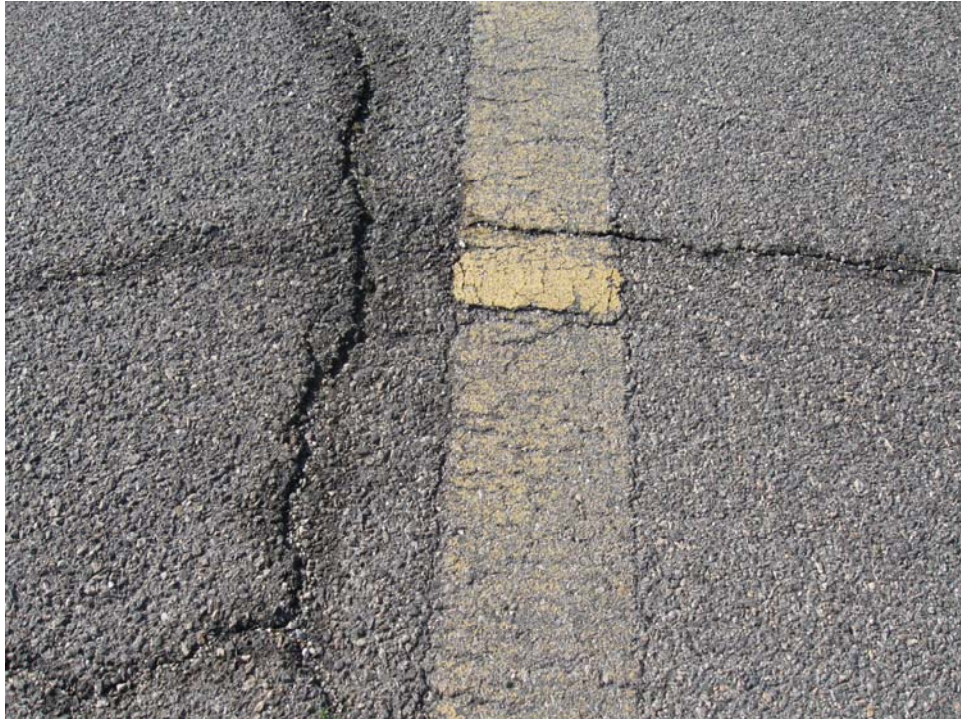
A01MGRA-60. Unsatisfactory Paint.

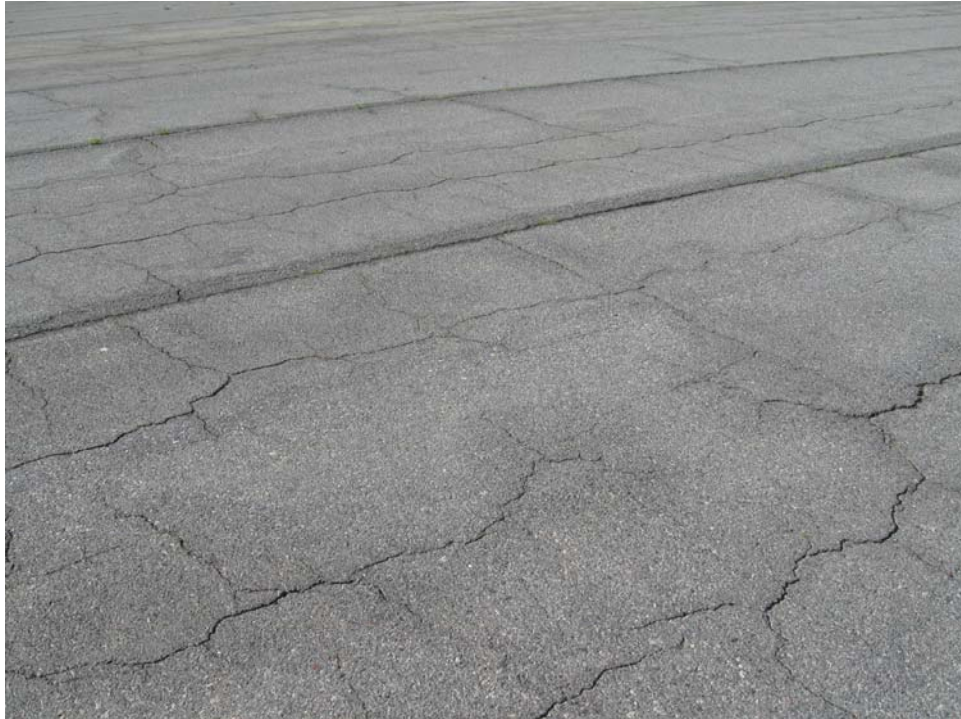
A01MGRA-70. Block Cracking (Sample Unit #08).

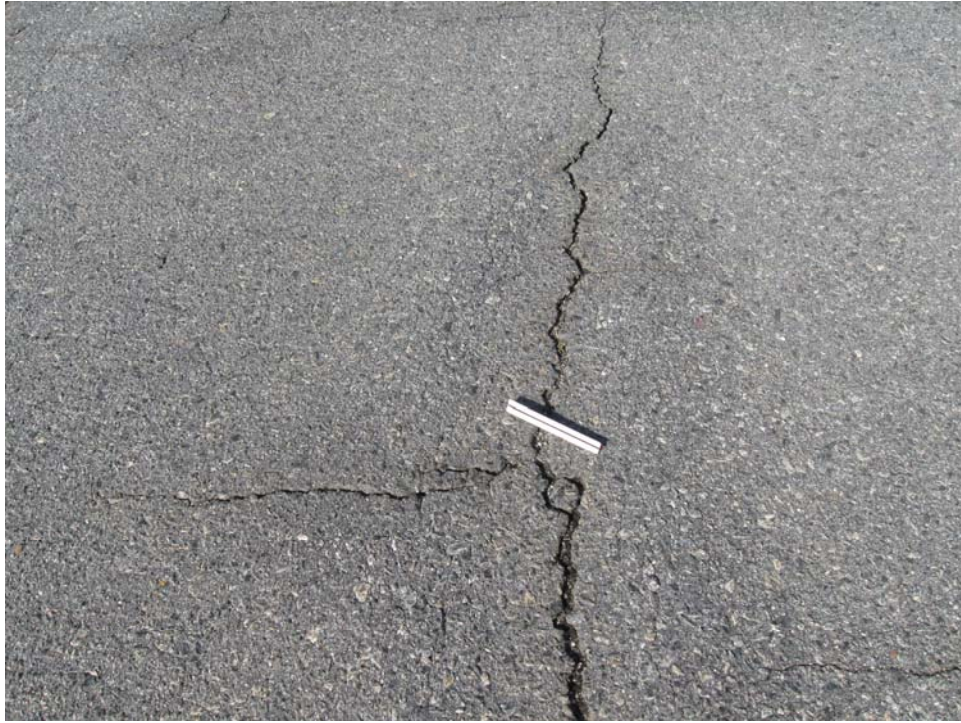
A01MGRA-70. Longitudinal and Transverse Cracking (Sample Unit #08).

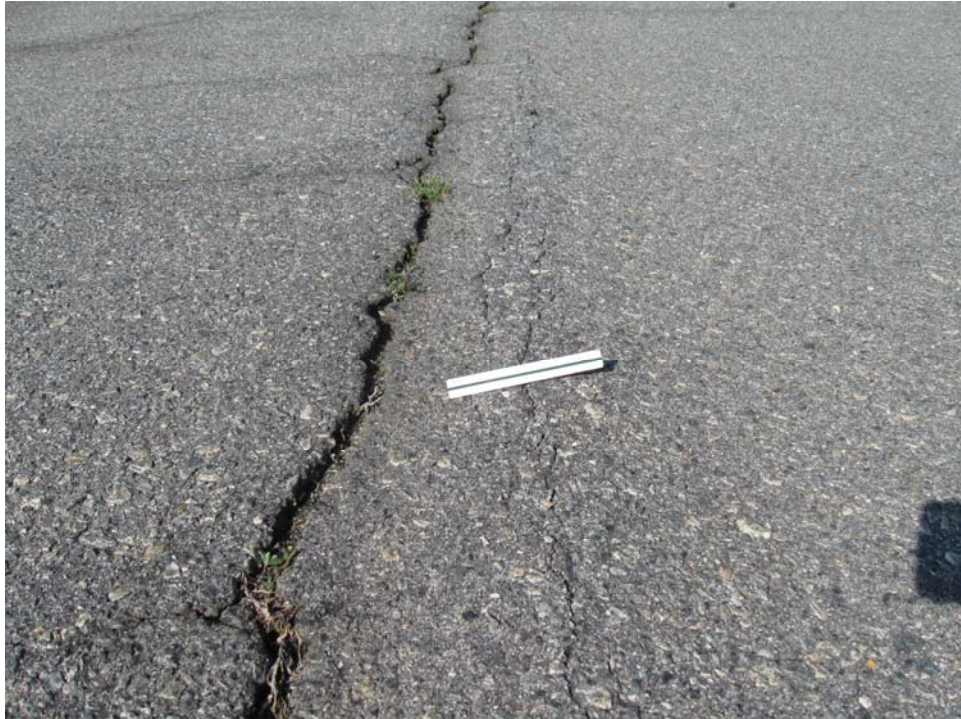
A01MGRA-70. Swelling (Sample Unit #08).

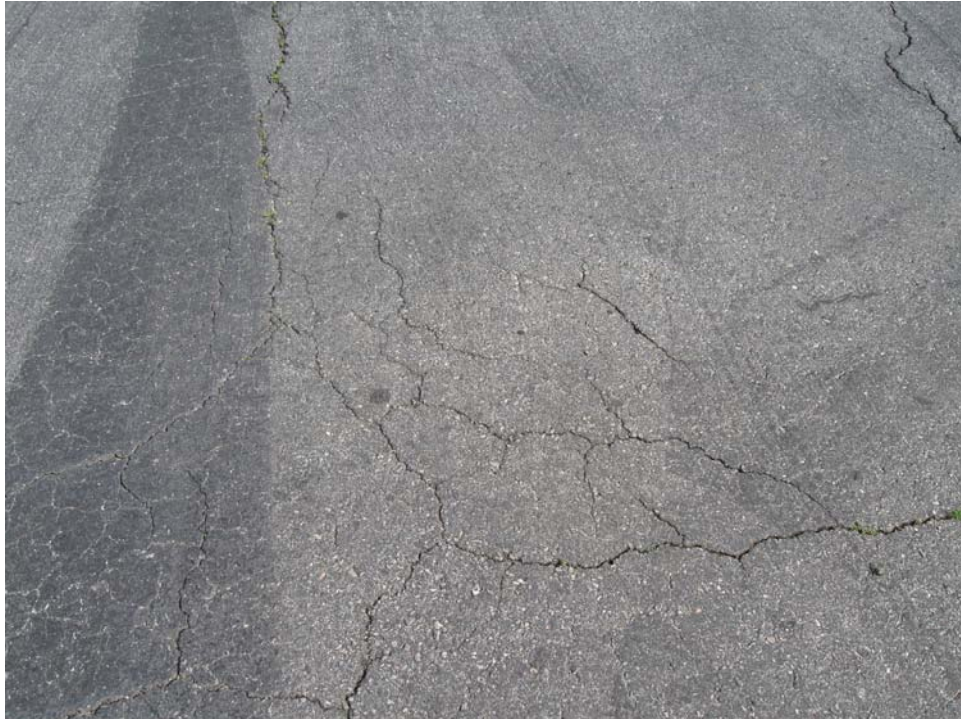
A01MGRA-80. Alligator Cracking (Sample Unit #13).

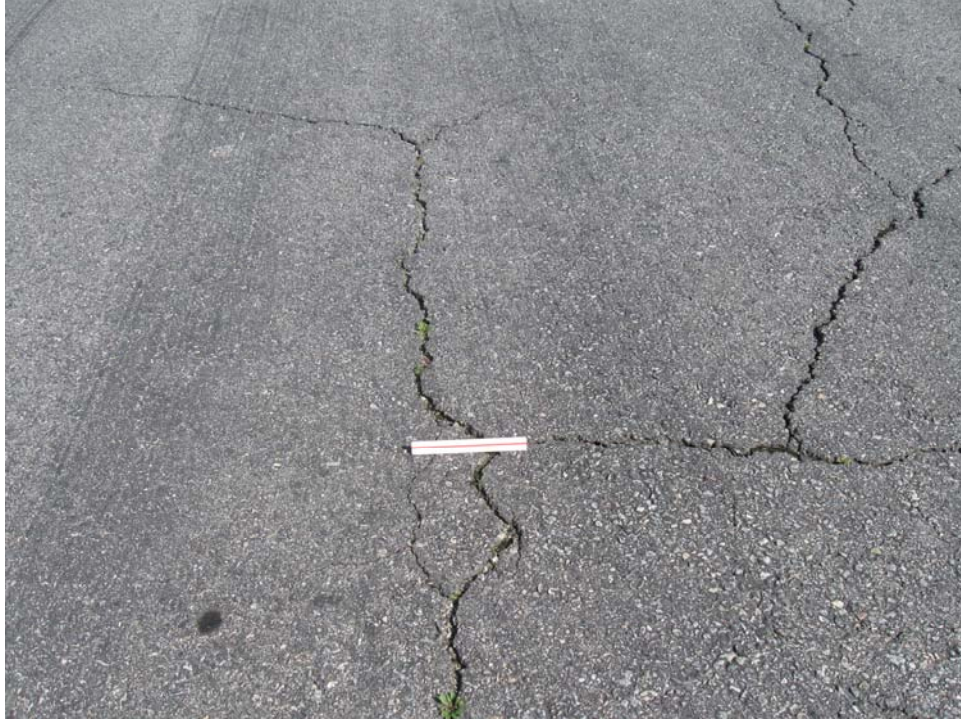
A01MGRA-80. Longitudinal and Transverse Cracking (Sample Unit #13).

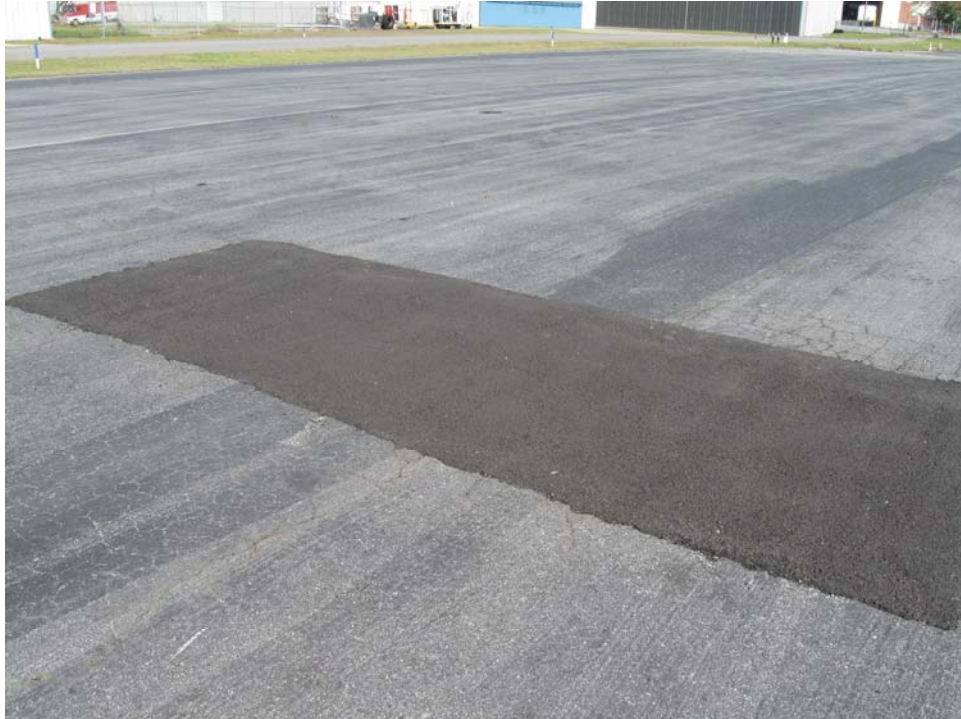
A01MGRA-80. Patching (Sample Unit #13).

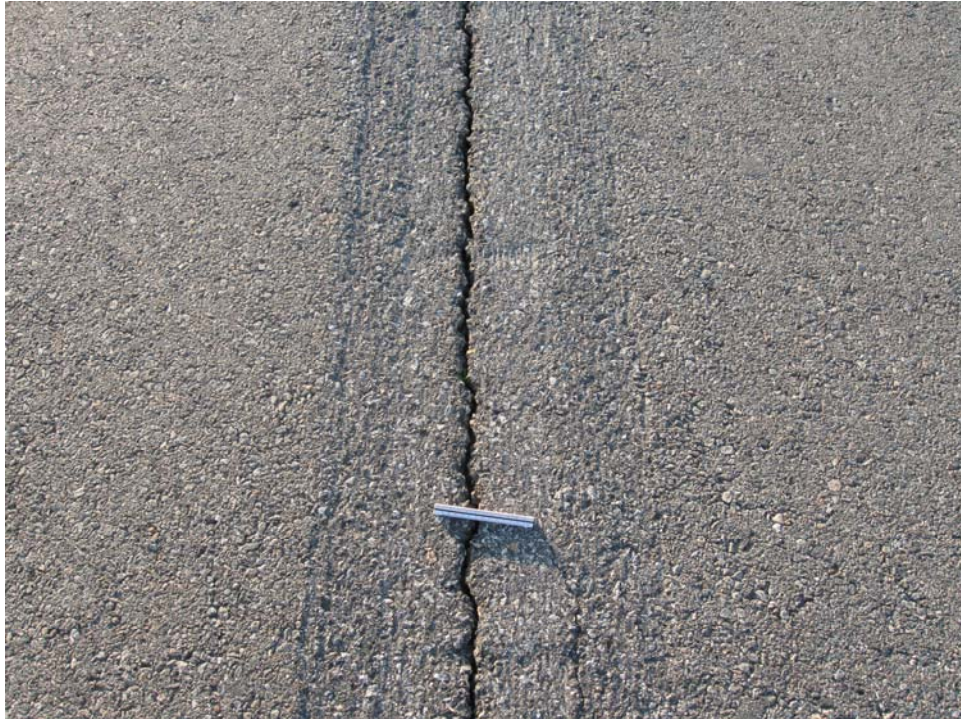
R1311MGRA-10C. Longitudinal and Transverse Cracking (Sample Unit #08).

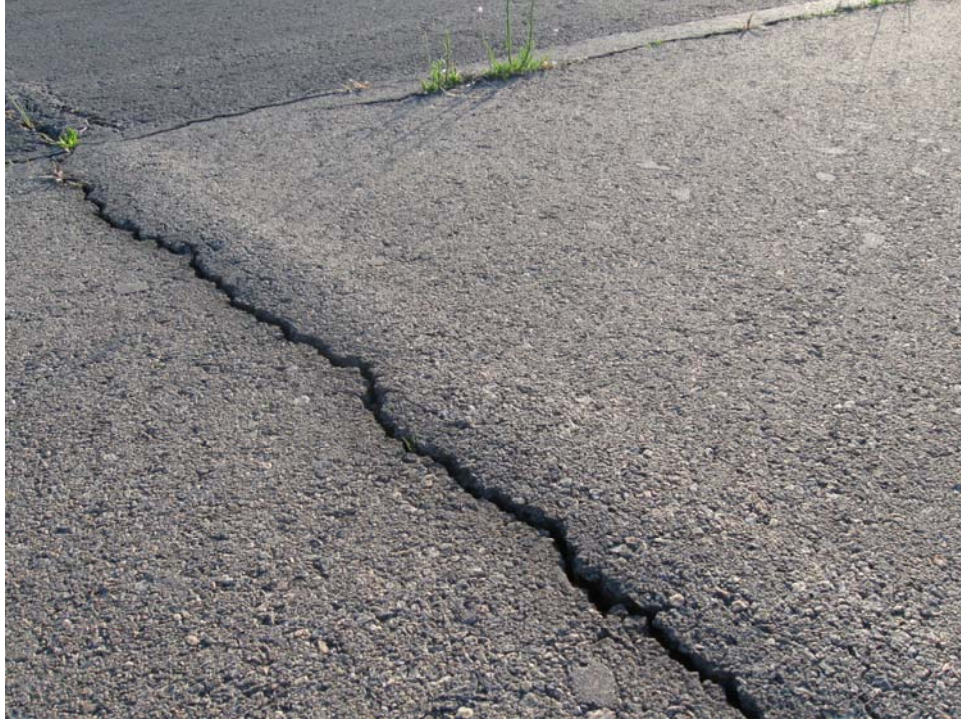
R1311MGRA-10C. Swelling (Sample Unit #08).

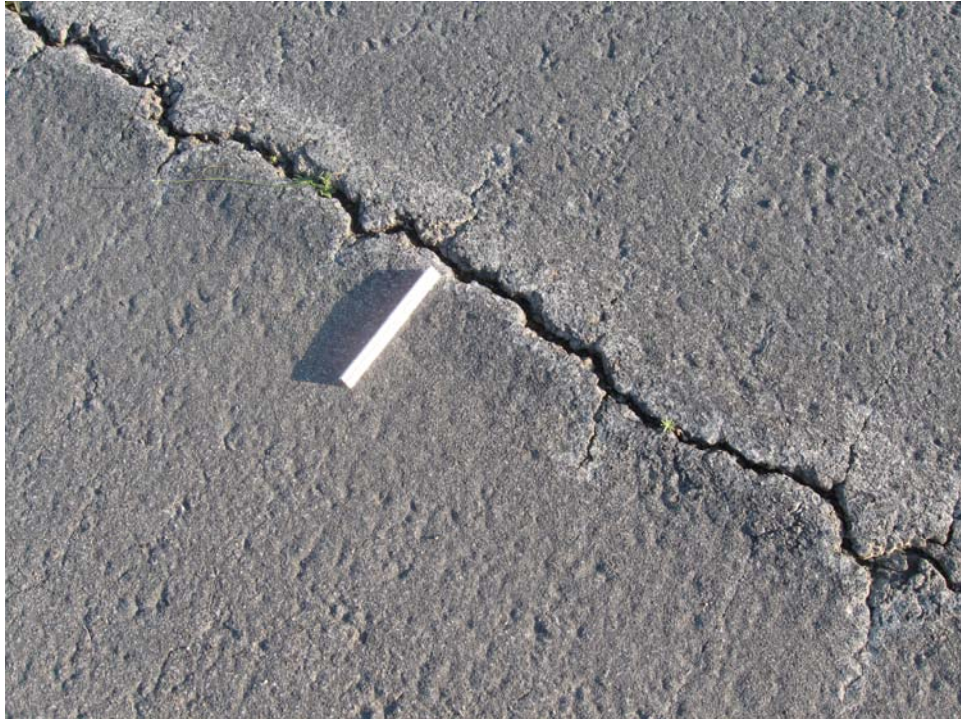
R1311MGRA-10N. Longitudinal and Transverse Cracking (Sample Unit #02) (2).

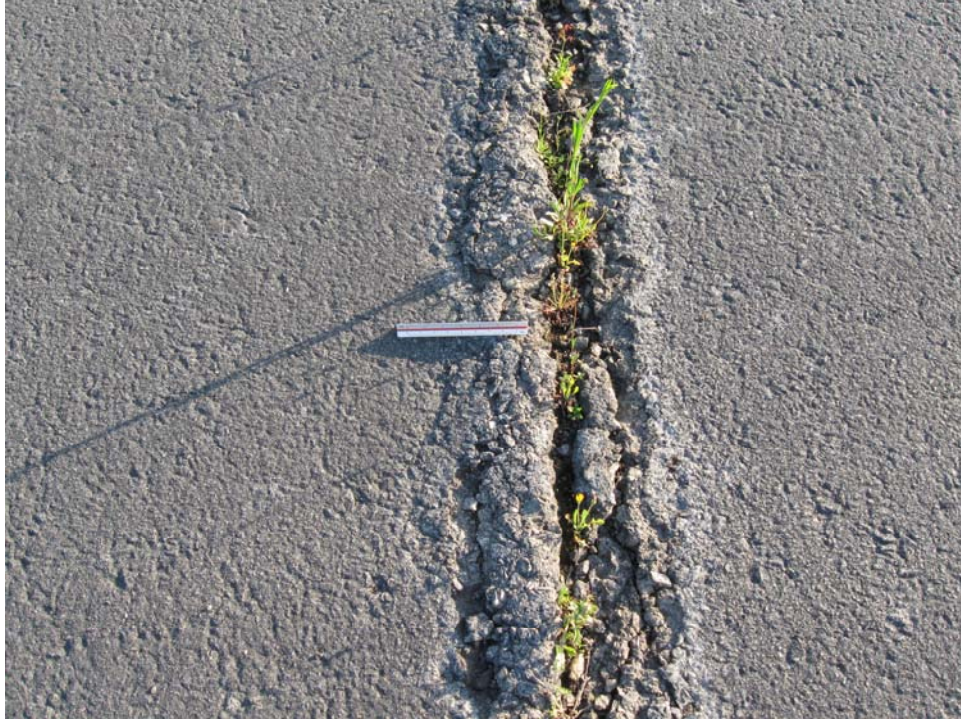
R1311MGRA-10N. Longitudinal and Transverse Cracking (Sample Unit #02).

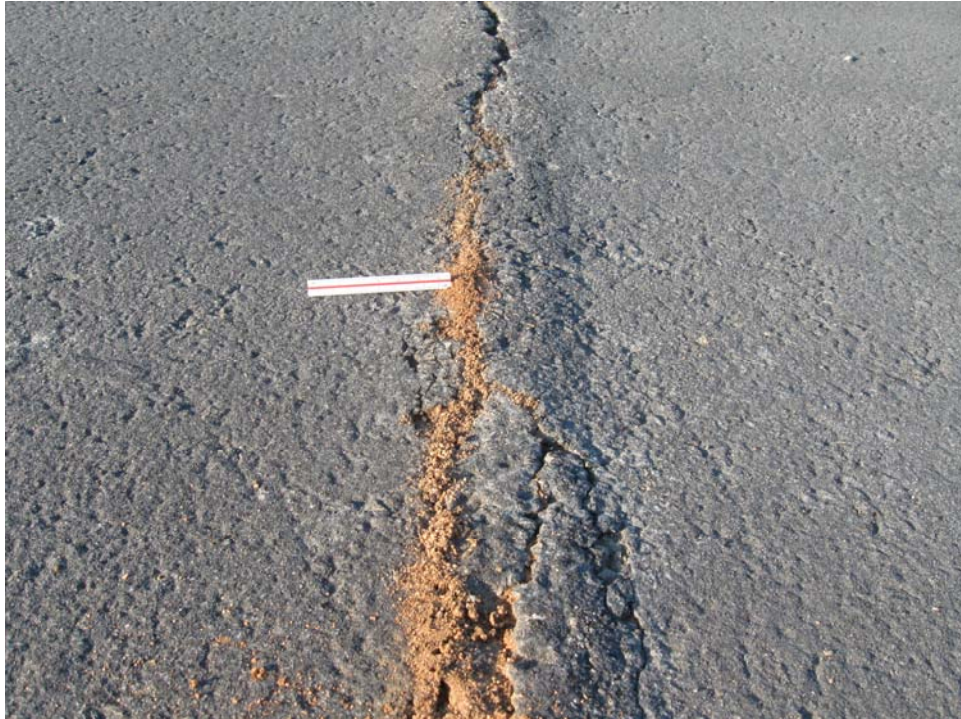
R1311MGRA-10N. Swelling (Sample Unit #02).

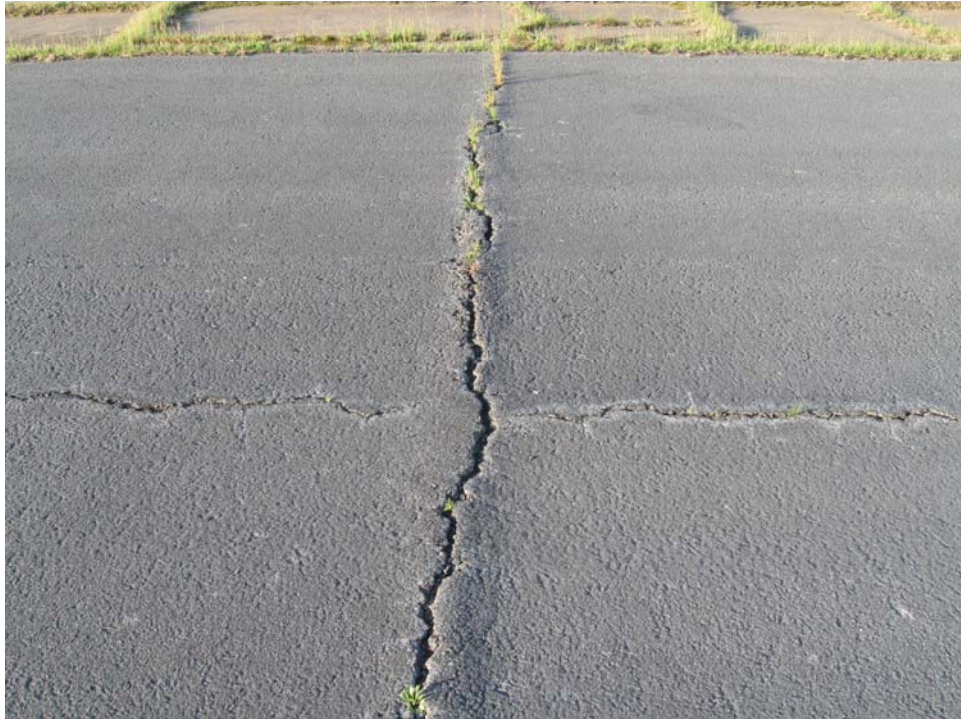
R1311MGRA-10S. Longitudinal and Transverse Cracking (Sample Unit #03).

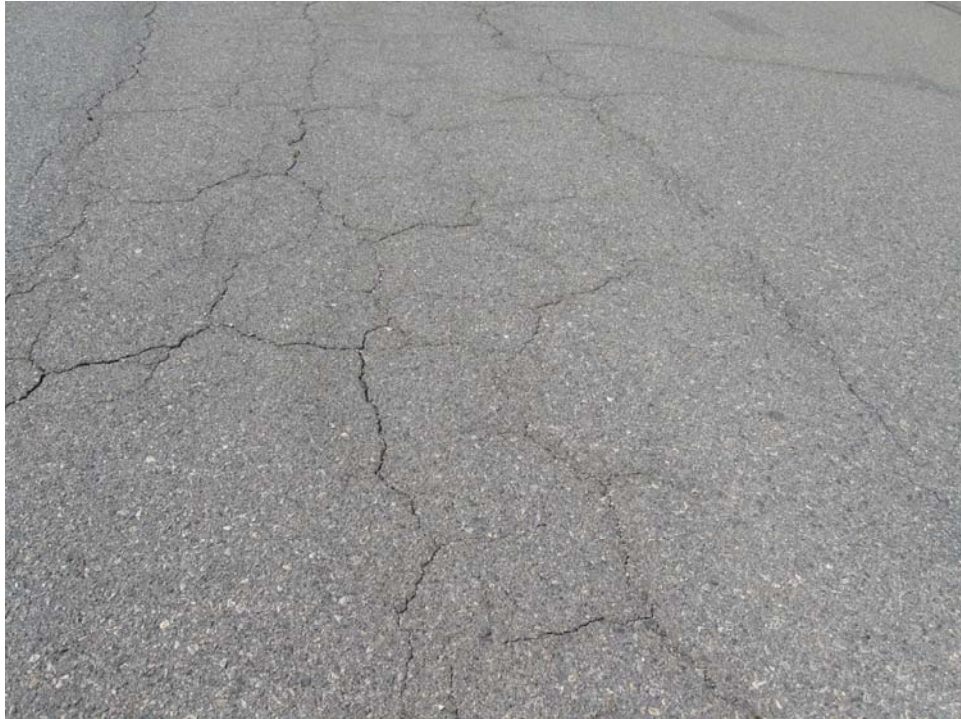
TAMGRA-10. Block Cracking (Sample Unit #21).

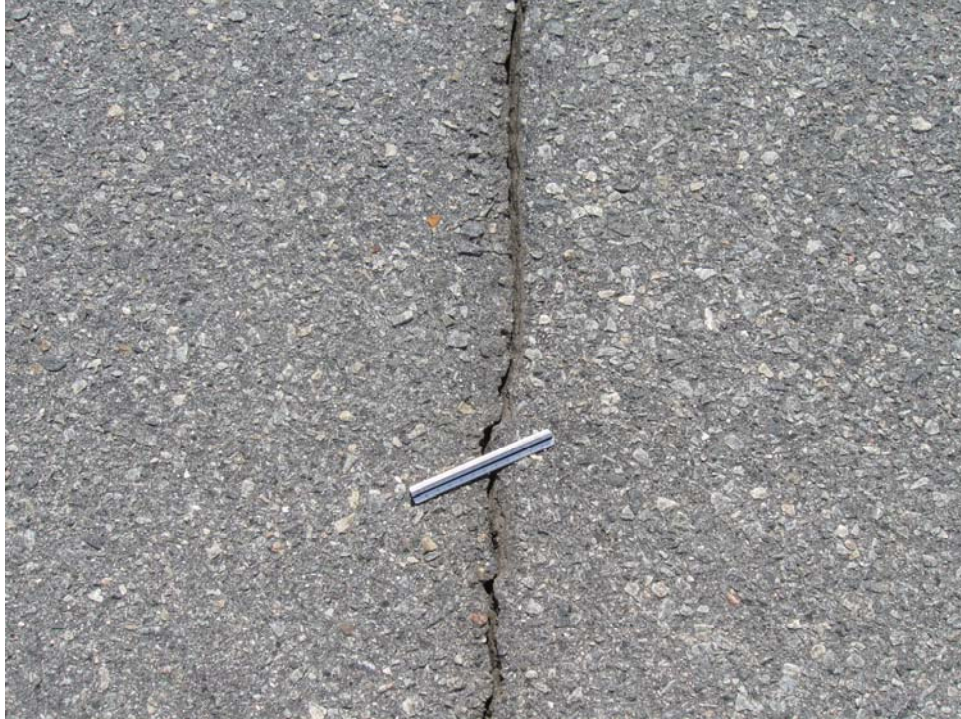
TAMGRA-10. Longitudinal and Transverse Cracking (Sample Unit #24).

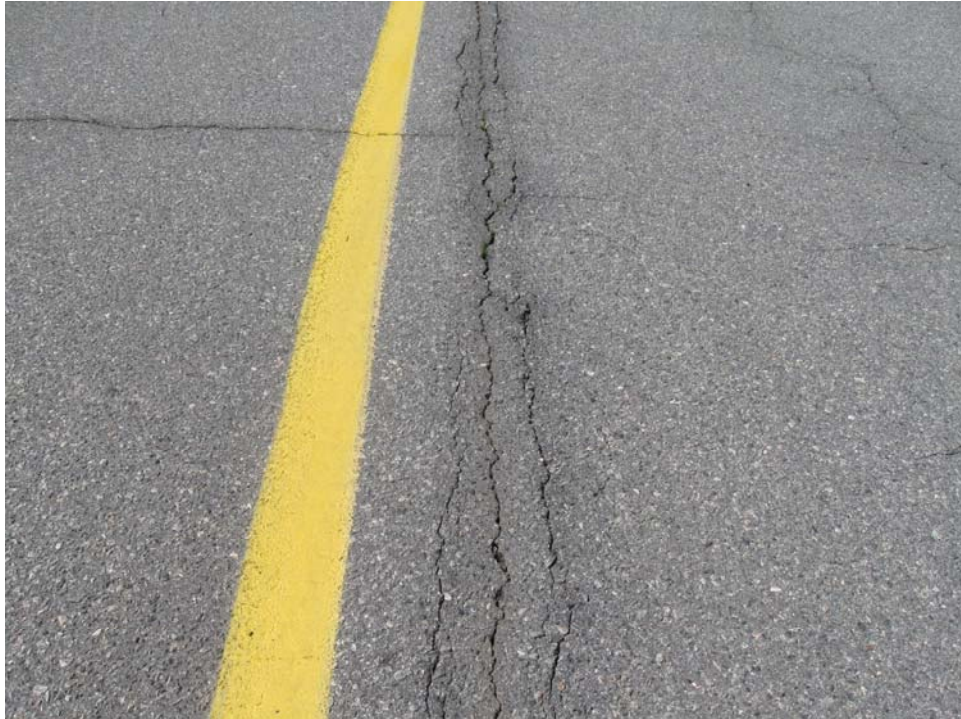
TAMGRA-10. Longitudinal and Transverse Cracking (Sample Unit #30).

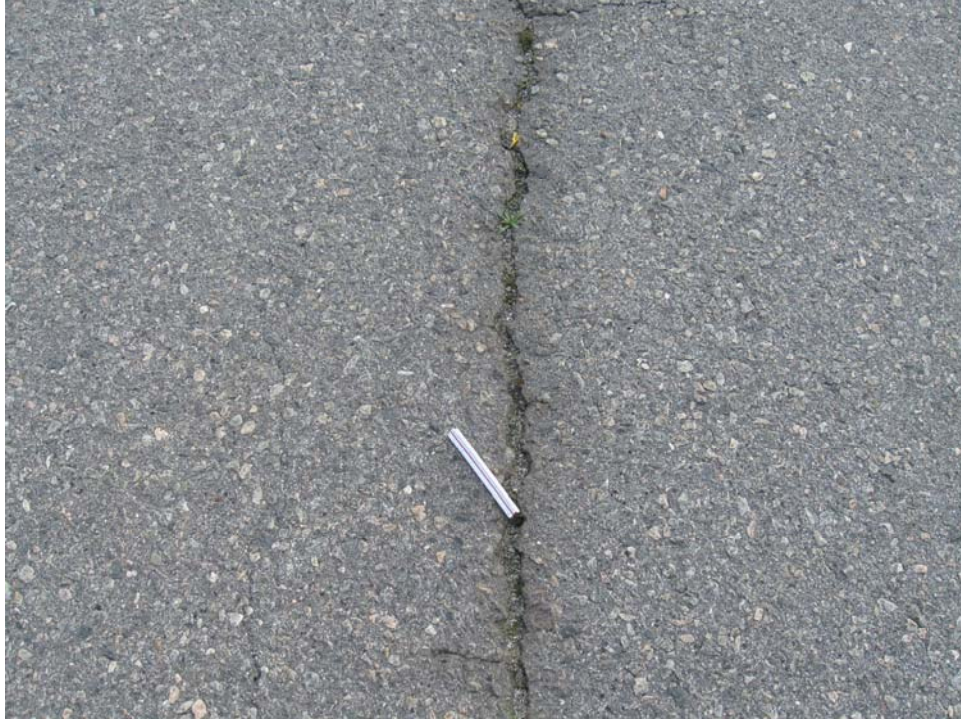
TB3MGRA-10. Longitudinal and Transverse Cracking (Sample Unit #04).

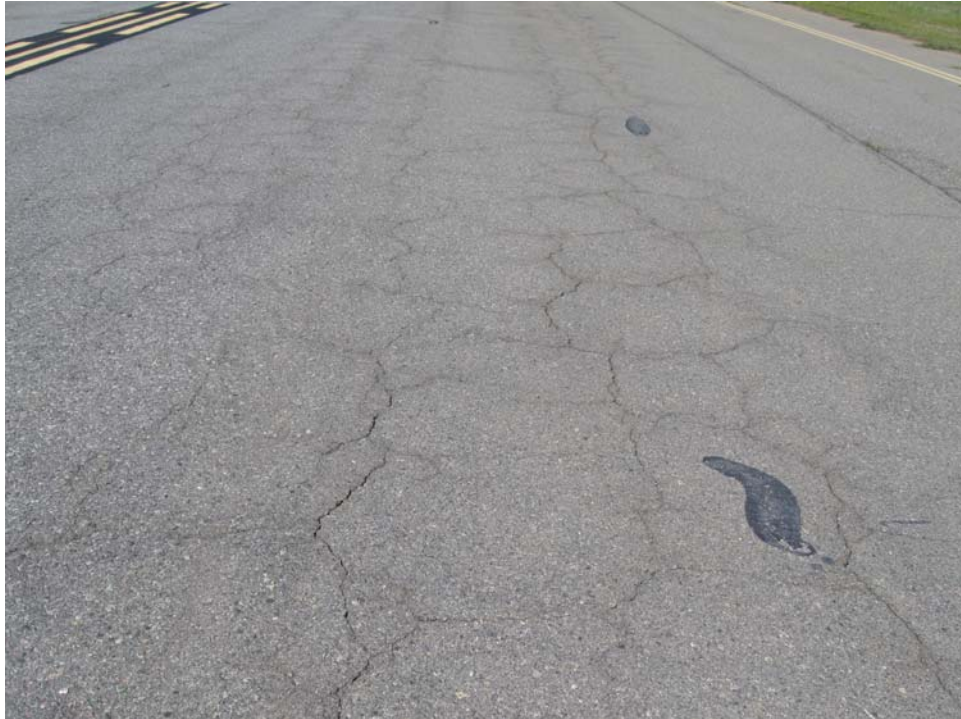
TCMGRA-10. Block Cracking (Sample Unit #14).

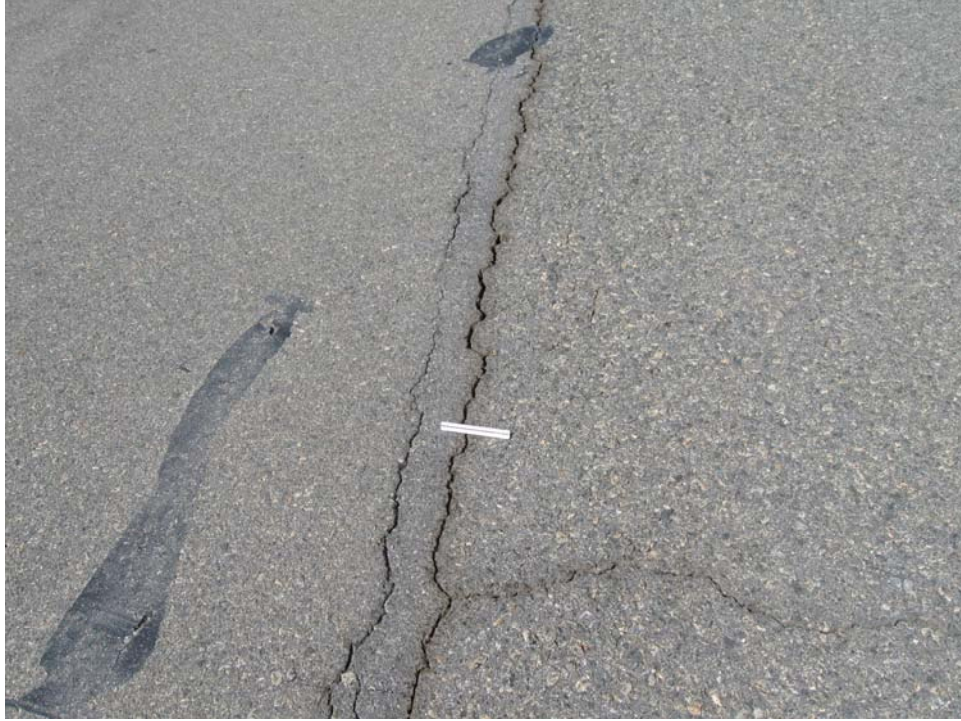
TCMGRA-10. Longitudinal and Transverse Cracking (Sample Unit #14).
