# 2012 Middle Georgia Regional Airport Pavement Management Plan

# MIDDLE GEORGIA REGIONAL AIRPORT

## PAVEMENT MANAGEMENT REPORT

**DECEMBER 2012**

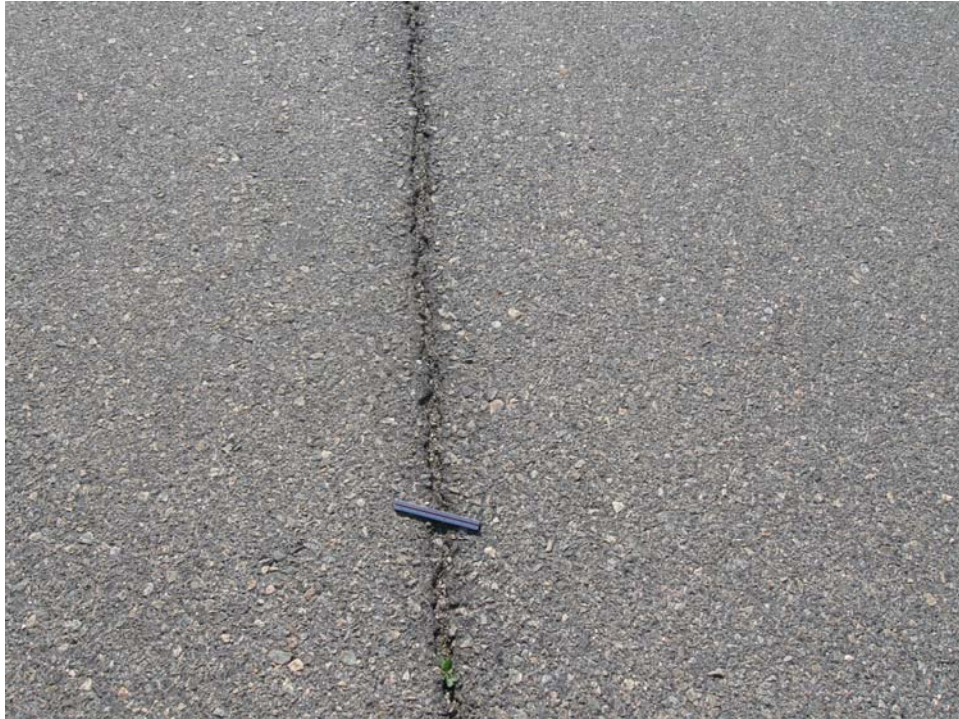
TCMGRA-20. Longitudinal and Transverse Cracking (Sample Unit #70).

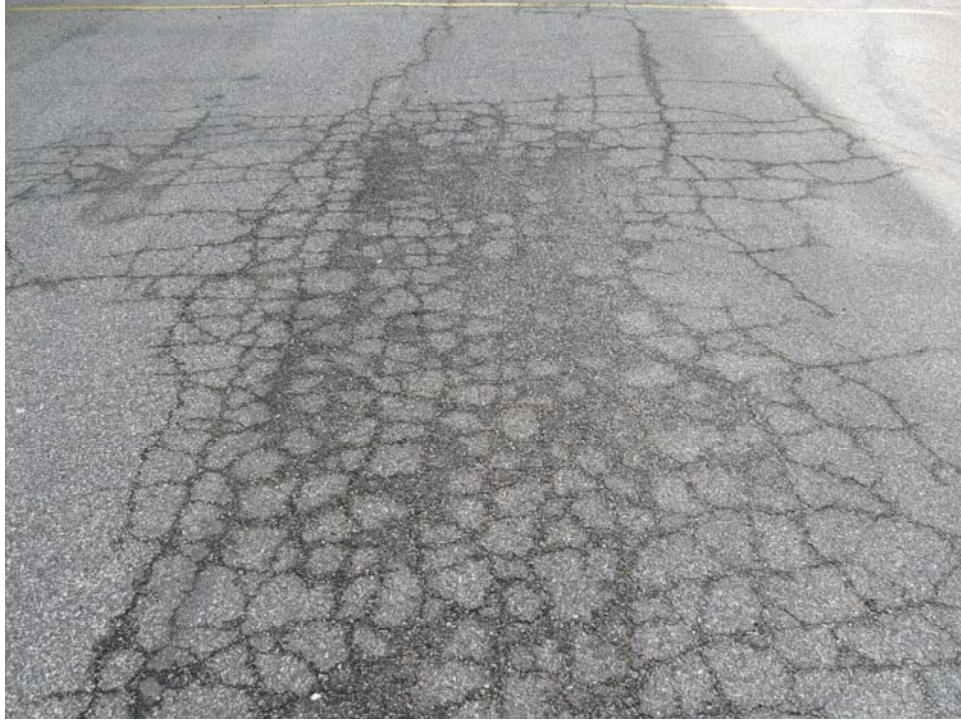
TGAMGRA-10. Alligator Cracking (Sample Unit #07).

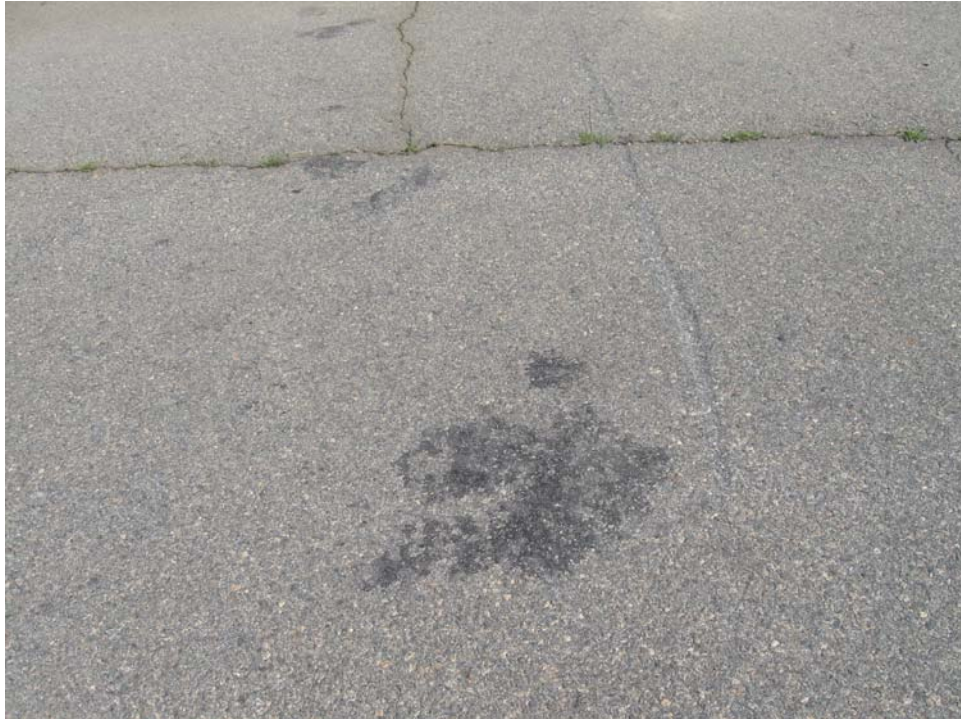
TGAMGRA-10. Bleeding (Sample Unit #11).

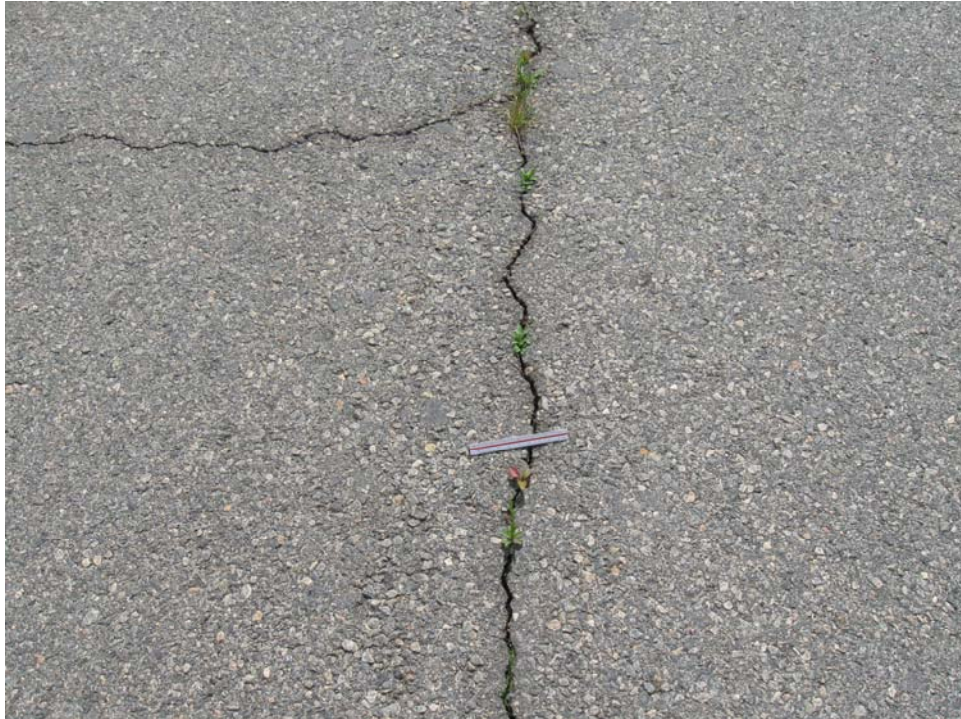
TGAMGRA-10. Longitudinal and Transverse Cracking (Sample Unit #11).

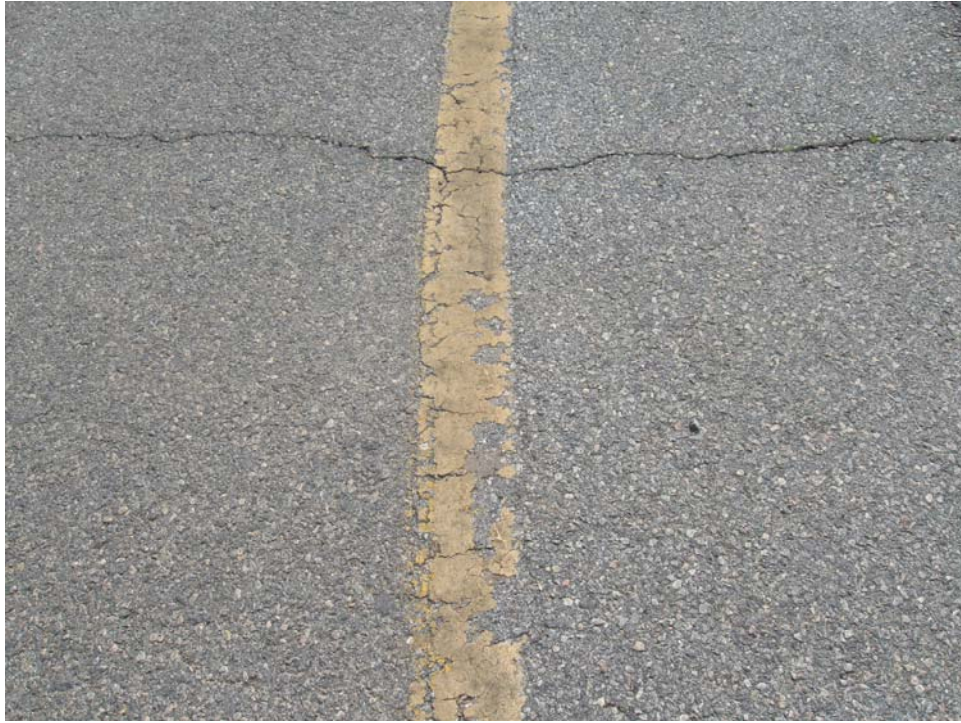
TGAMGRA-10. Unsatisfactory Paint.
