**BACON COUNTY AIRPORT
PAVEMENT MANAGEMENT REPORT**

**2007 GEORGIA AIRPORT
PAVEMENT MANAGEMENT REPORT**

BACON COUNTY AIRPORT

PAVEMENT MANAGEMENT REPORT

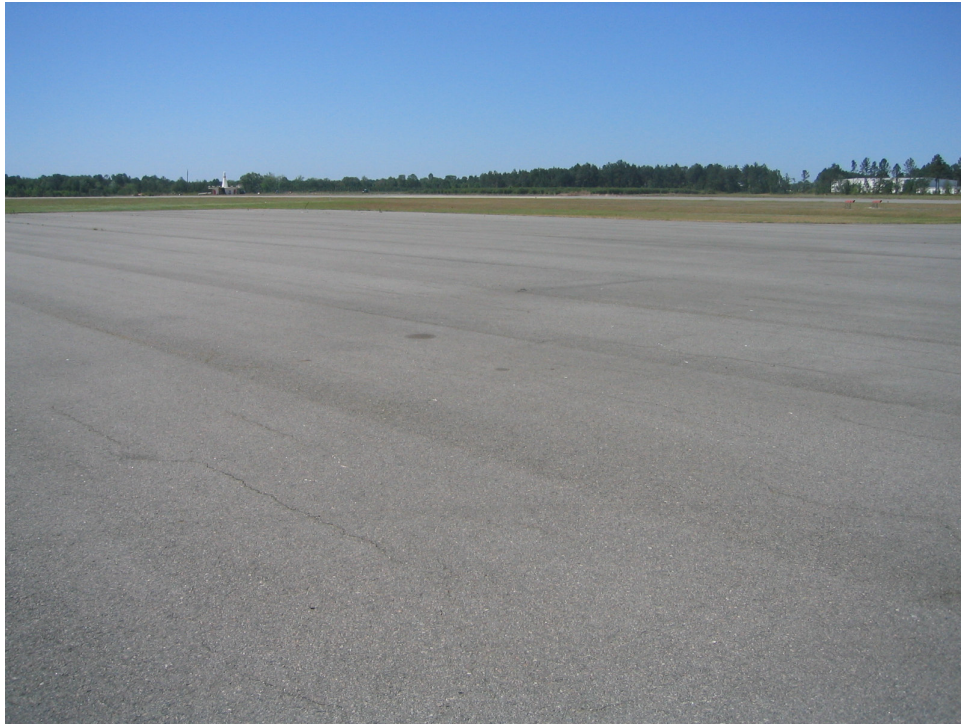
A01AL-10. Overview.

The apron was defined by one section. A01AL-10 is in fair condition with a PCI value of 75. Most commonly found in this area was low and medium-severity L&T cracking. Other distresses observed include a small amount of low-severity swelling and patching.

Branch	Section	Distress Type	Severity	Work Description	Work Quantity	Work Unit	Unit Cost	Work Cost
A01AL	10	Longitudinal and transverse cracking	Medium	Crack Sealing - AC	477	Ft	\$0.85	\$406

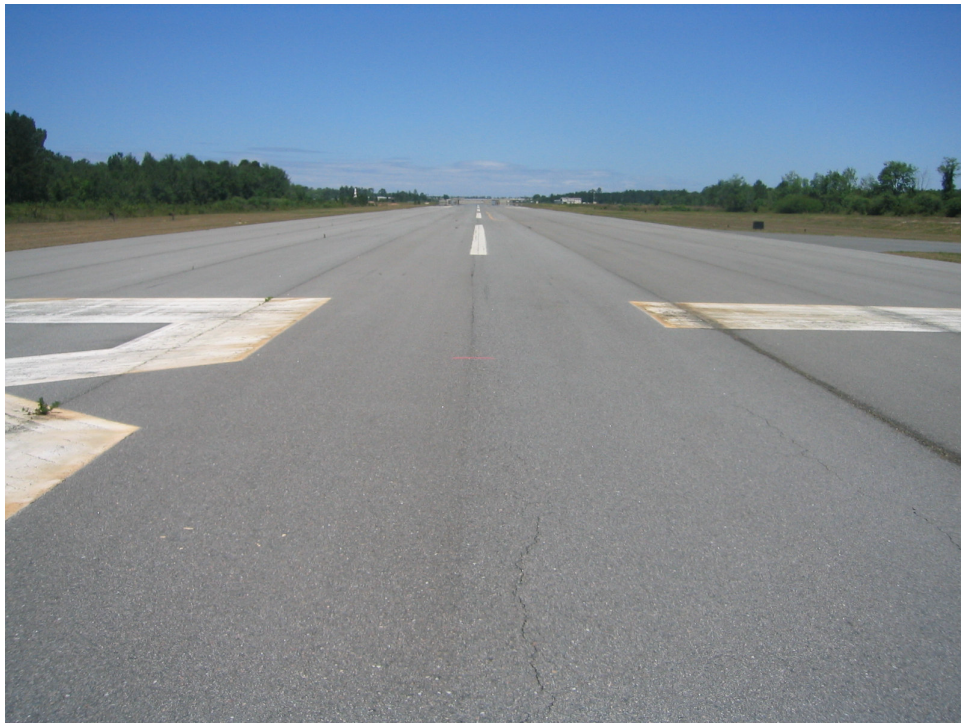
R1533AL-10. Overview.

Runway 15-33 is defined by one section, R1533AL-10, and is in fair condition with a PCI value of 77. The primary distress observed throughout this section was low-severity, unsealed, longitudinal and transverse (L&T) cracking. There was also a small amount of isolated bleeding observed.

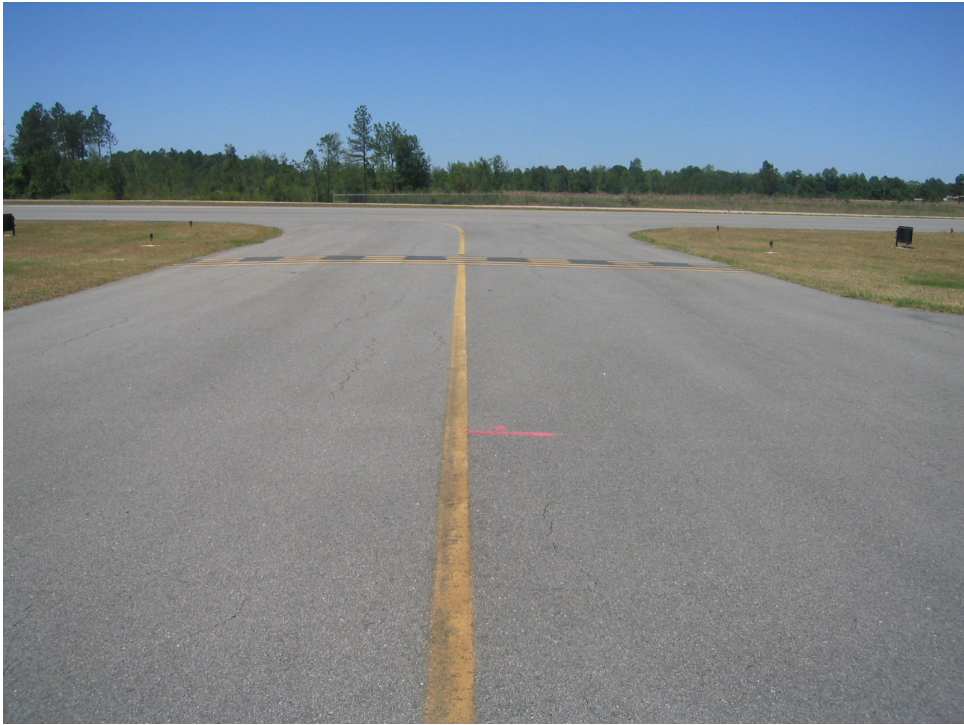
TAAL-10. Overview.

Taxiway A consists of one section. TAAL-10 is a small taxiway to Runway 15-33 from the apron area. TAAL-10 is in fair condition with a PCI value of 76. A moderate amount of low-severity L&T cracking and a very small amount of isolated low-severity swelling were observed.

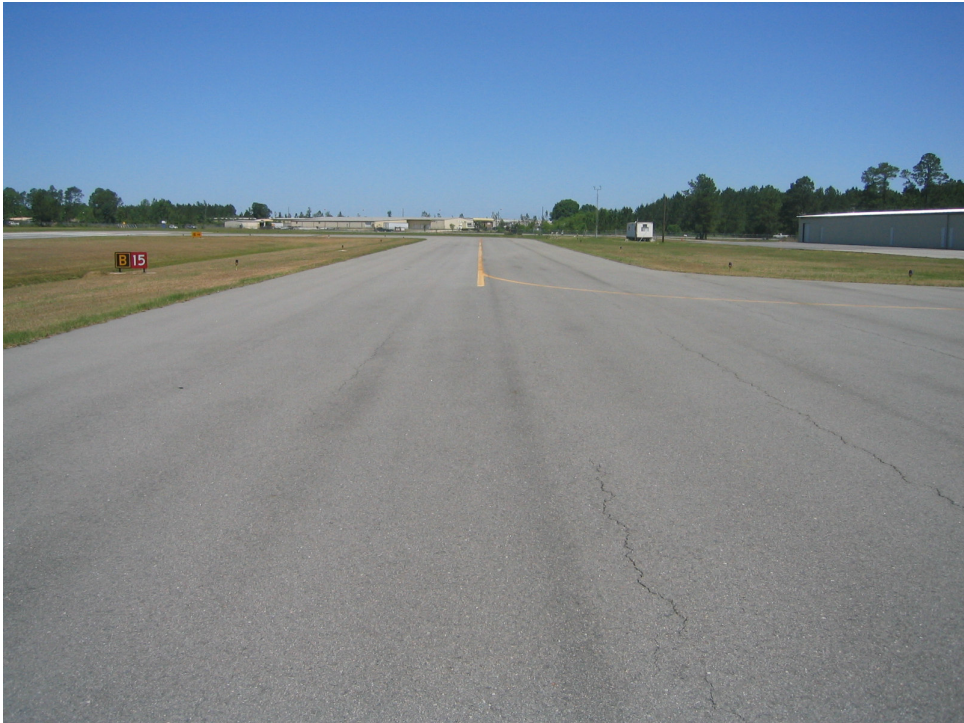
TBAL-10. Overview.

Taxiway B is defined by two sections. The pavement of TBAL-10 is in good condition with a PCI value of 83. The primary distresses observed were low-severity unsealed L&T cracking, and a small amount of isolated bleeding. TBAL-20 was recently constructed and is in excellent condition with a PCI value of 100 and no distress identified at the time of inspection.

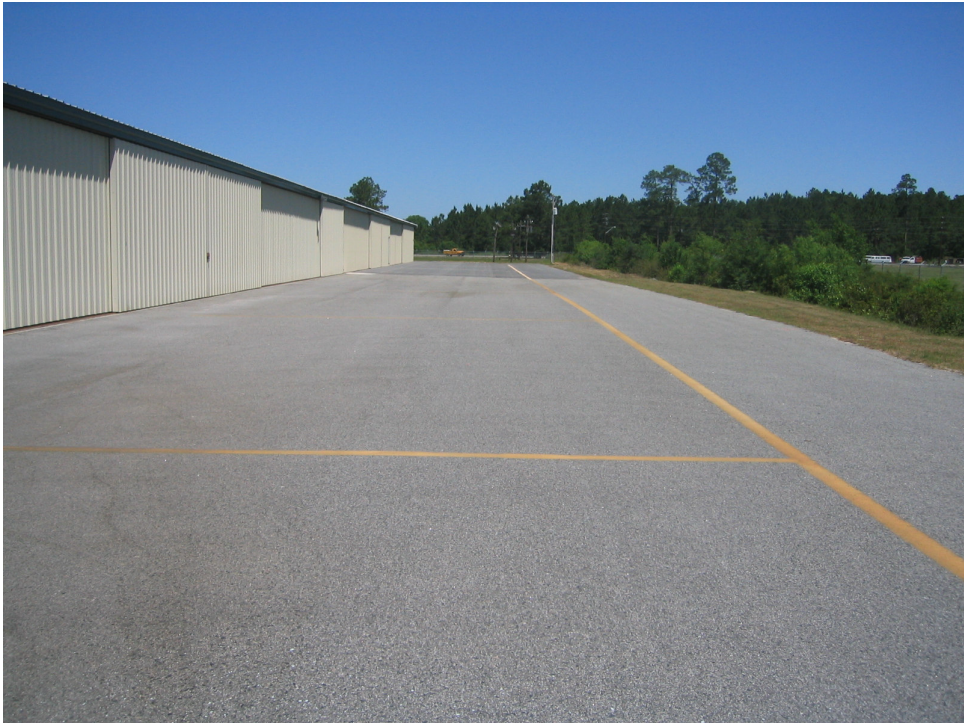
THANG01AL-10. Overview.

The T-Hangar is comprised of one section. THANG01AL-10 is in excellent condition with a PCI value of 97. A small amount of low-severity L&T cracking and alligator cracking were recorded.
